## Eastern Lebanon County School District

District-Wide Facilities Assessment

January 5, 2017

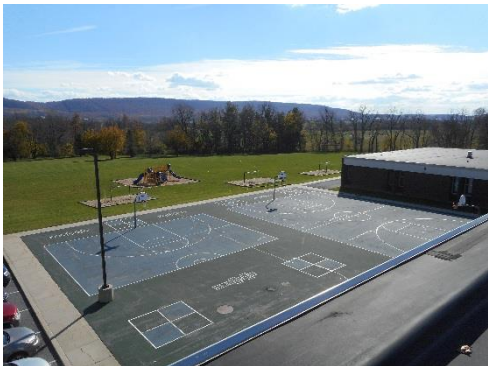
Hard play area with smaller soft play areas

There is also a large dedicated “hard surface” play area on the east side of the school. The surface finish of the play area is beginning to show signs of wear but is in good condition overall.

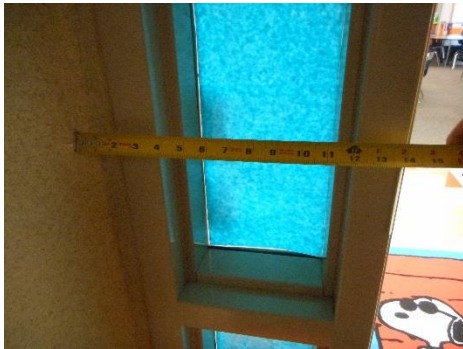
Pull side access width does not meet code

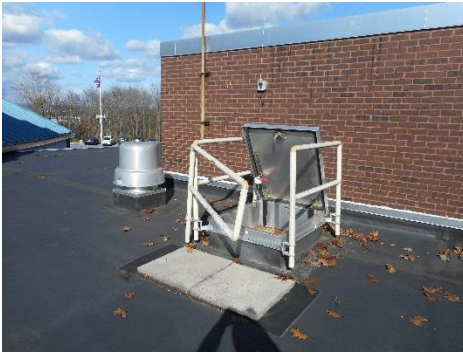
The roof hatch gate appeared to be broken and caused an unsafe condition for access.

Gate at roof hatch

ZES.BI.04 Repair/replace roof hatch gate.

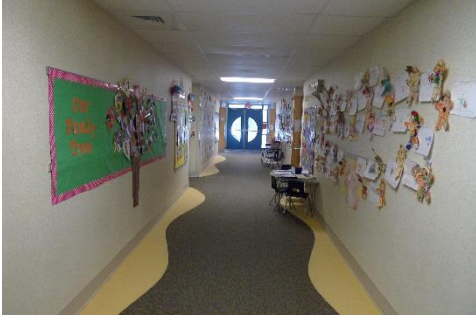
Hallway with furniture

The egress width of the corridors appeared to be obstructed by instructional furniture within the hallways.

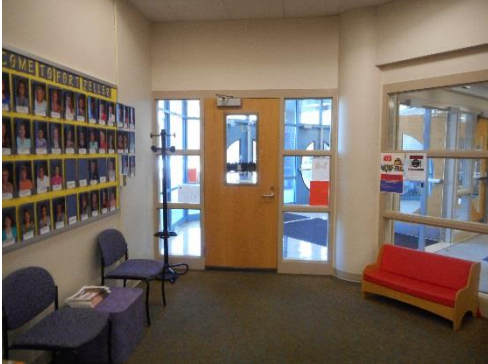
Office door is manual lock

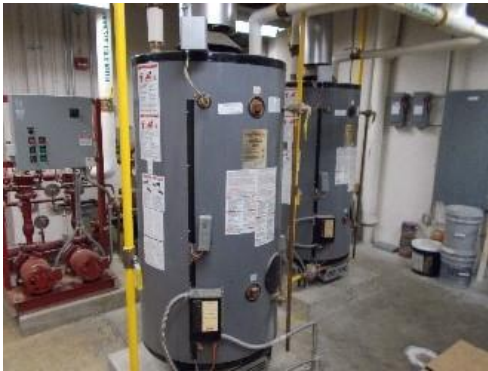
Two standard efficiency water heaters provide domestic hot water to the entire school. They are not at the end of their typical life expectancy but we recommend replacing them with high efficiency water heaters in the future.

Domestic water heaters

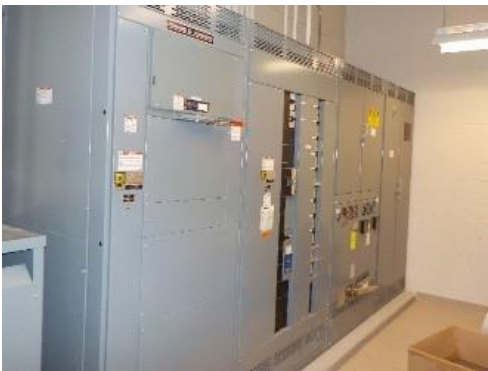
Main electrical switchgear

The electrical service enters the building by underground secondary feeders and terminates into a Square D 1600 Amp, 277/480volt main switchboard. The switchboard is in good condition and has provision for additional breakers to be added. A 300 KVA step-down transformer is located in the electrical room to obtain 120/208volt power for receptacle and miscellaneous circuits. Most branch panels are Square D and in good condition.

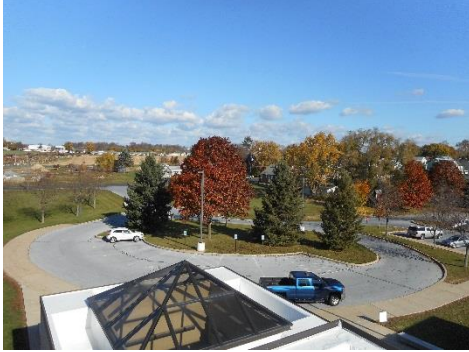
Vehicular Circulation & Parking: The bus pick-up/drop-off area is located along the front (north) side of the building. Buses line up "single file" in front of the building at a circular drive. The bus lane is shared with visitor parking which causes a potential crossing of paths for vehicles and pedestrians.

Bus drop off area

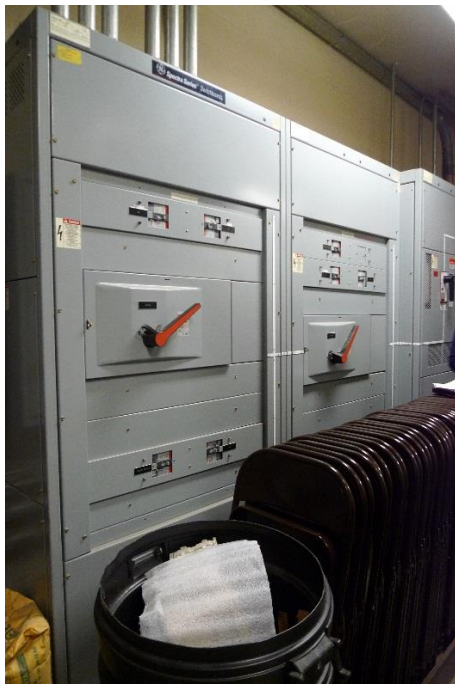
Mechanical room near kitchen

**JES.BI.06 Remove items stored in mechanical rooms.**

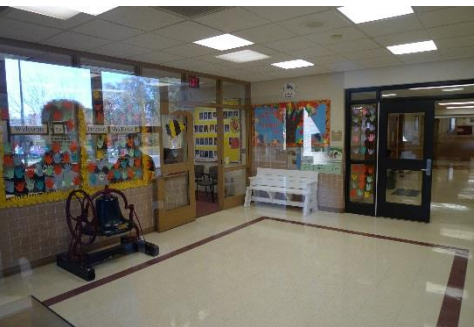
Administration: The front office and nurses suite is functional and in good condition. Visitors should enter directly into the office from the foyer, although the secondary foyer is secure.

Building entrance not secured through office

**JES.ED.05 Consider creating a more secure entrance sequence at the front office.**

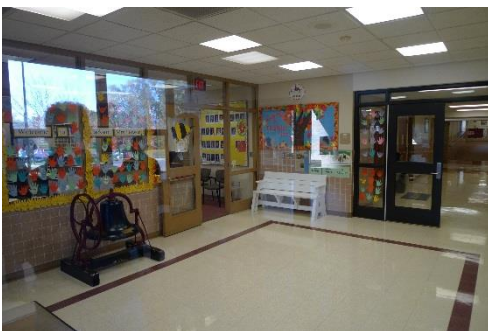
Security: The building entrance has a secure secondary vestibule directly attached to the front office, as long as the secondary doors (hallway and gymnasium) are secure the entrance functions securely.

Main entrance not secure through office

**JES.BI.08 Consider enhancing the secure entrance condition with visitors accessing the office rather than a secondary foyer.**

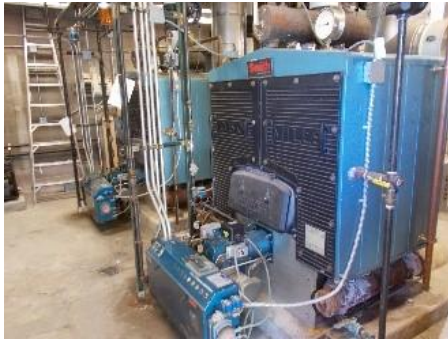
Hot water boilers

Two hot water boilers in the mechanical room serve the entire school. They were found to be in good condition except that they leak water at every shutdown and startup of the system which is causing premature corrosion. The chiller is located outside the building and was found to be in good condition except the compressors have a fair amount of corrosion and are nearing the end of their life expectancy.

**JES.HVAC.01 Repair boilers to stop water leakage.**

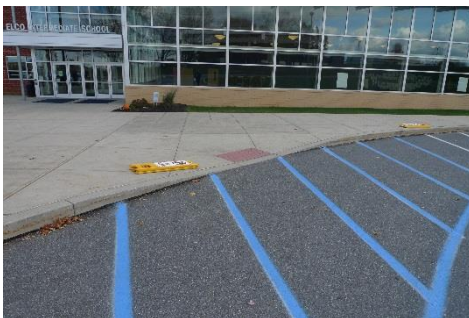
*Curb at building entrances*

**EIS.SI.01 Observation of heaving at curb should continue to determine if it poses a safety issue for pedestrians.**

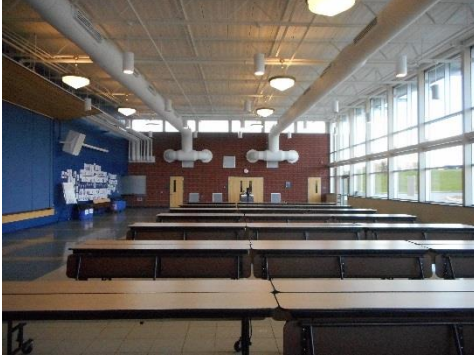
Food Service: It was noted that the food serving line is dimensionally tight and causes crowding during lunch. It was also noted that the cafeteria room is acoustically live (too noisy), creating a chaotic environment during lunches.

Cafeteria

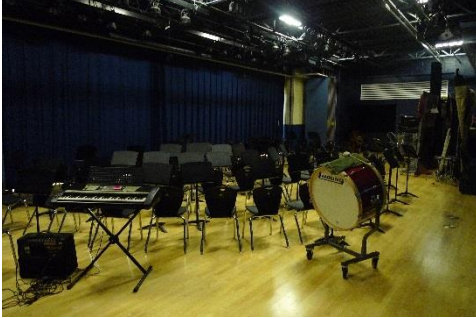
Stage used primarily for band

EIS.ED.02 Consider enlarging the band room to free up the use of the stage for other activities.

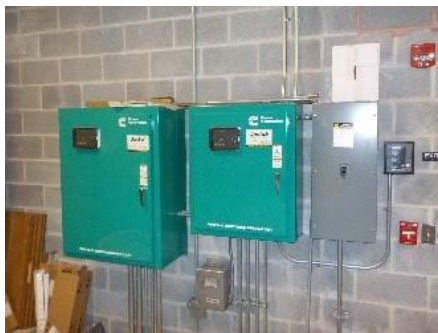
The emergency generator is a Cummins 80 kW diesel unit. The generator and associated equipment are in good condition. A 40 Amp Cummins Life Safety automatic transfer switch with a normal/emergency panel is installed in the electrical room. A 125 Amp Cummins Non-Required Loads automatic transfer switch with a normal/emergency panel is installed in the electrical room.

Emergency transfer switches

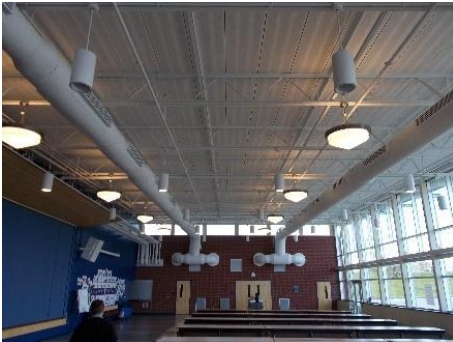
*Cafeteria near main entrance*

ELCO Intermediate School is six years old and in excellent condition. Minor improvements to functional aspects of specific rooms could be addressed to further improve the building performance. Acoustical dampening of the cafeteria and consideration to enclose or define the SGI's stand out as potential improvements based on end user comments.

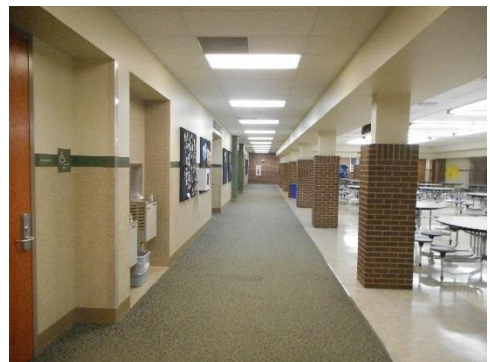
Flooring: The flooring is varied by area. The main entrance is primarily tile and in good condition. The corridors and classrooms are primarily carpet which wears hard in these high traffic areas. VCT in the cafeteria is in good condition.

Typical carpeted corridor and VCT cafeteria

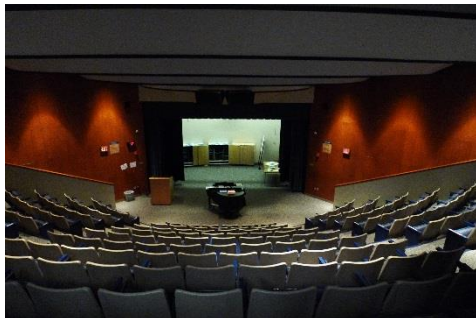
Code Compliance: Several instances of non-compliance were noted. The elevator did not appear to be ADA compliant for clearances. The control room of the forum was not ADA accessible. There was no provision for handicap seating in the forum.

*Amphitheater seating in the forum*

**EMS.BI.07** Consider making the control booth handicap accessible during any future renovations.

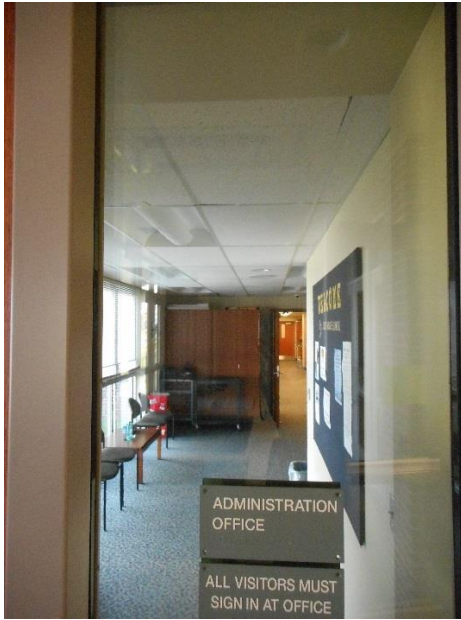
Security: The entry vestibule is secure but there is a lack of direct vision to the vestibule from the front desk. The front desk is also lacking direct vision to the main entry hall (blocked by an egress stair).

Limited direct vision from front desk

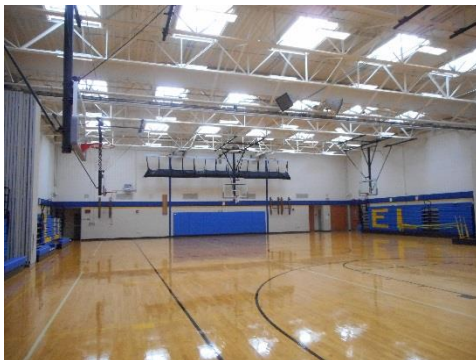
Gymnasium with natural light

Physical Education: The school has a gymnasium, fitness room, outdoor playfields and lockers to support the physical education program. It was noted that the gymnasium lights were on even though there was ample natural light to have the sensors trigger them off.

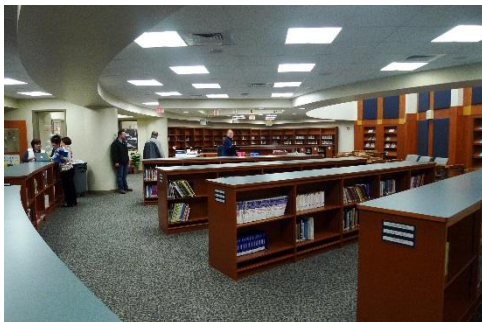
Library has no natural light

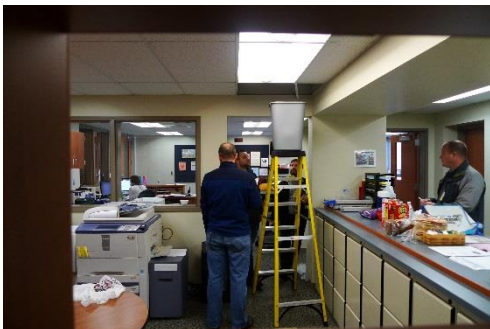
Water containment at the front office

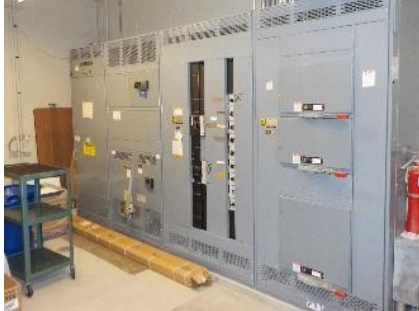
*Main electrical switchgear*

The electrical service enters the building by underground secondary feeders and terminates into a Square D 3000 Amp, 277/480volt main switchboard. The switchboard is in good condition and has provision for additional breakers to be added. There are (2) 300KVA step-down transformers located in the electrical rooms to obtain 120/208volt power for receptacle and miscellaneous circuits. Most branch panels Square D and are in good condition.

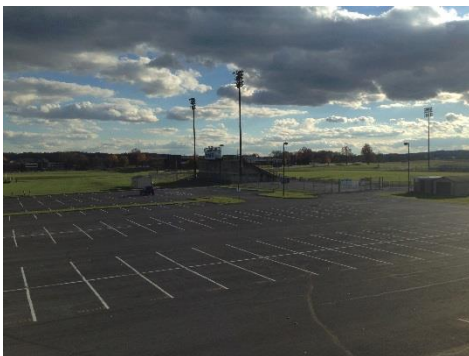
Parking is located on the rear (south) of the building and is accessed primarily by one driveway from Weavertown Road. This lack of access causes large backups at peak hours.

Parking in rear of school

**EHS.SI.02 Create a functional bus loop with visitor parking located closer to the building entry.**

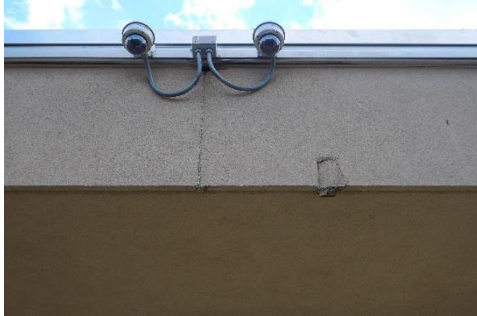
*EIFS at main entrance*

Facade: The exterior of the building is primarily brick with areas of EIFS. The brick is in fair condition, showing signs of surface deterioration and needs repointing and cleaning. The EIFS is in bad condition with several areas of damage noted as well as an overall need to be restored. Caulk joints are failing and require repair in several areas. Several areas of water damage were noted, the conditions were mostly caused by either poor site drainage around the base or water discharge from equipment pipes not properly discharged from the face of the building. Small portions of structural steel are exposed and subjected to rust and deterioration. The concrete base/footing was eroding at several areas and appeared to be floating above the soil in one area.

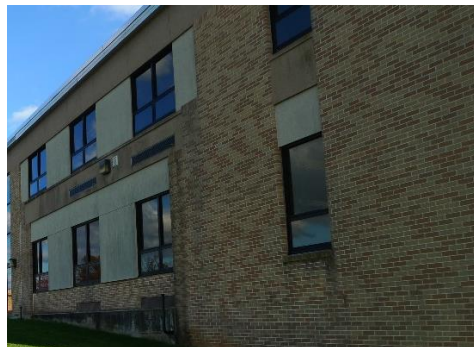
*Typical exterior conditions*

**EHS.EX.01** Repair brick as required.

**EHS.EX.02** Repair exterior concrete as required. Fill areas where concrete is floating above ground.

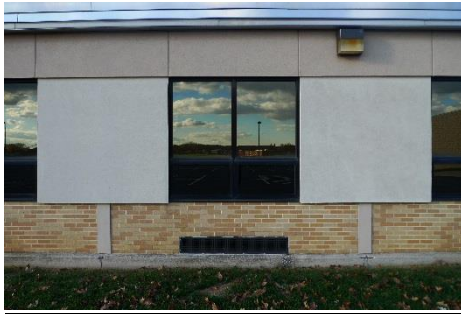
Typical exterior conditions

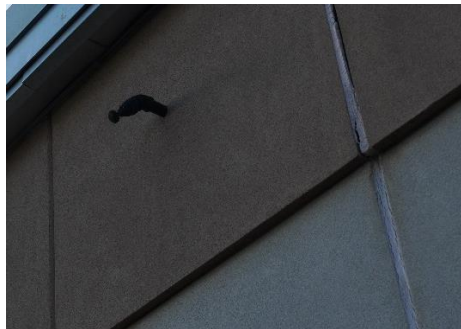
Typical EIFS condition

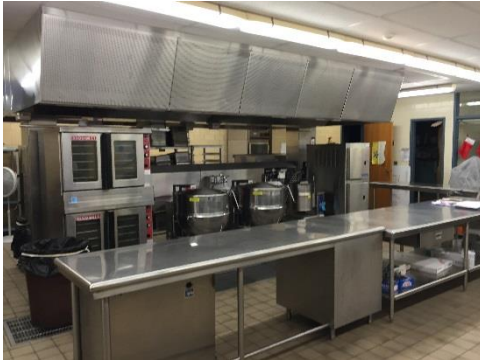
Food Service: The cafeteria currently serves three lunches with about 230 students per sitting. Capacity is meeting the needs and the space is currently not overcrowded. Scatter serve is desired, the current line service is inefficient. It was noted that some kitchen equipment is out of date and that the kitchen

*Kitchen equipment*

lacks proper storage. The school would like to consider a variety of spaces and types of seating to offer students choice. Please refer to the detailed report by Corsi Associates attached to this document.

**EHS.BI.08 Replace outdated equipment and implement more storage within the kitchen.**

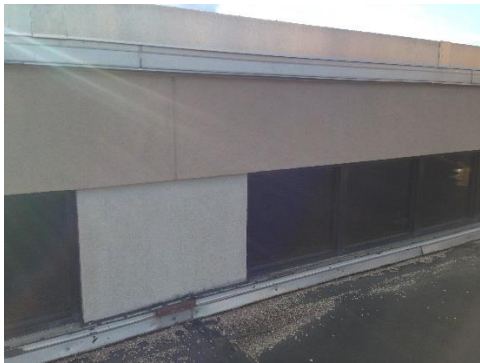
Roof: The roof is EPDM (black, non-reflective). Large portions of the roof are scheduled to be restored during the 2017/2018 year. Roof flashing at double height spaces and clerestory windows was observed to be low and possible source of water infiltration. Roof edge flashing was noted to be bent and pulling away in several areas, possibly failing under consistent high winds on the site.

*Roof at clerestory windows*

**EHS.EX.06** Replace existing roof with a white reflective roof.

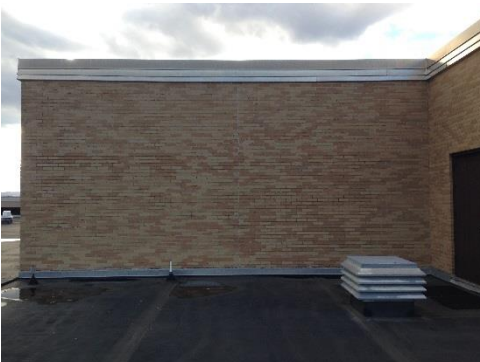
*Typical flashing height at roof*

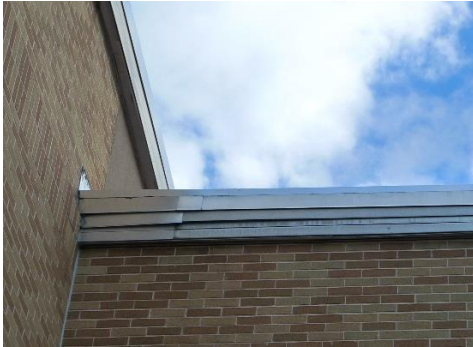
*Roof edge flashing*

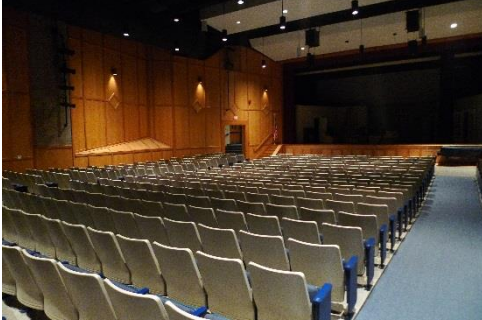
Auditorium floor creates difficult sight lines

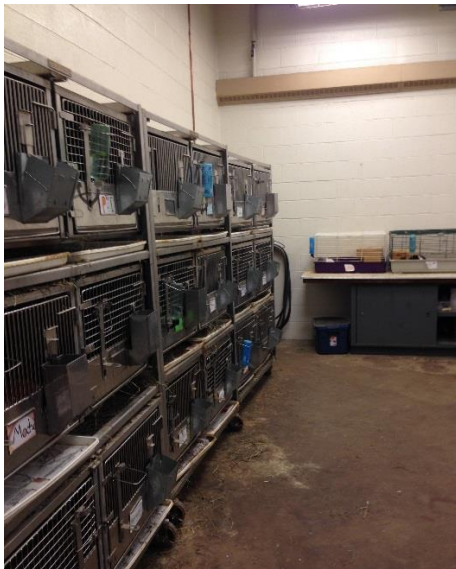
Agriculture science storage

It was noted that there is a lack of science classrooms with adequate lab space. Chemical storage and disposal systems are not sufficient to support the classrooms.

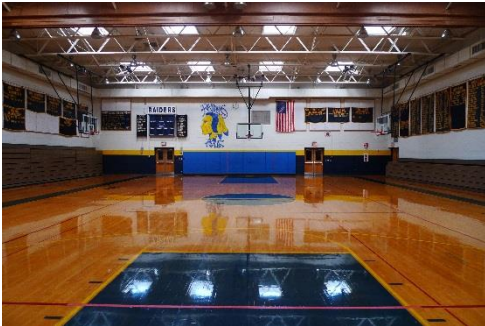
Gymnasium

The gymnasium has a large bi-folding door that is past its useful life and does not operate properly or safely. The gymnasium has a seating capacity of about 800 spectators which meets the desired capacity. However proper clearances from the competition zones are not sufficient putting both athletes and spectators into potentially dangerous situations.

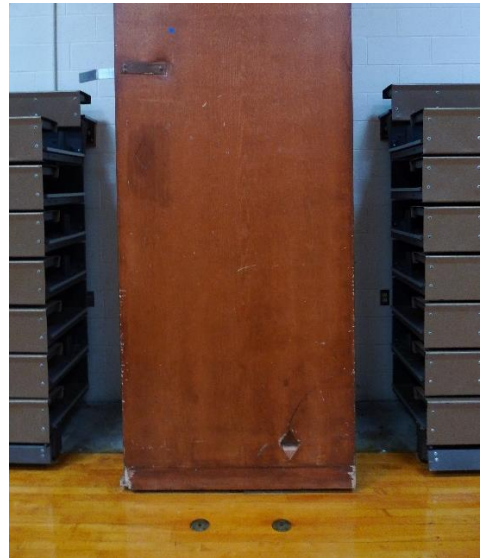
Gymnasium divider

The current gymnasium is not air conditioned, future facilities should be conditioned spaces. The gymnasium is also used for school dances and other high occupancy events.

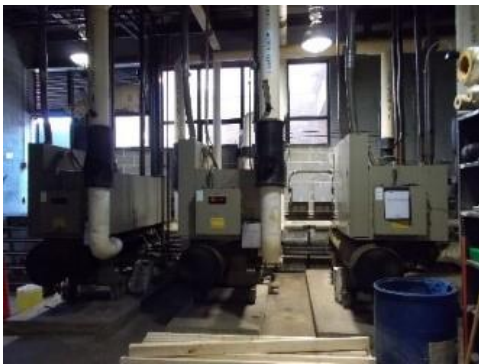
The HVAC system consists of an aging 4-pipe cooling and heating system. Individual unit ventilators are installed in most of the classrooms. Air handlers and fan coils serve the remainder of the building. The kitchen, gymnasium, and corridors do not have air conditioning installed in them. The weight room and wrestling room are served by rooftop units that were installed in 2000.

*Chillers*

The piping systems including the circulation pumps and valves are generally original to the school and at the end of their normal life cycle. Many sections of piping are in poor condition with sediment and this results in low flows to many parts of the building. Some of the piping was installed in exterior walls and causes freezing problems in the coldest part of the winter.

**EHS.HVAC.01 Due to the age and condition of the system, we recommend a complete upgrade of the HVAC system.**

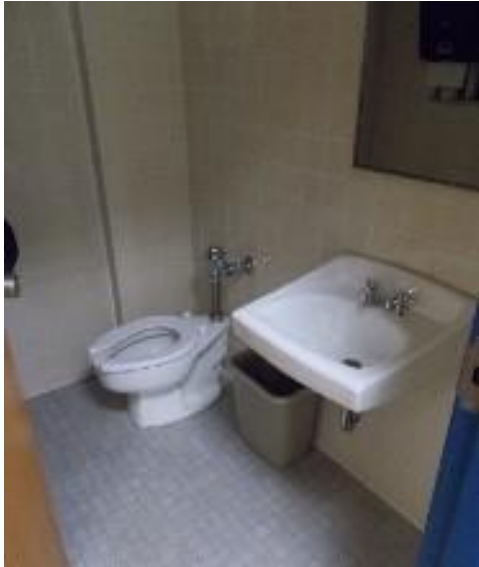
The plumbing system was found to be in fair to poor condition and showing many signs of aging. The fixtures are in fair condition and do not meet current ADA standards and are not the water conserving type. We recommend that the fixtures undergo a complete upgrade as part of any renovation project.

*Toilet room*

**EHS.PLUM.01** Due to the age and condition of the system, we recommend a complete upgrade of the plumbing system.

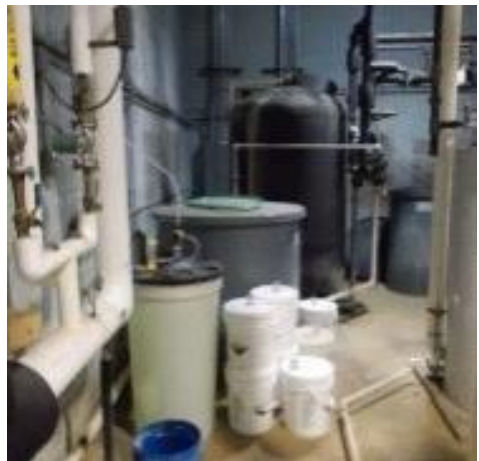
*Water softening system*

The domestic water piping system was replaced as part of the 1991 renovations. The water service is fed from a well with a submersible pump and an exterior vault with booster pumps. The submersible well pump was replaced in 2012. The domestic water piping system is copper and in poor condition due to poor water quality. The system has a nitrate removal system and a water softener although the water softener is old and not operational. The possibility of installing a new domestic water service from the public water system should be investigated to help with water quality issues. We recommend that the domestic water systems undergo a complete upgrade as part of any renovation project.

- There are (2) water softening systems, (1) for the dishmachine and (1) for the steamer. It was noted that the school deals with hard water. Going forward, the school would either look to keep the softening systems or potentially treat the water differently.

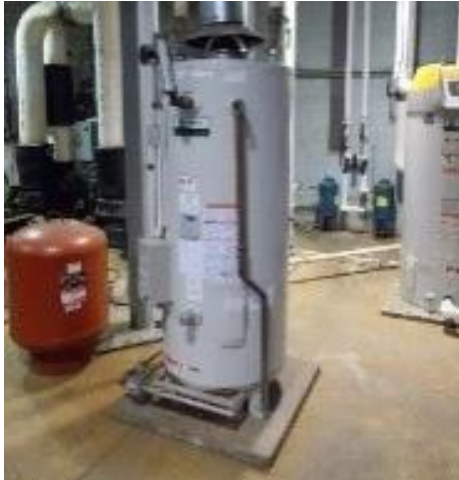
Three high efficiency storage type domestic water heaters were installed in 2009 and appear to be in good condition. No thermostatic mixing valves are installed. The water heater controls the temperature of the system which does not have precise control and does not allow for a higher storage temperature to prevent Legionella bacteria. A single standard efficiency atmospheric vent storage type domestic water heater was installed in 2013 to serve the kitchen only and appears to be in good condition. Consideration should be given in the future to install two water heaters for the kitchen hot water to provide redundancy. The water heaters are all propane fired. The propane piping appears to be in fair to good condition. The propane tanks are buried on the exterior of the building and were most likely installed along with all the propane piping in the 1991 renovation.

*Kitchen domestic water heater*

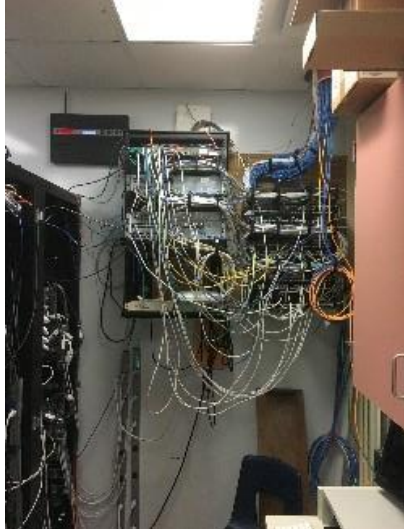
This building has an Avaya phone system. All cabling should be replaced with Category 6 cabling during major renovations.

IDF room
