## **Monomoy Regional Middle School Air Quality Testing Report**

# **MONOMOY REGIONAL MIDDLE SCHOOL**

## **Siding Replacement Feasibility Study**

Presented by  
**Raymond Design Associates, Inc.**

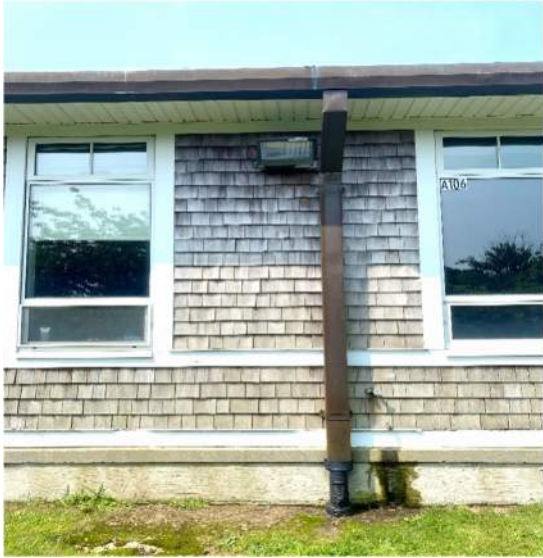
| 3. | A photograph showing the exterior of a building with grey shingle siding and white window frames. A dark brown downspout runs vertically from the roofline to the ground. At the base of the downspout, there is significant dark staining and what appears to be algae growth on the concrete foundation wall. | <p>View of additional condensate pipe location where continuous exposure to water is causing staining and algae growth on the foundation wall which is in otherwise good condition. This exposure to water can lead to serious deterioration and cracking if not repaired.</p> |

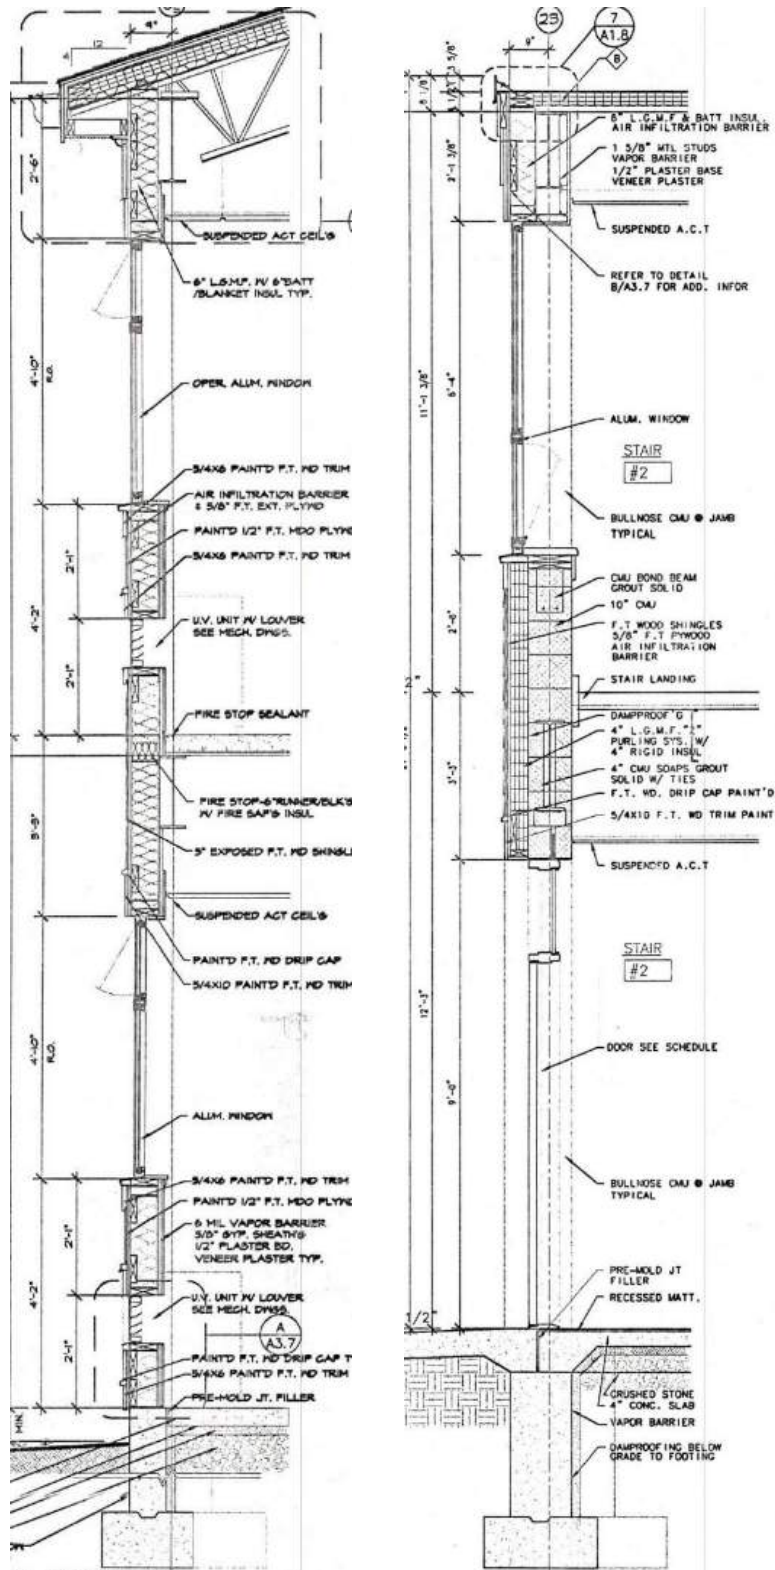
6.

View of two (2) exterior wall sections from the 1996 renovation construction drawings, representing typical metal stud and concrete masonry unit (CMU) general exterior wall construction types.

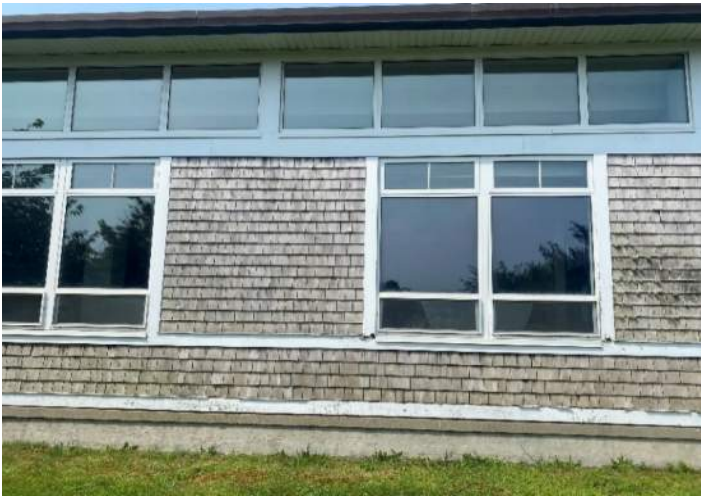
| 9. | | <p>View of typical deterioration and decay of shingles and trim. Shingles are uneven, stained and harboring lichen (right-hand side of photo). Wood drip cap on skirt board is visibly missing in many sections.</p> |

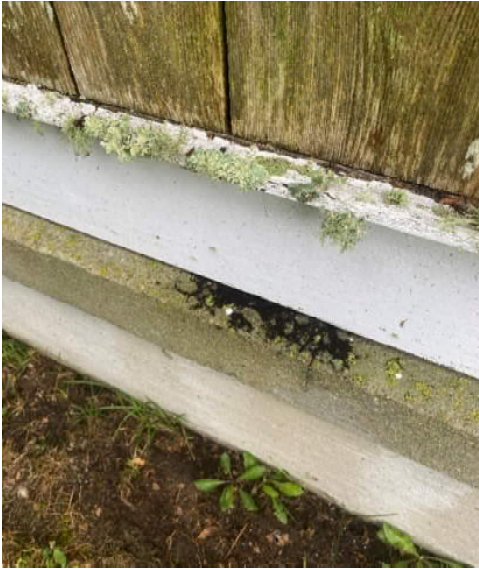
| 11. | | Close-up view of shingles and wood trim with considerable algae and lichen growth. |

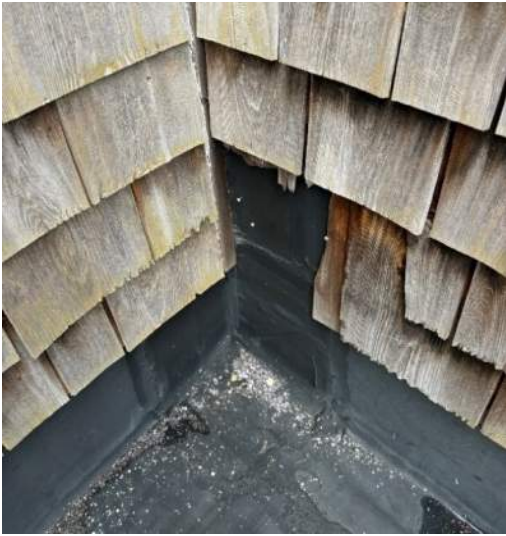
| 13. | | Photo of missing cheek wall shingles. Fortunately, the EPDM roofing membrane base flashing appears to extend at least 12-inches behind single siding which will help prevent leaking. |

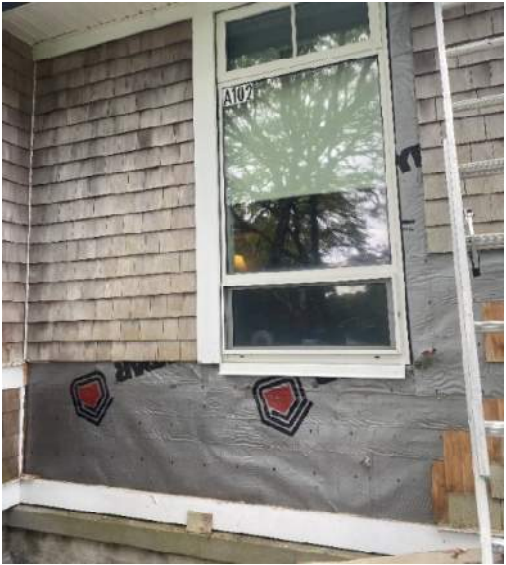
Air-infiltration barrier at several test cut locations was observed to be Typar brand (Photo 14), which is a well-known manufacturer of spunbonded polypropylene weather membrane still widely used in 2024. The Typar product was likely installed in most areas, but two (2) test cuts revealed alternative products that appear to be competing brands. We noted a blue and white-colored product that may be Tyvek brand (another well-established building wrap manufacturer), suggesting multiple products were used at the time of construction. This is not in line with best industry practices because performance of assorted brands can vary slightly, may not be compatible with each other, and can negatively impact product warranties. Best practice dictates that a single brand of a particular product should be approved by the Architect and installed as opposed to a patchwork of similar materials.

| 14. | | Photo showing Typar brand air-infiltration barrier that was exposed during the investigation. |

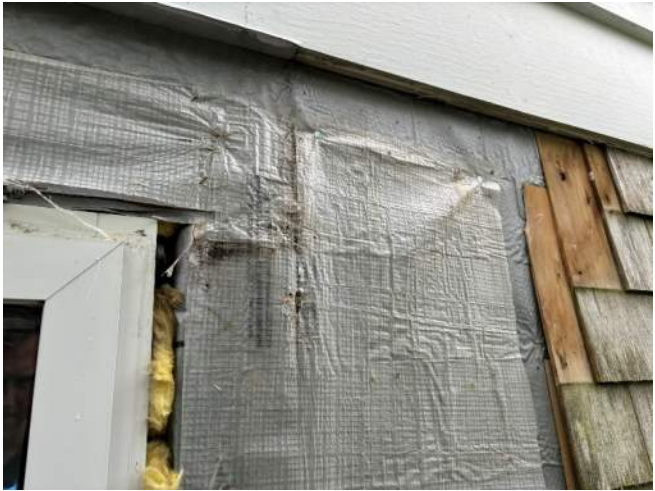
| 16. | | Photo showing a building wrap tape product that was installed improperly in 1996, possible to cover a tear in the building wrap. It is unclear whether or not the added tape is allowing the building wrap to breathe. |

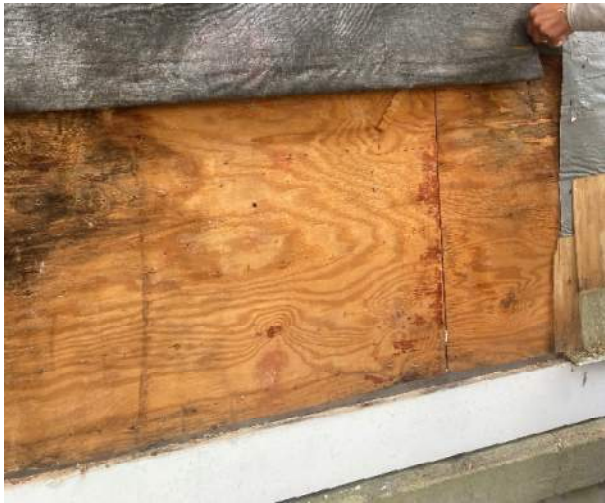
Plywood sheathing condition varies from good (Photo 17) to poor (Photo 18), depending upon the condition of nearby shingles and trim. At areas where wood trim and window casings are severely deteriorated, plywood was found to be damp, stained and in some cases rotted through (Photo 19). Such conditions were uncovered at various scattered test cut locations, indicating that similar deterioration is common throughout all building elevations. On the other hand, plywood appeared to be in good condition where trim and siding deterioration is less severe. The plywood has also been affected in some areas by mildew growth resulting from insufficient window flashing which is detailed later in the report.

| 18. | | View of plywood sheathing damaged by active water infiltration, evidenced by general dark hue in the wood and dark staining where plywood is beginning to rot. |

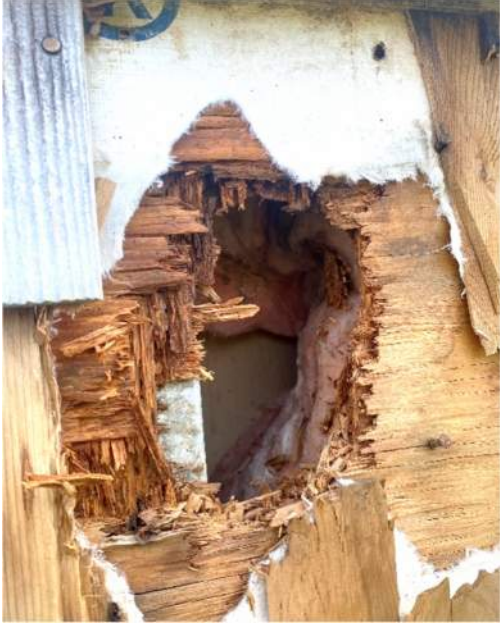
| 19. | | Close-up photo of hole seen in Photo 10 which shows (a) worn shingle with rusting nail, (b) Tyvek or similar air-infiltration barrier rather than Typar seen in other locations, (c) plywood sheathing that is rotted through and no longer sound, (d) stained batt insulation, and (e) absence of interior vapor barrier which would be visible against the backside of the GWB finish. Here, the GWB is exposed (tan color in photo) directly to the insulation. |

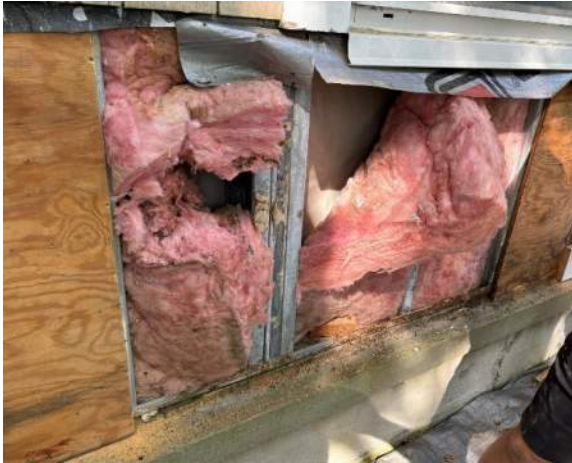
Fiberglass Batt insulation appears to have been installed at all exterior walls in accordance with the 1996 construction drawings. Based on our observations and MRSD's reports of previous exterior wall repairs, it is likely that a percentage of the insulation below the first-floor window line has been damaged by water infiltration and pests, as well as below second floor windows where trim is severely deteriorated (Photo 20).

| 20. | | View of existing fiberglass batt insulation that has been damaged by water and rodents to the point of requiring replacement. |

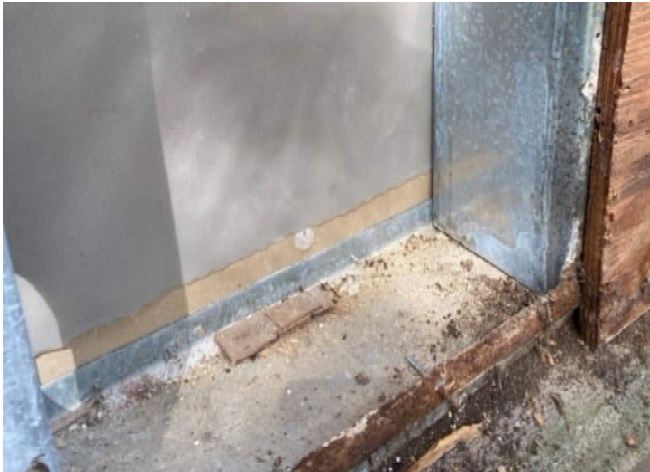
Poly-vapor barrier was installed in most areas but a consistent gap of approximately 2-inches (Photo 21) was observed between the bottom cut edge of the plastic sheet and the subfloor. At another test cut, a large tear from 1996 installation was uncovered which is substandard workmanship and introduces a path for moisture migration onto interior wall finishes (Photo 22). At an interior window stool that was removed for a window water infiltration test, the vapor barrier did not extend or was found to wrap the opening to the metal window. Current building envelope standards require a continuous vapor barrier wherein the membrane is uninterrupted and sealed from foundation to roof, and around the entire building perimeter. Proper quality products, controlled building ventilation, and sufficient weeping allow the system to breath and shed any moisture that manages to infiltrate. When the membrane is discontinuous, air is able to migrate through the breaks and edge gaps into wall cavities. Most often, interior and exterior air temperatures and humidity levels differ, so when moisture-laden air meets cold surfaces, condensation forms. This condensation can damage critical building materials within walls, along foundations and at structural intersections by rusting metal components and storing moisture in porous materials such as gypsum wall board, insulation, and wood.

| 21. | | View of same opening as Photo 20, with insulation removed, showing (a) close view of rotted plywood sheathing, (b) oxidation [rusting] of metal stud framing bottom channel caused by inadequate base flashing, and (c) continuous gap between the bottom of the wall and bottom edge of poly-vapor barrier. |

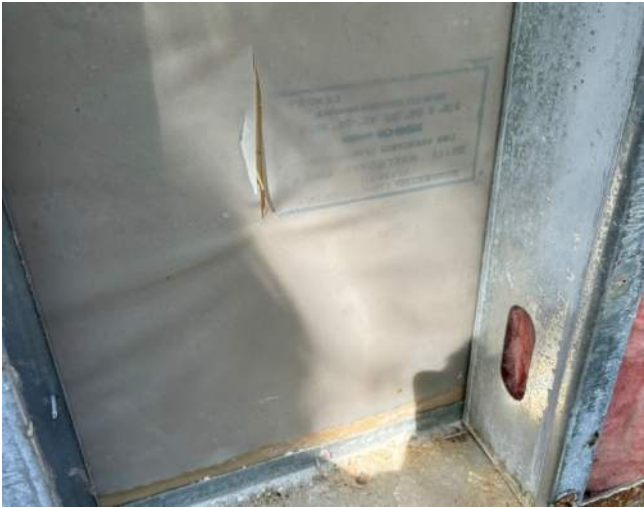
| 22. | A close-up photograph showing a vertical tear in a white vapor barrier material. The tear is located near the top of a metal frame. A small, rectangular label with illegible text is visible on the barrier to the right of the tear. The metal frame is blue-painted steel. | View of a tear in the vapor barrier that appears to be original to the 1996 installation. This indicates questionable workmanship and/or lack of understanding of vapor barrier function. |

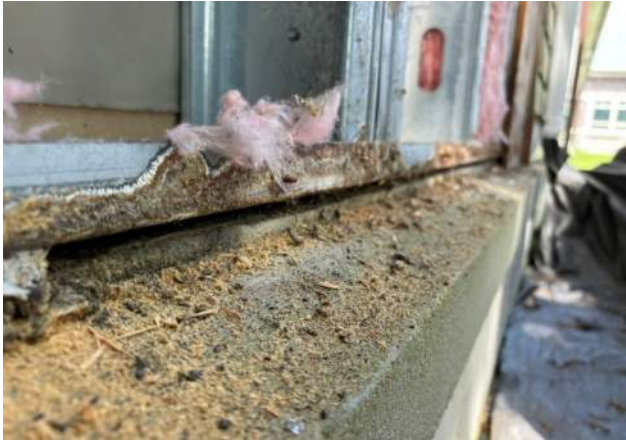
In the case of MRMS, the consistent gap above the foundation wall may be contributing to mildew and humidity issues in classrooms as infiltrating moisture vaporizes and rises into occupied spaces. We also observed oxidation (rusting) of metal studs and structural steel components which is further indicative of moisture within wall cavities (Photos 23 & 24).

| 24. | A close-up photograph of a metal frame showing significant oxidation and rust. A large pile of pink, fibrous material, likely insulation, is visible on the left side of the frame. The ground in the foreground is covered in a layer of brown, granular material, possibly soil or debris. | Close-up view of framing oxidation and rodent droppings exposed during the investigation. |

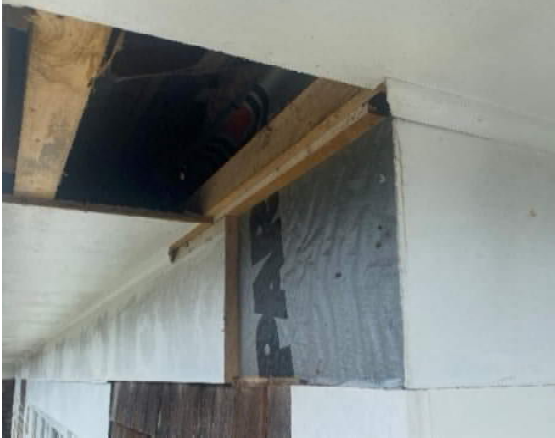
At soffits, the vapor barrier does not extend beyond the exterior wall height which suggests that air is able to infiltrate into attic spaces with little to no barrier other than wood trim components. Visible effects of the air barrier absence include premature rusting of corrugated metal decking and steel support angles was confirmed by test cut (Photos 25 & 26).

| 25. | | View of an E-Wing soffit test cut that shows non-vented wood soffit and termination of air-infiltration barrier which is not taped. There is no continuous vapor barrier to meet the roofing and is instead open to the attic interior. |

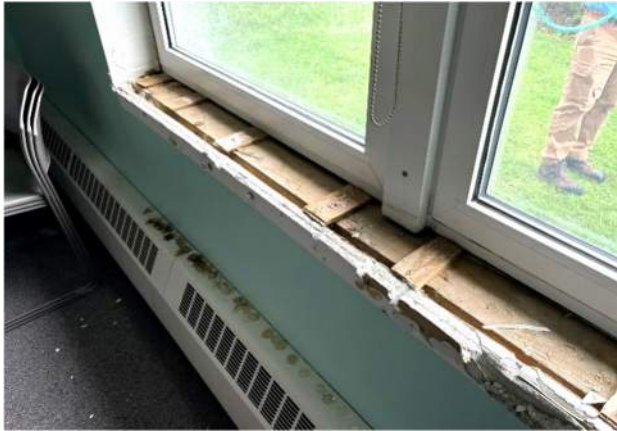
was observed where an interior wood window stool was removed, which has since been further investigated and repaired separately by MRSD (Photos 28 & 29). Consistency of visible window sill water damage and observation of similar water damage on exposed undersides of other existing wood stools (Photo 30) suggests GWB finish in other locations may be similarly affected. While damage to interior finishes will not be resolved by a siding replacement project, these conditions lend further evidence of active water infiltration.

| 28. | | View of window where existing interior wood stool was removed to revealed, showing stains on baseboard radiators caused by dripping water from the stool underside, likely caused by water infiltration through the rough opening. |

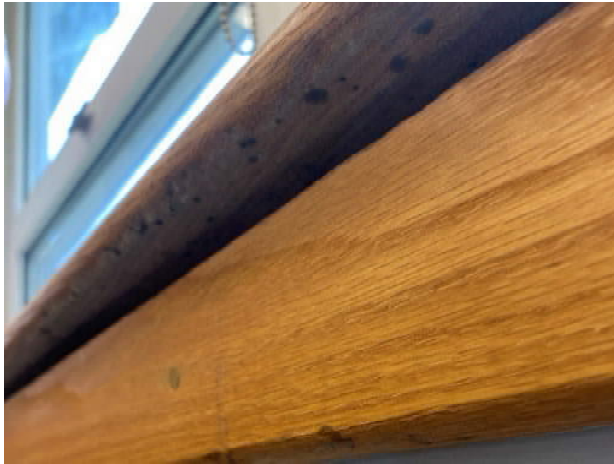
| 30. | | View of visible mildew growth on the underside of a wood window stool. |

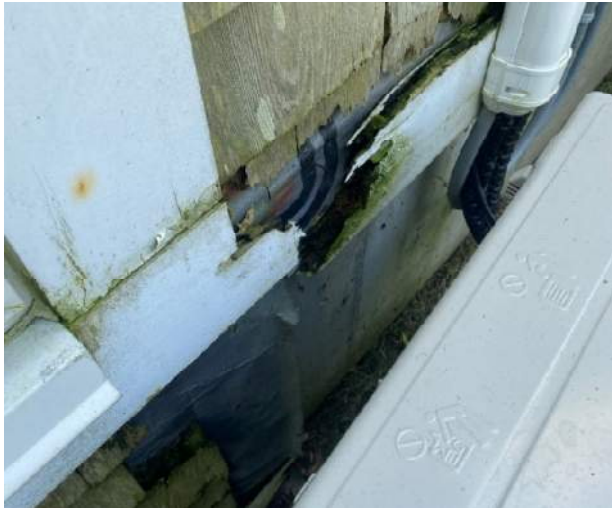
| 38. | | Additional view of severely rotted trim which has lost considerable mass. |

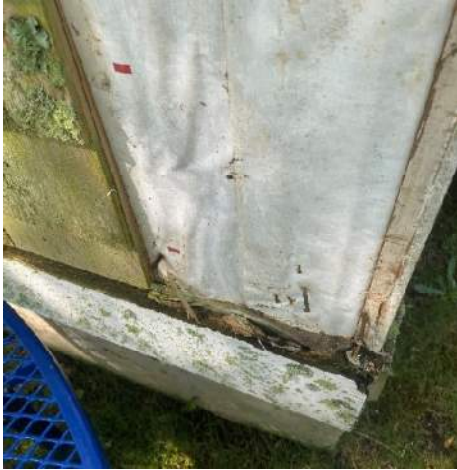
| 40. | | Top view of rotted corner base trim where wood has lost its integrity. |

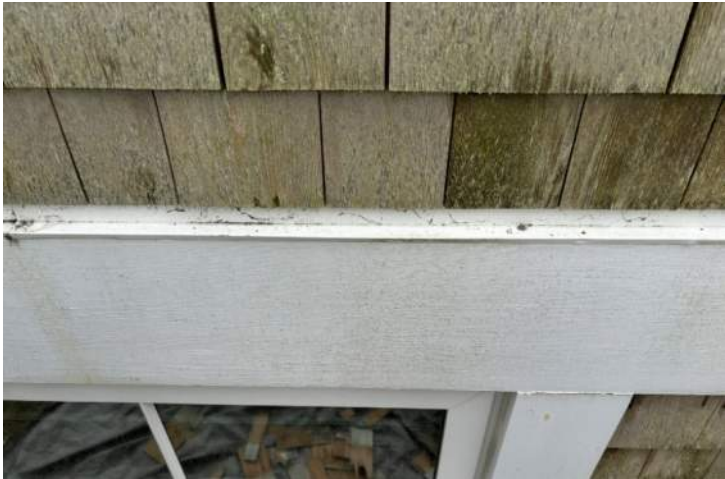
| 44. | | <p>View of one location where metal drip cap flashing was observed which provides more adequate protection. Ideally, there would be continuous hemmed drip edge to direct draining water away from the trim face.</p> |

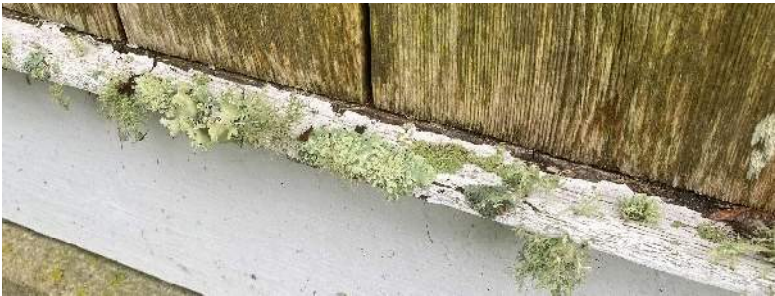
| 45. | | <p>View of wood cap trim installed in 1996 which is severely deteriorated, seen here with extensive lichen growth.</p> |

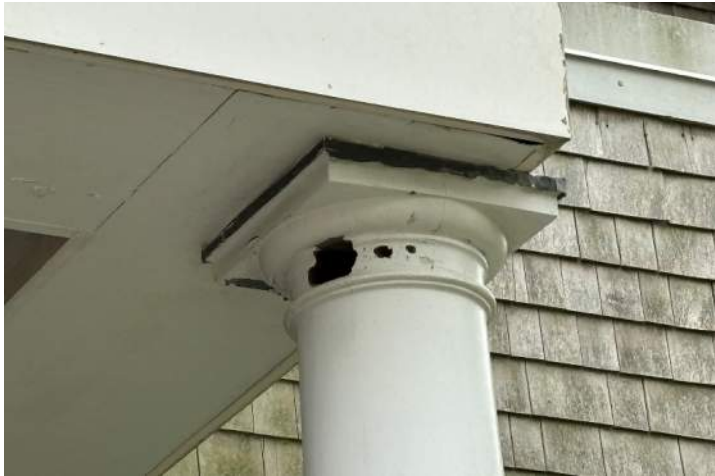
| 49. | | View of an open hole caused by wood rot in one of the column capitals. |

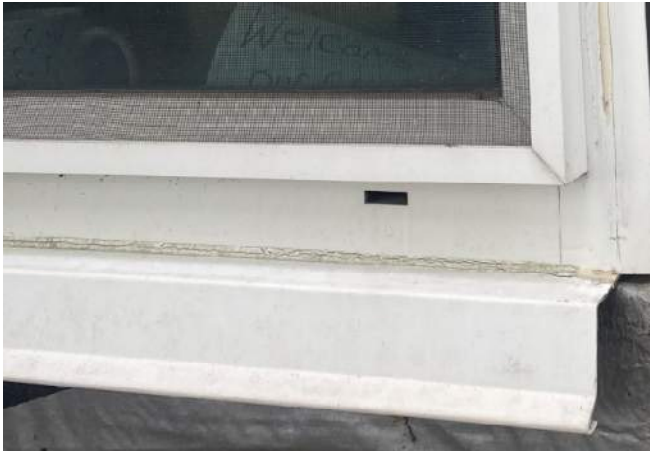
| 53. | | View of cracking and "alligatoring" of existing window sealant. |

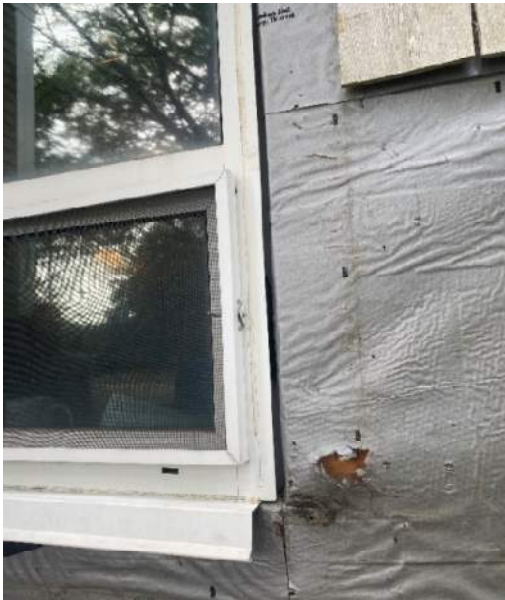
| 54. | | View of typical air-infiltration barrier termination at window opening. No flashing, backer rod or sealant was observed. |

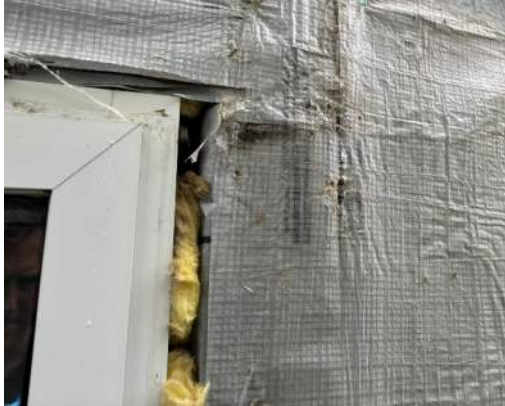
| 55. | | View of batt insulation that was found at one window opening corner which was loose and inconsistent. |

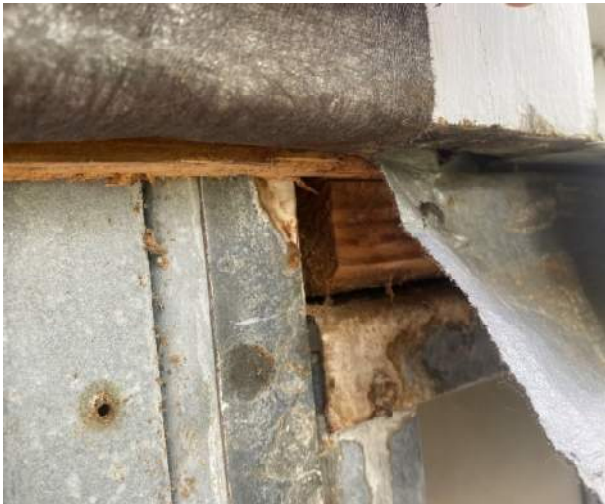
| 56. | | View of window sill framing showing dark (likely deteriorating) wood sub-sill and rusting steel stud framing. |

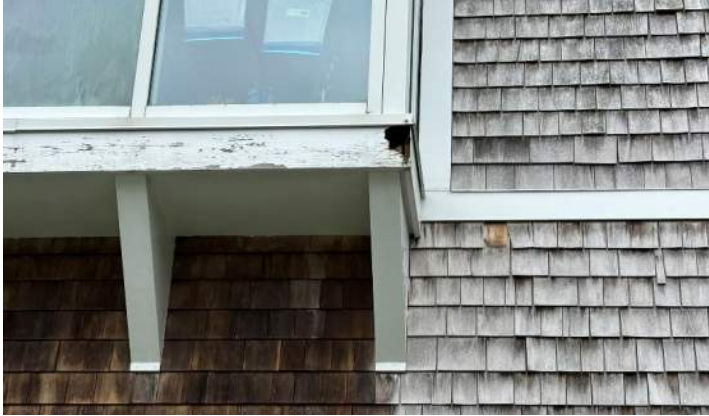
| 58. | | View of rotted second floor bay window trim. |

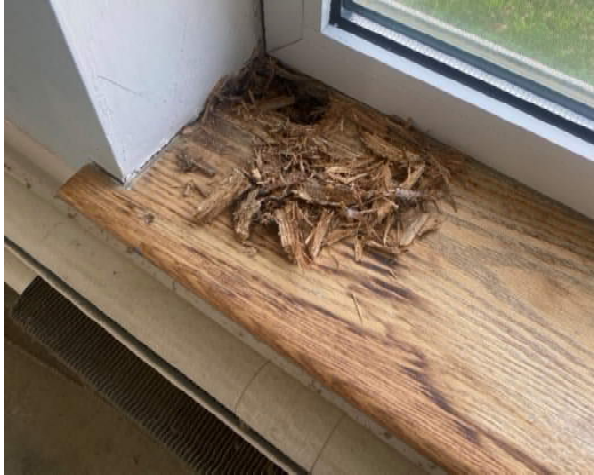
| 59. | | View of severely rotted interior wood window stool. Wood fibers flake apart to the touch due to rot caused by frequent water infiltration. |

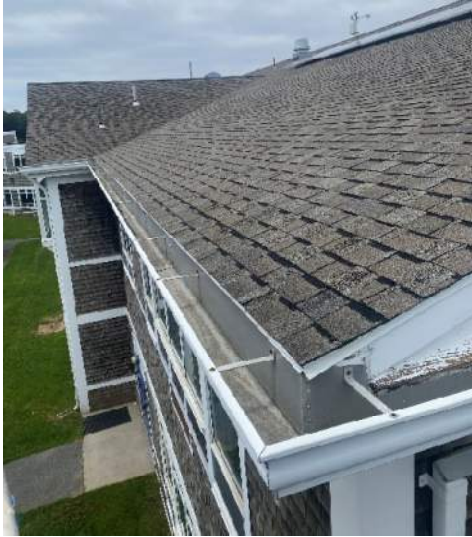
| 61. | | View of existing architectural asphalt shingles and eave overhang. The shingles are beginning to deteriorate as evidenced by loss of surface granules, seen in this photo as dark stippling on the field of most shingles. |

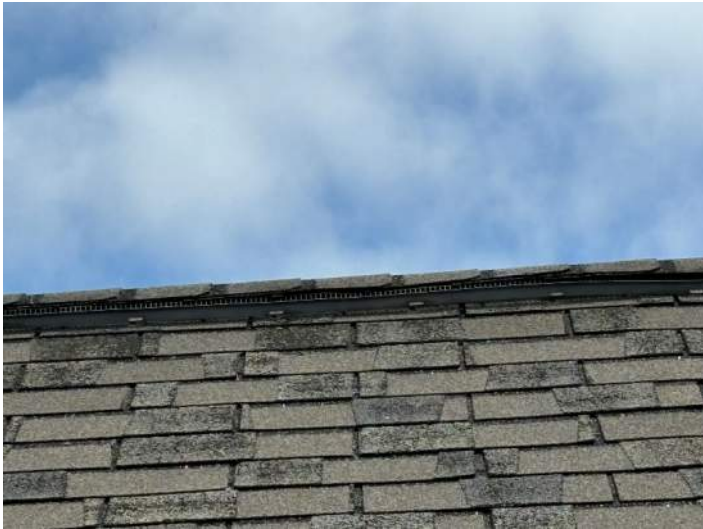
| 64. | | View of gable ridge vent that was observed. Not all ridges are fitted with vents. |

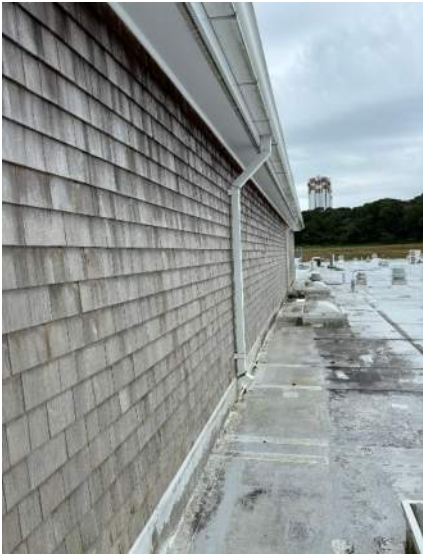
| 65. | | View of typical vented gable roof soffit. Not all soffits are vented. |

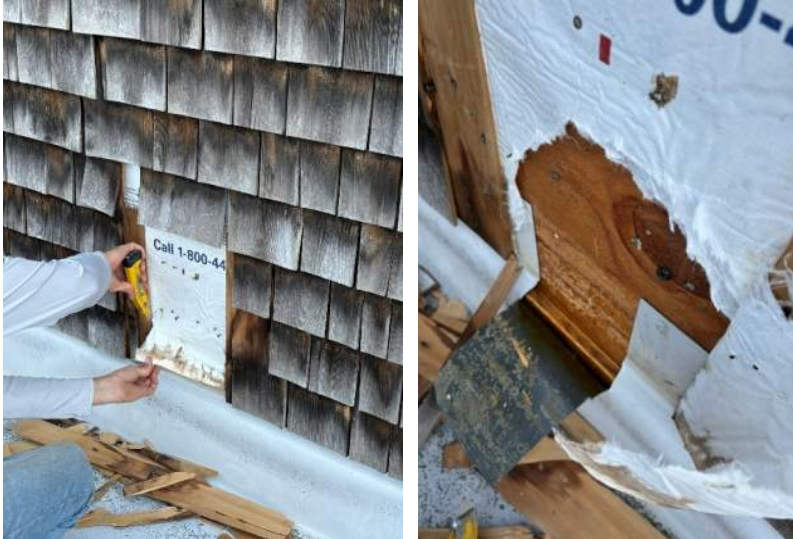
| 70. | | Additional roofing test cut photos showing shingle siding air-infiltration barrier lapping over PVC membrane base flashing. This is the proper overlap direction, but a more robust flashing termination is required by current building standards. |

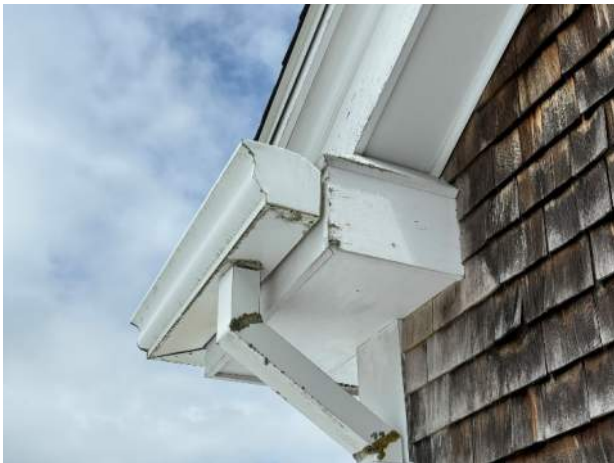
| 72. | | Photo showing evidence of leaking from existing downspout seams that appear to be have been sealed, and now the sealant has stained from airborne dirt and particles. |

- A. **7A:** At aluminum gutters (installed 1996), apply water-stop clear sealant to repair seams. For pricing, carry (2) workers for (24) hours each at mechanic wage rate. Lift will be required for higher elevations.

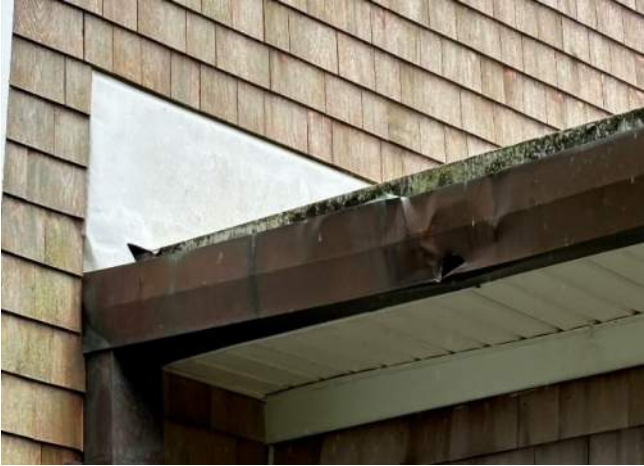
| 74. | | View of hole observed at one (1) copper gutter location. |

- C. **7C:** At copper gutters (original 1963 installation), repair seams with lead-free solder. For pricing, carry (2) workers at (32) hours each at prevailing wage rate. All copper gutters are ladder-accessible and can be repaired from roof edge.

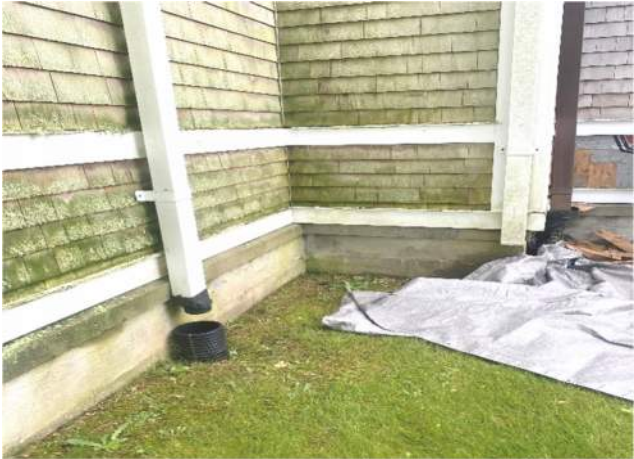
| 75. | | View of location where a downspout does not reach the corrugated plastic below-grade drainage connector. |

- B. **7B:** Remove, salvage and store existing aluminum downspouts. Protect drainage inlet at grade from dust and construction debris. Reinstall over new siding with new color-coated aluminum brackets. Reconnect to corrugated plastic drainage inlets. Do not scuff, dent or puncture downspouts. Replace any damaged, bent or punctured downspouts with new 3"x4" flat rectangular color-coated aluminum to match existing on a unit price basis. In the base bid, carry replacement of (5) downspouts (1 per unit price). Contractor is responsible for replacement in kind of any downspout damaged during construction.

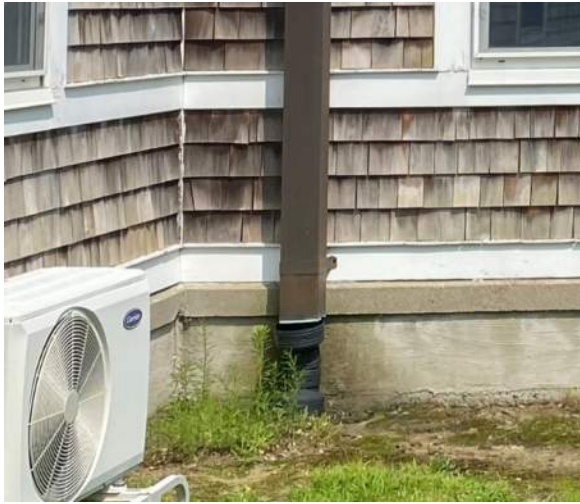
| 76. | | Additional view of a downspout that does not reach the below-grade drainage connector. Staining on the face of the concrete foundation wall indicates frequent splashing during rain events. |

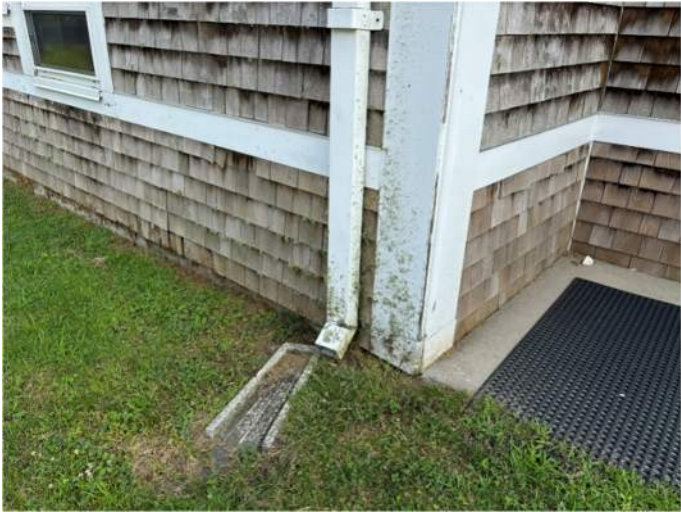
| 77. | | Photo showing an aluminum downspout fitted with a splash block, but the splash block is not aligned and may actually block drainage. Run-off should be directed at least three feet away from the foundation wall, especially where grade is close to the siding as seen in this image. |

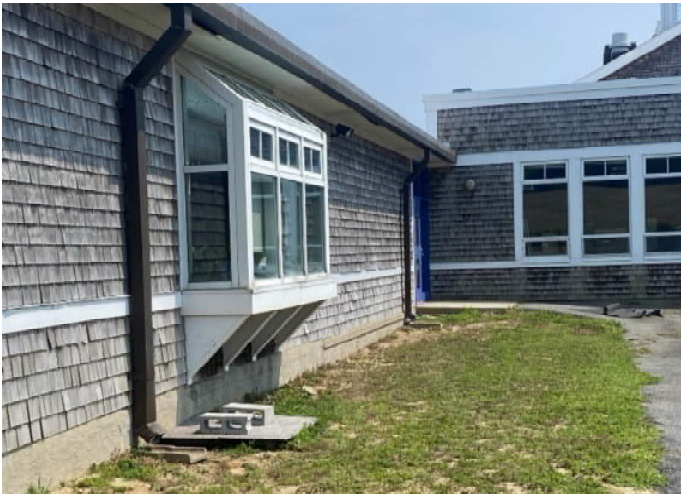
| 78. | | Photo showing a copper downspout fitted with a small splash block that is slightly tilted backward and likely does little to direct water away from the foundation wall. However, no staining on the concrete indicates acceptable drainage. |

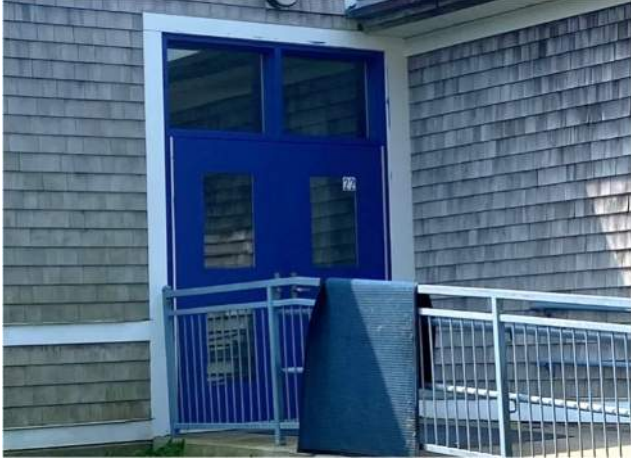
| 82. | | View of an exterior door with some over-painting which evidences recent repainting which will help preserve the lifespan of the frames and panels. |

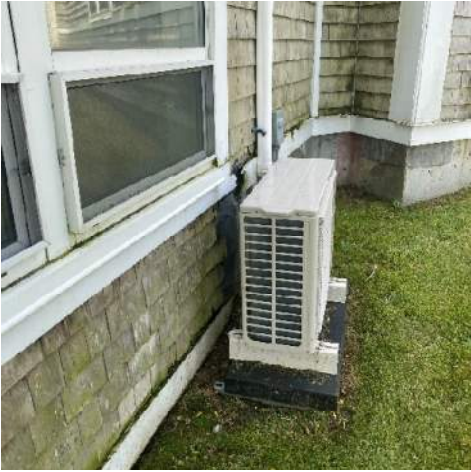
| 87. | | <p>View of one mini-split condenser that is located close to the exterior wall, behind which wood shingles and trim have completely rotted away to expose the air-infiltration barrier.</p> |

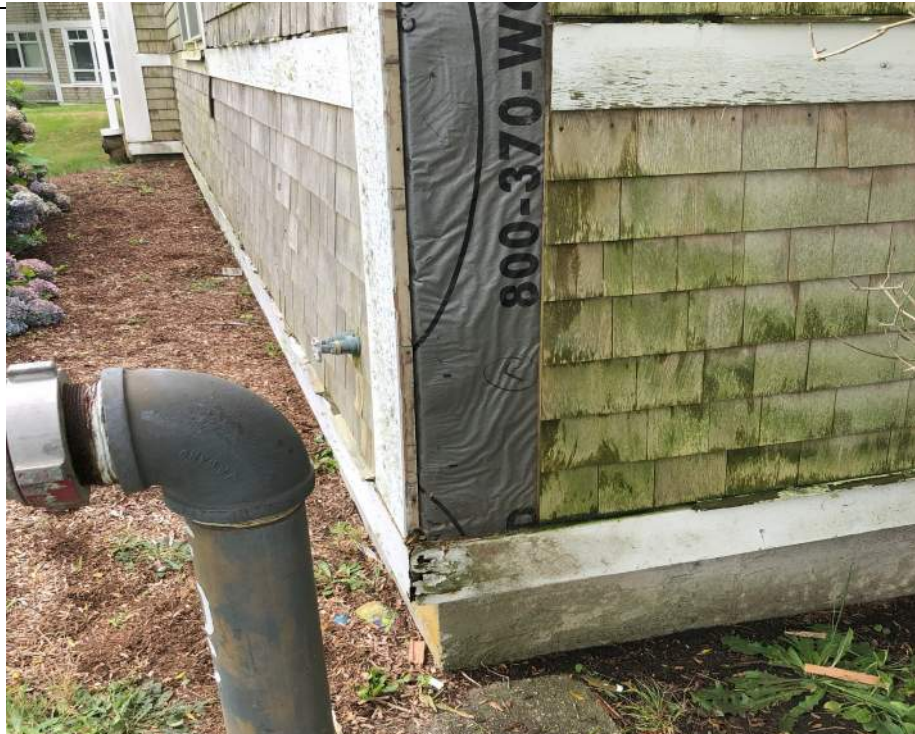
**Photograph: 6****Description:**

- Siding paper observed under wood shingles
- Window unit did not appear to be flashed properly with seam tape (Photo 6 and 7)
- Moisture mapping of the plywood sheathing to the right of the window unit as well as at the header was recorded between 15-16%. (Photo 8)

Photograph depicts general view of E205 window unit missing flashing tape.

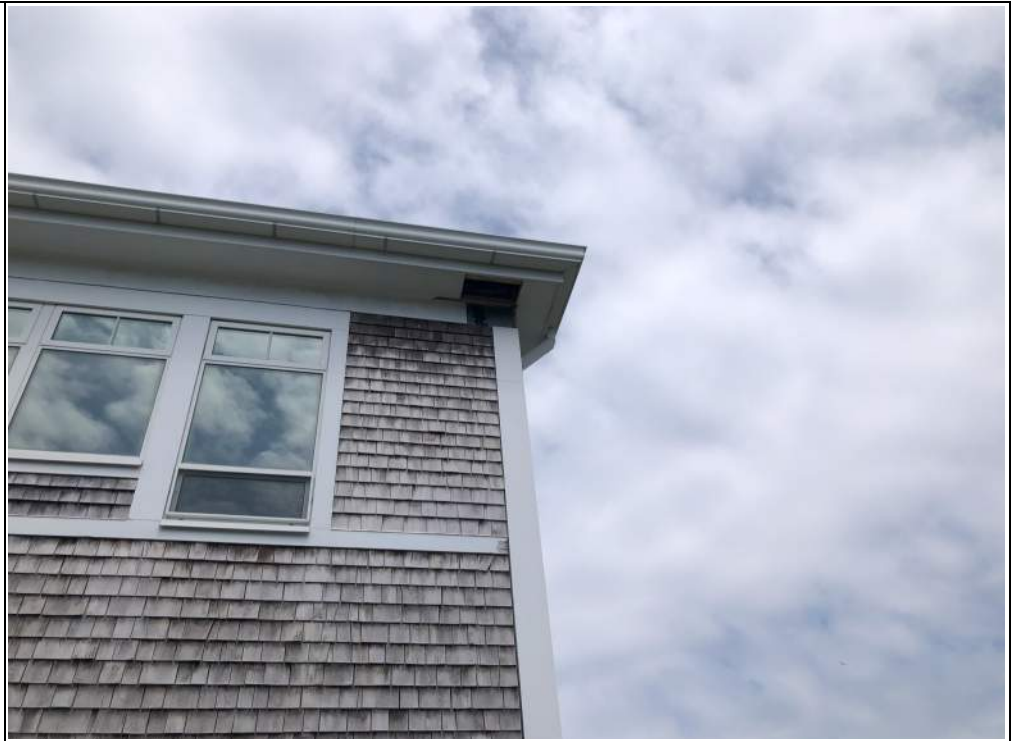
### Photograph: 10

- Soffit ventilation was not observed
- Oxidation (Rust) observed on underside of the roof decking. (Photo 10)
- Moisture mapping of the plywood sheathing under the soffit was recorded between 10-12%.

Photograph depicts general view of the roof deck above the window unit at E211.

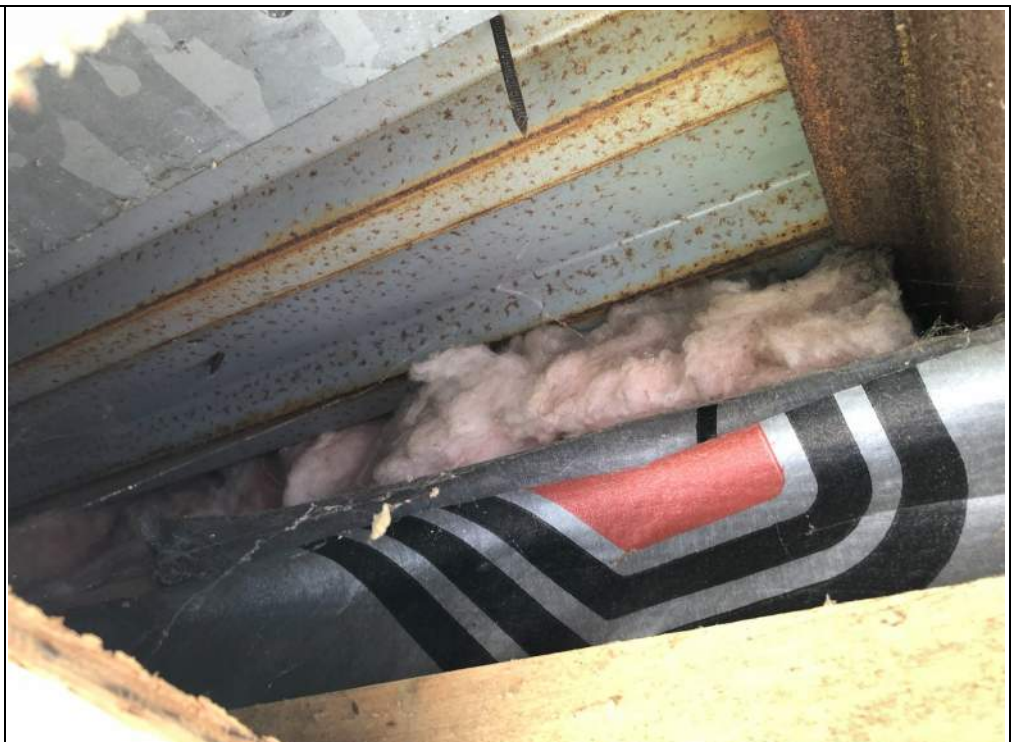
**Photograph: 11****Description:**

- Siding paper observed under wood shingles and window trim board
- Window units did not appear to be flashed properly with seam tape (Photo 11 and 12)
- Moisture mapping of the plywood sheathing to the right of the window unit as well as at between the windows was recorded between 15-16%.

Photograph depicts general view of B128 window unit missing flashing tape.

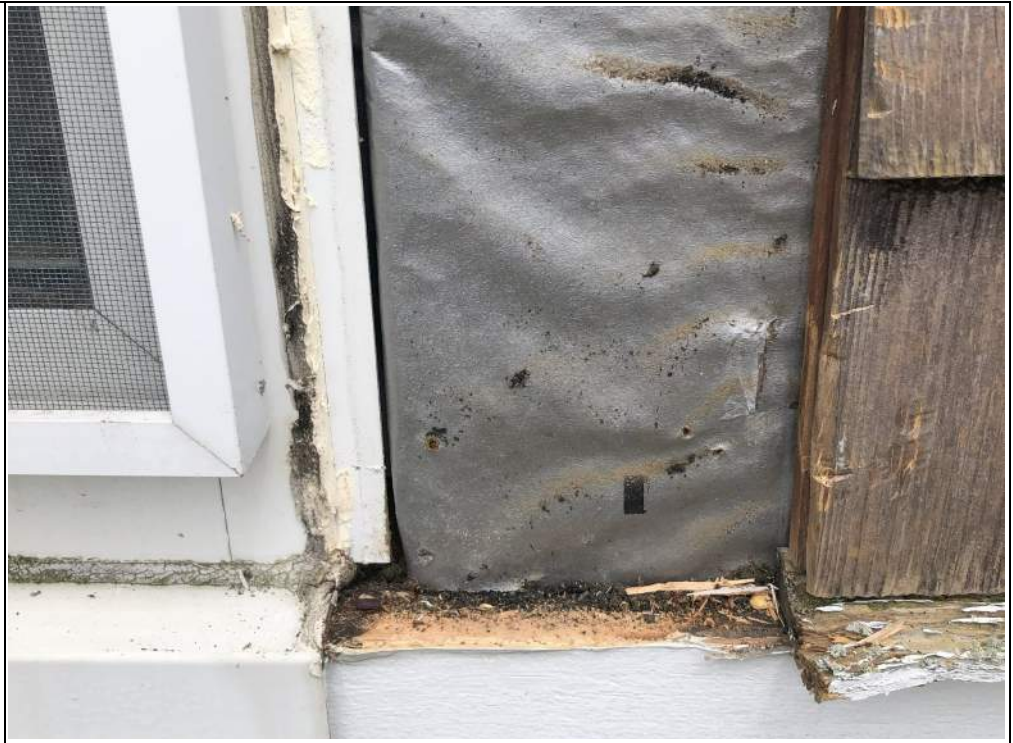
**Photograph: 12****Description:**

Photograph depicts general view of B128 window unit missing flashing tape.

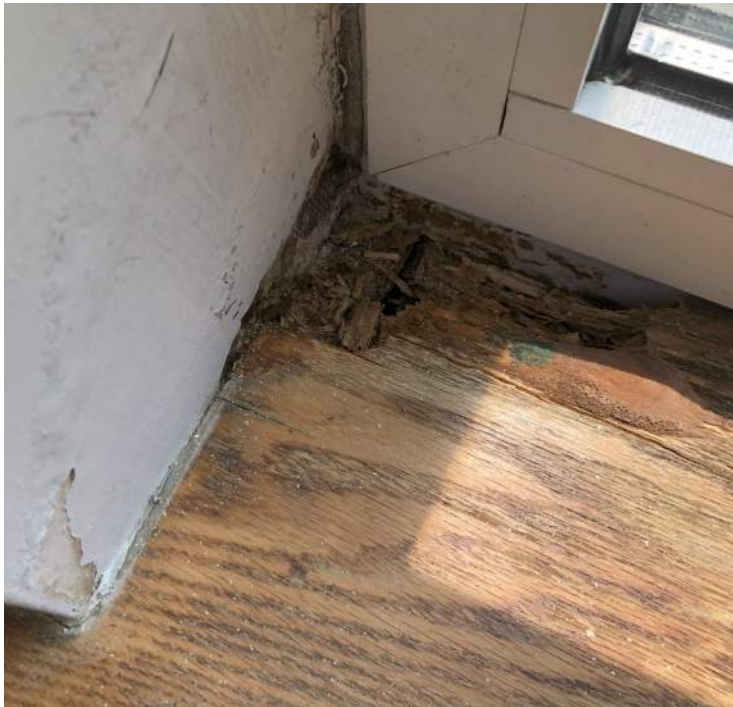
**Photograph: 21****Description:**

- Significant water damage observed on the wood windowsill. (Photo 21)
- Water-stained ceiling tiles
- Ventilation not operating

Photograph depicts general view of water damaged wood window sill and adjacent gypsum board within E119.

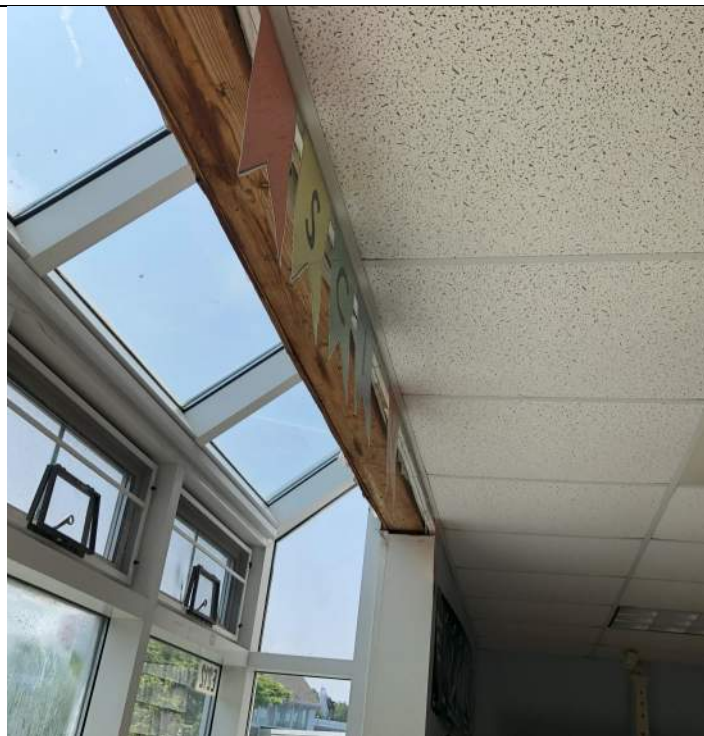
**Photograph: 23****Description:**

Photograph depicts general view of suspect mold growth on the drop ceiling tiles within the main office area.
