# INDOOR AIR QUALITY ASSESSMENT

## Centerville Elementary School

658 Bay Lane  
Centerville, MA  
November 2024

Prepared by:  
Massachusetts Department of Public Health  
Bureau of Climate and Environmental Health  
Division of Environmental Health Regulations and Standards

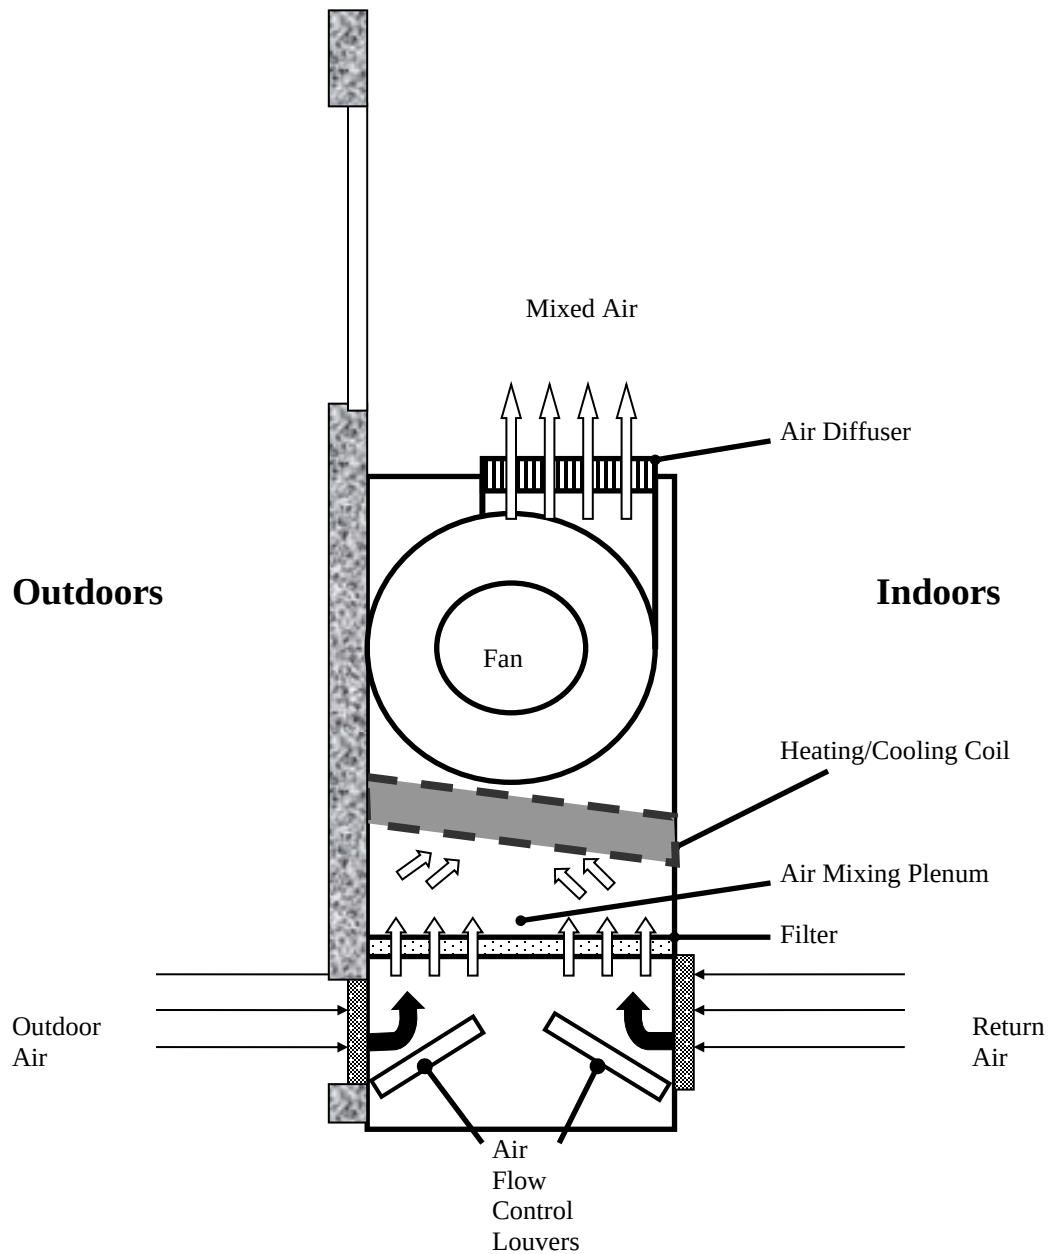
Figure 1  
Unit Ventilator (Univent)

Most classrooms are equipped with unit ventilators (univent, Picture 1). Univents bring in fresh air from a vent on the outside of the building (Picture 2), filter, heat it, and supply the air through a vent on the top. Some room air is recirculated along with the fresh air through a vent at the bottom (Figure 1). The univents are reported to be controlled by a computerized management system.

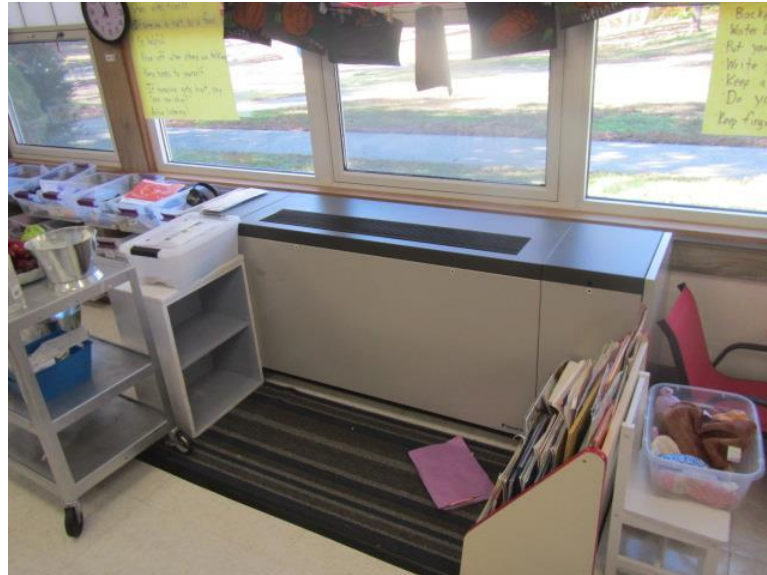
Picture 1

Univent in classroom

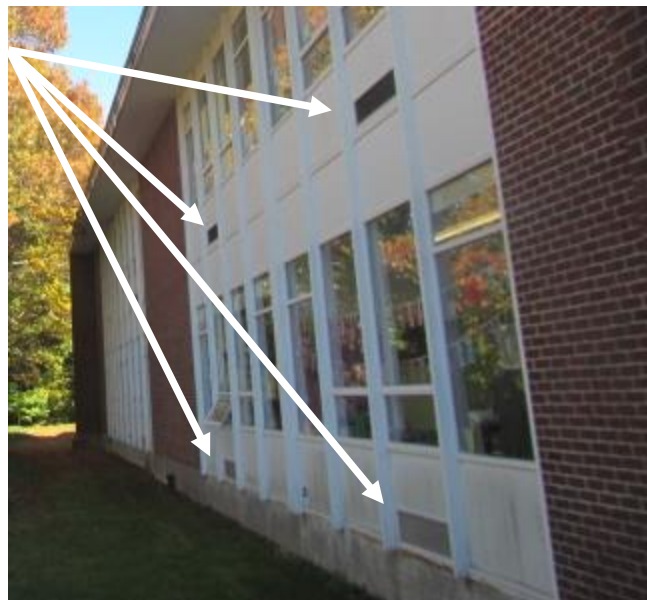
Picture 2

Univent fresh air intakes (arrows)

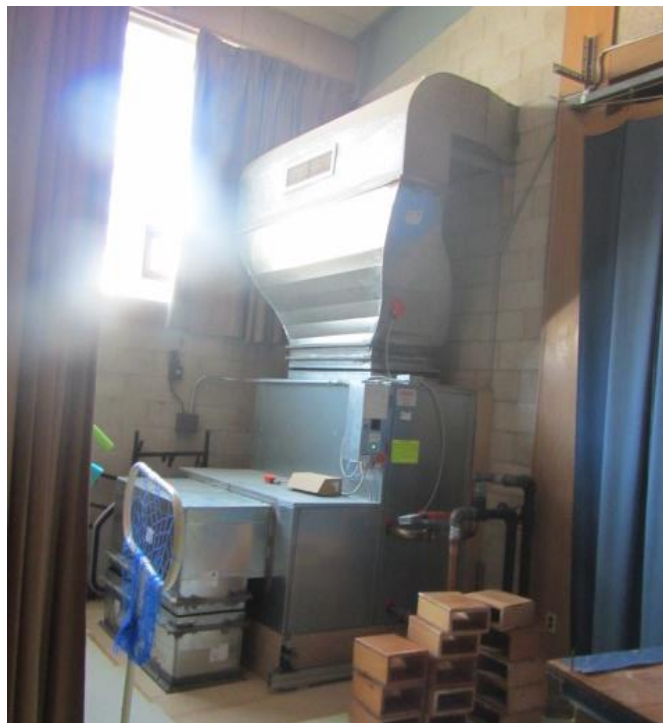
Picture 4

Mechanical ventilation to the gymnasium is provided by an air handling unit located in the corner of the gym (Picture 4). The AHU draws in air from the outside, heats it and distributes it via a wall-mounted vent near the ceiling. A corresponding return vent draws air back into the unit at the floor level. With both supply and return air being introduced and removed from the same corner of the gymnasium, it leads to an issue called short-circuiting (Picture 5). However, across the gym is a wall-mounted exhaust vent that was not functioning (Picture 6). If this exhaust vent could be activated, it would help pull air across the room for more even distribution.

Air handling unit in corner of gymnasium (stage view)

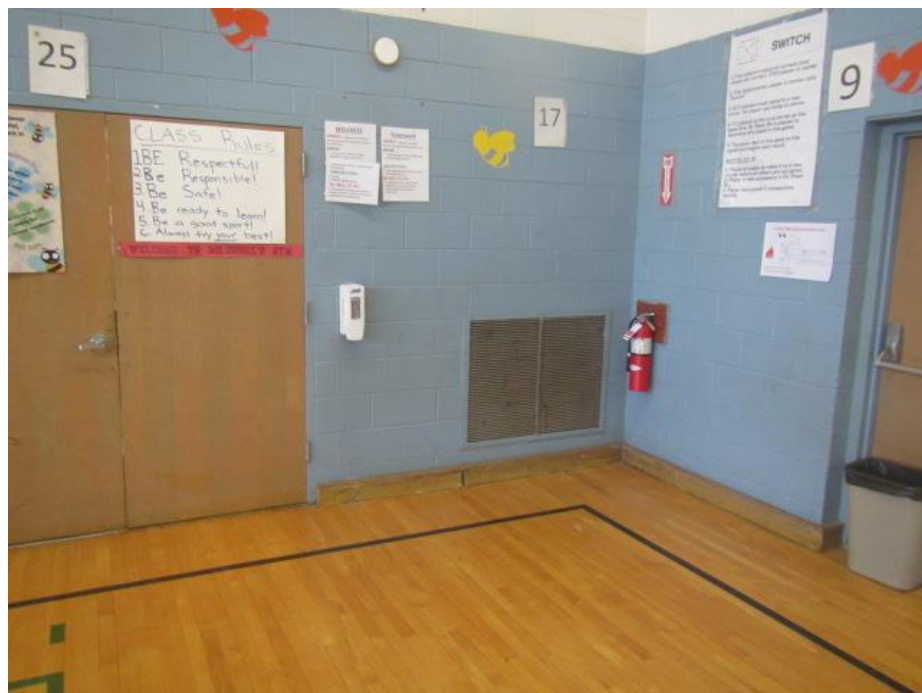
Picture 6

Exhaust vent on wall of Gym across from the AHU

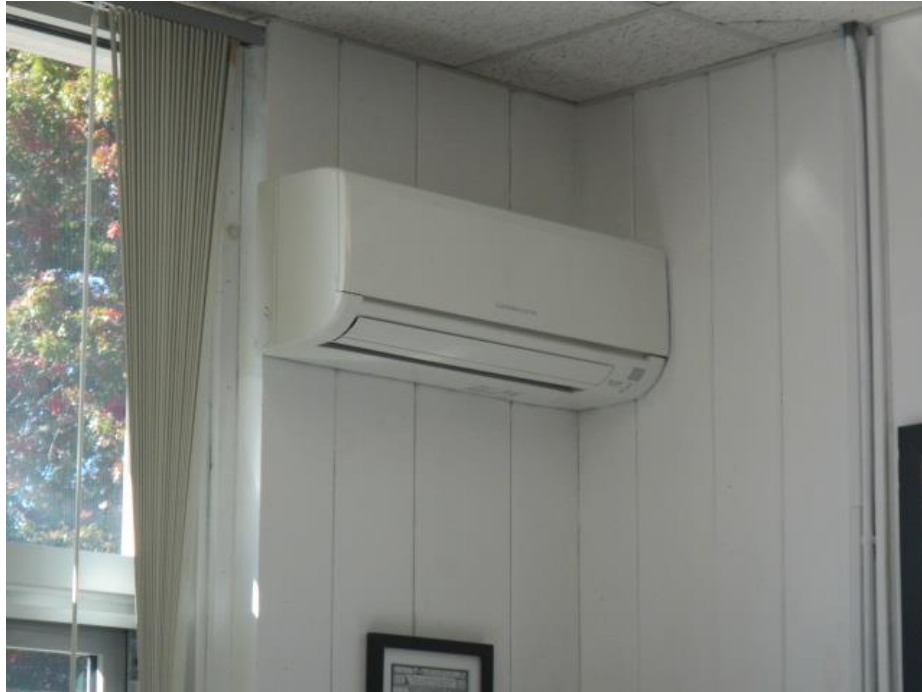
Picture 11

Cooling is provided in some rooms by wall-mounted mini-split/ductless air conditioners (Picture 11), and in others by portable air conditioners.

Wall-mounted mini-split

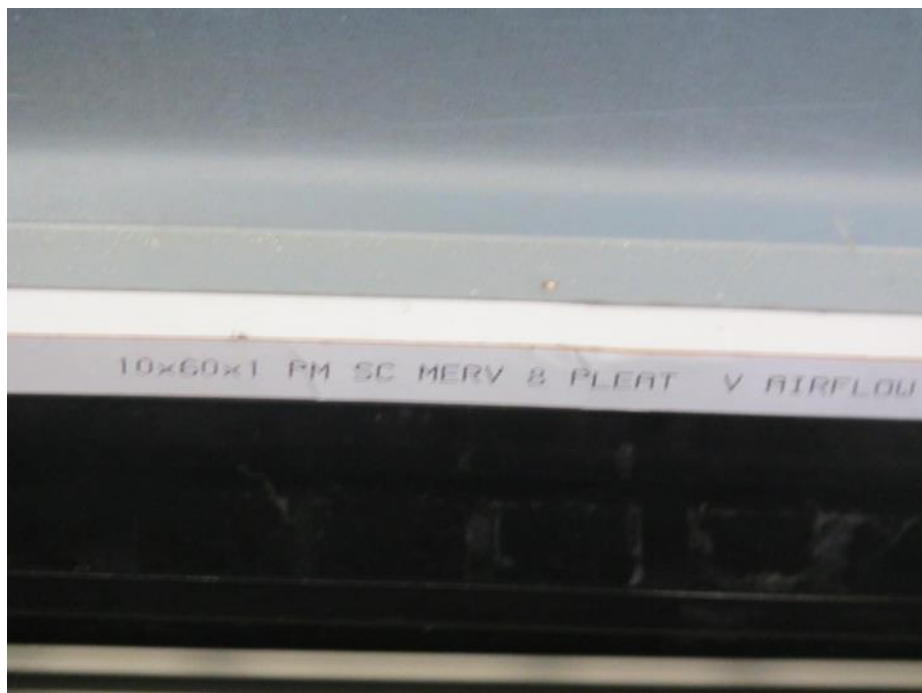
Picture 12

- MDPH recommends that filters of at least a Minimum Efficiency Rating Value (MERV) 8 be used as these are adequate to filter out pollen, mold, and similar particulates (ASHRAE, 2012). A univent was opened and the filter examined. Filters used in univents are pleated MERV 8, (Picture 12).
- **It was reported that MERV filters are replaced annually.** MDPH recommends that filters be changed two to four times a year or as per the manufacturers' recommendations.
- **Some of the univents were obstructed by items in front of return vents** (Picture 13) or along the top. To provide mechanical ventilation as designed and to prevent damage

MERV 8 filter in classroom univent

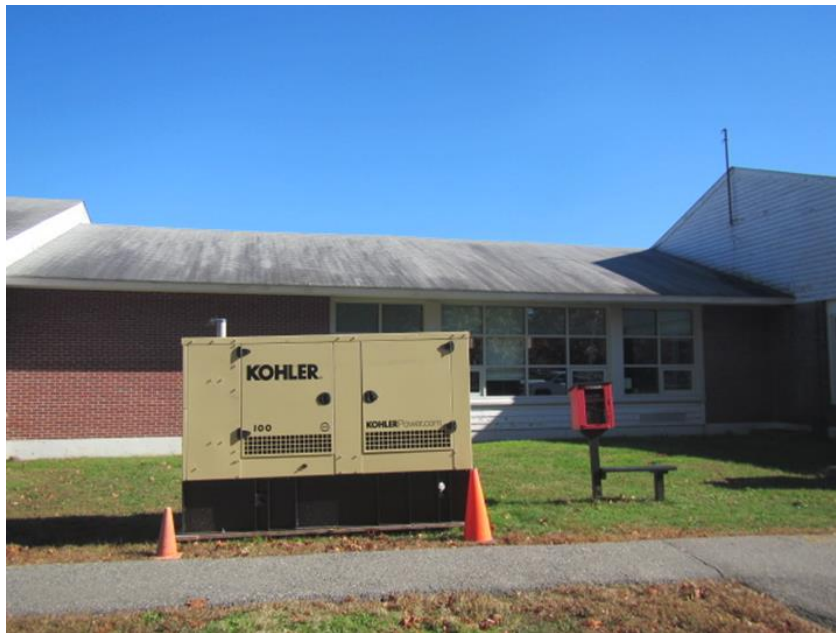
Picture 43

- **An emergency generator was stationed outside the building awaiting hookup (Picture 43).** It is important to note the area of installation and its proximity to openable windows and fresh air intakes. The generator should be set using automatic startup timers for after hours or weekends to prevent exposure to exhaust emissions and noise.

Emergency Generator
