Burr Elementary School

Fairfield Public Schools Recommissioning (RCx) and Testing, Adjusting, & Balancing (TAB) Study van Zelm Project # 2020102.00 (08-BES) November 20, 2022

FAIRFIELD PUBLIC SCHOOLS RECOMMISSIONING (RCx) AND TESTING, ADJUSTING, & BALANCING (TAB) STUDY

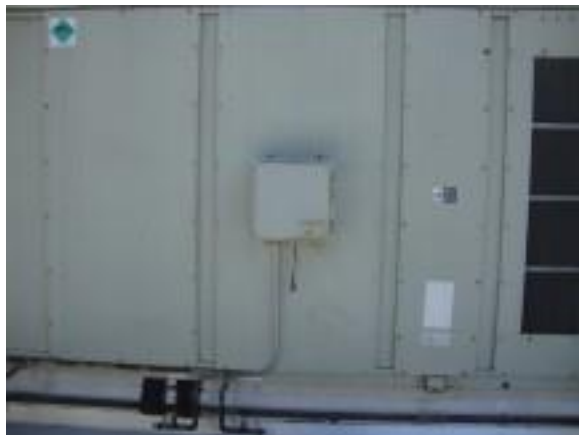
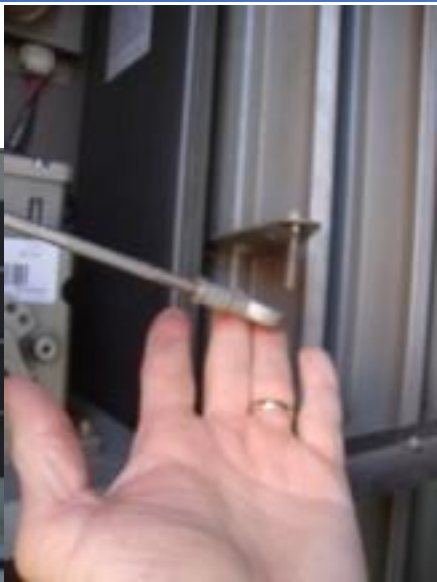
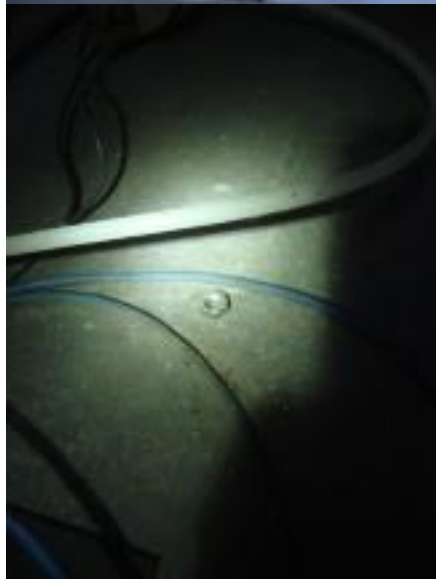
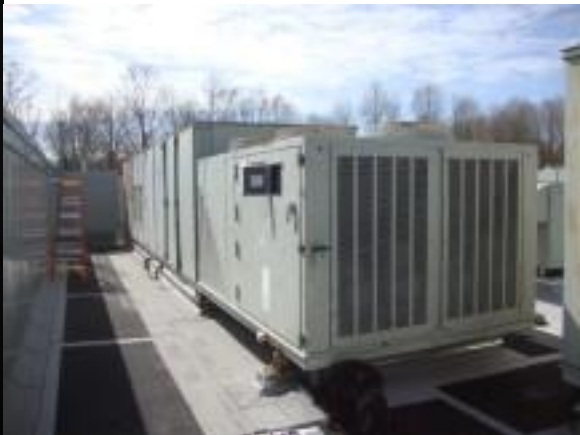
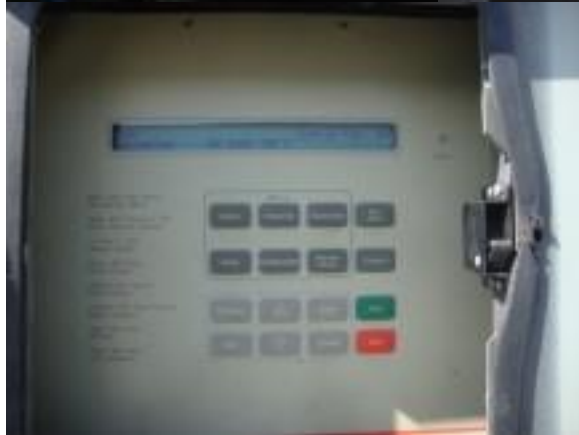
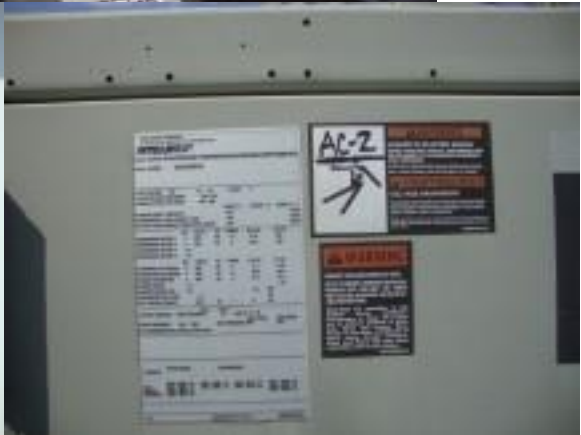
<u>Unit Tag</u>	<u>AC-3</u>	<u>Addition comments descriptions</u>
Location	Roof Pit	
Serving	Gymnasium (Per JCI Docs)	
Config/Style	Packaged RTU, DX Cooling ERW, HW Heating	
Mfr.	Trane Intellipak	
Model #	SLHFC50ED567S7B01000AOZ	
Serial #	C03J08046	
Age (years)	2003	
System CFM		
Max OA CFM		
V/Hz/Ph	200/60/3	
SF Qty/HP	(1) 25.0 (2) 5VX930 Belts	
SF VFD Data	N/A	
EF Qty/HP	(1) 10.0 (1) BX-87 Belts	
EF VFD Data	N/A	
Filter Data (Size Quantity)	(3) 12x24x2, (9) 24x24x2 (3) 12x24x4 (9) 24x24x4	
Filter Status	Filters are clean, proper spacer	4-5-22 Change date
Controls Type	Electronic DDC, Packaged BAS, Trane Package	
Controls Mfr.	Factory	
Economizer	Packaged economizer	
CO ₂ DCV	-	
Damper Styles	Factory parallel,	
Damper Status	Seals falling off, Clean adjust and Lubricate.	
Heating Type	Hot Water	
Heating Coil Condition	Unknown, no access doors for inspection, assumed dirty coils	
Cooling Type	DX Package	
Cooling Coil Condition	Dirty, Needs cleaning

ERW	Wheel, Airxchange Ser. -, ¼ HP. Filters, (3) 24x24x2, (3) 12x24x2 Aluminum	Filters Dirty and rusted, replace.
Wheel Exhaust	5.0 HP, Twin City Size - Type BAB-DW, Belt BX-65

Controls	Functionally it is unclear as to what mode system is in, Retro Cx recommended	
Drain Pan Status	OK, Flush after coil cleaning,	
Notes:	Door Hardware, rusted, adjust, and lubricate

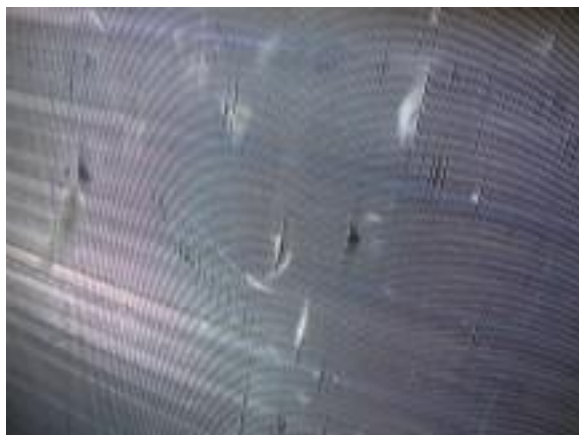
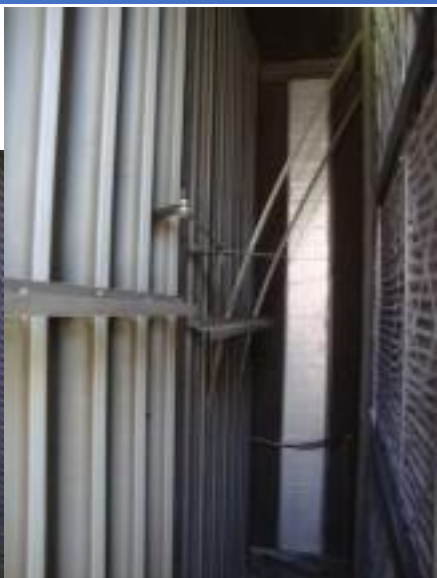
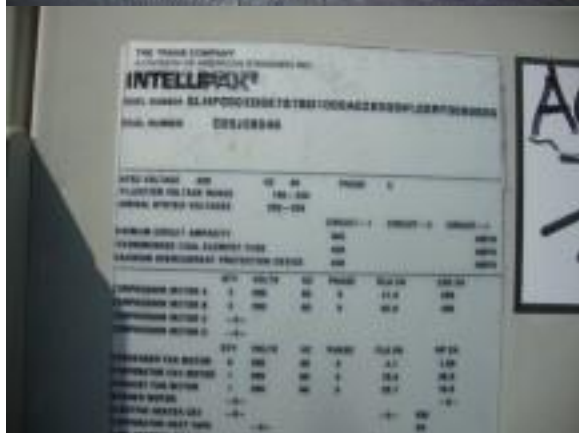
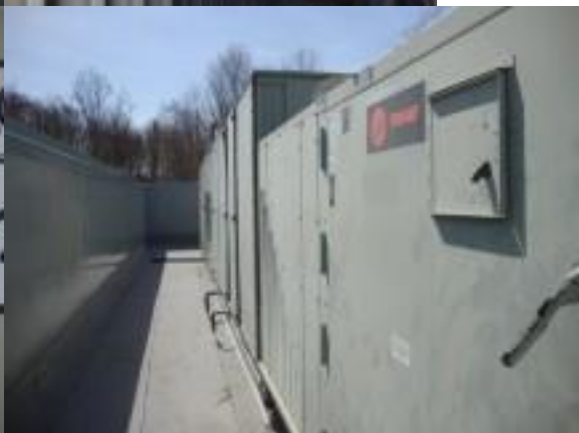
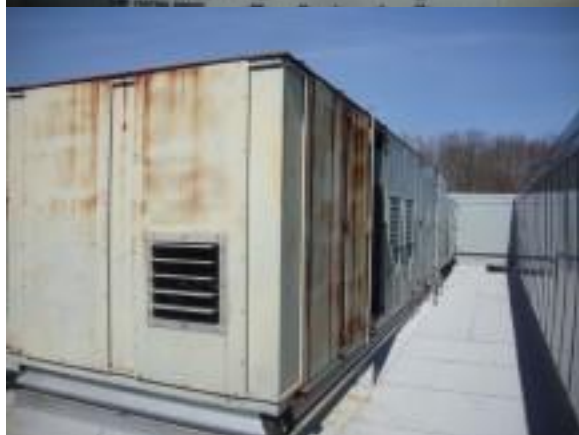
<u>Unit Tag</u>	<u>ERU-4</u>	<u>AC-4</u>
Location	Roof Pit	Roof Pit
Serving	Cafeteria (Per JCI Docs)	Cafeteria (Per JCI Docs)
Config/Style	ERW, Supply and Exhaust Fans	Packaged RTU, DX Cooling, HW Heating
Mfr.	Semco ERU	Trane Voyager
Model #	FV5000T-4RN4AB	TFD301C30GCA
Serial #	33266/M017531-01	343100396D
Age (years)	11/2003	10/2003
System CFM		
Max OA CFM		
V/Hz/Ph	200/60/3	200/60/3
SF Qty/HP	(1) 2.0 (1) Adj. Belt Fan section dirty	(1) 7.5 (1) BX-81 Belt
SF VFD Data	N/A	N/A
EF Qty/HP	(1) 3.0 (1) Belt	N/A
EF VFD Data	N/A	N/A
Filter Data (Size Quantity)	(3) 16x25x1 Aluminum dirty, Replace	(4) 20x20x2 (4) 20x25x2
Filter Status	Filters are dirty	Clean 4-5-22 Change date
Controls Type	Electronic DDC, Packaged BAS, Trane Package	JCI Metasys
Controls Mfr.	Factory	
Economizer	Packaged economizer, 100% O.A. If functional?	
CO ₂ DCV	-	
Damper Styles	Factory Slide, O.A. Needs to be cleaned adjusted and lubricated	N/A
Damper Status	Sketchy, Clean adjust and lubricate.	N/A

Heating Type	N/A	Hot Water
Heating Coil Condition	Unknown, no access doors for inspection, assumed dirty coils	No access to inspect
Cooling Type	Wheel	DX Package, Twin Circuit
Cooling Coil Condition	Wheel looks OK, did not seem to operate	Dirty, Needs cleaning
ERW	Horizontal Wheel, 1/15 HP.	N/A

Controls	Functionally is unclear as to if it works and or what mode system is in, Retro Cx recommended	
Drain Pan Status		OK, Flush after coil cleaning,
Notes:	Door Hardware, rusted, adjust, and lubricate

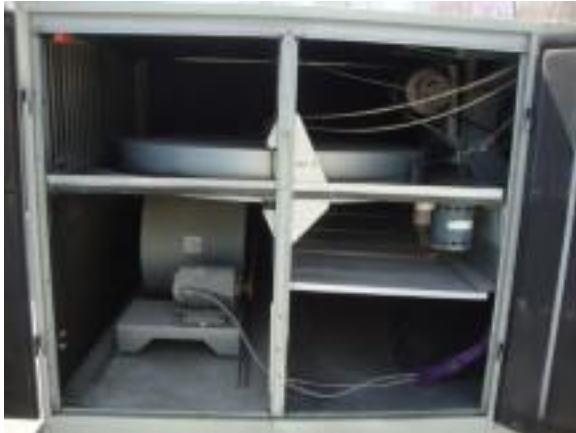
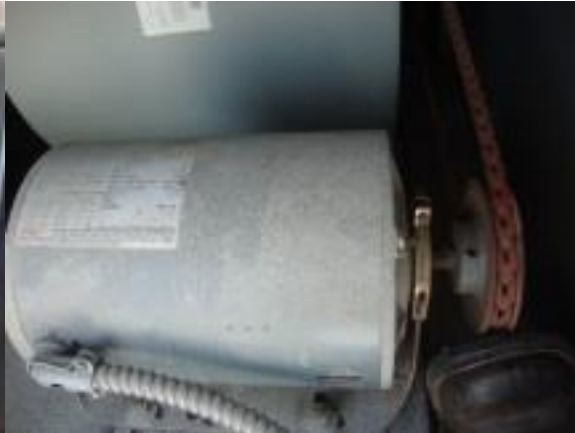
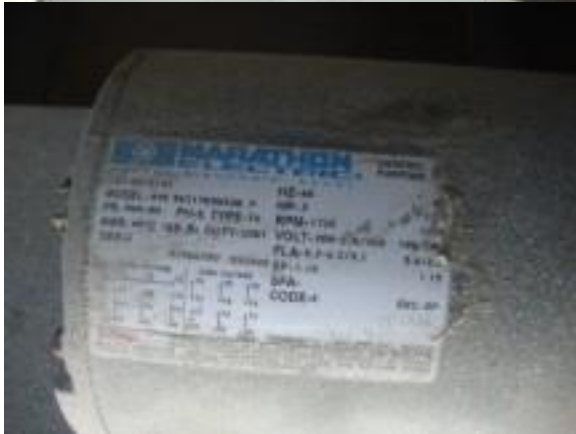
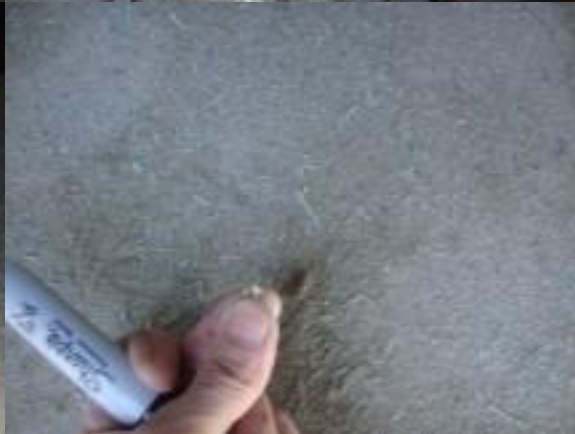
<u>Unit Tag</u>	<u>ERU-5</u>	<u>AC-5</u>
Location	Roof Pit	Roof Pit
Serving	Library (Per JCI Docs)	Library (Per JCI Docs)
Config/Style	ERW, Supply and Exhaust Fans	Packaged RTU, DX Cooling, HW Heating
Mfr.	Semco ERU	Trane Voyager
Model #	FV5000T-4RN4AB	TFD301C30GCA
Serial #	33266/M017532-01	343100435D
Age (years)	11/2003	10/2003
System CFM		
Max OA CFM		
V/Hz/Ph	200/60/3	200/60/3
SF Qty/HP	(1) 1.5 (1) AX-51Belt Loose	(1) 7.5 (1) BX-81 Belt
SF VFD Data	N/A	N/A
EF Qty/HP	(1) 1.5 (1) Belt AX-51	N/A
EF VFD Data	N/A	N/A
Filter Data (Size Quantity)	(3) 16x25x1 Aluminum dirty, Replace	(4) 20x20x2 (4) 20x25x2
Filter Status	Filters are dirty	Clean 4-5-22 Change date
Controls Type	Electronic DDC, Packaged BAS, Trane Package	JCI Metasys
Controls Mfr.	Factory	
Economizer	Packaged economizer, 100% O.A. If functional	
CO ₂ DCV	-	
Damper Styles	Factory Slide, O.A. Needs to be cleaned adjusted and lubricated	N/A
Damper Status	Sketchy, Clean adjust and lubricate.	N/A

Heating Type	N/A	Hot Water
Heating Coil Condition	Unknown, no access doors for inspection, assumed dirty coils	No access to inspect
Cooling Type	Wheel	DX Package, Twin Circuit
Cooling Coil Condition	Wheel looks OK, did not seem to operate	Dirty, Needs cleaning
ERW	Horizontal Wheel, 1/15 HP.	N/A

Controls	Functionally is unclear as to if it works and or what mode system is in, Retro Cx recommended	
Drain Pan Status		OK, Flush after coil cleaning,
Notes:	Door Hardware, rusted, adjust, and lubricate

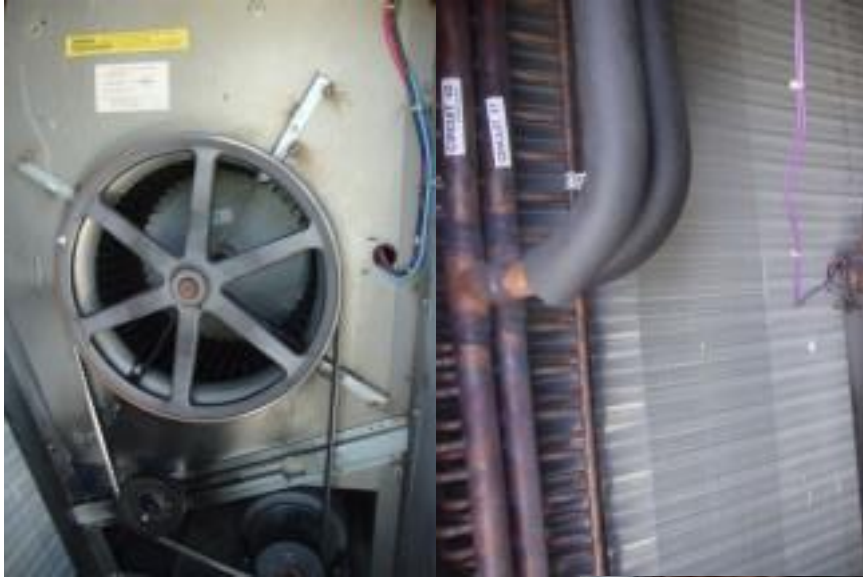
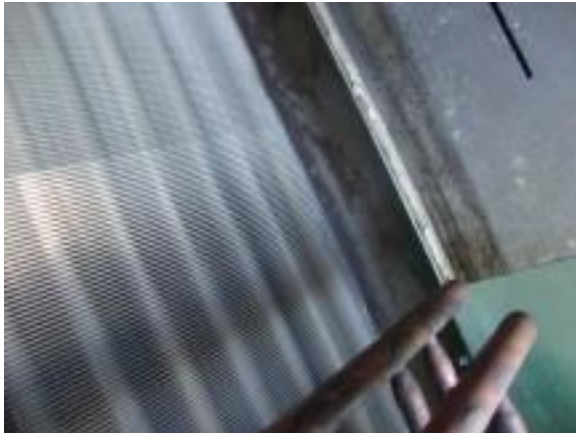
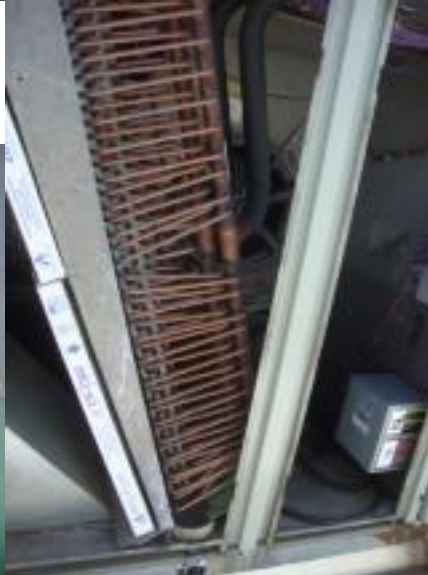
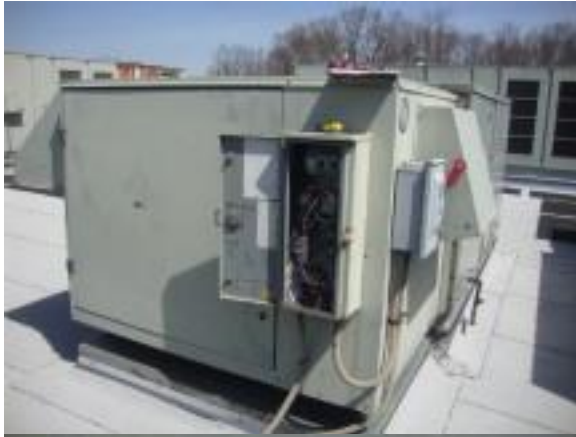
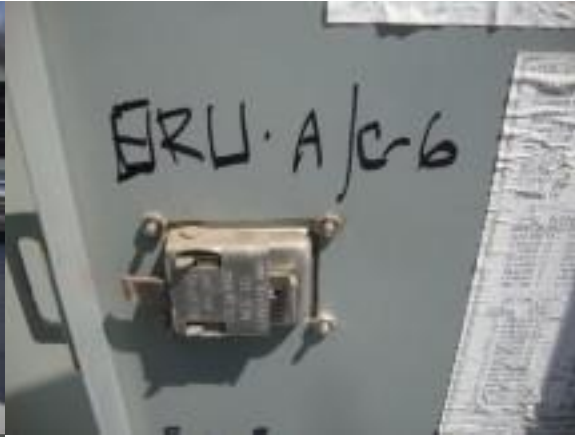
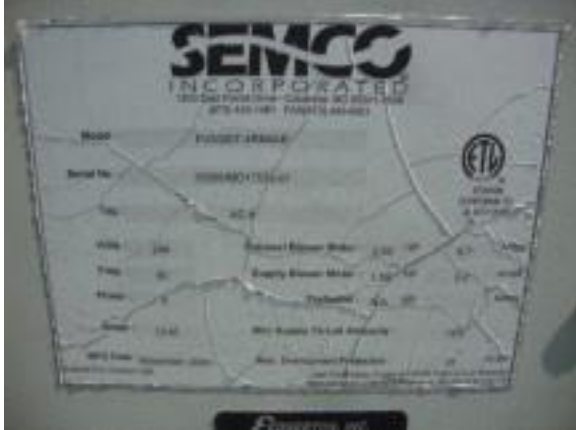
<u>Unit Tag</u>	<u>AC-7</u>	<u>Addition comments descriptions</u>
Location	Roof Pit	
Serving	Lobby- (Per JCI Docs)	
Config/Style	Packaged RTU, DX Cooling ERW, HW Heating	
Mfr.	Trane Intellipak	
Model #	SLHFC50ED56858DB1000A	
Serial #	C03J08216	
Age (years)	2003	
System CFM		
Max OA CFM		
V/Hz/Ph	200/60/3	Electrical Code clearances are not met
SF Qty/HP	(1) 30.0	
SF VFD Data	N/A	
EF Qty/HP	(1) 15.0 (1) BX-82 Belts	
EF VFD Data	N/A	
Filter Data (Size Quantity)	(3) 12x24x2, (9) 24x24x2 (3) 12x24x4 (9) 24x24x4	
Filter Status	Filters are clean, proper spacer	4-5-22 Change date
Controls Type	Electronic DDC, Packaged BAS, Trane Package	
Controls Mfr.	Factory	
Economizer	Packaged economizer	
CO ₂ DCV	-	
Damper Styles	Factory parallel,	
Damper Status	Seals falling off, Damper Linkage off. Clean adjust and Lubricate.	Found missing Bolt, reinstalled and corrected temporarily
Heating Type	Hot Water	
Heating Coil Condition	Unknown, no access doors for inspection, assumed dirty coils

Cooling Type	DX Package	
Cooling Coil Condition	OK, could use a cleaning	
ERW	Wheel, Airxchange Ser. 064248/0339, ¼ HP. Filters, (3) 24x24x2, (3) 12x24x2 Aluminum	Filters Dirty and rusted, replace. Wheel pie piece replaced, Wheel not running.
Wheel Exhaust	5.0 HP, Twin City Size 61 Type BAB-DW, Belt BX-65

Controls	Functionally it is unclear as to what mode system is in, Retro Cx recommended	
Drain Pan Status	OK, Flush after coil cleaning,	
Notes:	Door Hardware, rusted, adjust, and lubricate

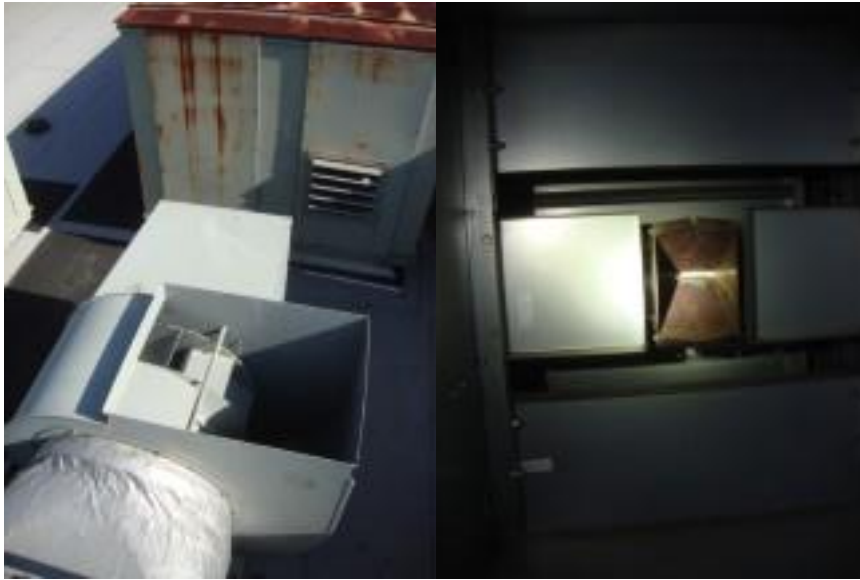
Photos

<u>Unit Tag</u>	<u>MAU-1</u>	<u>Addition comments descriptions</u>
Location	Enclosed Rooftop Equipment Area, South	
Serving	Kitchen JCI Documents	Associated with EF-7
Config/Style	Makeup Air Unit	
Mfr.	Greenheck	
Model #	DGX-112HH22-DB	
Serial #	03J103383	
Age (years)		
System CFM		
Max OA CFM		
V/Hz/Ph	208/60/3	
SF Qty/HP	3.0 (1) Belt AX-52	
SF VFD Data	N/A	
RF Qty/HP	N/A	
RF VFD Data	N/A	
Filter Data (Size Quantity)	(6) 20x20x2 Aluminum	
Filter Status	Dirty	
Controls Type	Factory Dampers and controls	Damper tightly closed when unit was off
Controls Mfr.		
Economizer	100% O.A.	
CO ₂ DCV	N/A	
Damper Styles	Opposed	
Damper Status	OK	
Heating Type	Gas	
Heating Coil Condition	Burner, OK	
Cooling Type	N/A	
Cooling Coil Condition	N/A	
Drain Pan Status	N/A	
Notes:	Operation Unknown,
