Timothy Dwight Elementary School

Fairfield Public Schools Recommissioning (RCx) and Testing, Adjusting, & Balancing (TAB) Study

van Zelm Project # 2020102.00 (03-DES)

June 28, 2022

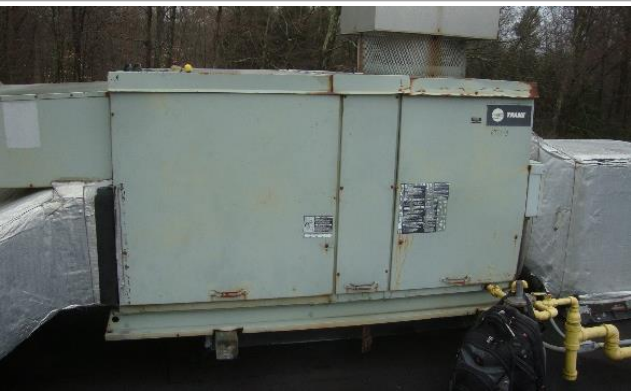
Unit from afar

<u>Unit Tag</u>	<u>Gym Office RTU</u>	<u>Addition comments descriptions</u>
Location	Roof	Unit was Off
Serving	Gym Office	
Config/Style	Gas/Dx Package	
Mfr.	Trane	
Model #	YCC018F1LOBJ	
Serial #	4293LUC2H	
Age (years)	7/2004	
System CFM		
Max OA CFM		
V/Hz/Ph	208/230V 60 1-PHASE	
SF Qty/HP	Unknown	
SF VFD Data	N/A	
RF Qty/HP	N/A	
RF VFD Data	N/A	
Filter Data (Size Quantity)	(1) 22"X16" (1) 22"X8"	
Filter Status	Change required (9-15-21)	
Controls Type	Factory	
Controls Mfr.		
Economizer	Yes	
CO ₂ DCV		
Damper Styles	Opposed	
Damper Status	OK, operational unknown	
Heating Type	Gas	
Heating Coil Condition	Burner	
Cooling Type	DX	
Cooling Coil Condition	OK	
CU Mfr.	N/A	
CU Model	N/A	
CU Serial	N/A	
Drain Pan Status	OK	
Notes:	Unit was off, functionality unknown. Compressor was wrapped, noise concerns?

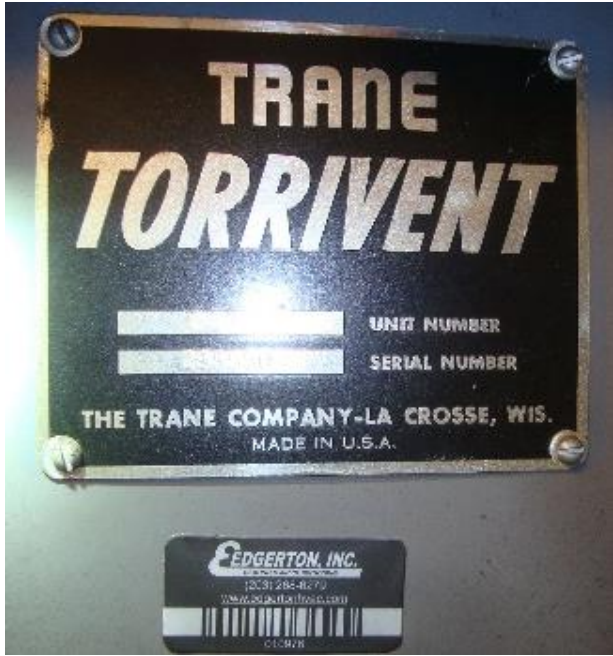
A black metal tag with white text. The top line reads 'TRANE' in a bold, sans-serif font. Below it, 'TORRIVENT' is written in a larger, bold, sans-serif font. Underneath, there are two horizontal white bars. To the right of the first bar is the text 'UNIT NUMBER' and to the right of the second bar is 'SERIAL NUMBER'. At the bottom, it says 'THE TRANE COMPANY-LA CROSSE, WIS.' and 'MADE IN U.S.A.'. Below the tag is a smaller black tag with 'EDGERTON, INC.' in white, followed by '12031 284-4170' and 'www.edgerton.com'. A barcode is at the bottom of this tag with the number '010878' below it.
Control Dampers: Linkage is not connected. Linkage laying on top of ductwork.

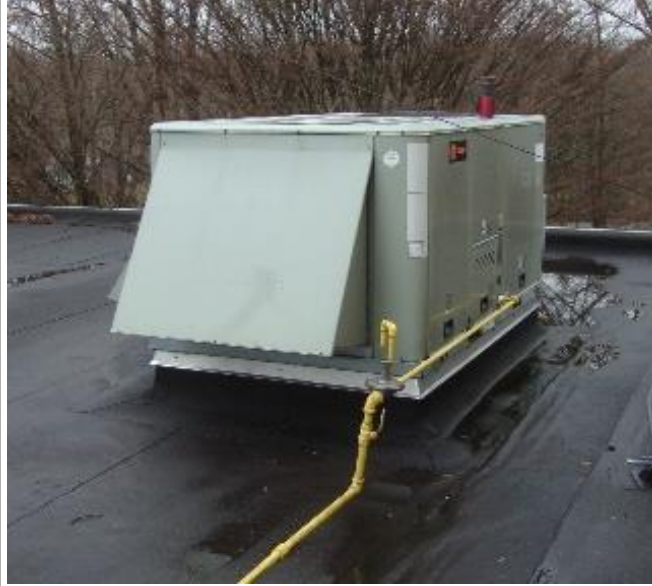
Unit from afar

<u>Unit Tag</u>	<u>Office RTU</u>	<u>Addition comments descriptions</u>
Location	Roof	
Serving	Main Offices	
Config/Style	Gas/Dx Package	
Mfr.	Trane	
Model #	YSC072A3EMA06Z9	
Serial #	432101954L	
Age (years)	8/2004	
System CFM		
Max OA CFM		
V/Hz/Ph	208/230v 60HTz. 3-Phase	
SF Qty/HP	(1) 1.0 Belt drive	
SF VFD Data	N/A	
RF Qty/HP	N/A	
RF VFD Data	N/A	
Filter Data (Size Quantity)	(4) 16"x25" x2"	
Filter Status	Change due	9/15/21
Controls Type	Package, functionality unknown	Wires were found unattached to the insulated electrical stake ons. Controllers were not mounted properly
Controls Mfr.	Factory	
Economizer	Yes	
CO ₂ DCV		
Damper Styles	Factory	
Damper Status	ok	
Heating Type	Gas	
Heating Coil Condition	Burner	
Cooling Type	DX	
Cooling Coil Condition	Dirty	
CU Mfr.	N/A	
CU Model	N/A	
CU Serial	N/A	
Drain Pan Status	Plastic, OK	
Notes:	Cooling not verified, Roof gas line supports poor.
