Fairfield Woods Middle School

Fairfield Public Schools Recommissioning (RCx) and Testing, Adjusting, & Balancing (TAB) Study van Zelm Project # 2020102.00 (05-FWMS) August 01, 2022

FAIRFIELD PUBLIC SCHOOLS RECOMMISSIONING (RCX) AND TESTING, ADJUSTING, & BALANCING (TAB) STUDY

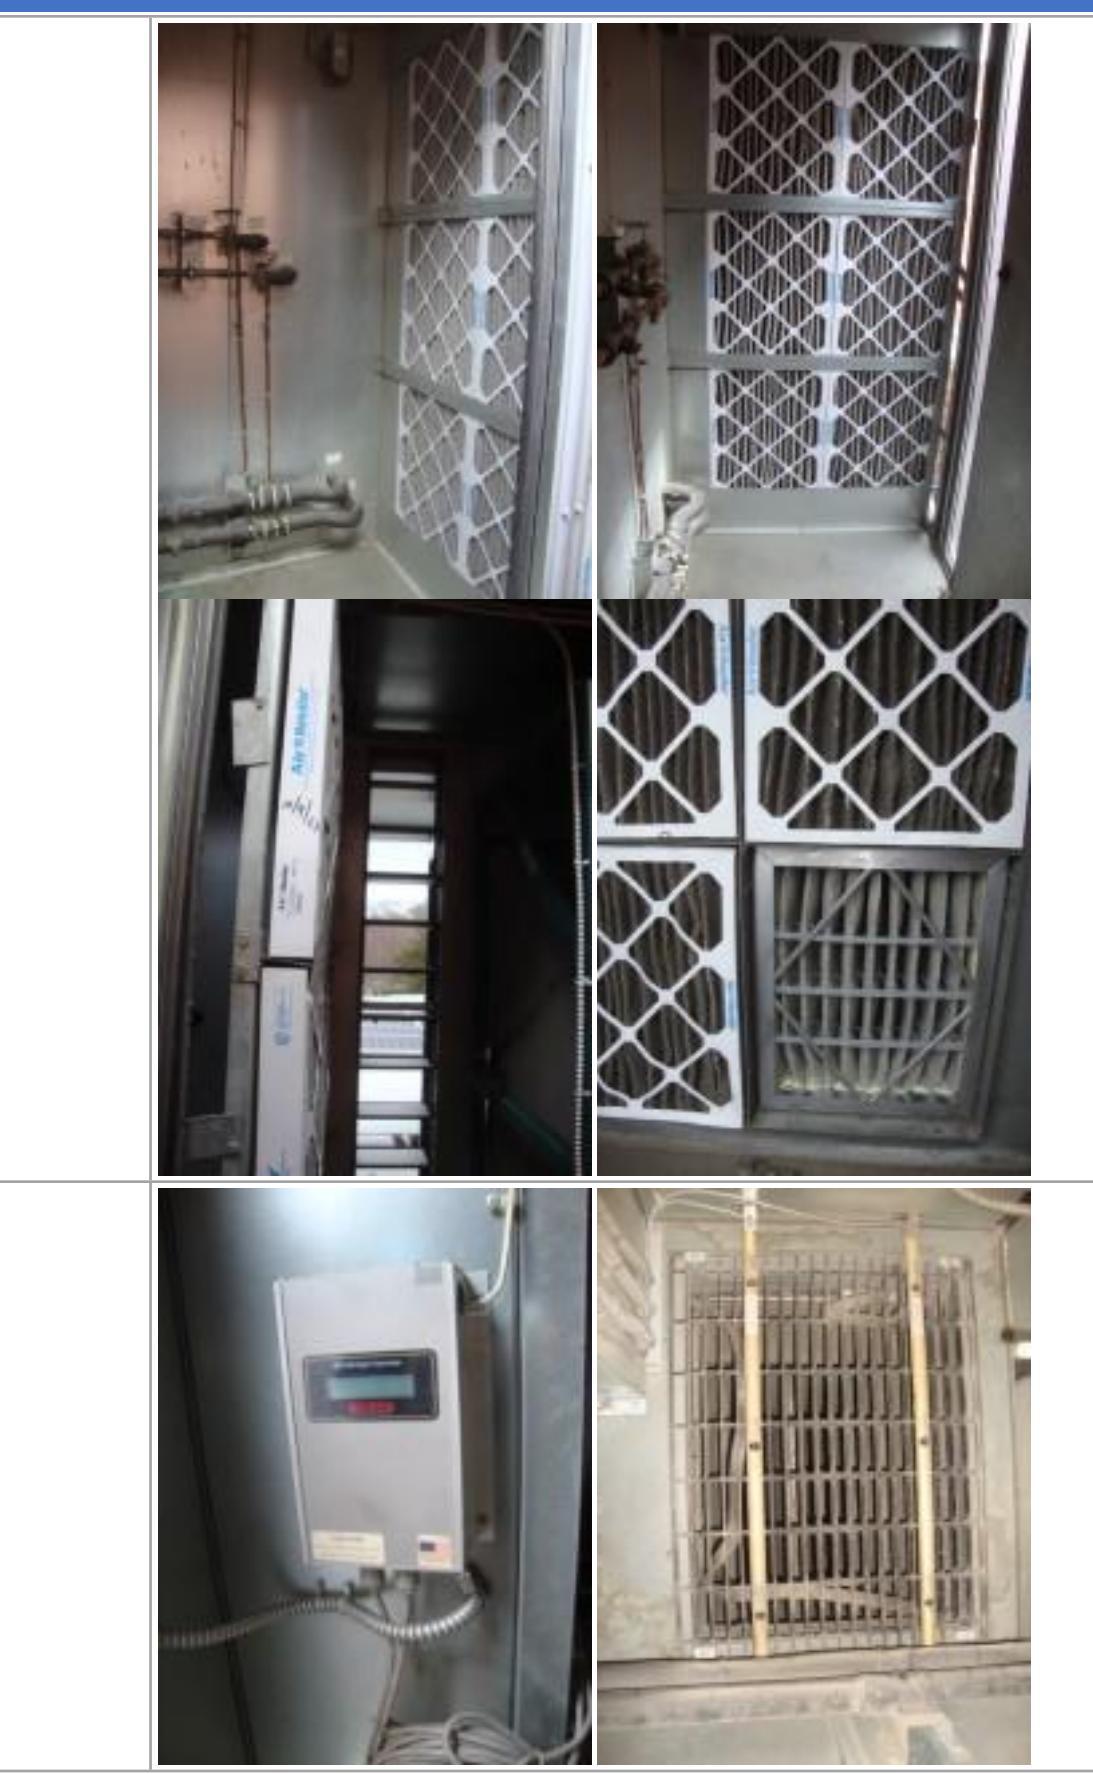
Filters

<u>Unit Tag</u>	RTU-8	Addition comments descriptions
Location	North Roof	
Serving	Cafeteria	
Config/Style	VAV AHU, SF/EF, HW, DX Cooling, ERW	
Mfr.	Venmar CES	
Model #	5WC-6-48x30x2-8AL	
Serial #	00547980-C04249	
Age (years)	80/2011	
System CFM	5600	1994 drawings indicate 8000 cfm max
Max OA CFM	5600	
V/Hz/Ph	460/60/3	
SF Qty/HP	(2) 3.0 Fan wall direct drive	
SF VFD Data	VFD ABB	
EF Qty/HP	(1) 5.0 Belt driven, mismatched (2) AX-56	
EF VFD Data	VFD ABB	
Filter Data (Size Quantity)	Outdoor intake: (6) 16"x20"x2" Pre (6) 16"x20"x11.5" Final	Return Air: (6) 24"x24"x2"
Filter Status	Dirty changed on (10-4-21)	Dirty changed on (10-4-21)
Controls Type	Packaged	
Controls Mfr.	Delta/Allerton	
Economizer	Yes 100% O.A. capable	
CO ₂ DCV		
Damper Styles	Tamco parallel	
Damper Status	Dirty, seals need to be cleaned, lubricated, and adjusted (All)	
Heating Type	Hot water	
Heating Coil Condition	Coil should be professionally cleaned (Coated)

Cooling Type	Packaged DX	
Cooling Coil Condition	Coil should be professionally cleaned (Herisite Coated)	
CU Mfr.		
CU Model		
CU Serial		
Drain Pan Status	Clean, should be flushed after coil cleaning	
Notes:	1/3 HP Wheel is clean, Wheel operation unknown, Unit in economizer upon inspection.

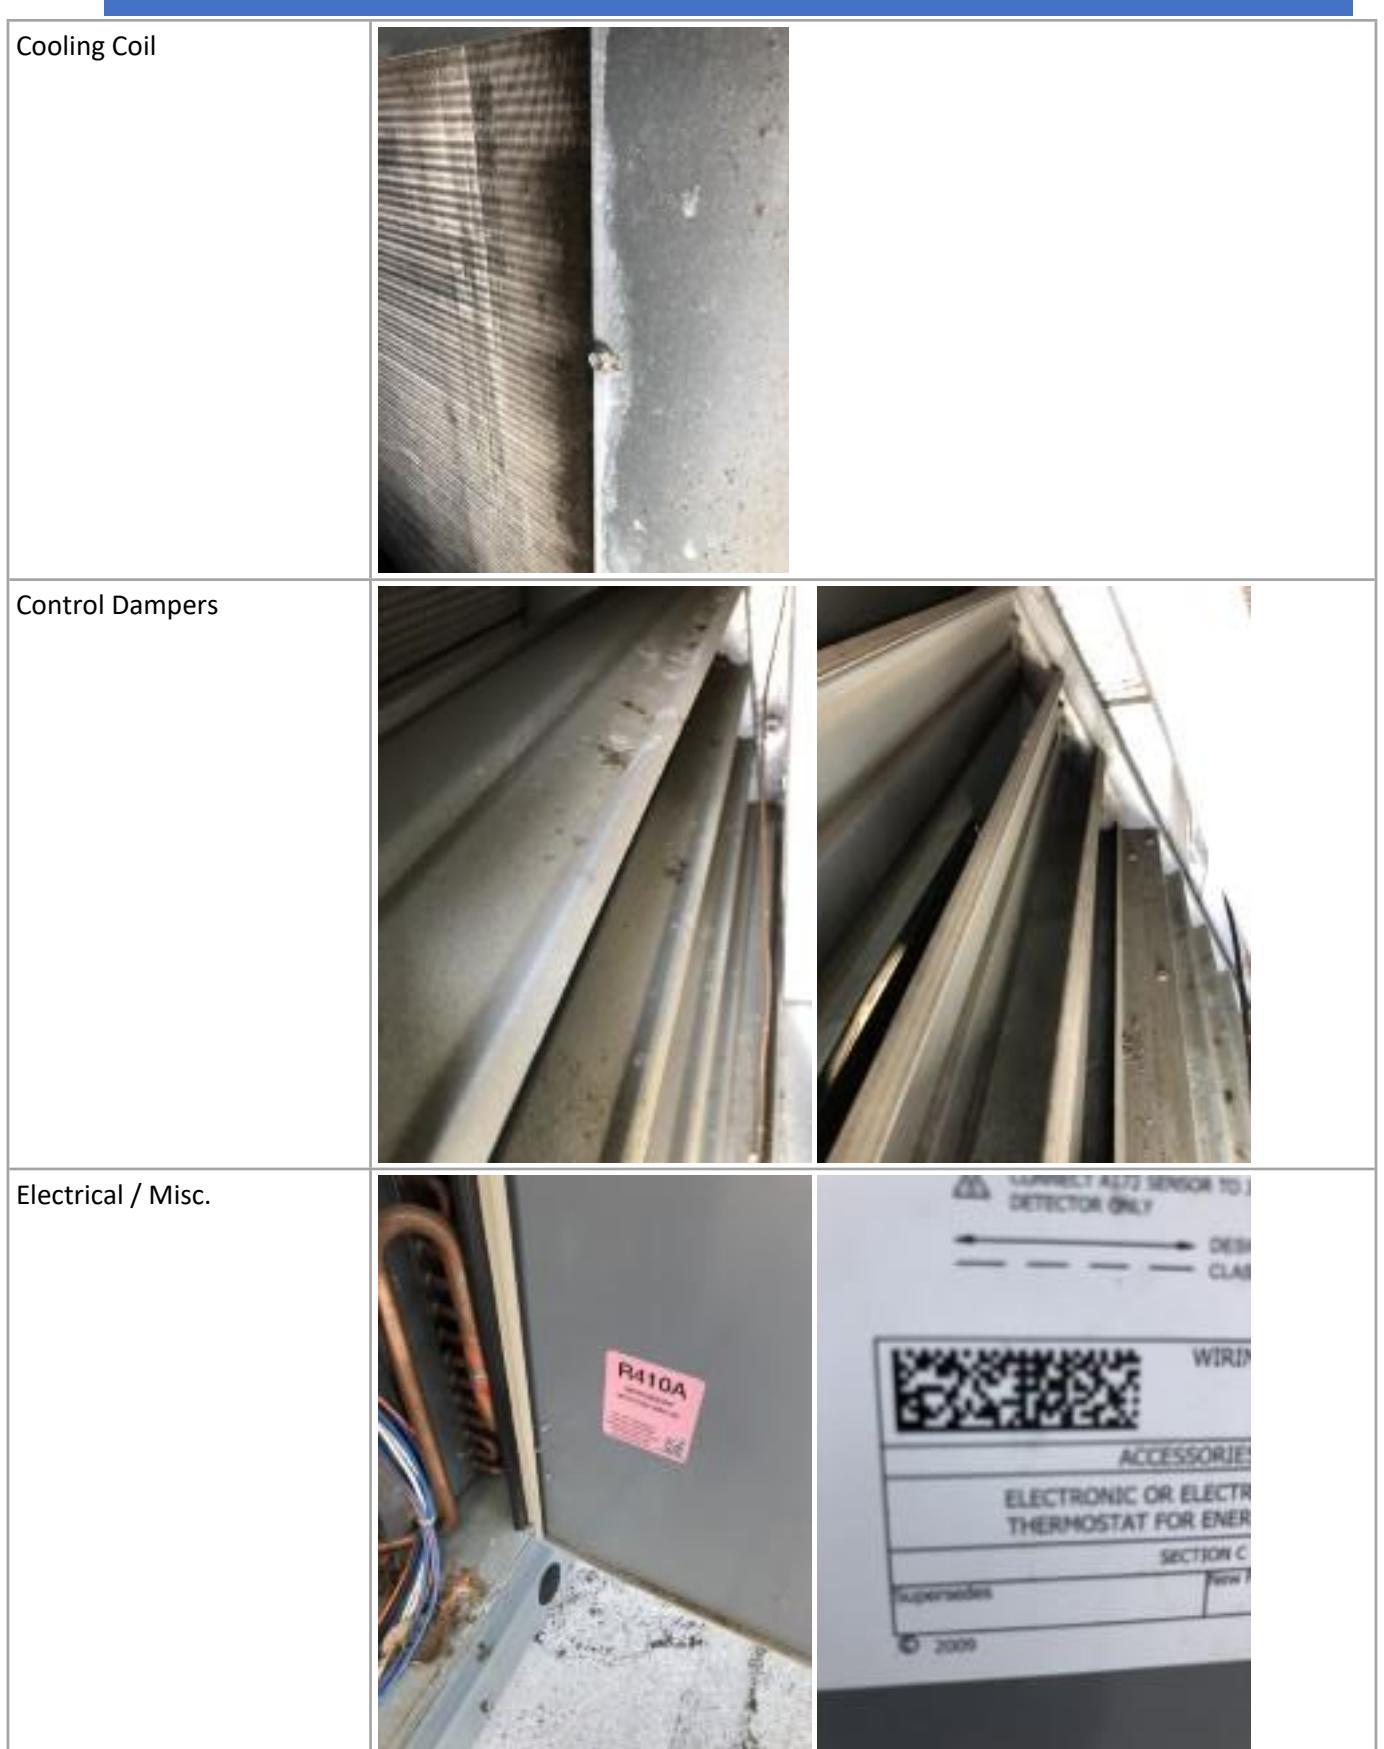
Unit Tag	RTU-20	Addition comments descriptions
Location	Center East Roof	
Serving	Classrooms	
Config/Style	CV AHU, SF, w/ Economizer, HW, DX Cooling	
Mfr.	Lennox	
Model #	LCH060H4ENiG	
Serial #	5611F01201	
Age (years)	2009?	
System CFM	1420	
Max OA CFM	320	
V/Hz/Ph		
SF Qty/HP		
SF VFD Data		
RF Qty/HP	1HP Looks to be an ECM motor	
RF VFD Data		
Filter Data (Size Quantity)	(4) 20 x 20 x 2	
Filter Status	Dirty	
Controls Type	DDC Electronic	
Controls Mfr.	Packaged /	No Alerton controller in cabinet
Economizer		
CO ₂ DCV		
Damper Styles	Opposed	
Damper Status	Dampers in need of cleaning, adjusting and lubrication	
Heating Type	NA	
Heating Coil Condition		
Cooling Type	DX 2-stage	
Cooling Coil Condition	Very dirty	
Drain Pan Status	Could use cleaning	
Notes:

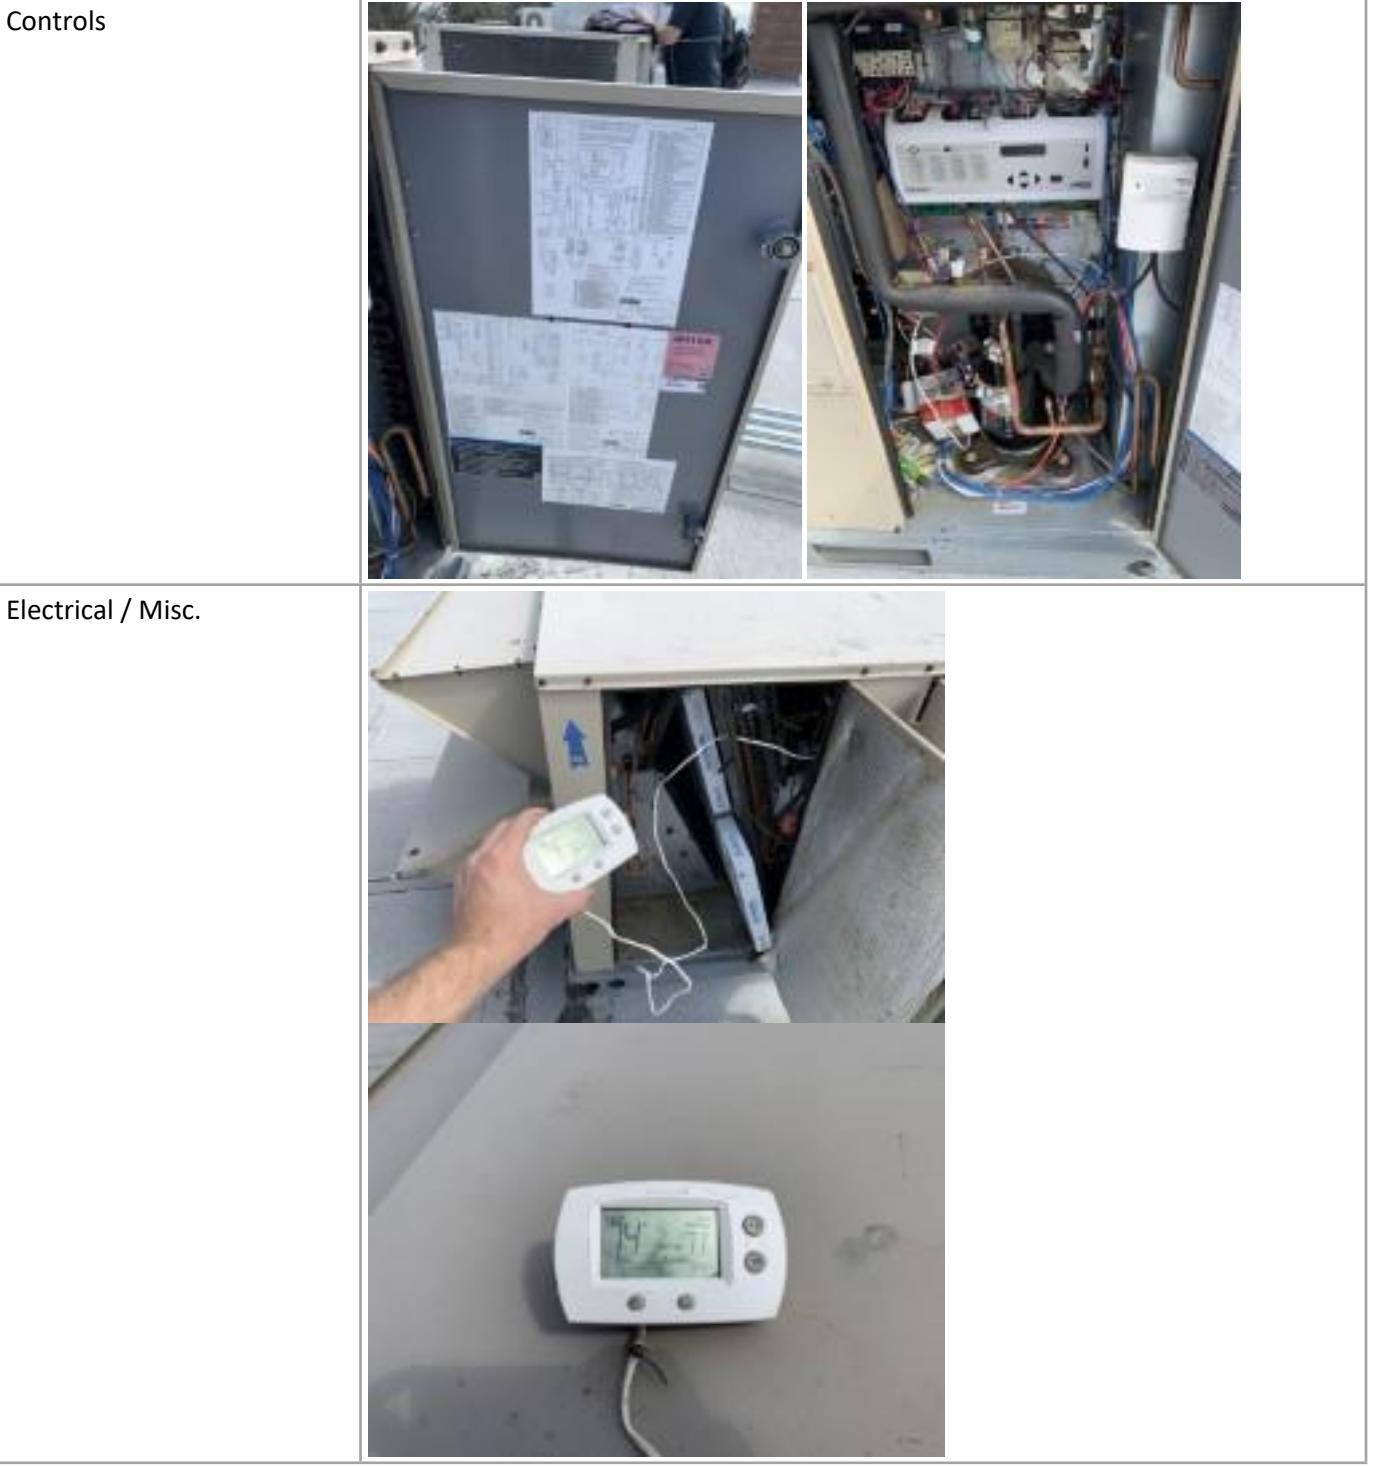
<u>Unit Tag</u>	RTU-22	Addition comments descriptions
Location	Center East Roof	
Serving	1 st Floor Offices	
Config/Style	CV AHU, SF, w/ Economizer, HW, DX Cooling	Found OFF and in alarm
Mfr.	Lennox	
Model #	LCH048S4TN1G	
Serial #	5611F01203	C/N: N3623
Age (years)	13?	
System CFM	1120	
Max OA CFM	390	
V/Hz/Ph	460V / 60Hz / 3Ph	
SF Qty/HP	1, 2.0	
SF VFD Data	460V / 2.0A / 60Hz	
RF Qty/HP	N/A	
RF VFD Data	N/A	
Filter Data (Size Quantity)	4x 16x20x2	
Filter Status	Very clean	Unit hasn't run or has run very little since the previous filter change
Controls Type	Lennox packaged	
Controls Mfr.	Lennox Commercial	
Economizer	Partial, relief damper	
CO ₂ DCV		
Damper Styles	Parallel blade	
Damper Status	Issue with closure on RA	Wall-mountable t-stat found wired and suspended in the RA duct section, presumably to control the unit based on "space" conditions rather than from a sensor down below. In theory this could work, but in practice it prevents the dampers from closing fully. The wire is quite damaged

Heating Type	Hot Gas Bypass	(Other Lennox units also have Hot Gas Bypass)
Heating Coil Condition	Good	
Cooling Type	DX	
Cooling Coil Condition	Good	
CU Mfr.	Copeland Scroll
