Holland Hill Elementary School

Fairfield Public Schools Recommissioning (RCx) and Testing, Adjusting, & Balancing (TAB) Study van Zelm Project # 2020102.00 (15-HHES)

August 08, 2022

FAIRFIELD PUBLIC SCHOOLS RECOMMISSIONING (RCX) AND TESTING, ADJUSTING, & BALANCING (TAB) STUDY

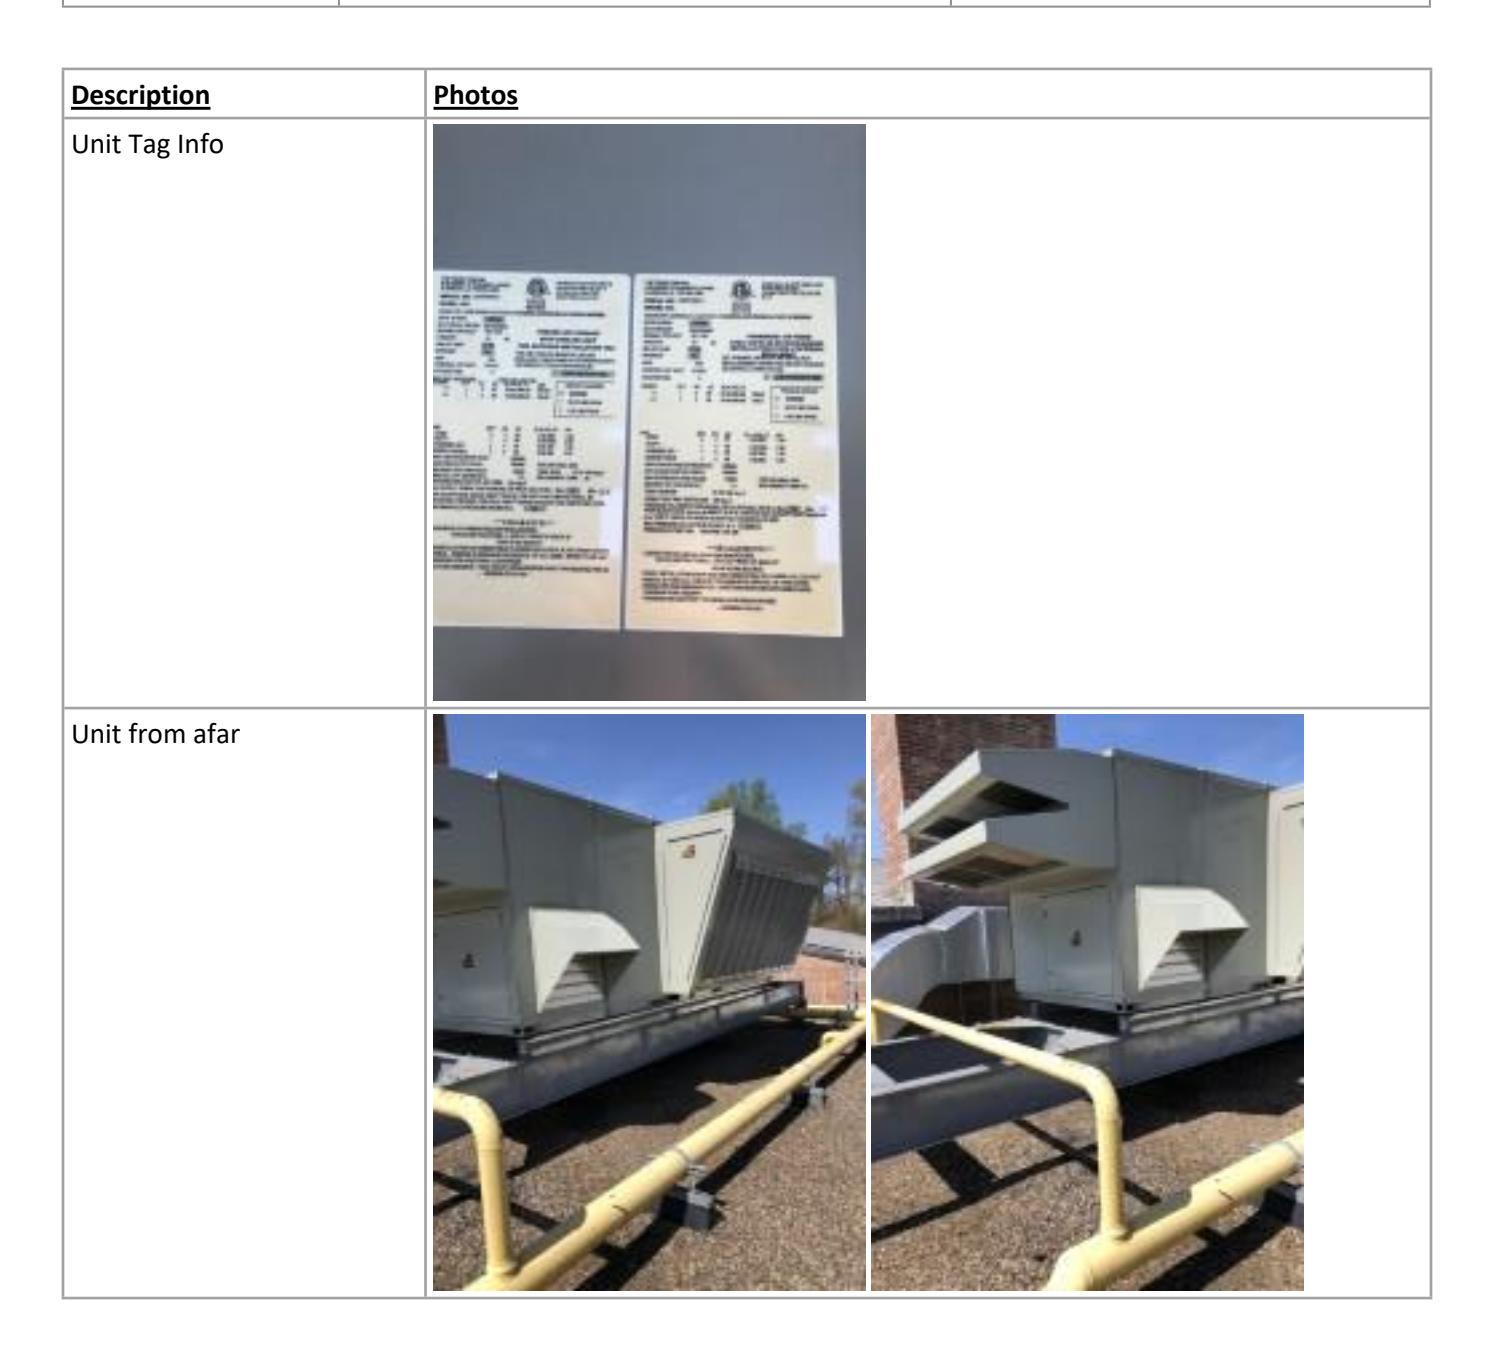
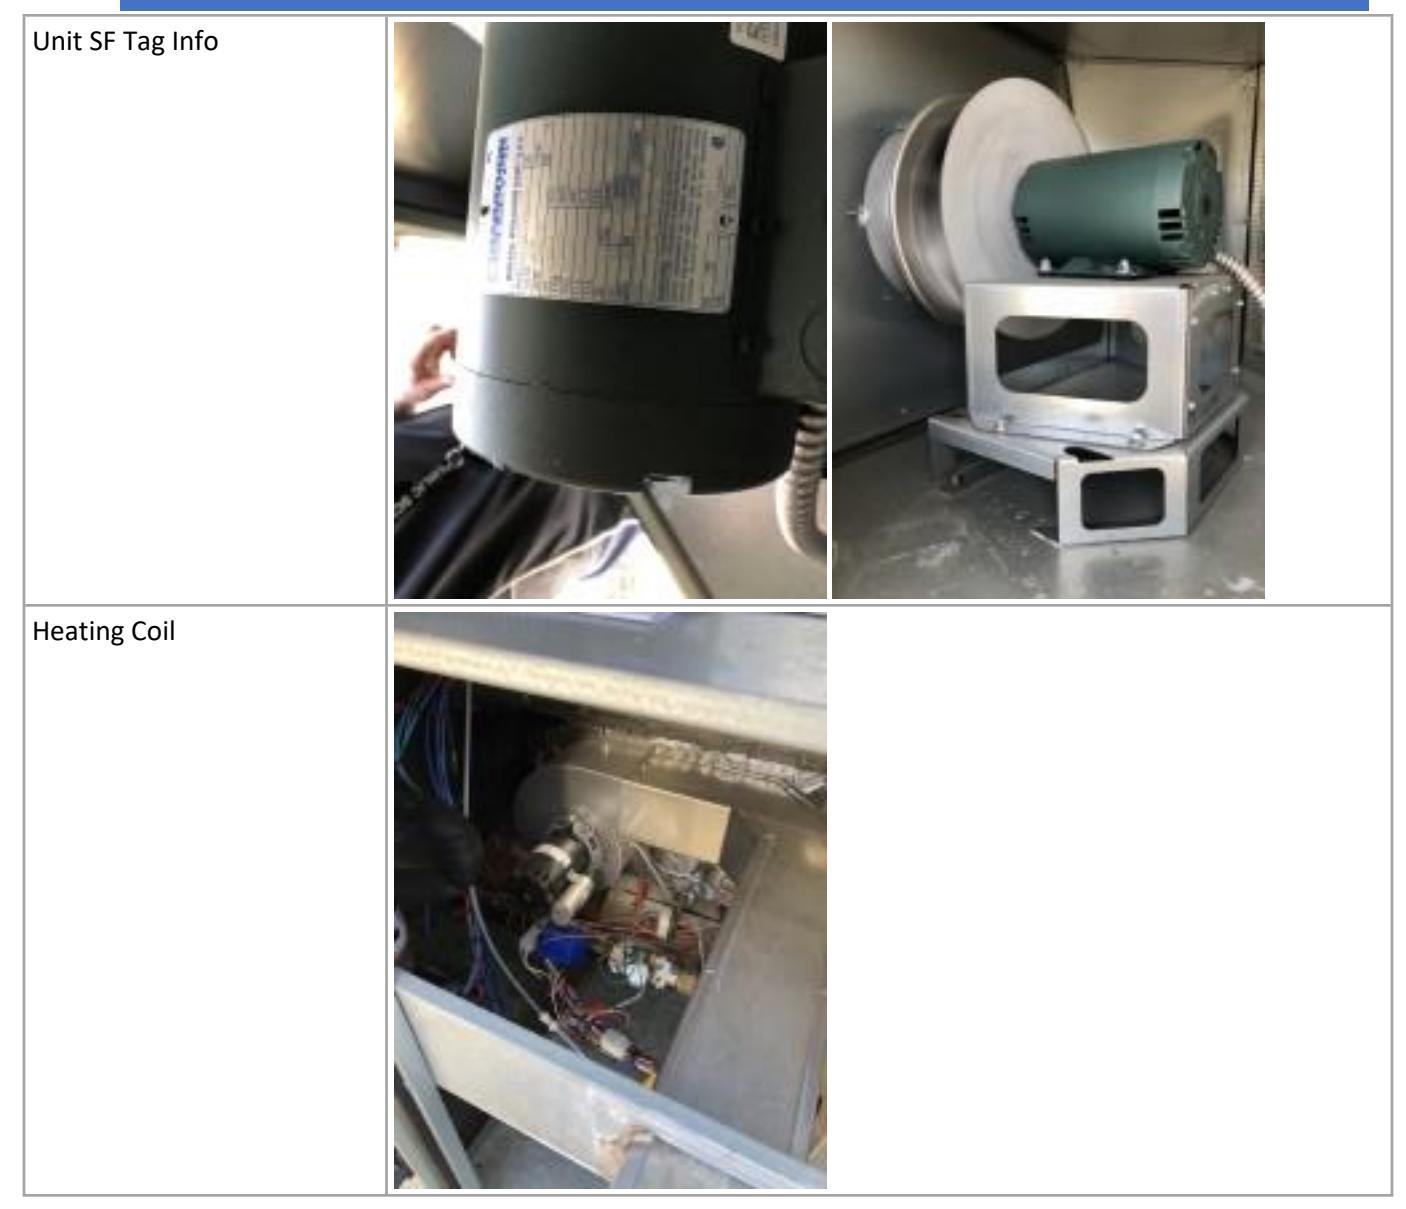
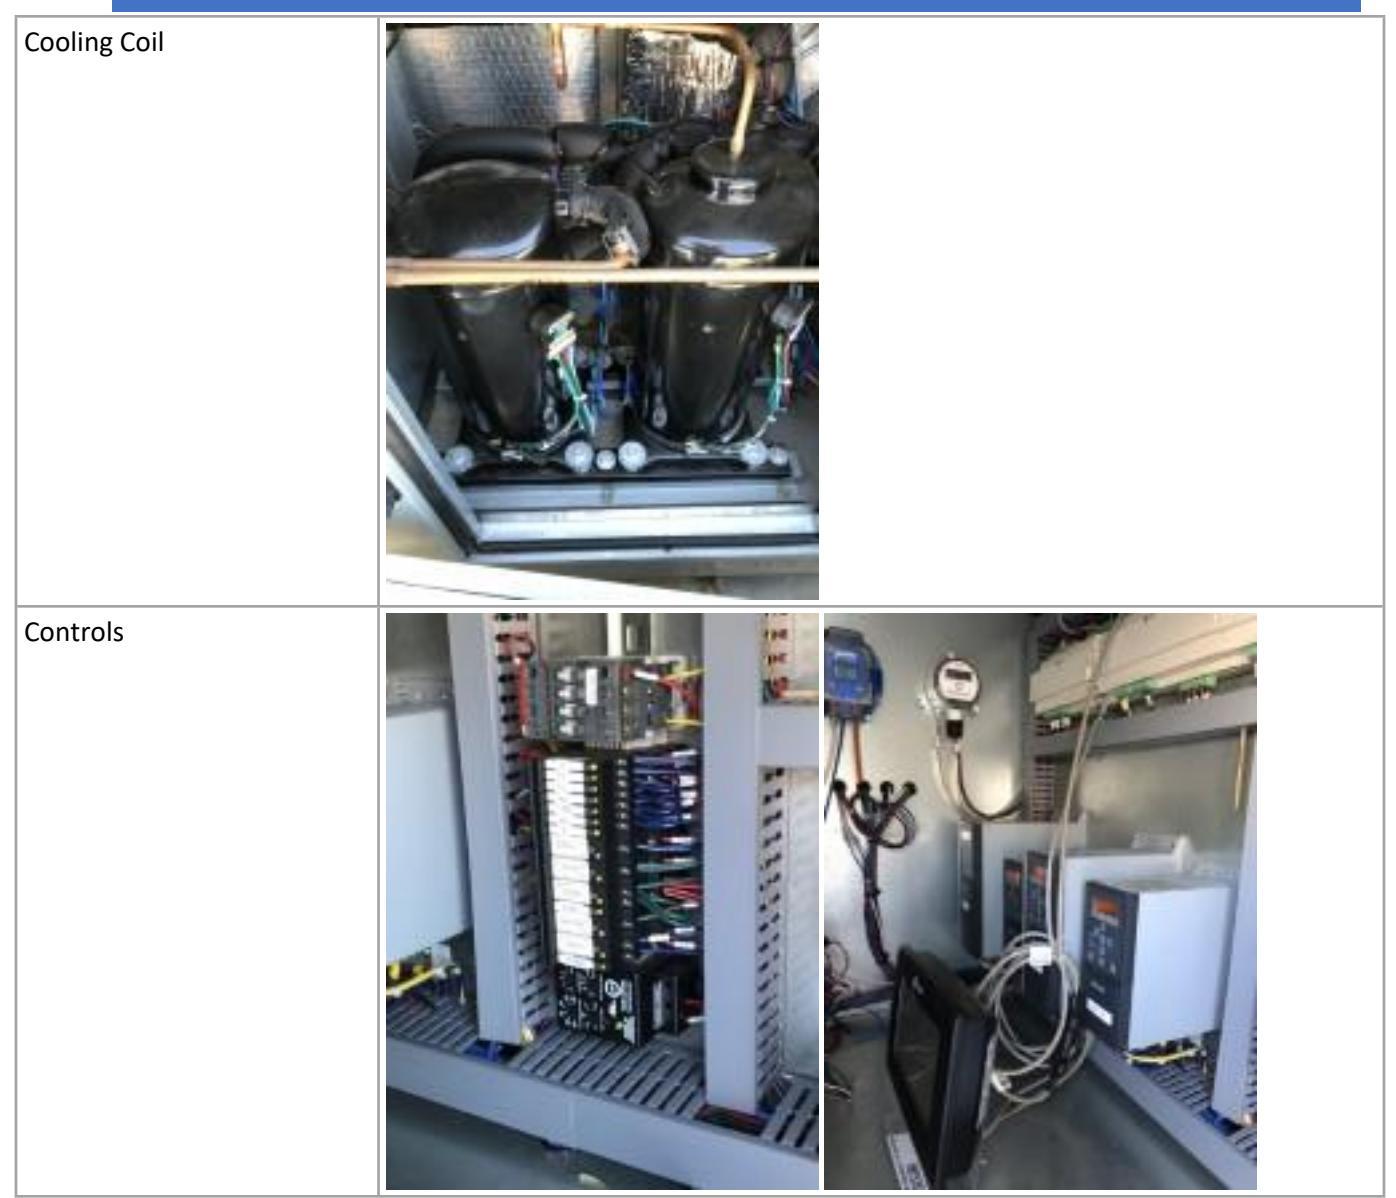
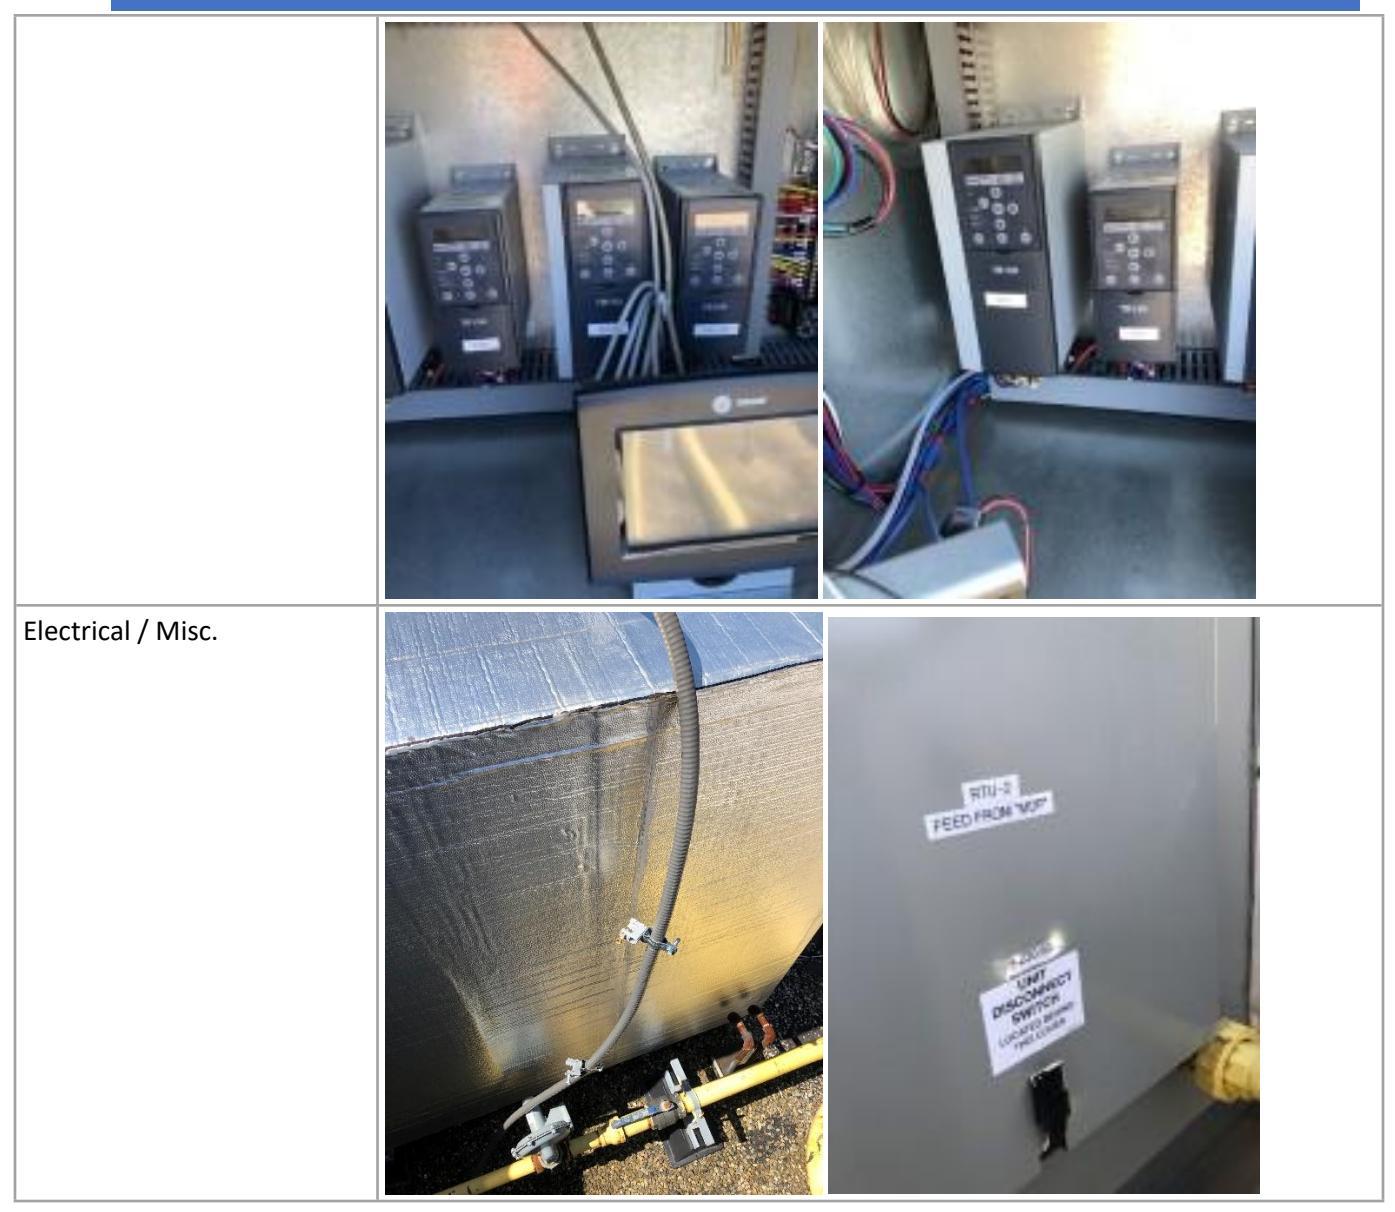
<u>Unit Tag</u>	RTU-2	Addition comments descriptions
Date: 5-5-22	Auditor: RCM	
Location	Middle Roof	
Serving	120 All-Purpose Room	
Config/Style	Rooftop SF/RF Gas Heat, DX cooling, ERW	
Mfr.	Trane	
Model #	0ADG012F1-CAB10AG00-J1AJC1AC1-41A40B03A- A00C00AB0-AA1A00A0	
Serial #	0A276188-5-1	
Age (years)	2019	
System CFM	5170	
Max OA CFM	1700	
V/Hz/Ph	208/60/3	
SF Qty/HP	5 HP	
SF VFD Data		
RF Qty/HP	1.5 HP Exh	
RF VFD Data		
Filter Data (Size Quantity)	(6) 18 X 24 X 2 SA, (6) 20 X 20 X 2 RA & ODA	
Filter Status	Clean 4-27-22	
Controls Type	Trane with BAS integration	
Controls Mfr.	Alerton BAS	
Economizer	Yes	
CO ₂ DCV	No	
Damper Styles		
Damper Status	Clean	
Heating Type	Gas Modulating	
Heating Coil Condition	250 MBH Output Modulation	
Cooling Type	DX Digital Scroll and Dx	
Cooling Coil Condition	Clean	
Drain Pan Status	Clean	
Notes:	Unit access doors very heavy and not hinged set up on dunnage. Access requires standing on Ductwork. Noted Electrical non-metallic conduit

to unit (not Main) not fastened and subject to	
damage and trip hazard
