# Jennings Elementary School 31 Palm Drive

# Fairfield Public Schools Recommissioning (RCx) and Testing, Adjusting, & Balancing (TAB) Study

van Zelm Project # 2020102.00 (10-JES) October 07, 2022

# **Jennings Elementary School**

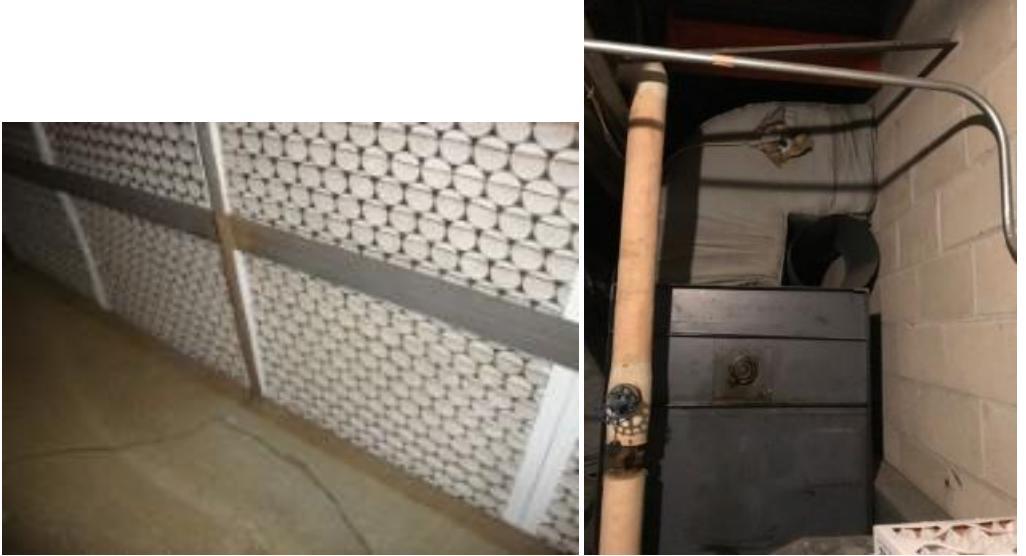
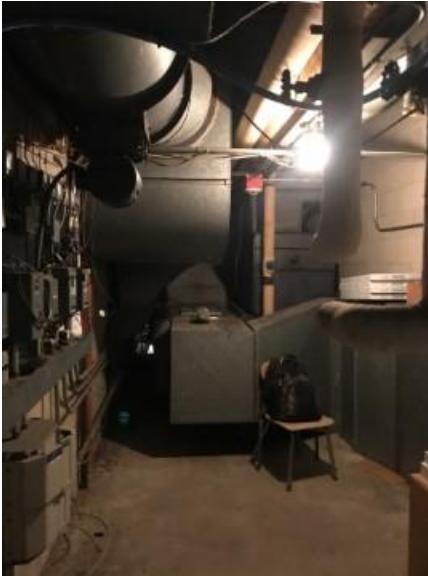
Unit Tag	HV-2	Addition comments descriptions
Location	Mezzanine	
Serving	Main Office	
Config/Style	Heating and Ventilation Unit, Climate Changer	
Mfr.	Trane	
Model #	Type L-17	
Serial #	К1003693	
Age (years)		
System CFM		
Max OA CFM		
V/Hz/Ph	208-230/60/3	
SF Qty/HP	(1) Unknown	
SF VFD Data	N/A-Starter constant speed	
RF Qty/HP	(1) Unknown	
RF VFD Data	N/A-Starter constant speed	
Filter Data (Size Quantity)	(XX) 16x22x12	
Filter Status	Clean, difficult to access	
Controls Type	Pneumatic	
Controls Mfr.		
Economizer		
CO <sub>2</sub> DCV		
Damper Styles	Duct Mounted, no access	
Damper Status	Unknown	
Heating Type	Hot Water	
Heating Coil Condition	Dirty	
Cooling Type	N/A	
Cooling Coil Condition	N/A	
Drain Pan Status	N/A	
Notes:	Units are beyond their useful life and should be replaced. Inline return fan appears to have not run in a long time. Belt rusted in place
