# McKinley Elementary School

## **Fairfield Public Schools Recommissioning (RCx) and Testing, Adjusting, & Balancing (TAB) Study** van Zelm Project # 2020102.00 (11-McKES) September 15, 2022

### **FAIRFIELD PUBLIC SCHOOLS RECOMMISSIONING (RCx) AND TESTING, ADJUSTING, & BALANCING (TAB) STUDY**

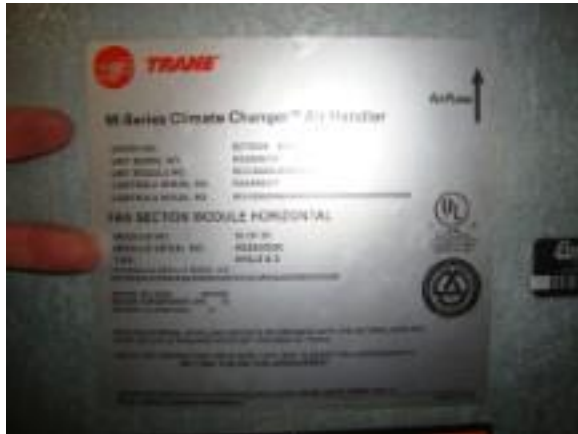
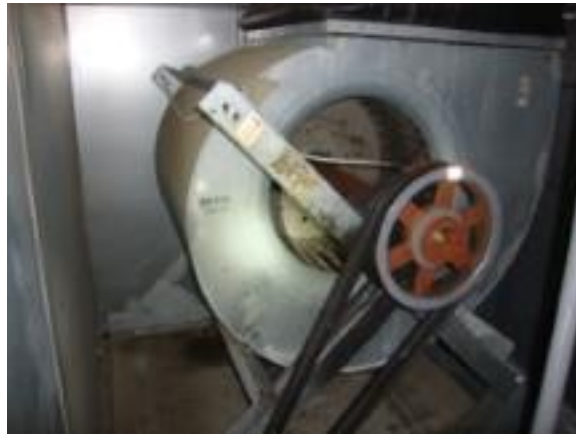
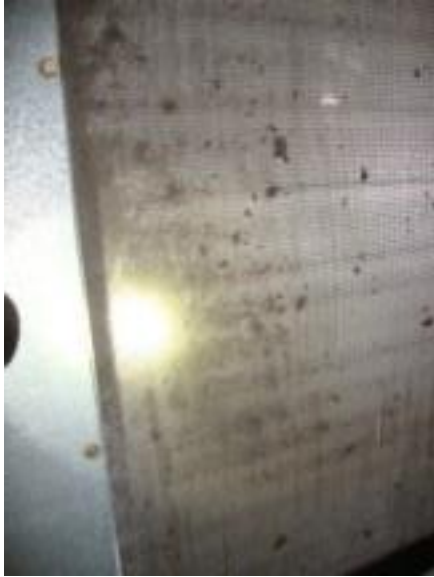
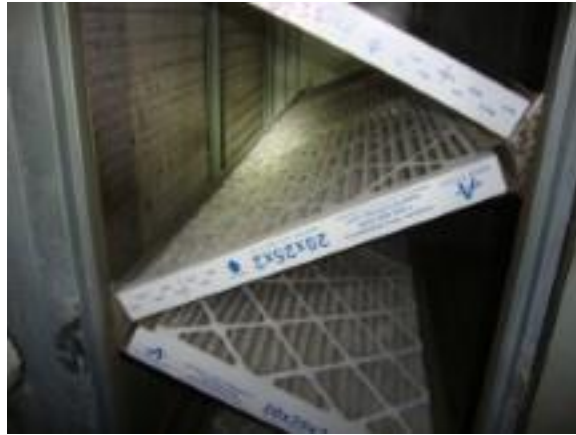
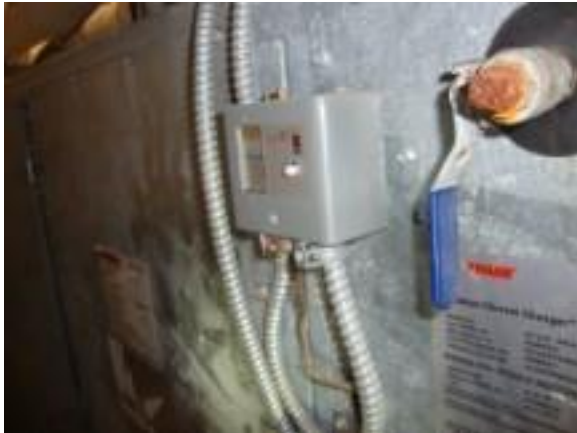
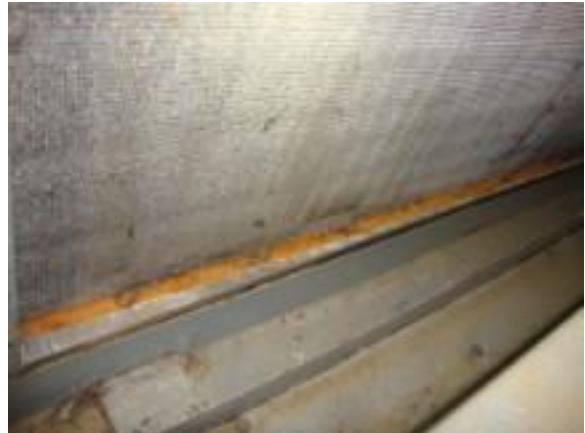
<u>Unit Tag</u>	<u>AHU-2</u>	<u>Addition comments descriptions</u>
Location	MER 205	
Serving	Gym	
Config/Style	Climate Changer	
Mfr.	Trane	
Model #	MCCB025UAOAOUA	
Serial #	KO3A00217	
Age (years)		
System CFM		
Max OA CFM		
V/Hz/Ph	460/60/3	
SF Qty/HP	15 (3) BX70	
SF VFD Data	VFD ABB	
RF Qty/HP	7.5 Inline Greenheck 24-TCF-9 (2) BX-61	
RF VFD Data	VFD ABB	
Filter Data (Size Quantity)	(12) 20x25x2	
Filter Status	OK 4/7/22	
Controls Type	DDC Metasys	
Controls Mfr.		
Economizer	Available	
CO <sub>2</sub> DCV		
Damper Styles	Ductwork mounted, Opposed blade	
Damper Status	OK, clean, adjust and lubricate	
Heating Type	Hot Water	
Heating Coil Condition	Dirty	
Cooling Type	Chilled water	
Cooling Coil Condition	Dirty	
Drain Pan Status	Rusty Galv.	
Notes:	Room full of lint from Gym non ducted return.

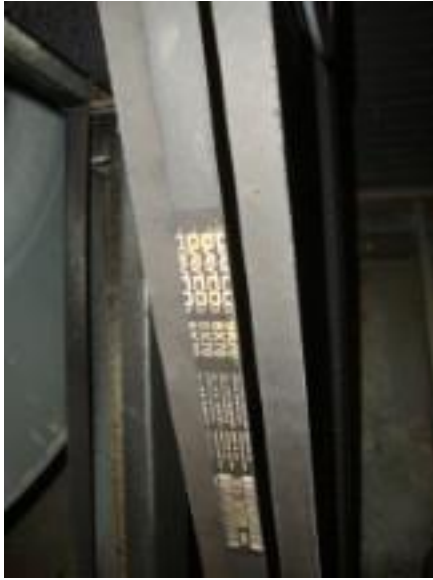
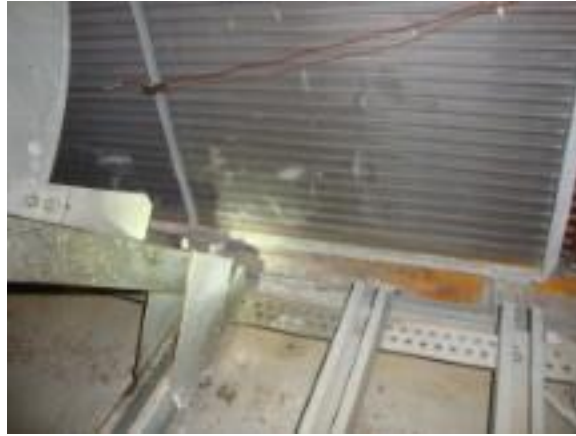
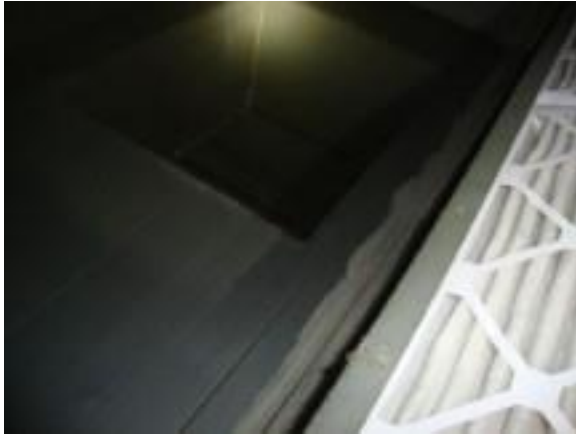
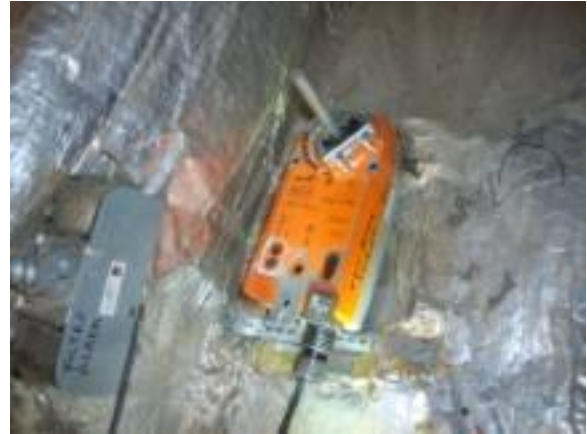
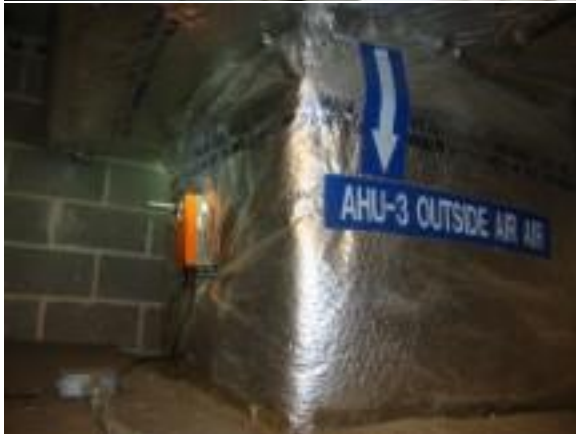
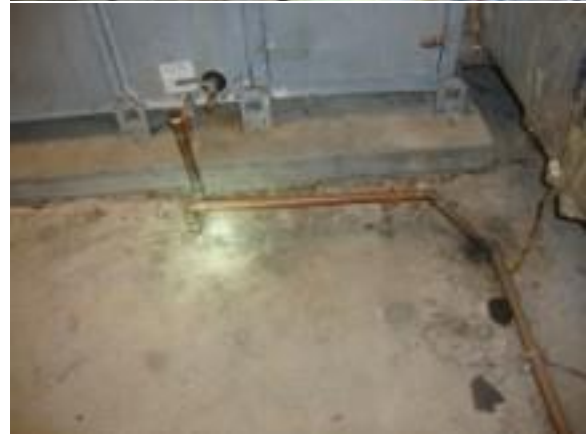
<u>Unit Tag</u>	<u>AHU-3</u>	<u>Addition comments descriptions</u>
Location	MEZZ 209	
Serving	-	
Config/Style	Climate Changer	
Mfr.	Trane	
Model #	MCCB025UAOAOUA	
Serial #	KO3A00204	
Age (years)		
System CFM		
Max OA CFM		
V/Hz/Ph	460/60/3	
SF Qty/HP	15 (3) BX70	
SF VFD Data	VFD ABB ACH-401	
RF Qty/HP	RF-3 7.5 Inline Greenheck 24 TCF-9 (1) AP-56	
RF VFD Data	VFD ABB	
Filter Data (Size Quantity)	(12) 20x25x2	
Filter Status	OK 4/7/22	
Controls Type	DDC Metasys	
Controls Mfr.		
Economizer	Available	
CO <sub>2</sub> DCV		
Damper Styles	Ductwork mounted, Opposed blade, no access	
Damper Status	OK, clean, adjust and lubricate	
Heating Type	Hot Water	
Heating Coil Condition	Dirty	
Cooling Type	Chilled Water	
Cooling Coil Condition	Dirty, cleaning would improve	
Cu Man		
Cu Model/Serial		
Drain Pan Status	Rusty Galv.	
Notes:	Damper operations unknown,

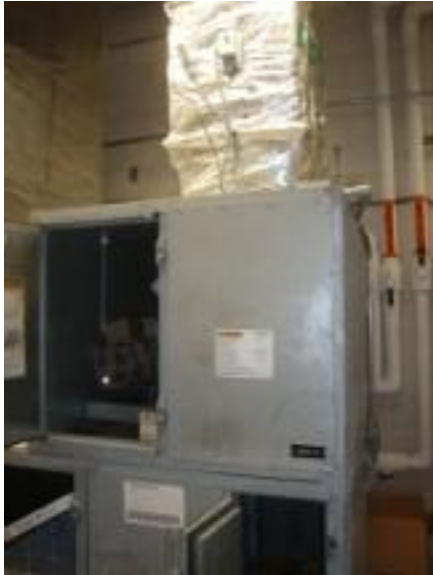
<u>Unit Tag</u>	<u>AHU-4</u>	<u>Addition comments descriptions</u>
Location	MER 113	
Serving	Main Offices	
Config/Style	Climate Changer	
Mfr.	Trane	
Model #	MCCB008UAOAOUB	
Serial #	KO3A00222	
Age (years)		
System CFM		
Max OA CFM		
V/Hz/Ph	460/60/3	
SF Qty/HP	5 (1) AX60	
SF VFD Data	VFD ABB	
RF Qty/HP	3.0 Inline Greenheck TCF-18 (2) A-60	
RF VFD Data	VFD ABB	
Filter Data (Size Quantity)	(4) 20x20x2	
Filter Status	OK 4/7/22	
Controls Type	DDC Metasys	
Controls Mfr.		
Economizer	Available	
CO <sub>2</sub> DCV		
Damper Styles	Ductwork mounted, Opposed blade	
Damper Status	OK, clean, adjust and lubricate	
Heating Type	Hot Water	
Heating Coil Condition	Dirty	
Cooling Type	Chilled water	
Cooling Coil Condition	Dirty	
Drain Pan Status	Rusty Galv.	
Notes:	Damper operations unknown

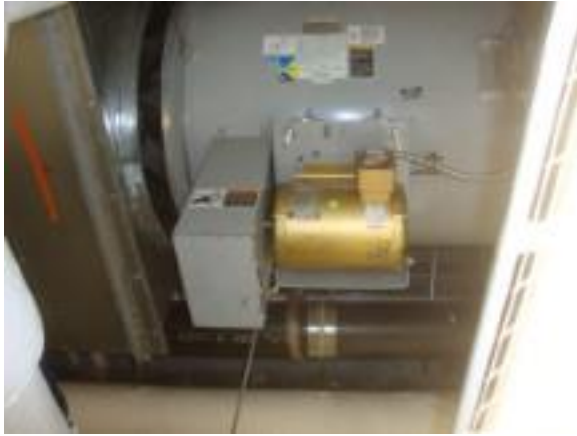
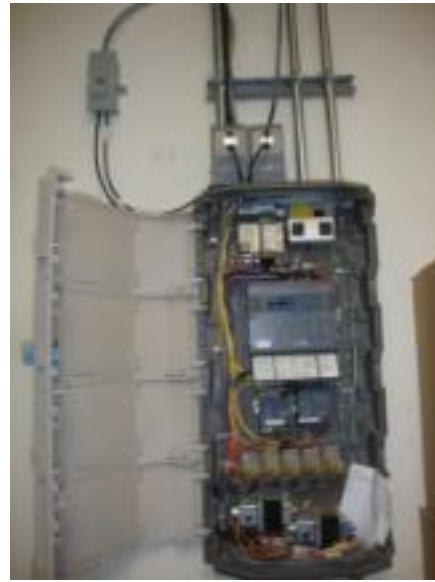
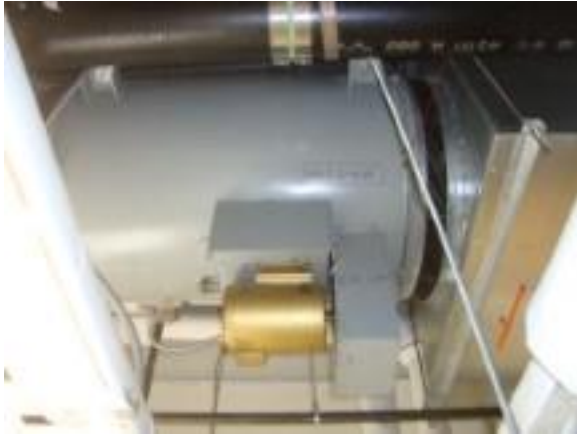
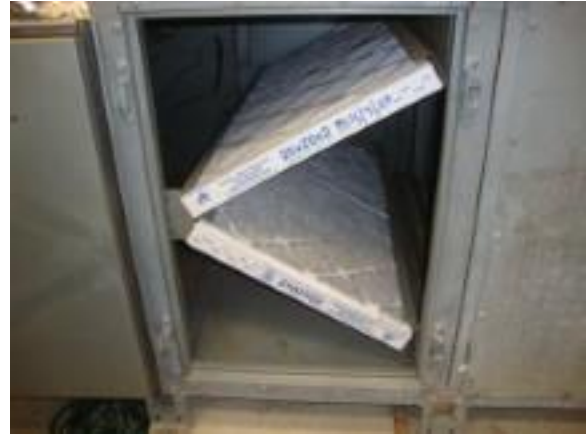
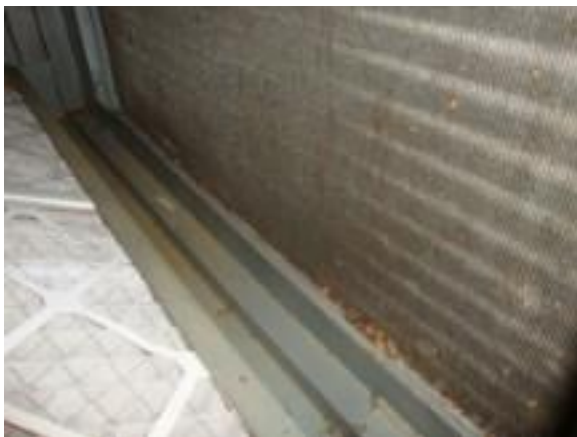
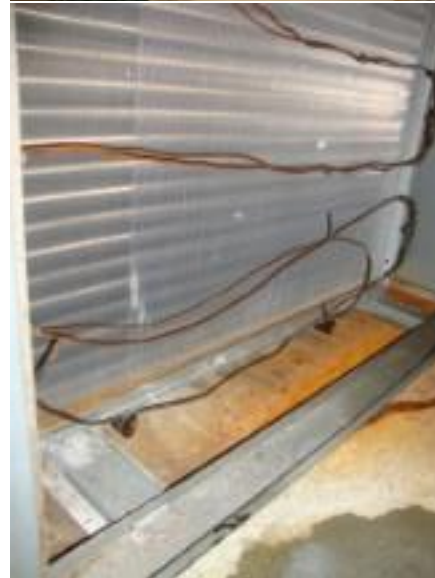
<u>Unit Tag</u>	<u>AHU-5</u>	<u>Addition comments descriptions</u>
Location	MER 139	
Serving	Kindergarten	
Config/Style	Climate Changer	
Mfr.	Trane	
Model #	MCCB017UAOAOUB	
Serial #	KO3A00235	
Age (years)		
System CFM		
Max OA CFM		
V/Hz/Ph	460/60/3	
SF Qty/HP	7.5 (1) BX6-0	
SF VFD Data	VFD ABB	
RF Qty/HP	7.5 Inline Greenheck TCF-24 (2) A-60	
RF VFD Data	VFD ABB	
Filter Data (Size Quantity)	(4) 16x25x2 (8) 16x20x2	
Filter Status	OK 4/6/22	
Controls Type	DDC Metasys	
Controls Mfr.		
Economizer	Available	
CO <sub>2</sub> DCV		
Damper Styles	Ductwork mounted, Opposed blade	
Damper Status	OK, clean, adjust and lubricate	
Heating Type	Hot Water	
Heating Coil Condition	Dirty	
Cooling Type	Chilled water	
Cooling Coil Condition	Dirty	
Drain Pan Status	Rusty Galv.	
Notes:	Damper operations unknown

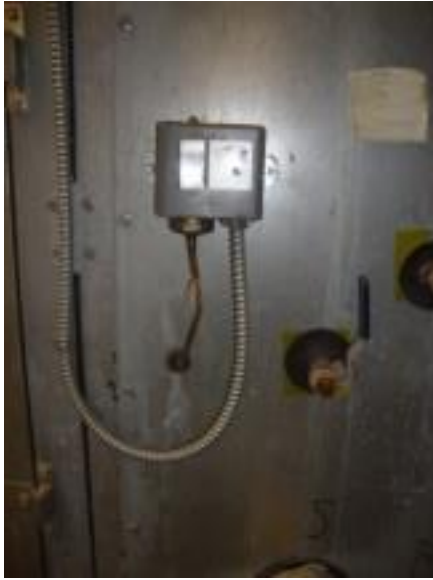
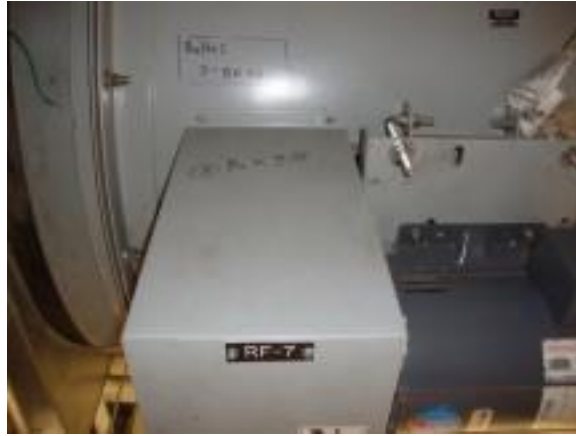
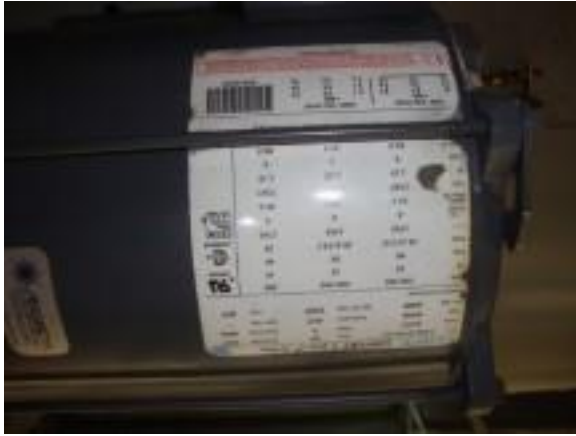
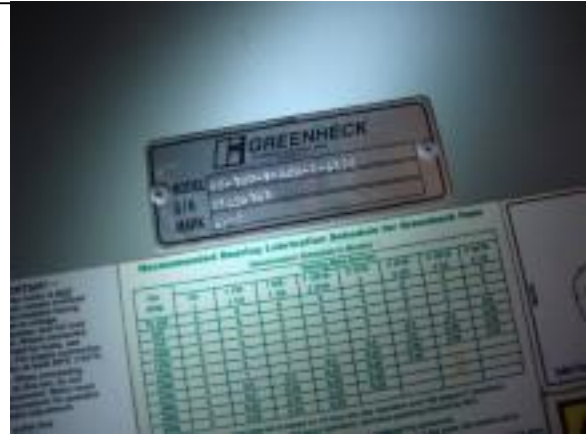
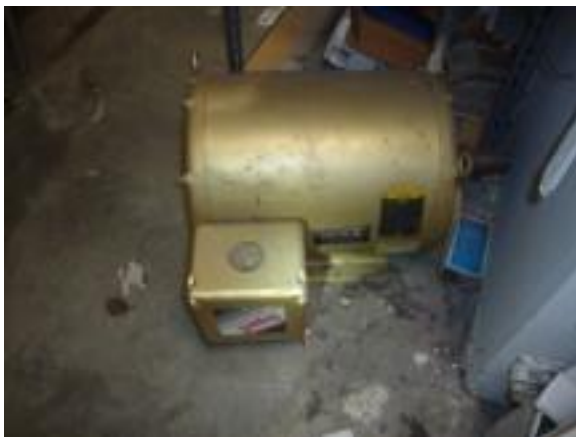
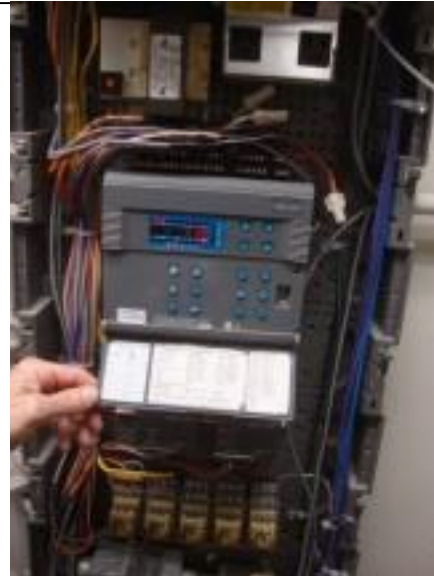
<u>Unit Tag</u>	<u>AHU-7</u>	<u>Addition comments descriptions</u>
Location	MER 222	
Serving	-	
Config/Style	Climate Changer	
Mfr.	Trane	
Model #	MCCB05UAOAOUA	
Serial #	KO3A00180	
Age (years)		
System CFM		
Max OA CFM		
V/Hz/Ph	460/60/3	
SF Qty/HP	25 (4) 3VX900	New Motor 20.0 HP
SF VFD Data	VFD ABB ACH-401	
RF Qty/HP	RF-7 10.0 Inline Greenheck 40 TCF-9 (1) AP-56	
RF VFD Data	VFD ABB	
Filter Data (Size Quantity)	(20) 20x25x2 (4) 16x25x2	
Filter Status	OK 4/7/22	
Controls Type	DDC Metasys	
Controls Mfr.		
Economizer	Available	
CO <sub>2</sub> DCV		
Damper Styles	Ductwork mounted, Opposed blade, no access	
Damper Status	OK, clean, adjust and lubricate	
Heating Type	Hot Water	
Heating Coil Condition	Dirty	
Cooling Type	Chilled Water	
Cooling Coil Condition	Dirty, cleaning would improve	
Cu Man		
Cu Model/Serial		
Drain Pan Status	Rusty Galv.	
Notes:	Damper operations unknown, Airflow probes dirty

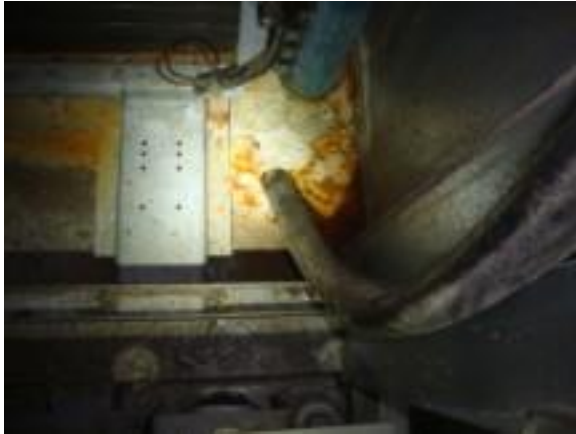
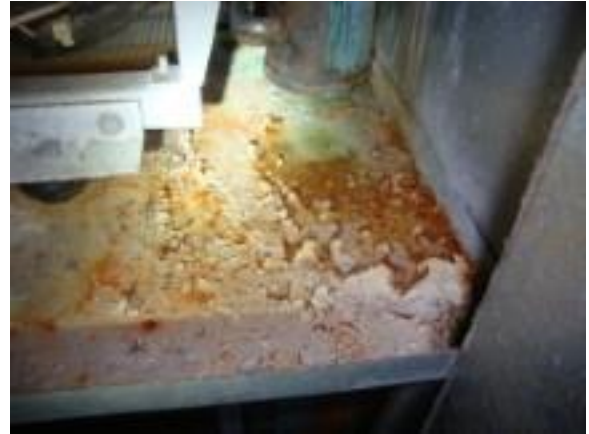
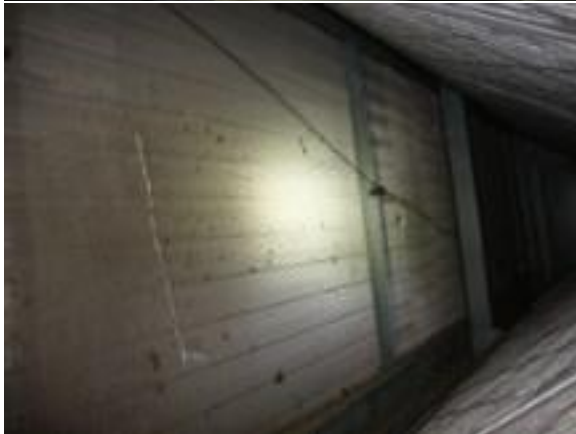
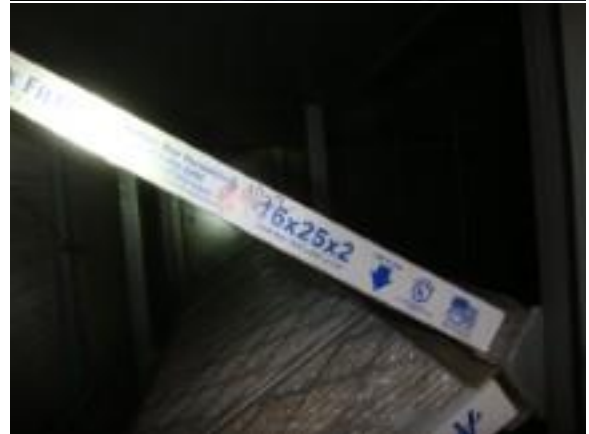
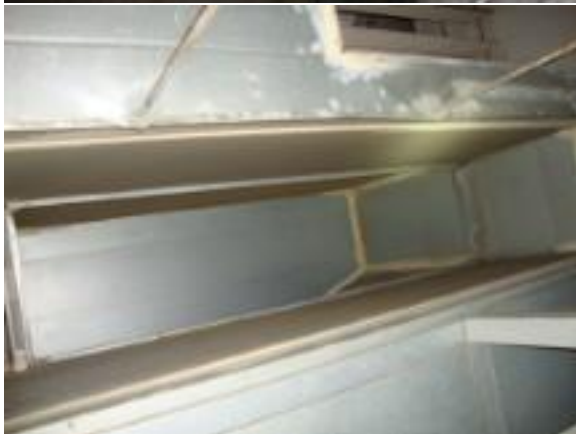
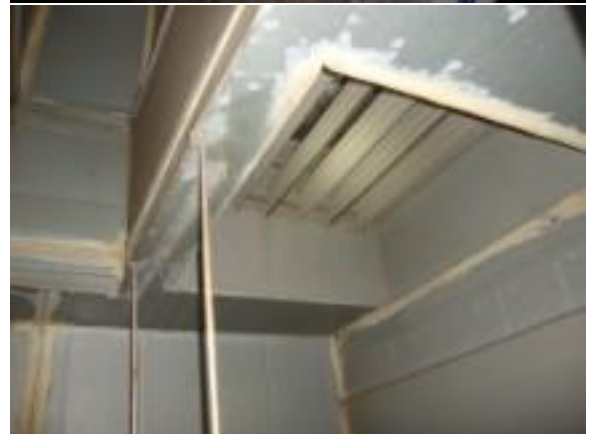
Photos

<u>Unit Tag</u>	<u>AHU-8</u>	<u>Addition comments descriptions</u>
Location	MER 205	
Serving	Cafeteria	
Config/Style	Climate Changer	
Mfr.	Trane	
Model #	MCCB05OUAOAOUA	
Serial #	KO3A00179	
Age (years)		
System CFM		
Max OA CFM		
V/Hz/Ph	460/60/3	
SF Qty/HP	25 (2) 5VX1000	
SF VFD Data	VFD ABB	
RF Qty/HP	10.0 Inline Greenheck TCF-22 (2) BX-93	
RF VFD Data	VFD ABB Fan drive locked out	
Filter Data (Size Quantity)	(20) 20x25x2 (16) 16x25x2	
Filter Status	OK	
Controls Type	DDC Metasys	
Controls Mfr.		
Economizer	Available	
CO <sub>2</sub> DCV		
Damper Styles	Ductwork mounted, Opposed blade	
Damper Status	OK, clean, adjust and lubricate	
Heating Type	Hot Water	
Heating Coil Condition	Dirty	
Cooling Type	Chilled water	
Cooling Coil Condition	Dirty	
Drain Pan Status	Rusty Galv.	
Notes:	Room full of lint from Gym non ducted return.
