Riverfield Elementary School

Fairfield Public Schools Recommissioning (RCx) and Testing, Adjusting, & Balancing (TAB) Study van Zelm Project # 2020102.00 (14-RES) October 07, 2022

FAIRFIELD PUBLIC SCHOOLS RECOMMISSIONING (RCX) AND TESTING, ADJUSTING, & BALANCING (TAB) STUDY

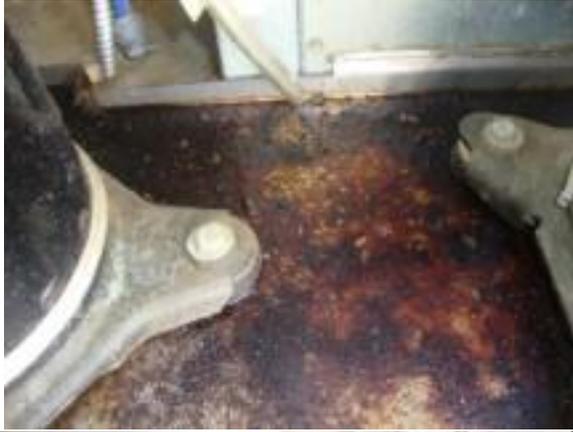
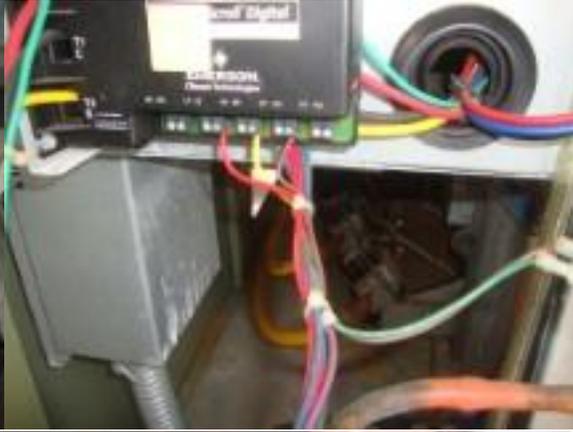
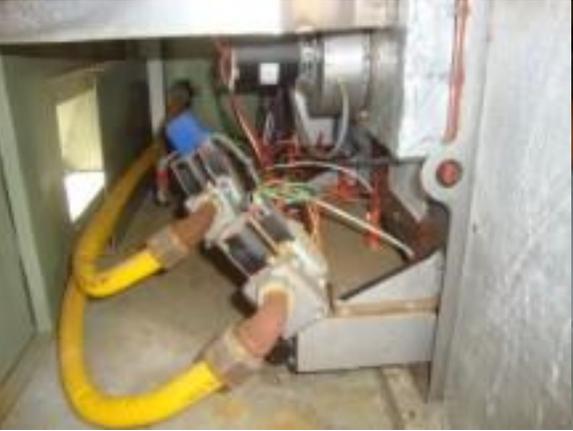
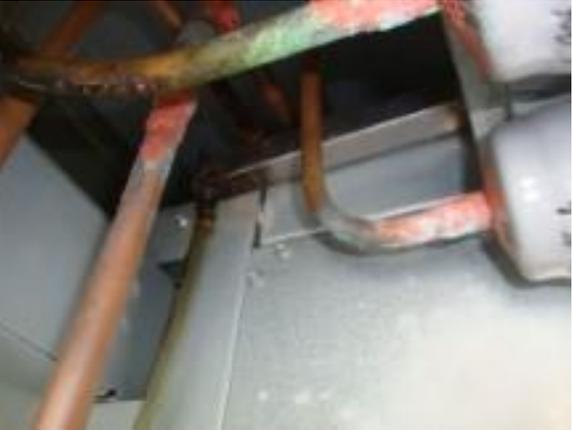
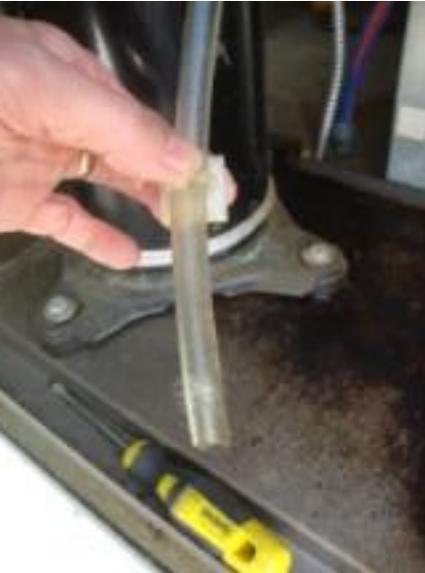
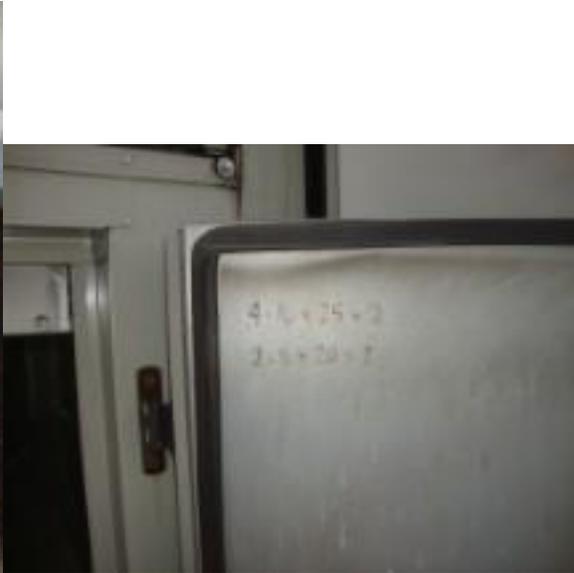
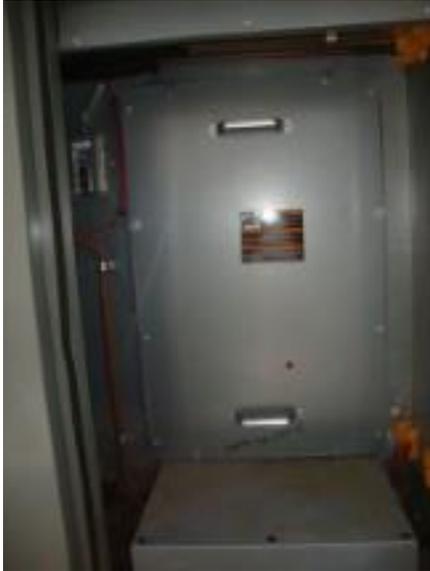
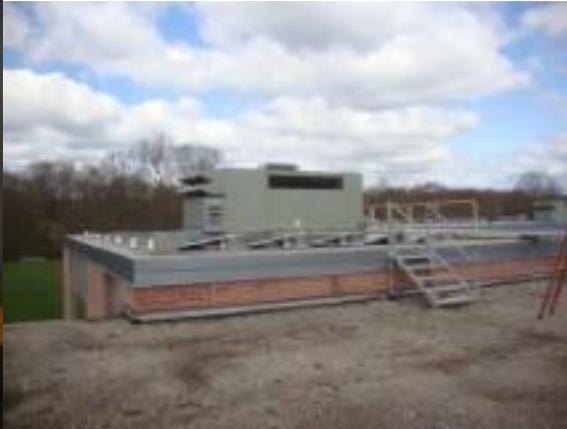
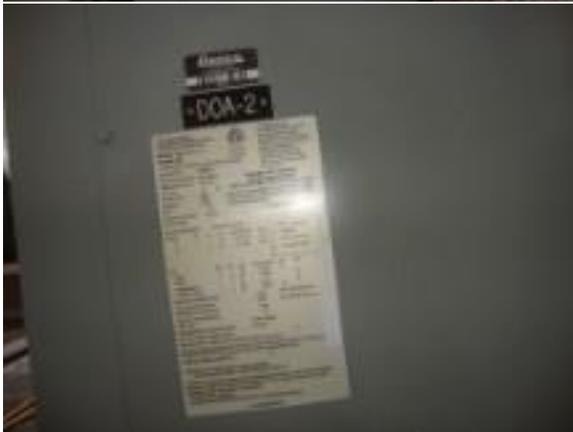
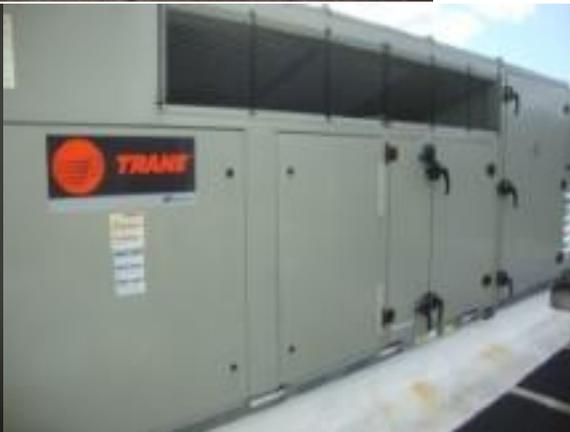
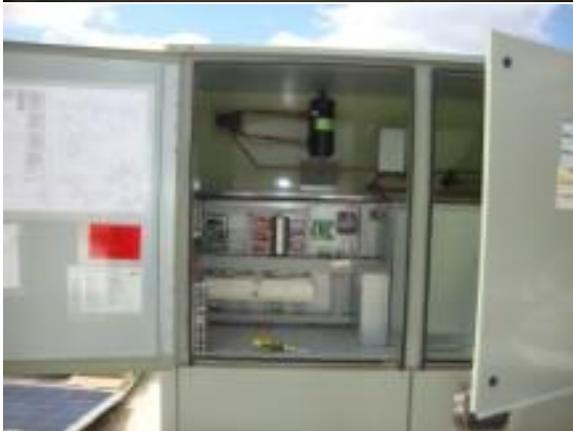
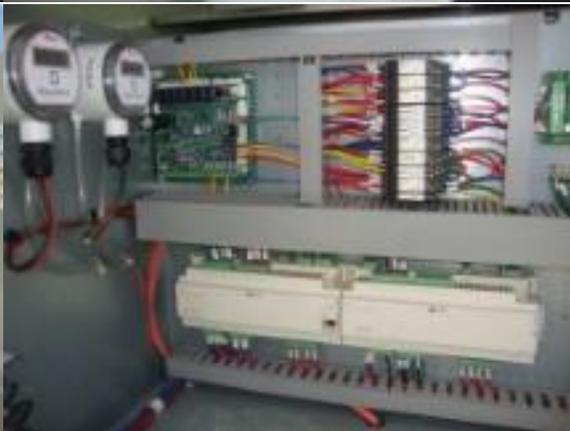
<u>Unit Tag</u>	<u>DOA-2</u>	<u>Addition comments descriptions</u>
Location	Roof	System appears to operate as required
Serving	Addition	
Config/Style	DOA with SF/EF, DX Cooling, Gas Heat, ERW	
Mfr.	Trane	
Model #	OAGD120A3-C1B100BC-A1E0C6BC-C30C3A4A0	
Serial #	0A238171-2-1	
Age (years)	4/2015	
System CFM		
Max OA CFM		
V/Hz/Ph	208-230/60/3	
SF Qty/HP	3.04 KW ECM Direct drive	
SF VFD Data	ECM	
PE Qty/HP	2.8 KW ECM Direct drive, (Power exhaust)	
PE VFD Data	ECM	
Filter Data (Size Quantity)	(4) 15x25x2 (2) 16x20x2 -Coil (8) 16x25x2 (4) 16x20x2 Wheel	Bracket missing screw on filter rack
Filter Status	Clean 4/26/22	
Controls Type	Factory ELECTRONIC DDC	
Controls Mfr.	Trane	
Economizer	DOAS 100% O.A.	
CO ₂ DCV		
Damper Styles	Parallel, Belimo Actuator	
Damper Status	OK, performance unknown, Clean lubricate and adjust.	
Heating Type	Gas Burner	
Heating Coil Condition	OK	
Cooling Type	Twin DX Copeland Scroll	
Cooling Coil Condition	OK

Wheel Mfr.	Semco, Model-VCPERP-0040/238171-2-1, Ser-64872-1	
Drain Pan Status	Clean	
Notes:	Door latches are rusted and need adjustment

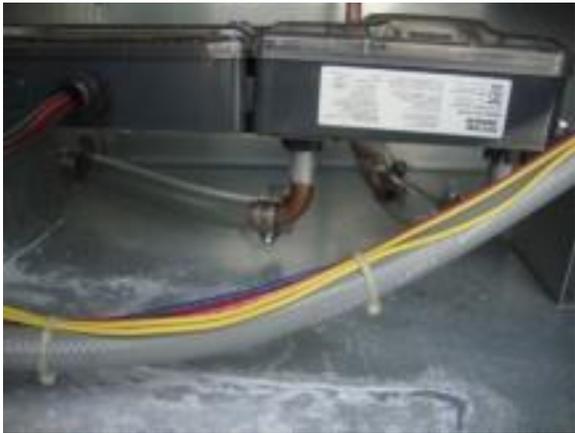
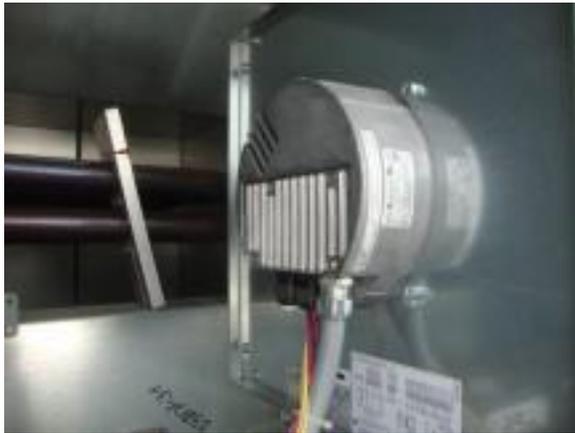
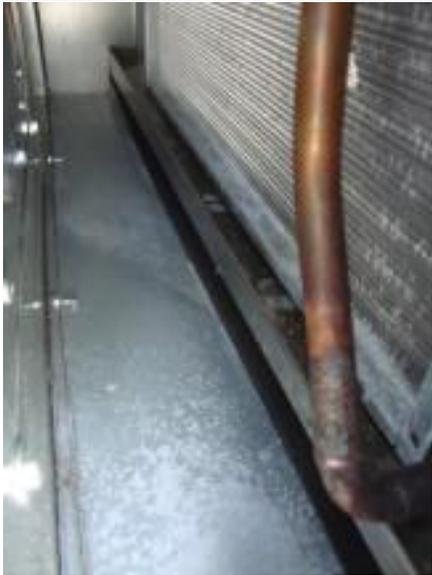
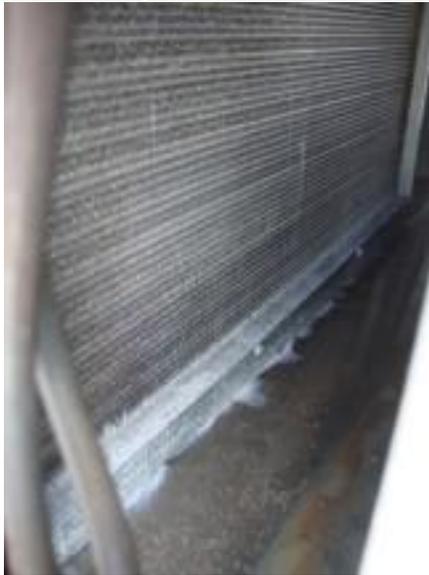
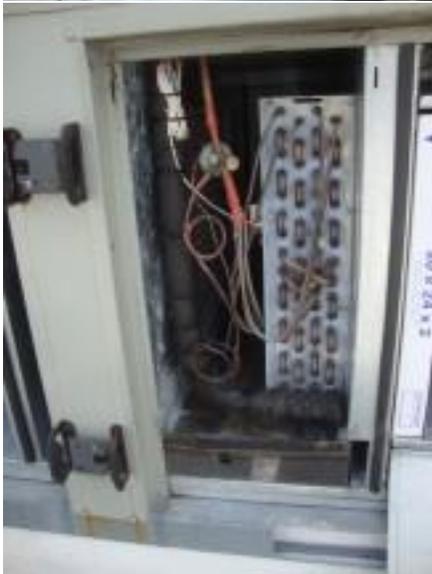
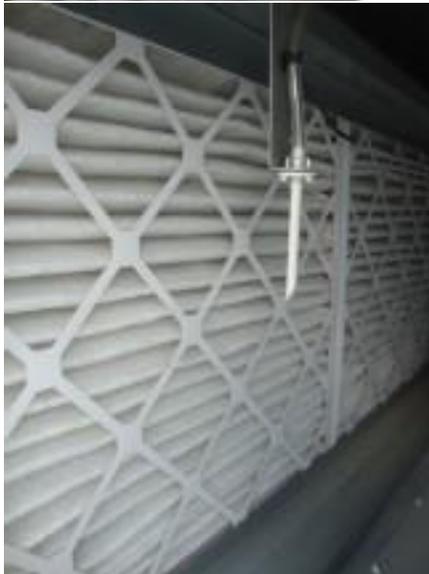
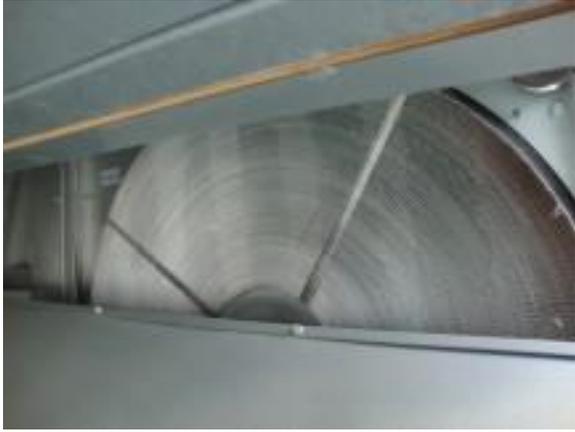
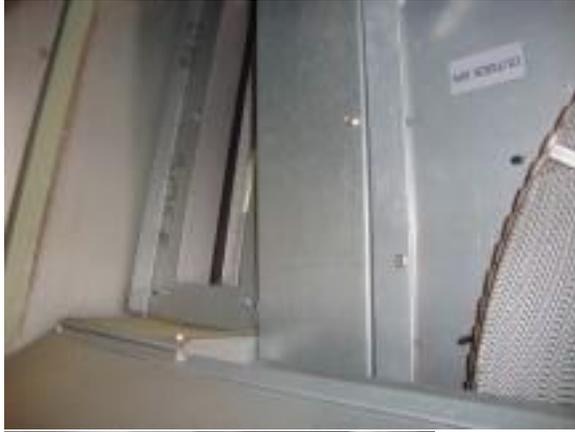
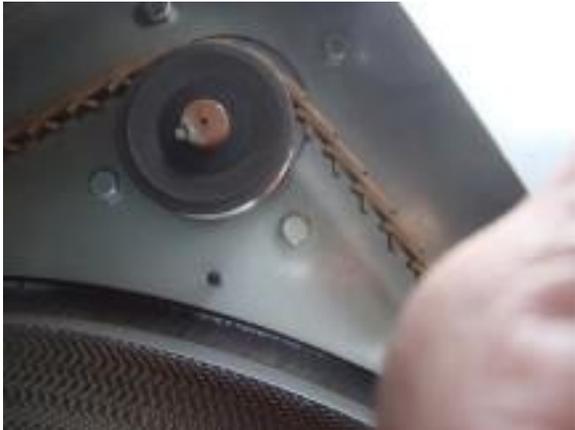
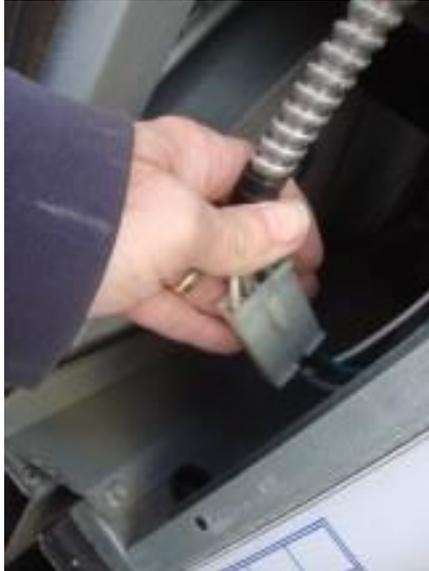
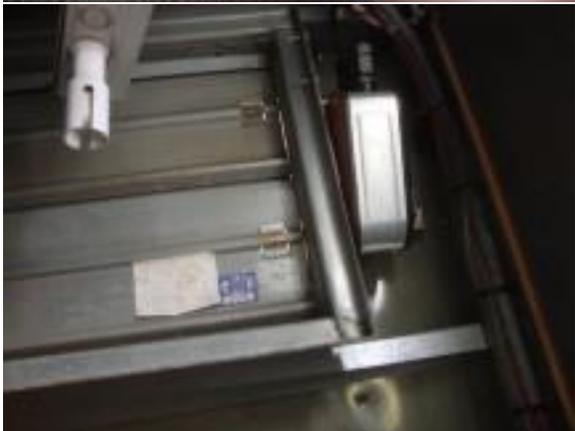
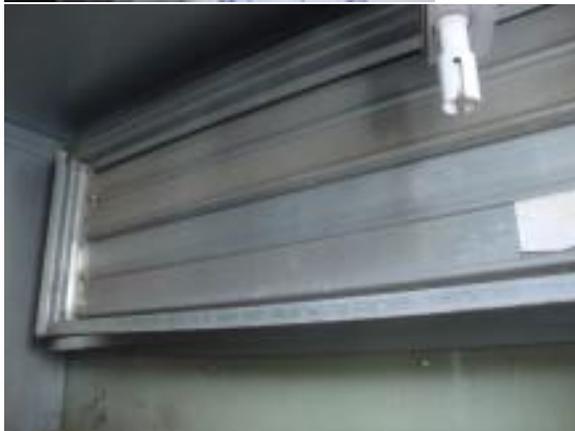
<u>Unit Tag</u>	<u>DOA-3</u>	<u>Addition comments descriptions</u>
Location	Roof	System not running?
Serving	Administration	
Config/Style	DOA with SF/EF, DX Cooling, Gas Heat, ERW	
Mfr.	Trane	
Model #	OABD48A3-C1B100AB-A1A00C6AB-C10C3A4A0	
Serial #	0A238171-3-1	
Age (years)	4/2015	
System CFM		
Max OA CFM		
V/Hz/Ph	208-230/60/3	
SF Qty/HP	ECM Direct drive	
SF VFD Data	ECM	
PE Qty/HP	ECM Direct drive, (Power exhaust)	
PE VFD Data	ECM	
Filter Data (Size Quantity)	(2) 20x24x2 -Coil (4) 20x24x2 Wheel	
Filter Status	Clean 4/26/22	
Controls Type	Factory ELECTRONIC DDC	
Controls Mfr.	Trane	
Economizer	DOAS 100% O.A.	
CO ₂ DCV		
Damper Styles	Parallel, Belimo Actuator	
Damper Status	OK, performance unknown, Clean lubricate and adjust.	
Heating Type	Gas Burner	
Heating Coil Condition	OK	
Cooling Type	DX Copeland Scroll	
Cooling Coil Condition	OK	
Wheel Mfr.	Semco, Model-VCPERP-0040/238171-2-1, Ser-64872-1	
Drain Pan Status	Clean

Notes:	Door latches are rusted and need adjustment

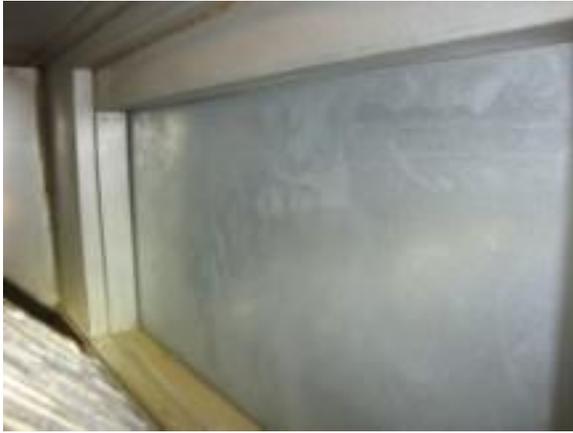
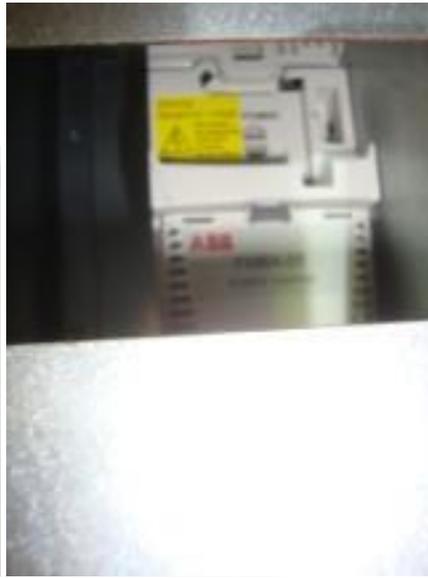
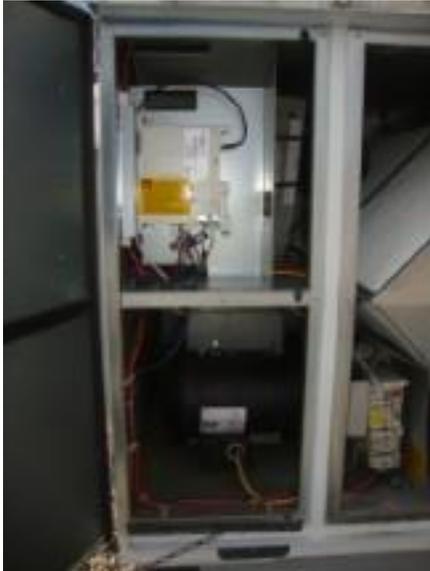
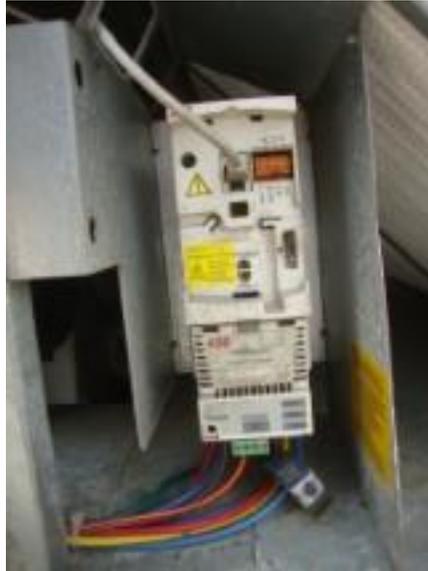
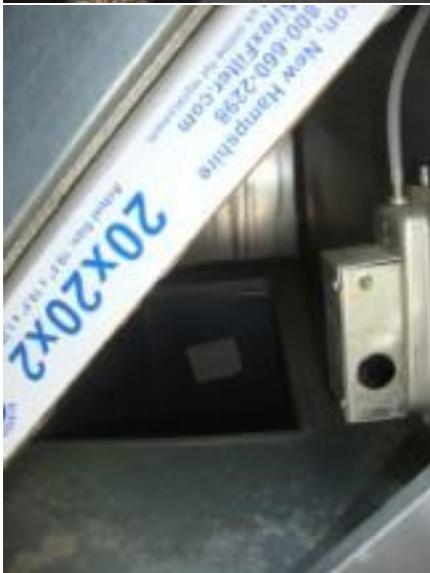
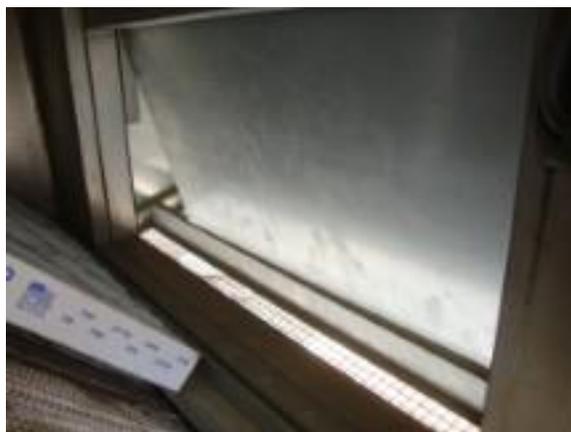
<u>Unit Tag</u>	<u>ERV-1</u>	<u>Addition comments descriptions</u>
Location	Middle Roof	
Serving		
Config/Style	Crossflow ERV no additional cooling/heating	
Mfr.	RenewAire	
Model #	HE2XRT	
Serial #		
Age (years)		
System CFM	900 (1200 EA)	
Max OA CFM	900	
V/Hz/Ph	208-230/60/3	
SF Qty/HP	(1) X.X (1) A-35	
SF VFD Data	VFD ADD	
EF Qty/HP	(1) X.X (1) A-35	
EF VFD Data	VFD ADD	
Filter Data (Size Quantity)	(4) 20x20x2	
Filter Status	Clean 4-26-22	
Controls Type	Electronic DDC Modbus	
Controls Mfr.		
Economizer	100% O.A.	
CO ₂ DCV		
Damper Styles	Flat Panel	
Damper Status	OK	
Heating Type	N/A	
Heating Coil Condition	N/A	
Cooling Type	N/A	
Cooling Coil Condition	N/A	
CU Mfr.	N/A	
CU Model	N/A	
CU Serial	N/A	
Drain Pan Status	N/A	
Notes:	Unit was operational.

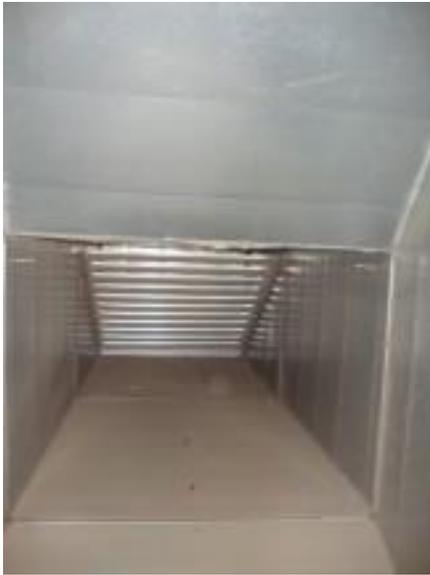
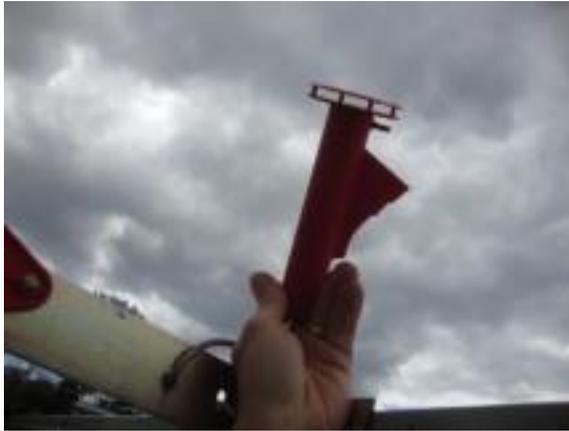
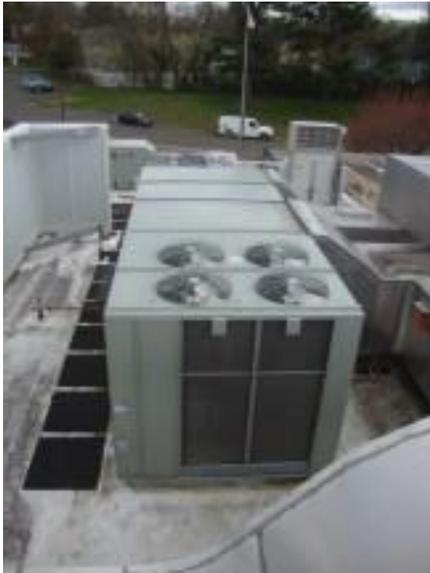
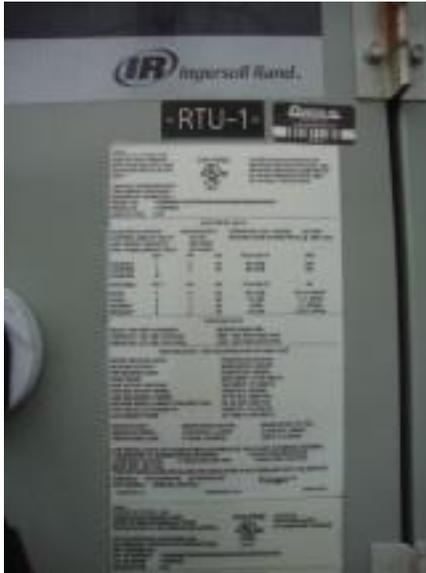
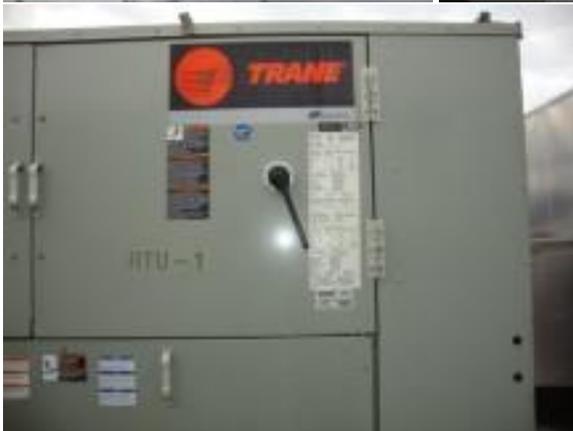
<u>Unit Tag</u>	<u>RTU-1</u>	<u>Addition comments descriptions</u>
Location	North Roof	
Serving	Gym/Cafeteria/Kitchen-	
Config/Style	Gas-fired rooftop unit with DX cooling	
Mfr.	Trane	
Model #	YCH480BETM603MH5ABC-0000H0B00R0	
Serial #	C15B00581	
Age (years)	2/2015	
System CFM	15000	
Max OA CFM	15000	3750 min OA cfm
V/Hz/Ph	208-230/60/3	
SF Qty/HP	15.0 (2) BX-97	Belts mis-matched
SF VFD Data	VFD	
RF Qty/HP	Twin prop fans w/actuators, Power exhaust 1.5 HP	
RF VFD Data	N/A	
Filter Data (Size Quantity)	(16) 16x20x4	
Filter Status	Clean 4-26-22	
Controls Type	Electronic DDC Factory	
Controls Mfr.	Trane	
Economizer	Available with Power exhaust, not witnessed	
CO ₂ DCV		
Damper Styles	Parallel, and BDD	
Damper Status	OK, clean adjust and lubricate, big damper single actuator, lots of linkage	
Heating Type	Gas	
Heating Coil Condition	Burner	
Cooling Type	DX	
Cooling Coil Condition	Twin Compressors	
CU Mfr.		
CU Model		
CU Serial

Drain Pan Status	OK	
Notes:	Outdoor air pressure sensor broken

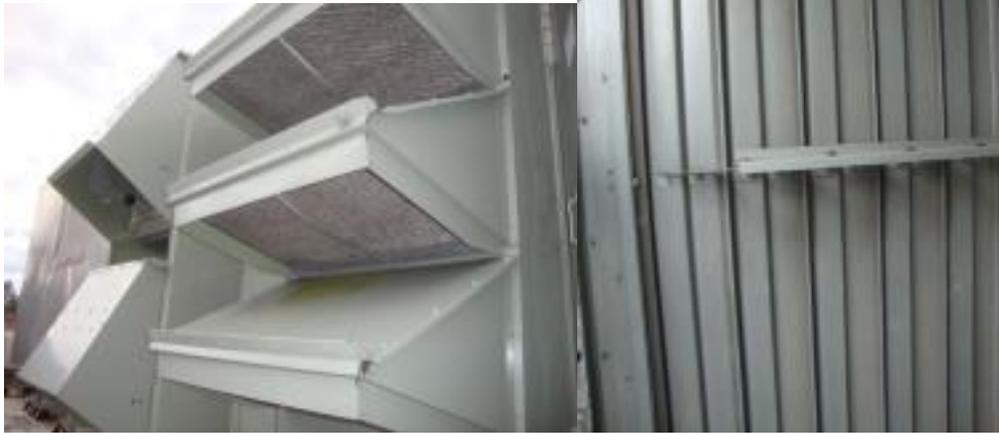
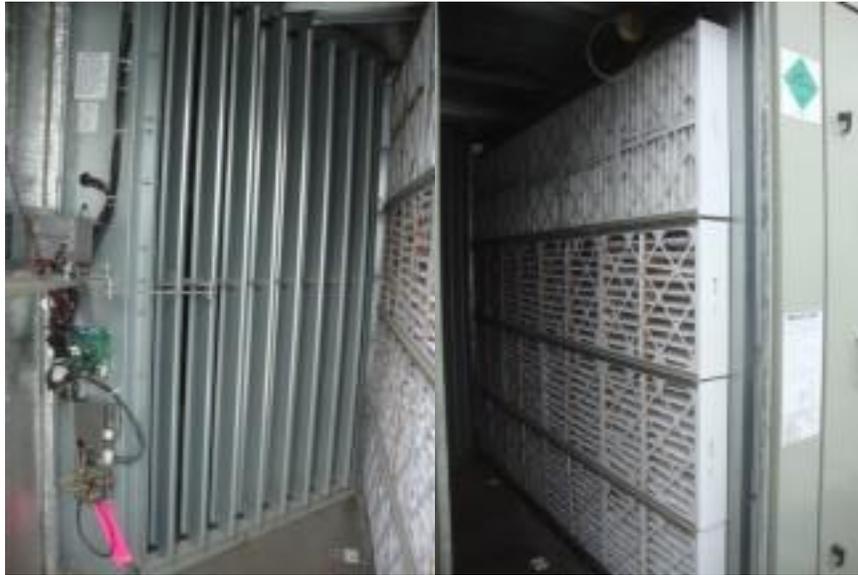
<u>Unit Tag</u>	<u>RTU-2</u>	<u>Addition comments descriptions</u>
Location	Roof	Unit is old and should be considered for replacement
Serving	Media Center	
Config/Style	Gas-fired rooftop unit with DX cooling-Voyager	
Mfr.	Trane	
Model #	YCH150C3H0CA	
Serial #	R331015202	
Age (years)	2000	
System CFM		
Max OA CFM		
V/Hz/Ph	208-230/60/3	
SF Qty/HP	3.0 (1) BX-62	
SF VFD Data	N/A	
RF Qty/HP	N/A	
RF VFD Data	N/A	
Filter Data (Size Quantity)	(4) 20x25x2	
Filter Status	Clean 4-26-22	
Controls Type	Electronic DDC Factory	
Controls Mfr.	Trane-Allerton	
Economizer	Available, not witnessed	
CO ₂ DCV		
Damper Styles	Parallel	
Damper Status	Clean adjust and lubricate,	
Heating Type	Gas	
Heating Coil Condition	Burner	
Cooling Type	DX Twin Compressors	
Cooling Coil Condition	Very Dirty	
Drain Pan Status	Dirty	
Notes:	Old and tired

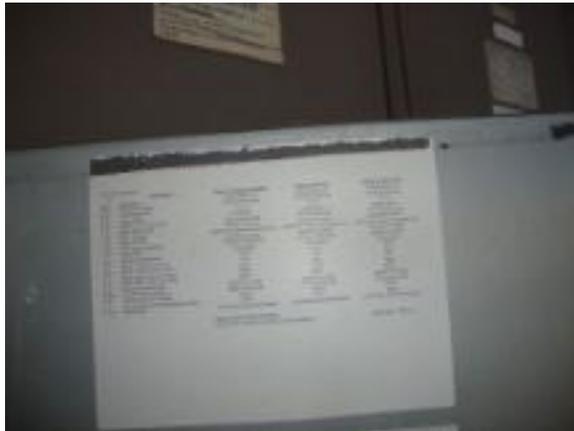
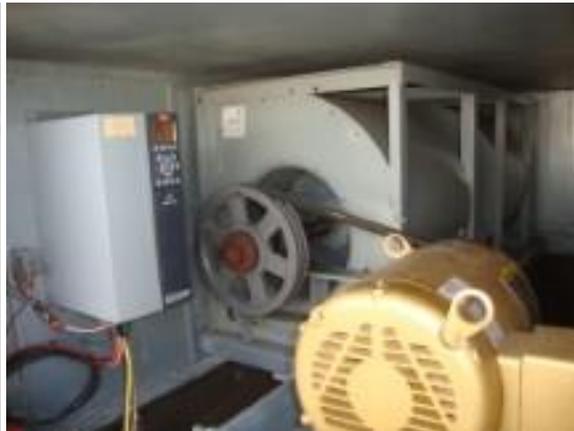
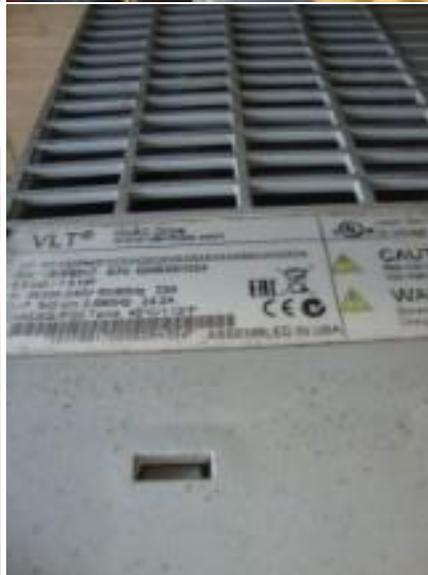
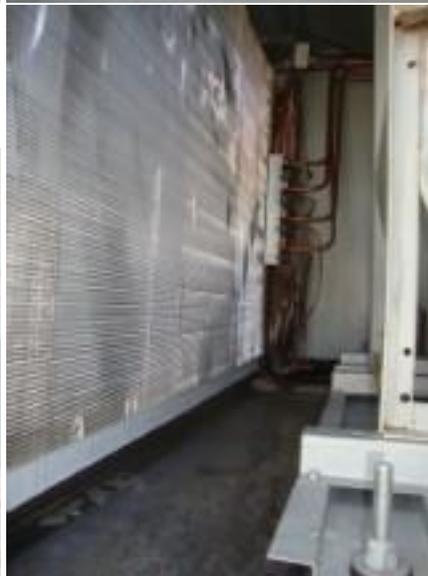
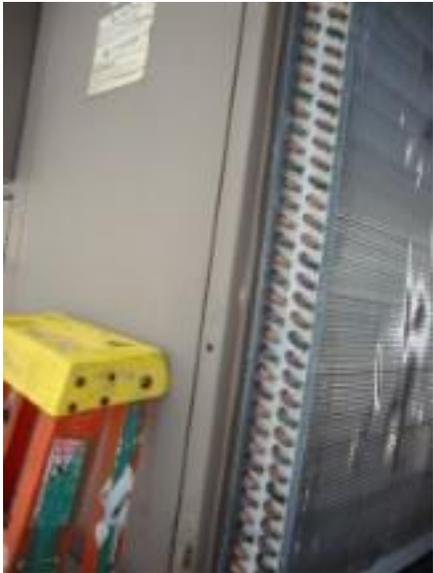
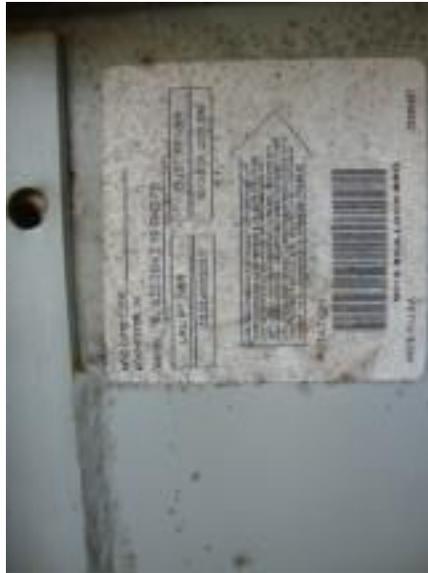
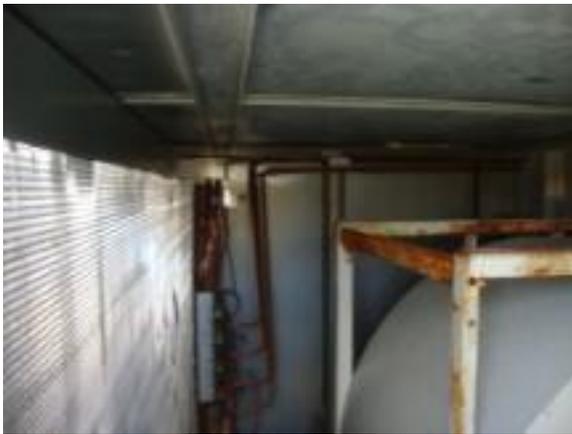
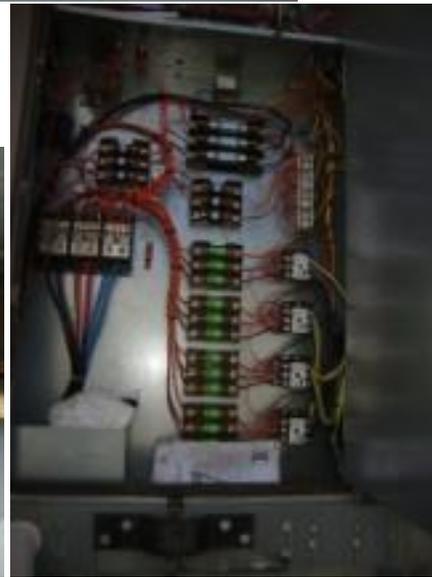
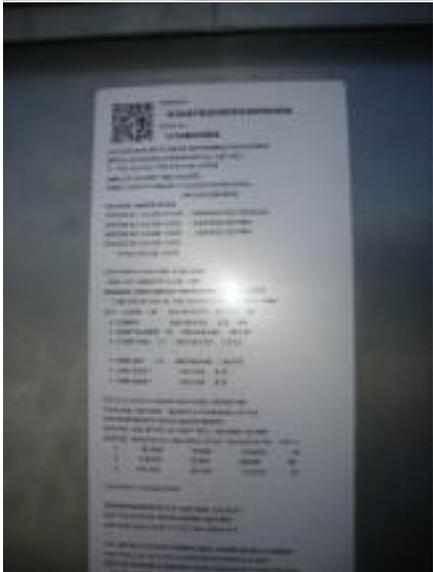
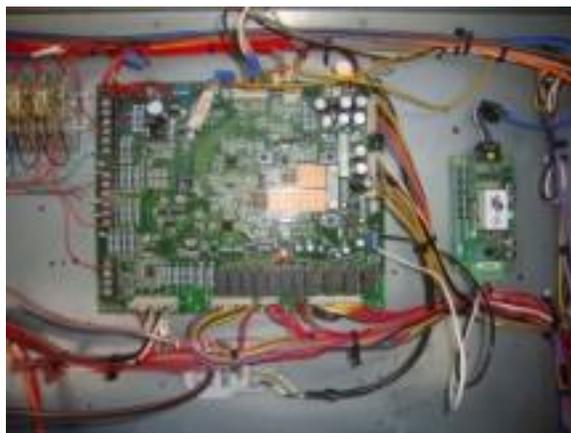
<u>Unit Tag</u>	<u>RTU-3</u>	<u>Addition comments descriptions</u>
Location	Roof	
Serving	Classrooms	
Config/Style	Gas-fired rooftop unit with DX cooling-	
Mfr.	Johnson Controls (JCI)	
Model #	V33AT52C6KDVAK0002A	
Serial #	N1H4043202	
Age (years)	Unknown	
System CFM		
Max OA CFM		
V/Hz/Ph	208-230/60/3	
SF Qty/HP	15 (2) Belts, size unknown	
SF VFD Data	VFD Danfoss	
RF Qty/HP	7.5-5.0	
RF VFD Data	VFD Danfoss	
Filter Data (Size Quantity)	(6) 20x25x2 (4) 16x25x2	
Filter Status	Clean 4-26-22	
Controls Type	Electronic DDC Factory	
Controls Mfr.	JCI	
Economizer	Available, Power Exhaust fans on VFD, Danfoss	
CO ₂ DCV		
Damper Styles	Parallel, seals falling off blades	
Damper Status	Clean adjust and lubricate,	
Heating Type	Gas	
Heating Coil Condition	Twin Burners	
Cooling Type	DX Four Compressors, 4-Expansion valves	
Cooling Coil Condition	Dirty needs cleaning, Condense coils dirty	
Drain Pan Status	S.S. cleans after coils
