Roger Ludlowe Middle School 689 Unquowa Rd

Fairfield Public Schools Recommissioning (RCx) and Testing, Adjusting, & Balancing (TAB) Study van Zelm Project # 2020102.00 (02-RLMS) June 09, 2022

ROGER LUDLOWE MIDDLE SCHOOL

FAIRFIELD PUBLIC SCHOOLS RECOMMISSIONING (RCX) AND TESTING, ADJUSTING, & BALANCING (TAB) STUDY

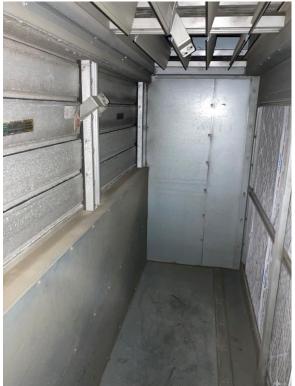
AHU-3 Min. O.A.

- AHU-3, which serves mostly classrooms and as mentioned above, did not have a functioning OA damper. The BAS was commanding the damper to 35% open but it remained closed. It is not clear at this time if that damper position will supply the necessary quantity of outside air. This will need to be assessed later after repairs or adjustments have been made.

Immediate action should be taken regarding the units delivering 0 CFM outside air. The six units that are either not running or have malfunctioning outside air dampers (AHU-3, 4, 6, RTU-3, 15, and 16) should be repaired with the assistance of a control technician and TAB Contractor to confirm proper control operation and positioning of the unit dampers. This alone will bring some quantity of outside air to spaces that currently have none and will necessarily improve building performance as a result . The HVAC systems should holistically be rebalanced to current design requirements after the BAS control system has been upgraded with new end devices where needed.

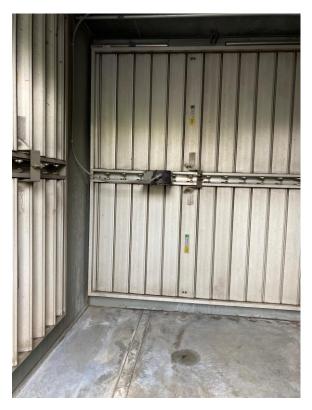
RTU-16 Min. O.A.

- RTU-15 and 16 serve the locker rooms and main gym, respectively. Despite receiving OA damper position commands from the BAS, neither of these units' OA dampers moved in a way that allowed for outside air to be introduced to these spaces, rather what little could be opened was resulting in air exhausting through outside air intake sections. The units did exhaust air normally as well, which caused these areas to produce a strong negative pressure area. This caused doors in the gym corridor and in the core stairwell to be pulled open. This effect was observed on every level of the stairwell. RTU-15 does not have a strict OA flow requirement but RTU-16 does, and a majority of this pressure issue is caused by that unit. The dampers on both units should be repaired immediately and adjusted to meet space OA and pressure demand.

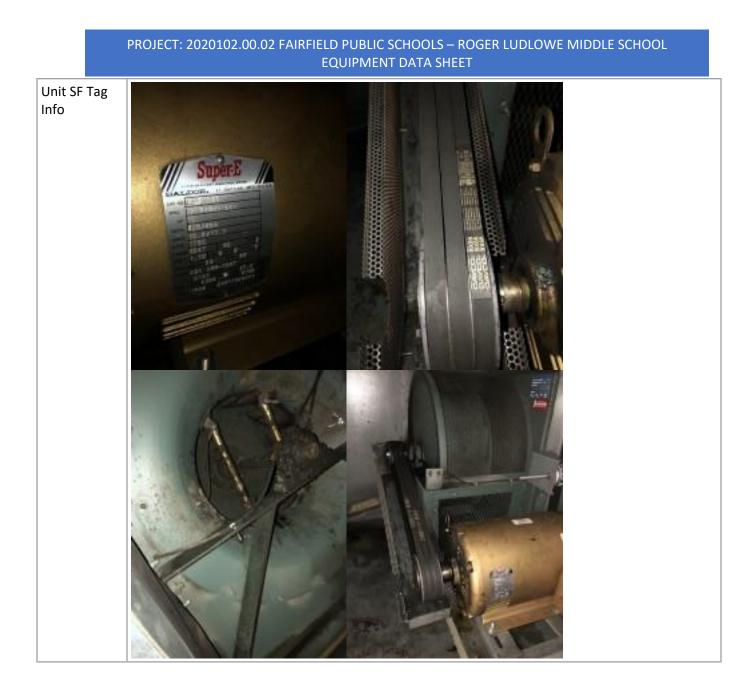
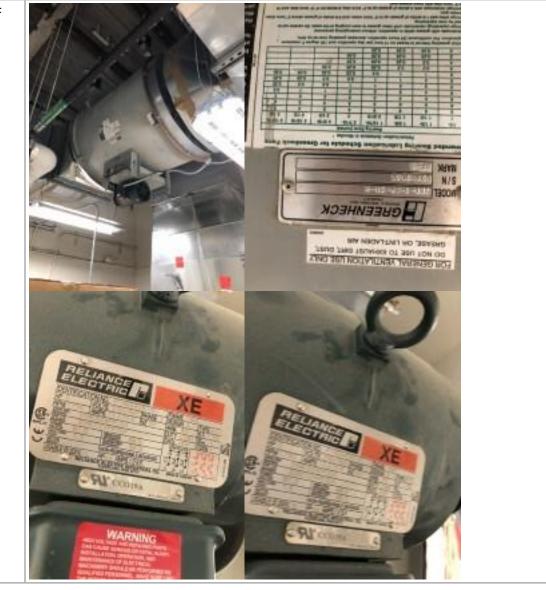
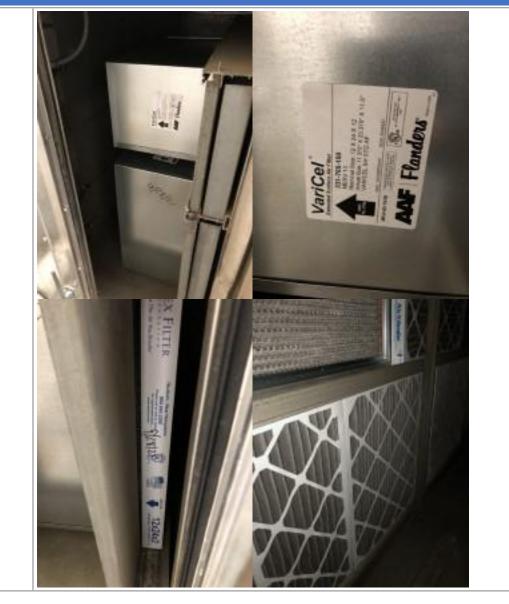
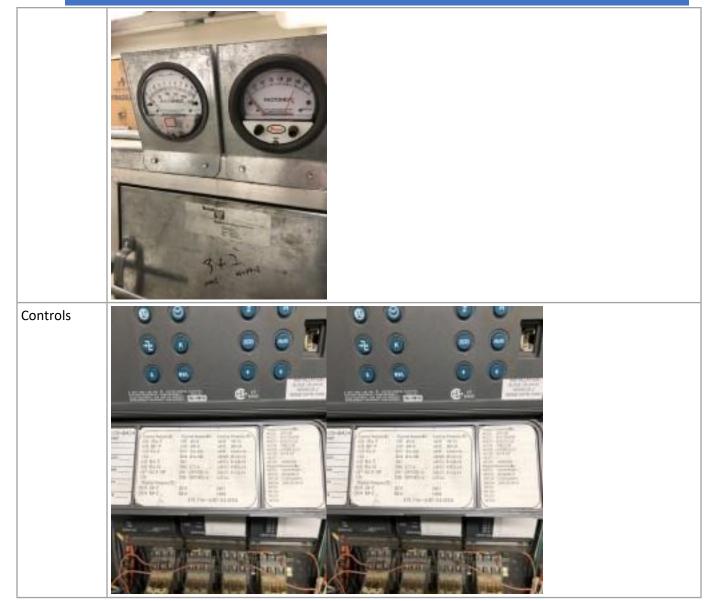
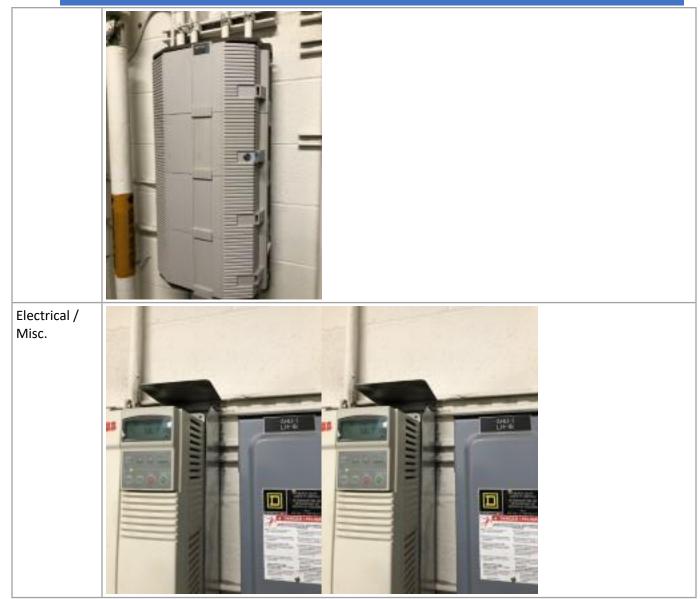
Unit Tag	RLMS AHU-2	Addition comments descriptions
Location	MER 194	
Serving	Art, Health	
Config/Style		
Mfr.	Ventrol	
Model #		
Serial #		
Age (years)	2003	
System CFM	9570@5.1" 1,612 RPM	
Max OA CFM		
V/Hz/Ph		
SF Qty/HP	(1) 15.0	
SF VFD Data	АВВ	
RF Qty/HP	(1) 7.5	Greenheck TCB-1-30
RF VFD Data	АВВ	
Filter Data (Size Quantity)	(6) 24X24X12 (6) 24X24X2	9/29/21 CHANGE OUT
Filter Status	Pre-filters dirty	Missing safing
Controls Type		
Controls Mfr.		
Economizer	Yes	
CO₂ DCV		
Damper Styles	OBD	
Damper Status	ТАМСО	
Heating Type	GLYCOL HOT WATER	
Heating Coil Condition	DIRTY	
Cooling Type	GLYCOL CHILLED WATER	
Cooling Coil Condition	ОК	
CU Mfr.	N/A	
CU Model	N/A	
CU Serial	N/A	
Drain Pan Status	S.S SHOULD BE CLEANED	
Notes:	FREEZE STAT SET @35, VORTEX AIR FLOW MEASURING

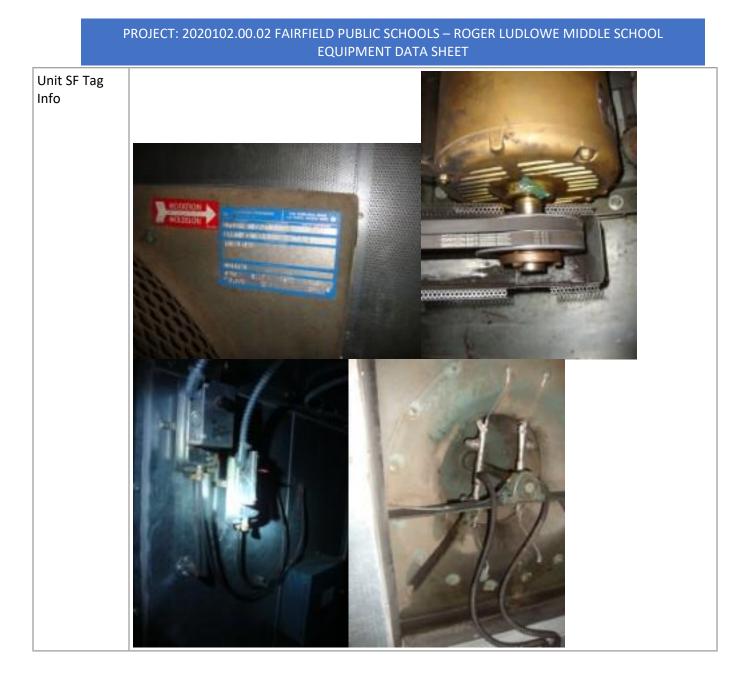
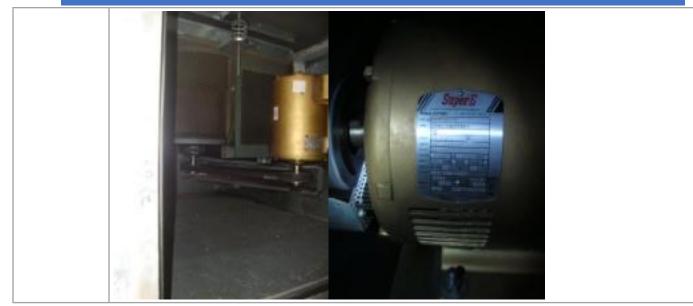
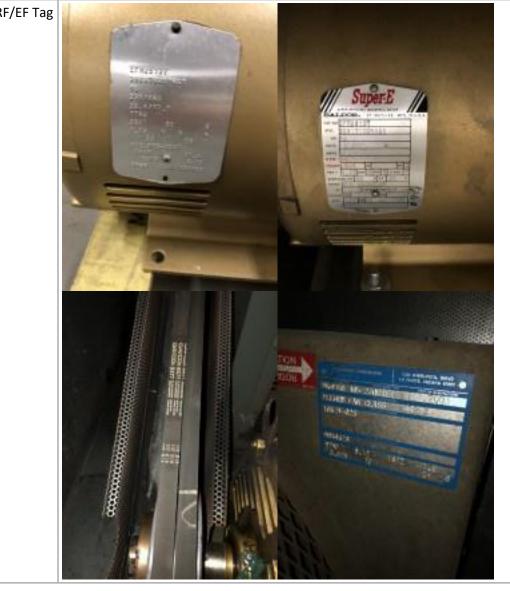
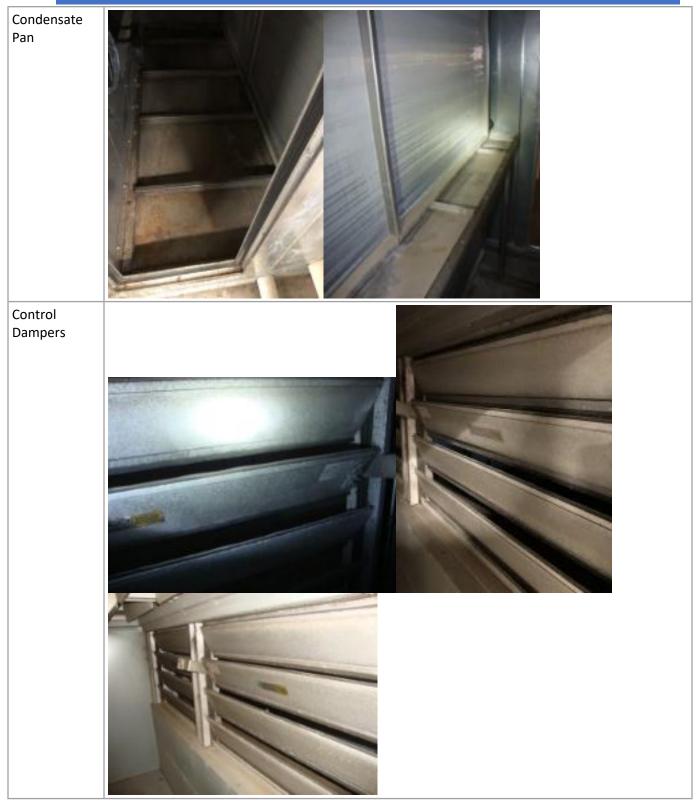
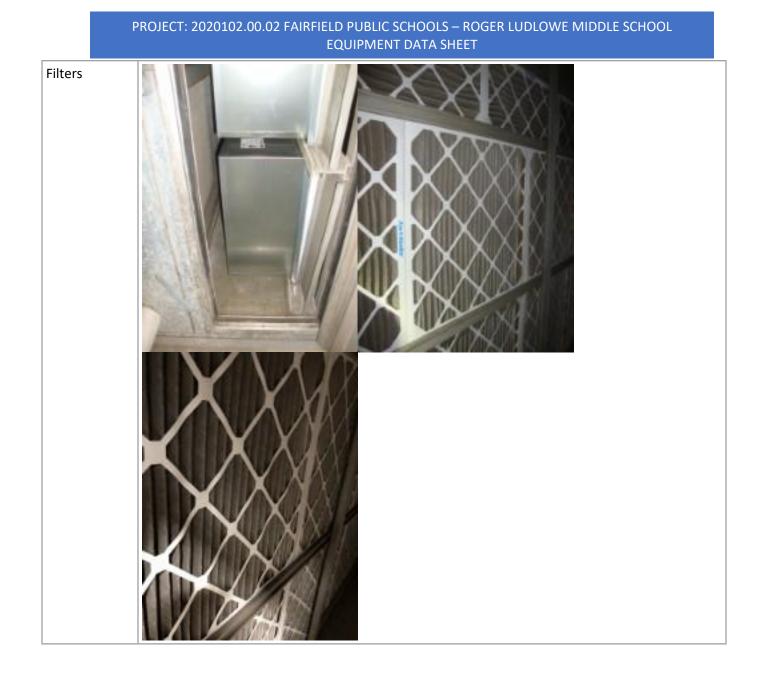
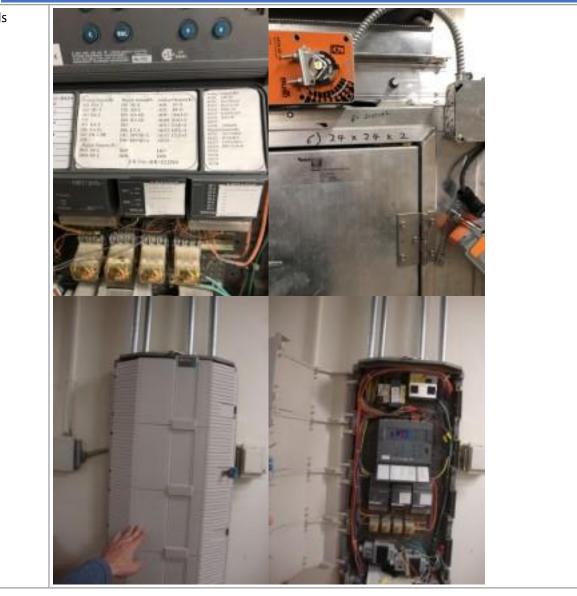
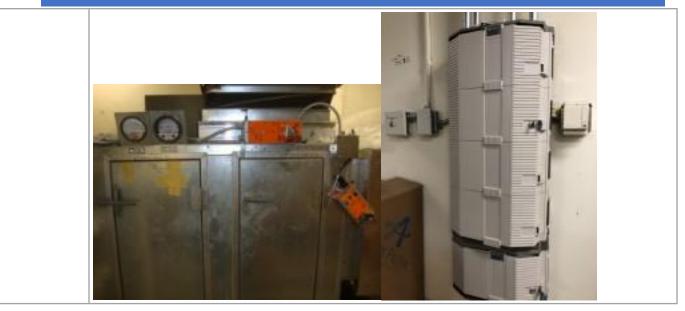
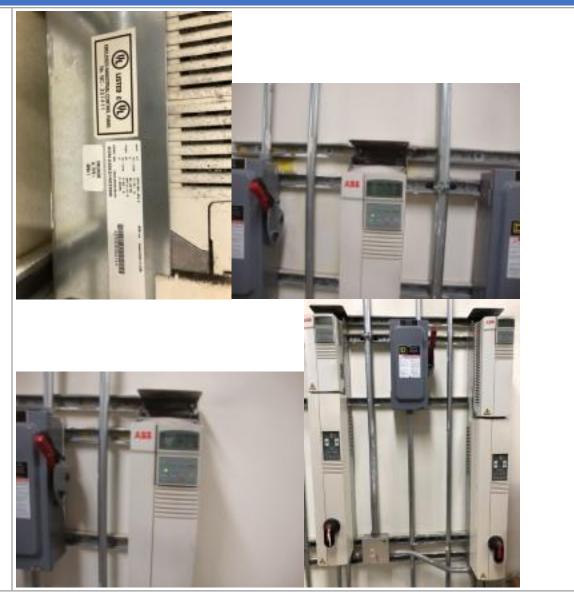
Unit Tag	RLMS AHU-3	Addition comments descriptions
Location	MER 220	•
Serving	Classrooms 221-237	
Config/Style		
Mfr.	Ventrol	
Model #		
Serial #		
Age (years)	2003	
System CFM	14520@5.3" 1,315 RPM	
Max OA CFM		
V/Hz/Ph		
SF Qty/HP	(1) 25.0	
SF VFD Data	АВВ	
RF Qty/HP	(1) 10.0 BELTS MIS-MATCHED	Greenheck TCB-2-36-100X
RF VFD Data	АВВ	
Filter Data (Size Quantity)	(6) 24X24-12 (6) 12X24X2	
Filter Status	PRE-FILTER DIRTY	
Controls Type		
Controls Mfr.		
Economizer	YES	
CO ₂ DCV		
Damper Styles	OBD TAMCO	
Damper Status	Ok CLEAN LUBRICATE AND ADJUST	Min OA Damper linkage missing
Heating Type	Glycol hot water	
Heating Coil Condition	dirty	
Cooling Type	Glycol chilled water	
Cooling Coil Condition	ok	
CU Mfr.	N/A	
CU Model	N/A	
CU Serial	N/A	
Drain Pan Status	S.S. SHOULD BE CLEANED	
Notes:		
L	1	1

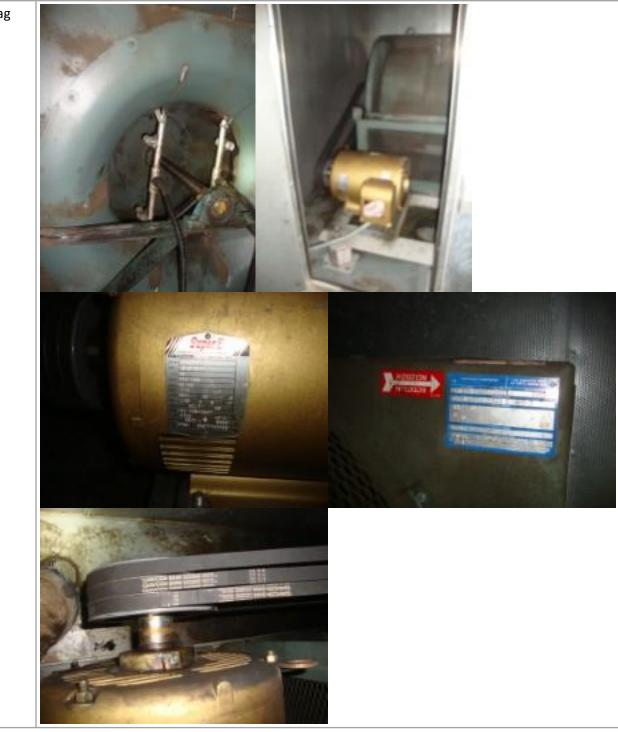
Unit SF Tag Info

Unit Tag	RLMS AHU-4	Addition comments descriptions
Location	MER 220	
Serving		
Config/Style		
Mfr.	Ventrol	
Model #		
Serial #		
Age (years)	2003	
System CFM	15070@5.28" 1,329 RPM	(3) BX93
Max OA CFM		
V/Hz/Ph		
SF Qty/HP	25.0	
SF VFD Data	АВВ	
RF Qty/HP	10.0	Greenheck TCB-2-36
RF VFD Data	АВВ	(2) BX105
Filter Data (Size Quantity)		
Filter Status		
Controls Type		
Controls Mfr.		
Economizer	YES	
CO ₂ DCV		
Damper Styles	Tamco OBD	
Damper Status	Clean adjust and lubricate	Dampers need adjustments Min OA damper linkage missing
Heating Type	Glycol hot water	
Heating Coil Condition	dirty	
Cooling Type	Glycol chilled water	
Cooling Coil Condition	dirty	
CU Mfr.	n/a	
CU Model	n/a	
CU Serial	n/a	
Drain Pan Status	S.S.	
Notes:	Flex connection torn on fan section, sup belts mis- matched

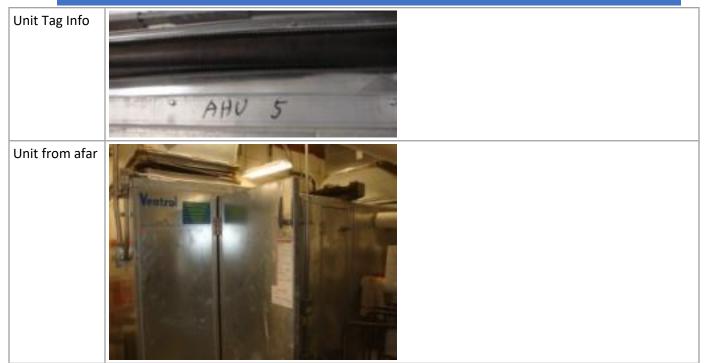
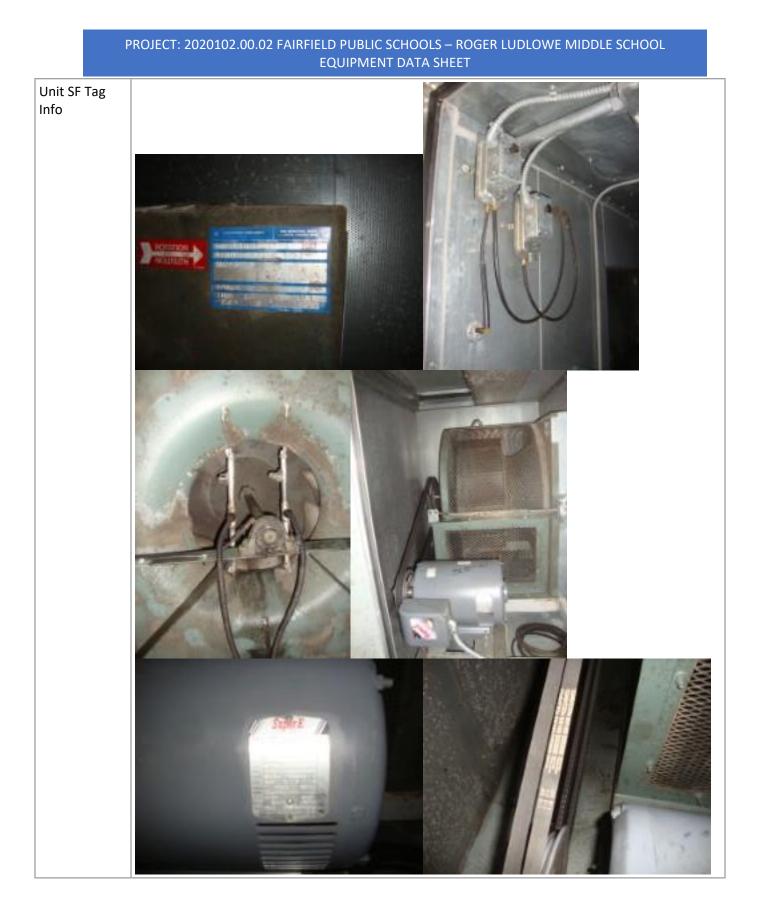
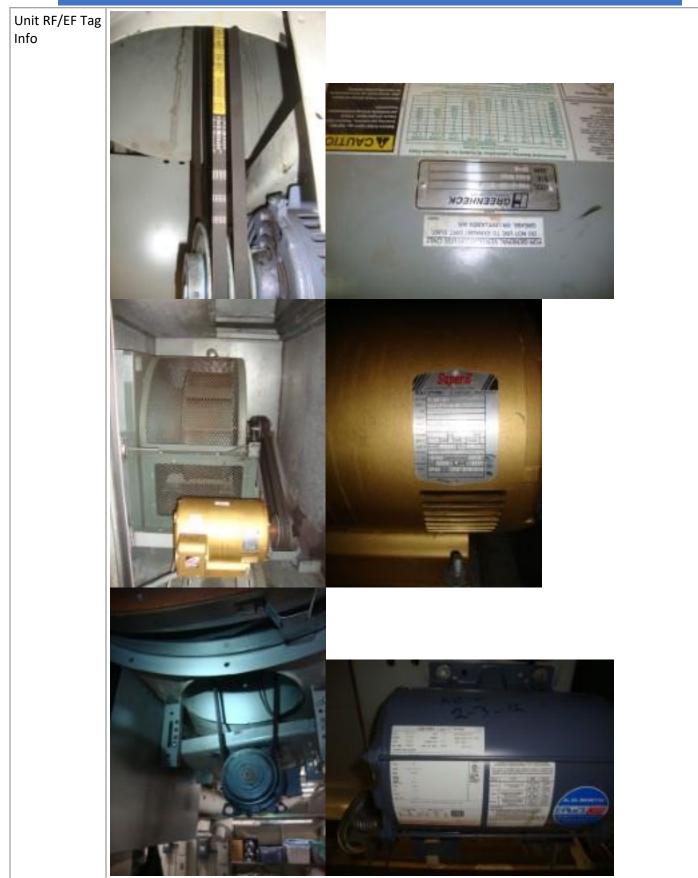
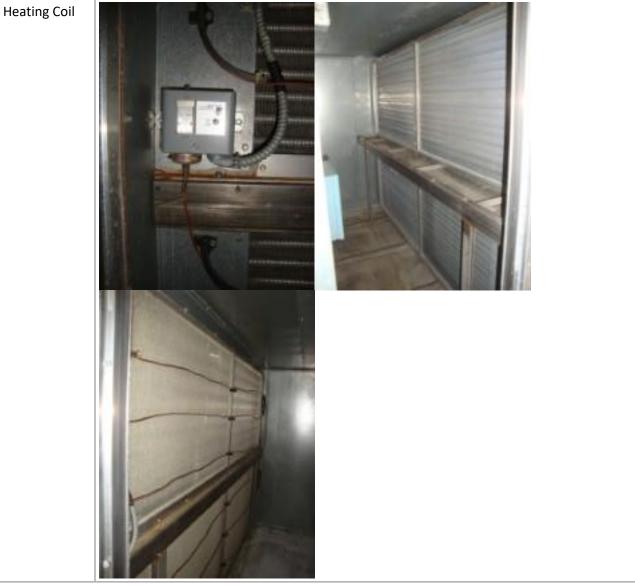
Addition commonte descriptions
Unit Tag	AHU-5	Addition comments descriptions
Location	MER 293	
Serving	Administration, Nurse, Team	
Config/Style		
Mfr.	Ventrol	
Model #		
Serial #		
Age (years)	2003	
System CFM	14450@5.11" 1,299 RPM	
Max OA CFM		
V/Hz/Ph		
SF Qty/HP	25.0	
SF VFD Data	АВВ	
RF Qty/HP	10	Greenheck TCB-2-36-100x
RF VFD Data	АВВ	
Filter Data (Size Quantity)	(6) 24X24X12 (5) 12X24X2	9-21-21
Filter Status	Pre dirty	
Controls Type		
Controls Mfr.		
Economizer	yes	
CO ₂ DCV		
Damper Styles	Tamco OBD	
Damper Status	Clean lubricate and adjust	
Heating Type	Glycol Hot Water	
Heating Coil Condition	ok	
Cooling Type	Glycol Chilled Water	
Cooling Coil Condition	ok	
CU Mfr.	n/a	
CU Model	n/a	
CU Serial	n/a	
Drain Pan Status	S.S.	
Notes:	Freeze stat set @38 Vortex Airflow

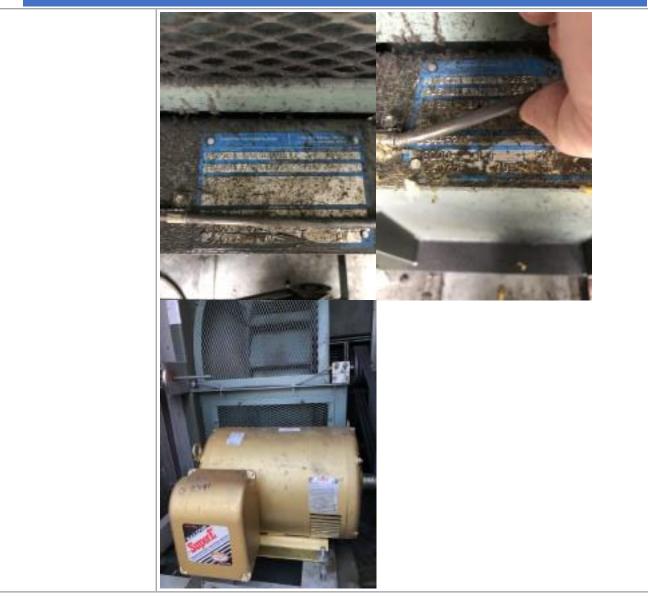
Unit SF Tag Info Super-E //

Unit Tag	RTU-2	Addition comments descriptions
Location	Auditorium Roof	
Serving	Auditorium	
Config/Style	CV SZ	
Mfr.	Ventrol	
Model #		
Serial #		
Age (years)	2003	
System CFM	16,000 CFM SA @ 6.22 SP 6.00 CFM RA @ 1.4 SP	
Max OA CFM		
V/Hz/Ph	230/460 3 Phase	
SF Qty/HP	25 HP 3-BX91 Belts	Fan Wheel needs cleaning
SF VFD Data	NA	
RF Qty/HP	7.5 HP 2-BX88 Belts	
RF VFD Data	NA	
Filter Data (Size Quantity)	6 - 24x24x2 M-136 - 24x24x12 M-13	
Filter Status	Pre filters dirty	
Controls Type	DDC	
Controls Mfr.	JCI	
Economizer		
CO ₂ DCV		
Damper Styles	Opposed TAMCO	ODA Does not fully close
Damper Status	Need Clean, Lubricate and Adjust	
Heating Type	Dual Hot Water	
Heating Coil Condition	Moderate	Some insects on coil
Cooling Type	Dual Chilled Water	
Cooling Coil Condition	Should be cleaned	
CU Mfr.		
CU Model		
CU Serial		
Drain Pan Status	Needs cleaning	
Notes:	Mold in Pipe Chase

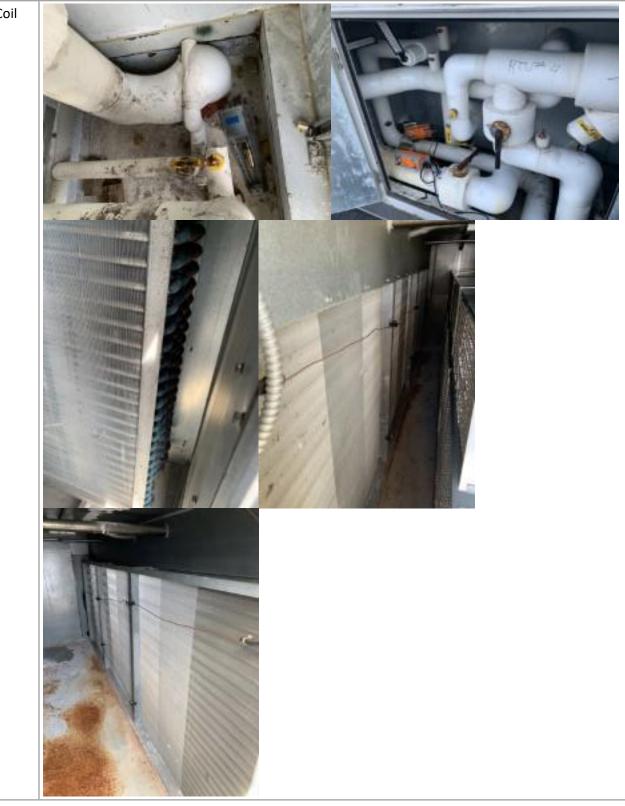
Heating Coil Condition	Ok	
Cooling Type	Dual-temperature Chilled Water	
Cooling Coil Condition	Minor header corrosion	
CU Mfr.	N/A

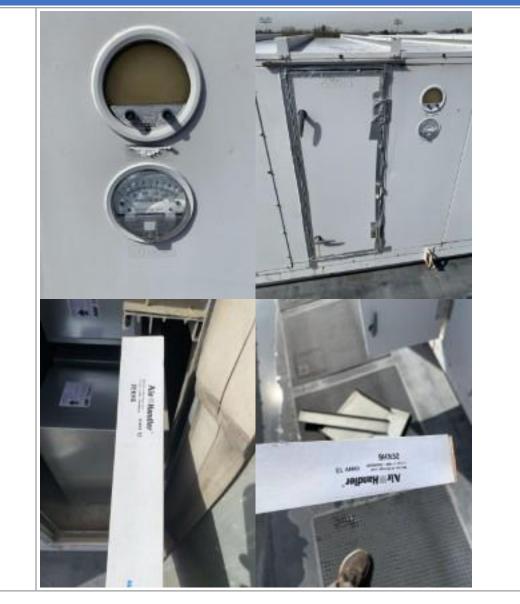
Condensate Pan	
Control Dampers

CU Model	N/A	
CU Serial	N/A	
Drain Pan Status	Significant rust located in the pan between the HW and CHW coils.	This section is not drained (typical)
Notes:

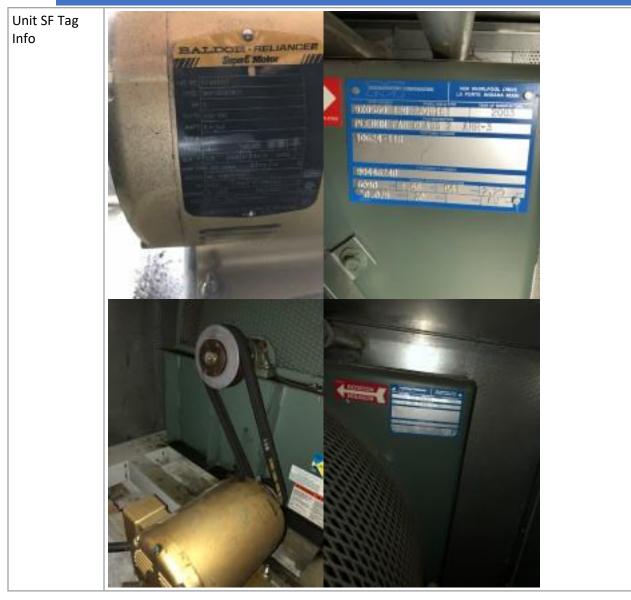
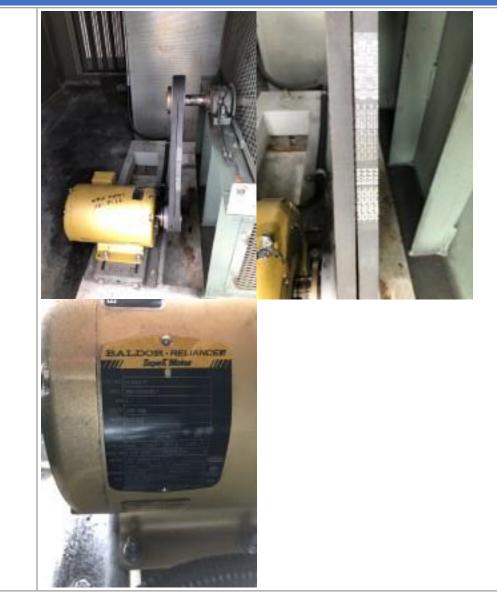
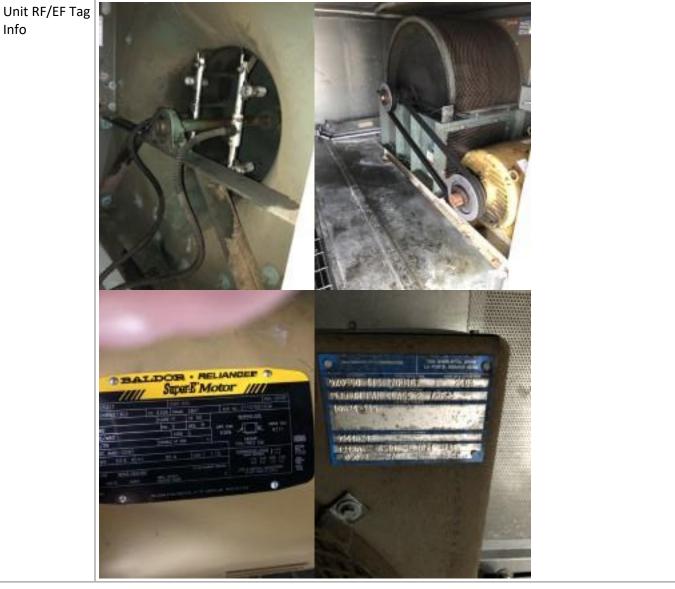
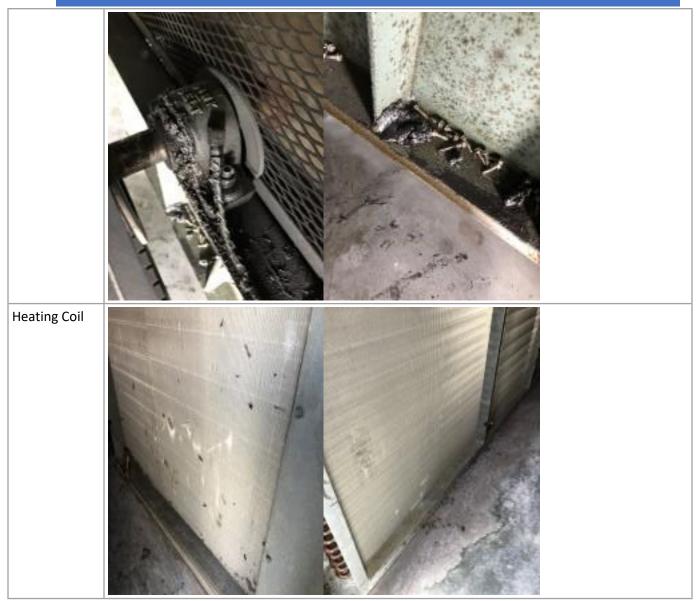
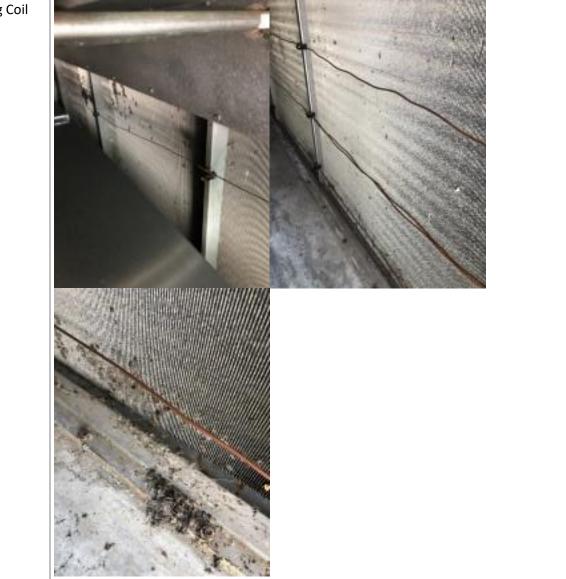
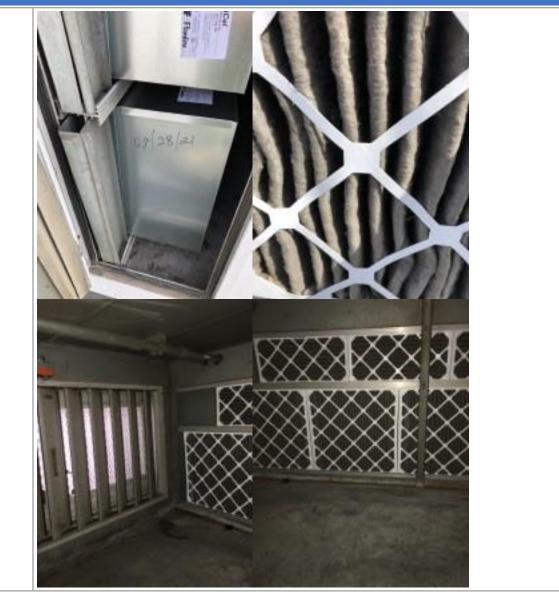
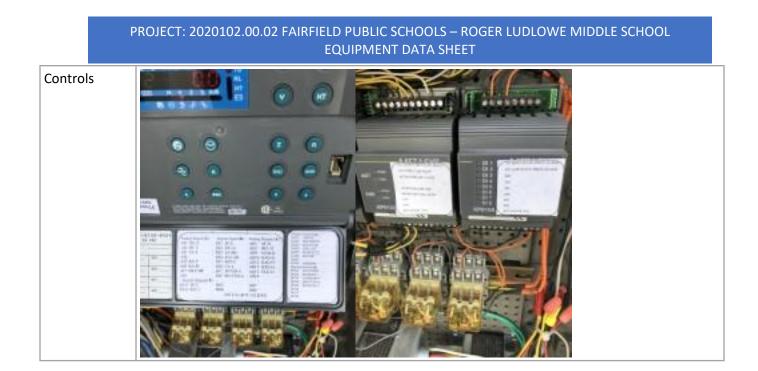
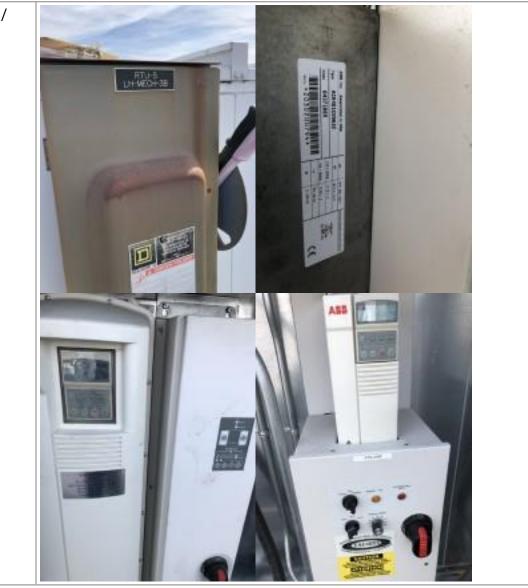
RLMS RTU-5	Addition commonts descriptions
Unit Tag		Addition comments descriptions
Location	Cafe Roof	
Serving	Faculty Dining, Cafe	
Config/Style	VAV	
Mfr.	Ventrol	
Model #		
Serial #		
Age (years)	2003	
System CFM	12.180 SA CFM @ 6.19 SP6090 Each RA CFM @ 1.58 SP	
Max OA CFM		
V/Hz/Ph	230-460 3 Phase	
SF Qty/HP	25?	Fan Dirty, bearings over greased
SF VFD Data	АСН	
RF Qty/HP	3 HP (2 Fans)	2 BX44 Belts
RF VFD Data	ACH401C00632	
Filter Data (Size Quantity)	5 - 12x24x2, 5 - 24x24x25 - 12x24x12, 5 - 24x24x12	MERV 13 9-28-21 Changed
Filter Status	Pre Dirty	
Controls Type		
Controls Mfr.		
Economizer		
CO ₂ DCV		
Damper Styles	Opposed	
Damper Status	Dirt needing Cleaning and Lubrication	OA Damper not moving freely, possible actuator gear stripped.
Heating Type	Dual Hot Water	
Heating Coil Condition	Needs Cleaning	
Cooling Type	Cool Chilled Water	
Cooling Coil Condition	Should be cleaned	
CU Mfr.		
CU Model		
CU Serial		
Drain Pan Status	Needs Cleaning

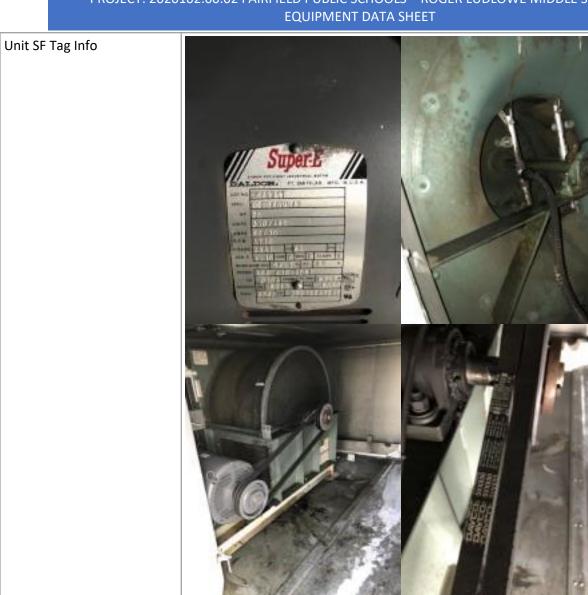
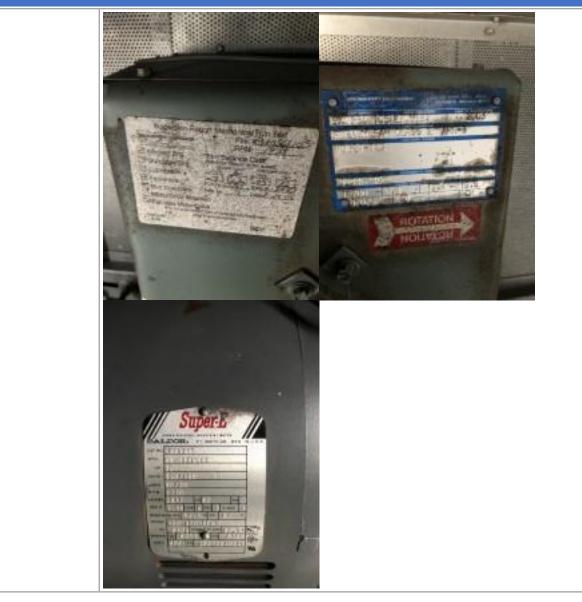
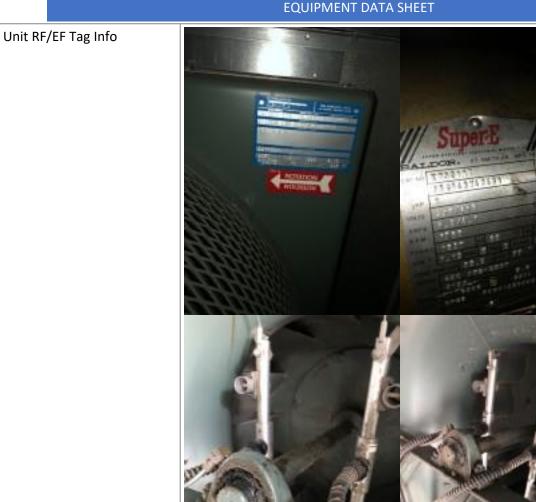
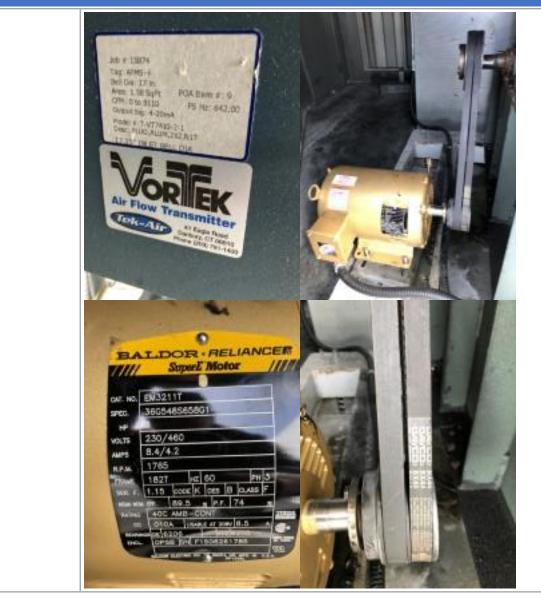
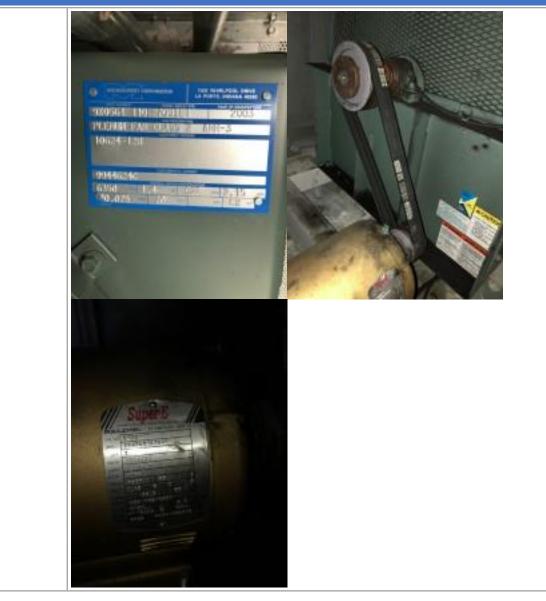
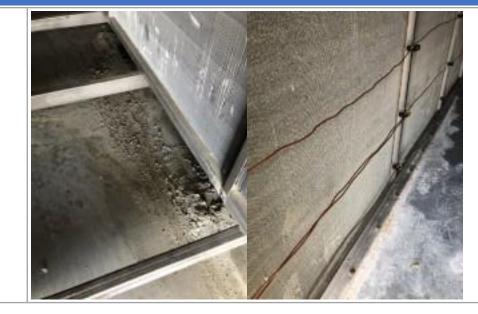
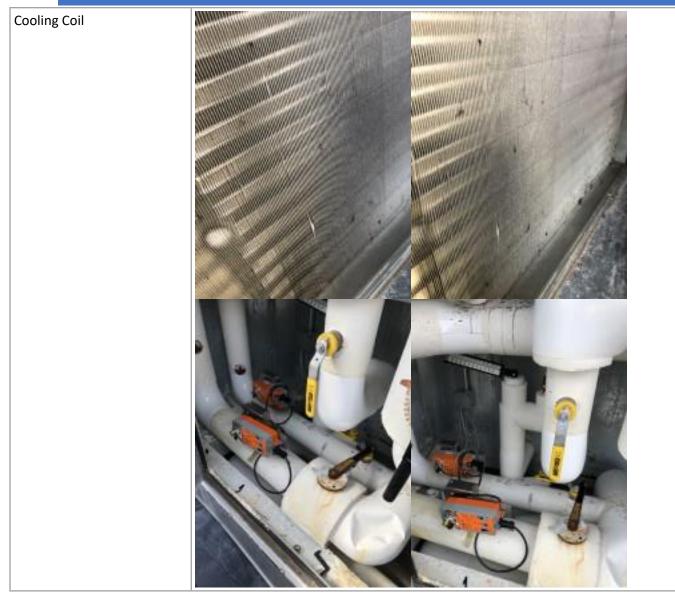
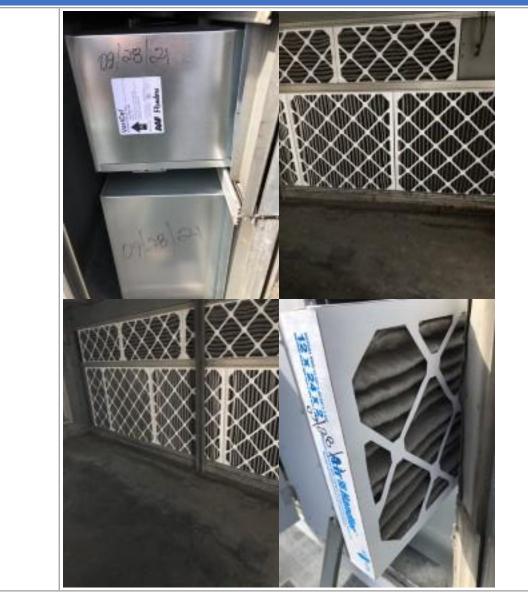
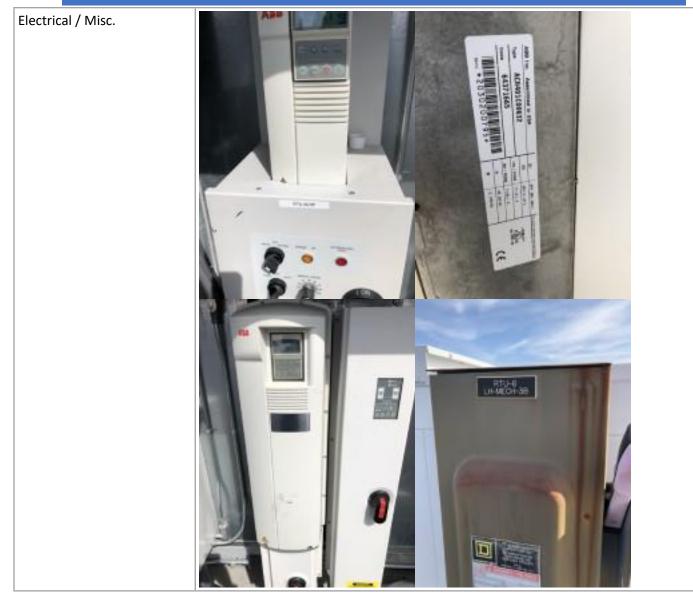
Unit Tag	RLMS RTU-6	Addition comments descriptions
Location	Central Roof	
Serving	Classrooms 320-328	
Config/Style		
Mfr.	Ventrol	
Model #		
Serial #		
Age (years)	2003	
System CFM	12,700 SF CFM @ 6.4 SP6350 RA CFM (2) @1.4 SP	
Max OA CFM		
V/Hz/Ph	230-460 3-Phase	
SF Qty/HP	25 HP	2 -5VX830 Belts
SF VFD Data	ACH	
RF Qty/HP	(2) 3 HP	2 - BX44 Belts each Fan
RF VFD Data	ACH401C00632	
Filter Data (Size Quantity)	5 - 12x24x2, 5 - 24x24x25 - 12x24x12, 5 - 24x24x12	MERV 13
Filter Status	Due to be changed	
Controls Type		
Controls Mfr.		
Economizer		
CO ₂ DCV		
Damper Styles	TAMCO Opposed	
Damper Status	Need Cleaning and Lubrication	
Heating Type	Dual Hot Water	
Heating Coil Condition	Should be cleaned	
Cooling Type	Dual Chilled Water	
Cooling Coil Condition	Should be cleaned	
CU Mfr.		
CU Model		
CU Serial		
Drain Pan Status	Needs Cleaning	
Notes:

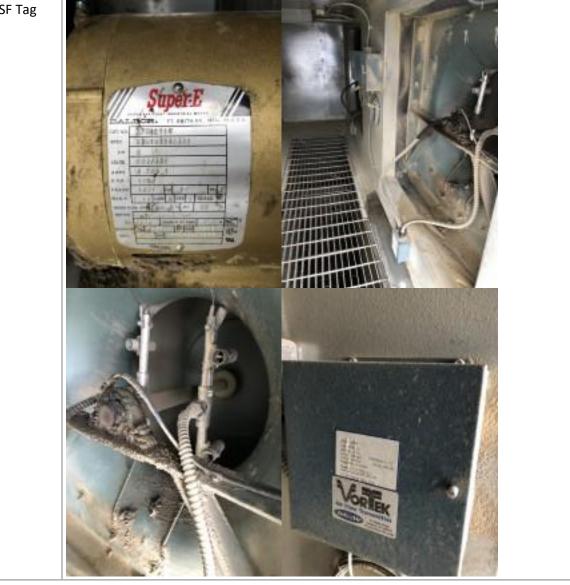
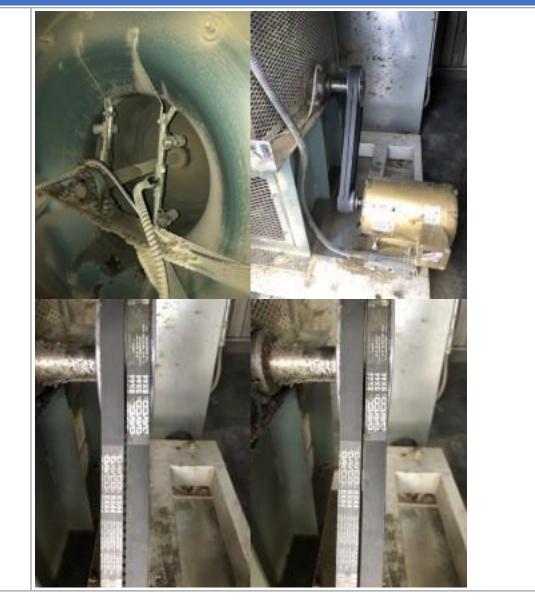
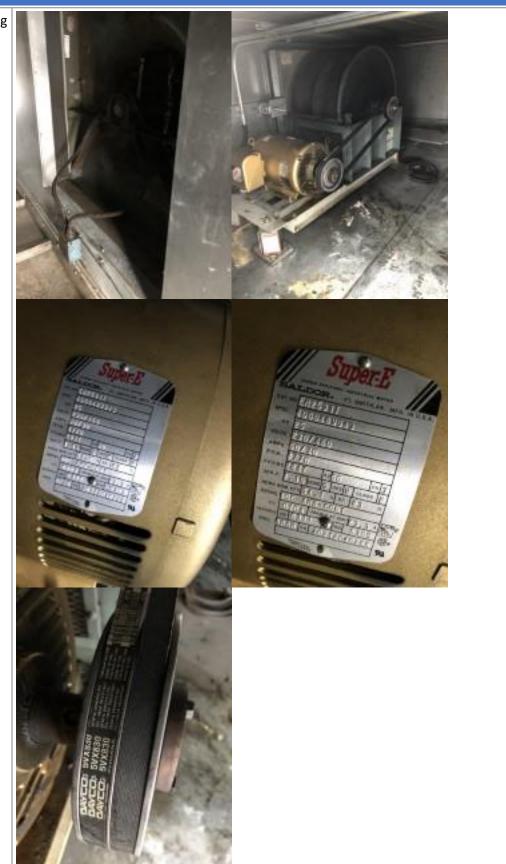
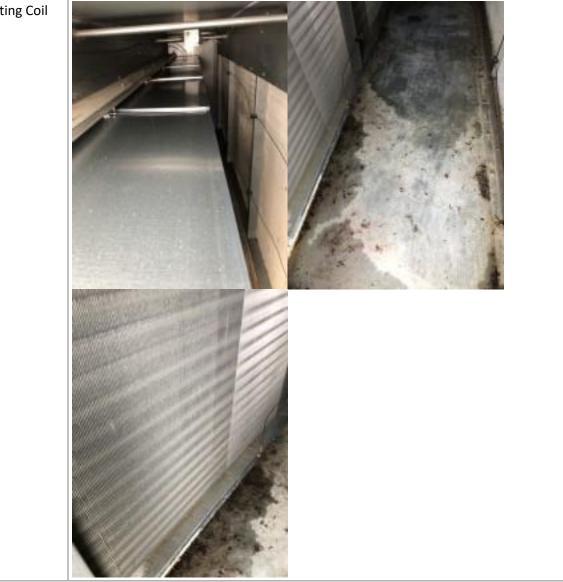
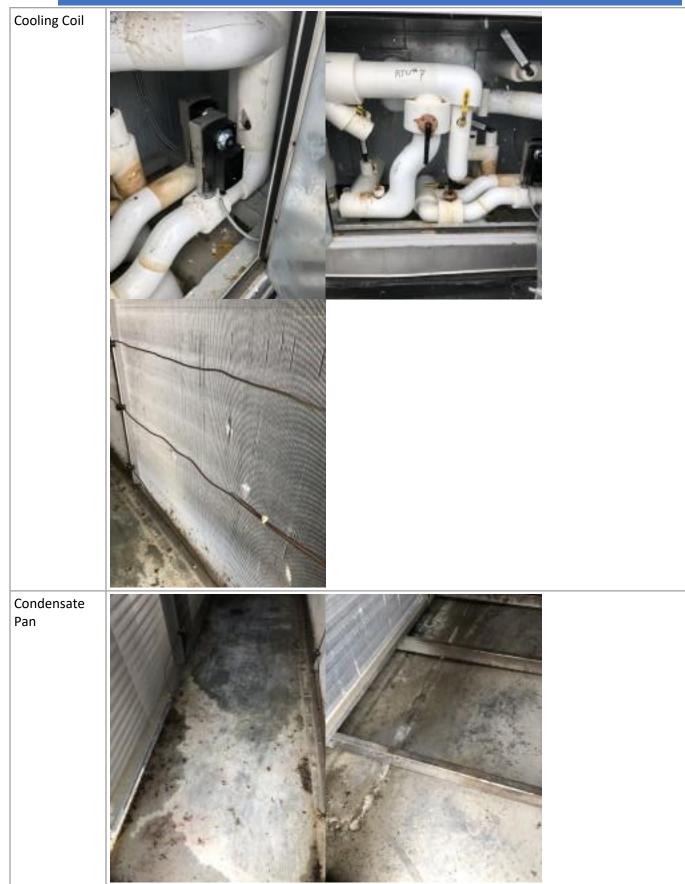
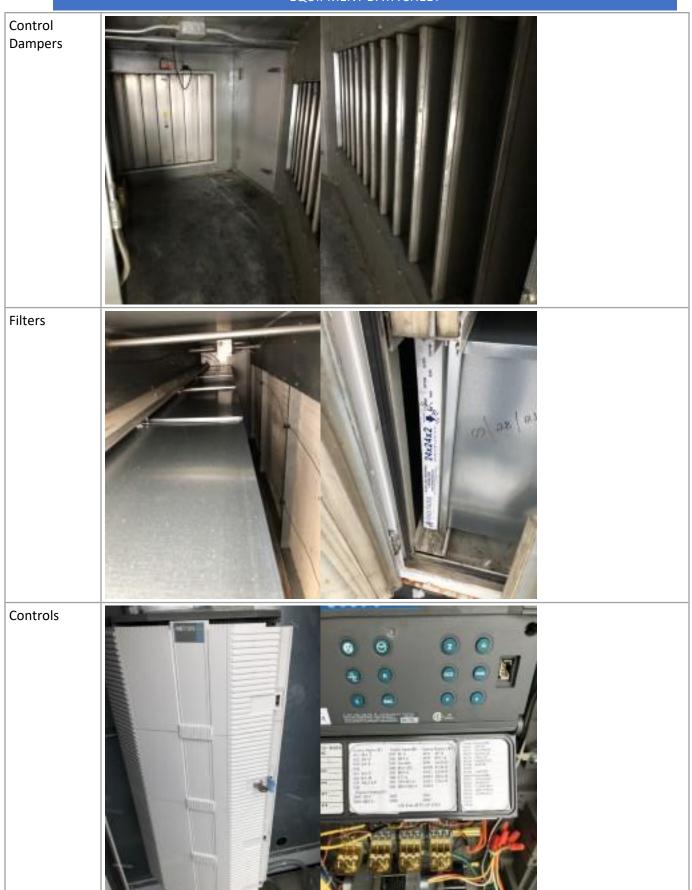
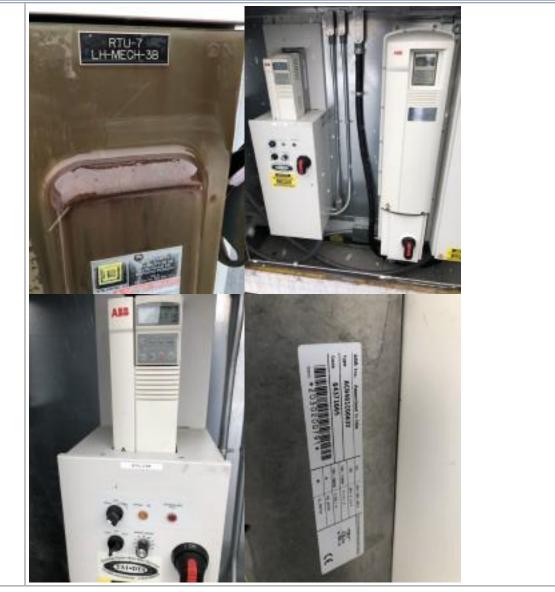
Description	Photos
Unit Tag Info	RTU-7 LH-MECH-38
Unit from afar	#

Unit Tag	RLMS RTU-7	Addition comments descriptions
		Addition comments descriptions
Location	Central Roof	
Serving	Technologies	
Config/Style	VAV Dual Temp Htg, Clg.	
Mfr.	Ventrol	
Model #		
Serial #		
Age (years)	2003	
System CFM	13800	
Max OA CFM		
V/Hz/Ph	230/460 3 Phase	
SF Qty/HP	(1) 25 HP	(2) 5VX830 Belts
SF VFD Data	ABB ACH with Bypass	
RF Qty/HP	(2) 3 HP	(2) BX44 Belts each fan
RF VFD Data	ABB ACH401C00632With Bypass	
Filter Data (Size Quantity)		
Filter Status	Pre-filters could be changed	
Controls Type		
Controls Mfr.		
Economizer		
CO ₂ DCV		
Damper Styles		
Damper Status	Not bad, could use lubrication	
Heating Type	Dual Temp Hot Water	
Heating Coil Condition	Somewhat dirty	
Cooling Type	Dual Temp Chilled Water	
Cooling Coil Condition	Somewhat Dirty	
CU Mfr.	N/A	
CU Model	N/A	
CU Serial	N/A	
Drain Pan Status	Moderate, cleaning in near future	
Notes:	Some signs of external rust and corrosion and algae growth

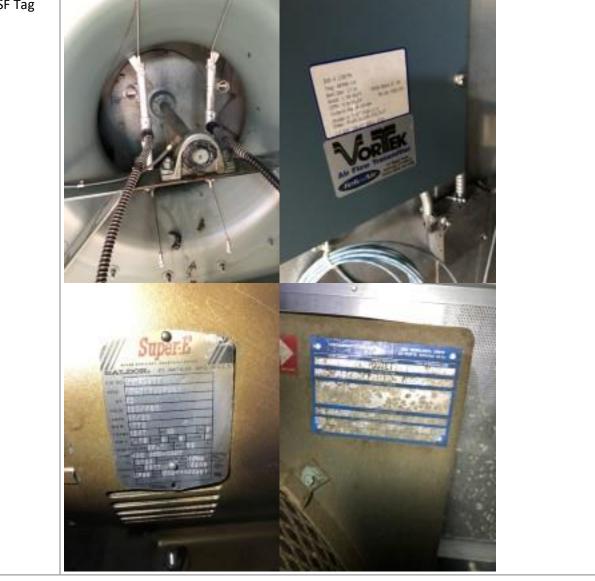
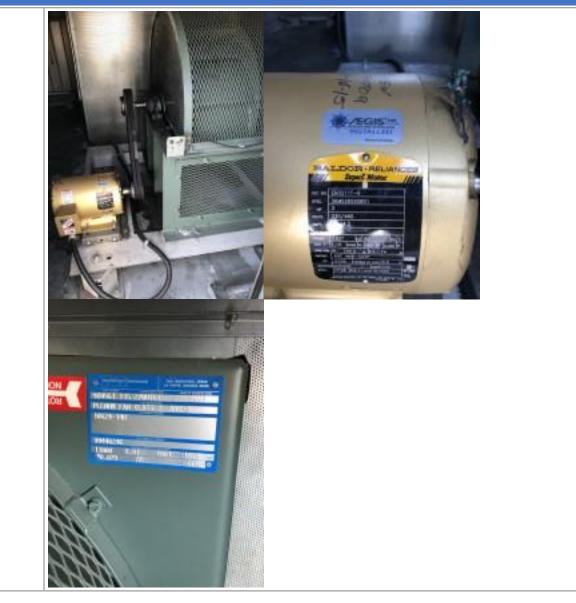
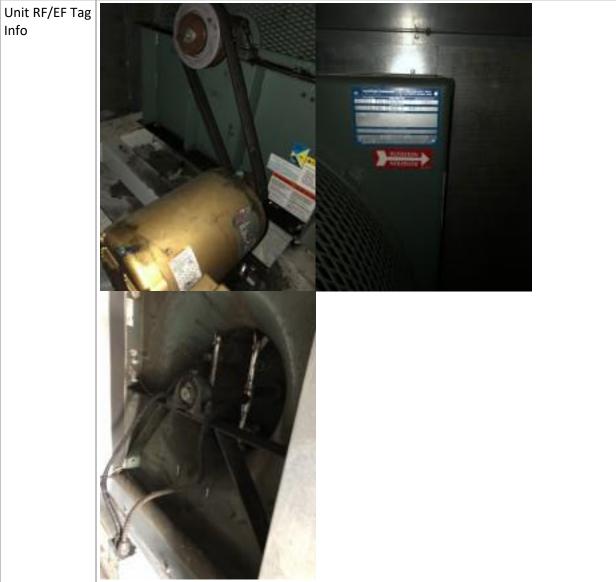
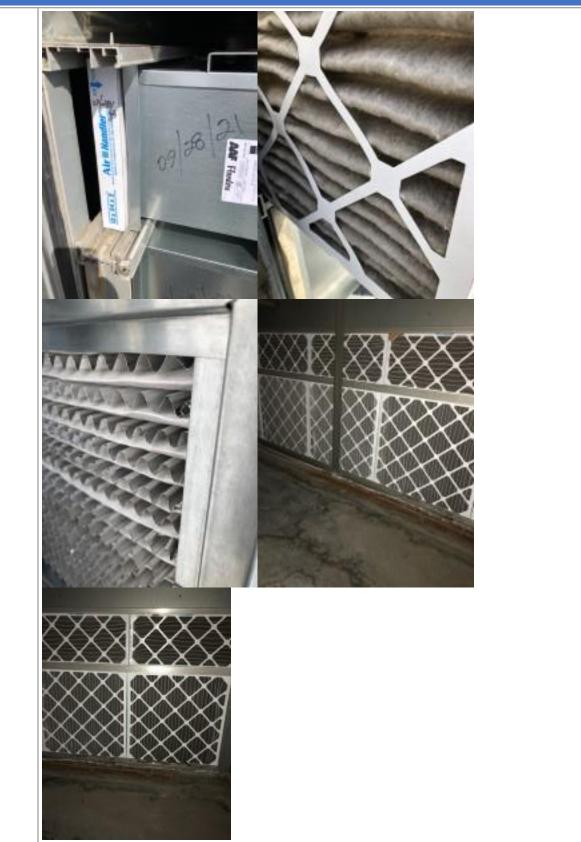
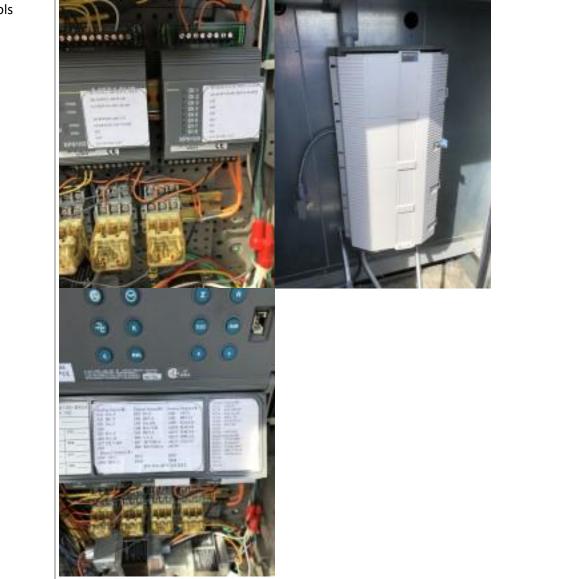
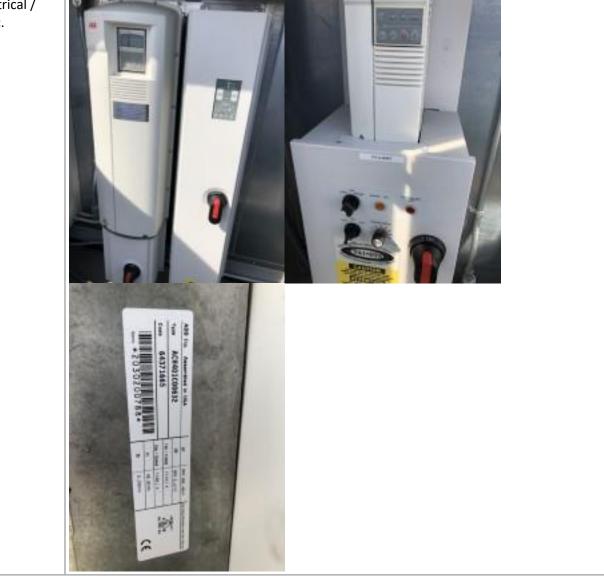
Addition comments descriptions
Unit Tag	RLMS RTU-8	Addition comments descriptions
Location		
Serving	Classrooms 322-335	
Config/Style		
Mfr.	Ventrol	
Model #		
Serial #		
Age (years)	2003	
System CFM	13,800 SF CFM @5.91 SP6,900 RF (2) CFM@5.91 SP	
Max OA CFM		
V/Hz/Ph	230-460 3-Phase	
SF Qty/HP	25 HP	2 - 5VX830 Belts
SF VFD Data	АСН	
RF Qty/HP	(2) 3 HP	(2) BX45 Belts
RF VFD Data	ACH401C00632	
Filter Data (Size Quantity)	5 - 12x24x2, 5 - 24x24x25 - 12x24x12, 5 - 24x24x12	
Filter Status	Pre should be cleaned	Last Changed 9-28-22
Controls Type		
Controls Mfr.		
Economizer		
CO ₂ DCV		
Damper Styles	Opposed TAMCO	
Damper Status	Should be Cleaned and Lubricated	
Heating Type	Dual HW	
Heating Coil Condition	Moderate	
Cooling Type	Dual CHW	
Cooling Coil Condition	Moderate	
CU Mfr.		
CU Model		
CU Serial		
Drain Pan Status	Cleaning needed	
Notes:	-
