Roger Ludlowe Middle School 689 Unquowa Rd

Fairfield Public Schools Recommissioning (RCx) and Testing, Adjusting, & Balancing (TAB) Study van Zelm Project # 2020102.00 (02-RLMS) June 09, 2022

ROGER LUDLOWE MIDDLE SCHOOL

FAIRFIELD PUBLIC SCHOOLS RECOMMISSIONING (RCX) AND TESTING, ADJUSTING, & BALANCING (TAB) STUDY

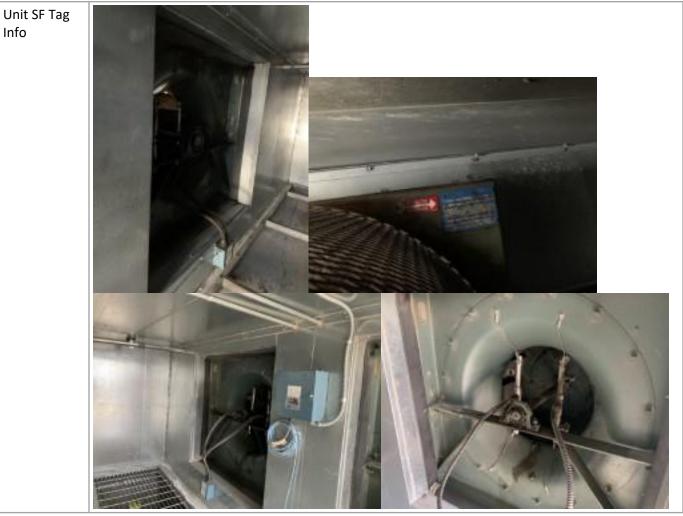
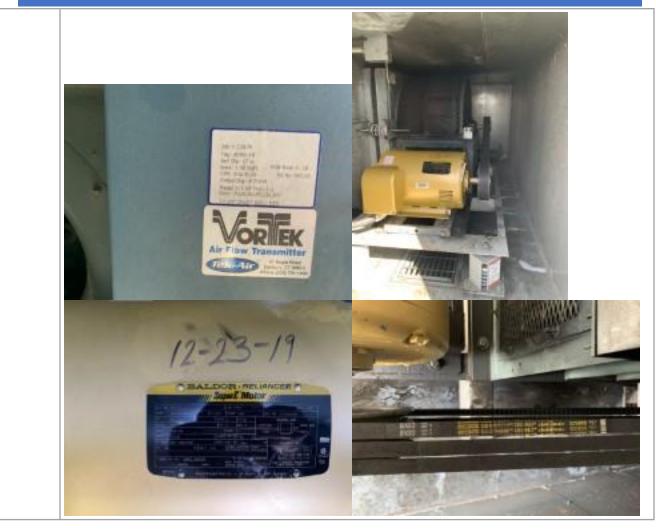
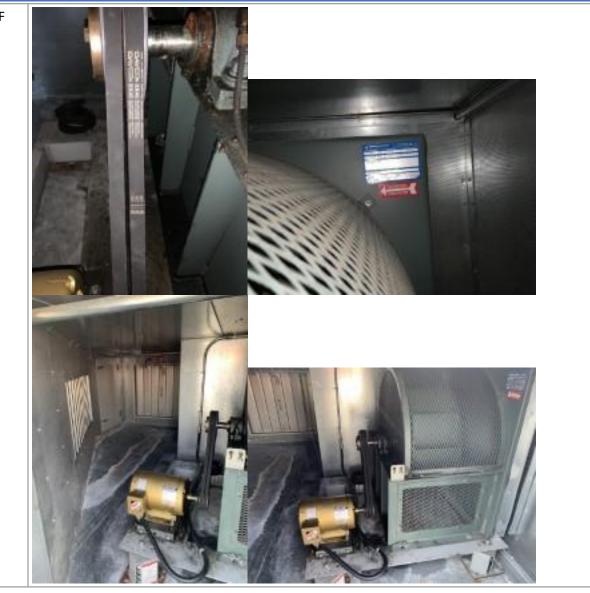
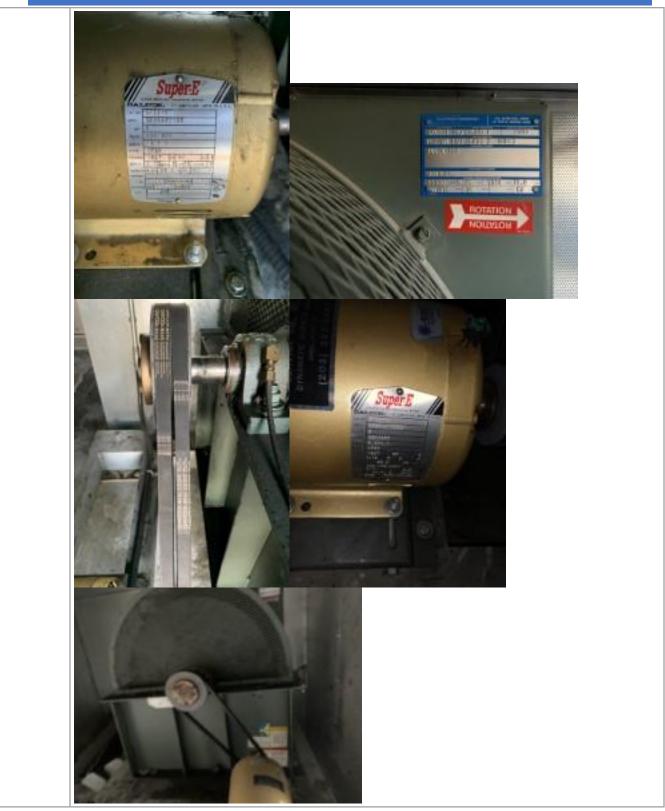
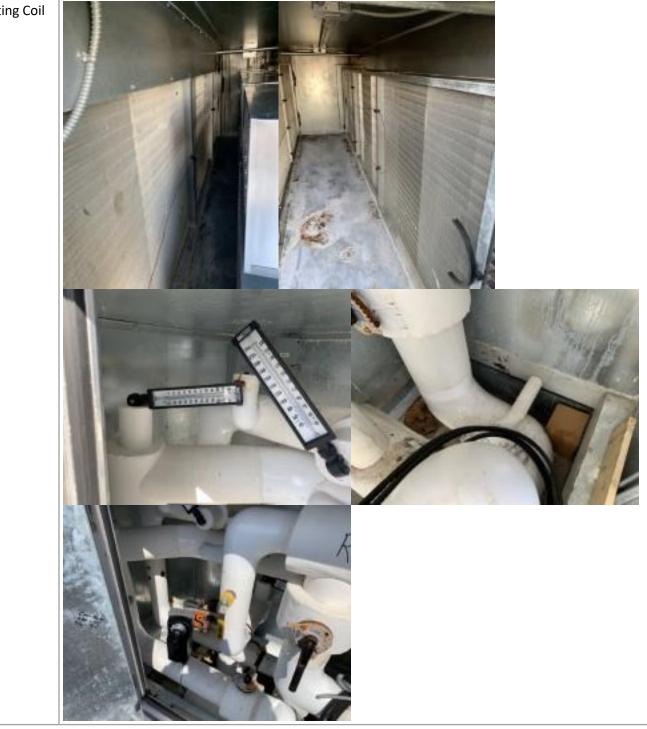
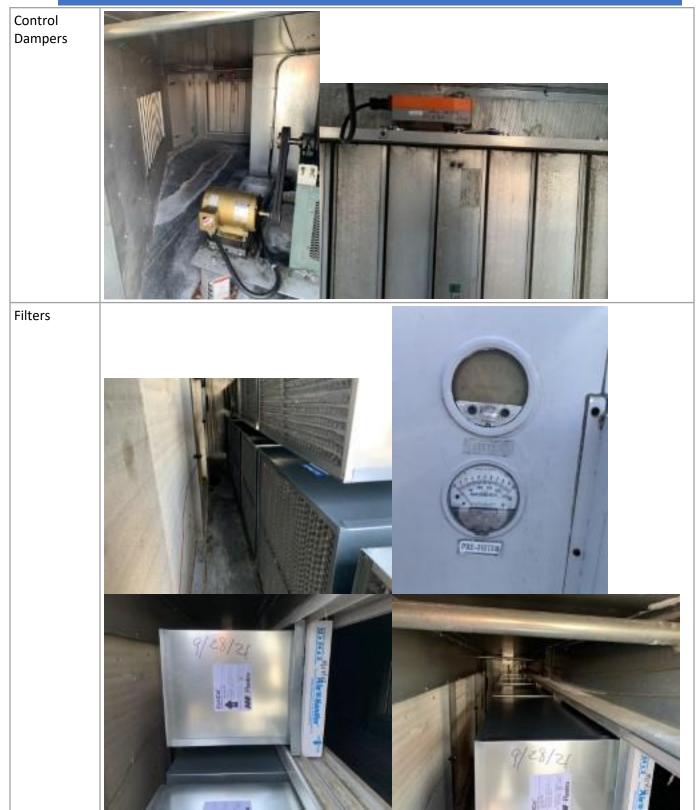
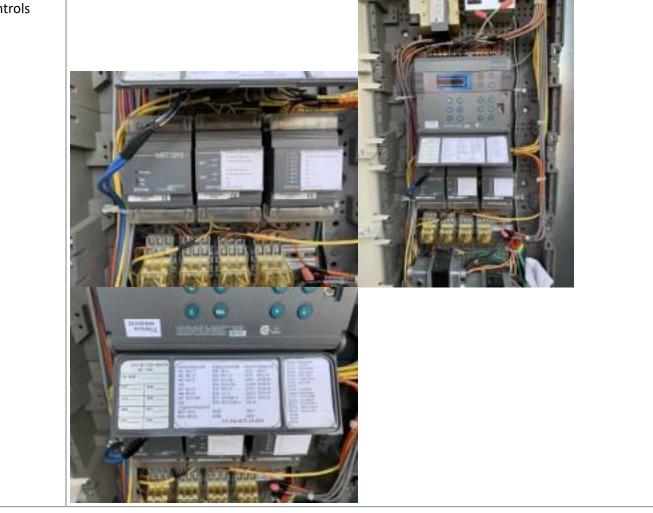
Unit Tag	RLMS RTU-9	Addition comments descriptions
Location	Central Roof	
Serving	Classrooms 248-269, Lobby	
Config/Style	S/R with economizer control and DT H/CHW	
Mfr.	Ventrol	
Model #	unknown	
Serial #	unknown	
Age (years)	20	
System CFM	16000	
Max OA CFM	16000	
V/Hz/Ph		
SF Qty/HP	1, 30hp, 230V/460V, 72A/36A, 1775rpm	Supply fan section door has no hinges
SF VFD Data	ABB M# H550-VH-045A-4, S# 2121403079	
RF Qty/HP	2, 5hp, 230V/460V, 13A/6.5A, 1750rpm	
RF VFD Data	ABB M# ACH401C00932, C# 6431673	480V, 14.8A
Filter Data (Size Quantity)	2" MERV 13, 12" MERV 13	
Filter Status	Pre-filters Dirty, final filters clean	
Controls Type		
Controls Mfr.		
Economizer	Yes	
CO ₂ DCV	Unknown	
Damper Styles	Tamco parallel blade	
Damper Status	Need to be cleaned	
Heating Type	Dual-temperature Hot Water	
Heating Coil Condition	Coil is ok, temperature sensor has poor coverage	
Cooling Type	Dual-temperature Chilled Water	
Cooling Coil Condition	Minor corrosion on the header

CU Mfr.	N/A	
CU Model	N/A	
CU Serial	N/A	
Drain Pan Status	Minor rust in the pan	
Notes:

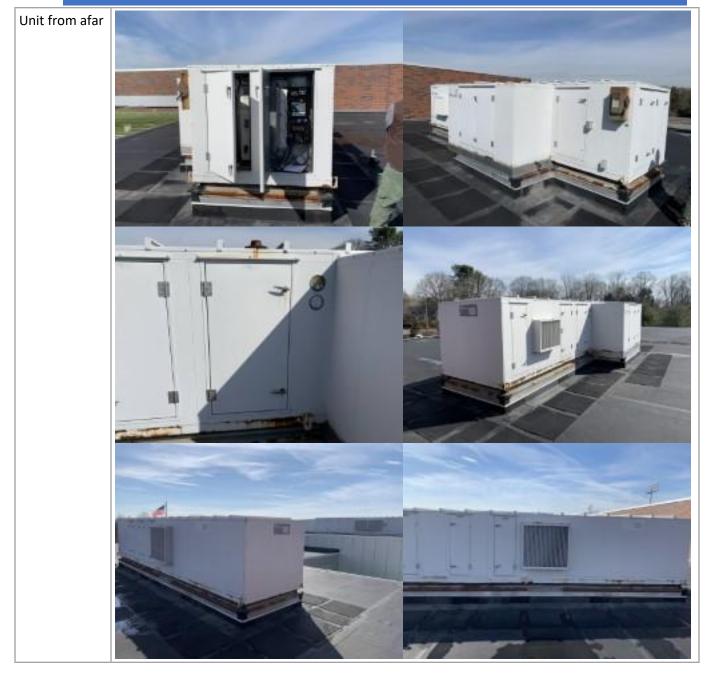
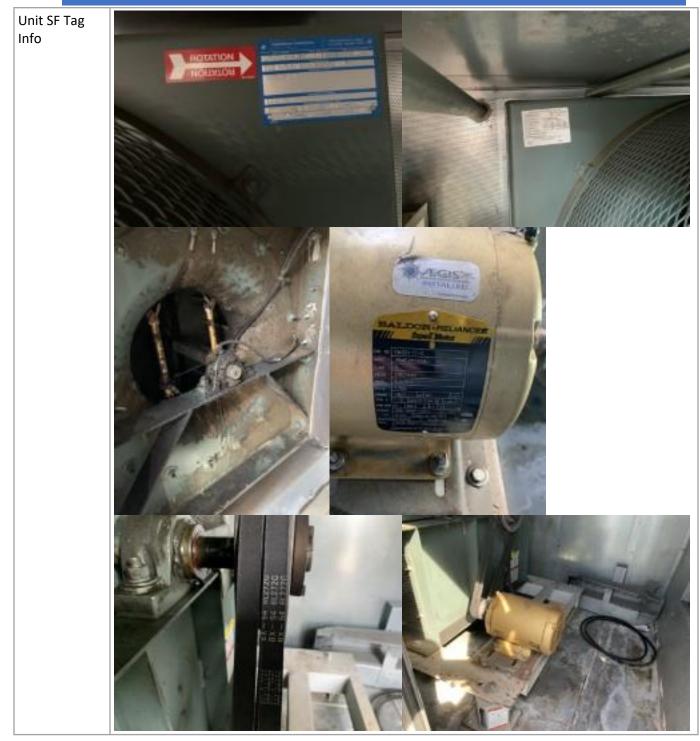
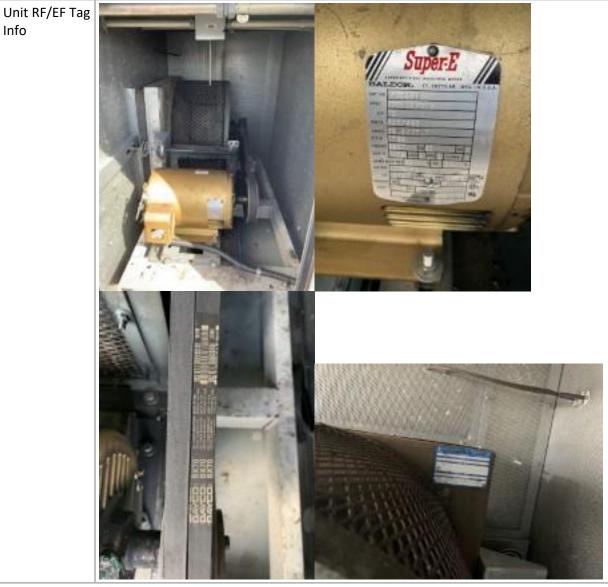
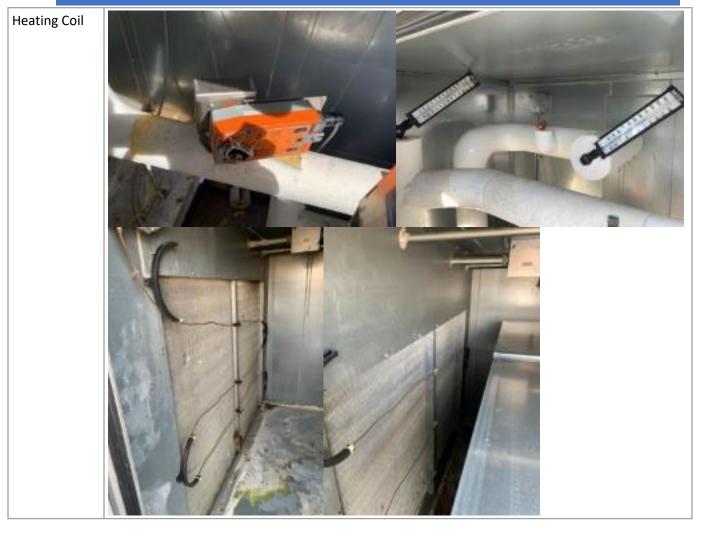
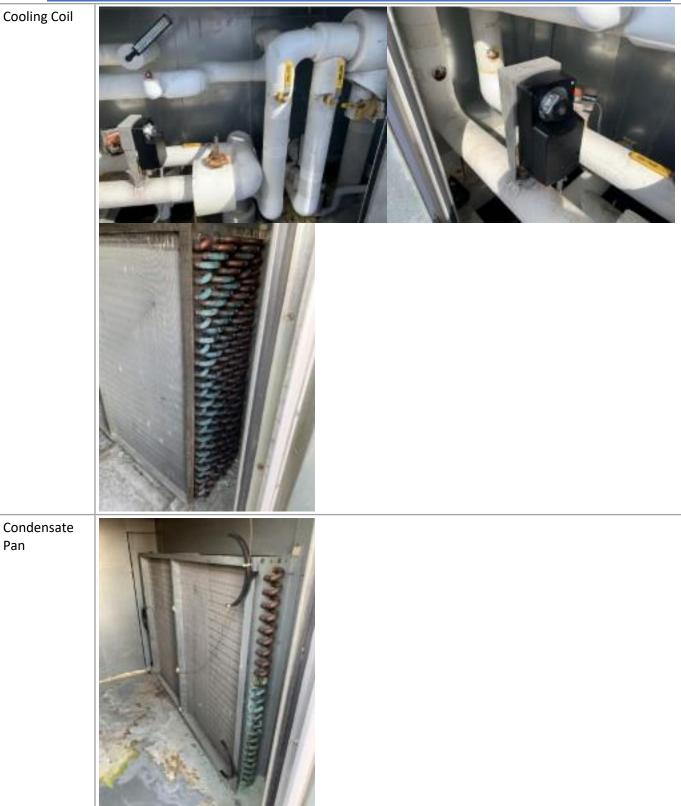
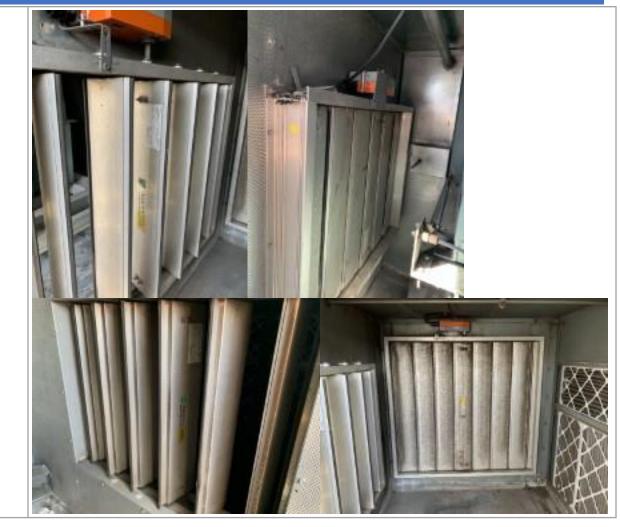
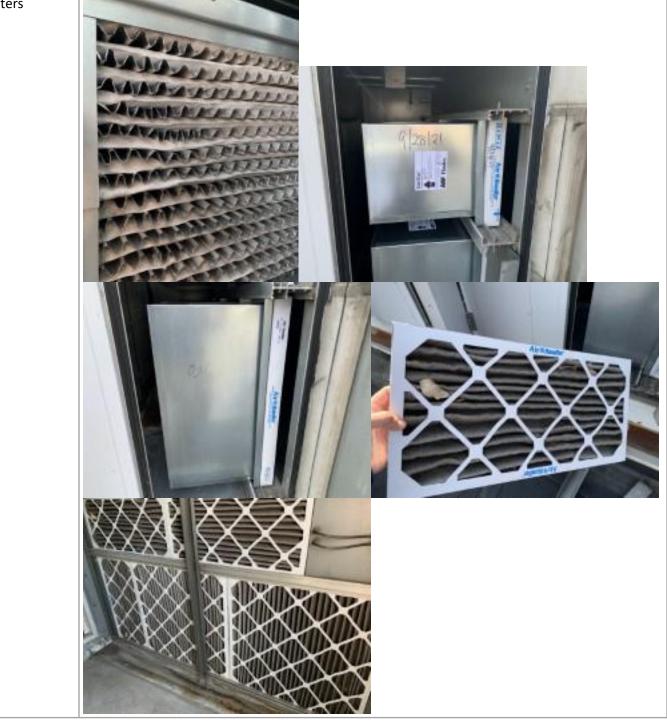
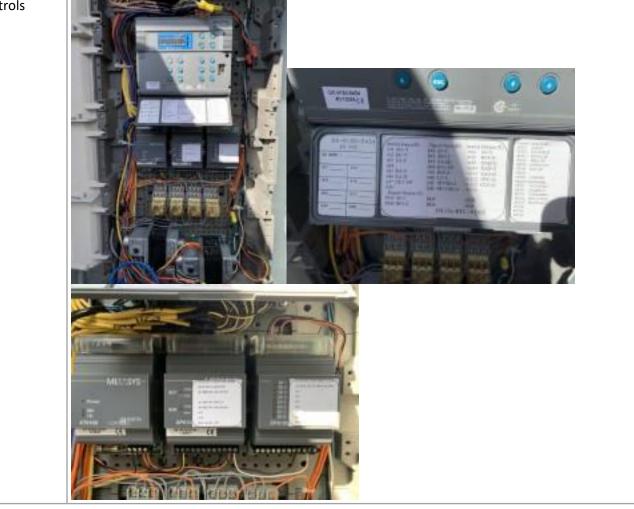
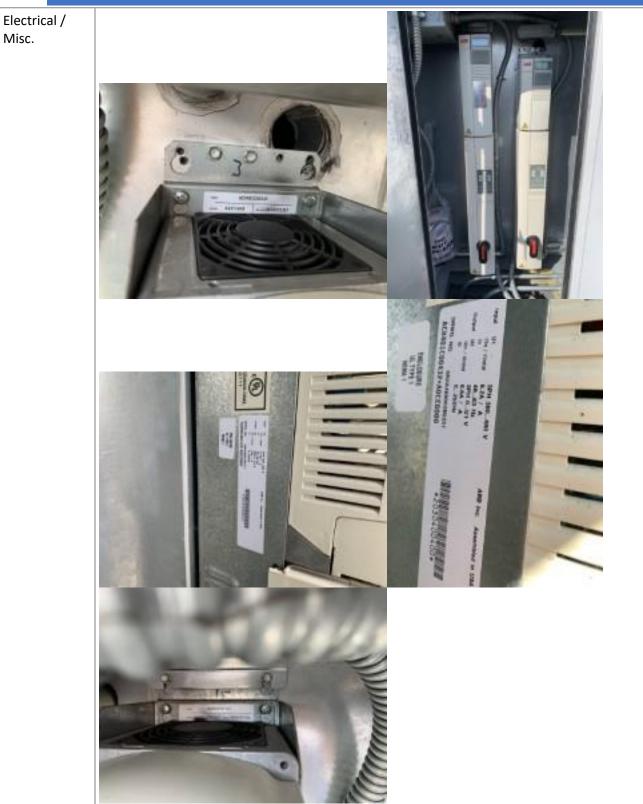
Description	Photos
Unit Tag Info	AIR FLOW RTU-10 Module # 1 10624-016
	the line Frank

Unit Tag	RLMS RTU-10	Addition comments descriptions
Location	North Roof	
Serving	Library	
Config/Style	S/R with economizer control and DT H/CHW	
Mfr.	Ventrol	
Model #	unknown	
Serial #	unknown	
Age (years)	20	
System CFM	6200	
Max OA CFM	6200	
V/Hz/Ph		
SF Qty/HP	1, 15hp, 230V/460V, 35.4A/17.7A, 1765rpm	Fan base squeaks and could use an adjustment
SF VFD Data	ABB M# ACH401C00432+A0CE0000	480V, 6.6A
RF Qty/HP	1, 3hp, 230V/460V, 8.4A/4.2A, 1765rpm	
RF VFD Data		
Filter Data (Size Quantity)	2" MERV 13, 12" MERV 13	
Filter Status	Dirty	
Controls Type		
Controls Mfr.		
Economizer	Yes	
CO ₂ DCV	Unknown	
Damper Styles	Tamco parallel blade	
Damper Status	OA dampers dirty, all need to be greased	
Heating Type	Dual-temperature Hot Water	
Heating Coil Condition	Noticeable air in the coil	
Cooling Type	Dual-temperature Chilled Water	
Cooling Coil Condition	Corrosion on the header	
CU Mfr.	N/A	
CU Model	N/A	
CU Serial	N/A	
Drain Pan Status	Debris found in drain pan, drain was not obstructed

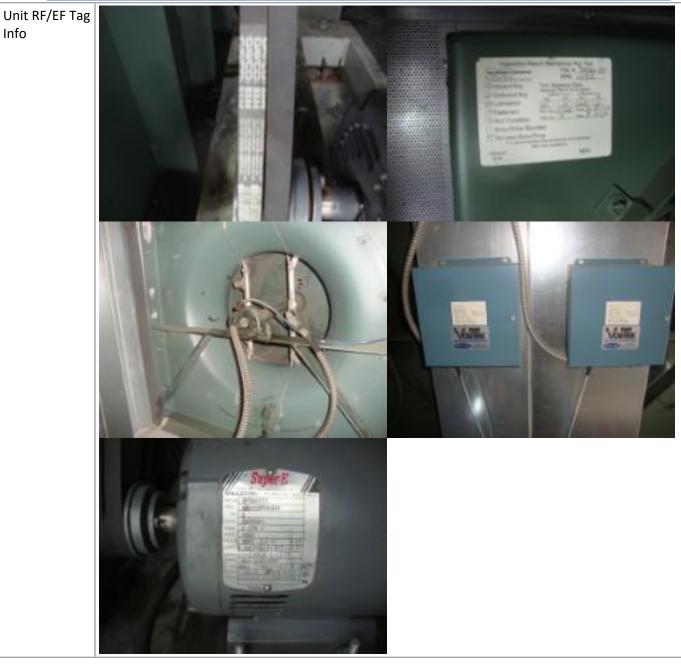
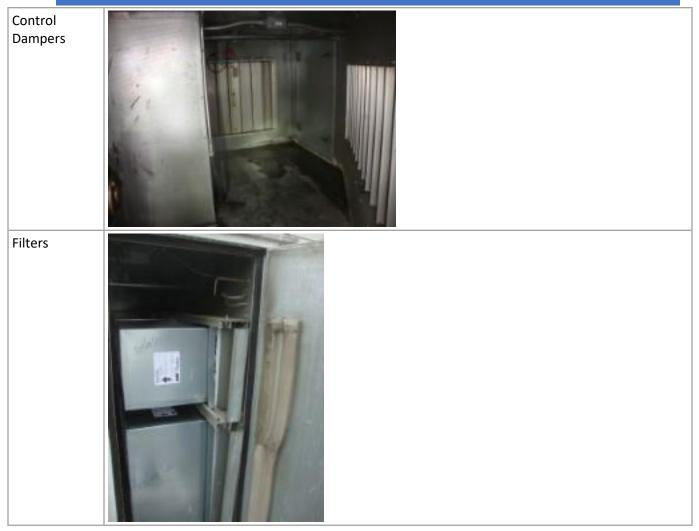
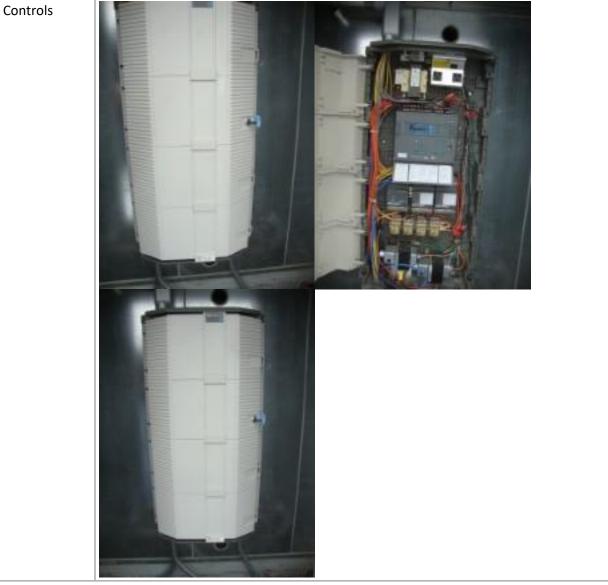
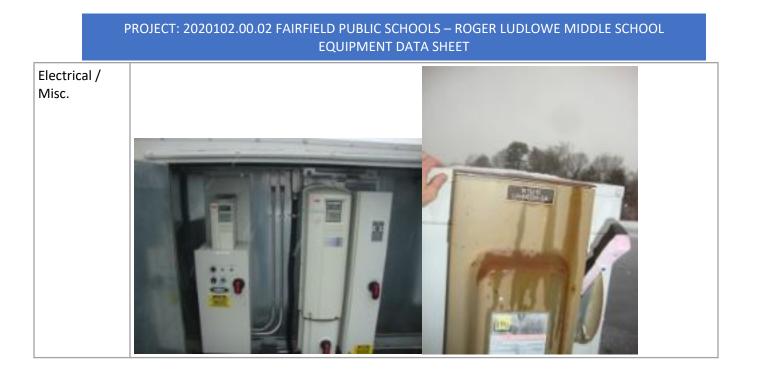
Description	Photos
Unit Tag Info	
Unit from afar	
	<image/>

Unit Tag	RLMS RTU-11	Addition comments descriptions
Location	Central Roof	
Serving	Classrooms 339-351	
Config/Style		
Mfr.	Ventrol	
Model #		
Serial #		
Age (years)	2003	
System CFM	12500@6.1: 1,887 RPM	(2) BX81
Max OA CFM		
V/Hz/Ph		
SF Qty/HP	20?	
SF VFD Data	АВВ	
RF Qty/HP	(2) 3.0	(2) BX84 ea.
RF VFD Data	АВВ	
Filter Data (Size Quantity)		
Filter Status	Prefilter very bad	9-27-21
Controls Type		
Controls Mfr.		
Economizer	Yes	
CO ₂ DCV		
Damper Styles	Tamco OBD	
Damper Status	Clean Adjust and lubricate	
Heating Type	Glycol Hot water	
Heating Coil Condition	Dirty	
Cooling Type	Glycol Chilled water	
Cooling Coil Condition	ОК	
CU Mfr.	n/a	
CU Model	n/a	
CU Serial	n/a	
Drain Pan Status	S.S	
Notes:	Belt guards removed, Freeze stats set @38	Heavy grease on pillow blocks
CU Model CU Serial Drain Pan Status	n/a n/a S.S	Heavy grease on pillow blocks

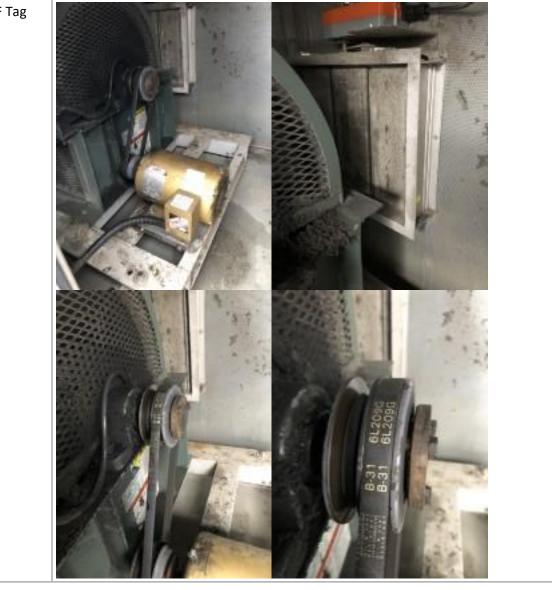
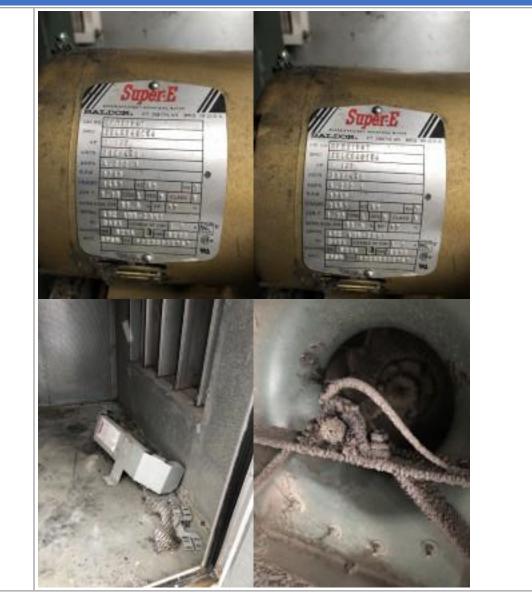
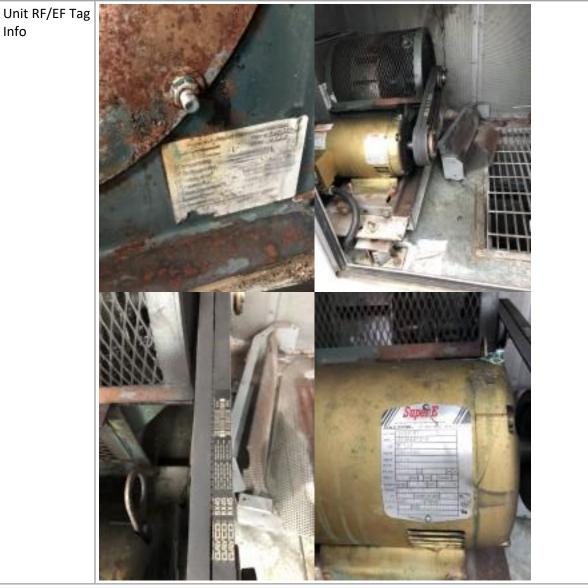
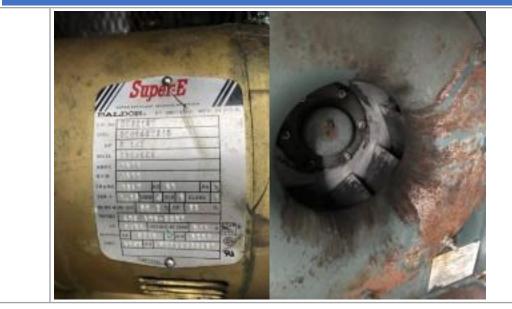
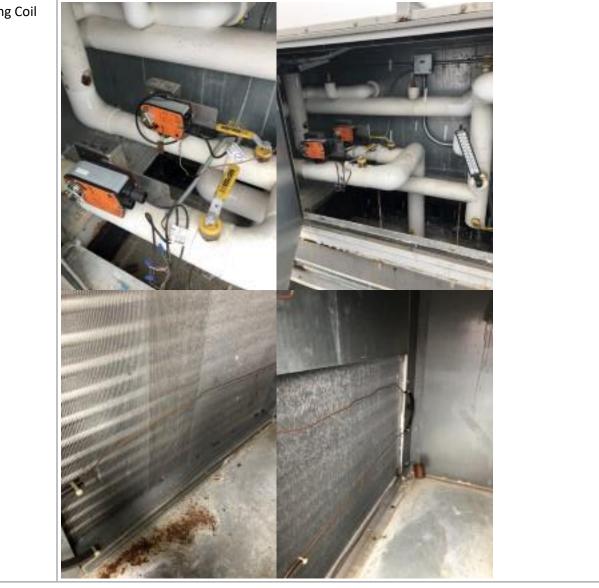
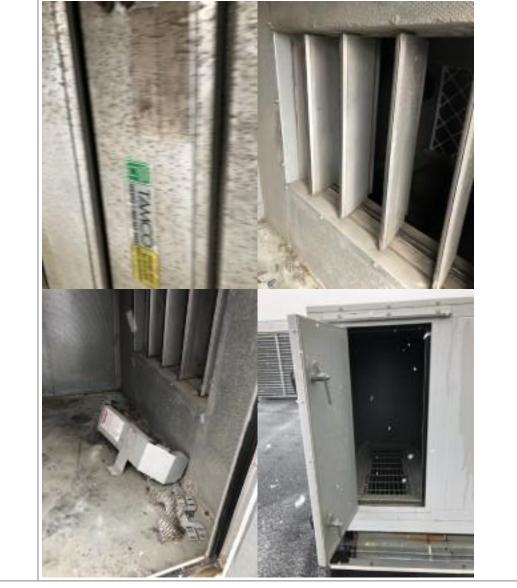
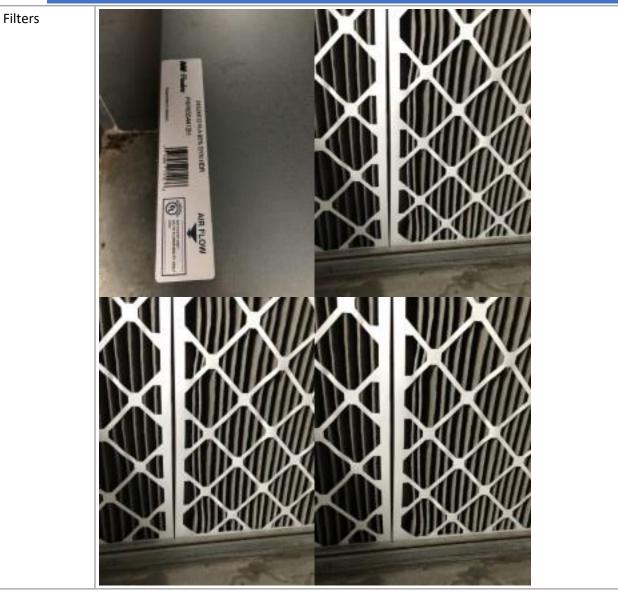
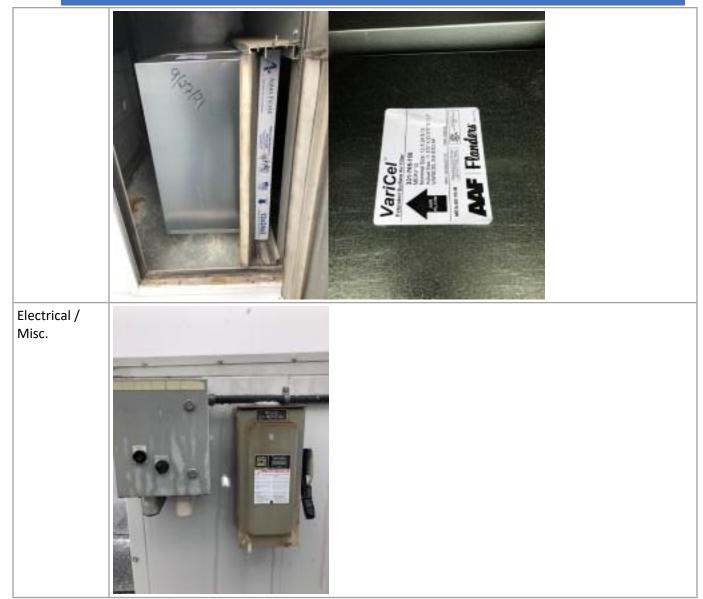
Description	Photos
Unit Tag Info	INCOME DE LA COMPACIÓN DE LA C
Unit from afar

Addition comments descriptions
CV Dual Temp Htg, Clg.	
Ventrol	
No Tag	
2003	
2650	
230/460 3 Phase	
7 1/2 HP	
NA	
1 1/2 HP	
NA	
1-24x24x2, 1-24x24x2,1-24x12x12, 1-24x24x12 Box	MERV 13 Both
Require Changing	
DDC	
ıcı	
Yes	
?	
Opposed	
Need Cleaning & Lubrication	
Dual Temp Hot Water	
Looks Clean	
Dual Temp Chilled Water	
Looks Clean	
ОК	
	Ventrol No Tag 2003 2650 230/460 3 Phase 7 1/2 HP NA 1 1/2 HP NA 1 1/2 HP NA 1-24x24x2, 1-24x24x2,1-24x12x12, 1-24x24x12 Box Require Changing DDC JCl Yes ? Opposed Need Cleaning & Lubrication Dual Temp Hot Water Looks Clean

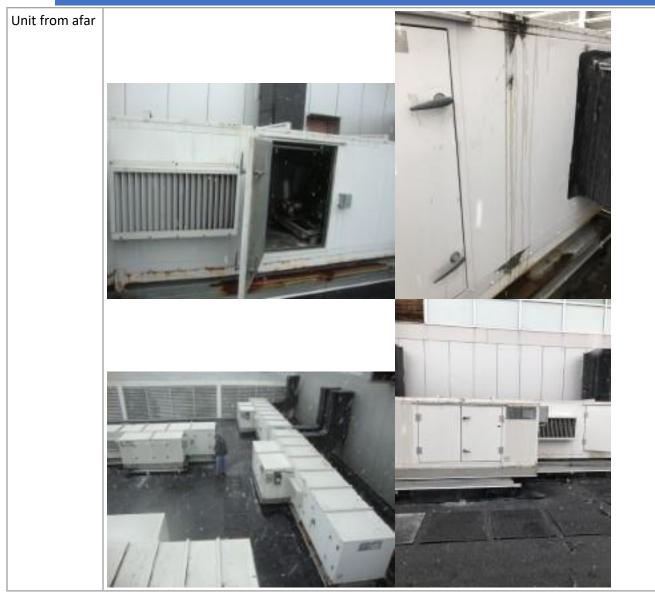
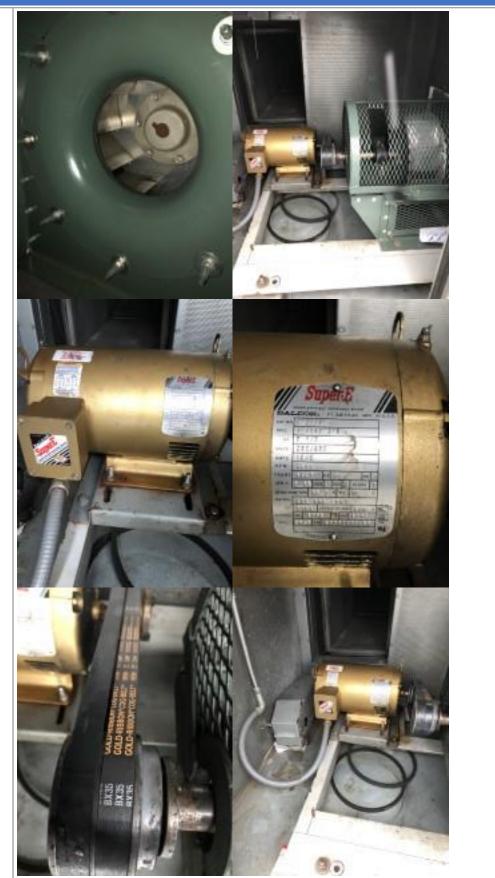
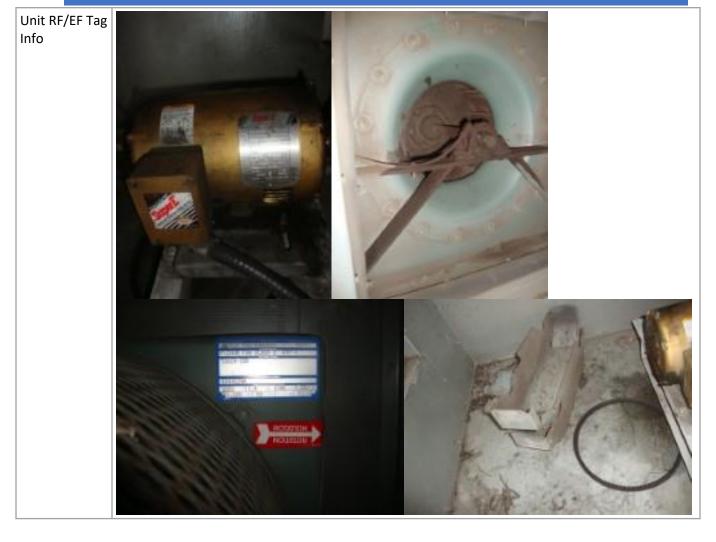
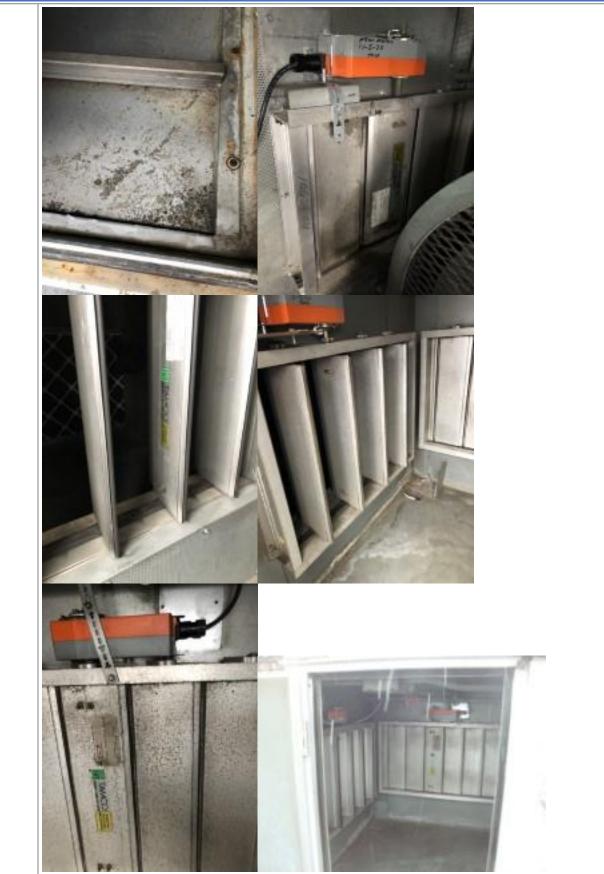
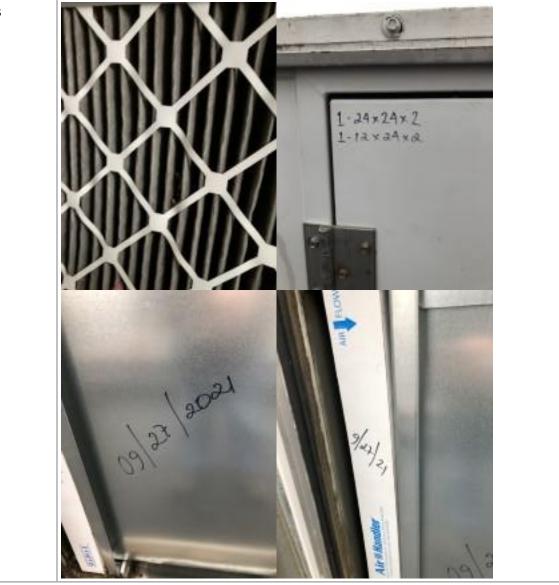
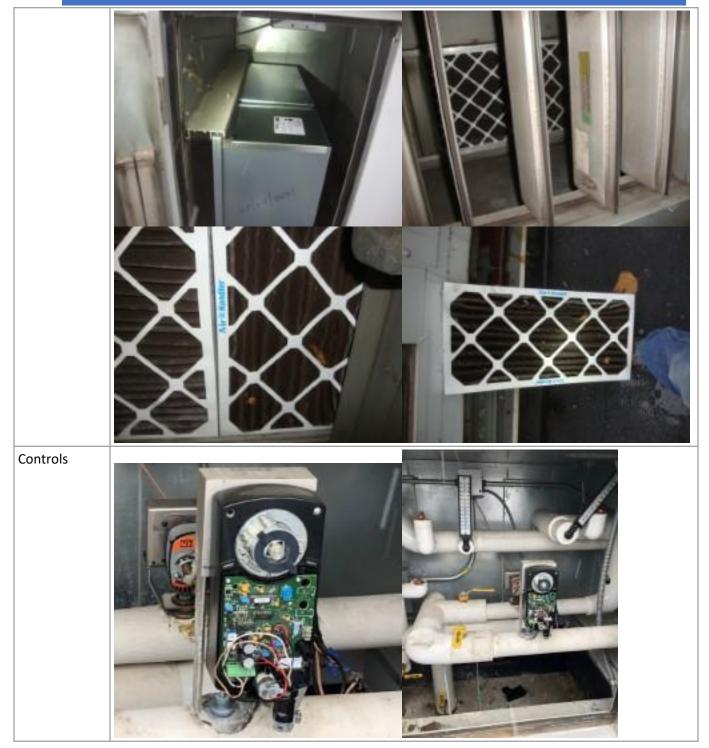
Unit Tag	RLMS RTU-14	Addition comments descriptions
Location	Gym Roof	
Serving	Project Room	
Config/Style	CV Dual Temp Htg, Clg.	
Mfr.	Ventrol	
Model #	No Tag	
Serial #		
Age (years)	19 (2003)	
Supply CFM	2650@5,3 4,412 RPM	(2) BX35. Belt Guard removed
Max OA CFM		
V/Hz/Ph	230-460 3-Phase	
SF Qty/HP	7.5	
SF VFD Data	None	
RF Qty/HP	1 1/2 HP	(2) BX32 Belts. Belt Guard removed 2650 CFM
RF VFD Data	None	
Filter Data (Size Quantity)	1-24x24x2, 1-24x24x2, 1-24x12x12, 1-24x24x12 Box	Merv 13
Filter Status	Dirty Pre needs cleaning	Last changed 9-27-21
Controls Type		
Controls Mfr.		
Economizer	Yes	
CO ₂ DCV		
Damper Styles	Tamco OBD	
Damper Status	Clean adjust and lubricate	
Heating Type	Duel Temp HW	
Heating Coil Condition	Should be cleaned	
Cooling Type	Dual Temp Chilled Water	
Cooling Coil Condition	Should be cleaned	
CU Mfr.	n/a	
CU Model	n/a	
CU Serial	n/a	
Drain Pan Status	Loose scale/dirt	
Notes:	Belt guards off side return and discharge Motor Bearings over-greased, RF fan wheel could be cleaned	Overall in good condition with a need for enhanced Maintenance

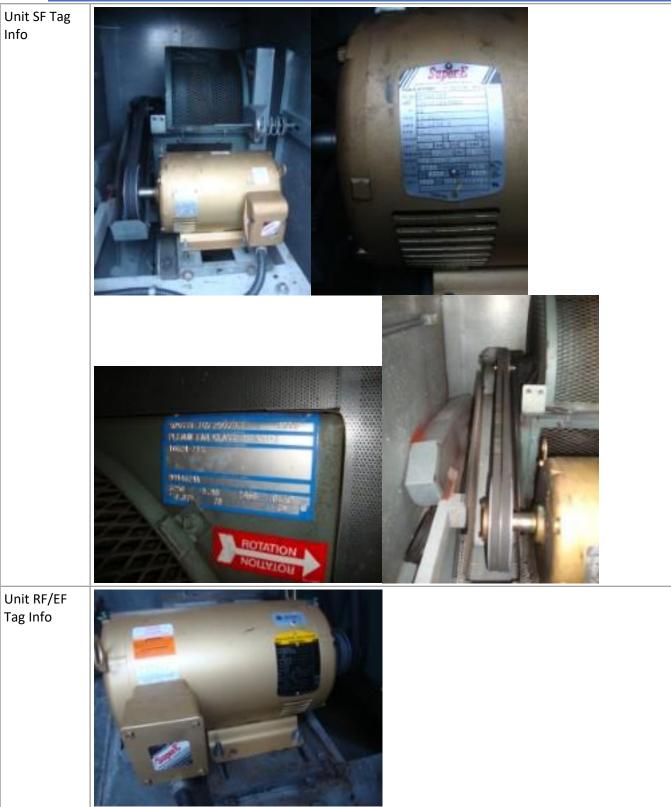
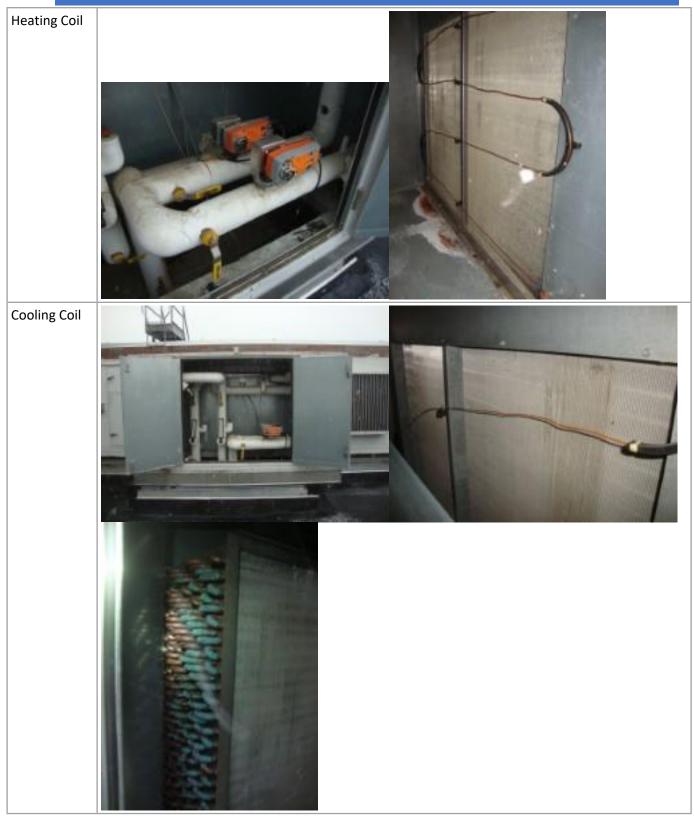
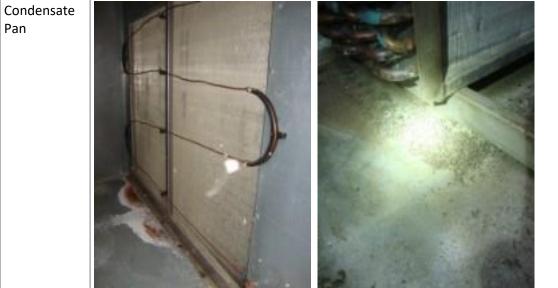
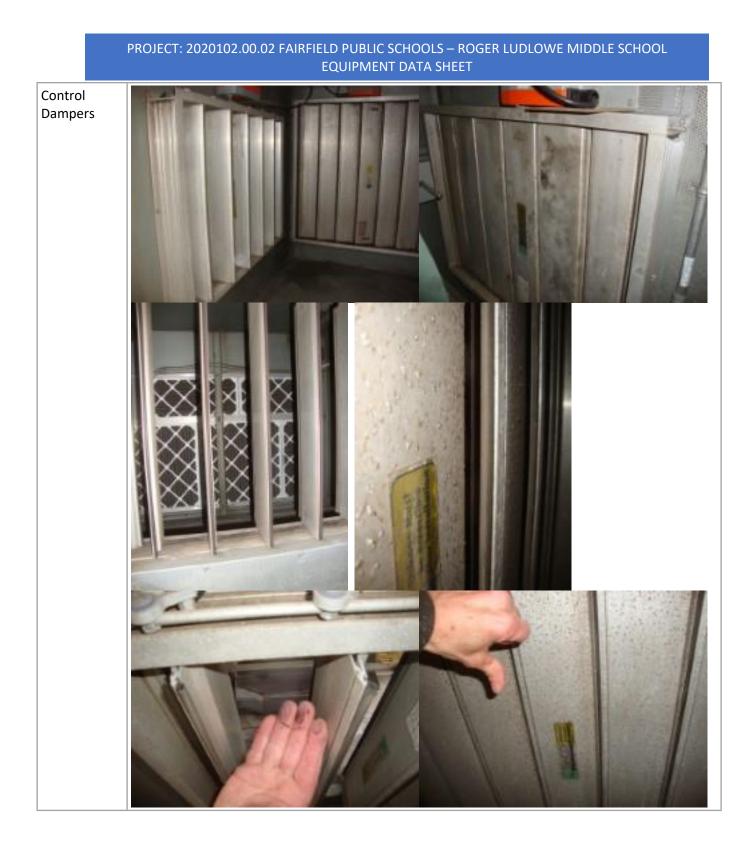
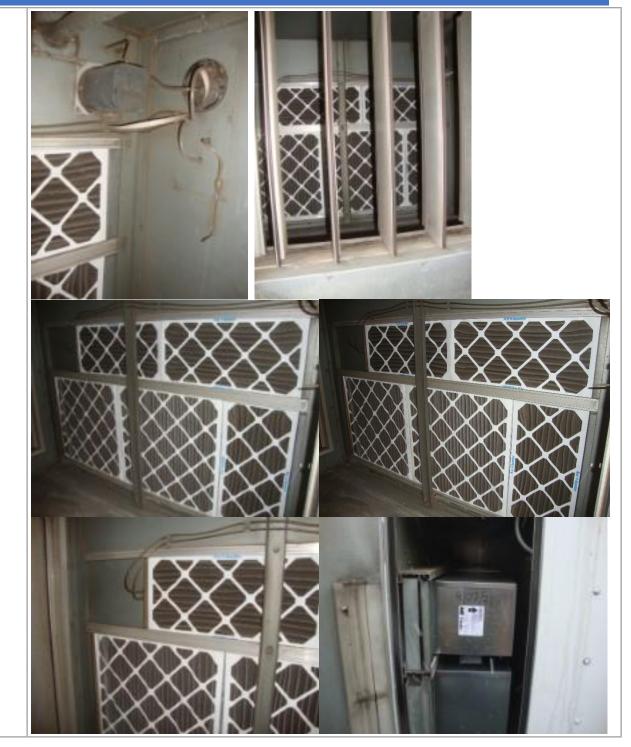
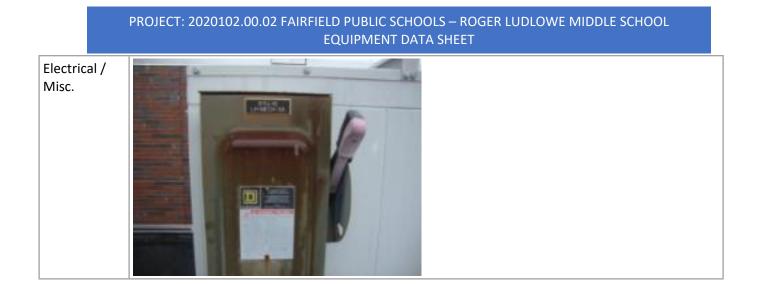
Notes:		
Description	<u>Photos</u>	
Unit Tag Info		
Unit from afar

RIMS RTU-15	Addition comments descriptions
ventroi	
6250@5.99″ 2,468 RPM	
15.0 (2) BX-68 Belts mismatched	
VFD ABB 230/460V	
5.0	
VFB ABB	
(3) 12x24x2 (3) 12x24x12 (2) 24x24x2 (2) 12x24x12	
Dirty 9/27/21	
Factory DDC	
Metasys, ALC	
Available	
unknown	
Parallel Tamco	
Clean, adj. and lubricate	Damper positions unknown
Hot water	
Dirty	
Chilled Water	
Dirty	
Grease covered, requires cleaning and calibration.	
Stainless Steel, clean after coils are completed	
Prime rusted areas on unit exterior. Exposed insulation on exterior ductwork has failed, repair.	
	Gym RoofBasement Locker RoomsVAVVentrolImage: Steel, clean after coils are completed6250@5.99" 2,468 RPM6250@5.99" 2,468 RPM6250@5.99" 2,468 RPM460/60/315.0 (2) BX-68 Belts mismatchedVFD ABB 230/460V5.0VFB ABB(3) 12x24x2 (3) 12x24x12 (2) 24x24x2 (2) 12x24x12Dirty 9/27/21Factory DDCMetasys, ALCAvailableUnknownParallel TamcoClean, adj. and lubricateHot waterDirtyChilled WaterDirtyChilled WaterDirtyParalel Steel, clean after coils are completedPrime rusted areas on unit exterior. Exposed

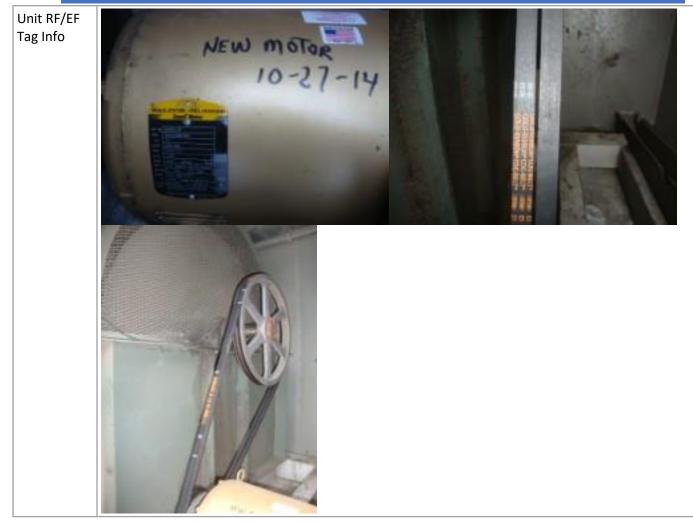
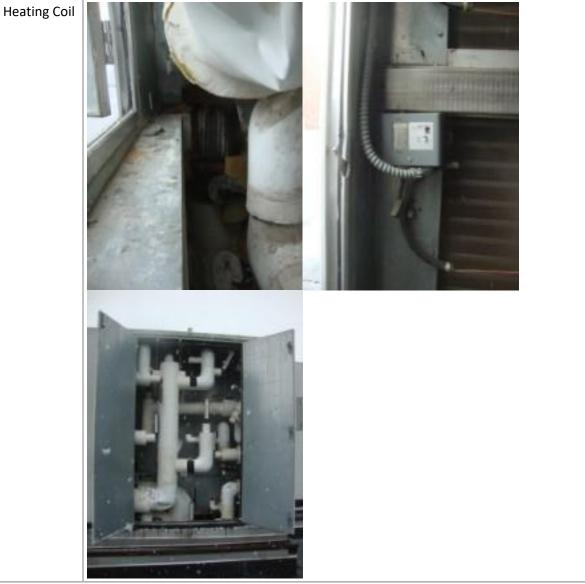
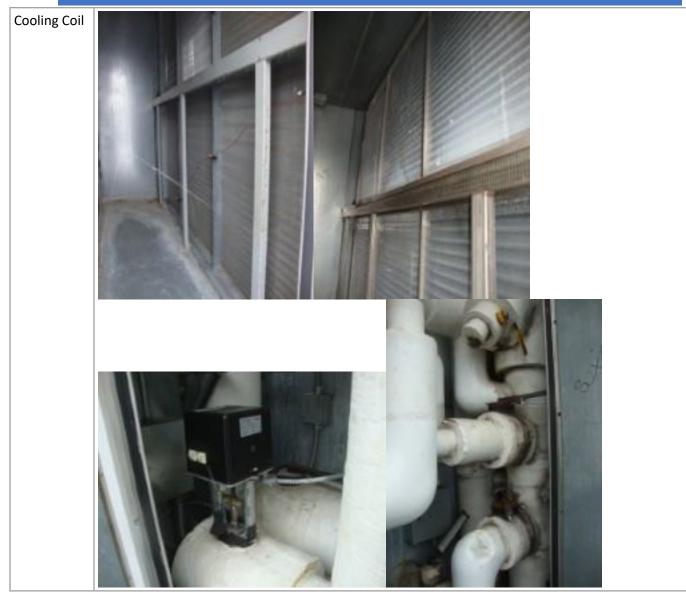
Description	Photos
Unit from afar	
Unit SF Tag Info

Unit Tag	RLMS RTU-16	Addition comments descriptions
Location	Gym Roof	
Serving	Gym	
Config/Style	VAV	
Mfr.	Ventrol	
Model #		
Serial #		
Age (years)		
System CFM	24,000	
Max OA CFM		
V/Hz/Ph	460/60/3	
SF Qty/HP	50.0	
SF VFD Data	N/A	
RF Qty/HP	15.0	New, 10/27/14
RF VFD Data	N/A	
Filter Data (Size Quantity)	(12) 24x24x2 (12) 24x24x12	
Filter Status	Dirty	
Controls Type	Factory DDC	
Controls Mfr.	Metasys, ALC	
Economizer	Yes	
CO ₂ DCV		
Damper Styles	Tamco OBD	
Damper Status	Clean, Lubricate and Adjust	Min OA damper linkage missing
Heating Type	Glycol Hot water	
Heating Coil Condition	Dirty	
Cooling Type	Glycol Chilled water	
Cooling Coil Condition	Dirty	
CU Mfr.	n/a	
CU Model	n/a	
CU Serial	n/a	
Drain Pan Status	OK, S.S. clean pan after coil is washed	
Notes:		
L
