Roger Sherman Elementary School

Fairfield Public Schools Recommissioning (RCx) and Testing, Adjusting, & Balancing (TAB) Study van Zelm Project # 2020102.00 (07-RSES) October 07, 2022

FAIRFIELD PUBLIC SCHOOLS RECOMMISSIONING (RCx) AND TESTING, ADJUSTING, & BALANCING (TAB) STUDY

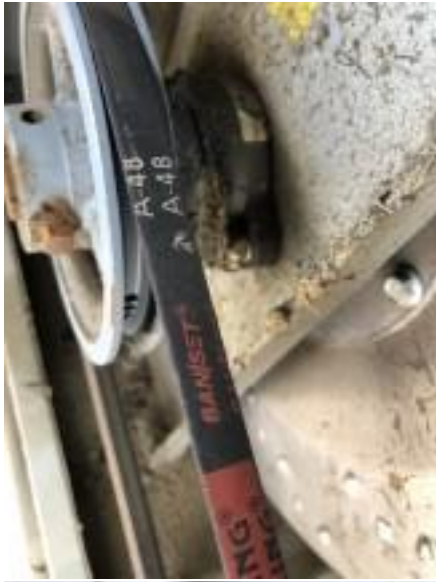
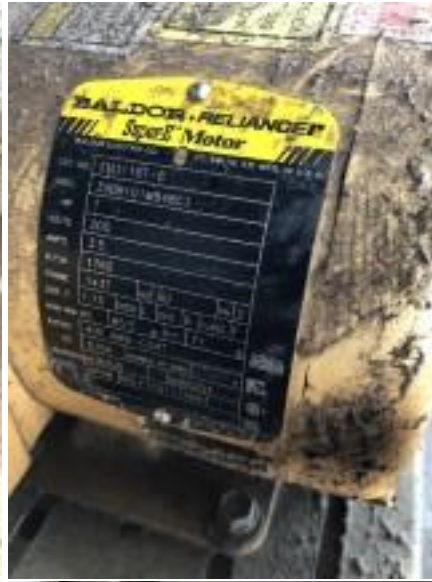
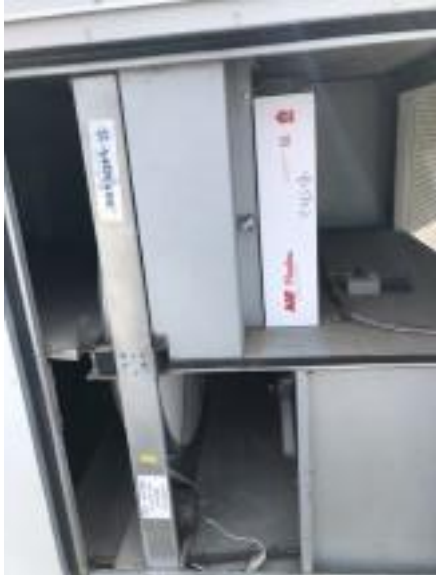
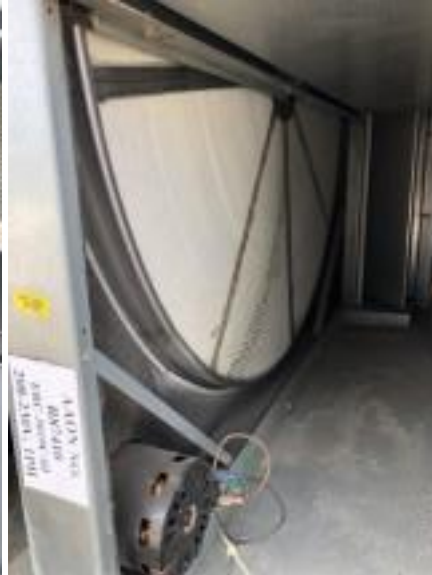
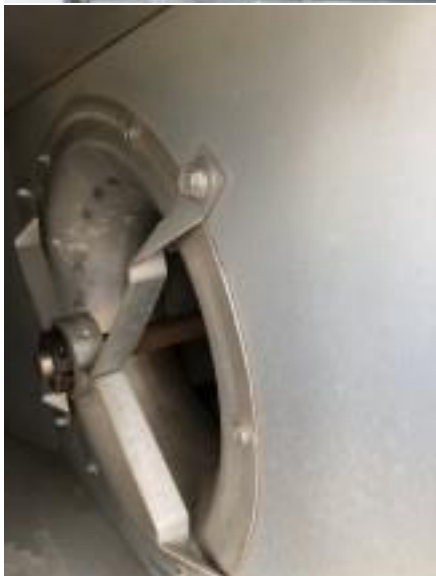
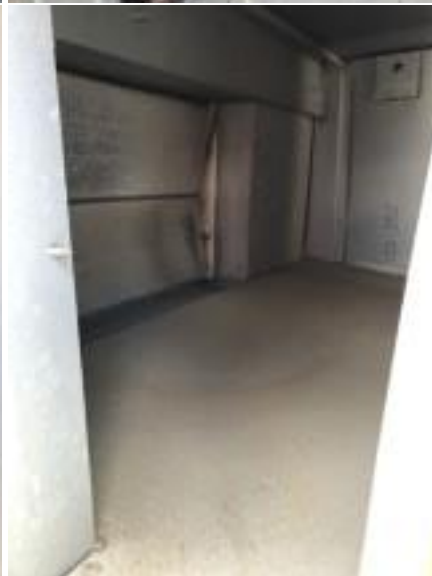
Cooling Coil Condition		
Drain Pan Status	Should be cleaned	
Notes:	Power Exhaust off with ERW off and bypass open, ODA closed. Low to no outside air being introduced	Unit rumbles upon start-up, possible bearing issue

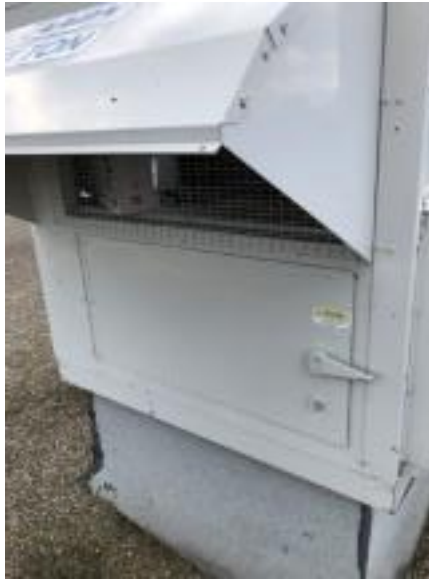
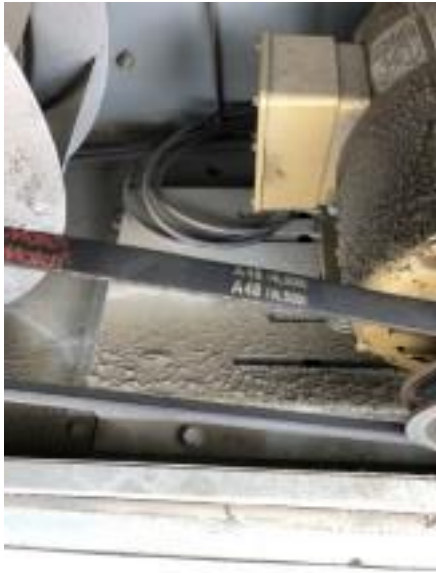
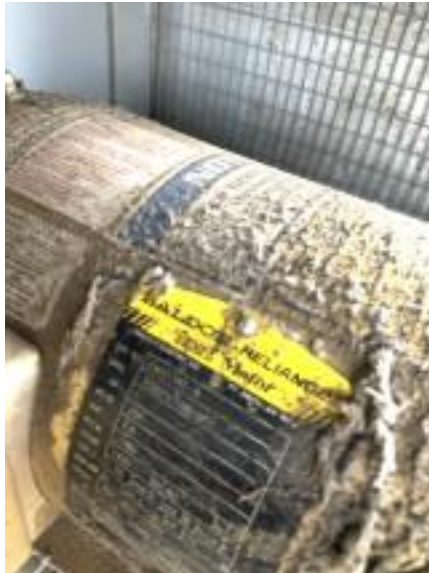
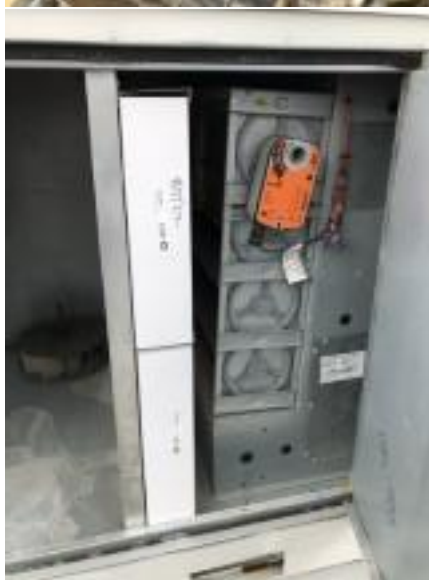
<u>Unit Tag</u>	<u>DOAS-7</u>	<u>Addition comments descriptions</u>
Location	Main Roof Back Center	
Serving	Classrooms 12	
Config/Style	Packaged Heating DOAS with ERW	
Mfr.	AAON	
Model #	RN-010 -8-0-0000-3L9	
Serial #	201205-ANGJ22567	
Age (years)	2012	
System CFM		
Max OA CFM		
V/Hz/Ph	208 / 60 /3	
SF Qty/HP	2 hp Direct Drive	Behind Door with Duct Smoke on Panel. Did not open for concern of DSD trip
SF VFD Data	YASKAWA J1000 Series	
RF Qty/HP	1 Hp	A-48 Belt
RF VFD Data		
Filter Data (Size Quantity)	(1) 16 X 25 X 4 Pre, (4) 20 X 16 X 4	
Filter Status	Clean 4-26-22 changed	
Controls Type	JCI FX Explorer	
Controls Mfr.	JCI	
Economizer	Packaged with Power Exhaust	
CO ₂ DCV	NA	
Damper Styles	Opposed	ODA Closed
Damper Status	Need Cleaning and Lubrication	
Heating Type	Natural Gas	168 MBH
Heating Coil Condition	Burners Clean but header showing age	Piping Rusty
Cooling Type	DX 1 Compressors	
Cooling Coil Condition		
Drain Pan Status	Should be cleaned

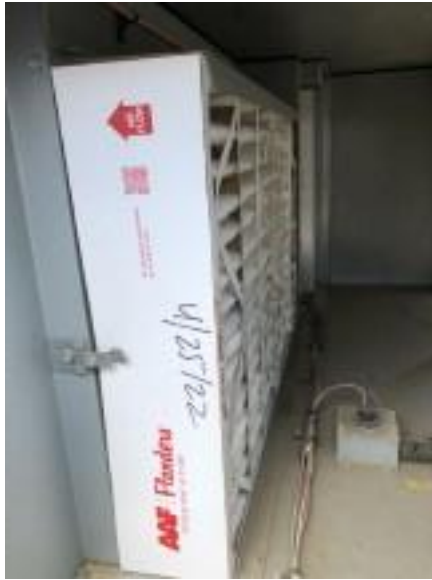
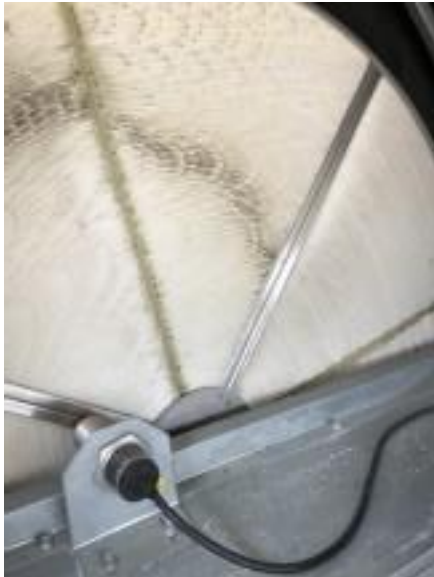
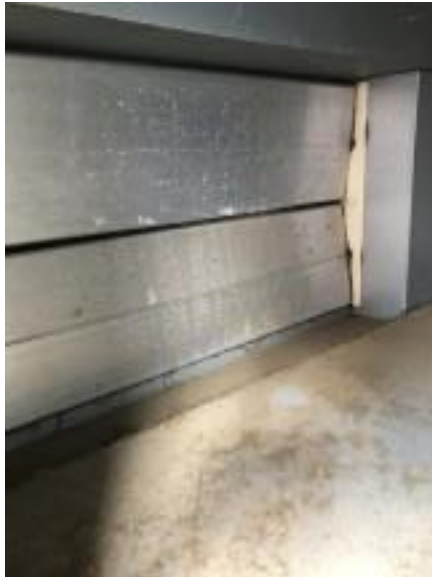
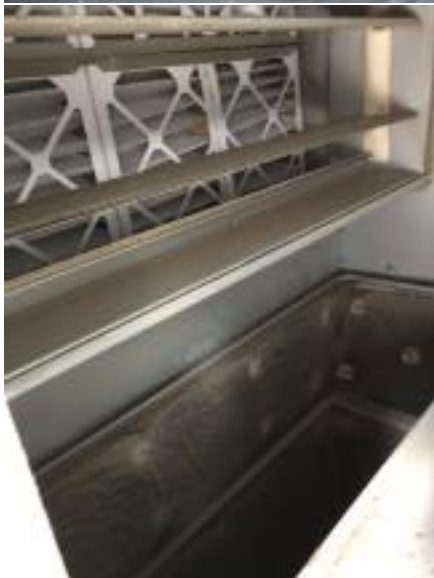
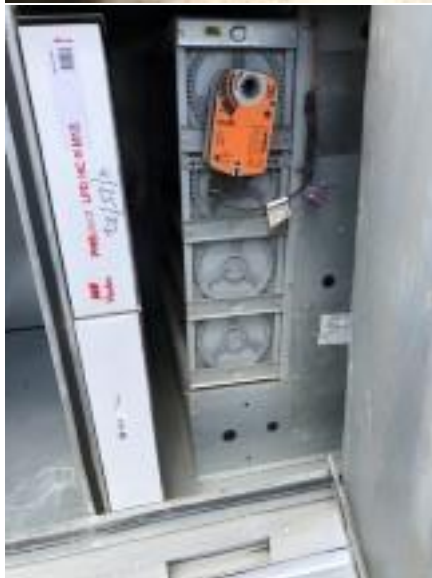
<u>Unit Tag</u>	<u>DOAS-8</u>	<u>Addition comments descriptions</u>
Location	Main Roof Back Left	
Serving	Classrooms 13-14	
Config/Style	Packaged Heating DOAS with ERW	
Mfr.	AAON	
Model #	RN-010 -8-0-0000-3L9	
Serial #	201205-ANGJ22559	
Age (years)	2012	
System CFM		
Max OA CFM		
V/Hz/Ph	208 / 60 /3	
SF Qty/HP	2 hp Direct Drive	Behind Door with Duct Smoke on Panel. Did not open for concern of DSD trip
SF VFD Data	YASKAWA J1000 Series	
RF Qty/HP	1 Hp	A-48 Belt
RF VFD Data		
Filter Data (Size Quantity)	(1) 16 X 25 X 4 Pre, (4) 20 X 16 X 4	
Filter Status	Clean 4-26-22 changed	
Controls Type	JCI FX Explorer	
Controls Mfr.	JCI	
Economizer	Packaged with Power Exhaust	
CO ₂ DCV	NA	
Damper Styles	Opposed	ODA Closed
Damper Status	Need Cleaning and Lubrication	
Heating Type	Natural Gas	168 MBH
Heating Coil Condition	Burners Clean but header showing age	
Cooling Type	DX 1 Compressors	
Cooling Coil Condition		
Drain Pan Status	Should be cleaned

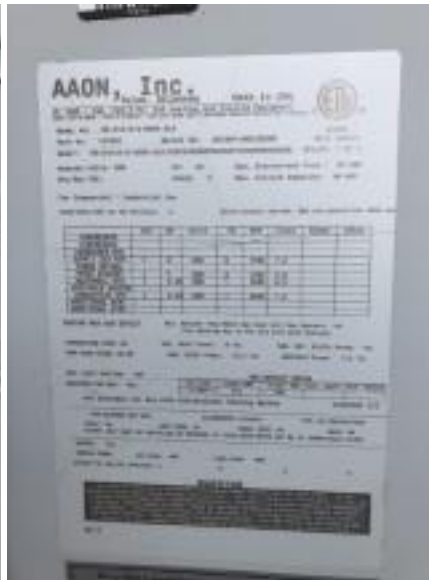
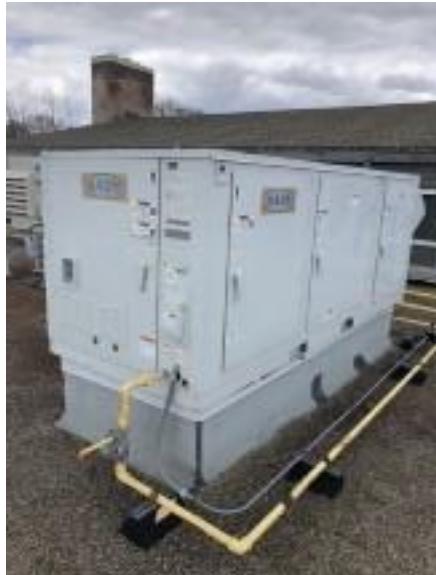
<u>Unit Tag</u>	<u>DOAS-9</u>	<u>Addition comments descriptions</u>
Location	Main Roof Back Right	
Serving	Classrooms 17-18	
Config/Style	Packaged Heating DOAS with ERW	
Mfr.	AAON	
Model #	RN-010 -8-0-0000-3L9	
Serial #	201205-ANGJ22566	
Age (years)	2012	
System CFM		
Max OA CFM		
V/Hz/Ph	208 / 60 /3	
SF Qty/HP	2 hp Direct Drive	Behind Door with Duct Smoke on Panel. Did not open for concern of DSD trip
SF VFD Data	YASKAWA J1000 Series	
RF Qty/HP	1 Hp	A-48 Belt
RF VFD Data		
Filter Data (Size Quantity)	(1) 16 X 25 X 4 Pre, (4) 20 X 16 X 4	
Filter Status	Clean 4-26-22 changed	
Controls Type	JCI FX Explorer	
Controls Mfr.	JCI	
Economizer	Packaged with Power Exhaust	
CO ₂ DCV	NA	
Damper Styles	Opposed	ODA Closed
Damper Status	Need Cleaning and Lubrication	
Heating Type	Natural Gas	168 MBH
Heating Coil Condition	Burners Clean but header showing age	
Cooling Type	DX 1 Compressors	
Cooling Coil Condition		
Drain Pan Status	Should be cleaned

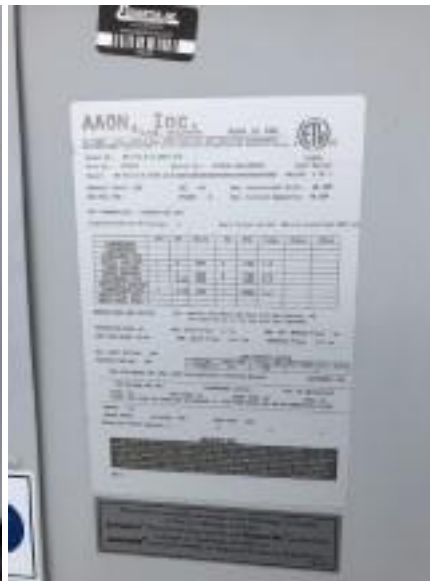
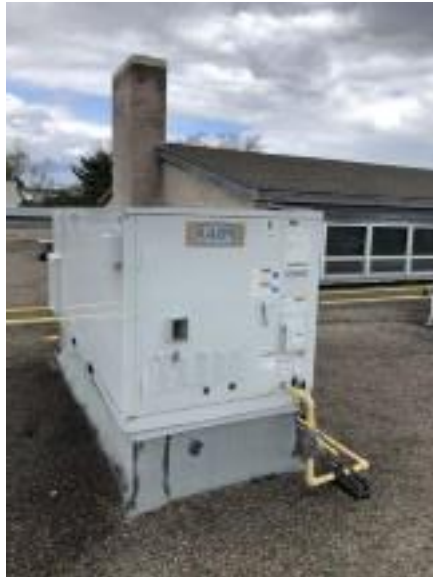
<u>Unit Tag</u>	<u>DOAS-10</u>	<u>Addition comments descriptions</u>
Location	Main Roof Back Right	
Serving	Kitchen Serveries	
Config/Style	Packaged Heating DOAS with ERW	
Mfr.	AAON	
Model #	RN-010 -8-0-0000-3L9	
Serial #	201205-ANGJ22562	
Age (years)	2012	
System CFM		
Max OA CFM		
V/Hz/Ph	208 / 60 /3	
SF Qty/HP	2 hp Direct Drive	Behind Door with Duct Smoke on Panel. Did not open for concern of DSD trip
SF VFD Data	YASKAAWA J1000 Series	
RF Qty/HP	1 Hp	A-48 Belt
RF VFD Data		
Filter Data (Size Quantity)	(1) 16 X 25 X 4 Pre, (4) 20 X 16 X 4	
Filter Status	Clean 4-26-22 changed	
Controls Type	JCI FX Explorer	
Controls Mfr.	JCI	
Economizer	Packaged with Power Exhaust	
CO ₂ DCV	NA	
Damper Styles	Opposed	ODA Closed
Damper Status	Need Cleaning and Lubrication	
Heating Type	Natural Gas	168 MBH
Heating Coil Condition	Burners Clean but header showing age	
Cooling Type	DX 1 Compressors	
Cooling Coil Condition		
Drain Pan Status	Should be cleaned

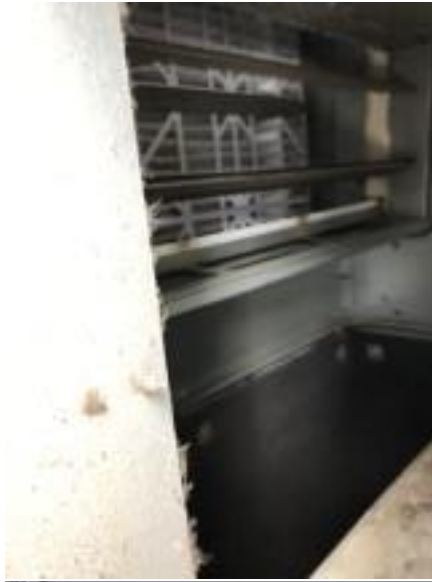
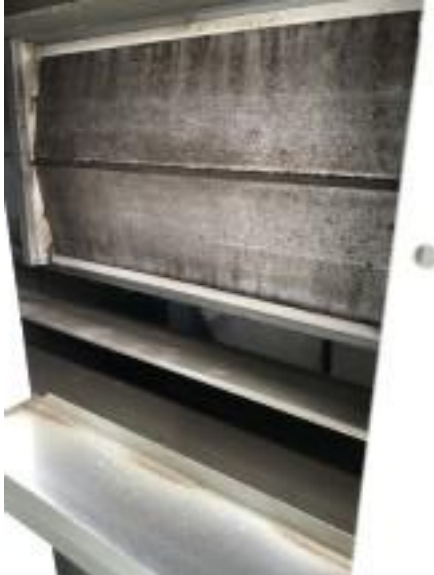
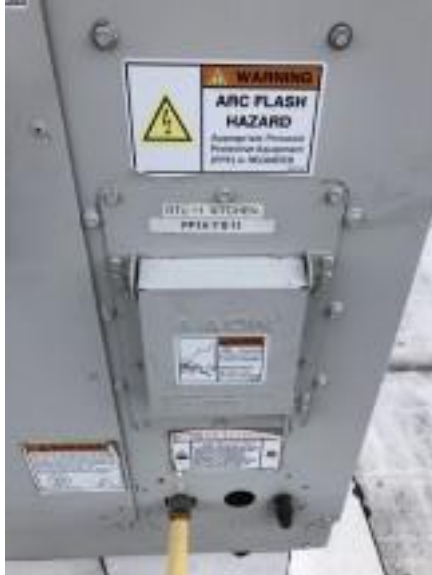
<u>Unit Tag</u>	<u>DOAS-11</u>	<u>Addition comments descriptions</u>
Location	Main Roof Right	
Serving	Kitchen	
Config/Style	Packaged Heating DOAS with ERW	
Mfr.	AAON	
Model #	RN-010 -8-0-0000-3K9	
Serial #	201203-ANGJ21334	
Age (years)	2012	
System CFM		
Max OA CFM		
V/Hz/Ph	208 / 60 /3	
SF Qty/HP	2 hp Direct Drive	Behind Door with Duct Smoke on Panel. Did not open for concern of DSD trip
SF VFD Data	YASKAWA J1000 Series	
RF Qty/HP	1 Hp	A-48 Belt
RF VFD Data		
Filter Data (Size Quantity)	(1) 16 X 25 X 4 Pre, (4) 20 X 16 X 4	
Filter Status	Clean 4-26-22 changed	
Controls Type	JCI FX Explorer	
Controls Mfr.	JCI	
Economizer	Packaged with Power Exhaust	
CO ₂ DCV	NA	
Damper Styles	Opposed	ODA Closed
Damper Status	Need Cleaning and Lubrication	
Heating Type	Natural Gas	120 MBH
Heating Coil Condition	Burners Clean but header showing age	
Cooling Type	DX 1 Compressors	
Cooling Coil Condition		
Drain Pan Status	Should be cleaned

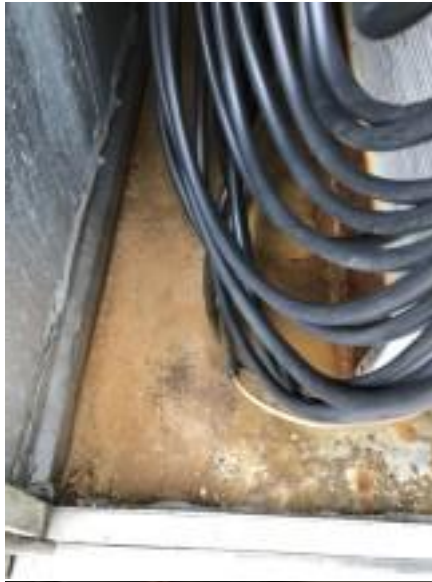
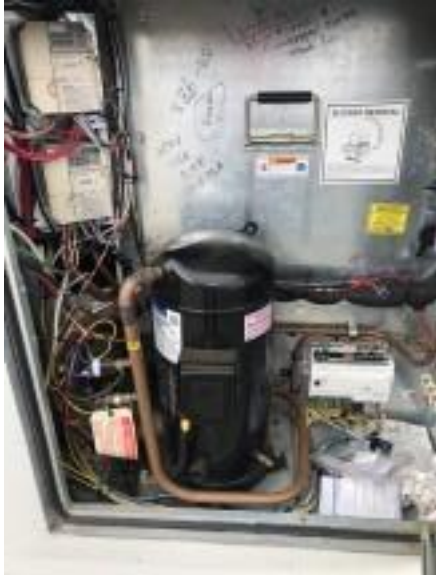
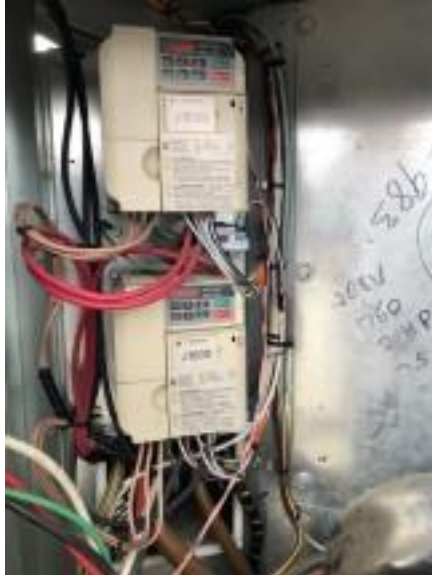
<u>Unit Tag</u>	<u>RTU-1</u>	<u>Addition comments descriptions</u>
Location	Main Roof	
Serving	Central Offices	
Config/Style	Packaged Heating and Cooling VFD ERW	
Mfr.	AAON	
Model #	RN010 -8-0-EA09-3L9	
Serial #	Not readable	
Age (years)	2012	
System CFM		
Max OA CFM		
V/Hz/Ph	208 / 60 /3	
SF Qty/HP	3 hp Belt Drive	Behind Door, may be 2 HP per handwriting
SF VFD Data	YASKAAWA J1000 Series	
RF Qty/HP	1	
RF VFD Data	YASKAAWA J1000 Series	
Filter Data (Size Quantity)	(1) 16 X 25 X 4 Pre, (4) 20 X 16 X 4	
Filter Status	Clean 4-26-22 changed	
Controls Type	JCI FX Explorer	
Controls Mfr.	JCI	
Economizer	Packaged with Power Exhaust	
CO ₂ DCV	NA	
Damper Styles	Opposed	
Damper Status	Need Cleaning and Lubrication	
Heating Type	Natural Gas	
Heating Coil Condition	Burners Clean	
Cooling Type	DX 1 Compressors	
Cooling Coil Condition		
Drain Pan Status	Should be cleaned	
Notes:	Power Exhaust running yet ERW was Off and Bypass Closed. No outside air being introduced

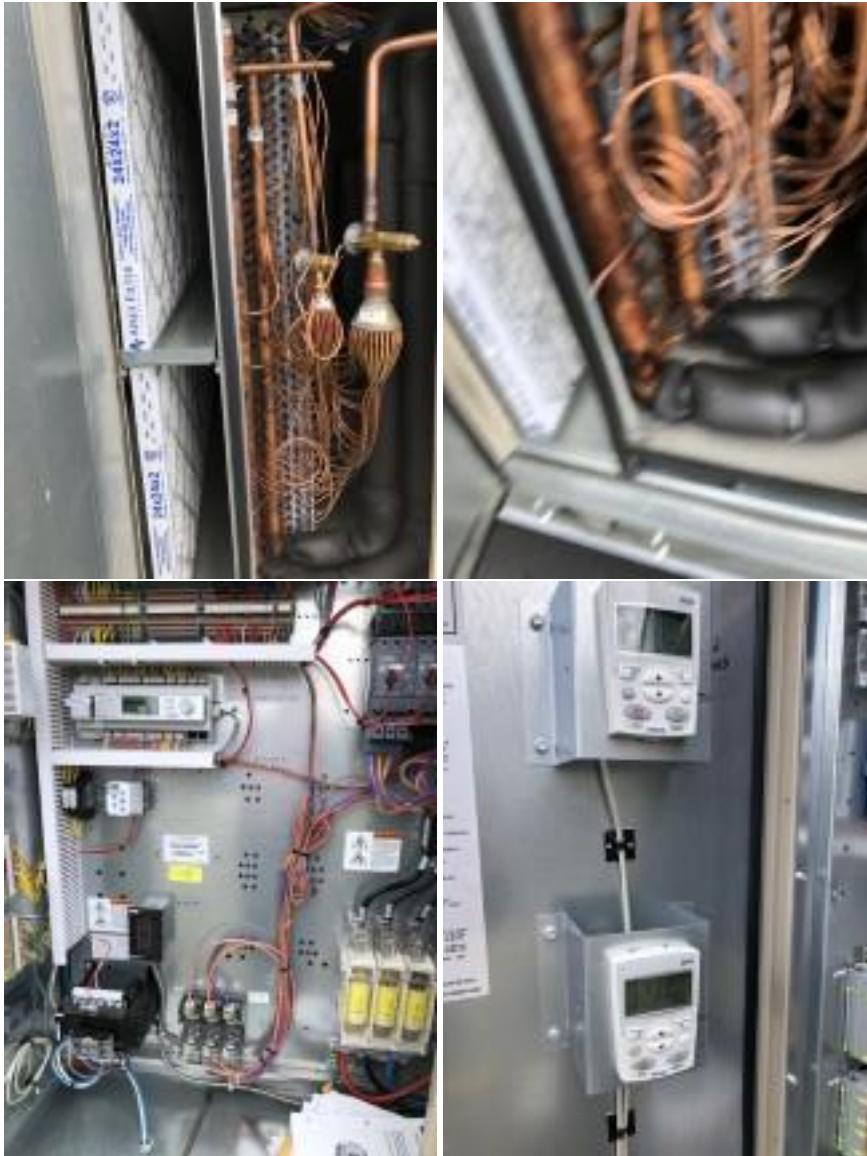
<u>Unit Tag</u>	<u>RTU-2</u>	<u>Addition comments descriptions</u>
Location	Gym Roof	
Serving	Gym	
Config/Style	Packaged Heating and Cooling	
Mfr.	Daikin	
Model #	MPS030FG2FV1CYBVDM	
Serial #	FB0U200602439	
Age (years)	2021	
System CFM		
Max OA CFM		
V/Hz/Ph	208 / 60 /3	
SF Qty/HP	10 Hp	
SF VFD Data	HVAC VFD	
RF Qty/HP	1	
RF VFD Data	HVAC VFD	
Filter Data (Size Quantity)	(8) 24 X 24 X 2	New filters being sucked in due to Pressure Drop
Filter Status	Clean 4-25-22 changed	
Controls Type	Packaged MicroTech III BACnet	
Controls Mfr.	Daikin	
Economizer	Packaged with Power Exhaust	
CO ₂ DCV	NA	
Damper Styles	Opposed	
Damper Status	Good	
Heating Type	Natural Gas Dual Modulating Burners Hi/Lo	
Heating Coil Condition	Burners Clean	
Cooling Type	DX 3 Compressors	
Cooling Coil Condition		
Drain Pan Status	Clean	
Notes:	Unit as new condition

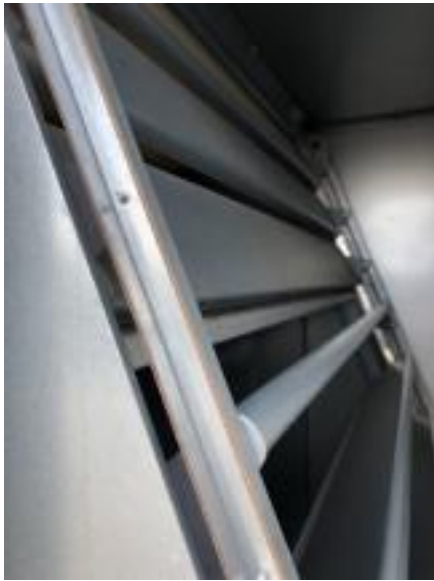
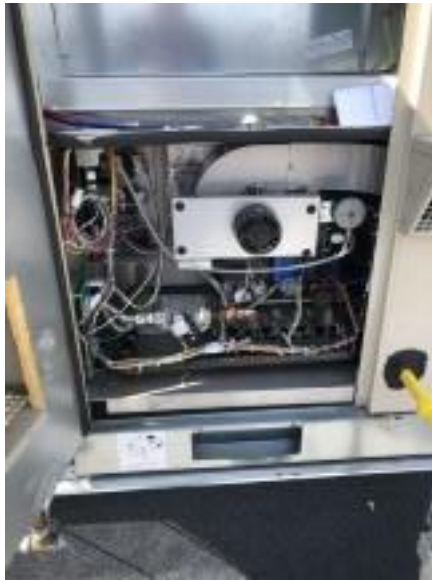
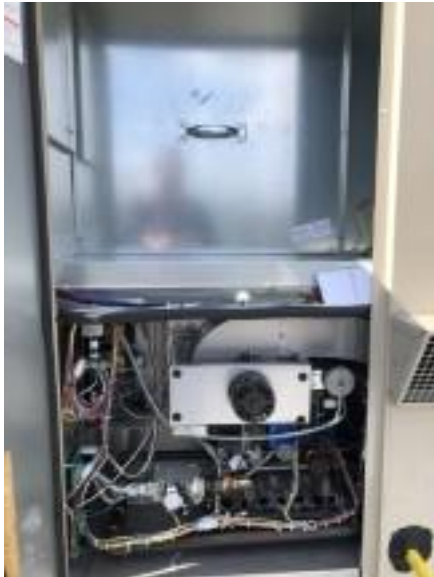
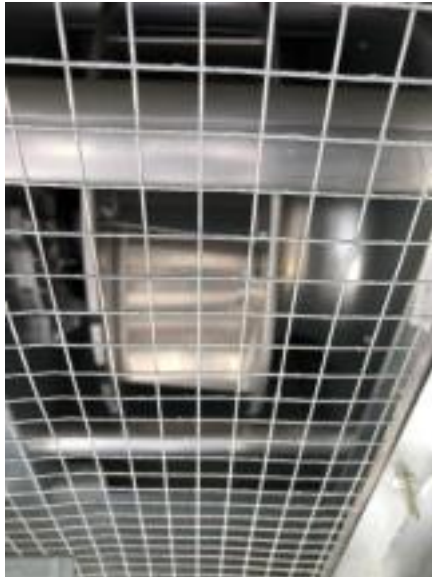
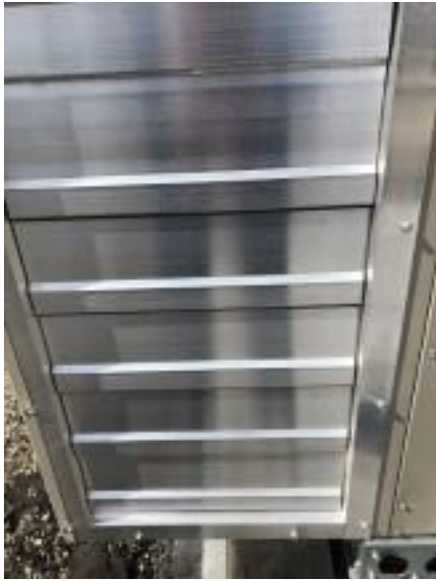
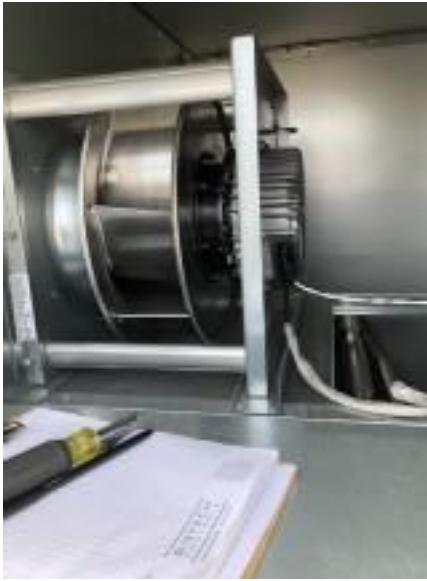
<u>Unit Tag</u>	<u>RTU-4</u>	<u>Addition comments descriptions</u>
Location	South Main Roof	
Serving	Media Center	
Config/Style	Packaged Heating and Cooling	
Mfr.	Daikin	
Model #	DPS007AAHMG2DW-3	
Serial #	FB0U200700616	
Age (years)	2021	
System CFM		
Max OA CFM		
V/Hz/Ph	208 / 60 /3	
SF Qty/HP	4 Hp 300 Watt EBM Pabst RG3400-AQ29-16	
SF VFD Data	Integral	
RF Qty/HP	2	
RF VFD Data	Integral	
Filter Data (Size Quantity)	(6) 18 X 25 X 2, (4) 26 X 22 X 2	New filters being sucked in due to Pressure Drop
Filter Status	Clean 4-26-22 changed	
Controls Type	Packaged MicroTech III BACnet	
Controls Mfr.	Daikin	
Economizer	Packaged with Power Exhaust	
CO ₂ DCV	NA	
Damper Styles	Opposed	
Damper Status	Good	
Heating Type	Natural Gas	
Heating Coil Condition	Burners Clean	
Cooling Type	DX 2 Compressors	
Cooling Coil Condition		
Drain Pan Status	Clean	
Notes:	Unit as new condition

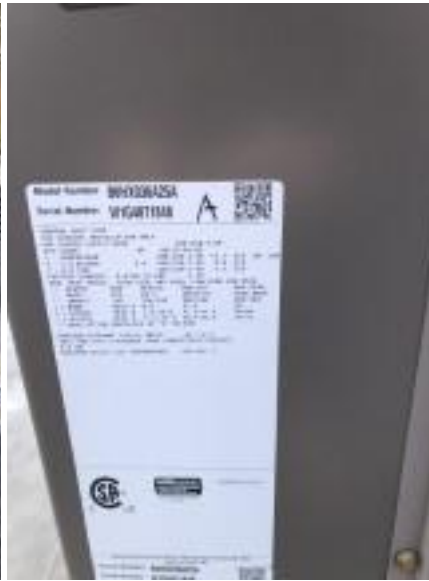
<u>Unit Tag</u>	<u>RTU-A</u>	<u>Addition comments descriptions</u>
Location	Modular	
Serving	A6	
Config/Style	Packaged Heat Pump	
Mfr.	York ?	
Model #	B6HX036A25A	
Serial #	W1G4871848	
Age (years)		
System CFM		
Max OA CFM		
V/Hz/Ph	208 / 60 /3	
SF Qty/HP	3/4 Hp	
SF VFD Data		
RF Qty/HP		
RF VFD Data		
Filter Data (Size Quantity)	(2)14 X 22 X 1	Change access restricted with electrical conduit
Filter Status	Clean 4-25-22 changed	
Controls Type	Local Programmable Thermostat	
Controls Mfr.		
Economizer	Packaged Minimum ODA only	
CO ₂ DCV	NA	
Damper Styles	Flapper Blades	ODA Closed
Damper Status	Need Cleaning and Lubrication	Poor condition
Heating Type	Heat Pump	Emergency Electric Heat not?
Heating Coil Condition		
Cooling Type	DX 1 Compressors	
Cooling Coil Condition	Dirty	
Drain Pan Status	Should be cleaned	
Notes:
