Stratfield Elementary School

Fairfield Public Schools Recommissioning (RCx) and Testing, Adjusting, & Balancing (TAB) Study van Zelm Project # 2020102.00 (13-SES) October 07, 2022

FAIRFIELD PUBLIC SCHOOLS RECOMMISSIONING (RCX) AND TESTING, ADJUSTING, & BALANCING (TAB) STUDY

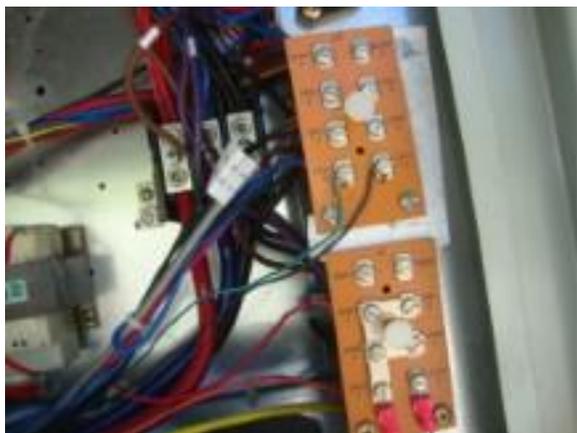
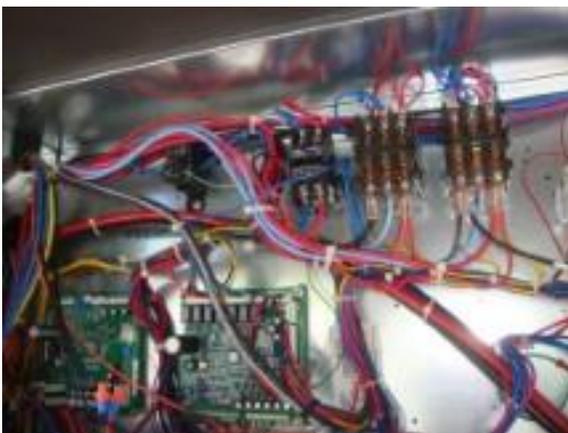
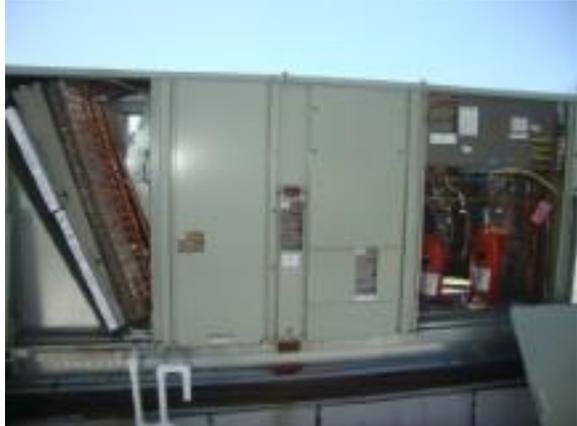
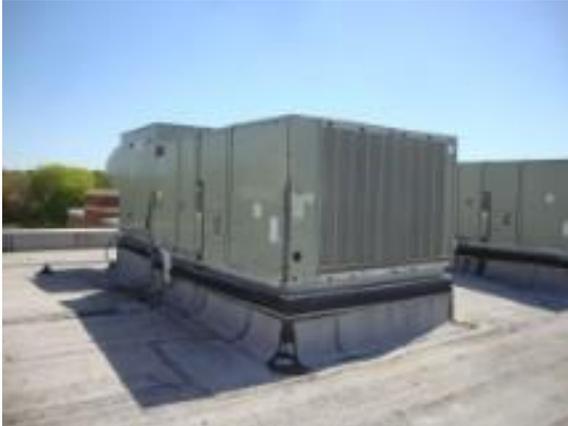
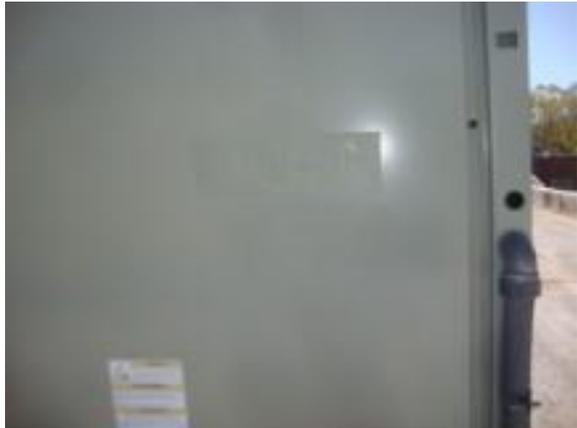
Photos

<u>Unit Tag</u>	<u>AHU-1C</u>	<u>Addition comments descriptions</u>
Location	Gymnasium Roof	Unit Off!!
Serving	Gymnasium	
Config/Style	Rooftop AHU with packaged CU HW Heating Coil	Packaged Heat recovery wheel, fan, dampers, and filters
Mfr.	Trane Voyager	Thybar Corporation
Model #	TCD151E30AAB	TV5230DF
Serial #	102310046D	C0105094
Age (years)	6/2010	6/2010
System CFM	5000	
Max OA CFM	2425	
V/Hz/Ph	208-230/60/3	208-230/60/3
SF Qty/HP	3.0 Standard 5.0 Oversized	2.0 (1) AP-45 Fan Off
SF VFD Data	N/A	N/A
RF Qty/HP	N/A	2.0 (1) AX-48 Fan Off
RF VFD Data		
Filter Data (Size Quantity)	(8) 20x25x2	(6) 20x24x2
Filter Status	Clean 4-14-22	
Controls Type	Packaged with DDC interface	
Controls Mfr.	Trane/Thybar/Distech CTC	
Economizer	Yes, available, operation in question	Operation in question
CO ₂ DCV	Wires connected to unit CO ₂ terminals, will need to explore BAS drawings	
Damper Styles	Trane, Flap	Thybar Parallel, BDD
Damper Status	OK, operation in question	OK, operation in question

Heating Type	Hot Water OK, system off operation unknown	Damper open, system off
Heating Coil Condition	Unknown	
Cooling Type	DX 2-Circuit R-410A	
Cooling Coil Condition	OK	
Wheel	OK but not operating,	Thybar ½ H.P. (OFF)
Drain Pan Status	Ok but should be flushed	
Notes:	Metal O.A. Pre-filters are Dirty, clean and or replace.

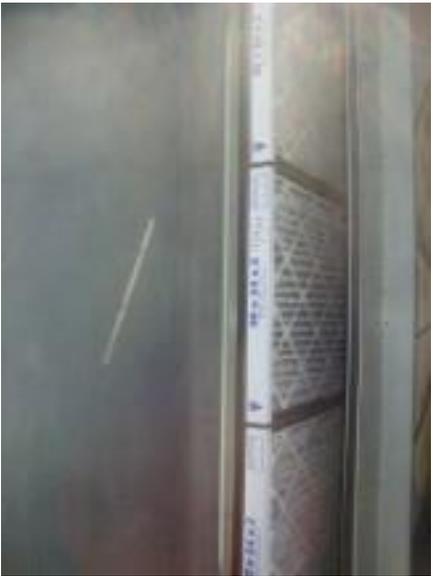
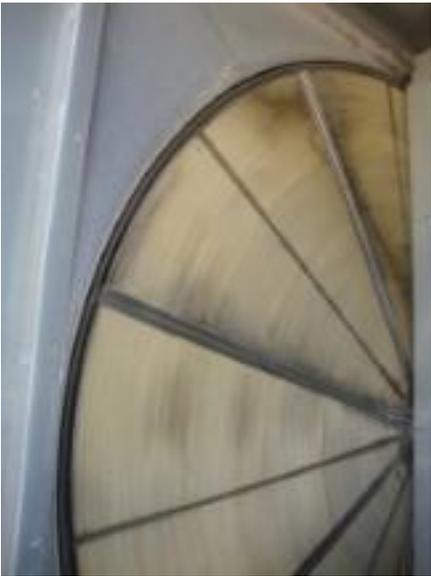
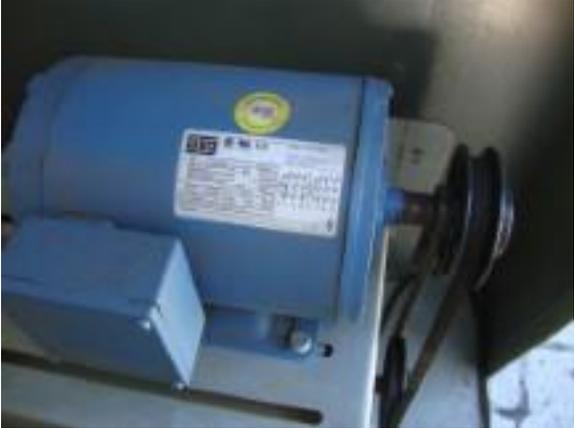
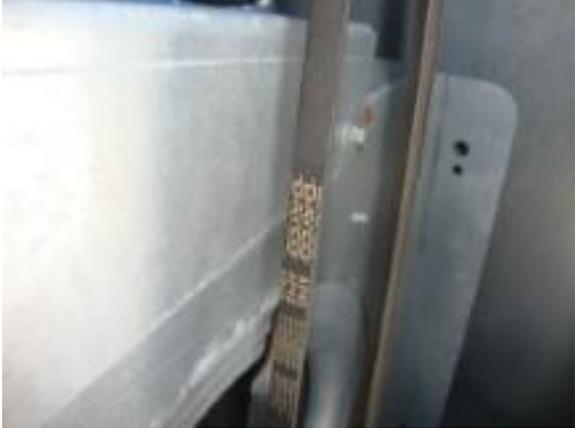
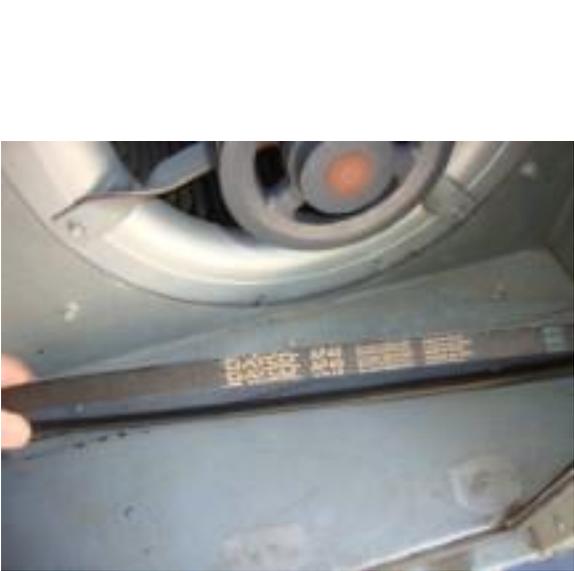
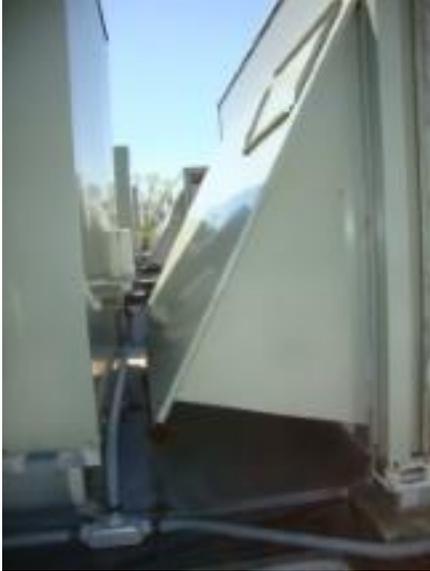
Photos

<u>Unit Tag</u>	<u>AHU-1D</u>	<u>Addition comments descriptions</u>
Location	Gymnasium Roof	Unit Off!
Serving	Stage-Gymnasium	
Config/Style	Rooftop AHU with packaged CU and HW Heating Coil	Packaged Heat recovery wheel, fan, dampers, and filters
Mfr.	Trane Voyager	Thybar Corporation
Model #	TCD151E30AAB	TV523DDF
Serial #	102310073D	C0105094
Age (years)	6/2010	7/6/2010
System CFM	5000	
Max OA CFM	2425	
V/Hz/Ph	208-230/60/3	
SF Qty/HP	3.0 Standard 5.0 Oversized	2.0 (1) AP-45 Fan Off
SF VFD Data	N/A	N/A
RF Qty/HP	N/A	2.0 (1) AX-48 Fan Off
RF VFD Data	N/A	N/A
Filter Data (Size Quantity)	(8) 20x25x2	(6) 20x24x2
Filter Status	Clean 4-14-22	
Controls Type	Packaged with DDC interface	
Controls Mfr.	Trane/Thybar/Distech CTC	
Economizer	Yes, available, operation in question	Operation in question
CO ₂ DCV	Wires connected to unit CO ₂ terminals, will need to explore BAS drawings	
Damper Styles	Trane, Flap. Functional, clean lubricate and adjust.	Thybar Parallel, BDD

Damper Status	OK, system off operation unknown	Damper open, system off
Heating Type	Hot Water	
Heating Coil Condition	Unknown	
Cooling Type	DX 2-Circuit R-410A	
Cooling Coil Condition	OK	
Wheel Mfr.		Thybar ½ H.P. (OFF)
Wheel Condition		OK but not operating,
Drain Pan Status	Ok but should be flushed	
Notes:	Metal O.A. Pre-filters are Dirty, clean and or replace.

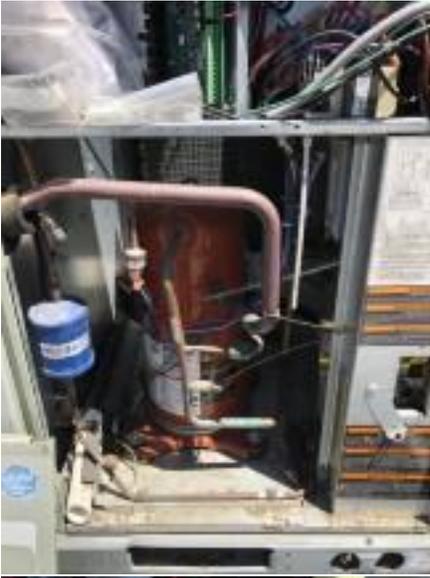
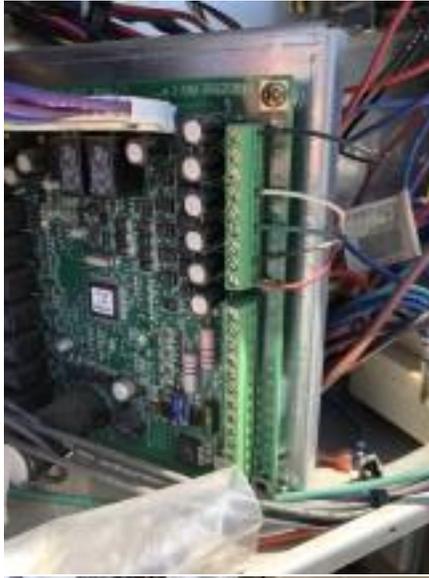
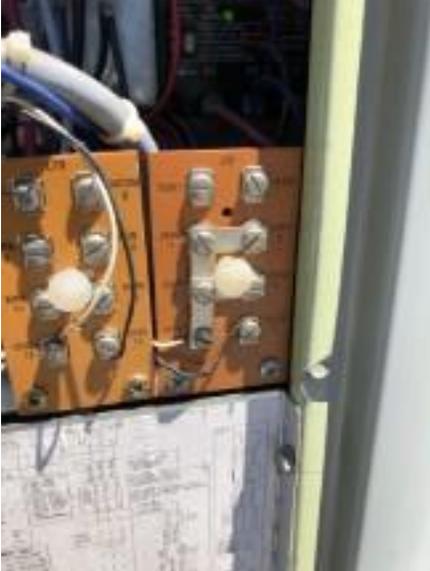
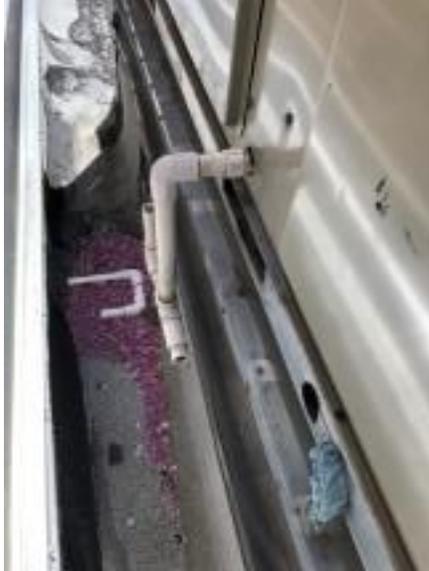
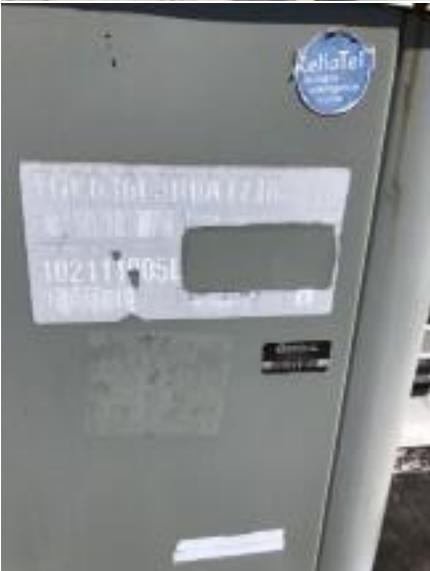
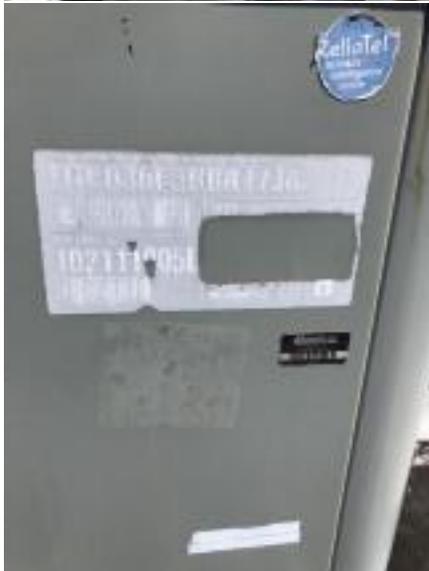
<u>Unit Tag</u>	<u>AHU-2 5-10-22 by RCM</u>	<u>Addition comments descriptions</u>
Location	Special Ed Roof	
Serving	Special Ed	
Config/Style	Rooftop AHU with packaged CU	
Mfr.	Trane	
Model #	THC036E3R0A17J8	
Serial #	102111?05L??	
Age (years)	+5	
System CFM	2000	
Max OA CFM	350	
V/Hz/Ph	208/230	
SF Qty/HP	Direct Drive ¾ HP	
SF VFD Data		
RF Qty/HP		
RF VFD Data		
Filter Data (Size Quantity)	(2) 20 x 30 x2	
Filter Status	Clean	
Controls Type	Package CTI	
Controls Mfr.	Trane with Distech relay interface	
Economizer	Package	
CO ₂ DCV	No	
Damper Styles	Flapper	
Damper Status		
Heating Type	NA	
Heating Coil Condition		
Cooling Type	DX Single stage 3 ton	
Cooling Coil Condition	Clean	
CU Mfr.		
CU Model		
CU Serial		
Drain Pan Status	Clean but Trap broken off	
Notes:	On a 60 degree day only Min ODA being introduced

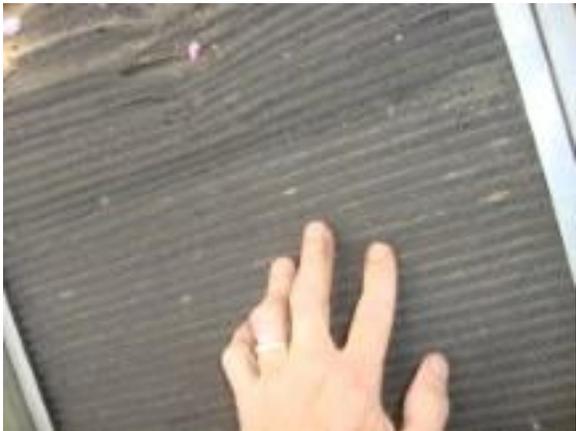
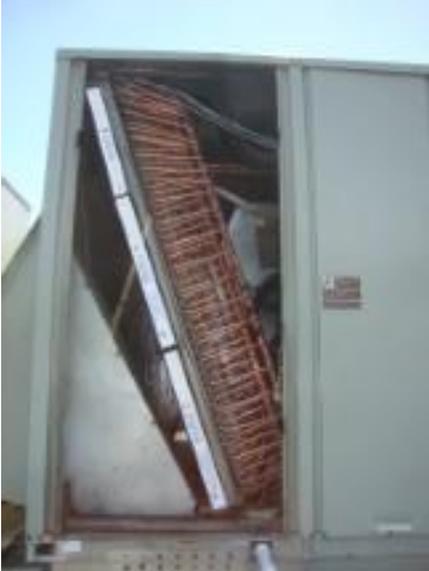
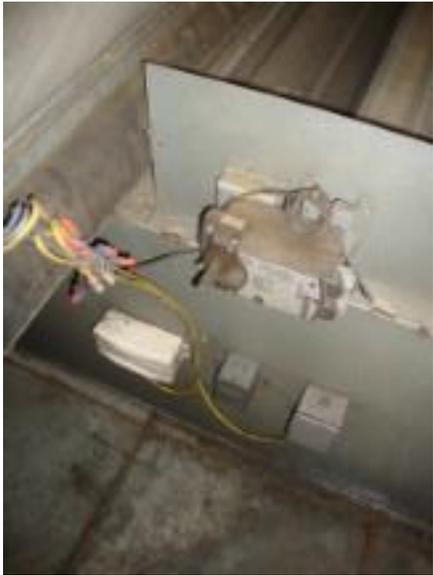
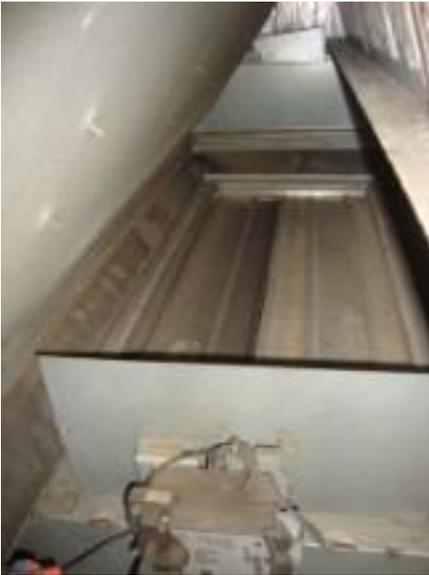
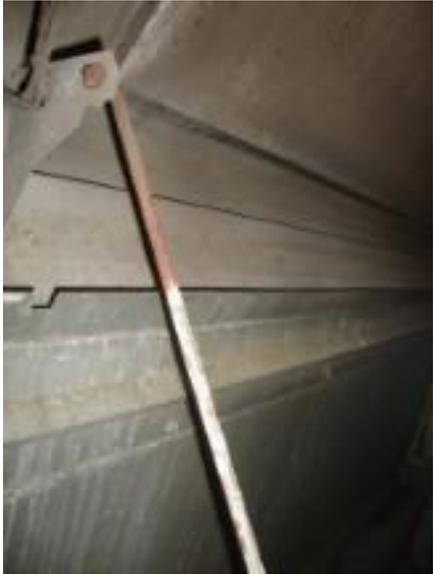
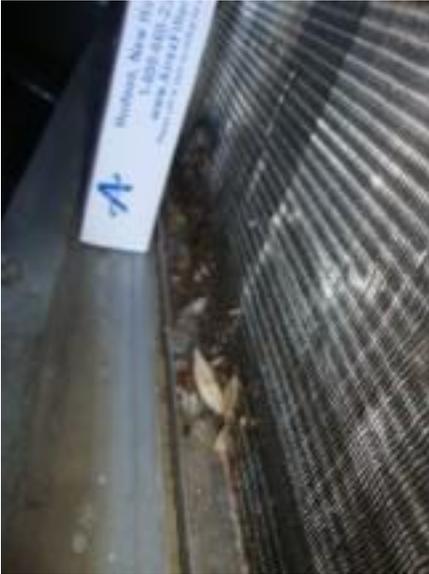
<u>Unit Tag</u>	<u>AHU-3</u>	<u>Addition comments descriptions</u>
Location	Cafeteria Roof Parapet.	
Serving	Cafeteria	
Config/Style	Rooftop AHU with packaged CU	
Mfr.	Trane Voyager	Energy Recovery Cassette, Thybar
Model #	TFD241E30AAB	
Serial #	102310059D	
Age (years)	6/2010	
System CFM	8000	
Max OA CFM	3000	
V/Hz/Ph	208-230/60/3	
SF Qty/HP	5.0	
SF VFD Data	N/A	
EF Qty/HP	2.0 (1) AX-48	OFF
EF VFD Data	N/A	
Filter Data (Size Quantity)	(8) 20x20x2 (4) 16x20x2 coil (6) 20x24x2 wheel	
Filter Status	Not Great for 1 month Old, Dirty	Metal Pre-Filters need replacement
Controls Type	Packaged with DDC interface	
Controls Mfr.	Trane/Thybar/Distech CTC	
Economizer	Yes, available, operation in question	Operation in question
CO ₂ DCV	Wires connected to unit CO2 terminals, will need to explore BAS drawings	
Damper Styles	Trane, Flap. Functional, clean lubricate and adjust.	Thybar Parallel, BDD
Damper Status	OK, functionality to be verified

Heating Type	Hot Water	
Heating Coil Condition	Unknown	
Cooling Type	DX R-410A	
Cooling Coil Condition	Very Dirty	
Wheel	Aire Xchange Inc. Ser. 124526/1023 Mod. ERC-5245-04-X30 Energy Cassette-1/6 HP	BELT ON WHEEL BROKEN
Drain Pan Status	Dirty	
Notes:	Supply fan on, O.A fan on, No exhaust, no wheel	Operation, sequence in question

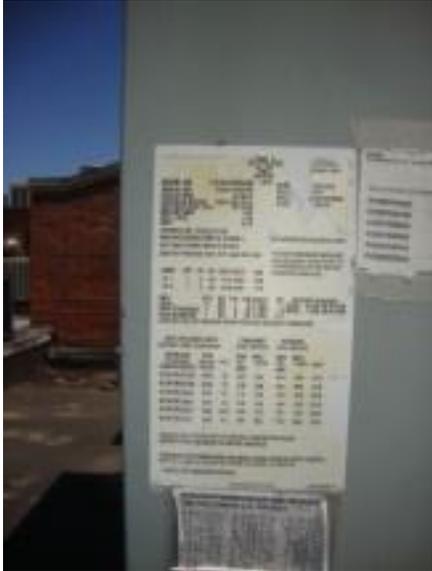
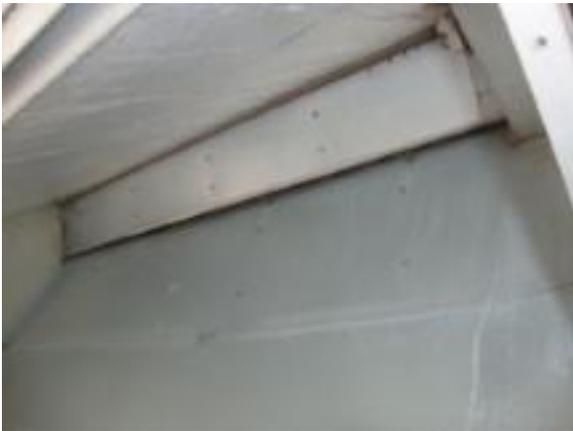
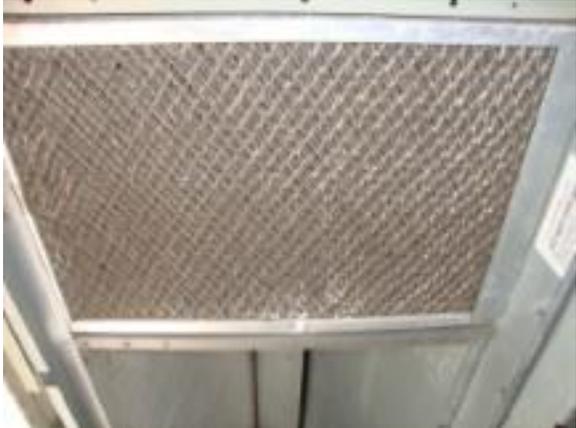
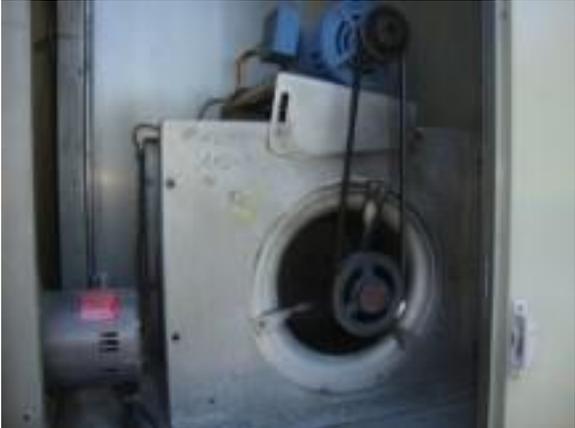
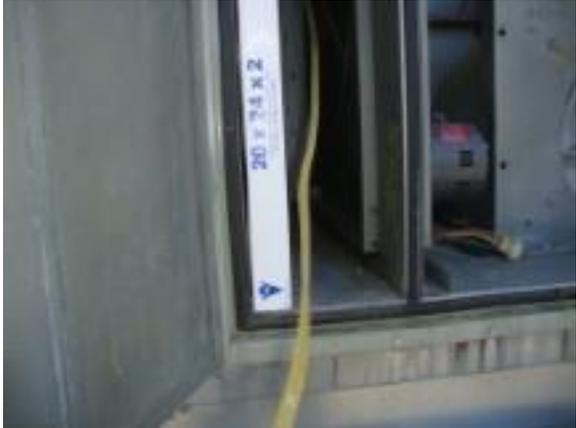
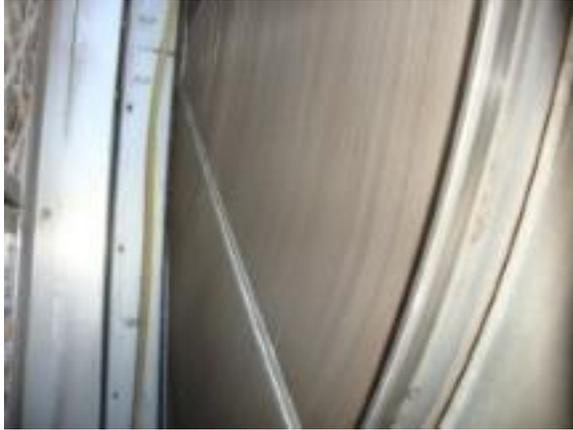
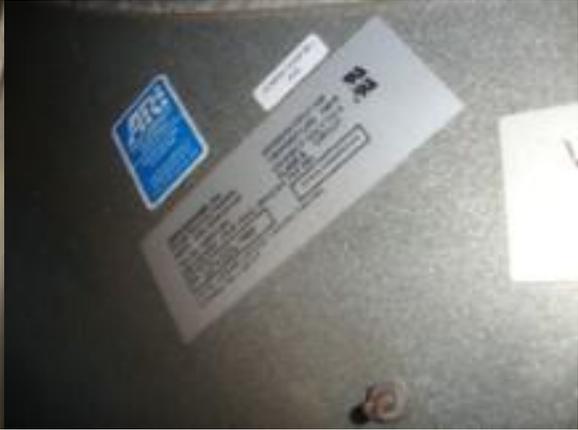
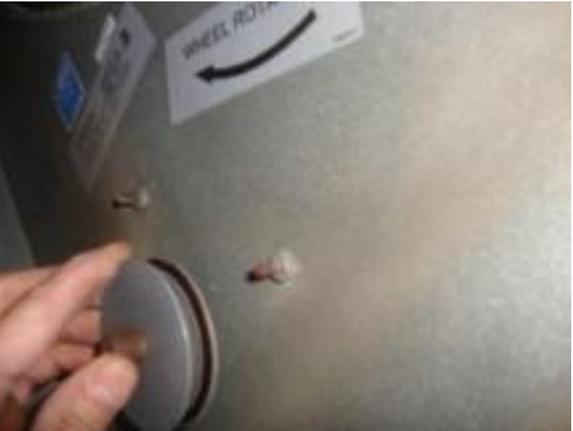
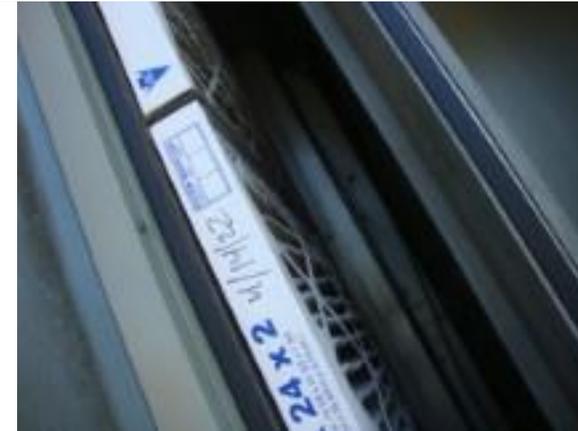
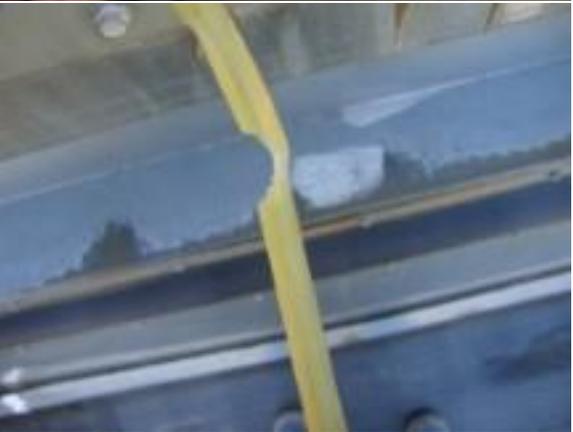
<u>Unit Tag</u>	<u>AHU-4 REA 5-10-22</u>	<u>Addition comments descriptions</u>
Location	Administration Roof	
Serving	Conference	
Config/Style	Rooftop DX cooling Hot water heating	
Mfr.	Trane Precedent	
Model #	TCH092E3ROA03EOB1A1B00004E	
Serial #	102111905L	
Age (years)	2010	
System CFM	3000	
Max OA CFM	390	
V/Hz/Ph	208-230/60/3	
SF Qty/HP	Direct Drive	
SF VFD Data	ECM .75 HP	
RF Qty/HP	N/A	
RF VFD Data	N/A	
Filter Data (Size Quantity)	(6) 20 X 25 X 2	
Filter Status	Standard filters Clean, Metal Pre filters are plugged, should be replaced	4-14-22
Controls Type	Packaged with DDC interface	
Controls Mfr.	CTC BAS Vendor	
Economizer	Yes	
CO ₂ DCV	Wires connected to unit CO2 terminals, will need to explore BAS drawings	
Damper Styles	Flapper packaged	
Damper Status	OK	
Heating Type	Hot water	
Heating Coil Condition	OK	
Cooling Type	DX Dual Compressor	
Cooling Coil Condition	Dirty	
Drain Pan Status	Dirty	
Notes:	Lots of air leakage under cooling coil. Should be reviewed.

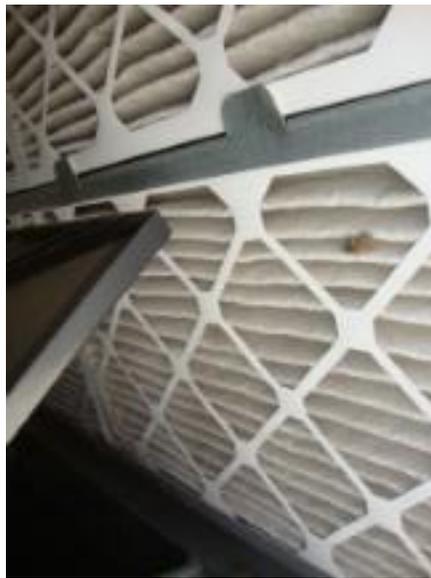
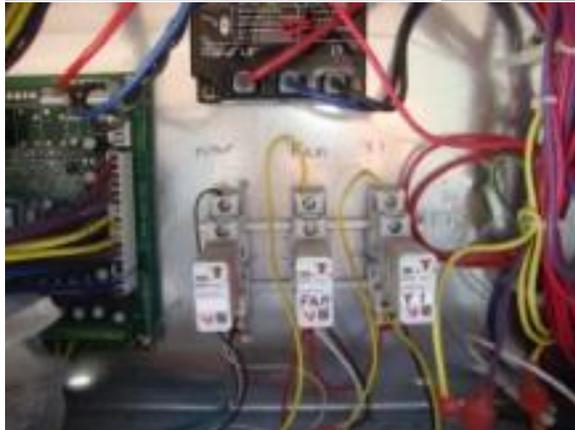
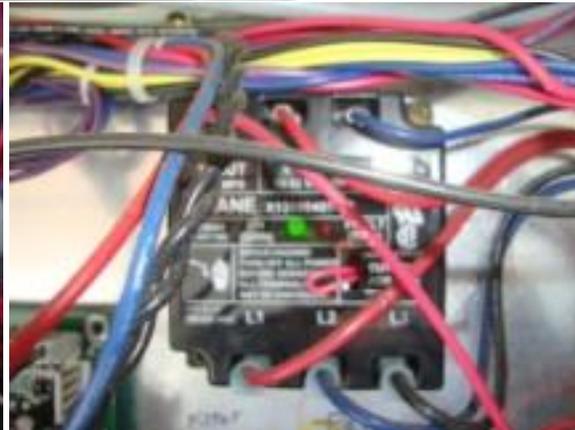
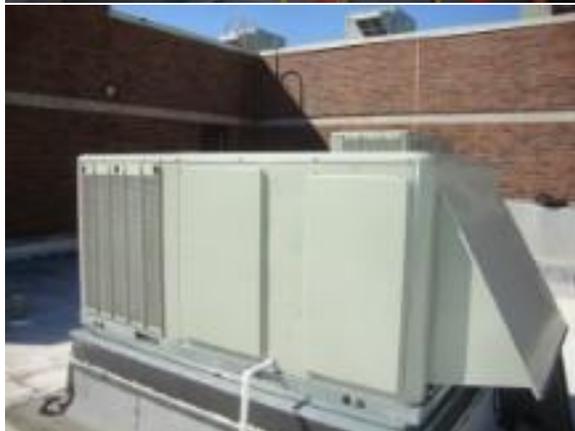
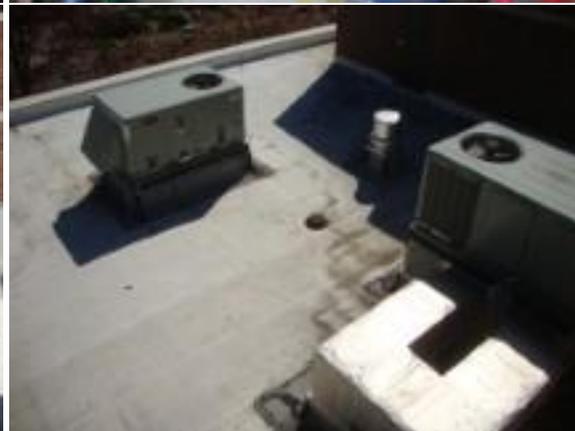
Photos

<u>Unit Tag</u>	<u>AHU-5</u>	<u>Addition comments descriptions</u>
Location	Media Center Roof	
Serving	Media Center	
Config/Style	Rooftop AHU with packaged CU	
Mfr.	Trane	
Model #	THC060E3R0A0PEOB1A1B00004C	
Serial #	102111876L	
Age (years)	2010	
System CFM	2000	
Max OA CFM	350	
V/Hz/Ph	208-230/60/3	
SF Qty/HP	7.6 Amps	
SF VFD Data	ECM	
RF Qty/HP	N/A	
RF VFD Data	N/A	
Filter Data (Size Quantity)	(4) 16x25x2	
Filter Status	Clean 4/14/22	
Controls Type	Packaged with DDC interface	
Controls Mfr.	CTC BAS Vendor	
Economizer	Yes	
CO ₂ DCV	Wires connected to unit CO2 terminals, will need to explore BAS drawings	
Damper Styles	Flap	
Damper Status	OK	
Heating Type	N/A	
Heating Coil Condition	N/A	
Cooling Type	DX Cooling R-410A	
Cooling Coil Condition	OK	
Drain Pan Status	OK	
Notes:	No heat in unit

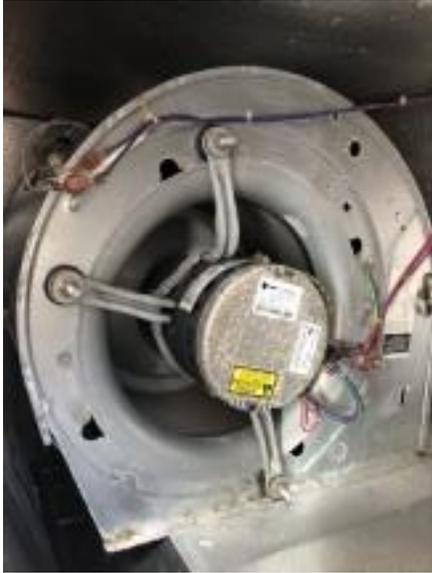
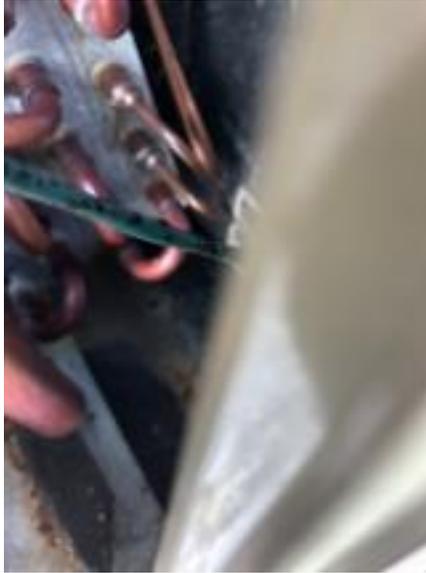
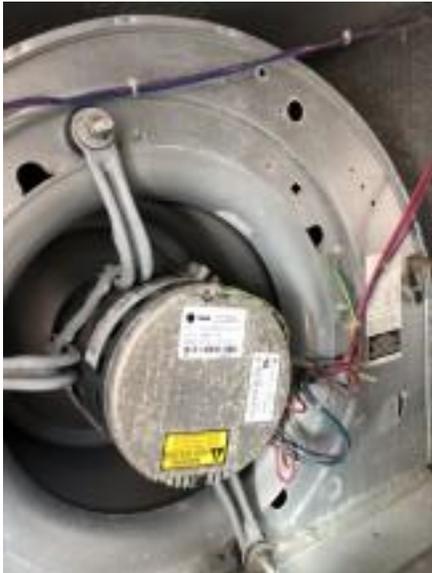
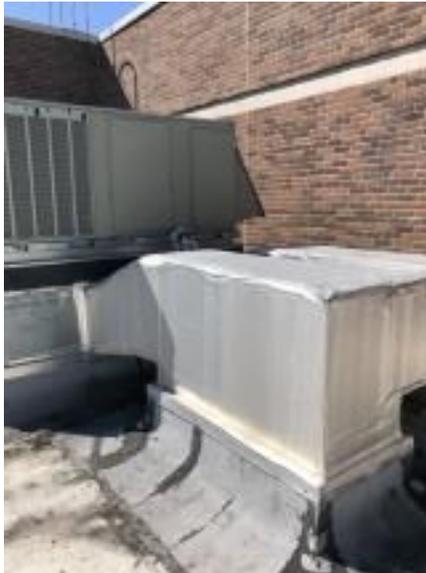
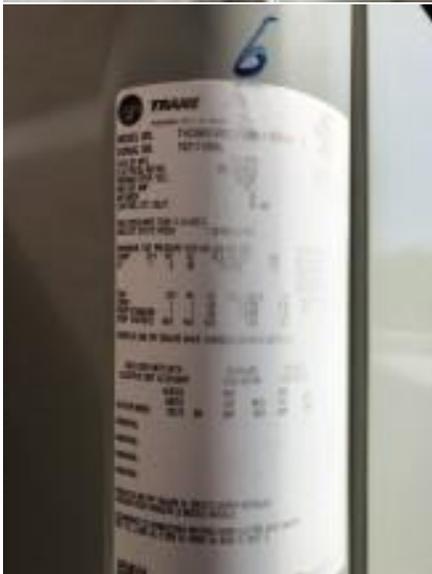
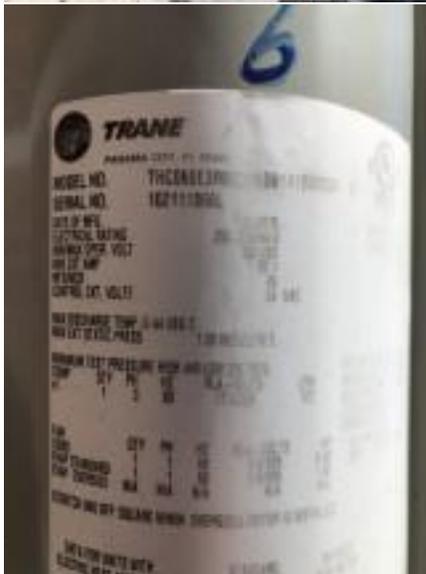
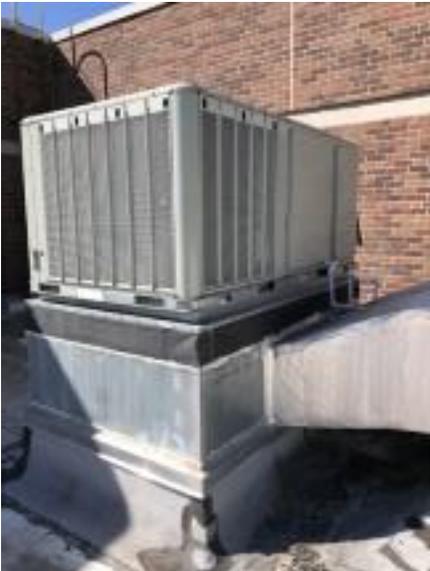
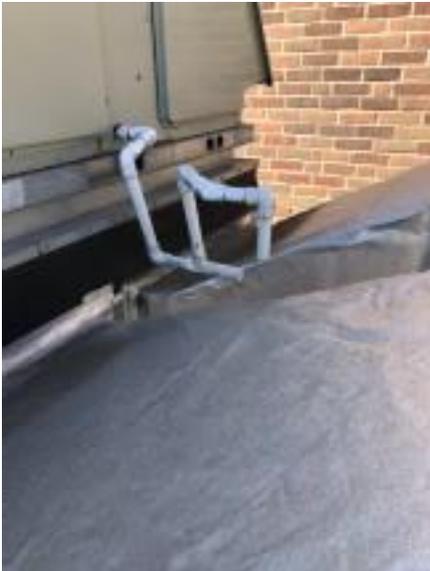
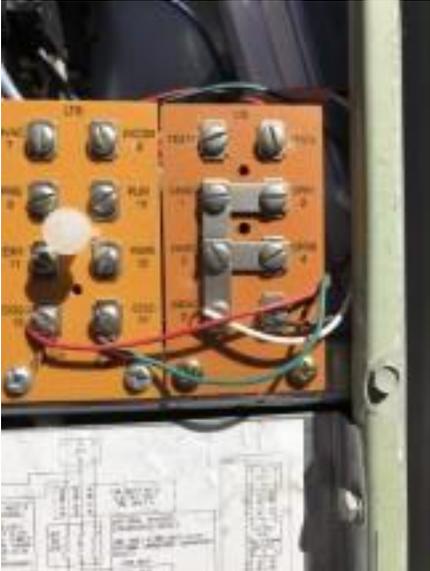
<u>Unit Tag</u>	<u>AHU-6</u>	<u>Addition comments descriptions</u>
Date: 5-10-11	Auditor: RCM	
Location	Media Center Roof	
Serving	Conference Room	
Config/Style	Rooftop Cooling Only	
Mfr.	Trane	
Model #	THC060ER0A0PE0B1A1B00004	
Serial #	102111866L	
Age (years)	2010	
System CFM	1200	
Max OA CFM	150	
V/Hz/Ph	208-230/60/3	
SF Qty/HP	1HP	
SF VFD Data	ECM	
RF Qty/HP		
RF VFD Data		
Filter Data (Size Quantity)	(4) 16 X 25 X 2	
Filter Status	Clean	
Controls Type	Packaged with DDC interface	Fan/Y1/Filter/Motor Status
Controls Mfr.	CTC BAS Vendor	
Economizer	Yes	
CO ₂ DCV	Wires connected to unit CO ₂ terminals, will need to explore BAS drawings	
Damper Styles	Flapper	
Damper Status	OK	
Heating Type	NA	
Heating Coil Condition		
Cooling Type		
Cooling Coil Condition		
Drain Pan Status	OK, trap needs repair	
Notes:	Cooling Running with 0% OA Intake

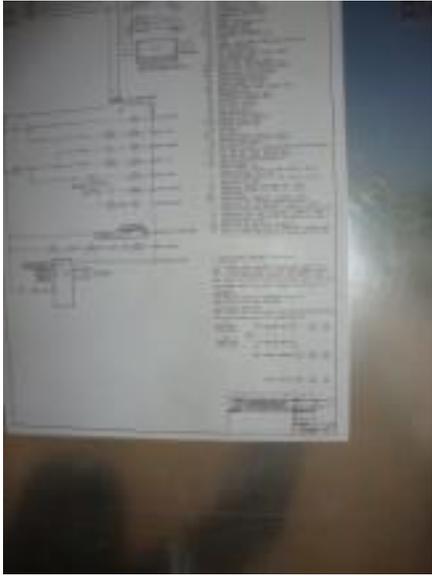
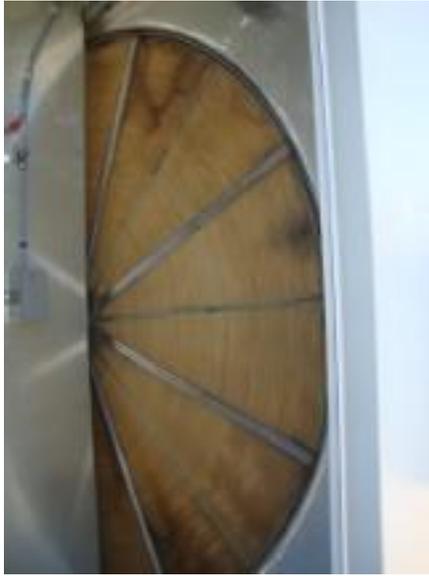
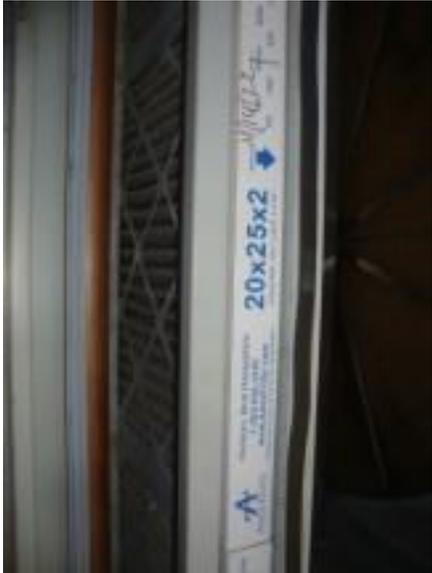
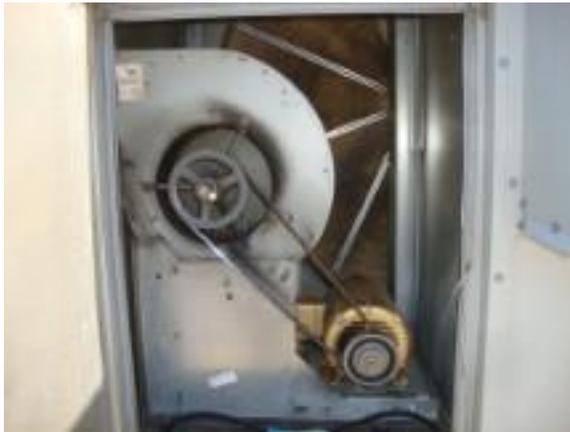
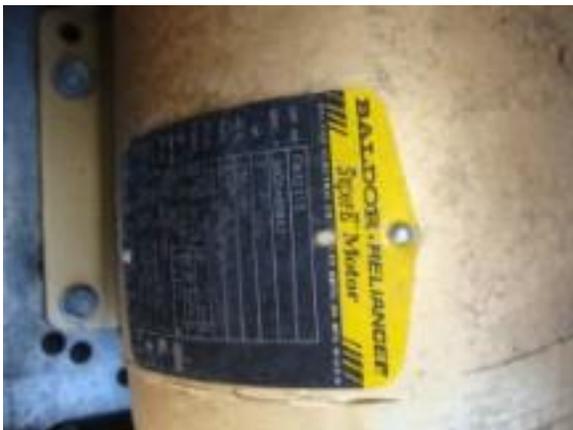
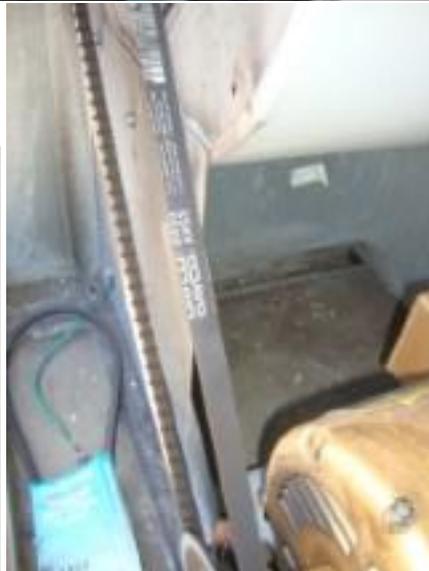
<u>Unit Tag</u>	<u>ERV-1</u>	<u>Addition comments descriptions</u>
Location	Northeast Wing Classroom Roof	
Serving	Northeast Wing Classrooms	
Config/Style	Rooftop Energy Recovery Ventilator	
Mfr.	Greenheck ERV	Wheel is dirty, Wheel has VFD.
Model #	ERCH-45H-15	
Serial #	12108440	
Age (years)		
System CFM		
Max OA CFM		
V/Hz/Ph	208/60/3	
SF Qty/HP	3.0 (1) AX-53	
SF VFD Data	N/A	
RF Qty/HP	3.0 (1) AX-53	
RF VFD Data	N/A	
Filter Data (Size Quantity)	(6) 20x25x2	
Filter Status	Metal Pre-Filters should be replaced, plugged	Large Pressure drop across pre-filters,
Controls Type	Package with DDC interface	
Controls Mfr.	Distech, CTC	
Economizer	No	
CO ₂ DCV	100% OA	
Damper Styles	Opposed	
Damper Status	Functional, clean lubricate and adjust	
Heating Type	HW	
Heating Coil Condition	Not Accessible	
Cooling Type	DX R-410A Dual Circuit	Refrigerant insulation has failed
Cooling Coil Condition	OK, could use a wash down	
CU Mfr.	CU-1 Trane

CU Model	Disconnect covers Data Plate	
CU Serial	10022PEGAD	
Drain Pan Status	Ok, but should be verified after coil wash	
Notes:	Exposed supply ductwork insulation has failed, see Photos

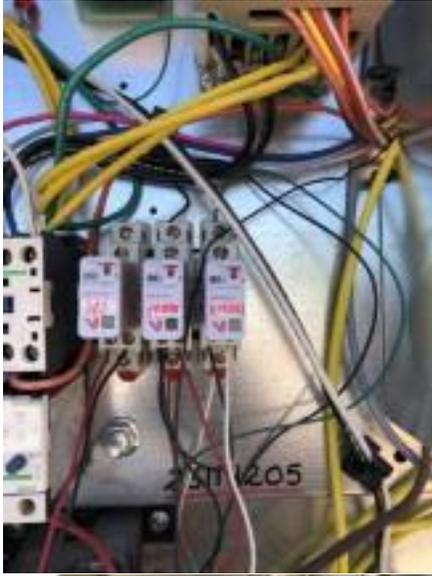
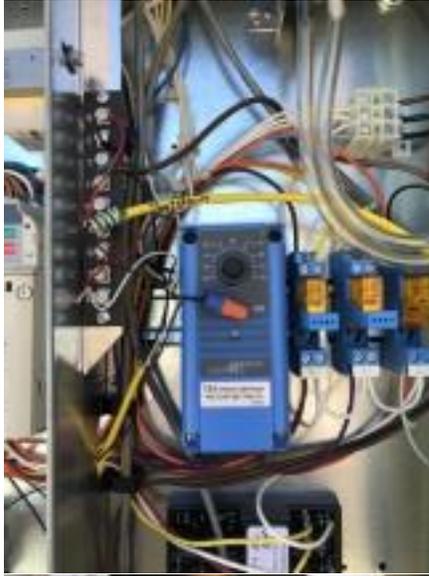
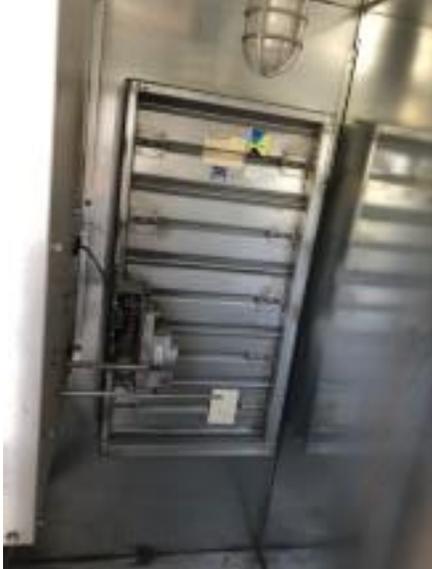
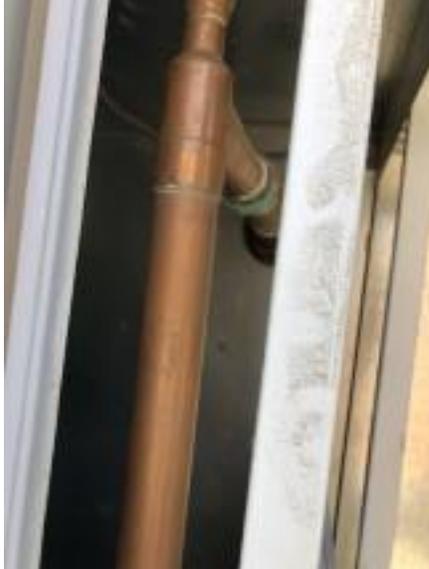
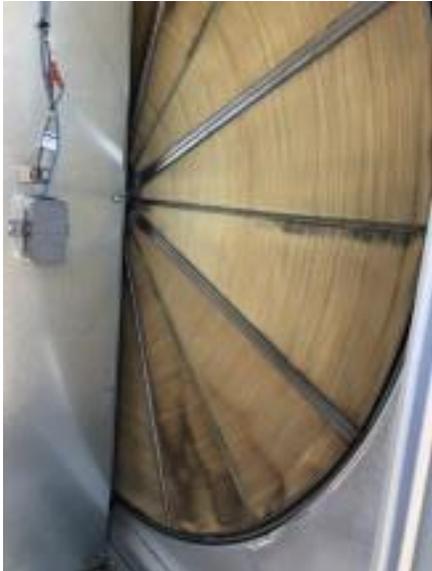
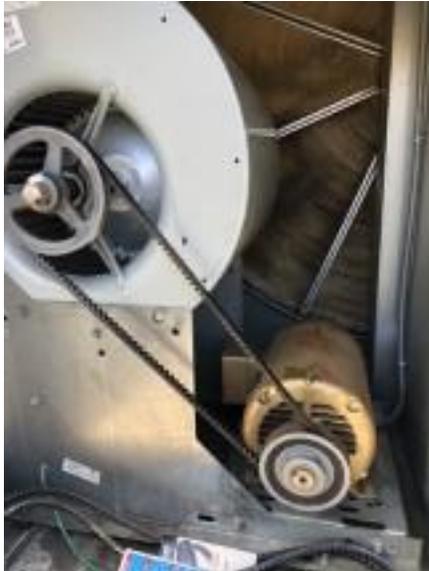
Unit Tag	ERV-2	Addition comments descriptions
Location	Southeast Wing Classroom Roof	
Serving	Southeast Wing Classrooms	
Config/Style	Rooftop Energy Recovery Ventilator	
Mfr.	Greenheck with Trane CU	
Model #	ERCH-45H-15	
Serial #	12108439	
Age (years)	2010	
System CFM		
Max OA CFM		
V/Hz/Ph		
SF Qty/HP	3 HP	AX 53 Belt
SF VFD Data	Yaskawa J100	
EF Qty/HP	3 HP ERW .17 HP	AX 53
EF VFD Data		
Filter Data (Size Quantity)	OA (3) 20 X 25 X 2, RA (3) 20 X 25 X 2 OA Prefilter Metal: 15.5 X 19.5 X .5	
Filter Status	Clean last changed	
Controls Type	Package with DDC interface	SST, Frost, Status
Controls Mfr.	Distech, CTC	
Economizer	No	
CO ₂ DCV	100% OA	
Damper Styles	Opposed	
Damper Status	Functional but OA intake Dirty	
Heating Type	HW	
Heating Coil Condition	Not Accessible	
Cooling Type		
Cooling Coil Condition		
CU Mfr.	Trane 2 Compressor/Stage	
CU Model	Tag covered by Disconnect	
CU Serial		
Drain Pan Status	Clean	
Notes:	OA intake very restricted due to plugged OA Metal Pre-Filters causing high negative pressure bypassing ERW with OA intake. OA door seals partially missing or had fallen off

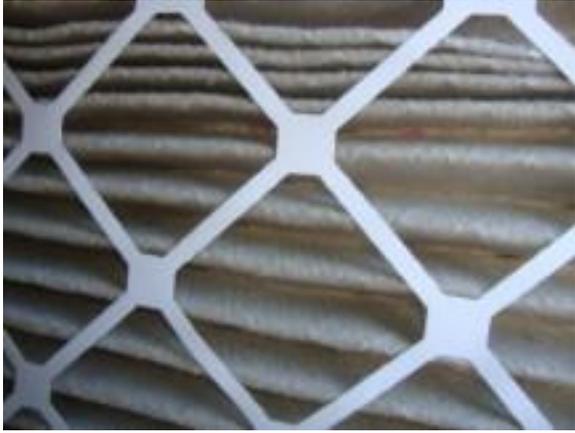
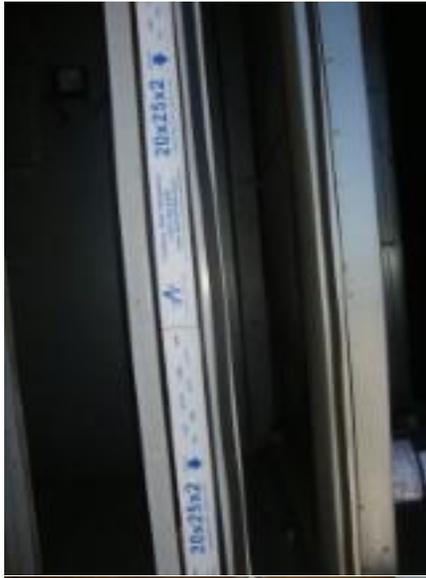
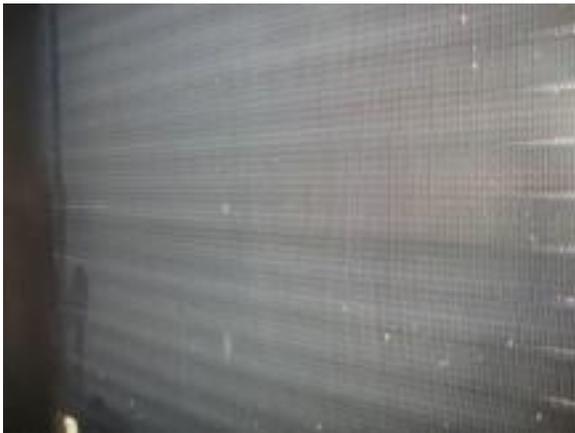
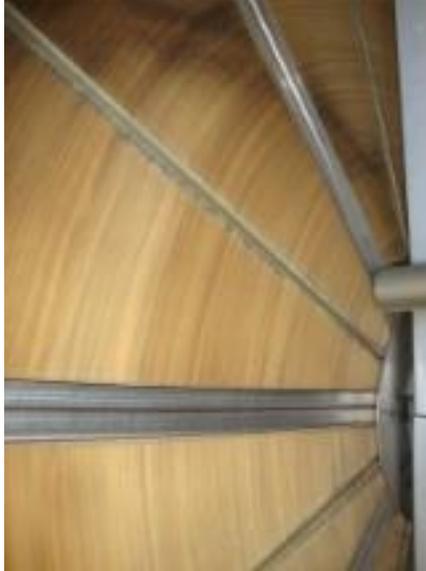
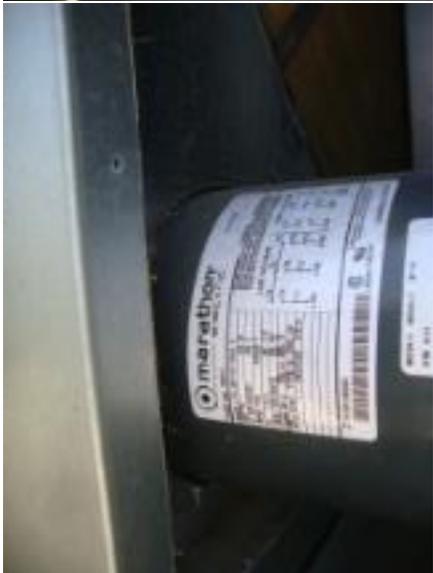
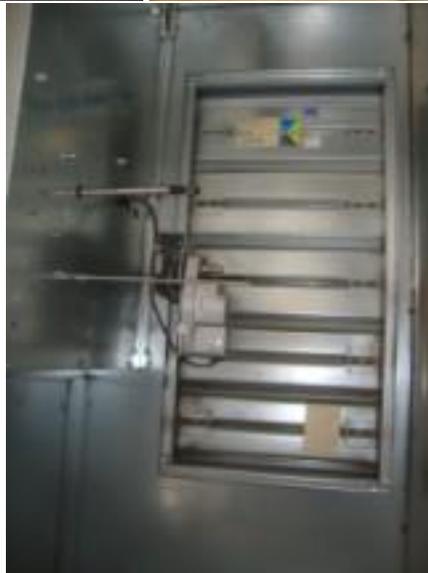
Photos

Unit Tag	ERV-3	Addition comments descriptions
Location	South Wing Classroom Roof	
Serving	South Wing Classrooms	
Config/Style	Rooftop Energy Recovery wheel Ventilator, DX cooling hot water heating	
Mfr.	Greenheck ERV-3	Trane CU-3
Model #	ERCH-45L-15	
Serial #	12108443	
Age (years)		
System CFM		
Max OA CFM		
V/Hz/Ph	208/60/3	
SF Qty/HP	2.0 (1) AX-51	
SF VFD Data	N/A	
RF Qty/HP	2.0 (1) AP-54, Belt is loose	
RF VFD Data	N/A	
Filter Data (Size Quantity)	(6) 20x25x2	
Filter Status	Metal Pre-Filters should be replaced, plugged	Although recently changed, partially dirty
Controls Type	Package with DDC interface	
Controls Mfr.	Distech, CTC	
Economizer	No	
CO ₂ DCV	100% OA	
Damper Styles	Parallel	
Damper Status	Functional, clean lubricate and adjust	
Heating Type	HW	
Heating Coil Condition	Not Accessible	
Cooling Type	DX R-410A Dual Circuit	
Cooling Coil Condition	OK, could use a wash down	
CU Mfr.	CU-3 Trane	
CU Model	Disconnect covers Data Plate

CU Serial	---0082RUXAD	
Drain Pan Status	Ok, but should be verified after coil wash	
Notes:	Door access seals have failed, coils/wheel are dirty

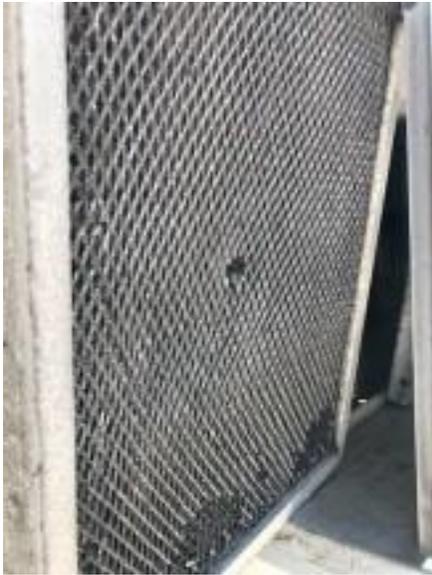
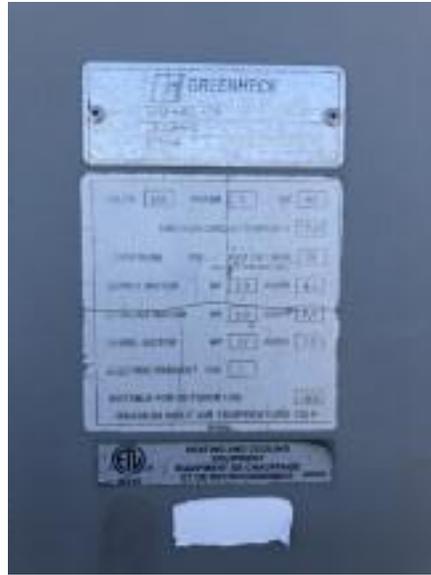
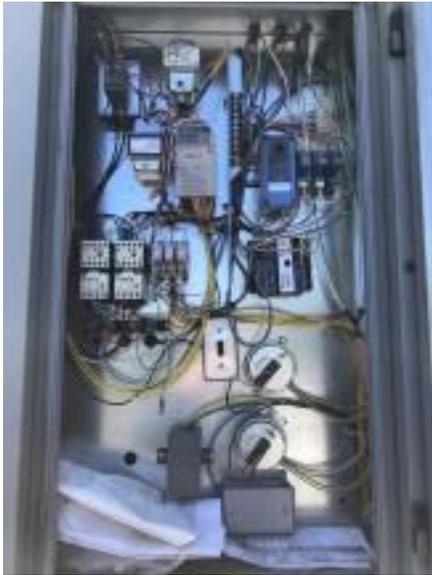
<u>Unit Tag</u>	<u>ERV-4</u>	<u>Addition comments</u>
Location	West Wing Classroom Roof	
Serving	West Wing Classrooms	
Config/Style	Rooftop Energy Recovery Ventilator	
Mfr.	Greenheck with Trane CU	
Model #	ERCH-45H-15	
Serial #	12108442	
Age (years)	2010	
System CFM		
Max OA CFM		
V/Hz/Ph		
SF Qty/HP	3 HP	AX 53 Belt
SF VFD Data	Yaskawa J100	
RF Qty/HP	3 HP ERW .17 HP	AX 53
RF VFD Data		
Filter Data (Size Quantity)	OA (3) 20 X 25 X 2, RA (3) 20 X 25 X 2 OA Prefilter Metal: 15.5 X 19.5 X .5	
Filter Status	Clean last changed	
Controls Type	Package with DDC interface	SST, Frost, Status
Controls Mfr.	Distech, CTC	
Economizer	No	
CO ₂ DCV	100% OA	
Damper Styles	Opposed	
Damper Status	Exhaust Damper Actuator non-functioning. OA intake Dirty	
Heating Type	HW	
Heating Coil Condition	Not Accessible	
Cooling Type	Remote DX Single Compressor	
Cooling Coil Condition		
CU Mfr.	Trane	
CU Model	Tag Covered	
CU Serial		
Drain Pan Status	Moderate

Notes:	Exh Damper Stuck open. OA intake very restricted due to plugged OA Metal Pre-Filters causing high negative pressure bypassing ERW with OA intake. OA door seals partially missing or had fallen off

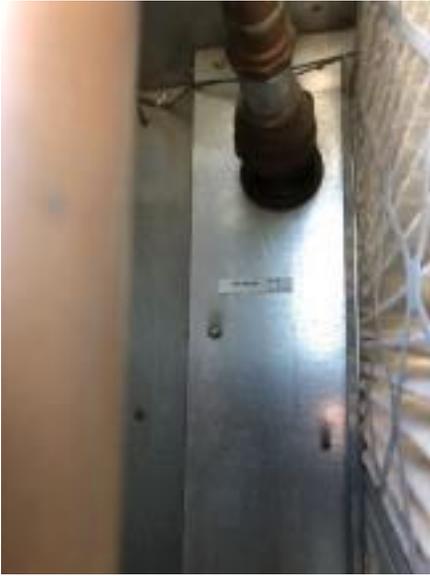
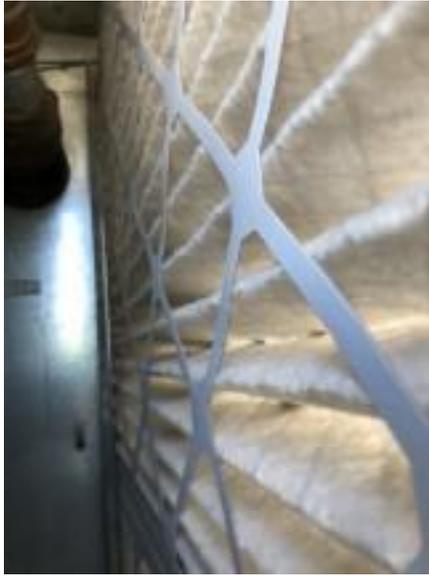
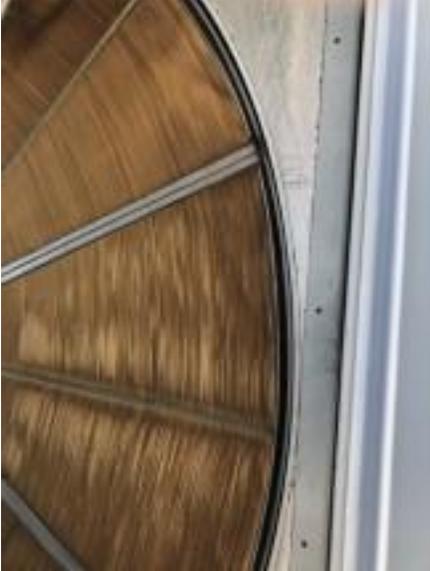
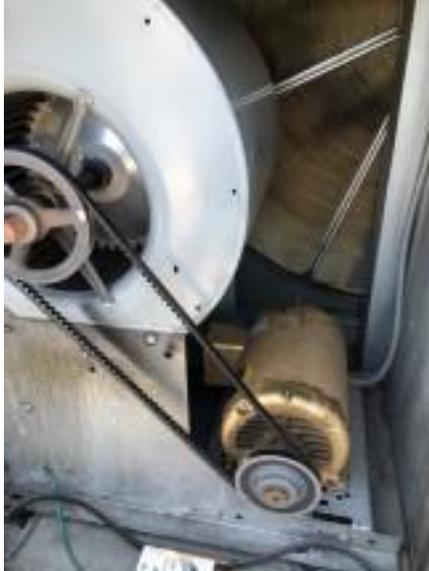
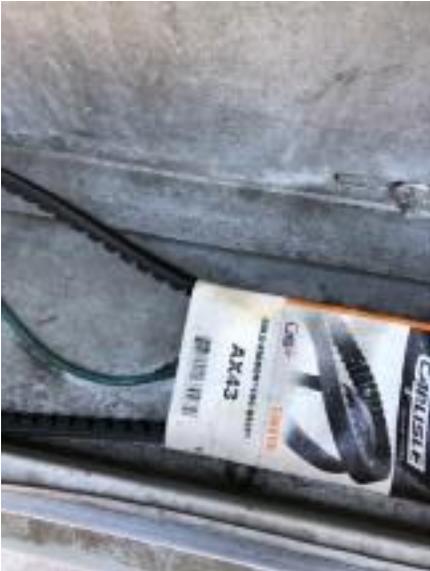
<u>Unit Tag</u>	<u>ERV-5</u>	<u>Addition comments</u>
Location	North Wing Classroom Roof	
Serving	North Wing Classrooms	
Config/Style	Rooftop Energy Recovery Ventilator	
Mfr.	Greenheck with Trane CU	
Model #	ERCH-45H-15	
Serial #	12108441	
Age (years)	2010	
System CFM		
Max OA CFM		
V/Hz/Ph		
SF Qty/HP	3 HP	AX 53 Belt
SF VFD Data	Yaskawa J100	
RF Qty/HP	3 HP ERW .17 HP	AX 53
RF VFD Data		
Filter Data (Size Quantity)	OA (3) 20 X 25 X 2, RA (3) 20 X 25 X 2 OA Prefilter Metal: 15.5 X 19.5 X .5	
Filter Status	Clean last changed	
Controls Type	Package with DDC interface	SST, Frost, Status
Controls Mfr.	Distech, CTC	
Economizer	No	
CO ₂ DCV	100% OA	
Damper Styles	Opposed	
Damper Status	Functional but OA intake Dirty	
Heating Type	HW	
Heating Coil Condition	Not Accessible	
Cooling Type		
Cooling Coil Condition		
CU Mfr.	Trane 2 Compressor/Stage	
CU Model	Tag covered by Disconnect	
CU Serial		
Drain Pan Status	Dirty	
Notes:	OA intake very restricted due to plugged OA Metal Pre-Filters causing high negative pressure bypassing ERW with OA intake. OA door seals partially missing or had fallen off
