# Tomlinson Middle School

## **Fairfield Public Schools Recommissioning (RCx) and Testing, Adjusting, & Balancing (TAB) Study** van Zelm Project # 2020102.00 (04-TMS) July 06, 2022

### **FAIRFIELD PUBLIC SCHOOLS RECOMMISSIONING (RCx) AND TESTING, ADJUSTING, & BALANCING (TAB) STUDY**

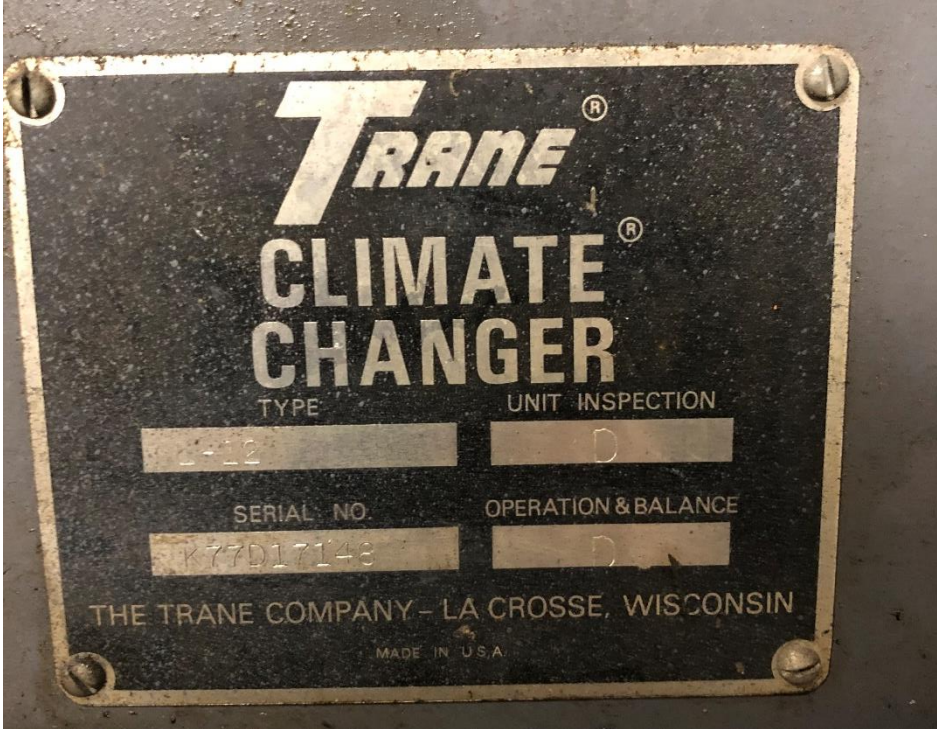
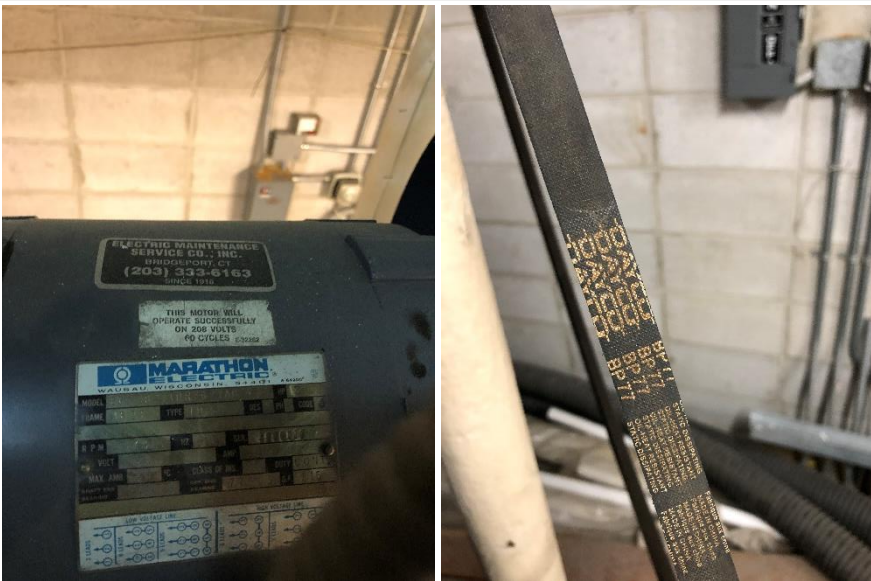
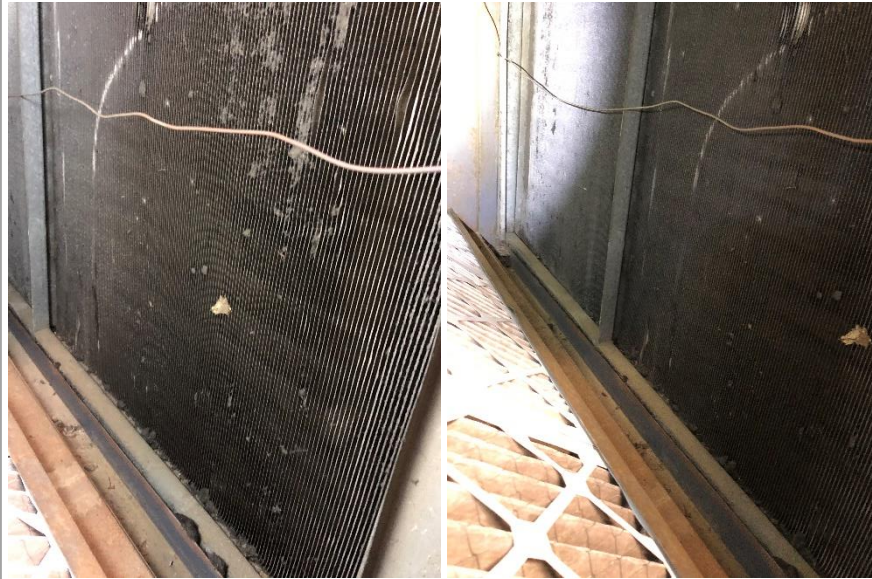
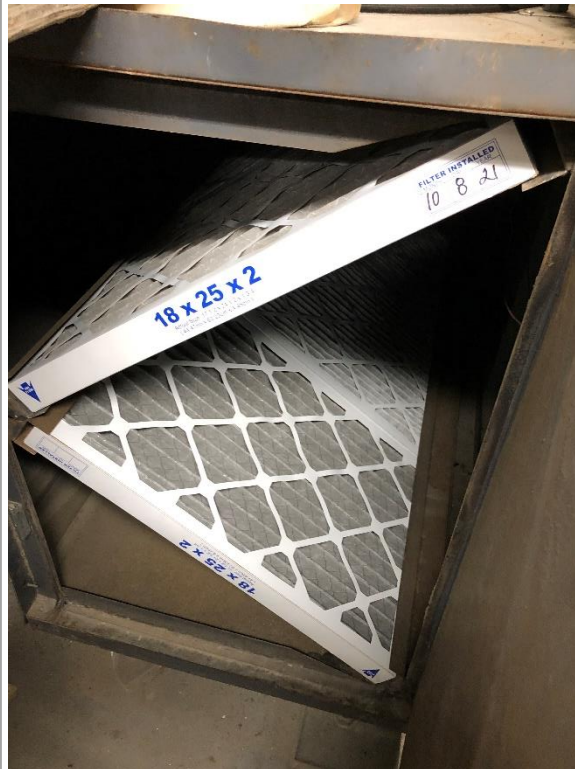
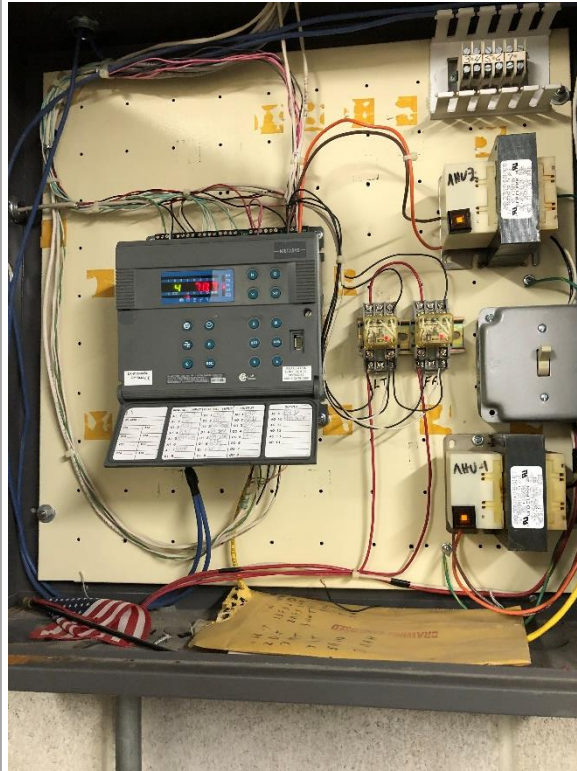
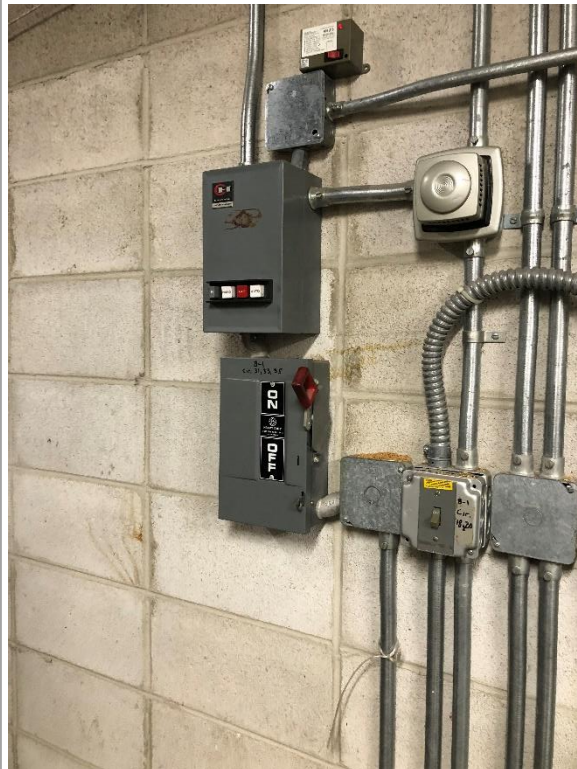
<u>Unit Tag</u>	<u>AHU-2</u>	<u>Addition comments descriptions</u>
Location	Gym Storage	
Serving	Project Adventure	
Config/Style	Min OA, HW w/ bypass, CHW, single fan (SF), relief	
Mfr.	Trane Climate Changer	
Model #	Type L-12	
Serial #	K77D17148	
Age (years)		
System CFM		
Max OA CFM		
V/Hz/Ph	208/230/460/60/3	
SF Qty/HP	(1)	
SF VFD Data	N/A	
RF Qty/HP	N/A	Roof Mounted Exhaust fans
RF VFD Data	N/A	
Filter Data (Size Quantity)	(6) 18"x25"x2"	
Filter Status	Clean	10-8-21
Controls Type	Factory	
Controls Mfr.	BAS	
Economizer	Not Identified but probably	
CO <sub>2</sub> DCV	-	
Damper Styles	Multi zone, bypass	Old Pneumatic actuators, NIU
Damper Status	Unknown	
Heating Type	Hot Water	
Heating Coil Condition	Dirty	
Cooling Type	N/A	
Cooling Coil Condition	N/A	
CU Mfr.	N/A	
CU Model	N/A	
CU Serial	N/A	
Drain Pan Status	N/A	
Notes:	Unit is old and need TLC to continue to function properly

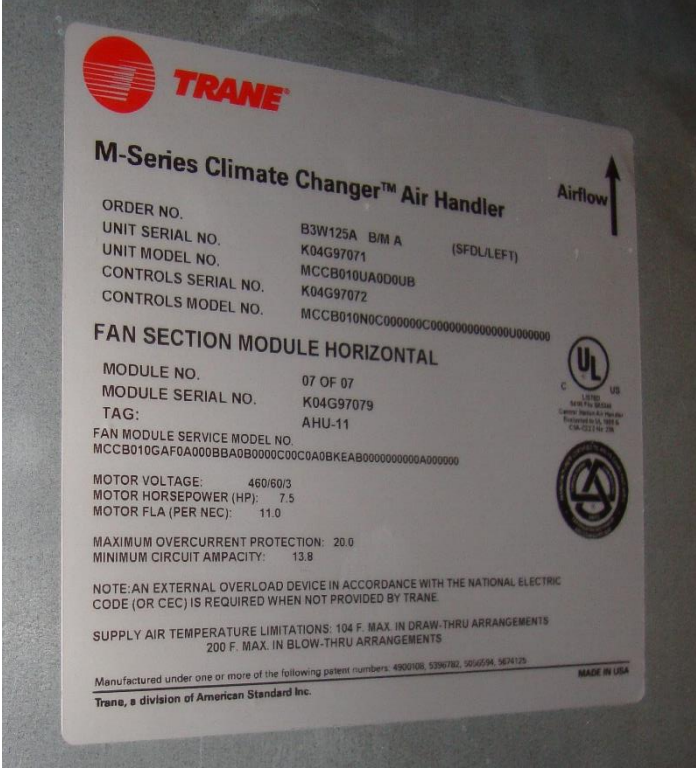
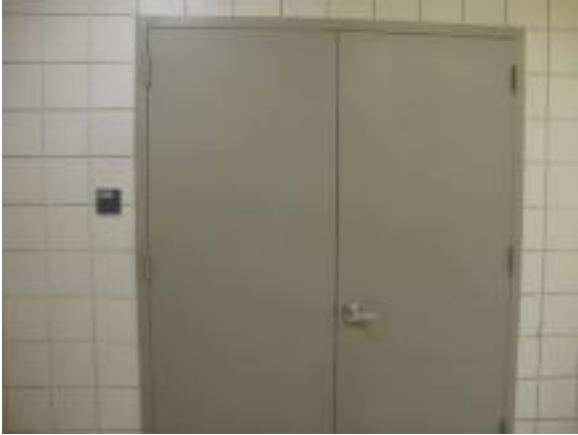
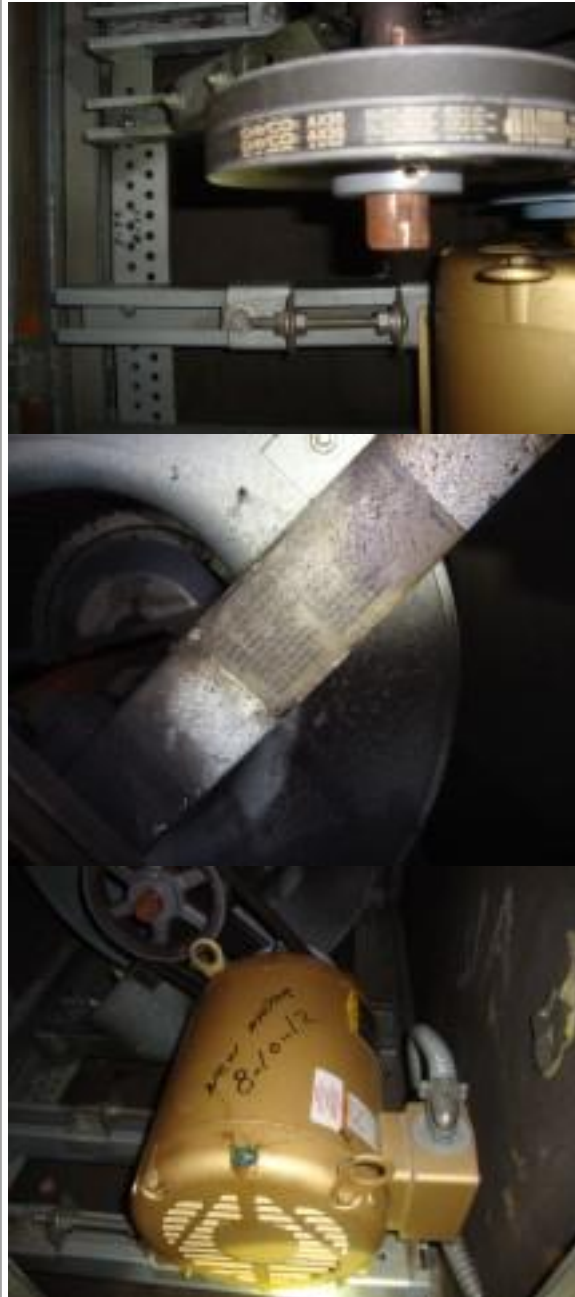
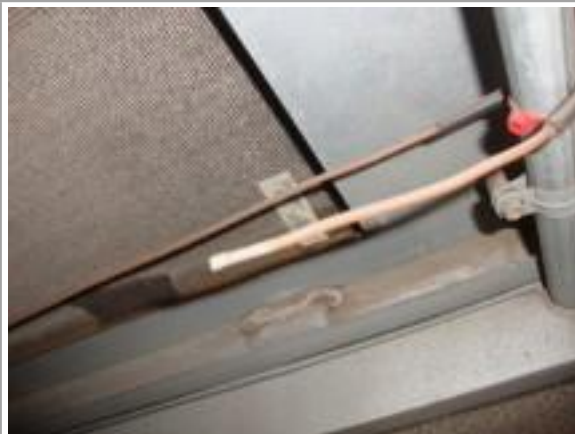
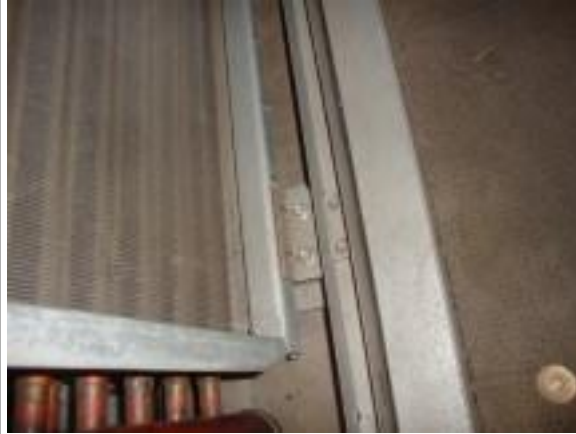
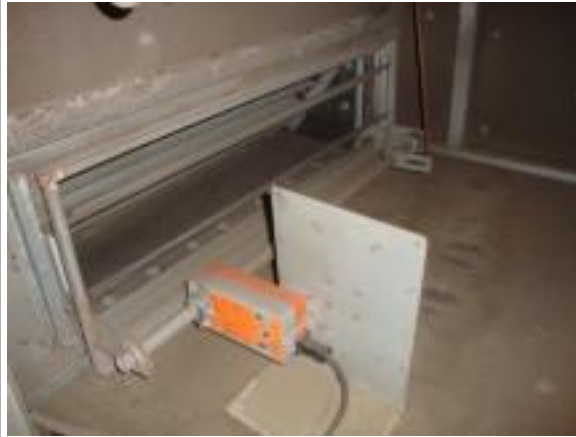
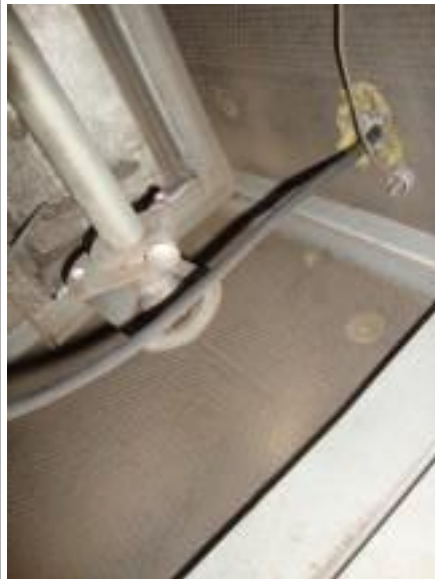
- AHU-11 serves the band/music education spaces in the Field level basement area. This unit fails to provide any outside air to the spaces. It is suspected that a fire damper might be closed preventing this airflow, as well as damper linkages found broken/need adjustment on the RA/OA dampers.. These spaces have fluctuating periods of high occupancy, so a lot of ventilation is required for relatively small periods throughout the day. This should be investigated further and corrected quickly.

<u>Unit Tag</u>	<u>AHU-11</u>	<u>Addition comments descriptions</u>
Location	Lower Level 036	
Serving	Band	
Config/Style	Min OA, HW w/ bypass, CHW, single fan (SF), relief	
Mfr.	Trane Modular	
Model #	MCCB010UA0D0UB	
Serial #	KO4G97072	
Age (years)		
System CFM		
Max OA CFM		
V/Hz/Ph	460/60/3	
SF Qty/HP	(1) 7.5 Belts (2) AX-75	NEW MOTOR 8/10/12
SF VFD Data	N/A	
RF Qty/HP	N/A	
RF VFD Data	N/A	
Filter Data (Size Quantity)	(2) 20"x15"x2" (1) 12"x25"x2"	10/8/21 Last change date
Filter Status	Dirty	Missing end Plates
Controls Type	DDC Electronic Packaged Controls	
Controls Mfr.	ALC	
Economizer	Yes	
CO <sub>2</sub> DCV		
Damper Styles	Factory Opposed	
Damper Status	Dampers all closed while unit operating	Linkage disconnected
Heating Type	Hot Water	
Heating Coil Condition	Dirty	
Cooling Type	Chilled Water	
Cooling Coil Condition	Dirty	
CU Mfr.		
CU Model		
CU Serial		
Drain Pan Status	Flush after coil cleaning	
Notes:	Face and Bypass dampers not functional, John and Tony corrected,

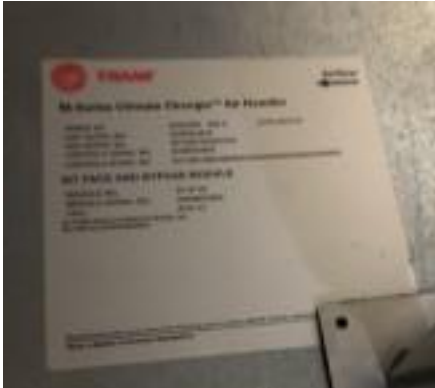
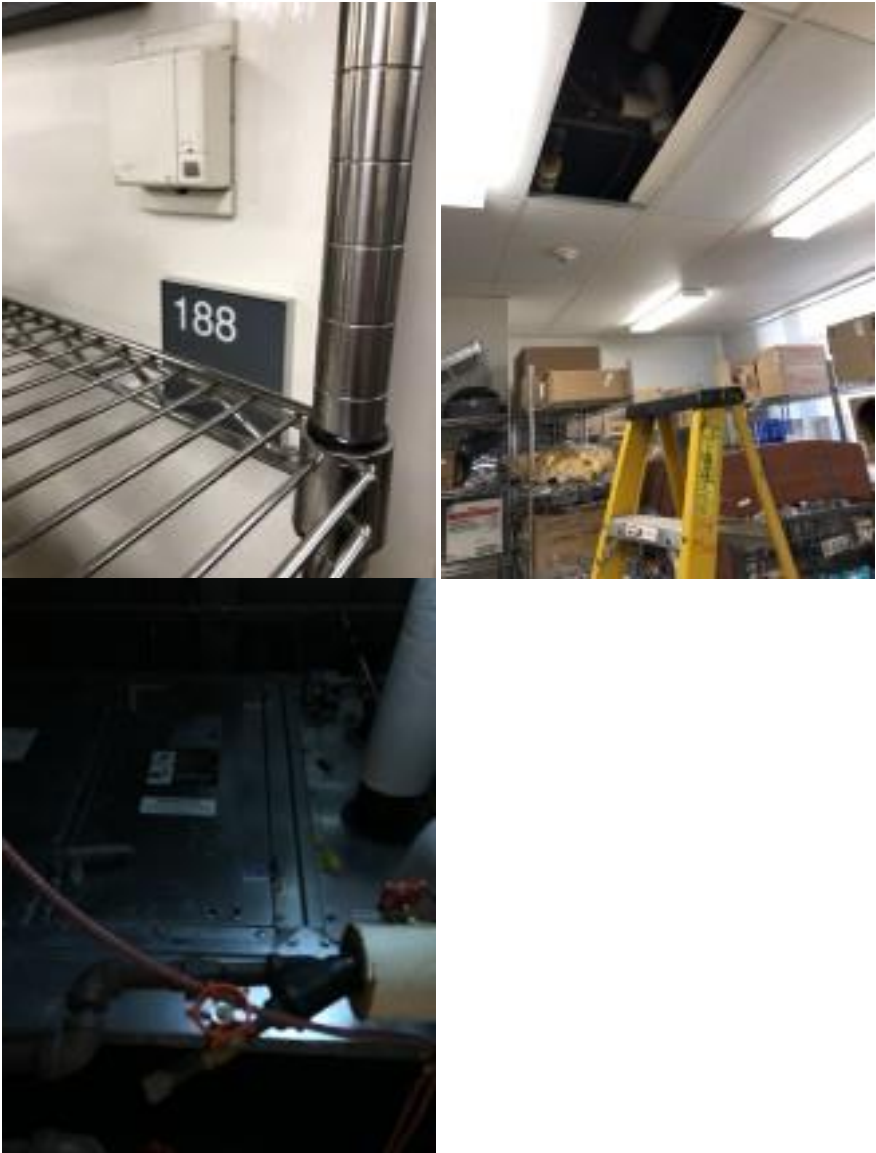
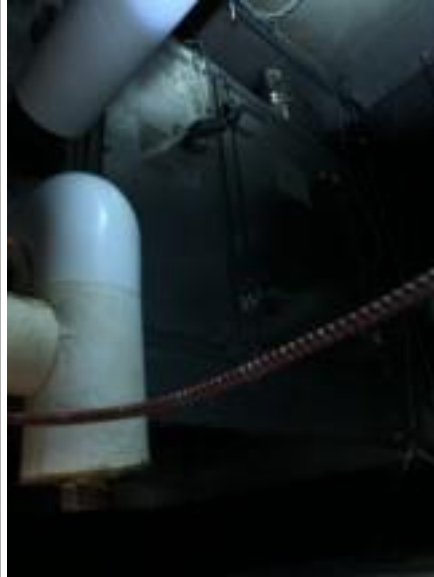
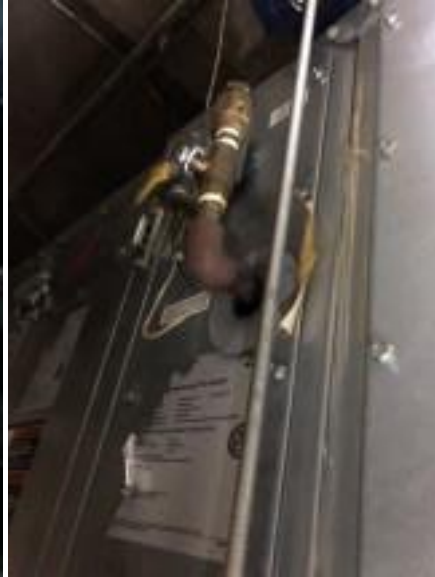
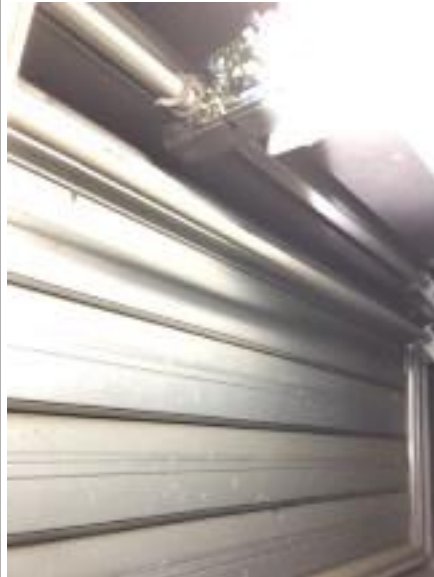
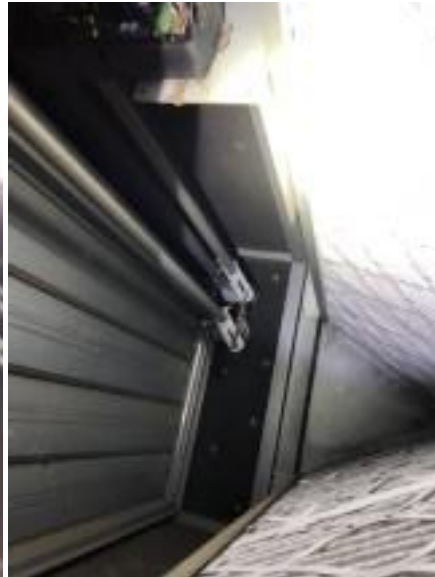
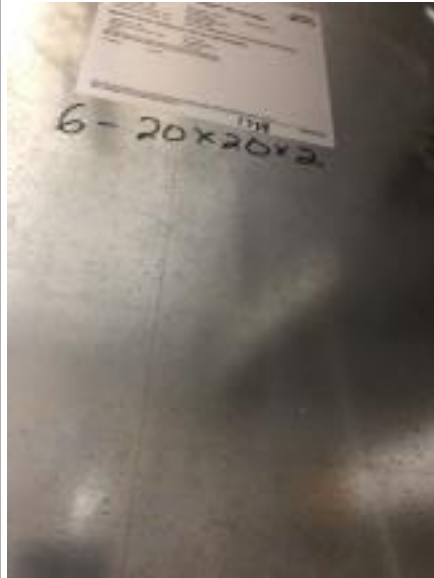
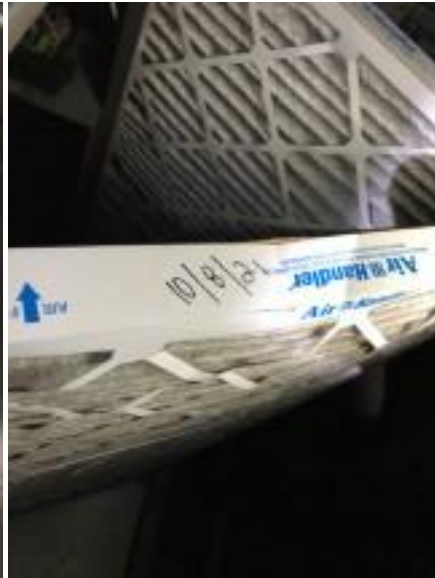
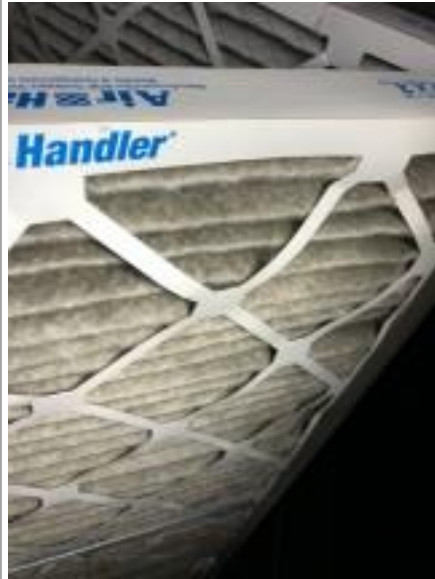
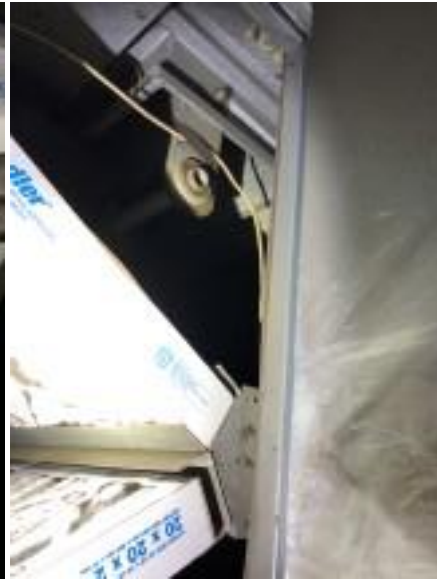
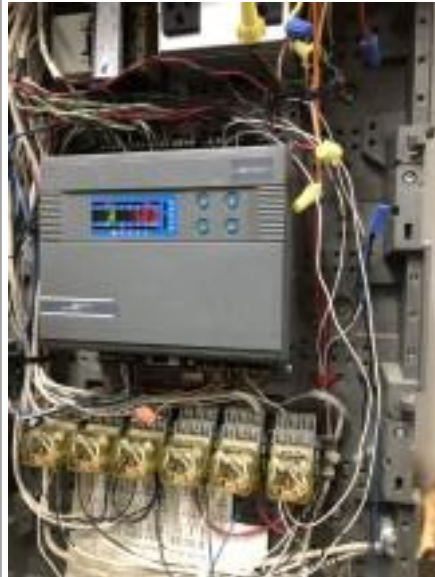
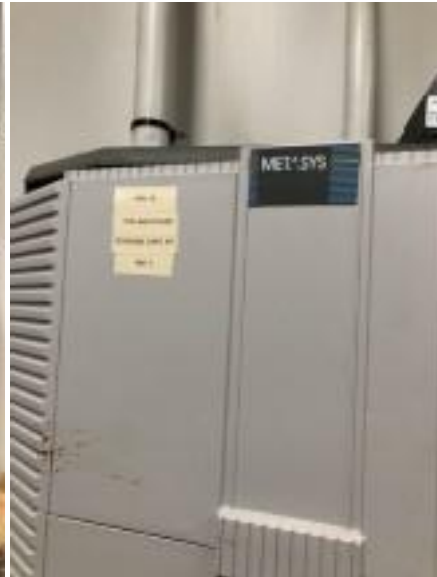
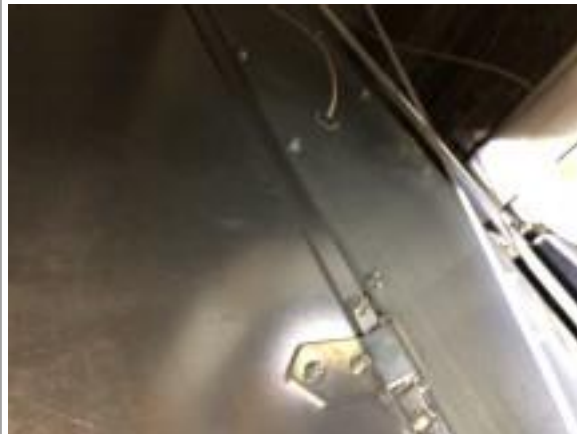
<u>Unit Tag</u>	<u>AHU-12/KEF-1</u>	<u>Addition comments descriptions</u>
Location	Storage 188 (Suspended)	
Serving	Kitchen/Servery	
Config/Style	100% Recirc capable with OA, Steam w/ bypass, Associated KEF	
Mfr.	Trane	
Model #	MCCB012UA0C0UA	
Serial #	K04M65395A	
Age (years)		
System CFM	5,600 Total, 4,000 CFM O.A.	
Max OA CFM		
V/Hz/Ph		
SF Qty/HP	Unable to verify due to access. Model look-up option	
SF VFD Data		
RF Qty/HP		
RF VFD Data		
Filter Data (Size Quantity)	(6) 20 x 20 x2	Last changed 10-18-21
Filter Status	Clean as unit does not appear to have run frequently	
Controls Type	BAS	
Controls Mfr.	JCI DX 9100	Soon to be converted to ALC
Economizer		
CO <sub>2</sub> DCV		
Damper Styles	Packaged/Opposed	
Damper Status	Could use lubrication	
Heating Type	Steam with Face & Bypass	
Heating Coil Condition	Unable to see	
Cooling Type	NA	
Cooling Coil Condition		
Drain Pan Status		
Notes:	Unit was not running and not providing ventilation to Café and Kitchen to offset KEF operation. KEF was not running during school lunch period 4-13- 22	Access limited due to dry food storage supplies below unit

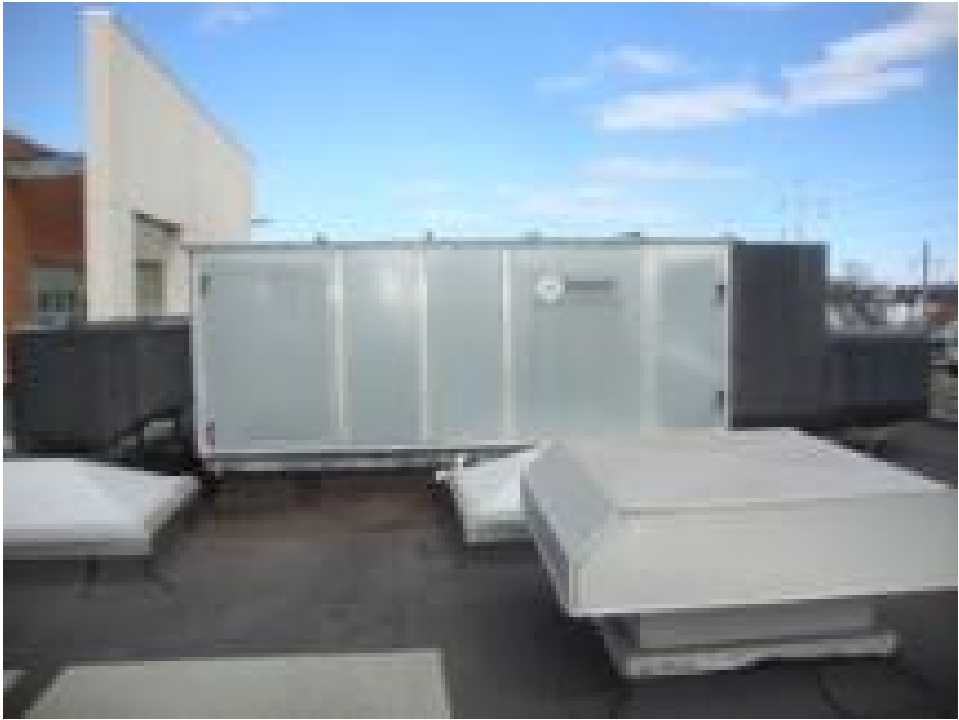
<u>Description</u>	<u>Photos</u>
Unit from afar

<u>Unit Tag</u>	<u>HX-1</u>	<u>Addition comments descriptions</u>
Location	Roof	System actually functions
Serving	Tech	
Config/Style	100% OA Heat exchanger, area reheat coils, bypass dampers	
Mfr.	Innovent	
Model #	E-5000-1F-6750-FR-1-C-R	
Serial #	204118-1	
Age (years)	9/2004	
System CFM		
Max OA CFM		
V/Hz/Ph	460/60/3	
SF Qty/HP	5.0 Belt B69	
SF VFD Data	N/A	
EF Qty/HP	5.0 Belt PB69	
EF VFD Data	N/A	
Filter Data (Size Quantity)	(8) 20"X25"X2"	
Filter Status	Dirty	10/8/21
Controls Type	Factory	
Controls Mfr.		
Economizer	100% O.A.	
CO <sub>2</sub> DCV	-	
Damper Styles	Opposed Blade, face and bypass, economizer, freeze bypass	Actuator AF-24-MFT-5-US
Damper Status	OK	
Heating Type	(Duct mounted Reheat, H.W.)	
Heating Coil Condition	Unknown	
Cooling Type	N/A	
Cooling Coil Condition	N/A	
CU Mfr.	N/A	
CU Model	N/A	
CU Serial	N/A	
Drain Pan Status	OK Trap intact	
Notes:	Discharge restricted

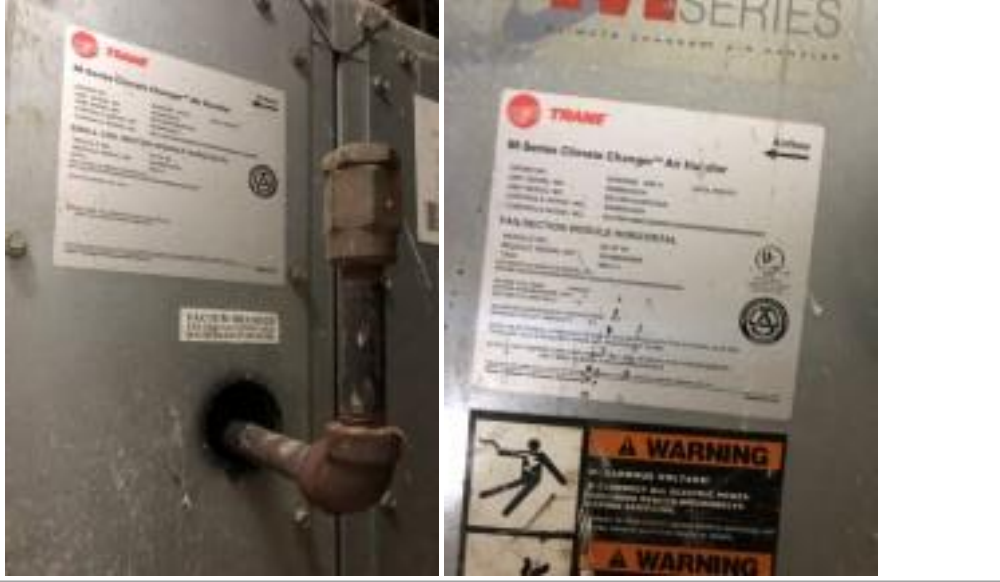
<u>Description</u>	<u>Photos</u>
Unit Tag Info

<u>Unit Tag</u>	<u>MAU-1</u>	<u>Addition comments descriptions</u>
Location	Boiler Room 172	
Serving	Combustion Air Makeup for 172 Boiler Room	
Config/Style	100% OA Steam heating only with coil bypass	
Mfr.	Trane	
Model #	MCCB014UA0C0UA	
Serial #	K04M654)2A	
Age (years)		
System CFM	7,300	
Max OA CFM	7,300	
V/Hz/Ph	460 3-Phase	
SF Qty/HP	5 HP with BX 46 Belt	Access to motor and belt on back wall side of suspended unit with no ladder setup possible. Must climb upon condensate pumps, cond. Tank and hand valve wheel to access
SF VFD Data	NA	
RF Qty/HP	NA	
RF VFD Data		
Filter Data (Size Quantity)	(4) 16 x 20 x 2, (4) 16 x 25 x 2	
Filter Status	Last changed 10-18-21 and very dirty/plugged	
Controls Type	DDC BAS	
Controls Mfr.	Being converted from JCI to ALC	
Economizer	NA	
Damper Styles	Opposed	
Damper Status	Both ODA and F&B dampers require cleaning, adjustment, and lubrication	Not able to verify OA Actuator as damper is withing ductwork and high up in room. OAD did not appear to close when unit was shut down

Heating Type	Steam with Face & Bypass	
Heating Coil Condition	Could not see but based upon filter condition we would presume coil is in need of cleaning	
Notes:	Service access is unsafe and filters should be changed 4 x per year

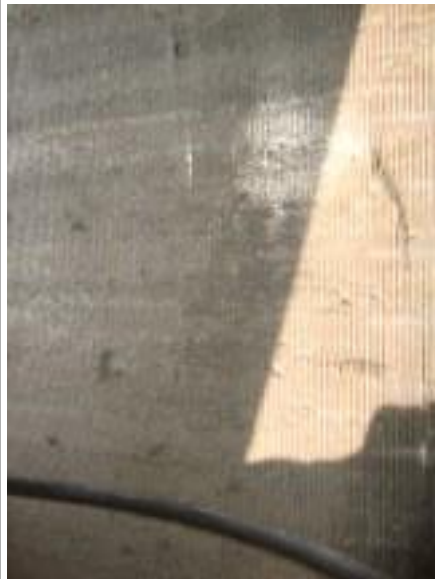
Heating Coil Condition	Dirty	
Cooling Type	Dx cooling, coil fins dirty	
CU Mfr.		
CU Model		
CU Serial		
Drain Pan Status	Crusty pan, Coil section rusted	
Notes:	Aire exchange Mod: ERC-5856C-DW-04-X460, Ser: 073640-0449.	Wheel is dirty, motor ¼ HP UV-Lamps in front of Filter racks, Door switch, Lamp operation is questionable, switch @Panel is off.

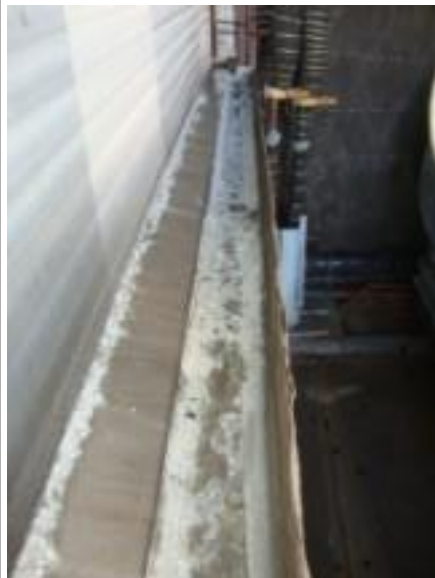
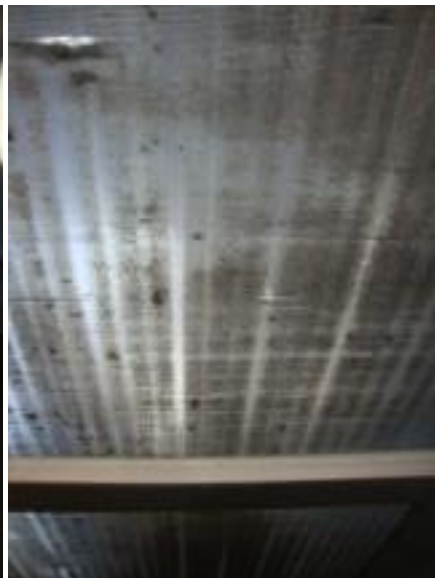
Cooling Coil

<u>Unit Tag</u>	<u>RTU-1</u>	<u>Addition comments descriptions</u>
Location	Roof	Unit controls are really questionable
Serving	Science Classrooms	
Config/Style	100% OA capable with ERW, HW, and DX	
Mfr.	Trane Intellipak	
Model #	SSHFC5045757C7BD901AOCE0G00L00TOY8600	
Serial #	C04L09543	
Age (years)		
System CFM	17,000	
Max OA CFM		
V/Hz/Ph	460 /3-PHASE/60Hz.	
SF Qty/HP	25 Twin (2) 5VX880 Belt: Browning V-Belt Drive Kit	
SF VFD Data	VFD	
EF Qty/HP	7-1/2 TCF NICOTRA 16" B-DWDI RDH K Belt BX78	
EF VFD Data	VFD	
Filter Data (Size Quantity)	(12) 25x25x2 (4) 16x25x2 O.A. Filters are filthy, wheel is dirty	10-7-21 Change
Filter Status	Filter change required, dirty	
Controls Type	Packaged	
Controls Mfr.	JCI-ALC-BAS	
Economizer	Yes	Functionality unknown
CO <sub>2</sub> DCV		
Damper Styles	Parallel	Damper did not close or move when powered unit down.
Damper Status	Operation unknown, seals falling off	
Heating Type	Water/Steam

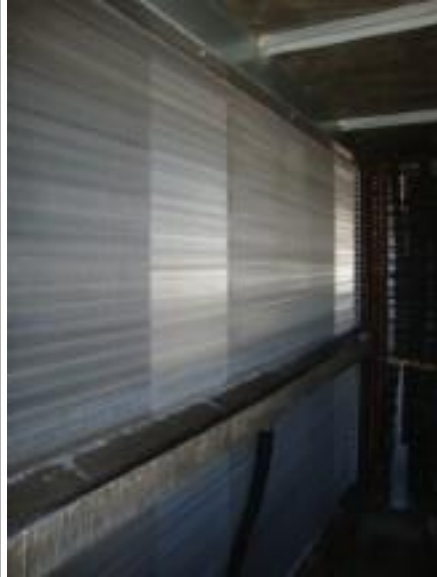
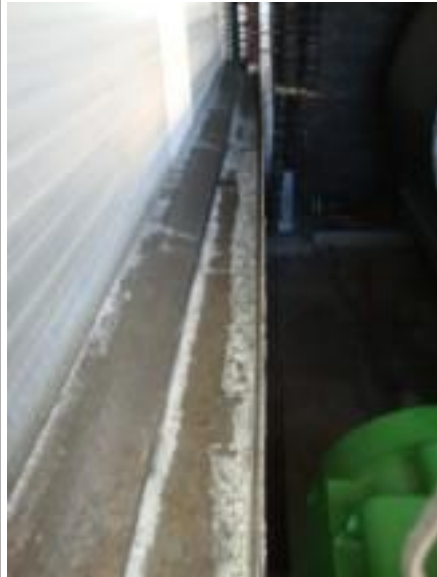
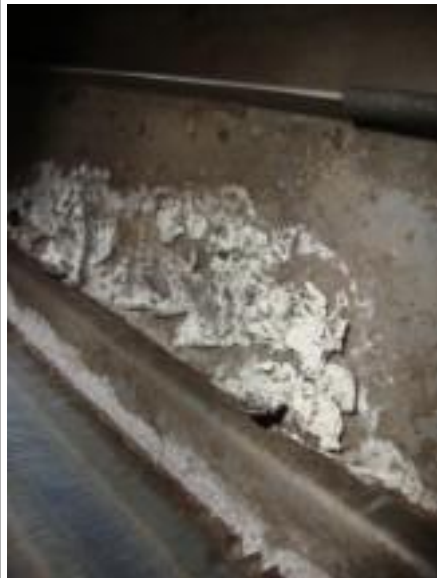
Heating Coil

Cooling Coil

Condensate Pan

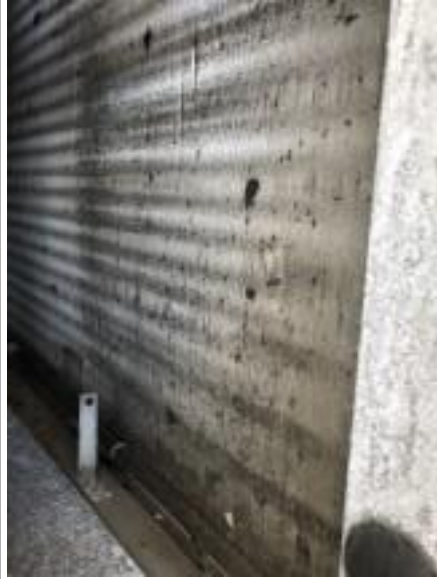
Heating Type	Steam	
Heating Coil Condition	Dirty	
Cooling Type	DX	
Cooling Coil Condition	Dirty	
Drain Pan Status	Needs Cleaning	
Notes:	UV Lights disconnected (6). NOTE: Unit sections between ERW and RF section has 2" gap bypassing OA air into RF section. Unit support may not be level.

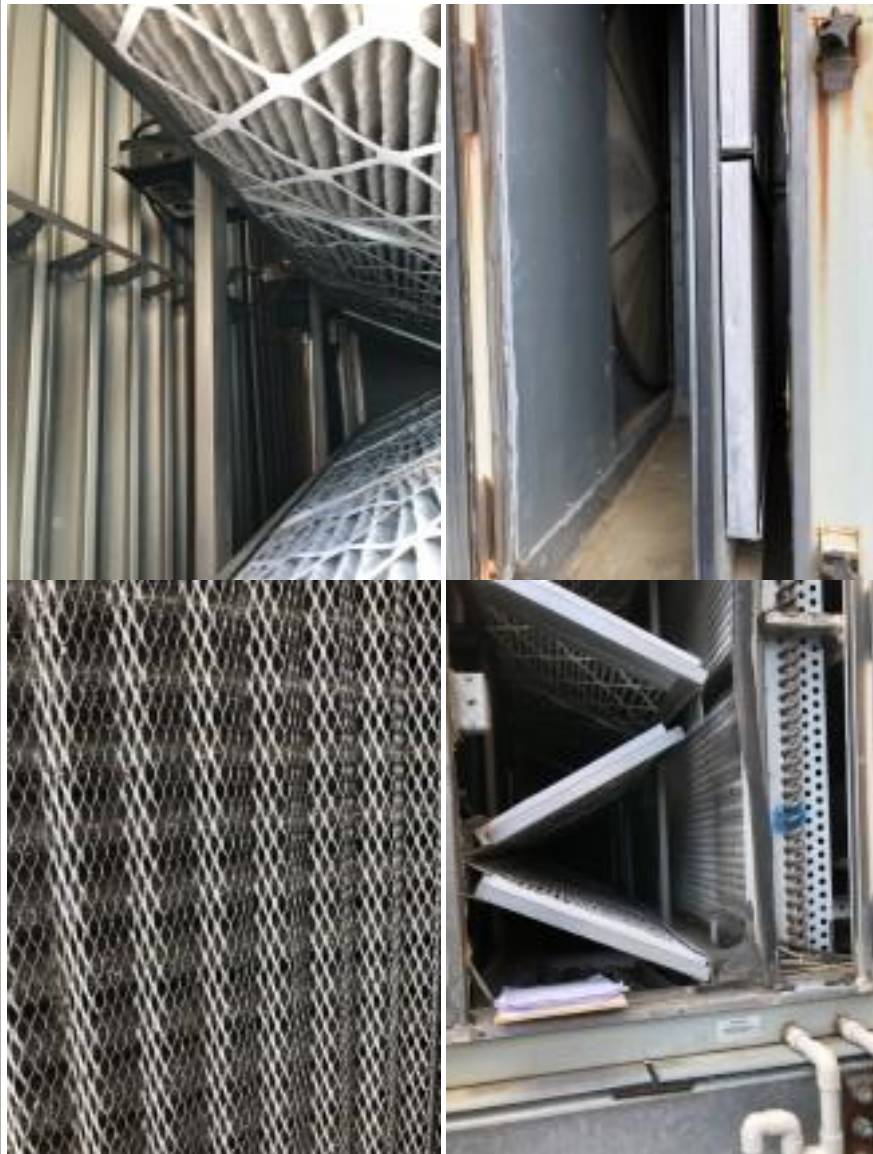
Filters

<u><b>Unit Tag</b></u>	<u><b>RTU-3</b></u>	<u><b>Addition comments descriptions</b></u>
Location	Roof	
Serving	New Science Wing	
Config/Style	100% OA capable with ERW, HW, and DX	
Mfr.	Trane	
Model #	SSHFC6045777C79D9001A0CE0000L00RT0Y8600	
Serial #	C04L09545	
Age (years)		
System CFM	18,500	
Max OA CFM		
V/Hz/Ph	440 – 460 -480	
SF Qty/HP	25-HP Century E-plus 3, 230/460	
SF VFD Data	Trane	
RF Qty/HP	ERW Power Exhaust 3- HP 208-230-460 Building Power Exhaust 15-HP Baldor	(2) BX 96 Belts. Wheel Very Dirty
RF VFD Data	Trane TR1- 18B554 Building PE, TR1 for ERW Exh	
ERW	Wheel Very Dirty 1/6 HP Motor	Belt off ERW
Filter Data (Size Quantity)	OA ERW Pre-Filters Metal Mesh (4) 24 x 24 x 2, (2) 12 x 24 x2 (25) 20 x 22 x 2 not correct size used	Very Dirty  Dirty
Filter Status	Needs Changing	
Controls Type		
Controls Mfr.		
Economizer	Not operational	
CO <sub>2</sub> DCV		
Damper Styles	Opposed	Dirty, frozen
Damper Status	With unit off OAD 30% open with missing end seals	UV Lights hitting dampers

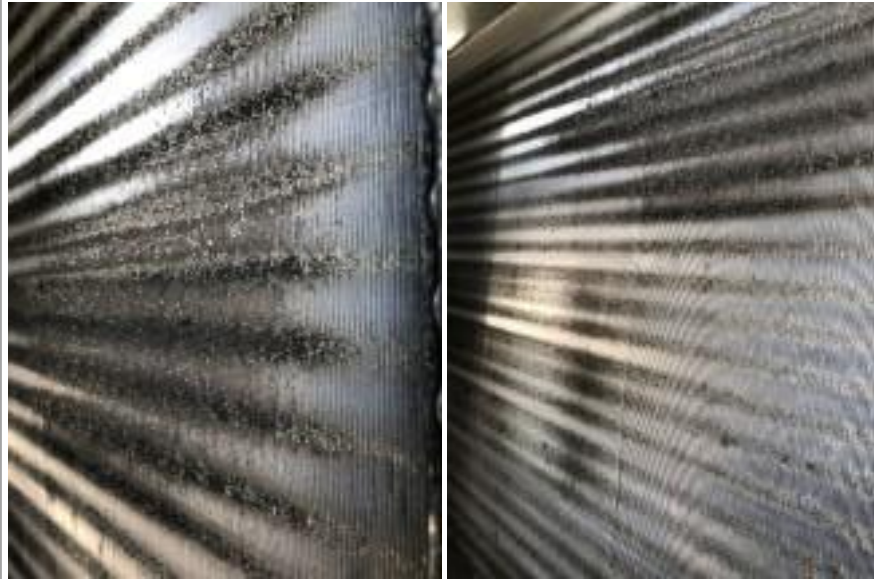
<b><u>Unit Tag</u></b>	<b><u>RTU-4</u></b>	<b><u>Addition comments descriptions</u></b>
Location	Roof	
Serving	Library Media	
Config/Style	SF/RF with mixing dampers, HW w/ bypass, and DX	
Mfr.	Trane	
Model #	SSHFC2545700C3BD700A0CE0G00L00RT)Y8600	
Serial #	C04L)9548	
Age (years)		
System CFM	8,000 (TAB-7,250)	Fan Wheel cups dirty reducing CFM
Max OA CFM		
V/Hz/Ph	46- 3-Phase	
SF Qty/HP	7.5 HP	(1) BX65 Belt
SF VFD Data	Trane TR-1 Series X13170391-38	
RF Qty/HP	NA	
RF VFD Data		
Filter Data (Size Quantity)	(12) – 20 x 20 x12	Last changed 10-7-21
Filter Status	Moderate	
Controls Type		
Controls Mfr.		
Economizer	ODA Dampers end seals separated and damper does not close more than 70%	
CO <sub>2</sub> DCV		
Damper Styles	Opposed	
Damper Status	In need of adjustment and lubrication	Dampers appear to be inoperable
Heating Type	Steam	
Heating Coil Condition	Very dirty	
Cooling Type	DX	
Cooling Coil Condition	Moderate	
CU Serial

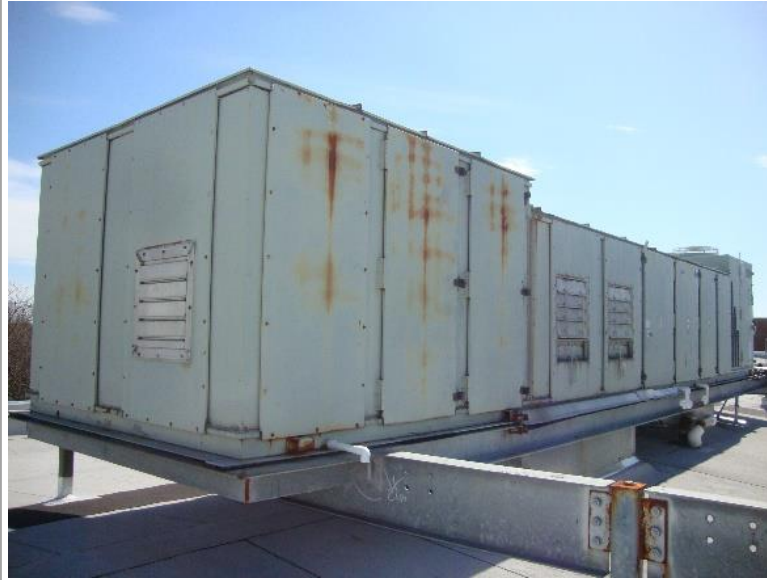
Unit from afar

<b><u>Unit Tag</u></b>	<b><u>RTU-5</u></b>	<b><u>Addition comments descriptions</u></b>
Location	Roof: Roof Pipe penetrations under unit missing insulation.	Fan was and has been off for a long time as filters are clean
Serving	Cafe	
Config/Style	100% OA capable with ERW, HW, and DX	
Mfr.	Trane Intellipak	
Model #	SSHFC3043736C5BD9001ADCE0000L00RTOY8600	
Serial #	C04L09546	
Age (years)		
System CFM	9,050	
Max OA CFM		
V/Hz/Ph	460/60/3	
SF Qty/HP	15 (1) BELT 5VX780	
SF VFD Data	VFD	
EF Qty/HP	3.0 (1) A67	
EF VFD Data	VFD	
Filter Data (Size Quantity)	(16) 20"x22"x2	10-7-21
Filter Status	Like new, factory end plates missing. End plates made up from Stud material, no seals on ends. Wheel O.A. intake filter in poor condition	
Controls Type	Factory	
Controls Mfr.	BMS	
Economizer	Not functional	
CO <sub>2</sub> DCV	-	
Damper Styles	Damper linkage unhooked, UV lamp brackets hitting dampers, seals falling off blades	
Damper Status	Contact with UV lights, Actuator unhooked, no control

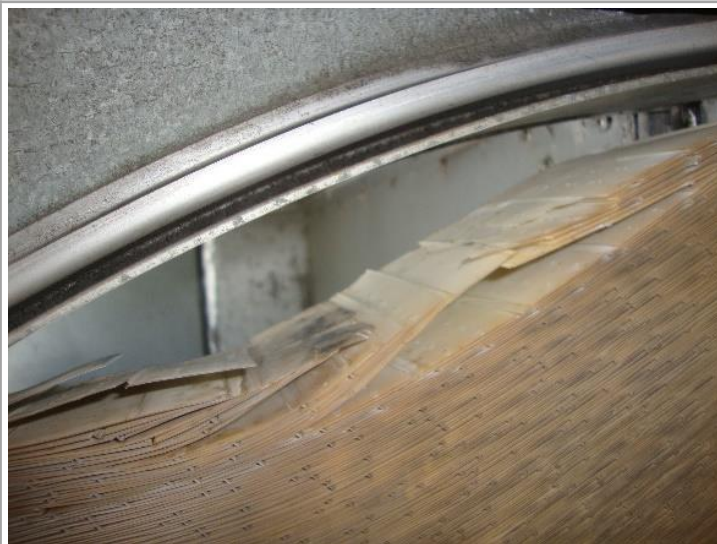
ER Wheel

HX Fan Twin City Size 141 3/4 HP Belt AP59  
Wheel belt loose, wheel falling apart,  
UV lights power panel off, not functional, wires  
inside cabinet

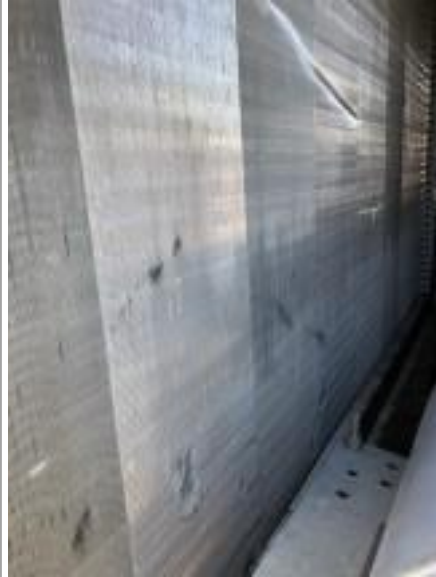
Condensate Pan

<u>Unit Tag</u>	<u>RTU-6</u>	<u>Addition comments descriptions</u>
Location	Roof	3
Serving	Admin Area	
Config/Style	SF/RF with mixing dampers, HW w/ bypass, and DX	
Mfr.	Trane	
Model #	SSHFC3043736C3AD9001A0CE000L00RT0Y8600	
Serial #	CO4L09549	
Age (years)		
System CFM	7825	
Max OA CFM		
V/Hz/Ph	460 3-Phase	
SF Qty/HP	7.5 HP Century 230/460 E-plus 3	BX 70 Belt
SF VFD Data	Trane	
RF Qty/HP	3-HP 208 -230- 460 Baldor Super-E	AP 67 Belt
RF VFD Data	Trane	
Filter Data (Size Quantity)	(16) 20 x 22 x 2	Changed 10-17
Filter Status	Should be changed	
Controls Type		
Controls Mfr.		
Economizer	Damper operation impeded by UV Lights	
CO <sub>2</sub> DCV		
Damper Styles		
Damper Status	Dampers likely not operational with OA Damper 25% open	
Heating Type	Steam	
Heating Coil Condition	Very dirty	
Cooling Type	DX	
Cooling Coil Condition	Dirty	
CU Mfr.		
CU Model		
CU Serial		
Drain Pan Status	Needs cleaning with dried scale on surface

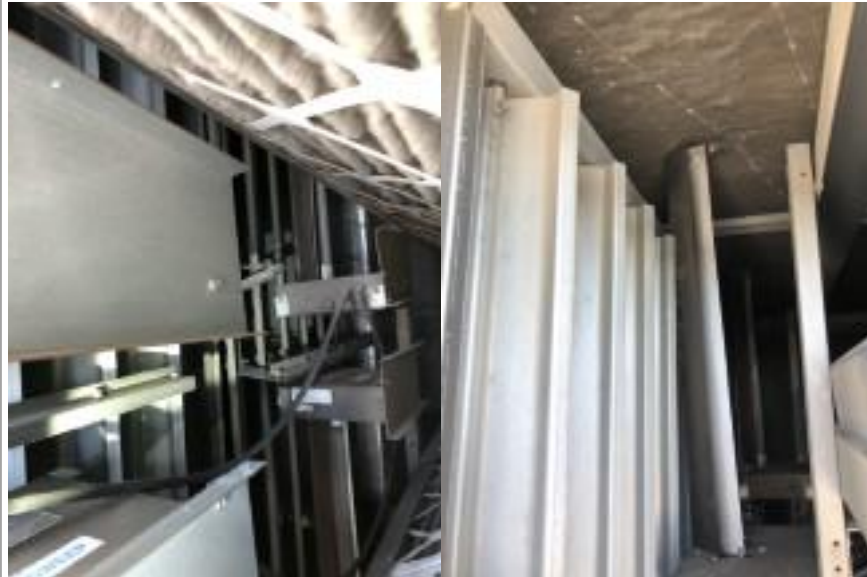
Control Dampers

Notes:	UV Lights disconnected and hitting RA Damper Blade. OA SP Pressure pickup device failed with sensing tube disconnected

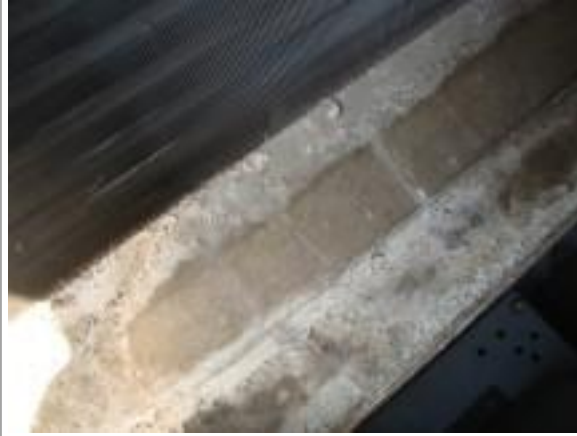
Condensate Pan

<u>Unit Tag</u>	<u>RTU-7</u>	<u>Addition comments descriptions</u>
Location	Roof	
Serving	Classrooms	
Config/Style	SF/RF with mixing dampers, HW w/ bypass, and DX	
Mfr.	Trane Intellipak	
Model #	SSHFC4045745C49D9001ADCE0000L00RTOY8600	
Serial #	C04L09550	
Age (years)		
System CFM	11,000	
Max OA CFM		
V/Hz/Ph	460/60/3	
SF Qty/HP	(1) 10.0	
SF VFD Data	VFD	
RF Qty/HP	(1) 5.0 (1) BX-77 (1) BX94	
RF VFD Data	VFD	
Filter Data (Size Quantity)	(12) 24"X25"X2" (4) 16"X25"X2"	
Filter Status	Dirty	10/8/21
Controls Type	Factory	
Controls Mfr.	BAS	
Economizer	yes	
CO <sub>2</sub> DCV		
Damper Styles	Factory, dampers did not modulate when unit was turned off	
Damper Status	End seal falling off	
Heating Type	Steam. Insulation under unit is in need of repair	
Heating Coil Condition	Dirty	
Cooling Type	DX	
Cooling Coil Condition	Dirty	
CU Mfr.		
CU Model		
CU Serial		
Drain Pan Status	Crusty	
Notes:	UV Lights, power off, wires inside cabinet, lights not working?

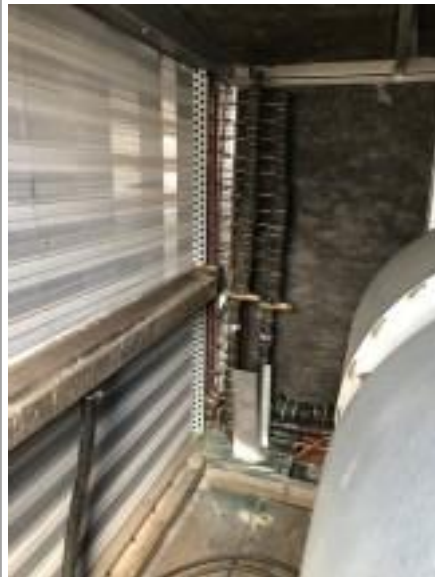
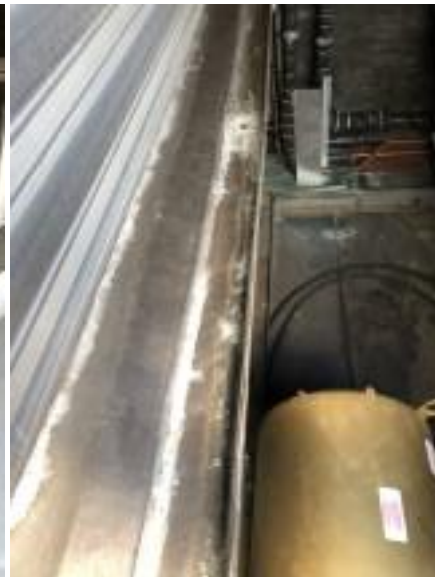
Heating Type	Steam	
Heating Coil Condition	Very Dirty	
Cooling Type	DX	
Cooling Coil Condition	Needs Cleaning	
CU Mfr.		
CU Model		
CU Serial

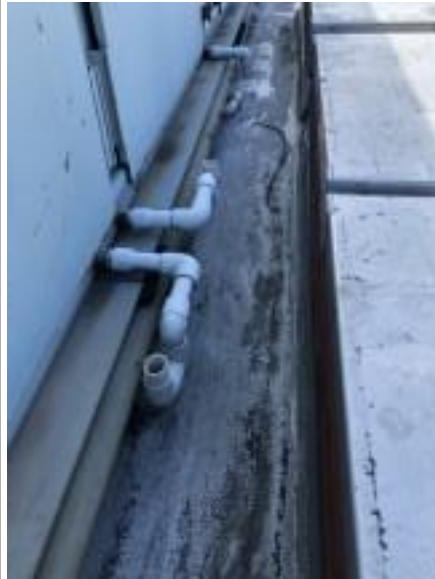
Condensate Pan

Drain Pan Status	Dirty with Traps in need of replacement. One U-bend broken off	
Notes:	All UV Lights unplugged and inoperative. System Static Pressure housing broken with air tube dangling.

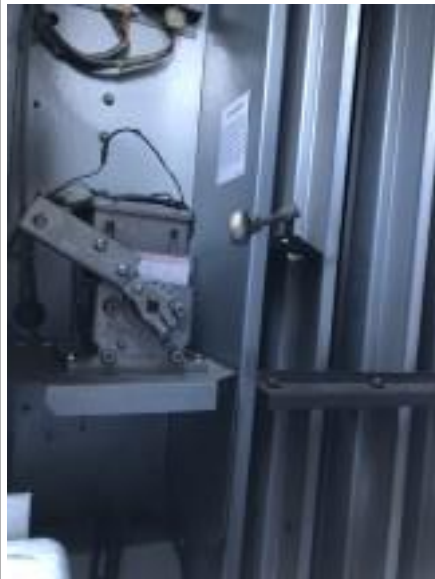
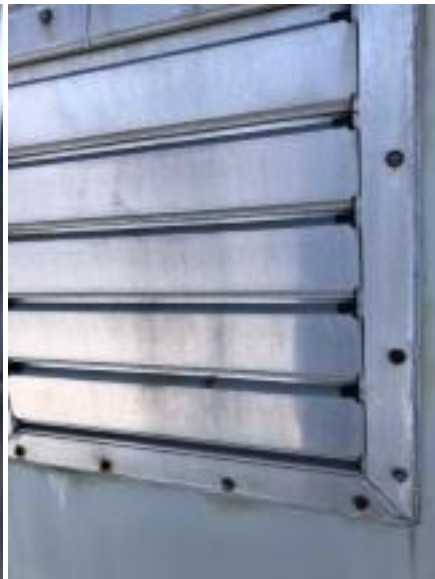
Control Dampers

<b><u>Unit Tag</u></b>	<b><u>RTU-9</u></b>	<b><u>Addition comments descriptions</u></b>
Location	Roof	
Serving	Auditorium	
Config/Style	100% OA capable with ERW, Steam, and DX	
Mfr.	Trane	
Model #	SSHFC4044756C5AD9001A0CE0000L00RTOY8600	
Serial #	C04L09547	
Age (years)		
System CFM	12,000	
Max OA CFM		
V/Hz/Ph	460 3-Phase	
SF Qty/HP	15-HP Baldor Super-E with (2) BX89 Belts	Belts mismatch with one very loose
SF VFD Data		
RF Qty/HP	5-HP ERW exhaust with AP 65 Belt 208/230 – 460 3-P 7.5 HP Century E-Plus 3 Building Power Exhaust with BX86 Belt	
RF VFD Data	Trane TR-200	
ERW Wheel	1/6 HP 200/400 VAC	Wheel very Dirty along with OA Pre-Filters Plugged
Filter Data (Size Quantity)	(3) OA Pre Metal Mesh 24 x 12 x2 (2) 24 x 24 x 2 (12) 25 x 25 x 2, (40) 16 x 25 x2	Plugged Very Dirty Dirty
Filter Status		
Controls Type		
Controls Mfr.	Trane / JCI	
Economizer	Non-Operational	
CO <sub>2</sub> DCV		
Damper Styles	Opposed	
Damper Status	Actuator Disconnected, need Clean and Lubrication	Inoperative UV Lights preventing damper free movement
