# **HOLDEN ELEMENTARY SCHOOL**

## **ASSESSMENT REPORT**

**November 5, 2019**

## **HOLDEN ELEMENTARY SCHOOL BUILDING ASSESSMENT**

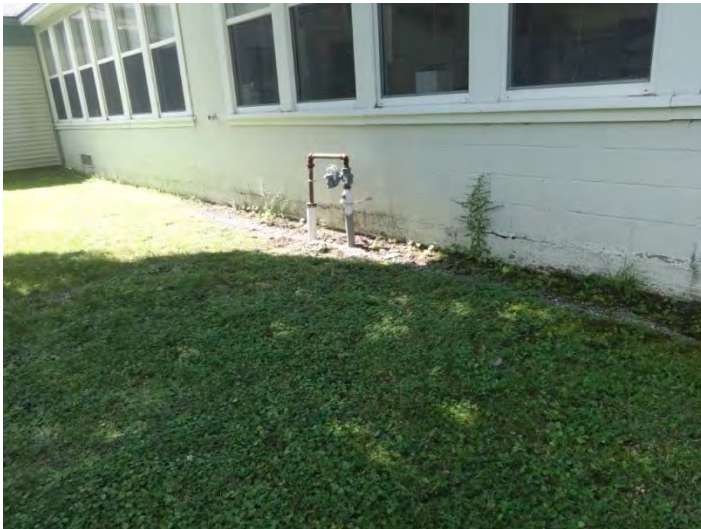
Exterior CMU

The older wing (1955) has CMU (Concrete Masonry Unit) wall construction. The 1990 additions are wood wall construction, with the gymnasium having a glulam arch system with wood end walls. The 1990 additions are wood wall construction. The exterior walls of the 1990 additions have vinyl siding and metal clad trim, in good condition. The original 1955 building has painted CMU block in fair condition. We expect the insulation within the walls to vary given the different ages of construction. As the norm, whenever an older building has outdated windows or the exterior eliminated, the void in the wall is framed in, insulated, sheathed, and sided with present day materials.

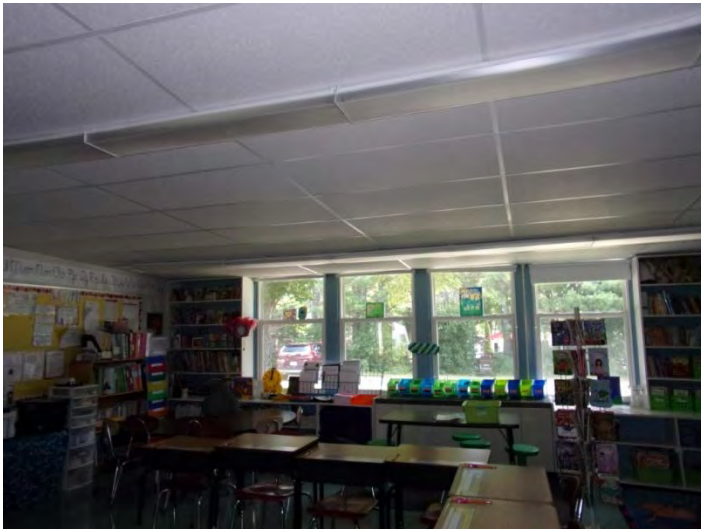
Classroom Lighting and Windows

The windows located in the original 1955 classrooms are double hung vinyl windows with estimated age of installation in the 90s. Some windows open with difficulty and do not stay open in some cases. The 1990 additions have wood casement windows with stained wood trim. Some of the windows cranking system did not work. There are some windows with condensation between the panes indicating seal failure. Overall the windows are in poor to fair condition.

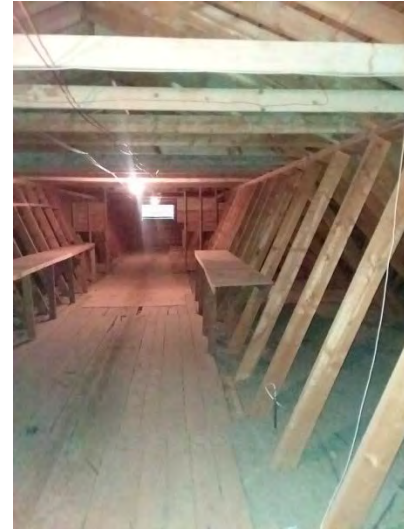
Attic

The building structure overall appears sound, with no structural problems observed. In the original 1955 building at the east end the trusses have been covered with plywood and bolted in place. There is no record of this work.

**Action:** Recommend an engineering review to identify current conditions and any other deficiencies. **Priority:** 3 \$ 3,000
