1MWO25001-RPT-01

PRELIMINARY Report – Structural and Fire Protection Concerns at Jenkins Middle School, Colorado Springs, CO

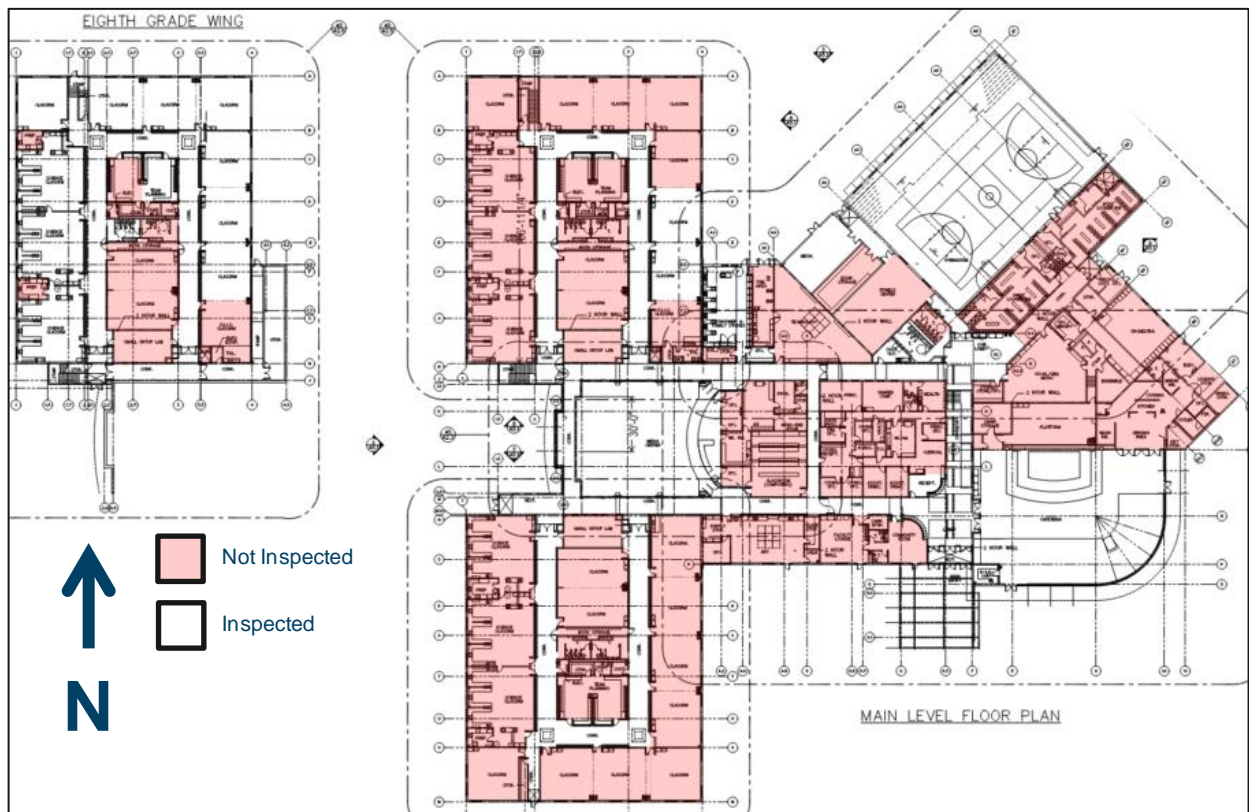
Figure 4.2: Areas of JMS Inspected for Structural Purposes (January 11, 2025)

The areas that were not inspected on January 11, 2025 are the shaded areas indicated within Figure 4.2 below.

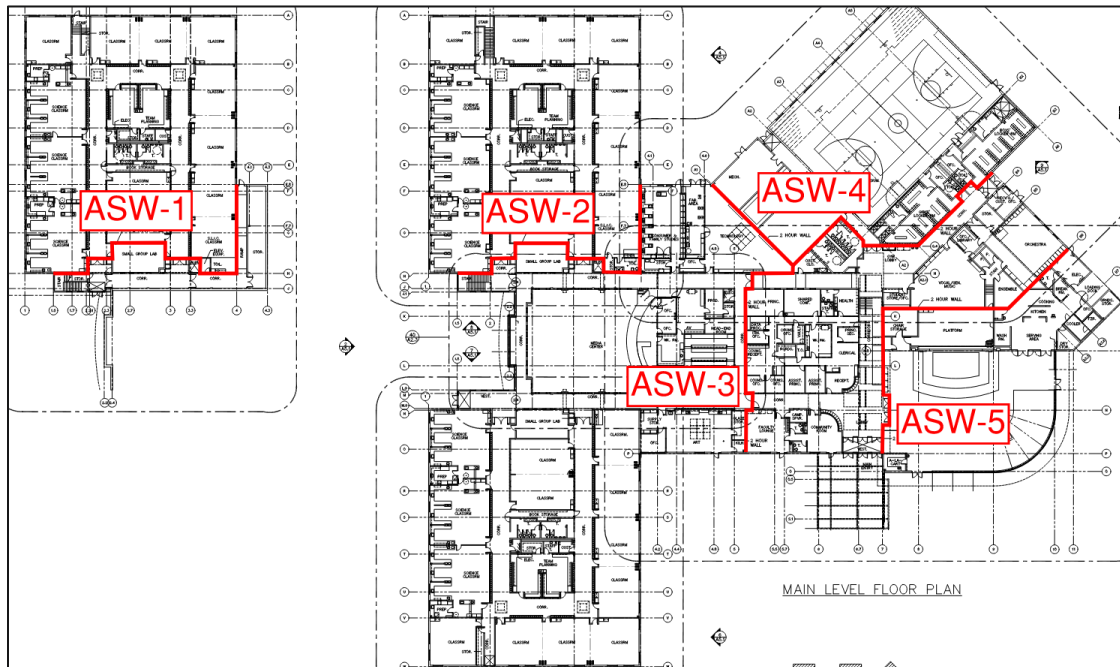
Figure 5.6. Area Separation Walls within JMS

The JMS is separated by five (5) area separation walls, each with a 2-hour fire-resistance-rating, according to the Construction Documents dated January 28, 1998. These area separation walls are shown in Figure 5.6.
