## FACILITY NEEDS ASSESSMENT

### ESSEX ELEMENTARY SCHOOL AND MANCHESTER ESSEX MIDDLE-HIGH SCHOOL

#### Manchester Essex Regional School District

DRAFT REPORT: January 27, 2023  
H&A JN 2217.01

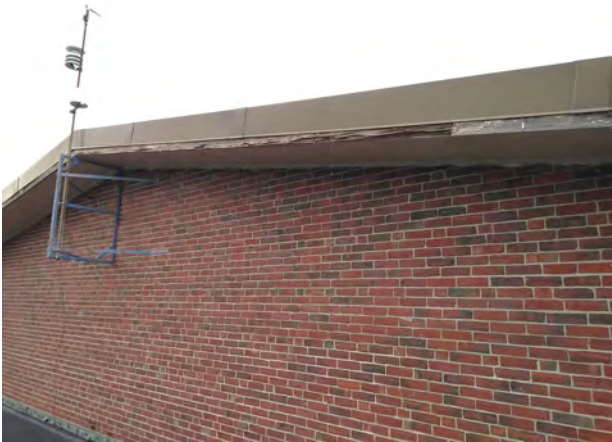
13. The fascia is rotted at the Cafetorium.

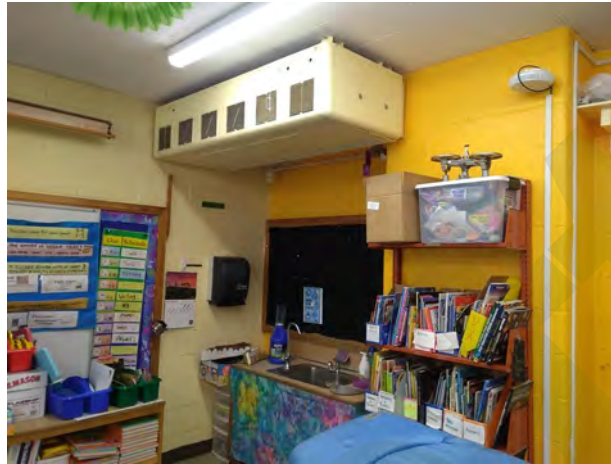
20. Classrooms have outdated and inefficient unit ventilators.
