1MWO25001-RPT-01

Final Report – Structural and Fire Protection Concerns at Jenkins Middle School, Colorado Springs, CO

3/10/2025

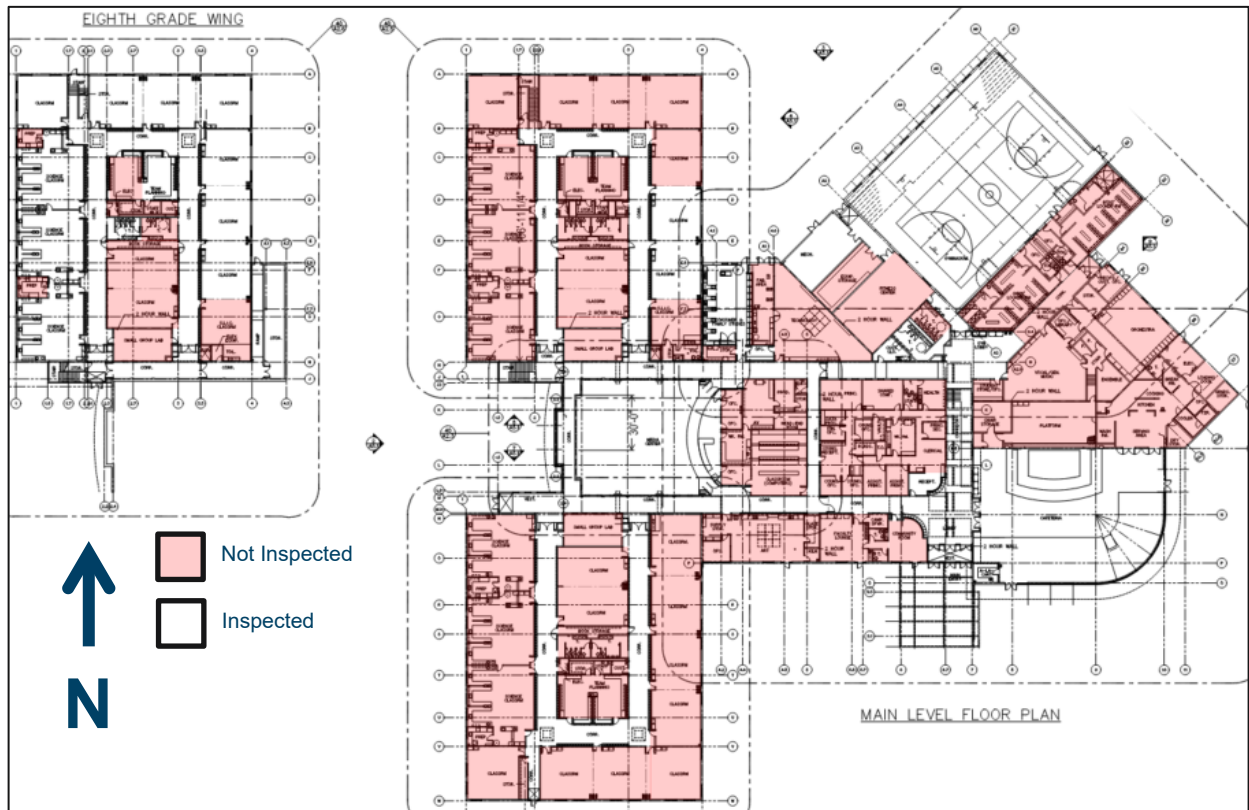
Figure 4.2: Areas of JMS Inspected for Structural Purposes (January 11, 2025)

The areas that were not inspected on January 11, 2025 are the shaded areas indicated within Figure 4.2 below.

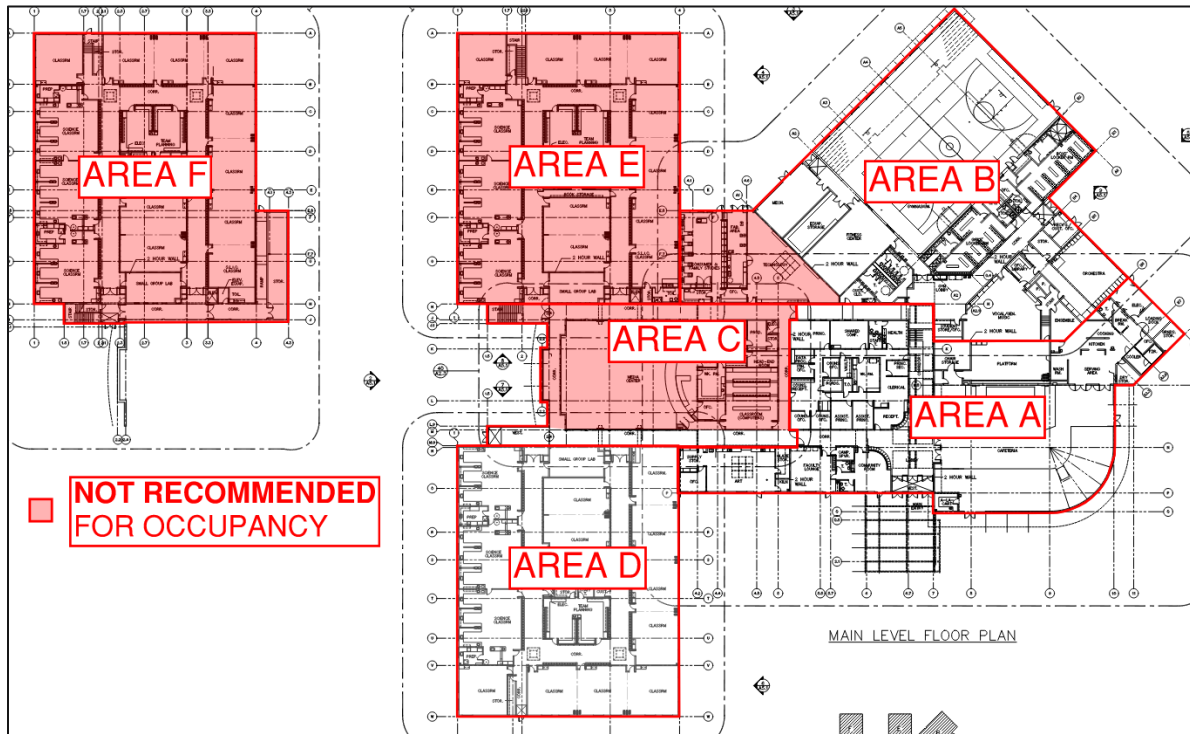
Figure 5.5. Areas Not Recommended for Occupancy by Structural Assessment

Recognizing the decisions of the structural assessment, discussed in Section 6.1 of this report, Areas C, E, F, and a portion of B were determined to not be recommended for occupancy. As such, these areas were not intensively analyzed from a fire protection perspective. However, a summary of the findings based on cursory obseError! Reference source not found. for clarity.

1. **Walls** – Walls (both CMU and gypsum assemblies) had significant cracking below and above the ceiling. In some corridor walls, where CMU walls transition to drywall above the ceiling, significant gaps are identified between the transitions due to differential movement of the foundation (primary support for the lower wall sections) and the roof (primary support for the upper wall sections).

4. See Figure 5.5 of this report for an annotated drawing of which areas of the site are recommended to not be occupied.

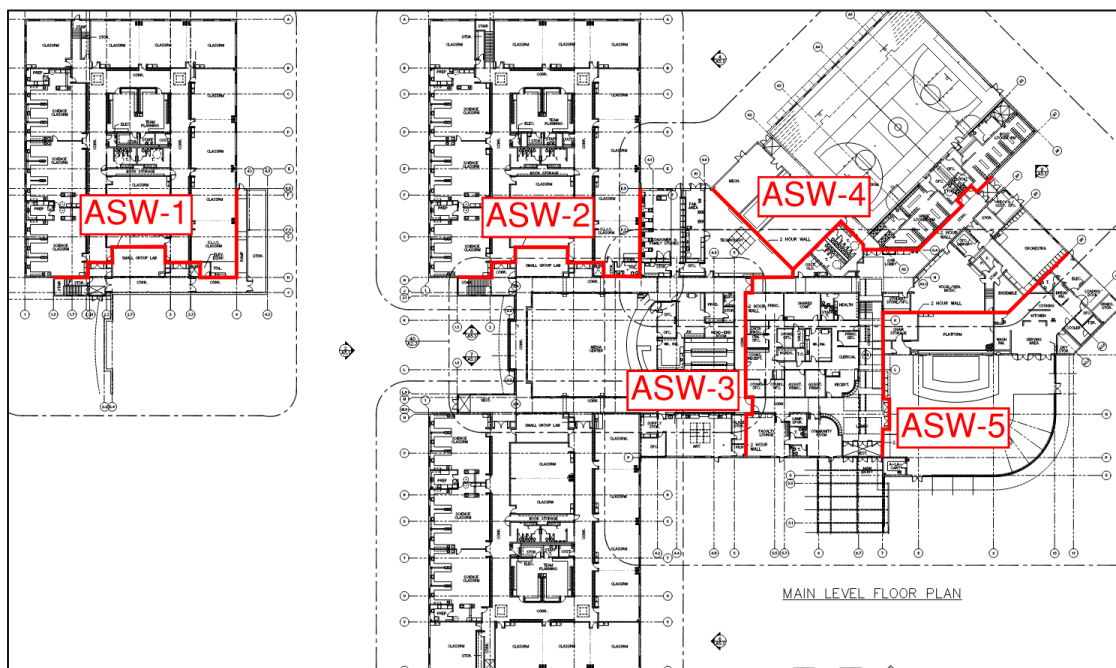
Figure 5.6. Area Separation Walls within JMS

The JMS is separated by five (5) area separation walls, each with a 2-hour fire-resistance-rating, according to the Construction Documents dated January 28, 1998. These area separation walls are shown in Figure 5.6.
