## **Re: Statement of Interest - Medford High School - Core Program**

# Report of Findings: Focused Facility Condition Review

Medford High School

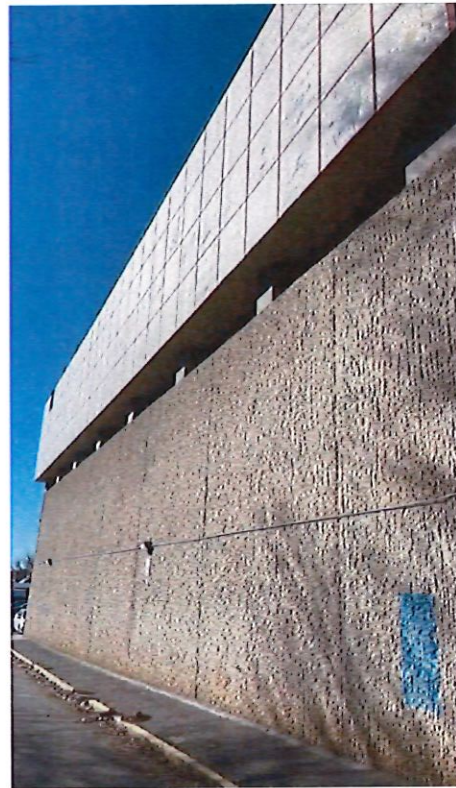
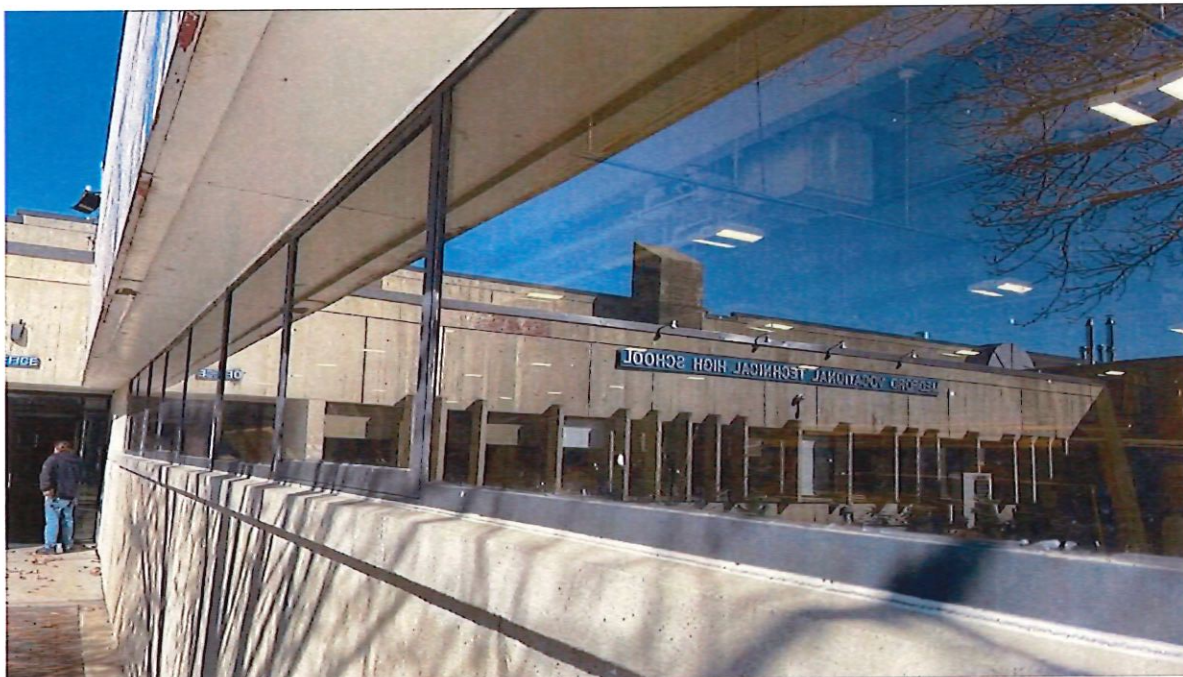
At the auditorium, pool and select areas of the Vocational School, the exterior assembly includes semi-opaque fiberglass panels which allow daylight into the interior of the building. These panels were installed during the original building construction and a 2007 study completed by Drummey Rosane Anderson, Inc., with assistance from Simpson Gumpertz & Heger, identified the panels to be "in very poor condition, and need replacement at this time"<sup>4</sup>. They are well beyond useful life expectancy.

Door openings are enclosed by a mixture of metal door and doorframe assemblies and are sealed with exterior caulking of several types. Most of the openings in the building exterior were constructed when the building was originally built in 1971.

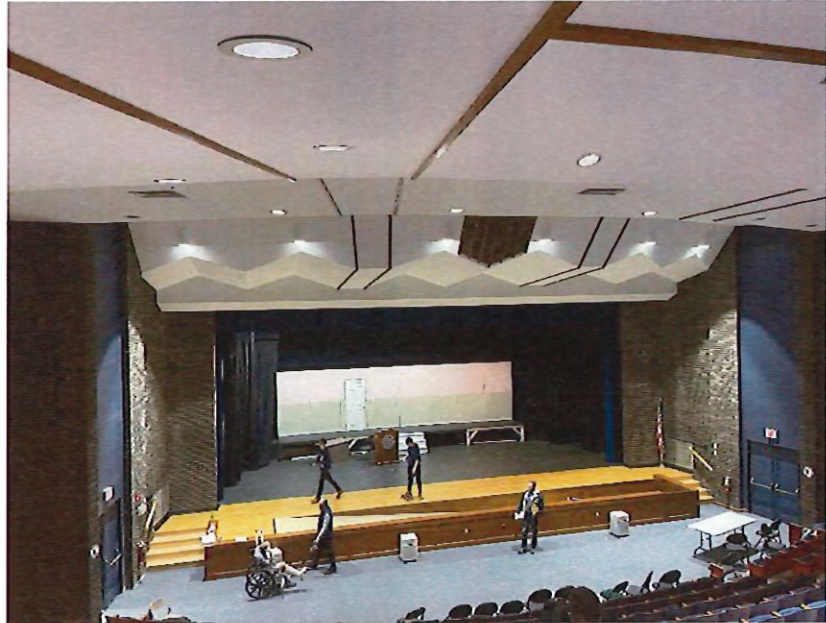
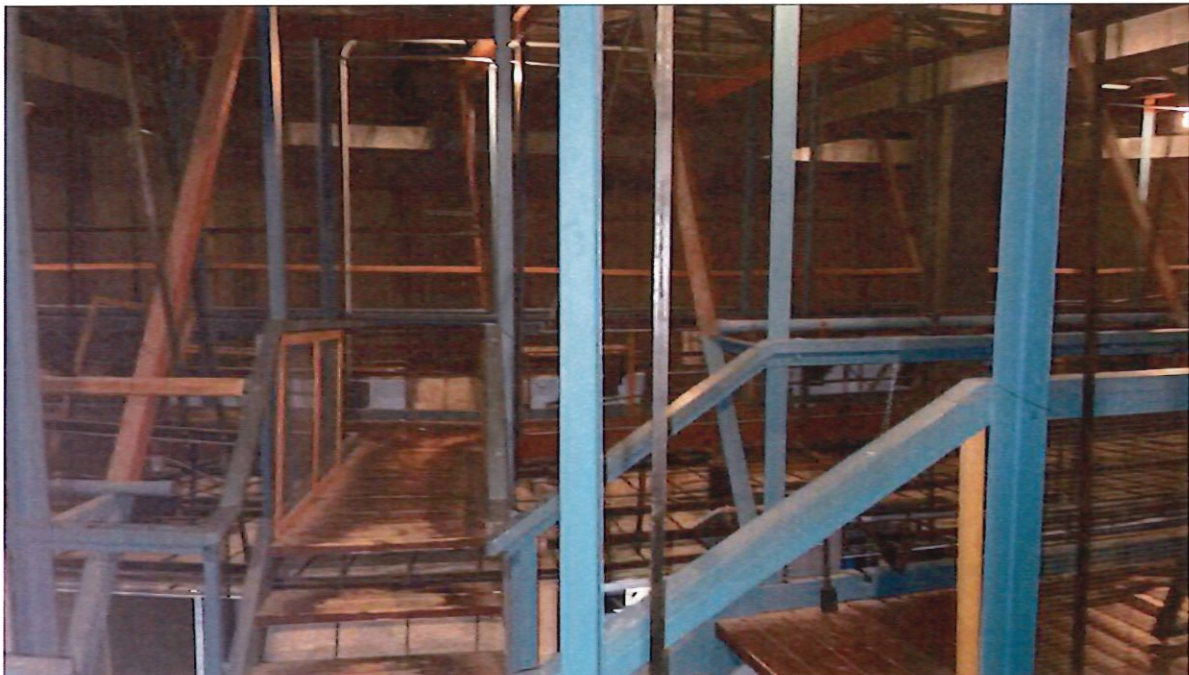
The main auditorium, located adjacent to the main lobby consists of wall elevations of polished brick and painted concrete. The walls were observed to be in well maintained condition. The main auditorium floor consists of a broadloom carpet assembly which was installed as an improvement to the original flooring. The carpet appears to have been installed

within the last 10-20 years. The walls consist of painted concrete and CMU with fabric wrapped acoustical panels. The timing of the installation appears to be within the last 10-20 years. The ceiling assembly consists of a finished GWB suspended ceiling which sits below a composite steel and wood framed catwalk assembly.

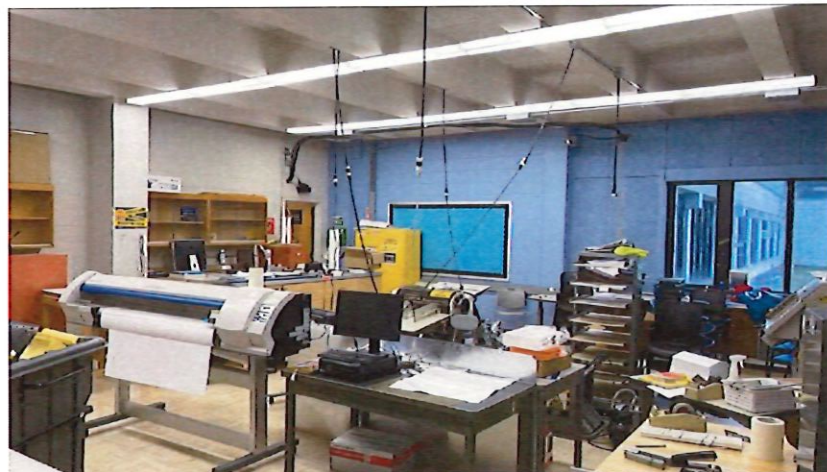
Univents (Unit Ventilators) were observed in each classroom and function as the primary ventilation. The ventilators were installed during the original school construction and were observed to be in poor condition, and well beyond useful life expectancy. In most of the classrooms the exhaust did not appear to function. The ventilators are of particular concern, as they are not only a significant factor of the buildings' HVAC performance, but also are part of the exterior opening assembly. Both interior and exterior sealants and caulking were in poor and most cases failing condition and in need of immediate abatement, improvement and/or replacement. It should be noted that the staff has found it exceedingly difficult to find parts for these obsolete units.

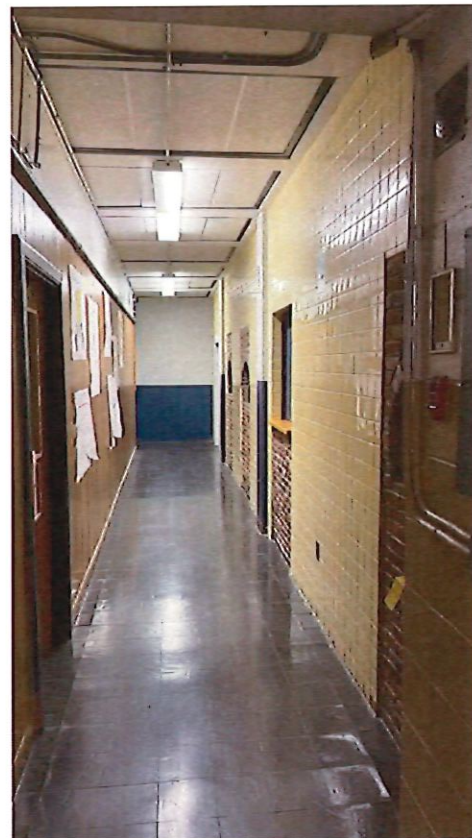
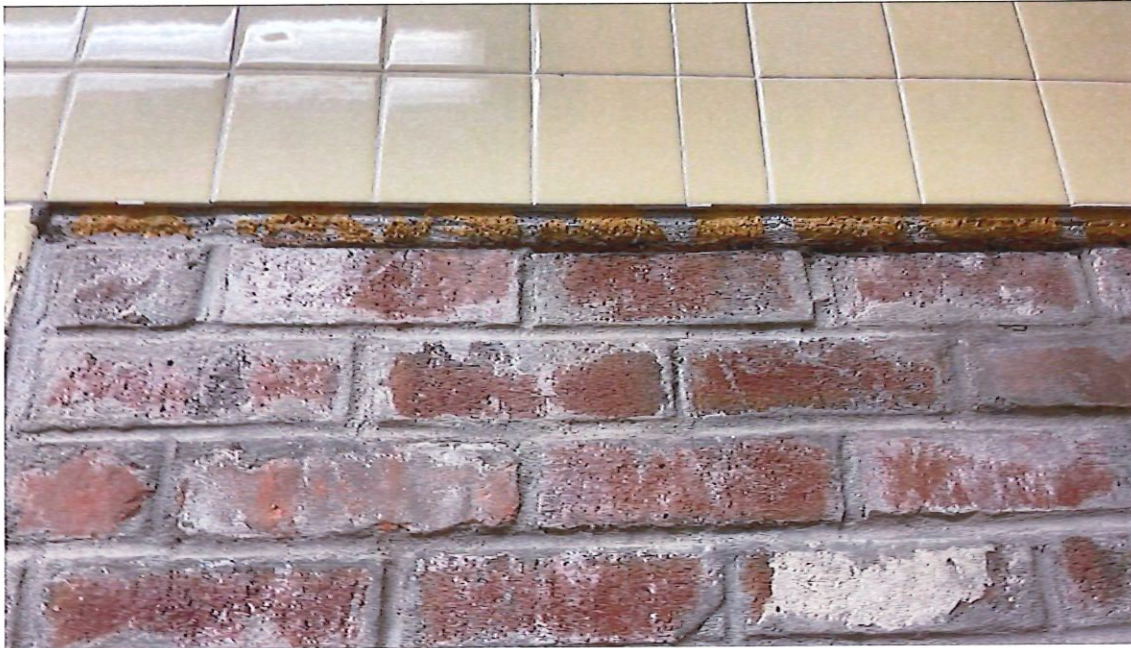
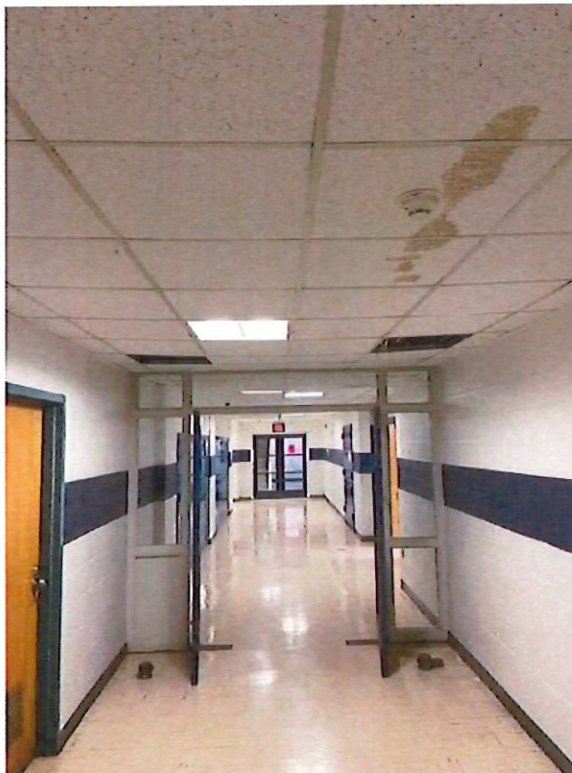
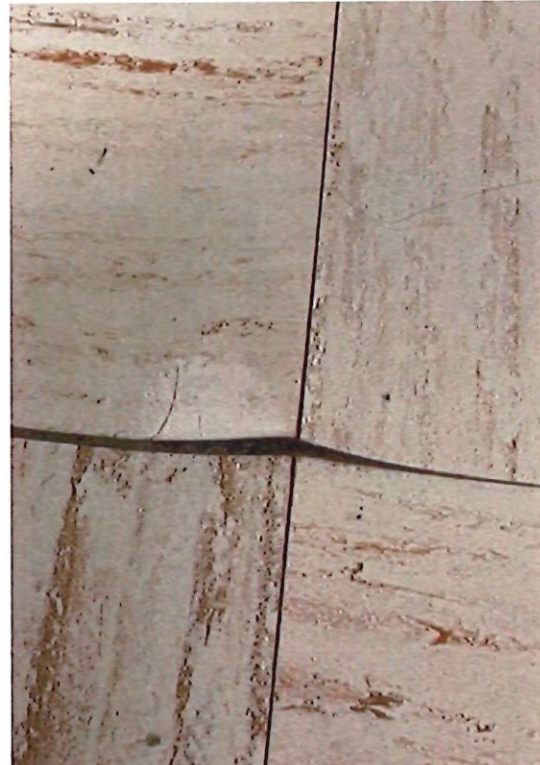
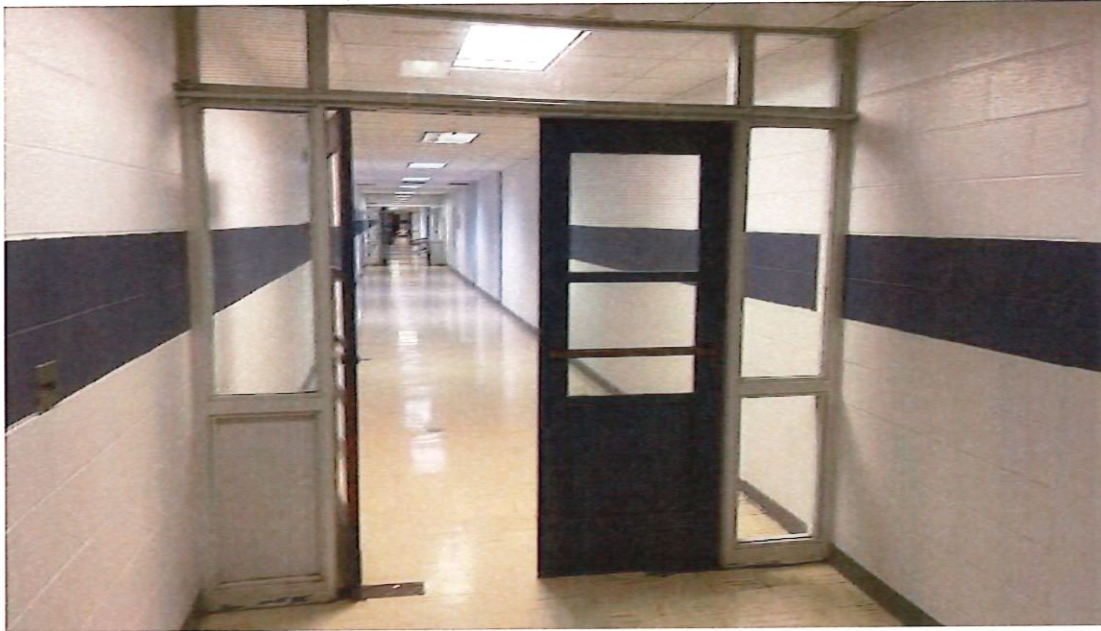
Several corridors within the high school were inspected as part of the survey. Wall assemblies were observed to be painted CMU and concrete, some of which had ceramic tile and wood panel finishes. Interior sealant joints were observed where painted CMU and concrete walls abut. **Flooring observed in all locations consisted of 9" x 9" flooring tiles installed during the original building construction.** A variety of acoustic suspended ceiling tile assemblies were observed. Please refer to the EH&E Report (Appendix A) for more information on paint, sealants and caulking materials present in this location as it should be assumed that hazardous materials are present.

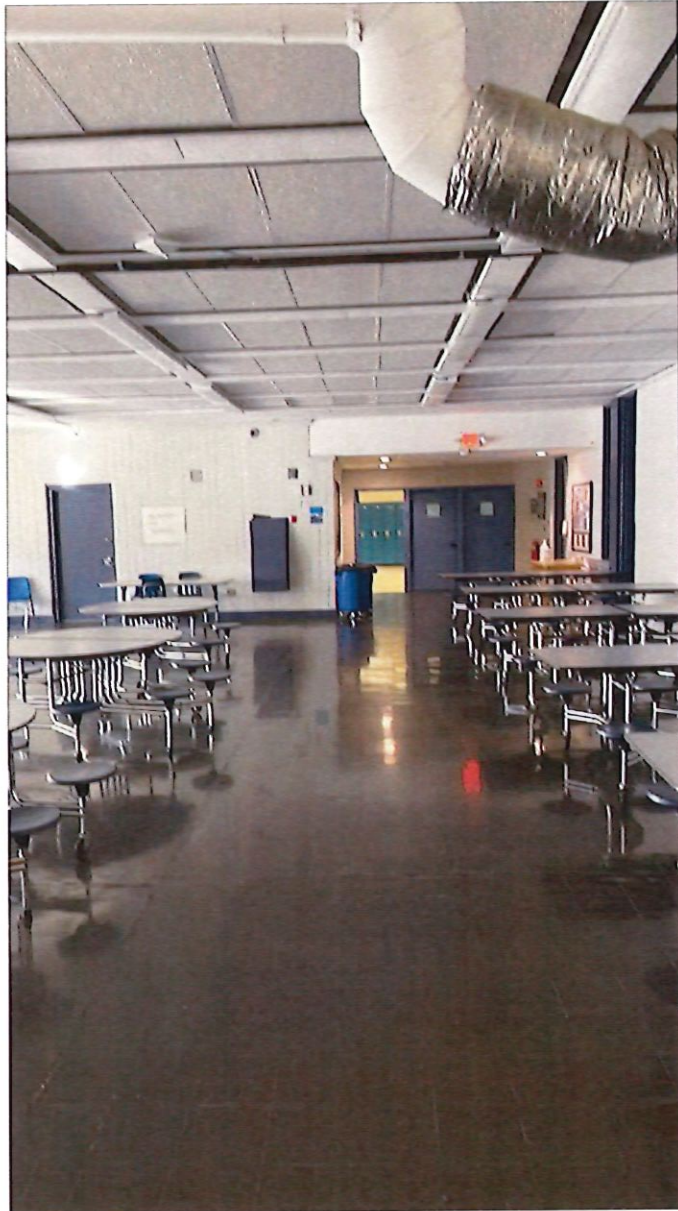
Wall assemblies within the cafeteria were observed to be painted CMU and concrete walls, some of which had ceramic tile and wood panel finishes. Interior sealant joints were observed where painted CMU and concrete walls abut. Flooring observed in all locations were 9" x 9" flooring tiles which were installed during the original building construction. The cafeteria includes a suspended acoustical ceiling assembly.

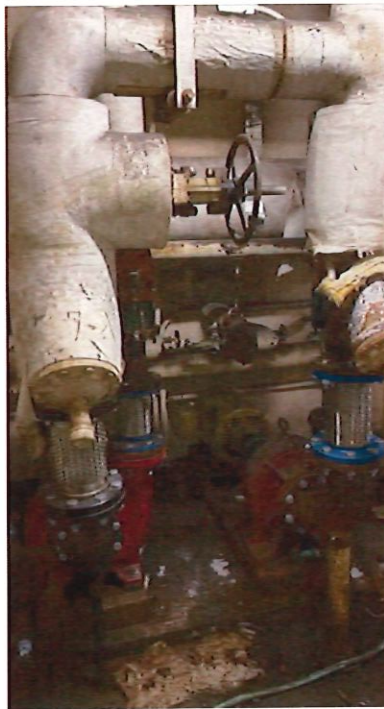
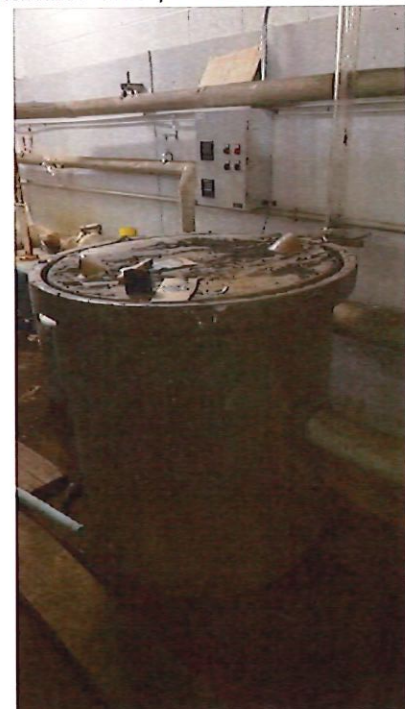
On each day during the field inspection period significant amounts of water had pooled on the floor. It was reported that the origin of the water was a combination of equipment leaks and ground water seepage. **This standing water is of particular concern. Its origin is possibly related to hydraulic pressure from below the slab system. The under-slab drainage system should be assessed to confirm whether pockets of water or artesian wells are present below the building and are a contributing factor to the standing water in the main mechanical room.** Key pieces of equipment within the room included heat exchangers for buildings A, B and D; two handler units, domestic hot water

decommissioned air tanks and pumps, boilers, electric motor control panels and transformers, the main chemical waste tank, the sprinkler standpipe servicing the new science wing on the third floor, and an obsolete pneumatic control system. All but the new domestic water equipment was observed to be installed at the time the Building was constructed, in poor condition and beyond useful life expectancy.

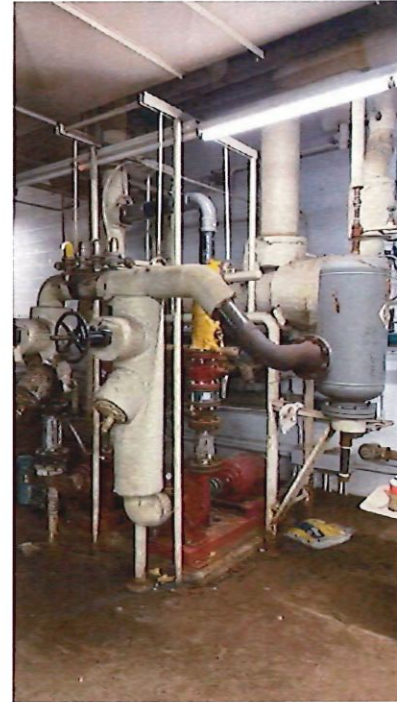
The interior, or core area of each quadrant originally had cooling but no longer functions, due to lack of the central chiller being operational. The chiller, which was a steam absorption type, has failed in recent years and has not been repaired or replaced.

**Reported deficiencies include dirty ductwork and clogged reheat coils which are contributing to poor indoor air quality. The classroom spaces also overheat in the warmer weather due to lack of air conditioning.**

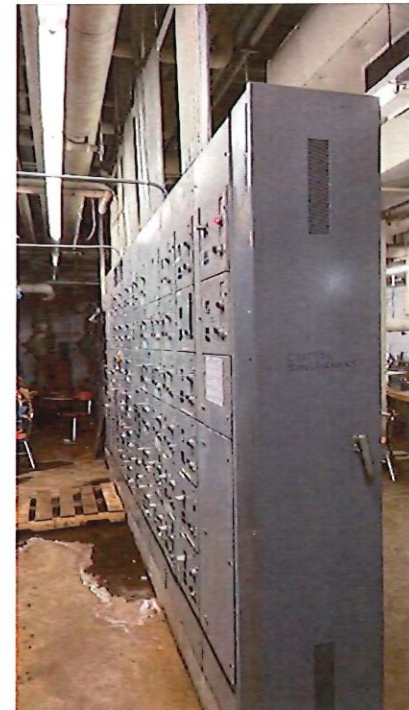
The main electrical room located in building D houses the electrical equipment servicing the building. The power distribution system including panels and feeders were observed to be installed during original construction of the building, beyond useful life expectancy and in poor condition.

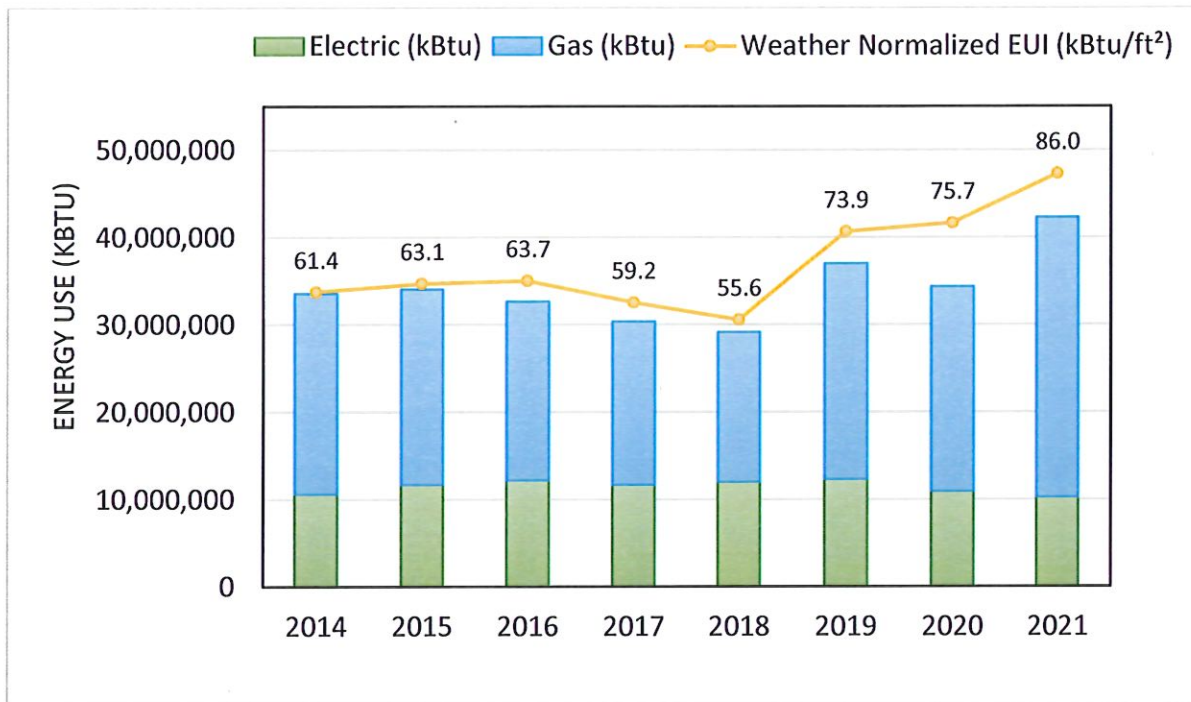
**Figure 1** Energy Use and Weather Normalized Energy Use Intensity (EUI) for Medford High School from 2014 to 2021<sup>4</sup>

from 4.5 to 139.7 kBtu/ft<sup>2</sup>, with an average of 52.7 kBtu/ft<sup>2</sup> (N = 137).<sup>3</sup> In 2020, the Building was less efficient than 82% of Boston K-12 schools. In the past 3 years, the Building's EUI has increased from 55.6 kBtu/ft<sup>2</sup> in 2018 to 86.0 kBtu/ft<sup>2</sup> in 2021, possibly due to increased ventilation demands in response to the COVID-19 pandemic. The trends in Building EUI indicate that energy use is increasing, and the Building is less energy efficient than the national and regional averages.
