BUCKEYE LOCAL SCHOOL DISTRICT Building Assessment & Condition Review

Building Assessment & Condition Review March 2025

CPL Architects and Engineers, Inc 111 Front Street Berea, Ohio 44017

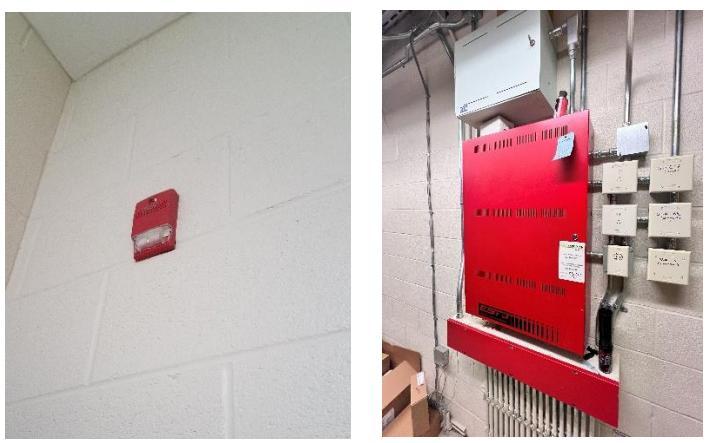
Typical Fire Alarm

Routinely test fire alarm system. Replace any defective or damaged devices.

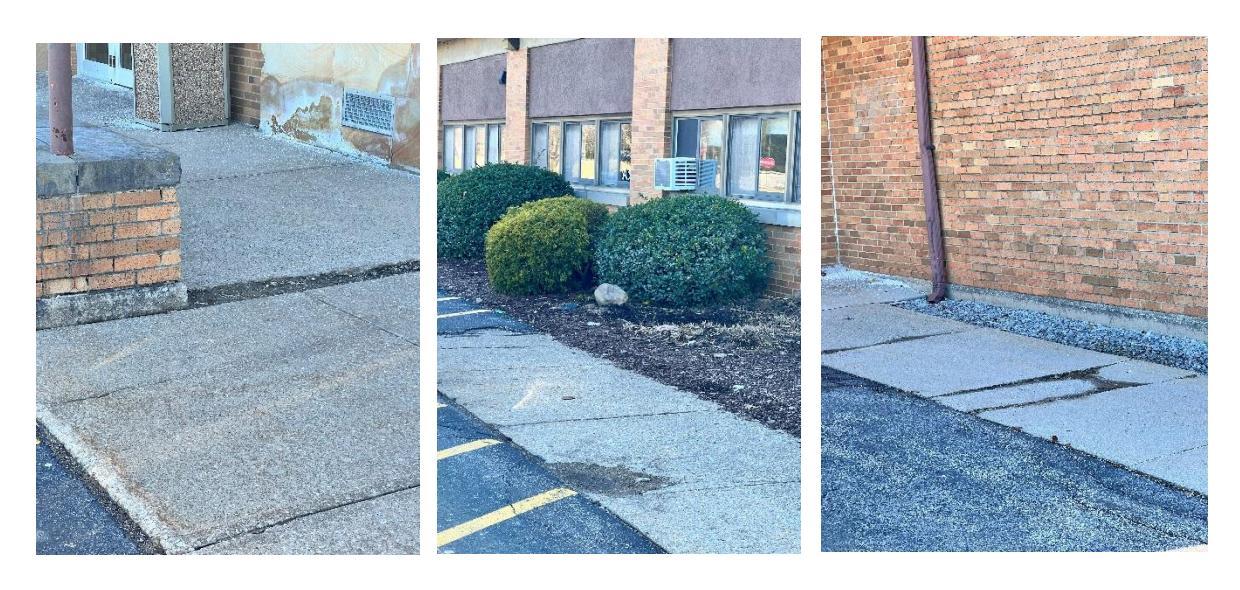
The concrete sidewalks will need repairs ranging from simple crack sealing to full depth replacement. There is approximately 1210 square feet of full depth concrete walk replacement that is recommended.

- Replace cracked, spalling or settled concrete entrances, walks and frost slabs
- Seal minor concrete cracks to prevent further damage

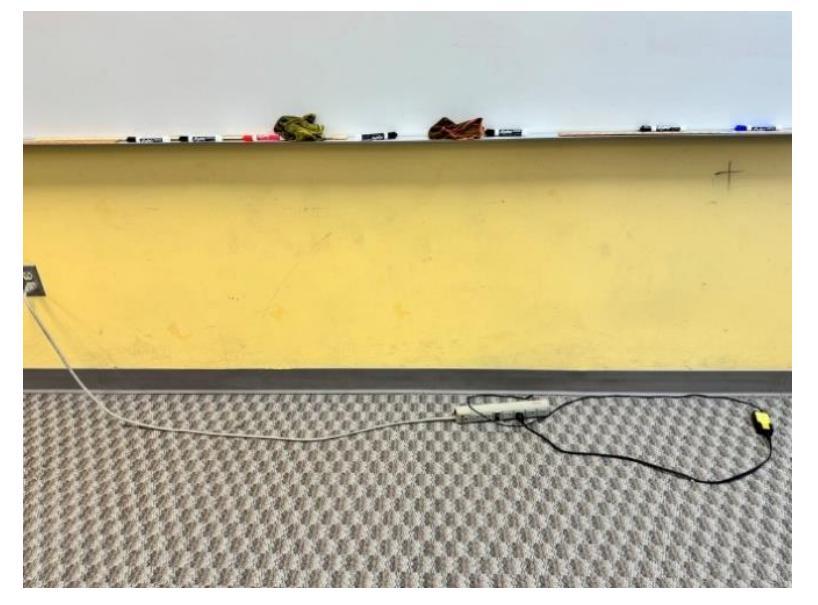
Typical Classroom

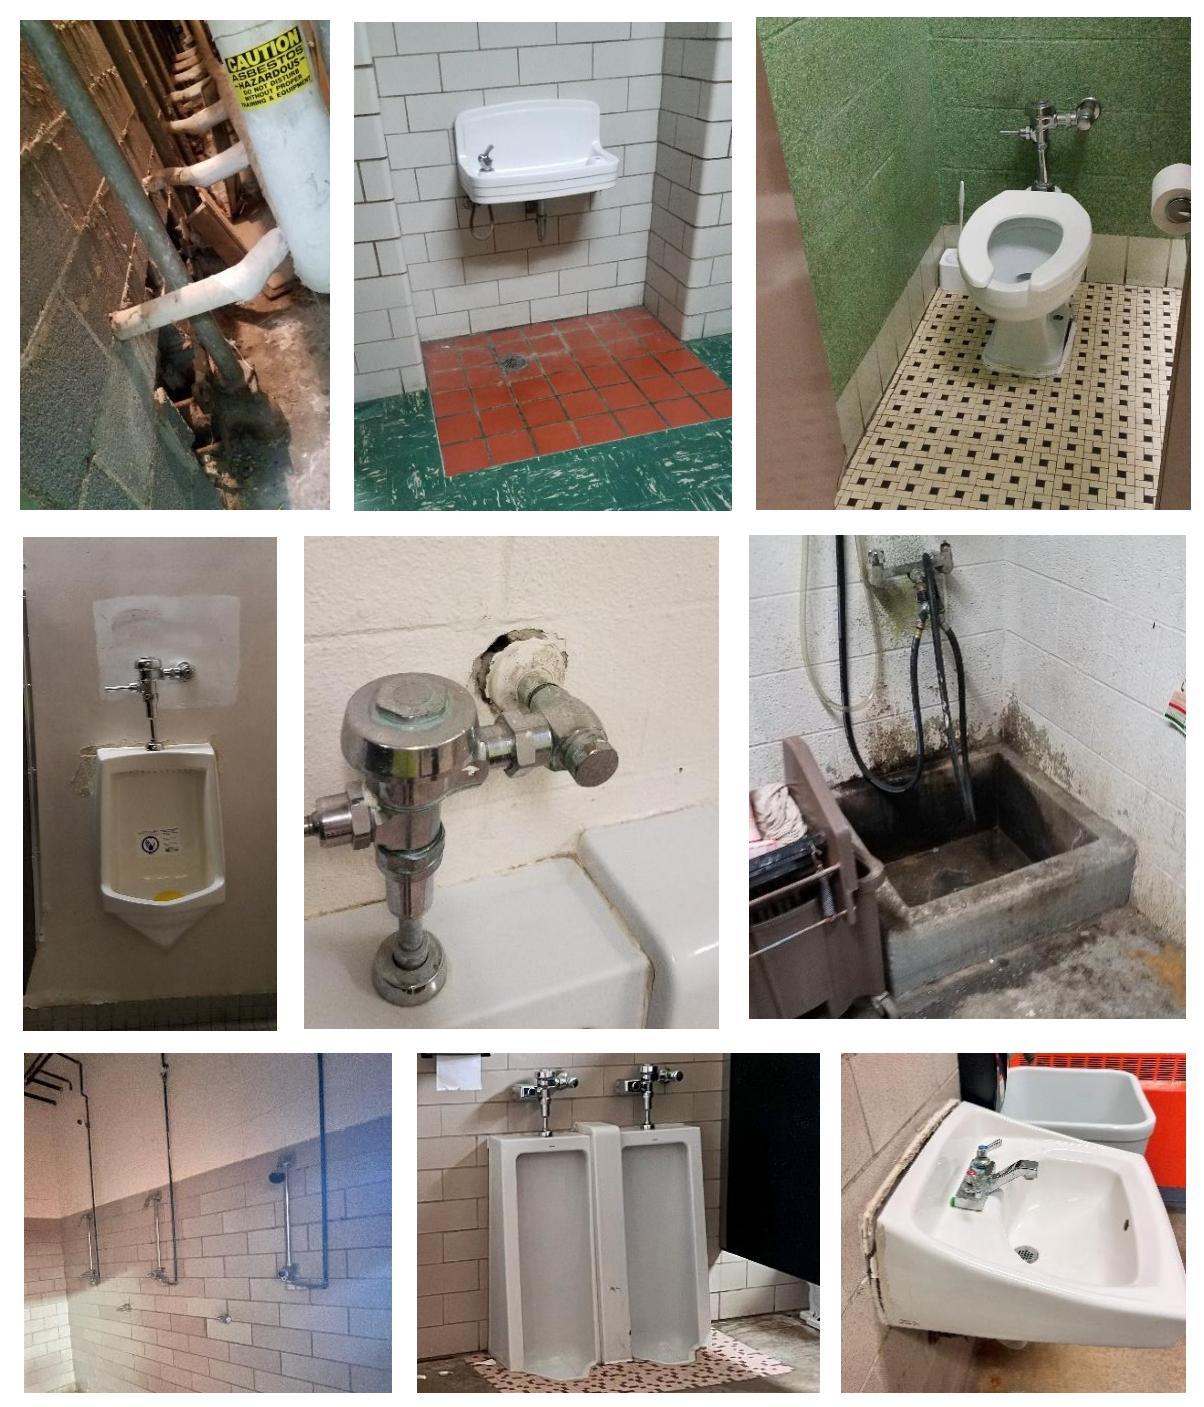
Typical Condition of Plumbing Fixtures
Technology and Security

- Routinely test operation of all fixtures. Replace any fixtures that are not operating as intended.
- Consider replacement of dated or worn fixtures throughout.

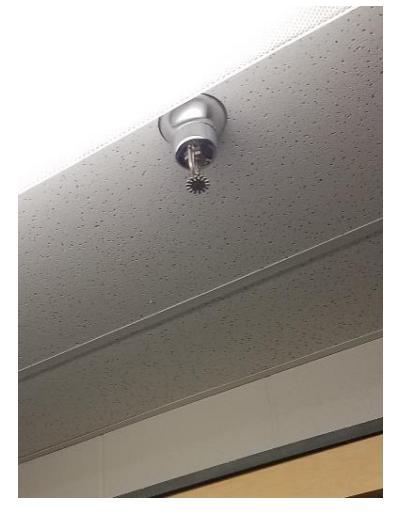
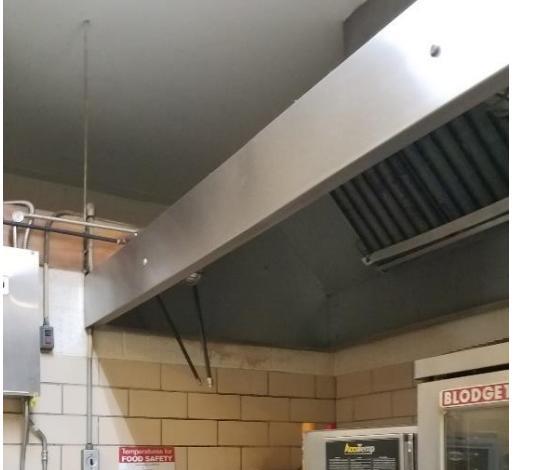
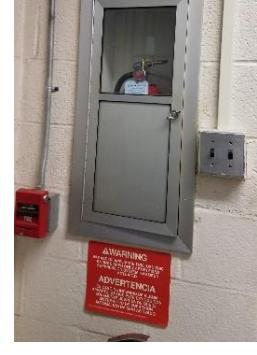
The sprinkler system was observed to be in good condition with adequate spacing between heads. Missing or damaged escutcheons were present in areas.

Typical Fire Suppression Devices

- Extend sprinkler system to original building to meet current life safety requirements
- Replace missing or damaged escutcheons at sprinkler head locations throughout
- As the facility performs annual inspections it is imperative to address inspection deficiencies as soon as possible. Items such as missing escutcheons can impact sprinkler operation and negate the protection provided depending on the severity of the various deficiencies.

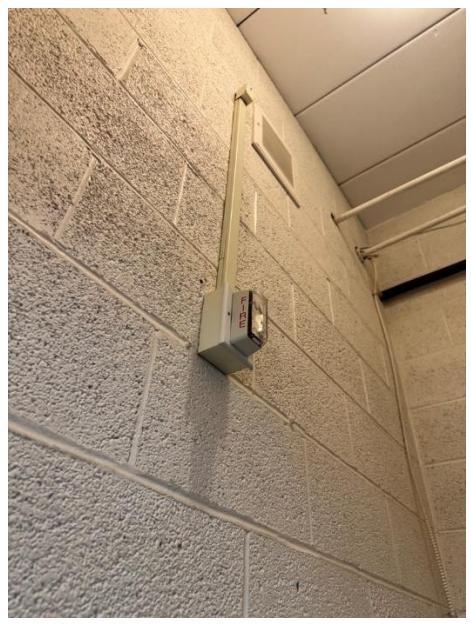
Typical Fire Alarm Strobe

• Routinely test fire alarm system. Replace any defective or damaged devices.

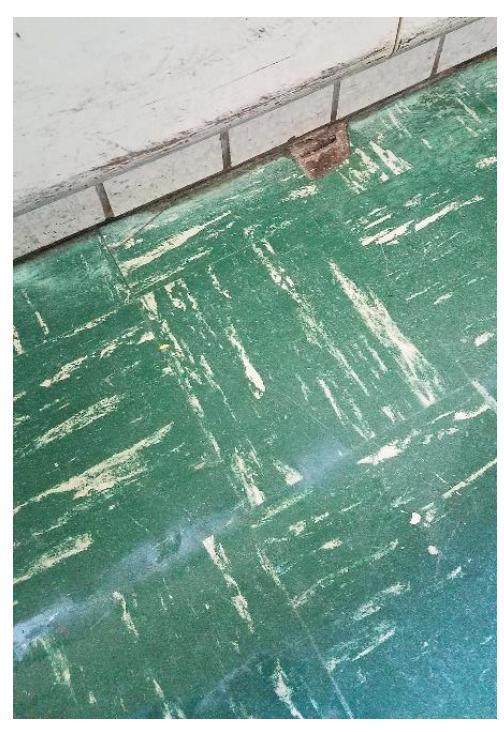
Condition of each material is considered to be in fair to poor condition with need for abatement. Some rooms have cracked or missing 9x9 tiles floor tiles and missing 12x12 ceiling tiles. Pipe fittings were properly labeled and in fair condition.

9" x 9" Vinyl Floor Tile with Black Mastic

- Demolition/Renovation of asbestos-containing materials (ACM) should follow applicable EPA, OSHA, and DOT regulation.
- Before disposal or handling of regulated materials, they must be characterized by either generator knowledge or by laboratory testing for the presence/absence of known regulated substances prior to waste hauling and disposal or recycling.

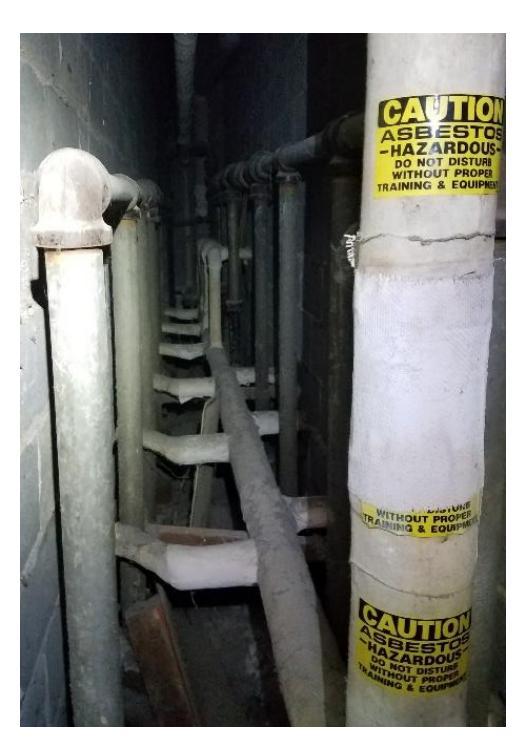
Pipe fittings

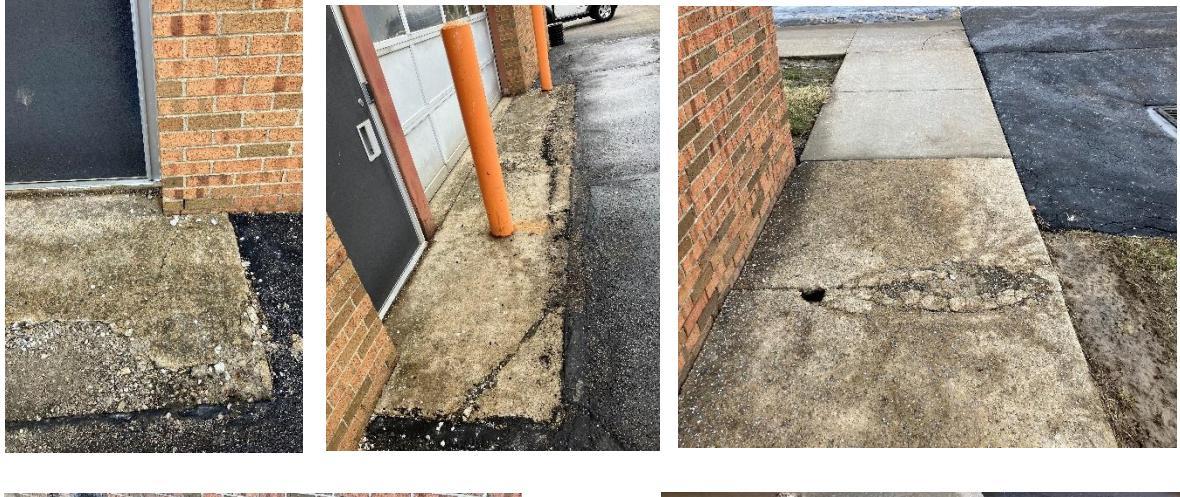
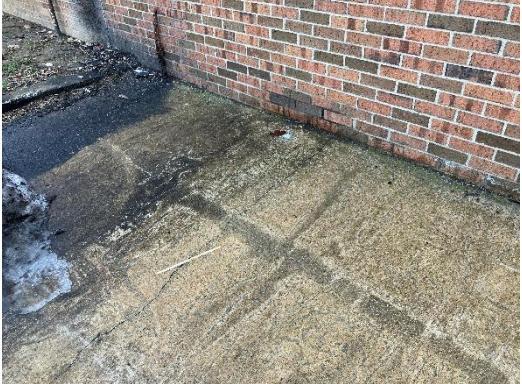
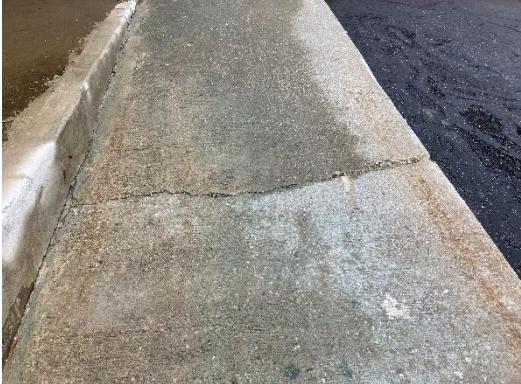
Currently there are approximately 60 linear feet of existing curbing that need to be replaced. These sections of the curb have missing sections, large cracks, have sunken or are completely missing.

- Repair damaged or spalling concrete curbs
- Replace cracked or settled concrete entrances and walks and frost slabs
- Seal minor concrete cracks to prevent further damage

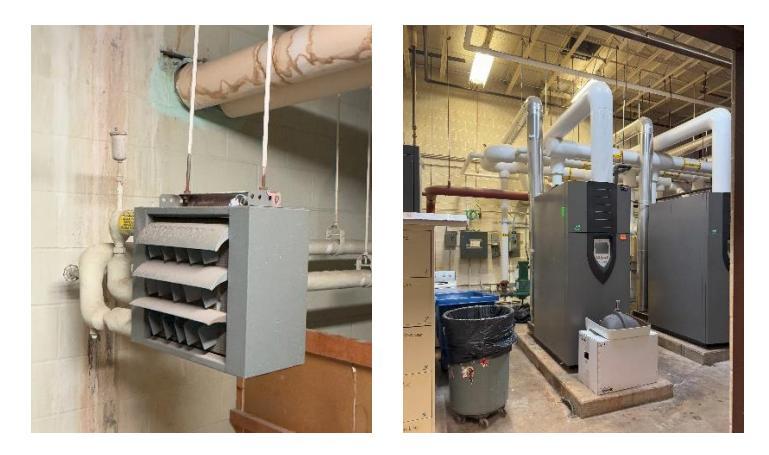
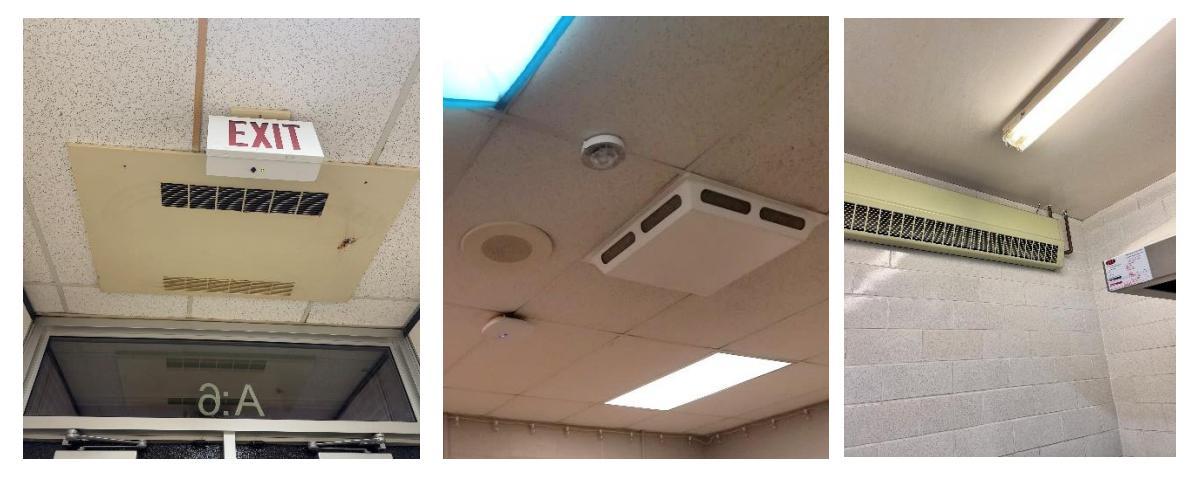
Most mechanical equipment appeared to be in good condition and regularly maintained for its age. Distribution systems for supply and ventilation were producing dust and debris to the surrounding ceiling areas.

- Perform immediate manufacturer recommended maintenance on all units.
- Clean all existing ductwork and diffusers
- Equipment 35+ years is recommended to be fully replaced
- Replace unit ventilators

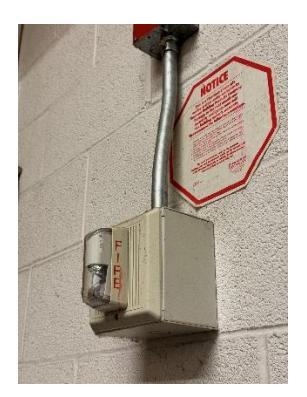
Typical Fire Alarm

• Routinely test fire alarm system. Replace any defective or damaged devices.

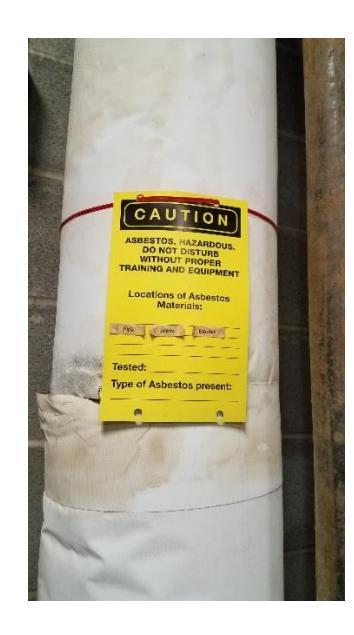
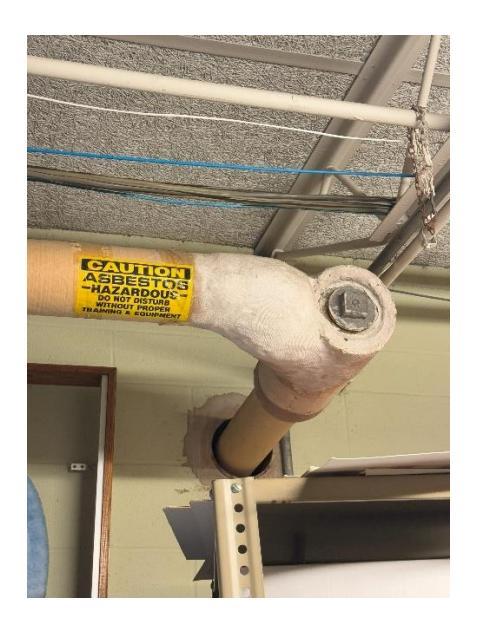
• Pipe fittings

- Demolition/Renovation of asbestos-containing materials (ACM) should follow applicable EPA, OSHA, and DOT regulation.
- Before disposal or handling of regulated materials, they must be characterized by either generator knowledge or by laboratory testing for the presence/absence of known regulated substances prior to waste hauling and disposal or recycling.

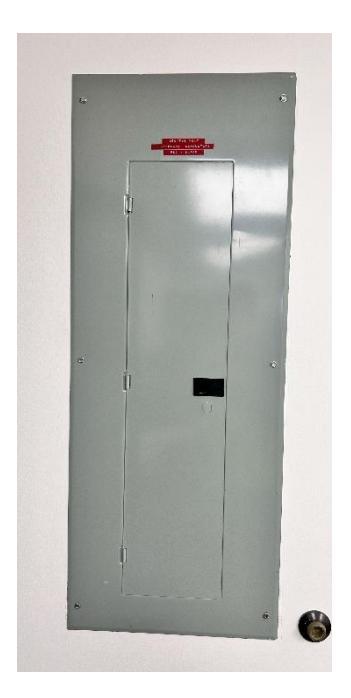
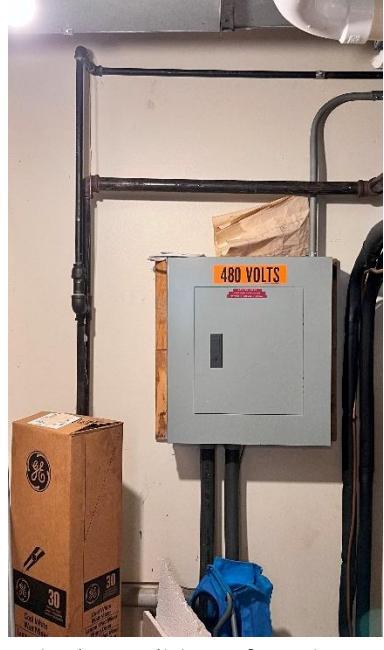
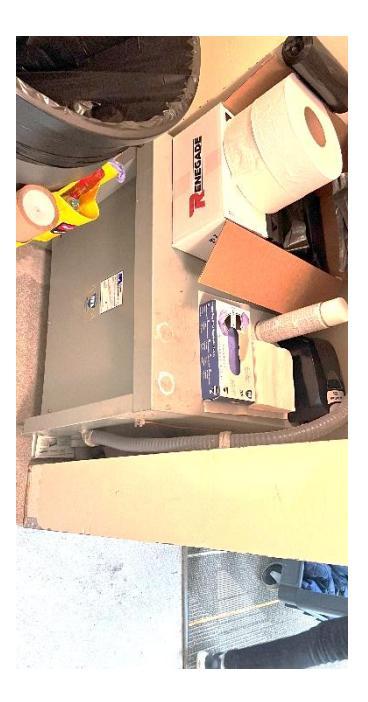
The general condition of the distribution panels and branch circuit panels varies between good to very good condition. Electrical rooms and closets are secured, orderly, dry and have adequate ventilation. Electrical equipment is operational while most are of the age of the building and require attention. Devices throughout the building are not properly secured in their junction boxes or are missing covers.

Typical Condition of equipment.

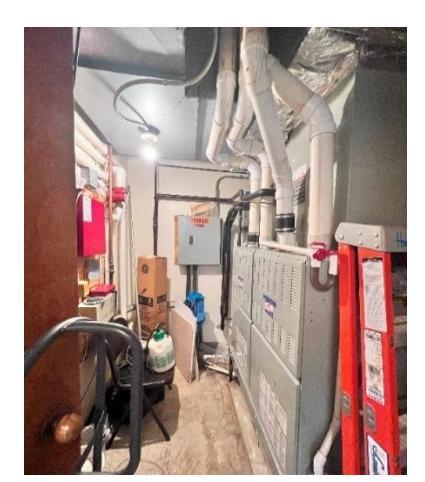
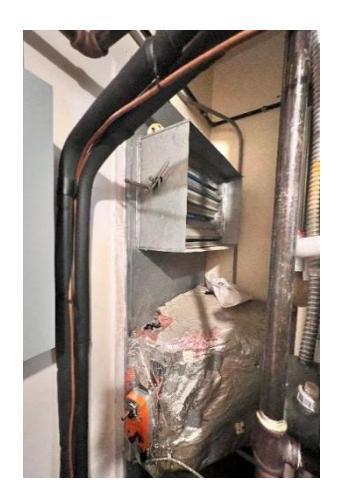
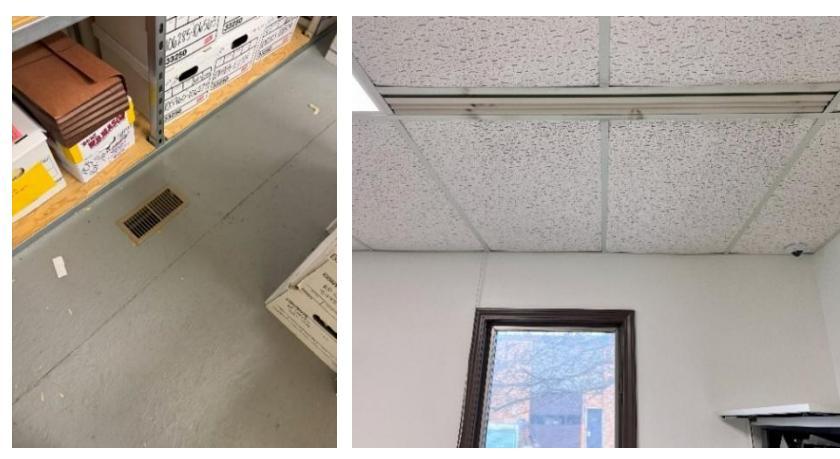
Most mechanical equipment appeared to be in good condition and regularly maintained for its age. Distribution systems for supply and ventilation were producing dust and debris to the surrounding ceiling areas.

- Perform immediate manufacturer recommended maintenance on all units.
- Clean all existing ductwork and diffusers.
- Equipment over 35+ years should consider replacement.

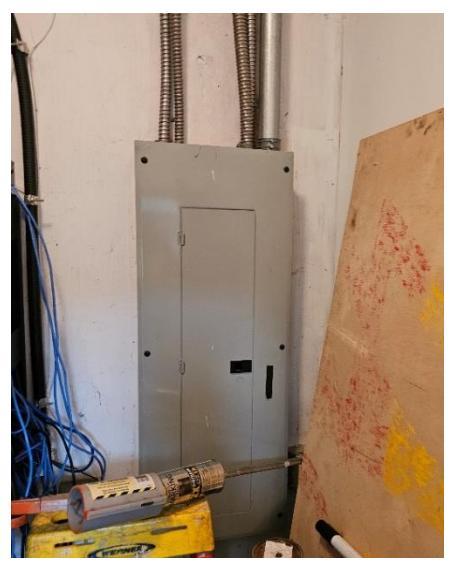
A branch 120/208V 3-Phase circuit panel is located in the buildings utility closet and is in good condition. The utility room was secured and dry.

Condition of panel.

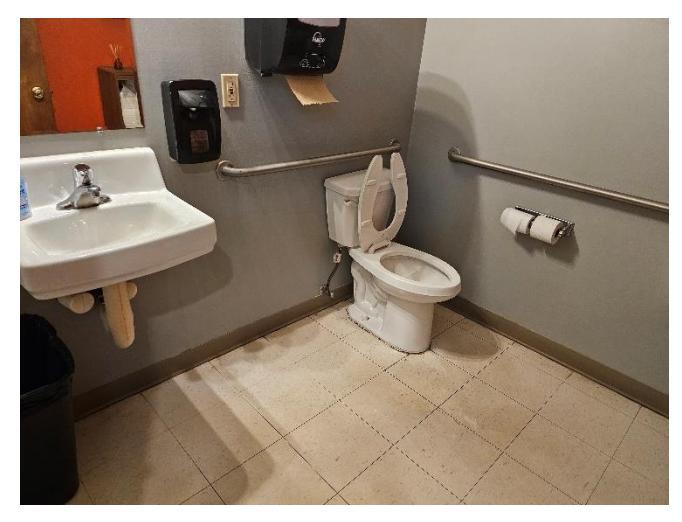
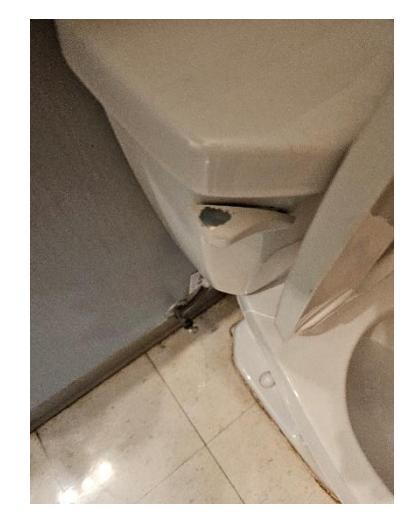
All plumbing equipment and fixtures appeared to be in fair condition and regularly maintained, depending on the location. Fixtures are a mix of old and new throughout.

Typical Condition of Plumbing Fixtures

- Routinely test operation of all fixtures. Replace any fixtures that are not operating as intended.
- Replace dated or worn fixtures throughout.

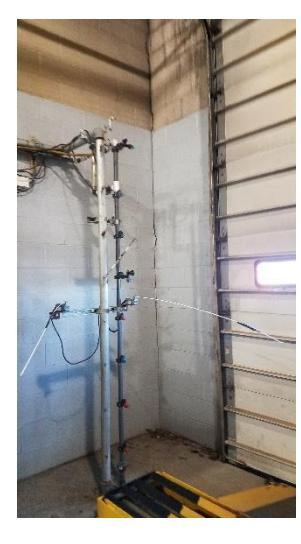
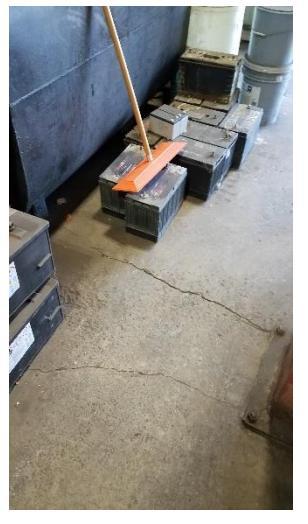
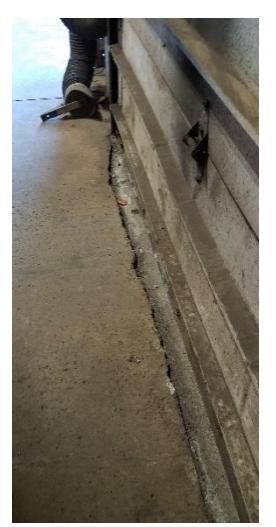
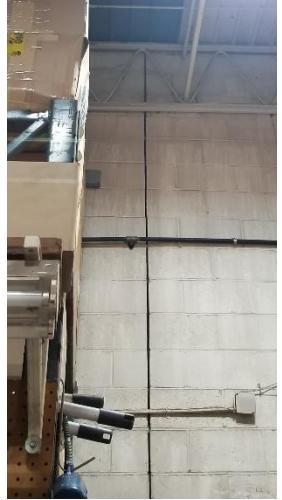
Typical Condition of Structural Elements

Exterior - The exterior load-bearing walls were composed of CMU with wood posts at the lean-to addition at the back of the building. The steel lintels at openings have experienced heavy corrosion.

Interior – CMU walls have vertical and step cracking. Structural roof members show signs of corrosion.

Based on the observed conditions, the overall structural condition of the Bus Maintenance garage is in fair to poor condition. All items mentioned fall under the short term to long term time frame of requiring repairs. From what was visible, the building's superstructure is considered in fair condition. Overall, the building's floors are considered in good-to-fair condition. The exterior structural walls of the building are in poor condition and extensive through-block and step cracking were observed. It suspected that more extensive cracking is present but not immediately visible under the existing exterior and interior paint coatings.

- Grout and seal all separations in CMU walls on the exterior and interior.
- Replace compromised wood structural members.
- Prep and paint all metal structural members
- Replace expansion joints
- Replace damaged full depth concrete slabs
- Rout fill and seal concrete floor cracks
- Clean and seal corroded lintels

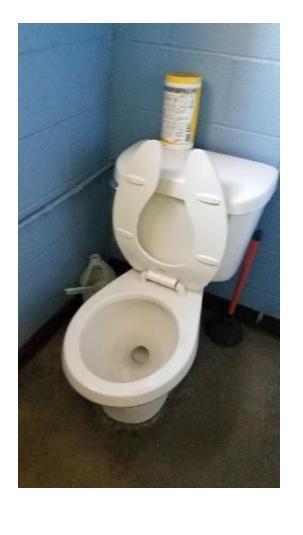
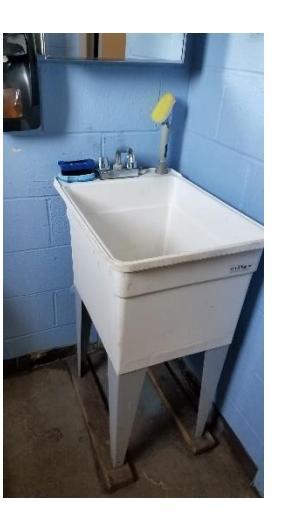
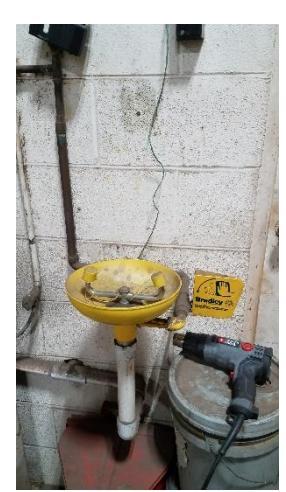
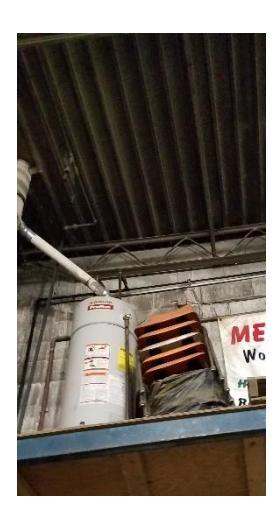
Typical Condition of Plumbing Fixtures

Plumbing Fixtures – Plumbing fixture for water closets, and lavatories are manual type operation. Fixtures are worn but were still observed to be operational. Valves and hardware show signs of minor corrosion.

All plumbing equipment and fixtures appeared to be in fair condition and regularly maintained.

- Routinely test operation of all fixtures. Replace any fixtures that are not operating as intended.
- Replace dated or worn fixtures throughout.

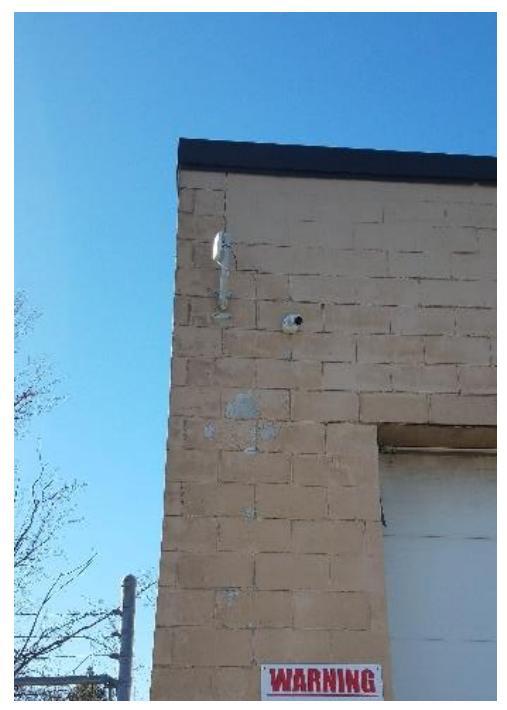
Typical Exterior Surveillance Camera

Video surveillance cameras were observed exclusively on the exterior of the building.

Develop a near term plan to convert all analog cameras to network connected cameras with higher resolution and better features/analytics. As a function of this plan, carefully review current video storage capacity and upgrade both the quantity of storage and the architecture of the storage as required fit that capacity.

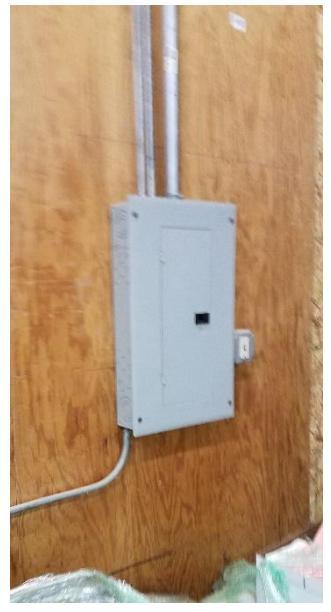
Condition of panel.

A branch 120/208V 3-phase circuit panel was observed on the East wall.

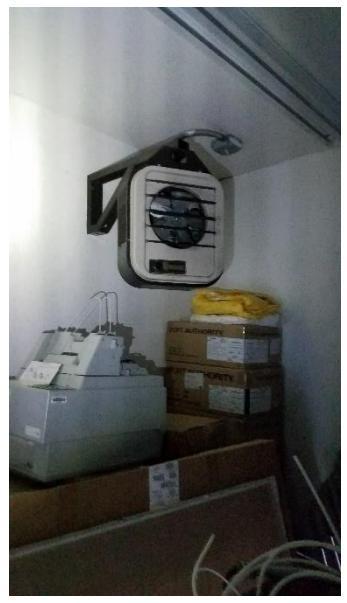
Condition of Unit Heater

The electric heat blower appears in good condition and regularly maintained for its age. **Recommendations:**

• Ensure proper interval maintenance of individual heat blower.

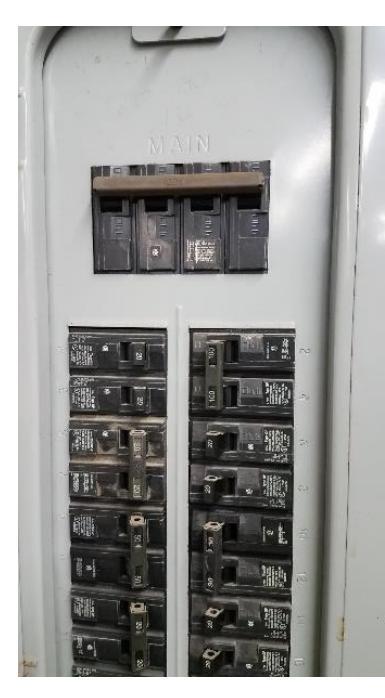
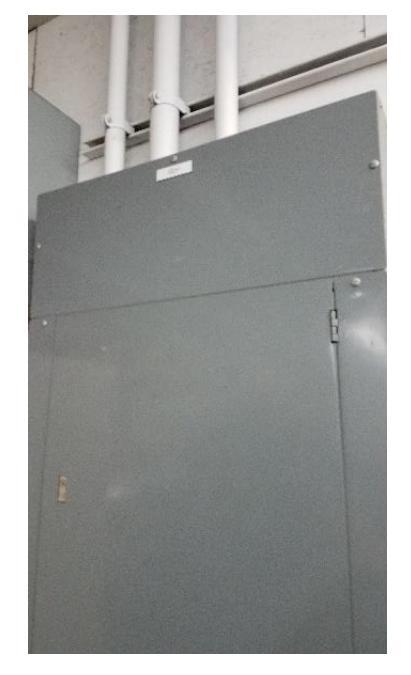
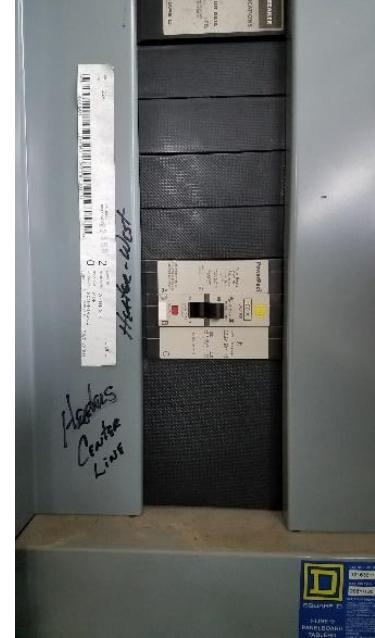
Typical condition of panel.

A branch 120/208V 3-phase circuit panel was observed on the East wall.

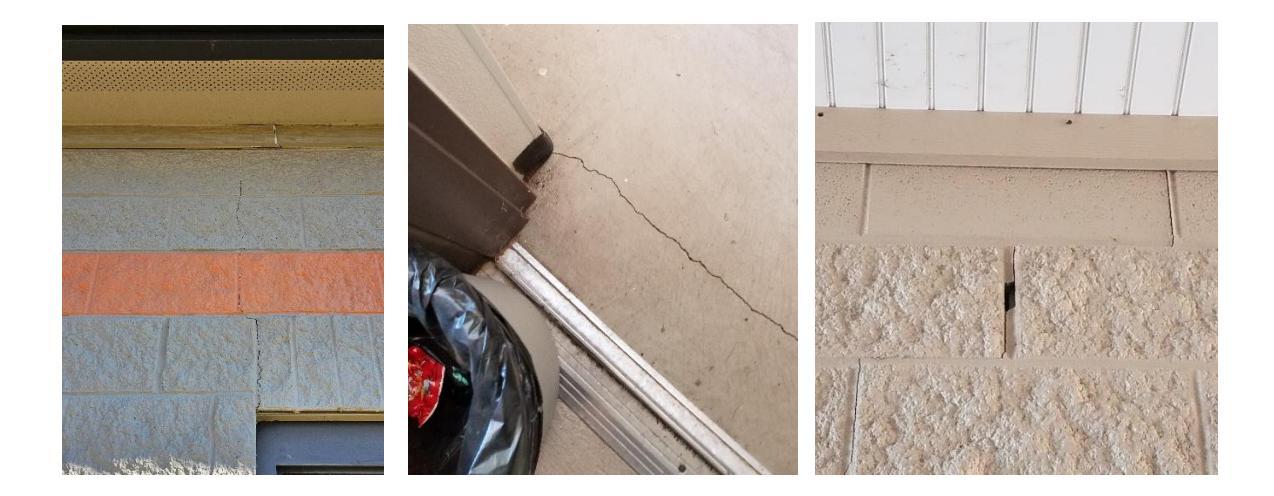
Based on the observed conditions, the overall structural condition is good. All items mentioned fall under the short term to long term time frame of requiring repairs. If not taken care of in this time frame, further deterioration could occur. There were no signs of foundation distress visible from the building's interior or exterior and it is considered in good condition. From what was visible, the building's superstructure is considered in good condition. Overall, the building's floors are considered in good condition. The overall façade of the building is in good condition but minor step and vertical cracks in the CMU were observed.

- Grout and Seal concrete floor slab cracks.
- Tuckpoint deteriorated mortar joints.

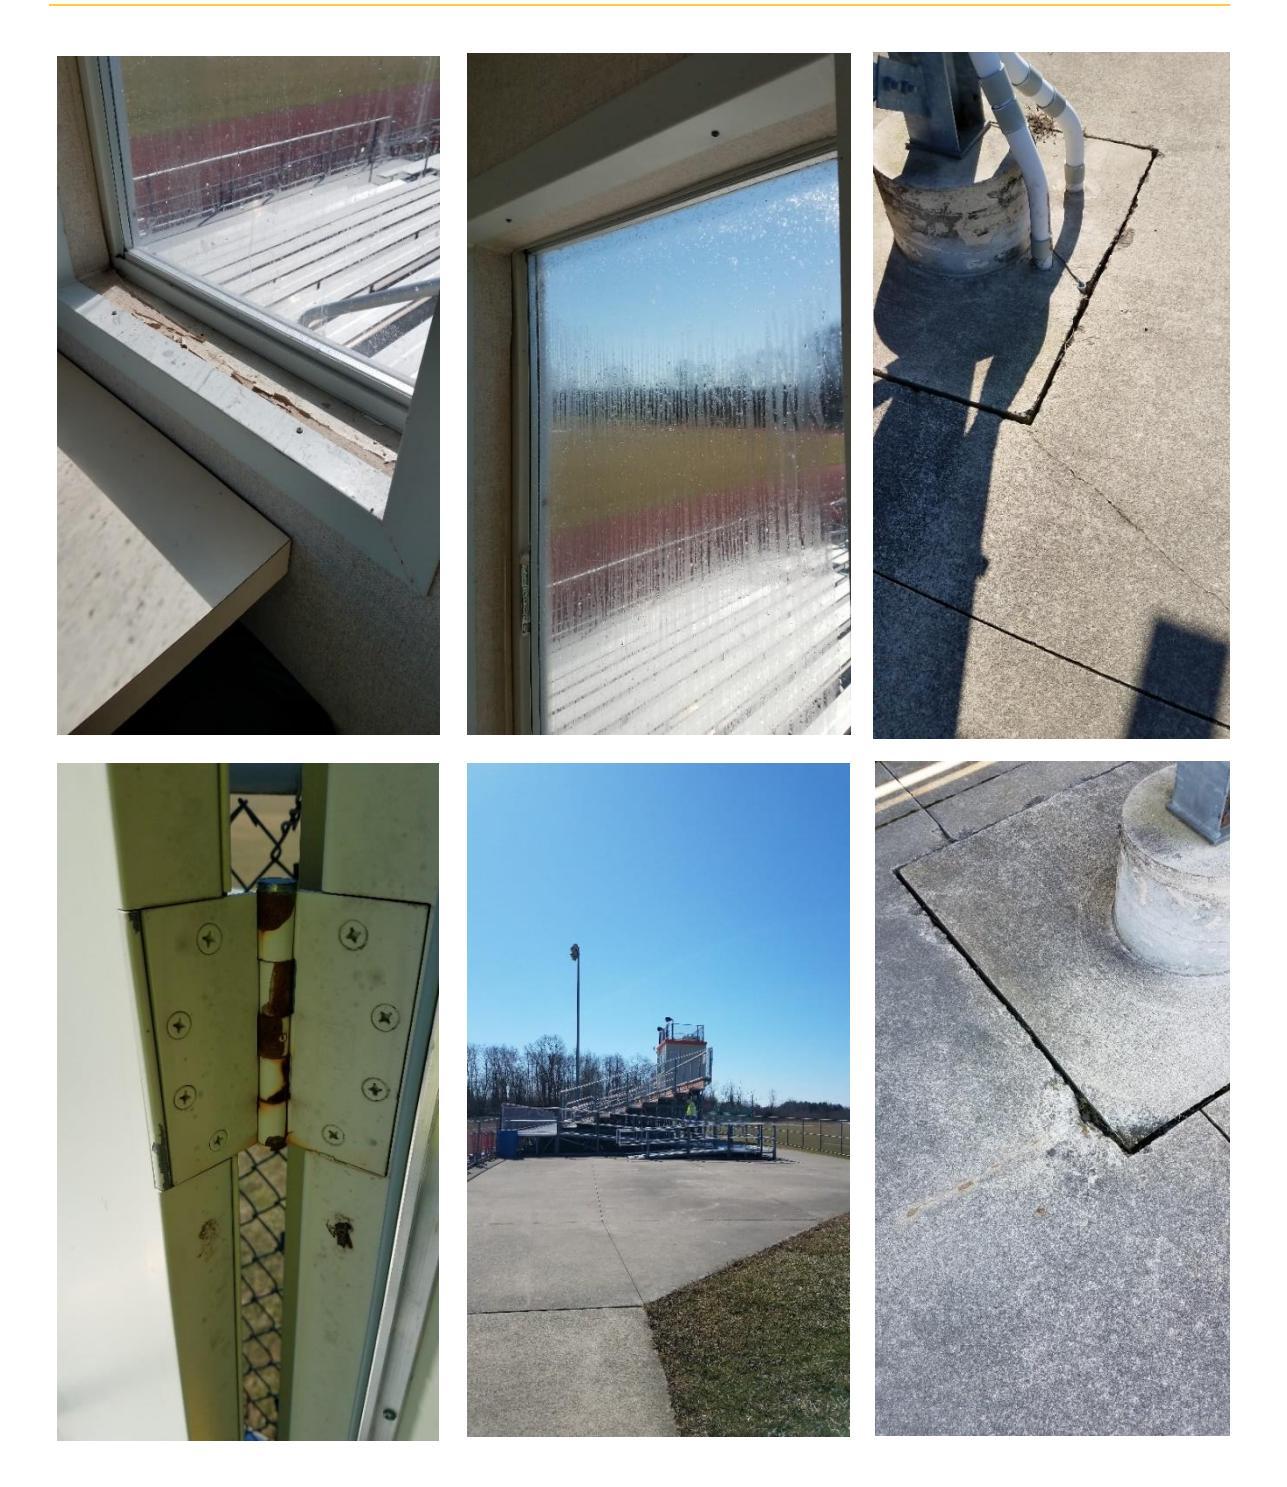
Press box: The press box is in a functional but fair condition. The interior finishes have experienced moisture resulting in peeling of the floor base, delamination of the wall boards, staining of ceiling tiles and condensation in the double-paned windows. The windowsills are also damaged. The door hinges are corroded. A branch circuit panel was observed, which services ground outlets and an audio-visual system.

- Replace door hinges with weather resistant hinges
- Rout fill and seal concrete cracks
- Repair spalling concrete
- Replace damaged finishes in press box
- Seal roof of press box
- Replace windows in press box

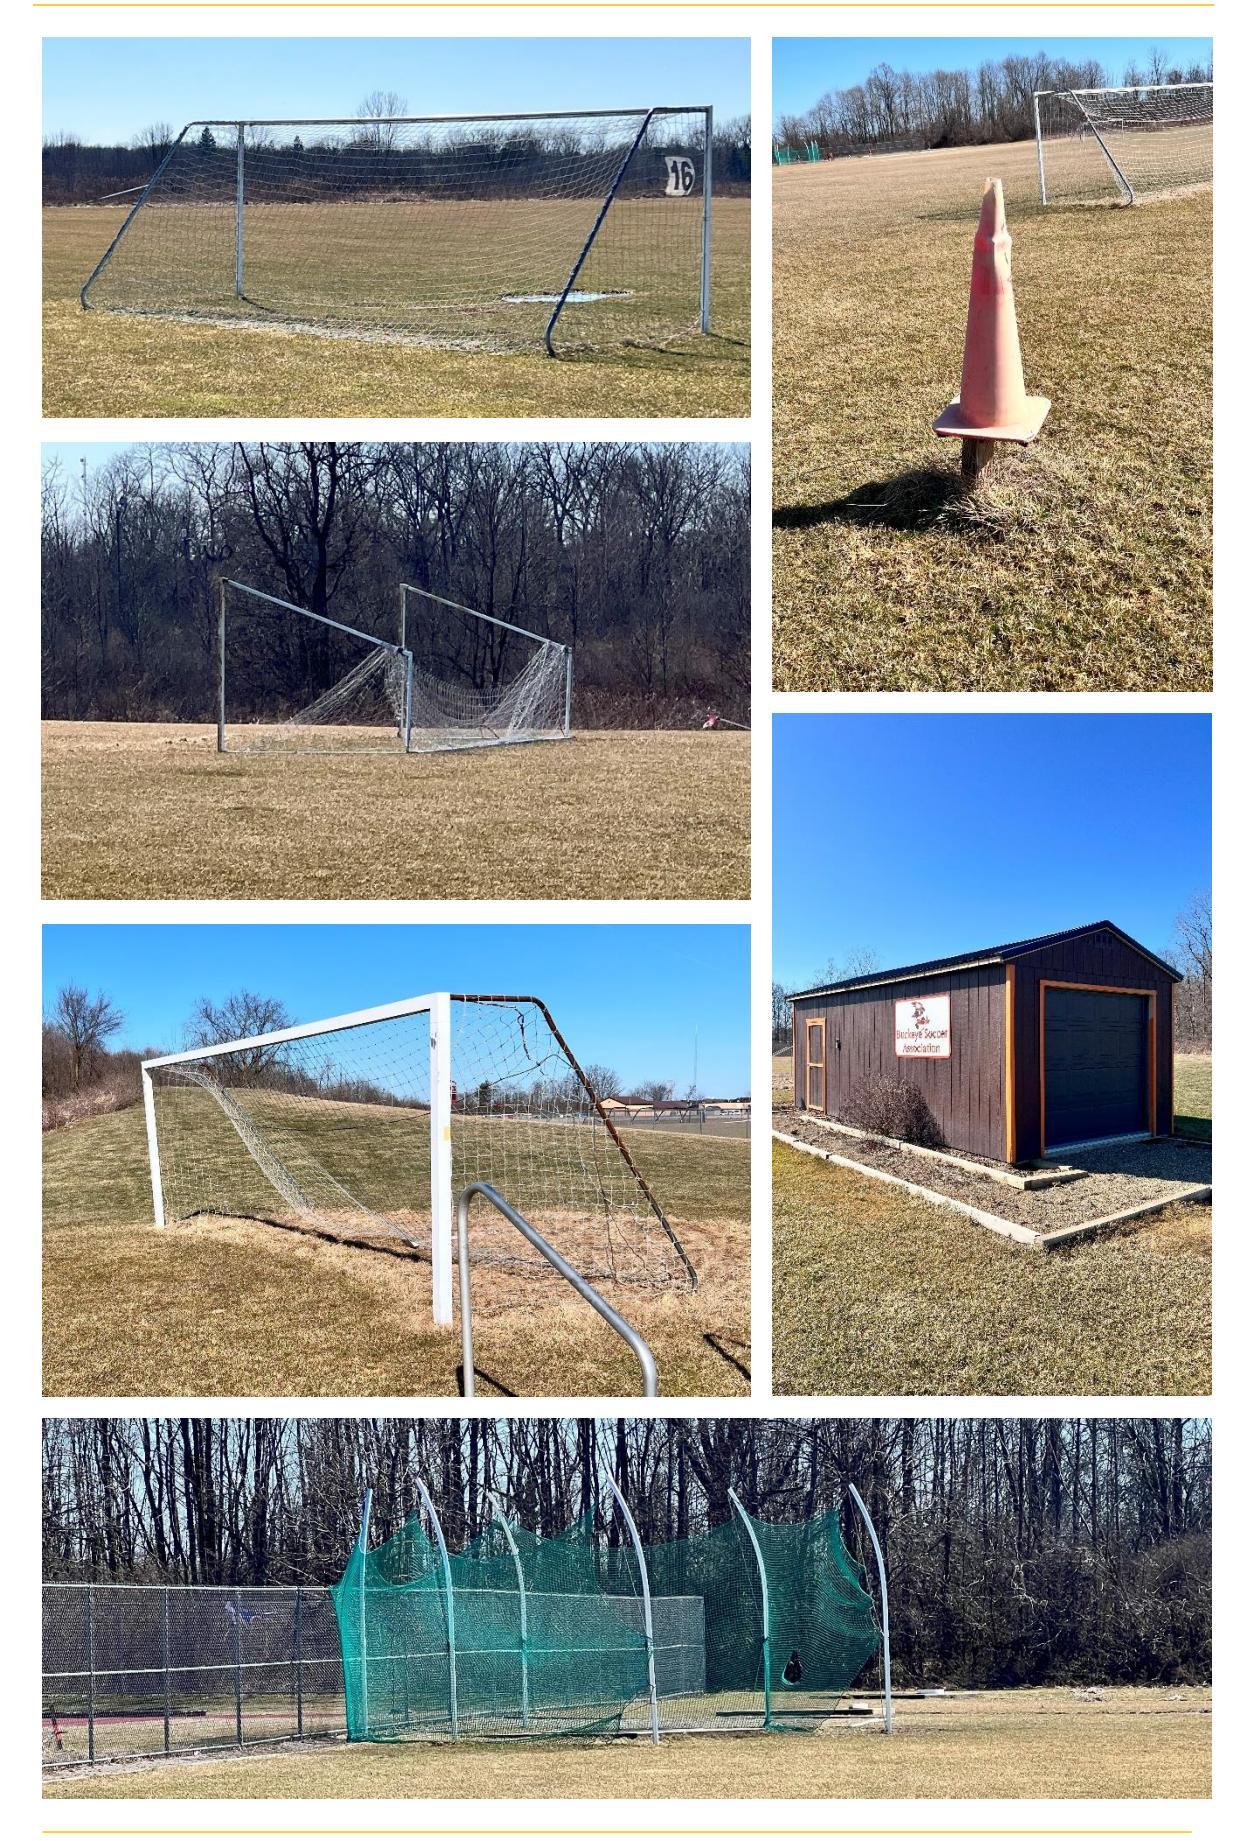
Goals: Most goals and nets were observed to be in good condition. Some goals show signs of corrosion, with one goal near the shed being heavily corroded and damaged. Some nets were torn and should be replaced.

- Replace damaged or heavily corroded goals and nets
- Remove post from fields to prevent injury
- Replace or repair lightly corroded or damaged nets
- Regrade the earth to prevent further ponding on the fields. Consider soil amendments to assist with proper and timely drainage
