BUCKEYE LOCAL SCHOOL DISTRICT Building Assessment & Condition Review

Building Assessment & Condition Review March 2025

CPL Architects and Engineers, Inc 111 Front Street Berea, Ohio 44017

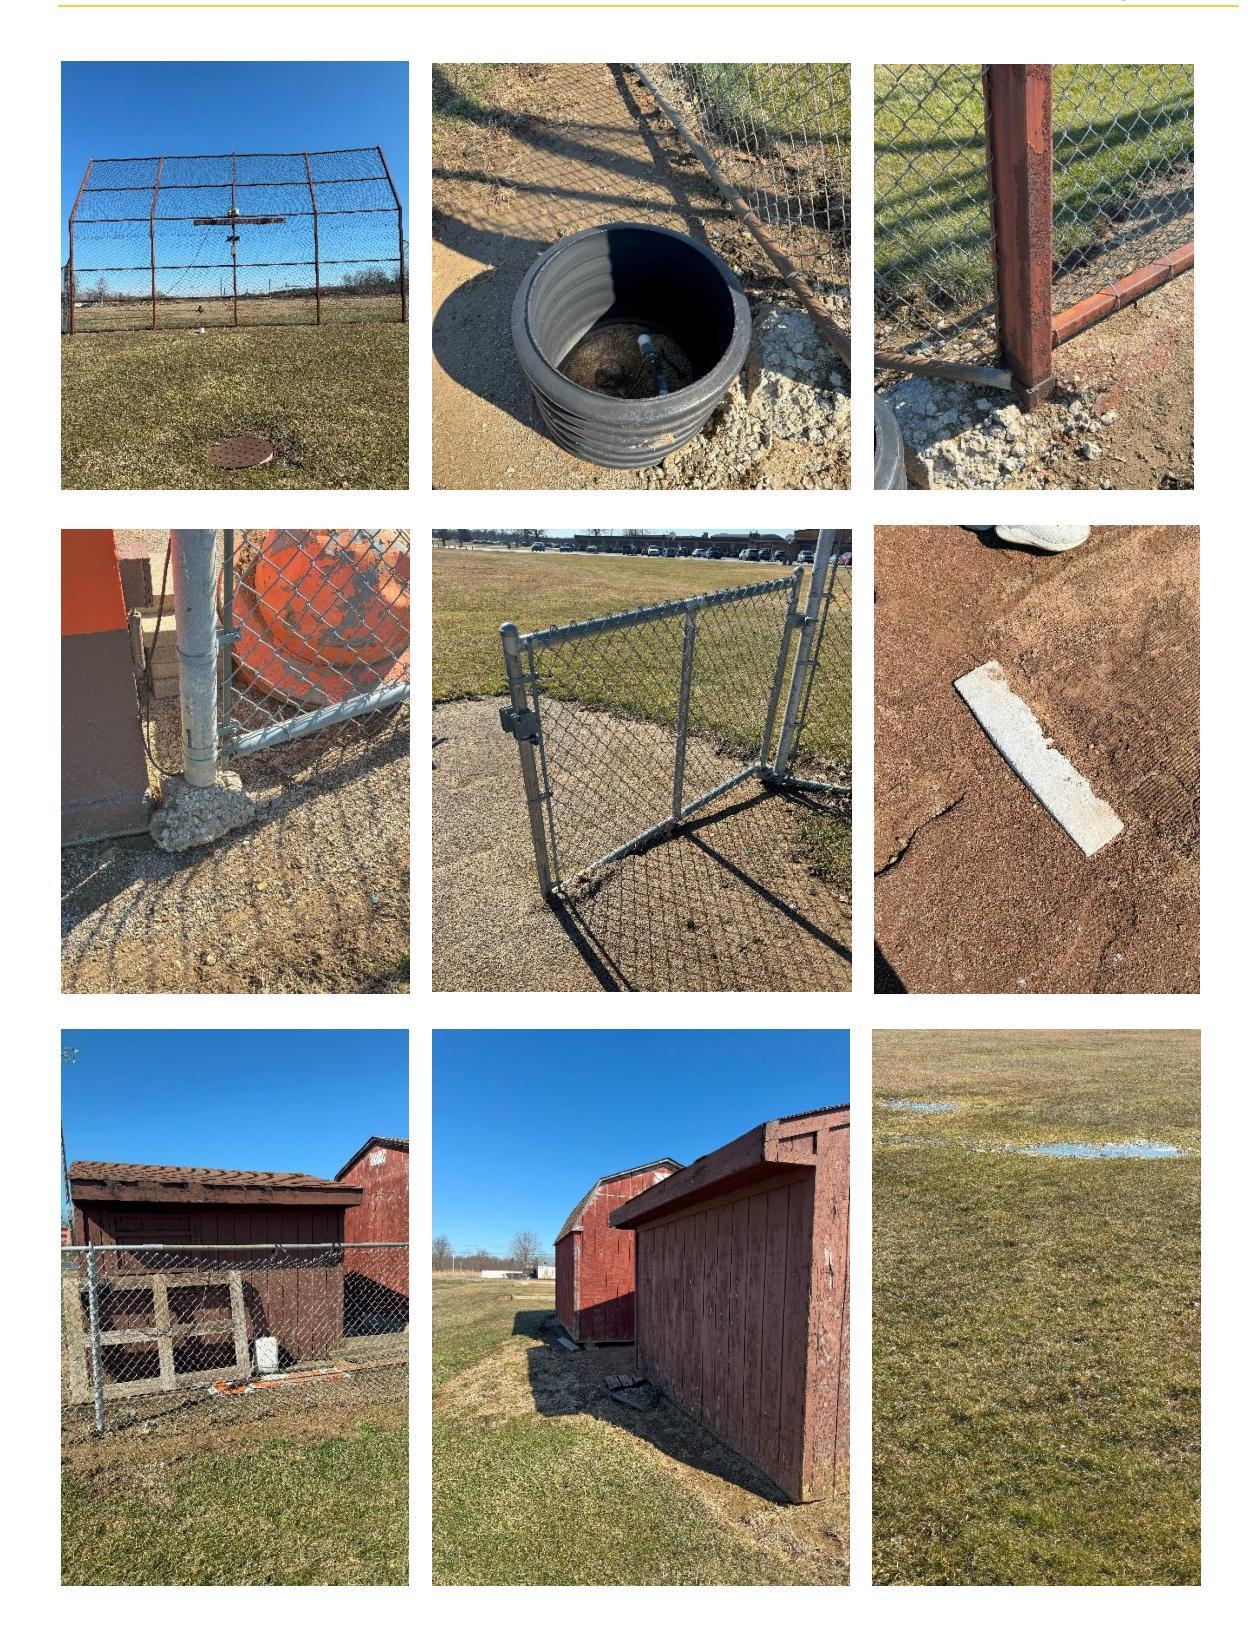
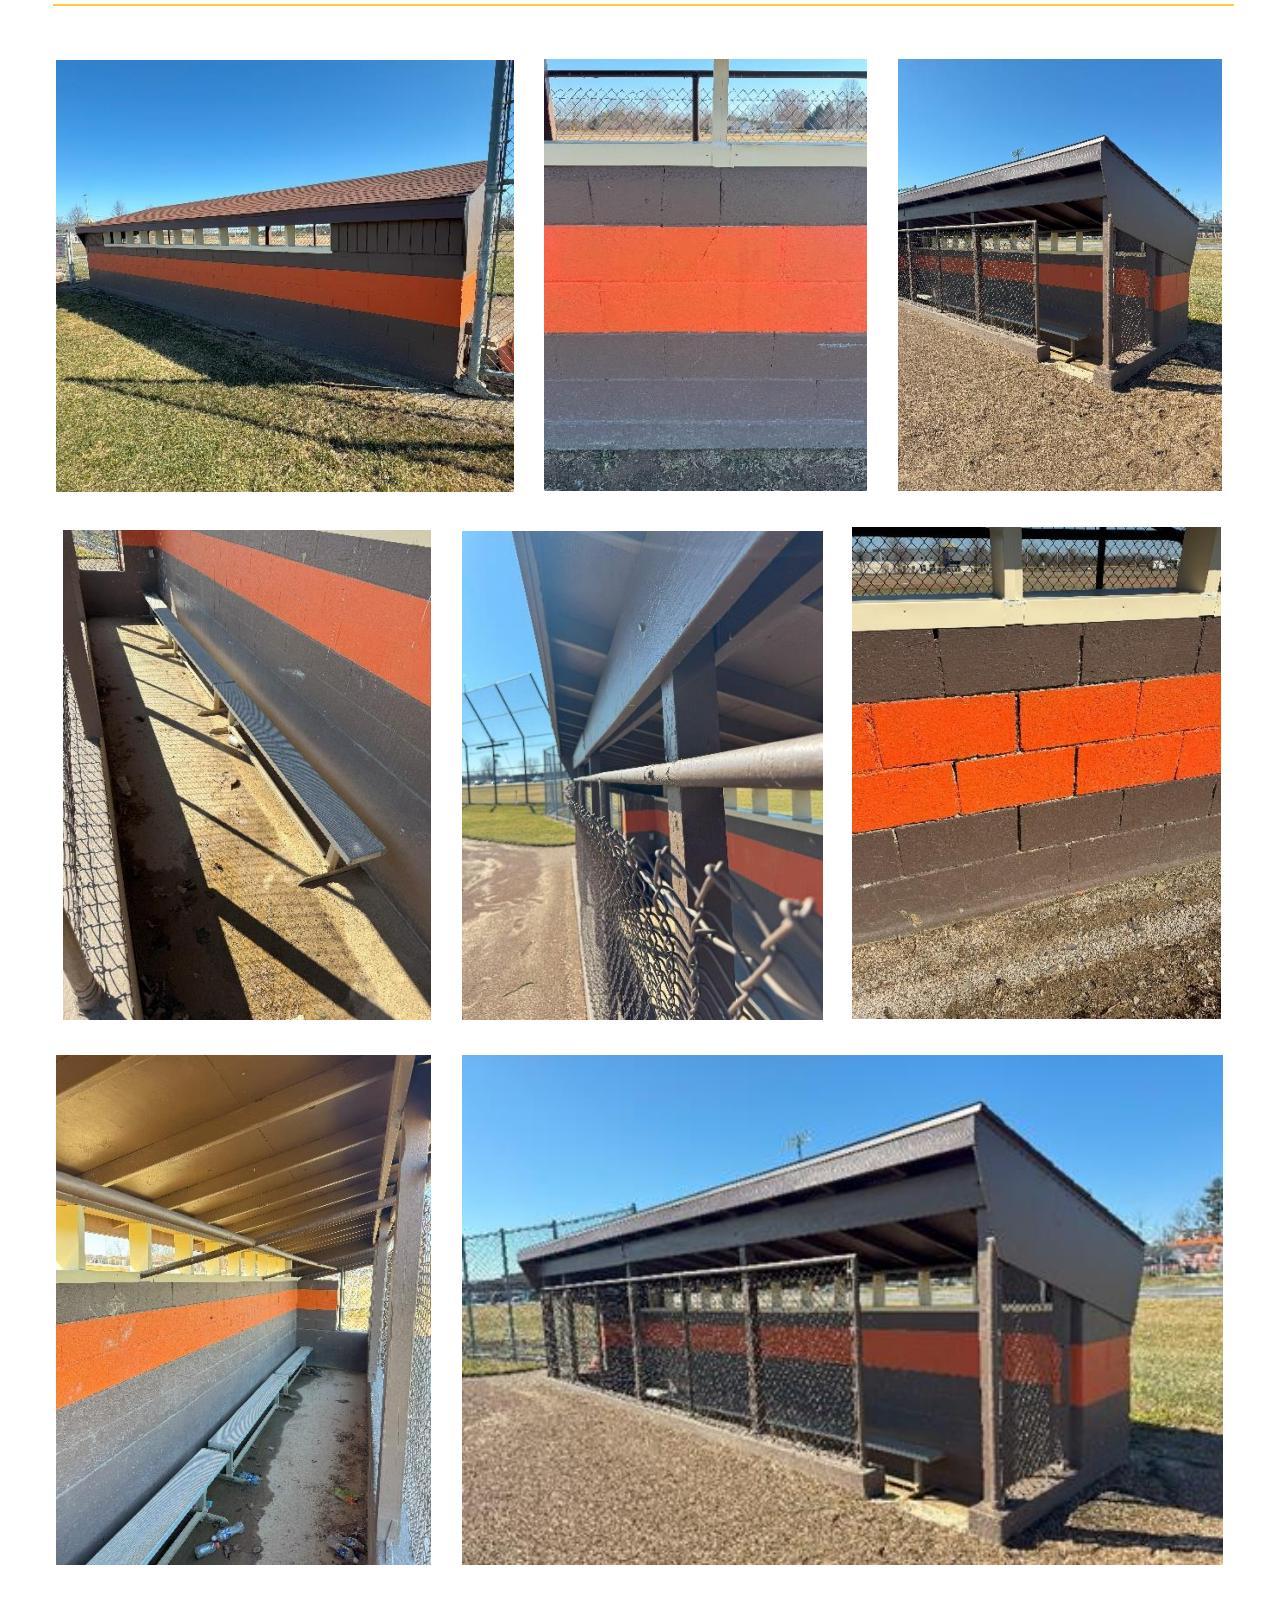
Field: The field is natural grass and is approximately regulation size for a high school. The perimeter fence is heavily damaged, and the gates are either missing or are irrelevant due to site conditions. This field has no light fixtures or scoreboard. Ponding was observed in the grass along the southern side of the outfield and area near first base.

Misc. Structures: Two (2) wood-framed sheds for storage. Worn and damaged. The smaller shed has passed its likely expected life.

Dugouts: Structural components are in good condition with some cracks in the concrete walls. The roof system is in good condition. There is evidence of standing water along the bottom of the dugouts- no floor drains. Fences are damaged. Paint is worn away along entire structure/fence.

- Replace/repair all fences 1,270 LF
- Prep and paint corroding posts on backstop fence
- Repair and tuckpoint all masonry and mortar joints
- Re-grade land for proper drainage
- Replace bases
- Repair/replace bullpen/practice bases
- Clean litter and bird residue
- Install scoreboard
- Paint larger shed and replace smaller shed

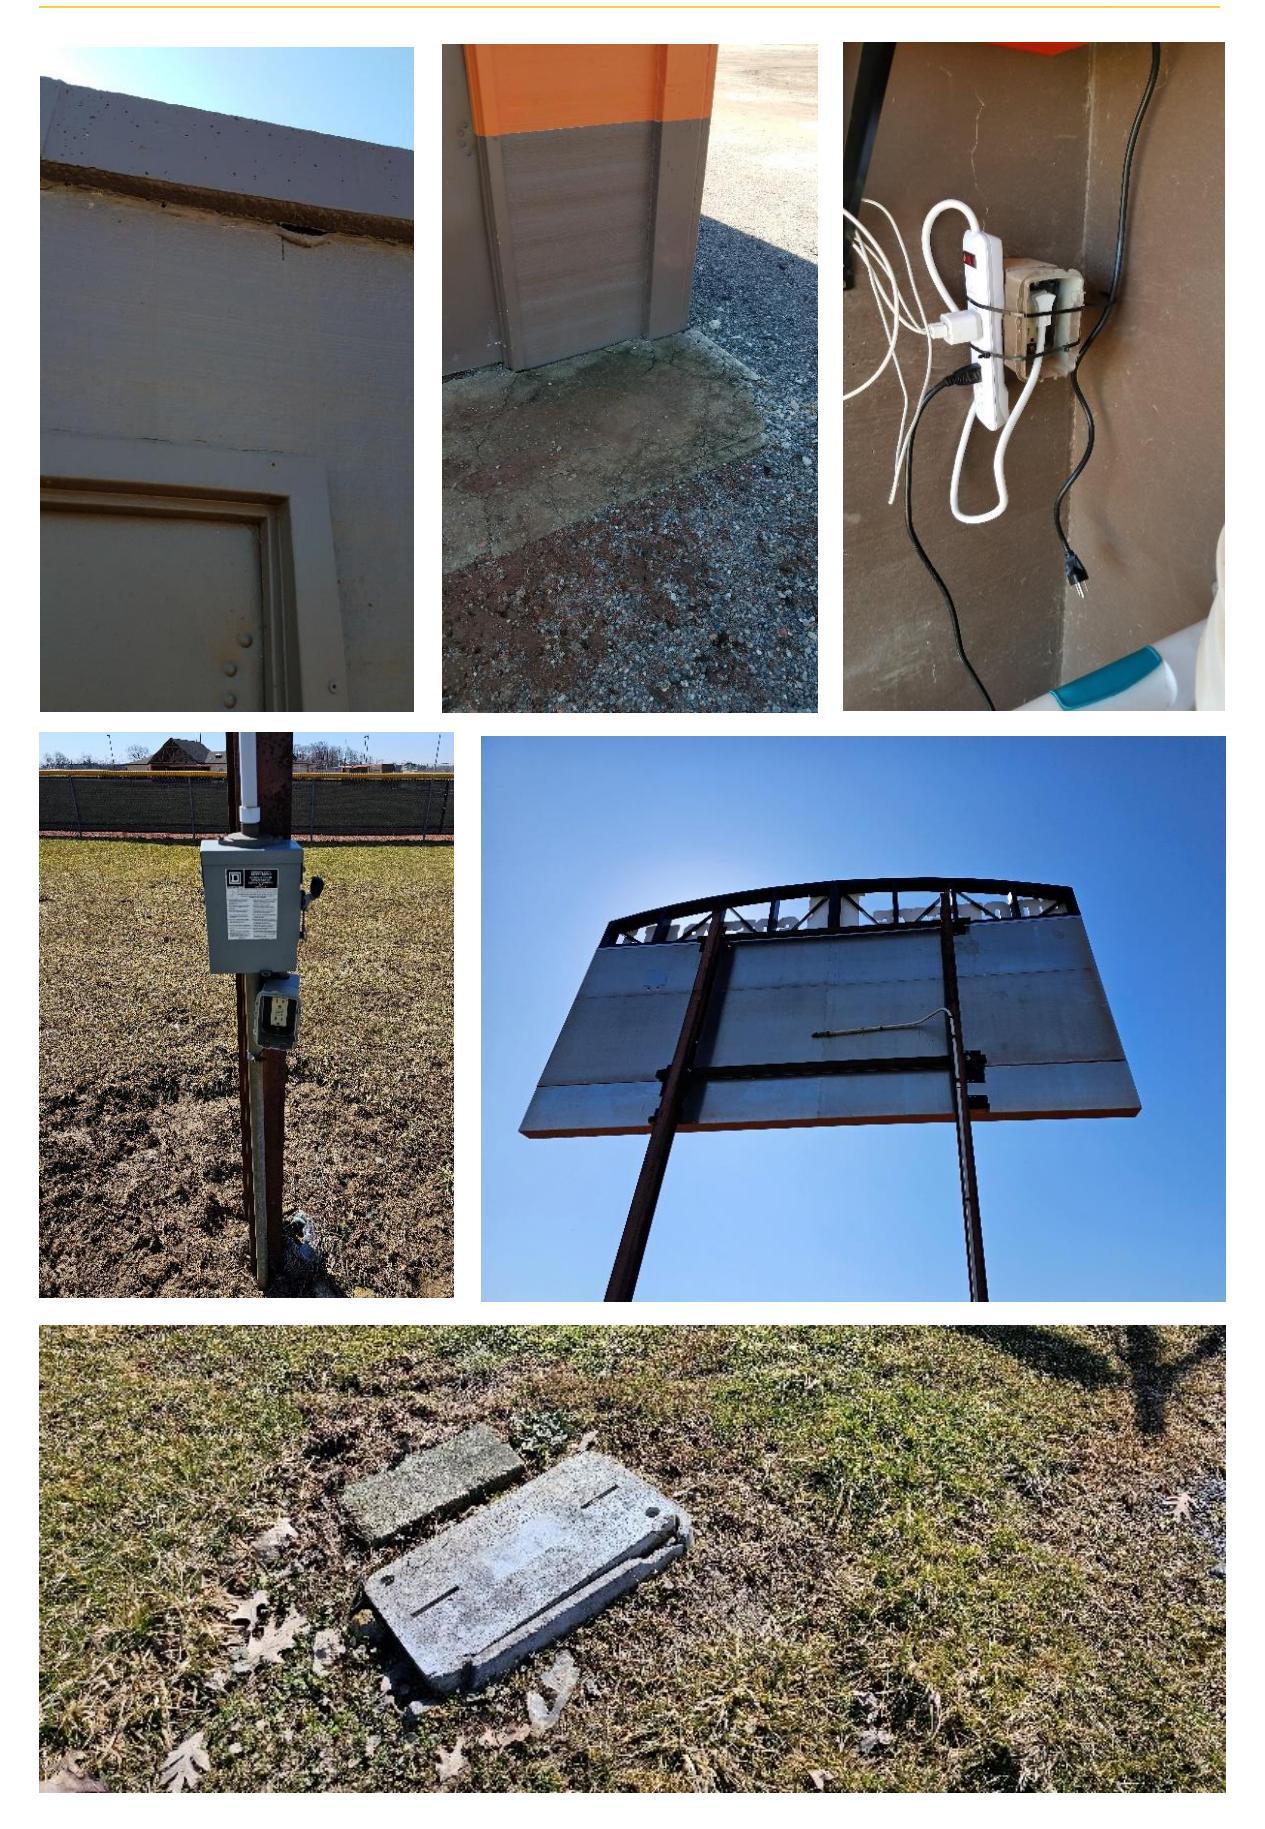
Field: The field is natural grass and is approximately regulation size for a high school. The perimeter fence is in good condition. This field has no light fixtures. Ponding was observed in the grass along the exterior side of the outfield fence.

Dugouts: Structural components are in good condition with a couple holes in a concrete wall and cracking frost slab foundation. The roof slab is in good condition. One electrical receptacle was observed with a zip tie fastened expansion pack. The paint has some small worn spots. The ground experiences water saturation in and around the dugouts.

- Remove power extender from electrical receptacle. Add additional receptacles
- Install new receptacle weather covers in dugout and at scoreboard
- Re-grade land for proper drainage
- Re-grade gravel away from dugouts
- Clean and coat steel scoreboard posts
- Place concrete slabs in dugouts to reduce ground water saturation
- Repair or replace damaged utility ground box
- Replace frost slabs at storage doors
- Replace wall graphic
- Replace fencing

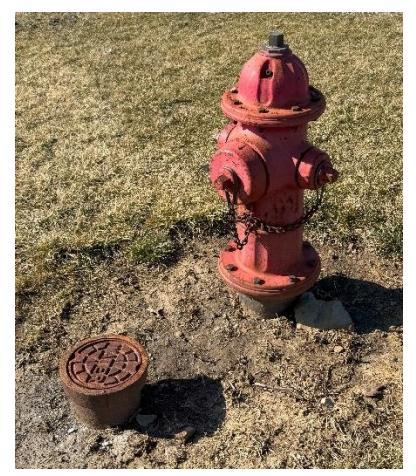
Of the existing onsite hydrants, 5 will need to be repainted. The repainting is currently an aesthetics issue. However, without proper maintenance and repair, the hydrants will continue to deteriorate and will need more attention in the coming years. The remaining hydrants are in good condition.

Typ. hydrant to be repainted

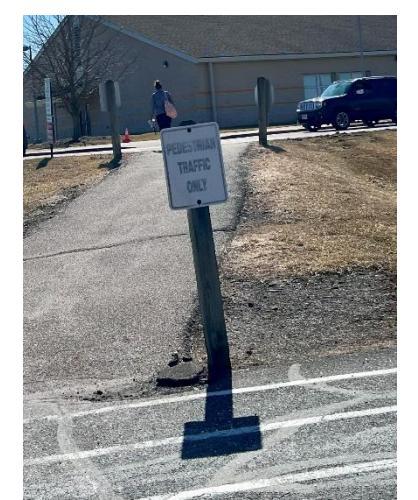
Overall, the signs on campus are in fair condition with a few newer signs and poles that look to have been installed recently. A large percentage of the existing signs will need to be updated or replaced.

Typ. misc. sign to be replaced

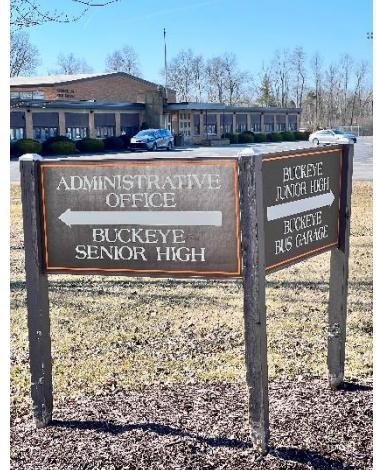
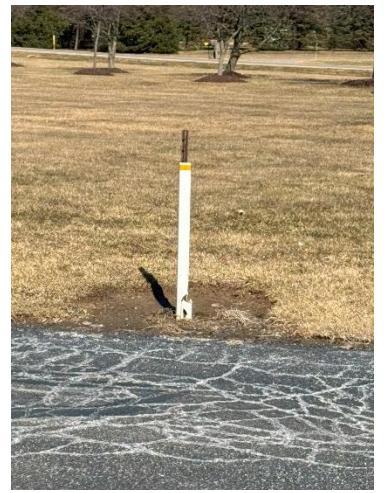
Typ. bldg. sign to be replaced Typ. sign post to be removed
