**Agenda Item Title:** Amendment to the FY26 Capital Request (GHS Pool Repairs)

# Facility Assessment and Recommendations for the Swimming Pool at Greenwich High School Greenwich, CT

TLB Architecture, LLC  
92 West Main Street  
Chester, Connecticut  
**March 3, 2025**  
TLBA Project # 2025-002

## III. Existing Conditions Analysis

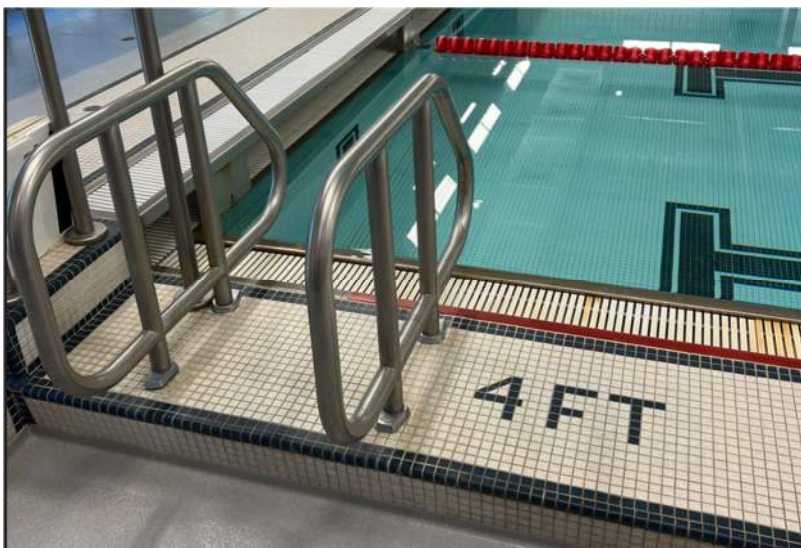
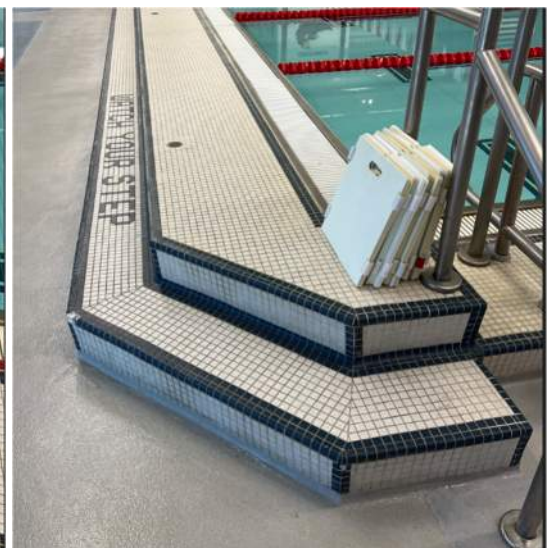
Photo 7 (Below Left): The bulkhead curb transitions from fully recessed at touch walls to semi-recessed at side walls.

Photo 8 (Below Right) Steps to raised bulkhead at shallow-end touch wall.

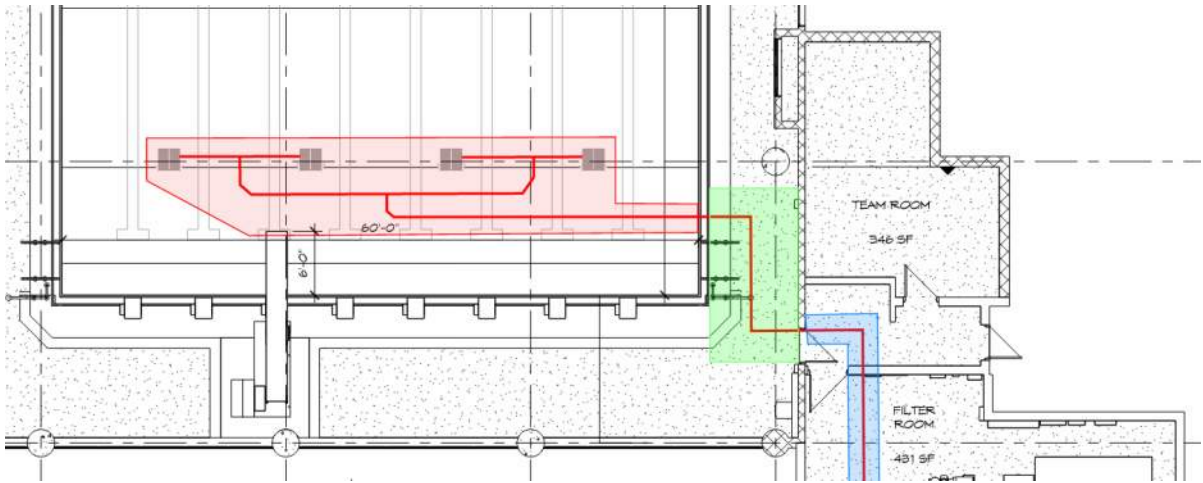
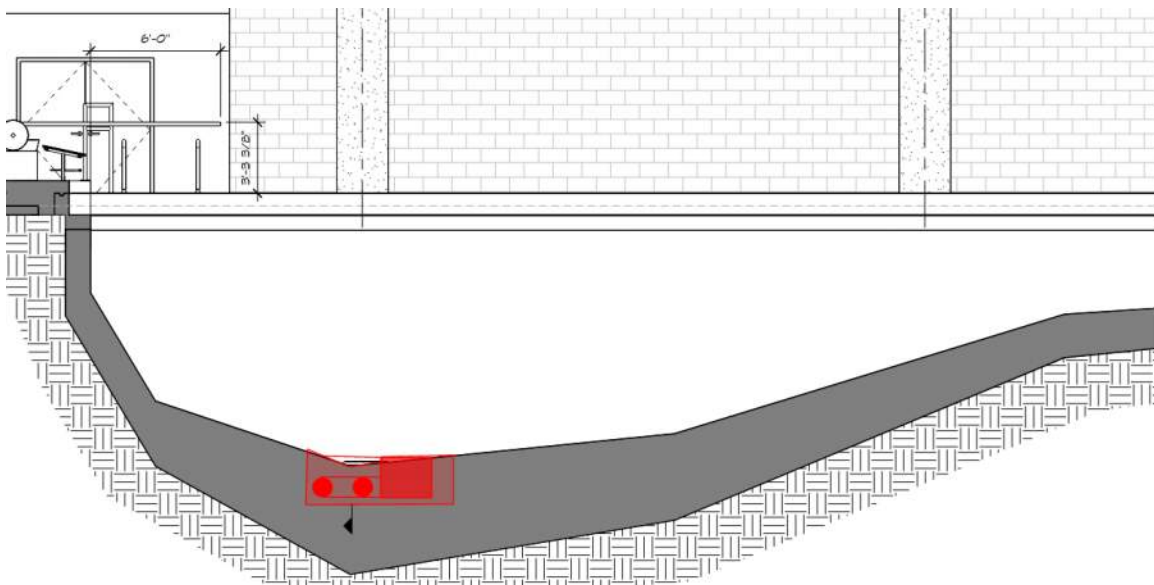
Pool Section (Not to Scale)

Option 2: For a fully compliant system, remove a portion of concrete pool floor to install new fully compliant sumps and drains, and properly configured piping. The pool floor is approximately 5-feet thick in the area of the drains. The approach would require removal of approximately 30" of concrete over an area of approximately 10-feet x 45-feet. It would also require remove of a portion of deck slab and excavation along the pool wall to the depth of the drain pipe.

Sawcut and remove approximately 30" deep concrete for new drains and piping.

Trench floor and excavate for new piping to surge tank, approximately 4-feet deep.

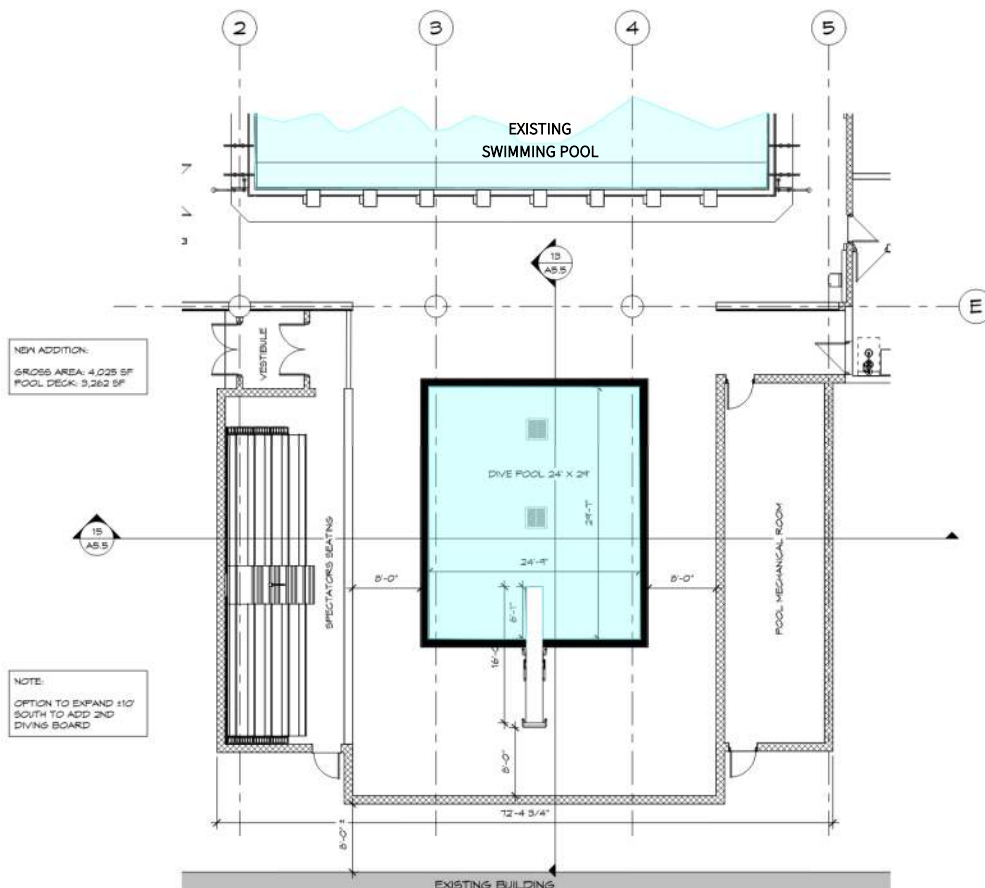
Floor Plan at Addition (Not to Scale)

- Option 3: Eliminate the diving well as noted in Option 1 and add a diving facility outside the footprint of the existing building, where sufficient height and depth is achievable. Below is a concept for locating the addition on the south side, in the courtyard area. This approach can provide a solution to all issues identified in this report.

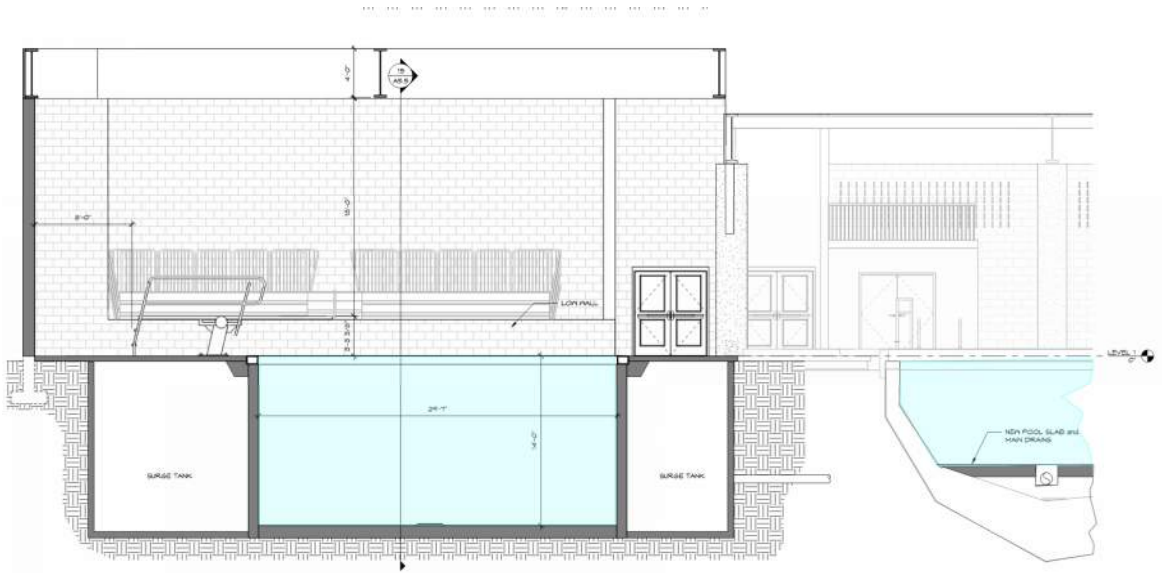
Pool Section at Addition (Not to Scale)

Option 3 (continued): Site utilities within the courtyard include electrical, storm piping and gas piping. All are original to the building and would require replacement in the proposed option. They could be re-routed further north and tie into the existing utilities where they enter the building.
