# 5.3 Kings Highway Elementary School

### Master Plan Facility Study for Westport Public Schools

# KINGS HIGHWAY ELEMENTARY SCHOOL

## 5.3.1 Architectural Conditions Analysis

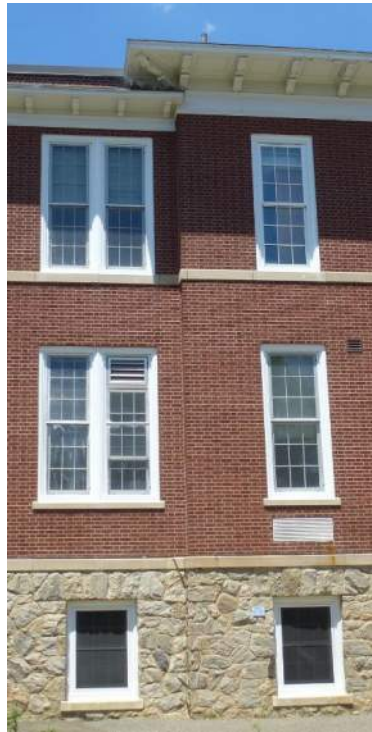
The exterior walls of this portion of the facility are constructed of rough stone/granite veneer on the Gymnasium Level and Ground Floor and brick veneer above, separated by stone belt courses. The brick has a Flemish bond pattern with raked joints. Walls are solid masonry with plaster interior finish typical of this period for a total wall thickness of approximately 15”.

The brick veneer and mortar joints are in good condition given their age. Mortar at rough stone veneer is cracked in multiple locations (predominantly at window heads; see structural facility survey) and requires repointing. Multiple joints in the stone belt courses are missing mortar. Minimal brick repointing required.

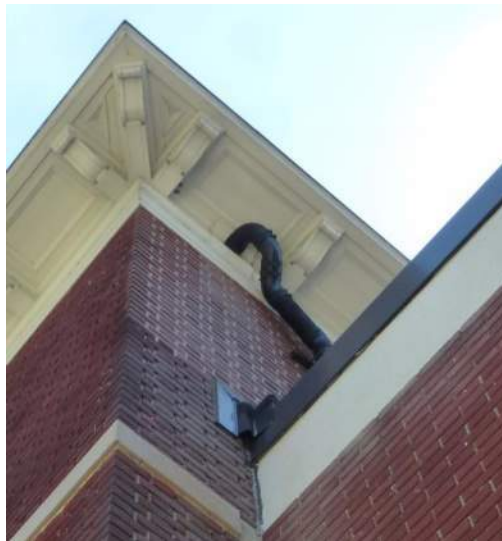
When the brick at the upper portion of the west wall was repointed, the joints were tooled as typical concave/flush and not raked as would match this building and the 1960's addition. Proper repointing recommended.

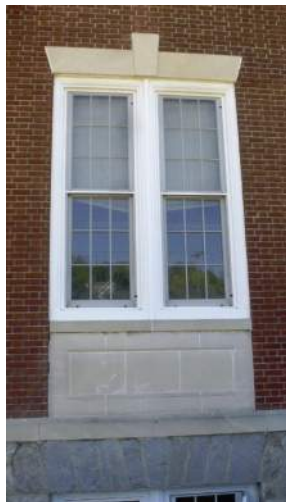
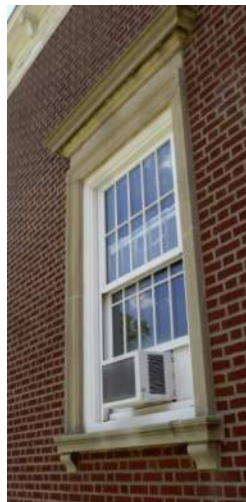
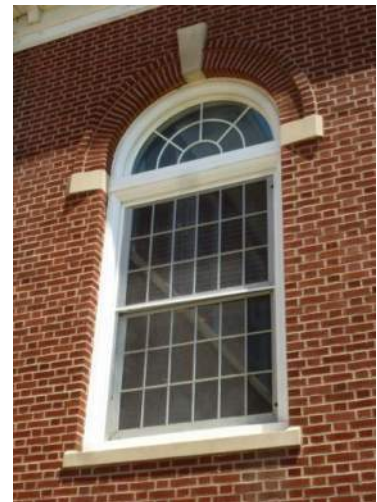
Windows and openings have various stone elements, including sills, lintels, arches, panels, and accents. Elements are in good condition given their age.

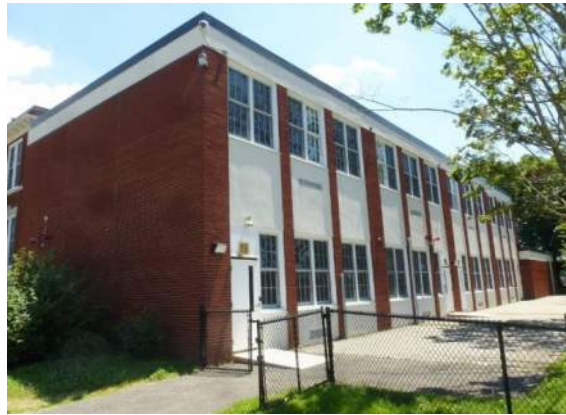
vener with stucco panels along the top of the building and between the first and second story windows. The brick has a standard running bond pattern with raked joints and concrete masonry unit (CMU) backup walls for a total wall thickness of approximately 13” (likely no insulation).

The brick veneer and mortar joints are in good condition with some mortar repointing required (notably on the east side). The Head Custodian conveyed that the brick of the entire south wall above the roof of the 1-story portion of the Addition was recently repointed. The sealant in most brick movement joints is aged and stiff (and missing in some areas). Rake joints completely and provide appropriate backer rod and sealant to complement mortar color.

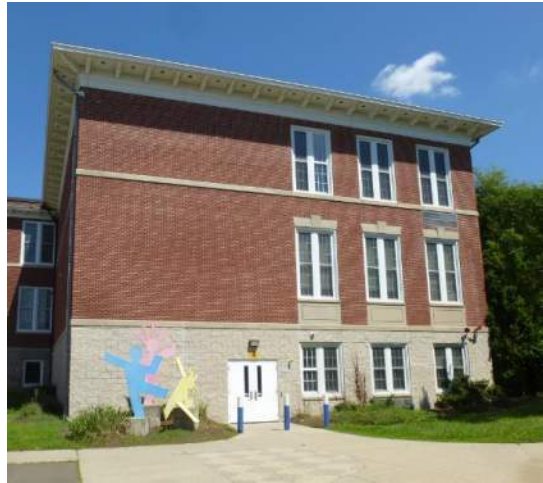
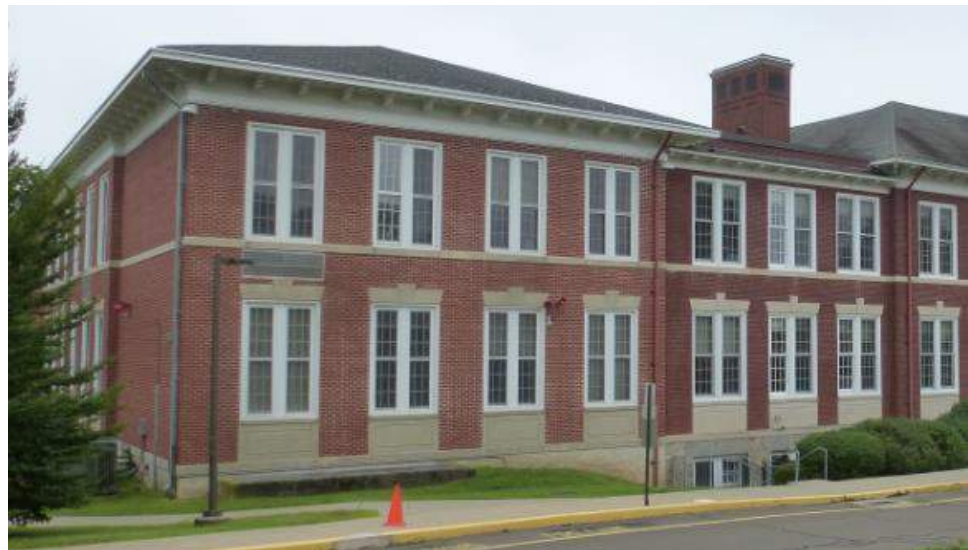
A split face concrete block ground floor is separated from two stories of brick veneer by a cast stone belt course. The same belt course defines the window sill line at the Second Floor windows. First Floor windows have cast stone lintels with keystones and sills with panels below. The design is intended to replicate the elements of the Original Building.

The brick is laid in standard running bond with standard, tooled mortar joints. Brick and mortar are in good condition, with only a few locations noticed for repointing. The walls are cavity-type construction with an airspace, 2” rigid insulation, and concrete block backup walls for a total wall thickness of 19”. Some interior walls, such as at the Library, are furred out with metal studs and finished with gypsum board.

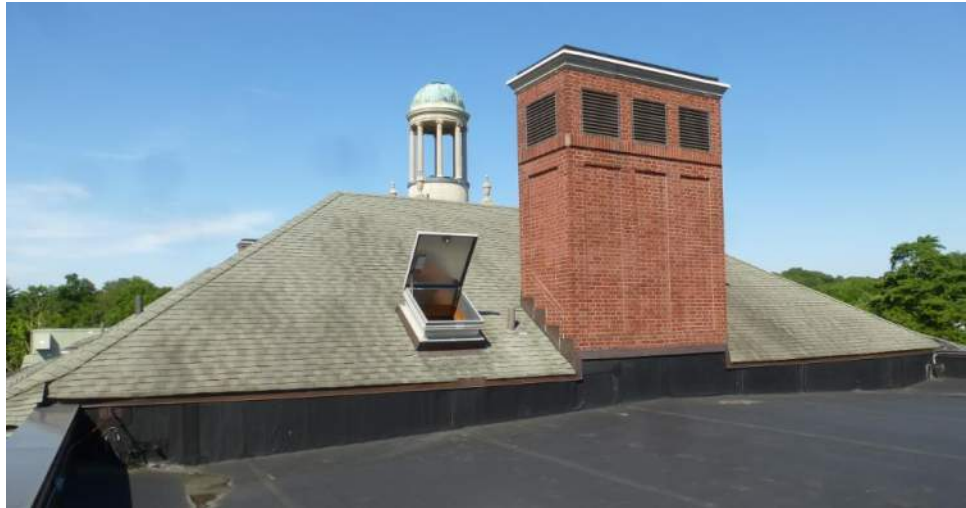
Flat roofs are typically 060 EPDM single-ply membrane in good condition. Per Offshore Construction, the Carlisle (manufacturer) warranty expires in 2021 and therefore should be replaced in perhaps 5 to 7 years. Roof drainage varies from traditional interior roof and overflow drains to perimeter parapet drains (piped to exposed downspouts) with thru-wall overflow scuppers. No major ponding was observed, and walkway pads are provided to and around major rooftop equipment.

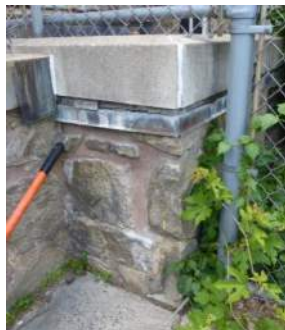
Metal copings and roof edges appear to be generally in good condition. At ground-level roof areas, the mortar underneath the stone copings requires repair in some locations.

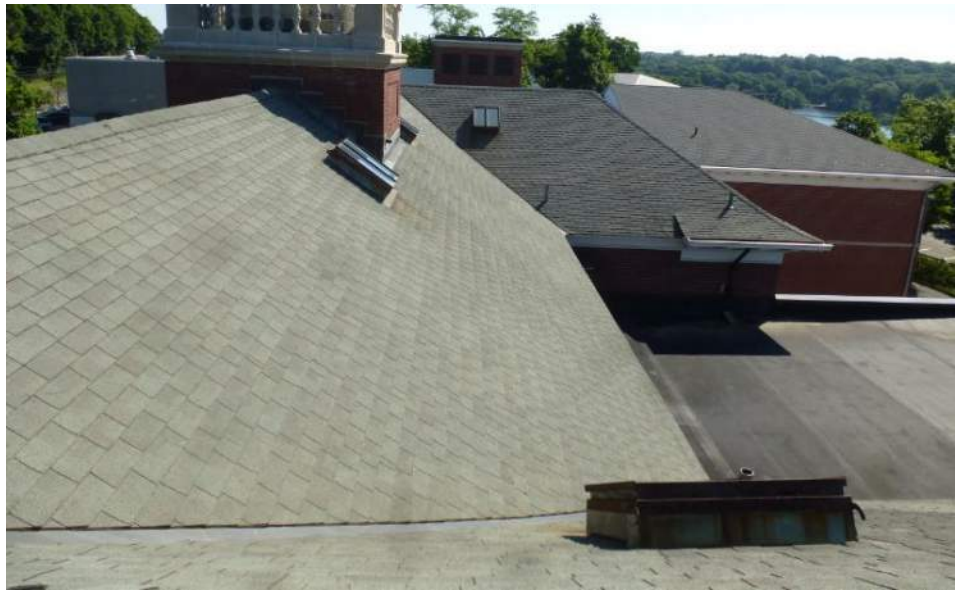
High-slope roofs are architectural asphalt shingles in hip and gable configurations with snow guards. Shingles and flashings are in good condition. The system warranty on the East Addition has expired per Offshore Construction (unsure of date) while the shingled roof areas of the Original Building appear to have been replaced in 2011 per data from the Westport Public Schools Facility Summary dated 5-6-2019.

Roof drainage consists of box gutters (copper at Original Building; aluminum and rubber membrane at East Addition) attached to various downspouts (painted round metal pipe at Original Building; galvanized square at East Addition) which empty to grade, onto other roof surfaces, or piped underground. Gutters and downspouts appear to be in good condition except that paint on downspouts is scratched in some areas.

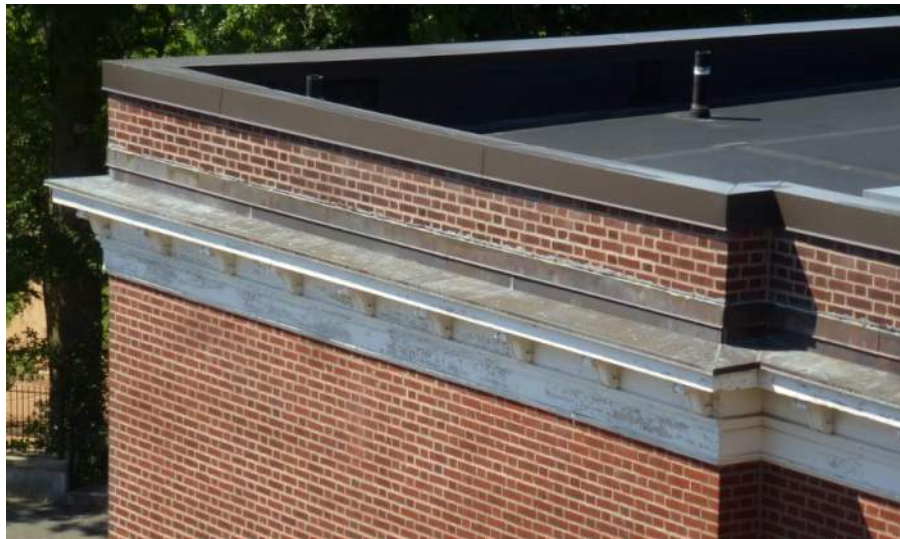
The Original Building has copper flashing and roofing on top of all cornices, which appears to be in good condition.

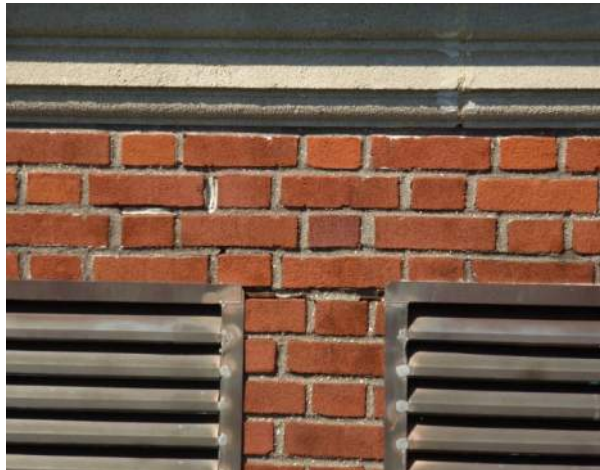
Both flat and sloped roofs are dotted with vent pipes, exhaust fans, and major mechanical equipment units. See the mechanical facility survey.

The various chimneys of the Original Building are constructed of mass brick with stone copings or caps and appear to be in good condition given their age. The two large main chimneys are used for ventilation and have rubber membrane roofs in good condition. Louvers are in fair condition but repointing

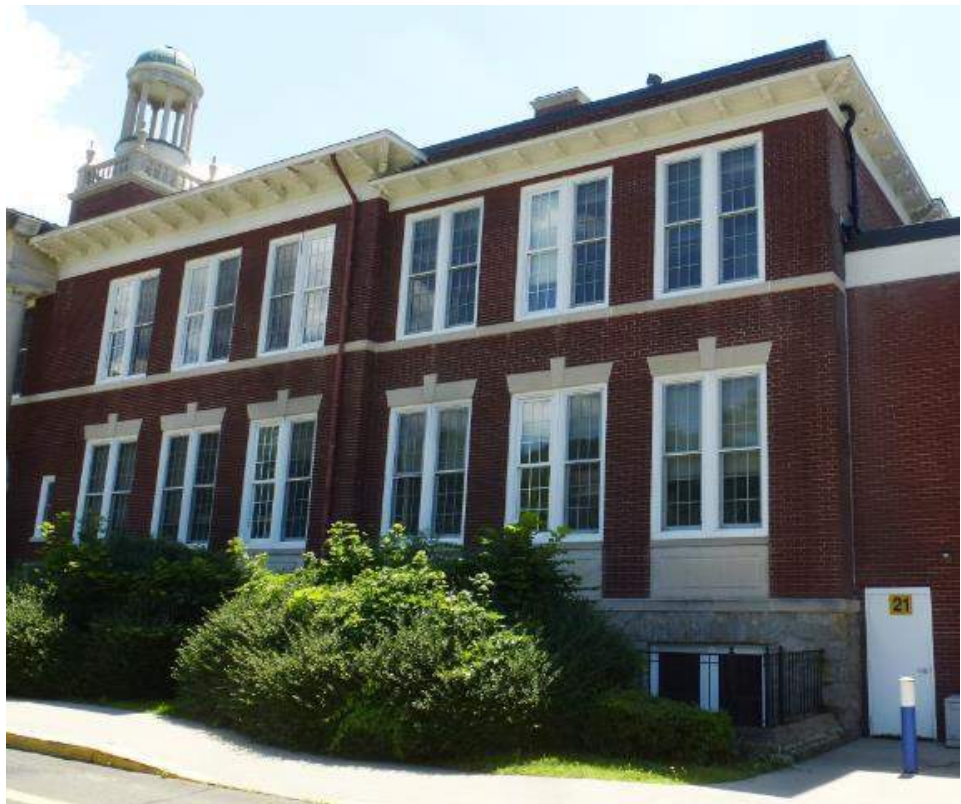
Most of the facility now has ducted air conditioning, so operable windows are typically no longer opened. Many insect screens are missing throughout the facility. According to the Head Custodian, most of these locations were former window air conditioners and the whereabouts of the missing screens is unknown. Missing screens are particularly unsightly on the north and east facades (facing the main roads) and should be installed.

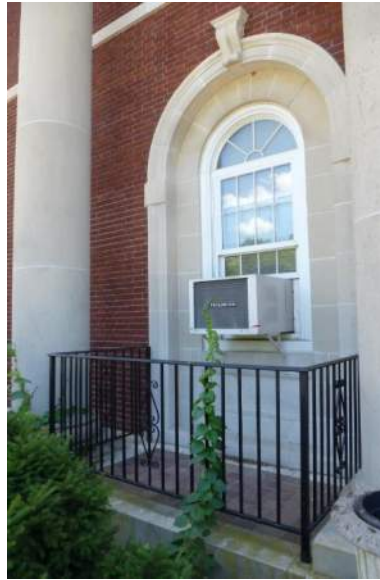
Several rooms (including Custodial Office, Mail Room, and Office adjacent to the stage in the Auditorium) still utilize window air conditioners. These commonly are maintenance and weather-tightness problems and they put strain on the window assembly. The Mail Room is particularly unsightly, being located at the main entrance to the school.

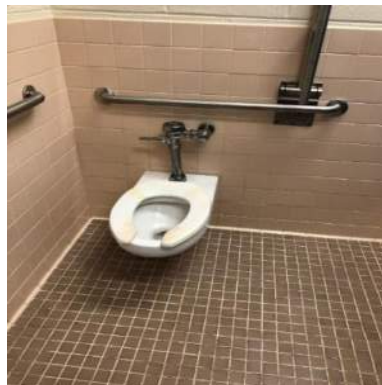
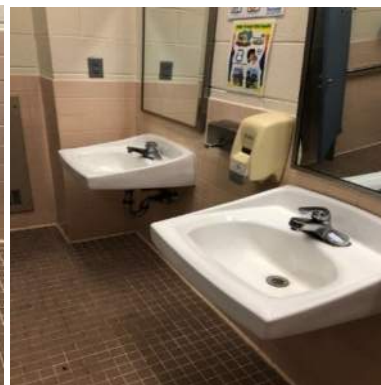
- I. Plumbing fixtures:
  - a. Water closets are vitreous china with manual flush valves though sensor activated flush valves were observed in a few locations. An upgrade to consider is the use of sensor activated flush valves.
  - b. Lavatories are wall hung vitreous china with varying faucets which are manual, lever handle or twist type. An upgrade to consider is the use of infrared activated faucets.
  - c. Urinals are vitreous china with manual flush valves. An upgrade to consider is the use of sensor activated flush valves.
  - d. Electric water coolers varied within the building. Some are simple manual activated units, some are more updated Elkay units, and some are more updated Elkay units with a sensor activated bottle filling station.
  - e. In general, many of the fixtures are old and need to be replaced.

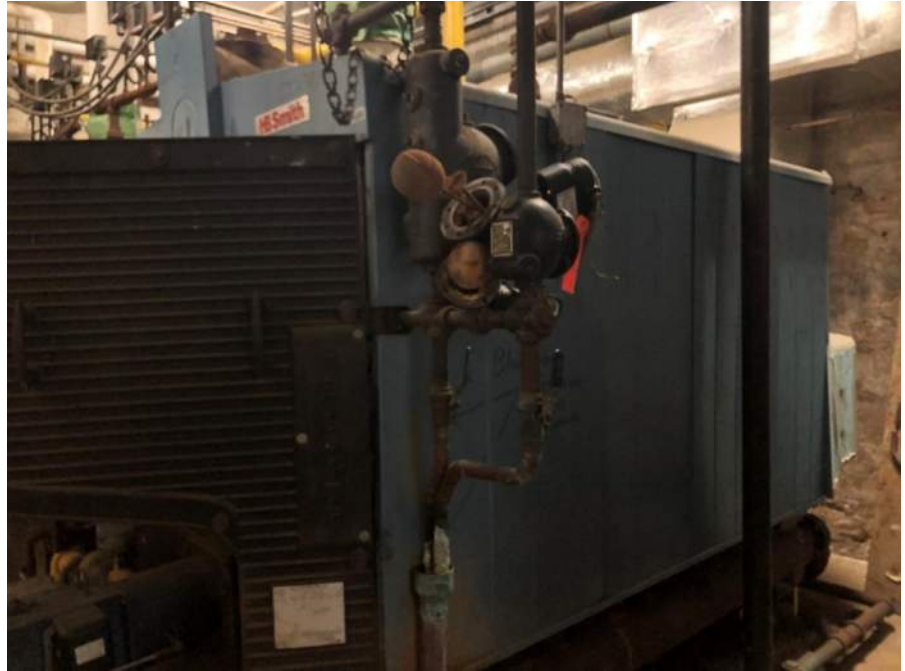
2. The boilers and accessories including but not limited to the burners, boiler feed pumps, condensate pumps and fuel oil transfer pumps are in poor condition.

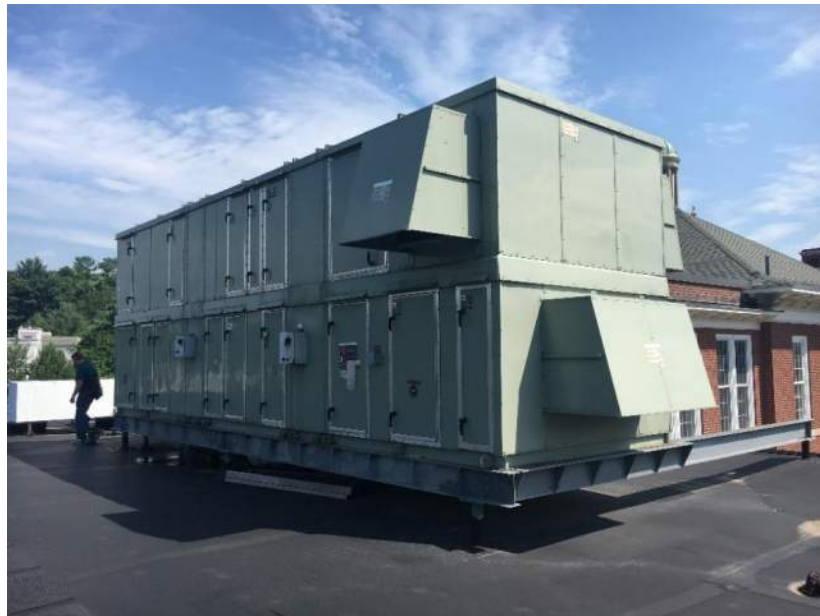
- I. Heating, ventilating and air conditioning is accomplished with a central dedicated outdoor air unit (DOA-I) and a number of air handling units and fan coil units. The units listed below are connected to the chiller plant.
  - a. DOA-I: This TRANE TCCB030 dedicated outside air unit was observed to be in good condition.
  - b. Large AHU's: There is one Trane Model BCV 090 unit serving the gym which is in good condition.
  - c. Small AHU's (AHU's / FCU's mostly located in the attic of ceiling space): There are 38 small Trane AHU's which were generally observed to be in good condition.

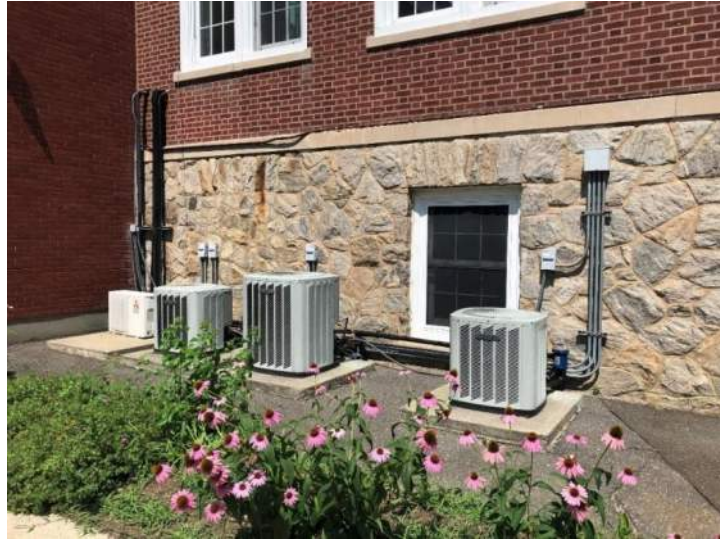
3. In addition to air handling equipment served by the chiller, there are also a few units as listed below which are DX and are served by a dedicated condensing units located outside the building:
  - a. There are three ceiling mounted units at the Main Office, Conference Room and Nurse's Office. These units were installed in 2004 and were observed to be in fair condition. They are served by outdoor units shown below.

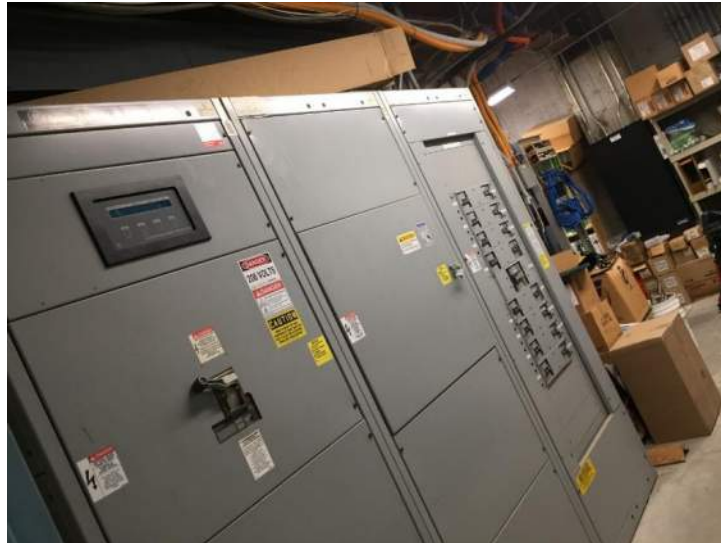
1. The building is served by GE Spectra switchgear at the service entrance which is rated at 1200 amperes, 208Y/120 volts, 3-phase, 4 wire. This is a three section switchboard. The service equipment is in good condition.

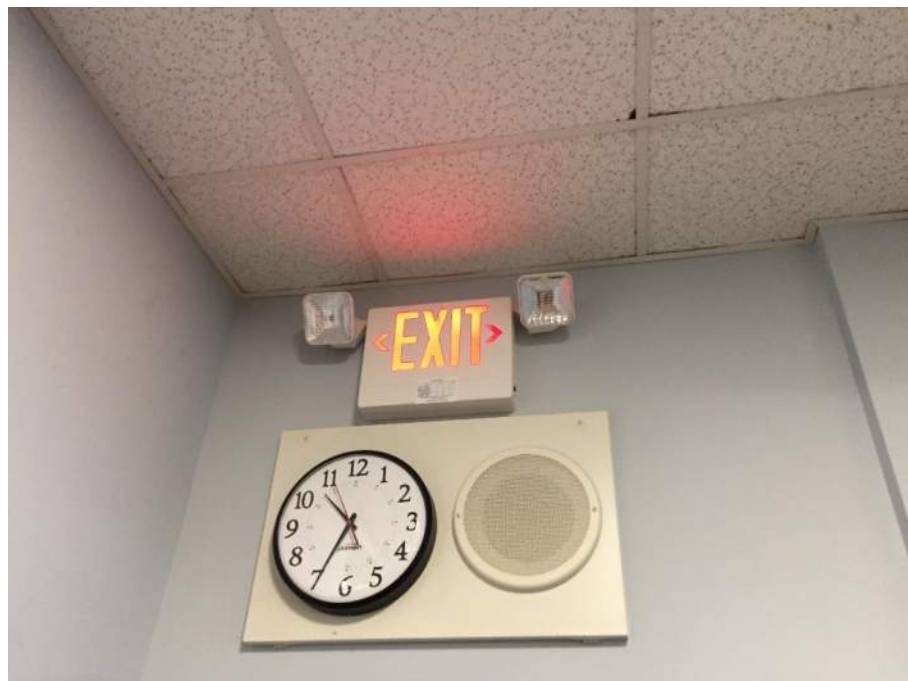
7. The PA system is a Telecor system. The head end and most of the end devices are in good condition. Classroom speakers appeared dated and damaged and were observed to be in fair condition.
8. The clock system is a Master Clock System and is in excellent condition.
9. The security system is a Sonitrol system and is in excellent condition.
10. Exit signs are battery backed LED, some with dual head emergency lights. Signs were in good condition.
