5.2 Greens Farms Elementary School

5.0 Existing Facility Survey

Master Plan Facility Study for Westport Public Schools

5.2.1 Architectural Conditions Analysis

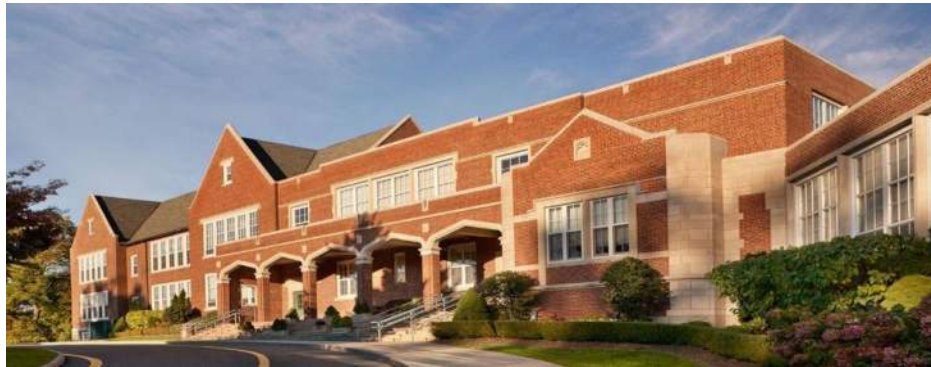
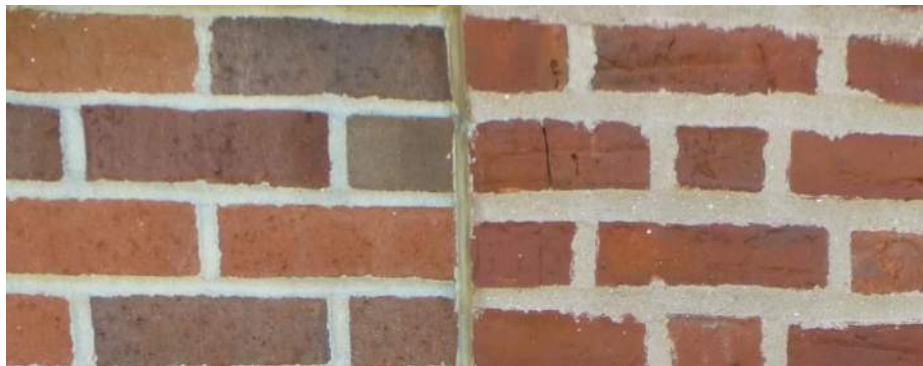
Overall, there were no obvious cracks in the masonry and stone veneer, and it appears to be in good condition. Mortar joints and caulk joints also appear to be free of deterioration and shrinkage.

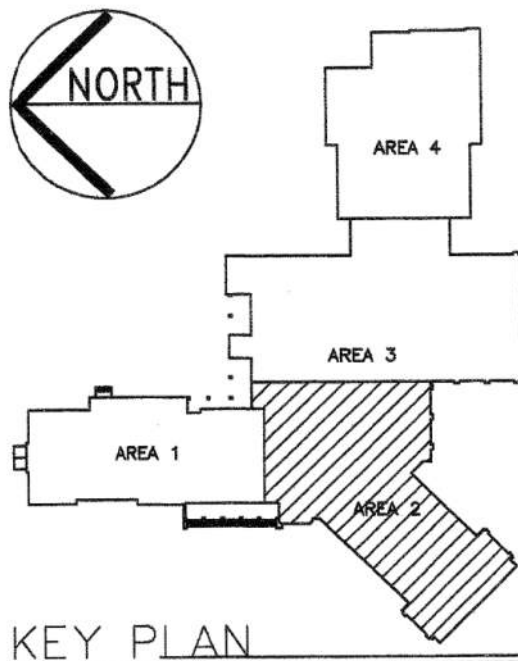
The structure consists of three distinct structures. The original structure (Area 1) built in 1925, a subsequent addition constructed to the south and angled to the west (Area 2) circa 1950, followed by an addition to the east of the original structure (Areas 3 & 4) constructed in 1997. Please refer to the Key Plan below.
