SCHOOL DISTRICT OF
WASHBURN

FACILITY Assessment

June 27, 2023

School District of Washburn Middle School and High School
305 West 4th Street
Washburn, WI 54891

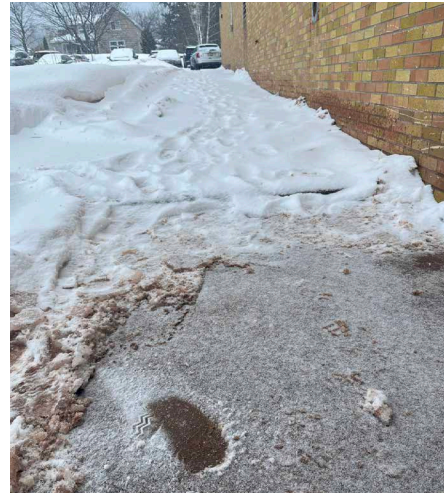
Sub-Category	Element	Condition	Priority	Details	Recommendation
Drainage	Parking Lot/ Near Door 25	Poor	I	Drainage in the area immediately outside of door 25 shows signs of ponding and sediment deposits due to improper drainage.	Reconstruct parking lot with stormwater management system.
Drainage	Door 23 Area	Poor	I	Drainage pattern flows across foundation at west facade and leads to step down at door 23, likely causing water issues. Regrade entire area for positive drainage away from door and foundation.	Improve site drainage.
Drainage	Door 26 Area	Poor	I	Drainage in the area immediately outside of door 26 shows signs of negative drainage towards entrance.	Regrade and consider retaining wall to achieve positive drainage.
Drainage	Door 20 Area	Poor	I	Drainage from scupper above door 20 has scoured and eroded the ground below creating negative drainage toward the building foundation.	Improve site drainage by adding fill and armoring ground with riprap rock.

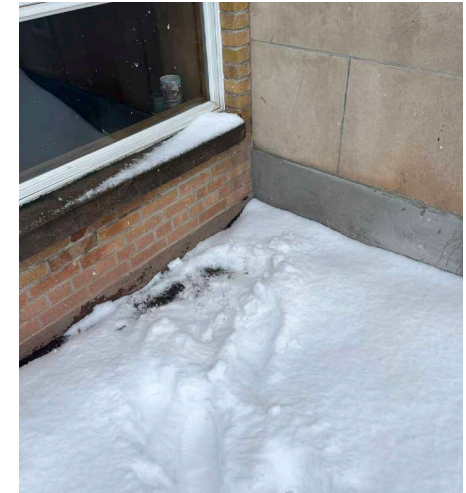
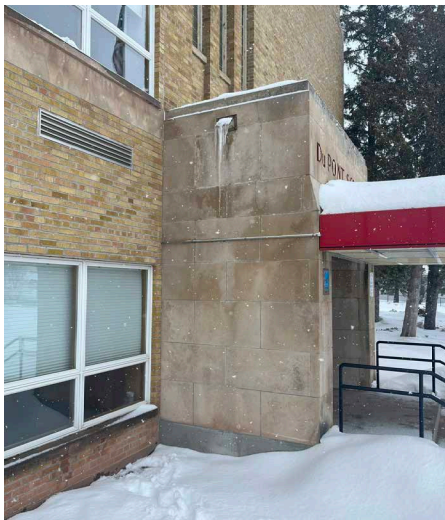
Door 20 Area

Drainage	Southern Facade Between Doors 20 + 21	Poor	I	Drainage from roof scupper has scoured and eroded the ground below and has created negative drainage toward the building foundation.	Improve site drainage by adding fill and armoring ground with riprap rock mulch.
Drainage	Door 21 Area	Poor	I	Drainage from scupper above door 21 has scoured and eroded the ground below and have created negative drainage toward the building foundation.	Improve site drainage by adding fill and armoring ground with riprap rock mulch.

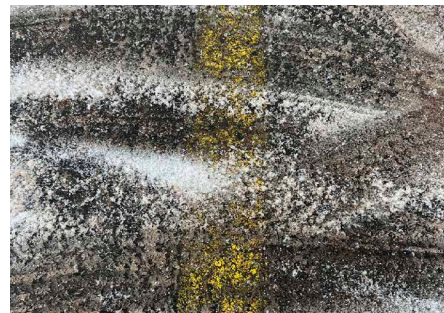
Vehicle Routes	Stop Sign at Northwest Parking Lot Entrance	Poor	2	Stop sign shows damage from snow removal and is out of plumb.	Reinstall sign.
Vehicle Routes	Pavement Striping	Fair	3	Pavement markings are fading.	Restripe parking areas.
Vehicle Routes	Pavement + Curbing/ Throughout Site	Fair	2	Due to weather conditions at the time of the site visit, the existing pavement and curbing throughout the site was not evaluated.	Reevaluate pavement and curbing in the spring.
Vehicle Routes	Street Sign/West 4th Street Near Solar Array	Poor	1	The street sign is missing.	Replace missing street sign.

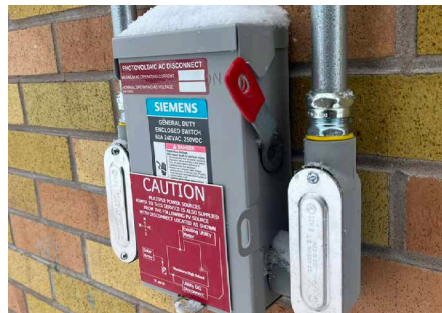
Disconnect/West Facade

Other Site Civil	Disconnect/ West Facade	Poor	1	Electrical disconnect should have lock to prevent tampering.	Install lock Immediately.
Other Site Civil	Chain-link Fence at Mechanical Equipment	Poor	1	Chain link security fence is compromised and damaged.	Repair and replace damaged elements.
Other Site Civil	Railing/Door 20 Area	Fair	2	Scratches and chips in railing paint are beginning to rust.	Prepare and repaint railing.
Other Site Civil	Railing/Door 21 Area	Fair	2	Scratches and chips in railing paint are beginning to rust.	Prepare and repaint railing.
Other Site Civil	Monument Sign	Fair	2	Paint is worn on wood elements of monument sign.	Prepare and repaint sign.

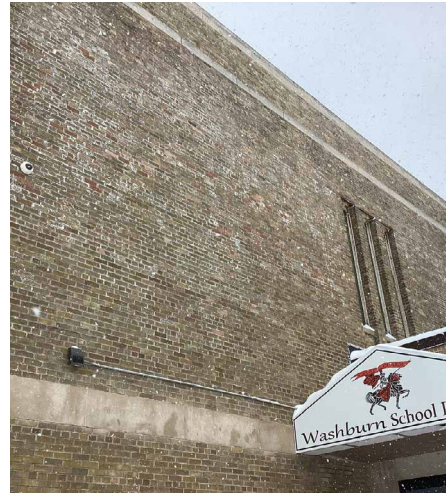
Sub-Category	Element	Condition	Priority	Details	Recommendation
Exterior Walls	Missing Vent Cover/ West Facade Near Door 23	Poor	1	Vent of unknown origin is missing vent cover.	Replace vent cover.
Exterior Walls	1942 Original Building Brick	Poor	1	Large portions of the brick are discolored and spalling due to moisture intrusion. The mortar is heavily damage throughout.	Perform exterior masonry repairs including repointing.
Exterior Walls	1948 Addition Brick	Fair	2	The 1948 addition features a common brick bond. No brick face damage was observed. Minor staining is evident to the west of the high school entrance.	Perform minor masonry repairs above and to the west of the high school entrance.
Exterior Walls	1954 Addition (Gym) Brick/Plaster	Poor	1	There is evidence of limited repointing done in the past. However, large portions of the brick are damaged, specifically on the upper north wall and west entrance. The mortar is missing in spots. The stucco material is missing from the west stack and moisture intrusion appears to be occurring at column locations throughout addition.	Perform exterior masonry repairs including repointing.

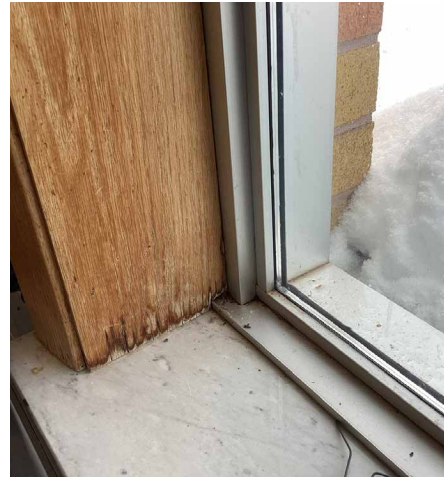
Sub-Category	Element	Condition	Priority	Details	Recommendation
Exterior Walls	Sealants/Throughout	Poor	1	Exterior sealants throughout the building are cracking and have lost flexibility.	Remove and replace exterior sealants.
Exterior Windows	Windows/ Throughout	Poor	1	Windows throughout the building are double-pane glass with aluminum frames. Older portions of the building feature glass block windows. Moisture penetration was apparent throughout. Most of the operable windows were difficult to open/close.	Replace windows.
Exterior Doors	Doors, Frames,+ Hardware/ Throughout	Fair	2	Exterior doors and frames have corrosion. The original gym entrance doors are not being utilized as the main entrance to the gym any longer. The number of doors could be reduced and still keep code required exit.	Replace corroded exterior doors, frames, and hardware.
Exterior Other	Window Opening Lintels/Original Building	Poor	2	Many of the original window opening lintels are heavily corroded. The corrosion appears to be the worst on the accent windows and the third floor openings.	Prepare and repaint lintels throughout. Replace in cases where lintels appear wavy or are delaminated.

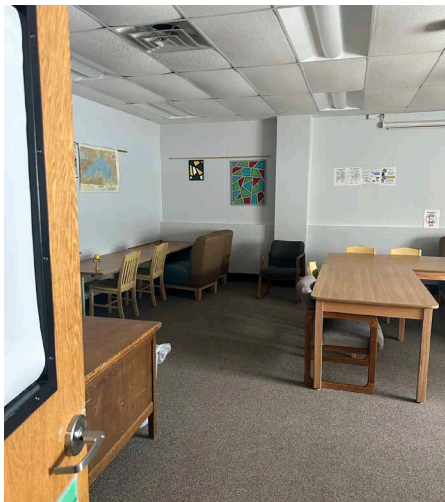
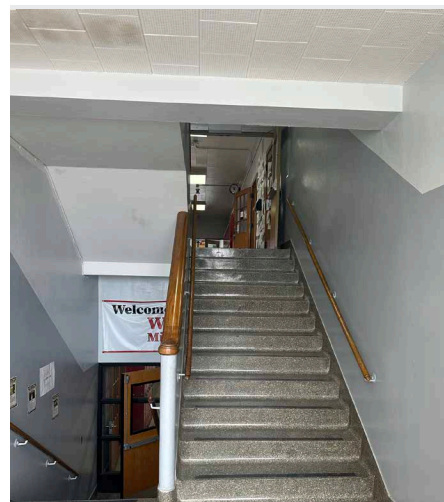
Interior Ceiling	Ceiling/Common Areas + Classrooms	Poor	1	Ceilings in common areas and classrooms are a combination of acoustical ceiling tiles (ACTs) that have water damage. Two by four ceiling tiles are sagging.	Replace ACT ceiling grid and tiles.
Interior Ceiling	Ceilings/ Locker Rooms	Poor	1	Locker room ceiling tiles are missing and replacements are not available.	Replace ceiling with hard surface gypsum ceiling.
Interior Ceiling	Ceiling/Band Room	Poor	2	The band room does not have a ceiling, which impacts acoustics.	Install a ceiling, new lighting, and acoustical wall treatments.

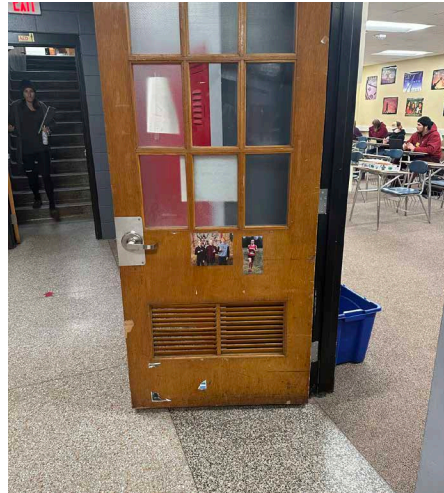
Sub-Category	Element	Condition	Priority	Details	Recommendation
Interior Walls	Walls	Fair	2	Walls are a combination of masonry, gypsum board, or fiberglass reinforced plastic (FRP), and while functional they give an outdated and worn look to spaces.	Refinish masonry and gypsum board walls and replace restroom floor and wall tile to refresh spaces.
Interior Walls	Display Cases/ Branding/Corridors	Poor	2	Most corridors lack quality display cases of student work. Materials and branding is inconsistent.	Increase the quantity of visual display cases in corridors. Replace corridor flooring, wall, and ceiling finishes to be consistent.
Interior Walls	Interior Signage/ Branding	Poor	2	Interior signage and branding is missing, worn, or outdated.	Replace room signage and incorporate branding into public spaces.
Interior Doors	Interior Doors	Poor	2	Many interior doors are original and damaged.	Replace doors.

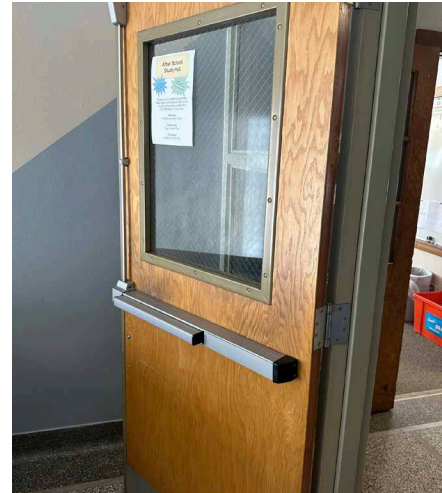
Interior Doors	Doors/Corridor	Poor	1	Original corridor to stair doors have wire glass, which is a safety hazard for students and staff.	Replace all wire glass with rated glass.
Interior Floors	Carpet + VCT Throughout	Poor	1	Carpet and vinyl composition tile (VCT) is outdated, worn, and has exceeded its useful service life.	Replace classroom flooring with new carpet and corridor type spaces with polished concrete. Replace stair flooring with new rubberized treads and risers.
Interior Floors	Floor/Stage	Poor	2	Stage floor is outdated, worn, and has exceeded its useful service life.	Replace stage floor with new wood stage floor assembly.

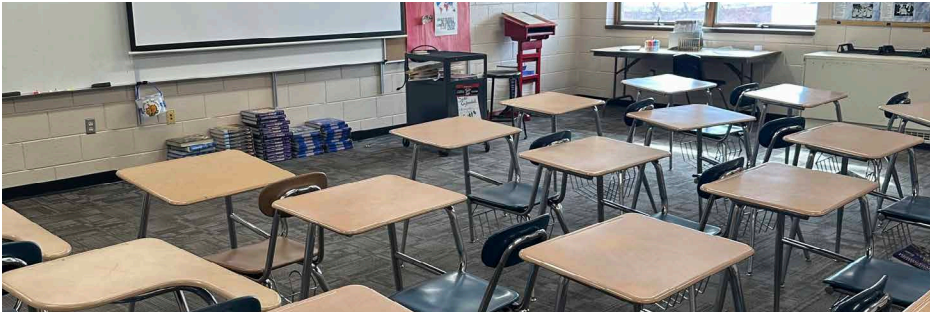
Lack of Casework

Sub-Category	Element	Condition	Priority	Details	Recommendation
Interior Floors	Vestibule Flooring	Poor	1	Vestibules have loosely-laid walk-off mats that can be a trip hazard.	Replace mats with walk-off carpet in vestibules
Interior Casework	Casework	Poor	2	Most classrooms lack casework for storage of materials. Instructional Materials Center (IMC) circulation desk is due for replacement.	Add mix of base and upper and tall storage cabinets in classrooms.
Interior Casework	Casework/ Science Lab	Poor	2	Casework in science lab is worn and due for replacement.	Replace casework.
Interior Other	Accessibilities/ Restroom Clearance	Poor	1	Many restroom floors lack proper accessible clearance.	Reconfigure restrooms for accessibility.
Interior Other	Stair Rails + Extensions	Poor	2	Many of the older stairs have handrails without proper extensions, or have handrails only on one side.	Replace handrails with proper extensions and install handrails on both sides.

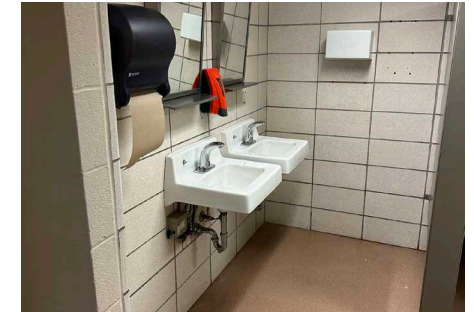
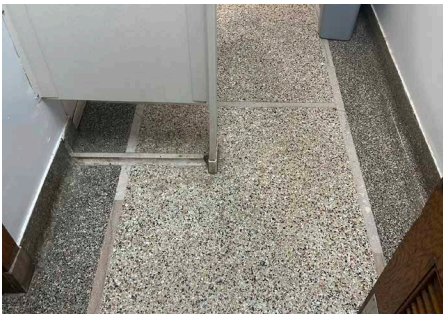
Accessibilities/Restroom Clearance

Interior Other	Accessible Route/ Entrance to Office	Poor	1	No accessible route from main entrance into office.	Reconfigure office, or create office addition in front of building to create accessible entrance with ramp/elevator to remainder of school levels.
Interior Other	Door Hardware	Poor	2	Some doors have non-ADA-compliant knob hardware.	Replace hardware with lever-style hardware.
Interior Other	Accessible Sink/ Art Room	Poor	1	Art room does not have ADA-compliant forward approach to the sink.	Replace restroom counter.
Interior Other	Ramp/Band Room	Poor	2	Ramp from band room to band storage is not ADA-compliant as it lacks handrails.	Replace ramp with handrails.
Interior Other	Shower Stall	Poor	1	Shower areas lack ADA-compliant shower stall.	Reconfigure showers.
Interior Other	Restrooms	Poor	1	Some restroom stalls are too narrow for required accessibility clearance and are therefore not ADA-compliant.	Reconfigure restroom stall.

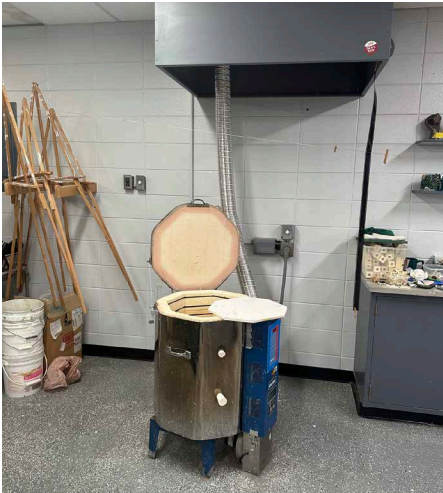
Sub-Category	Element	Condition	Priority	Details	Recommendation
Interior Other	Cooler/Freezer	Poor	1	Horizontal surface above cooler/freezer is used for storage, resulting in dust collection.	Enclose space above cooler/freezer.
Interior Other	Kiln/Art Room	Poor	1	Art room kiln is not in an enclosed, fire-rated room.	Construct a fire-rated kiln enclosure.
Interior Other	Framing/Technical Education Mezzanine	Poor	1	Technical education area mezzanine appears to be wood framed, which is not allowed under construction type.	Replace mezzanine.
Interior Other	Equipment/Gym	Poor	2	Gym equipment is outdated, worn, and has exceeded its useful service life.	Replace equipment.
Interior Other	Stage/Gym	Poor	1	There is no accessible route to the stage from the gym.	Construct an accessible route from the stage to the gym.
Interior Other	Furniture/Art Room and IMC	Poor	2	Some furniture is outdated, worn, and has exceeded its useful service life.	Replace furniture.

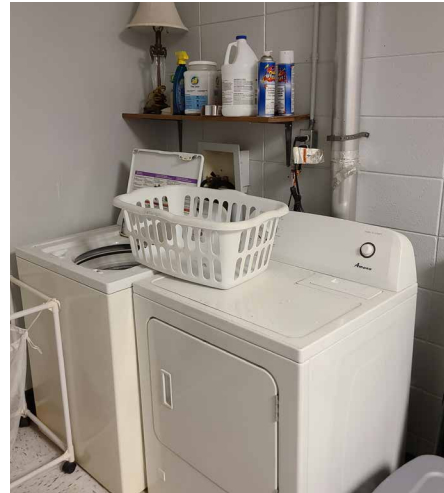
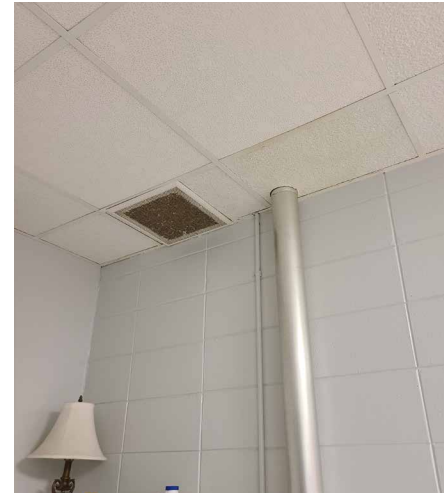
Mini-split, Washer + Dryer/Kitchen

Sub-Category	Element	Condition	Priority	Details	Recommendation
Heating Cooling	Mini-split, Washer and Dryer/Kitchen	Fair	3	Kitchen office has a mini-split heating and cooling system serving it. A washer and dryer are in the office corner. The dryer is near the exterior wall but must verify venting goes to outside.	Verify dryer vent length meets requirements and route directly outside, not into other ductwork if not already.
Heating Cooling	First Floor HVAC/1942	Poor	I	Building area served by gravity exhaust with pneumatic controlled dampers and classroom unit ventilators. There is no cooling or dehumidification. There is no exhaust in restrooms. Equipment was installed in the 1980s and is at the end of its useful life in terms of maintenance and controls operation.	Demolish existing systems/controls. Replace existing systems with new central air handling unit (AHU), ductwork and diffusers. New exhaust fan in restrooms, new DDC Controls.

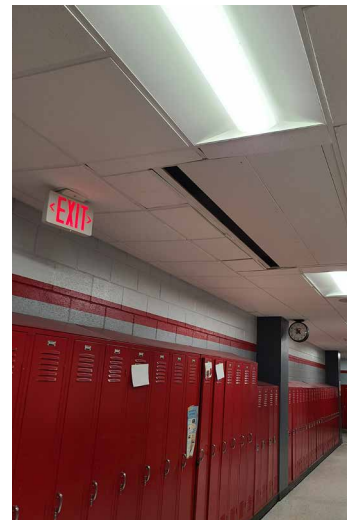
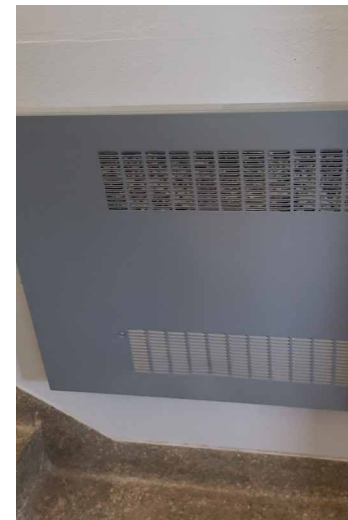
Heating Cooling	First Floor HVAC/1948	Poor	I	Building area served by gravity exhaust with pneumatic controlled dampers and classroom unit ventilators. There is no cooling or dehumidification. There is no exhaust in restrooms. Equipment was installed in the 1980s and is at the end of its useful life in terms of maintenance and controls operation.	Demolish existing systems/controls. Replace existing systems with new Central AHU, ductwork and diffusers. New exhaust fan in restrooms, new DDC Controls.

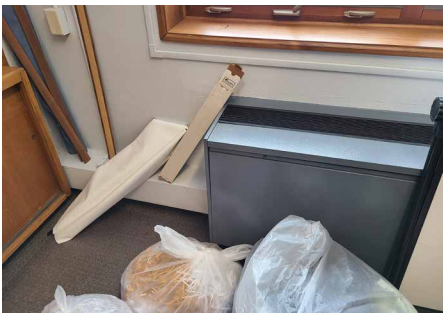
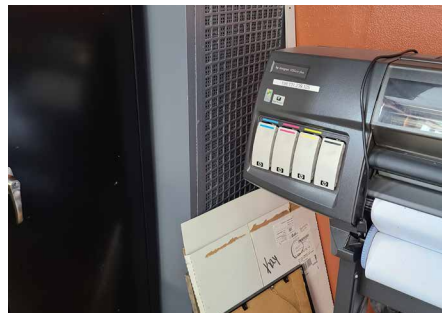
Second Floor HVAC/I942

Heating Cooling	Third Floor HVAC/1942	Poor	I	Building area served by gravity exhaust with pneumatic controlled dampers and classroom unit ventilators. There is no cooling or dehumidification. There is no exhaust in restrooms. Equipment was installed in the 1980s and is at the end of its useful service life in terms of maintenance and controls operation.	Demolish existing systems/controls. Replace existing systems with new central AHU, ductwork and diffusers. Install new exhaust in restrooms and new direct digital controls (DDC).

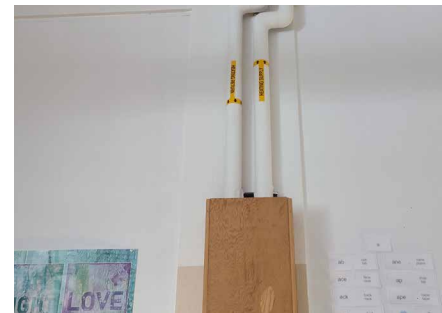
Second Floor HVAC/I942

Sub-Category	Element	Condition	Priority	Details	Recommendation
Heating Cooling	Second Floor HVAC/1948	Poor	I	Building area served by gravity exhaust with pneumatic controlled dampers and classroom unit ventilators. There is no cooling or dehumidification. There is no exhaust in Restrooms. Equipment was installed in the 1980s and is at the end of its useful life in terms of maintenance and controls operation.	Demolish existing systems/controls. Replace existing systems with new central AHU, ductwork, and diffusers. New exhaust fan in restrooms, new DDC controls.
Heating Cooling	Second Floor HVAC/1972	Poor	I	Area is served by gravity exhaust with pneumatic controlled dampers and classroom ducted fan coil units. There is no cooling or dehumidification. There is no exhaust in restrooms. Equipment was installed in the 1980s and is at the end of its useful life in terms of maintenance and controls operation.	Demolish existing HVAC systems. Provide new air handler and exhaust to meet code. Route new laundry exhaust duct.

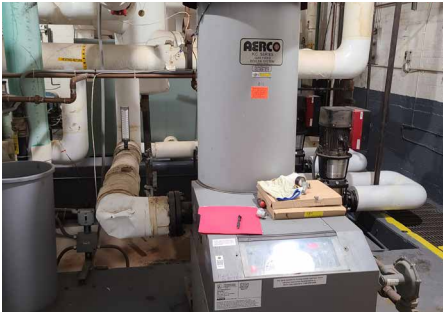
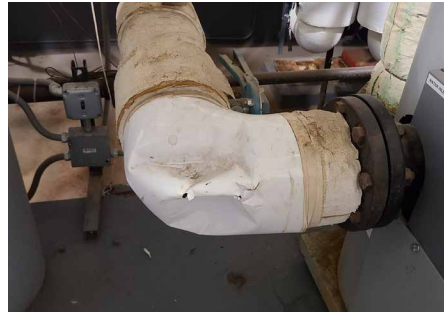
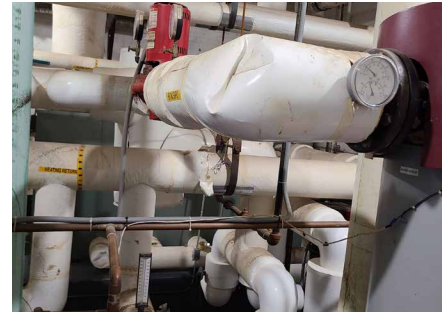
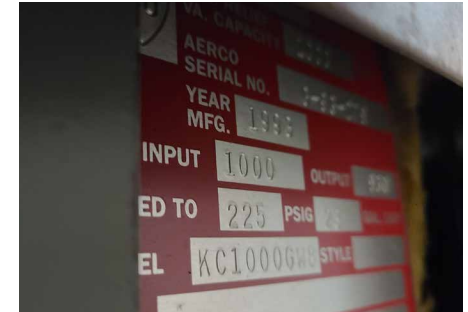
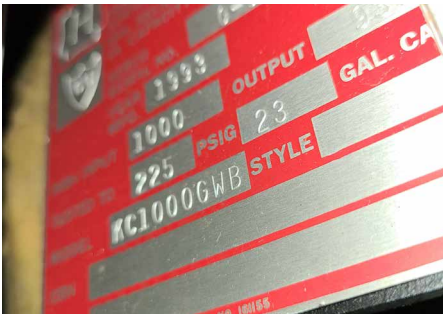
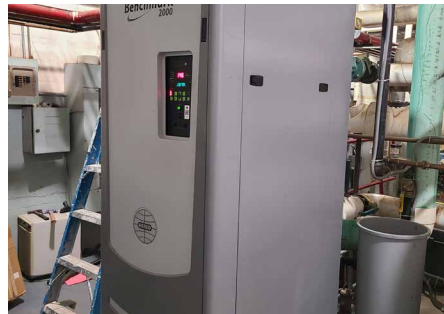
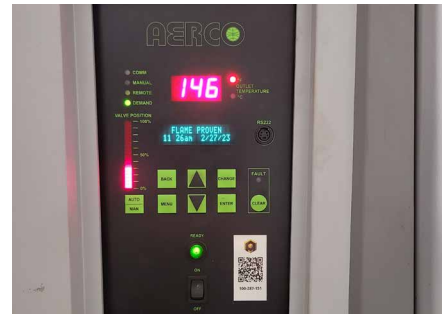
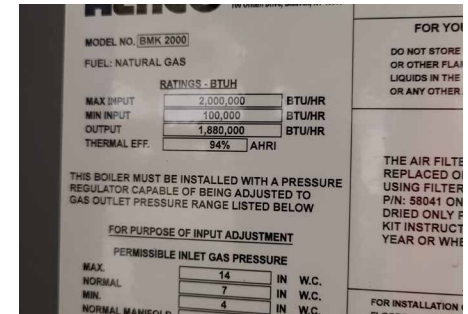
Sub-Category	Element	Condition	Priority	Details	Recommendation
Heating Cooling	Structural Reinforcement for HVAC/Building	Poor	1	Structural reinforcement for new HVAC system is likely due to added equipment and ductwork for central system.	Update structural as required to support new roof-mounted equipment.
Piping Heating Cooling	Water Boilers/105/Boiler Room	Poor	1	There are two natural gas-fired hot water boilers that supply the building's heating system. One was installed in 1993 and the other in 2018. The average useful service life is 15 years.	Replace 1993 Boiler with a 2 million btu Aerco Benchmark to match 2018 installation. Add new unit to existing boiler plant controls.
Piping Heating Cooling	Steam Boiler/105/Boiler Room	Poor	2	The abandoned steam boiler remains in place in the boiler room. This boiler is no longer in use along with the back-up fuel oil system.	Remove the boiler and fuel oil tanks.

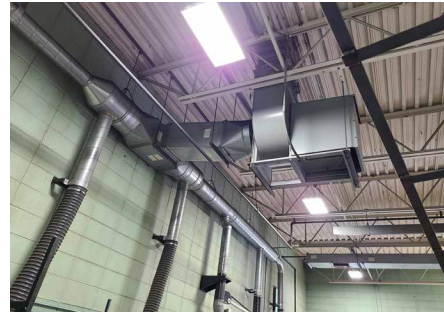
Sub-Category	Element	Condition	Priority	Details	Recommendation
Other Mechanical	240/Technology Education	Fair	2	Staff reported the fan to be slightly underpowered for the quantity of welding booths that are connected. Utility set fan is noisy and disruptive.	Provide new roof-mounted fan and ductwork through existing penetration.
Other Mechanical	Walk-In Freezer and Cooler/Kitchen	Poor	1	Walk in freezer and cooler are original per staff (1972). Floors are rotted out. Water and moisture is frozen under the floor. If freezer and cooler are shut off, the floor thaws and floods. Compressors are in tunnel below stairs and overheat due to lack of cooling.	Replace refrigeration system serving freezer and cooler. Cost to replace enclosure for new freezer and cooler, is provided in the architectural costs).
Other Mechanical	Emergency Gas Shut Off Valve 124/Science	Poor	1	The emergency gas shut off valve is in a locked box in the hallway. This is not code compliant and will need to be updated.	Update gas shut offs to include required manual valve at or near teachers station. Install emergency power off (EPO) switch under plastic cover at egress doorway.

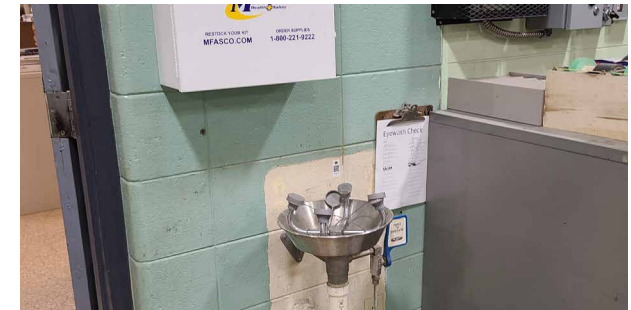
240/Technical Education Eye Wash Station

Other Mechanical	Grille/Mini-Split/214/ Main Server Room	Fair	2	Grille and mini-split serve the main server room. Staff report the room exceeds 80°F if the door is closed in winter. Mini-split is off in the winter and the cooling provided by the HVAC isn't adequately serving the space.	Modify HVAC to increase airflow to server closet to adequate levels to offset the heat gain. Cost is included in the HVAC replacement for the 1987 addition.
Plumbing Water	Water Heaters/105/ Boiler Room	Fair	1	There are two gas-fired water heaters installed in 1998 that provide potable hot water to the building. The average useful service life of water heaters is 15 years. Equipment is past expected useful service life.	Remove and replace water heaters with equivalent natural gas fired water heaters.
Plumbing Water	240/Tech Education	Fair	2	Emergency eye-wash station is original to the building, but still functioning. This only has cold water supplied to it which is not compliant with current code.	Replace with current code compliant eye-wash with tepid water (60-100°F). Route hot water pipe to new fixture or add instant water heater with new eye-wash.

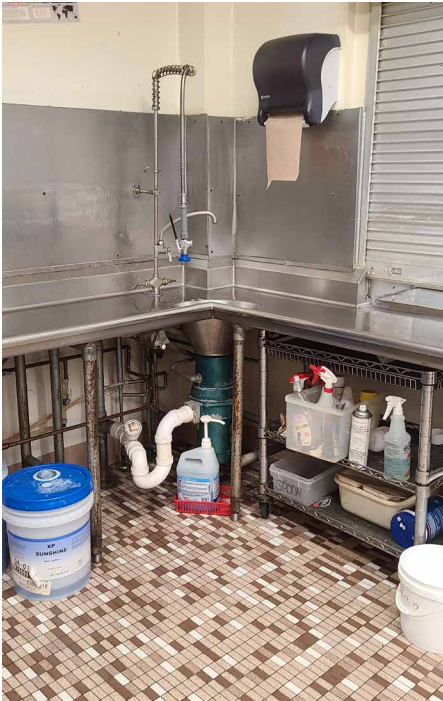
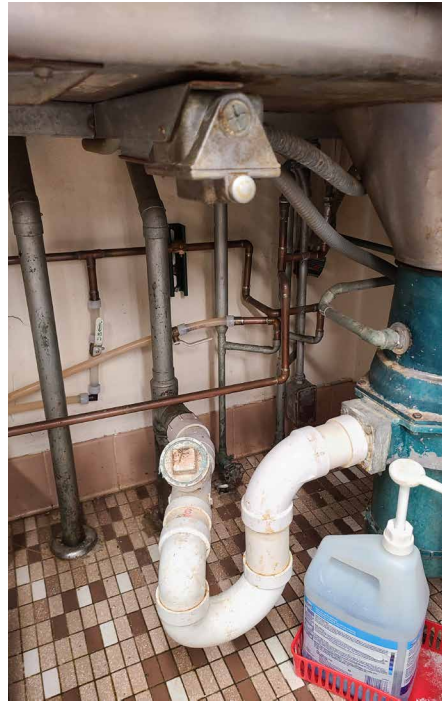
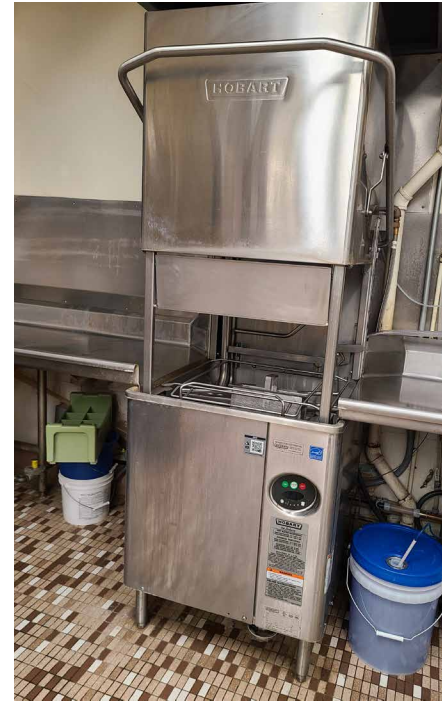
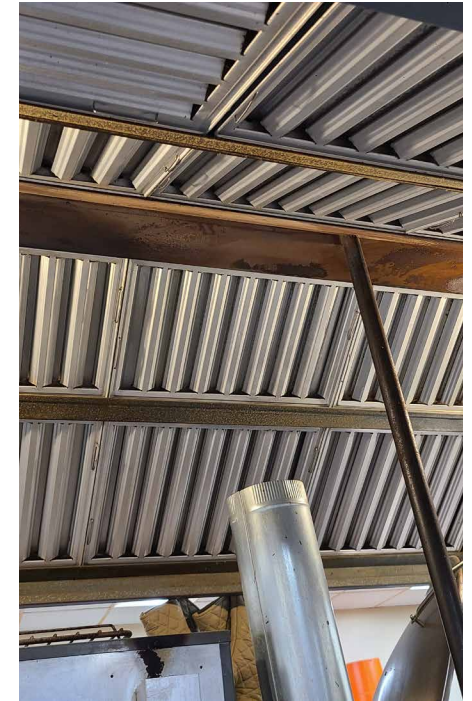
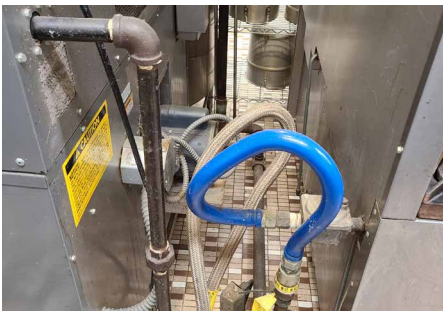
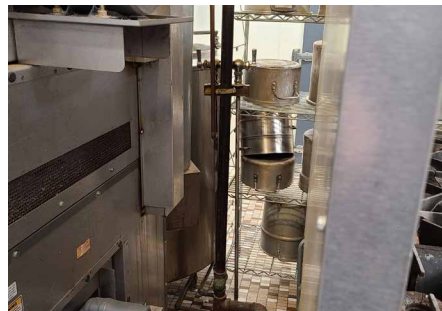
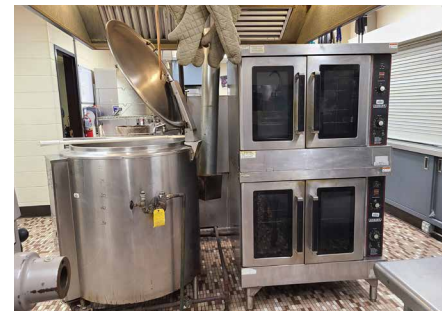
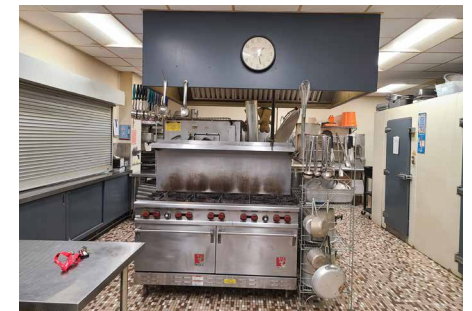
Sub-Category	Element	Condition	Priority	Details	Recommendation
Plumbing Water	Galvanized Pipes/ Building	Poor	1	Existing galvanized sanitary pipes are failing in multiple locations throughout the building. Many of the failures are inaccessible or underground. Repairs have been made with PVC/cast iron in accessible areas as needed. Many fixtures are no longer able to drain.	Further investigations can be made by using cameras. Is it likely the entire drainage system will have to be replaced. Substantial floor cutting and patching would be necessary to replace under-floor piping. Replace plumbing fixtures and reconfigure restrooms as necessary. Provide floor drains in restrooms.
Plumbing Water	Plumbing/Kitchen	Poor	1	Kitchen equipment and piping original to building and outdated. Walk in cooler and freezer are failing and will be replaced by architecture per individual component line item. Galvanized piping serving fixtures needs to be replaced. A three-compartment sink sanitary drainage needs to route to grease interceptor and this cannot be verified above floor.	Provide new plumbing/HVAC as part of full kitchen renovation. Cost does not include kitchen equipment. This shall be provided by kitchen designer. Route all fixtures to grease interceptor per code requirements.

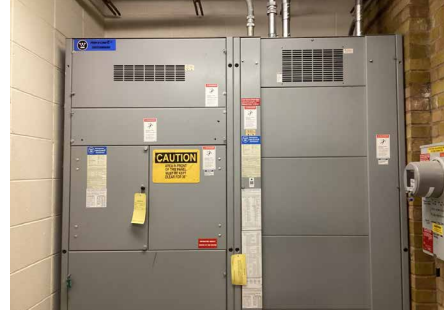
Sub-Category	Element	Condition	Priority	Details	Recommendation
Power Supply	Power Cord Reels/ Art Room	Poor	1	Power cord reels are hung from the structure and enter rooms through removed ceiling tiles.	Move cord reels below the ceiling tiles and re-install missing ceiling tile to maintain smoke separation.
Power Supply	Main Distribution Panel/ Concession Stand	Good	3	The main distribution panel is located in a small room adjacent to the concession stand. The 1,200 amp, Westinghouse brand panel was installed in 1994. The average useful life is 40 years. It appears to be adequately sized for the building.	Perform regular maintenance.
Power Supply	Switchboards/ Throughout Original Building + 1948 Addition	Poor	1	There are three Cutler-Hammer brand fusible switchboards located in the original building and 1948 addition. They appear to be original to construction. The average useful life is 40 years.	Replace with a switchboard that has circuit breakers.

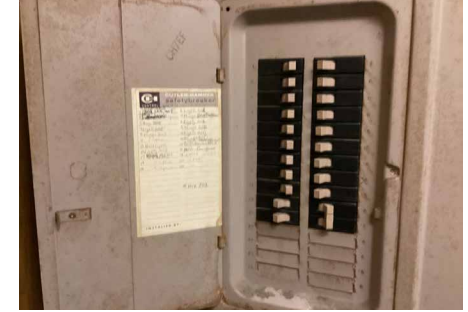
Branch Panels

Power Supply	Branch Panels/ Throughout	Fair	2	All of the branch panels observed throughout the facility are either past or approaching their average useful service life. All were installed between 1972 and 2000. Some panels have missing breakers with exposed wiring. System components are obsolete.	Replace panels.
Power Supply	Classroom Receptacles	Poor	2	The facility lacks receptacles for devices resulting in power strips and extension cords. There are no tamper resistant receptacles.	Replace and add receptacles.

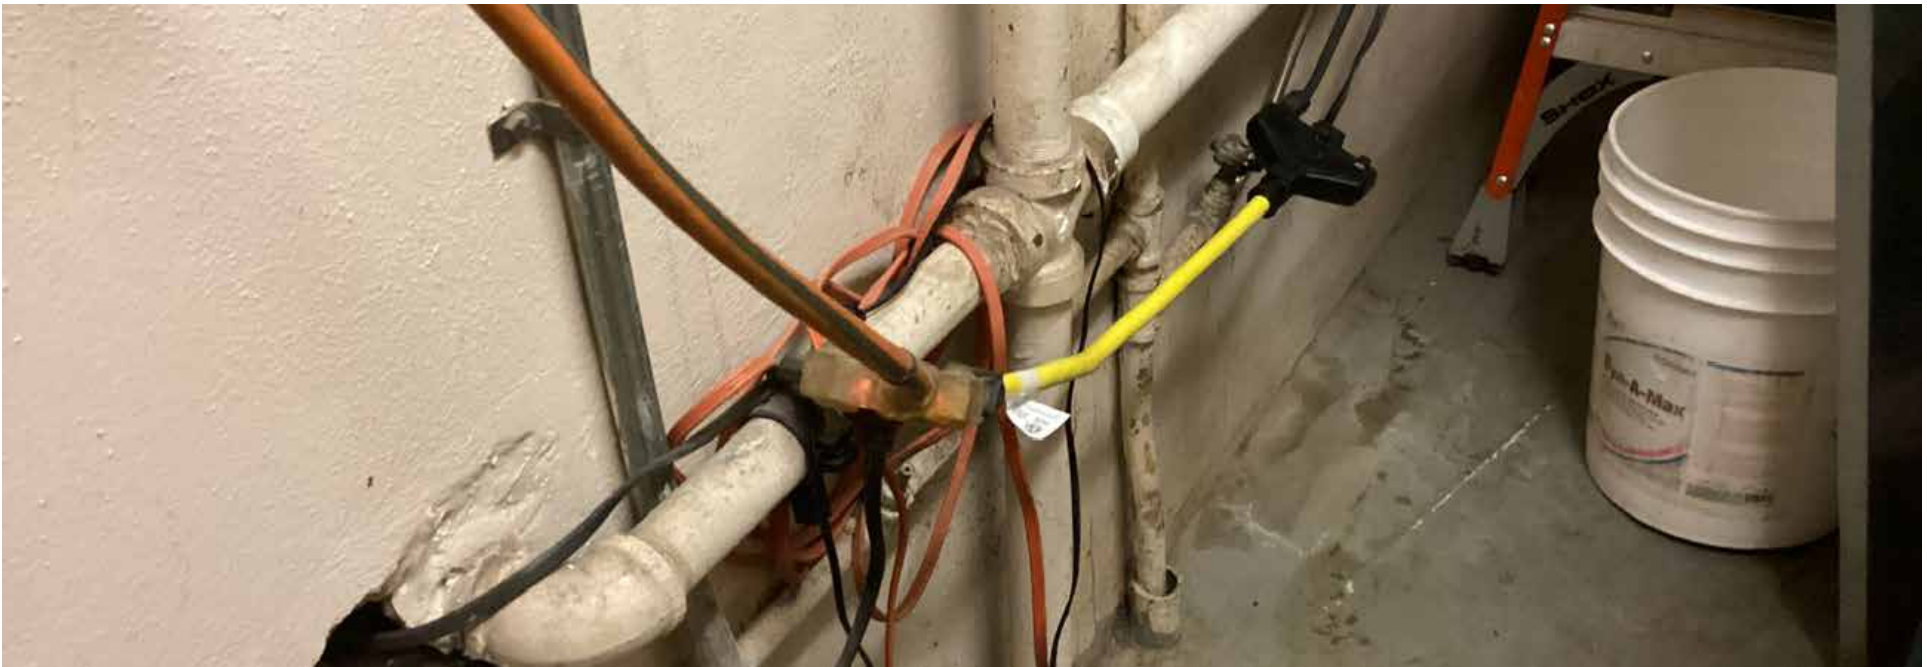
Extension Cord Used as Permanent Wiring

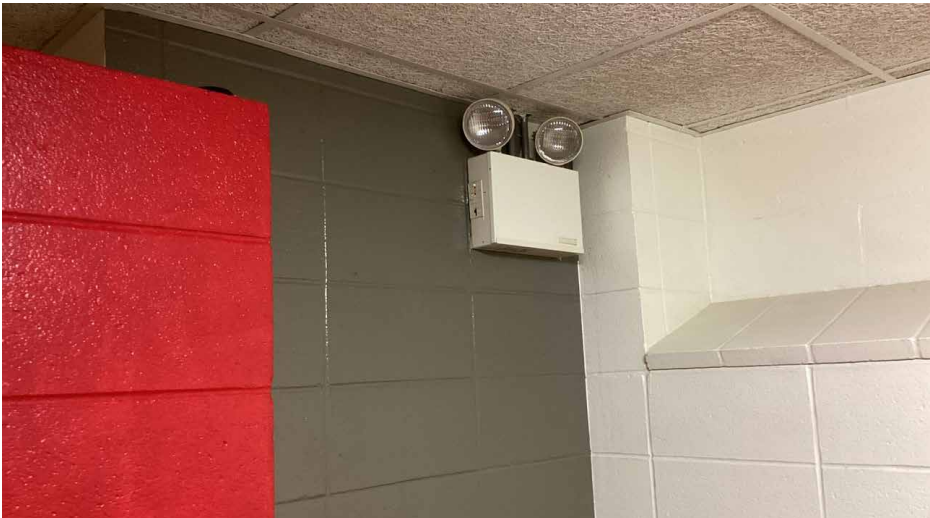
Emergency Lighting

Life Safety	Fire Alarm	Good	3	The fire alarm panel and associated devices were recently updated to voice notification.	Perform regular maintenance.
Life Safety	Emergency Lighting/ Throughout	Poor	1	Many of the emergency lighting fixtures appeared past their useful service life.	Replace emergency lighting system.
Life Safety	Paging System/ Throughout	Fair	2	The paging system is connected to the clocks, bells, and phone system. The main system controls are having issues. The speakers throughout the building are outdated.	Upgrade main system controls and speakers.
Security	Security Cameras/ Throughout	Fair	2	A network of Verkade brand security cameras are located throughout the building interior and exterior. They were installed around 2017. Coverage appears to be adequate. Cameras are programmed to detect intruders while building is unoccupied.	Perform regular maintenance.

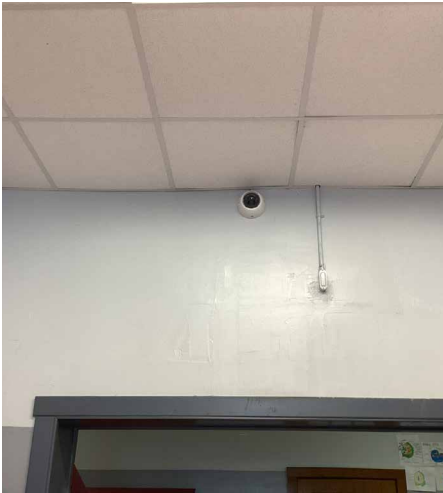
Security Cameras

Sub-Category	Element	Condition	Priority	Details	Recommendation
Security	Door Access/ Throughout	Fair	2	An Axis brand door access system is installed on five exterior doors around the building. The IT Director reports having issues with this system. Other doors located around the building have access control installed without audio/video capabilities.	Upgrade door access and video intercom system.
Data Network	Wi-Fi/Throughout	Good	3	Wi-Fi access points are located throughout the building. Coverage is reported to be adequate. The system was updated in 2020.	Perform regular maintenance.
Data Network	214/Technology Room	Good	3	Servers and technology equipment for the building appear to be in working order. Cables within the equipment racks could be better organized.	Perform regular maintenance and clean up cabling in equipment racks.
Audiovisual	Gym Speakers + Scoreboards	Good	3	The gym speakers were updated recently. The two scoreboards were also replaced.	Perform regular maintenance.
