| FIVE-YEAR CAPITAL FACILITIES PLAN | | | | | | | | | | | | | | | | |
| District Name: | Onteora CSD | | | <div>ITEM NUMBER LEGEND</div> <div>BLDG BCS# ITEM BCS YR.</div> <div>FES - 067 - 01 - 21 [00 is no BCS #]</div> | | <div>SYSTEM TYPE</div> <div>HS - Health &amp; Safety</div> <div>ST - Structure</div> <div>EE - Energy Efficiency</div> <div>AP - Asset Preservation</div> | | <div>SYSTEM RATING</div> <div>E - Excellent</div> <div>S - Satisfactory</div> <div>U - Unsatisfactory</div> <div>NF - Non-Functioning</div> <div>CF - Critical Failure</div> | | <div>COST TYPE</div> <div>NEW - New Construction</div> <div>ADD - Addition</div> <div>ALT - Alterations</div> <div>MSR - Major System Replacement</div> <div>REP - Repair</div> <div>ENG - Energy</div> <div>MNT - Maintenance</div> | | Y* - Must be part of larger building project | | <div></div> <div>Clark Patterson Lee</div> <div>ARCHITECTURE ENGINEERING PLANNING</div> | | |
| Facility Name: | High School/Middle School | | | | | | | | | | | | | | | |

## 2020 BUILDING CONDITION SURVEY - 2020

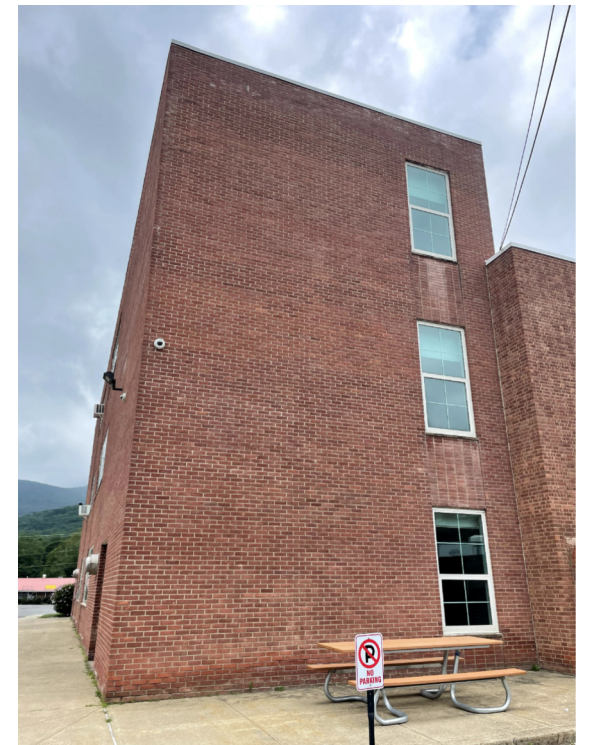
(A7)

| HSMS-072-01-21 | 5 | EE | S | Window Panels | Replace damaged panels @ west façade | | | | A7 | REP | Y* | | \$ 5,900 | \$ 590 | \$ 1,180 | \$ 590 | \$ 8,260 | | | | | | |
