**DeKalb County School District/Middle Schools**

# **Lithonia Middle**

## **School Assessment Report**

**May 20, 2016**

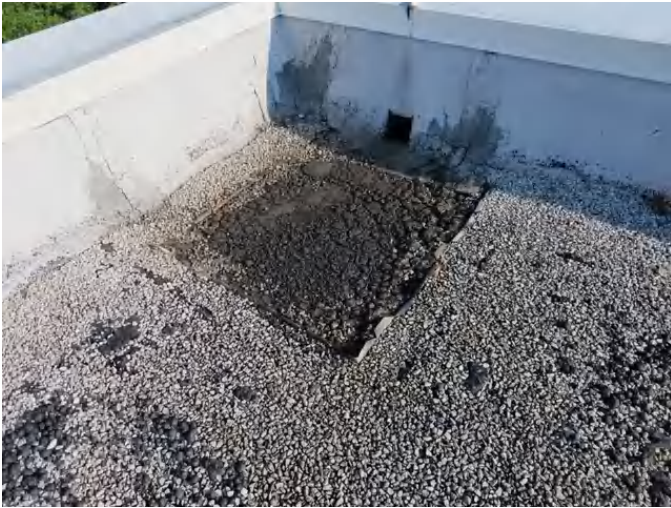
#### **System: B3010 - Roof Coverings - BUR**

**Location:** Roof

**Distress:** Beyond Service Life

**Notes:** The built-up roof covering is aged, showing signs of failure, and should be replaced. SPLOST project 119-422 to replace the roof on the 38 building.

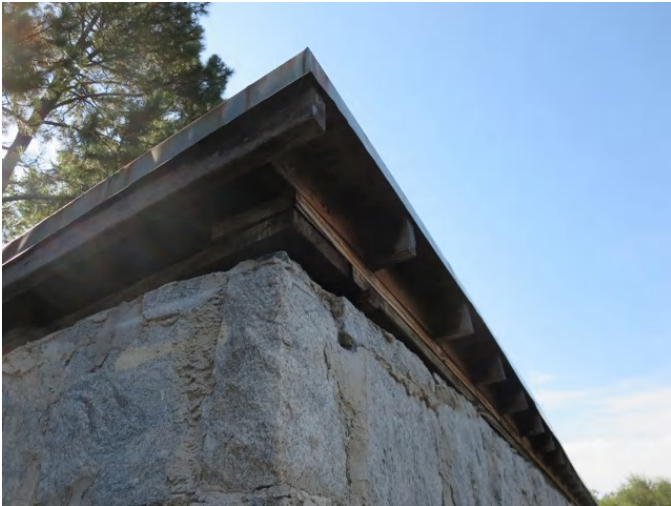
#### System: B3010 - Roof Coverings

**Location:** Roof

**Distress:** Beyond Service Life

**Notes:** The roof covering is aged, showing signs of failure, and should be replaced.

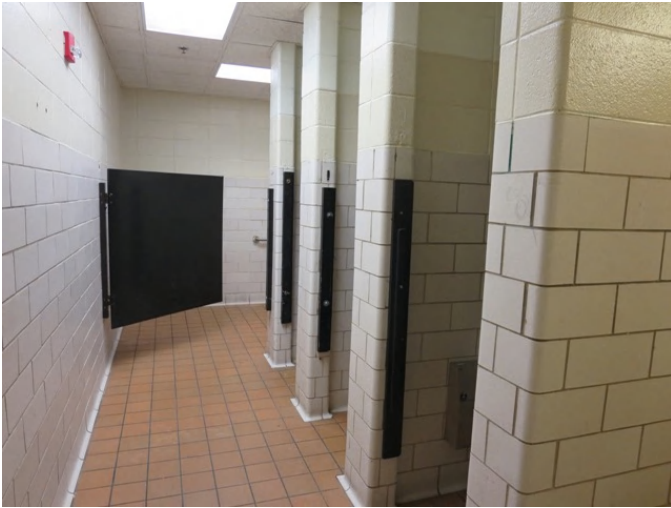
#### **System: C1030 - Fittings**

**Location:** Throughout Building

**Distress:** Beyond Service Life

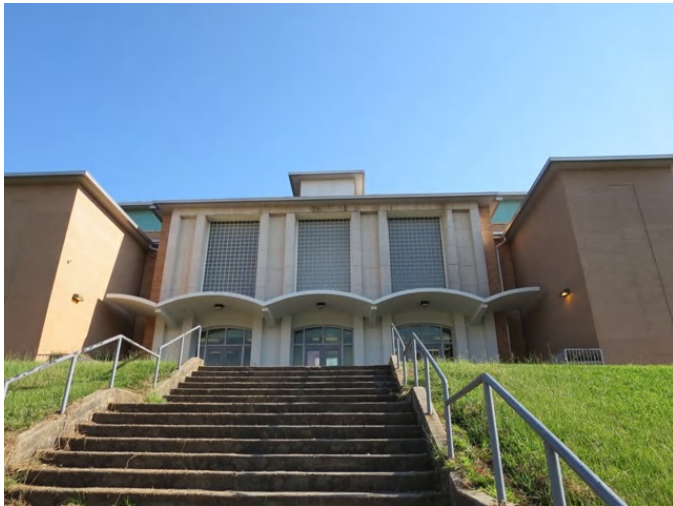
**System: B2010 - Exterior Walls**

**Location:** Exterior by Lobby to Gym

**Distress:** Beyond Service Life

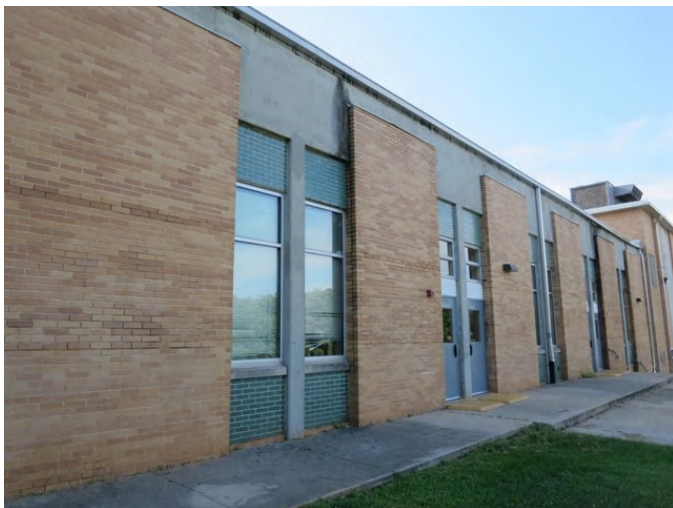
**System: B2020 - Exterior Windows**

**Location:** Throughout Building

**Distress:** Beyond Service Life

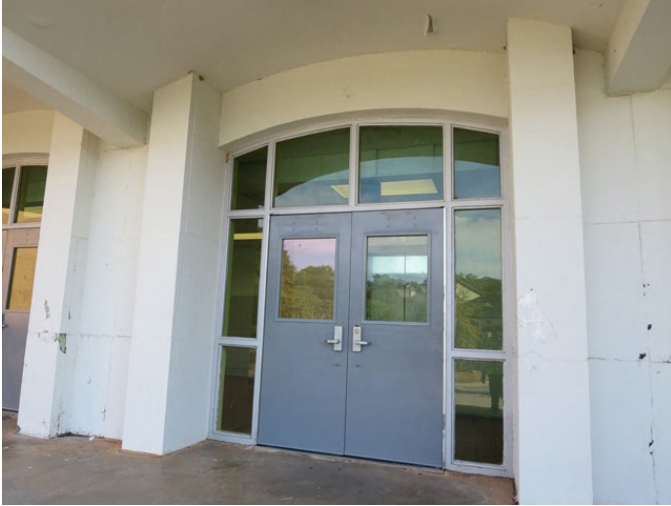
**System: B2030 - Exterior Doors**

**Location:** Throughout Building

**Distress:** Beyond Service Life

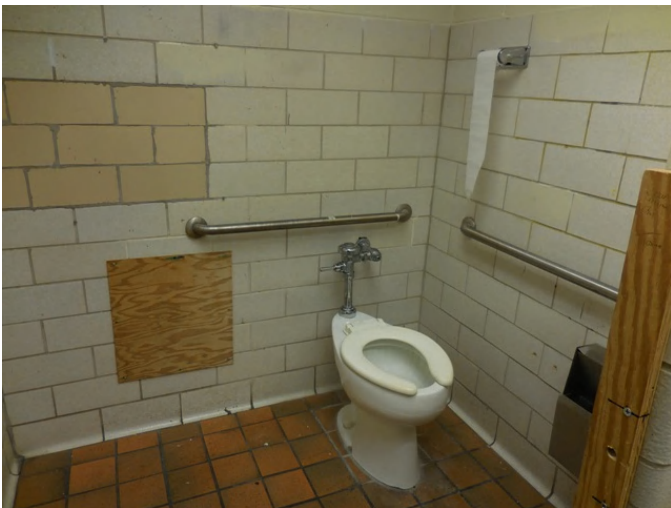
**System: C3010 - Wall Finishes - Ceramic & Glazed**

**Location:** Restrooms

**Distress:** Damaged

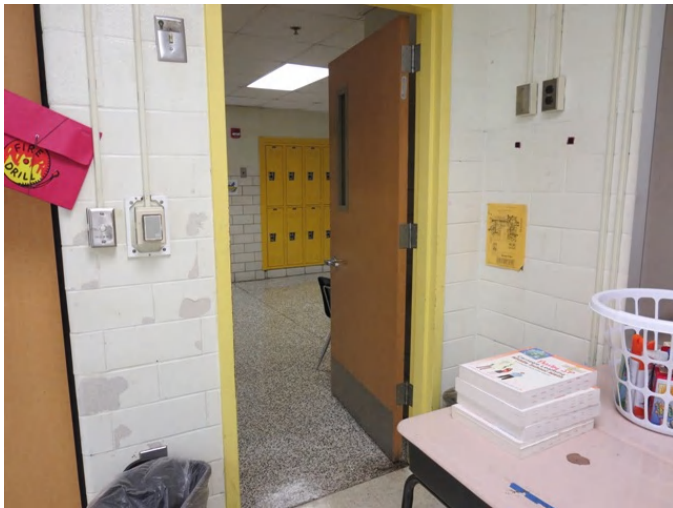
**System: C3010 - Wall Finishes - Paint**

**Location:** Throughout Building

**Distress:** Beyond Service Life

**Notes:** The painted wall finish is beyond its expected service life, damaged, fading, stained, and should be re-painted.

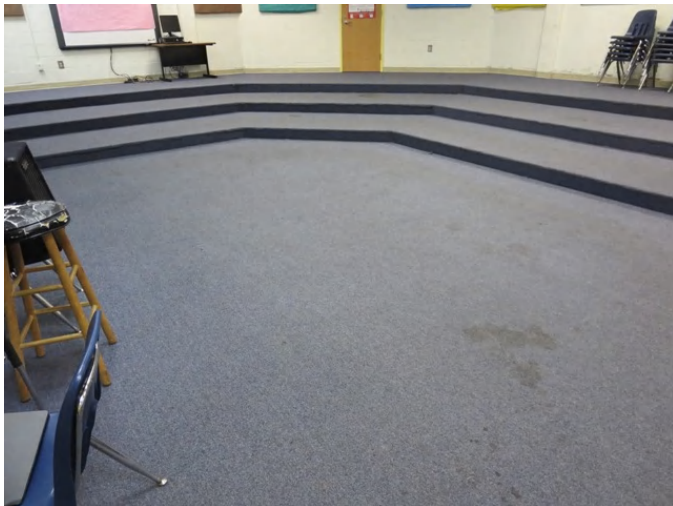
**System: C3020 - Floor Finishes - Carpet**

**Location:** Offices, Media Center, and Music

**Distress:** Beyond Service Life

**Notes:** The carpet is beyond its expected service life, stained in areas, and should be scheduled for replacement.

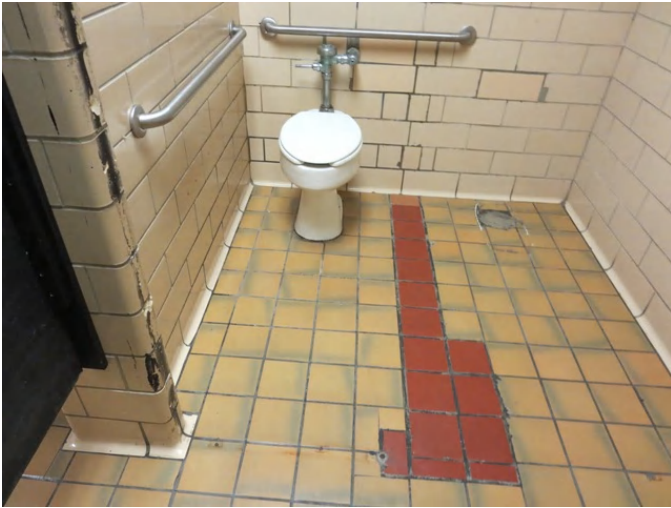
**System: C3020 - Floor Finishes - Ceramic & Quarry Tile**

**Location:** Kitchen and Restrooms

**Distress:** Beyond Service Life

**Notes:** The quarry tile is aged, chipped, cracked, and patched, and should be replaced.

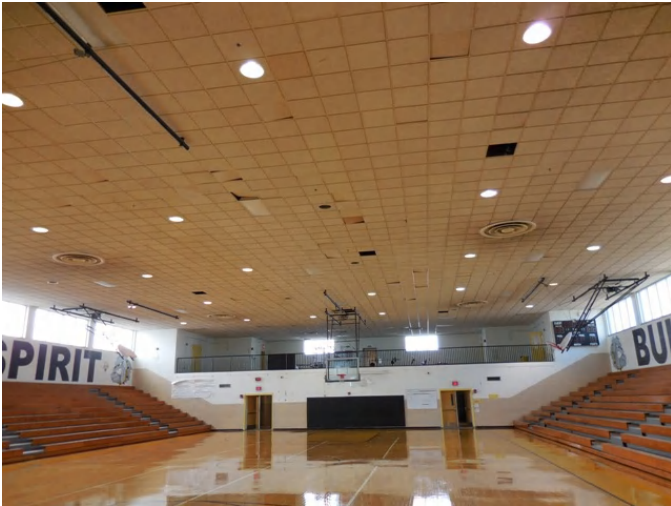
**System: C3030 - Ceiling Finishes**

**Location:** Gym

**Distress:** Inadequate

**Notes:** The original ceiling is aged and damaged, and should be replaced.

**Correction:** Replace acoustic tile ceiling, fire-rated

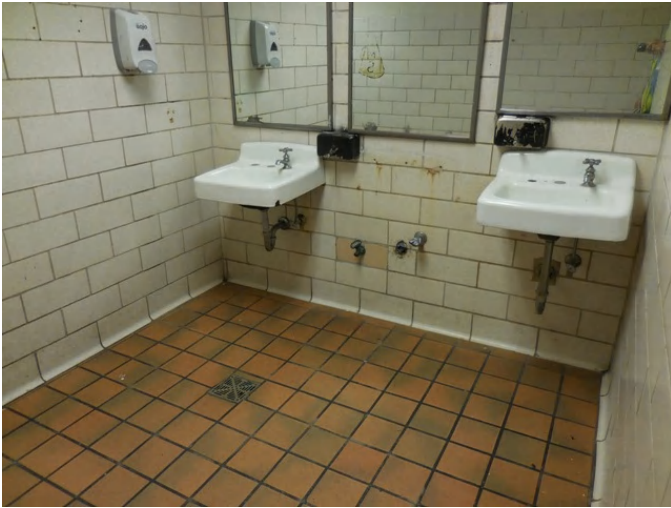
**System: D2010 - Plumbing Fixtures**

**Location:** Throughout Building

**Distress:** Damaged

**Notes:** Plumbing fixtures are broken, missing, worn and stained, are not ADA compliant, and should be replaced. The plumbing fixtures in the boys locker room are in particularly bad condition. SPLOST project 119-422 to provide hall restroom renovations.

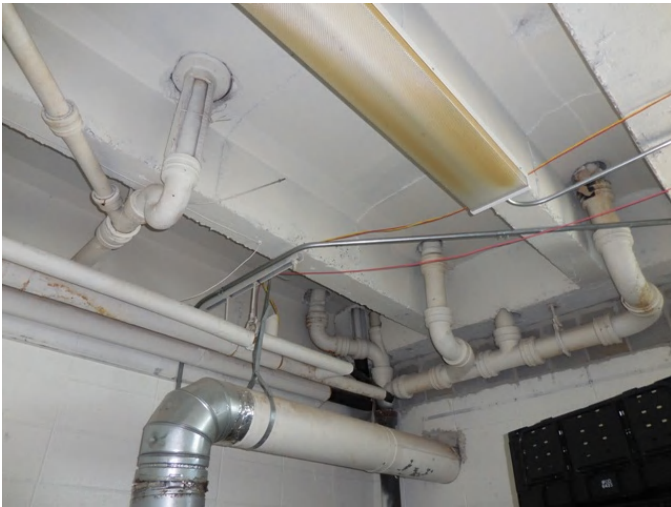
**System: D2030 - Sanitary Waste**

**Location:** Throughout Building

**Distress:** Beyond Service Life

**Notes:** Teachers have reported several backups and sewer odors coming from the restrooms. The system is beyond its expected service life and should be scheduled for replacement.

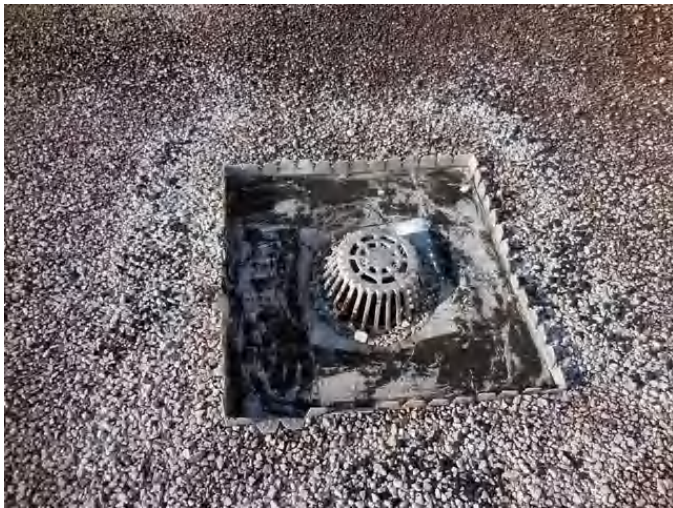
**System: D2040 - Rain Water Drainage**

**Location:** Roof

**Distress:** Beyond Service Life

**Notes:** Rain water drainage system is beyond its expected service life and should be scheduled for replacement.

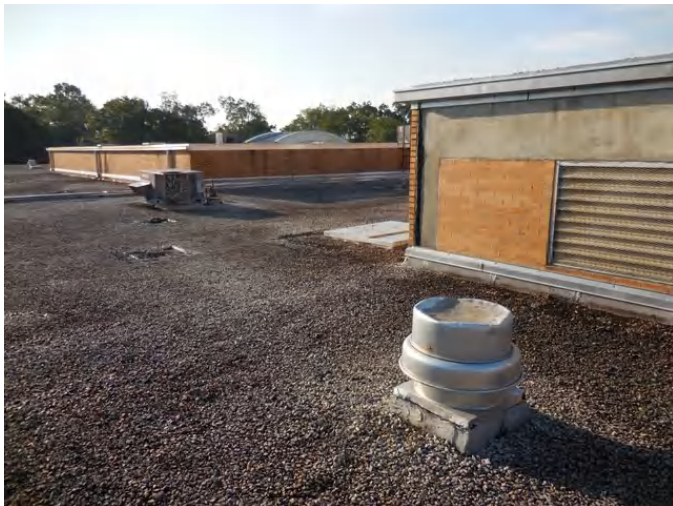
**System: D3040 - Distribution Systems & Exhaust Systems**

**Location:** Roof

**Distress:** Damaged

**Notes:** Exhaust units have been vandalized, resulting in no exhaust circulation in the restrooms throughout the building. System should be scheduled for replacement and measures should be take to prevent unauthorized access to the roof.

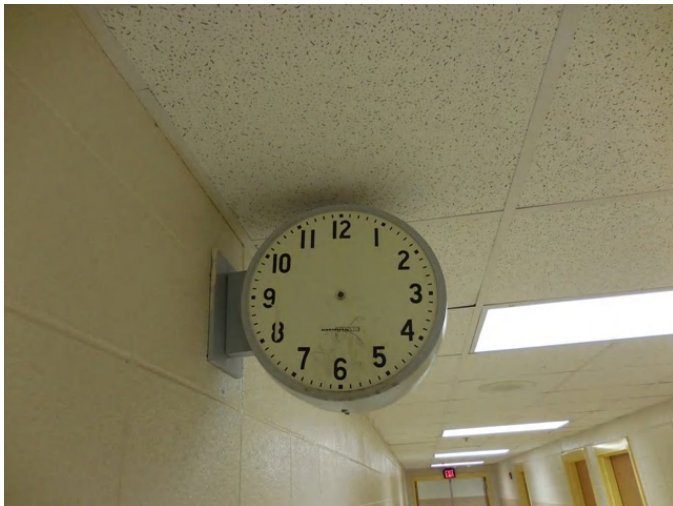
**System: D5030 - Communications and Security - PA & Clock Systems**

**Location:** Throughout Building

**Distress:** Beyond Service Life

**Notes:** PA and clock systems are beyond their expected service life, have reported outages, and should be scheduled for replacement.

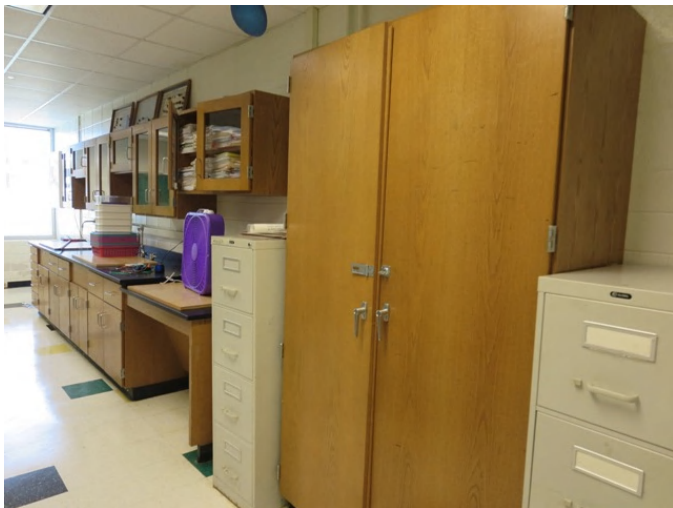
**System: E2010 - Fixed Furnishings**

**Location:** Throughout Building

**Distress:** Beyond Service Life

**Notes:** Fixed furnishings are aged, failing, and should be repaired or replaced.

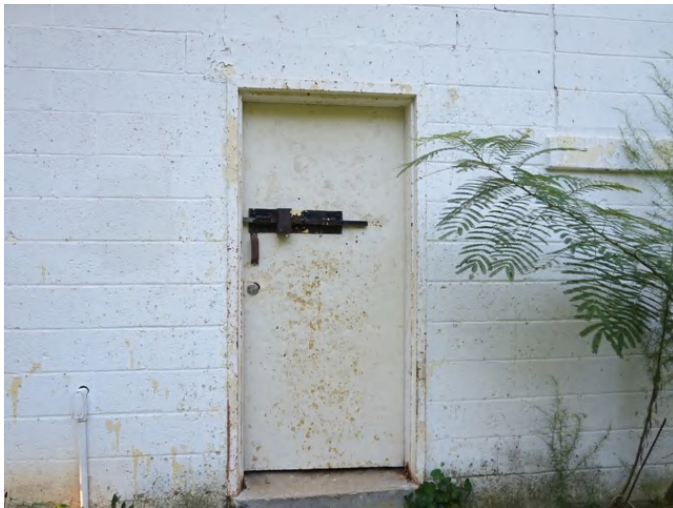
#### **System: B2030 - Exterior Doors**

**Location:** Exterior Wall

**Distress:** Beyond Service Life

**Notes:** The exterior door is aged, rusted, and should be replaced.

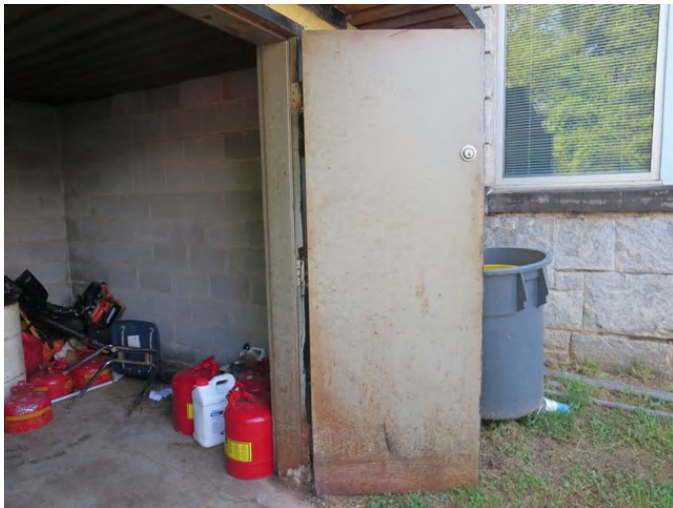
#### **System: B2030 - Exterior Doors**

**Location:** Exterior Wall

**Distress:** Beyond Service Life

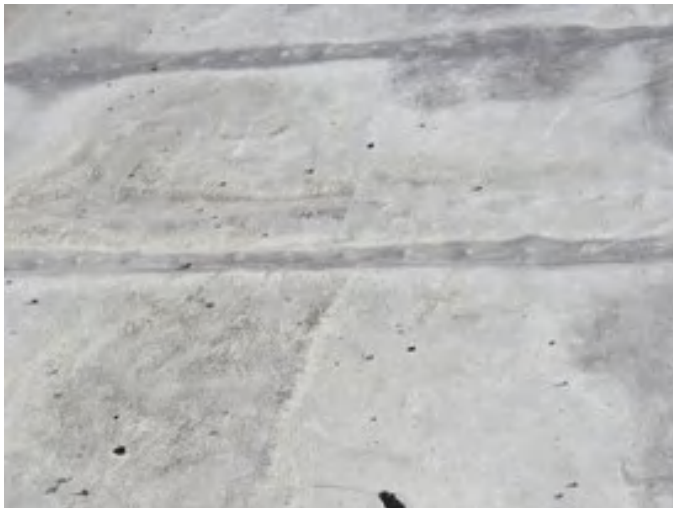
#### **System: B3010 - Roof Coverings**

**Location:** Roof

**Distress:** Beyond Service Life

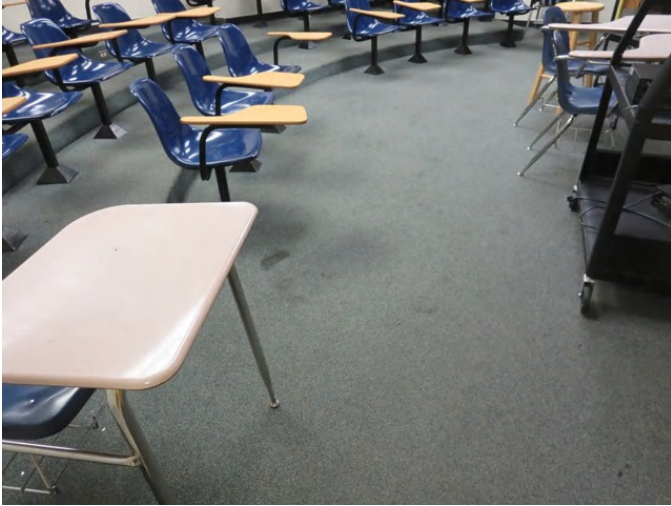
#### System: C3020 - Floor Finishes - Carpet

**Location:** Offices and Classroom

**Distress:** Beyond Service Life

**Notes:** The carpet is beyond its expected service life, stained, and should be replaced.

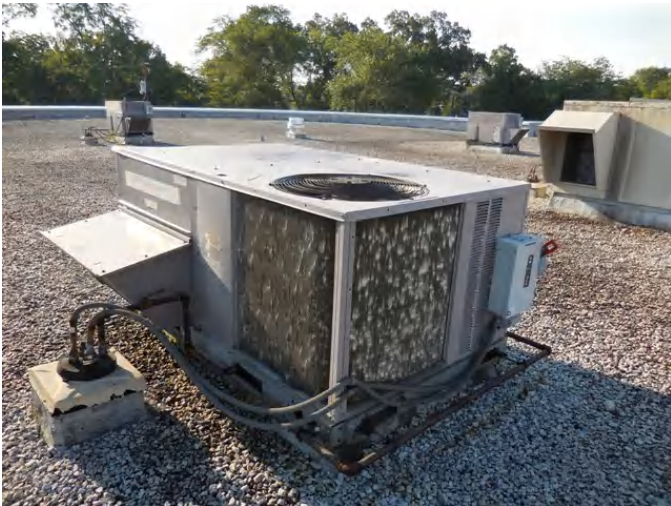
#### System: D3050 - Terminal & Package Units

**Location:** Roof

**Distress:** Damaged

**Notes:** Maintenance staff reports that someone has gained access to the roof near the kitchen area on several occasions. From the roof, AC units have been vandalized. The coils are damaged and causing units to continuously breakdown. RTUs should be scheduled for replacement and measures should be taken to prevent unauthorized access to the roof.

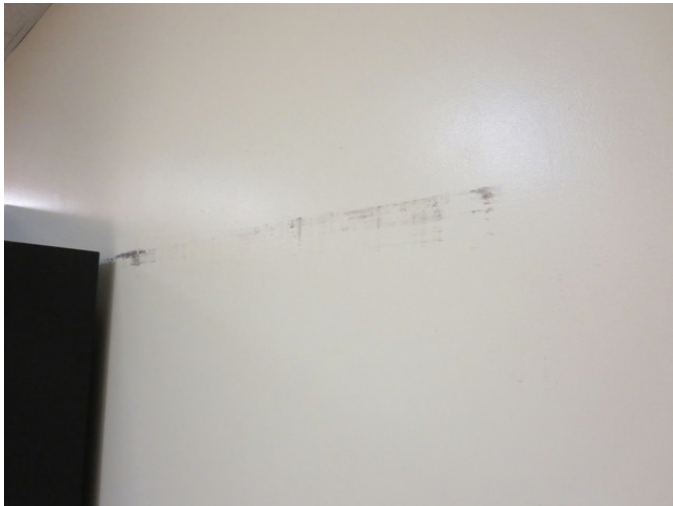
**System: C3010 - Wall Finishes - Paint**

**Location:** Throughout Building

**Distress:** Beyond Service Life

**Notes:** The painted wall finish is beyond its expected service life, scuffed and stained in areas, and should be scheduled for replacement.

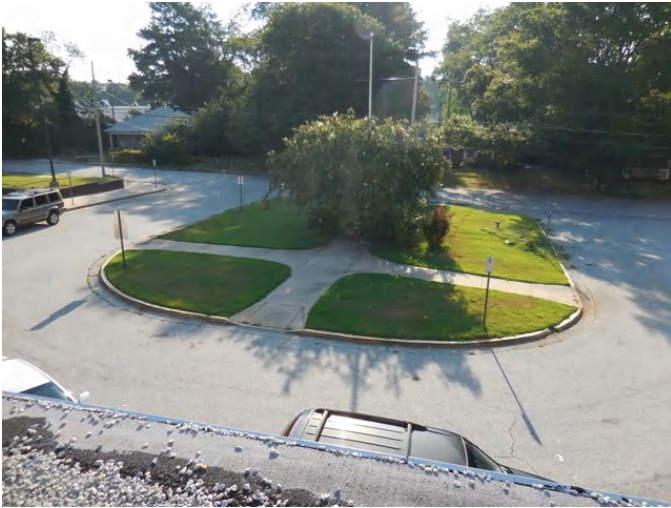
#### **System: G4020 - Site Lighting**

**Location:** Site

**Distress:** Beyond Service Life

**Notes:** Site lighting is beyond its expected service life, inadequate throughout the site, and should be replaced and expanded, as this is a safety concern.

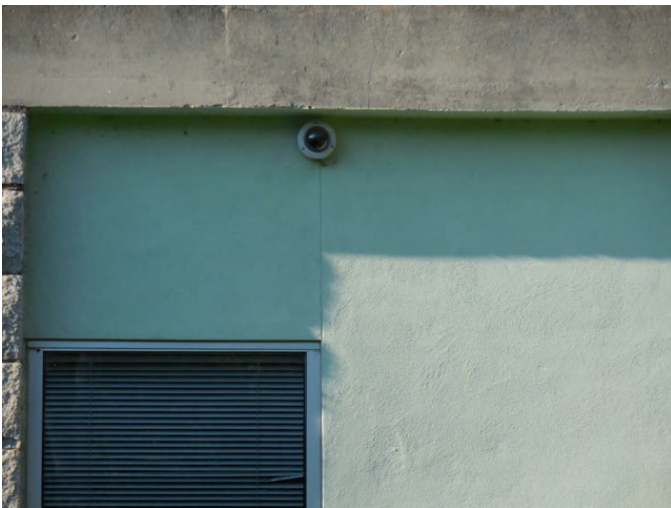
#### **System: G4030 - Site Communications & Security**

**Location:** Site

**Distress:** Beyond Service Life

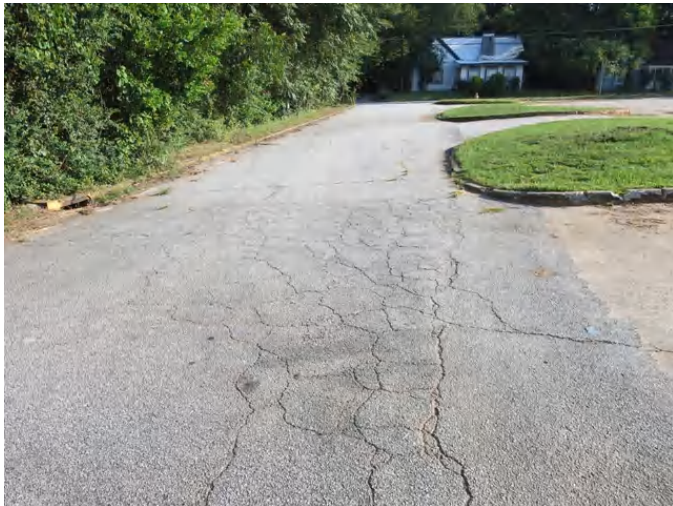
**System: G2010 - Roadways**

**Location:** Site

**Distress:** Beyond Service Life

**Notes:** Roadways are aged, damaged with many road cracks and potholes, and should be resurfaced.

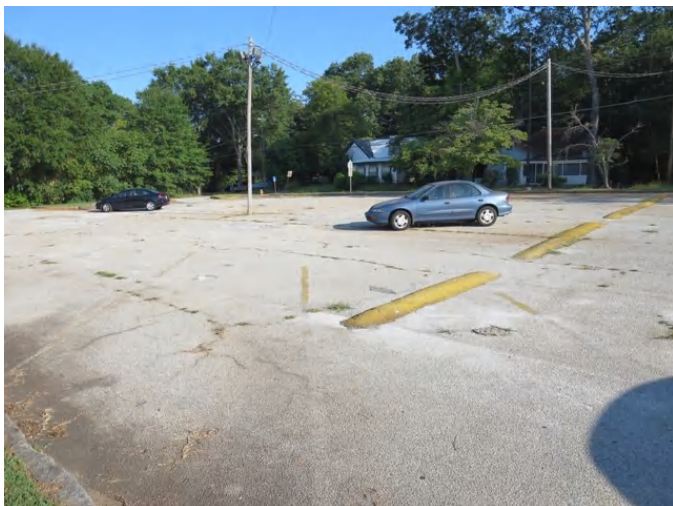
**System: G2020 - Parking Lots**

**Location:** Site

**Distress:** Beyond Service Life

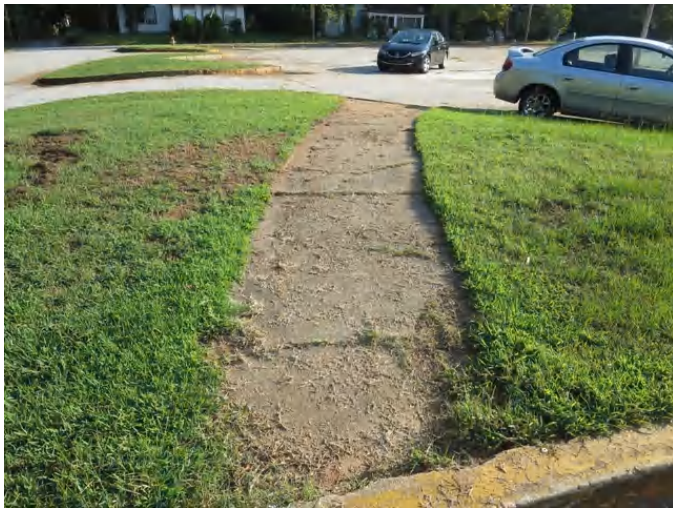
**System: G2030 - Pedestrian Paving**

**Location:** Site

**Distress:** Beyond Service Life

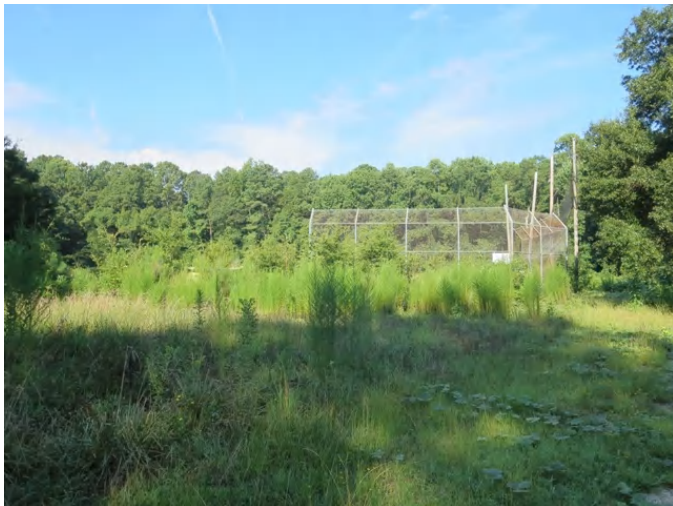
**System: G2040 - Baseball Field**

**Location:** Site

**Distress:** Beyond Service Life

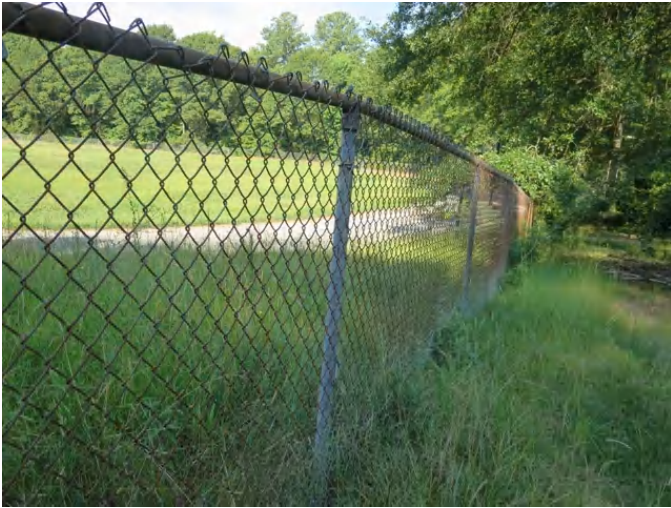
**System: G2040 - Fencing & Guardrails**

**Location:** Site

**Distress:** Beyond Service Life

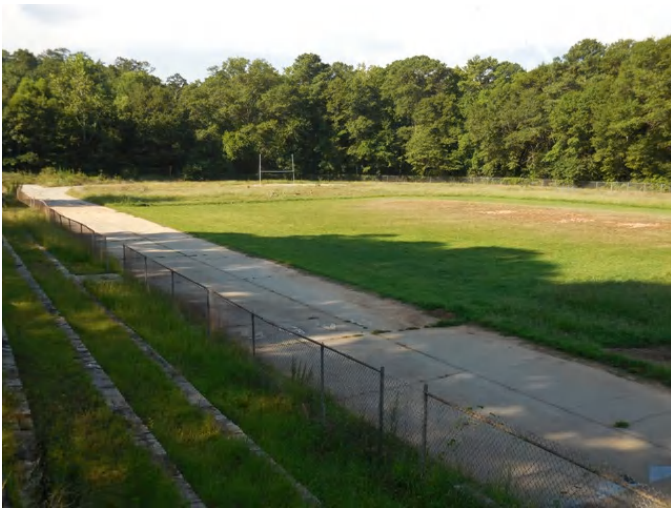
**System: G2040 - Football Field**

**Location:** Site

**Distress:** Beyond Service Life

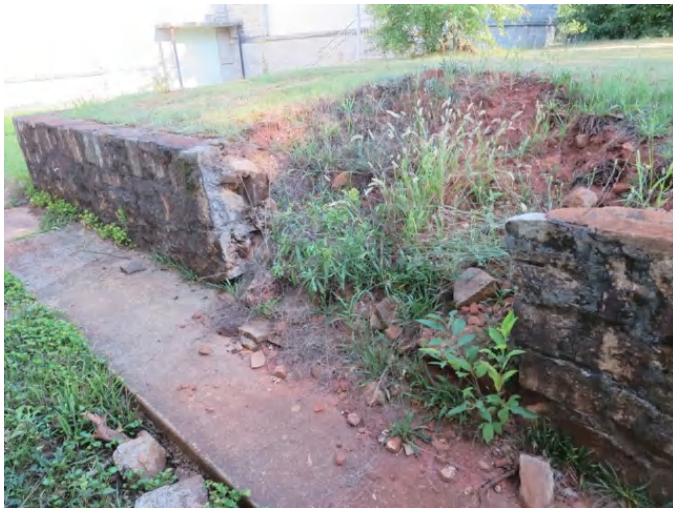
**System: G2040 - Retaining Wall**

**Location:** Site

**Distress:** Damaged

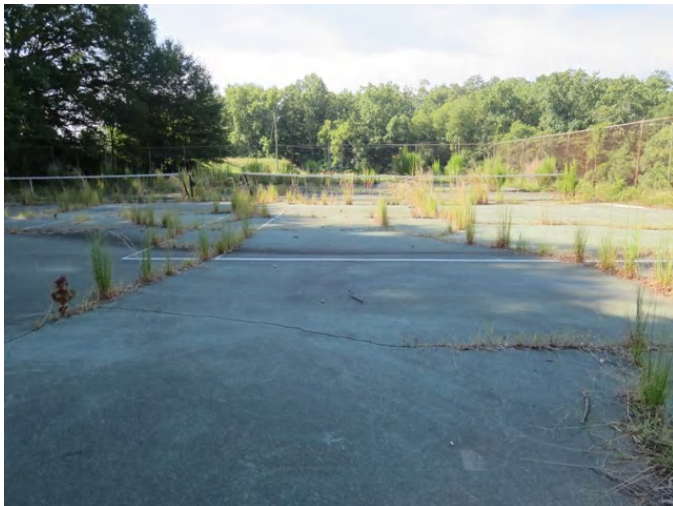
**System: G2040 - Tennis Courts**

**Location:** Site

**Distress:** Beyond Service Life

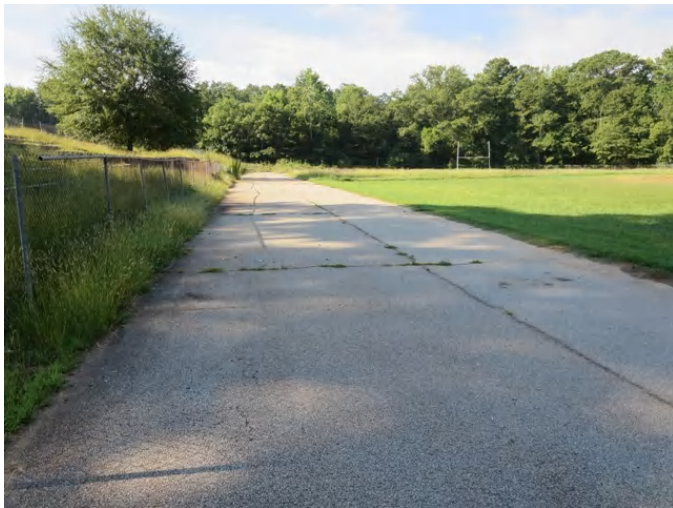
### **System: G2040 - Track**

**Location:** Site

**Distress:** Beyond Service Life

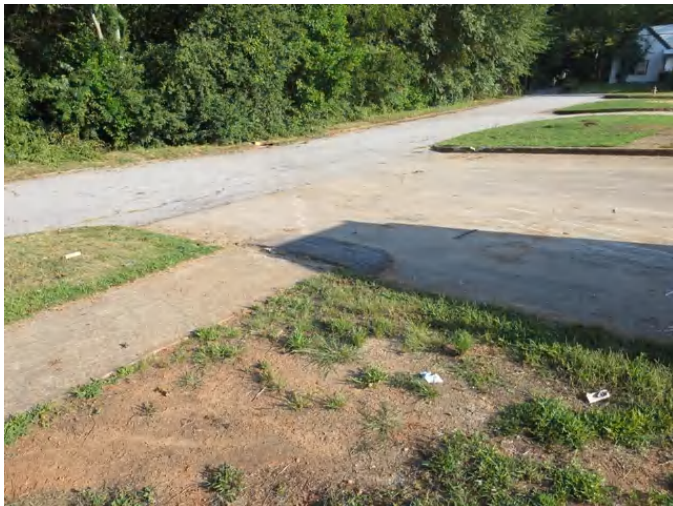
### **System: G2050 - Landscaping**

**Location:** Site

**Distress:** Beyond Service Life

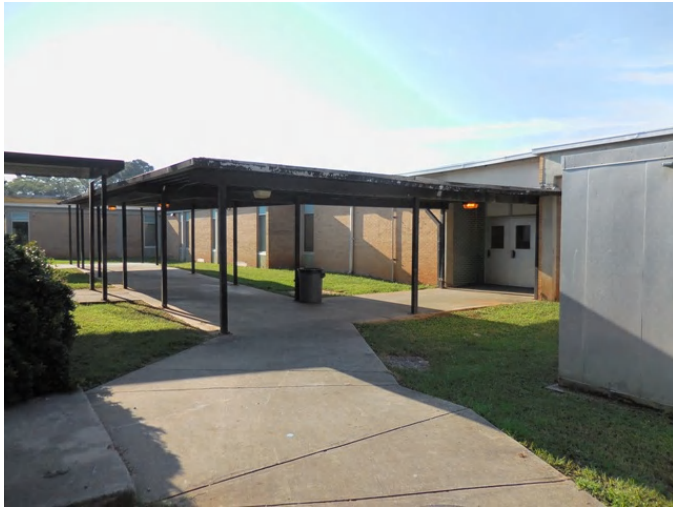
**System: G3030 - Storm Sewer**

**Location:** Site

**Distress:** Beyond Service Life
