# DRUID HILLS HIGH SCHOOL MODERNIZATION REPORT

## MODERNIZATION REPORT

The Modernization Report catalogs facility deficiencies in the current facility. Deficiencies are classified as follows:

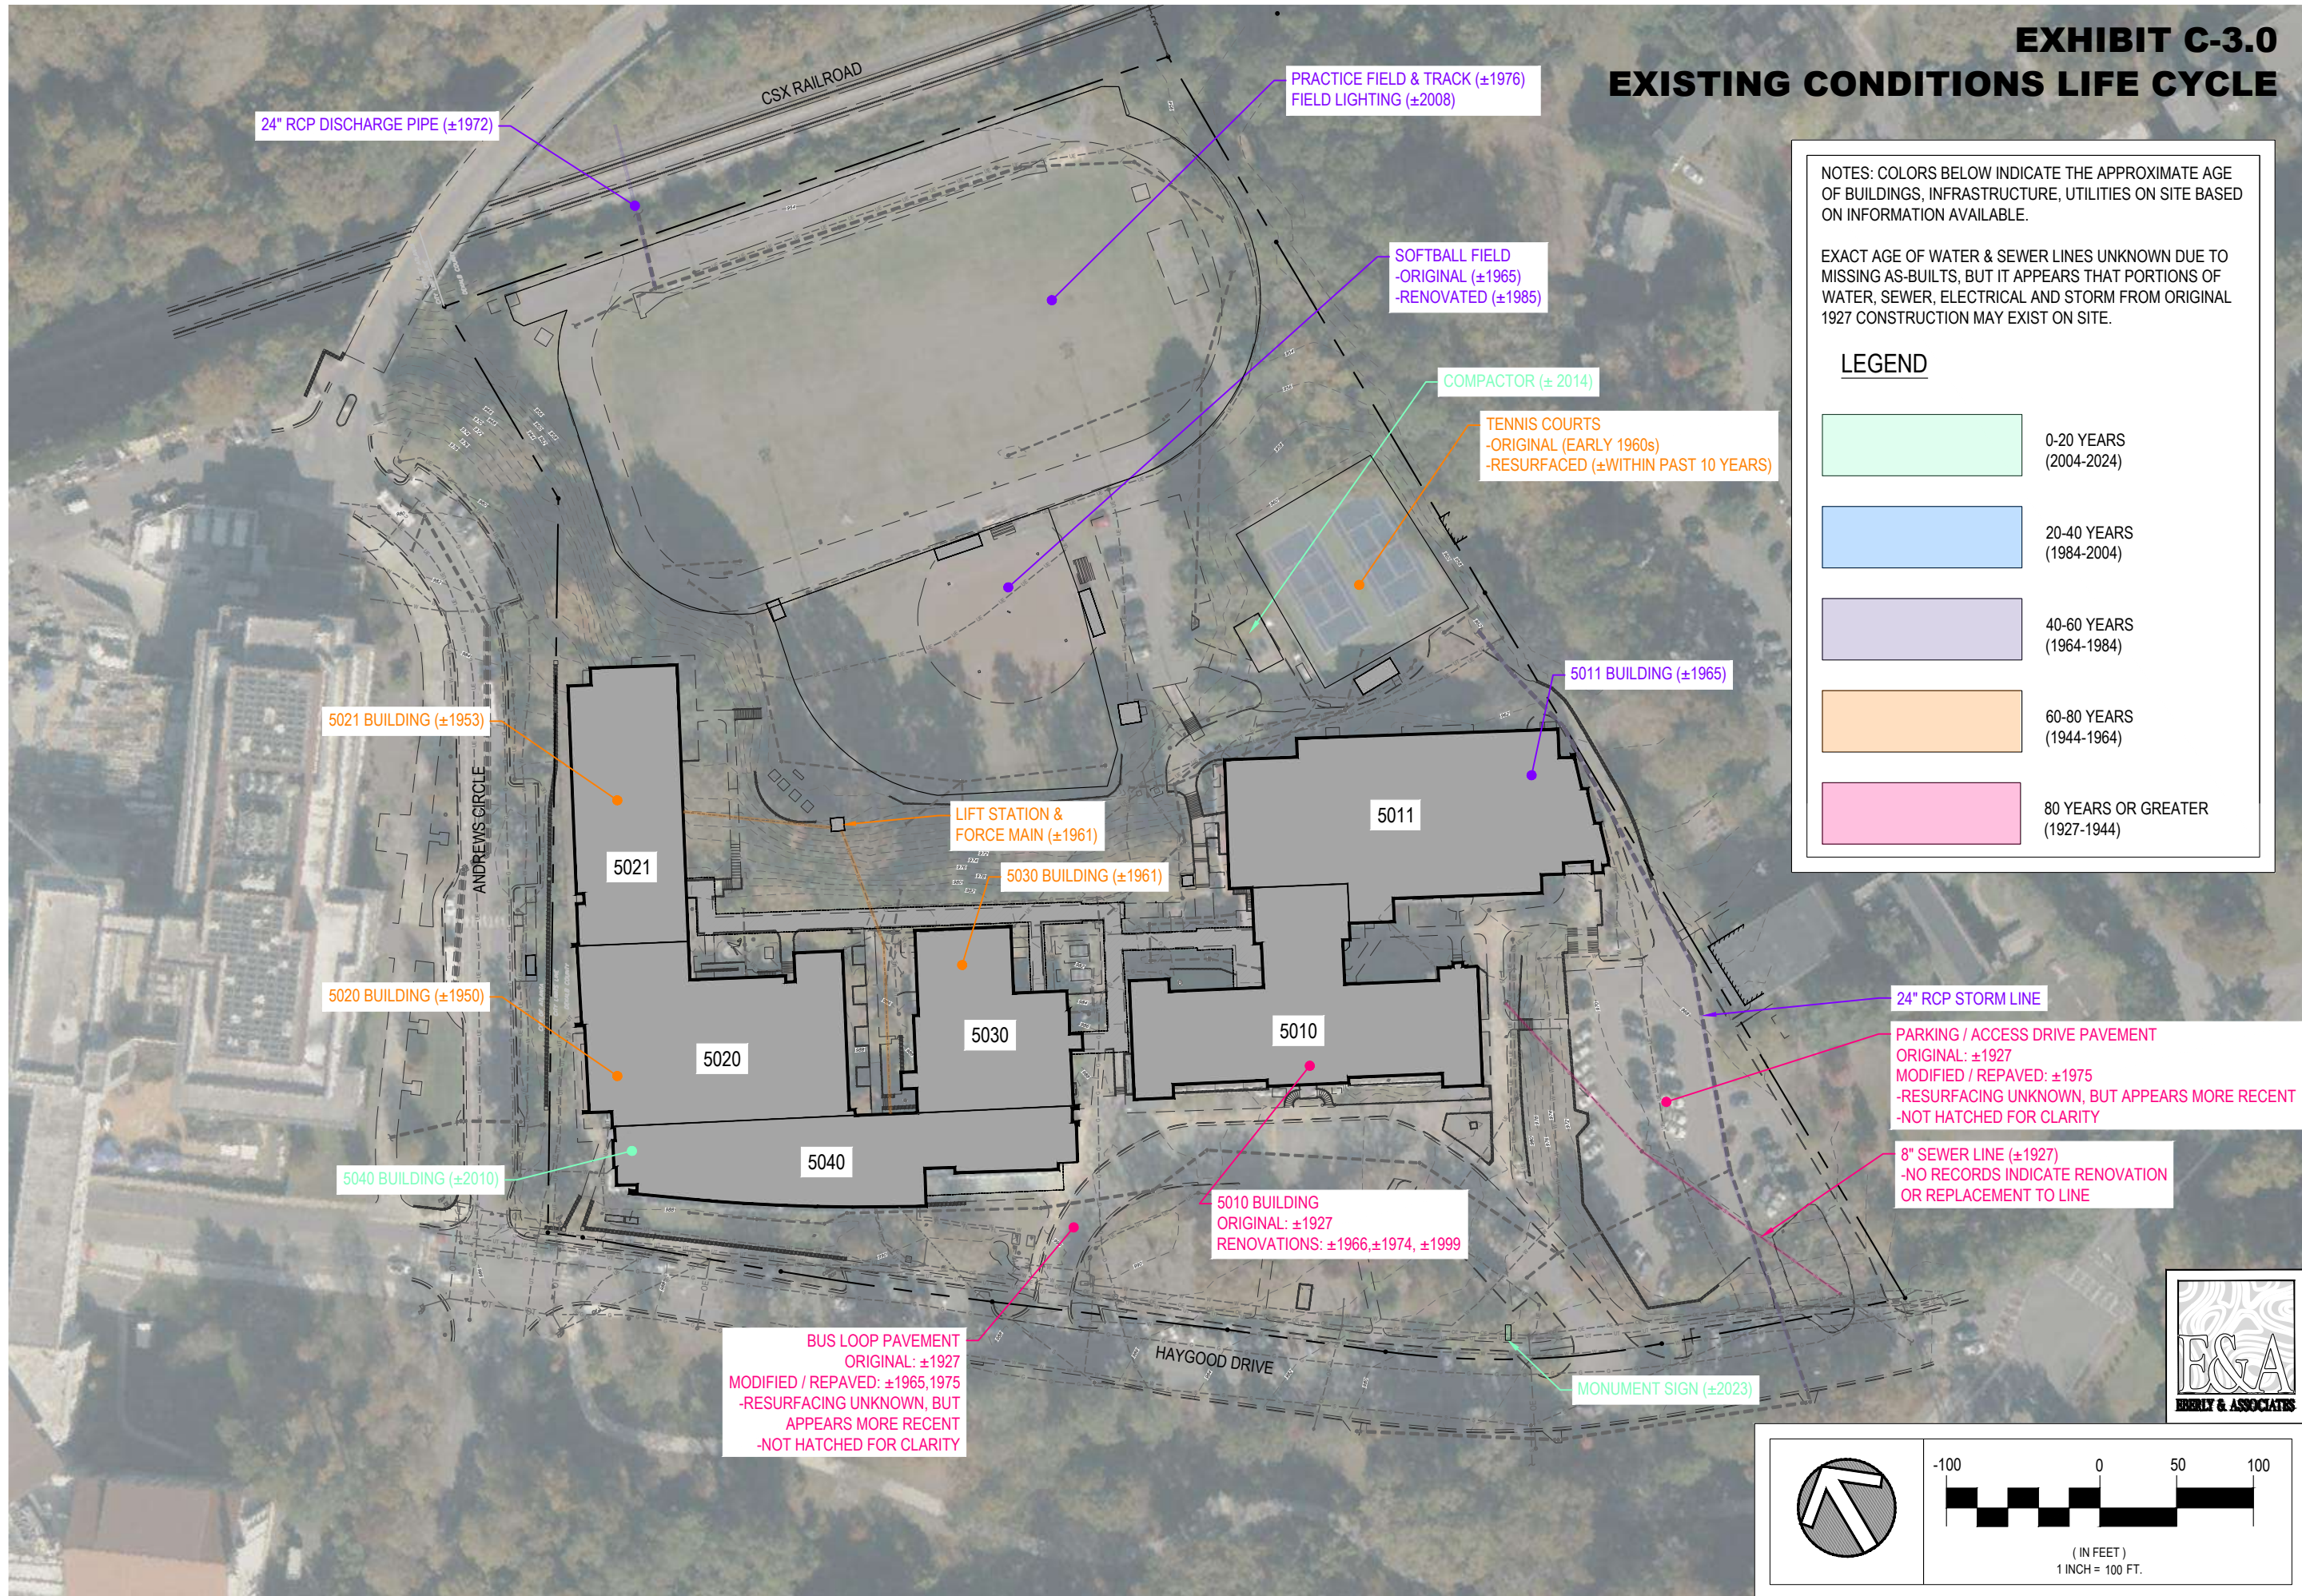
**EXISTING CONDITIONS LIFE CYCLE**

EXACT AGE OF WATER & SEWER LINES UNKNOWN DUE TO MISSING AS-BUILTS, BUT IT APPEARS THAT PORTIONS OF WATER, SEWER, ELECTRICAL AND STORM FROM ORIGINAL 1927 CONSTRUCTION MAY EXIST ON SITE.

24" RCP DISCHARGE PIPE (±1972)

8" SEWER LINE (±1927)  
-NO RECORDS INDICATE RENOVATION  
OR REPLACEMENT TO LINE

BUS LOOP PAVEMENT  
ORIGINAL: ±1927  
MODIFIED / REPAVED: ±1965, 1975  
-RESURFACING UNKNOWN, BUT  
APPEARS MORE RECENT  
-NOT HATCHED FOR CLARITY

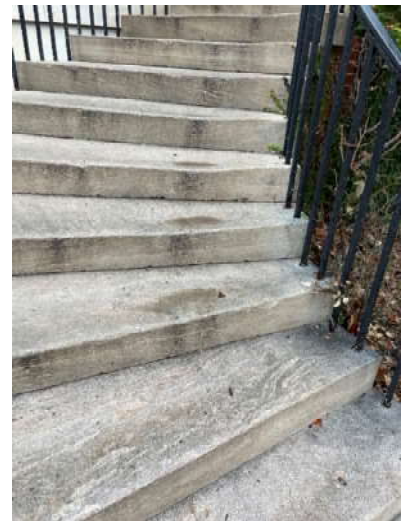
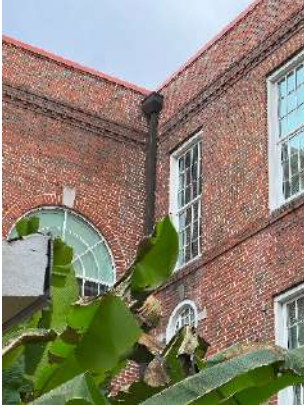
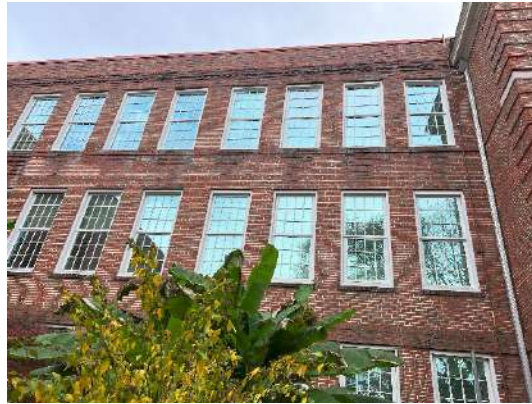
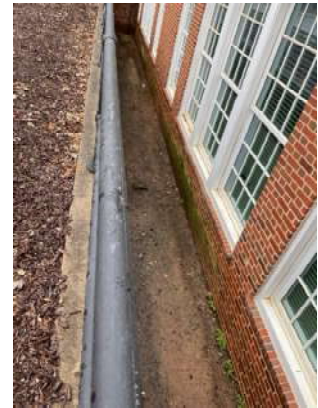
1. The entire building should be cleaned, and biological growth removed from lower levels, decorative banding and behind gutters and downspouts.
2. There is limited mortar joint erosion. Repoint banding between brick masonry and decorative stone cladding and banding where joints are missing and/or eroded.
3. Brick is in relatively good condition. Repoint brick masonry in select areas. Ensure sky facing joints are properly pointed in all locations. Assume 10% of the total building area shall be repointed.
4. Route and patch vertical cracks in stone banding. Assume 5 locations.
5. Recalk all stone coping stones. Remove and replace caulk with any reroofing efforts.
6. Bricks at rear stoop are coming off and need to be reset.
7. The front steps are worn and ponding. Replacing the stone treads should be considered but not mandatory. There are no

good products to fill these areas. Stone replacement is the only viable option.

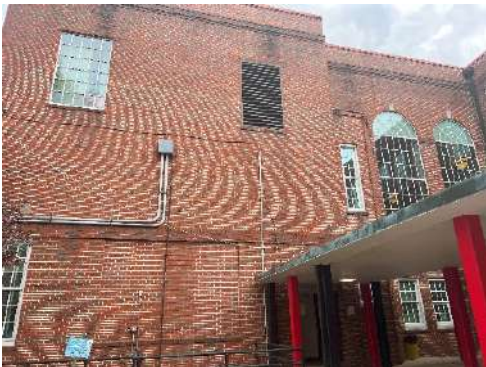
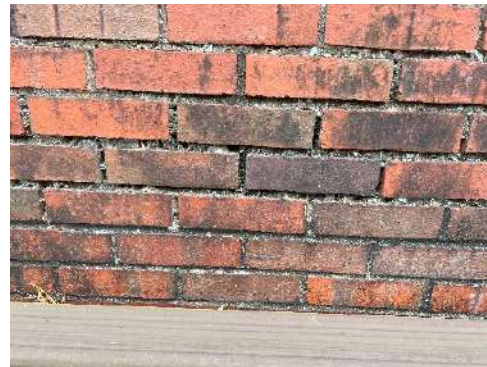
1. Miscellaneous conduits and wires need to be removed from the building and any holes filled with masonry or mortar depending on the size.
2. Vegetation and trees closer than 5' from the building should be removed.
3. The entire building should be cleaned, and biological growth removed from lower levels, decorative banding and behind gutters and downspouts.
4. There is limited mortar joint erosion. Repoint banding between brick masonry and decorative stone cladding and banding where joints are missing and/or eroded.
5. Brick is in relatively good condition. Repoint brick masonry in select areas. Ensure sky facing joints are properly pointed. Assume 20% of the total building area at lower levels.

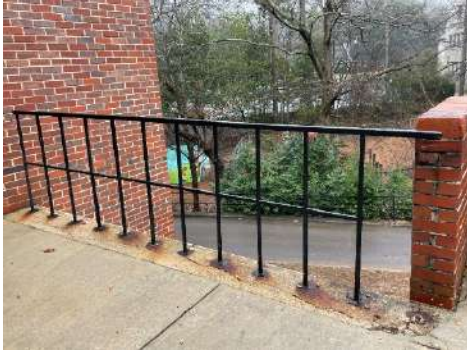
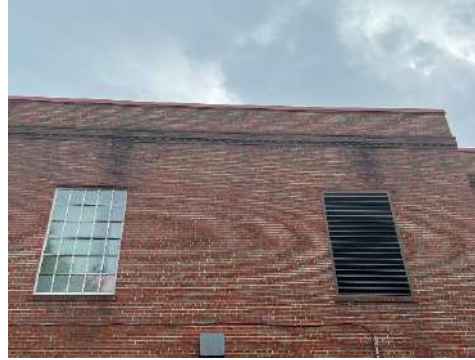
1. A number of railings around the building do not meet the code requirements for handrails or guardrails. Replace railings with code compliant railings for specific conditions.

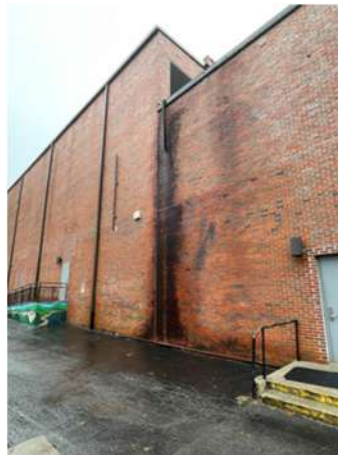
1. There has been and is evidence of former moisture infiltration along this wall of the gym and classrooms below. This entire wall should be excavated and waterproofed to below the foundations.

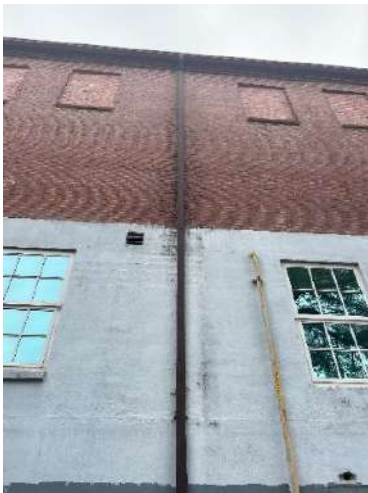
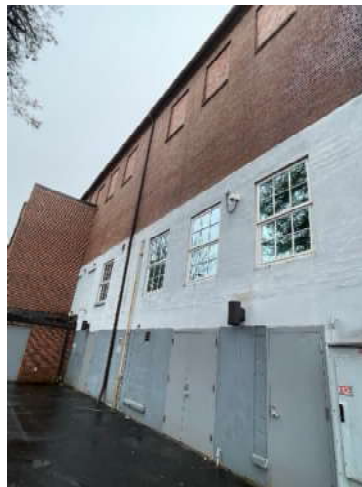
1. Reopen windows of the gymnasium to allow more natural light in the space.

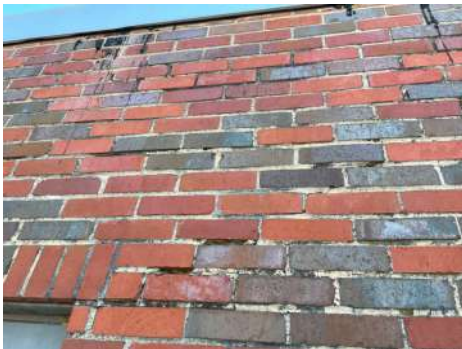
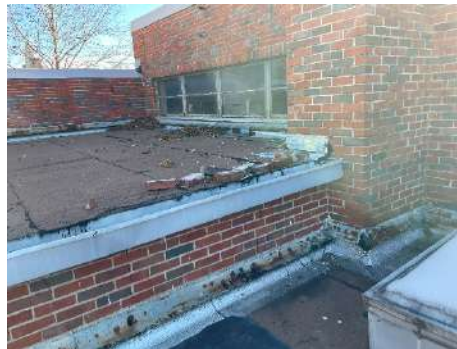
1. The entire building should be cleaned, and biological growth removed.
2. There is mortar joint erosion at corners and around windows. Brick is in fair condition. Repoint brick masonry in select areas. Ensure sky facing joints are properly pointed. Assume 30% of the total building area. There is step cracking on the exterior eastern elevation that should be addressed.

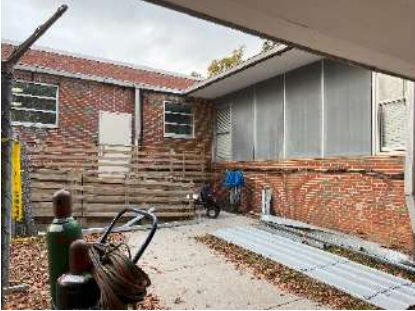
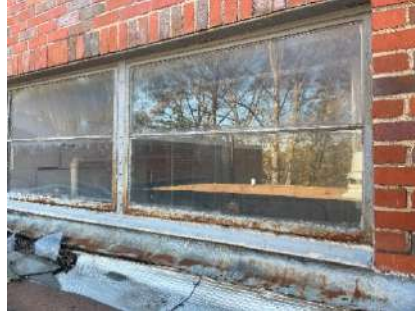
1. Clean and repaint areas of previously painted wall panel.
2. Replace windows and window infill on roof level at east elevation. Windows are in poor condition.
3. Replace windows and potentially panel wall for more windows along south façade.

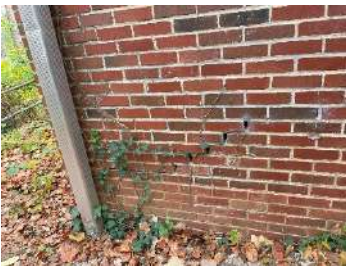
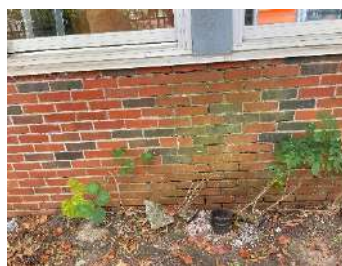
1. The entire building should be cleaned, and biological growth removed.
2. There is mortar joint erosion at corners and around windows. Brick is in fair condition. Repoint brick masonry in select areas. Ensure sky facing joints are properly pointed. Assume 20% of the total building area. There is step cracking on the exterior eastern elevation that should be addressed.

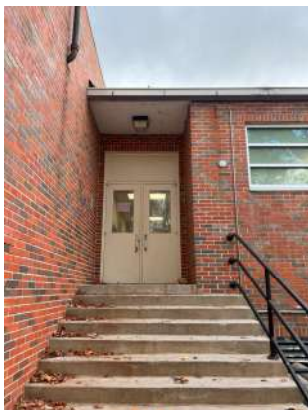
1. Downspouts and gutters need to be inspected and replaced in most locations.

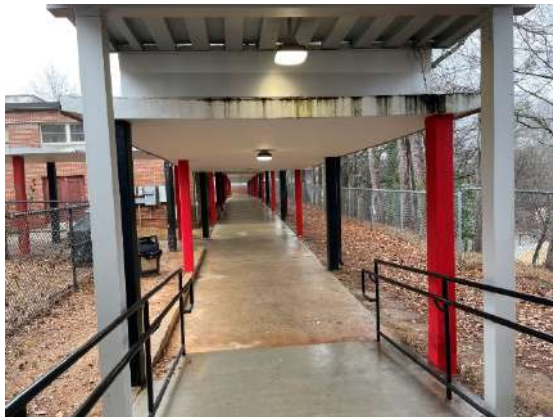
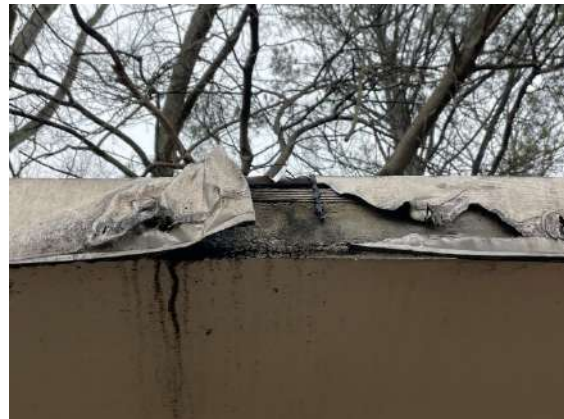
1. Reroof all concrete canopies. Flashings are dented and there is biological growth on the top of a majority of them.

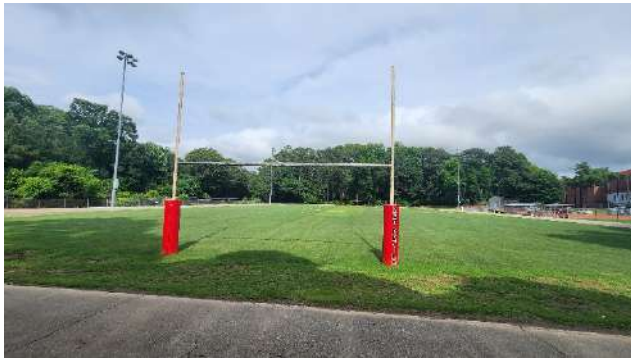
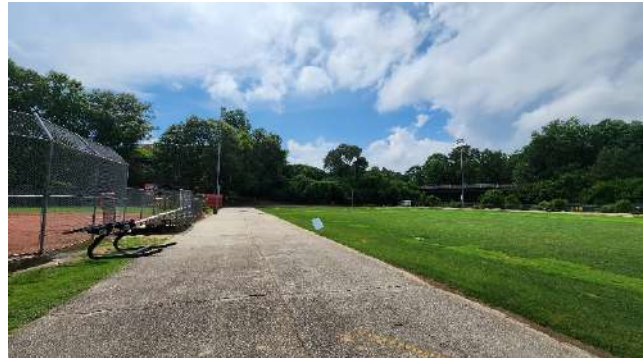
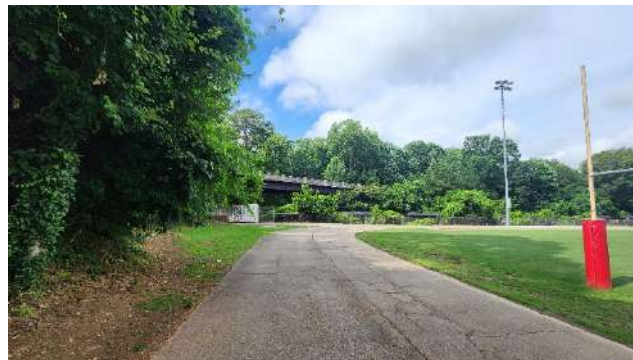
- i. Orientation of the long dimension of the track is east west and does not follow the DCSD standards
- ii. Space can meet the DCSD requirement of a 120 yard long x 78 yard wide
- iii. Track surface is in poor condition and has reached its life span
- iv. Grass turf surface is uneven due to deferred maintenance. Grass turf may be irrigated due to color of sod in winter months, but irrigation was not investigated by the consulting team.
- v. No netting exists to prevent damage or balls from entering adjacent areas
- vi. Fixed goal posts are provided and soccer goals may be stored in storage

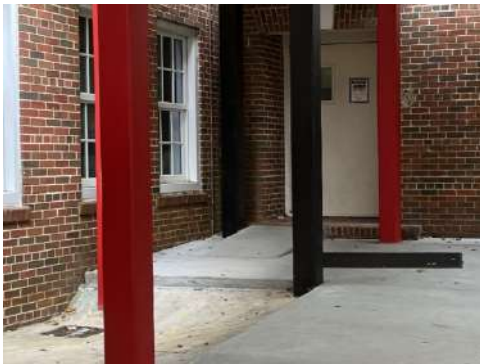
**Building 5010 Ramp 2:** Located to the northwest side of Bldg 5010. Ramps are not up to code.

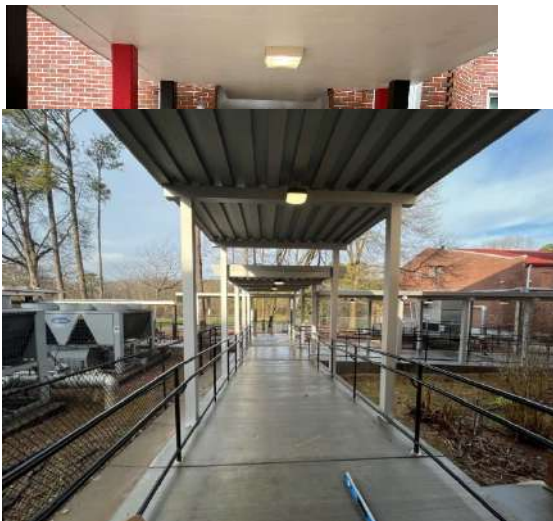
**Building 5010 Ramp 3:** Located to the northwest side of Bldg 5010. Ramps are not up to code.

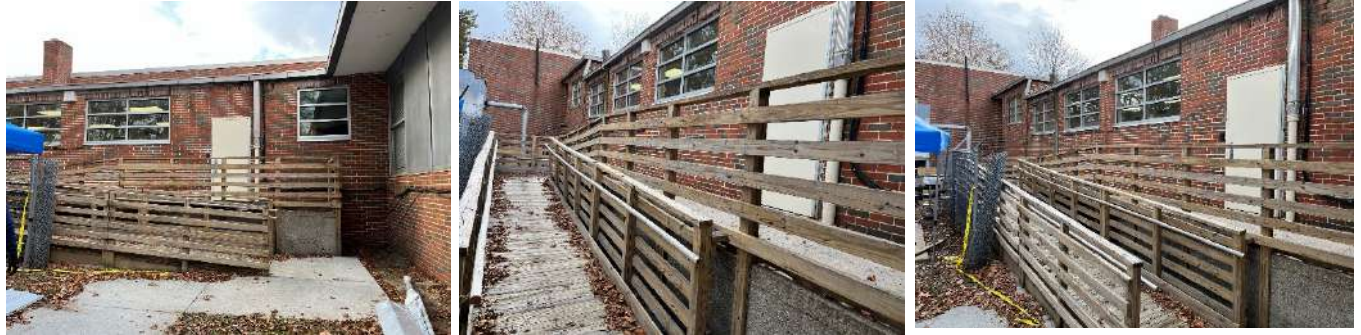
**Building 5020 Ramp 1:** Located behind the 5020 building. Wood at end of life span

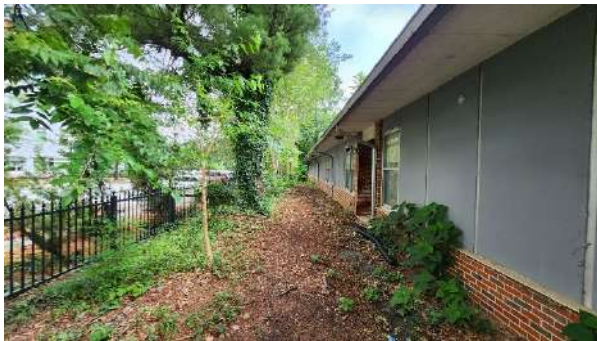
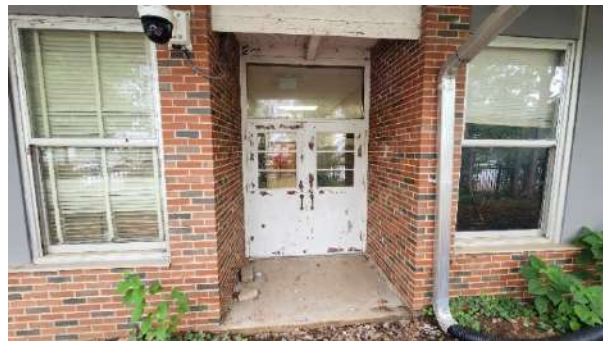
**Building 5021 Door 1:** Located west of building 5021. No direct connection to the public way.

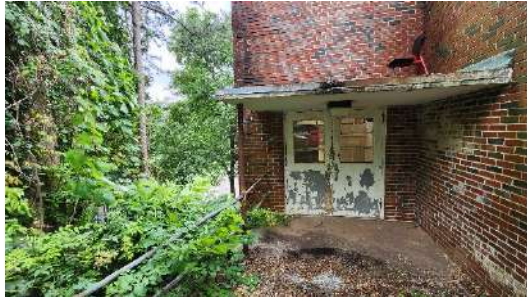
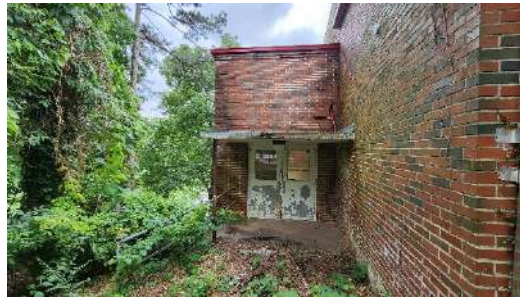
**Building 5021 Door 2:** Located to the North of building 5021. No direct connection to the public way.

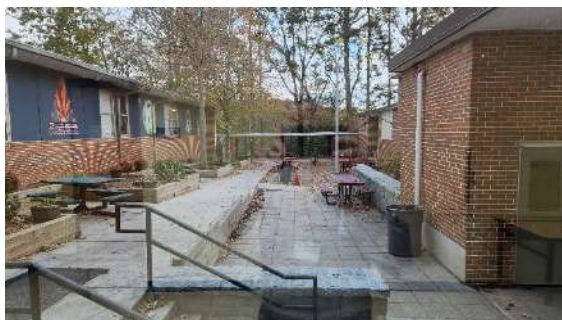
**Building 5030 Ramps 2:** Serves as the main ramp that leads to the back of building 5040.

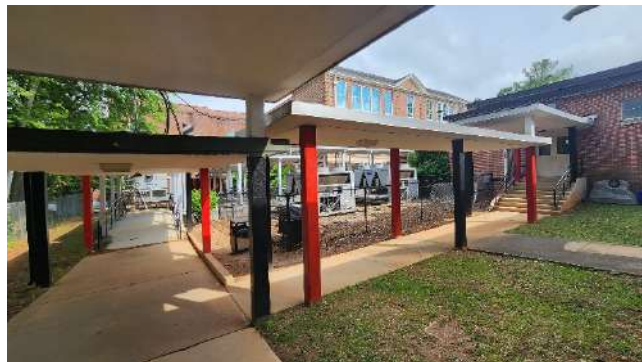
**Building 5030 Ramp 3:** Covered Walkway

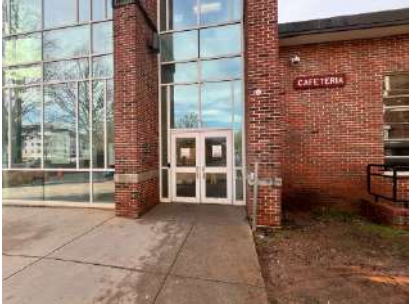
**Building 5040 Door 2 and 3:** Located on the front façade of the building under a glass walkway.

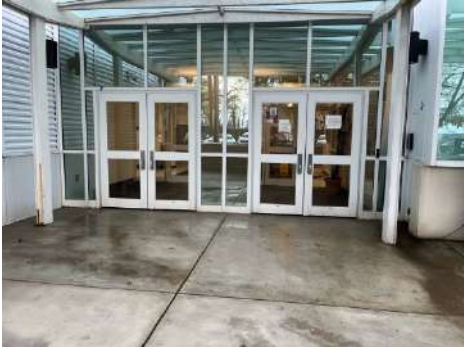
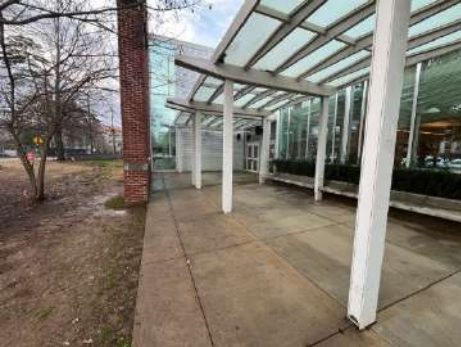
**Building 5040 Door 4:** Located west of the new building and leads directly to the right of way.

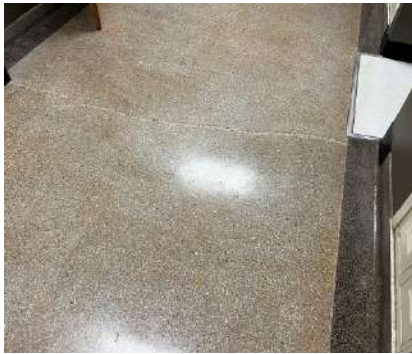
- Cracks in the terrazzo in the corridor were observed, which prompted observation of the floor slab. When viewed from underneath, the bottom of the floor slab in the corridor did show cracks, which are likely full-depth cracks in the concrete slab.
  - Scope: Occurs in multiple locations in hallway.
  - Correction: The slab was confirmed to span parallel to the cracks, which makes these cracks likely temperature- and shrinkage-related and non-structural. No structural remediation is required.

*Crack in hallway*

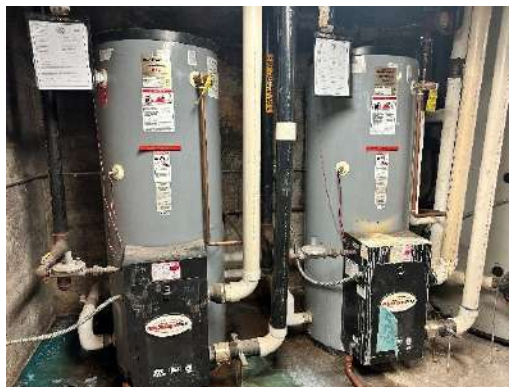
1. Gas water heaters were manufactured in 2009. Water heaters should be replaced based off life cycle and current state. Water heaters are currently passed expiration date per operation permit (1/1/2023). Pressure relief valve currently leaking.
  - Scope: Main Mechanical Room – Building 5010
  - Correction: Replace with new gas water heaters per DCS standards.

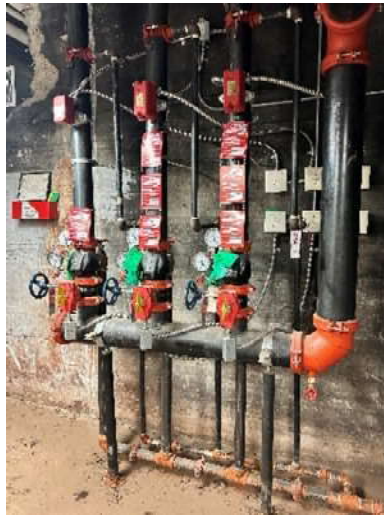
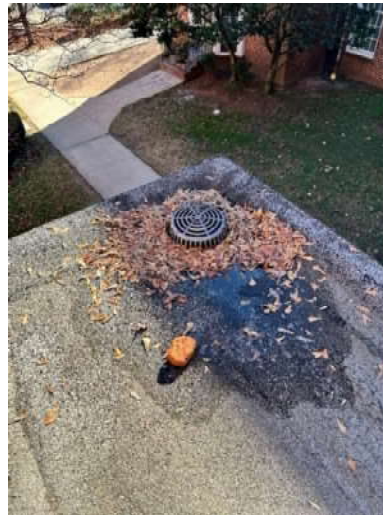
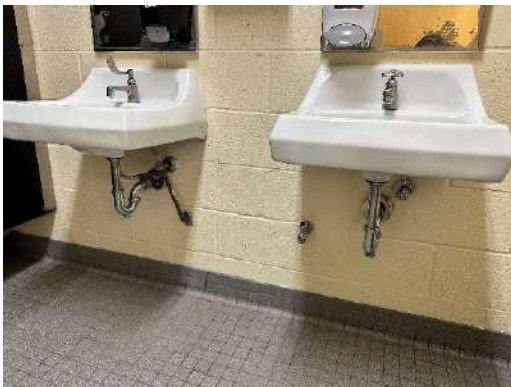
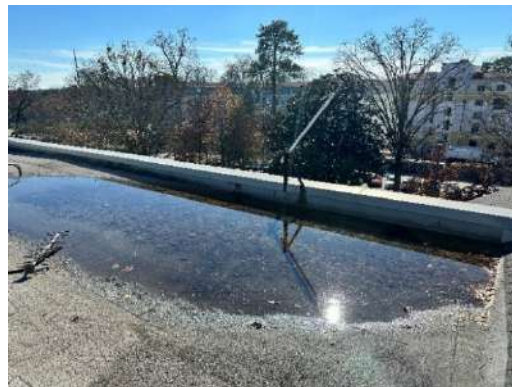
1. Building is fully sprinkled. Fire risers are in good condition.
  - Scope: Throughout the entire Building 5010.
  - Correction: None
2. Fixtures are outdated and do not meet DCS standards.
  - Scope: Specific restroom in Building 5010.
  - Correction: Replace fixtures that meet current DCS standards.
3. Roof drain is blocked and standing water is present.
  - Scope: Main Mechanical Room – Building 5010
  - Correction: Remove debris from roof drain.

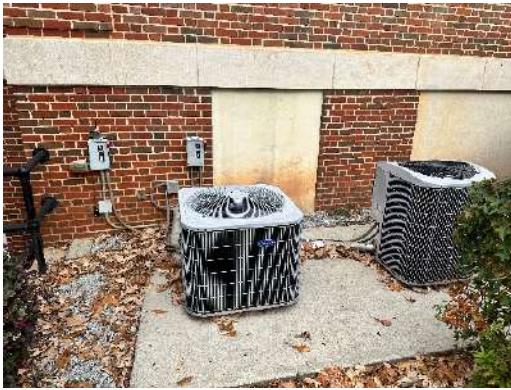
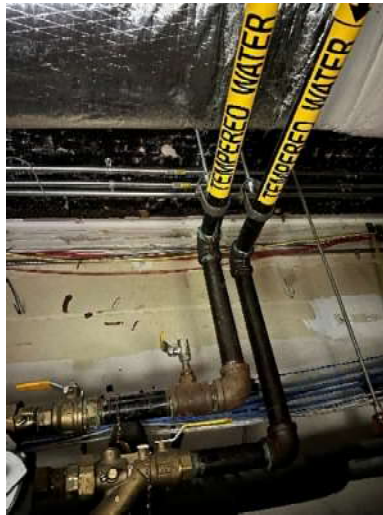
13. HVAC piping was noted to be original to the building and should be replaced based off age and life expectancy.
- Scope: Throughout the building 5010.
  - Correction: Replace piping due to reaching life cycle.

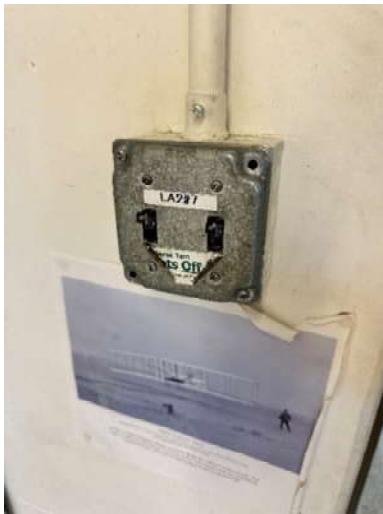
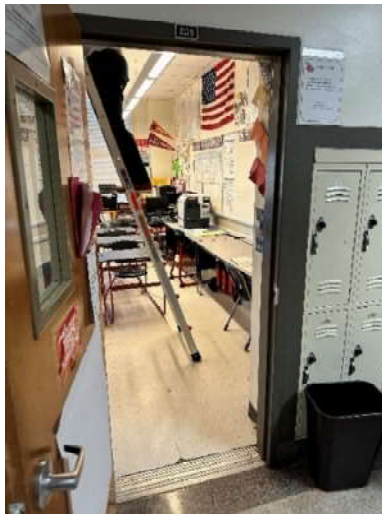
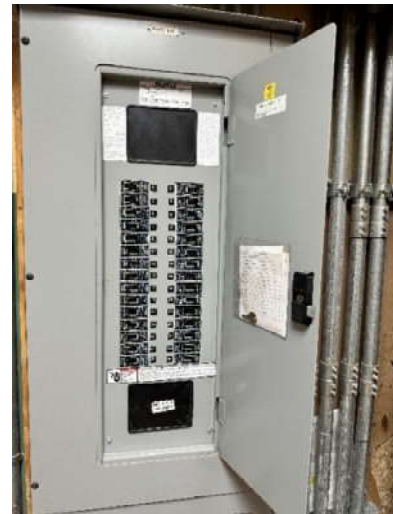
1. Classrooms shall have lighting control devices (occupancy control) per code and DCS standards.
  - Scope: Building 5010 – Classrooms
  - Correction: Replace lighting to LED and include upgraded/updated lighting controls.
2. Building (excluding Administration Areas) include existing outdated fluorescent lighting.
  - Scope: Throughout the building (excluding Administration Area)
  - Correction: Replace lighting to LED throughout to match DCS standards.
3. Electrical panel boards and distribution panel were replaced in 2009 and in good condition.
  - Scope: Throughout the building 5010.
  - Correction: Replace lighting to LED throughout

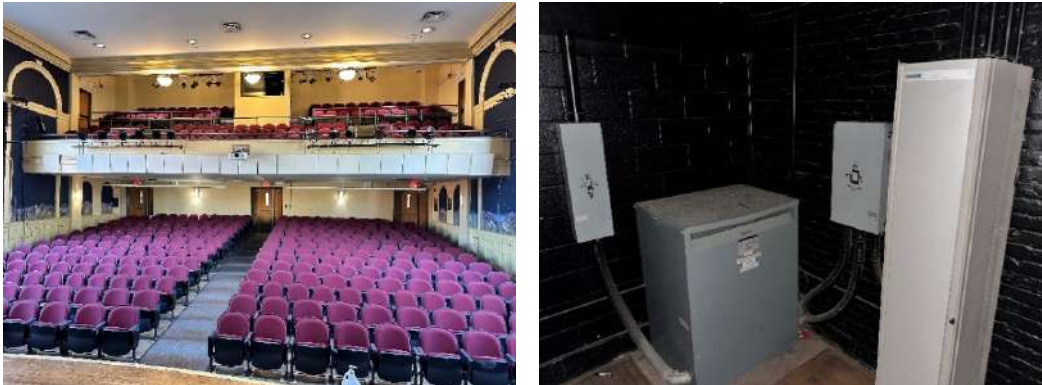
4. Stage Lighting and Dimmer Rack were installed in 2000 and are outdated. Existing Dimmer Rack parts are becoming obsolete and stage lighting is not LED.
  - Scope: Auditorium / Stage
  - Correction: Replace Dimmer Rack with new ETC rack along with new LED stage lighting. Another option would be to existing panel could be left as existing and upgraded

with new modules in the rack for LED loads from ETC as a cost savings option compared to replacing with new.

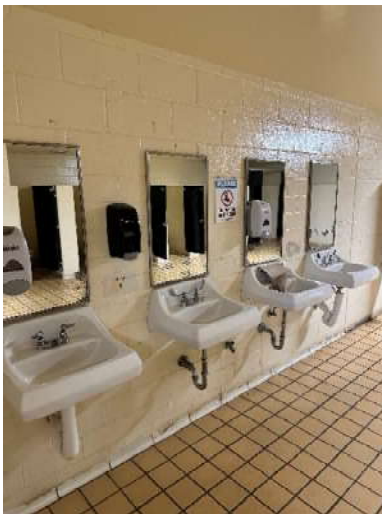
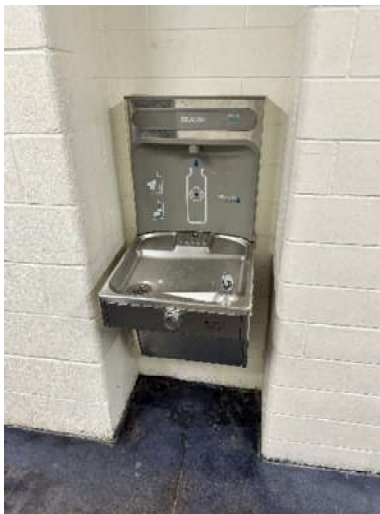
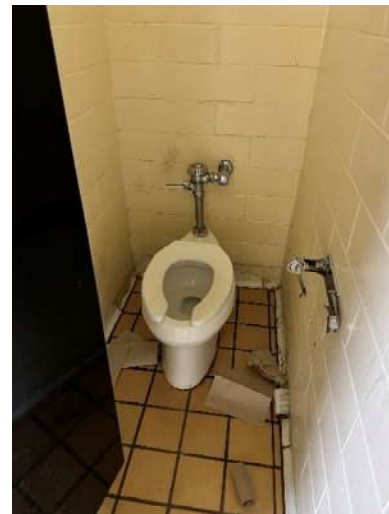
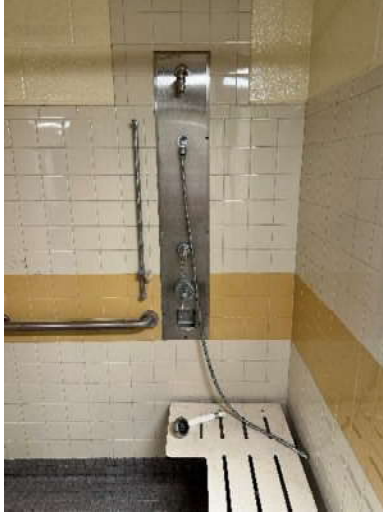
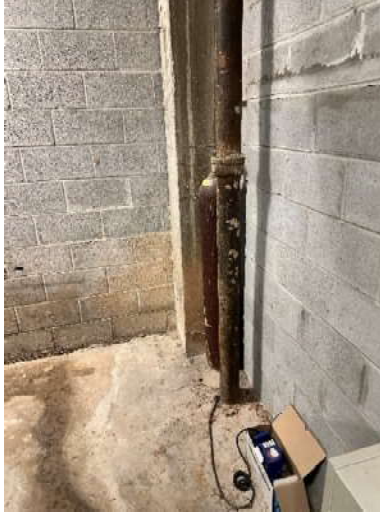
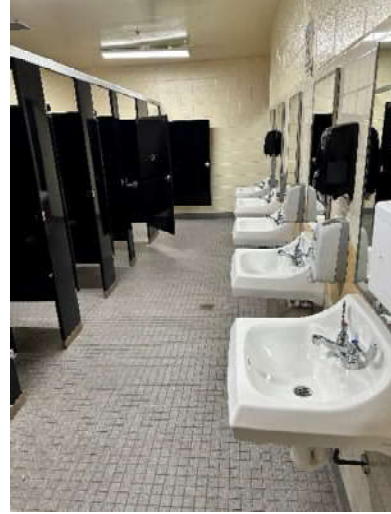
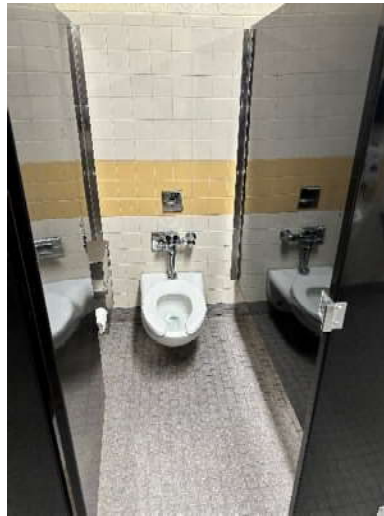
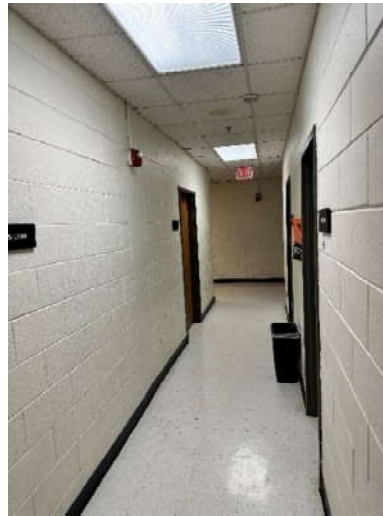
2. Fixtures are in fair condition (Boys).
  - Scope: Building 5011 – Gang Restrooms (Boys)
  - Correction: Plan to replace fixtures to match DCS standards and based off life cycle.
3. Showers are in fair condition (Boys).
  - Scope: Building 5011 – Gym Showers (Boys)
  - Correction: Plan to replace fixtures to match DCS standards and based off life cycle.
4. Sanitary piping is deteriorating in places.
  - Scope: Building 5010 – Mechanical Room
  - Correction: Replacement piping as required.
5. Fixtures are in good condition (Girls).
  - Scope: Building 5011 – Gang Restrooms (Girls)
  - Correction: None
6. Showers are in fair condition (Girls).
  - Scope: Building 5011 – Gym Showers (Girls)
  - Correction: Plan to replace fixtures to match DCS standards and based off life cycle.

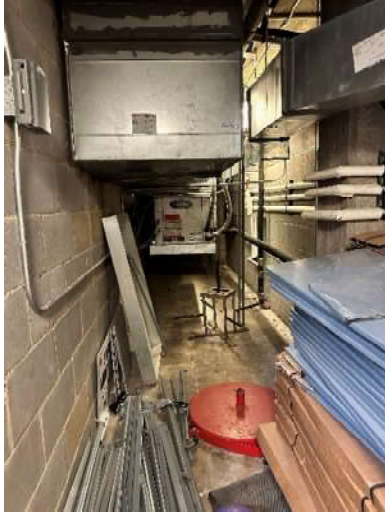
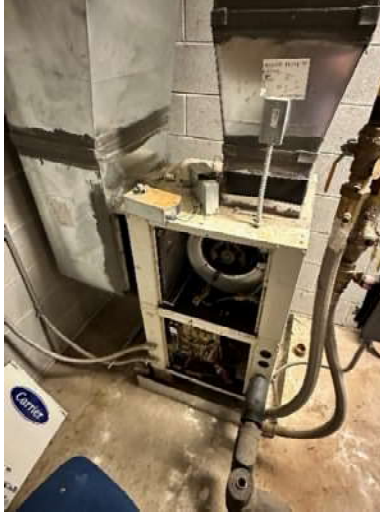
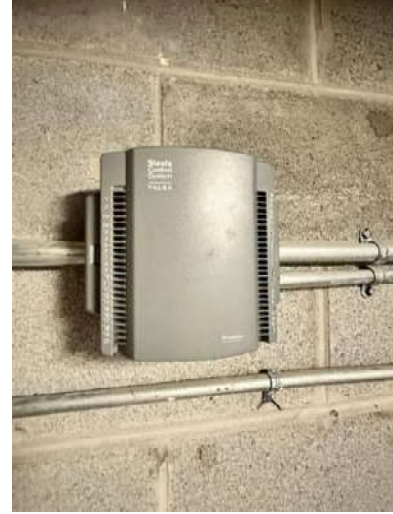
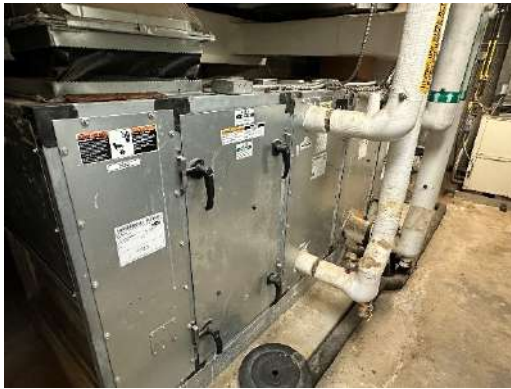
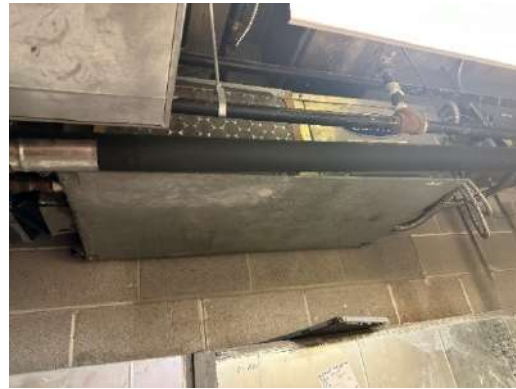
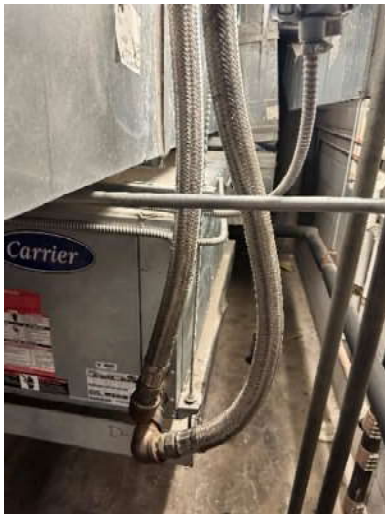
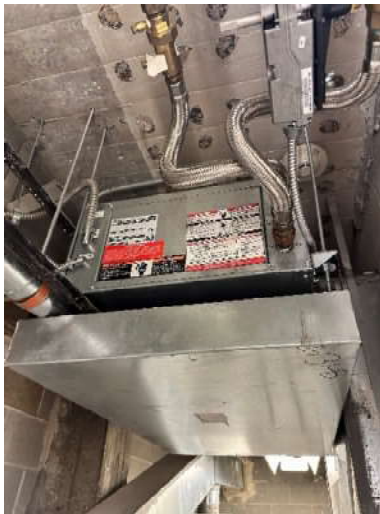
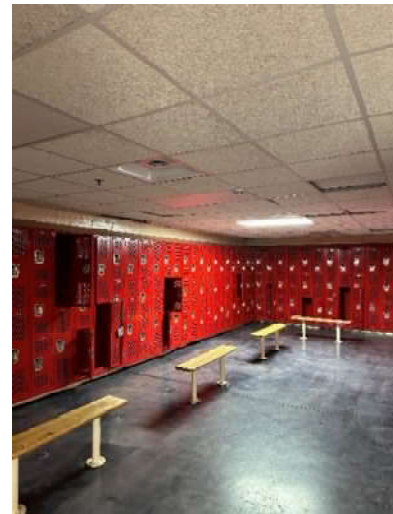
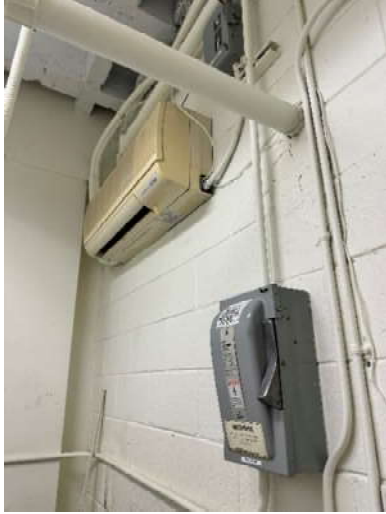
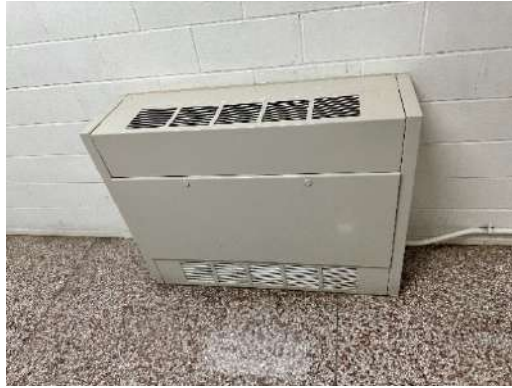
1. Airside Equipment was manufactured and installed in 2009.
  - Scope: Throughout the entire Building 5011.
  - Correction: Units are approaching typical life cycle. Recommendation is to plan for the replacement of the existing system within the next 5 years. Units do not have adequate maintenance clearances.

2. Gym Locker-rooms needs better ventilation.
  - Scope: Building 5011 – Locker-rooms
  - Correction: Provide or repair existing ventilation/exhaust fans to ensure proper airflow to reduce chances of musk odors and mold.

3. DX Minisplits at MDF/IDF Rooms. Multiple units were in alarm or not working.
  - Scope: Building 5011 – IDF Room(s)
  - Correction: Replace Minisplits to ensure MDF/IDF rooms are properly conditioned and do not overheat.

4. Building Automation System is becoming outdated and should plan to be replaced. Parts will become obsolete.
  - Scope: Throughout entire Building 5011.

- Correction: Upgrade BAS system for campus to single front-end.
5. Ductwork is internally lined.
  - Scope: Throughout entire Building 5011.
  - Correction: Replace ductwork.

6. Locker-room areas with gypsum ceiling do not have access panels for maintenance.
  - Scope: Building 5011 – Restrooms + Showers
  - Correction: Provide and install access panels per DCS standards.

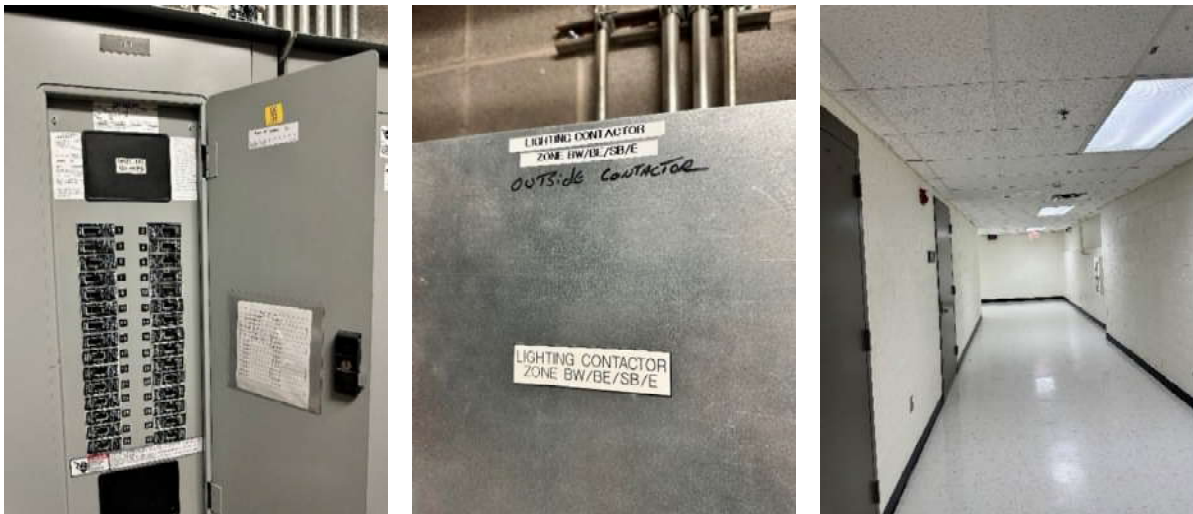
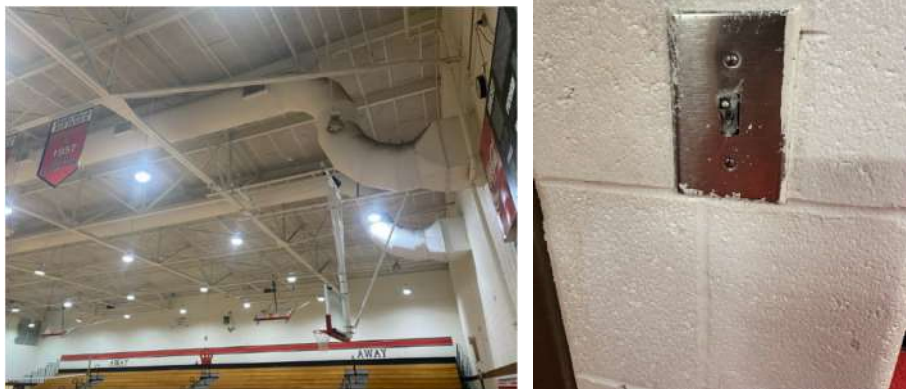
1. Instructional Spaces and Corridors have fluorescent lighting with toggle switches.
  - Scope: Building 5011 – Instructional Spaces and Corridors
  - Correction: Replace lighting to LED and include upgraded/updated lighting controls.
2. Building exterior includes existing outdated HID lighting.
  - Scope: Building 5011 – Exterior
  - Correction: Replace lighting to LED throughout to match DCS standards.
3. Electrical panelboards and distribution panels were replaced in 2009 with the HVAC and in good condition. Panelboards also have spare capacity.
  - Scope: Building 5011 – Electrical Rooms
  - Correction: None
4. Main Competition Gym lighting is in good condition.
  - Scope: Building 5011 – Competition Gym
  - Correction: None
5. Practice/Stage area in main Gym lighting is in good condition.
  - Scope: Building 5011 – Practice/Stage Area
  - Correction: None

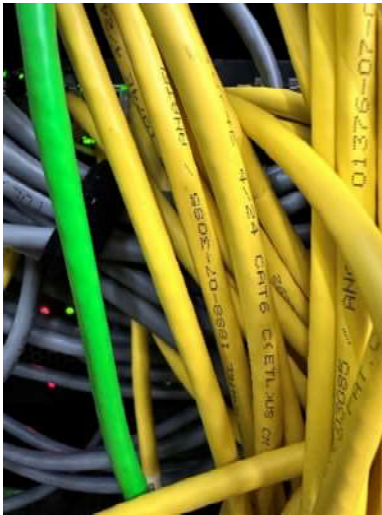
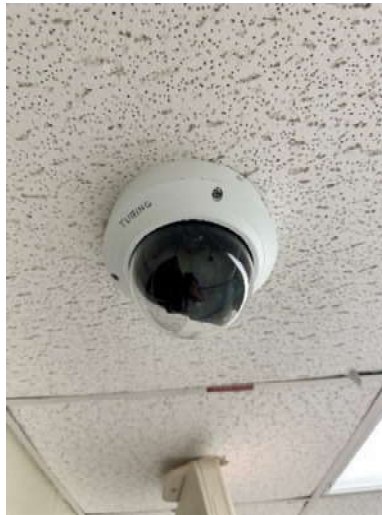
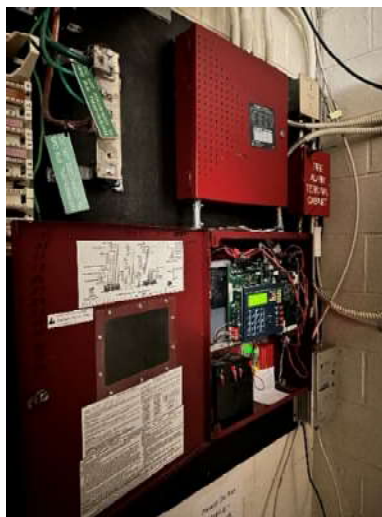
1. Fire Alarm is nearing life cycle. Replace due to age/life cycle and consistent faults.
  - Scope: Throughout the building 5011.
  - Correction: Replace with new system based off DCS standards.

2. Intrusion Detection system is in fair condition. May need to be replaced due to age/life cycle.
  - Scope: Throughout the building 5011.
  - Correction: Replace with new system based off DCS standards.

3. Existing Intercom/Clock system is in fair condition. Parts are becoming obsolete, and system should be replaced due to age within the next 5 years.
  - Scope: Throughout the building 5011.
  - Correction: Replace with new system based off DCS standards.

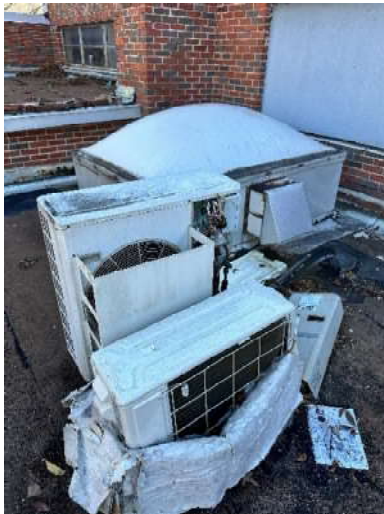
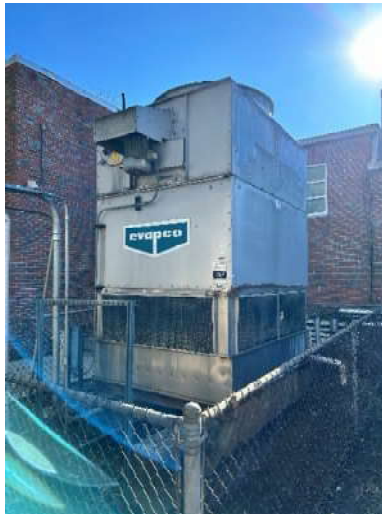
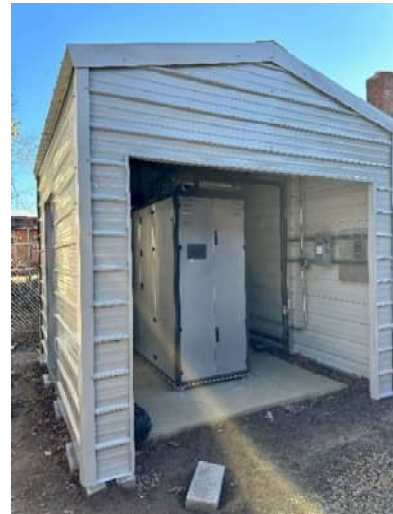
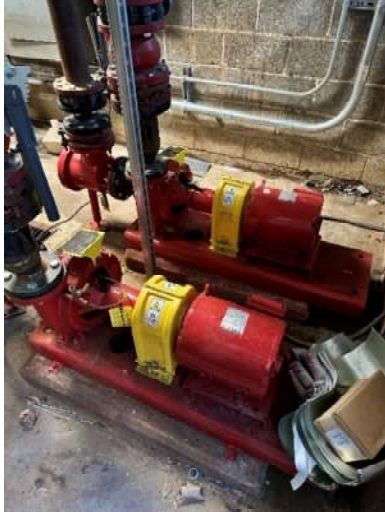
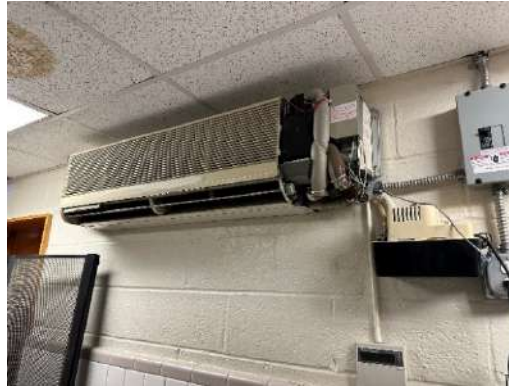
- Scope: Building 5020 – MDF Room
  - Correction: Replace unit with new and provide new BAS control interface.
2. EvapCo Cooling Tower was replaced in 2009. Tower is showing visible signs of wear and rust.

- Scope: Building 5020 – Mechanical Room Yard
  - Correction: Plan for replacement within the next 5 years. Average life cycle average is 20 years.
3. Heating Hot Water Boiler is new and recently replaced in December 2023.

- Scope: Building 5020 – Mechanical Room Yard
  - Correction: None. Existing boiler was abandoned in place in the Mechanical Room.
4. Tempered Water pumps were replaced in 2023. No visible or known issues.

- Scope: Building 5020 – Mechanical Room
  - Correction: None
5. Plate Frame Heat Exchanger was manufactured in 1994 and past life cycle.
  - Scope: Building 5020 – Mechanical Room

- Correction: Replace with new system per DCS standards.
