# DRUID HILLS HIGH SCHOOL MODERNIZATION REPORT

## MODERNIZATION REPORT

The Modernization Report catalogs facility deficiencies in the current facility. Deficiencies are classified as follows:

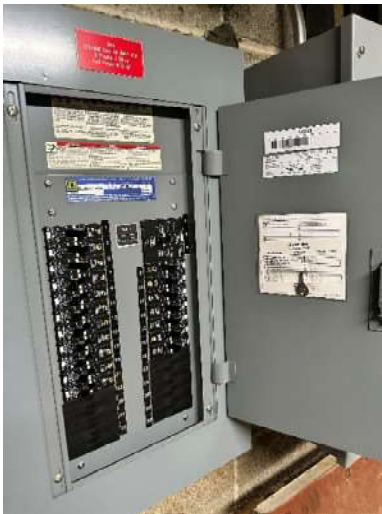
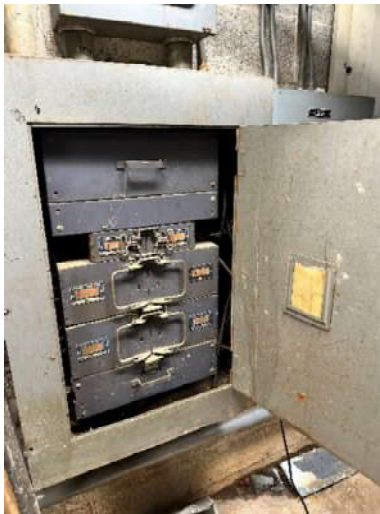
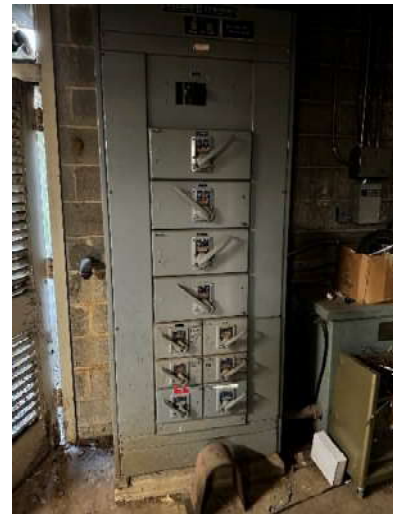
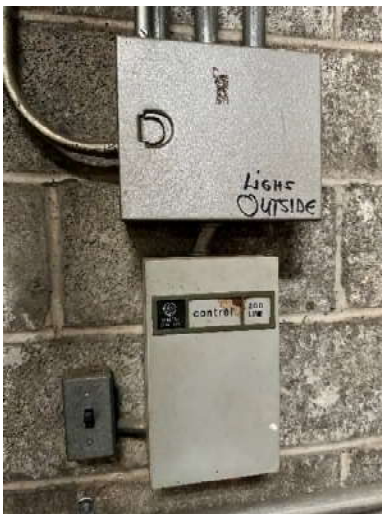
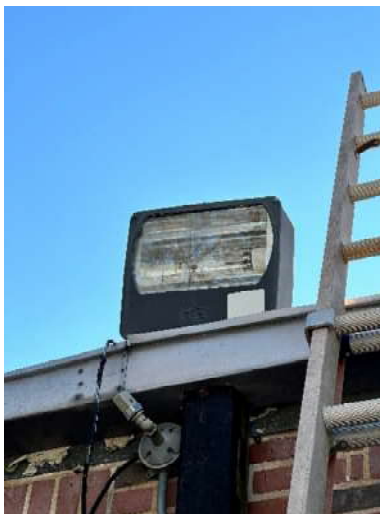
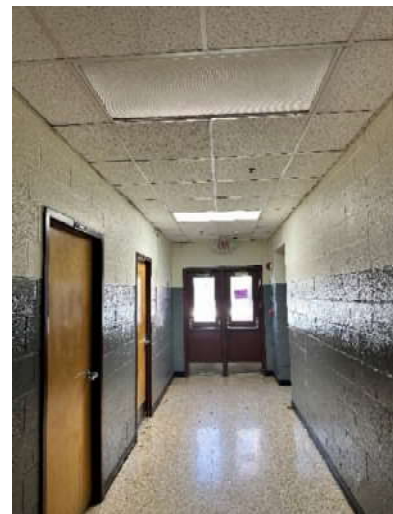
1. Existing Emergency Panelboards and ATS were in good condition with spare capacity.
  - Scope: Building 5020 – Main Mechanical Room
  - Correction: None

2. Existing Normal Power Panelboards are outdated.
  - Scope: Building 5020 – Main Mechanical Room +
  - Correction: Replace panelboards with new.
3. Existing Normal Power Panelboards are outdated and range from fair to poor condition.

- Scope: Building 5020 – Main Mechanical Room
  - Correction: Replace panelboards with new.
4. Existing Square D 800A switchboard is outdated. Replacement breakers are not available from the manufacturer.

- Scope: Building 5020 – Main Mechanical Room
  - Correction: Replace panelboards with new.
5. Existing exterior lighting control system is outdated.
  - Scope: Building 5020 – Main Mechanical Room

- Correction: Replace system with new to match DCS standards.
6. Existing exterior lighting is HID.
  - Scope: Building 5020 – Exterior

- Correction: Replace lighting to LED for energy efficiency and better security visibility.
7. Existing interior lighting and controls system in fluorescent with toggle switches.
- Scope: Building 5020 – Interior
  - Correction: Replace lighting to LED for energy efficiency. Upgrade lighting controls system to include occupancy control to satisfy code and DCS standards.
8. Siemens 1000A switchboard is in good condition and manufactured in 2009.
- Scope: Building 5020 – Interior
  - Correction: None.

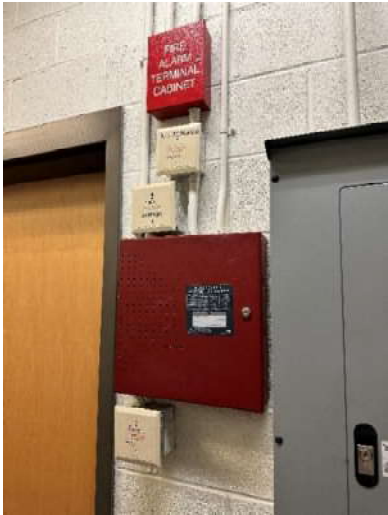
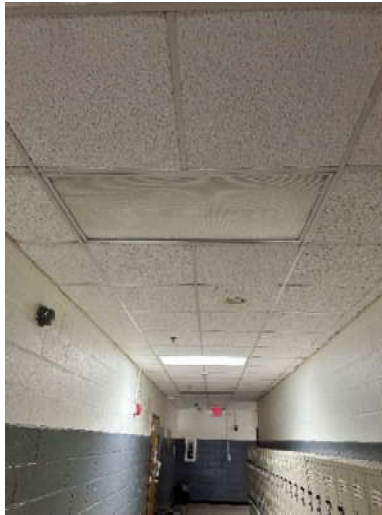
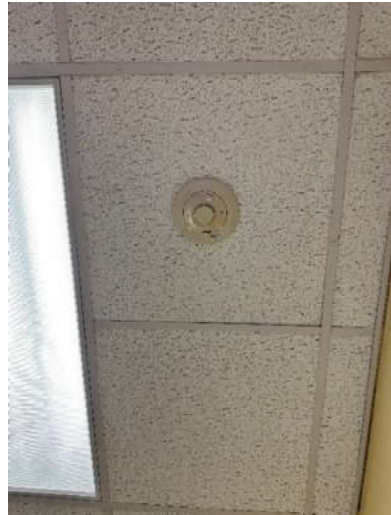
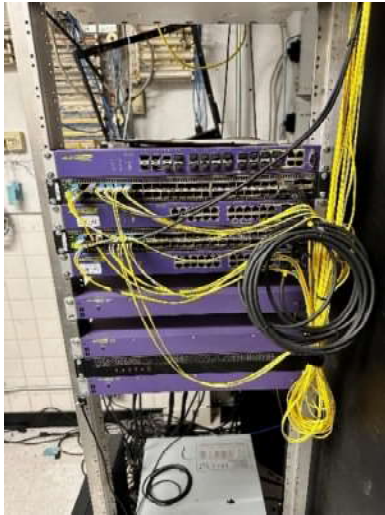
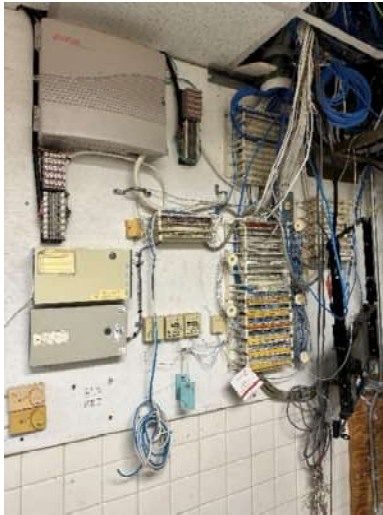
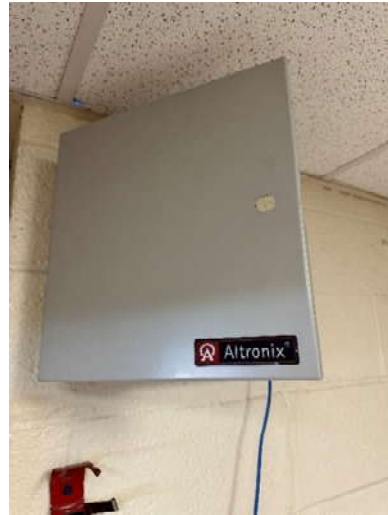
1. Building is sprinkled; however, areas might be lacking coverage. Entrance to Building 5021 from interior courtyard is not sprinkled.
  - Scope: Throughout the entire Building 5021.
  - Correction: Provide coverage to areas not sprinkled. Check existing suppression piping for leaks. Visible leaks were observed on a number of ceiling tiles.
2. Drinking Fountain does not meet DCS standards.
  - Scope: Building 5021 – Corridor
  - Correction: Replace with Hi/Lo fixture with bottle filler to match DCS standards.
3. Electric water heater was manufactured in 2015. Water heater was in good condition with no visible signs of rust or issues.
  - Scope: Building 5021 – Storage Room
  - Correction: Drain water heater to clean seasonally.
4. Custodial mop sink is in poor condition.
  - Scope: Building 5021 – Custodial Room
  - Correction: Replace fixture with new.

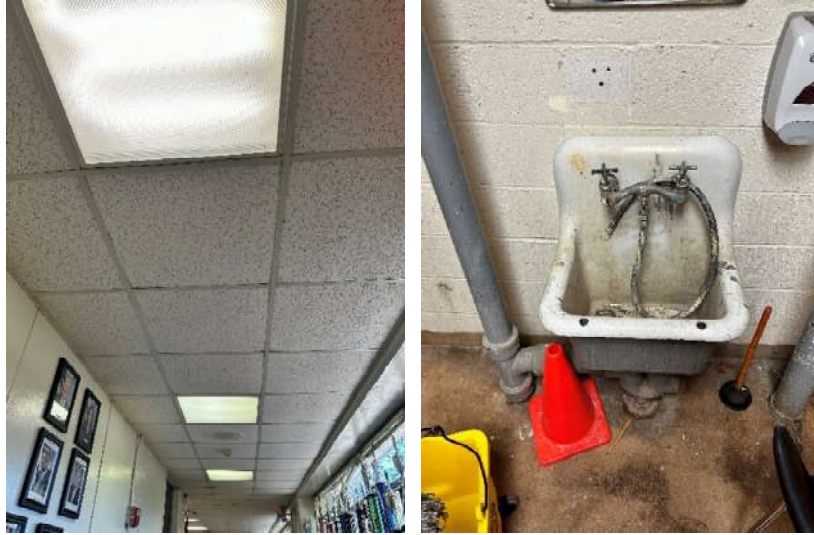
1. Water Source Heat Pumps were replaced in 2009. Units are in fair condition.
  - Scope: Building 5021 – Above Ceiling
  - Correction: Plan for replacement within the next 5-10 years.
2. BAS controls are obsolete. Not all buildings are on the same BAS front-end as Building 5010.
  - Scope: Building 5021 + Entire Campus
  - Correction: Replace BAS controls system for entire campus with one new, single front-end.
3. Replace restroom exhaust fans.
  - Scope: Building 5021 – Gang Restrooms
  - Correction: Fans should be replaced based off life cycle to avoid stagnant odors.
4. Existing ductwork is internally lined.
  - Scope: Building 5021 – Above Ceiling
  - Correction: Replace ductwork due to age. Replace with externally insulated ductwork.

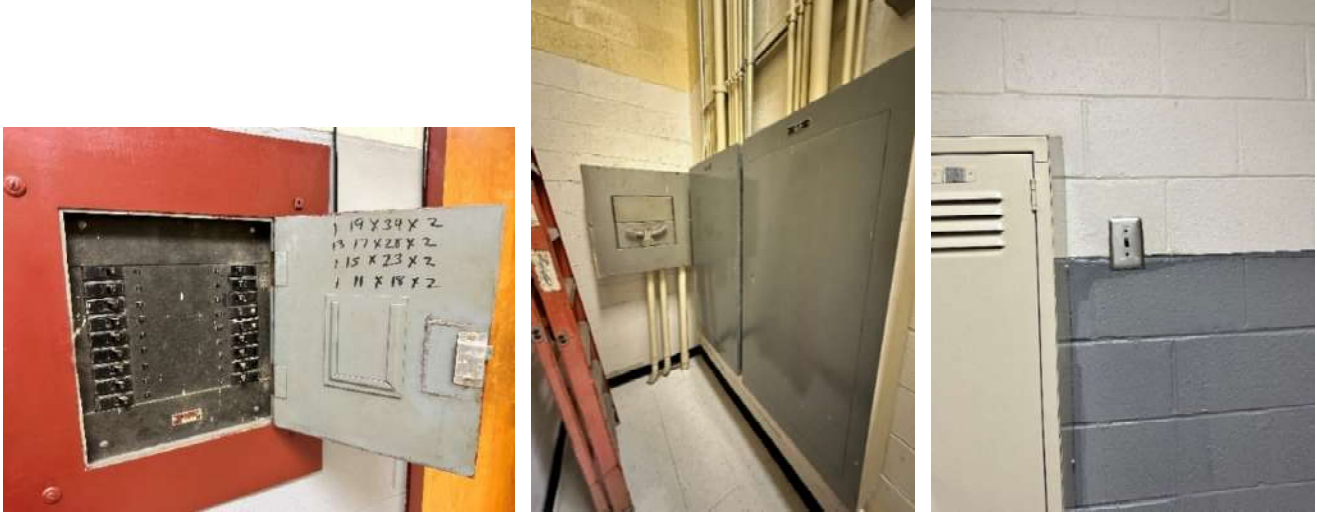
1. Existing Panelboards in corridor are outdated, and replacement breakers are obsolete.
  - Scope: Building 5021 – Main Mechanical Room
  - Correction: Replace outdated panelboards. Existing panelboards are in corridors, which conflicts with DCS standards via student access. Existing panelboards are also missing identification cards.
2. Existing Square D distribution panels are in fair condition.
  - Scope: Building 5021 – Corridor Electrical Room
  - Correction: None
3. Lightings controls are toggle switches and do not need DCS standards.
  - Scope: Building 5021 – Corridor
  - Correction: Replace toggle switches with keyed switches in the corridors and provide dimmer switches in classrooms with occupancy sensors, per standards.
4. Lighting is outdated and should be upgraded to LED.
  - Scope: Throughout Building 5021
  - Correction: Replace all lighting with new LED fixtures.

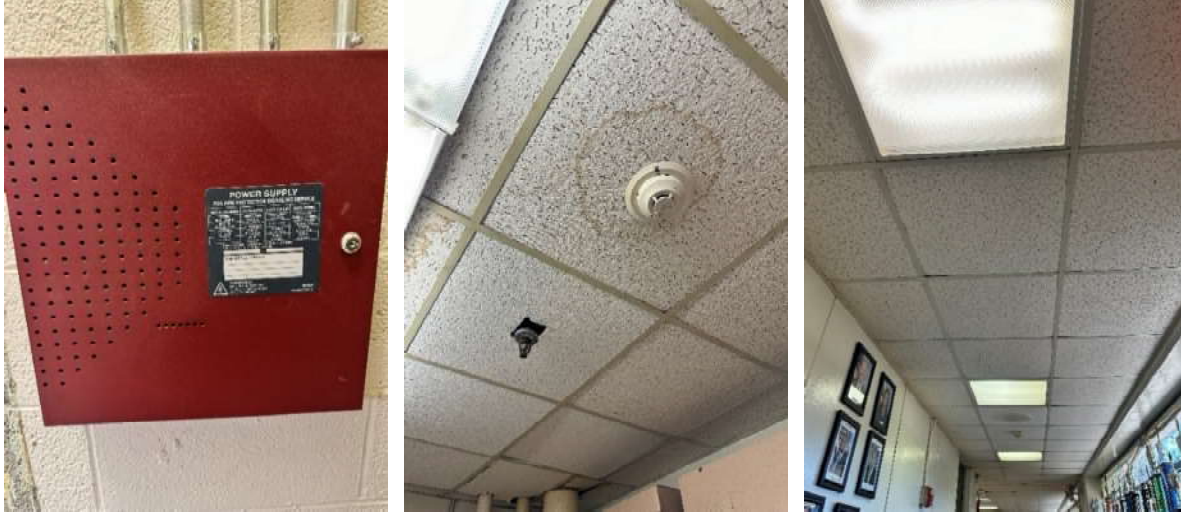
1. Fire Alarm is nearing life cycle. Replace due to age/life cycle and consistent faults.
  - Scope: Throughout the building 5021.
  - Correction: Replace with new system based off DCS standards.
2. Intrusion Detection system is in fair condition. May need to be replaced due to age/life cycle.
  - Scope: Throughout the building 5021.
  - Correction: Replace with new system based off DCS standards.
3. Existing Intercom/Clock system is in fair condition. Parts are becoming obsolete, and system should be replaced due to age within the next 5 years.
  - Scope: Throughout the building 5021.
  - Correction: Replace with new system based off DCS standards.

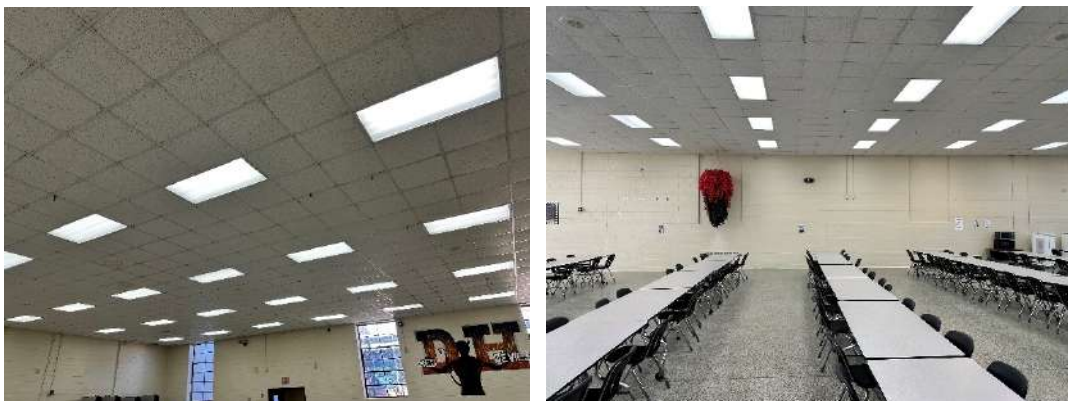
1. Cafeteria area is not sprinkled. Area of building is under required sprinkler per code; however, the building should be sprinkled for campus consistency and added protection.
  - Scope: Building 5030
  - Correction: Provide fire suppression system as required by code and DCS standards.

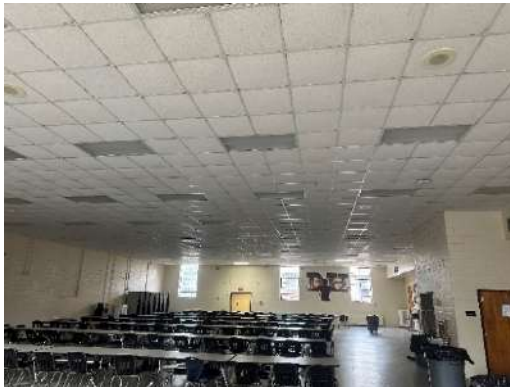
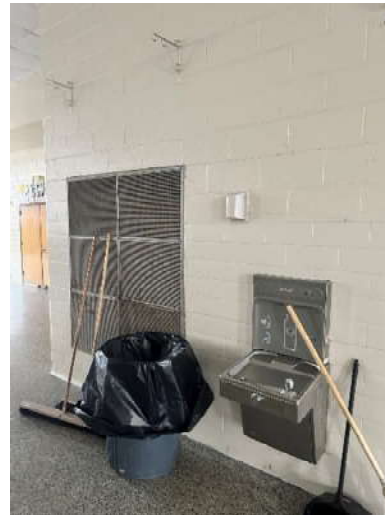
1. Drinking Fountain should be Hi/Lo setup to meet DCS standards.
  - Scope: Building 5021 – Cafeteria
  - Correction: Replace with Hi/Lo fixture with bottle filler to match DCS standards.
2. Fixtures are outdated and do not meet DCS standards.
  - Scope: Specific restroom in Building 5010.
  - Correction: Replace fixtures per DCS standards.
3. 100 Gallon – Gas Kitchen Water Heater
  - Scope: Building 5030 – Kitchen
  - Correction: Replace with new gas water heater.

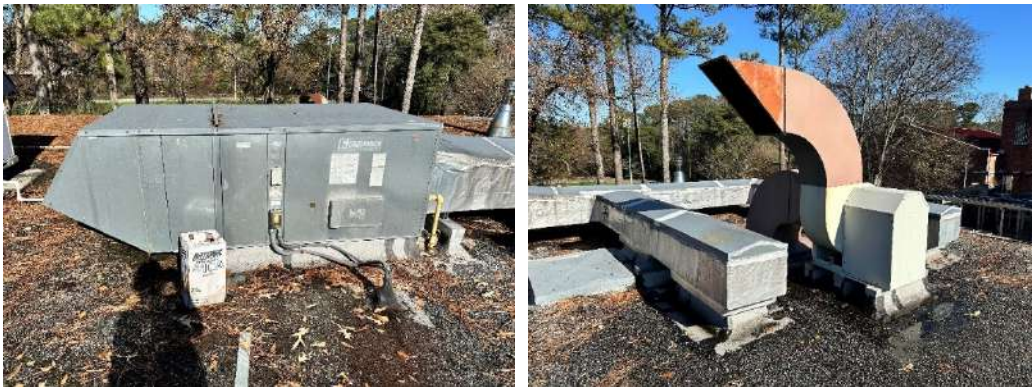
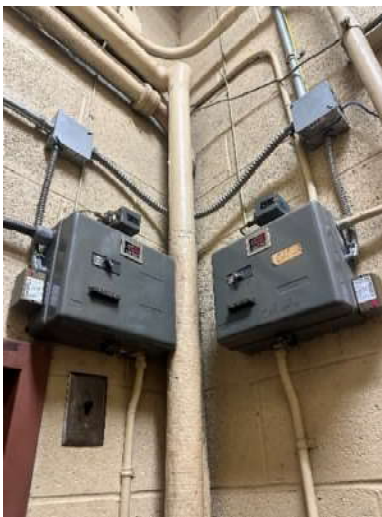
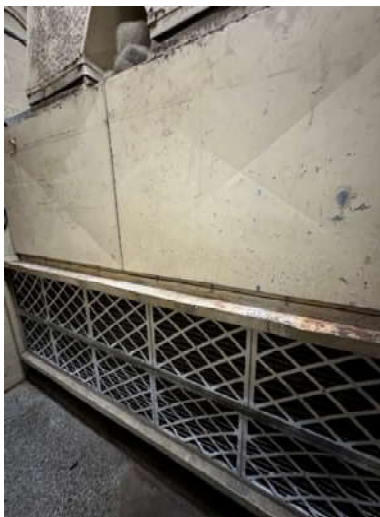
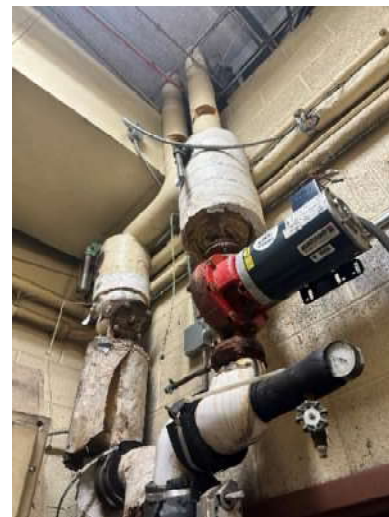
1. Existing Cafeteria Air Handling Unit (15,000 cfm) is past life cycle.
  - Scope: Building 5030 – Mechanical Room
  - Correction: Replace AHU with new unit and BAS controls.
2. BAS controls are obsolete. Not all buildings are on the same BAS front-end as Building 5010.
  - Scope: Building 5030 – Mechanical Room

- Correction: Replace BAS controls system with new alongside AHU replacement.
3. Kitchen exhaust fans were manufactured in 2009.
    - Scope: Building 5030 – Mechanical Room
    - Correction: Replace exhaust fans.
  4. Kitchen HVAC DX Gas Heat Rooftop unit was manufactured in 2009. Unit is in fair condition. Visible signs of refrigerant leak on the condenser coils.
    - Scope: Building 5030 – Roof
    - Correction: Replace unit with new.
  5. Carrier 100 Ton Chillers (each) are in fair condition and manufactured in 2009.
    - Scope: Building 5030 – Chiller Yard
    - Correction: Chillers are nearing life cycle. Plan for replacement within the next 5 years.

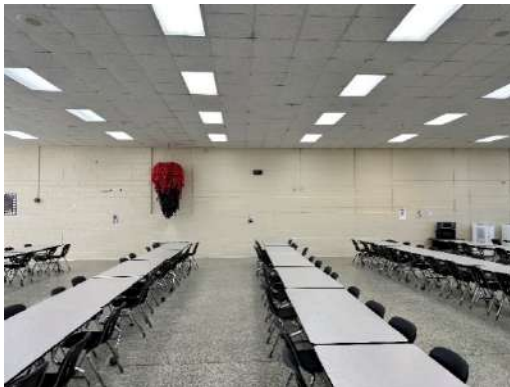
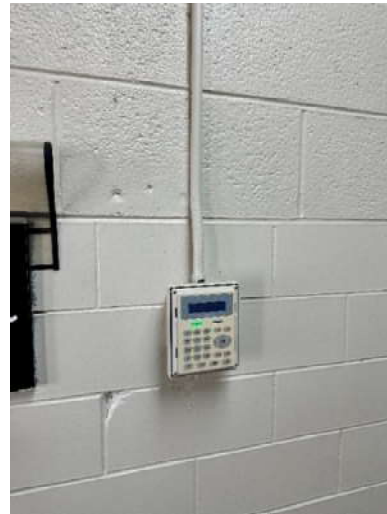
1. Fire Alarm is nearing life cycle. Replace due to age/life cycle and consistent faults.
  - Scope: Throughout the building 5030.
  - Correction: Replace with new system based off DCS standards.
2. Intrusion Detection system is in fair condition. May need to be replaced due to age/life cycle.
  - Scope: Throughout the building 5030.
  - Correction: Replace with new system based off DCS standards.
3. Existing Intercom/Clock system is in fair condition. Parts are becoming obsolete, and system should be replaced due to age within the next 5 years.
  - Scope: Throughout the building 5030.
  - Correction: Replace with new system based off DCS standards.

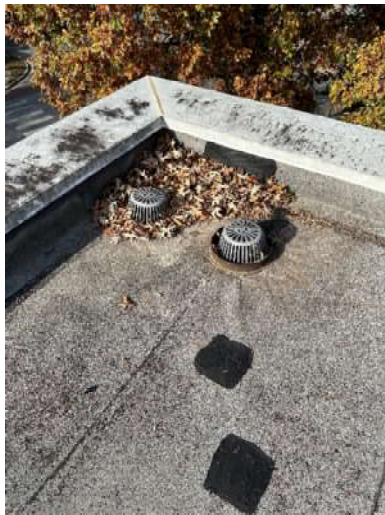
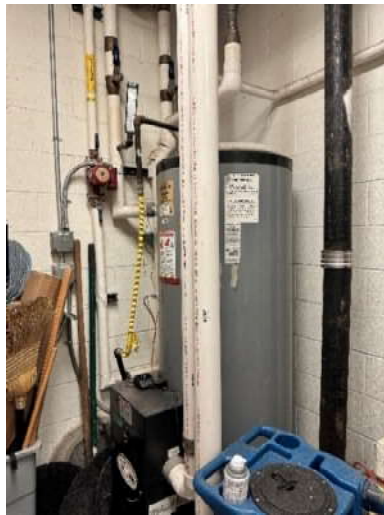
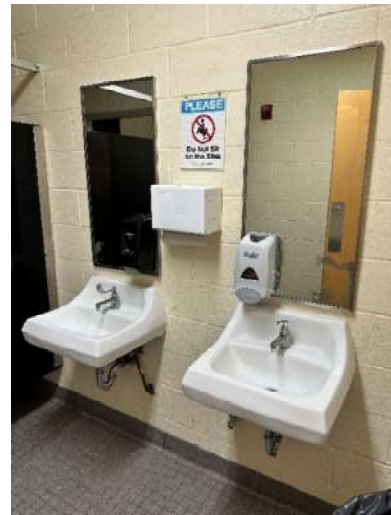
1. Building is fully sprinkled. Fire risers are in good condition.
  - Scope: Throughout Building 5040.
  - Correction: None
2. 120-gallon gas domestic water heater is in fair condition.
  - Scope: Building 5040 – Custodial Closet
  - Correction: Water heater should be replaced within the next 5 years.
3. Plumbing fixtures are in fair condition. Gang restrooms have automated, hard-wired flush valves.
  - Scope: Building 5040 – Gang Restrooms
  - Correction: Replace fixtures within the next 5-10 years.
4. Roof drains are in fair condition.
  - Scope: Building 5040 – Roof
  - Correction: Remove debris from roof drains to avoid ponding and roof leaks.

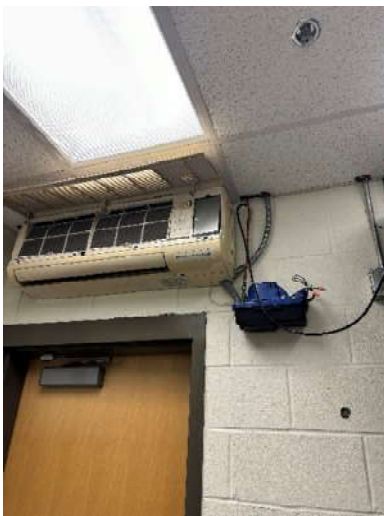
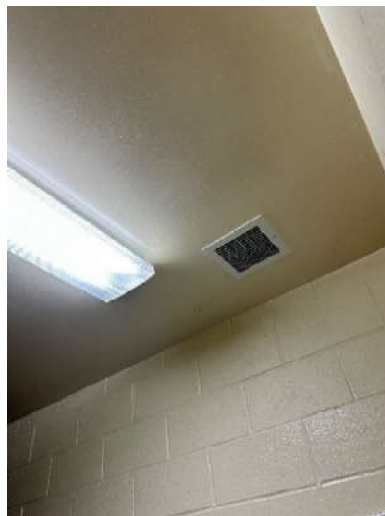
1. DX Minisplit units were not operating.
  - Scope: Building 5040 – IDF Room(s)
  - Correction: Replace Minisplits with new to avoid server racks from overheating.
2. BAS controls are becoming obsolete. Not all buildings are on the same BAS front-end as Building 5010.
  - Scope: Throughout Building 5040
  - Correction: Replace BAS controls system.
3. DX Rooftop Gas Heat Units were manufactured and installed in 2009. Units are at life cycle.
  - Scope: Building 5040 – Roof
  - Correction: Replace DX Rooftop Units.
4. Vektor high-plume exhaust fans are in fair condition. Equipment was manufactured and installed in 2009.
  - Scope: Building 5040 – Roof
  - Correction: Replace exhaust fans.
5. Energy Recovery Unit (8000 cfm) was installed in 2009 and is in fair condition.
  - Scope: Building 5040 – Roof
  - Correction: Plan for replacement within the next 5 years.

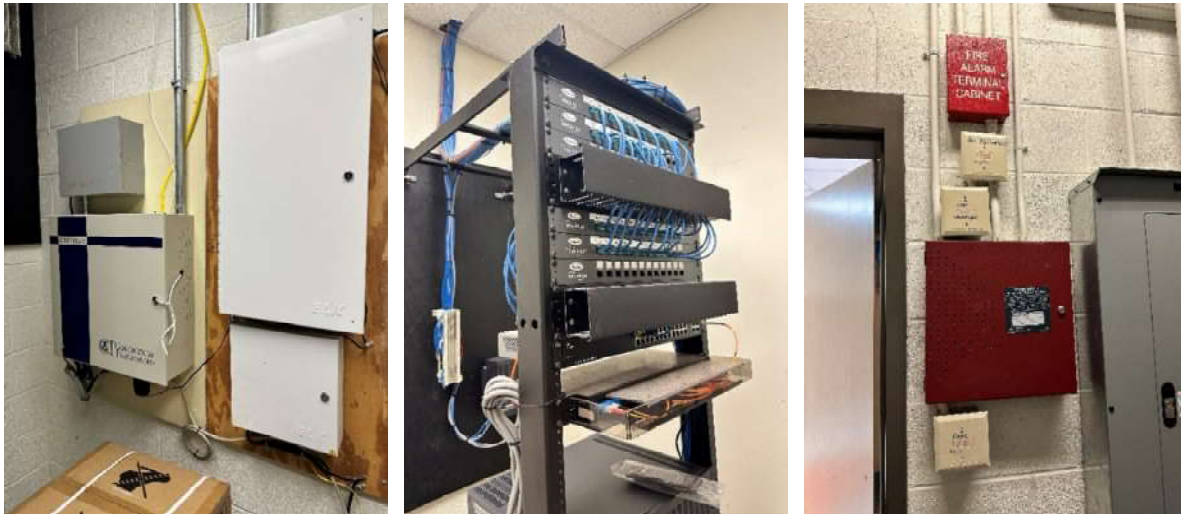
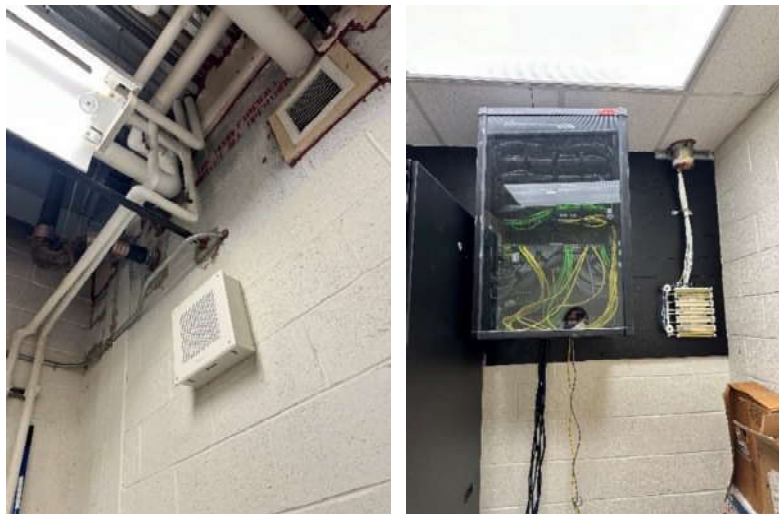
3. Existing Intercom/Clock system is in fair condition. Parts are becoming obsolete, and system should be replaced due to age within the next 5 years.
  1. Scope: Throughout the building 5040.
  2. Correction: Replace with new system based off DCS standards.

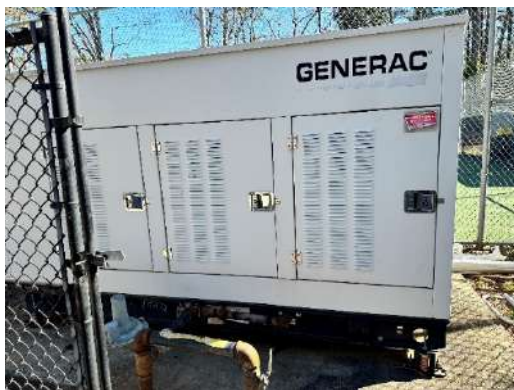
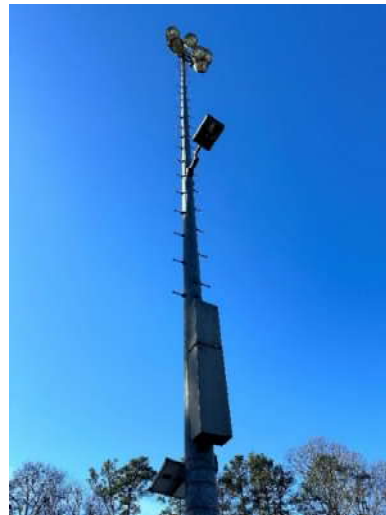
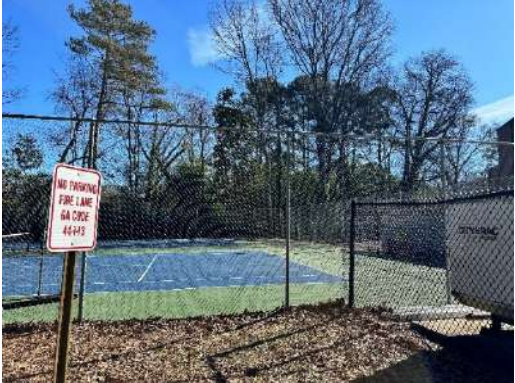
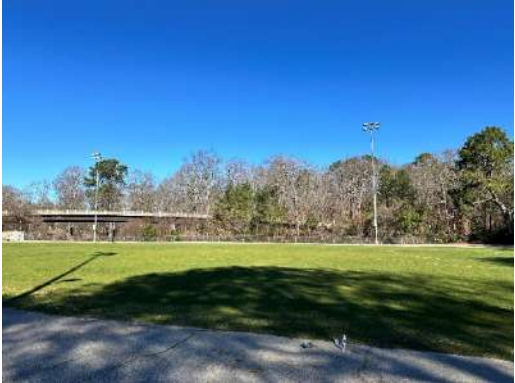
1. Generator (Natural Gas) was installed in 2009.
  1. Scope: Site
  2. Correction: Generator is in good condition. Spare capacity on emergency panels.
2. Baseball/Softball practice field does not have existing sports lighting.
  1. Scope: Baseball/Softball Field
  2. Correction: Provide sports lighting per DCS standards.
3. Tennis Courts do not have sports lighting or after-hours lighting.
  1. Scope: Tennis Courts
  2. Correction: Provide sports lighting per DCS standards and security.
4. Football field has existing MUSCO lighting. Sports lighting is not LED.
  1. Scope: Football field
  2. Correction: Upgrade sports lighting to LED per DCS standards.

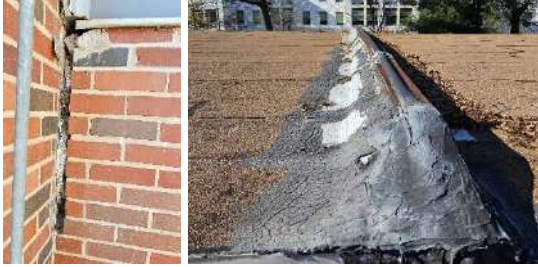
1. Widespread blisters of roofing membrane.
  - Scope: Occurs in multiple locations.
  - Correction: Replacement of existing.
2. Deteriorated & unsealed flashings / flashing terminations.
  - Scope: Occurs in multiple locations.
  - Correction: Replacement of existing.
3. Widespread cap sheet granule loss.
  - Scope: Occurs in multiple locations.
  - Correction: Replacement of existing.
4. Deteriorated expansion joint flashings.
  - Scope: Occurs in multiple locations.
  - Correction: Replacement of existing.
5. Deteriorated window opening components.
  - Scope: Window units and temporary covering which have been placed over some windows.
  - Correction: Remove and replace.

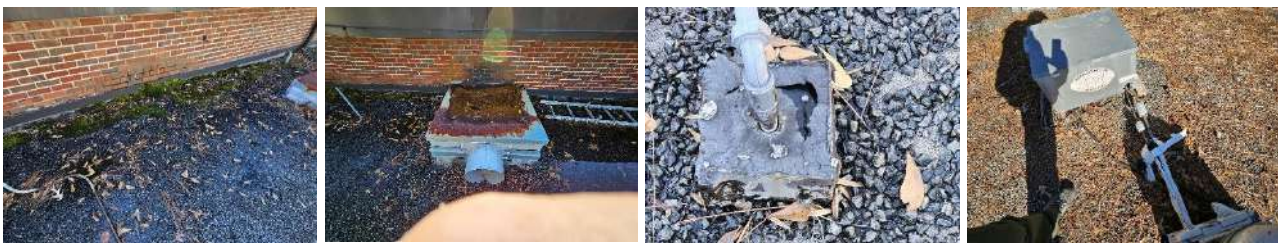
6. Damaged soffits.
  - Scope: Occurs in multiple locations.
  - Correction: Replacement of existing.
7. Pipe penetration flashing is damaged.
  - Scope: Occurs in multiple locations.

- Correction: Replacement of existing.
8. Deteriorated curb covers.
  - Scope: Occurs in multiple locations.
  - Correction: Remove and replace.

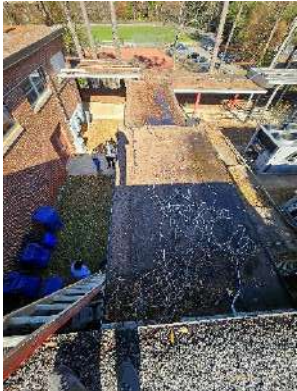
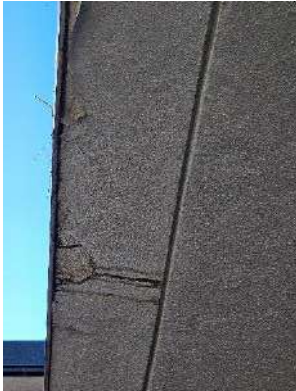
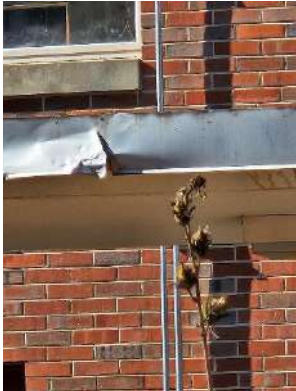
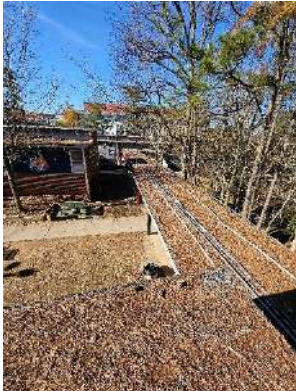
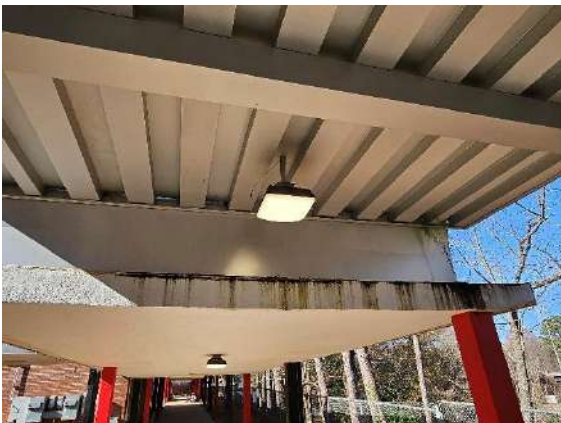
1. Ponding water.
  - Scope: Occurs in multiple locations.
  - Correction: Replacement of existing.
2. Widespread cap sheet granule loss.
  - Scope: Occurs in multiple locations.
  - Correction: Replacement of existing.
3. Excess debris, both organic and manmade
  - Scope: Occurs in multiple locations.
  - Correction: Replacement of existing.
4. Roofing membrane past its useful life (dried out).
  - Scope: Occurs in multiple locations.
  - Correction: Replacement of existing.
5. Damaged soffits.
  - Scope: Occurs in multiple locations.
  - Correction: Replacement of existing.
6. Damaged metal fascia.
  - Scope: Occurs in multiple locations.
  - Correction: Replacement of existing.
7. Organic growth.
  - Scope: Occurs in multiple locations.
  - Correction: Replacement of existing.

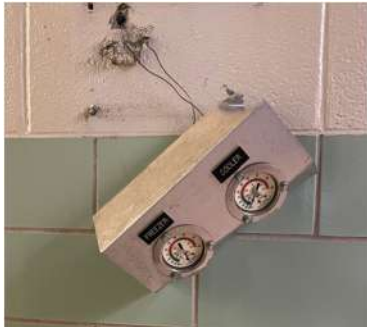
1. The walk-in cooler and freezer temperature gauge is not operational.

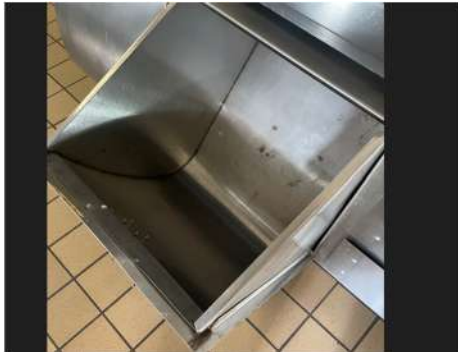
4. Storage bins included on prep tables do not allow easy rotation of products and difficulty in cleaning. Not a sealed lid.

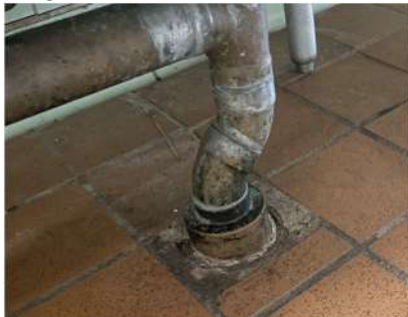
5. Air gap not provided at prep sink.
