HUTTEBALL  
+ OREMUS  
architecture

# 2021 FACILITY ASSESSMENT

## GRANITE FALLS SCHOOL DISTRICT

Spring 2021

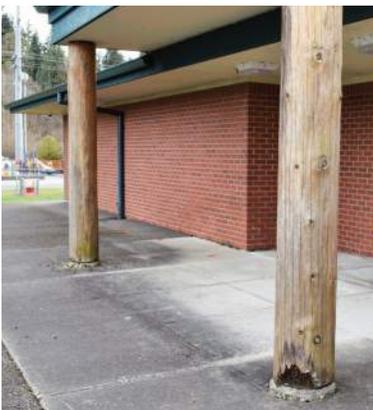
16" diameter peeler pole columns support canopies around the building. Multiple instances of rot was observed at the bases of the peeler poles where the wood has wicked water. Peeler poles appear to be nearing the end of their useful life. It is likely that by the time the rot has been removed, there will not be enough structural integrity in the peeler pole to allow it to remain. Further investigation is highly recommended to determine best course of action for each column; however, we anticipate it will likely be more expensive to repair and keep the poles than to replace with something new.

▲ Degradation visible at wood peeler pole columns.

- > Cedar siding is showing signs of weathering and should be prepped and painted to prolong serviceable life.
- > Monitor efflorescence at service yard enclosure.
- > Roofing & all associated transitions and flashings should be carefully monitored over the next 3-5 years as it is reaching the end of its expected serviceable life.
- > Replace door lock cylinders district-wide.
- > Re-secure downspout sleeves at base of all downspouts.
- > Engage a structural engineer to do a full assessment of all peeler poles. Repair / replace peeler pole columns as necessary.

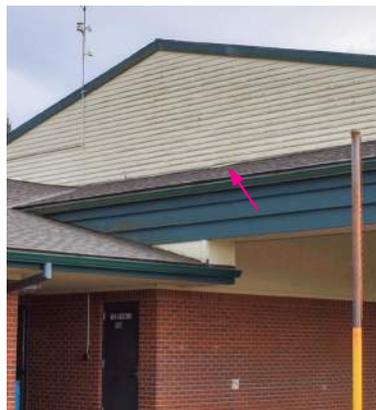
▲ High wall over the covered play area showing weathering at cedar siding and slipped piece of through-wall flashing.

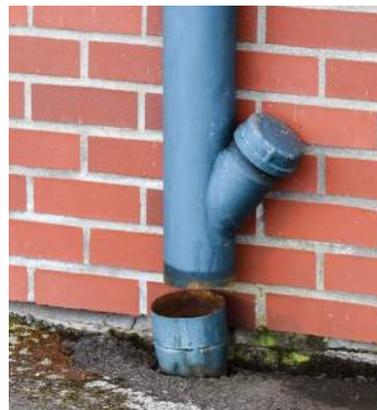
▲ Secure sleeve to base of downspouts.

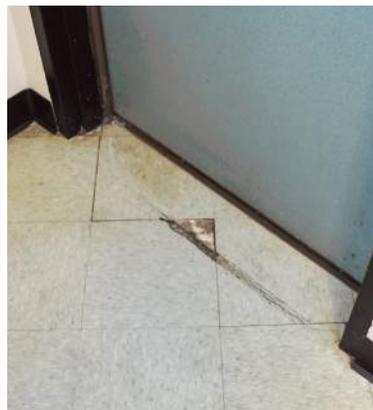
▲ VCT damage at mechanical room entry door.

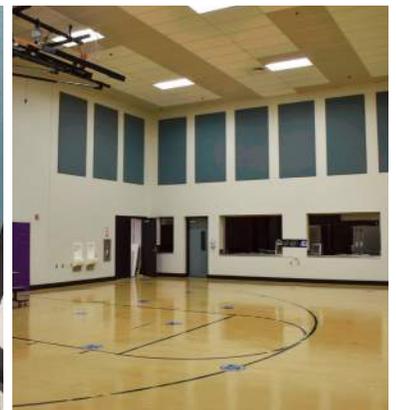
Gym resilient flooring original to the building and is worn, but serviceable. Consider re-stripping the gymnasium court lines as part of a future flooring project.

▲ Resilient flooring at gymnasium.

- > Consider a future project to replace all original carpet and re-stripe the gym flooring at Monte Cristo Elementary.

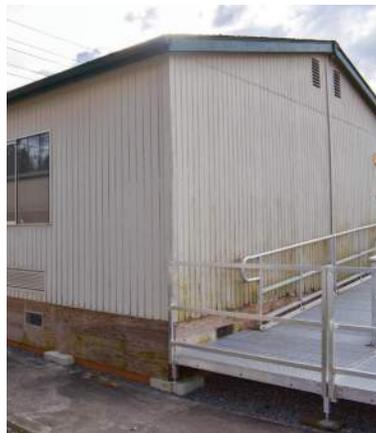
▲ Visible weathering of the siding at Portable P5

- > Portable siding is showing signs of weathering and should be prepped and painted to prolong serviceable life.
- > Assess need for a more permanent fencing solution at preschool play area.

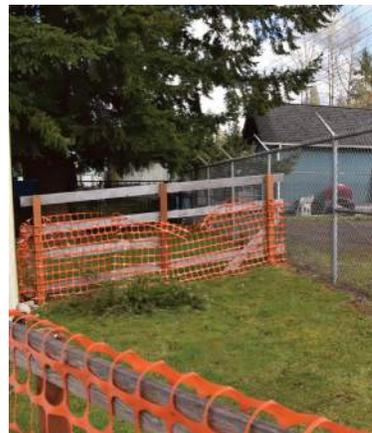
Wood fence structure surrounding the preschool play area has been supplemented with orange plastic mesh safety barrier fence. Assess need for a more permanent fencing solution.

▲ Safety barrier fencing over wood fence structure.

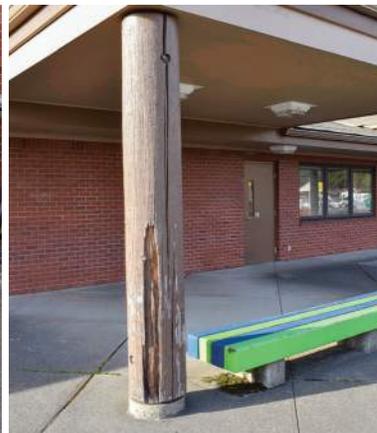
▲ Checking and rot apparent at multiple peeler pole locations.

be nearing the end of their useful life. It is likely that by the time the rot has been removed, there will not be enough structural integrity in the peeler pole to allow it to remain. Further investigation is highly recommended to determine best course of action for each column; however, we anticipate it will likely be more expensive to repair and keep the poles than to replace with something new.

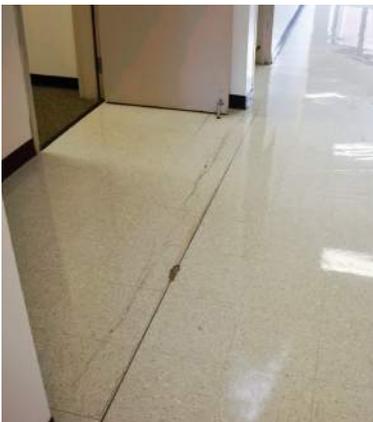
▲ Pronounced cracking in VCT at corridor.

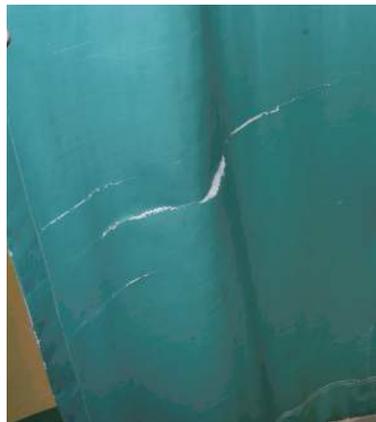
▲ Wear and rips in the operable divider curtain at the gymnasium

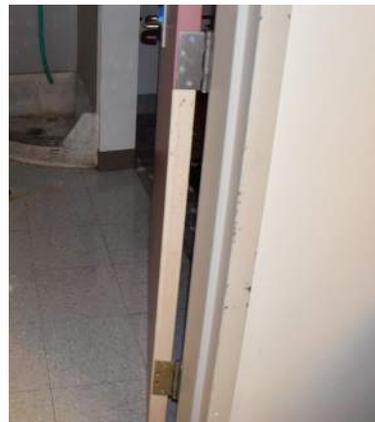
▲ The plastic laminate finish is peeling away from the interior doors.

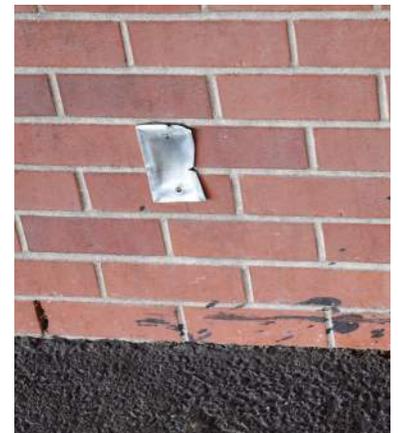
Junction covers were observed to be damaged at the school entry and attached covered play area. Due to the sharp edges these covers should be replaced immediately.

▲ Damaged junction box cover at attached covered play area.

- > *Replace damaged junction box covers at building exterior.*
- > *Engage a mechanical and electrical engineer to provide a full facility assessment.*

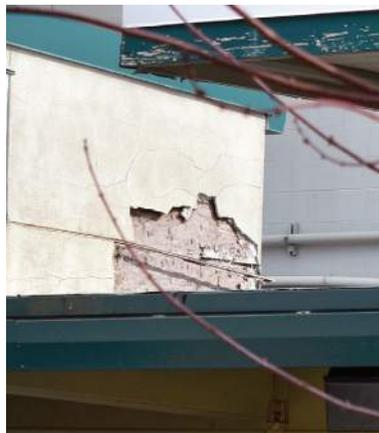
The exterior of the middle school is a combination of painted reinforced masonry or concrete, fiber cement panels, and stucco. According to the 2001 contract documents the stucco cladding assembly includes 7/8" stucco over building paper on 1/2" plywood sheathing. A multitude of cracks were observed in the south wall of the 2001 choral addition, as well as an adjacent wall of the original 1974 building which may indicate systematic failure of the system.

▲ Large area of stucco is missing on south wall.

Further signs of water intrusion were visible at the masonry columns and some exterior masonry walls of the facility. Water intrusion has the potential to decrease the lifespan of the facility at an accelerated rate. Therefore it is in our opinion that fixing the building envelope to ensure weather-tightness should be as high a priority as budget will allow. Further investigation of the entire building envelope (siding and roofing) should be undertaken by a building envelope specialist to determine best course of action for remediation.

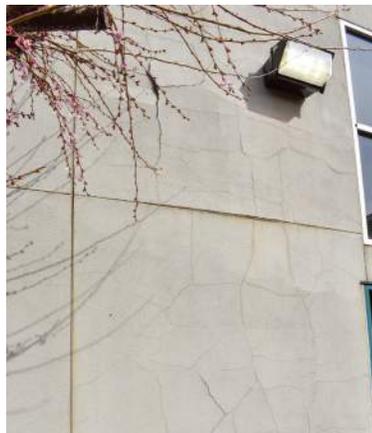
▲ Visible cracking in stucco siding at south wall.

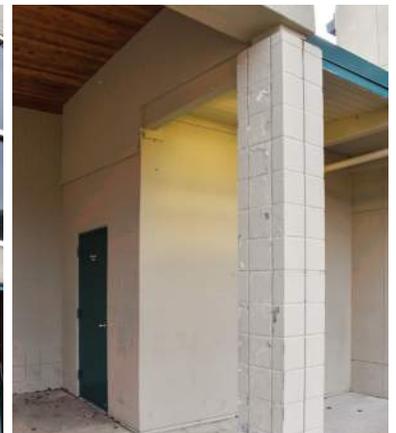
▲ Water intrusion at masonry entry columns.

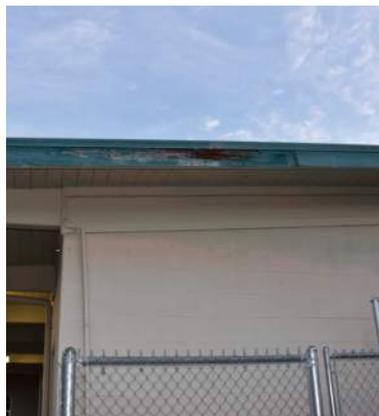
▲ Deterioration at the fascia.

- > Middle school roofing, including fascia, gutters and downspouts, should be replaced as soon as financially feasible to prolong life expectancy of the facility.
- > Install anti-slip tape on roof-access ladder treads.

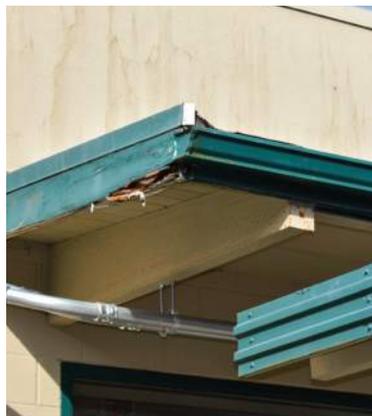
▲ Deterioration at the fascia.

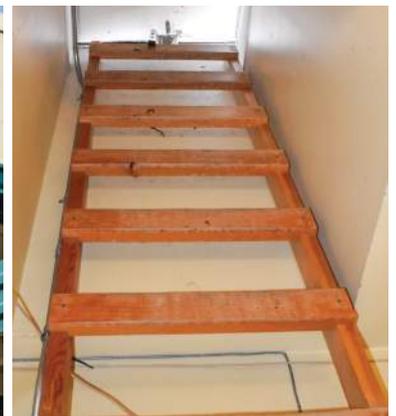
It is recommended that anti-slip tape be installed on all roof-access ladder treads.

▲ Install anti-slip tape at roof-access ladder treads.

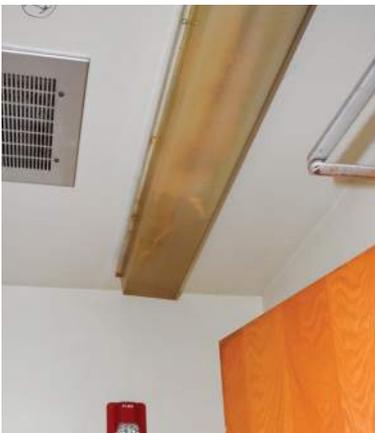
▲ Standing water in the light fixture at the staff restroom.

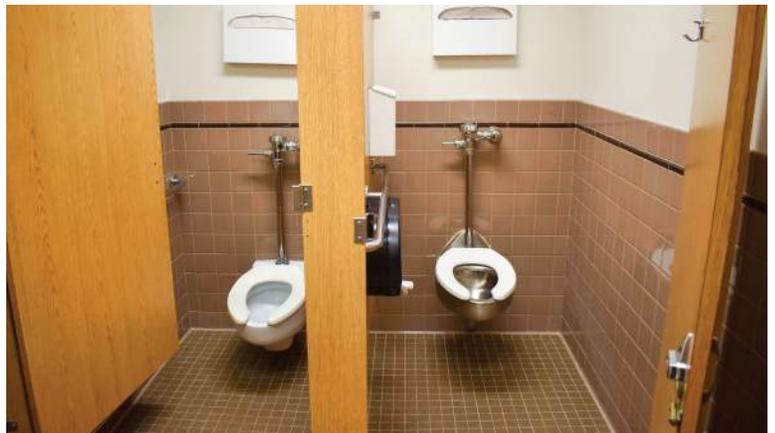
▲ *Restroom does not appear to meet accessibility standards with regards to floor clearances and grab bar installation.*

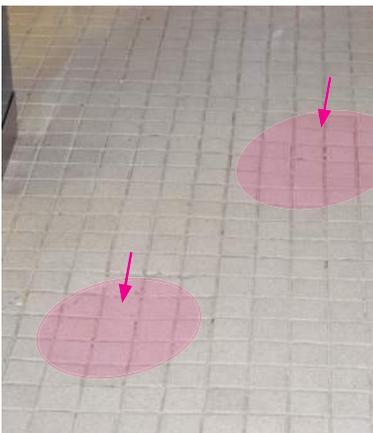
Restroom tile is cracking at the floor-to-wall and corner seams in select areas across the facility. Caulk corners to prevent water intrusion and degradation of the tile. At the student restroom central to the classroom wing multiple area of depressed tile were visible, potentially due to settlement in the mortar bed. Continue to monitor depressions to ensure condition does not worsen.

⚠ Depressions in ceramic floor tile at restroom.

- > Consider a future project to replace all carpet at Granite Falls Middle School.
- > Carefully monitor bubbling in VCT. Replace or patch if tile begins to break loose.
- > Caulk restroom tile at corner cracks.
- > Monitor depressions in ceramic tile at the middle school for degradation.

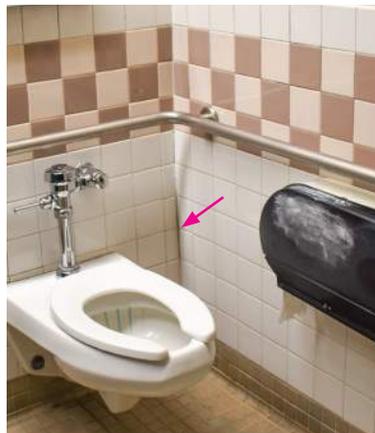
⚠ Tile is cracking at corner seams.

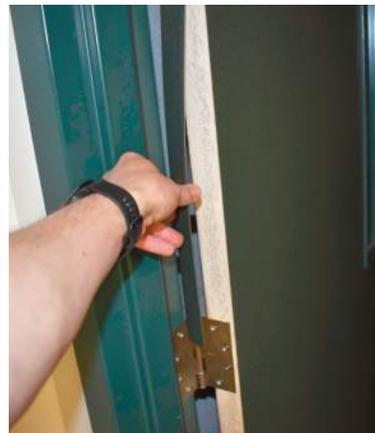
⚠ De-laminating interior door.

Generally, the interior doors and window are in good condition, with few exceptions. Interior doors are generally faced with plastic laminate, which is beginning to crack, de-laminate and break away. Monitor degradation and replace door when function is called into question

- > *Monitor middle school interior doors for degradation and replace when function is called into question.*
- > *Confer with district risk management to determine whether replacement of all wired glass relites should be considered.*

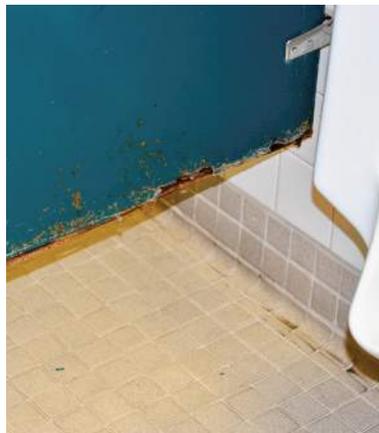
Student restroom partitions are typically rusting and dented in locations across the facility. Toilet partitions in the locker rooms at the ganged restrooms in the commons are plastic laminate. Consider

▲ *Rusting toilet partition at boys restroom in classroom wing.*

replacing toilet partitions with a durable solid phenolic, overhead-braced partition. Student restroom mirrors are rusted in locations across the facility.

- > Consider replacing middle school casework as part of a larger renovation project.
- > Consider replacing all furniture.
- > Replace rusted restroom mirrors.
- > Replace damaged restroom partitions with durable solid phenolic, overhead-braced partitions.
- > Verify that the commons display case is equipped with safety glass.

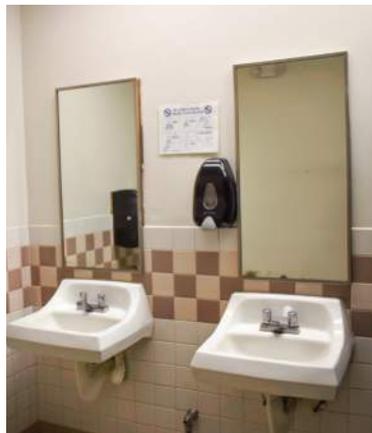
▲ *Mirrors are starting to rust.*

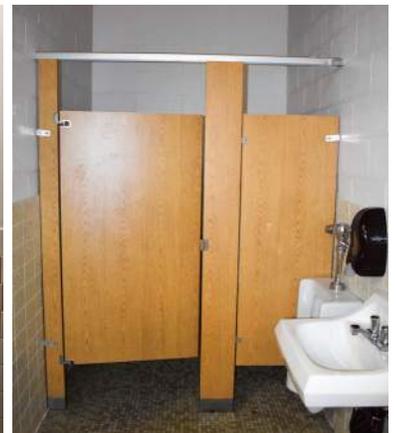
▲ *Plastic laminate toilet partitions at boys locker room.*

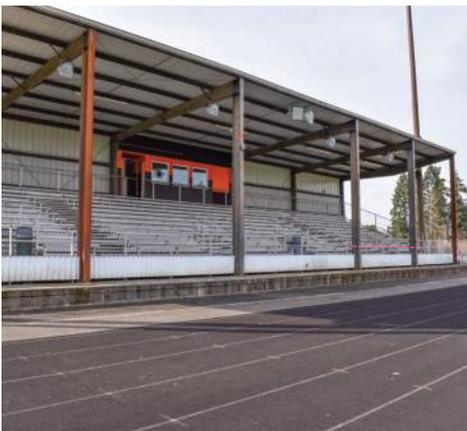
We recommend giving all exposed metal structure a thorough cleaning and repainting to extend the life of the structure. Replace missing section of guardrails at the front of the grandstand to provide fall protection. Continue the yearly routine maintenance of pressure washing all bleachers prior to the start of the athletic season.

▲ Middle school grandstand. Dashed line showing ▲ Missing section of guardrail at middle school grandstand.  
location of missing guardrail.

- > *Continue yearly routine maintenance of pressure washing bleachers prior to start of the athletic season.*
- > *Remove rust, clean and repaint all exposed steel at middle school grandstand.*
- > *Replace missing section of guardrails at middle school grandstand to provide fall protection to spectators.*

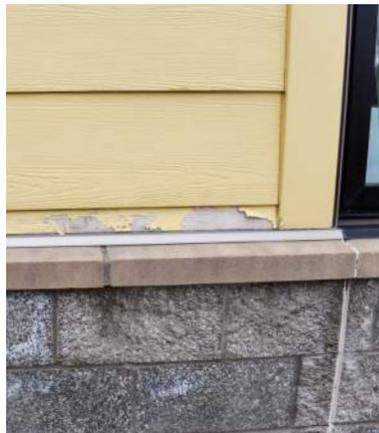
▲ Peeling paint at fiber cement siding indicates moisture intrusion at fiber cement termination.

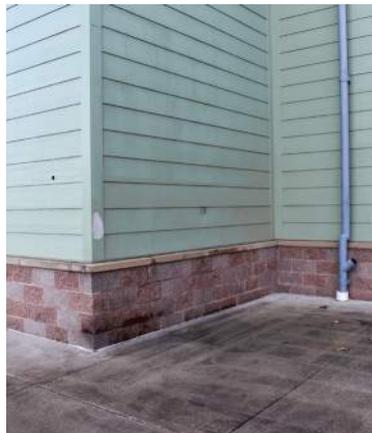
▲ Small holes in fiber cement siding.

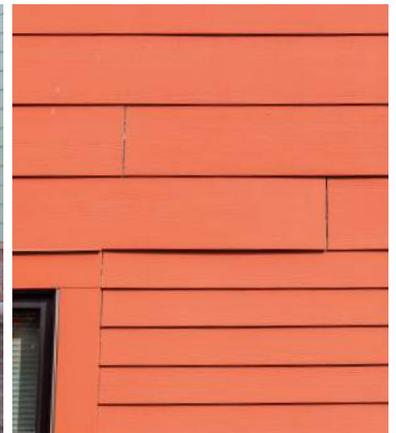
▲ Butt joints at fiber cement siding should be periodically re-caulked.

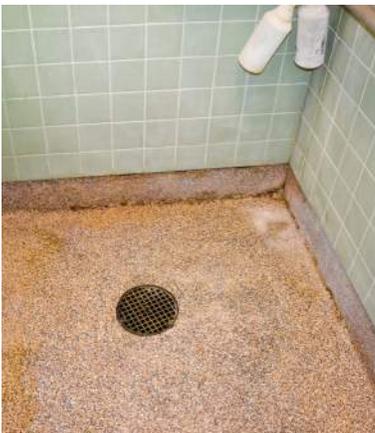
▲ *Cracking at floor-to-wall seam in acrylic resin flooring.*

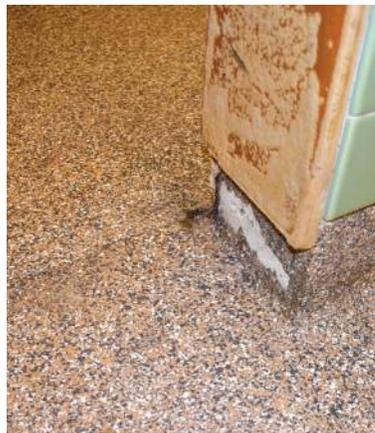
MDF wainscot in corridors has scuffs and scratches. Maintenance has applied oil to lessen the impact of the scuffed areas. MDF wainscot at locker rooms is bubbling and de-laminating in some areas due to moisture. Replacement options for the MDF include fiber resin panels, veneer plaster or ceramic tile.

▲ *Cracking in flooring, and wainscot water damage.*

- > *Secure loose vinyl wall covering seams.*
- > *Replace MDF wainscot in locker rooms*

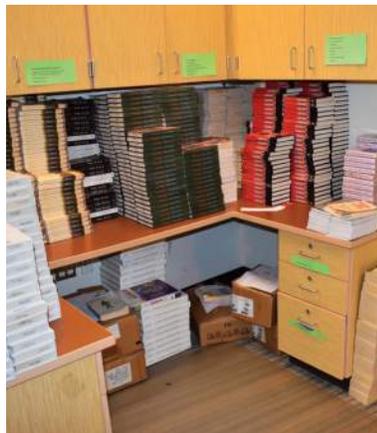
▲ *Library workroom countertop.*

- > *Secure upper casework at special education classroom.*
- > *Secure casework countertop at classroom A218.*
- > *Upgrade supports, and/or re-distribute load at library workroom countertop.*

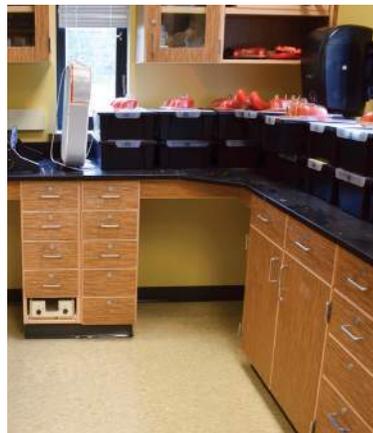
▲ *Science casework with missing drawer fronts and drawer hardware.*

- > Consider a future renovation project to replace science casework as necessary.
- > Replace toilet partitions at boys locker room.
- > Replace rusting restroom mirrors.

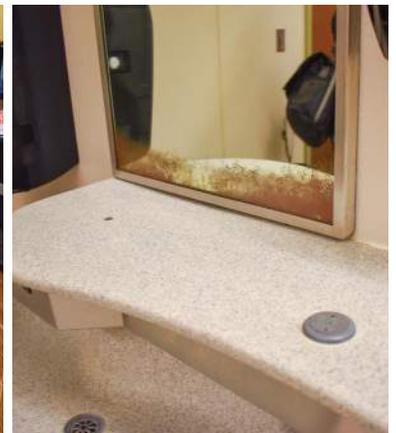
Lockers in both girls and boys locker rooms are in good condition. All partitions in the boys restrooms were in the process of being replaced with phenolic, overhead braced due to abuse. Boy's locker room partitions would also benefit from replacement. Student restroom mirrors are rusted in locations across the facility.

▲ *Mirror rust at restroom.*

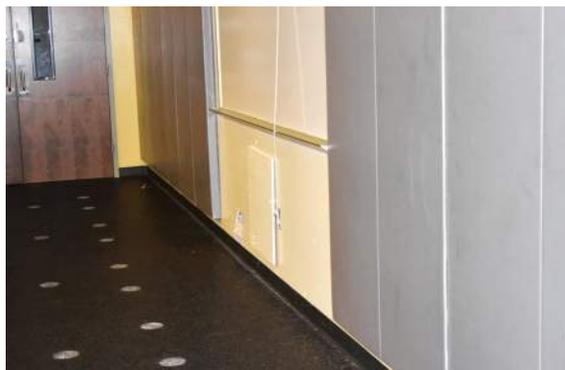
▲ *Remove markerboard and install additional wall pads where exposed gypsum occurs at wrestling room.*

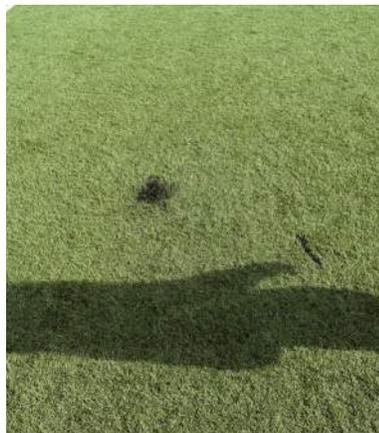
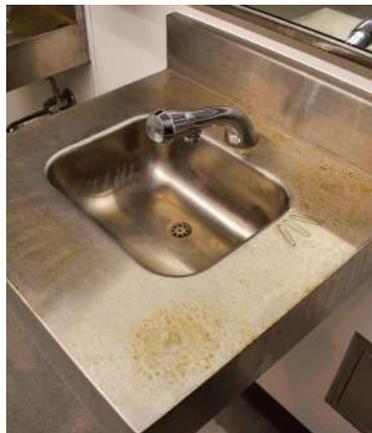
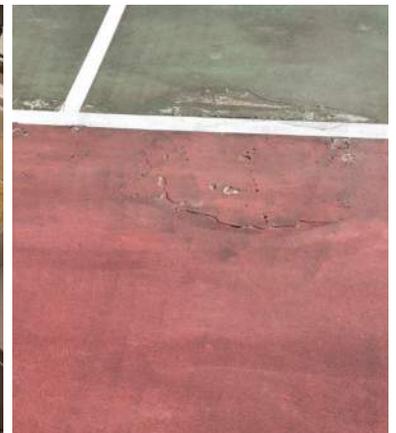
The lavatories and toilets at the support building were observed to be rusting. Both lavatories and toilets are Type 304 stainless steel, which is highly resistant to corrosion but can be susceptible when exposed to certain chemicals. When this has been observed in the past it usually indicated the use of a cleaning agent that is not compatible with stainless steel with the usual culprits being dilute acids, bleach, lye's (lime from the ballfield foul lines) and Trisodium phosphate. The discoloration and surface damage may have been accelerated as an unintended consequence of rigorous COVID protocols and the use of bleach (sodium hypochlorite) or something similar.

▲ *Firework damage to turf field at Tiger Stadium.* ▲ *Surface rust at stainless steel sinks.* ▲ *Cracking at tennis courts.*

After cleaning the stainless steel fixtures in a manner in accordance with manufacturer recommendations, the rust stains should not return if cleaning procedures are followed with a Type 304 stainless steel compatible product.

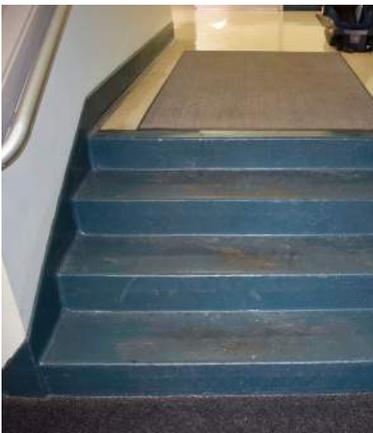
▲ *Recommend non-slip tape at administration stairs.*

that non-slip tape be applied at each step of the stairs in the administration wing.

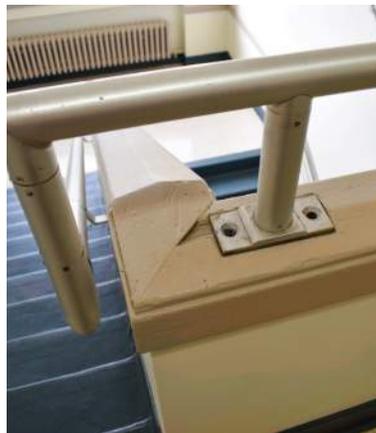
Elements of the handrail at the stair are pulling apart and should be re-aligned and secured. Additionally the entire handrail is loose at the second floor and should be secured. It is recommended

▲ *Secure handrail at administration stairs.*

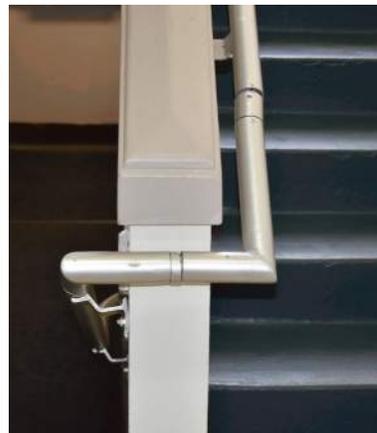
▲ *Re-align and secure elements of handrail at administration stair.*

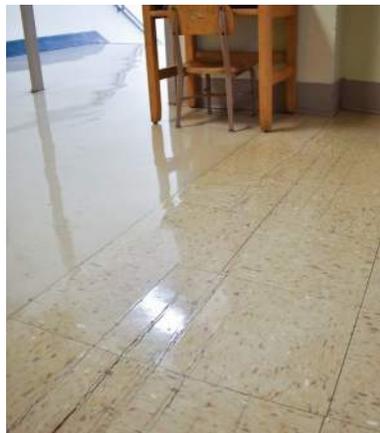
▲ *Cracking in VCT at second floor.*

The VCT tile has cracked, and portions are missing in a few areas. This separation is not posing a trip hazard but should be monitored to ensure it does not continue to deteriorate. VCT is bubbling at transition line between carpet and tile in classrooms 110 & 108.

- > Consider replacing all carpet as part of a future renovation project.
- > Monitor VCT cracking for degradation building-wide.
- > Replace sheet vinyl at nurse's restroom as part of a future renovation project.

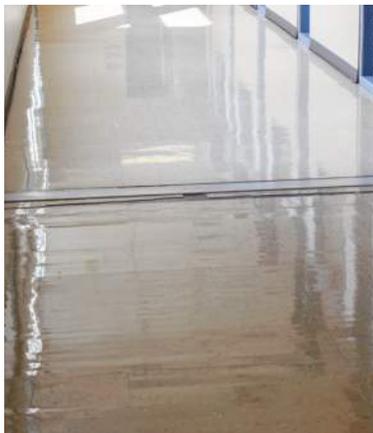
▲ *Missing VCT at second floor expansion joint.*

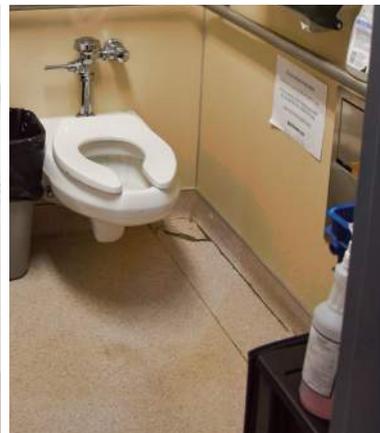
▲ *Pronounced cracking in sheet vinyl at nurse's restroom.*

Pronounced cracking was observed at the floor-to-wall transition in the sheet vinyl at the nurse's restroom. Flooring should be replaced in a future renovation project.

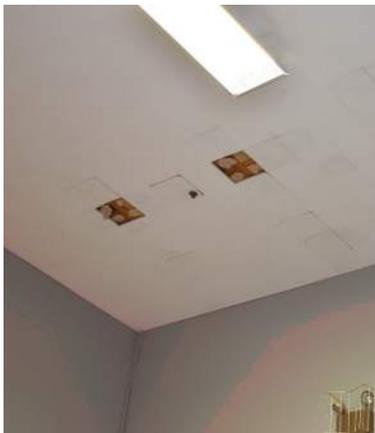
▲ Acoustical tile detaching and falling from gym ceiling.

Ceiling tiles are worn, and stained in places from on-going leaks. The gym has 12" x 12" glue on tiles that are falling off the substrate. Further investigation is need to determine cause of weakening adhesive, and to correct the issue.

- > *Continue to replace worn and stain ceiling tiles throughout the building.*
- > *Determine cause of weakening adhesive at 12x12 acoustical tile in gymnasium, and re-secure tiles.*

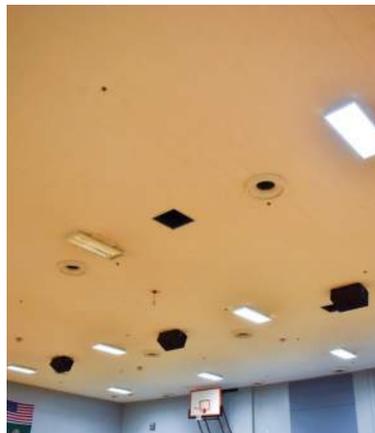
▲ Missing HVAC grilles and broken lighting at gym.

The gymnasium has seen significant abuse, and would benefit from being refreshed. Grilles are missing from the HVAC ducting in the ceiling, and cages are broken missing from emergency exit signage and lighting. Damage from a previous roof leak is visible in the wall and acoustical wall panels. Acoustical wall panels are sagging and torn around the space. Scoreboard is reported to be unreliable and replacement parts are difficult to procure. Remnants of this facility serving as the district's middle school are visible in the lettering on the gym floor.

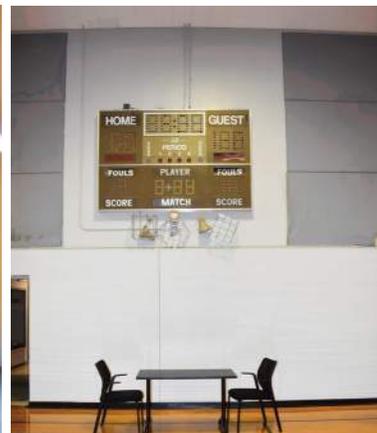
▲ Defunct scoreboard, and water damage to wall and acoustical wall panels at gym.

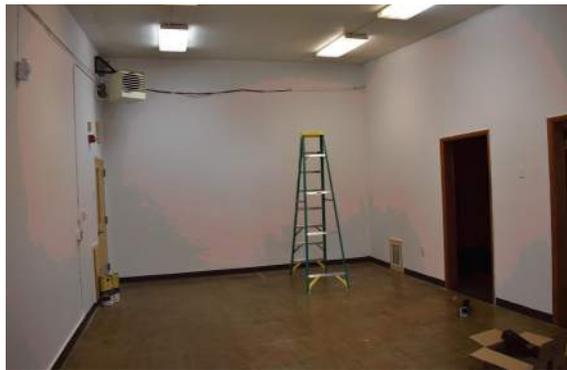
▲ *Renovation of south west quadrant underway.*

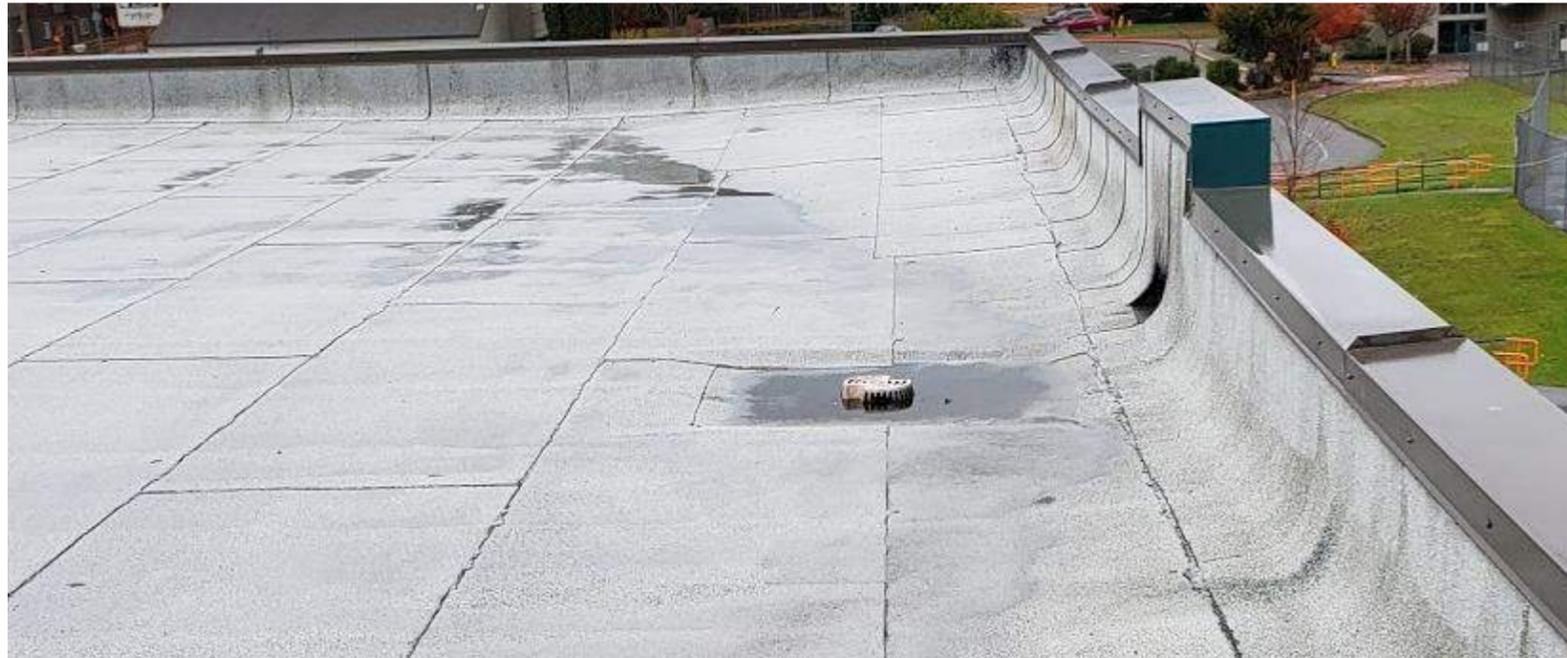
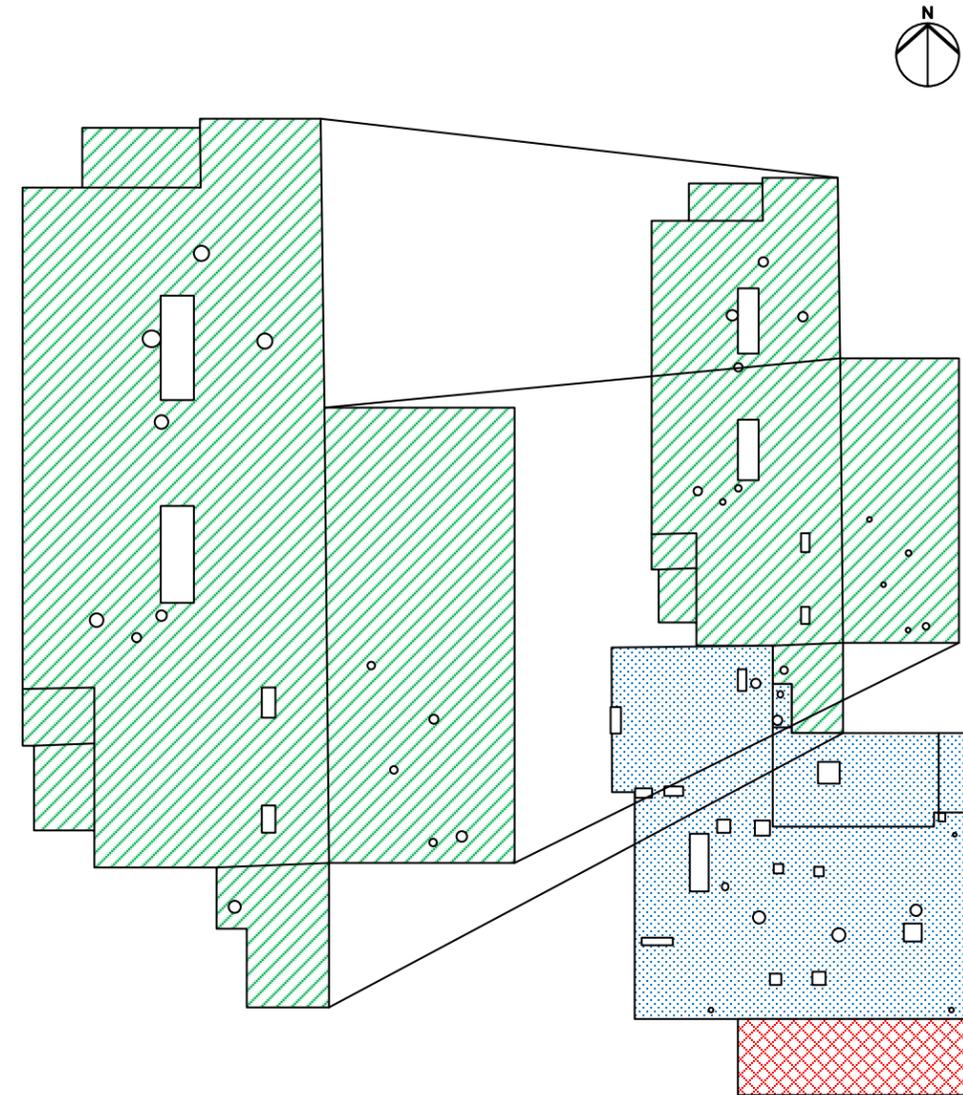
# Granite Falls School District Office Low Slop Roof

- The granules that protect the asphalt cap sheet are beginning to wear away. Granules protect the waterproofing agents in the roofing plies from UV exposure and foot traffic.
- The EPDM expansion joint that separates the District Office from the original Alternative School is aging faster than the rest of the roofing system, as seen in the photo to the right. I recommend installing a metal cover over the 80 linear ft of expansion joint to protect the existing joint.
- Being that this system is well designed and not at the point of failure, I recommend budgeting for a restoration system before the system fails like other roof sections.

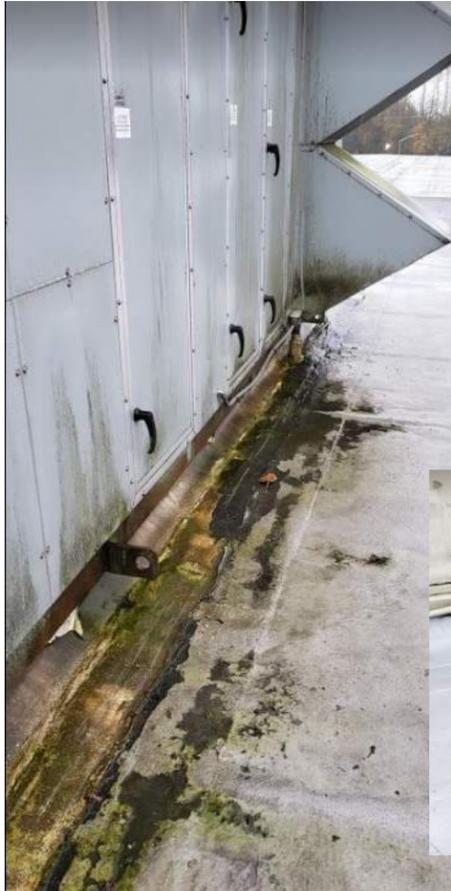
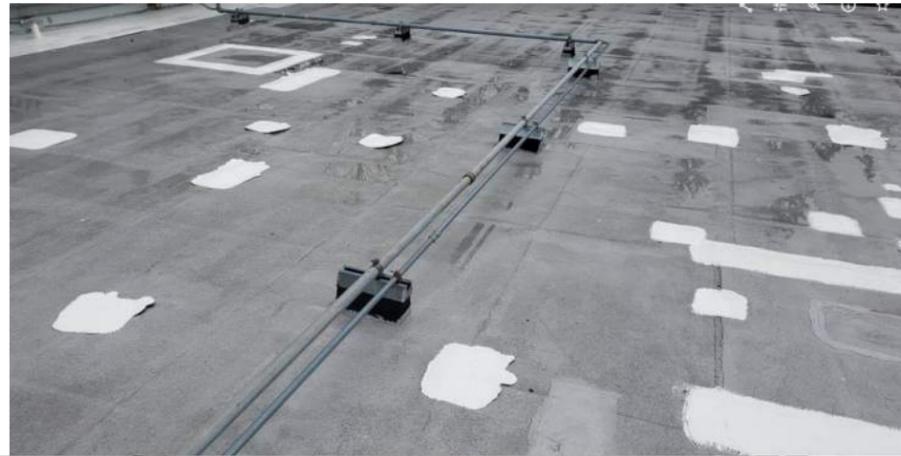
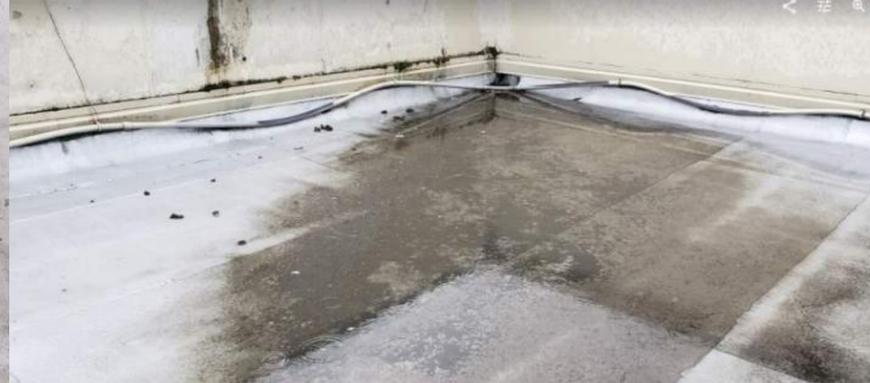
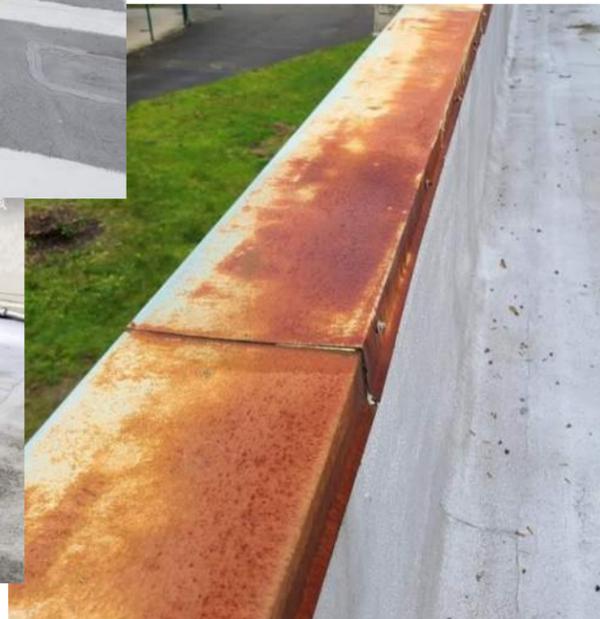
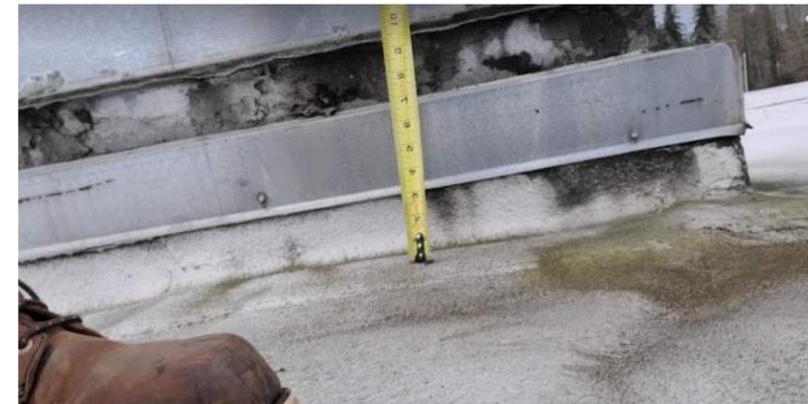
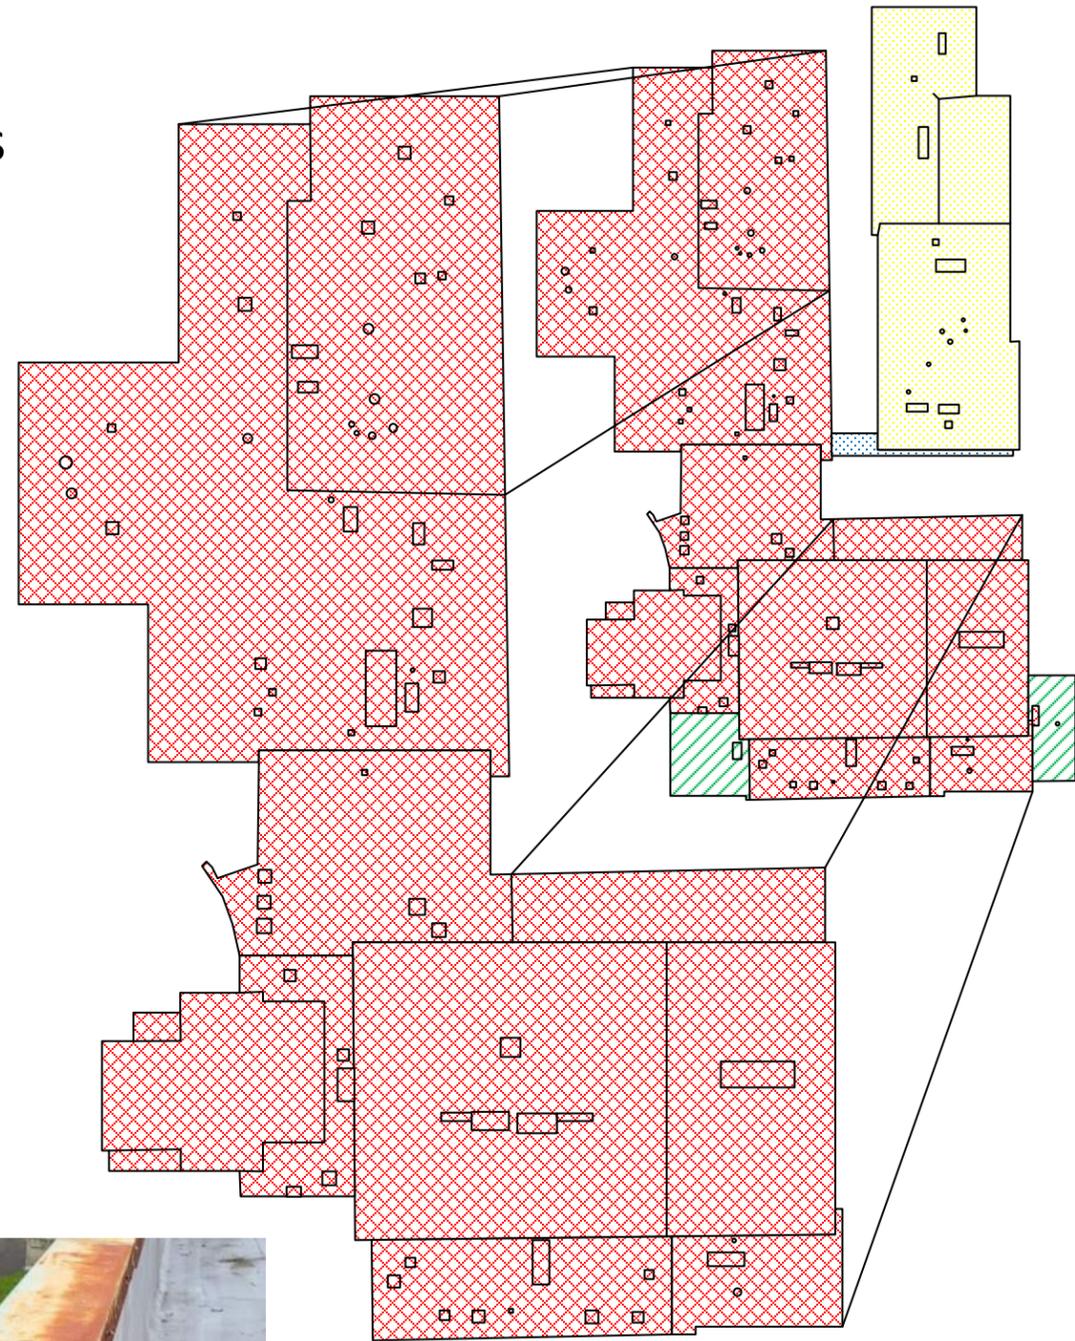
- The membrane's reinforcement scrim can often be seen in most of the crucial details and the drain sumps are literally "coming apart at the seams".
- The coping details have been repaired over and over and are now missing fasteners, leaving openings in the cap.
- The existing curbing is low to the roof line, making a re-roofing project difficult.
- There were several HVAC units that were added after the original installation and were flashed with a completely different roofing material than the existing roof.

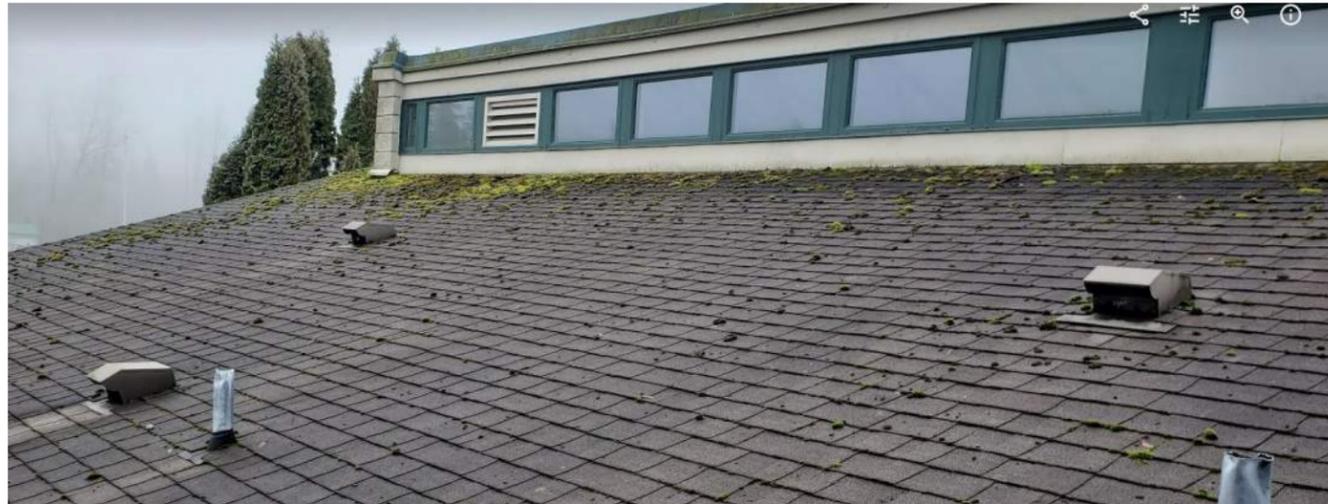
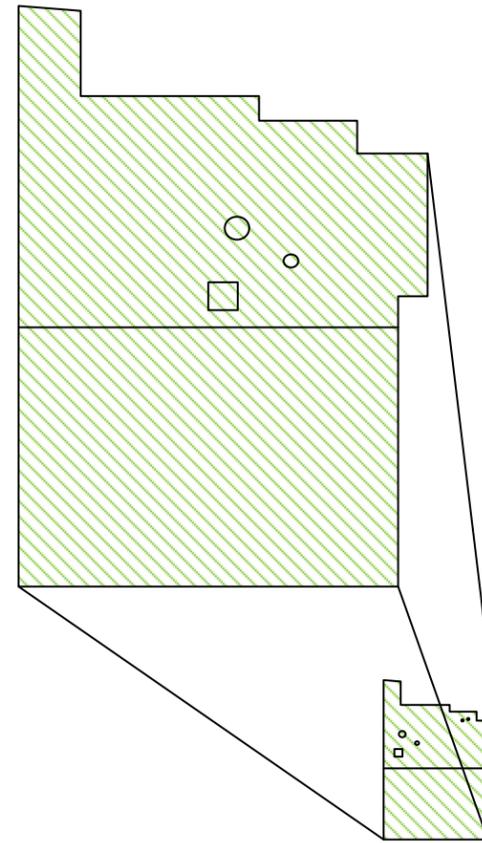
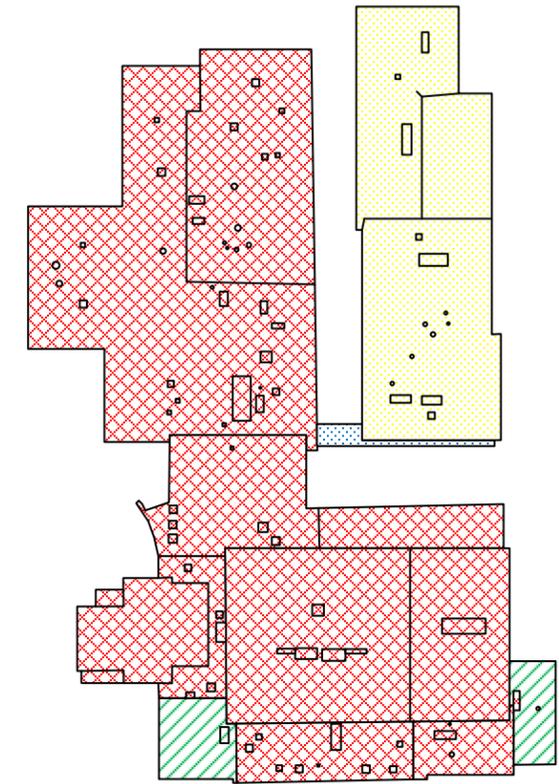
# Granite Falls Middle School Cafeteria Roof

We are beginning to see active leaks pop up on the cafeteria roof. The aged composite shingles along with the commodity detailing is beginning to break down, allowing water to enter the envelope. Moss and other vegetation is beginning to build up on the shingles as well.

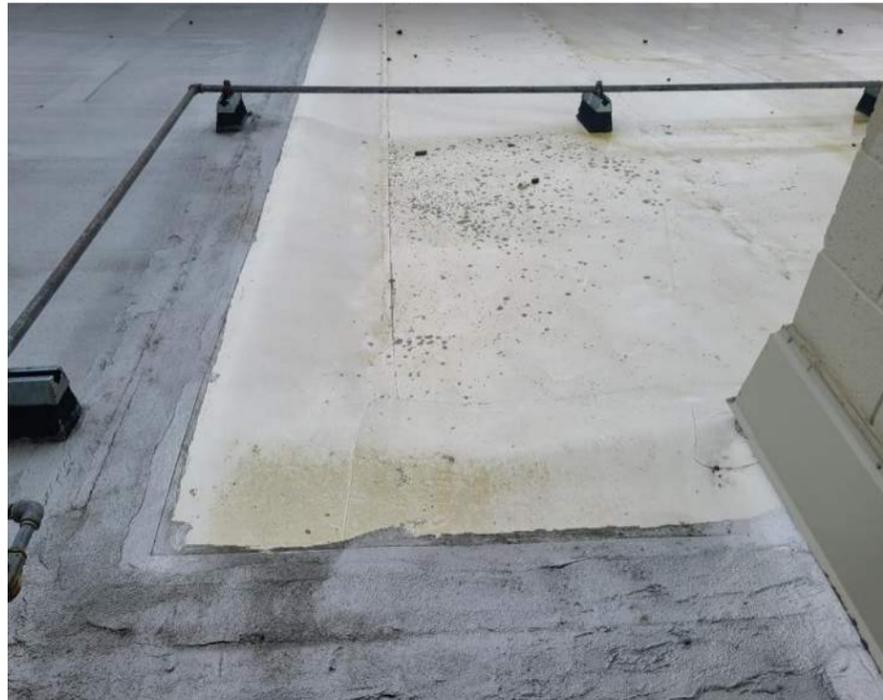
# Granite Falls Middle School Single Ply Roof Sections

There are two roof sections on the middle school that have been overlayed with a mechanically fastened singleply. In my inspection I found:

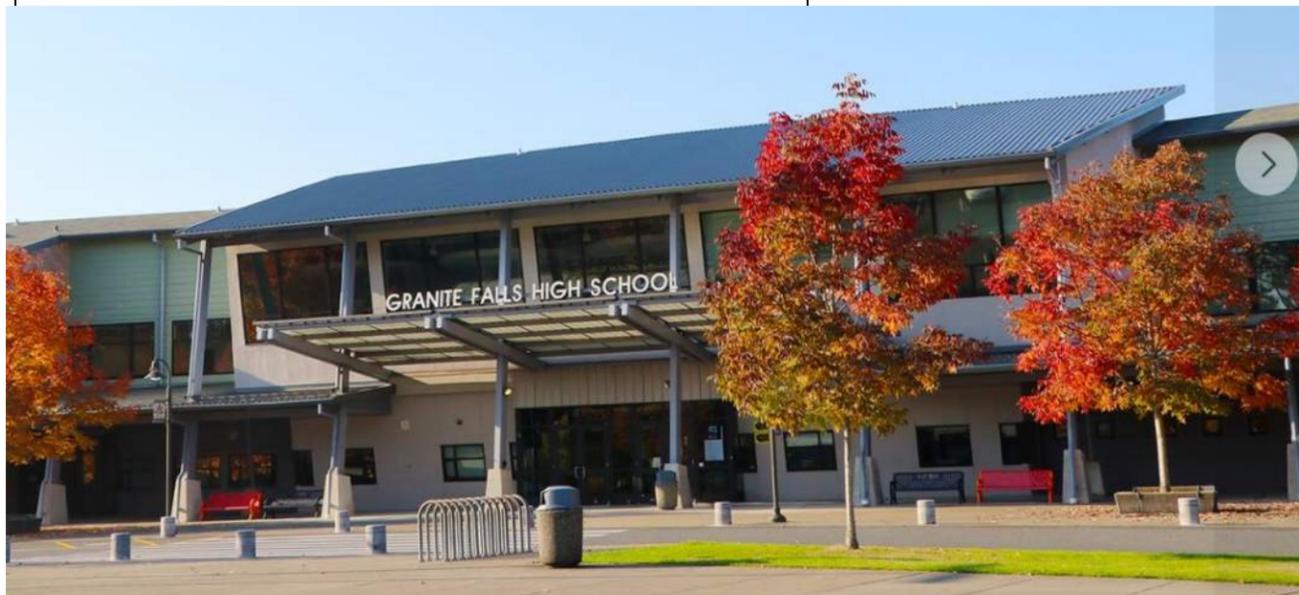
The High School is roughly 10 years old and is already showing some signs of aging. The original low slope roof was completed with a commodity membrane and we have already had to address major defects. The other major concern that Deon and I have found is the masonry and windows around the campus. We have seen water intrusion in multiple classrooms.

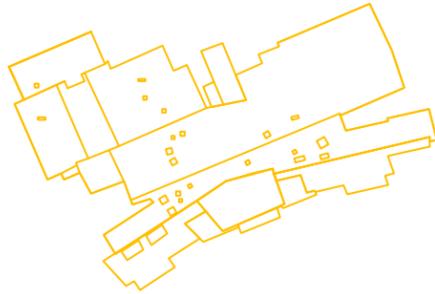
Granite Falls High School Window Resealing and Masonry Restoration	TBD	Commercial Grade Panes and Splitfaced CMU block	TBD	TBD	TBD
