6 | Easterly Parkway Elementary School

Address:	234 Easterly Parkway State College, PA 16801
Construction Timeline:	Originally constructed in 1955; renovation/addition in 2002.
Building Square Footage:	55,895 sf
Site Acreage:	11.4 acres

Building Summary

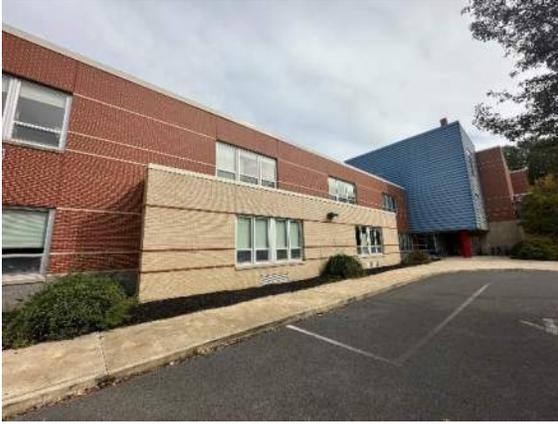
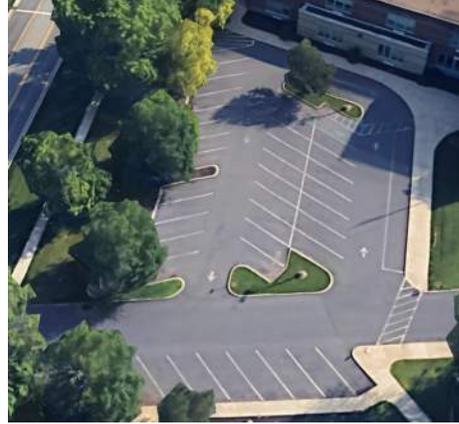
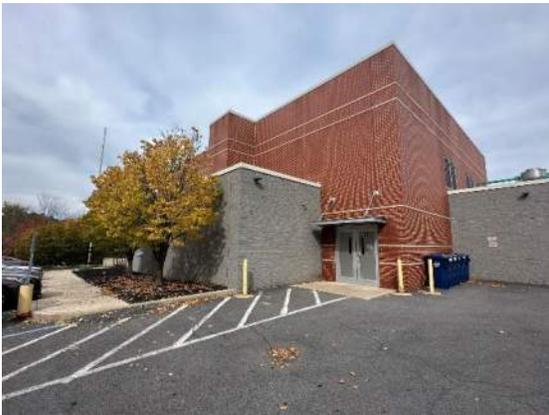
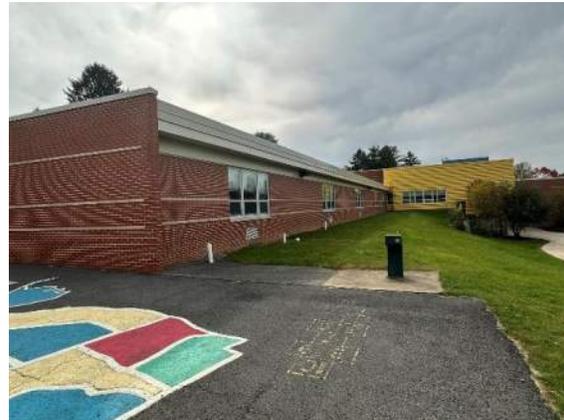
Some of the concrete walks are aging and starting to show signs of wear in that the aggregate (in the concrete) is beginning to show through to the outside surface. The concrete is also stained in many places. Cracking is occurring on some of the paved surfaces. Some of the games painted on the paved surfaces years ago are wearing off and hard to be used for the games they were intended.

- The short-term recommendation for paving is to apply a pourable sealer to the cracks, seal the paving, and repaint lines. The long-term recommendation is to a mill and overlay of existing paved surface and to provide a new wearing course with any new building project. The short-term recommendation for the concrete walks is to clean and remove stains and provide a sealer. The long-term recommendation is to replace the concrete with any new building project.

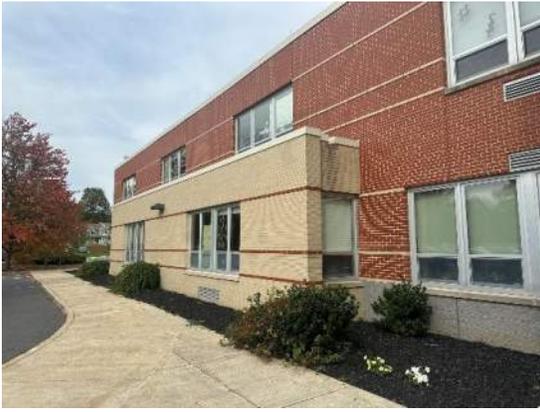
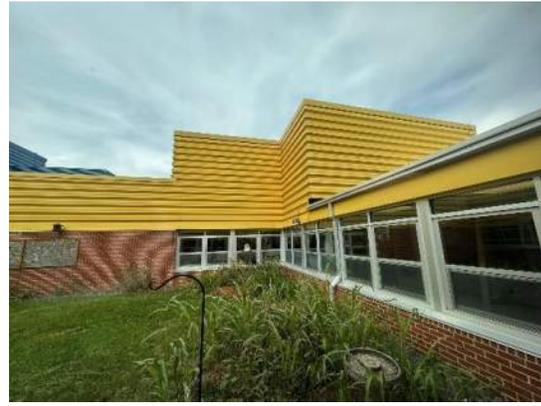
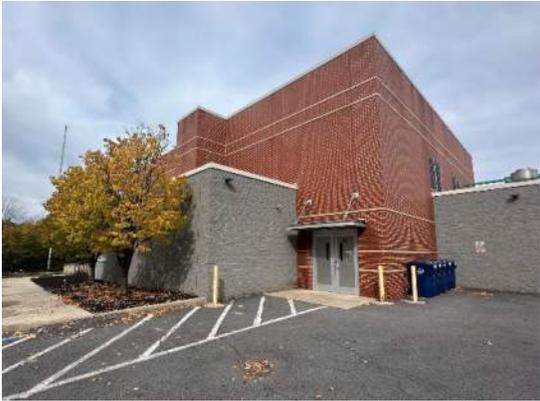
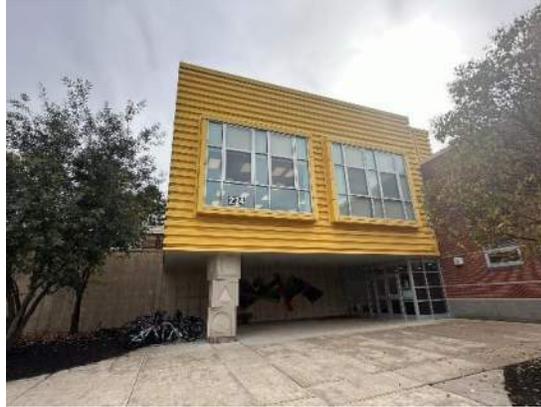
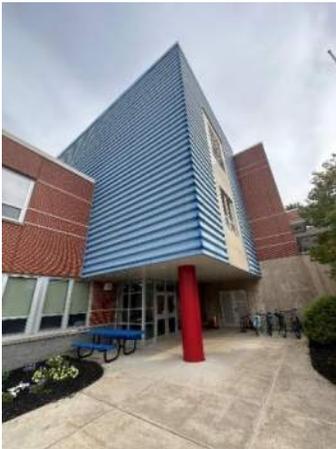
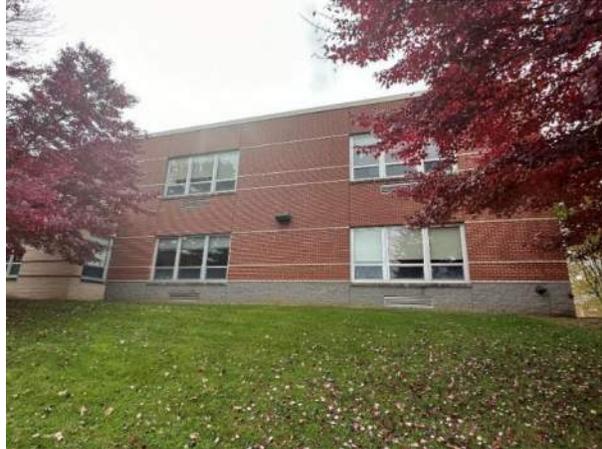
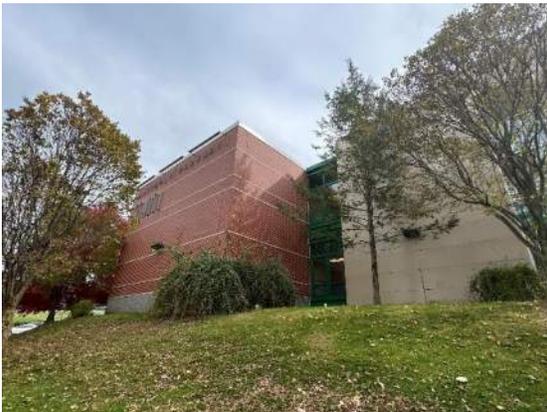
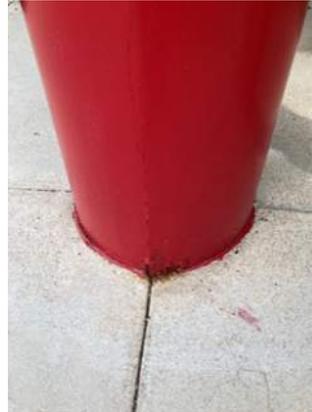
The building exterior consists of insulated masonry cavity walls with various brick and CMU veneers and CMU backup. Masonry walls are in very good condition with plenty of control joints located throughout the building envelope. There is some staining on the face brick below overflow scuppers where downspouts were not provided to collect the water. Windowsills are cast stone and in good condition, however some of the sills are becoming stained. Portions of the building are clad in various colors of corrugated metal wall panels as well as precast wall panels.

- General cleaning of brick veneer, cast stone sills, and precast and metal wall panel systems. May want to consider painting of metal wall panels where colors are beginning to fade or eventual replacement. At precast wall panels, tuck point joints between panels and caulk.
- Metal column covers are beginning to deteriorate at the base where water tends to settle and wear through the paint finish. Consider patching column bases and re-painting.
- Monitor caulking at control joints and replace with any new building project.

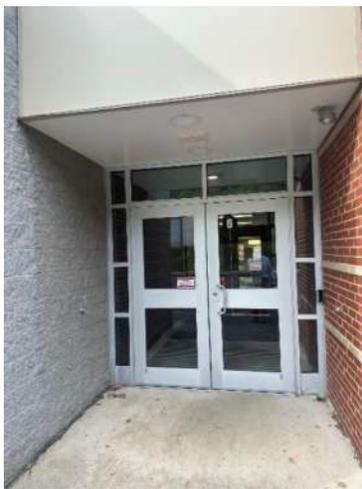
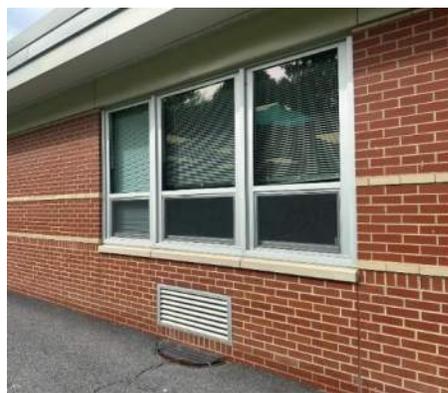
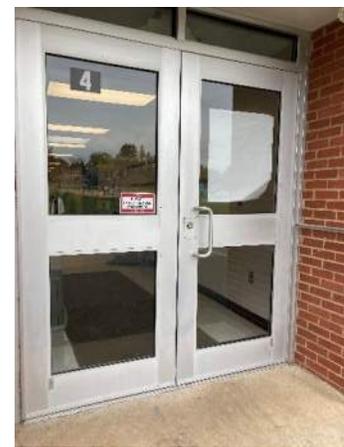
Windows are clear anodized and combination of operable (awning type) and fixed windows with window treatment mounted to the head of the opening. Entrances are also clear anodized aluminum storefront with the wide style door design. Aluminum is beginning to show signs of aging with discoloration.

- None at this time, however, should consider replacement with any building renovation project, since they are coming to the end of their life expectancy, however they should easily operate for 10+ years longer if maintained correctly.

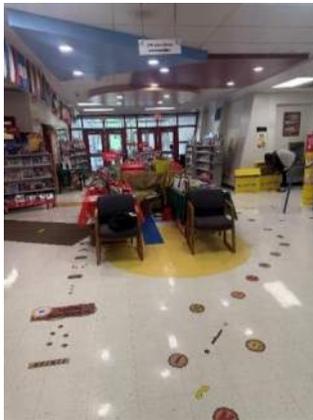
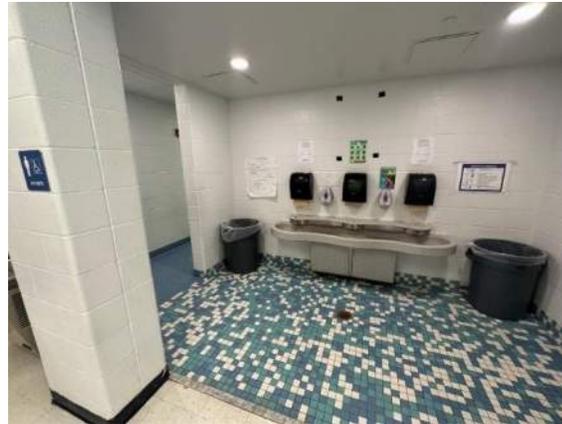
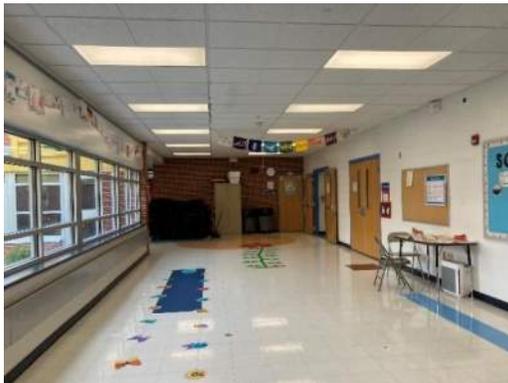
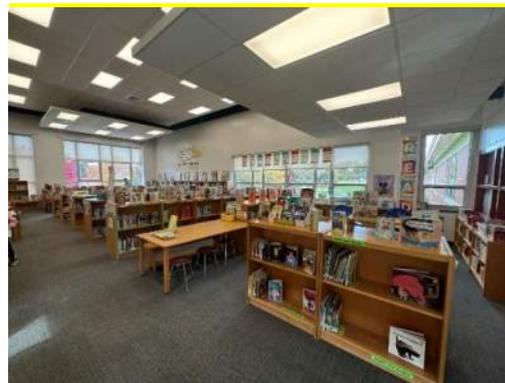
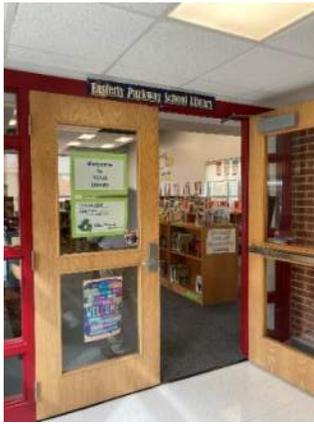
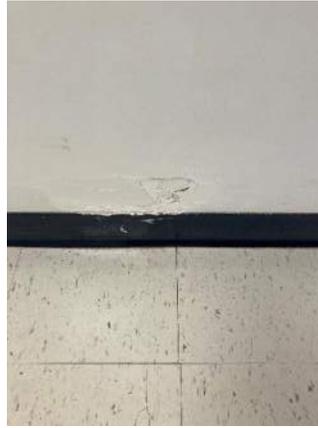
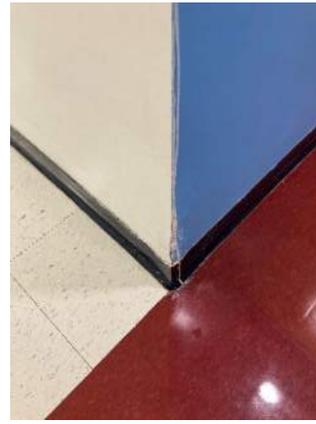
Interior walls are mainly painted CMU and are in good condition. There are areas of exposed brick which is also in good condition. There are also painted GWB partitions in areas where the carpet occurs. Those partitions could use some repair in selected areas and touch-up paint.

- Patch and repair GWB in-house over the summer or as part of a project.

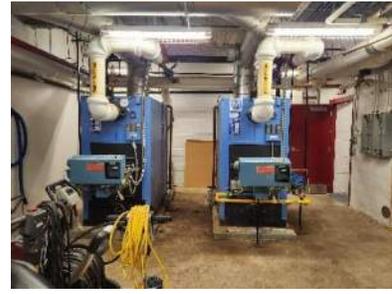
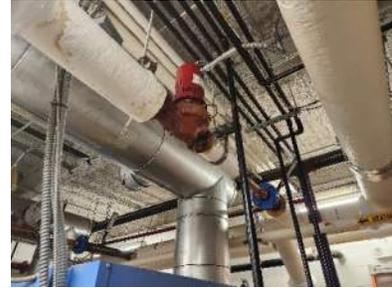
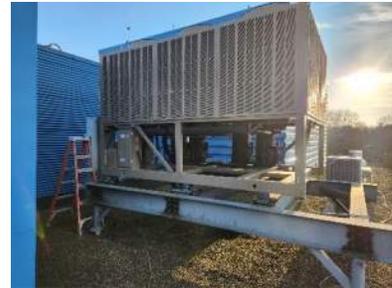
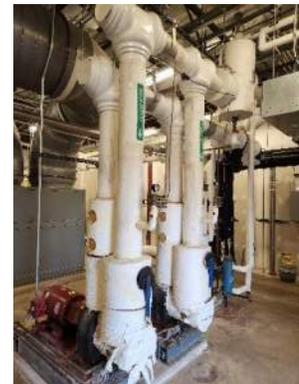
- Two Unilux flex tube boilers (2001) with gas fired burners develop heating hot water for the school. The boilers appear to be in good condition. The tube boilers are very serviceable as the tubes can be replaced in the event of failure.

- The Gordon Piatt burners appear to be in good to fair condition, but it is likely that they will need to be replaced in advance of the boilers. In addition, Gordon Piatt is no longer in business so parts can be difficult to obtain. Consideration should be given to replacing the burners in advance of any major failure to avoid significant downtime.

- Duplex hot water pumps circulate hot water throughout the school. These pumps were installed in 2001 and are in fair condition. They were running rough at the time of our site visit. The pumps do not have VFD's. If a motor were to fail, a replacement motor should be inverter duty for use with a VFD.

- Blend pumps on the boilers are original and in poor condition. While the motors have been replaced, the pump bodies are corroded. They should be replaced in the next few years.

- Duplex chilled water pumps circulate chilled water throughout the school. These pumps were installed in 2001 and are in fair condition. There is some corrosion and deterioration which appears to be a result of condensation from failed insulation. The extent of the corrosion was not able to be verified as the pump is covered with insulation. The pumps do not currently have VFD's. If replacement were to occur, the new pumps shall be inverter duty and include VFD's.

- The chilled water pipe insulation is deteriorating, and moisture related issues were evident in some areas. We recommend that any damaged pipe insulation be replaced.

- HVAC valves throughout are original. It was noted that some of the valves no longer hold, making service and maintenance difficult. We recommend that key valves be replaced when a comprehensive upgrade occurs.

- Repair/seal penetration in the boiler room fire walls.
- Replace the burners.
- Replace the boiler blend pumps.
- Replace the chilled water pumps.
- Replace and damaged pipe insulation.
- Replace strategic HVAC valves for improved maintenance serviceability.

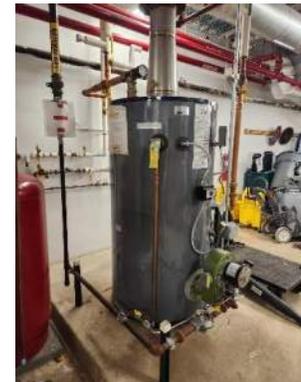
- Domestic hot water is developed by a Bock gas fired water heater that was installed in 2013. The unit is in good condition and should provide several more years of service. It does not, however, have a backup heater. This is highly recommended in case the water heater fails.
- The mixing valve appears to have been replaced and was reported to be in good operating condition. The piping around the water heater and mixing valve is not insulated.

- Install a second water heater for backup.
- Install insulation on the domestic hot water piping.

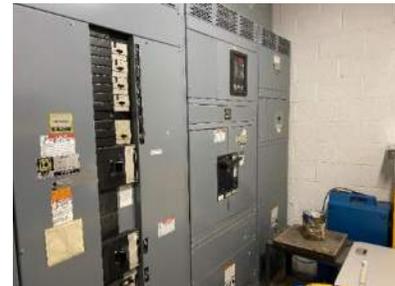
- The existing electrical service is 480/277-volt, 3-phase, 4-wire, and fed from an exterior utility pad mounted transformer. There are two service entrance distribution switchboards that have been installed back-to-back. One of them has a 1200-amp main breaker and the other has a 600-amp main breaker. All the breakers used in the switchboards are obsolete but there are equivalent replacements available. The 1200-amp switchboard does not meet the current NEC requirements. Both main breakers appear to have ground fault protection settings.

- Dry-type transformers are used to step down voltage to 208/120-volt.
- 480/277-volt and 208/120-volt branch circuit panelboards provide power throughout the building. The panelboard types used have been replaced with newer equipment versions. Circuit breakers are still available for the existing panelboards.

- Electrical distribution equipment was manufactured by Schneider/Square D and installed in the 2001/2002 construction project. It appears to be in good condition.

- Obsolete customer meters are located on the switchboards.
- Feeder wiring and raceways appear to be in good condition.

- Upgrade electrical distribution equipment to meet current code requirements with any building wide renovations.
- Inspect electrical equipment connections including thermal imaging, visual inspection and wire connection torque values confirmed with manufactures requirements.
- Follow the manufacturer's recommended maintenance requirements.
- Have a study completed to identify arc flash and PPE requirements for electrical equipment.

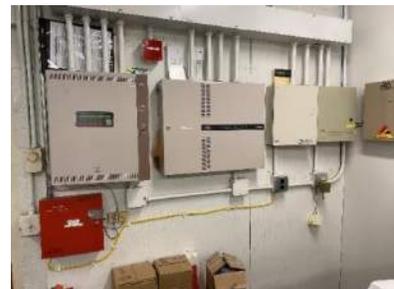
- A Simplex 4010 panel is used in this building. The panel is an addressable system with horn/strobe notification devices and appears to be in good condition but is outdated. The manufacturer's technicians are servicing the system. Simplex is now a part of Johnson Controls (JCI). The system is not compliant with current codes and requirements.
- There are system panels installed that do not appear to be in use.

- There is a piece of Romex wiring used to power the fire alarm communicator. Replace the nonmetallic sheathed cable (Romex) with MC cable or conduit to meet requirements of an educational/commercial installation.
- Remove equipment that is not in use or planned for future use.
- The fire alarm system panels and equipment should be replaced with any major building renovations.

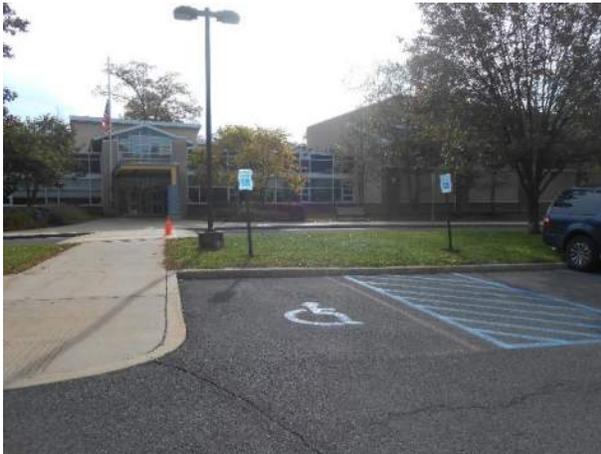
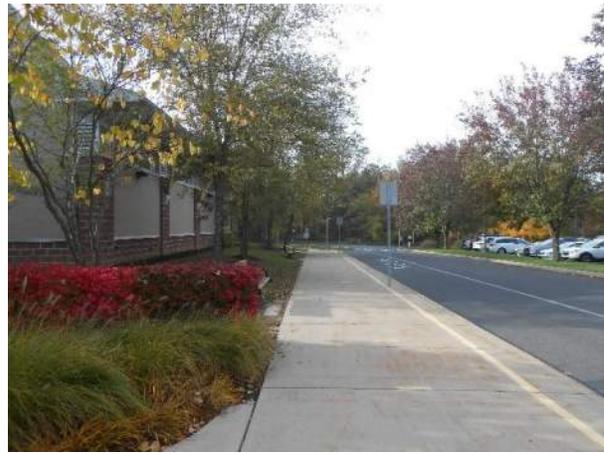
Vehicular access to the site is from Brackenbourne Drive and Grays Woods Boulevard. Parents and buses pick up and drop off from a drive running parallel with the front of the school and side of the school. Traffic appears to be currently managed well at both start of school and dismissal.

Deliveries are made at the front entrance of the school and side entry for receiving. Staff park in the paved lots east and south of the school. Visitors park in the paved lot east of the school. There are ADA accessible parking spaces in the staff/visitor lots, and an accessible route from the parking spaces to the front entrance of the building.

- Limited recommendations at this time, traffic appears to be controlled at this time.

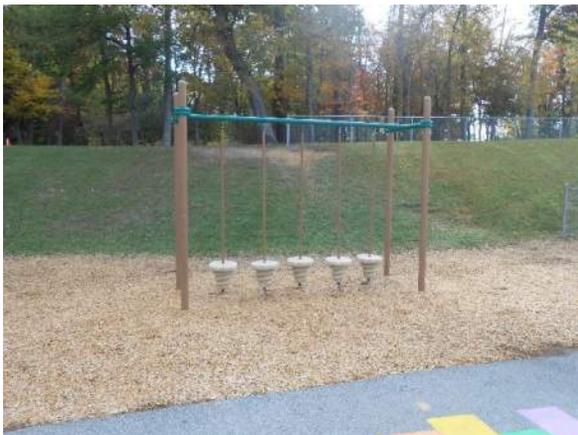
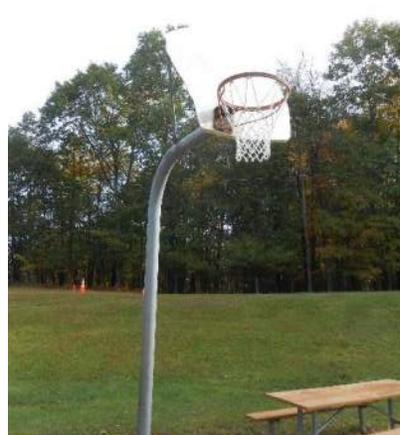
The site has 2 hard-surface play areas with basketball backboards. One backboard is heavily damaged. There are also 2 soft-surface play areas with play equipment. All play areas are in good condition. The 2 soft-surface play areas are surfaced in loose wood chips. All play areas are well separated from vehicular traffic.

- Replace damaged basketball backboard. This is considered routine maintenance.

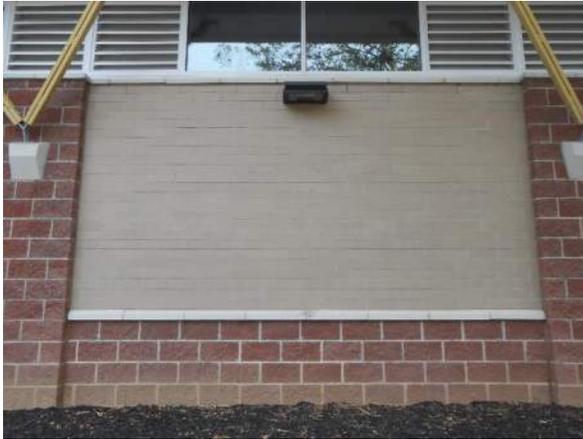
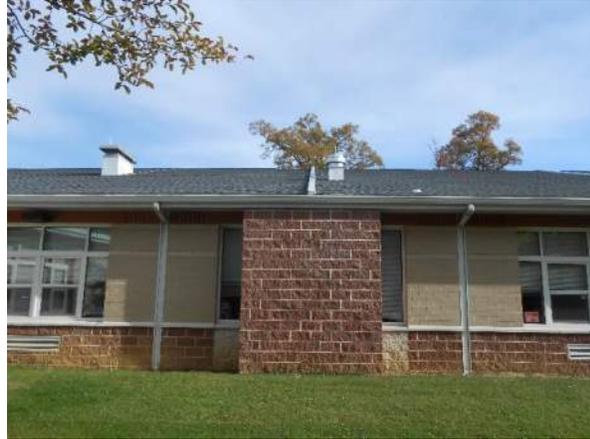
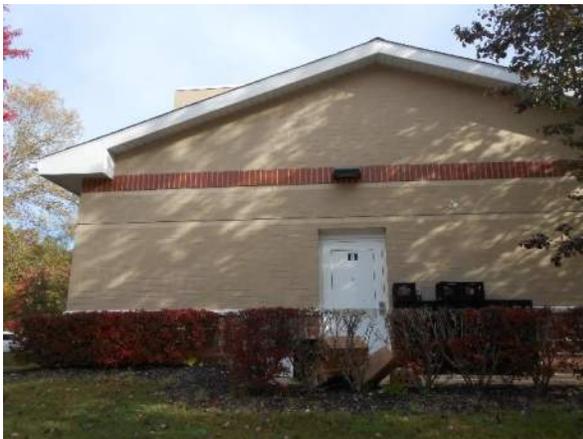
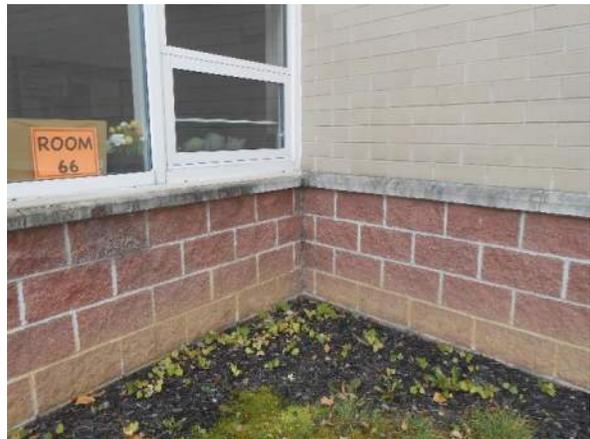
The building exterior consists of insulated masonry cavity walls with modular brick veneer and split face CMU and CMU backup. Window stools are precast concrete and in good condition. Some stools are moderately stained.

- Clean exterior precast concrete stools to remove staining.
- Inspect weep holes at the base of the exterior walls to make sure they are not blocked and trapping moisture within the wall cavity.

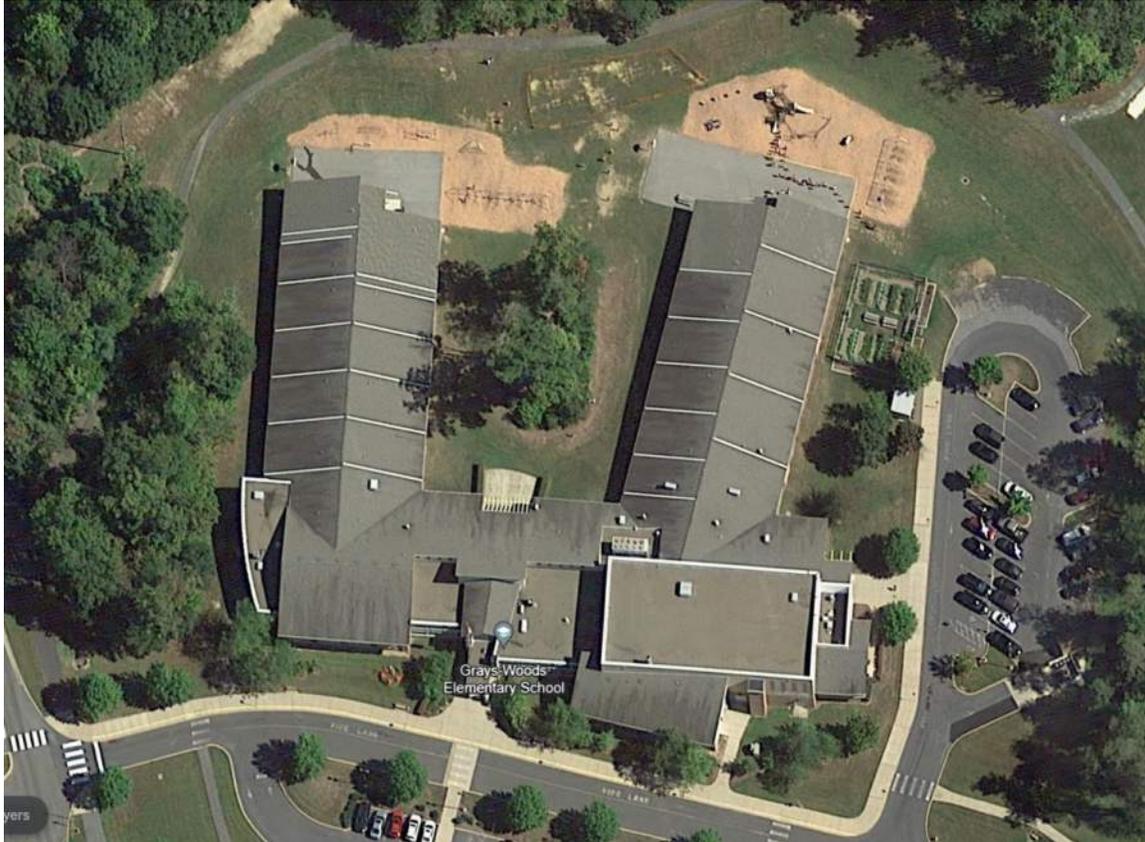
The existing asphalt shingle roofs that were part of the original building constructed in 2002 were replaced in 2023.

The flat roofs associated with the original building constructed in 2002 are a modified bitumen built-up roofing system and are now out of warranty. These roofs are at the end of their life expectancy and should be monitored closely to determine when they should be replaced in the next 5-10 years. If maintained, life expectancy can be extended.

The two small flat roofs at the end of each of the classroom wings that were added in 2011 are fully adhered TPO/EPDM roofs and are in good condition.

For most of the building where the sloped roofs occur, rainwater is collected by gutters and downspouts that ultimately tie into an underground storm system. Roofing and rainwater conveyance appear to be in good condition.

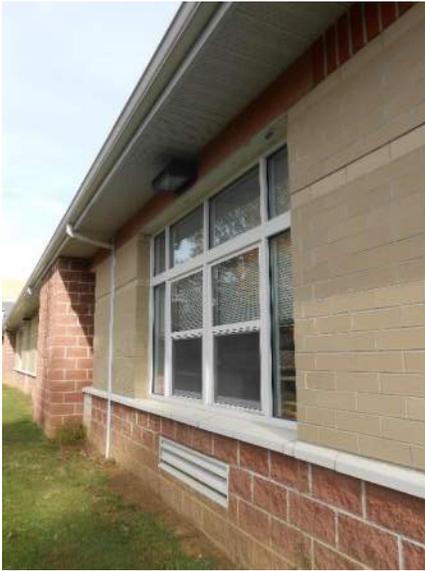
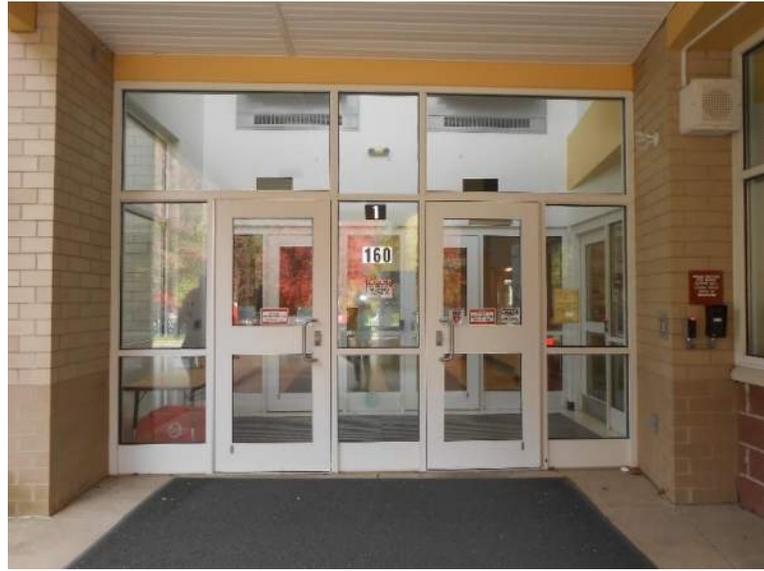
Windows are combination of operable and fixed window units with window treatment mounted at the head of the window. The blinds and shades appear to be in good condition. Entrances are clear anodized aluminum storefront with the wide style door design. Windows and storefront entrances are in good condition.

- Windows and doors are original to when the building was built in 2002 and are in good condition, they will be at the end of their life expectancy in the coming 10 years, but if recaulked regularly and maintained life expectancy can be extended for another 10-20 years.

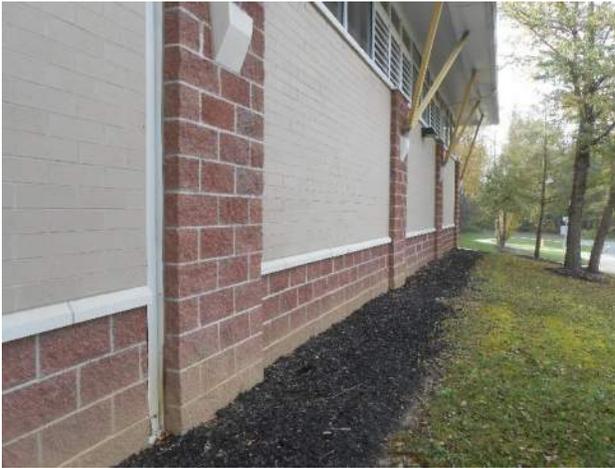
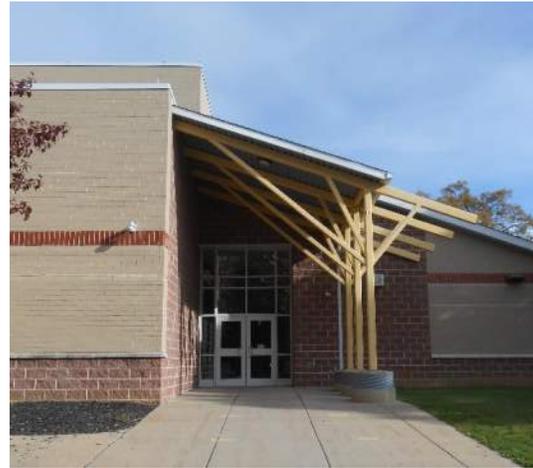
The building is a 1-story masonry load bearing structure with a slab on grade foundation. There is exposed steel structural support at exterior canopies and overhangs. Overall, the building structure does not have any major cracks and appears to be in good condition.

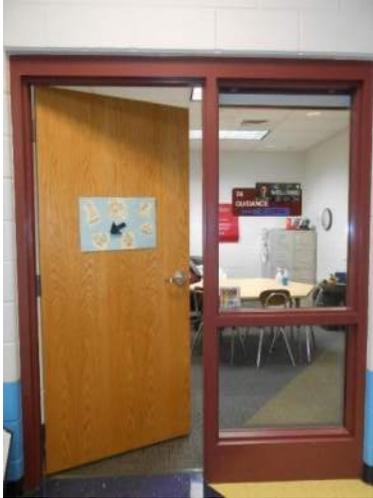
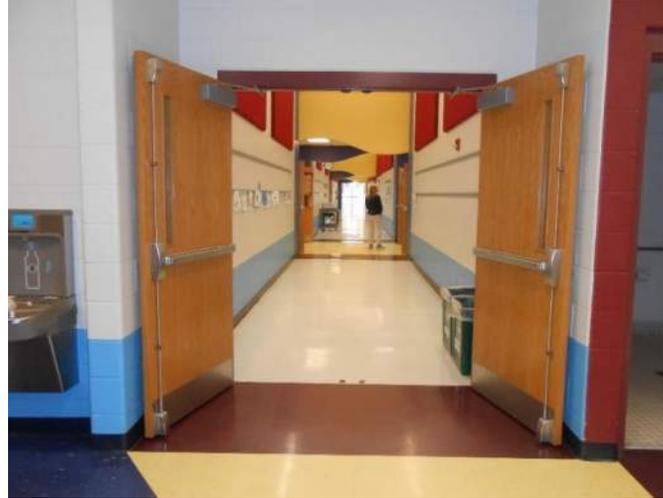
Interior doors are solid core wood and painted hollow metal in painted hollow metal frames and are in good condition.

- None at this time.

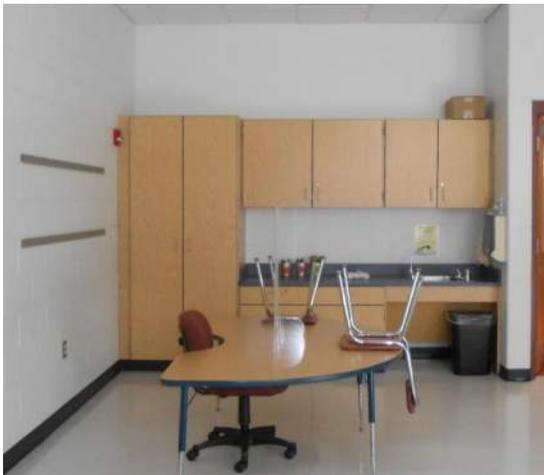
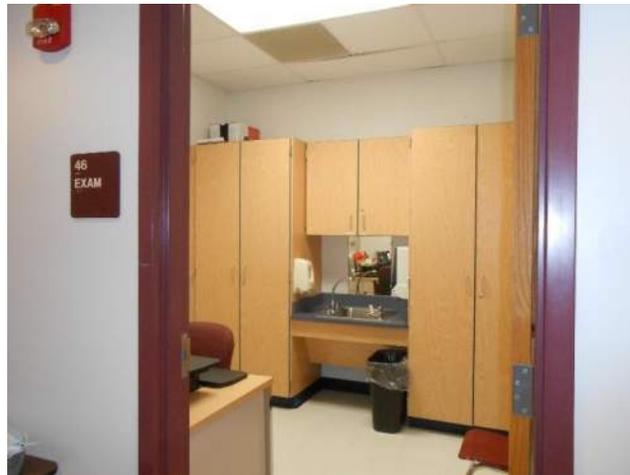
Interior casework is in good condition. Casework allows for forward approach to sinks for accessibility.

- None at this time.

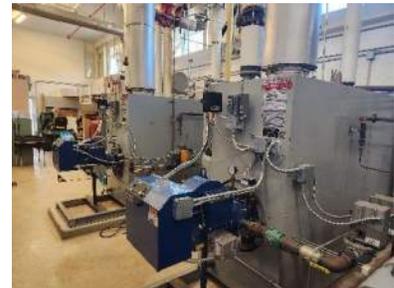
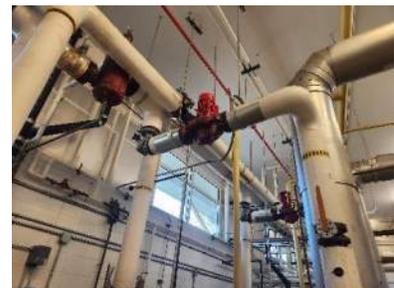
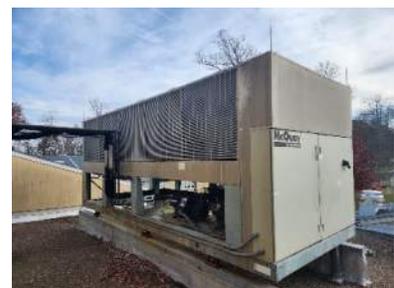
- Two Bryan bent tube boilers (2001) with gas fired burners develop heating hot water for the school. The boilers appear to be in good condition. Bent tube boilers are very serviceable as the tubes can be replaced in the event of failure.

- The Power Flame burners also appear to be in good condition, but it is likely that they will need to be replaced in advance of the boilers.
- Duplex hot water pumps circulate hot water throughout the school. These pumps were replaced in 2022, include VFD's, and are in excellent condition. It was not clear how the VFD's are currently operating. We recommend that control strategies be implemented to allow for variable system flow to reduce pumping power and energy use.

- Blend pumps on the boilers are original and beginning to show signs of aging. They will likely need to be replaced in the next few years.
- The hot water system air separator is in poor condition and should be replaced.

- One of the expansion tanks is original and in need of being replaced.
- The gas fired makeup air unit for the boiler room is operable and in fair condition. We were not able to inspect the heat exchanger, but the normal life cycle of this type of unit is around 20 years.

- Replace the burners.
- Replace the boiler blend pumps.
- Replace the air separator and the old expansion tank.
- Replace the chiller system.

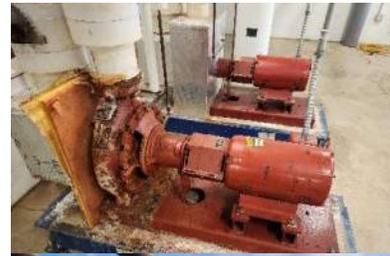
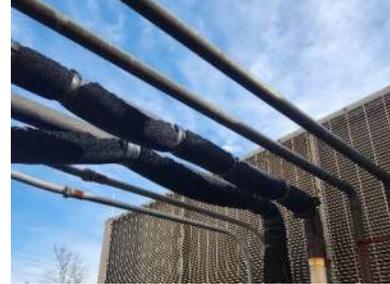
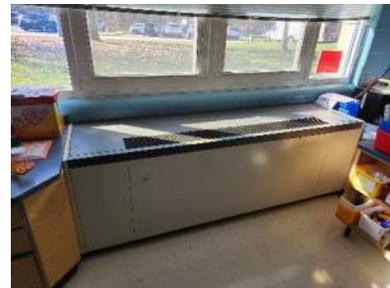
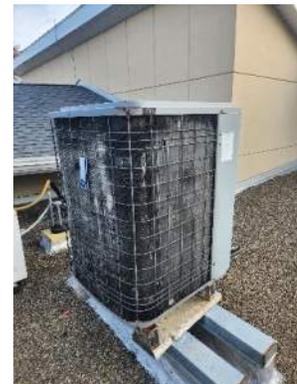
- A McQuay split system chiller is utilized to develop chilled water for cooling. This chiller is original and utilizes R-22 refrigerant. Three of the four compressors are original and have lasted beyond their normal expected lifecycle. R-22 refrigerant has been phased out of production in 2020 due to its ozone depleting characteristics. We highly recommend that the chiller be replaced with a new unit that uses current refrigerants and provides improved energy efficiency.

- The spring isolators on the chiller are in poor and failing condition. These components should be replaced as part of any chiller project.
- The chiller refrigerant piping insulation system has fully deteriorated and needs to be replaced.

- Duplex chilled water pumps circulate chilled water throughout the school. These pumps are original and are starting to show signs of their age. There is some significant deterioration which appears to be a result of condensation from failed insulation. We recommend that the pumps be replaced as part of any chiller replacement project. Consideration should be given to utilizing a primary/secondary pumping arrangement to allow constant flow through the chiller and variable flow to the building. This will result in pump energy savings.

- The pipe insulation is deteriorating in some areas. We recommend that any wet or damaged pipe insulation be replaced.
- HVAC valves throughout are original. It was noted that some of the valves no longer hold, making service and maintenance difficult. We recommend that key valves be replaced when a comprehensive upgrade occurs.

- DX cooling units are installed in several areas including the office, library, and server room. The units are original and utilize R-22 refrigerant. R-22 refrigerant has been phased out of production in 2020 due to its ozone depleting characteristics. We highly recommend that the units be replaced with new units that use current refrigerants and provide improved energy efficiency.

- Note that some of the exterior condensing unit fins are damaged. This can result in poor performance and a reduction in efficiency.
- Exhaust fans throughout are original but appear to be in fair condition.

- Replace the chilled water pumps and specialties.
- Replace and damaged pipe insulation.
- Replace strategic HVAC valves for improved maintenance serviceability.
- Replace R-22 DX cooling systems.
- Repair/comb the damaged fins on the exterior condensing units.

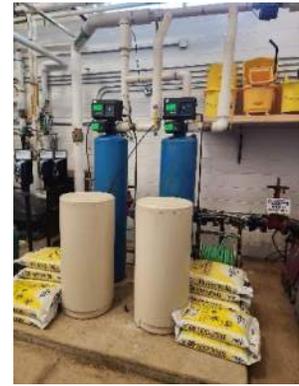
- Plumbing valves throughout are original. It was noted that some of the valves no longer hold, making service and maintenance difficult. We recommend that key valves be replaced when a comprehensive upgrade occurs.
- The domestic water system includes a water softening system. The softeners appear to be original to the building construction. It is likely that these units will need to be replaced in the next few years.

- Replace strategic plumbing valves for improved maintenance serviceability.
- Replace the water softening system.

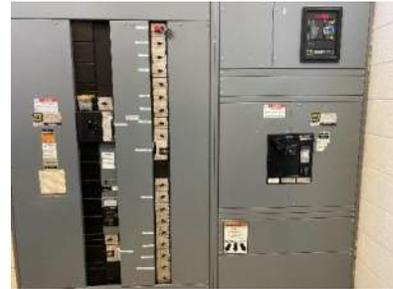
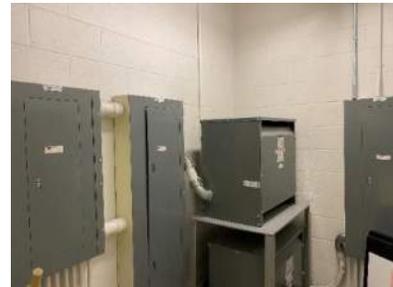
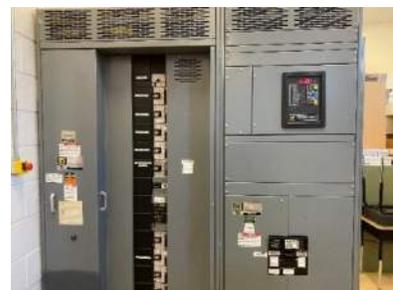
- The existing electrical service is 480/277-volt, 3-phase, 4-wire, and fed from an exterior utility pad mounted transformer. There are two service entrance distribution switchboards that have been installed back-to-back. One of them has a 1200-amp main breaker and the other has an 800-amp main breaker. All the breakers used in the switchboards are obsolete but there are equivalent replacements available. The 1200-amp switchboard does not meet the current NEC requirements. Both main breakers appear to have Ground Fault protection settings.

- Dry-type transformers are used to step down voltage to 208/120-volt.
- 480/277-volt and 208/120-volt branch circuit panelboards provide power throughout the building. The panelboard types used have been replaced with newer equipment versions. Circuit breakers are still available for the existing panelboards.

- Electrical distribution equipment was manufactured by Schneider/Square D and installed in the 2001/2002 construction project. Equipment appears to be in good condition.

- Obsolete Customer meters are located on the switchboards.
- Feeder wiring and raceways appear to be in good condition.

- Upgrade electrical distribution equipment to meet current code requirements with any building wide renovations.
- Inspect electrical equipment connections including thermal imaging, visual inspection and wire connection torque values confirmed with manufactures requirements.
- Follow the manufacturer's recommended maintenance requirements.
- Have a study completed to identify arc flash and PPE requirements for electrical equipment.

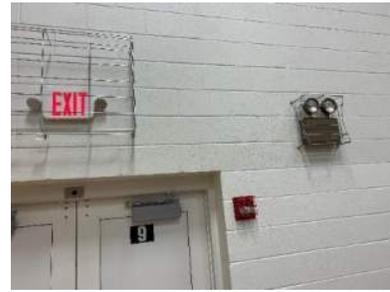
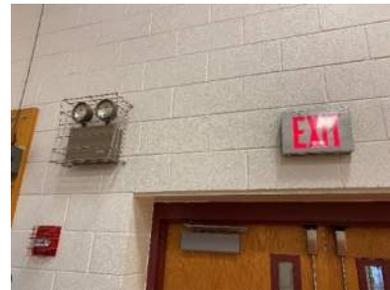
- This building does not have an emergency generator.
- Life-safety egress emergency lighting consists of wall-mounted battery-pack units with integral and remote mounted heads. Also, lamps are used inside fluorescent luminaires that operate on batteries upon a power loss condition.
- Self-contained exit signs with battery back-up are installed in the building.
- Emergency equipment is in poor to fair condition and has had multiple charging board and battery failures requiring replacements. Complete battery-pack replacements have been observed. This type of equipment requires ongoing maintenance and the purchasing of equipment.
- The equipment being replaced is using LED heads.

- Install a generator with automatic transfer switches, normal/emergency panelboards and associated equipment. The generator would be used for life-safety egress emergency lighting and could also be used for optional equipment loads like kitchen walk-in refrigerators, freezers, and mechanical equipment.
- A New generator should be sized to include the building heating equipment branch circuit loads IE: Boilers, blend, and circulator pumps to keep system equipment from damage during a utility power loss.

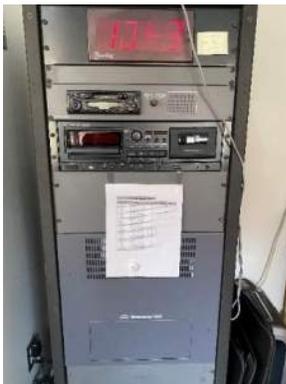
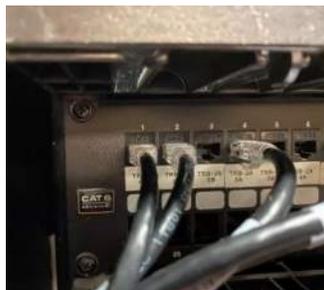
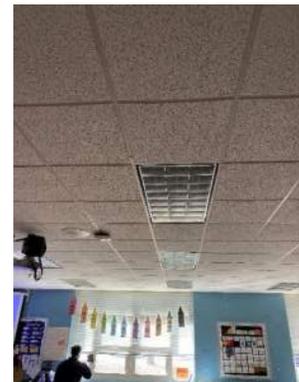
- Category 6 cables/jacks and Wi-Fi wireless access devices are used throughout the building and appear in good condition.
- A VoIP phone system appears to be in use in the building.
- A Rauland Telecenter ICS Intercom system is used in the building and is original to the 2001/2002 construction. This system is obsolete and service parts will be difficult to get.
- Sapling analog clocks are used throughout the building, they are original to the 2001/2002 construction. Digital clock segments are no longer working at the head end location, and the system is in fair condition.

- The School District is currently upgrading data telecommunication systems.
- Remove existing telecommunications systems equipment and cables that are no longer in use.
- Upgrade/Replace the obsolete Intercom system with a newer IP-based system.
- Upgrade/Replace the clocks and associated equipment as they are very close to their life expectancy.

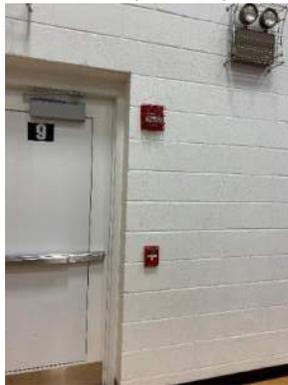
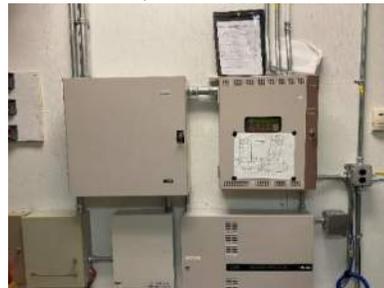
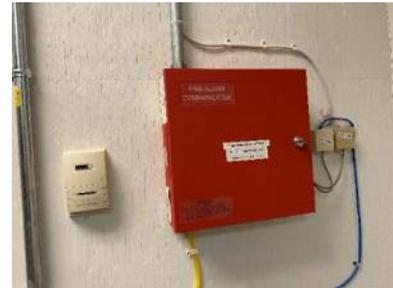
- A Simplex 4010 panel is used in this building. The panel is an addressable system with horn/strobe notification devices and appears to be in good condition but outdated. The manufacturer's technicians are servicing the system. Simplex is now part of Johnson Controls (JCI). The system is not compliant with current codes and requirements.
- Strobe devices appear to be installed lower than they are required to be.
- There are system panels installed that do not appear to be in use.
- Any new systems installed will be required to have voice/speaker notification devices.

- Review strobe notification device installations and confirm required heights are correct. Correct as needed.
- There is a short piece of Romex wiring used to power the fire alarm communicator. Replace the nonmetallic sheathed cable (Romex) with MC cable or conduit to meet requirements of an educational/commercial installation.
- Remove equipment that is not in use or planned for future use.
- The fire alarm system panels and equipment should be replaced with any major building renovations.
- The new fire alarm system installation will require the use of voice-based speaker systems to meet the NFPA requirements.
- Carbon monoxide sensors should be used in areas where fuel combustion occurs inside the building.

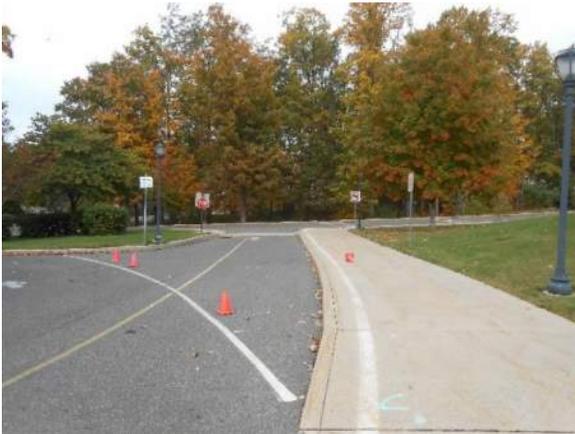
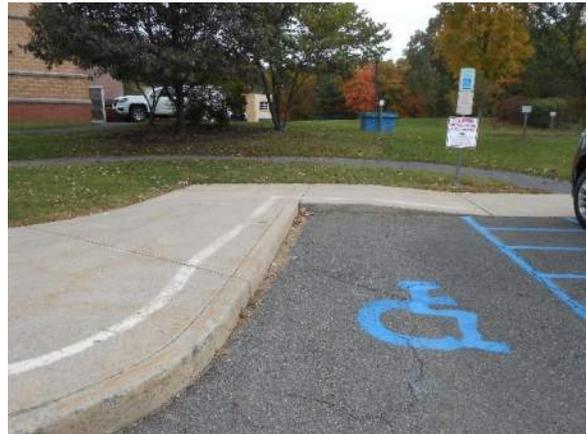
Vehicular access to the site is from School Drive and Amblewood Way. There is a drive running parallel with the front of the school on which parents pick up and drop off students. There is a separate entrance drive for buses to pick up and drop off, which loops around a parking area for staff.

Deliveries are made to south and southeast entrances of the school. Staff park in the paved lot located to the south of the school. Visitors park in the paved spaces across from the main entrance of the school. There are ADA accessible parking spaces in the in both parking areas, and an accessible route from the parking spaces to the front entrance of the building.

- Visitor parking could be expanded in the future if possible, which is limited at this time.

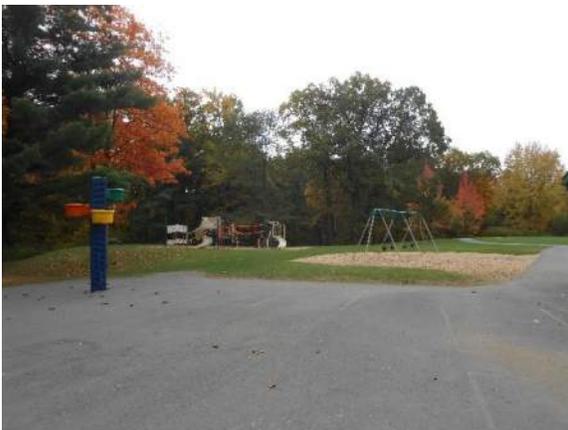
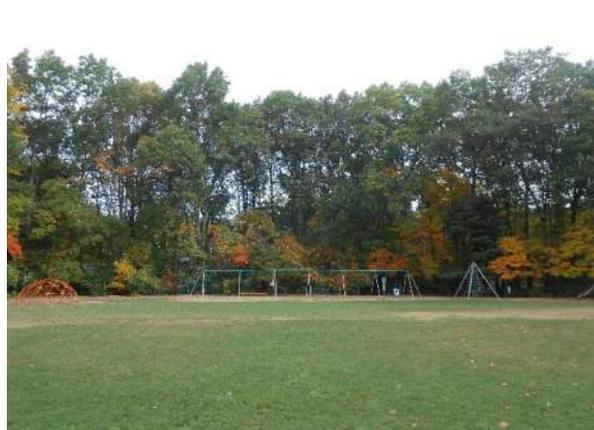
The site has one hard-surface play area, which includes a basketball backboard. There are multiple soft-surface play areas with play equipment, which are surfaced in loose wood chips. The site also features two grass fields. All are in good condition and all play areas are well separated from vehicular traffic.

- None at this time.

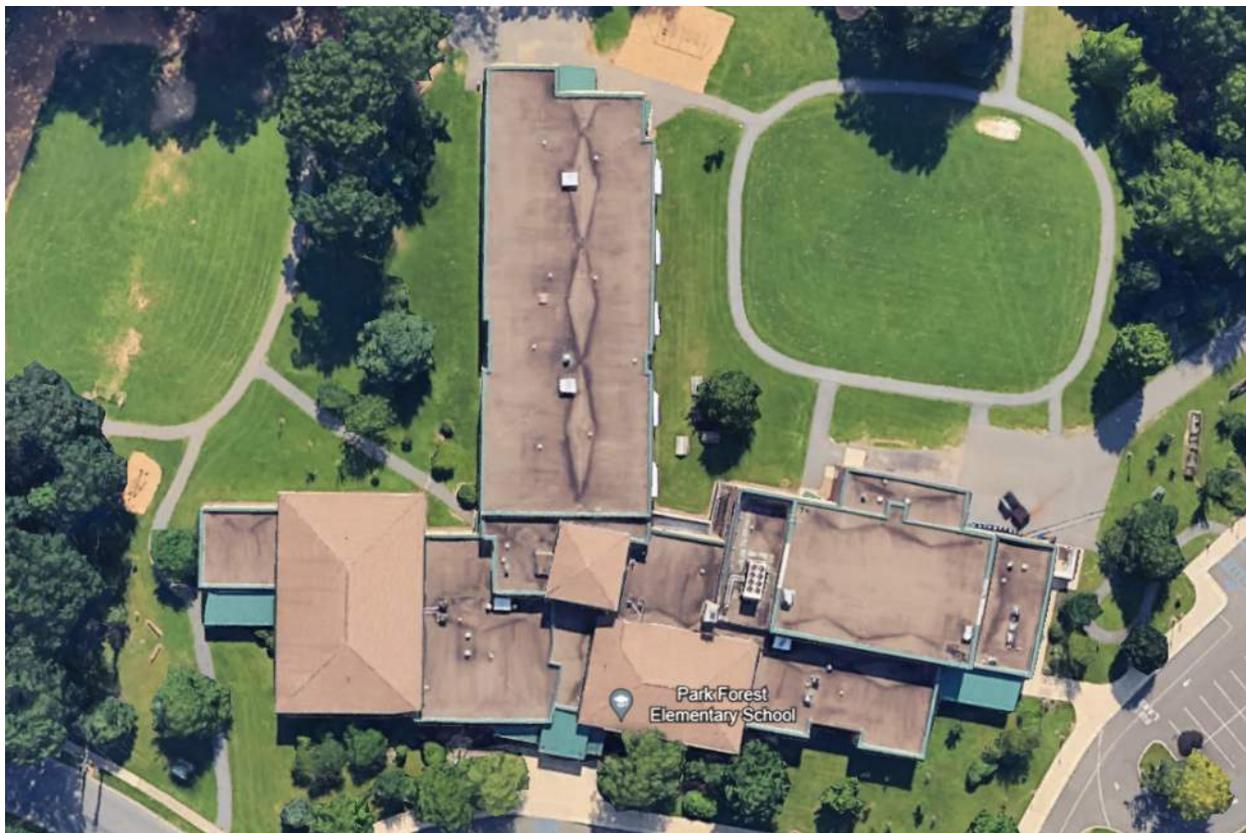
All three types of roofs (asphalt shingles at sloped roofs, built-up roofing system at flat roofs and metal roofing at sloped roof canopies at entrances) are original and are at the end of their life expectancy and should be monitored closely to determine when they should be replaced in the near future. This should be a capital project in the coming 5-10 years.

Where the sloped roofs occur, rainwater is collected by gutters and downspouts that ultimately tie into an underground storm system. Roofing and rainwater conveyance appear to be in good condition.

- Monitor to determine replacement.

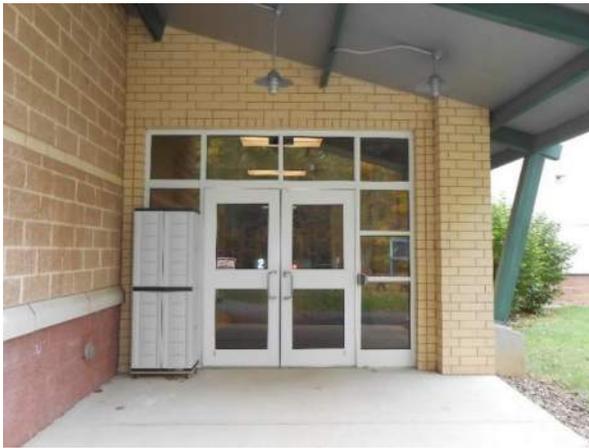
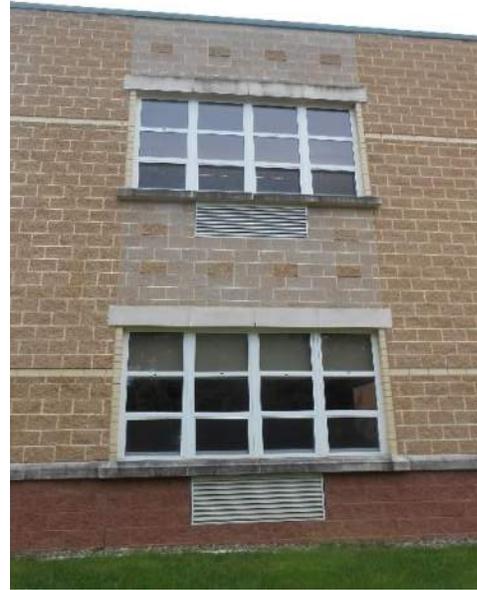
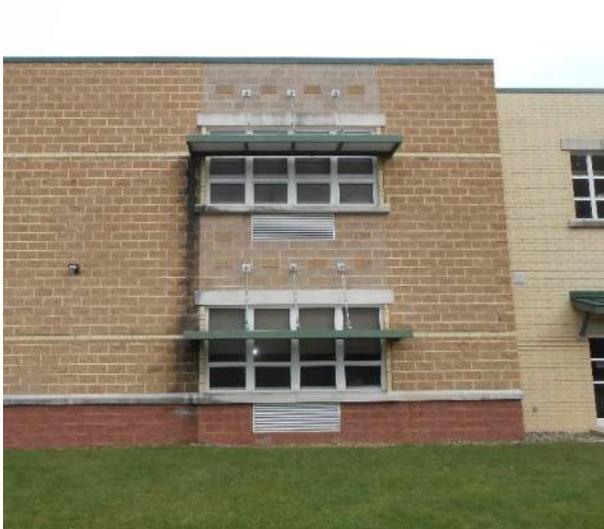
Windows are combination of operable and fixed window units with window treatment mounted at the head of the window. The blinds and shades appear to be in good condition. Entrances are clear anodized aluminum storefront with the wide style door design.

Upper and lower-level windows on the south sides of the building have integral shading devices with the aluminum storefront system.

- Windows and doors are original to when the building was built in 2005 and are in good condition, they will be at the end of their life expectancy in the coming 10 years, but if recaulked regularly and maintained life expectancy can be extended for another 10-20 years.

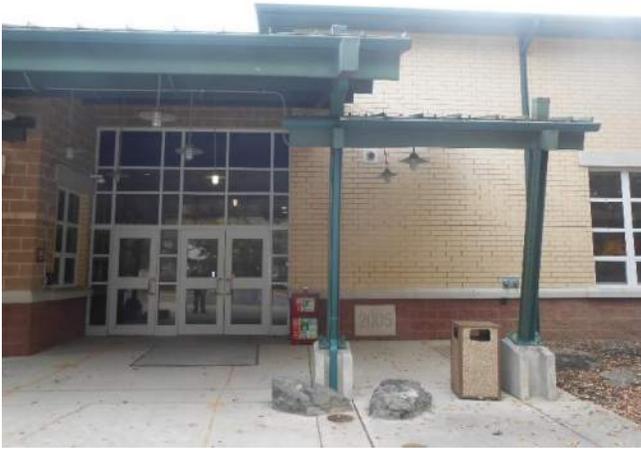
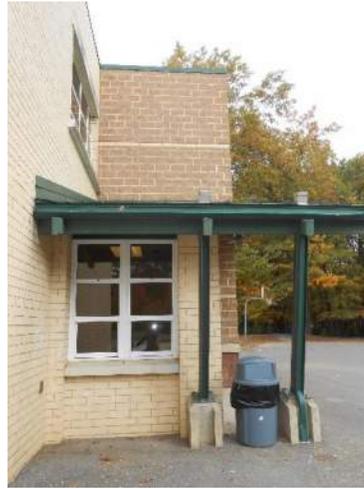
The building is a 2-story masonry load bearing structure. Exterior canopies are supported with steel beams and columns. Overall, the building structure does not have any major cracks and appears to be in good condition.
