6 | Easterly Parkway Elementary School

Address:	234 Easterly Parkway State College, PA 16801
Construction Timeline:	Originally constructed in 1955; renovation/addition in 2002.
Building Square Footage:	55,895 sf
Site Acreage:	11.4 acres

Building Summary

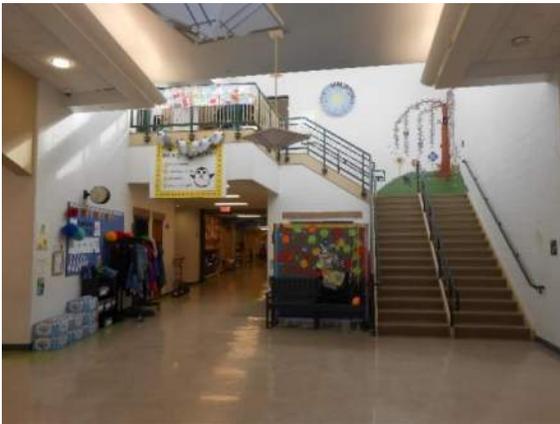
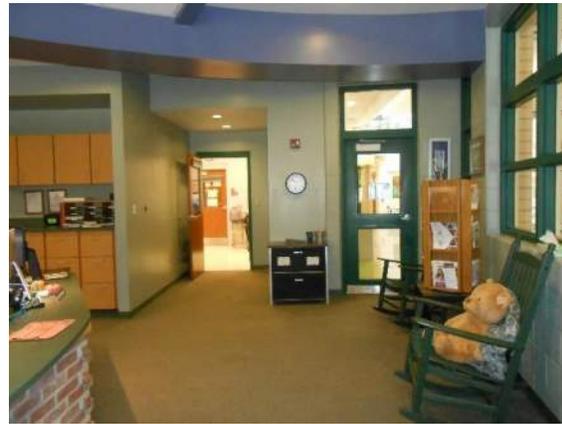
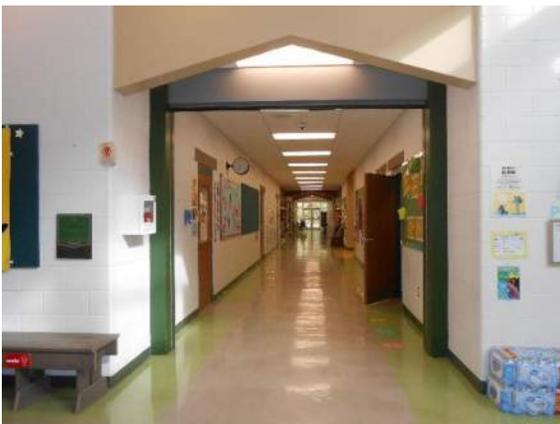
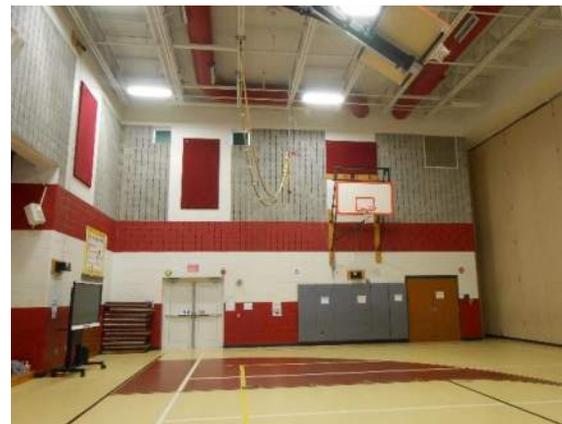
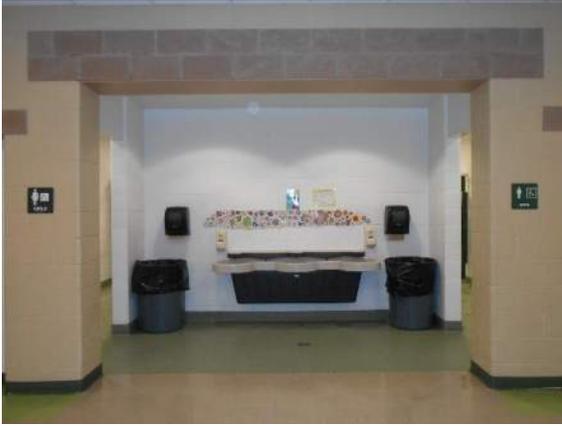
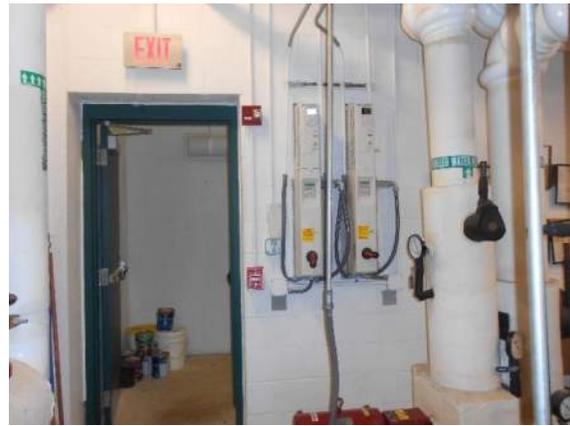
Most of the flooring throughout the school is VCT and is in good condition. Carpet exists in the main office and is well maintained. The flooring in toilet rooms is porcelain tile. Mechanical areas have painted concrete. The gymnasium has sheet vinyl flooring which is in good condition.

Interior walls are predominantly painted CMU and are in good condition. Acoustical and gypsum board ceilings and bulkheads throughout the building are in good condition.

- Due to the building being 19 years old, while VCT is in good condition, it would be recommended to plan for VCT replacement in the next 10 years as a capital project.

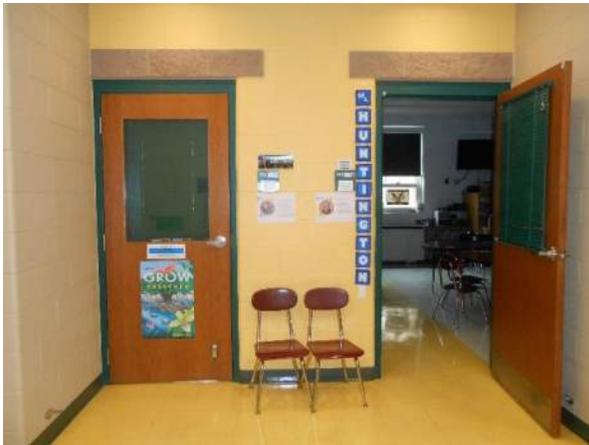
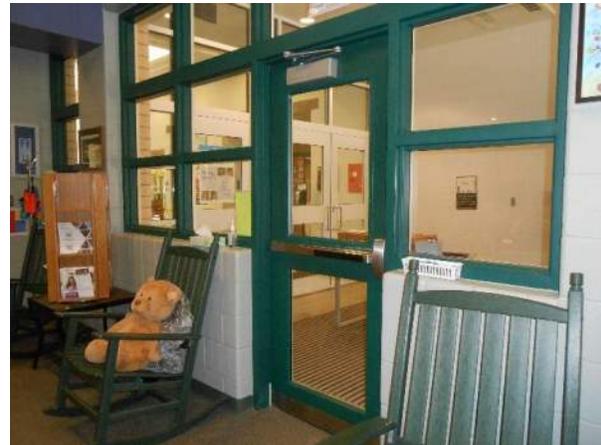
Interior doors are solid core wood and painted hollow metal in painted hollow metal frames and are in good condition. Interior aluminum doors are also in good condition.

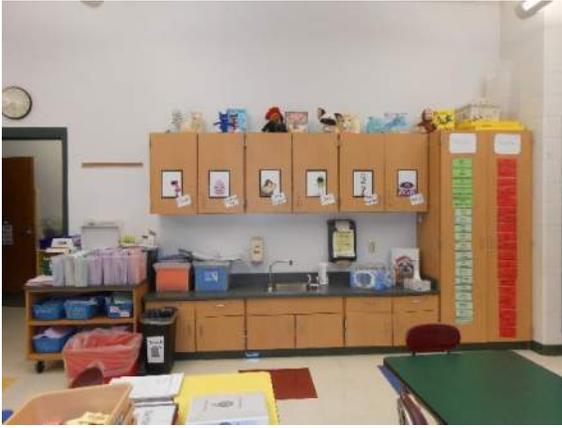
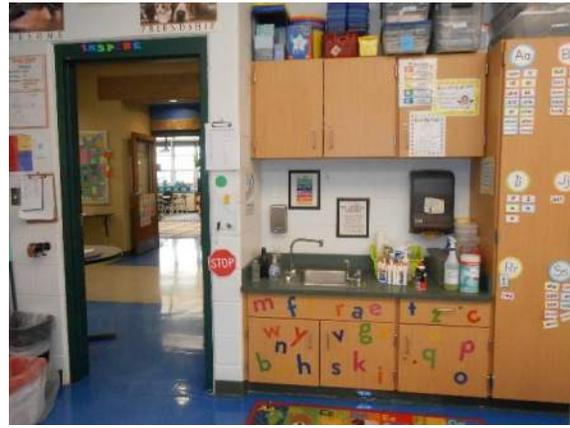
Interior casework is in good condition. Casework underneath the sinks throughout the building do not allow for a forward approach for accessibility.

- Provide casework that includes sinks that meet ADA accessibility guidelines. This should only occur if a future casework replacement would occur. Casework met code requirements when installed and does not require replacement at this time.

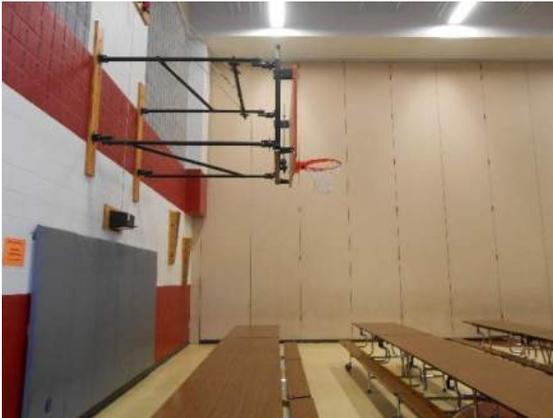
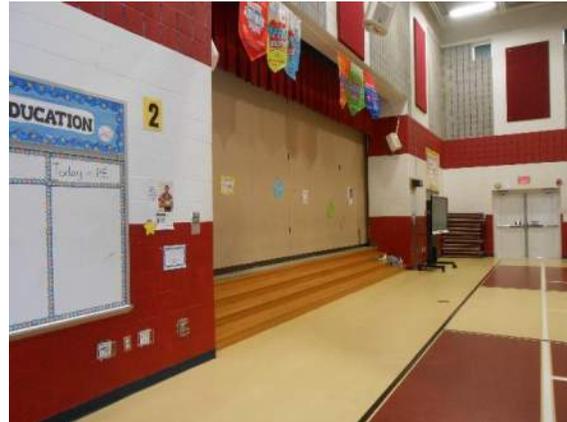
The multi-purpose room equipment consists of retractable, ceiling-hung and wall-hung basketball backstops. There is a folding wall partition for the multi-purpose room and the stage. All are in good condition. The stage curtain/ folding partition and lighting are original to the building but are also in good condition.

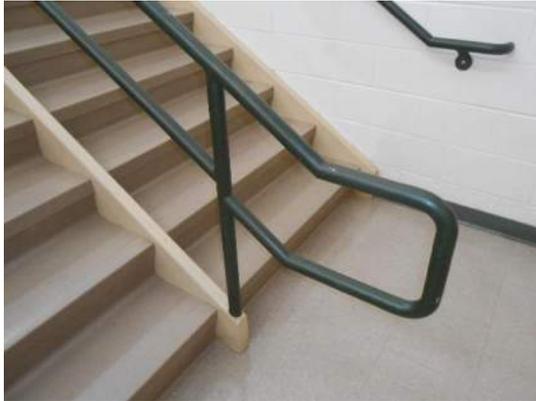
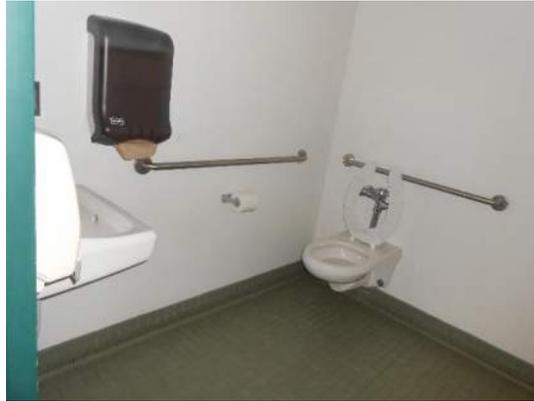
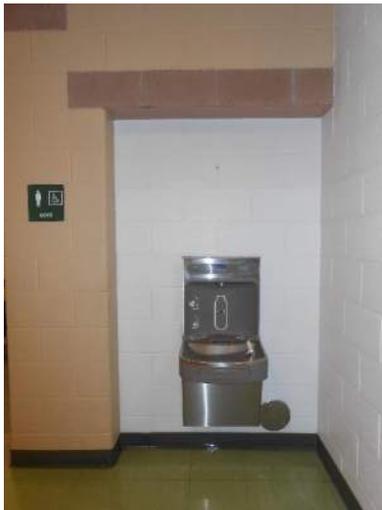
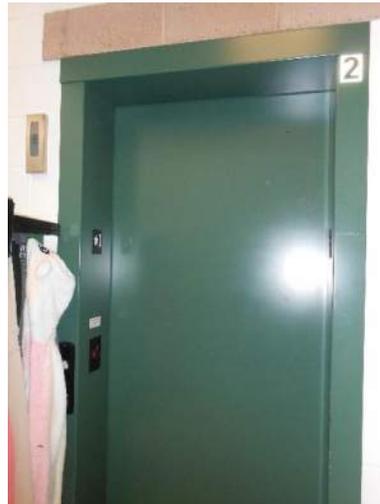
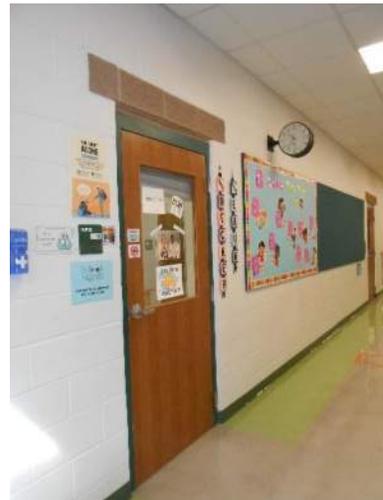
Water coolers are the new ones where bottles can be refilled.

There is an elevator that serves both floors and appears to be ADA compliant.

- Provide ADA compliant grab bars in group toilet rooms.
- Provide new room signage with the braille tactile writing system with any comprehensive renovation project.

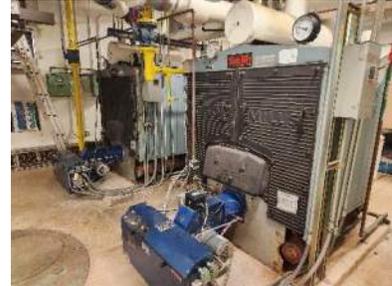
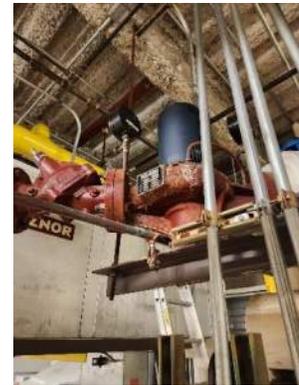
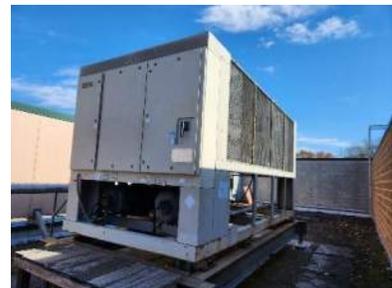
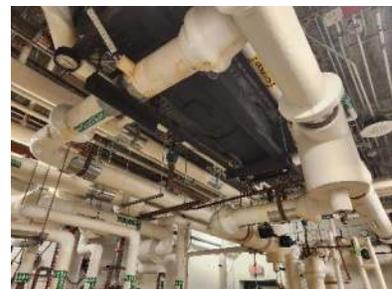
- Two cast iron Smith 350 Mills boilers (2005) with gas fired burners develop heating hot water for the school. The boilers appear to be in good condition. It should be noted that these boilers are no longer manufactured by Smith. They stopped casting new sections several years ago, so parts availability could be a challenge if a section were to crack or fail.

- The Power Flame burners also appear to be in good condition, but it is likely that they will need to be replaced in advance of the boilers.
- Duplex hot water pumps circulate hot water throughout the school. These pumps appear to be original and include newer VFD's. They were running well at the time of our observation. It was not clear how the VFD's are currently operating. We recommend that control strategies be implemented to allow for variable system flow to reduce pumping power and energy use.

- Blend pumps on the boilers are original and beginning to show signs of aging. One of the pumps has a newer motor. They will likely need to be replaced in the next few years.

- The expansion tank appears to be original, but it seems to be operating properly and is in good condition. We were not able to inspect the bladder.
- The gas fired makeup air unit for the boiler room is operable and in good condition. We were not able to inspect the heat exchanger, but the normal life cycle of this type of unit is around 20 years.

- A roof mounted McQuay split system chiller is utilized to develop chilled water for cooling. This chiller is original and utilizes R-134a refrigerant. Based on its age, the chiller will likely need significant maintenance or replacement in the next few years.

- The unit frame and spring isolators on the chiller are rusting and in poor condition.
- The internal bundle is in the ceiling of the mechanical room and is difficult to access.

- Duplex chilled water pumps circulate chilled water throughout the school. These pumps appear to be original and include newer VFD's. They were running well at the time of our observation. It was not clear how the VFD's are currently operating. We recommend that control strategies be implemented to allow for variable system flow to reduce pumping power and energy use.

- The internal condition of the HVAC piping system is unknown, but we would expect that it is in good condition based on the report that the district maintains a good water treatment program.

- The pipe insulation is deteriorating in some areas. We recommend that any wet or damaged pipe insulation be replaced.

- Consider boiler and burner replacement. Replace them with high efficiency gas boilers.
- Replace the hot water pumps and the boiler blend pumps as part of any boiler project.
- Replace the chiller.
- Replace the chilled water pumps as part of any chiller replacement project.
- Replace/repair and damaged HVAC pipe insulation.
- Replace strategic HVAC valves for improved maintenance serviceability.
- Replace R-22 DX cooling systems.

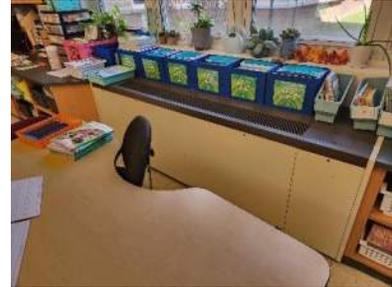
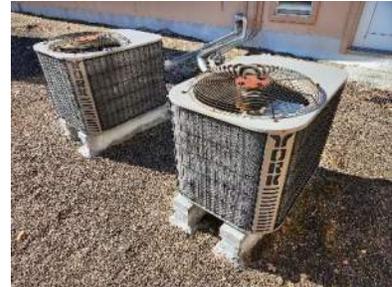
- HVAC valves throughout are original. It was noted that some of the valves no longer hold, making service and maintenance difficult. We recommend that key valves be replaced when a comprehensive upgrade occurs.

- Classrooms are served by vertical 4-pipe unit ventilators on the exterior walls. Some of the larger spaces are served by McQuay 4-pipe air handlers. These units are original but appear to be in good condition.

- Note that classroom unit ventilators have many shortcomings including high noise levels, excessive room drafts, temperature variations, and inconsistent ventilation. They are no longer an industry recommended approach to providing HVAC in a learning environment.

- DX cooling units are installed in several areas including the office, library, and server room. Some units have new compressors. The units are original and utilize R-22 refrigerant. R-22 refrigerant has been phased out of production in 2020 due to its ozone depleting characteristics. We highly recommend that the units be replaced with new units that use current refrigerants and provide improved energy efficiency.

- Exhaust fans throughout are original but appear to be in fair condition.

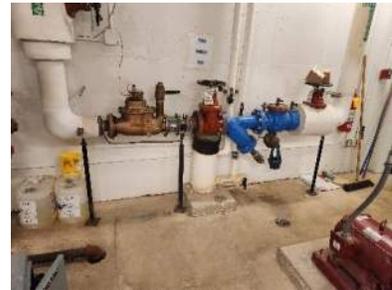
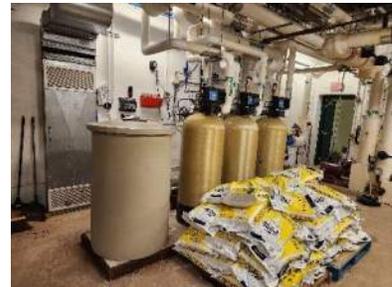
- The school is served off a public water service. The 4" service size is adequate for the school's needs. There were not any observed or noted issues.
- The water service includes a code compliant backflow prevention device that appears to be operational.
- The piping system was reported to be in good condition, but we noted that some copper piping was replaced with PEX. We recommend that further inspection be carried out to determine if the pipe systems have internal or pin hole issues.
- Plumbing valves throughout are original. It was noted that some of the valves no longer hold, making service and maintenance difficult. We recommend that key valves be replaced when a comprehensive upgrade occurs.
- The domestic water system includes a water softening system. The softeners appear to be in good condition.

- Inspect the internal condition of the domestic water piping.
- Replace strategic plumbing valves for improved maintenance serviceability.

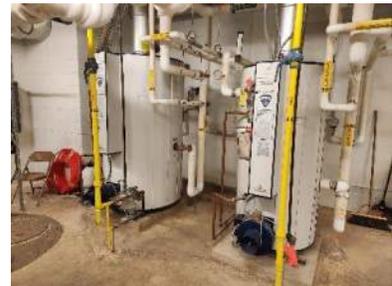
- Domestic hot water is developed from two PVI gas fired water heaters that were installed in 2005. They are in fair condition. Based on age, it is likely that they will soon need to be replaced.
- Note that the water heaters are not currently interconnected. We recommend that the new system be piped together to provide redundancy/backup capabilities.
- The hot water recirculation pumps appear to be in aged and poor condition and should be replaced as part of any water heating system upgrade.
- The domestic hot water mixing valve appears to be in aged and poor condition and should be replaced as part of any water heating system upgrade.

- Replace/upgrade the domestic water heating system.

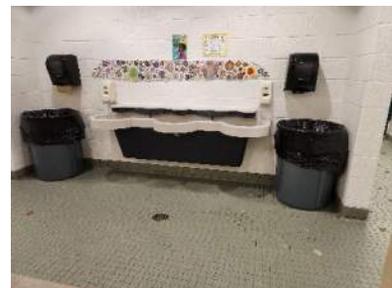
- Plumbing fixtures throughout appear to be in good condition.
- Water closets and urinals utilize manual flush valves.
- Multi-station lavatories are utilized at group toilet rooms. These units include hands free faucets. There were not any reported issues with these units.
- Classroom sinks include bubblers and faucets with blade handles.
- Water coolers include bottle fillers. They do not appear to all be ADA compliant.

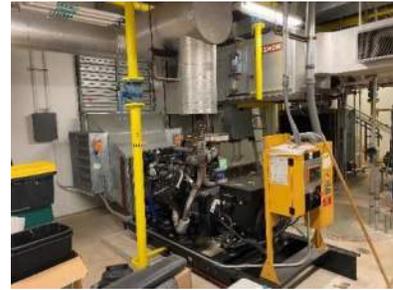
- A 150kW natural gas generator provides emergency power.
- The generator is manufactured by Olympian and the automatic transfer switches are manufactured by ASCO.
- Both life-safety and optional-standby building loads each have a separate automatic transfer switch for emergency power distribution.
- The generator, transfer switches and area protection panel are in good condition.
- The life safety equipment is in the same room as the service entrance and building electrical distribution systems. This does not meet the code requirements.
- Generator has one distribution breaker that is used for both Life safety and Optional standby distribution systems.
- Boilers, blend pumps and circulator pumps appear to be backed up by the generator.

- The emergency power distribution system is in fair to good condition.
- Relocate life-safety equipment as needed to meet code requirements.
- Anchor/fasten generator to foundation per manufactures requirements.
- Maintain generator per manufacturer's requirements.
- Review building equipment systems that are to be powered by the generator upon a utility power loss with owner and address as needed.
- Confirm the heating systems are backed up by the emergency generator.
- Review adding a dedicated breaker on gen set and feeder for life safety systems.

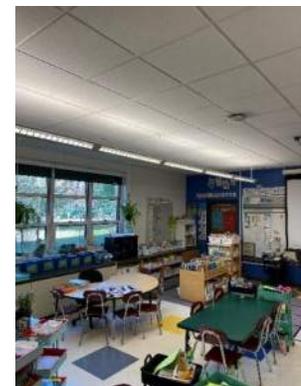
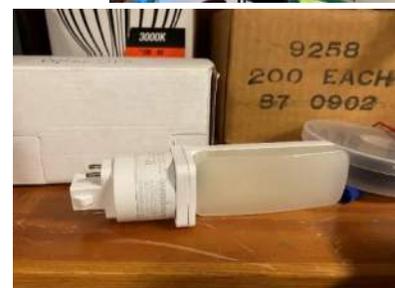
- It appears that standard 4' fluorescent lamps are still being utilized but the compact fluorescent lamps are being replaced with LED type lamps.
- The multi-purpose room has linear fluorescent high-bay lighting fixtures.

- Exit signs are LED type with battery back-up.
- Lighting controls do not meet current energy code requirements for automatic switching, daylight harvesting, and dimming.

- Interior lighting and lighting controls should be replaced throughout with LED type luminaires and energy code compliant controls. It is our understanding that lighting upgrades are scheduled for this year..
- Exterior LED lighting is in good condition and no further action is required.

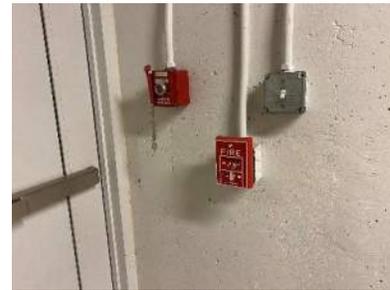
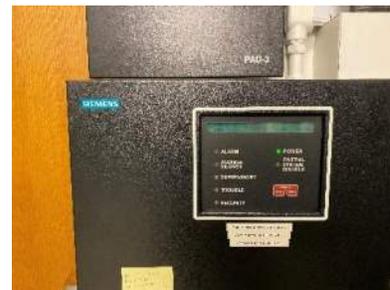
- A Siemens MXL-IQ addressable fire alarm system panel and horn/strobe notification devices are used in this building. This panel and some of the associated devices that are used with it are obsolete. The system is not compliant with current codes and requirements.

- System testing appears to be completed by JCI.
- The system does not provide notification in classrooms and public spaces per code requirements.
- The existing building horn-based notification system is grandfathered, but current NFPA codes require voice-based (speaker) annunciation in education buildings. Voice fire alarm communication capabilities and speaker-type notification devices will need to be installed for any future renovations that require changes to the fire alarm system.

- There is a sprinkler flow and tamper switch located in an open ceiling area that is not being monitored by the fire alarm system. This should be reviewed and corrected if in use.

- Future renovations will necessitate installation of voice communication capabilities for the fire alarm system. Audio Horn devices will need to be replaced with speaker type notification devices.
- The fire alarm system should be considered for full replacement with any major building renovations.
- Add a fire alarm monitoring device and associated wiring to the sprinkler system unmonitored valve and flow switch if it is in use.

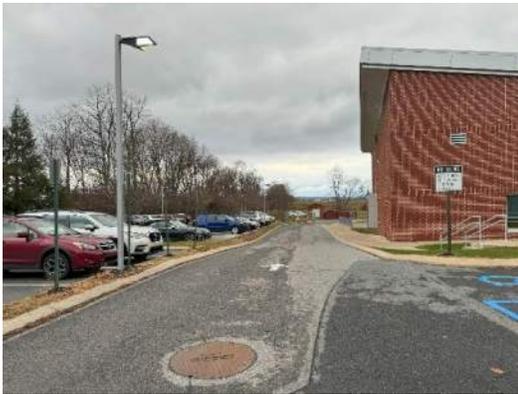
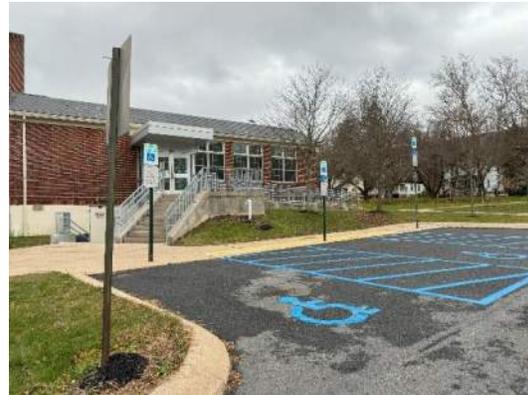
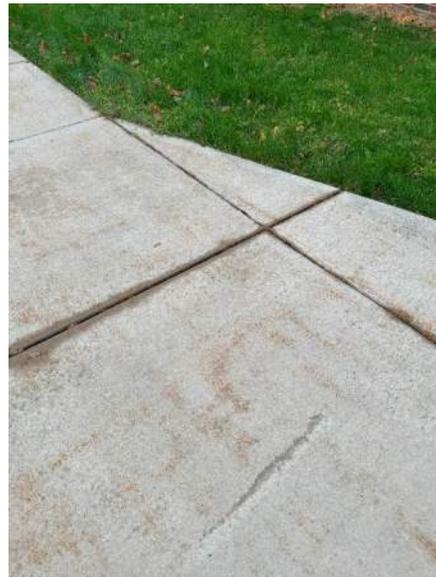
Some of the concrete walks are aging and starting to show signs of wear and tear, in that the aggregate (in the concrete) is beginning to show through to the outside surface. The concrete is also stained in many places. Cracking is occurring on some of the paved surfaces.

- The short-term recommendation for paving is to apply a pourable sealer to the cracks, seal the paving, and repaint lines. The long-term recommendation is to remove 1" to 1-1/2" of existing surface and to provide a new wearing course with any new building project. The short-term recommendation for the

concrete walks is to clean and remove stains and provide a sealer. The long-term recommendation is to replace the concrete with any new building project.

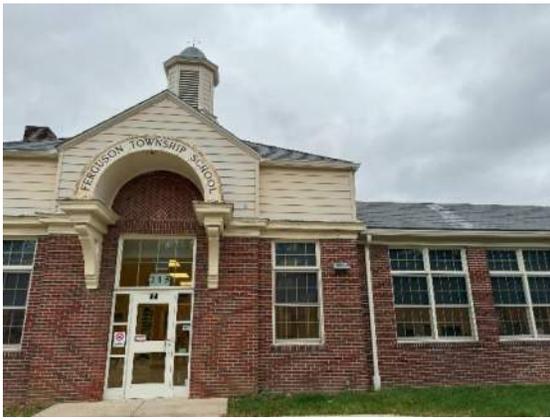
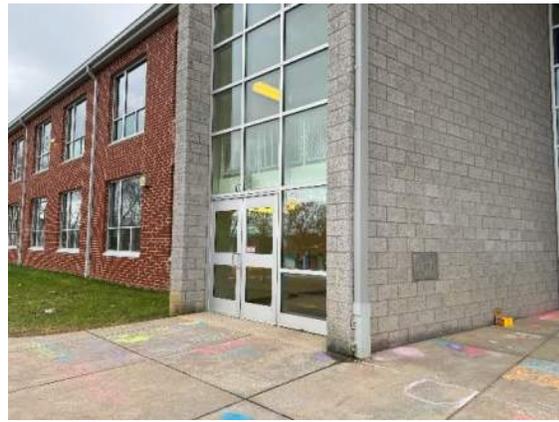
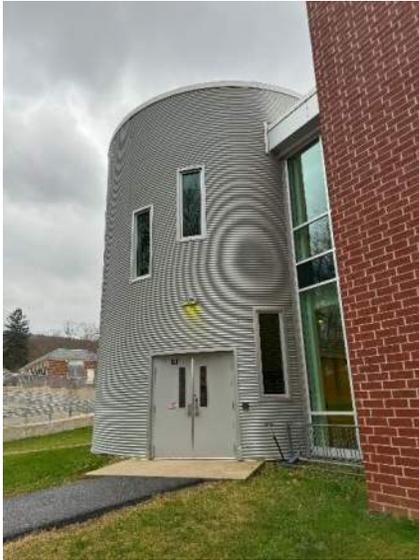
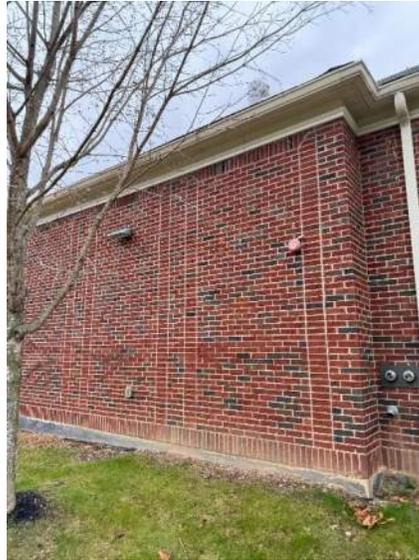
At the base of some of the masonry walls there is a moisture build-up and is creating staining on the masonry. Weep holes should be checked to make sure they are not plugged up or covered. Window stools are metal drip edges and are in good condition.

- Clean stained masonry and clean out weep holes in the masonry.

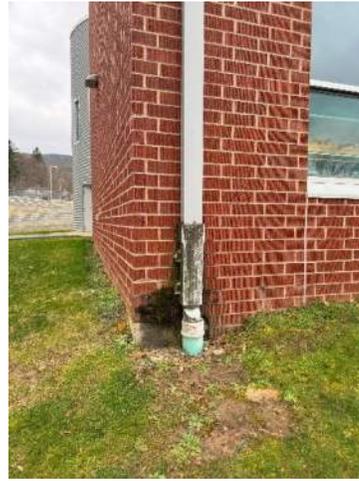
Rainwater for the most part is collected in metal gutters and taken down metal downspouts that tie into an underground storm system. Roofing and rainwater conveyance appear to be in good condition except for the one downspout/underground stormwater piping (shown below) that may be clogged and is staining the face brick.

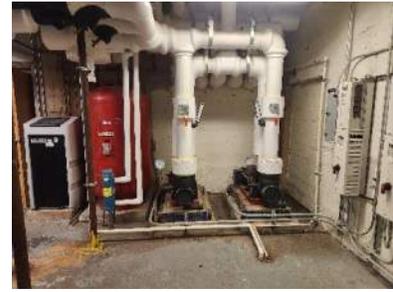
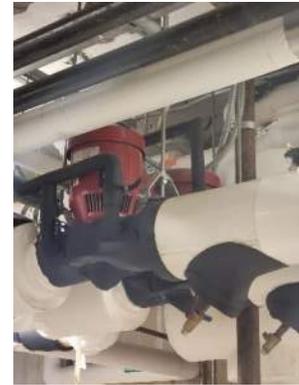
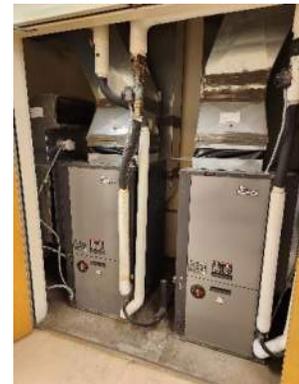
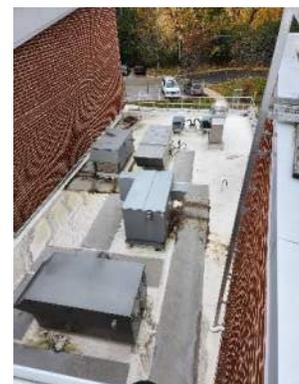
- Some of the loop water pipe insulation is failing and in need of repair or replacement. Condensation was evident because of the failed or inadequate pipe insulation.

- Test and verify water chemistry and glycol concentration.
- Clean classroom heat pump closet plenums.
- Replace/repair damaged pipe insulation.

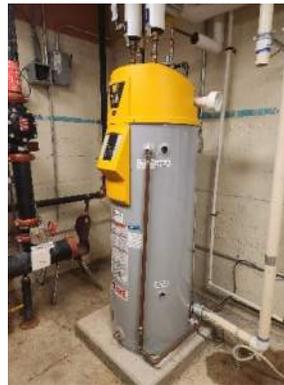
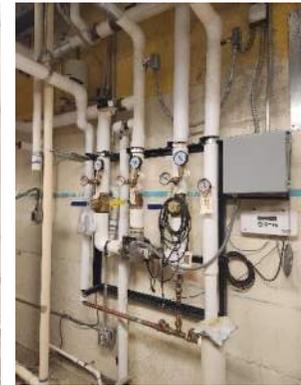
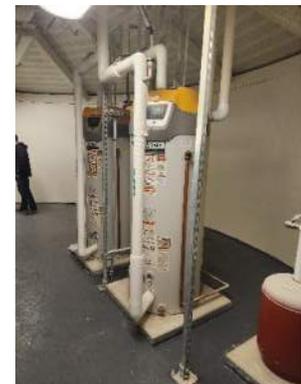
- The single water heater in the lower mechanical room was installed in 2016. The unit appears to be in good condition. It does not, however, have a backup heater. This is highly recommended in case the water heater fails.

- The mixing valve in the lower mechanical room is valved off and bypassed. It was not evident as to the issue. We recommend that this be repaired or replaced so it can be put back into service.

- Duplex water heaters are installed in the upper mechanical room above the stairs. These units were installed in 2011. They appear to be in good condition, but their typical lifecycle is 12-15 years. Replacement may be necessary in the next few years.

- The mixing valve in the upper mechanical room appears to have been replaced and was reported to be in good operating condition. The piping around the mixing valve is not insulated.

- Install a second water heater for backup in the lower mechanical space.
- Repair or replace the lower mechanical room mixing valve.
- Install insulation on the domestic hot water piping at the mixing valve.
- Replace the water heaters in the upper mechanical room in the next few years.

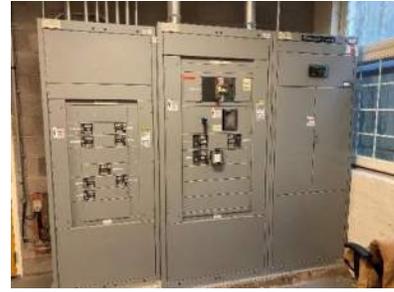
- A GE Spectra Series 1200-amp 480/277-volt 3-phase, 4-wire switchboard is installed and is fed from an exterior utility pad-mount transformer. The service and distribution equipment were installed during the 2011 construction project. It does not meet current code requirements.
- The switchboard includes ground-fault protection, customer metering and surge protection.
- 208/120-volt is provided in the building via dry-type step-down transformers.
- 480/277-volt and 208/120-volt panelboards provide branch circuit power throughout the building.
- Electrical distribution equipment appears to be in good condition.
- Feeder wiring and raceway are in good condition.

- The distribution system is in good condition. Upgrade to meet current codes as needed with any renovations.
- Inspect electrical equipment connections including thermal imaging, visual inspection and wire connection torque values confirmed with manufactures requirements.
- Have a study completed to identify arc flash and PPE requirements for electrical equipment.

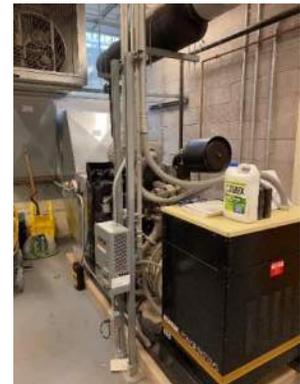
- The emergency power distribution system is in good condition.
- Panelboard NELEQGA used for normal emergency power of optional loads has a damaged Transient Voltage Surge Suppressor and appears to have a line 1 failure and is in an alarm condition. The Unit should be serviced and replaced if needed.

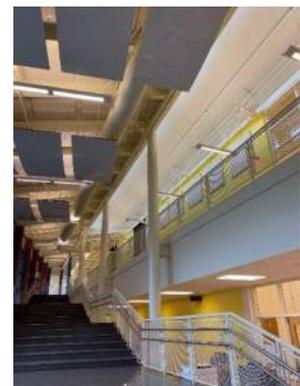
- Interior lighting is primarily comprised of 2' x 4' recessed fluorescent luminaires with prismatic lens. (in corridors), direct/indirect pendants (in classrooms and special areas), and compact fluorescent downlights.
- It does not appear that LED retrofit lamps have been utilized.
- The multi-purpose room is lighted with linear fluorescent high-bay lighting fixtures.
- Exterior building mounted and pole mounted lighting has been upgraded to LED type fixtures and is in good condition.
- Emergency lighting is integrated into the standard lighting fixtures.
- Lighting controls include low-voltage multi-button preset switches, occupancy sensors and daylight harvesting.
- Exit signs are LED type.

- LED retrofit lamps should replace fluorescent lamps throughout the building until a renovation occurs.
- The lighting and controls are in good condition and will operate adequately for a few years to come; however, fluorescent lamps will become more scarce and costly to replace.
- Interior lighting should be replaced throughout with LED type luminaires and energy code compliant controls with any major building renovation.
- Exterior LED lighting is in good condition and no further action is required.
- Lighting controls are not working properly and could need to be replaced/updated.

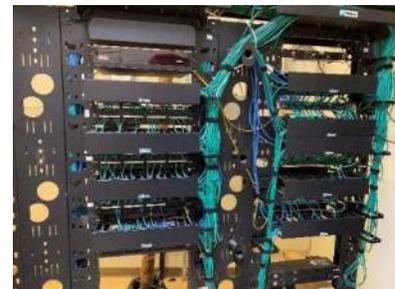
- Telecommunications systems were updated during the 2011 renovations.
- Hardwired data drops and Wi-Fi coverage are provided throughout the building, and in good condition.
- Data cabling is Cat-6 and in good condition.
- A VoIP phone system is used.
- A Rauland Telecenter intercom system with Sapling master clock system was installed during the 2011 renovations. The intercom system is obsolete.
- Digital clocks are in educational spaces, corridors, and offices. A couple of clocks have digital segments missing and are starting to dim. Clock replacements should be planned.

- Upgrade/Replace the existing obsolete intercom system.
- Replace/Repair failing digital clocks.
- Upgrade Data Telecommunications system as needed to meet the School Districts requirements with any planned building renovation.

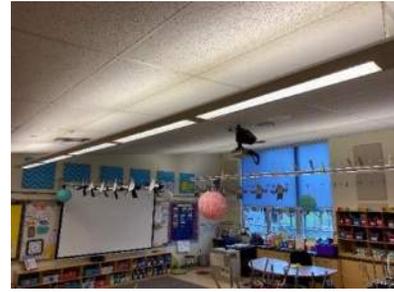
- Ceiling-mounted projectors with an audio speaker and pull-down projection screens are used in classrooms. Teachers have input stations at their desks. Equipment is dated with older equipment types.
- The Multi-purpose Room has the AV system from 2011. It appears to be used and in fair condition, but a portable sound system was also set up at the time of the survey.
- A cart with multiple projectors was at the Audio Closet in the Multi-purpose Room.

- The multi-purpose room sound system should be further investigated to determine the use of the portable system.
- Upgrade the building with new A/V Technology equipment and wiring systems.

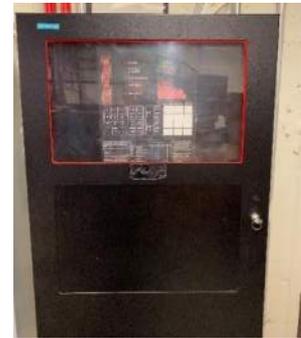
- The existing fire alarm system (Siemens) is a zone addressable system with horn/strobe alarm notification. The system is not compliant with current codes and requirements.

- The main fire alarm panel was replaced during the 2011 renovations and appears to be in fair condition. It is our understanding that there have been issues with maintaining this system.

- Smoke detector coverage and manual pull stations are provided where required.
- The existing building horn-based notification system is grand-fathered, but current NFPA codes require voice-based (speaker) notification in education buildings. Voice fire alarm communication capabilities and speaker type notification devices will need to be used for any future renovations that requires changes to the fire alarm system.

- The fire alarm system is having maintenance and servicing issues and should be considered for full replacement with a new code compliant system.

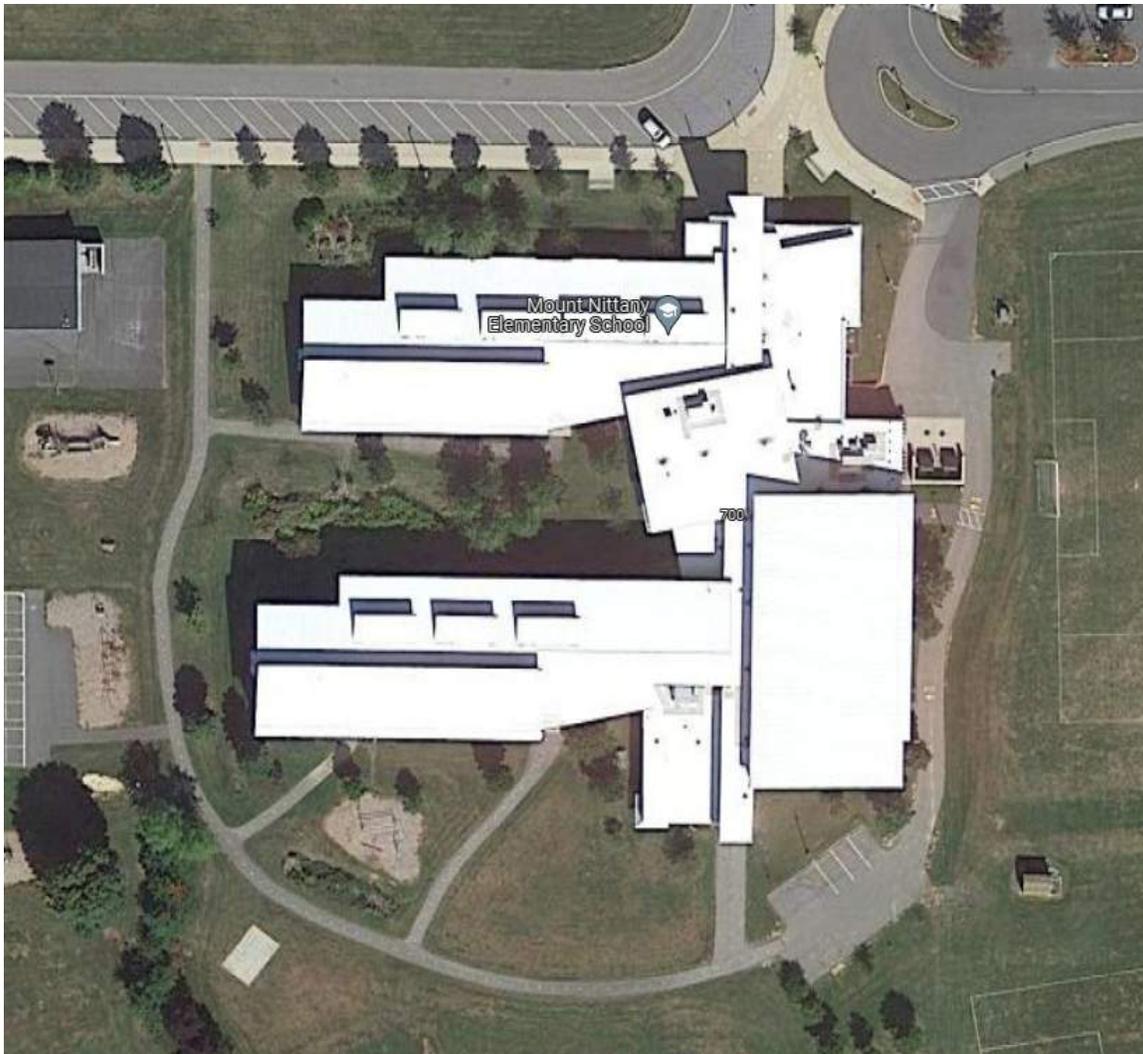
The existing roofs are a combination of sloped metal roofs and white flat fully adhered TPO/EPDM roofing systems and are in good condition. Rainwater is taken off of the sloped roofs with gutters and downspouts with cast iron boots that tie into an underground storm system. Roofing and rainwater conveyance appear to be in good condition.

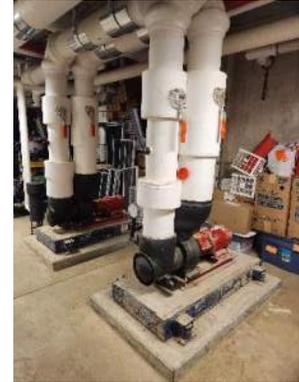
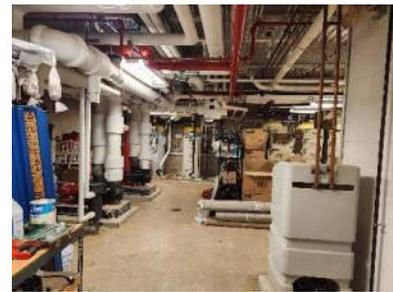
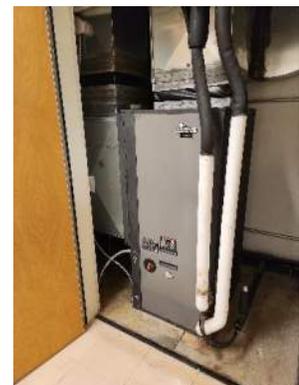
- Some of the loop water pipe insulation is failing and in need of repair or replacement. Condensation was evident because of the failed or inadequate pipe insulation.

- Test and verify water chemistry and glycol concentration.
- Clean classroom heat pump closet plenums.
- Replace/repair damaged pipe insulation.

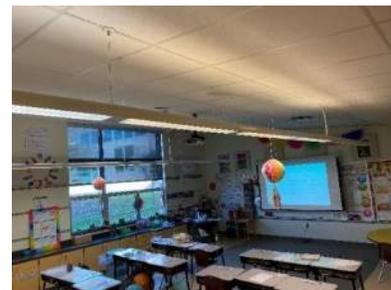
- Interior lighting is primarily comprised of 2' x 4' recessed fluorescent luminaires with prismatic lens. (in corridors), direct/indirect pendants (in classrooms and special areas), and compact fluorescent downlights.
- It does not appear that LED retrofit lamps have been utilized.
- The multi-purpose room is lighted with linear fluorescent high-bay lighting fixtures.
- Exterior building mounted and pole mounted lighting have been upgraded to LED type fixtures and are in good condition.
- Emergency lighting is integrated into the standard lighting fixtures.
- Lighting controls include low-voltage multi-button preset switches, occupancy sensors and daylight harvesting and are not working correctly.
- Exit signs are LED type.

- LED retrofit lamps should replace fluorescent lamps throughout the building until a renovation occurs.
- Luminaires and controls are in good condition and will operate adequately for a few years to come; however, fluorescent lamps will become more scarce and costly to replace. Interior lighting should be replaced throughout with LED type luminaires and energy code compliant controls with any major building renovation.
- Exterior LED lighting is in good condition and no further action is required.
- Replace/upgrade lighting controls and associated equipment that are no longer working correctly.

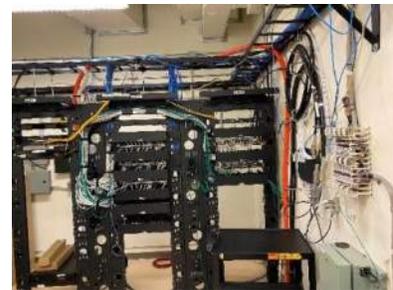
- Telecommunications systems were installed during the 2011 building construction.
- Hardwired data drops and Wi-Fi coverage are provided throughout the building and in good condition.
- Data cabling is Cat-6 and in good condition.
- A VoIP phone system is used.
- The Rauland Telecenter intercom and Sapling master clock systems were installed during the 2011 building construction. The Rauland Telecenter intercom system is obsolete and service parts will be difficult to get.
- Digital clocks are in classrooms and other educational spaces and offices throughout the building. The digital clocks are starting to have failed digital segments and reduced lumen levels.

- The School District is currently upgrading data telecommunication systems.
- Remove existing telecommunications systems equipment and cables that are no longer in use.
- Upgrade/Replace the obsolete Intercom system with a newer IP-based system.
- Upgrade/Replace the clocks and associated equipment as they are very close to their life expectancy.

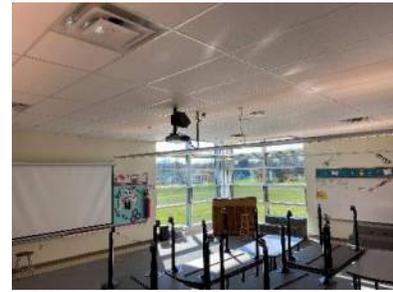
- Ceiling-mounted projectors with an audio speaker and pull-down projection screens are used in the classrooms. Teachers have input stations at their desks. Equipment is dated with older connection types.

- The multi-purpose room has the AV system from 2010. It appears to be in fair condition.
- A portable projector is used in the multi-purpose room.

- Upgrade the building with new A/V Technology equipment and wiring systems.

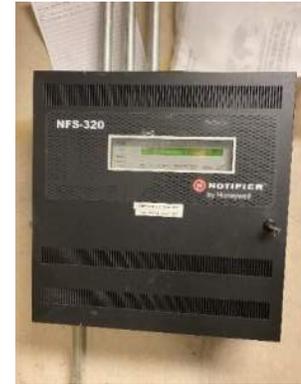
- The existing fire alarm system is a Notifier and manufactured by Honeywell. It is a zone addressable system with horn/strobe alarm notification.
- It was installed as part of the 2010 renovations and is in good condition.
- Smoke detector coverage and pull stations appear to be provided where required.
- The existing fire alarm system is grandfathered, but current NFPA codes require voice-based (speaker) notification in educational buildings. Voice fire alarm communication capabilities and speaker notification devices will need to be introduced for any future renovations that require changes to the fire alarm system.
- A rescue assistance system exists at stairs where egress is restricted.

- Future renovations will necessitate installation of voice communication capabilities for the fire alarm system. Horn based notification devices will need to be replaced with speaker type devices, and additional modules/components will be required at the head-end fire alarm control panel.
- The fire alarm system should be considered for full replacement with any major building renovations.

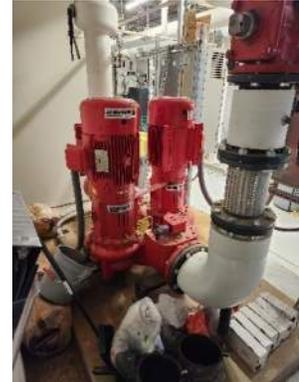
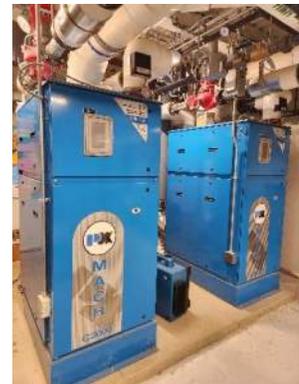
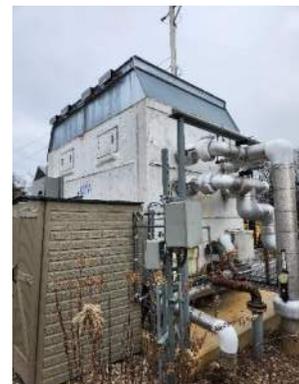
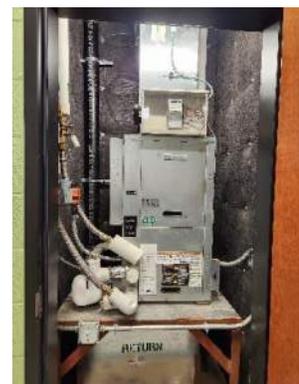
- The tower was found to be in fair condition. It was reported that there have been coil freeze issues with the tower. We suggest that a control strategy be implemented to circulate water through the tower to prevent freezing in the future. A flow meter should be added and monitored through the DDC system to verify that adequate flow is being circulated.

- The tower is showing general signs of corrosion. Cleaning and refinishing the surfaces will help to extend the unit life.
- Patterson Kelly high efficiency gas boilers are utilized to heat the loop during the heating season. The boilers were found to be in good condition.

- Implement freeze protection flow strategies on the existing tower system.
- Clean and refinish the tower surfaces that are showing signs of corrosion.
- Test and verify water chemistry and glycol concentration.
- Clean classroom heat pump closet plenums.

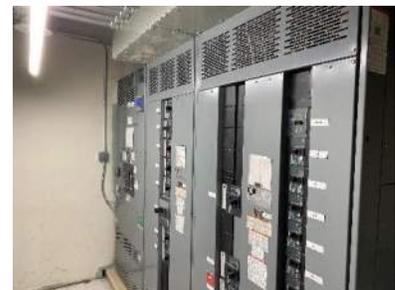
- The electric service entrance comes into the building from a 300 KVA pad-mounted Utility transformer to a three section 4000-amp, 208/120-volt, 3-phase, 4-wire switchboard with a 4000-amp main breaker with 2500a trip setting in one section and two sections for distribution circuit breakers.
- Utility CT's and meter are located at the pad mounted utility transformer.
- The Switchboard has a surge suppression device and a customer meter.
- Distribution and branch circuit panelboards are located throughout the building.
- All electrical distribution equipment was manufactured by Schneider/Square D and installed during the 2018-2019 project. The equipment appears to be in very good condition.

- The Switchboard does not appear to meet the current code requirements to have Arc Energy Reduction which became an adopted code requirement after this project was completed.
- There is a Solar Photovoltaic System located on the roof of this building and its service disconnect is located on the rear exterior wall across from the utility transformer.

- Maintain equipment per manufactures requirements.
- Replace surge suppression devices. It is our understanding that the Surge Suppression Devices have been recalled by the manufacturer and that the Owner is working with Farfield Electrical contractor and Schneider/Square D to replace them.
- Review ways to address new Arc Energy Reduction code requirement.

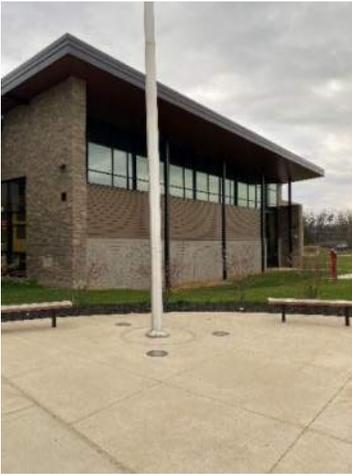
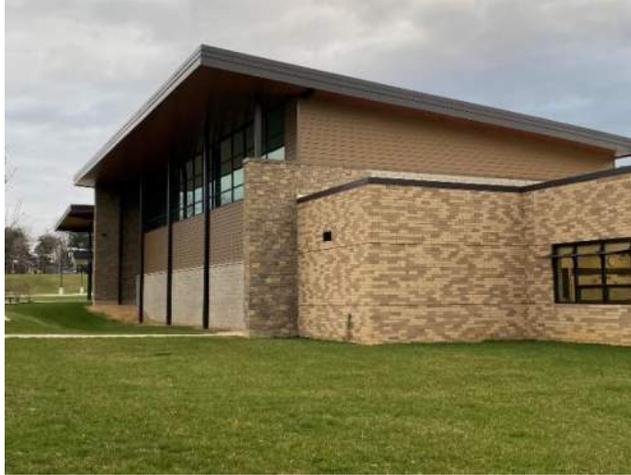
The building exterior consists of insulated masonry cavity walls with combination of brick, ground face CMU, and manufactured stone veneer, with CMU backup. Cavity insulation is spray foam insulation. There is minor staining on the face brick where rainwater conductors for overflow drains empty out onto grade.

- Minor cleaning of face brick where stains have occurred. This is localized to only 2 or 3 locations building wide and is a routine cleaning item.

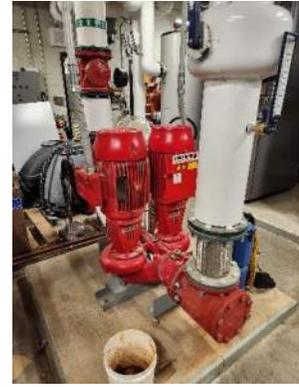
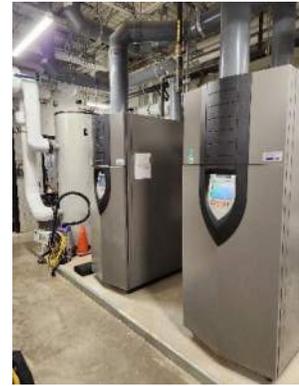
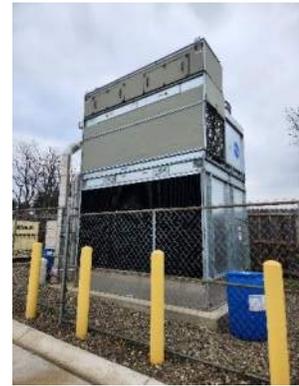
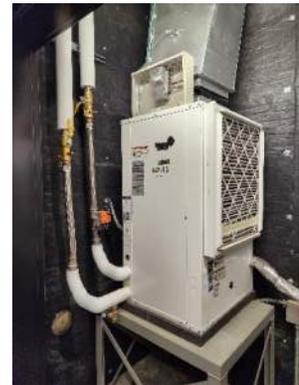
- The building is served by a water source heat pump system. Most of the system and components date back to the 2019 additions and renovation project.
- Duplex loop water pumps circulate water through the building systems. These pumps include VFD's to vary system flow based on demand. The pumps are in good condition.

- Loop water temperature is maintained using a closed-circuit cooling tower in the cooling season and boilers in the heating season.
- The Baltimore Aircoil closed-circuit cooling tower is installed remote from the building. There are 6" underground loops connecting the tower to the building system. Loop water is circulated through the tower to reject heat from the heat pump loop to the outside. The tower was found to be in good condition. It was reported that there have been coil freeze issues with the tower. We suggest that a control strategy be implemented to circulate water through the tower to prevent freezing in the future. A flow meter should be added and monitored through the DDC system to verify that adequate flow is being circulated.

- Lochinvar high efficiency gas boilers are utilized to heat the loop during the heating season. The boilers were found to be in good condition.
- Classrooms are mainly served by vertical heat pumps located in closets. The units utilize R-410a, are serviceable, and were found to be in good condition. These units typically have a 20-year lifecycle if properly serviced and maintained.

- Classroom outdoor air ventilation is provided by York roof mounted energy recovery wheels. Pre-conditioned air is delivered to the closets and circulated through the plenum returns. These units were found to be in good operating condition.

- Large zones utilize roof mounted units with compressors to provide HVAC to the related space. These units were found to be in good operating condition.

- Mini split units are provided for several IT areas. All were noted to be in good operating condition.
- Electric unit heaters and cabinet heaters are utilized for specific space heating only needs.

- Exhaust fans throughout are up to current standards and in good condition.

- Implement freeze protection flow strategies on the existing tower system.
- Test and verify water chemistry and glycol concentration.
- Clean classroom heat pump closet plenums.

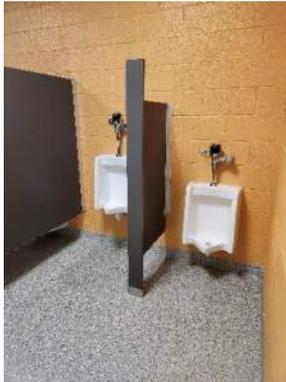
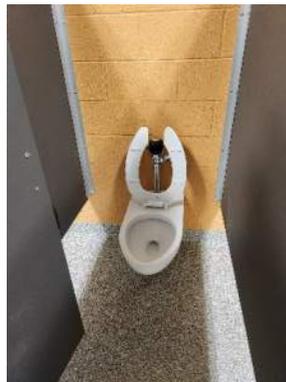
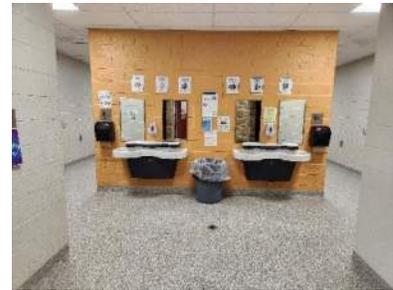
- Plumbing fixtures throughout appear to be in good condition. Fixtures and fittings are low flow for water savings.
- Water closets and urinals utilize automatic hands-free flush valves.
- Multi-station lavatories are utilized in group toilet rooms. These units include hands free faucets.
- Classroom sinks include bubblers and faucets with blade handles.
- Dual level water coolers appear to meet ADA and include bottle fillers.

- None.

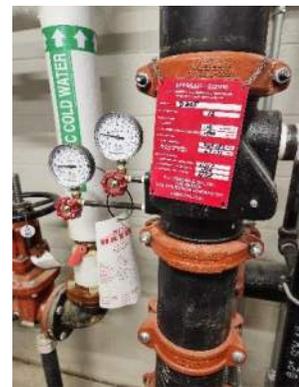
- The building is fully protected by a fire sprinkler system. This system is served off a 6" public water service. There are multiple feeds to separate sections of the building based on fire areas.
- The system is a wet pipe system.

- None.

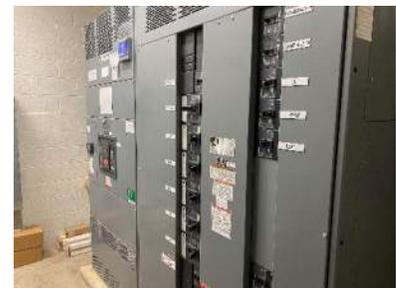
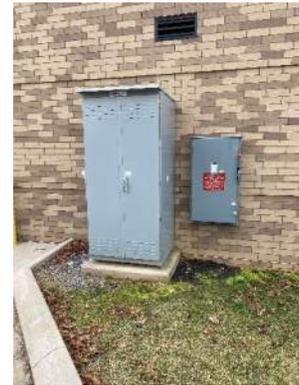
- The electric service entrance comes into the building from a 300 KVA pad-mounted Utility transformer to a two section 4000-amp, 208/120-volt, 3-phase, 4-wire switchboard with one section containing the 4000A main frame breaker with 2500a trip setting and one section for distribution circuit breakers.
- Utility CT's and meter are located at the exterior pad mounted CT cabinet located next to the building across from the utility transformer.
- The Switchboard has a surge suppression device and a customer meter.
- Branch circuit panelboards are located throughout the building.

- All electrical distribution equipment was manufactured by Schneider/Square D and installed during the 2018-2019 building construction. The equipment appears to be in very good condition.
- The Switchboard does not appear to meet the current code requirements to have Arc Energy Reduction which became an adopted code requirement after this project was completed.
- There is a Solar Photovoltaic System located on the roof of this building and its service disconnect is located on the exterior wall beside the pad mounted CT cabinet across from the utility transformer.

- Maintain equipment per manufactures requirements.
- Replace surge suppression devices. It is our understanding that the Surge Suppression Devices have been recalled by the manufacturer and that the Owner is working with Farfield Electrical contractor and Schneider/Square D to replace them.
- Review ways to address new Arc Energy Reduction code requirement.

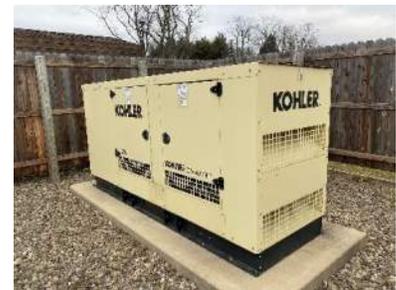
- An exterior pad mounted 125 KW, 208/120v, 3 Ph, 4 W, Natural Gas generator is used for both life safety loads and optional equipment loads in this building.
- There are three separate automatic transfer switches and panelboards used for life safety loads and optional standby equipment loads. They are in their own dedicated room away from the normal distribution equipment.
- There are separate life safety and optional standby branch circuit panelboards located at multiple locations in the building.
- Generator and Automatic Transfer Switches are manufactured by Kohler and all equipment appears to be in good condition.
- Emergency generator and associated equipment were installed in 2018-2019 during the building construction project.
- A wall mounted generator remote annunciator is in the receptionist office area.

- Maintain Generator per manufactures requirements.
