6 | Easterly Parkway Elementary School

Address:	234 Easterly Parkway State College, PA 16801
Construction Timeline:	Originally constructed in 1955; renovation/addition in 2002.
Building Square Footage:	55,895 sf
Site Acreage:	11.4 acres

Building Summary

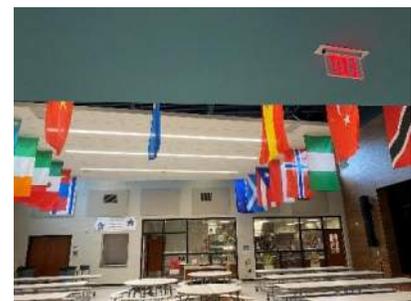
- Site lighting consists of LED type luminaires.
- 2'x 2' recessed LED luminaires with prismatic lens are used in corridor areas.
- 2'x 2' recessed LED luminaires with opal diffuser are used in classrooms.
- The library has recessed linear LED luminaires, pendant mounted LED luminaires with white diffuser, pendant mounted and recessed downlight LED luminaires.
- The cafeteria has pendant mounted LED downlight luminaires and recessed LED linear luminaires.
- LED strip luminaires with diffusers are in the mechanical/electrical, and storage rooms areas.
- Luminaires are controlled by Energy Management Devices.

- All LED luminaires and energy management devices were installed during the 2018-2019 building construction project. They appear to be in good condition.

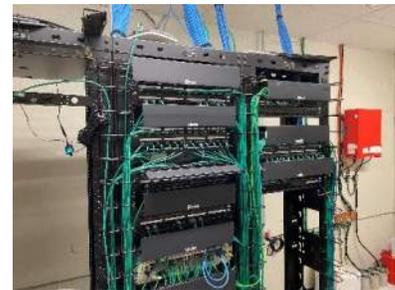
- Data cable is Category 6 and in good condition.
- WiFi coverage is provided in classrooms and learning areas throughout the building.
- A VoIP phone is used.
- A Rauland Telecenter IP intercom system with call stations is in use in this building.
- Analog IP Clocks manufactured by Sapling are used throughout the building in classrooms, corridors, office areas, Multi-Purpose, Library, and other learning areas.
- A small nurse call system is in use in the nurse suite area.
- New systems were installed during the 2018-2019 building construction project. They appear to be in good condition.

- None

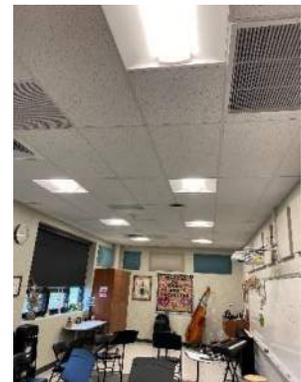
- Wall mounted projectors with white boards are used in every classroom.
- Wall mounted projector is used in learning stair area.
- A rear mount projector is used with a projection screen on the stage area.
- Crestron A/V systems are used in classrooms and other learning spaces.
- All installations were completed during the 2018-2019 building construction project. They appear to be in good condition.

- None

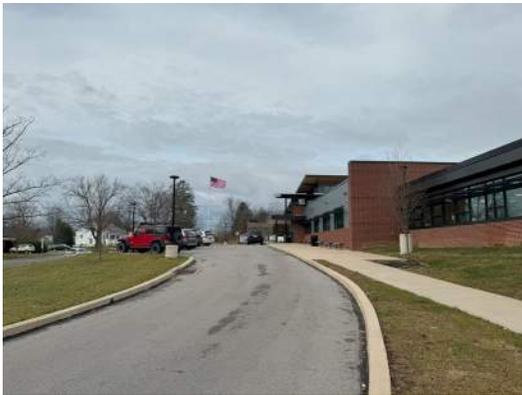
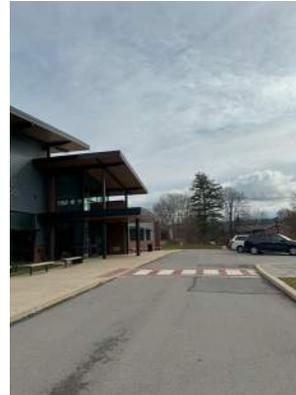
Vehicular access to the site is from South Corl Street. There is a drive running parallel with the front of the school on which parents pick up and drop off students and also from S. Corl Street. There is another drive along W. Highland Alley that connects from the front drive that runs parallel to the north side of the school which is used by buses to pick up and drop off.

Deliveries are made along West Highland Alley. Staff park is located in the paved lot located at the back of the school in the northeast corner. Visitors park in the paved spaces across from the main entrance of the school. There are ADA accessible parking spaces in both parking areas, and an accessible route from the parking spaces to the front entrance and rear entrance of the building exist at both locations.

- None at this time.

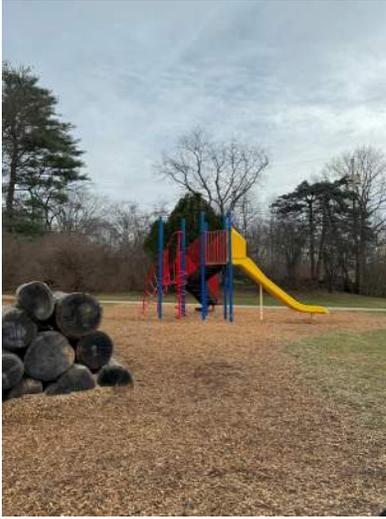
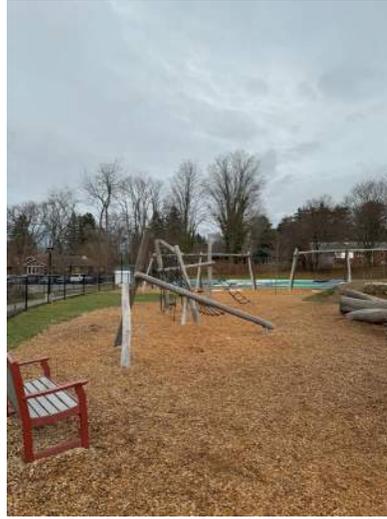
The site has one hard-surface play area in the northeast corner of the site, which includes a basketball court with backboards. There is a large soft-surface play area with naturally designed play equipment, and is surfaced in loose wood chips that does require routine maintenance. The site also features a small grass play area. All are in good condition and all play areas are well separated from vehicular traffic.

- None at this time.

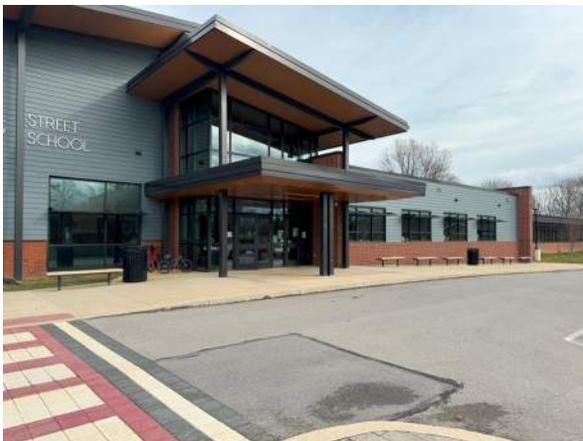
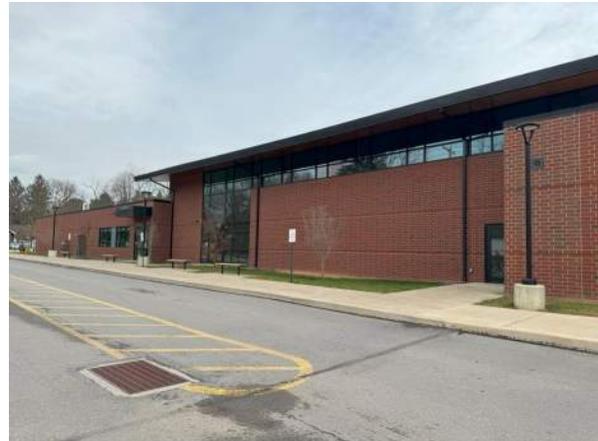
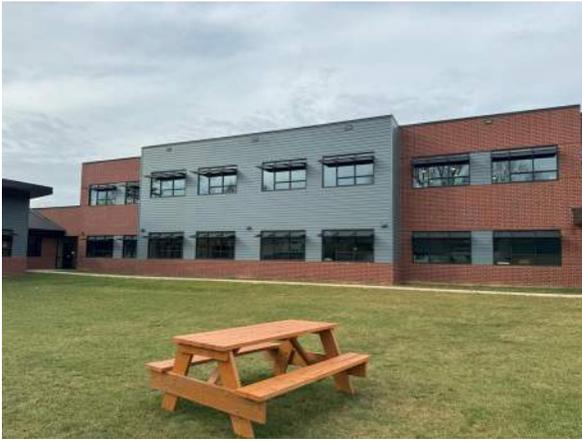
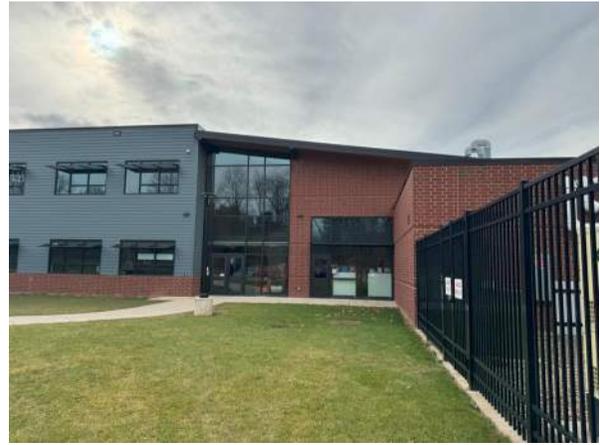
The building exterior consists of insulated masonry cavity walls with brick veneer and concrete plank over CMU backup. Window stools are brick and in good condition.

- None at this time.

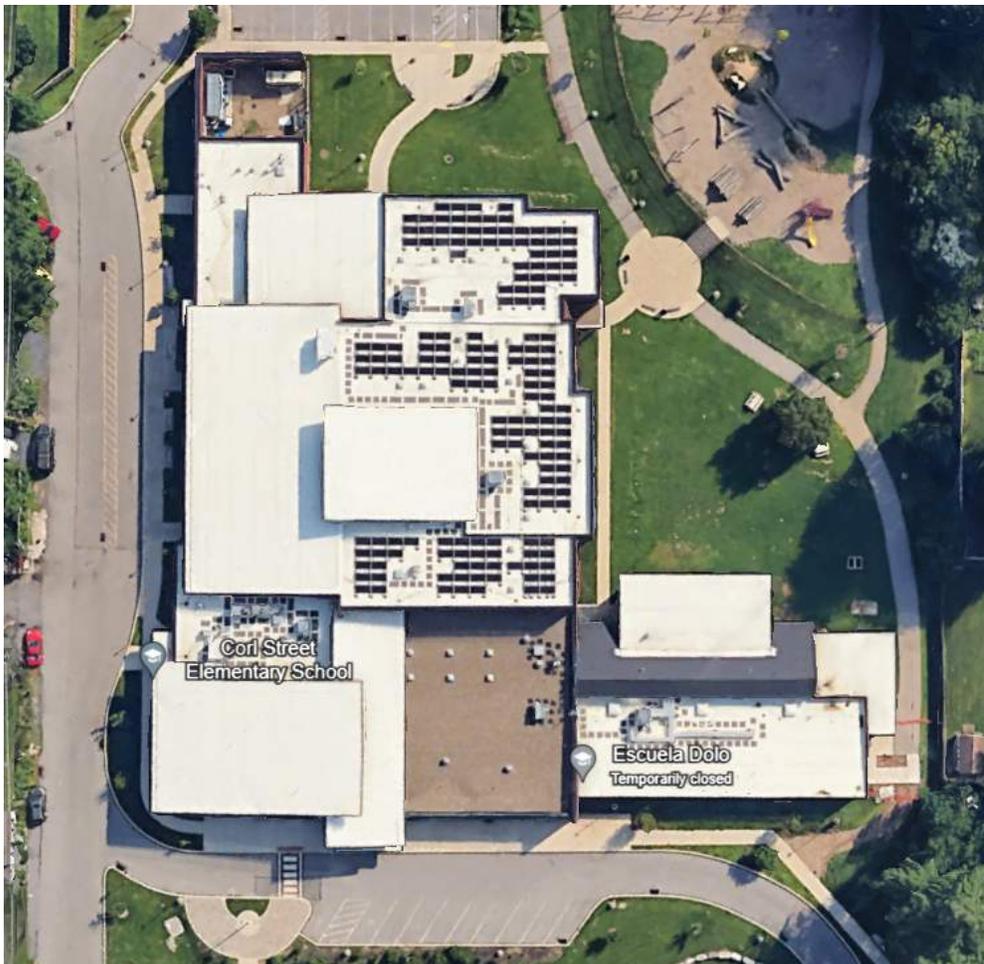
The existing roof was replaced in 2019 and is under warranty. Rainwater is conveyed away from the building by roof drains, gutters and downspouts that tie into an underground storm system. Roofing and rainwater conveyance are in good condition.

- None at this time.

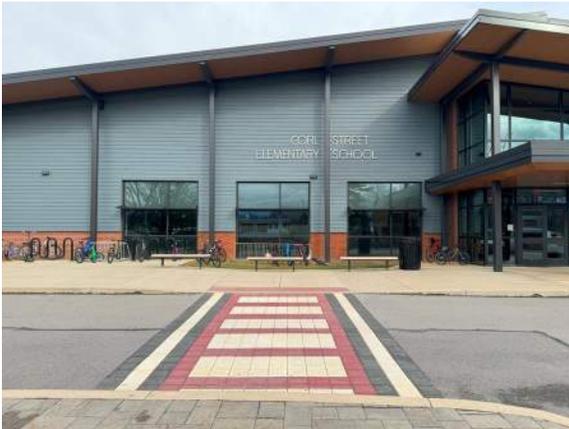
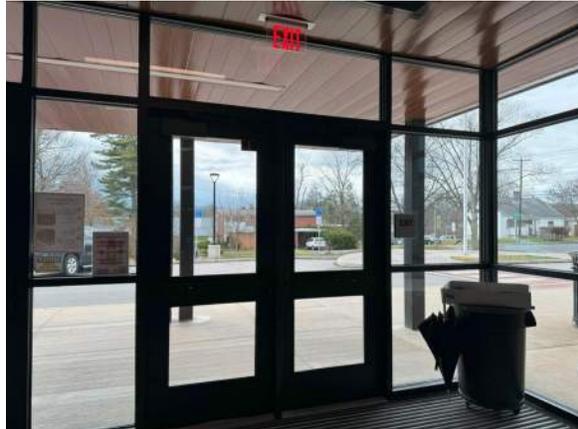
Windows are operable, awning windows with blinds mounted to the window head opening. Entrances are anodized aluminum storefront. Windows and doors are in good condition.

- None at this time.

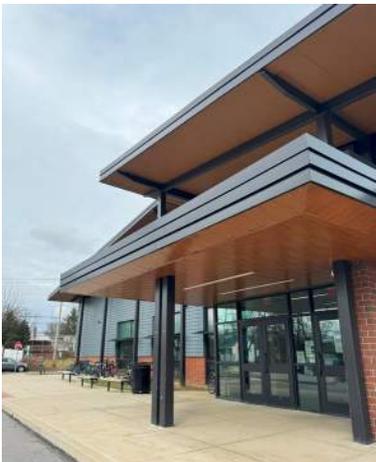
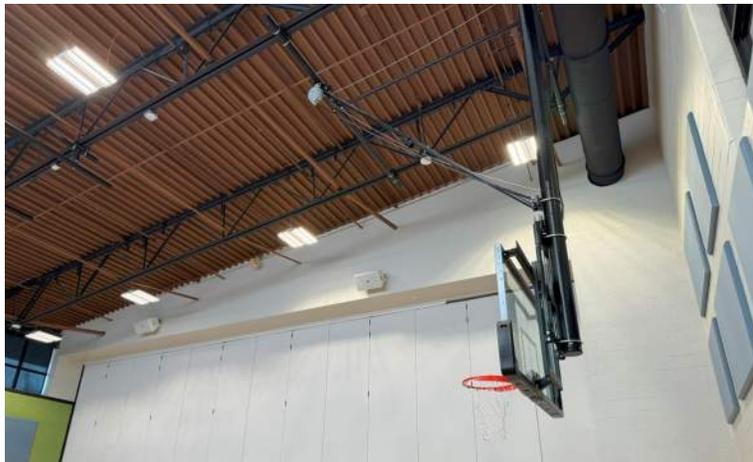
The building is a 2-story masonry load bearing & central steel frame structure along the main street of the school and central public program functions. The multi-purpose room has an exposed steel structure. Exterior canopies are supported with steel beams and columns. Overall, the building structure is in good condition.

- None at this time.

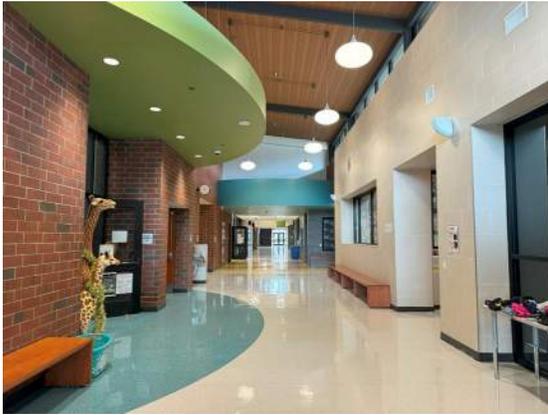
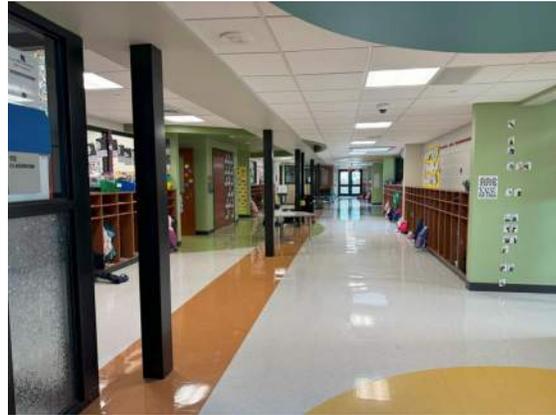
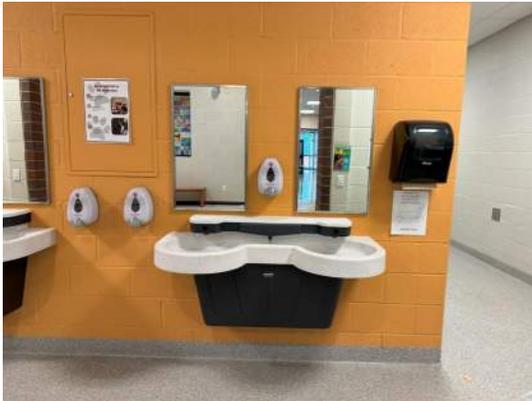
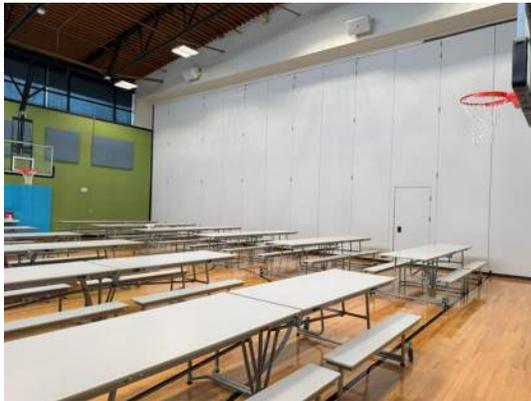
Most of the flooring throughout the school is VCT and is in good condition. Carpet exists in the main office and is well maintained. The toilet rooms and kitchen have a resinous floor. Mechanical areas are sealed concrete. The multi-purpose room is wood flooring which is in good condition.

Interior walls vary between exposed brick, tile, and CMU and are in good condition. Acoustical and gypsum board ceilings and bulkheads throughout the building are in good condition.

- None at this time.

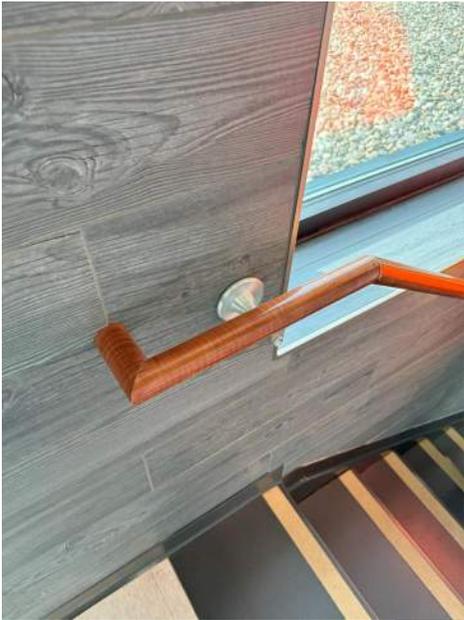
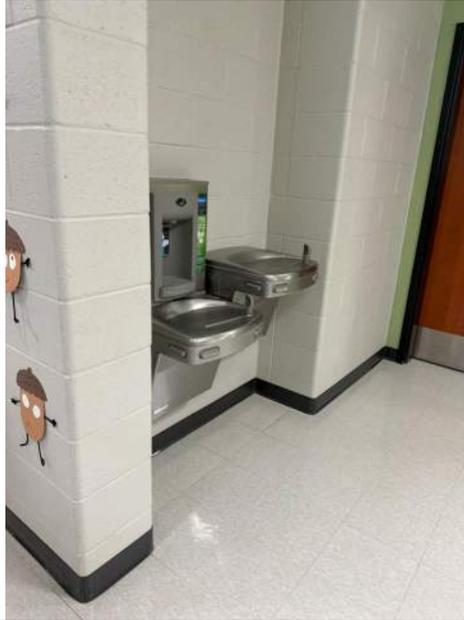
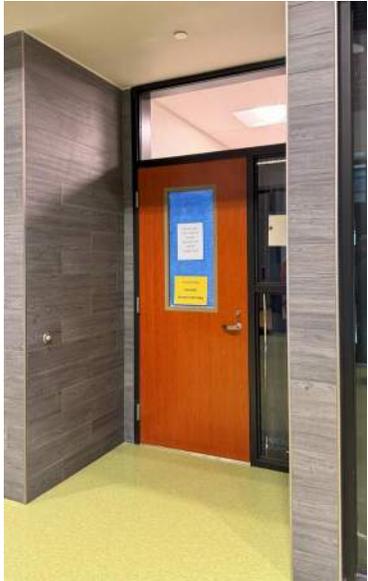
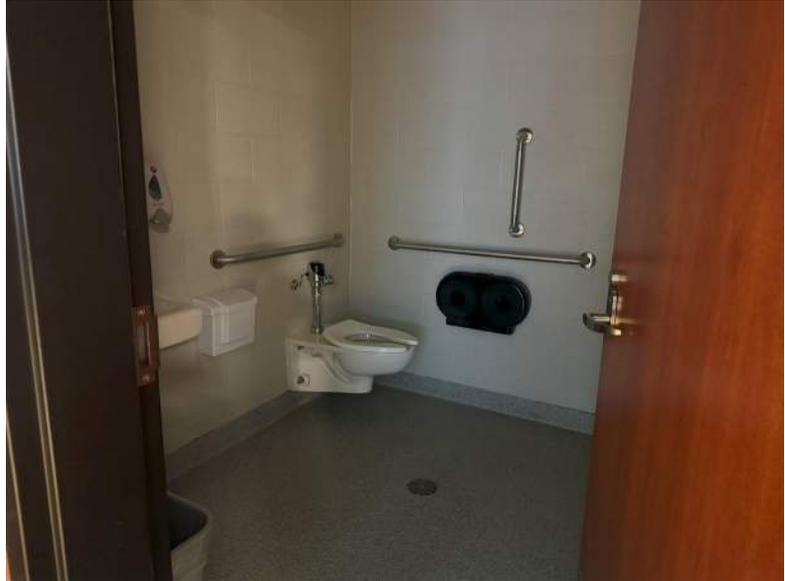
Toilet rooms are accessible.

Door hardware throughout the building has ADA compliant lever-style handles. There is an elevator that serves both floors.

- None at this time.

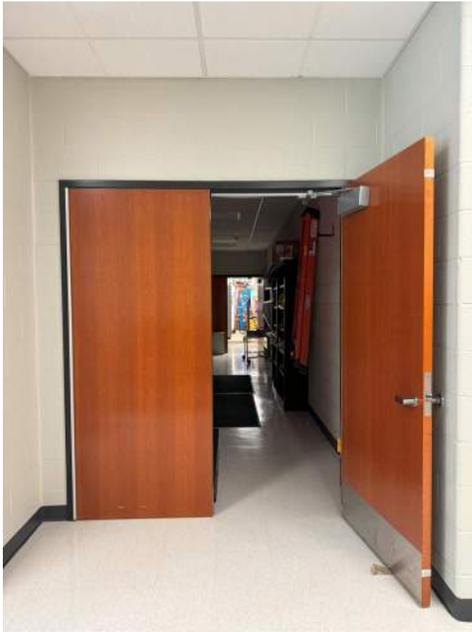
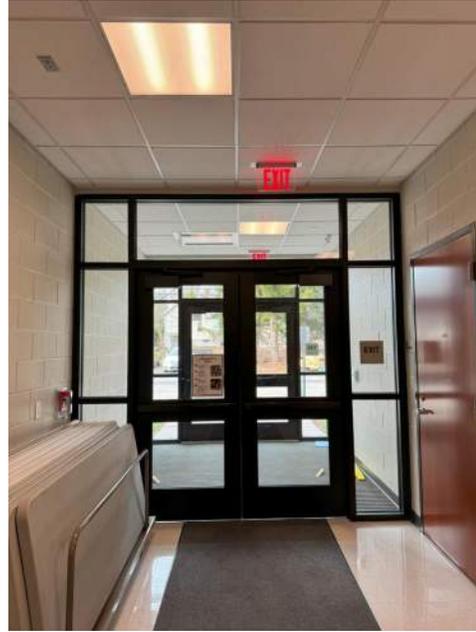
Interior doors are wood and are in good condition. Interior aluminum doors are also in good condition.

- None at this time.

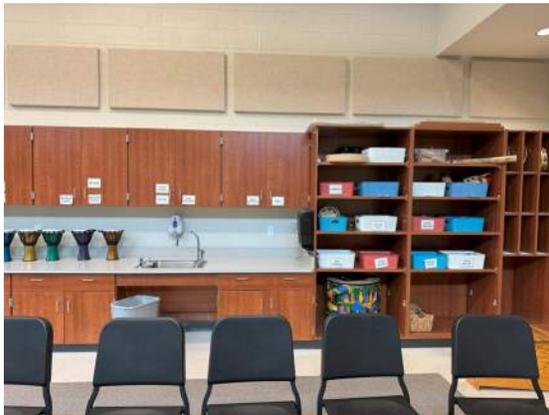
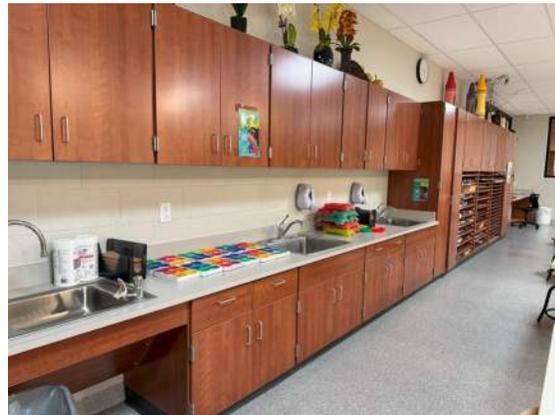
Interior casework is in good condition. Casework underneath the sinks throughout the building allow for a forward approach for accessibility.

- None at this time.

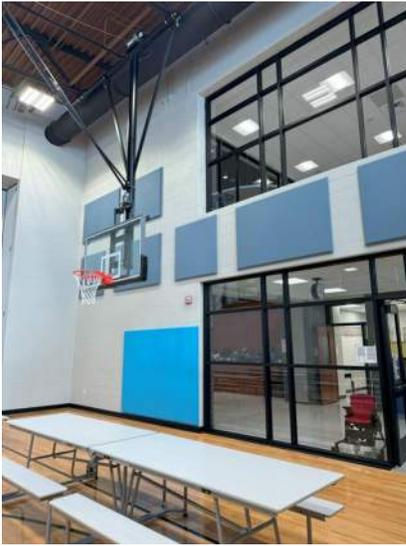
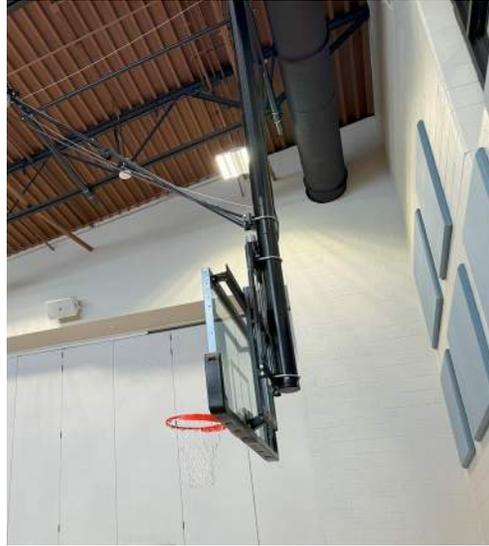
The multi-purpose room equipment consists of retractable basketball backstops. There is a folding wall partition for the multi-purpose room. All are in good condition. The stage curtain and lighting are also in good condition.

- None at this time.

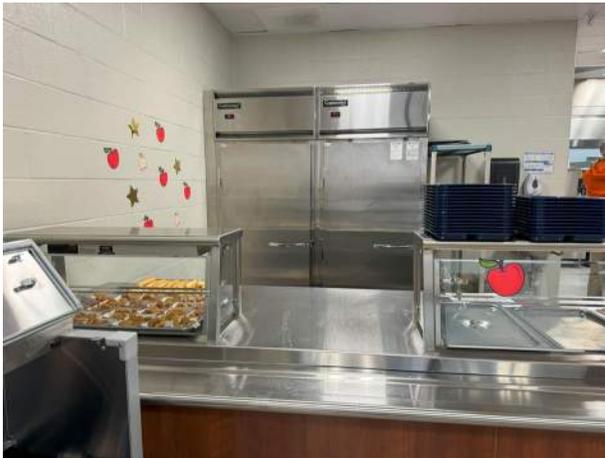
The kitchen was a 100% replacement as part of recent construction project completed in 2019, due to this the kitchen is in good/new condition.

- None at this time, due the new/good condition of the entire kitchen, no large expenditures should be planned at this time, beyond routine maintenance and/or equipment issues that might occur periodically and be budgeted in a yearly food service capital budget.

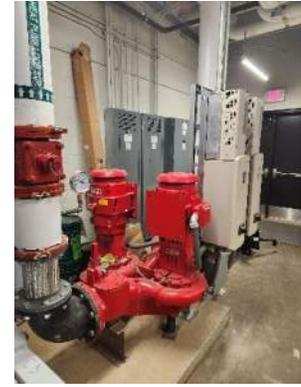
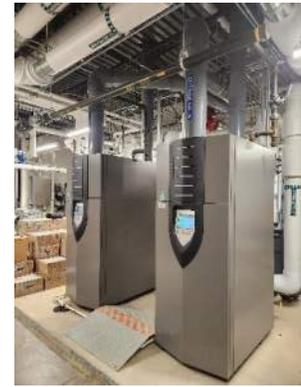
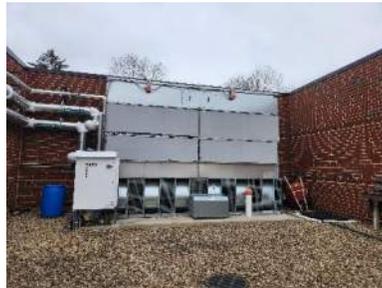
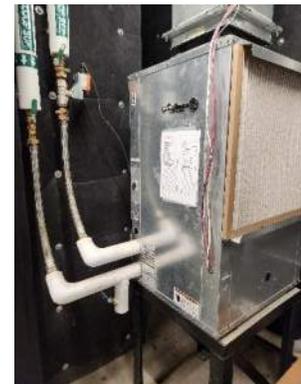
- The building is served by a water source heat pump system. Most of the system and components date back to the 2019 additions and renovation project.
- Duplex loop water pumps circulate water through the building systems. These pumps include VFD's to vary system flow based on demand. The pumps are in good condition.

- The tower fan shafts are showing signs of corrosion. Clean and refinish to extend the life.
- Lochinvar Crest high efficiency gas boilers are utilized to heat the loop during the heating season. The boilers were found to be in good condition.

- Implement freeze protection flow strategies on the existing tower system.
- Clean and refinish the tower fan shafts.
- Test and verify water chemistry and glycol concentration.
- Clean classroom heat pump closet plenums.

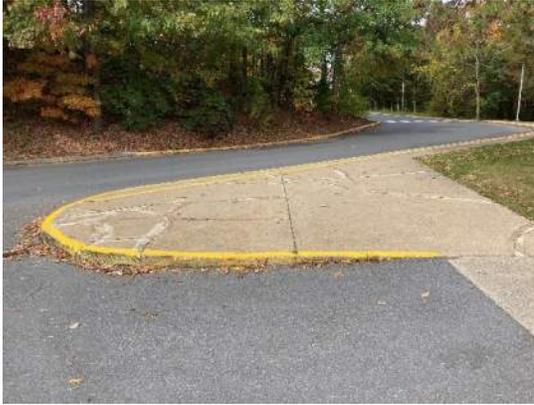
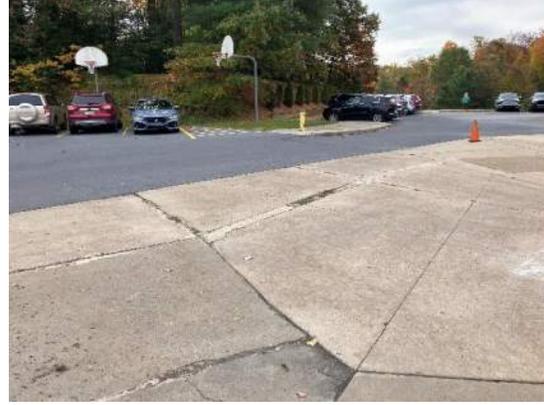
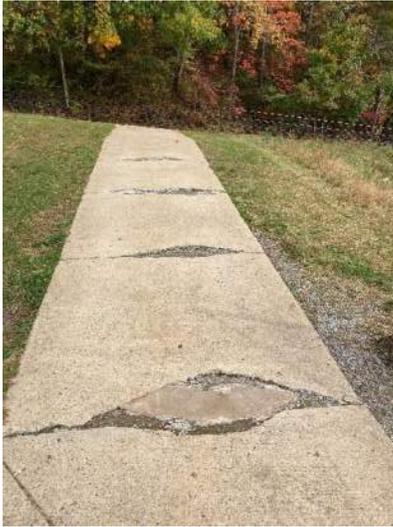
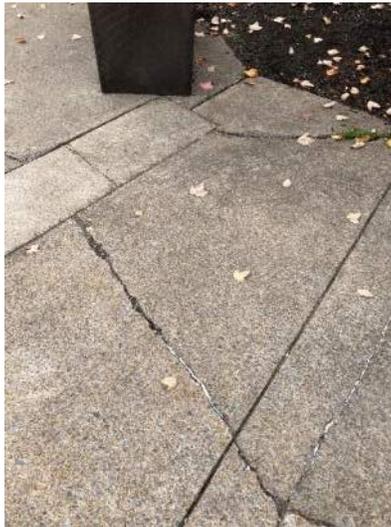
Paving and walkways are cracked and spalling in many locations. Some are original to the original construction in 1971 and is in poor condition.

- Vehicular circulation should be improved to clearly separate buses and parents, however, while this is a recommendation it appears to not be able to be achieved due to the constrained site.
- Parking for staff should be consolidated to prevent being distant from the school. Again, this appears to not be achievable at the existing site location.
- Paving and walkways should be repaved or patched to remove cracks and/or fill in missing pavement. Consideration should be made to do a mill and overlay for the paving and concrete replacement with any comprehensive renovation project or if the building is maintained.

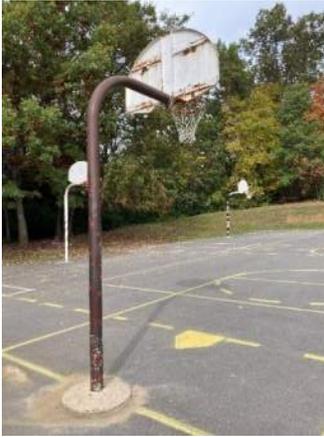
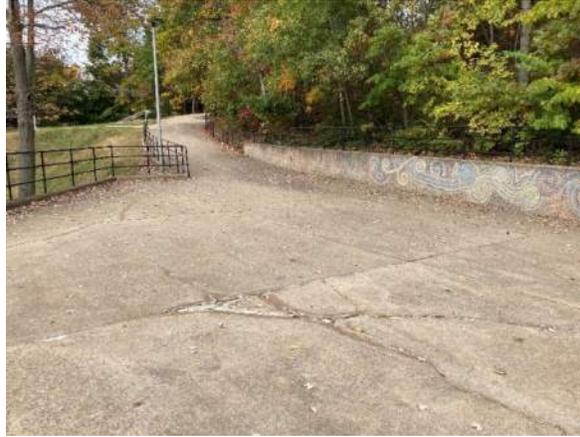
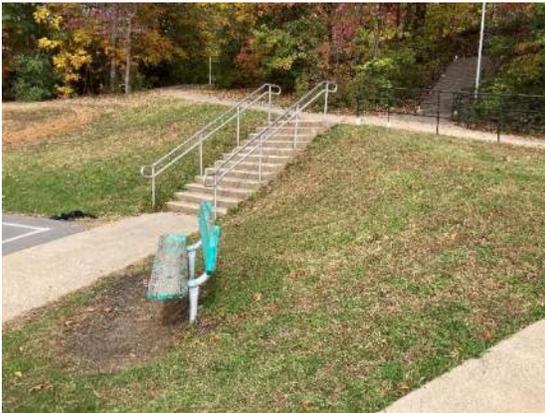
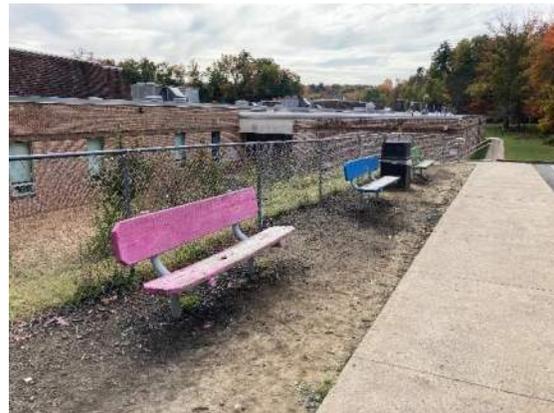
The site has one hard-surface play area with one main basketball court and multiple basketball backboards. The basketball backboards are rusting and in poor condition. There are benches that surround the hard-surface play area that are also in poor condition. There is a hard-surface patio area at the north end of the school which is heavily cracked and floods during heavy rain. The site also has two play/baseball fields in fair condition.

- Replace basketball backboards and benches.
- Patch and repair paved areas.

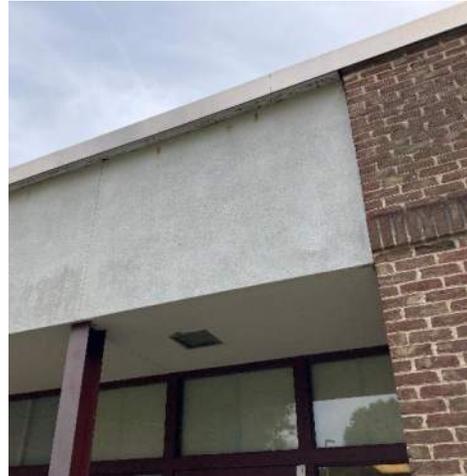
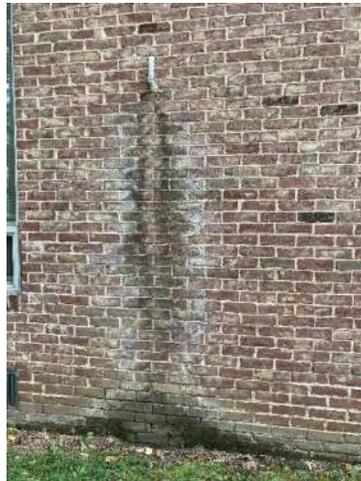
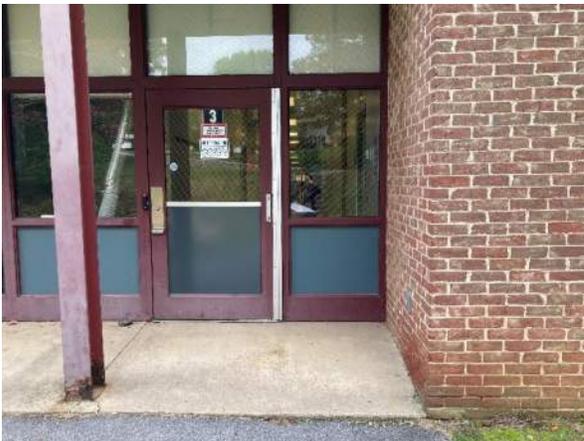
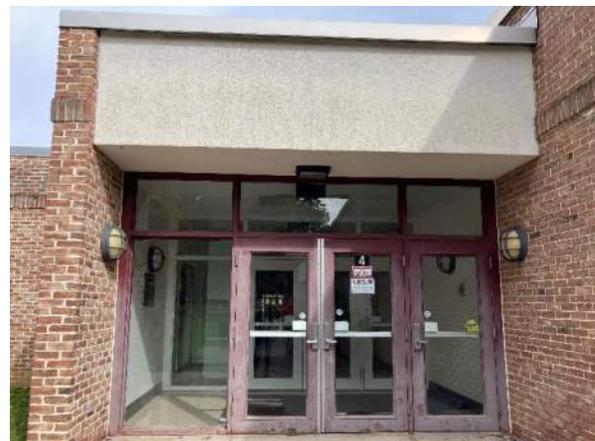
The building exterior consists of insulated masonry cavity walls with brick veneer and CMU backup. Window stools are a sloped brick rowlock course and show signs of staining and efflorescence in addition to some of the mortar joints beginning to spall and deteriorate. The soldier brick course going around the top of the exterior walls is stained and darkened in several areas as well as areas above the soldier course and along finish floor. Some of the mortar joints where this is happening the worst are also beginning to

spall and deteriorate. This is a sign of moisture getting trapped behind the face brick and either the weep holes being clogged or nonexistent.

Some exterior EIFS/Exterior Portland Cement Plaster has cracking and is beginning to stain.

There is exposed exterior steel at some of the entrances and the steel is beginning to deteriorate at the base where the steel meets the ground.

- Clean exterior brick veneer to remove efflorescence and staining.

- Inspect weep holes at the base of the exterior walls to make sure they are not blocked and trapping moisture within the wall cavity. If weep holes are nonexistent will have to remove brick and install through wall flashing, cavity drainage material and weep holes and/or cavity vents.
- Cap all brick rowlock windowsills with metal.
- Repair exposed steel at base and re-paint.
- Repair and clean EIFS/Exterior Portland Cement Plaster.

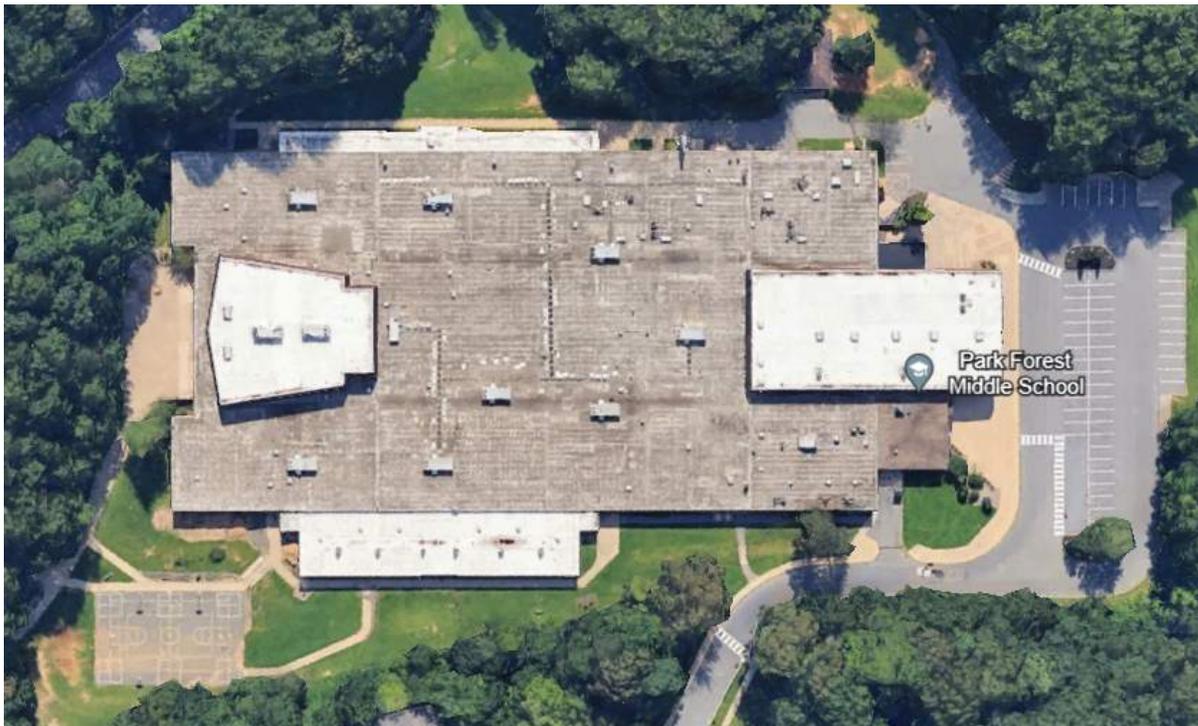
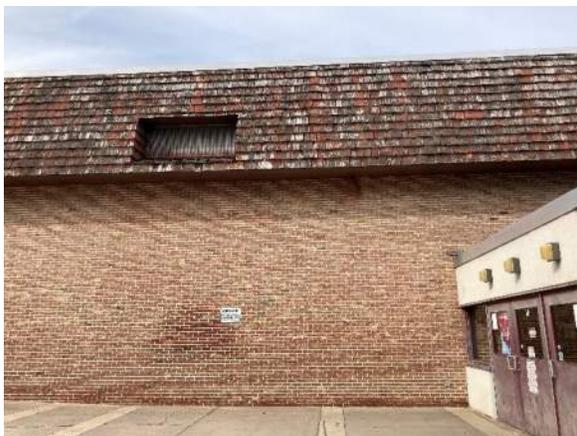
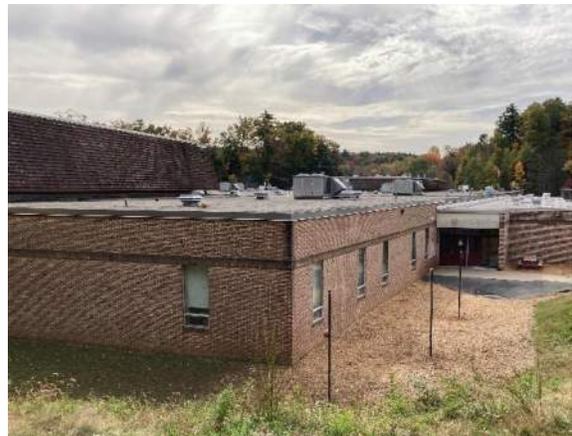
The roofs that are lighter in color on the plan below were roofs replaced in 2015 with a white TPO/EPDM membrane roofing system. The remainder of the flat roofs are built-up roofs that were replaced in 2009. One of the higher roofs has a mansard style roof with wood shingles and a flat roof in the middle that was one of the roofs replaced in 2015. The wood shingles appear to be in fair to poor condition. Rainwater is collected via roof drains and the internal roof water conductors run vertically to a point underground. From there they run horizontally and tie into exterior underground storm water piping.

- Replace wood shingles with asphalt shingles or reconfigure the mansard style with a vertical surface and accent the building with metal wall panels to give the building a modern and fresh look.

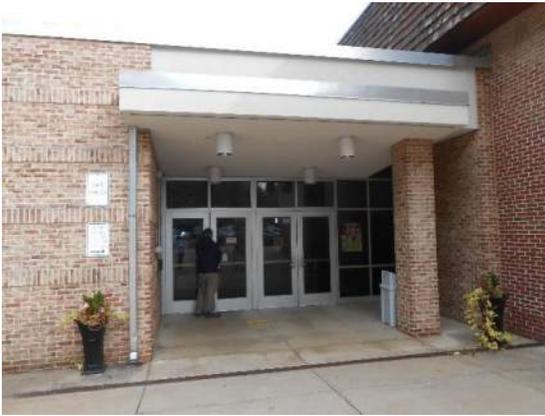
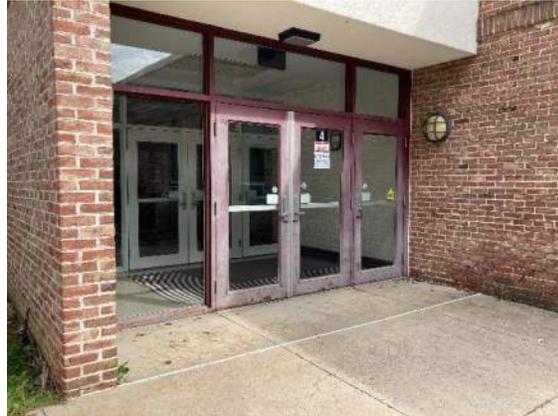
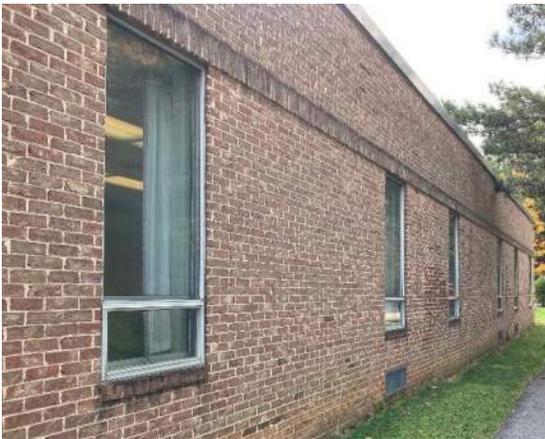
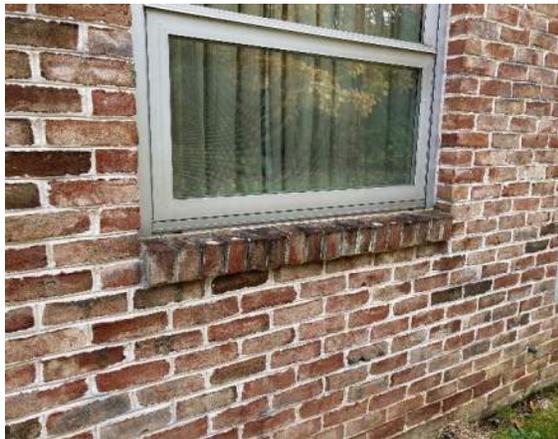
Windows are a combination of operable awning type windows with fixed glass above. The frames are clear anodized and may have been replaced with the 1995 addition and renovation project and are in fair condition. Entrances for the most part are clear anodized aluminum storefront. Doors are the wide style but do not have the intermediate horizontal stile where the panic hardware is usually mounted on. Some of the storefront framing and entrance doors appear to have been painted perhaps to extend the life of the storefront. Those doors and frames appear to be rusting and chipping and are in poor condition.

- Replace all windows and entrance framing and doors with any potential renovation project.

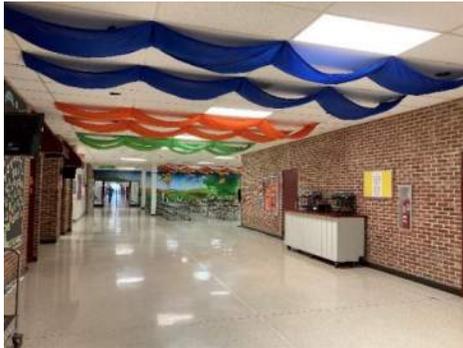
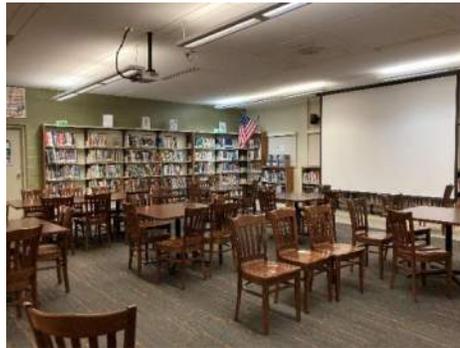
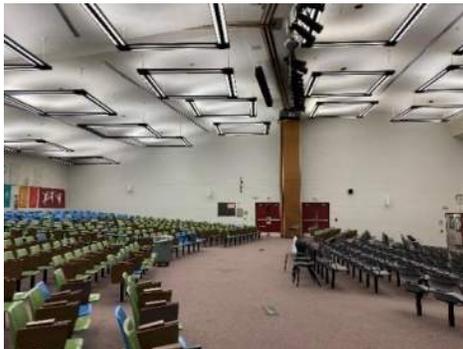
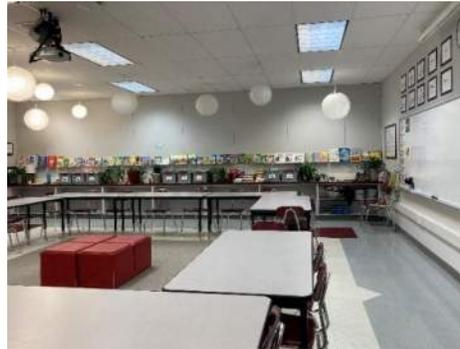
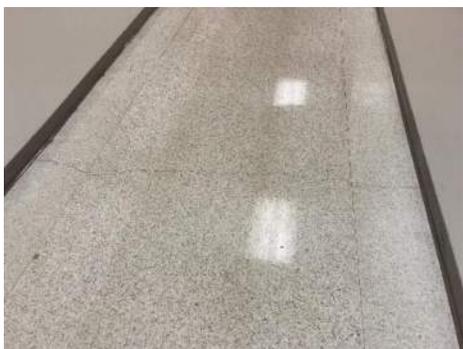
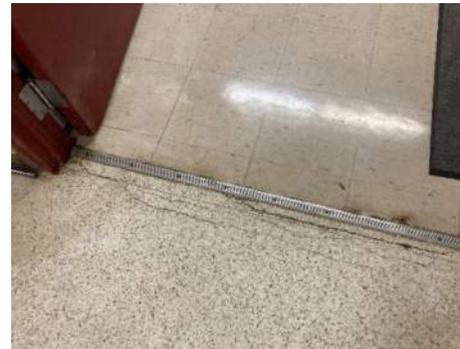
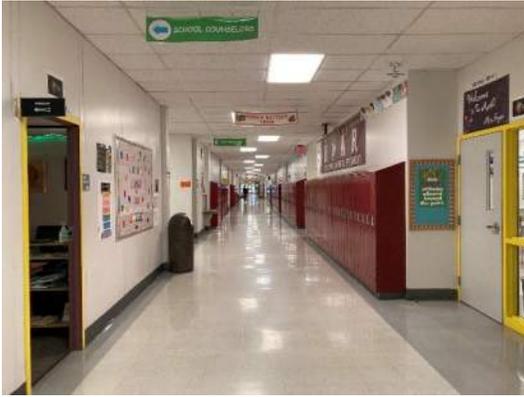
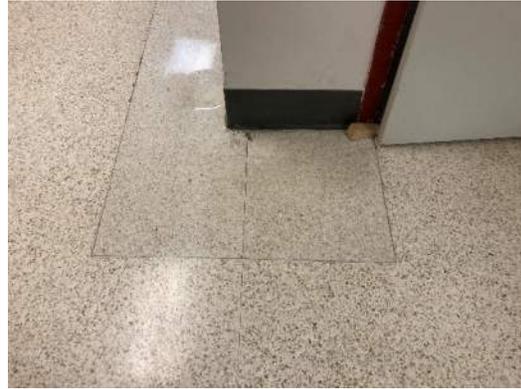
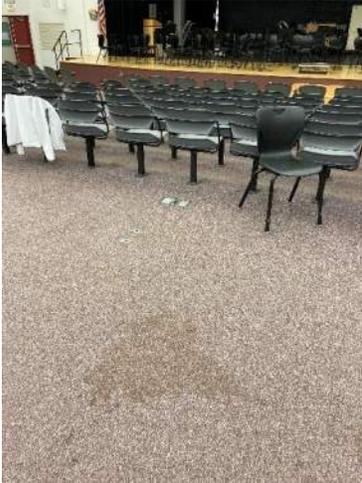
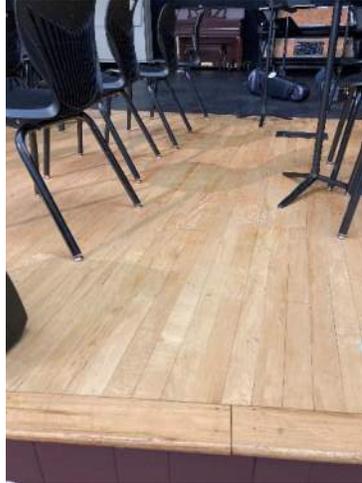
VCT and terrazzo exist throughout most of the school. The terrazzo is located in the corridors, while the VCT is located in the classrooms and also in some of the corridors, where it was part of a floor replacement project. There is significant cracking in some areas of the terrazzo as well as some terrazzo patching that has already occurred.

Carpet is in the main office, library, and auditorium. The carpet in the auditorium has stains and is showing signs of age.

There is a solid wood floor on the stage in the auditorium and appears to be in good to fair condition.

- Replace carpet in the auditorium.
- Repair and/or recondition the terrazzo floors throughout.
- Refinish wood floor on auditorium stage with any renovation project.

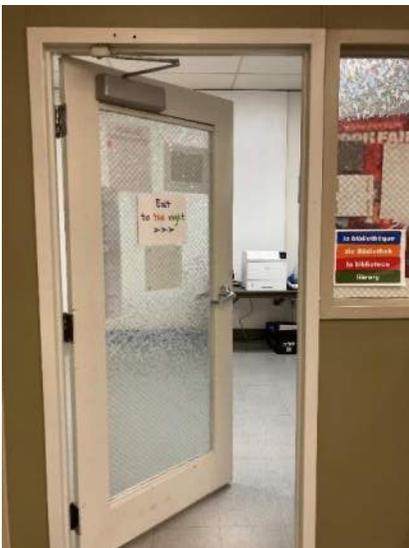
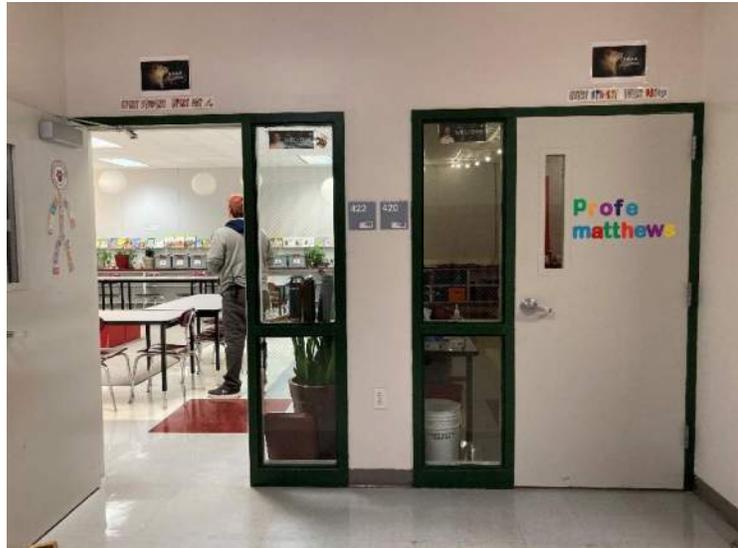
Interior doors are painted wood or painted hollow metal in painted hollow metal frames. Some interior doors have wire glass in the door or in the adjacent sidelight.

- Replace wire mesh in glazing with glazing that is code compliant.

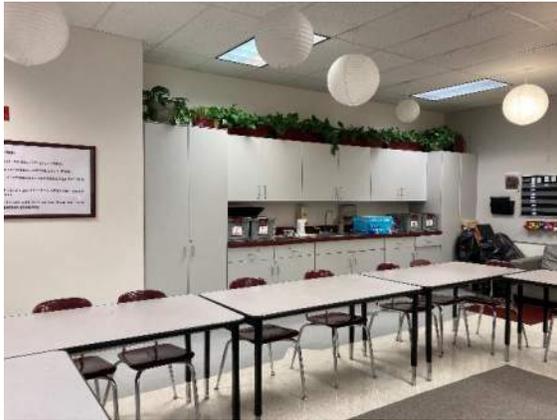
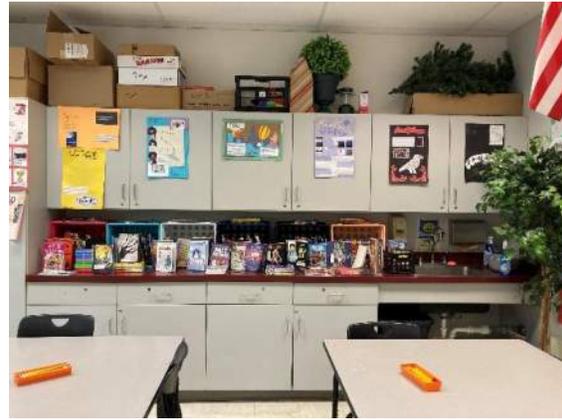
Interior casework is plastic laminate and in fair condition. Not all casework underneath the sinks allows for a forward approach for accessibility.

- Casework should include sinks that meet ADA accessibility guidelines.

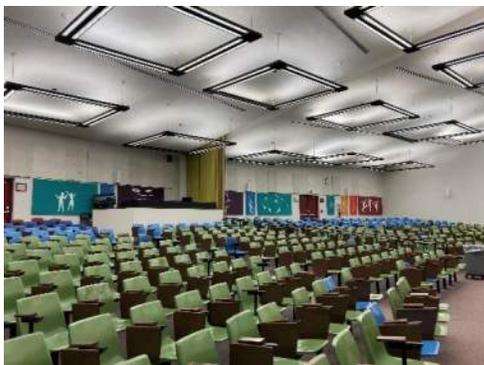
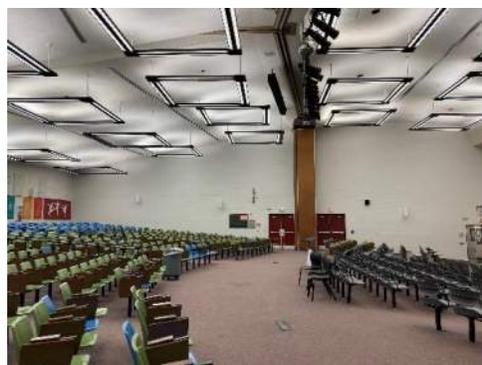
Auditorium seating is original to when it was installed in the building and is at the end of its useful life.

There is minimal acoustical treatment to the walls in the auditorium and no suspended clouds from the roof deck.

- Replace peeling fabric on folding partitions in the classrooms.
- Replace auditorium seating.
- Improve acoustics in auditorium.
- Relocate lighting to open the folding partition in the auditorium.

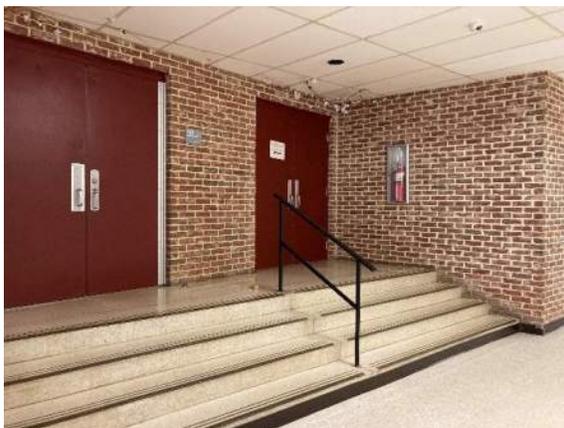
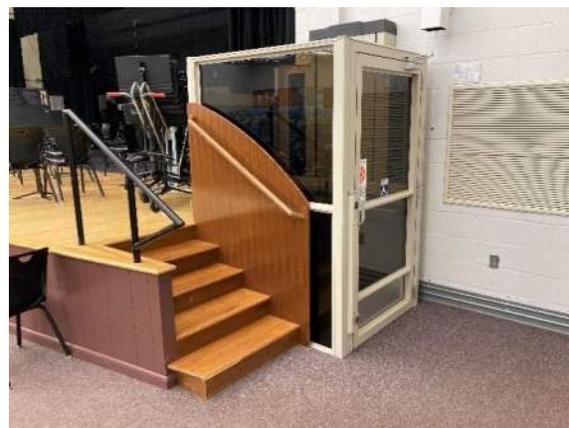
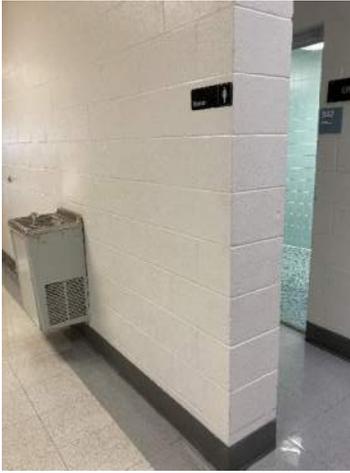
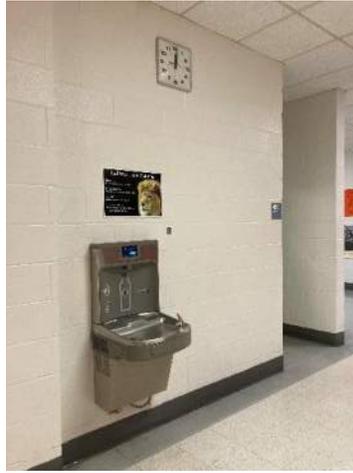
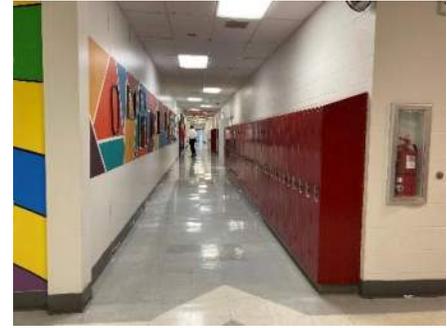
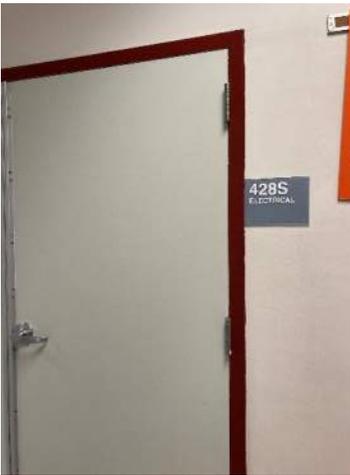
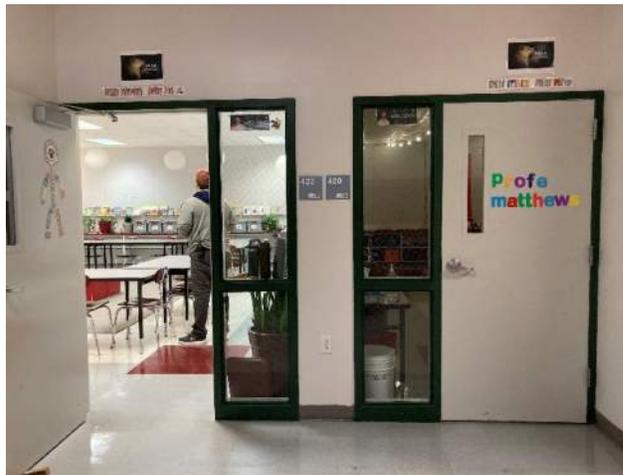
Most of the glass in interior doors and hollow metal frames is wire glass which is not code compliant.

- The recommendation would be to install an automatic fire sprinkler system throughout the building with any comprehensive renovation project.
- Provide ADA compliant lever-style handles for all doors.
- Provide properly designed ADA accessible handrails.
- Provide accessible drinking fountains throughout the building.
- Provide new room signage with the braille tactile writing system with any comprehensive renovation project.
- Replace wire glass with clear code compliant glass.

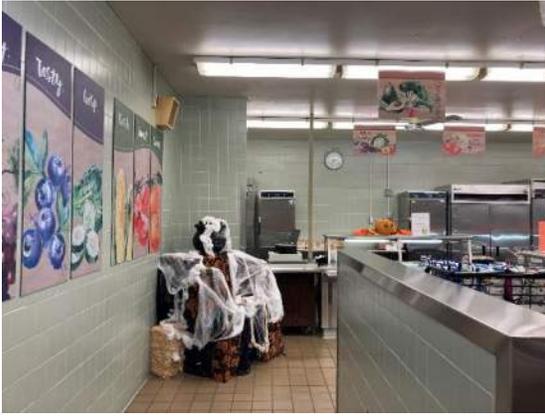
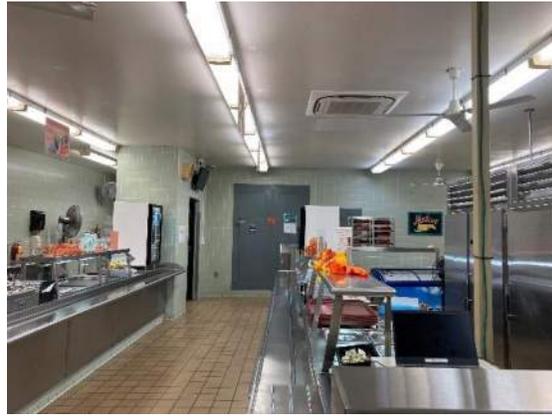
Food Service equipment is in fair condition and equipment has periodically been replaced over the life of the building. However, much of the equipment and serving lines is built into the building. With the knowledge that a renovation or replacement was going to occur at some point in the past 10+ years, SCASD purposely did not replace equipment for the entire kitchen to be efficient with financial resources and allow a large construction project to address concerns and layout changes.

- Due to SCASD Board of Directors decision to plan for a new construction option for Park Forest's Middle Schools future, the existing kitchen will eventually be replaced and or demolished in the next 5 years. At this time, it is recommended to maintain the existing kitchen through routine maintenance, but not to spend additional dollars at this time that can be focused to funding o the new construction. It should be anticipated that due to the age and built nature of the majority of existing equipment, that no equipment would be repurposed to other schools after the new school is completed.
