6 | Easterly Parkway Elementary School

Address:	234 Easterly Parkway State College, PA 16801
Construction Timeline:	Originally constructed in 1955; renovation/addition in 2002.
Building Square Footage:	55,895 sf
Site Acreage:	11.4 acres

Building Summary

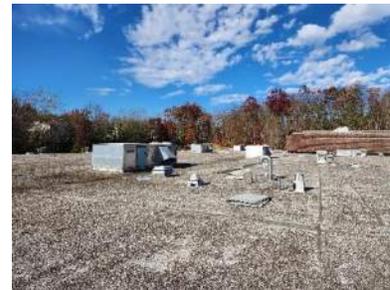
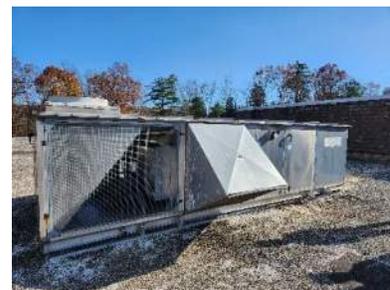
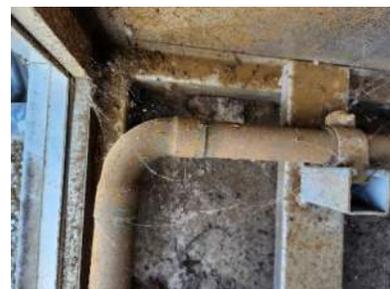
- Rooftop packaged multizone units and split system DX cooling units with electric heat coils are used to serve most areas of the school. The units are no longer manufactured or supported by the original manufacturer. While required maintenance and repairs have resulted in some upgraded components, most of the units are original and in need of replacement.

- The HVAC units utilize R-22 refrigerant. R-22 refrigerant was phased out of production in 2020 due to its ozone depleting characteristics. Any new equipment should utilize current refrigerants.

- Complete HVAC system replacement.
- Provide systems that meet current codes and accepted design standards.

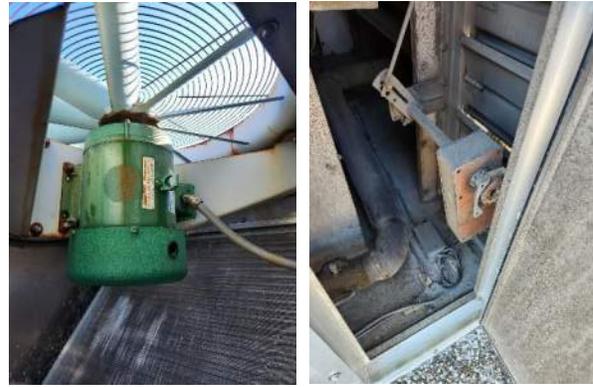
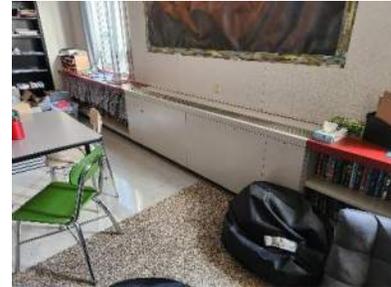
- Exhaust fans throughout are original but appear to be in fair to poor condition. Some are no longer operating properly. Most do not comply with current air volume standards.

- The dust collection system was installed in 2008 and is in good condition.

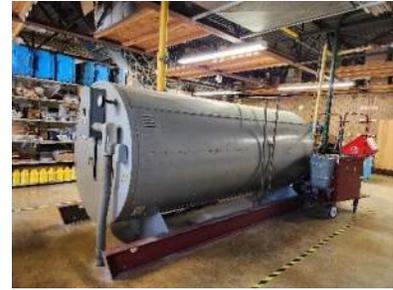
- Domestic hot water is developed from a large horizontal storage tank with electric coils. The tank is dated 1970 and is original to the building construction. The electric coils have been replaced over the years as they fail. The tank is well beyond its expected lifecycle.
- The hot water recirculation pumps are not original and have been replaced over the years.
- The recirculation system does not meet current standards.
- It was noted that there are other electric water heaters in the building to provide specific needs or to boost the temperature. All the units are electric.
- Insulation on the domestic water piping does not meet current energy codes.

- Replace/upgrade the entire domestic water heating and recirculation systems.

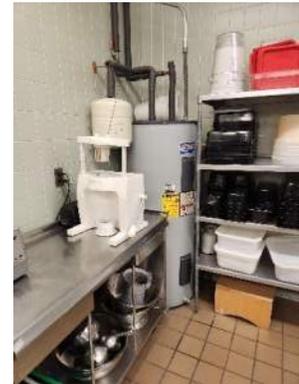
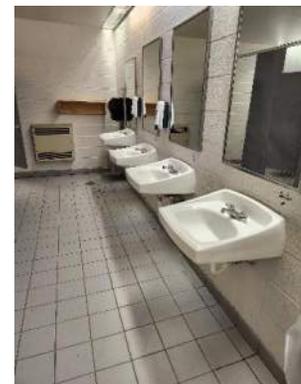
- Plumbing fixtures throughout appear to be in good condition.
- Water closets and urinals utilize manual flush valves.
- Lavatories utilize manual faucets.
- Faucets are mainly aged and in need of replacement.
- Toilet rooms and fixtures do not generally comply with current ADA standards.
- Water coolers and drinking fountains do not appear to be ADA compliant. Some are aged and may not meet current lead free standards.

- Replace faucets.
- Install hands free fittings on lavatories.
- Upgrade system to be ADA compliant.
- Replace older water coolers.

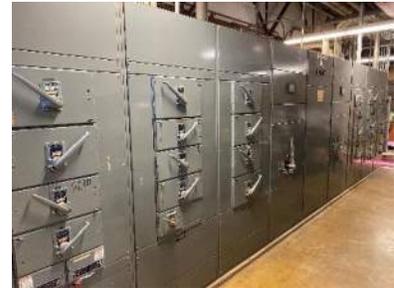
- The existing electrical service is 480/277-volt, 3-phase, 4-wire, and fed from an exterior utility pad mounted transformer. A 4000-amp QMB switchboard is installed, it has two 2000-amp main bolt-loc switches and fusible distribution disconnects. The bolt-loc main switches can be unreliable and the switchboard is obsolete. The switchboard does not meet current code requirements and is over 50 years old. The switchboard is in poor condition.
- Dry-type transformers are used to step down voltage 208/120-volt.
- 480/277-volt and 208/120-volt branch circuit panelboards provide power throughout the building. The panelboard types are obsolete.
- There are a few branch circuit panelboards that were manufactured in 1994 that were part of a building addition that are in poor to fair condition.
- Electrical distribution equipment was manufactured by Square D and Cutler Hammer/Westinghouse.

- Most of the existing equipment is over 50 years old. All the electrical distribution equipment and all associated distribution wiring should be replaced.

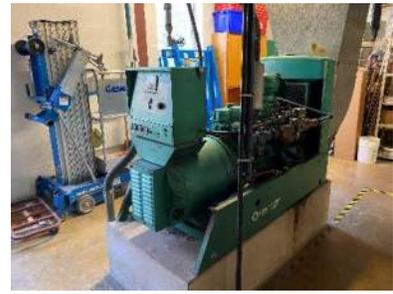
- A 208/120-volt, 3-phase, 30KW natural gas generator is installed. It is manufactured by Onan and appears to be original to the building. It is in poor condition.
- A replacement Cummins automatic transfer switch and area protection panel appear to have been installed in 2017 and are in good condition. The location of the automatic transfer switch does not meet the requirements of the codes.
- Self-contained exit signs with battery back-up are being used throughout the building and most are in poor condition.
- Designated recessed downlight luminaires are connected to the emergency system and are used for emergency lighting.

- Install new generator, life-safety and optional equipment automatic transfer switches, distribution equipment, and new raceways and wiring.

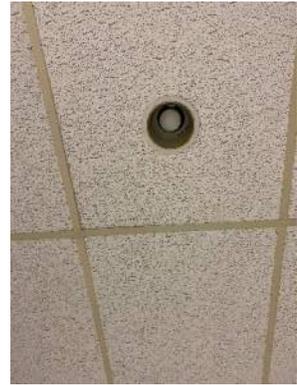
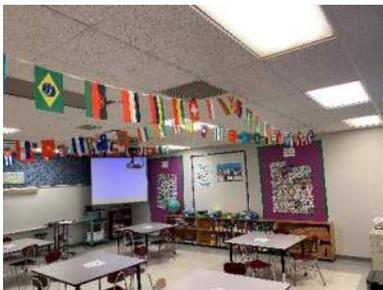
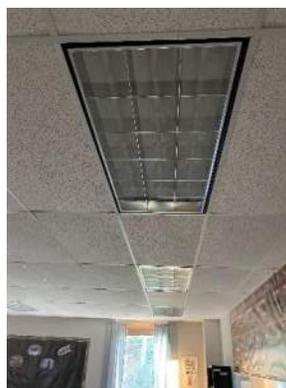
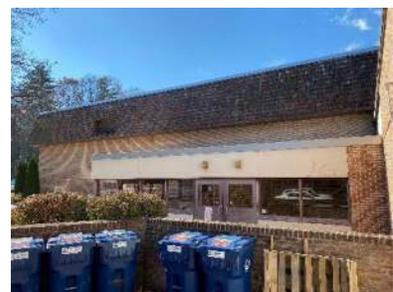
- The multi-purpose room appears to be using high-bay type fluorescent luminaires.
- Existing luminaires use 120-volt and 277-volt for power.
- The Auditorium has pendant stem-mounted luminaires assembled in a square shape using fluorescent lamps.

- Existing lighting controls do not meet current energy code requirements for automatic switching, daylight harvesting, and dimming.
- Exterior lighting consists of luminaires using HID, PL fluorescent lamps and LED lamps.

- Luminaires are outdated and in poor to fair condition and should be replaced with new LED luminaires.
- Install new lighting controls that will meet the energy code requirements.
- Replace exterior luminaires that have not already been replaced with new luminaires with LED lamps.

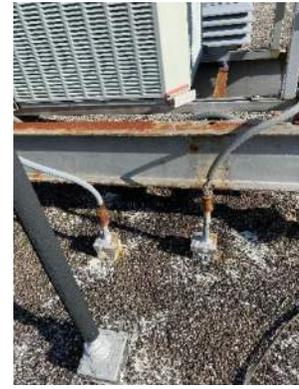
- The wiring devices are in poor to fair good condition.
- Receptacles do not meet current codes.
- Auditorium floor receptacles are flush mounted without protective covers and do not meet the code requirements.
- Equipment wiring on roof is in poor condition. Broken raceways and open conductors have been observed.

- Repair worn out raceways/wiring used for equipment connections on roof.
- Wiring devices and branch circuit wiring should be replaced for any building renovation.
- Receptacles should be replaced with Tamper-Resistant type for any building renovations.
- Current code requires receptacles to have ground-fault circuit interruption protection at additional locations. Devices should be changed for personnel protection.

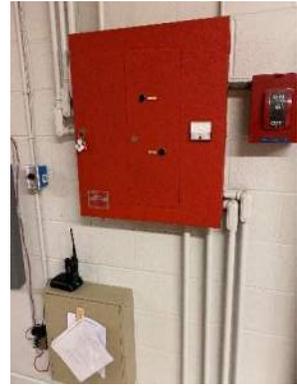
- A Simplex 4100 panel and an addressable controller panel are in use in this building.
- Notification devices and their installations do not meet current code requirements.
- Classrooms do not have the code required notification devices in them.
- An Edwards fire alarm system panel and pull stations appear to still be in use from the original building construction in 1971.

- Completely replace existing fire alarm system and devices with a new fire alarm system.
- A new system will be required to be voice-based speaker notification devices to meet NFPA requirements.

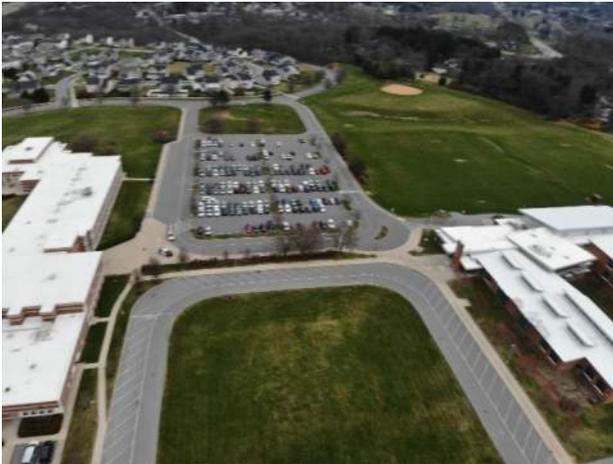
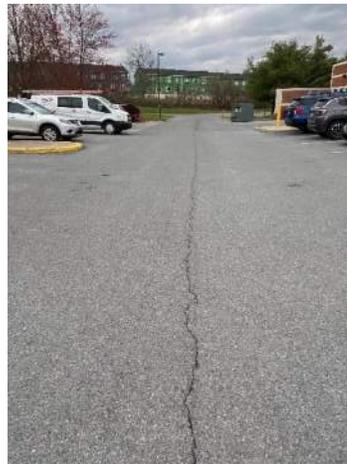
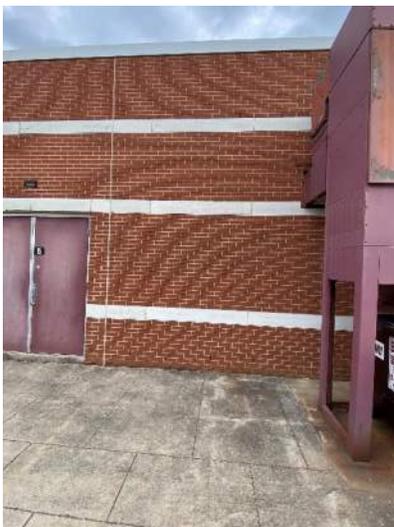
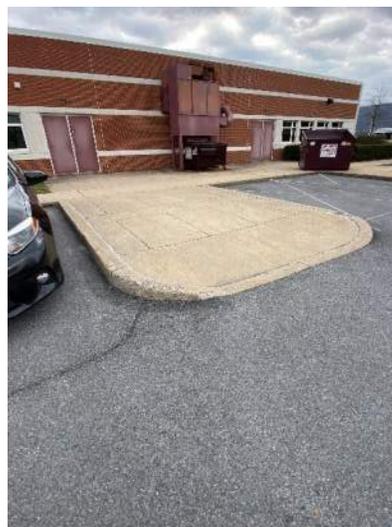
Vehicular access to the site is from Brandywine Drive. Parents and buses pick up and drop off from the drive loop at the front of the school. These pick up and drop off areas are shared with the elementary school on the opposite side of the parking area. The pick up and drop off times of the two schools are different which helps with traffic, however traffic can be problematic, particularly in the afternoon with the number of parents picking up their children varies with after school activities. Paving and concrete walkways are in good condition at the drop off area with some cracking occurring down the middle of some of the paved access drives and also the concrete walks in the rear of the building, that were installed when the building was constructed, are showing signs of aging.

Deliveries are made at the opposite side of the school in the rear of the building. Staff and visitors park in the paved parking area out front that is also shared with the elementary school and also in the parking area in the rear of the school. There are ADA accessible parking spaces in the parking area in the front, and an accessible route from the parking spaces to the front entrance of the building.

- Use pourable sealer on crack and monitor to see if crack increases in size. Provide seal coat over rear parking area.
- Replace concrete in rear of building with any renovation project.

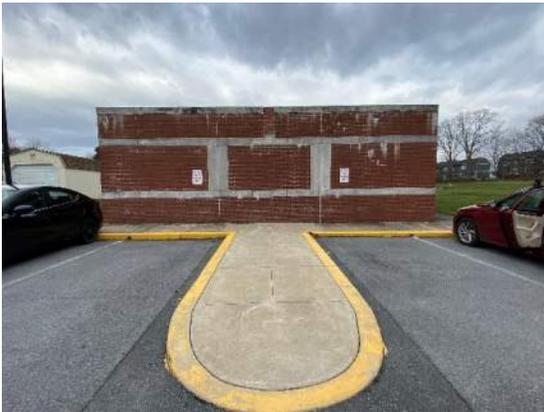
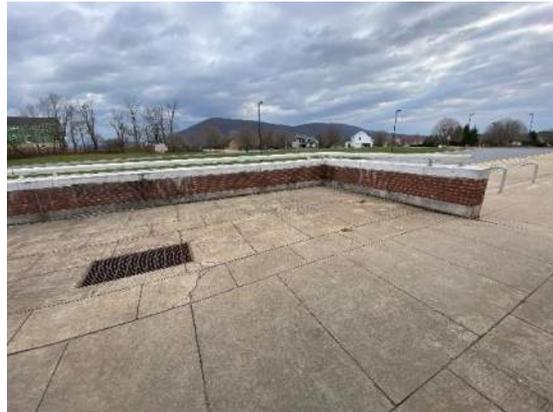
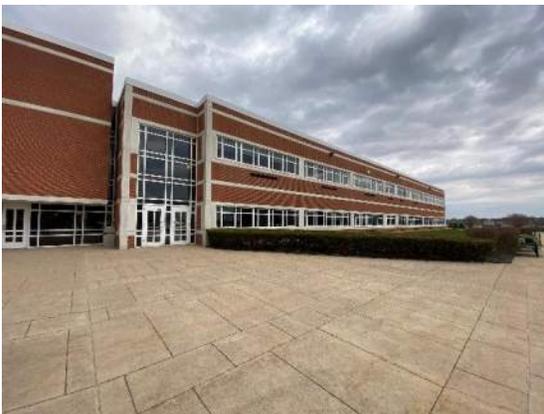
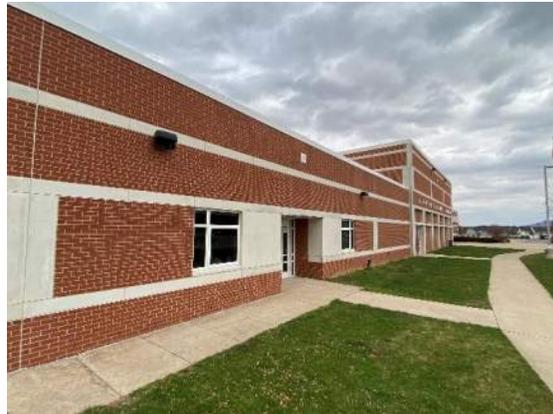
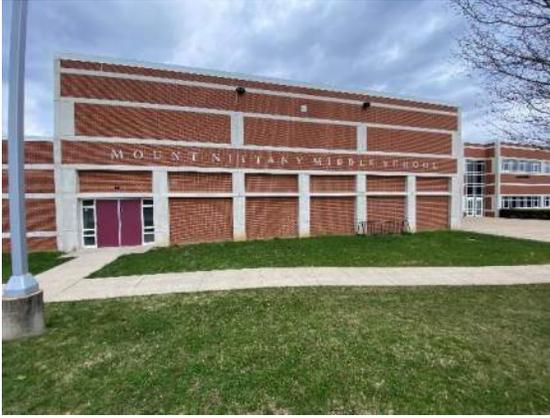
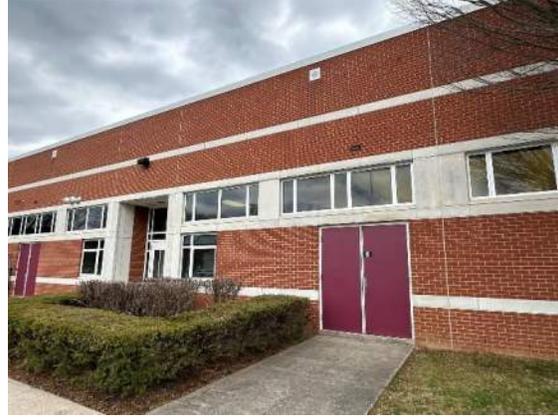
Masonry screen walls with precast or cast stone caps and accent bands in the rear of the building are badly stained with efflorescence and dirt. Masonry seat walls with precast or cast stone caps outside the Gymnasium entrance are also badly stained with efflorescence and dirt.

The paint on the exterior hollow metal doors and frames is faded.

- Clean exterior brick veneer to remove efflorescence and staining on masonry screen and seat walls that were not part of the building cleaning in 2023.
- Prep and paint exterior hollow metal doors and frames.

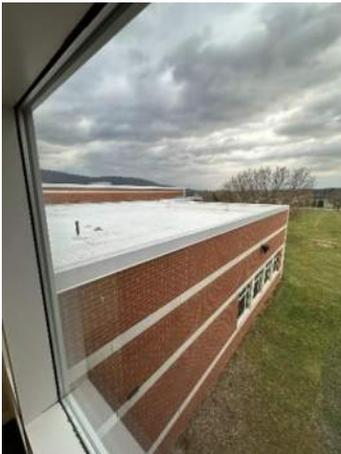
The roof on the building was replaced in 2016 with a white fully adhered TPO roofing system and is in good condition. Rainwater is collected via roof drains. Roofing and rainwater conveyance appear to be in good condition.

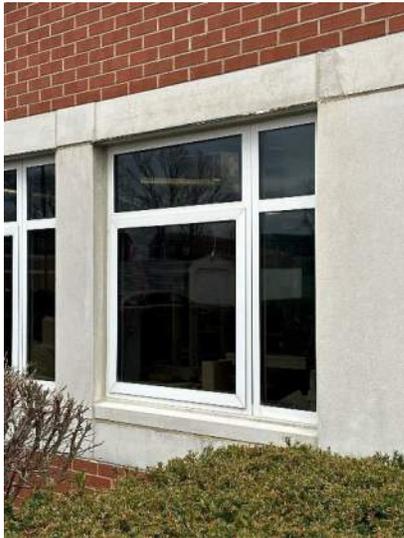
Windows are a combination operable, casement-style and fixed white anodized aluminum window units. Aluminum windows are original to when the building was built and showing signs of age.

Entrances are clear anodized aluminum storefront with custom wide stile insulated aluminum doors. Aluminum doors and entrances are original to when the building was built and showing some signs of age.

- Replace aluminum windows, doors and entrances with any new renovation project as they are at the end of their life expectancy. However, if maintained life can be extended 10+ years and not to be added to the current capital budget.

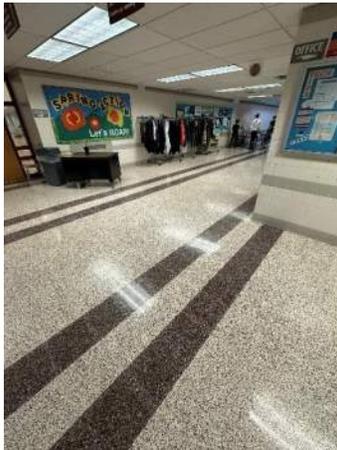
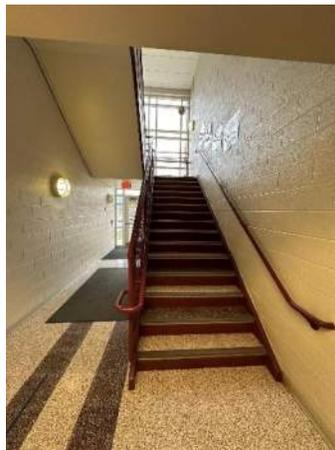
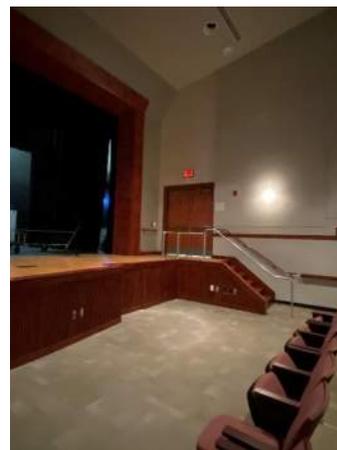
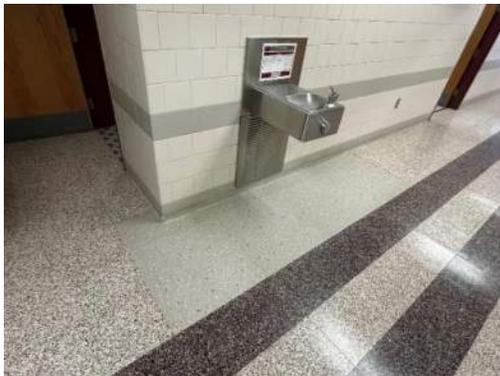
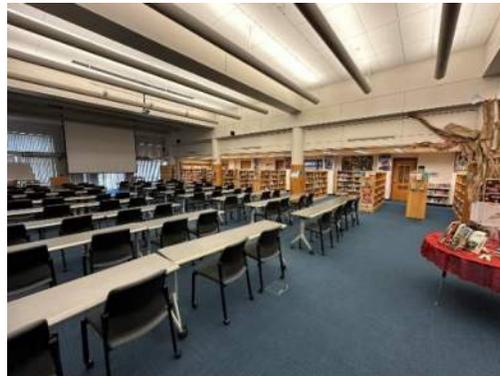
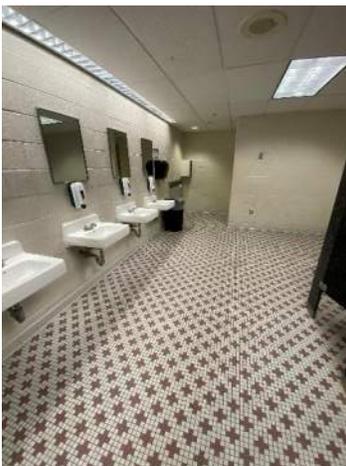
VCT and terrazzo tiles (Fritz Tile) exist throughout most of the school. The terrazzo tiles are located in the corridors and stair towers (including stair treads), while the VCT is located in the classrooms. Over the years the terrazzo tiles were replaced with thinset terrazzo at each of the water coolers as water was getting under and loosening the tiles.

Carpet is found in the main office, miscellaneous offices throughout the school, Media Center, and Auditorium. Carpet throughout is showing signs of age.

Acoustical ceilings throughout for the most part are in good condition with the exception of miscellaneous stains on tiles.

- Replace carpet throughout with any renovation project.
- SCASD staff indicated they are also investigating replacement of the corridor floors in the future, investigate further with interiors team and SCASD.

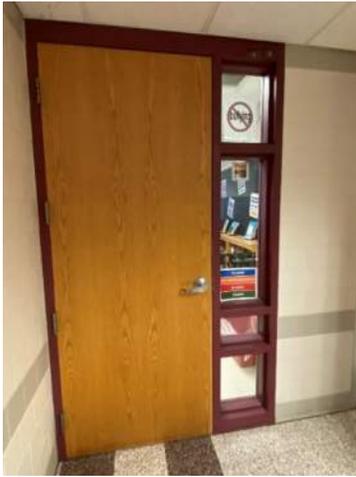
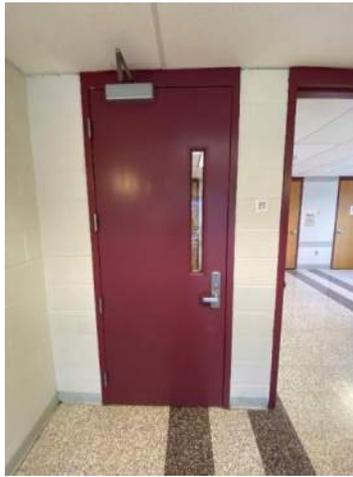
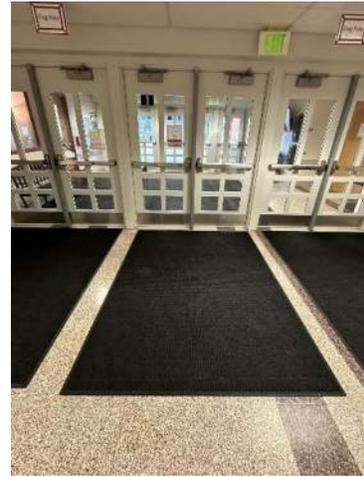
Interior doors are solid core wood or painted hollow metal in painted hollow metal frames. Most of the interior doors and side lites have glazing with wire mesh which does not meet the current code.

Where interior aluminum entrance doors in aluminum frames occur at interior vestibules, doors and frames are in fair condition.

- Replace wire mesh in glazing with clear glazing that is code compliant.
- Replace aluminum entrance doors and frames with any new renovation project as the existing doors and frames are at the end of their life expectancy.

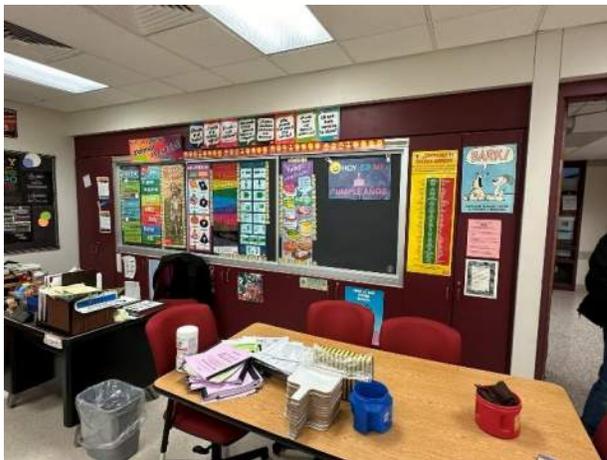
Interior casework is plastic laminate and in good condition.

- The casework is at the end of its life expectancy and should be replaced with any renovation project.

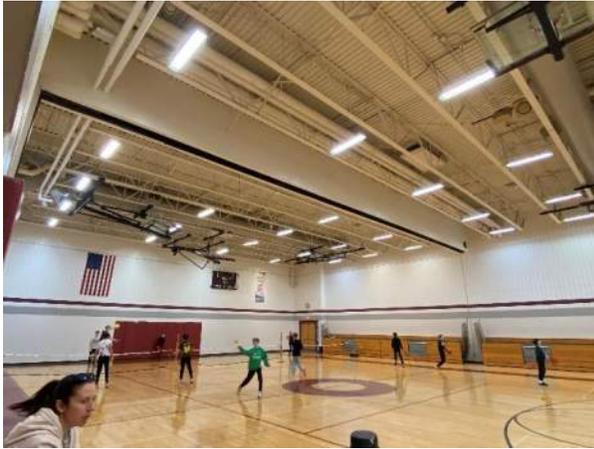
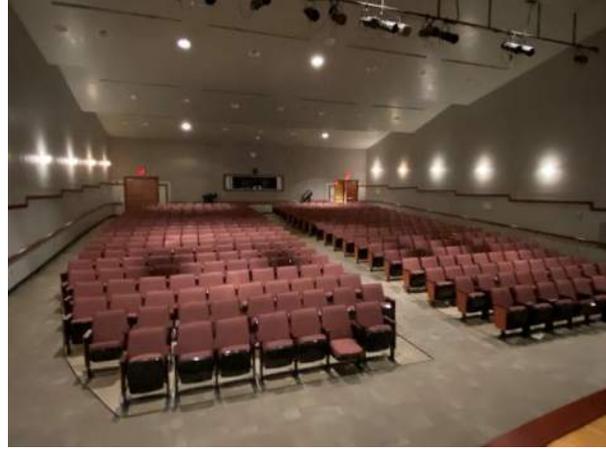
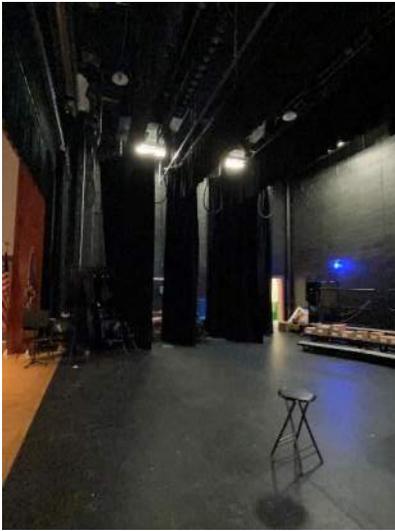
Gymnasium equipment consists of retractable, ceiling-hung basketball backstops, scoreboard, wood bleachers and folding partitions. All are in fair to good condition. The folding partitions are electrically operated and are in working order. It appears that the staff does periodically have issues with the backstops going up and down. The wood bleachers are not ADA compliant.

Athletic welded steel lockers in the locker rooms as well as the wood benches appear to be in good condition, however provisions for an ADA compliant locker and bench were not provided.

The metal corridor lockers appear to be in good condition, however there are no lockers labeled to be ADA compliant lockers.

The auditorium seating appears to be original to when the building was constructed and is in fair condition. Some of the seats do not fold up when they are not being used.
The rigging and lighting on the stage are original to when the building was constructed.

- Replace the athletic equipment and folding partitions with any renovation project as it has exceeded its life expectancy.
- Renovate a portion of the existing corridor lockers to be ADA compliant lockers.

- Replace the auditorium seating and stage rigging and lighting with any renovation project as they have exceeded their life expectancy.
- Renovate a portion of the existing welded steel lockers in the locker rooms to be ADA compliant lockers and add a separate 24"x48" ADA compliant bench.

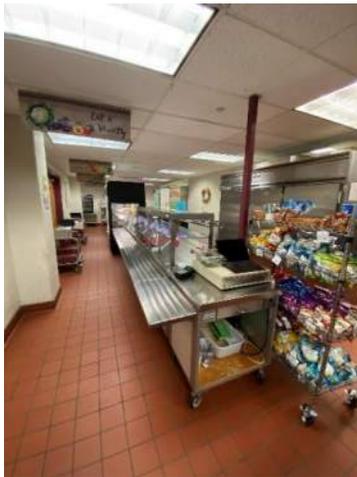
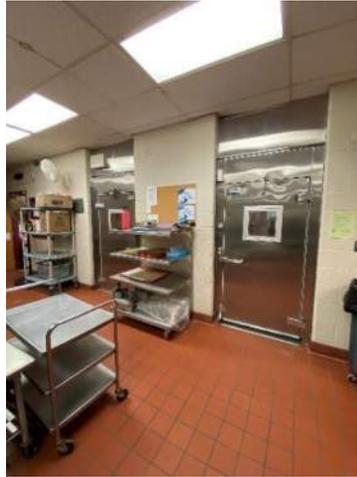
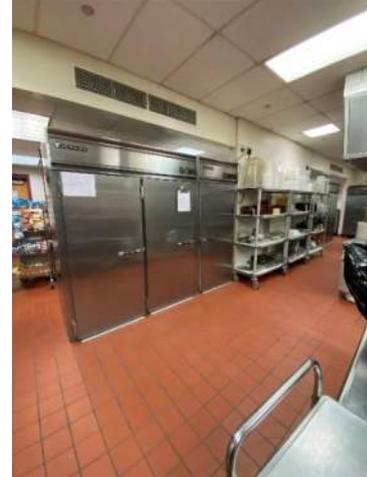
Most of the food service equipment is original to the building's construction and is in good to fair condition. SCASD is currently planning to replace the hoods and HVAC equipment serving the kitchen in 2024. Additional work includes replacement of the serving lines and the diswash equipment was replaced in 2019.

- While some of the equipment is approaching 30 years the current projects in process at this time along with routine capital budgeting will maintain the equipment into the foreseeable future.

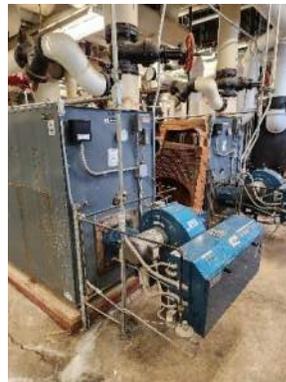
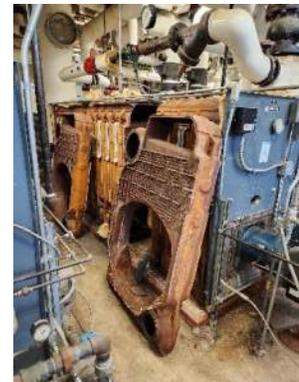
- The building is served by a four-pipe hot and chilled water heating and cooling system. Most of the HVAC systems and components appear to date back to a 1994/1995 system upgrade.

- Three Weil McLain Series 88 cast iron boilers with gas fired burners develop heating hot water for the school. The boilers appear to be in fair to good condition. One boiler was disassembled and under repair due to a cracked section. Note that the Series 1 version of these boilers has been discontinued and no longer serviced. Obtaining sections and related parts can be difficult. We suggest that the district plan for replacement in the next few years.

- Replace the boilers.
- Test and inspect the underground chilled water piping system.
- Reinsulate the chilled water piping system.
- Replace strategic HVAC valves for improved maintenance serviceability.
- Replace the HVAC equipment and provide humidity control as part of any planned renovation or system upgrade.

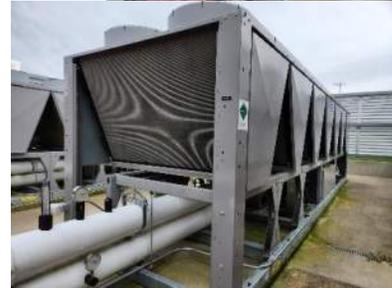
- Two Carrier packaged air cooled chillers develop chilled water for cooling. The chillers were manufactured in 2019 and utilize R-134a refrigerant. They were found to be operating well and in good condition.

- The piping for the chiller is buried between the remote chiller enclosure and the pumps in the mechanic room. The age and condition of this piping system was unknown. We highly recommend that this be further evaluated as accessing the pipe for an unplanned repair will be difficult, expensive, and time intensive.

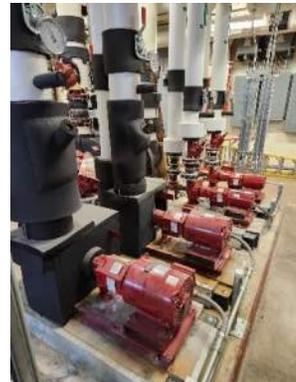
- The chilled water loop includes a propylene glycol solution and feeder. The feeder is in good condition.

- The chilled water pipe insulation is deteriorating in many areas. This is a sign of age and high humidity. We recommend that all wet or damaged pipe insulation be replaced.

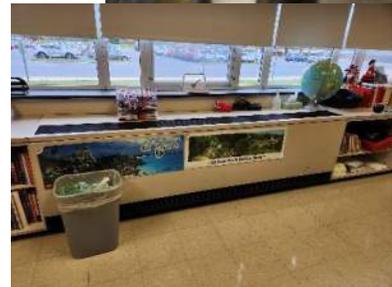
- Classrooms are served by vertical 4-pipe unit ventilators on the exterior walls. The units are vintage 1994 and do not have integral reheat for humidity control.

- Note that classroom unit ventilators have many shortcomings including high noise levels, excessive room drafts, temperature variations, and inconsistent ventilation. They are no longer an industry recommended approach to providing HVAC in a learning environment.

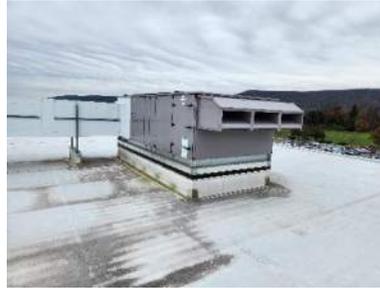
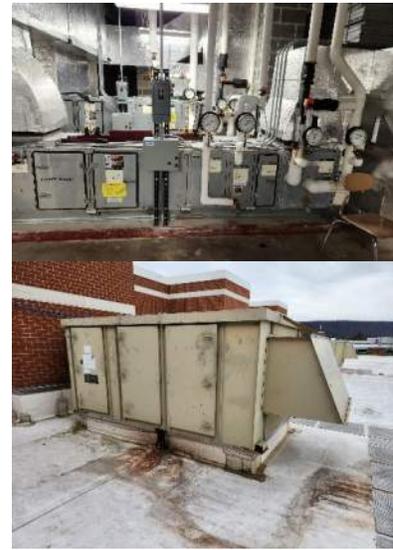
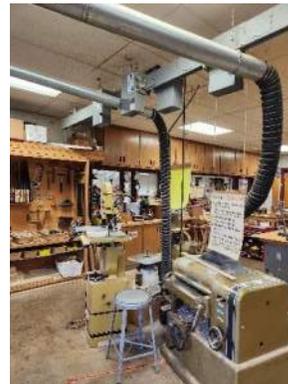
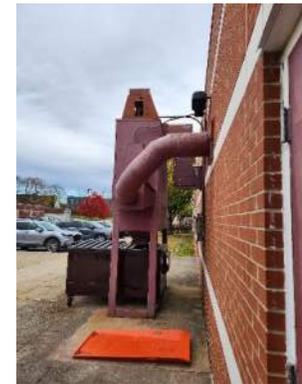
- Larger spaces are served by constant volume Trane 4-pipe indoor and outdoor air handlers that were installed in 1994. The indoor units appear to be in good to fair condition and the outdoor units are in fair to poor condition. All 1994 units are beyond normal lifecycle. The units could be refurbished to extend their life if desired, but replacement should be considered and planned. There was one newer Carrier unit on the roof that was installed in 2019 and found to be in good condition.

- DX cooling units are installed in several areas including the office, library, and server room. The units are original and utilize R-22 refrigerant. R-22 refrigerant has been phased out of production in 2020 due to its ozone depleting characteristics. We highly recommend that the units be replaced with new units that use current refrigerants and provide improved energy efficiency.

- Exhaust fans throughout are a mix of original and replacement units. All appear to be operating and in good condition.
- The dust collection system does not meet current standards and is aged. We recommend replacement with any planned wood shop renovation.

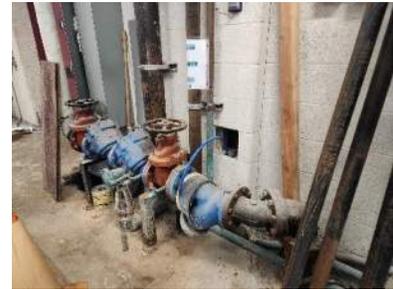
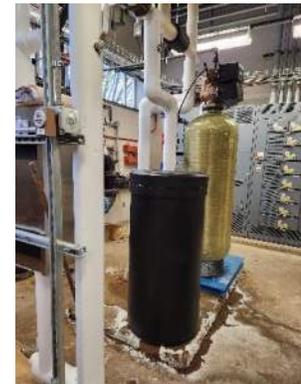
- The school is served off a public water service. The 4" service size is adequate for the school's needs. There were not any observed or noted issues.
- The water service includes a code compliant backflow prevention device that appears to be operational.
- The piping system was reported to be in good condition with no known pipe issues.
- Plumbing valves throughout are original. It was noted that some of the valves no longer hold, making service and maintenance difficult. We recommend that key valves be replaced when a comprehensive upgrade occurs.
- The domestic water system includes a simplex water softening system that was recently installed. We recommend that additional softeners be provided to provide redundancy and to allow regeneration based on use. We also noticed that the system was leaking and in need of repair.

- Replace strategic plumbing valves for improved maintenance serviceability.
- Provide redundancy for the water softening system and repair leak.

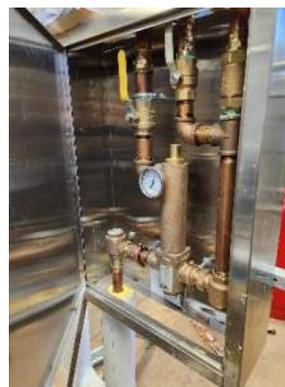
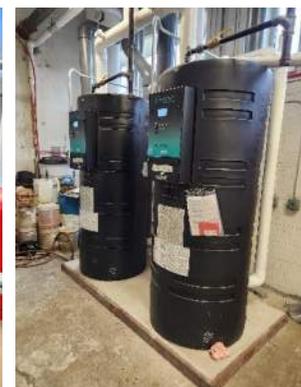
- Domestic hot water is developed from two PVI high efficiency gas water heaters that were installed in 2022. They are in good condition and do not need any attention.
- The domestic hot water mixing valve and the recirculation pumps were also replaced in 2022 and appear to be in good condition.

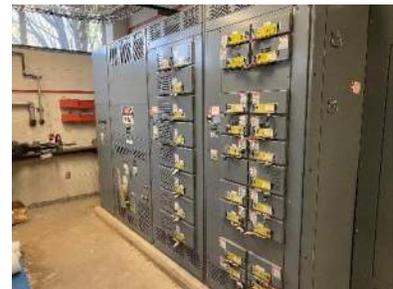
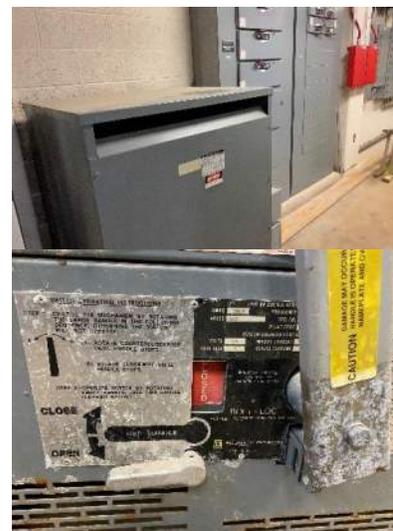
- The electrical distribution equipment was manufactured by Schneider/Square D and installed during the 1995 construction project. It appears to be in fair condition.

- Feeder wiring and raceways appear to be in fair to good condition.

- The bolt-loc switches can be unreliable and not operate correctly. This switch should be serviced by the manufacture's technicians to service and confirm that the operation will be reliable.
- Replace/Upgrade electrical distribution equipment to meet current code requirements with any building wide renovations.
- Inspect electrical equipment connections including thermal imaging, visual inspection and wire connection torque values confirmed with manufactures requirements.
- Follow the manufacturer's recommended maintenance requirements.
- Have a study completed to identify arc flash and PPE requirements for electrical equipment.

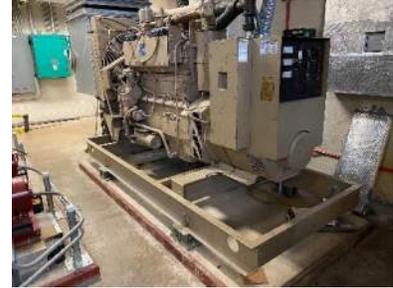
- A natural gas 125KW, 480/277-volt, 3-phase, 4-wire, generator is installed inside the building and appears to be an original installation from 1995.
- A single 225A automatic transfer switch is used for both emergency life safety and optional standby loads.
- All equipment was manufactured by Cummins/Onan.
- Installations do not meet NFPA code requirements. Life safety loads must be separated from optional equipment loads.
- The equipment appears to be in fair condition.

- Separate Life Safety loads from optional equipment loads.
- Have oil tested to determine engine wear.
- Maintain generator system per manufactures requirements.
- Confirm heating system loads are connected to this system.

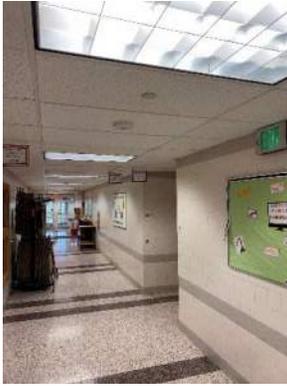
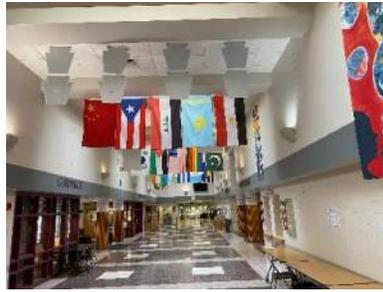
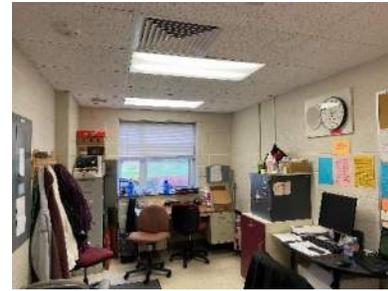
- The Gym appears to have a high bay luminaire using fluorescent lamps and integral occupancy sensors.
- High wall mounted luminaires are used in corridor/lobby for indirect lighting that appear to be using HID and LED replacement lamps.

- Exit signs appear to have been installed in the last renovation and are failing. Some exit signs have been replaced and are self-contained with battery back-up.

- Luminaires are in fair condition.

- Fluorescent lamps and ballast will become more scarce and costly to replace. Interior lighting should be replaced throughout with LED type luminaires and energy code compliant controls with any major building renovation.
- Exterior luminaires should be upgraded to LED type.

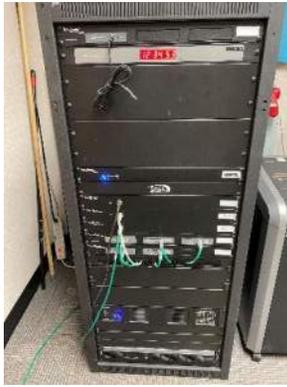
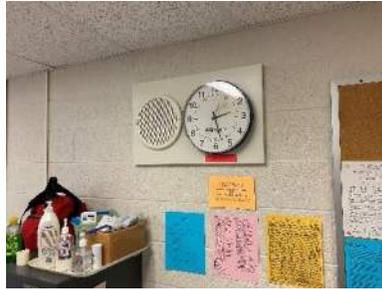
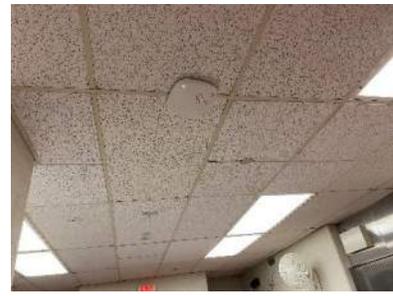
- Cat 6 cables/jacks are used in the building.
- Wi-Fi wireless access devices are installed in classrooms and other learning spaces and appear to be in good condition.
- A new Rauland Telecenter IP intercom system and a Sapling master clock system have been recently installed in the head end equipment rack and are in new condition. Existing intercom speakers and clocks have not been replaced and are still in use with this system.
- Combined wall mounted speaker/analog clock assemblies are used in the classrooms and other learning areas. The clocks are manufactured by Lathem. They appear to be original to the 1994/1995 construction of the building. Clocks are starting to fail and will need to be replaced.

- Upgrade data telecommunications system as needed to meet the School Districts requirements with any planned building renovation.
- Upgrade/replace the existing intercom speakers, clocks, and wiring with new equipment with any planned building renovation.

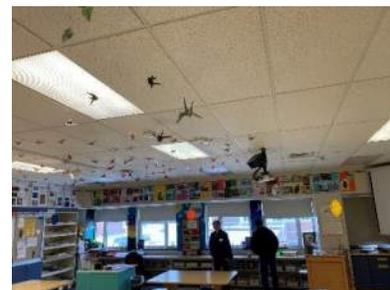
- Ceiling-mounted projectors with an audio speaker and pull-down projection screens are used in the classrooms. Teachers have input stations at their desks. Equipment is dated with older connection types.
- Audio systems with older technologies are used in the building.

- Upgrade the building with new A/V technology equipment and wiring systems.

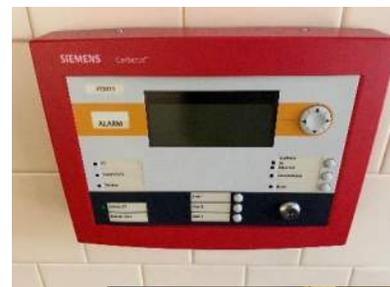
- A new Siemens Cerberus fire alarm system and associated equipment with new notification speaker/strobe devices and wiring has recently been installed and is in a new condition.
- A rescue assistance system is installed. It appears to be in good condition.

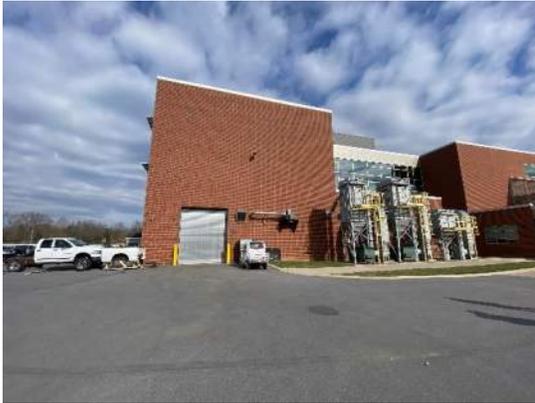
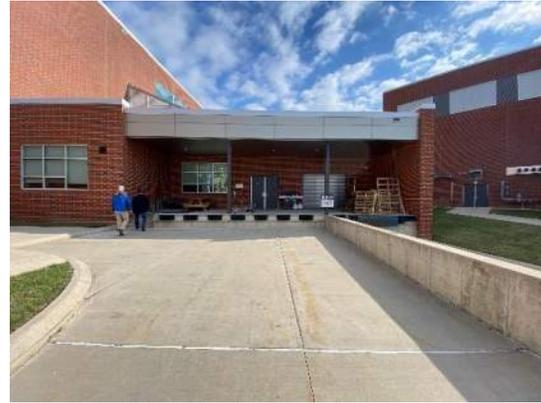
Paving and walkways are in good condition, being completed in the past 6 years related to the high school renovations.

- To maintained, long range planning for regular seal coating of paving should occur to extend the life of the paving.

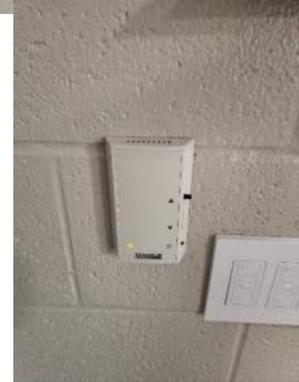
- The office areas utilize LG VRF systems with interior compressors that are connected to the loop water system. The system was not in operation during our visit due to failed control boards. We recommend that the district stock control boards minimize downtime in the future. Obtaining parts quickly can be challenging with some VRF systems.
- Extensive dust collection and welding smoke collection systems are utilized in the Tech shops. All systems were reported to be in good working order.
- Mini split units are provided for several IT areas. All were noted to be in good operating condition.
- Electric unit heaters and cabinet heaters are utilized for specific space heating only needs.
- Exhaust fans throughout are up to current standards and in good condition.

- Provide BAS integration with the VRF system where possible.

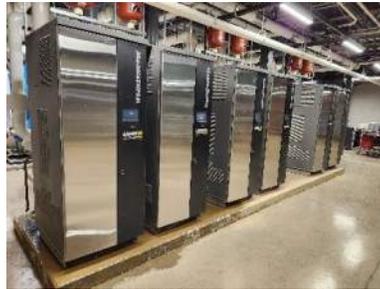
- Domestic hot water is developed by six LAARS high efficiency gas fired boilers. Each water heater includes an inline pump. Several of the pumps were vibrating more than typical. It appears that there have been pipe fitting failures which may be a result of the vibration. We recommend that the vibration be addressed by added support or possibly flex connectors.
- The water heaters are connected to three vertical storage tanks. The tanks were observed to be in good condition.
- The hot water recirculation pumps are in good working condition with no reported issues.

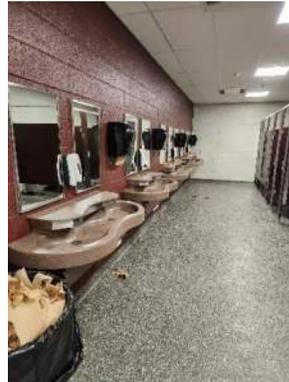
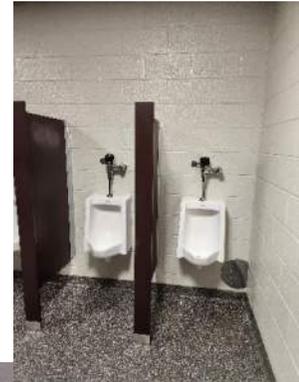
- Plumbing fixtures throughout appear to be in good condition. Fixtures and fittings are low flow for water savings.
- Water closets and urinals utilize automatic hands-free flush valves.
- Multi-station lavatories are utilized in group toilet rooms. These units include hands free faucets.
- Mixing valves below the lavatories have been problematic and have been prematurely failing.
- Dual level water coolers appear to meet ADA and include bottle fillers.
- The Emergency shower and eye wash stations mixing valves are not providing tempered water when activated. We recommend that additional recirculation be provided to help resolve this issue.

- Provide additional hot water recirculation for the emergency showers and eye wash stations.

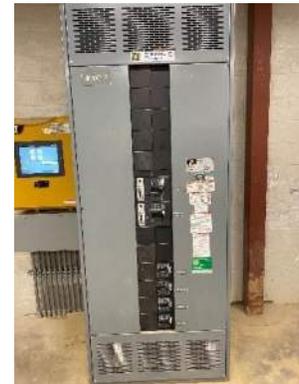
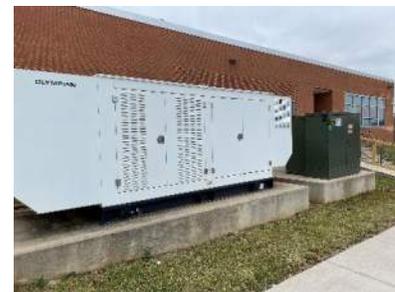
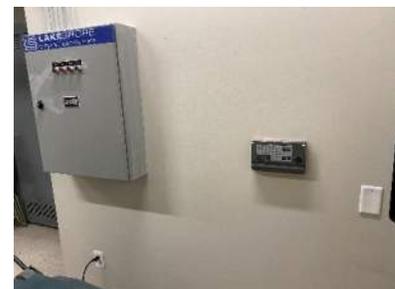
- All equipment was installed during the 2017-2019 building renovation and addition project appears in good condition.

- Maintain the five generators and their associated equipment per the manufacturer's requirements.
- Relocate generator remote annunciators to an occupied location so that any generator troubles can be observed, and any required service can be completed.

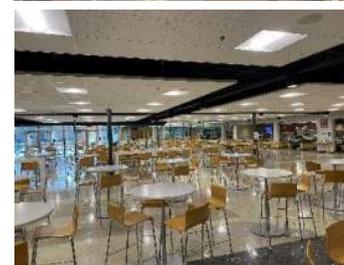
- Lutron manufactured the energy management devices for this project. The devices are wireless and will require batteries to be replaced.
- The school district noted that students are removing wireless wall controls. Also, when devices are located and returned, the controls were not possible to identify where they were previously used and would need to be reprogrammed.

- For corridor wall station controls, review lighting plans and wall control station locations to determine if the controls can be removed and allow ceiling occupancy sensors to control lighting through scheduled programming.
- Consider installing covers over wireless wall switch devices where they have been tampered with to reduce the chances of them being removed.
- Schedule lighting control manufacturer programming training if needed so that removed wireless devices can be programmed and re-installed.

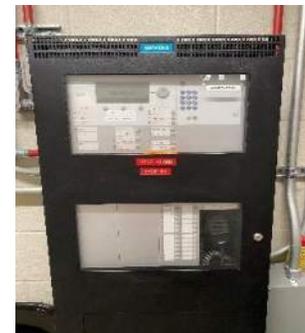
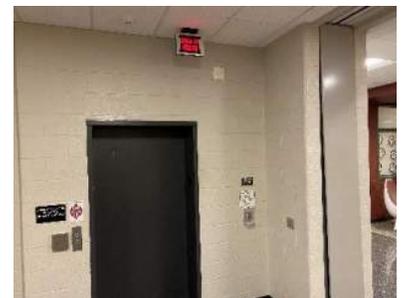
- Siemens manufactured the fire alarm system and is using Model FC2025/FC2050/FV2025 panels. This fire alarm system consists of panels that are located throughout the building, and they are serviced by JCI technicians.
- Protective covers have been installed on pull stations at most locations.
- The Remote annunciator is in the corridor by the main vestibule entrance.
- Area of rescue assistance stations are installed in this building with the annunciator located in corridor by main vestibule entrance.
- Systems were installed during the 2017-2019 building renovation and additions project. They appear to be in good condition.
- The Exterior key lock box is located at the main building entrance.

- Add protective covers on devices where needed to protect from damage and false alarms.
- Maintain system per manufactures and code requirements.

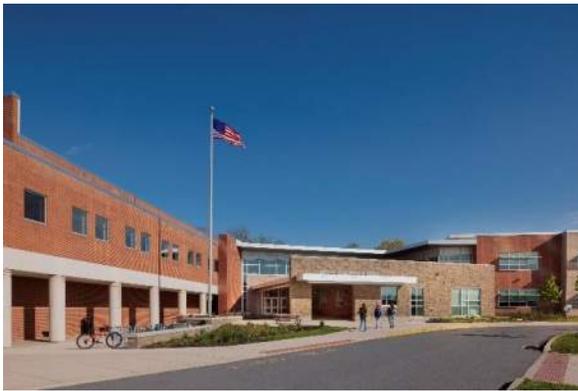
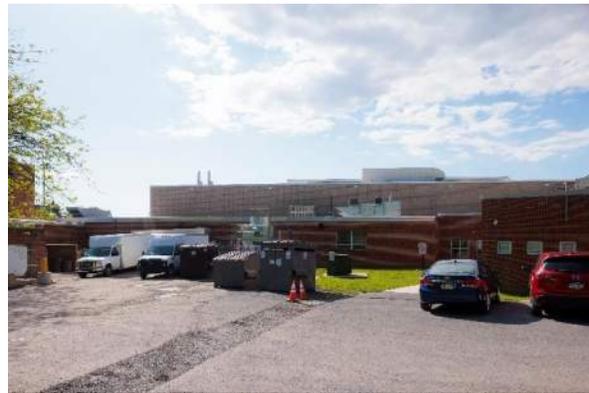
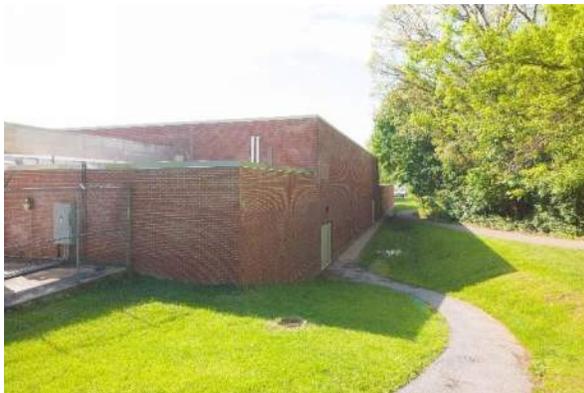
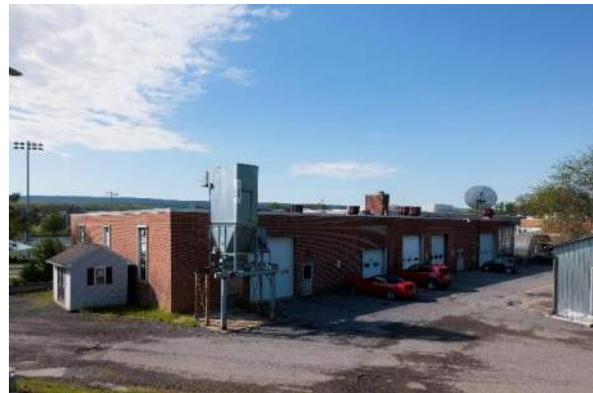
Deliveries are made from a separate access drive towards the rear of the site. Some of the walkways the perimeter of the building and in these areas are original to the original building are in good to fair condition. The paved access drives in this area are also original to the original building are deteriorating and in fair to poor condition.

- Consideration should be made to do a mill and overlay for the paving at the rear of the building at service area.

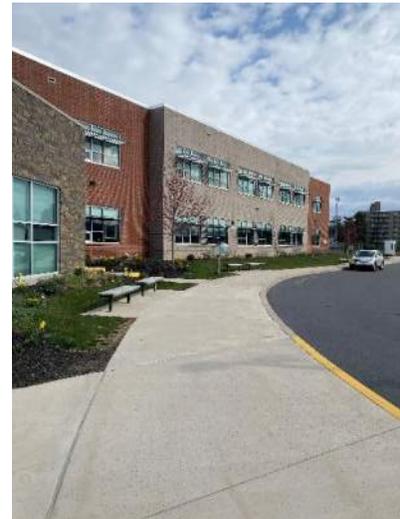
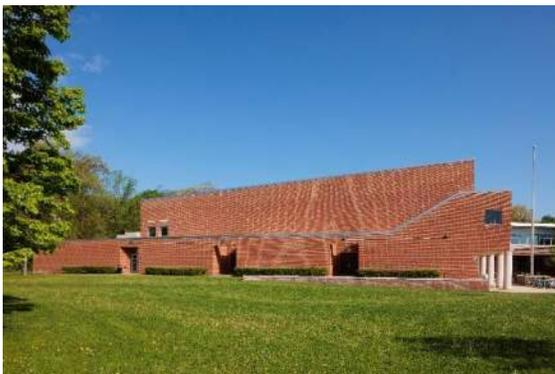
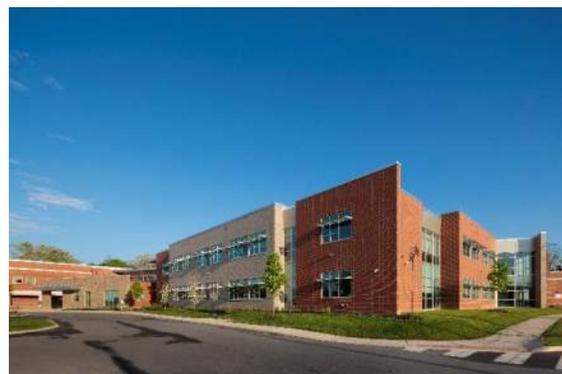
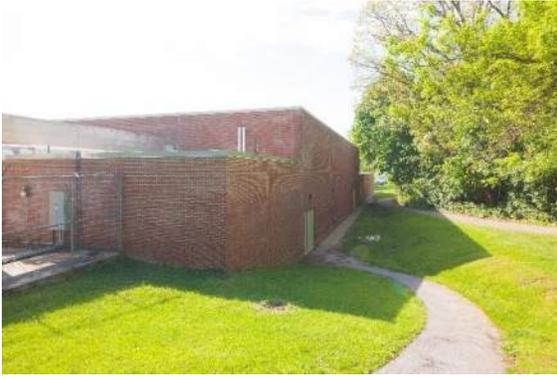
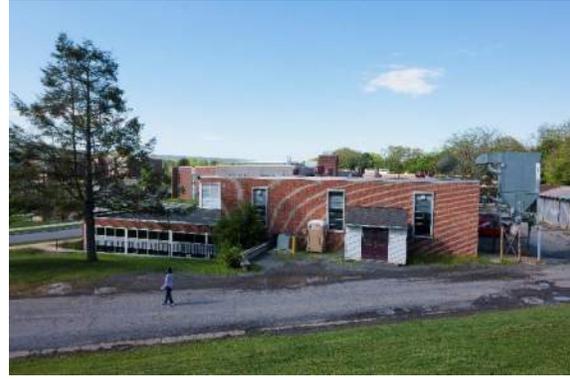
All face masonry associated with the additions is in excellent condition with the face masonry for the original building being in good condition. On the original portion there is some minor efflorescence staining that should be addressed.

- Minor cleaning of original face brick where stains have occurred. This is localized to certain areas of the building and should be monitored.

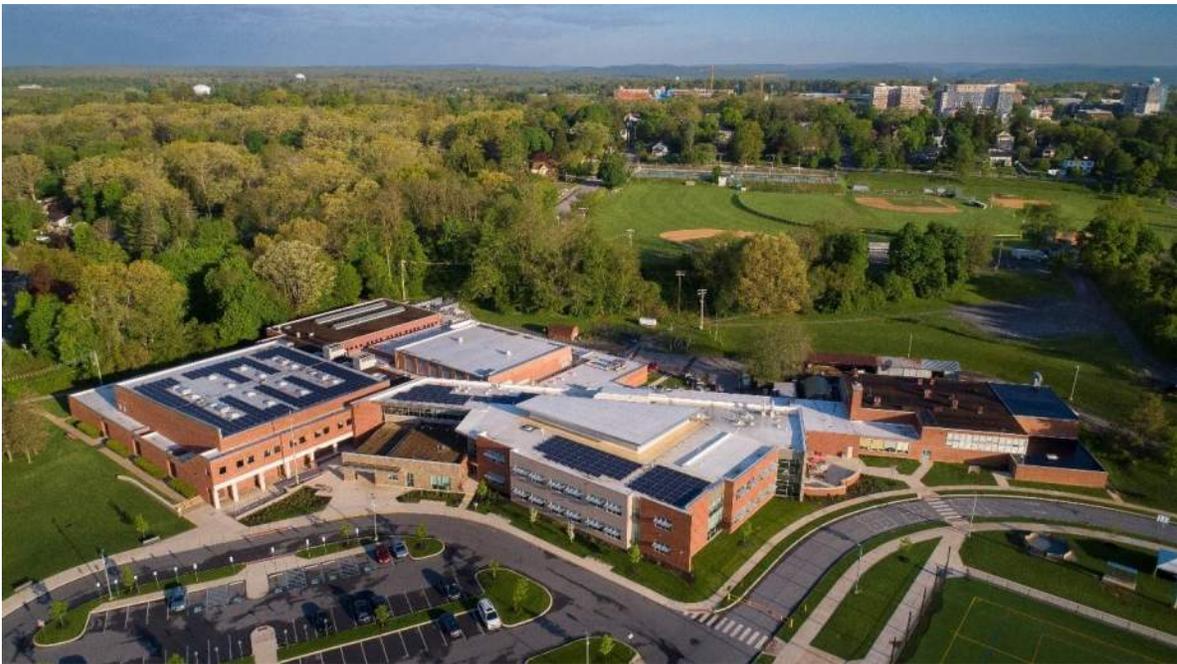
The roof is a white fully adhered TPO roofing system and is in very good condition. Some of the small roofs outside second floor spaces have a river stone ballast for aesthetic purposes where viewable from second story spaces.
