6 | Easterly Parkway Elementary School

Address:	234 Easterly Parkway State College, PA 16801
Construction Timeline:	Originally constructed in 1955; renovation/addition in 2002.
Building Square Footage:	55,895 sf
Site Acreage:	11.4 acres

Building Summary

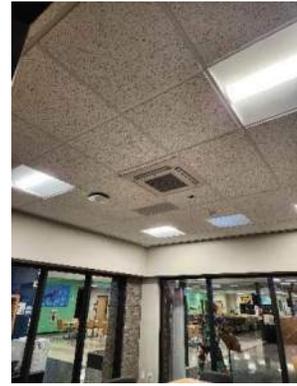
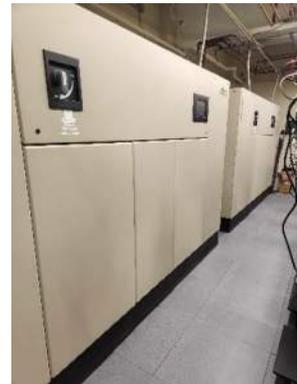
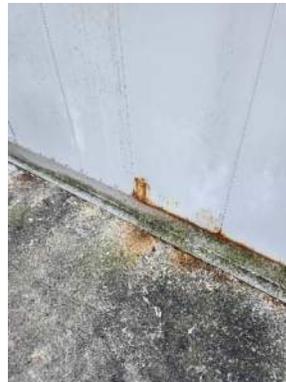
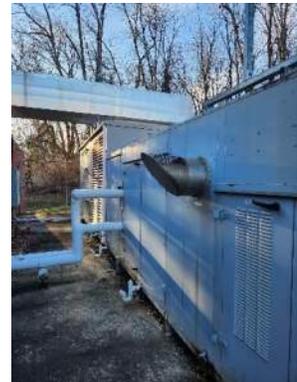
- The pool HVAC units is located at the rear of the building and ducted into the building. The units is starting to show signs of aging and will likely need to be replaced in the next 5 years. The exterior duct system will also require replacement at that time.

- Test and verify water chemistry.
- Clean classroom heat pump closet plenums.
- Address the cooling tower airflow issues.
- Plan on replacement of the pool HVAC units.

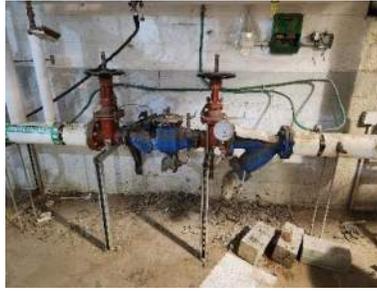
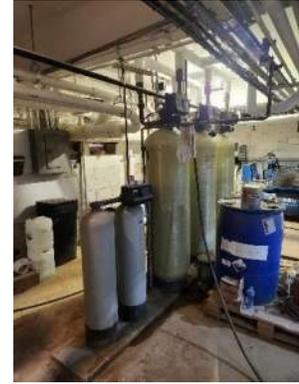
- The school is served off a public water service. The 4" service size is adequate for the school's needs.
- The water service includes a code compliant backflow prevention device that appears to be operational.
- The piping system was reported to be in good condition with no known pipe issues.
- The domestic water system includes a triplex water softening system and a duplex water softener. The softeners are starting to age and will likely need to be replaced in the next 3-5 years.

- Replace the aged water softener systems.

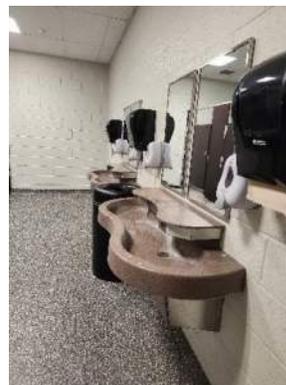
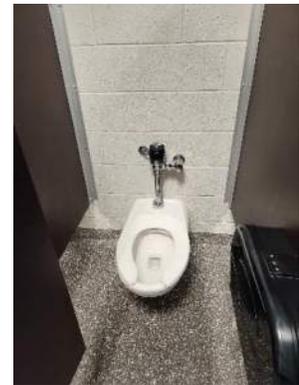
- Plumbing fixtures throughout appear to be in good condition. Fixtures and fittings are low flow for water savings.
- Water closets and urinals utilize automatic hands-free flush valves.
- Multi-station lavatories are utilized in group toilet rooms. These units include hands free faucets.
- Mixing valves below the lavatories have been problematic and have been prematurely failing.
- Dual level water coolers appear to meet ADA and include bottle fillers.

- Provide additional hot water recirculation for the emergency showers and eye wash stations.

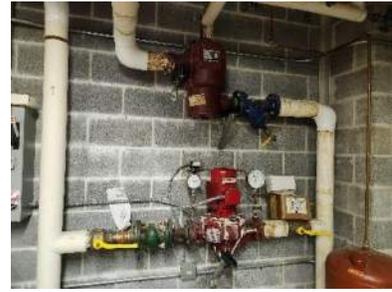
- The building is fully protected by a fire sprinkler system. This system is served off a 4" public water service. There are multiple feeds to separate sections of the building based on fire areas.
- The computer rooms utilize a chemical extinguishing system that was in good working order.
