UPPER DARBY SCHOOL DISTRICT

Long Range Facilities Master Plan

Facility Condition Assessment

Finance and Operations Committee Meeting
28 February 2023

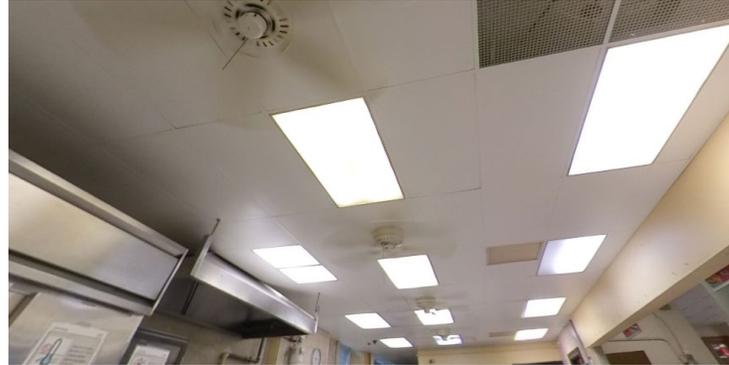
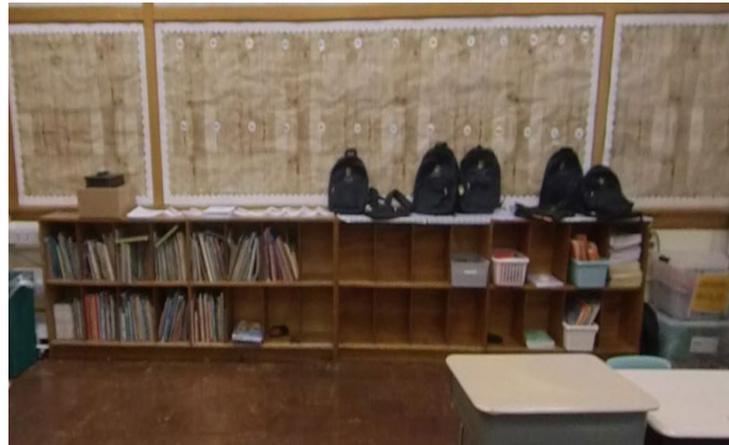
- ✓ Casework needs repair or replacement
- ✓ Custom kitchen ceiling tile needs repair or replacement

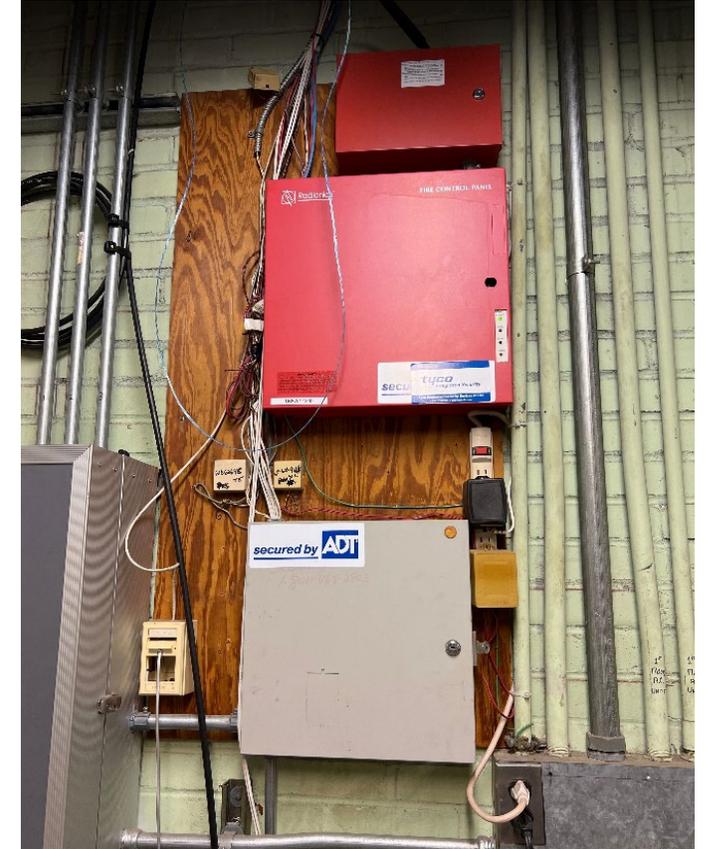
- ✓ PA/clock/fire alarm systems are functional but operating at the end of rated service life
- ✓ Ceiling tile, flooring, paint needs repair

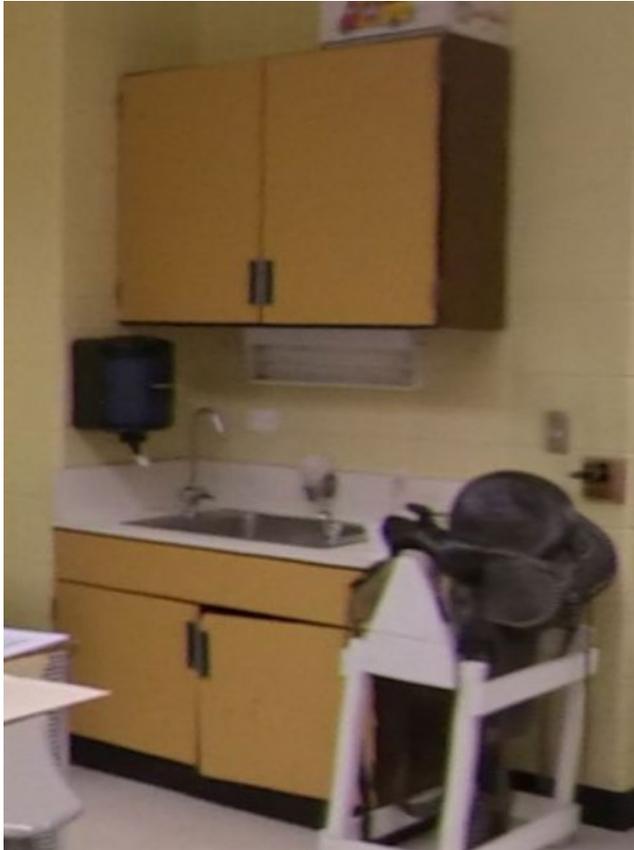
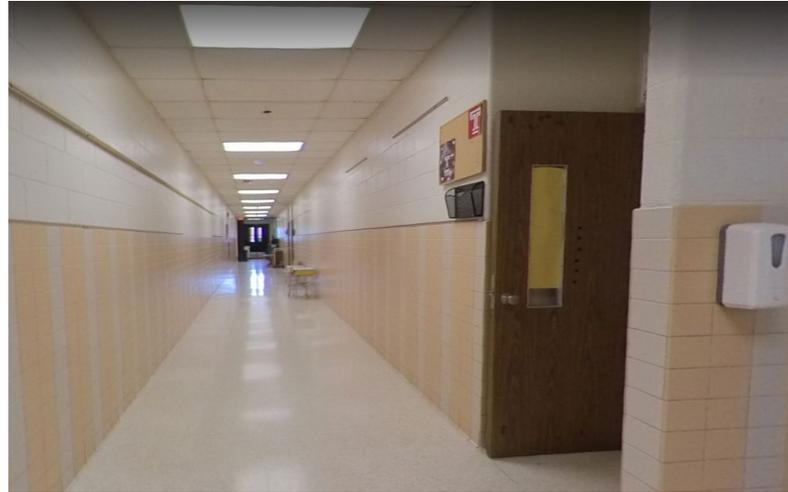
- ✓ Casework needs repair or replacement
- ✓ ACT in corridors is cupping and has staining in areas

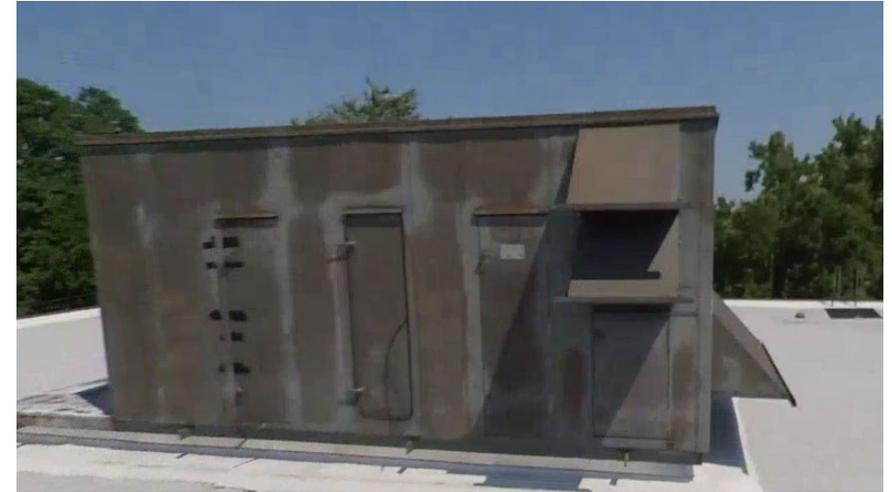
- ✓ Rooftop units, AHUs, HVAC terminal equipment, unit ventilators, condensing unit equipment operating in a degraded condition
- ✓ Boilers, chillers, pumps, and fire alarm/PA/clock systems are all in acceptable condition and within useful life
- ✓ Ceiling tile, flooring, paint needs repair

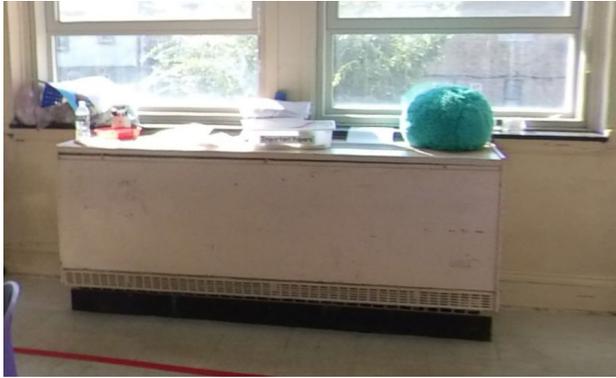
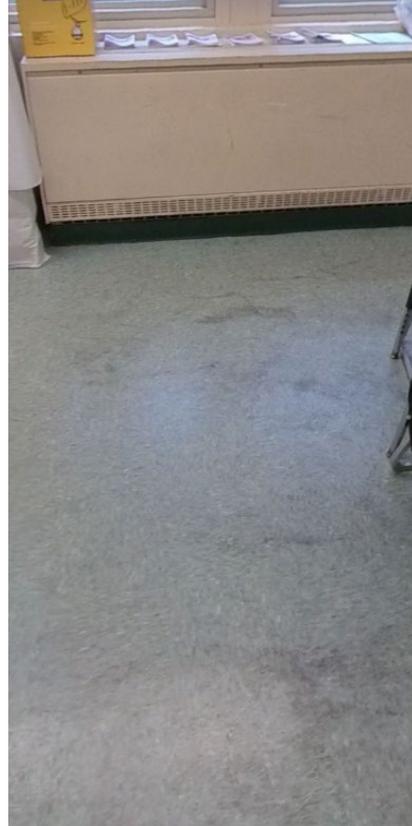
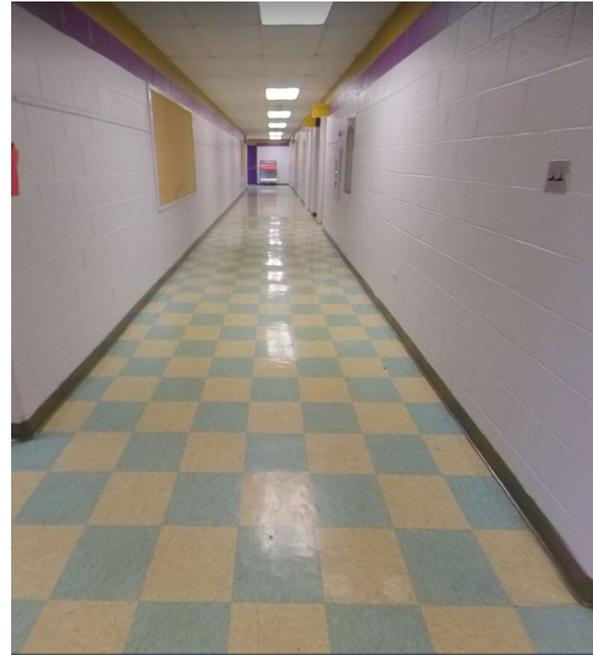
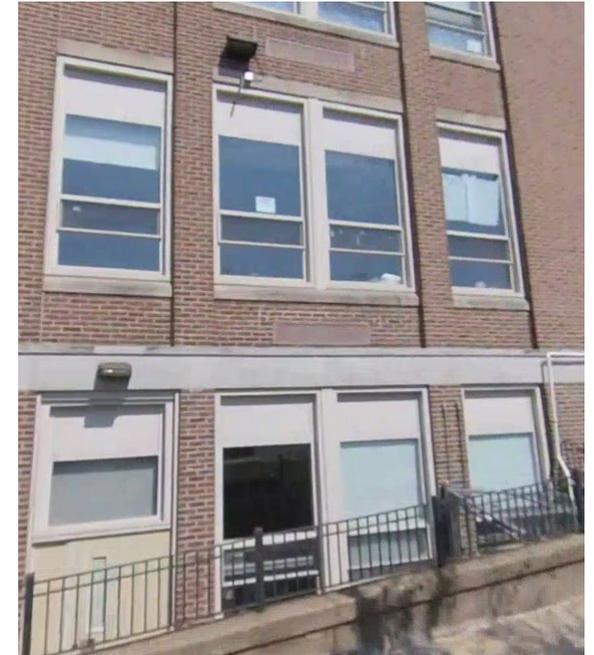
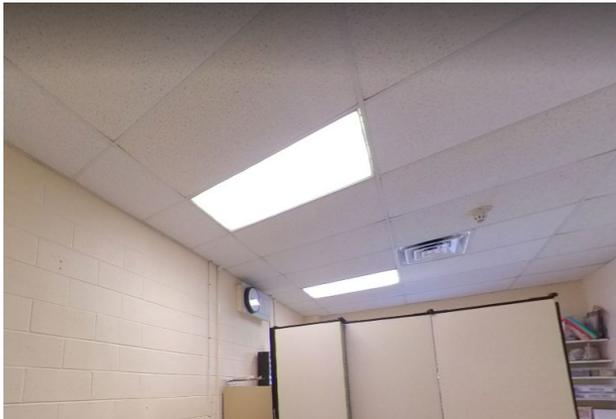
- ✓ Carpeting and finishes in Admin areas and support spaces

- ✓ Building Envelope
 - ✓ Exterior aluminum doors
 - ✓ Exterior window systems

- ✓ Mechanical equipment
 - ✓ Terminal equipment
 - ✓ Classroom unit ventilators
 - ✓ Radiators in corridors

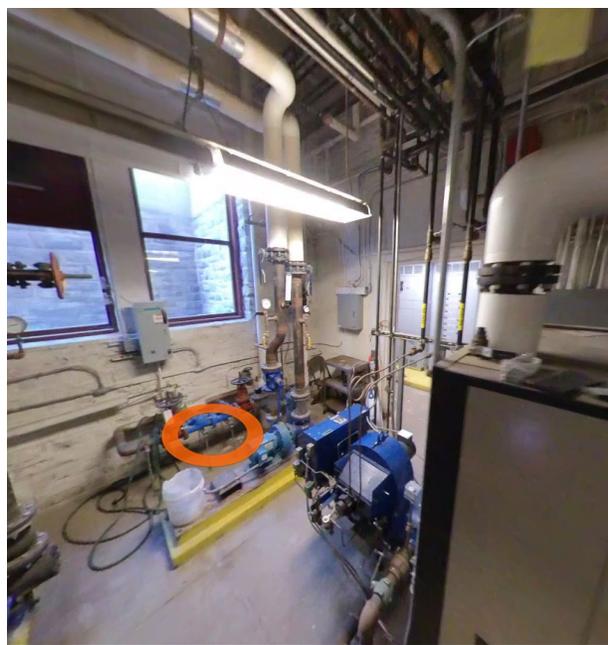
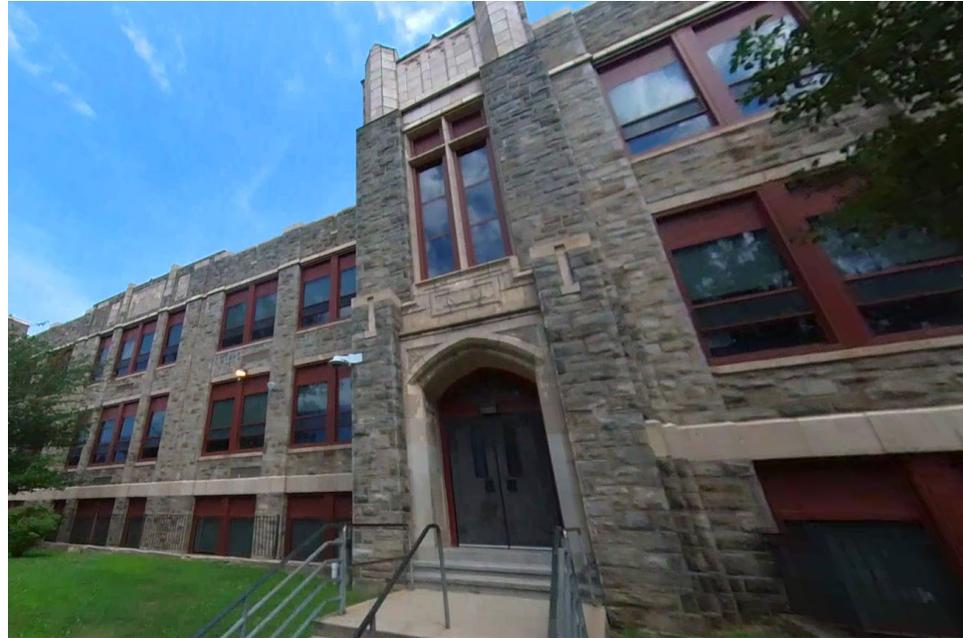
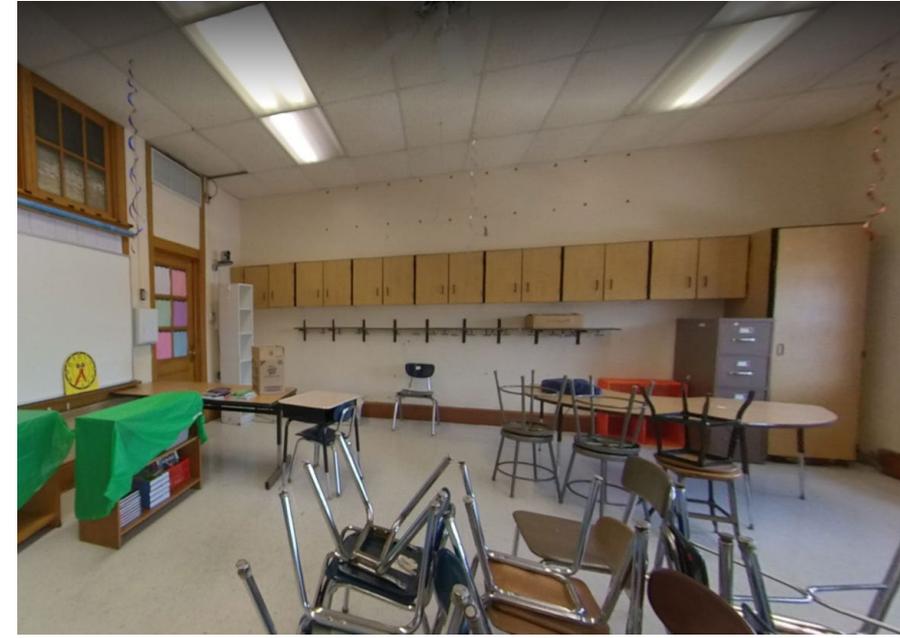
- ✓ Domestic hot water heater replacement
- ✓ Unit Cabinet heater replacement
- ✓ Building generator installed in 1988
- ✓ Stone masonry repair and restoration on both 1926 and 1988 addition required

- ✓ Upgrade fire alarm system
- ✓ Upgrade / replace master clock system
- ✓ Air handling unit serving library is outdated, requiring frequent maintenance

- ✓ Replace water to air heat pump units serving classrooms
- ✓ Building classroom finishes throughout are in worn condition
- ✓ Modular classrooms are aging with degraded finishes

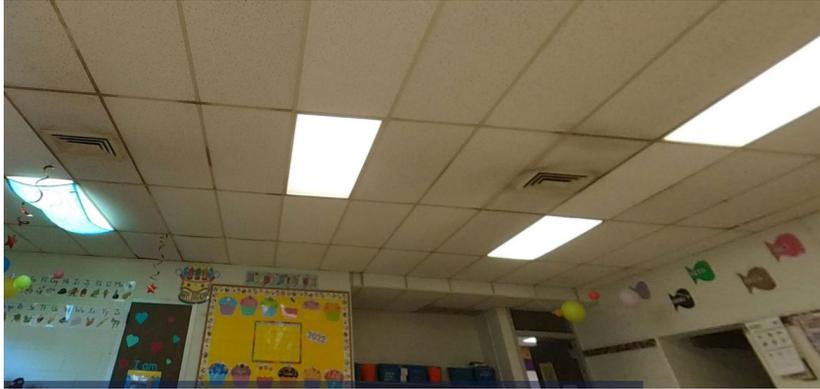
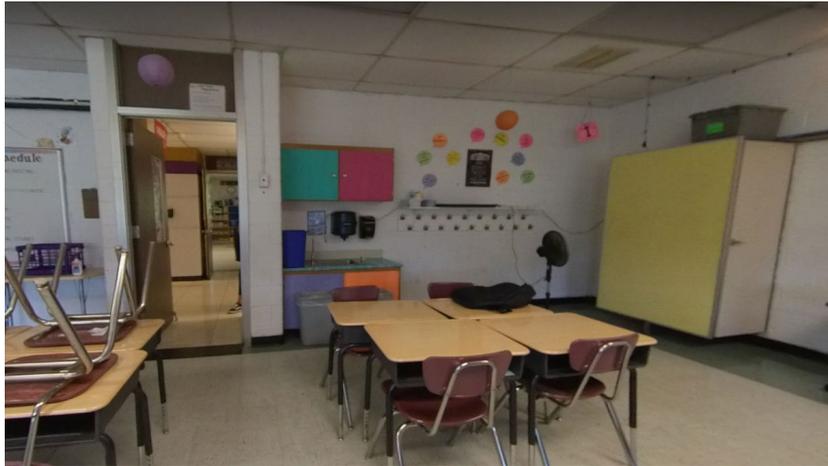
- ✓ Ceiling tiles need repair/replacement
- ✓ Gym bleachers need repair/replacement

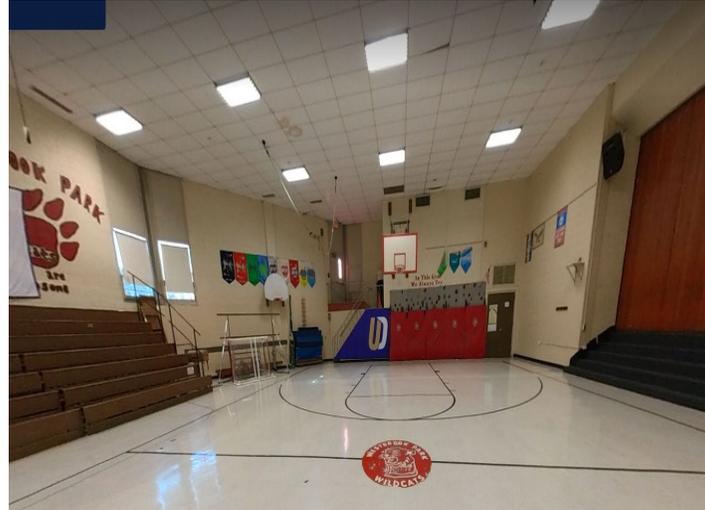
- ✓ Casework, carpeting finishes upgrade
- ✓ Non-ADA accessible door hardware

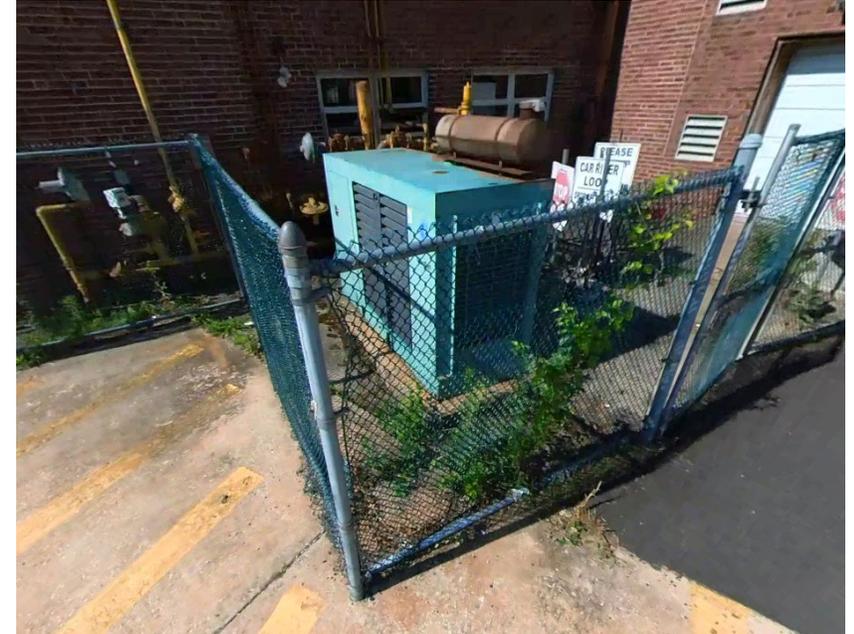
- ✓ Condensing units, electrical distribution, fire alarm system, PA/clock system, lighting fixtures equipment operating in a degraded condition
- ✓ Exterior doors ADA inaccessible
- ✓ Brick façade deterioration

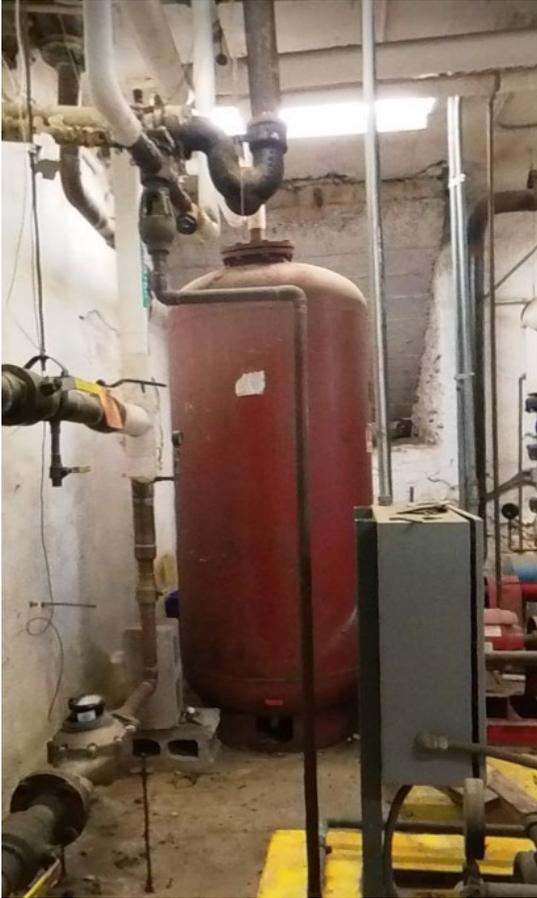
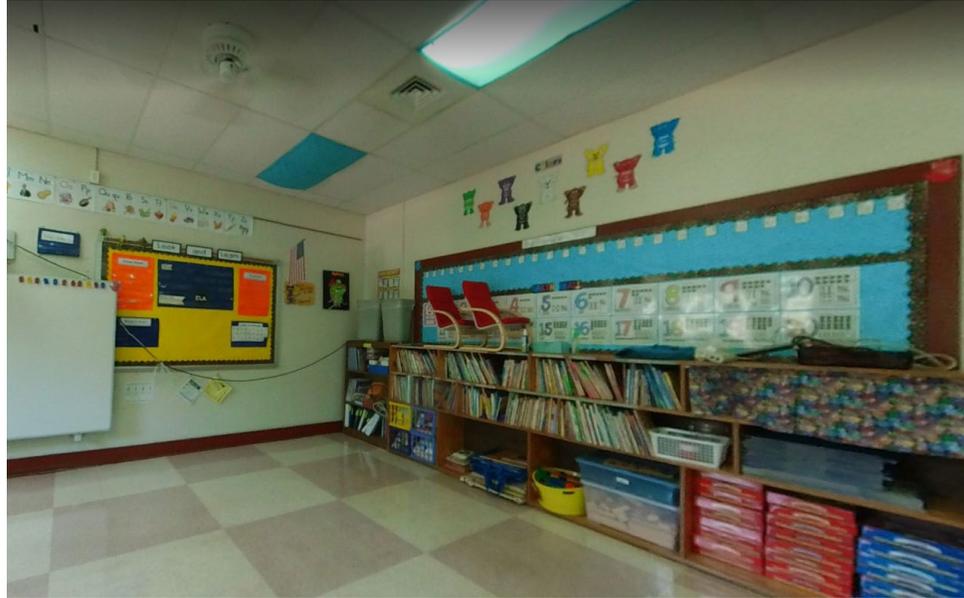
- ✓ Domestic hot water heater is excessively past useful life

- ✓ VCT has some gaps, consider repair / replacement in select areas
- ✓ Finishes upgrades throughout

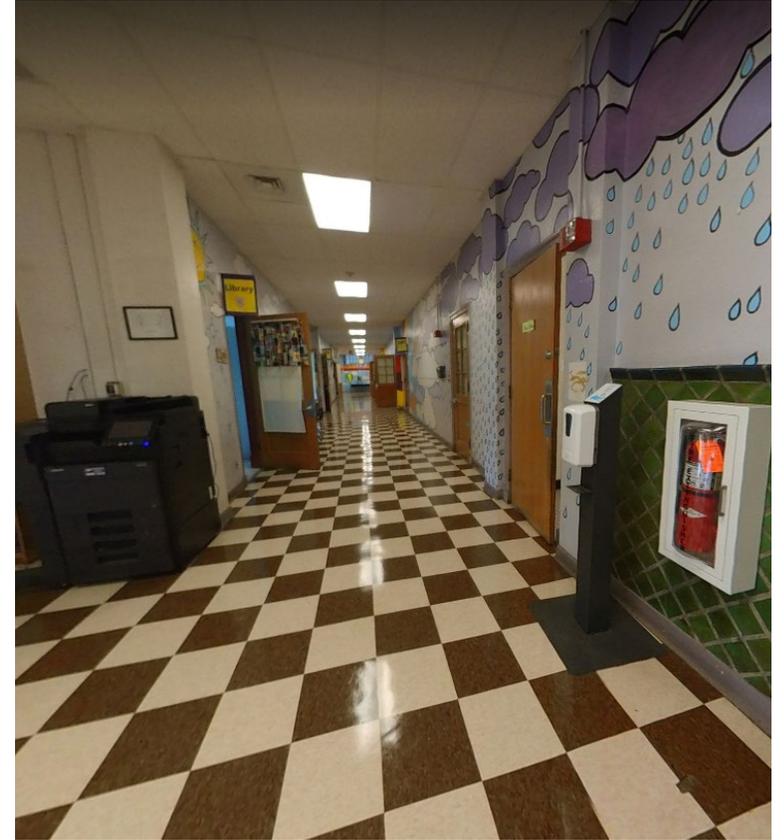
- ✓ Lighting, clock/PA/fire alarm, electrical distribution system equipment operating in a degraded condition
