FRANKLIN-MCKINLEY  
SCHOOL DISTRICT  
District Service Center

645 Wool Creek Drive, San Jose, CA 95112

## Franklin-McKinley School District Service Center - Master Planning Evaluation

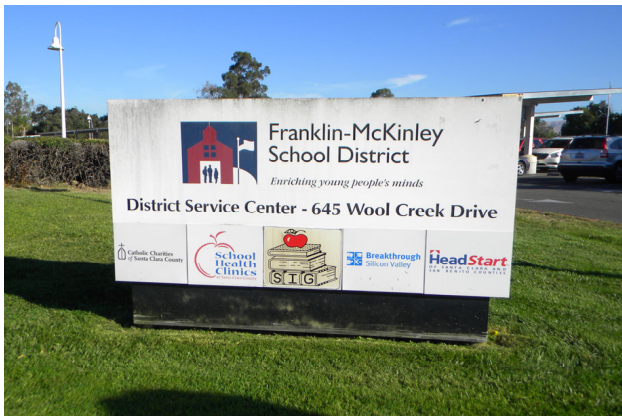
This complex consists of mostly single story spaces which include a printing dept., large

storage areas, large refrigeration spaces, the Business Center, Educational Center, textbook storage, a computer lab, several conference spaces and the Board room. There is a large two story area housing the Information Technology and other support facilities.

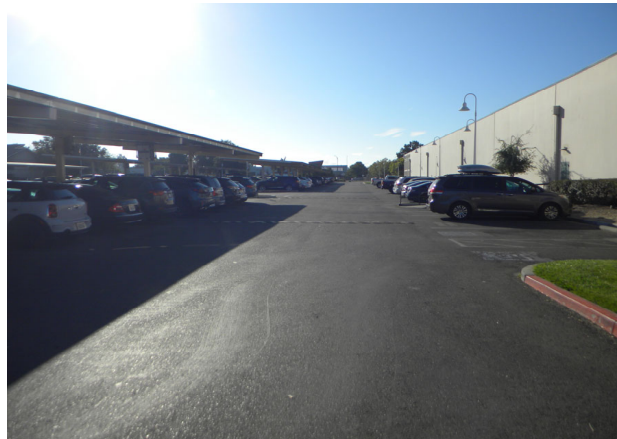
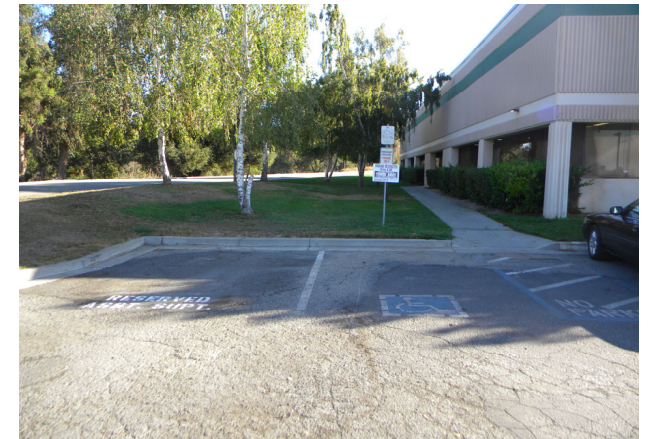
The Ed Service Department was recently modernized.

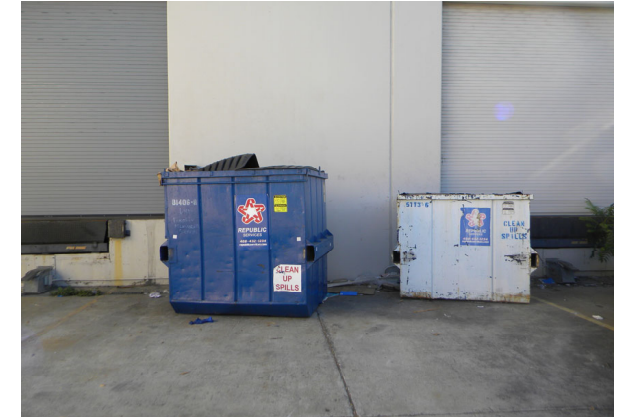
Although there is no current trash enclosure, the large garbage bins are stored at the loading dock which is adequate for the needs of the

Service Center. There is no need for upgrades at this time.

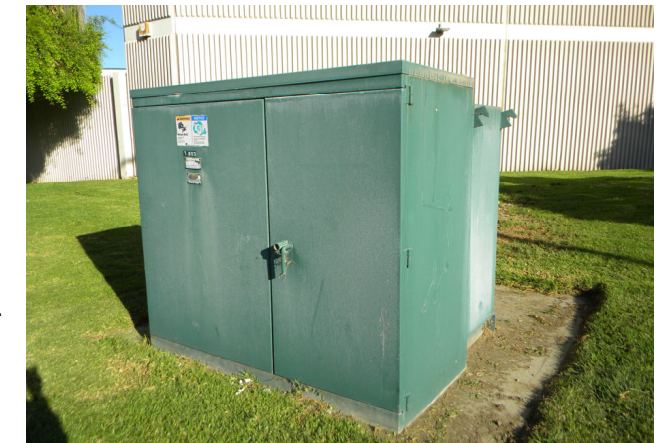
Underground utilities supplying gas and water to the site are over 30 years in age. These underground utilities are approaching their intended service life. Replacing the underground utilities will drastically reduce the need for ongoing

maintenance of these systems, however, there have been no known recent complaint about utilities servicing the site.

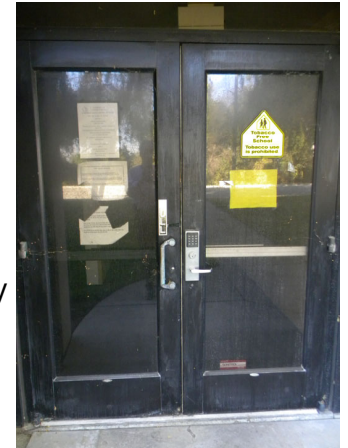
Generally the existing doors and hardware meet the minimal needs of the District. The main doors to the Service Center should be updated using the District Standard key pad and/or badge system.

It is recommended that the main front doors be retrofitted with new key pad per the District Standards.

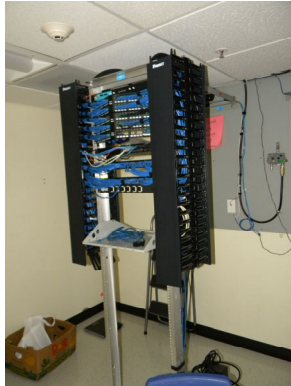
The current number of data drops does not meet the minimum district standards.

It is recommended that data drops be added to meet the District Standards.

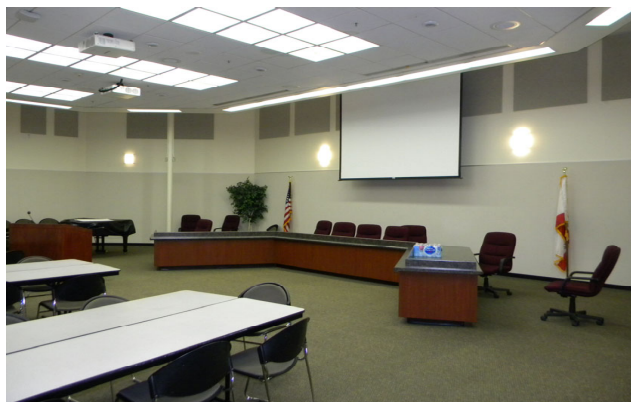
There is a computer lab set up in a central location. Computer labs were originally intended to allow for accessibility to the web and to teach keyboarding. The computer lab is not currently being utilized as a computer lab but being used more as a lecture conference center.

It is recommended that the computer lab be converted to a conference center utilizing the latest furnishings and technology that will serve the existing space more effectively.

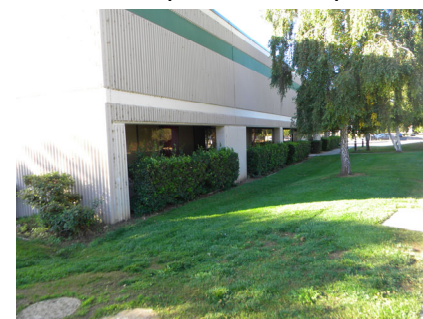
It would be desirable to add professional photographs of all of the District owned facilities and campuses in the board rooms and scattered at public spaces throughout the Service Center. It would be ideal to add a covered shade structure near the front of the DSC.
