# FMSD M.O.T. Yard

420 Tully Road, San Jose, CA

## FMSD Maintenance Operations and Transportation (M.O.T) - Master Planning Evaluation

### **Evaluation Summary**

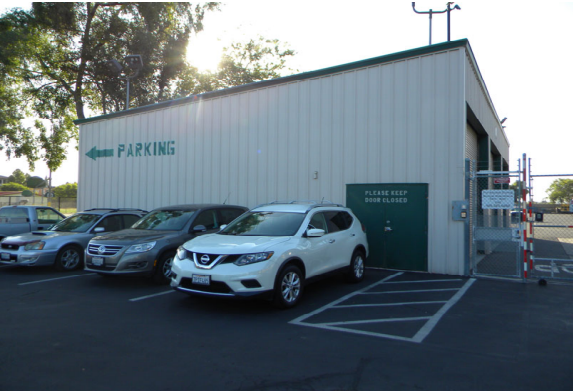
better known as the Corp Yard, is shared on the existing Franklin Elementary School site at 420 Tully Road, San Jose, CA. The maintenance yard is a fully enclosed area that house a series of warehouses for maintenance and storage as well as a portable building housing of-office space for the employees.

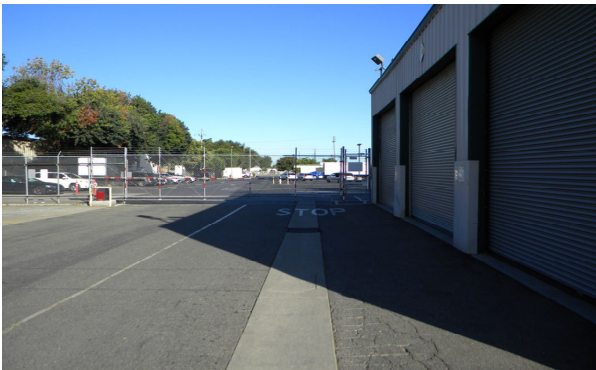
There are no known site utilities issues at this time.

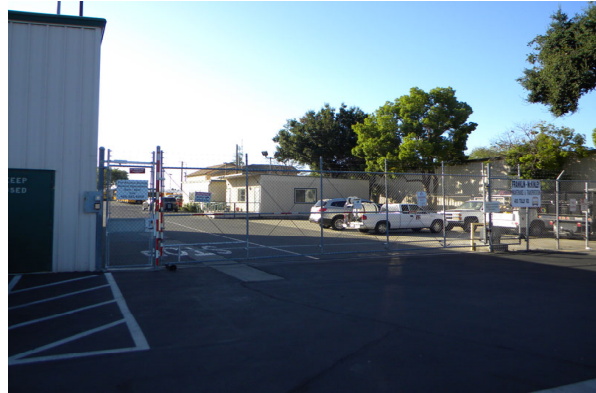
This site has adequate electrical service to this site.

There is no need for additional electrical upgrades to the service.

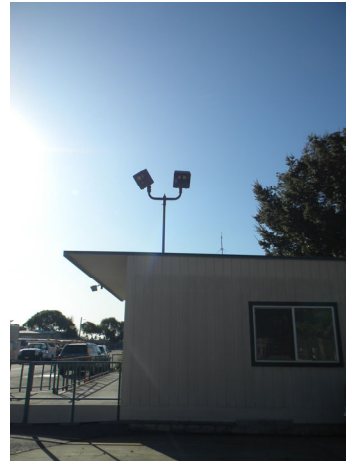
There are no known site drainage issues at this location.

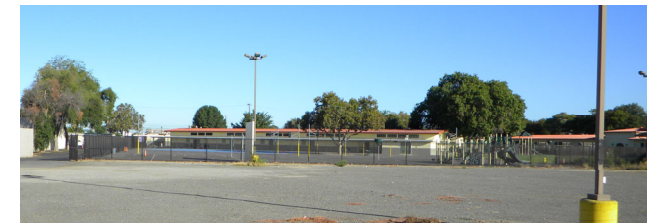
These maintenance buildings were installed complying with the code requirements at the time of installation.

It is recommended that should any of the existing be altered or relocated or reconstructed, that a structural engineer reevaluate the structural system and create a plan for voluntary seismic upgrades at that time.

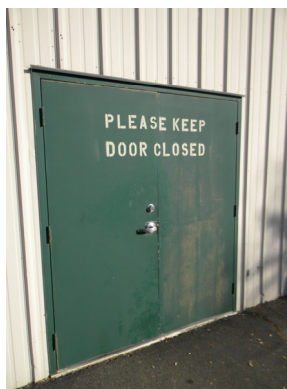
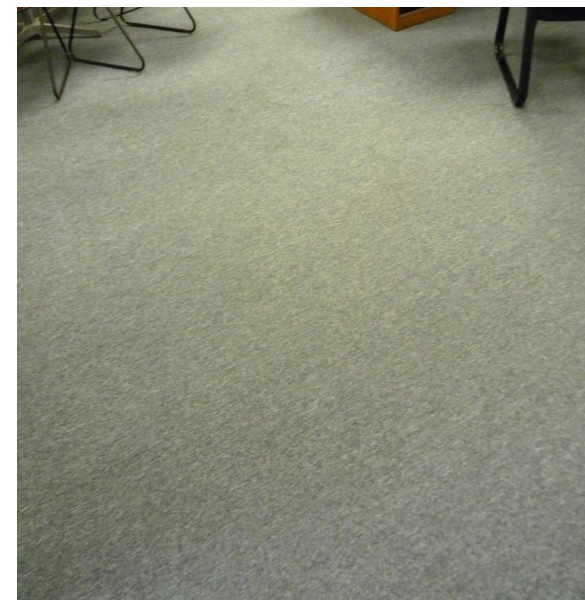
Most of the flooring is on good condition and

does not need upgrades at this time.

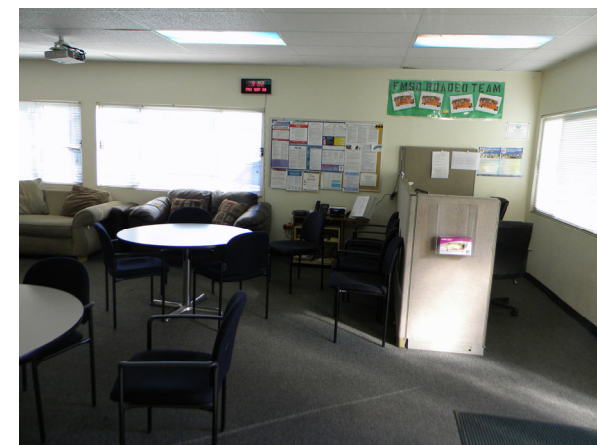
Interior wall finishes are in good condition at this time. There is no need for updating interior wall finishes at this time.

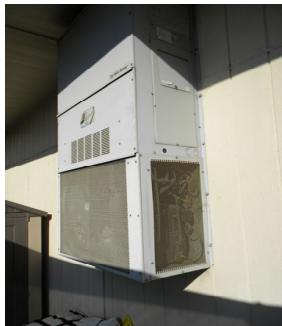
Many of the larger warehouse spaces do not require AC units. The smaller staff rooms have

heat pumps which are working in fair condition.

There is no known reason for replacing current HVAC systems at this site.

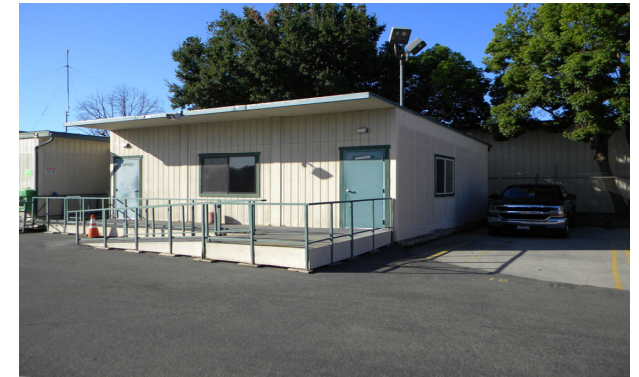
The existing portable buildings are in good con-

dition and do not need to be upgraded at this time.

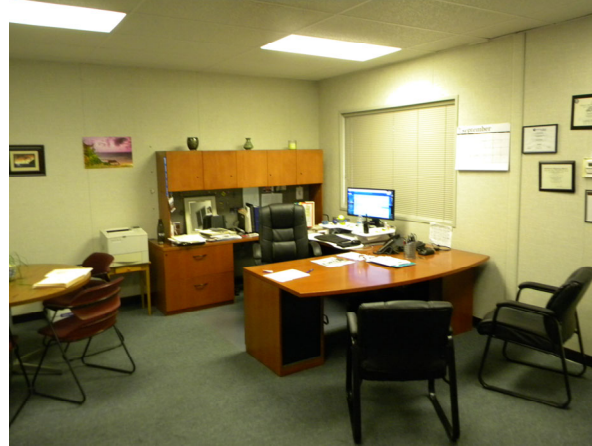
The administration area which is composed of office space and a reception area is in good

condition.

There is no need to upgrade finishes at the administrative spaces.

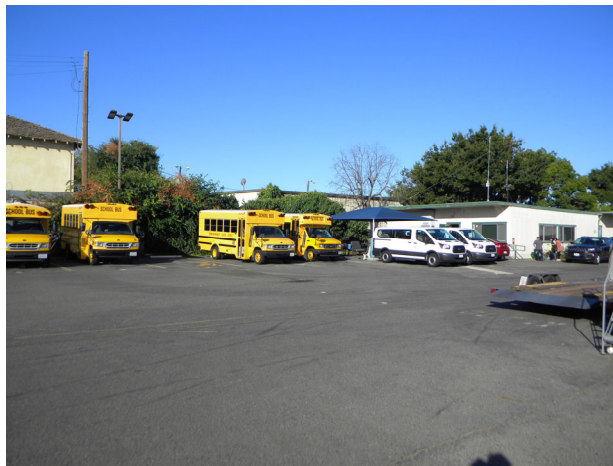
Although there are no covered walkways at this site, it is unlikely that the need for covered walk-

ways ranks at the top of the list for needs within the District.

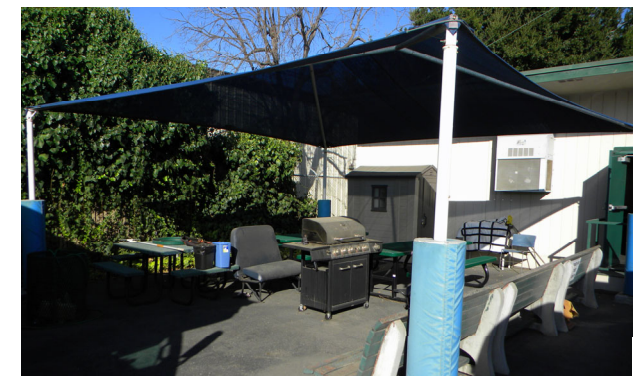
There is an existing covered fabric structure

used by the staff as a lounge and work area outside. The structure appears to meet the needs of the site at this time.
