**AHERA ASBESTOS  
INSPECTION REPORT**

**C.I. WAGGONER ELEMENTARY SCHOOL  
1050 EAST CARVER ROAD  
TEMPE, ARIZONA 85284**

Dominion Project Number: AZ1418.36

AHERA Inspection Date: June 4, 2025

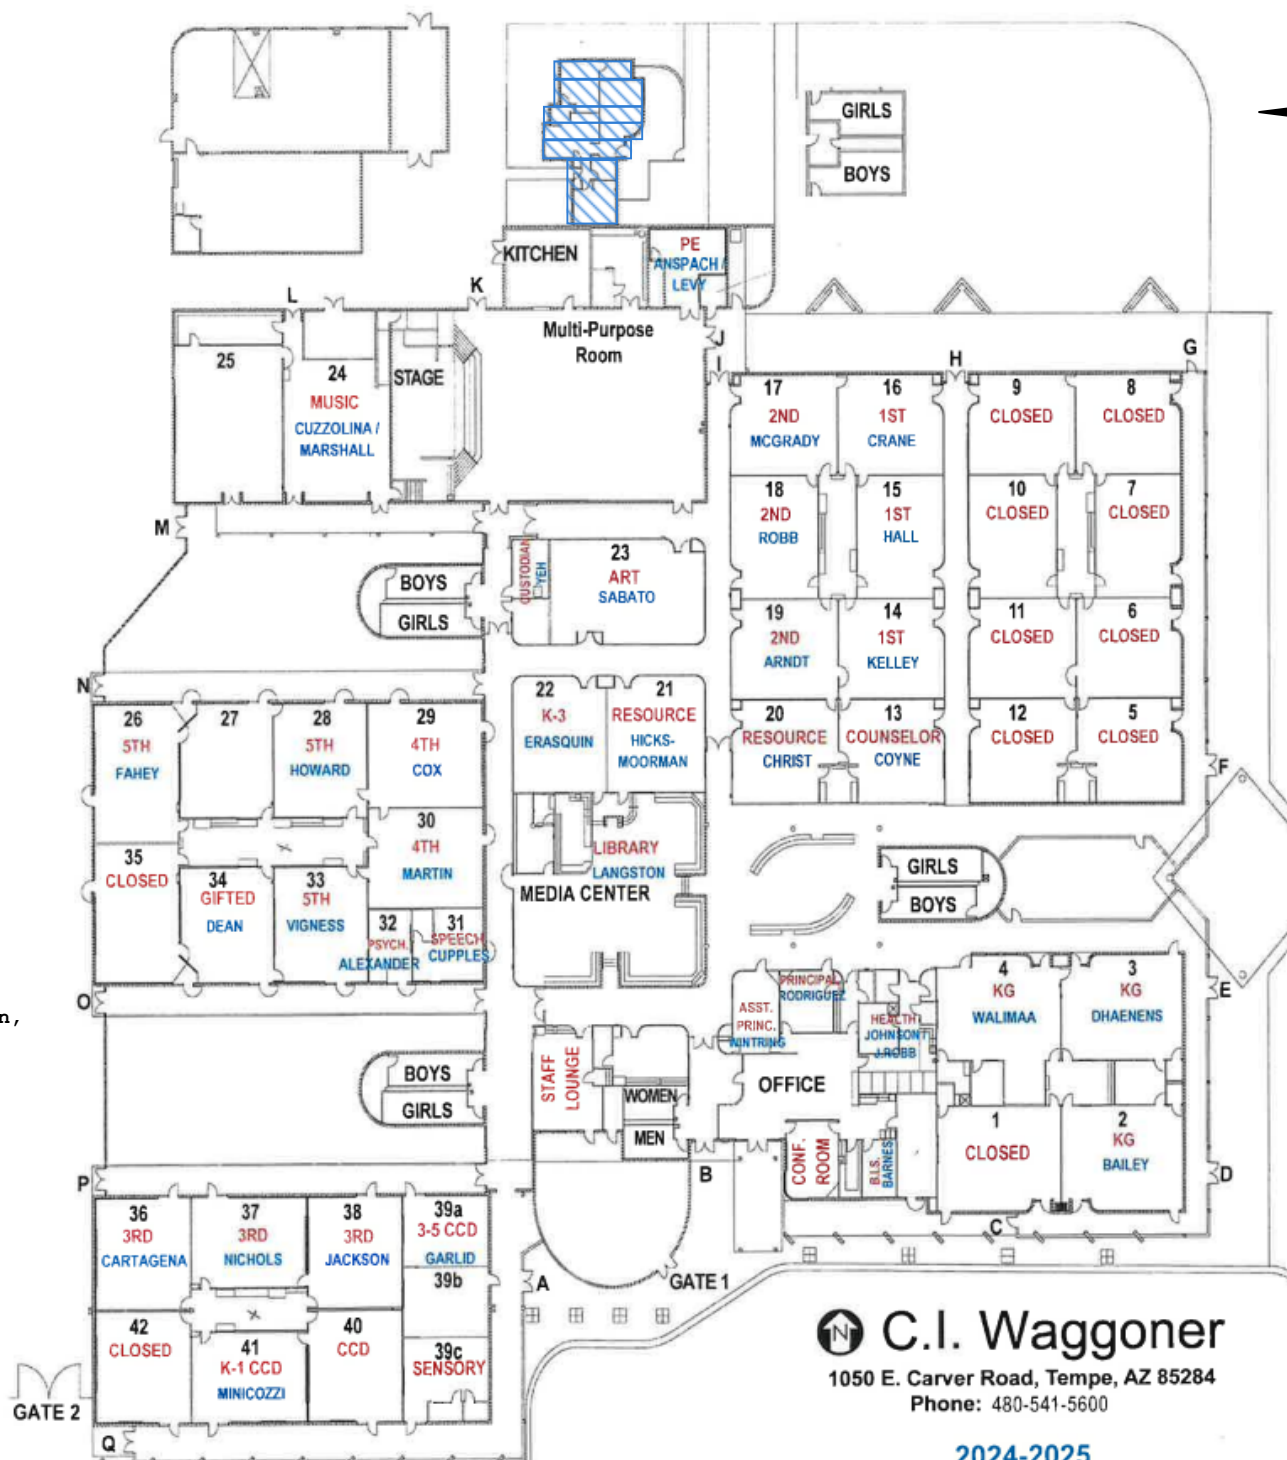
#### Assumed Asbestos-Containing

Silver Duct Wrap & Insulation,  
Silver Flex Duct & Insulation,  
Large Silver Duct Wrap  
& Insulation,  
Large Silver Flex Duct Wrap  
& Insulation,  
Pipe Wrap, Mastic, & Insulation,  
Black Foam Pipe & Insulation,  
& Pink Wall Insulation &  
Backing

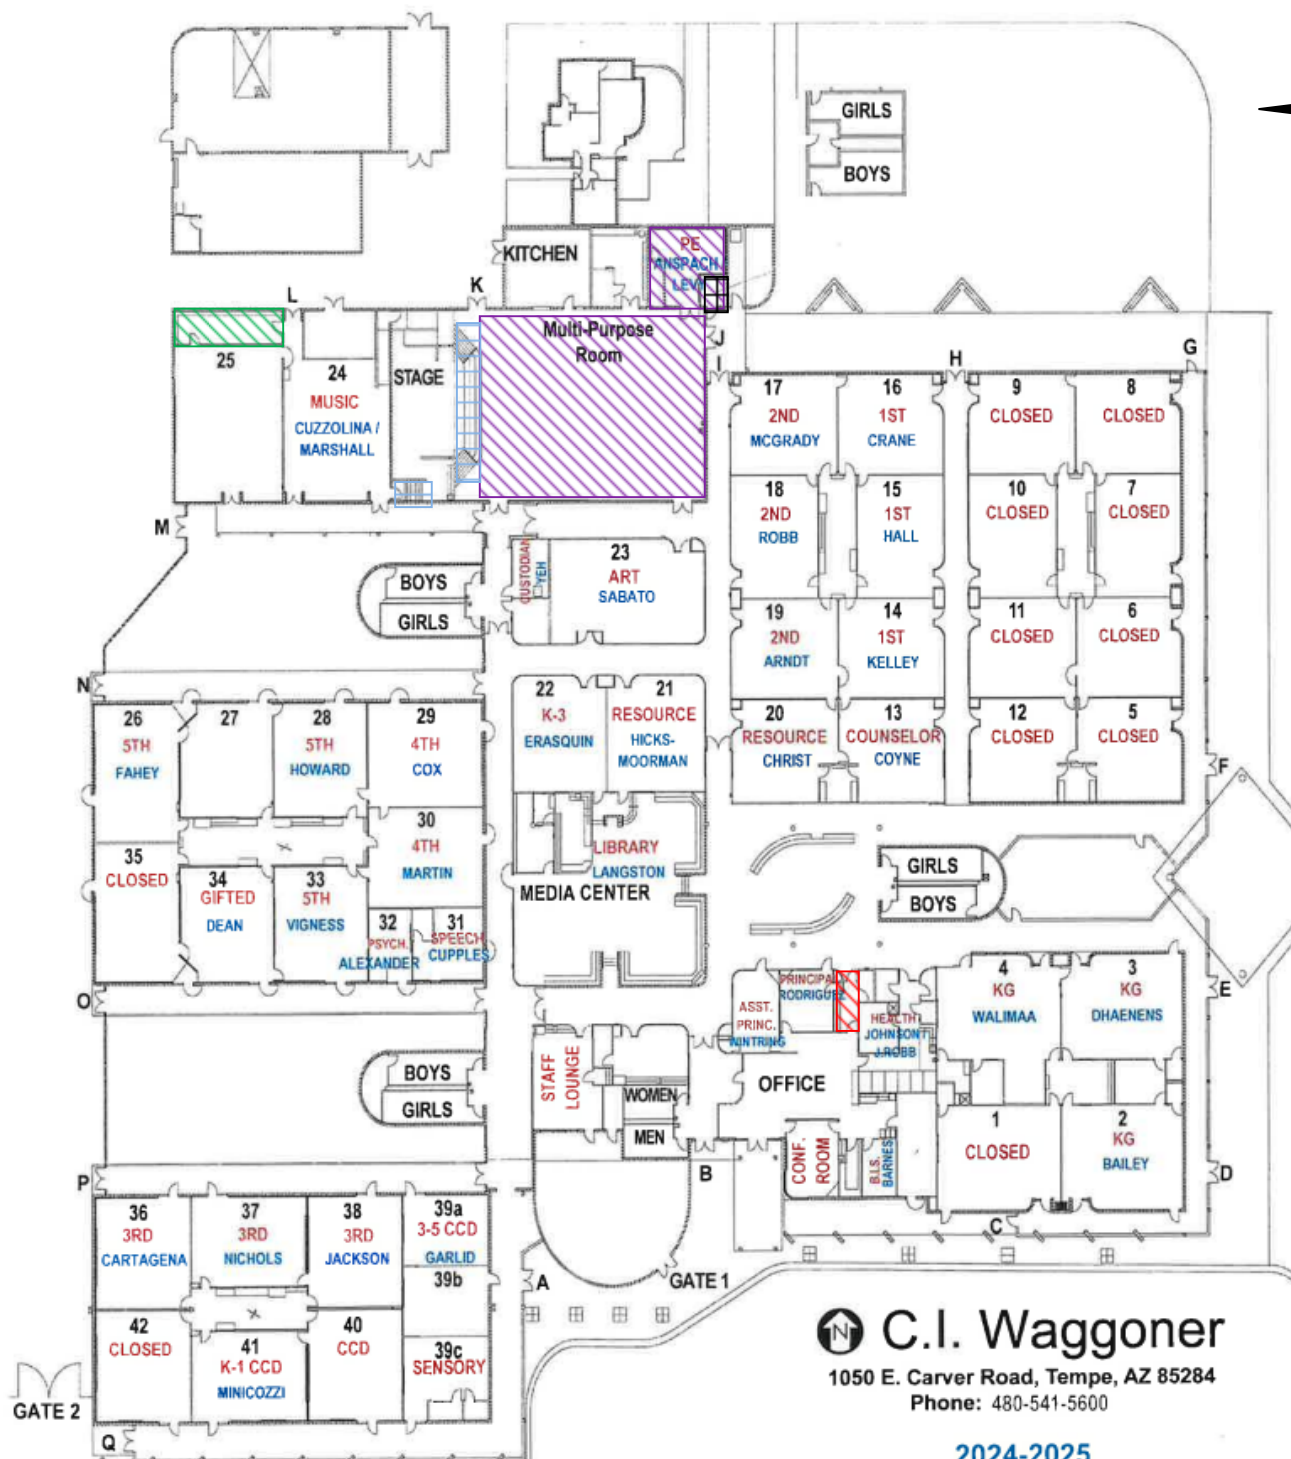
Main Building

Assumed Asbestos-Containing  
Tan 12" x 12" VCT & Mastic
