## GREENWICH PUBLIC SCHOOLS PERFORMANCE PLATFORM STAGE FACILITY ASSESSMENT

**GREENWICH PUBLIC SCHOOLS  
290 GREENWICH AVENUE  
GREENWICH, CT 06830**

**25558.00**

**June 27, 2025**

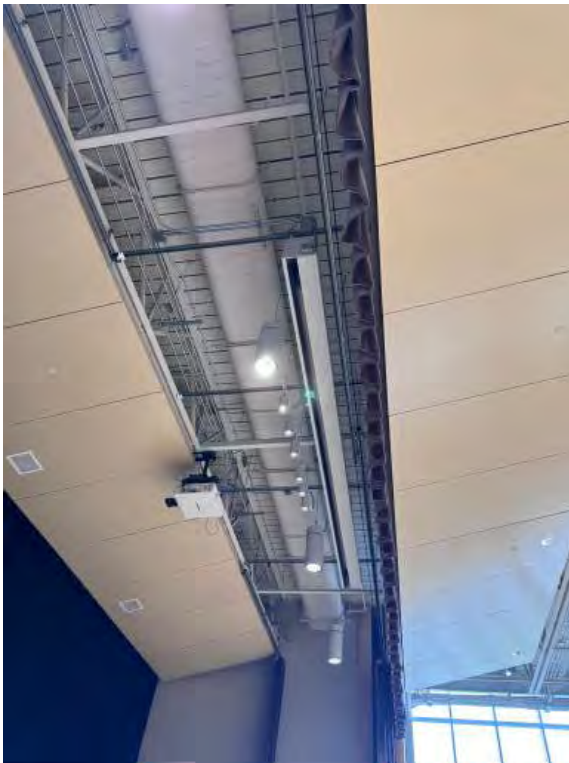
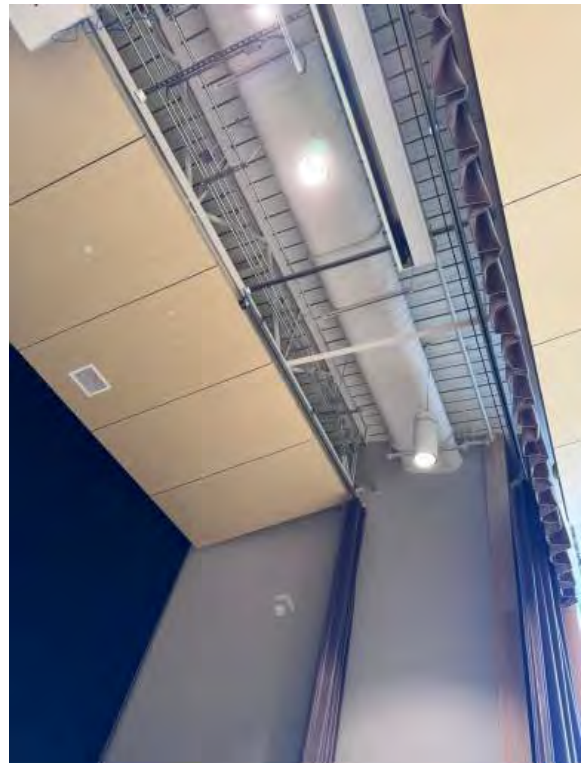
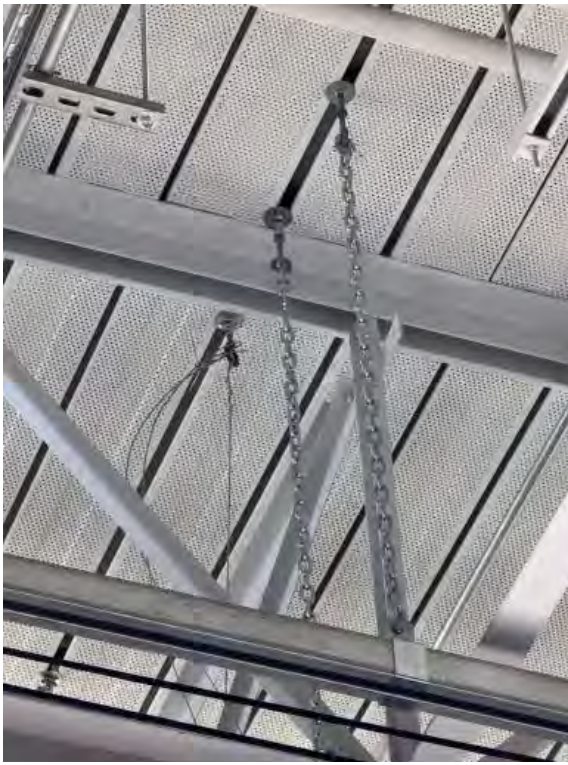
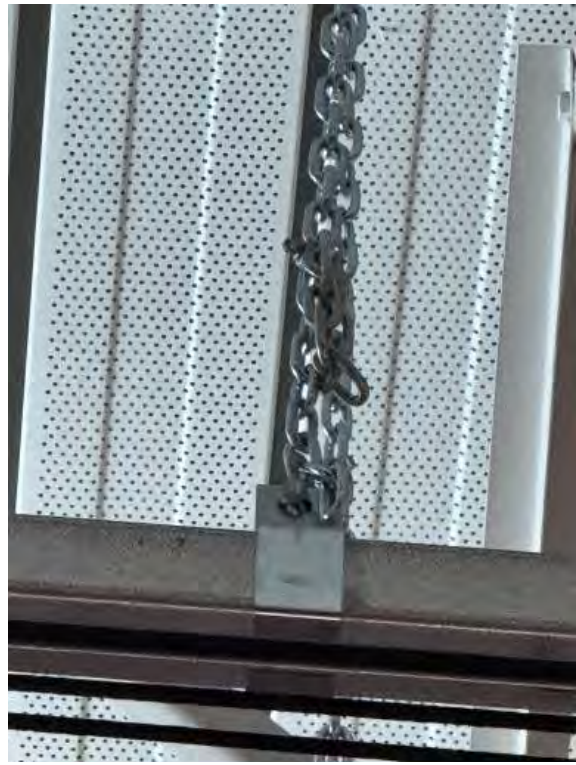
Lebanon School has a basic rigging system consisting of a valance, front main traveller curtain, side leg curtains on tracks and a rear traveller track. The front traveler track were in good working order. The front traveller floor pulley was missing the center bolt. The rigging is connected to a ceiling track system that is atypical for theatrical rigging, however, given the weight of the curtain tracks, I think this is an acceptable connection. Track connection rigging is acceptable but messy and should have excess chain removed. The lighting system on stage is architectural lights and offers little performance flexibility.

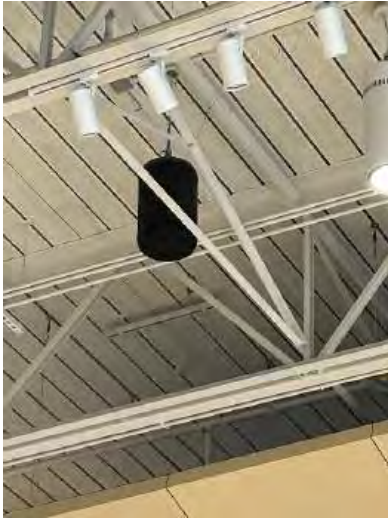
Image #1

The current system is a digital distributed speaker system with pendant speakers positioned in the ceiling throughout the room facing downward. ( see image #1). A wall mounted touchscreen controller is functional on stage with limited control features programmed in it (see image #2) The equipment is housed in 2 small open wall mounted racks in closet (see image #3)

1. The speaker arrangement is meant more for general PA use in the room and not for theatrical stage performances.
2. There are no wireless microphones presently installed in the system.
3. The equipment is exposed and unprotected in the storage room environment. (see image #3)
4. The equipment racks are not professional wired (see image #4)

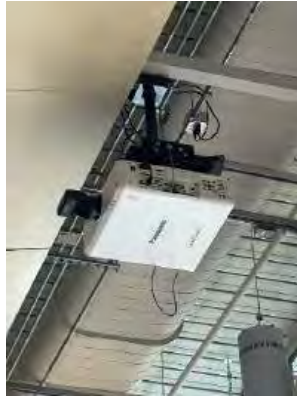
Image #5

The current video projector is a lamp based rear projection system on stage. (see image #5)

1. The current lamp-based projector has a flashing error light indicating it's in need of repair or replacement.
2. The lack of a proper HDMI input on stage will result in HDMI wires being draped along the stage floor for video connections.

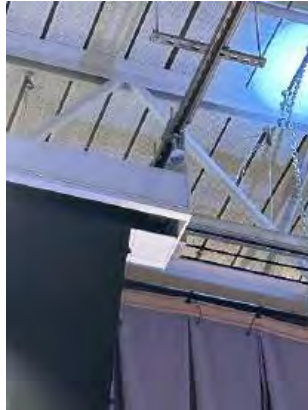
Image #6

The rear projection screen is an appropriate size for the room and is properly mounted to the building structure (see Image #6)

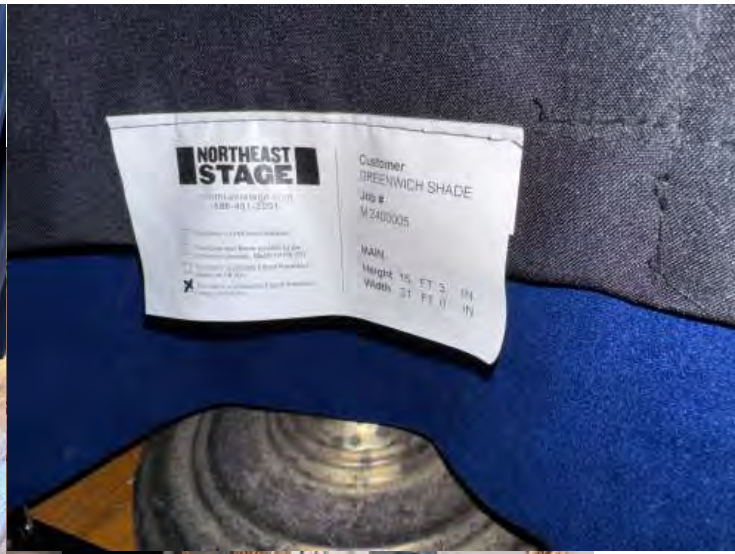
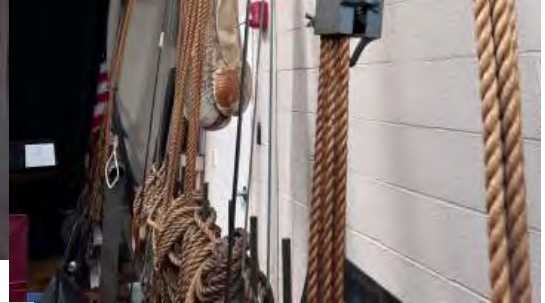
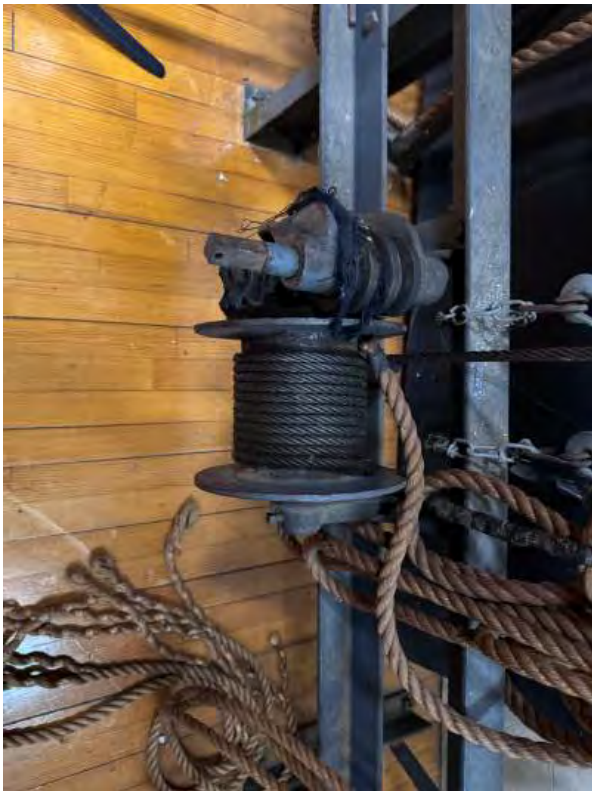
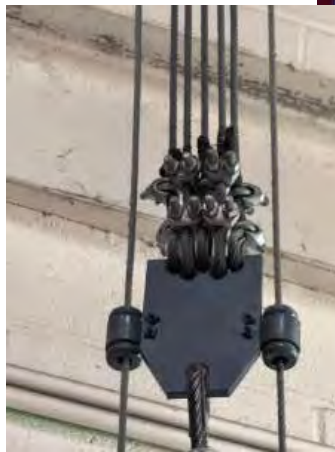
Western School has a full rigging system consisting of a valance, front main, mid and rear traveller curtain, side leg curtains on tracks and a rear traveller track. The front traveler track is improperly rigged with unrated chain

the carriers and pulleys are worn and need replacement. Several of the support battens are undersized and should be replaced. The most critical issue is the old hemp system. The system should be removed as soon as possible. The hemp rope can fail given the age of the system. The lines are not properly secured to the pin rails. The biggest risk is improper use of the system. The lines don't have a safety system preventing the lines from running if untied from the pin rail, this could lead to a batten crashing on the deck. The electric lift winches lack

In summary, the rigging systems has several critical issues. The hemp system due to age or improper operation could lead to serious injury. The hand crank winches on the electrics lacks a redundant brake system. The tracks need to be rigged with new carriers, pulleys and rope. Several of the battens are improperly sized and rigged with unrated chain. The front torarms are not up to current industry standards. A significant number of the drapes are worn, damaged and need replacement. I would recommend that any battens hanging on the old hemp system be dead hung from the beams and the hemp be removed from use until the rest of the systems can be brought to current standards.

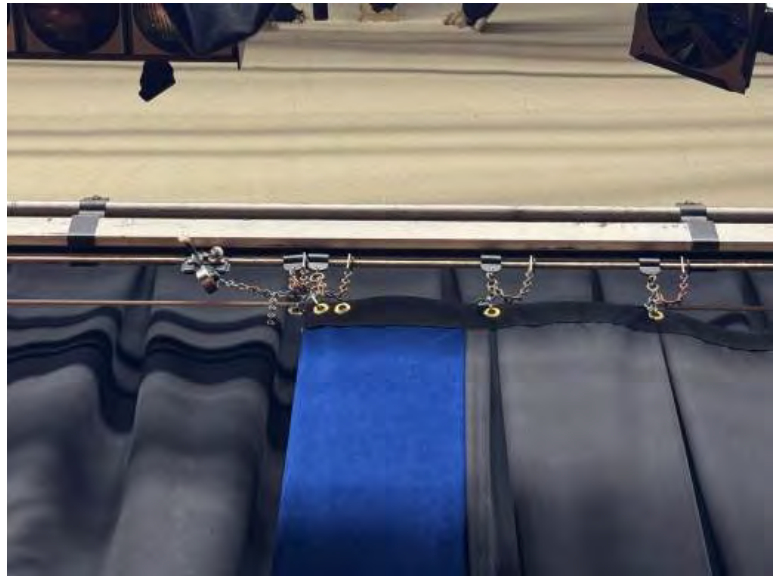
The drapes are listed as inherently and permanently flame retardant. Drapes appear worn and several of them are torn or stained. A significant number of them need replacement

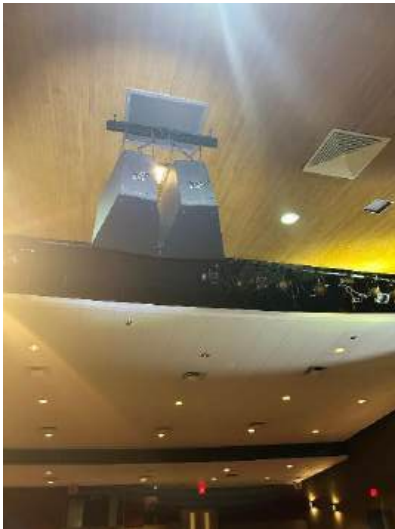
Image #1

The current system is an analogue point source speaker system which is common for an auditorium of this size.  
(see image #1) when it was installed, it had all the common features found of its time. ie: cassette players, CD decks etc.  
(see image #2)

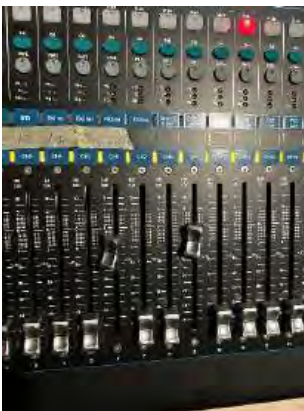
Image #3

1. The age of the system is the main deficiency, its age is approximately 23+ years old
2. The mixing console has been upgraded since the original installation but has been damaged.  
(see image #3, 4)
3. All the equipment in the rack is obsolete analog equipment
4. The system does not offer wireless hearing-impaired units as per required by ADA
5. The eyebolts that the main speakers are suspended from have heavy oxidation for reasons unknown
6. (see image # 5)

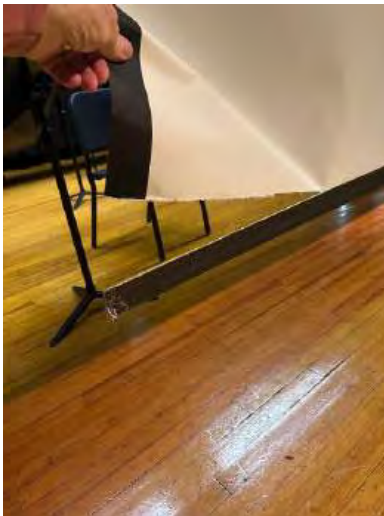
Image #6

1. The projection screen is old and damaged beyond repair (see image # 6)
2. The projection screen is suspended via chain wrapped around 1 1/2" pipe ( see image #7)
3. The projection screen fly points are wrapped around structural ceiling beam and does not meet current ANSI codes. (see image #8)

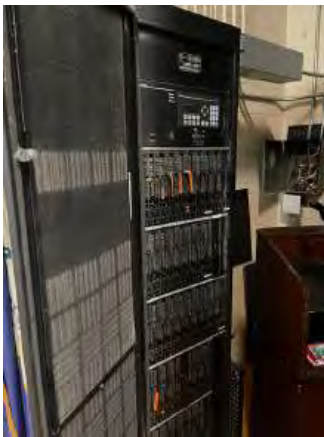
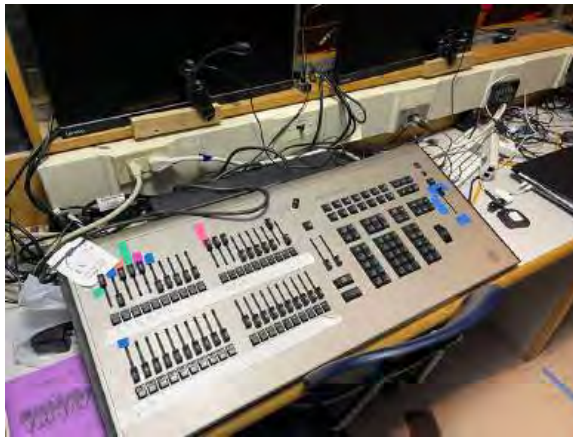
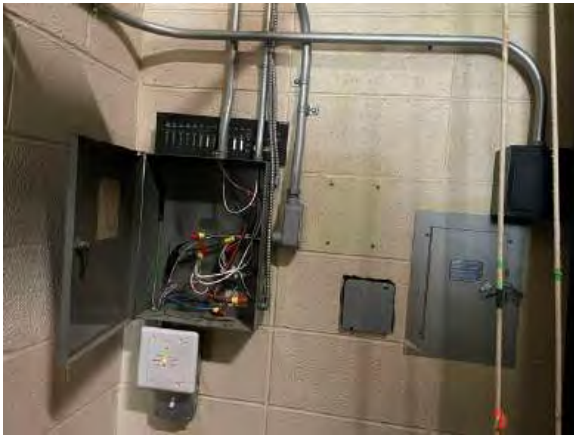
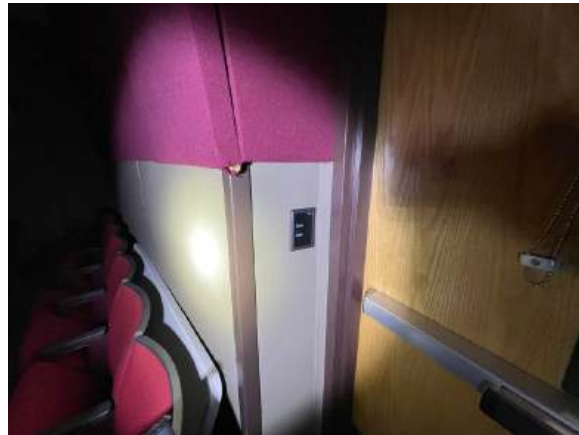
The stage lighting system has FOH positions, Torm positions, and three electrics on stage. The dimming system is a Lehigh dimming system with 60 dimmers. The control console has been updated to an ETC Element since the original installation. There are architectural controls that are inoperative.

Existing Lehigh dimming system and controls should be replaced with a relay based system, along with modern power distribution. Installation of touchscreen controls, so that the theatrical lighting systems can be operated without the use of a control console, for day to day activities. Entry stations should be replaced as part of the updated control system. DMX networking and controls should be installed for the new LED systems.

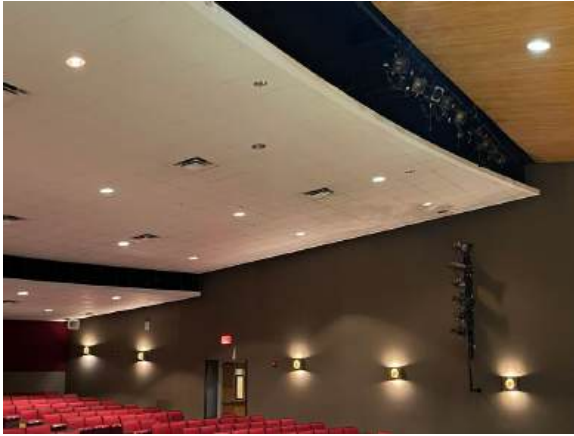
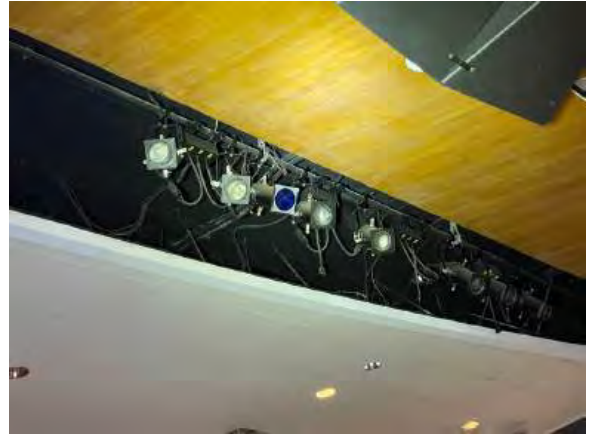
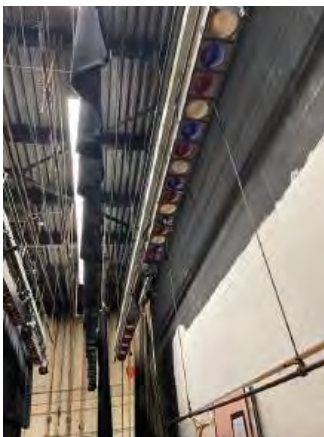
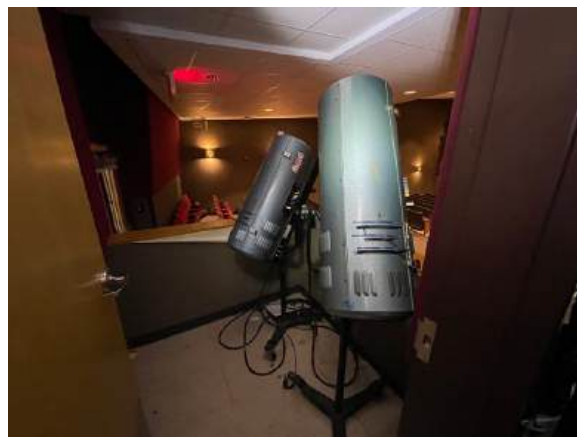
The lighting fixtures are obsolete Altman ellipsoidals and fresnels. Many of the lighting fixtures need to be re-lamped or require other maintenance. There are also incandescent strip lights on stage. Two incandescent follow spots require maintenance and re-lamping.

***Recommendation:*** A full system upgrade with theatrical LED fixtures, which will offer increased capabilities. These capabilities include power and HVAC savings, color changing features, and reduced maintenance. Follow spots should be updated to LED follow spots.

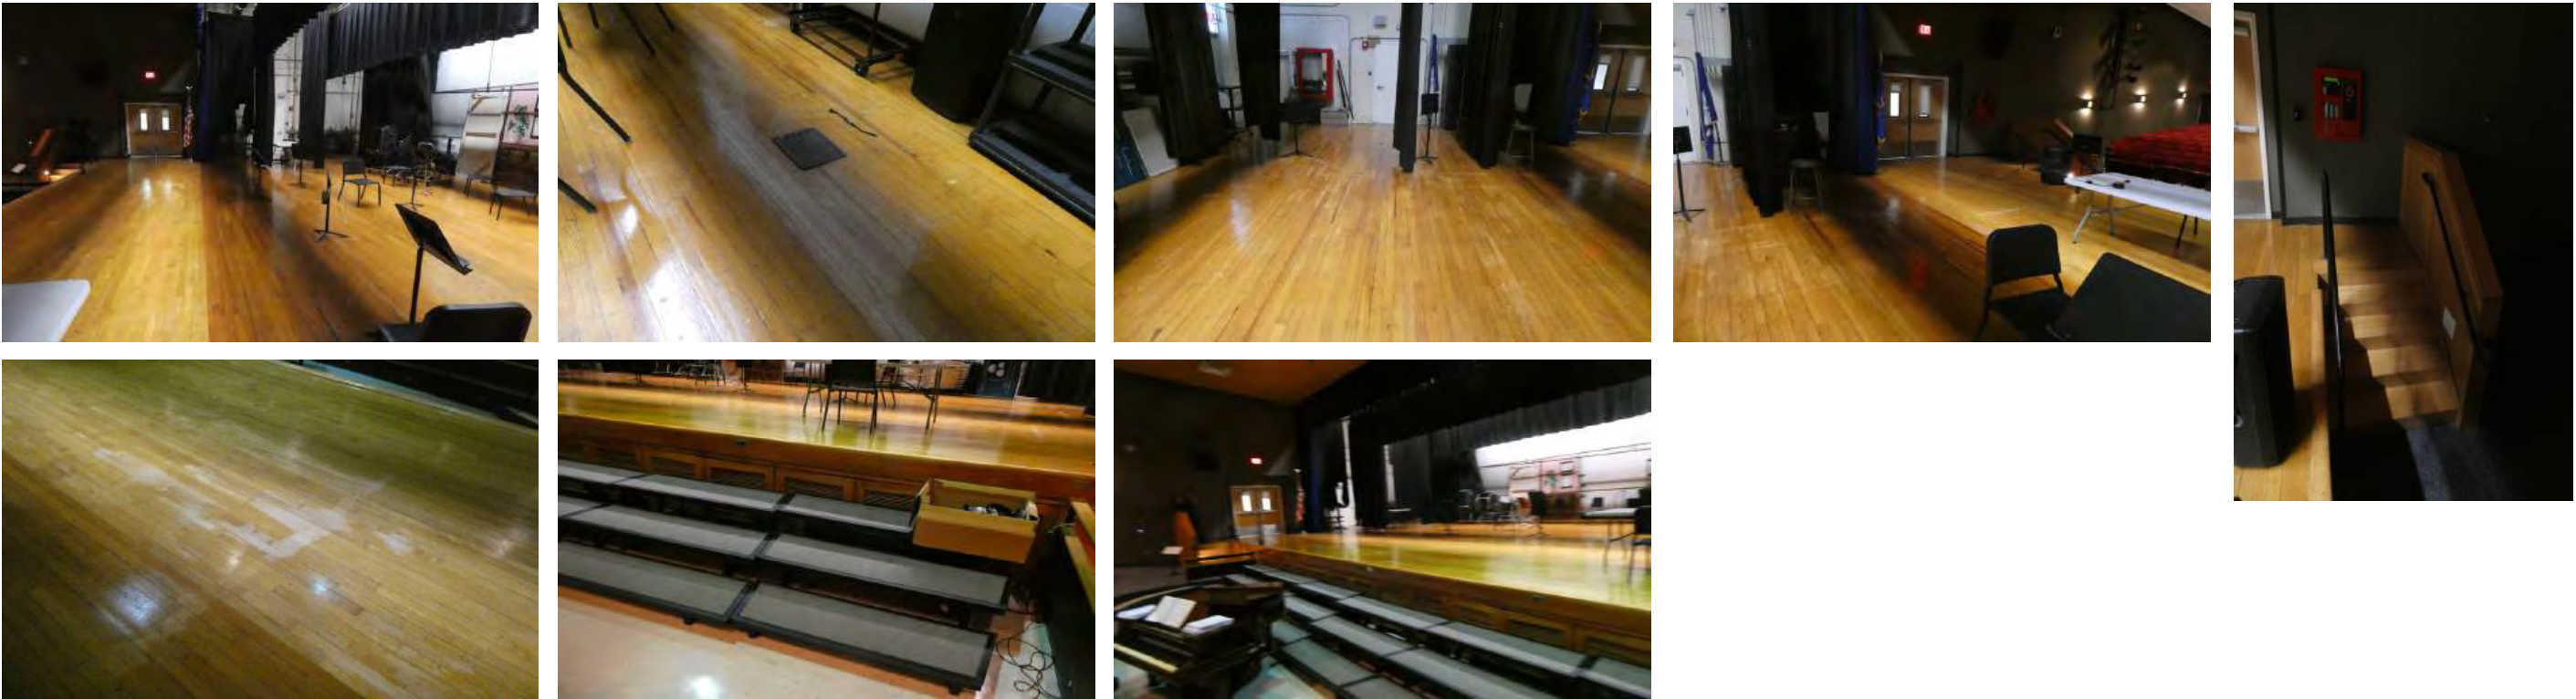
Stage and Stairs

| Observations | Level of<br>Compliance 1-<br>10 | SQFT | Wall<br>Height | Finish<br>Material | Comments | Cost |
|---|---|---|---|---|---|---|
| Trip Hazards: [Document gaps, cracks, or protruding elements] | 5 | | | | One black box center stage - provide beveled trim | |
| Surface Damage: [Assess scratches, dents, warping] | 7 | | | | Medium wear, gets yearly summer bruch and coat, front of stage added to in 2006. Refinish completely in 2-3 years | |

| Recommendations for Repair or Replacement: [List suggested actions if issues are found] | | | | | Refinish stage - in 2 to 3 years , repair tripping hazard shortly | |

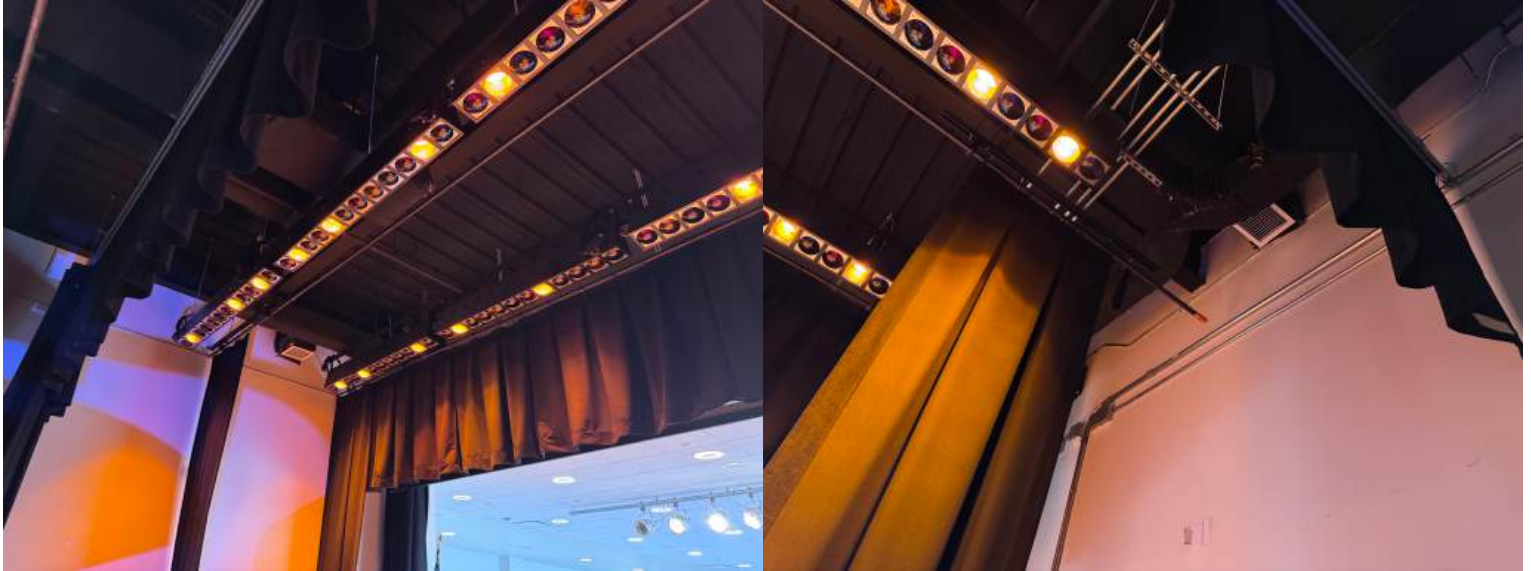
Hamilton Ave School has a basic rigging system consisting of a valance, front main traveller curtain, side leg curtains on tracks and a rear traveller track. The front traveler track were in good working order but operations stiff and should be updated. The supporting rigging pipes are undersized and not installed to current standards. Supporting unistrut was installed upside down.

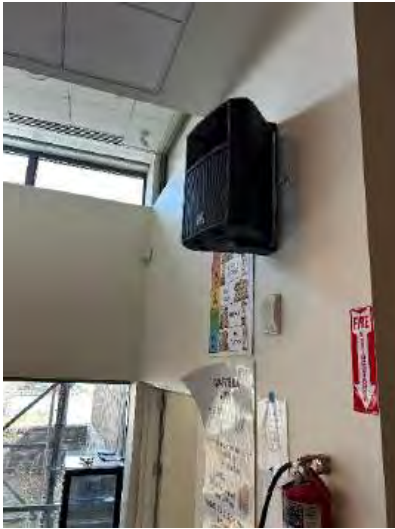
Image #1

The current system is an analogue point source speaker system which is common for an auditorium of this size. (see image #1)

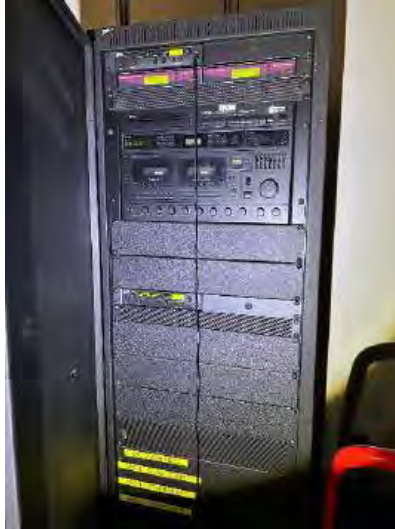
Image #2

When it was installed, it had all the common features found of its time. ie: cassette players, CD decks etc. (see image #2)

1. The age of the system is the main deficiency, its age is approximately 23+ years old
2. All the equipment in the rack is obsolete analog equipment

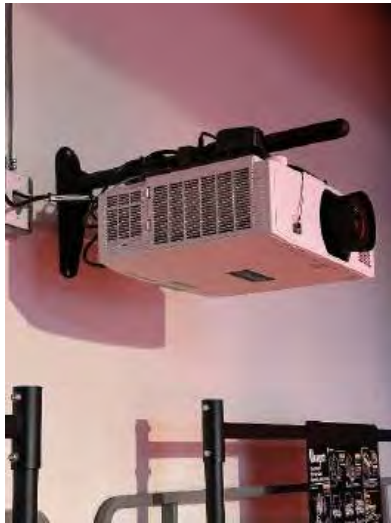
Image #3

1. The projector is an old-style lamp-based model (see image # 3)
2. The projection screen is an obsolete square format image (see image #4) The tension strings are snapping.

1. The video projector should be replaced with a new Laser rear projection unit to avoid costly lamps changes and filter replacements.
2. The video projector screen needs to be replaced.

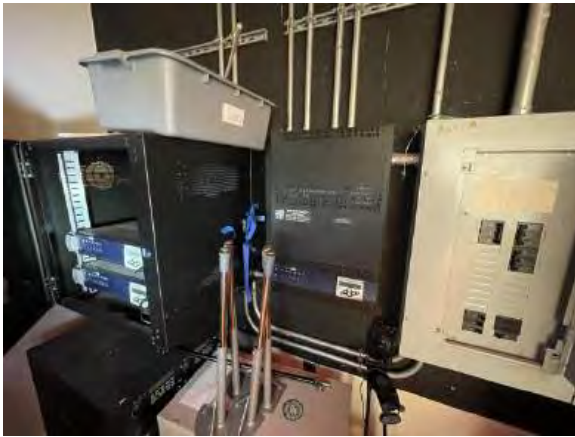
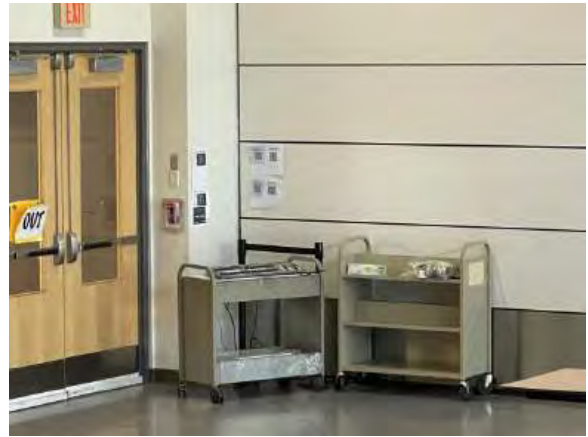
The stage lighting system has a Front of house position, and two electrics on stage. The dimming system is a ETC SmartPack dimming system with 18 dimmers. The control console is a ETC SmartFade console. There is one architectural control station on stage.

Existing ETC dimming system and controls should be replaced with a relay based system, along with modern power distribution. Installation of touchscreen controls, so that the theatrical lighting systems can be operated without the use of a control console, for day to day activities. DMX networking and controls should be installed for the new LED systems.

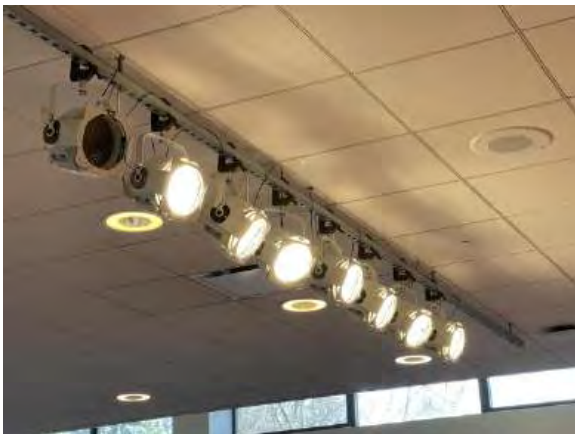
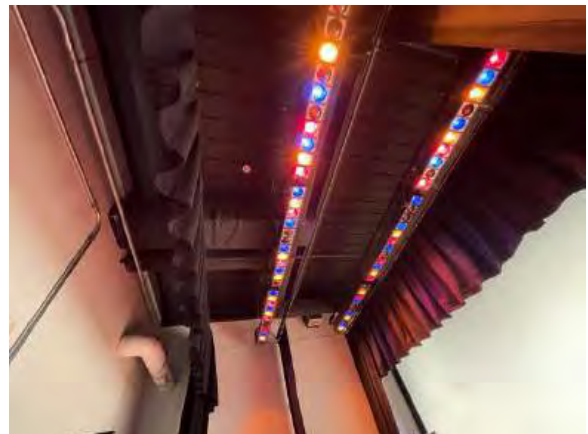
The lighting fixtures are ETC SourceFour PAR's mounted on a front of house Unistrut beam. There are also six Altman border lights (strips) on two electrics on stage. C-clamps are designed for mounting on 1 1/2" schedule 40 pipe. One or more lamps were out and in need of replacement.

***Recommendation:*** A full system upgrade with theatrical LED fixtures, which will offer increased capabilities. These capabilities include power and HVAC savings, color changing features, and reduced maintenance. LED Follow spots should added to the lighting system.

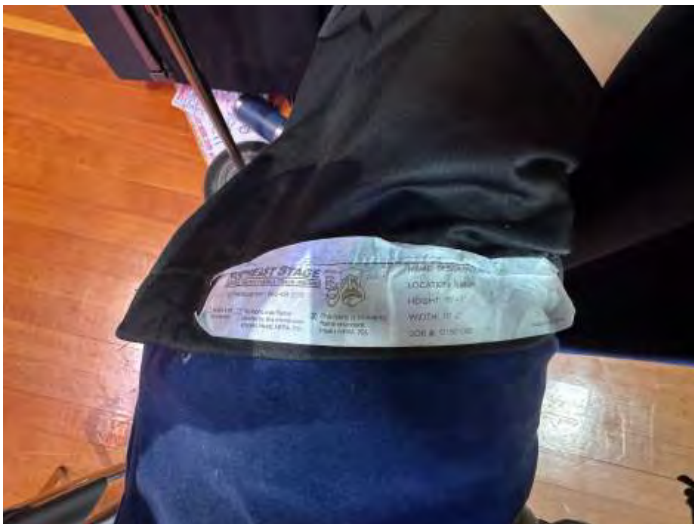
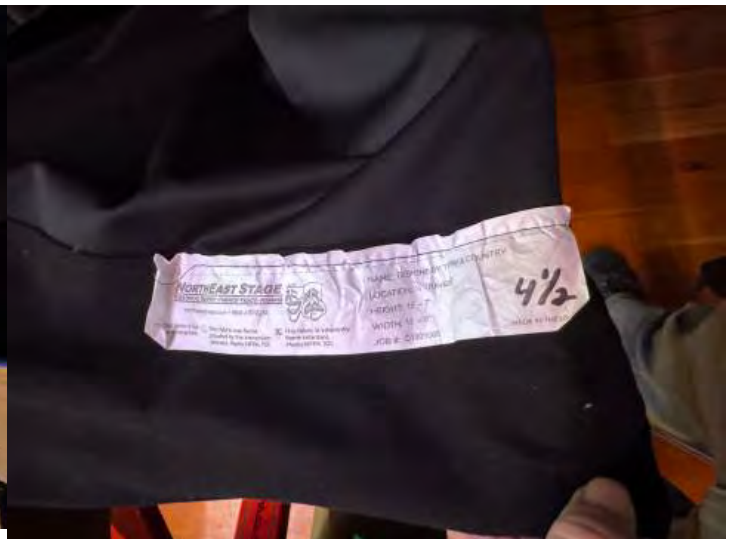
Julian Curtiss School has a basic rigging system hung from the building on steel I beams. All of the rigging is not up to current or acceptable industry standards and should be replaced. Current layout consists of a front main traveller curtain, valance, side leg curtains and a rear traveller tracks. The rigging on all of the tracks is in need of replacement. Several of the curtain pipes are undersized and hanging from chain and connections that are not rated for overhead use and should be replaced. Unrated chains are running through the beams and need to be replaced with rated beam clamps.

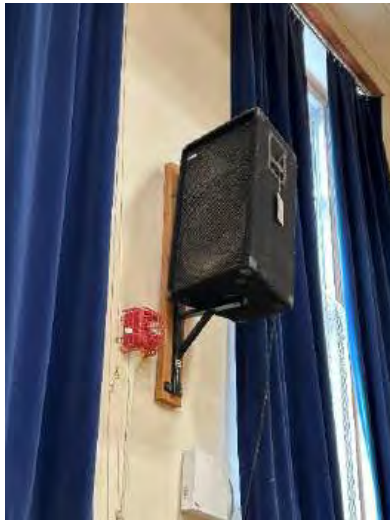
Image #1

The current system is a digital point source system which is common for a room of this size. ( see image #1 & 2)

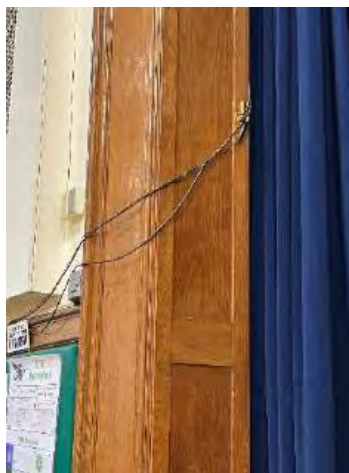
Image #4

1. The age of the system is the main deficiency; it is approximately 25 + years old
2. The system has two different types of speakers. The first set are home audio speakers and the second set are primarily used for mobile applications.
3. The home audio speakers are useless in this environment as they cannot achieve the need output.
4. The speakers are chained to the HVAC system and use homemade mounting brackets. (See image # 3
5. The speakers are not properly aimed for maximum coverage (see image #2)
6. Speaker cables are not properly installed (see image #4)
7. The wall mounted audio rack is very basic and outdated (see image #5)

The audio system is approximately 25+/- years old and is in “D” condition based upon a A-F grade scale.  
The speakers are not installed properly are not mounted safely

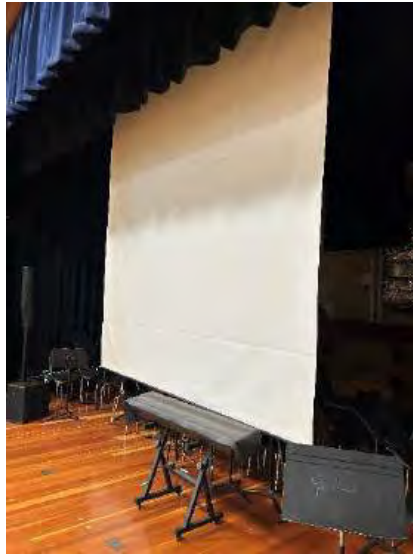
Image # 6

The current video projection screen is an old square format. (see image #6)  
There is currently no video projector installed.

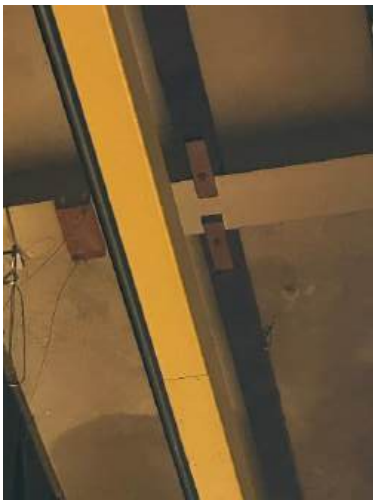
Image #7

1. The projection screen is an outdated square format image.
2. No video projector installed.
3. The video screen is suspended via wood blocks from the ceiling structure. (see image #7)

The Video system is approximately 25+/- years old and is in "D" condition based upon a A-F grade scale. The video screen is installed improperly and must be replaced.

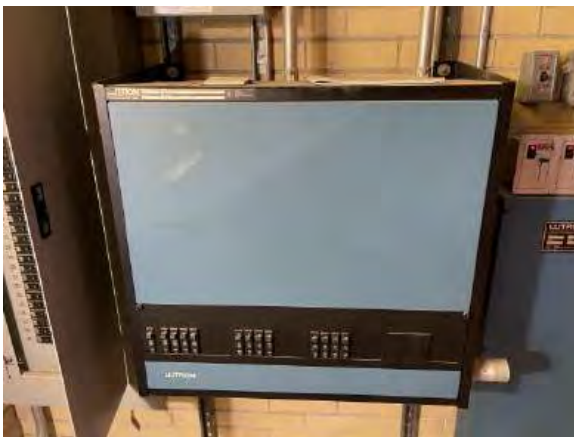
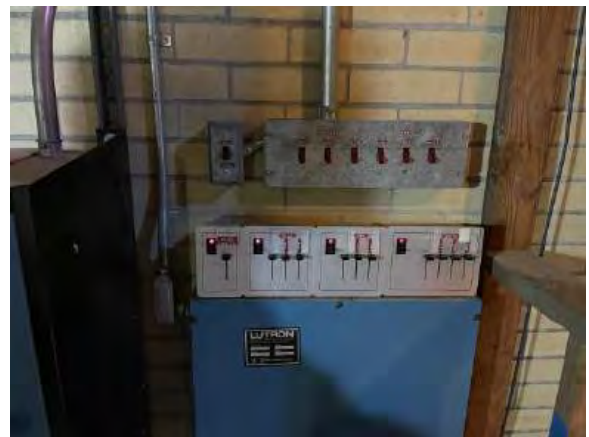
The stage lighting system has no front of house positions or torm positions. There are two electrics on stage. The dimming system is a Lutron dimming system with 12 dimmers. The control console is wall mounted above the dimmer rack.

The condition of the existing dimming system is adequate. A new control console, which is compatible with the proposed LED fixture upgrades, would be required. The existing lighting fixtures are no longer manufactured, and require greater power usage and maintenance than new LED fixtures.

Existing Lutron dimming system and controls should be replaced with a relay based system, along with modern power distribution. Installation of touchscreen controls, so that the theatrical lighting systems can be operated without the use of a control console for day to day activities. DMX networking and controls should be installed for the new LED systems.

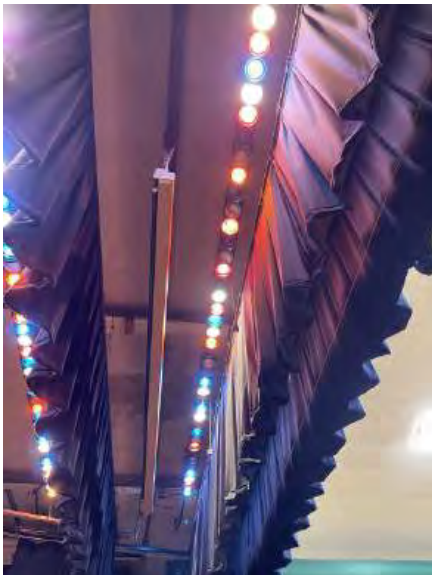
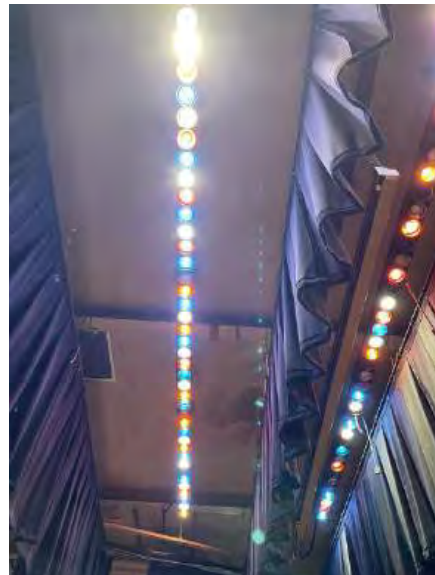
There are continuous border strip lights on stage. Some of the lighting fixtures need to be re-lamped or require other maintenance. There are no front of house fixtures.

***Recommendation:*** A full system upgrade with theatrical LED fixtures, which will offer increased capabilities. These capabilities include power and HVAC savings, color changing features, and reduced maintenance.

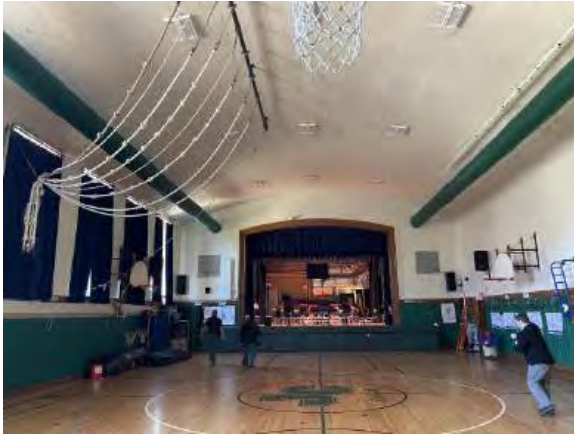
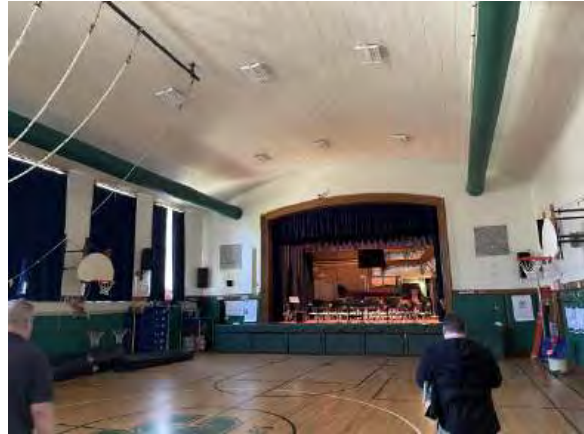
The house lights are newer LED high bay fixtures.

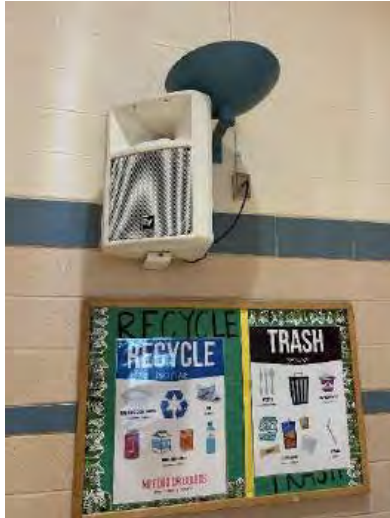
Image #1

The current system is a digital point source system which is common for a room of this size.(see image #1 & 2, 4).

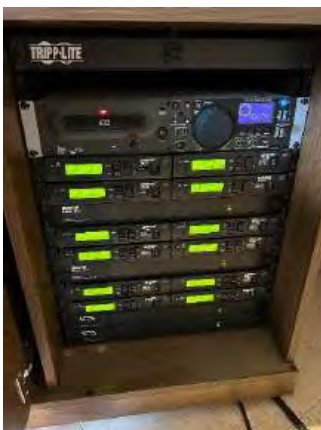
Image #3

It has multiply speakers that were installed over the years (see image #5). There are 12 wireless microphones installed in the system. ( see image # 3)

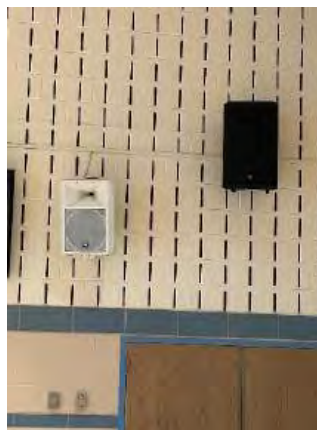
Image #5

1. The dual speakers are not needed and are more of a negative cosmetic issue than an audio issue (see image #5)
2. The system is in need of service for failing cables (see image #6)

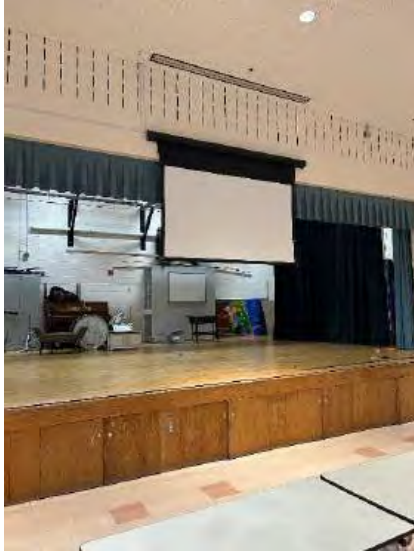
Image # 7

The current video projection screen is small a very small electric front projection (see image #7)  
The video projector is a small desk top model. (see image #8).

1. The projection screen is too small for the space for classroom use as well as moving viewing.
2. The video projector is a low output model and inadequate for the space.
3. The video projector is installed improperly from the theatrical lighting bar in front of the stage .

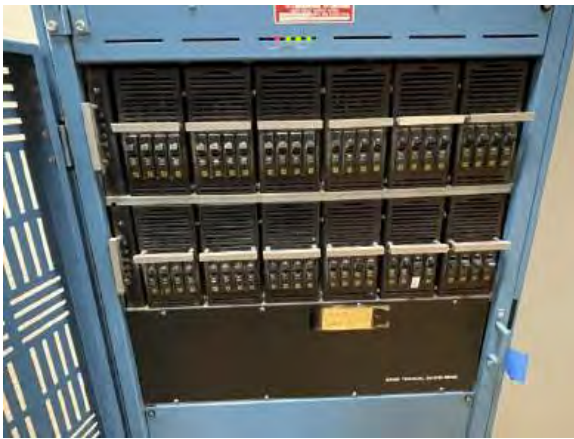
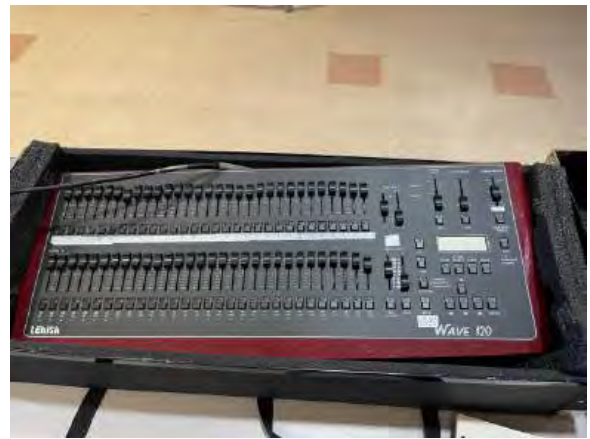
The stage lighting system has three front of house positions, and four electrics and a track light system on stage. The dimming system is a Lehigh dimming system with 48 dimmers. The control console is a Lehigh Wave 120. There is a panic station on SR. The system was installed in 1993.

The condition of the existing system is fair, but the equipment is obsolete and maintenance options for the dimming system are limited. The existing control console is not compatible with the proposed LED fixture upgrades. The existing lighting fixtures are no longer manufactured, and require greater power usage and maintenance than new LED fixtures.

Existing Lehigh dimming system and controls should be replaced with a relay based system, along with modern power distribution. Installation of touchscreen controls, so that the theatrical lighting systems can be operated without the use of a control console for day to day activities. Entry stations should be installed as part of the updated control system. DMX networking and controls should be installed for the new LED systems.

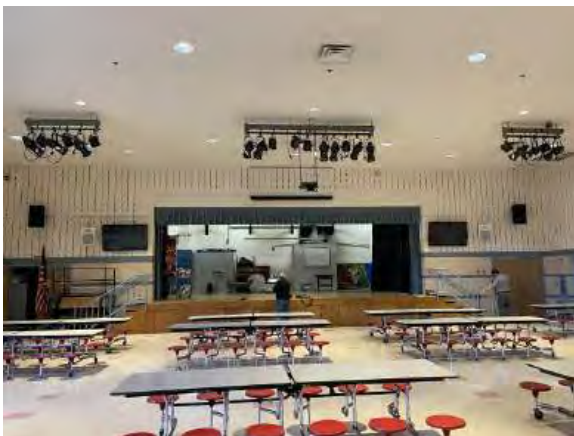
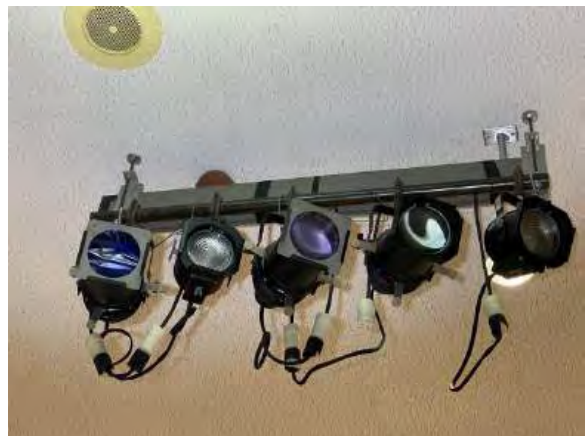
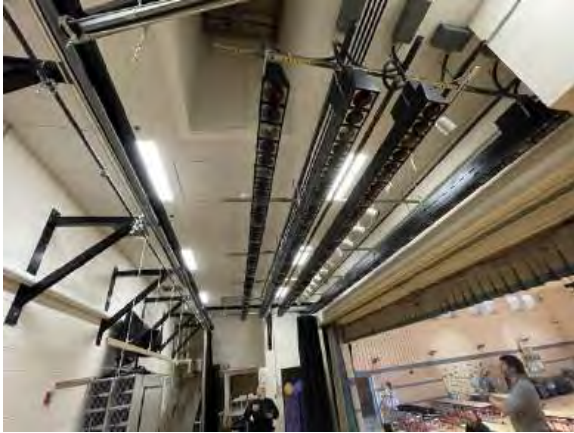
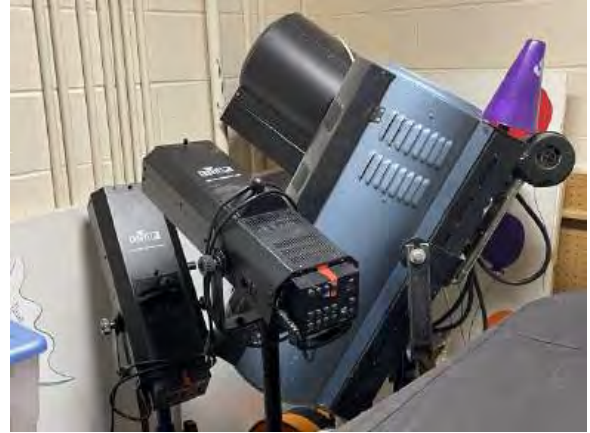
The lighting fixtures are obsolete Altman ellipsoidals and fresnels. Some of the lighting fixtures need to be re-lamped or require other maintenance. There are also four sets of incandescent strip lights and one full width track with fifteen track lights on stage. There are two incandescent follow spots and two Chauvet LED follow spots.

**Recommendation:** A full system upgrade with theatrical LED fixtures, which will offer increased capabilities. These capabilities include power and HVAC savings, color changing features, and reduced maintenance.

Stage electric strip lights and track lights should be removed and replaced with electrics and LED fixtures and spaced appropriately to better cover the stage area.

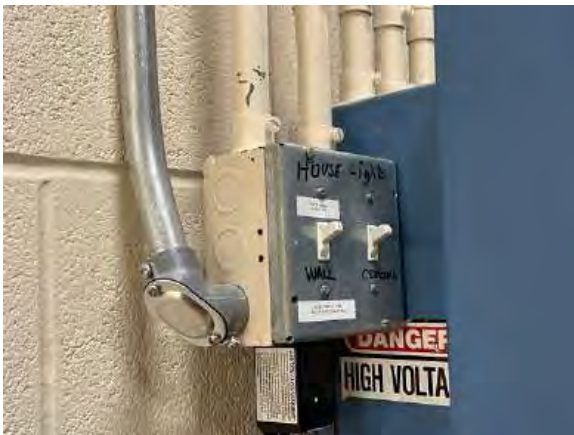
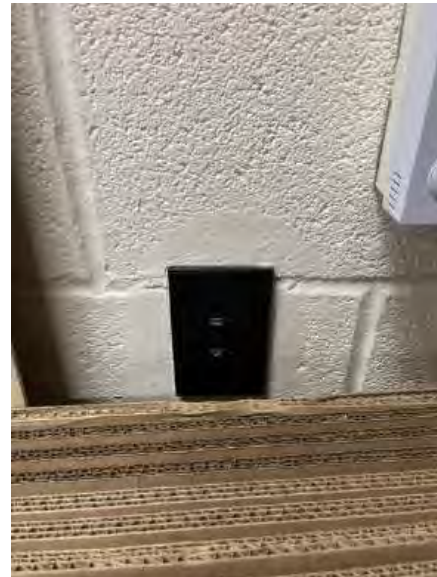
The house lights are recessed incandescent fixtures and there are wall sconces as well, that seem to be disconnected. They are not controlled through the theatrical lighting system.

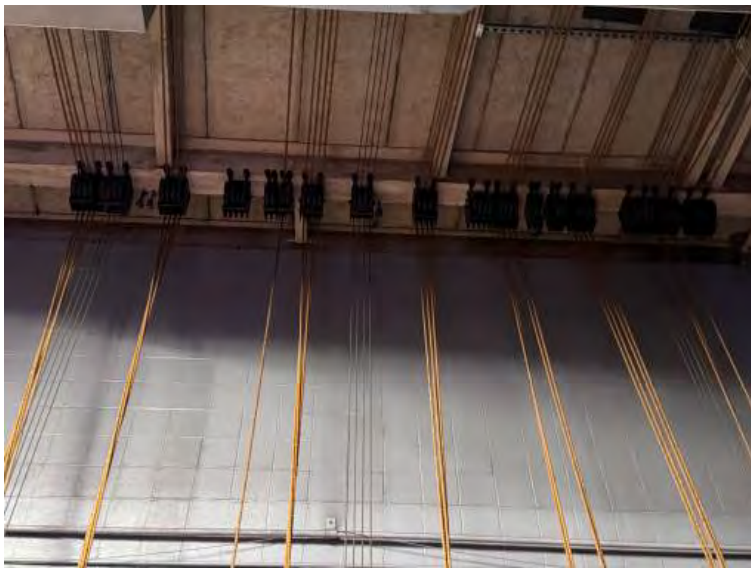
Eastern Middle School has a full rigging system consisting of a valance, front main, mid and rear traveller curtain, side leg curtains on tracks and a rear traveller track. The front traveler track is improperly rigged with unrated chain the carriers and pulleys are worn and need replacement. Several of the support battens are undersized and should be replaced. The most critical issue is the old hemp system. The system should be removed as soon as possible. The hemp rope can fail given the age of the system. The lines are not properly secured to the pin rails. The biggest risk is improper use of the system. The lines don't have a safety system preventing the lines from running if untied from the pin rail, this could lead to a batten crashing on the deck. The electric lift winches lack safety braking systems and should be replaced.

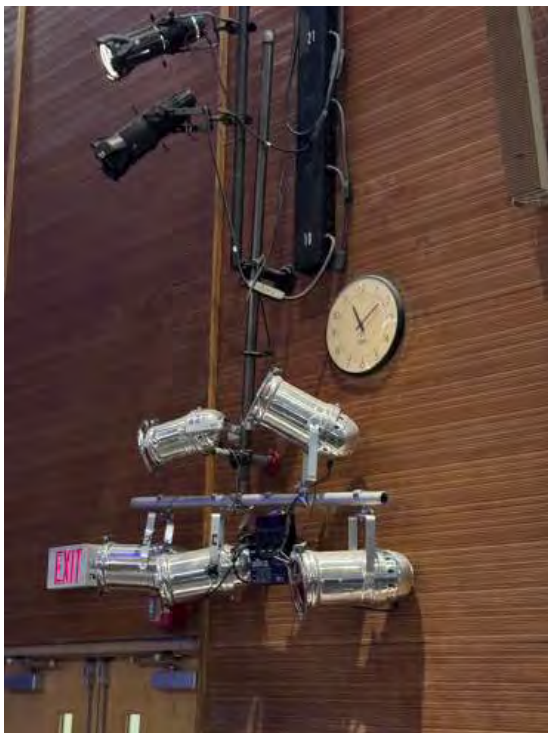
The house Torarm pipes are made with coupled sections which does not meet currently industry standards. The standard ANSI E1.4-2 requires that the pipe sections be welded or mechanically joined. It should be monitored periodically to see if there is any failure.

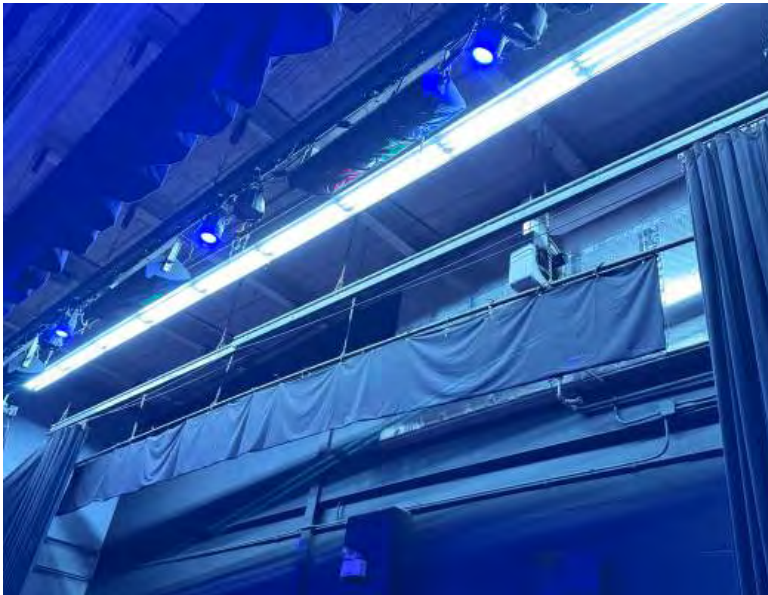
The drapes are listed as inherently and permanently flame retardant. Drapes appear worn and several of them are torn or stained. A significant number of them need replacement

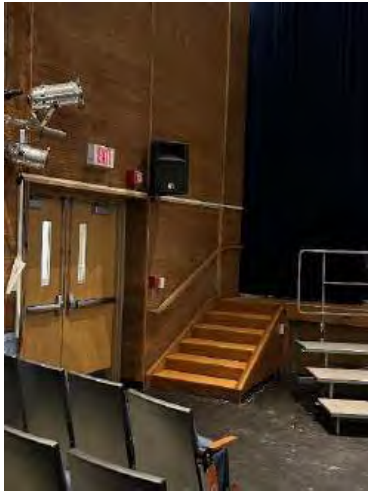
Image #1

The current system is an analog point source speaker system. (see image #1) with delay speakers (See image #2) which are common for an auditorium of this size.

The audio system is approximately 25+/- years old. and is in "C" condition based upon a A-F grade scale. There are no apparent life safety issues that need to be addressed at this time.

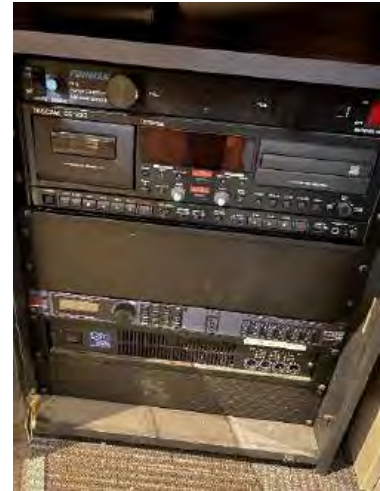
Image #3

It has a CD player and cassette decks which were common when it was installed (see image #3)
