## GREENWICH PUBLIC SCHOOLS PERFORMANCE PLATFORM STAGE FACILITY ASSESSMENT

**GREENWICH PUBLIC SCHOOLS  
290 GREENWICH AVENUE  
GREENWICH, CT 06830**

**25558.00**

**June 27, 2025**

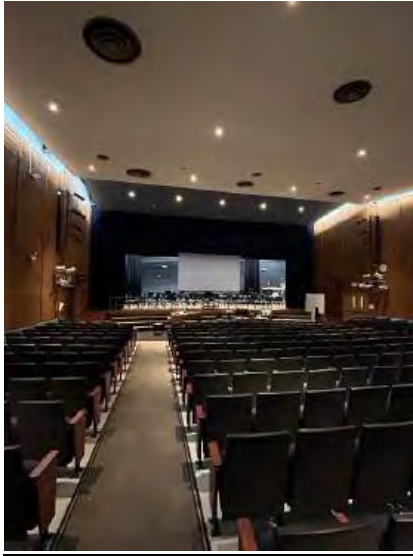
Image #1

The current projection screen is 25 + years old and is an old square format image. (see image #1)

The Video system is approximately 25+/- years old and is in “D” condition based upon a A-F grade scale. There are no apparent life safety issues that need to be addressed at this time.

1. Replace existing video projector with HD format rear projection screen.
2. Install new Laser rear projection video projector
3. A wall mounted HDMI input device will remove the unwanted cables on the stage floor.

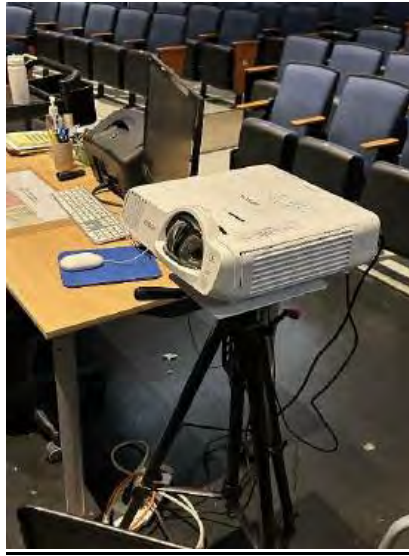
Image #2

There is currently no video projector installed. There is a portable projector on a cart currently in use (see image #2)

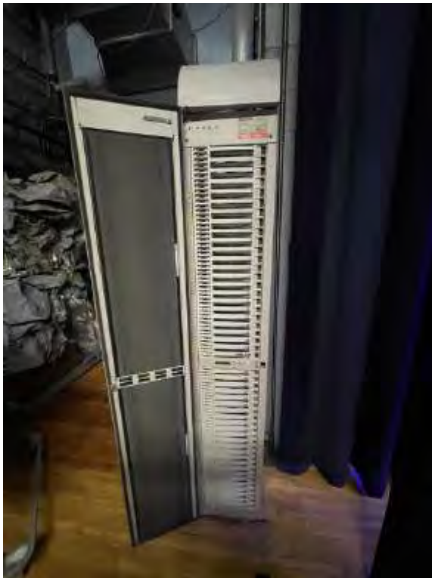
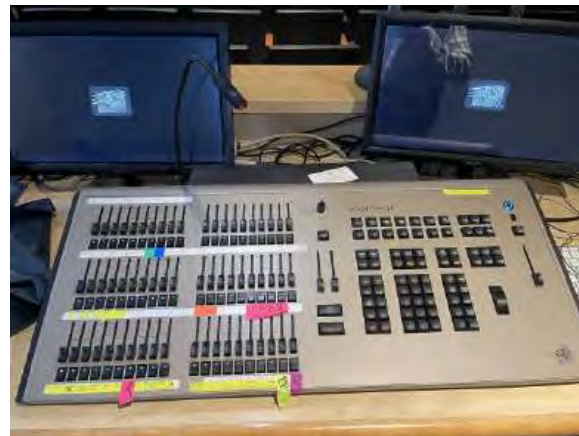
The stage lighting system has a front of house position, two torm positions, and three electrics on stage. The dimming system is an ETC Sensor+ dimming system with 96 dimmers. The control console is an ETC Element 120. There are architectural controls near the entry doors.

**Recommendation:** An upgrade to theatrical LED fixtures, which will offer increased capabilities, including power and HVAC savings, color changing features, and reduced maintenance is recommended. The dimmer rack should be updated to the latest version, so that it can utilize available modules for LED and low voltage lighting.

Installation of touchscreen controls, so that the theatrical lighting systems can be operated without the use of a control console for day to day activities. Entry stations should be added as part of the updated control system. DMX networking and controls should be installed for the new LED systems.

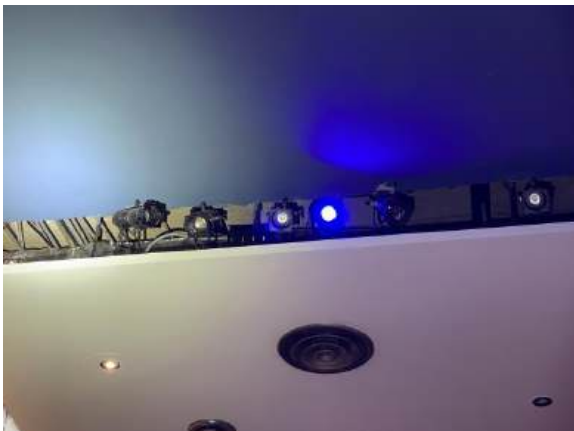
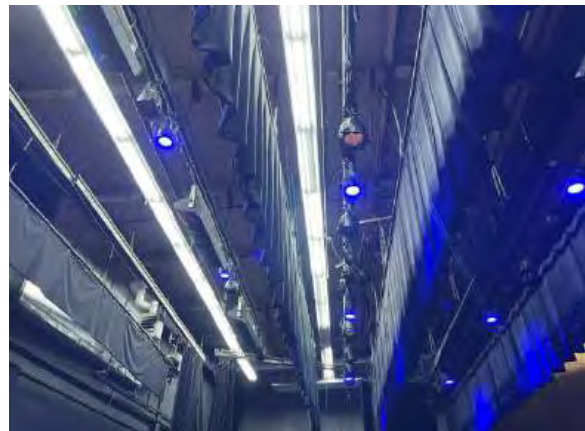
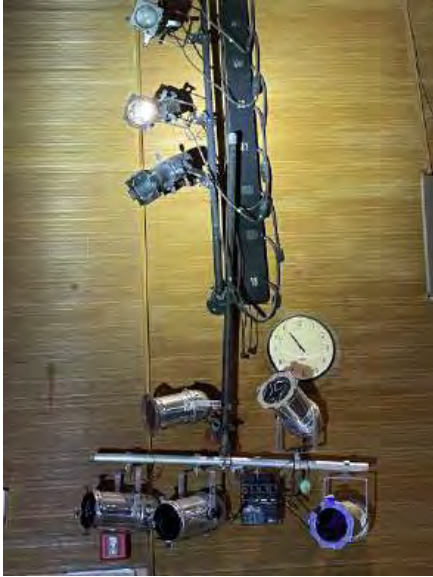
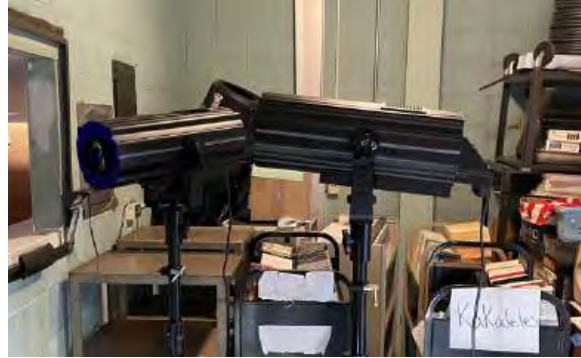
The front of house lighting fixtures are ETC SourceFour ellipsoidals and Chauvet PAR's dimming from a local Chauvet dimmer pack. Some of the lighting fixtures need to be re-lamped or require other maintenance. On stage, there are ETC SourceFour ellipsoidals , ETC Parnels, Altman Far cycs, and Chroma-Q Color One 100's. Two Altman Comet incandescent follow spots may require maintenance and re-lamping. There are also two Mega-Lite Drama FS LED 700 follow spots.

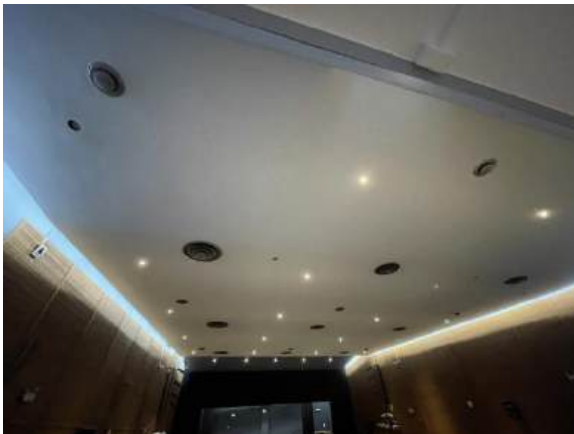
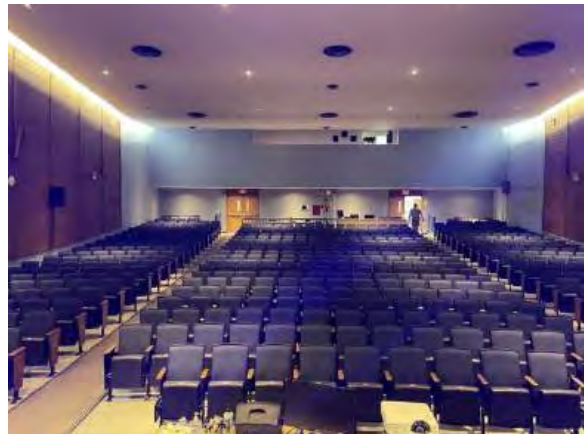
The house lights were formerly incandescent, and were re-lamped with LED PAR 38's. They are controlled by the theatrical dimming system. There are strip lights above the ceiling, near the walls on each side. They do not light the walls as they were probably intended to do.

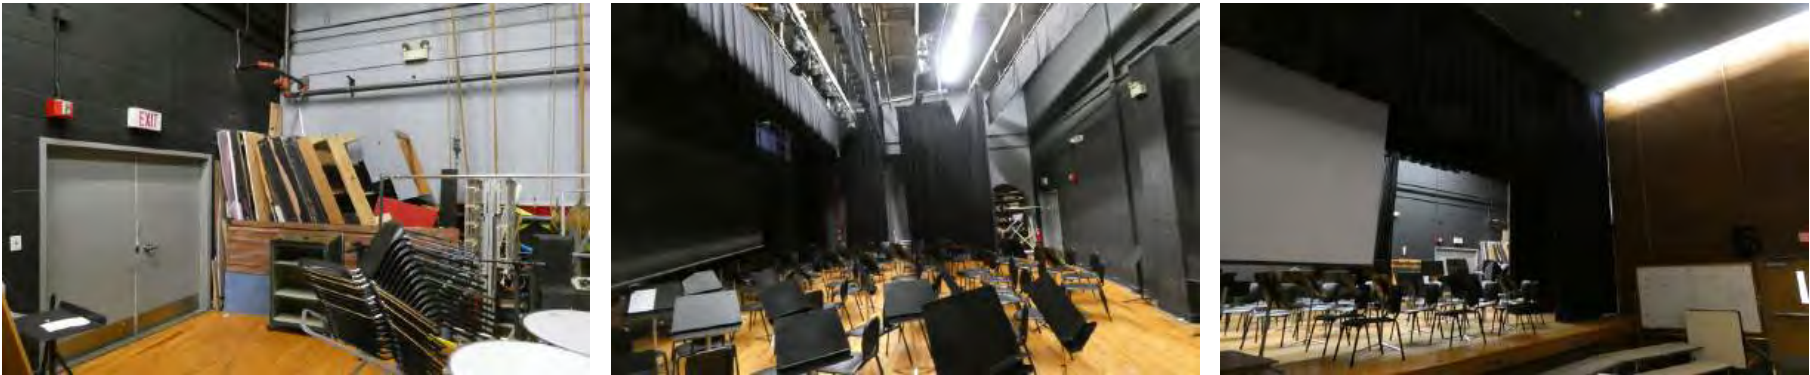
Stage and Stairs

| Observations | Level of<br>Complainece | SQFT | Wall<br>Height | Finish<br>Material | Comments | Cost |
|---|---|---|---|---|---|---|
| Surface Damage: [Assess scratches, dents, warping] | 9 | | | | heavier wear, ( especially in middle area) stage could use refinishing next year | |

| <b>Past Repairs &amp; Upkeep:</b> [Document any previous maintenance or repairs] | 8 | | | | Apron of stage added onto, has differing wood color. | |

| <b>Recommendations for Repair or Replacement:</b> [List suggested actions if issues are found] | | | | | Refinish stage, have the Apron and Main stage refinished to look aetetically the same.<br>Clean up storage areas, clean below stage, paint storage areas. | |

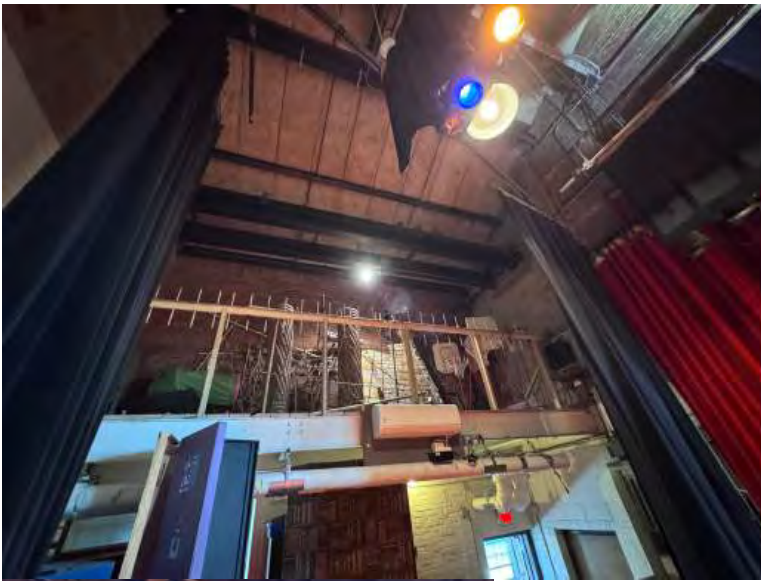
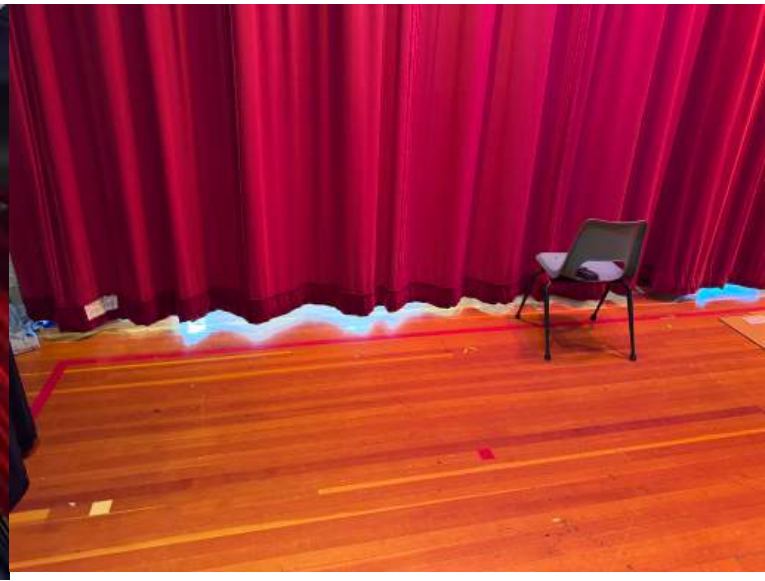
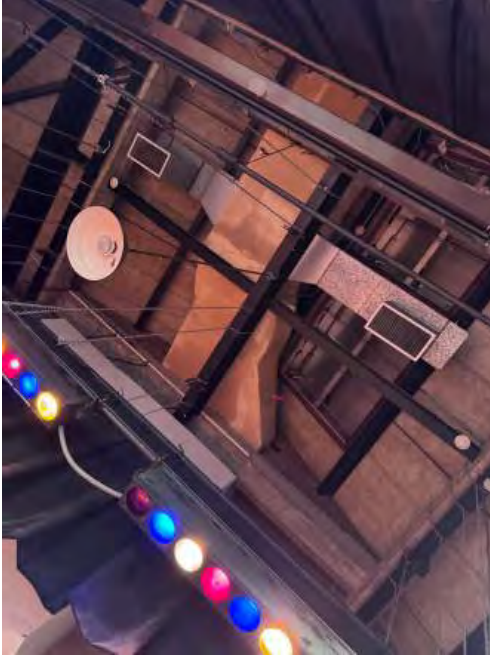
Front lighting positions gives limited options

In summary, the rigging system is not in good working order or meets current industry standards. The rigging is with unrated chain and/or connections and should be replaced. The undersized pipes need to be replaced and hung with appropriate hardware. The curtain tracks need to be rerigged and need new drapes, several need updates on the track hardware. Lighting system needs to be hung properly with rated hardware and connections. There is duct work above the grid that could have asbestos, further investigation by a qualified asbestos recommended.

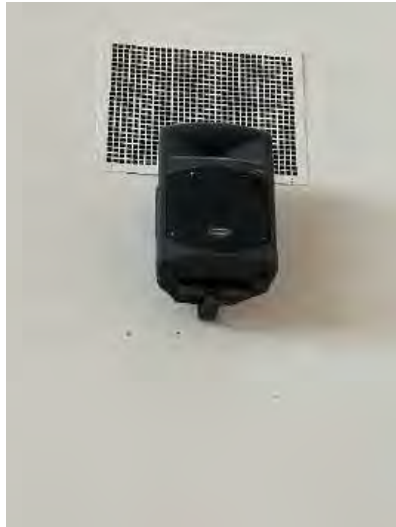
Image #1

The current system is an analogue point source “surround” speaker system with rear speakers which is uncommon for an auditorium of this size. (see image #1 & 2)

The audio system is approximately 25+/- years old and is in “C” condition based upon a A-F grade scale. There are no apparent life safety issues that need to be addressed at this time.

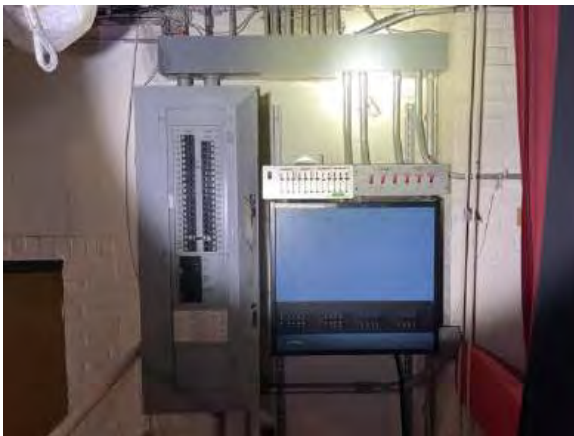
The stage lighting system has two front of house positions with three ellipsoidal fixtures each, and no top positions. There are two electrics on stage. The dimming system is a Lutron dimming system with 16 dimmers. The control console is wall mounted above the dimmer rack.

Existing Lutron dimming system and controls should be replaced with a relay based system, along with modern power distribution. Installation of touchscreen controls, so that the theatrical lighting systems can be operated without the use of a control console for day to day activities. DMX networking and controls should be installed for the new LED systems.

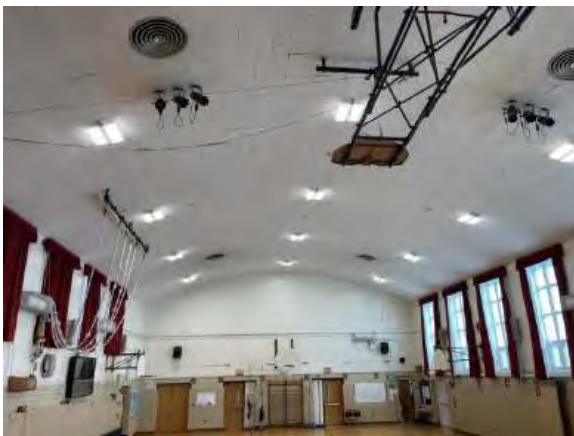
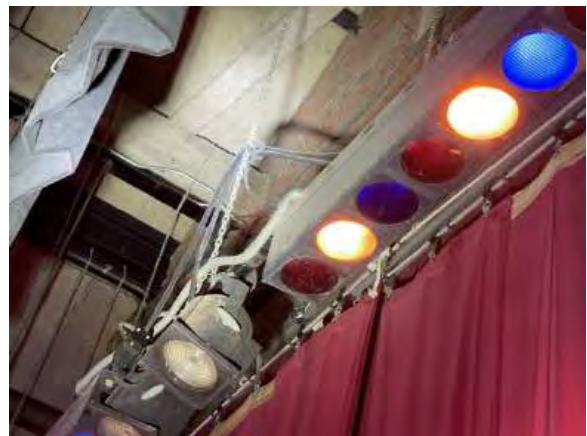
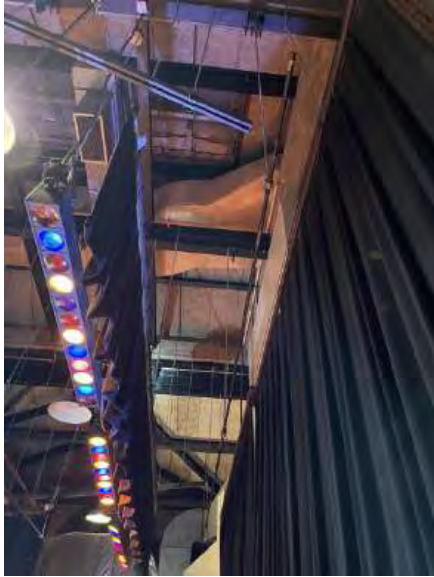
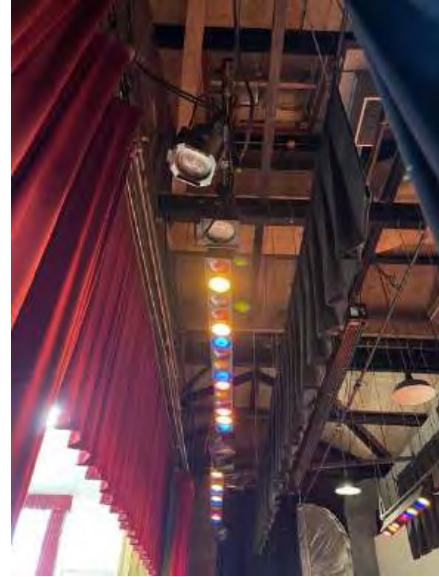
The front of house lighting fixtures are ETC SourceFour ellipsoidals. There are Century fresnels and strip lights on the first electric. There are also incandescent strip lights on the second electric. Some of the lighting fixtures need to be re-lamped or require other maintenance.

The condition of the existing dimming system is adequate. A new control console, which is compatible with the proposed LED fixture upgrades, would be required. The existing Century lighting fixtures are no longer manufactured, and require greater power usage and maintenance than new LED fixtures.

**Recommendation:** A full system upgrade with theatrical LED fixtures, which will offer increased capabilities. These capabilities include power and HVAC savings, color changing features, and reduced maintenance.

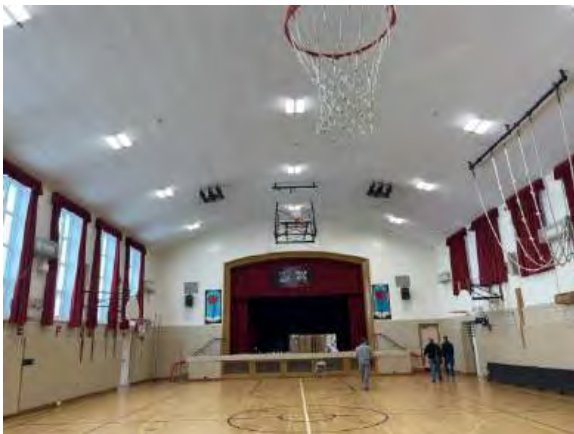
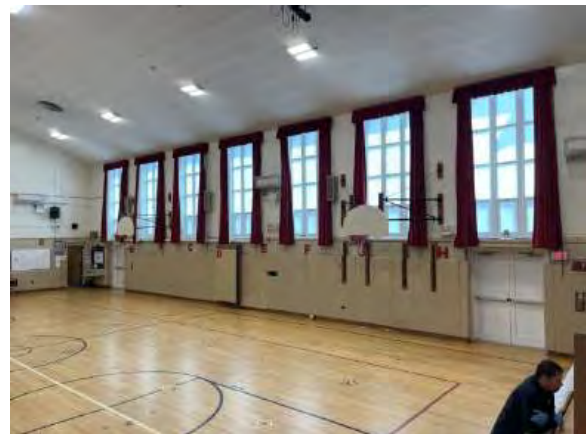
The house lights are newer LED high bay fixtures.

Replacement work lights should be added over the stage area.

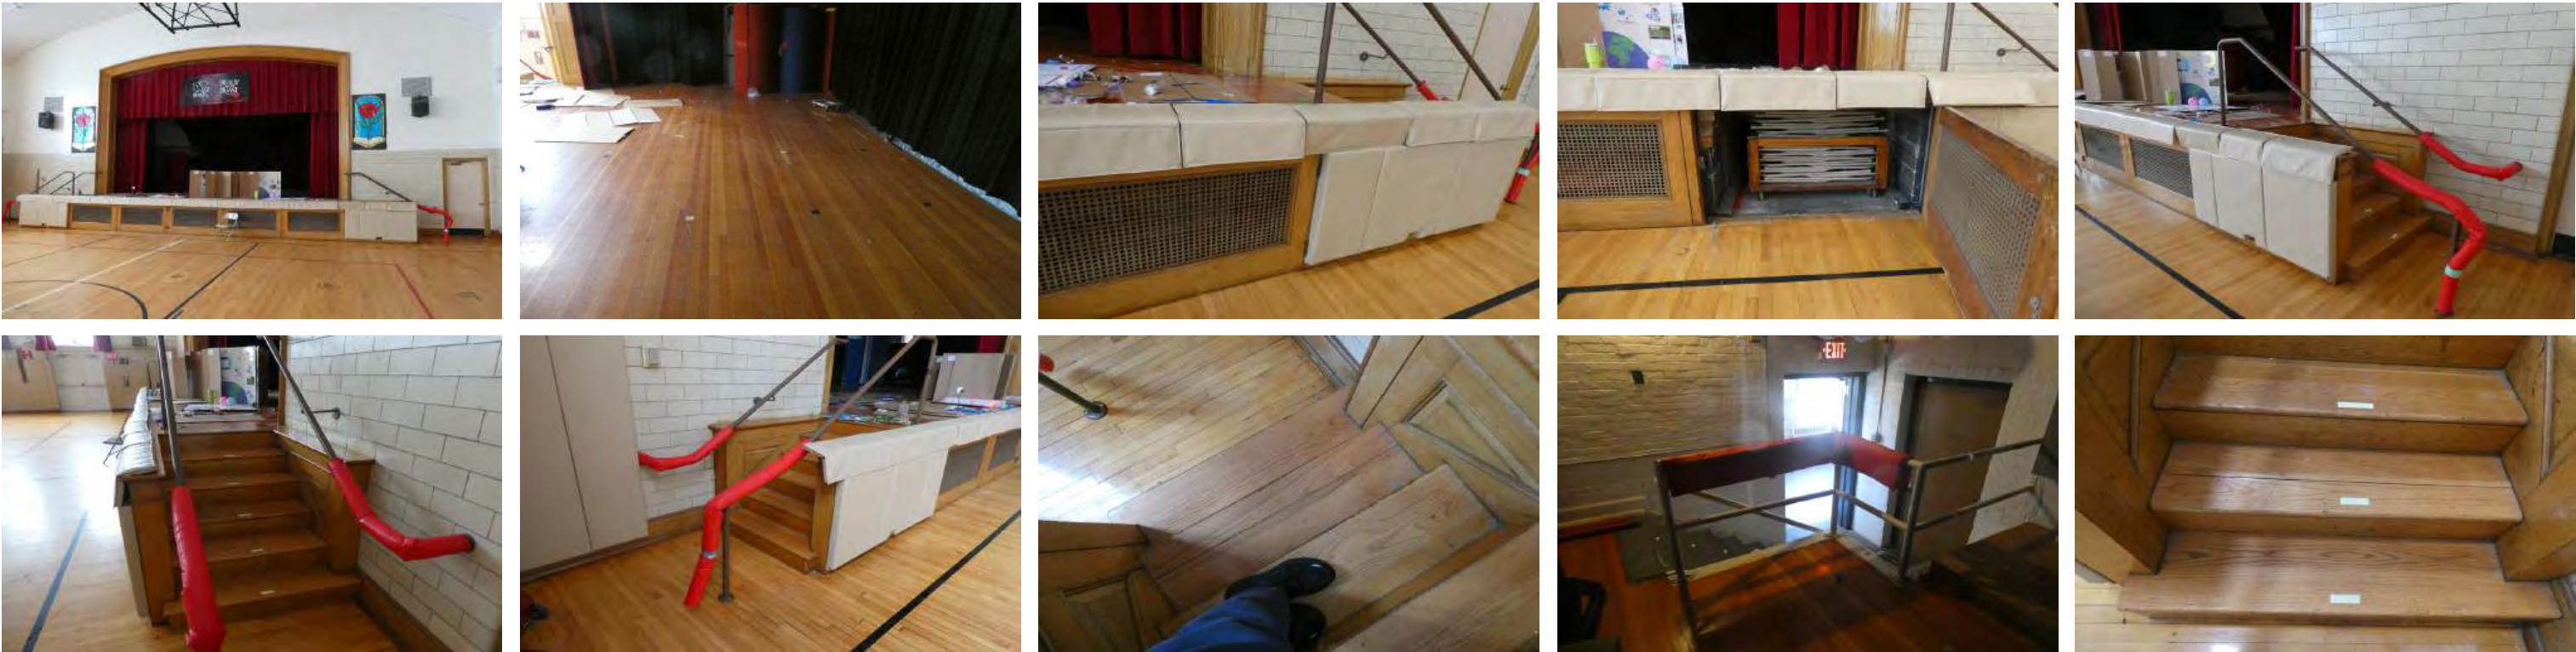
Stage and Stairs

| Observations | Level of<br>Compliance | SQFT | Wall<br>Height | Finish<br>Material | Comments | Cost |
|---|---|---|---|---|---|---|
| <b>Stability &amp; Load Capacity:</b> [Describe any signs of instability, sagging, or obervation of structural weakness] | 8 | 1,196 SF | | Wood | No instability or sagging observed - each side 2nd steps require replacement | |
| <b>Surface Damage:</b> [Assess scratches, dents, warping] | 8 | | | | Medium wear with scrathces - Refinish in 2 years | |

| <b>Past Repairs &amp; Upkeep:</b> [Document any previous maintenance or repairs] | 9 | | | | Repair Stair Treads 2nd step both sides, railings have padding ( falling off) | |

| <b>Recommendations for Repair or Replacement:</b> [List suggested actions if issues are found] | | | | | Re- attch padding at railings immediately. Refinish stage 1-2 years, repair steps, repair front stage doors. | |

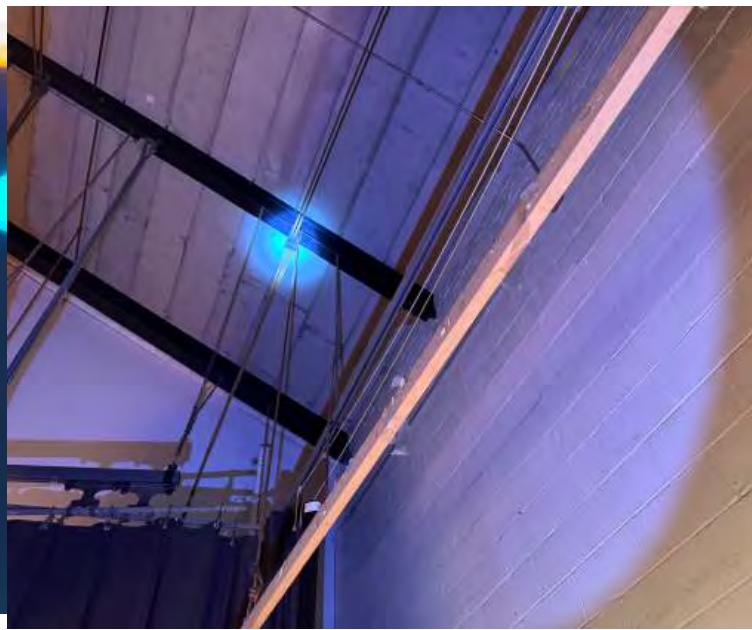
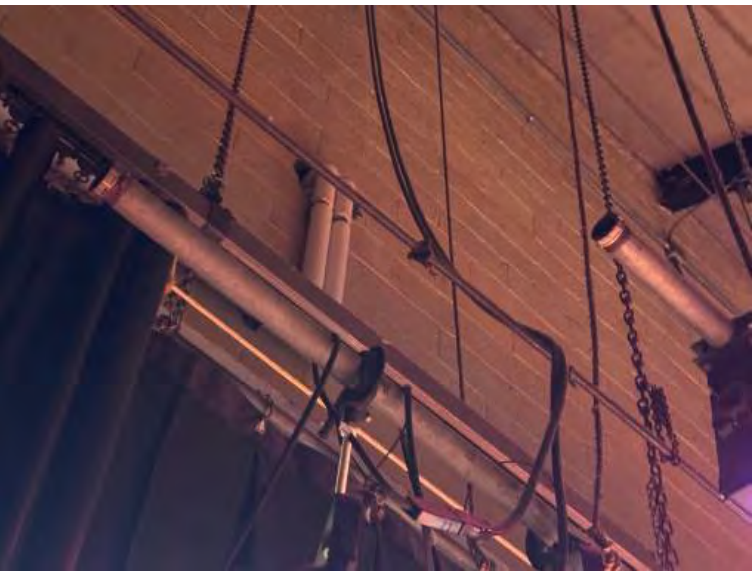
Riverside School has a basic rigging system hung from the building on steel I beams. All of the rigging is not up to current or acceptable industry standards and should be replaced. Current layout consists of a front main traveller curtain, valance, side leg curtains and a rear traveller tracks. The rigging on all of the tracks is in need of replacement. The lighting system is hanging from unrated chain and connectors that should be upgraded as soon as possible. Several of the curtain pipes are undersized, the wrong type of pipe and hanging from chain and connections that are not rated for overhead use and should be replaced. There is an old hemp rope system is use that should be removed immediately and replaced with rated rigging.

Use of wood beams for backdrops is not recommended for overhead. Immediate removal recommended.

In summary, the rigging system is not in good working order or meets current industry standards. The rigging is with unrated chain and/or connections and should be replaced. The undersized, improper pipes need to be replaced and hung with appropriate hardware. The curtain tracks need to be rerigged, several need updates on the track hardware. Lighting system needs to be hung properly with rated hardware and connections. All equipment hung from hemp rope or wood should be removed immediately.

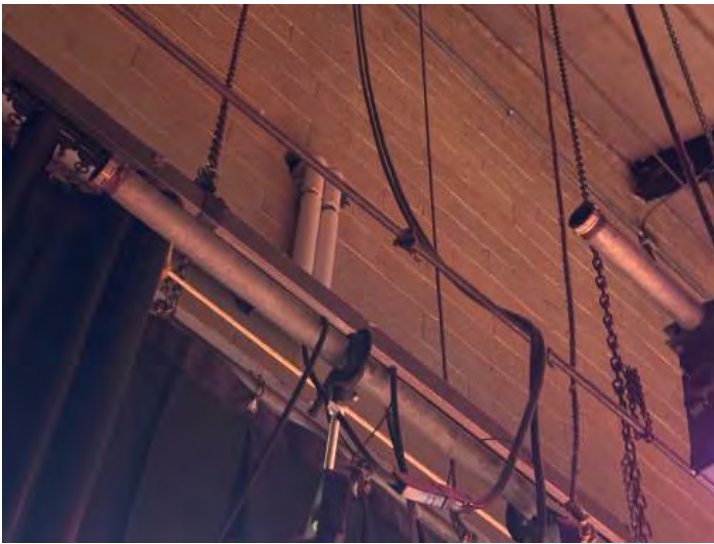
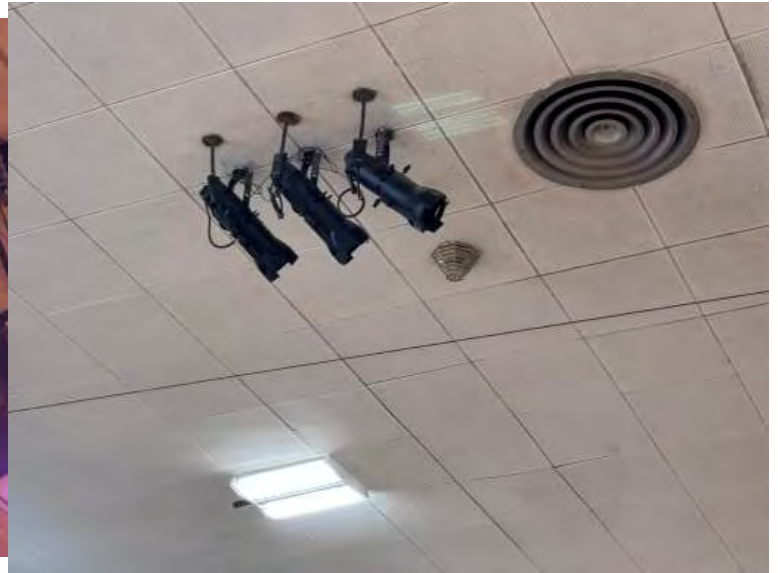
Front and stage lighting positions gives limited options

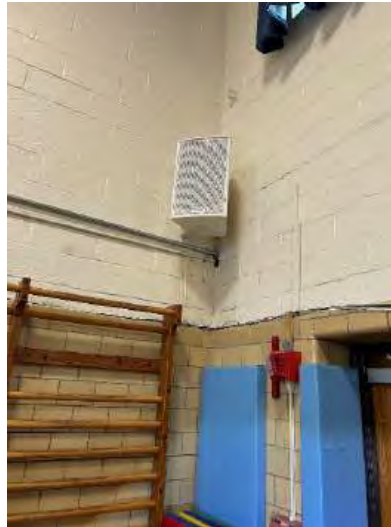
Image #1

The current system is a digital point source system with rear delay speakers which is common for a room of this size. ( see image #1)

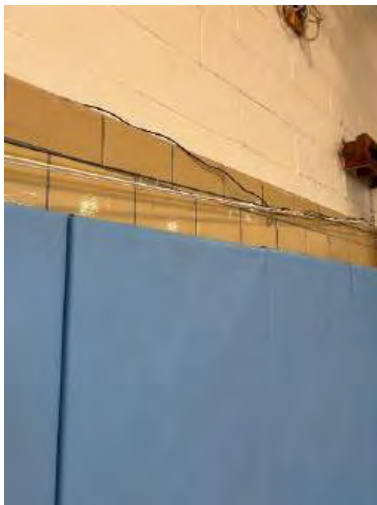
Image #2

1. There are no deficiencies with the operation of the system at this time.
2. There are some wires that are not properly attached to the building and should be installed properly for neatness. ( see image #2 & 3)

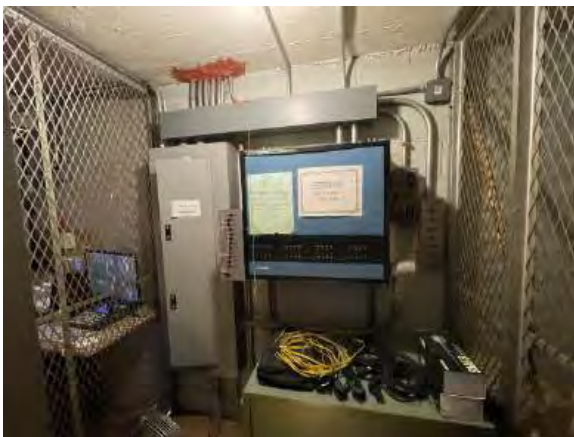
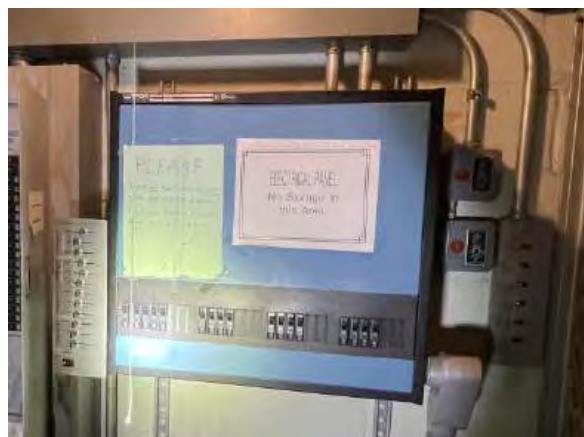
The stage lighting system has two front of house positions with three fixtures each, and three electrics on stage. The dimming system is a Lutron dimming system with 16 dimmers. The control console is wall mounted next to dimmer rack.

Existing Lutron dimming system and controls should be replaced with a relay based system, along with modern power distribution. Installation of touchscreen controls, so that the theatrical lighting systems can be operated without the use of a control console for day to day activities. DMX networking and controls should be installed for the new LED systems.

Cages should be installed for front of house lighting, to replace the existing FOH position, which does not currently meet electrical codes. Cages will also protect the new fixtures during gymnasium activities,

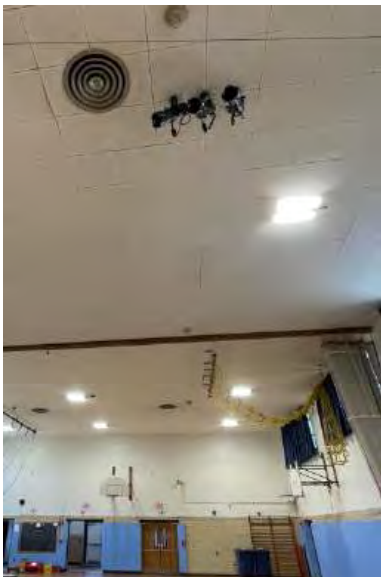
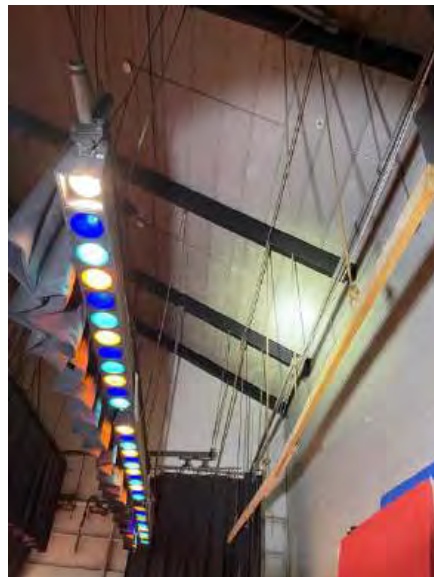
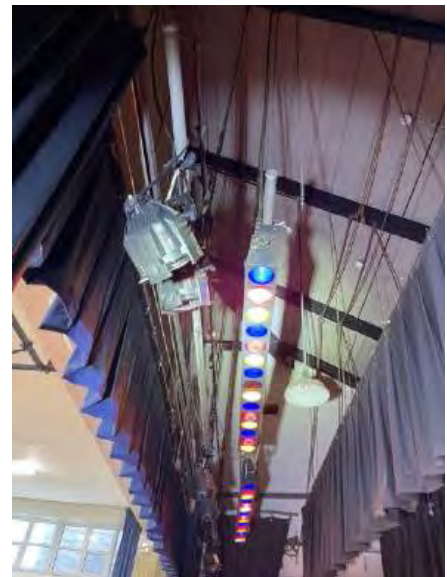
The lighting fixtures are ETC SourceFour Jr. ellipsoidals and ETC Parnels. Some of the lighting fixtures need to be re-lamped or require other maintenance. There are also incandescent strip lights on stage.

**Recommendation:** A full system upgrade with theatrical LED fixtures, which will offer increased capabilities. These capabilities include power and HVAC savings, color changing features, and reduced maintenance.

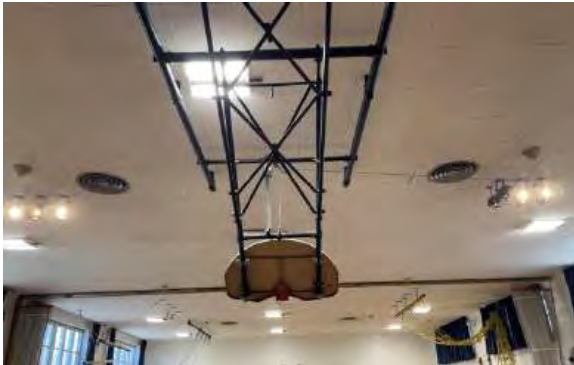
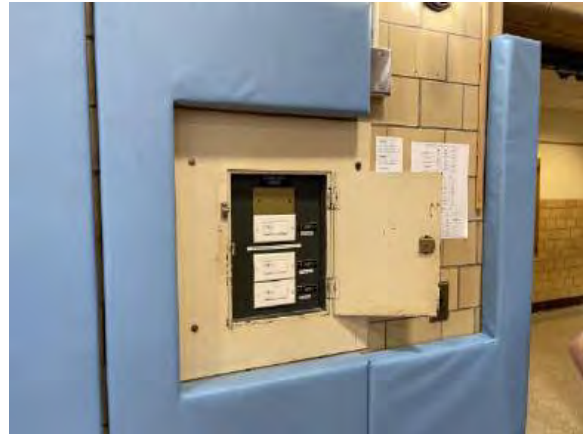
The house lights are newer LED high bay fixtures. They are not controlled by the theatrical lighting system.

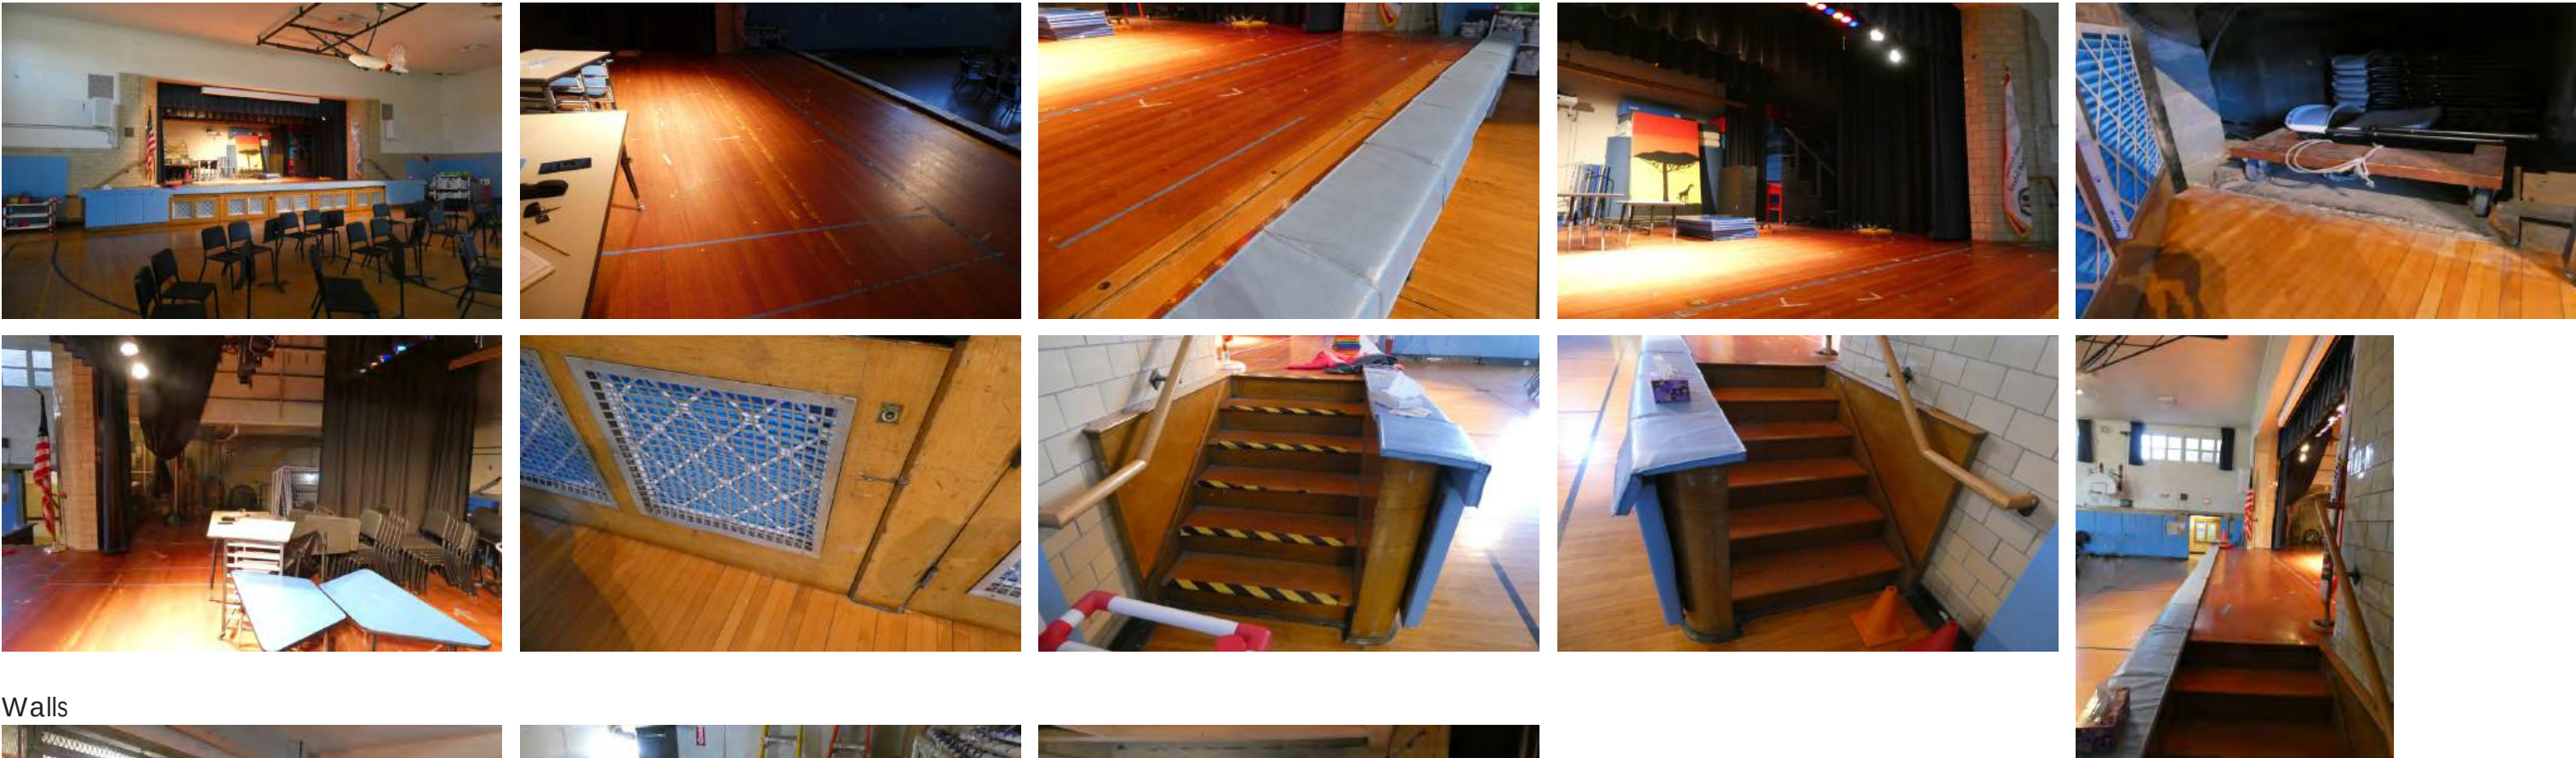
Stage and Stairs

| Observations | Level of<br>Compliance | SQFT | Wall<br>Height | Finish<br>Material | Comments | Cost |
|---|---|---|---|---|---|---|
| Trip Hazards: [Document gaps, cracks, or protruding elements] | 10 | | | | none observed - stage has medium amount of stoarge - steps have caution tape on tread nosing, some missing | |
| Surface Damage: [Assess scratches, dents, warping] | 8 | | | | Medium wear with scrathces - Refinish in 2 years | |

| <b>Recommendations for Repair or Replacement:</b> [List suggested actions if issues are found] | | | | | Refinish stage shortly 2-3 years, add nosing caution tape to all treads, replace padding at front of stage, <b>paint walls</b> | |

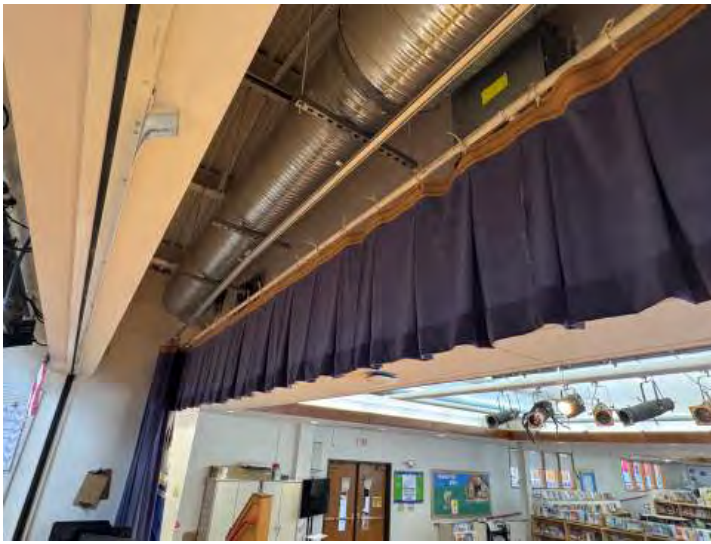
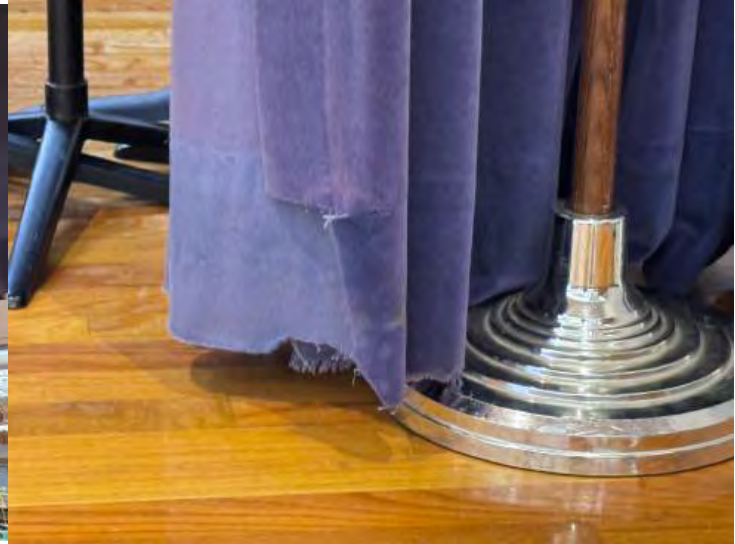
International School has a basic rigging system hung from the building IBeams. All of the rigging is not up to current or acceptable industry standards and should be replaced. Current layout consists of a valance, front main traveller curtain, side leg curtains and a rear traveller tracks. The Valance is hung from plastic pipe and should be replaced.

The front traveler track is not made of theatrical hardware and in need of replacement. The main curtain is faded, worn in torn in several places . The valance is currently hung on plastic pvc pipe and should be replaced. The mid and rear curtain tracks are not designed for theatrical use and should be replaced. The mid and rear drapes are in decent condition .

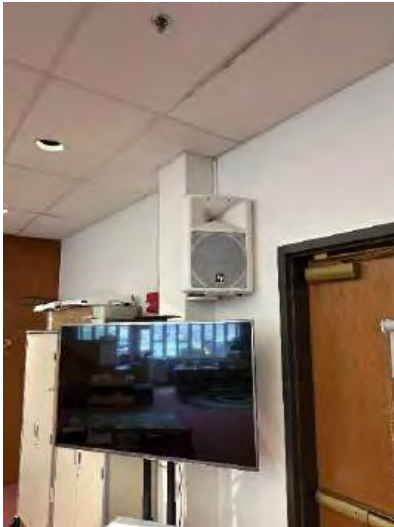
Image #1

The current system is an analogue point source speaker system (see image #1) with two rear delay speakers (see image #2) for additional coverage which is required for this size space.

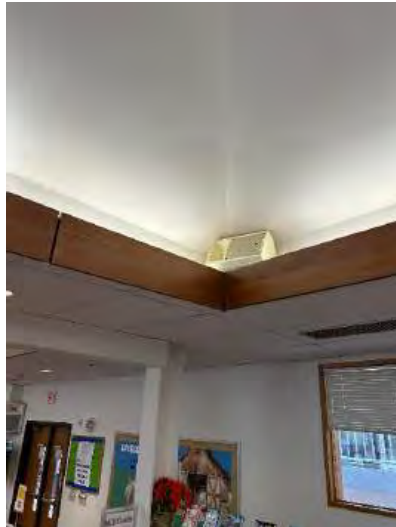
Image #2

The required electronics to utilize the delay speaker was not installed and thus making those speakers useless. The system is functional but has very basis features.

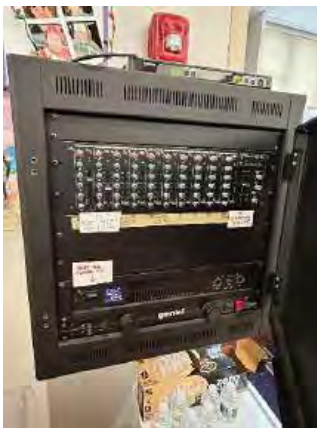
Image #3

1. The age of the system is the main deficiency.
2. The equipment is obsolete and inadequate for the room (see image #3)
3. There are no wireless microphones presently.
4. The use of overhead wireless microphones are temporarily installed (see image 4 & 5)

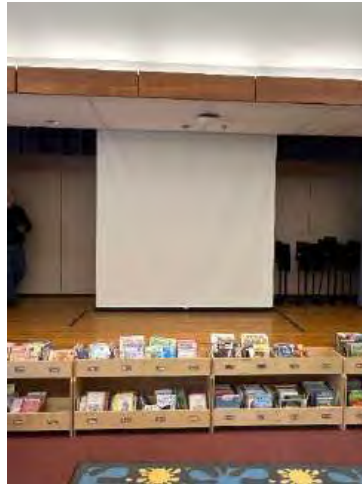
Image # 6

1. The projection screen is an obsolete square format image (see image #6)

1. The video projection screen to be replaced with a HD format front projection screen.
2. Replace video projector with a new Laser front projector. This will eliminate the need for costly lamp replacement and filter changes.
3. New projector will be mounted in front of the house theatrical lighting pipe.
4. A new wall mounted HDMI input device will be installed on stage left or stage right wall.

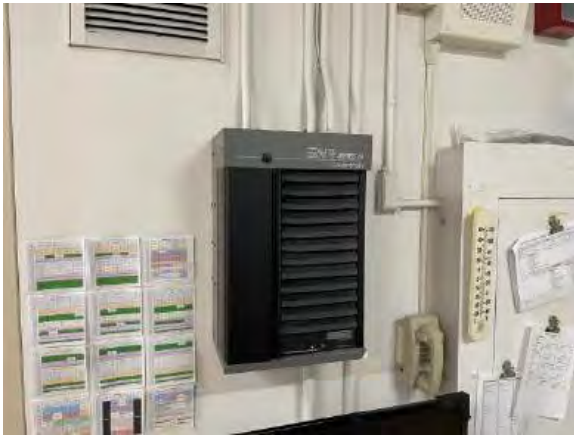
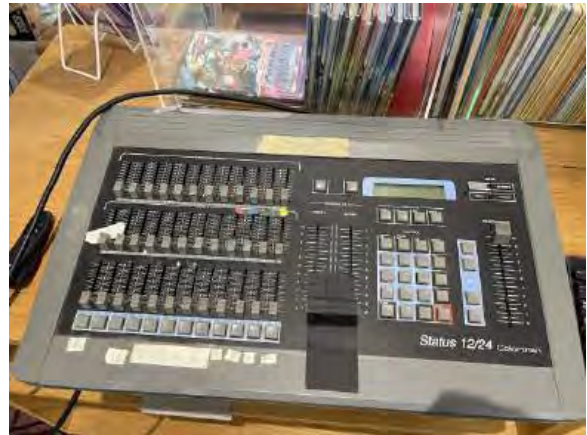
The stage lighting system has a FOH position, and two electrics on stage. The dimming system is a Colortran ENR dimming system with 24 dimmers. The control console is a Colortran Status 12/24 two scene preset console. Colortran discontinued manufacturing of these systems in the early 1990's. The system is in good condition and functional. There are no architectural controls which are connected to the theatrical system.

Existing Colortran dimming system and control console should be replaced with a relay based system, and a control console compatible with new LED fixtures. Power distribution should be updated and rigged higher to provide more distance between the fixtures and the talent. Installation of touchscreen controls, so that the theatrical lighting systems can be operated without the use of a control console for day to day activities, should be added. DMX networking and controls should be installed for the new LED systems.

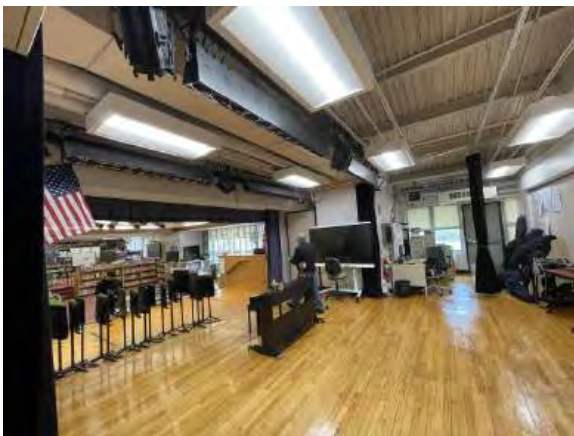
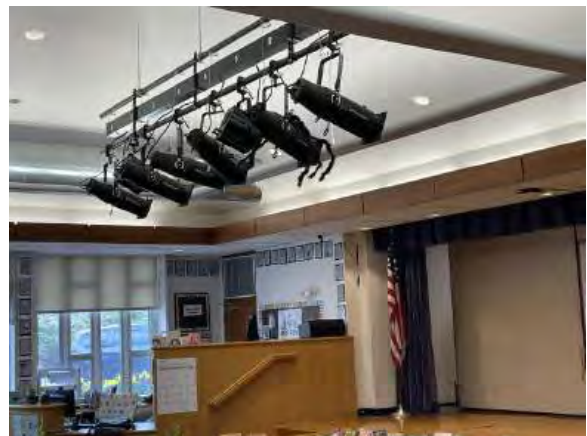
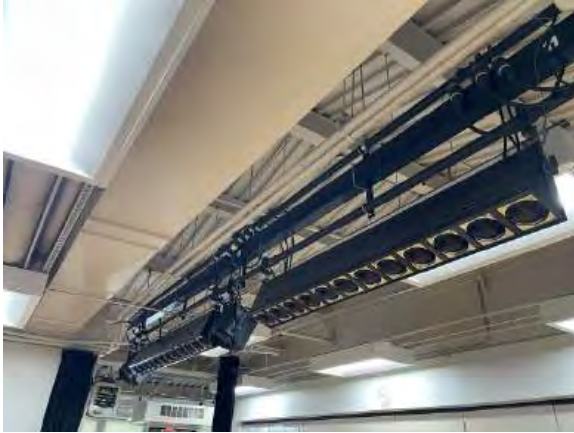
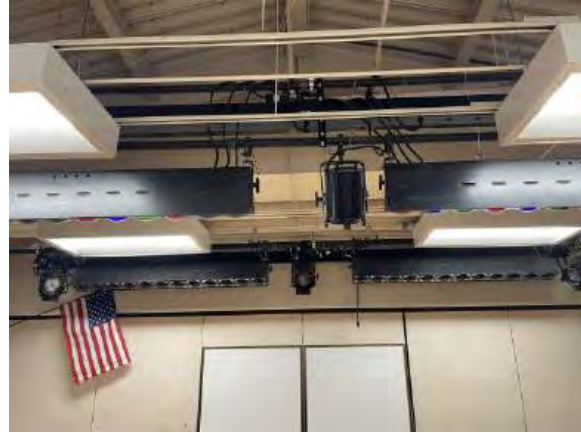
The lighting fixtures are obsolete Colortran ellipsoidals, and fresnels. There are also incandescent strip lights on stage. The system generates significant heat due to the close proximity of the fixtures to the stage. The stage ceiling height is very low.

***Recommendation:*** A full system upgrade with theatrical LED fixtures, which will offer increased capabilities. These capabilities include power and HVAC savings, including reduction of heat generated by the fixtures in such a small space, color changing features, and reduced maintenance.

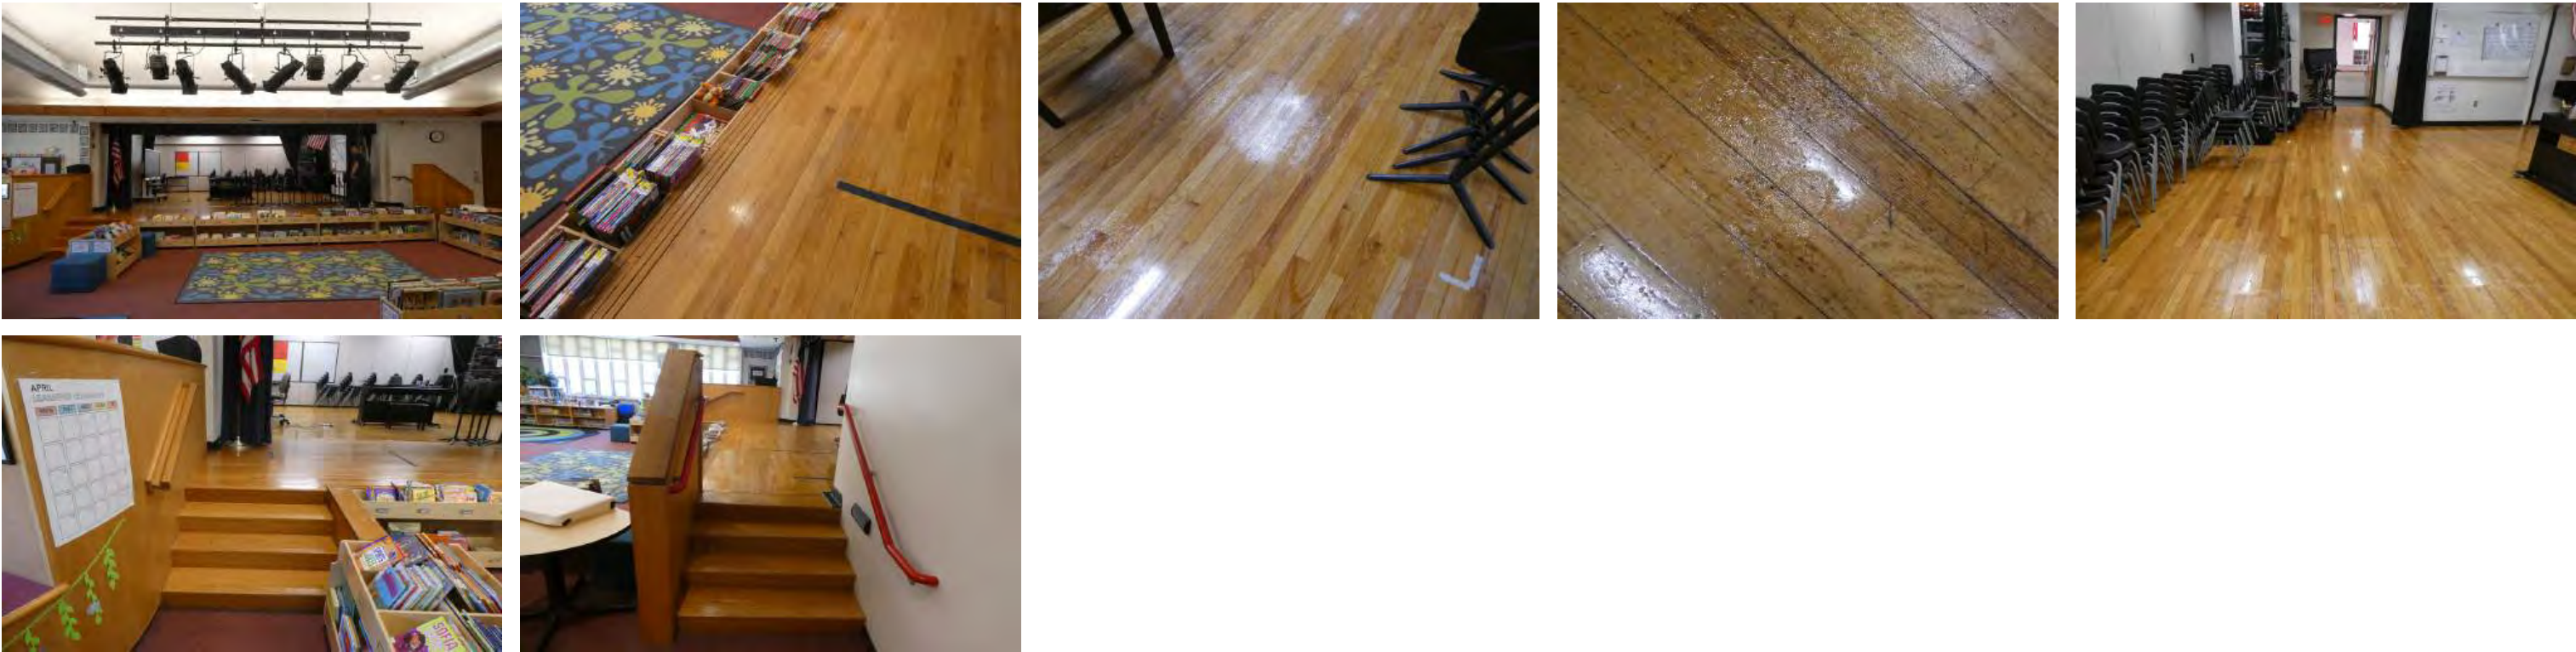
Stage and Stairs

| Observations | Level of<br>Compliance | SQFT | Wall<br>Height | Finish<br>Material | Comments | Cost |
|---|---|---|---|---|---|---|
| Surface Damage: [Assess scratches, dents, warping] | 8 | | | | Upstage area refinished recently, crinkle in 50% of flooring coating, no refinishing on stage Apron area ( in front ) of movable partition. Aprox 8 feet x width of stage. | |

| <b>Recommendations for Repair or Replacement:</b> [List suggested actions if issues are found] | | | | | Redo stage flooring finish shortly, to include front apron area, replace vinly on some folding partition doors, review handrails in ADA study. | |
