## GREENWICH PUBLIC SCHOOLS PERFORMANCE PLATFORM STAGE FACILITY ASSESSMENT

**GREENWICH PUBLIC SCHOOLS  
290 GREENWICH AVENUE  
GREENWICH, CT 06830**

**25558.00**

**June 27, 2025**

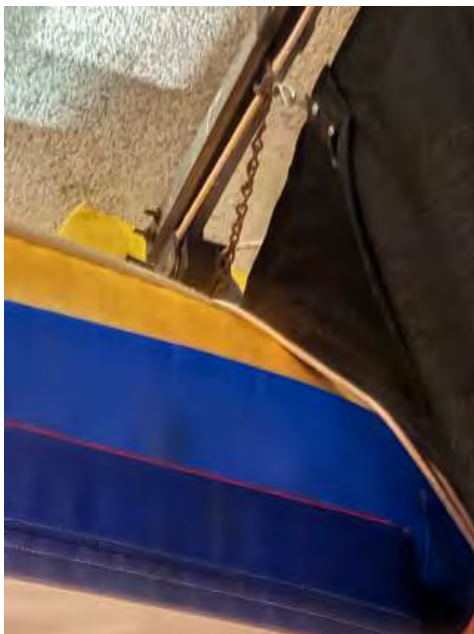
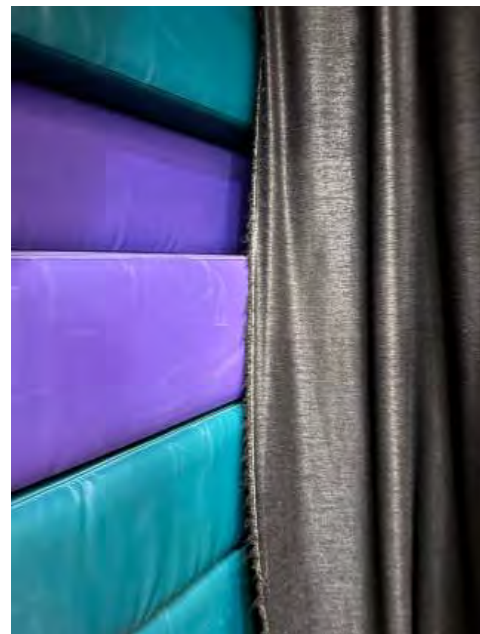
North Mianus School has a basic rigging system hung from the building on concrete encased beams. All of the rigging is not up to current or acceptable industry standards and should be replaced. Current layout consists of a valance, front main traveller curtain, side leg curtains and a rear traveller tracks. The rigging on all of

the tracks is in need of replacement. Several of the curtain pipes are undersized and hanging from chain and connections that are not rated for overhead use and should be replaced. The rear traveller was unable to be used because of the storage of gymnastic equipment. The toarms are made with coupled pipe and do not meet current industry standards.

In summary, the rigging system is not in good working order or meets current industry standards. The Rigging is with unrated chain and connections and should be replaced. The curtain tracks need to be rigged and several need updates on the track hardware. Gym equipment should be stored in a way that doesn't damage the track system.

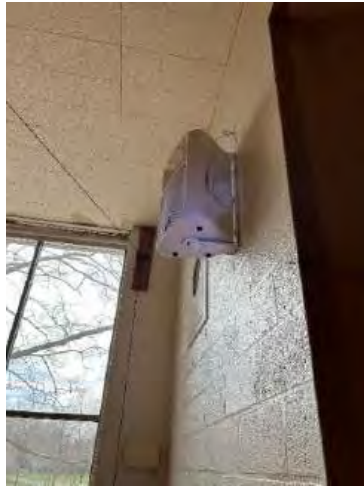
Image #1

The current system is a analog point source speaker system (see image #1)

The system is partially functional and has very basic features

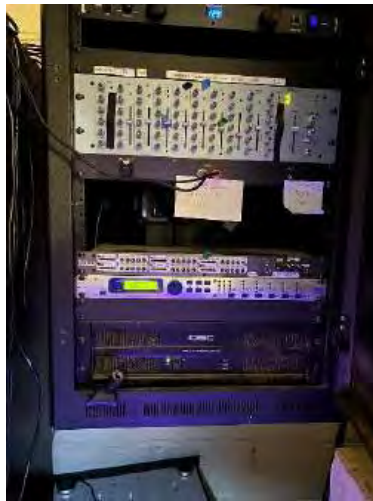
Image #2

1. The technology in the rack is obsolete and inadequate for the room. (see image #2)
2. There are no wireless microphones presently installed in the system.

The audio system is approximately 20+/- years old and is in “D” condition based upon a A-F grade scale. There are no apparent life safety issues that need to be addressed at this time.

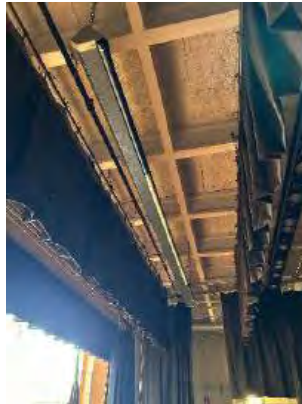
Image #3

The current video projection system consists of an old projection screen with no installed projector (see image #3)

The Video system is approximately 25+/- years old and is in "F" condition based upon a A-F grade scale. There are no apparent life safety issues that need to be addressed at this time.

1. The video projection screen to be replaced with an HD format rear projection screen.
2. The video projector should be replaced with a new Laser rear projection unit to eliminate the need for costly lamp replacements and or filter cleaning in the future.
3. A wall mounted HDMI input device will remove the unwanted cables on the stage floor.

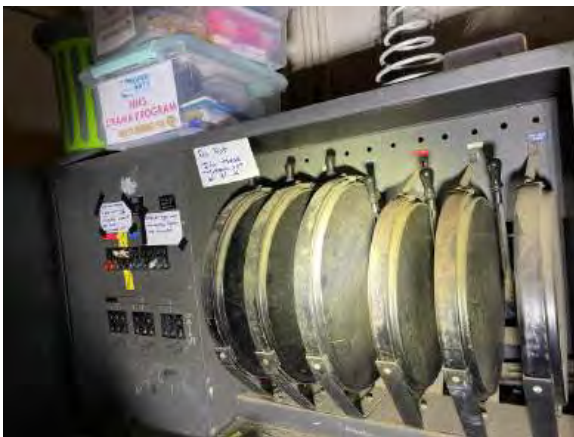
The stage lighting system has Torm positions, and two electrics on stage. There are no other front of house positions. The dimming system is a 1950's era Kliegl auto-transformer dimming system with 6 dimmers. There is no separate control console.

Existing Kliegl dimming rack should be replaced with a relay based system, along with modern power distribution. Kliegl has been out of business since 1990 and the current auto-transformer should be discarded as soon as possible. Installation of touchscreen controls, so that the theatrical lighting systems can be operated without the use of a control console for day to day activities. DMX networking and controls should be installed for the new LED systems.

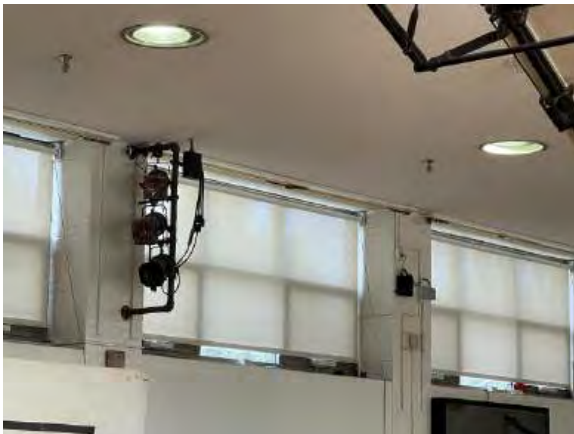
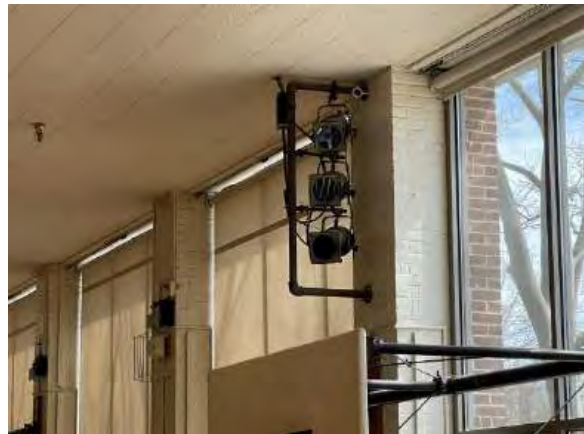
The lighting fixtures are obsolete Altman ellipsoidals and continuous border strip lights. Some of the lighting fixtures need to be re-lamped or require other maintenance.

***Recommendation:*** A full system upgrade with theatrical LED fixtures, which will offer increased capabilities. These capabilities include power and HVAC savings, color changing features, and reduced maintenance.

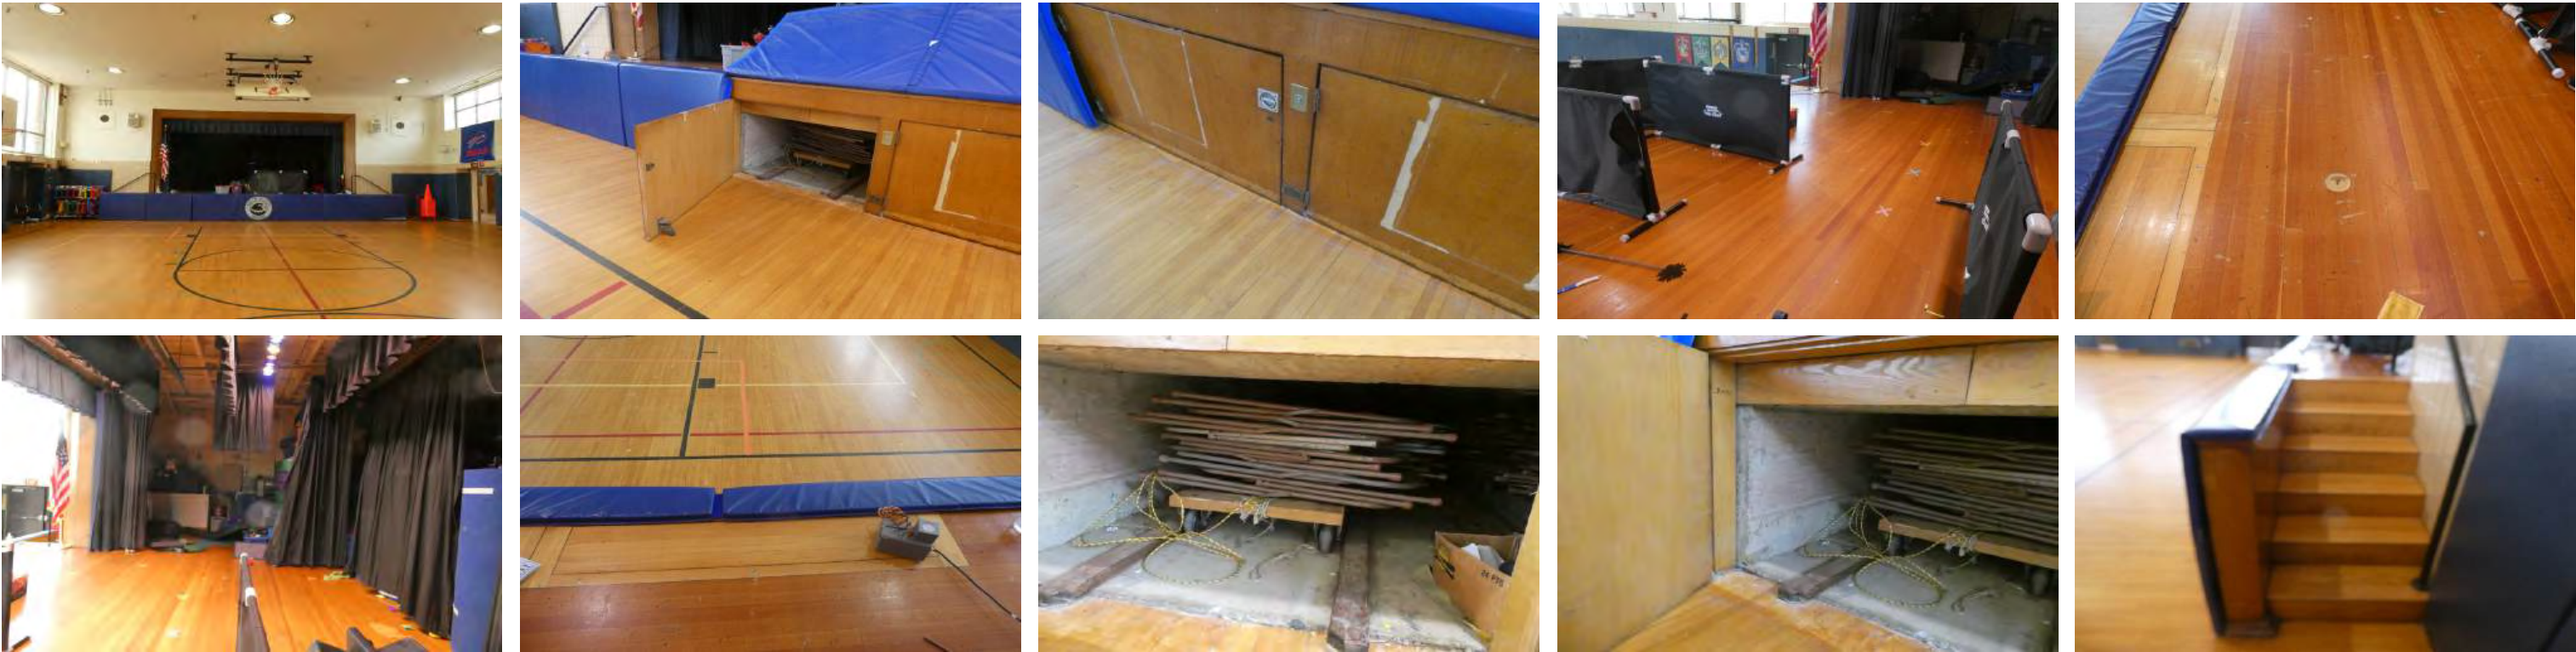
Stage and Stairs

| Observations | Level of<br>Complainece | SQFT | Wall<br>Height | Finish<br>Material | Comments | Cost |
|---|---|---|---|---|---|---|
| Slip Resistance: [Evaluate the traction level; note any slippery areas] | 7 | | | | 2 Wood Floor - floor worn, gouged, scratched, medium red color stain, with worn finish | |
| Trip Hazards: [Document gaps, cracks, or protruding elements] | 10 | | | | Observed plates, which have been sanded flush on edges. Padding exists at top edge of stage | |
| Surface Damage: [Assess scratches, dents, warping] | 10 | | | | Scratches, goughes , paint, worn, footlight covers sanded flush. | |

| <b>Recommendations for Repair or Replacement:</b> [List suggested actions if issues are found] | | | | | Stage floor to be fully refinished in 2-3 years, immediate fixes open ( non lockable) electrical panels should be completed, understage areas cleaned, painted and doors made to better working order or replaced. On stage house lighting missing , require new including rear exit stair area. | |

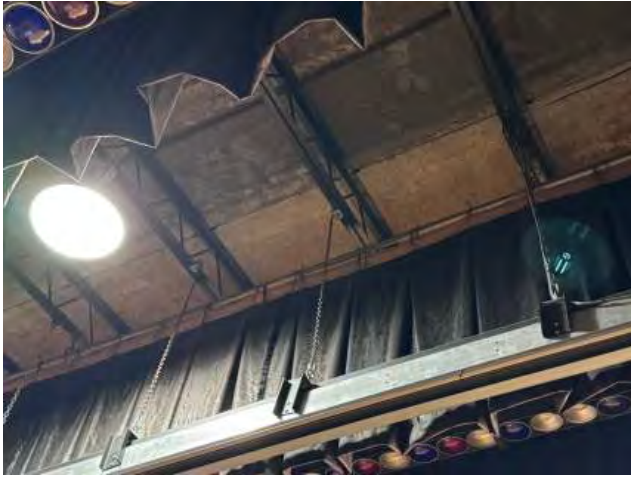
North street School has a basic rigging system hung from the building on light gauge open web steel joists. All of the rigging is not up to current or acceptable industry standards and should be replaced. Current layout consists of a valance, front main traveller curtain, side leg curtains and a rear traveller tracks. The rigging on all of the tracks is in need of replacement. Several of the curtain pipes are undersized and hanging from chain and connections that are not rated for overhead use and should be replaced. The main curtain and valance are switched, the valance should be hung in front of the main. Several of the drapes are torn or frayed and I couldn't find tags on the rear curtains to confirm fire rating. Non fire rated drapes should be removed.

In summary, the rigging system is not in good working order or meets current industry standards. The rigging is with unrated chain and/or connections and should be replaced. The undersized pipes need to be replaced and hung with appropriate hardware. The curtain tracks need to be rerigged and several need updates on the track hardware. The drapes need to be replaced with fire retardant material. The back drop board needs to be removed.

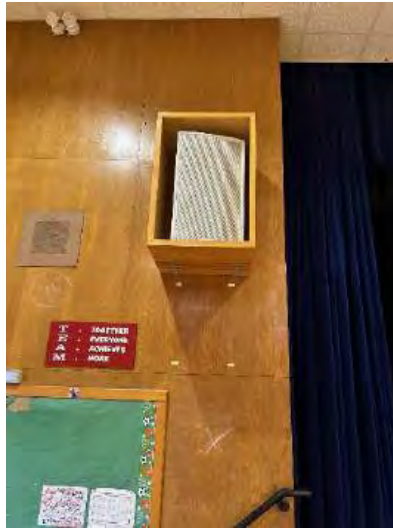
Image #1

The current system is an analog point source speaker system. (see image 31)

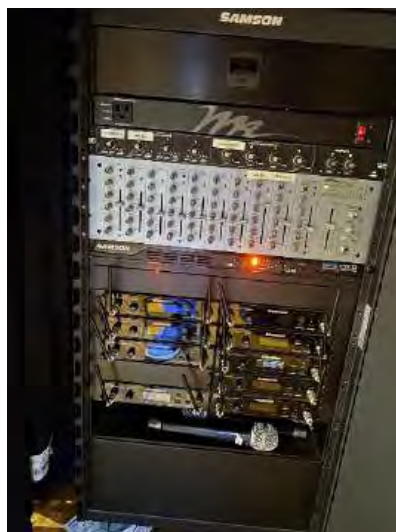
Image #2

1. The technology in the rack is obsolete and inadequate for the room. (see image #2)
2. The speakers are housed in handmade wood enclosures which are preventing the proper sound coverage the room requires. This is not an industry standard for mounting speakers.
3. The speaker enclosures only allow the speakers to project straight back restricting the ability to be able to properly aim the speakers for better coverage and performance.
4. There are newer low grade wireless microphones being used that have been added on over the years.

The audio system is approximately 20+/- years old with the wireless microphone being approximately 10+ years old. Both are in "C" condition based upon a A-F grade scale. There are no apparent life safety issues that need to be addressed at this time.

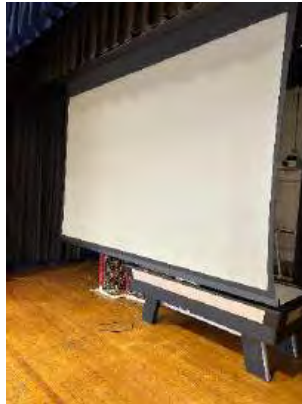
Image #3

The current video projection system consists of a rear projection screen with rear projection projector. The projection screen is usable with minor damage (see image #3)

The Video system is approximately 15+/- years old and is in "C" condition based upon a A-F grade scale. There are no apparent life safety issues that need to be addressed at this time.

1. The video projection screen is in good condition and can provide additional years of use.
2. The video projector should be replaced with a new Laser rear projection unit to eliminate the need for costly lamp replacements and or filter cleaning in the future.
3. A wall mounted HDMI input device will remove the unwanted cables on the stage floor.

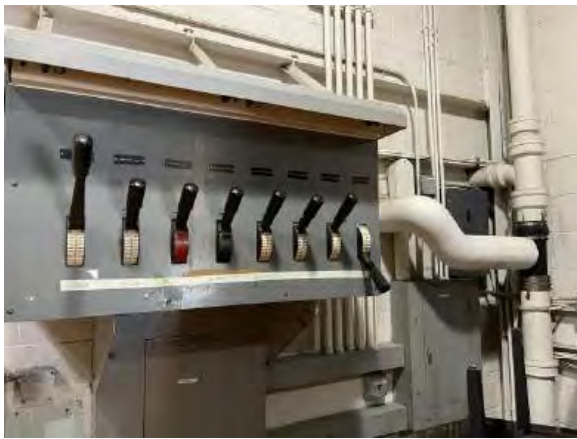
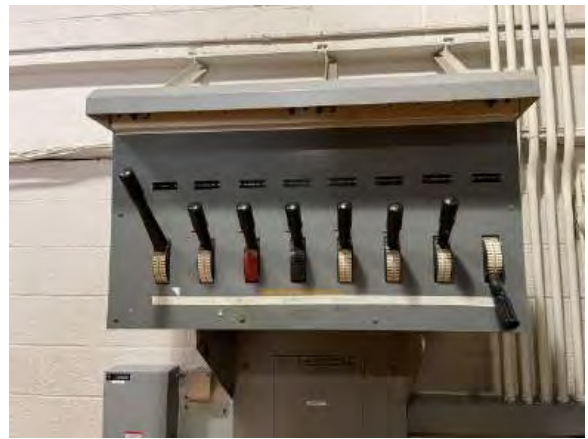
The stage lighting system has two ceiling ports for three fixtures each, and two electrics on stage. There are no other front of house positions. The dimming system is a 1950's era Kliegl auto-transformer dimming system with 7 dimmers and a master bank. There is no separate control console.

Existing Kliegl dimming rack should be replaced with a relay based system, along with modern power distribution. Kliegl has been out of business since 1990 and the current auto-transformer should be discarded as soon as possible. Installation of touchscreen controls, so that the theatrical lighting systems can be operated without the use of a control console for day to day activities. DMX networking and controls should be installed for the new LED systems.

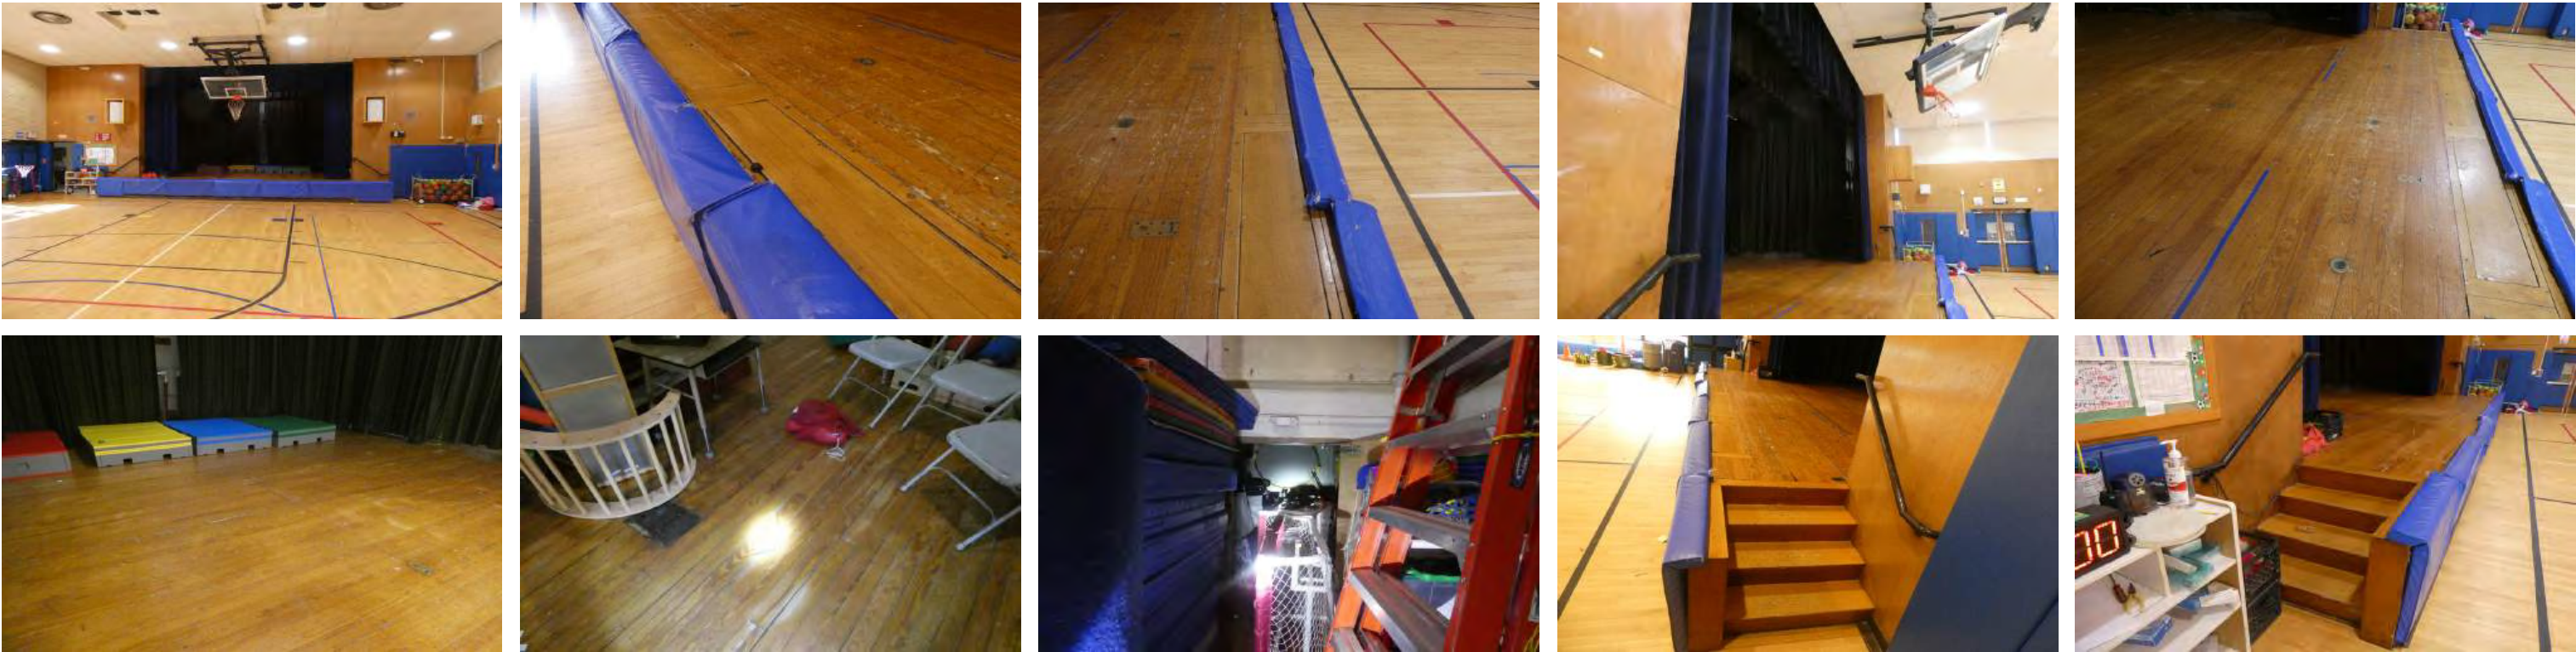
Stage and Stairs

| Observations | Level of<br>Compliance | SQFT | Wall<br>Height | Finish<br>Material | Comments | Cost |
|---|---|---|---|---|---|---|
| Slip Resistance: [Evaluate the traction level; note any slippery areas] | 7 | | | | 2 " Old Wood Floor - floor worn, gouged, scratched, many patches | |
| Trip Hazards: [Document gaps, cracks, or protruding elements] | 3 | | | | A few trip hazards are evident, floor boxes which protrude from floor face. Front ( Down stage) footlight box covers and padding overlapping stage front also uneven areas. | |
| Surface Damage: [Assess scratches, dents, warping] | 3 | | | | Scratches, goughes , paint, worn | |
| Moisture & Rot Issues: [Inspect for water damage, mold, or rot] | 4 | | | | Damaged areas observed DR, CL and UL where observable | |

| <b>Ease of Cleaning:</b> [Note how manageable the floor is for maintenance] | 4 | | | | Standard wood floor, needs replacement, floor beyond refinishing. Met Life cycle expectancy. | |

| <b>Recommendations for Repair or Replacement:</b> [List suggested actions if issues are found] | 4 | | | | Stage floor to be fully replaced in 1 year, immediate fixes to tripping hazards should be completed, understage areas cleaned and made to better working order. New house lighting required . | |

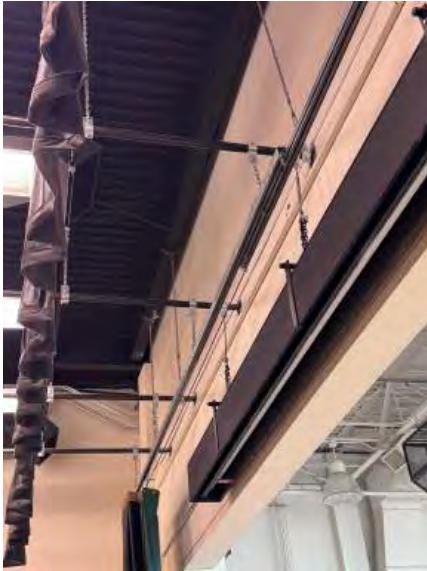
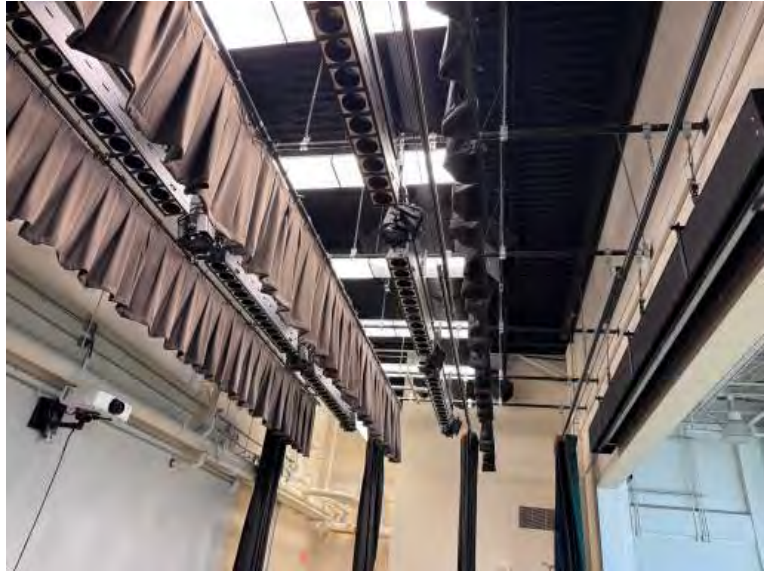
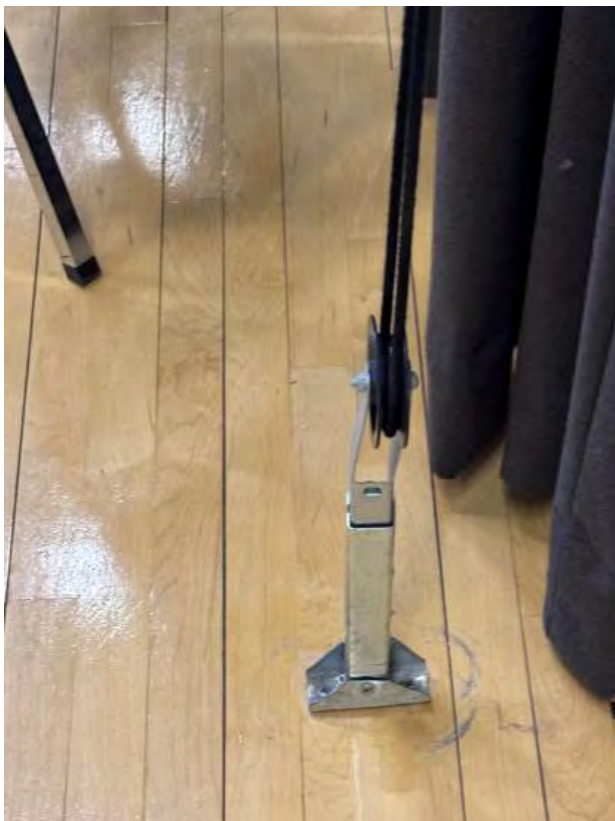
Hamilton Ave School has a basic rigging system hung from a pipe grid, consisting of a valance, front main traveller curtain, side leg curtains and a rear traveller tracks. The front traveler track is in good working order. I was unable to test the mid stage tracks operation because of chairs on stage. The Rear floor pulley is not installed properly under the track live end pulleys causing difficulty in operation and the pulley to bend.( Pictured below) The lighting system on stage is significantly out of date.

In summary, the rigging systems does not appear to present any critical issues. I would recommend the rear drape replacement, rerigging, moving the floor pulley into alignment and finally to remove or pad the pipe bracket to prevent further damage to the drapes.

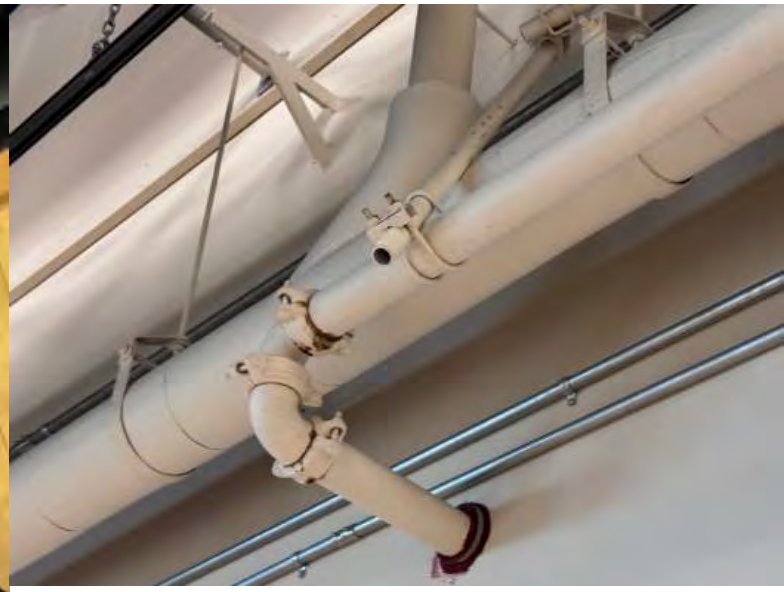
The drapes are listed as inherently and permanently flame retardant. Drapes appeared to be in good condition and in good working order except for the rear traveler which has several tears that seem to be caused by the exposed bolt ends on the pipe bracket

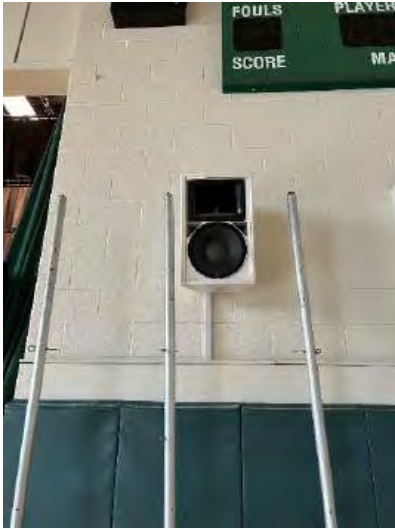
Image #1

The current system is a digital dual purpose point source and distributed speaker system which is common for a gym/stage of the size. (see image #1-point source)

1. The age of the system is the main deficiency. Its age is approximately 20+ years old
2. The system is currently non-operational
3. Most of the equipment is obsolete and the newer equipment is not functioning
4. The wall controllers are obsolete
5. The ceiling speakers can be re-used but the main speakers are missing components

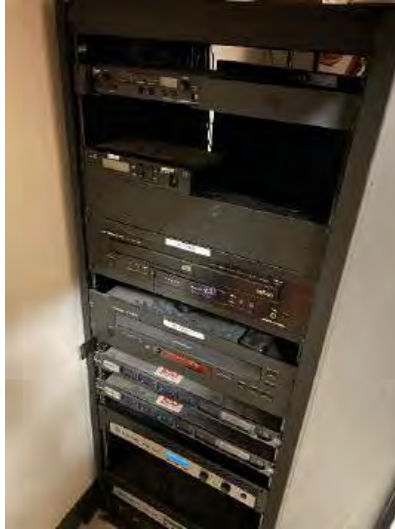
Image #2

When it was installed, it had all the common features found at its time. ie: CD decks etc. (see image # 2) and analogue wall control (see image #3)

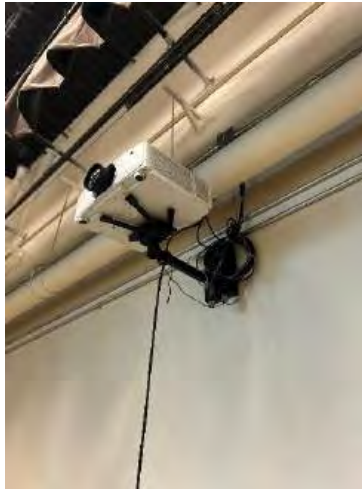
Image #4

The current video projection system is a lamp based rear projection system commonly found in a gym/stage setting. (see image #4)

The Video projector is approximately 20+/- years old and is in "C" condition based upon a A-F grade scale.

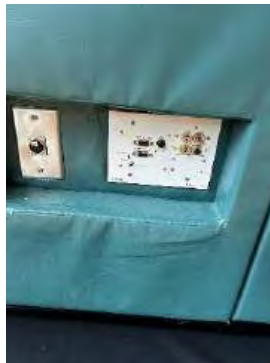
Image #5

1. The video projection screen is in good condition and can be re-used.
2. The video projector is mounted on the back wall and prevents the rear traveler curtain to close all the way.
3. The video projector wiring is obsolete (VGA) resulting in temporary HDMI cable to be draped down the wall.  
(see image #5)

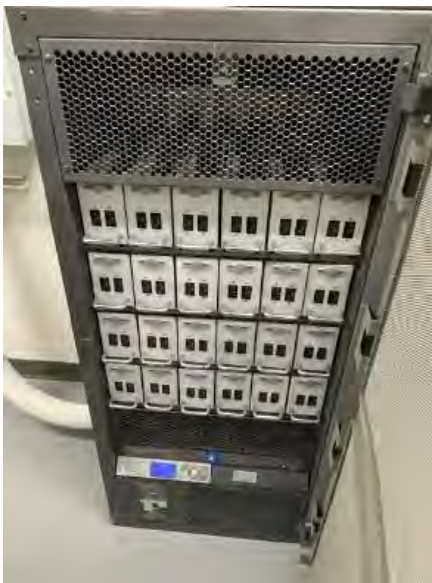
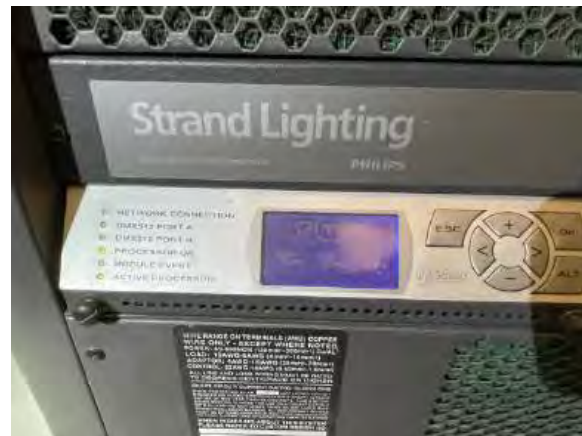
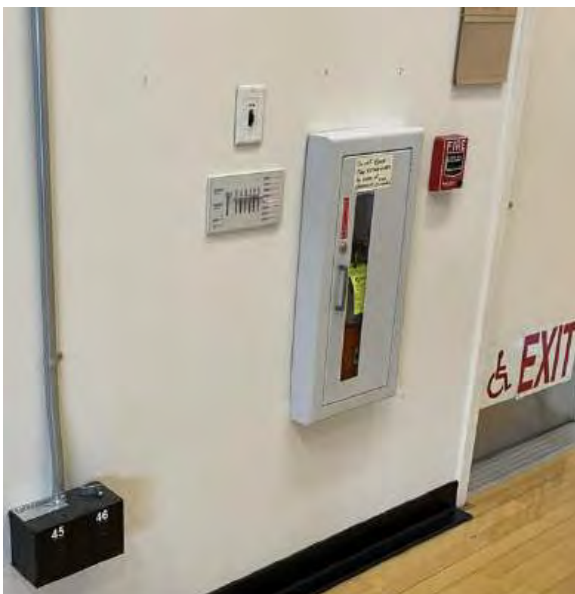
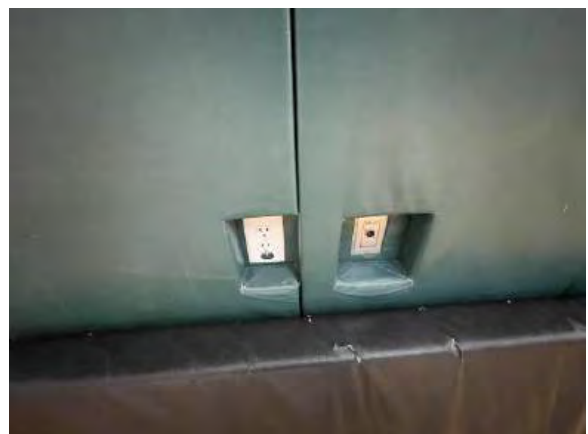
The stage lighting system has front of house positions located in cages over the gymnasium floor. There are two electrics on stage. The dimming system is a Strand C21 dimming system with 48 dimmers. The control console was not observed in the space. There is one architectural control station USL.

The condition of the existing system is good, but the equipment is discontinued and maintenance options for the dimming system are limited. The existing lighting fixtures are no longer manufactured, and require greater power usage and maintenance than new LED fixtures.

Existing Strand dimming system and controls should be replaced with a relay based system, along with updated power distribution. Installation of touchscreen controls, so that the theatrical lighting systems can be operated without the use of a control console, for day to day activities. DMX networking and controls should be installed for the new LED systems.

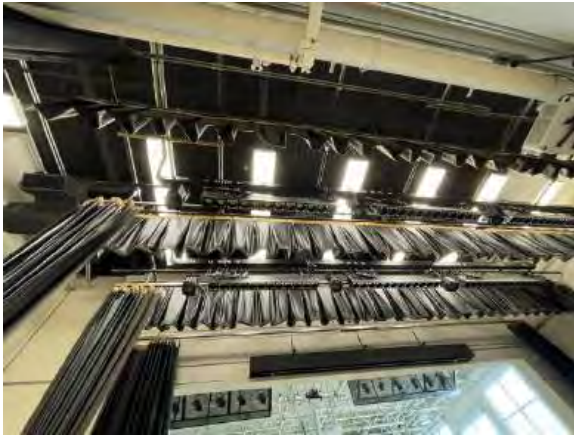
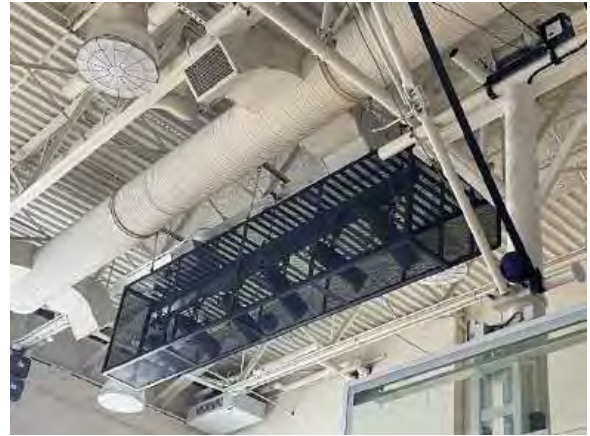
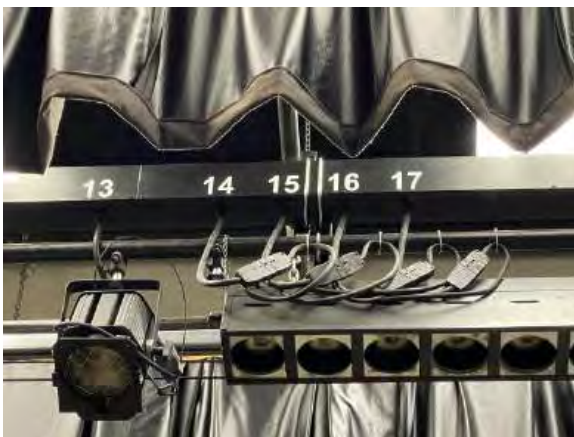
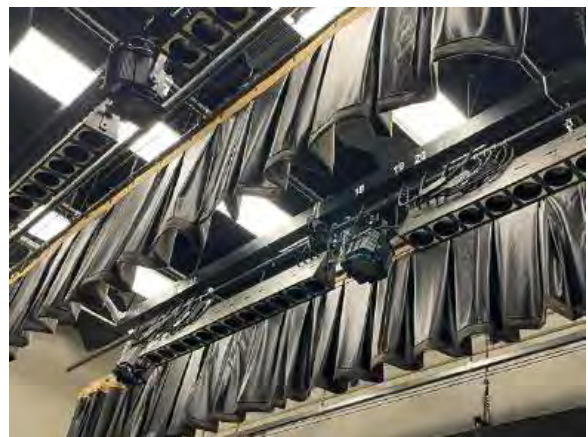
The lighting fixtures are obsolete Strand incandescent ellipsoidals, mounted in cages at the front of house positions. There are Strand incandescent fresnels and strip lights on stage. They appear to be in relatively good condition.

**Recommendation:** A full system upgrade with theatrical LED fixtures, which will offer increased capabilities. These capabilities include power and HVAC savings, color changing features, and reduced maintenance. LED follow spots should be added to complete the front of house lighting. A third electric could be added to improve the stage coverage.

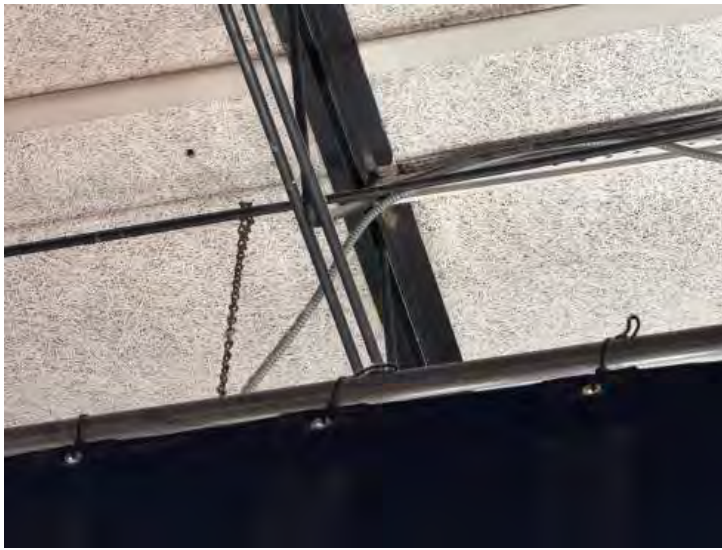
Parkway School has a basic rigging system hung from the building on light gauge open web steel joists. All of the rigging is not up to current or acceptable industry standards and should be replaced. Current layout consists of a front main traveller curtain, valance, side leg curtains and a rear traveller tracks. The rigging on all of the tracks is in need of replacement. Several of the curtain pipes are undersized and hanging from chain and connections that are not rated for overhead use and should be replaced. The main curtain and valance are switched, the valance should be hung in front of the main curtain. There is a hand crank winch attached to the electrics that should be removed immediately, none of the lines are terminated properly either on the winch or on the electrics.

In summary, the rigging system is not in good working order or meets current industry standards. The rigging is with unrated chain and/or connections and should be replaced. The undersized pipes need to be replaced and hung with appropriate hardware. The curtain tracks need to be rerigged and several need updates on the track hardware. The winch should be replaced as soon as possible. When the rigging is replaced, then swap the valance and main curtain.

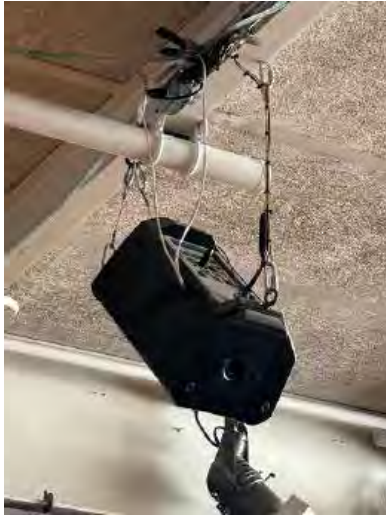
Image #1

The current system is a digital point source system which is common for a room of this size. ( see image #1)  
When it was installed, it had all the common features found of its time such as a cd player. (see image #2)

1. The age of the system is the main deficiency; it is approximately 15 + years old
2. The audio equipment in the rack is obsolete. ( image #2)
3. The audio rack is oversized for the system and is wasting stage space.
4. The current system does not offer wireless hearing impaired as per ADA requirements.
5. The main speakers are self-powered and poorly installed from the building. (see image #1)
6. The speaker cabling is fastened to the building structure via temporary clamps ( see image #3)

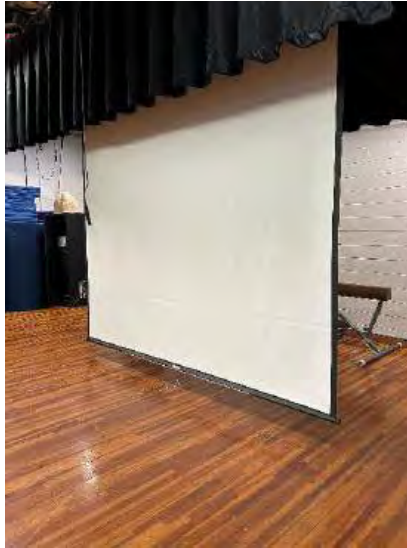
Image # 4

The current video projection screen is an old square format. (see image #4)  
There is currently no video projector installed.

The Video system is approximately 25+/- years old and is in "D" condition based upon a A-F grade scale. There are no apparent life safety issues that need to be addressed at this time.

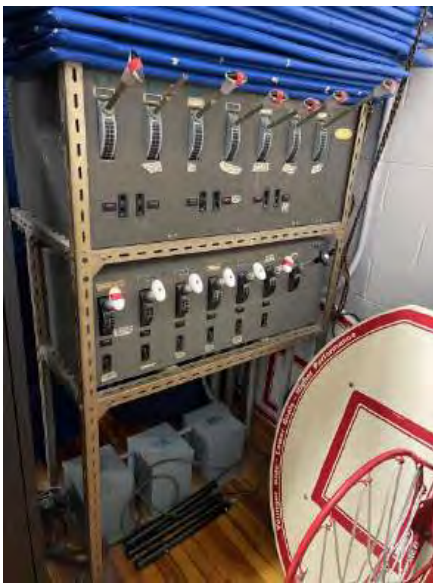
The stage lighting system has two front of house pipes with three non-axial fixtures on each, and two electrics on stage. There are no other front of house positions. The dimming system is a 1950's era Century auto-transformer dimming system with 12 dimmers total and a master bank on each row. There is no separate control console.

The condition of the existing system is ancient, and the equipment is obsolete and maintenance options for the dimming system are non-existent. A control console, compatible with the proposed LED fixture upgrades should be added. The existing lighting fixtures are no longer manufactured, and require greater power usage and maintenance than new LED fixtures.

Existing Century dimming racks should be replaced with a relay based system, along with modern power distribution. Century has been out of business since 1969 and the current auto-transformer system should be discarded as soon as possible. Installation of touchscreen controls, so that the theatrical lighting systems can be operated without the use of a control console for day to day activities. DMX networking and controls should be installed for the new LED systems.

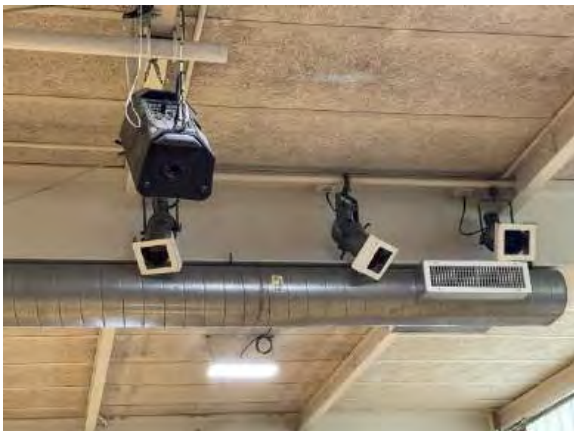
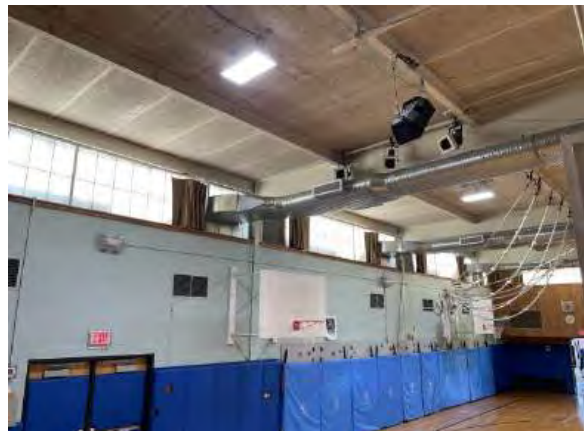
The lighting fixtures are obsolete Century ellipsoidals and fresnels. Some of the lighting fixtures need to be re-lamped or require other maintenance. There are also border strip lights on stage. Front of house fixtures are hung on pipes welded between the beams. A newer air duct appears to provide some protection for the fixtures.

**Recommendation:** A full system upgrade with theatrical LED fixtures, which will offer increased capabilities. These capabilities include power and HVAC savings, color changing features, and reduced maintenance.
