**BUILDING ENVELOPE EVALUATION  
FOR  
THE TOWN OF SOUTHAMPTON POLICE STATION  
8 EAST STREET, SOUTHAMPTON, MA  
MI-2516-001**

**FINAL DRAFT**

**January 2021**

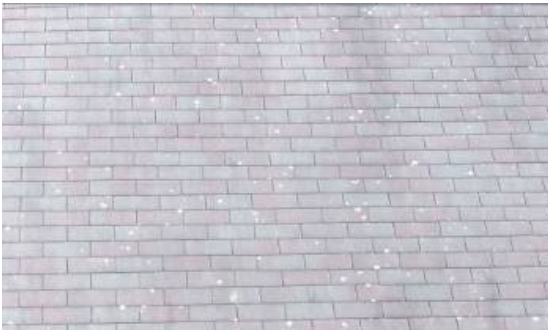
Lichen growth on the northerly and westerly roof slopes. (Little concern.)

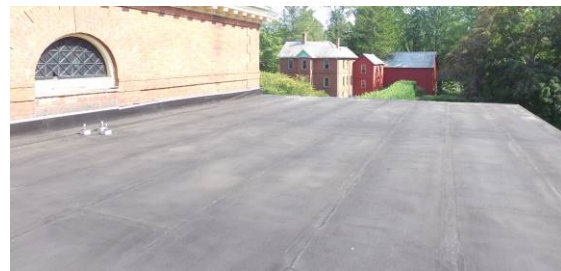
Sign of wear (below)

(Condition: Fair/Good) – According to historic records, the southerly addition was constructed in the early 1970's for two (2) garages and a meeting-voting room above. Based upon appearance, this is likely the original roof. The existing roofing appears to be a built-up torch-down roofing system. The general field appears in good condition. Due to the age, it is showing evidence of chalking and breakdown at seams. This is a common effect as the membrane ages and wears.

There are no roof drains or interior drainage. The roof is sloped to the exterior roof edges where gutters and downspouts are present for drainage.

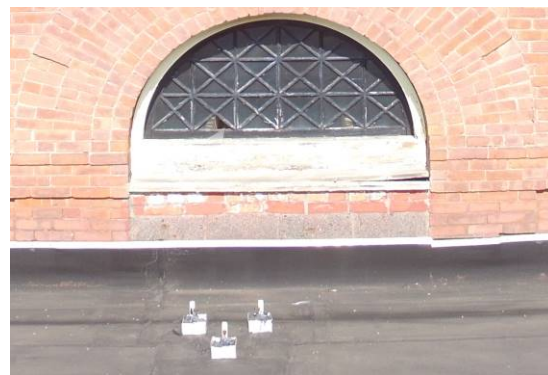
Abandoned antenna mounts  
(Remove with next roof replacement)

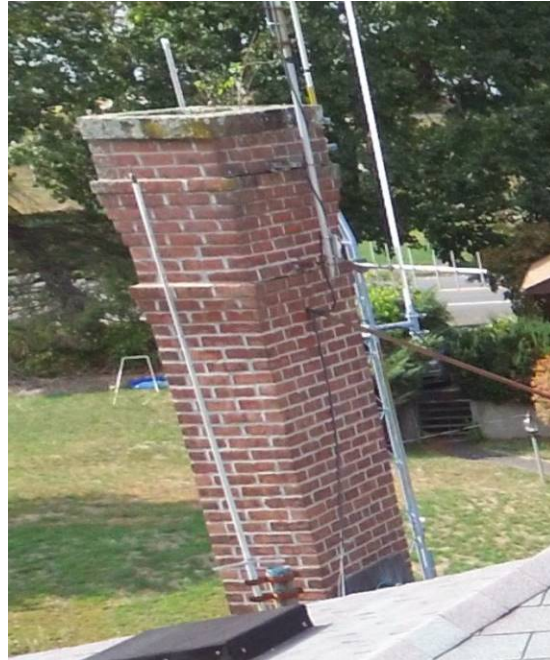
South Chimneys

Review chimneys for repointing  
(Being used for support of antennas)

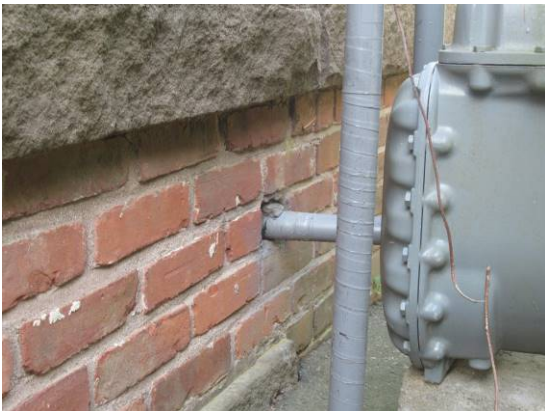
Wall penetrations should be sealed.

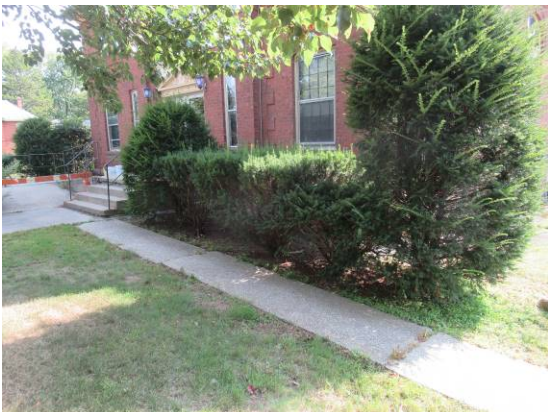
The overgrown vegetations should be kept clear of the building so surfaces will dry.

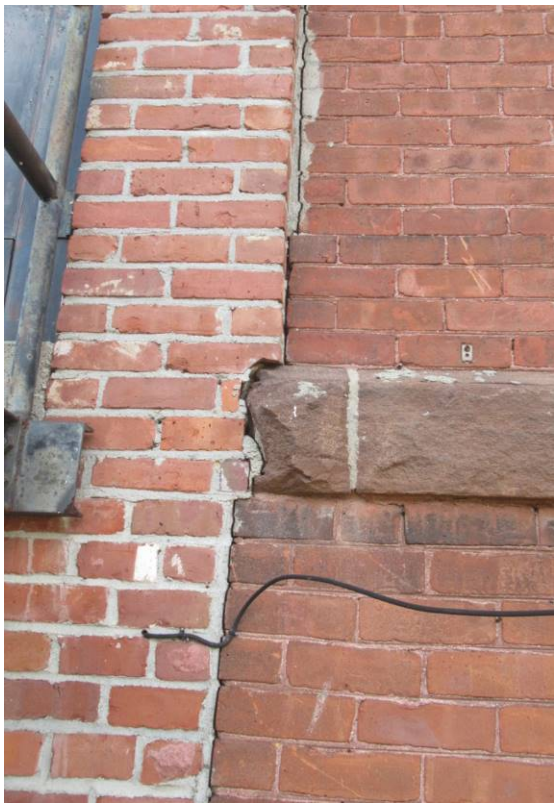
Seal joint between 1904 and 1960 buildings.  
(Irregular building settlement)
