# ACCESSIBILITY ASSESSMENT

January 8, 2025

## **ADA TITLE II ASSESSMENT**

Douglas Gardens Elementary School  
3680 Jasper Road  
Springfield, OR 97478

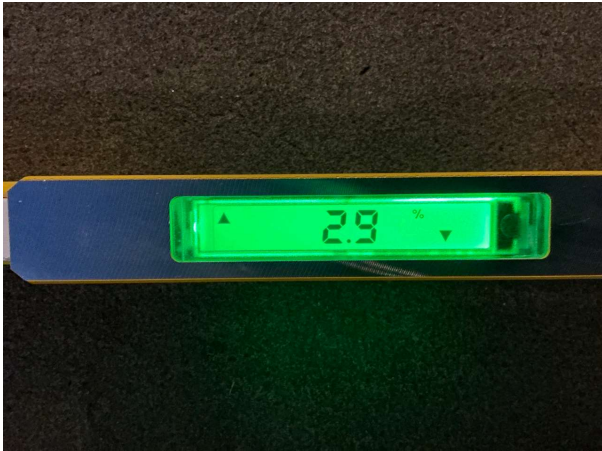
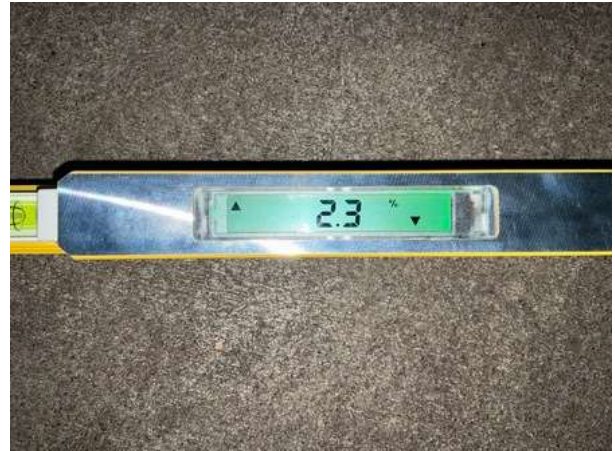
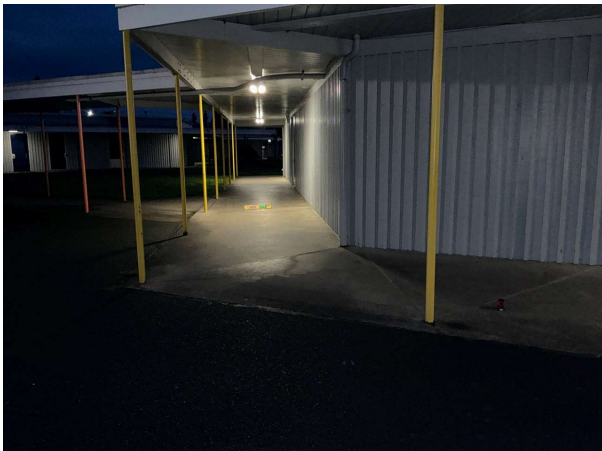
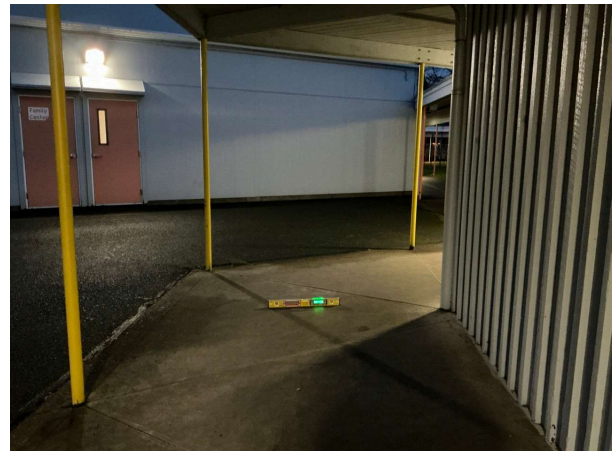
Photos for Barrier ID: AX528455

| <b>Site Conditions</b> | The accessible route has cross slopes from 2.3% to 2.9%. |

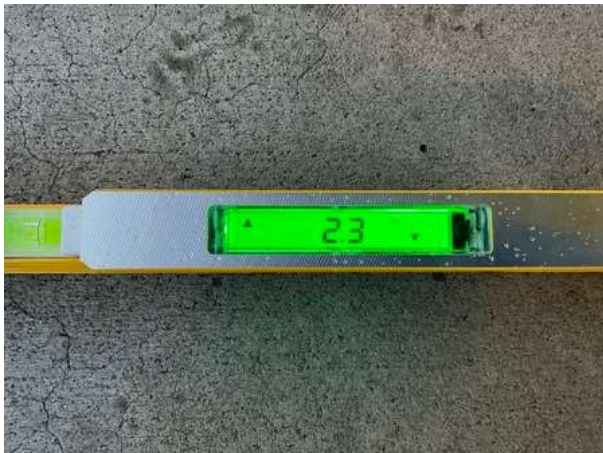
Photos for Barrier ID: AX528456

| Site Conditions | The accessible route has a cross slope of 2.3%. |

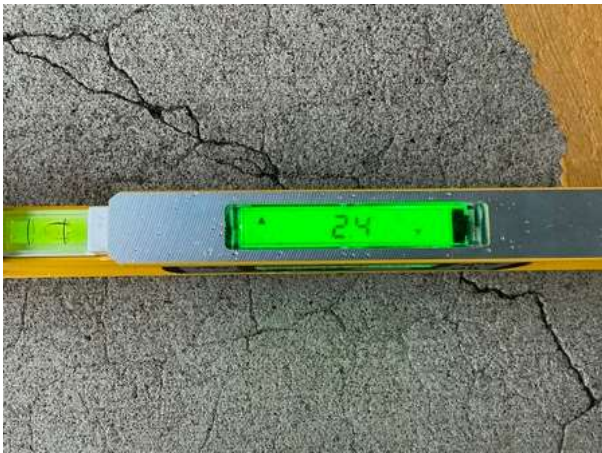
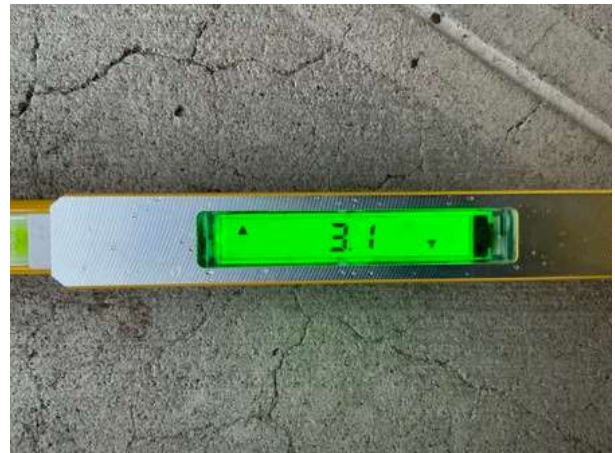
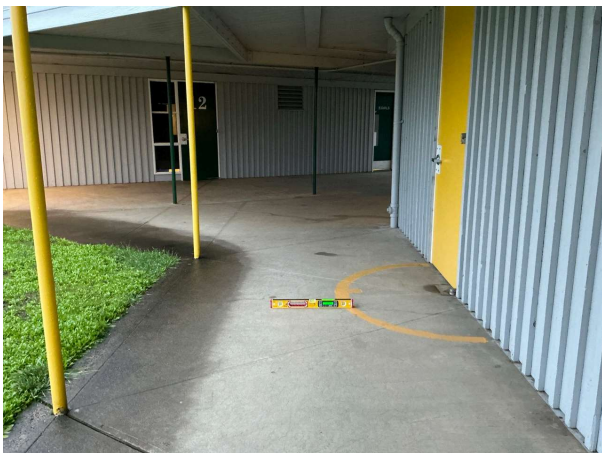
Photos for Barrier ID: AX528458

| <b>Site Conditions</b> | The accessible route has cross slopes from 2.4% to 3.1%. |

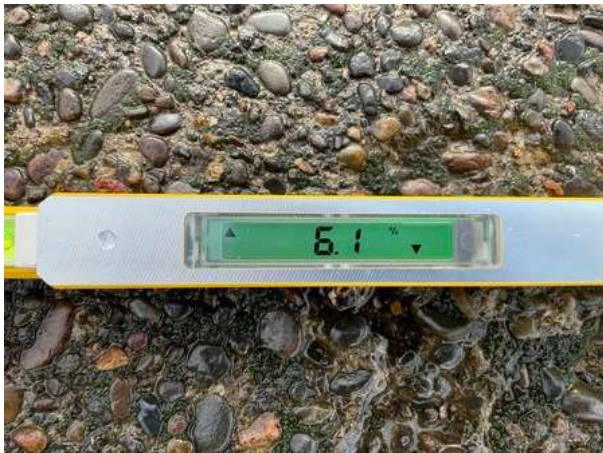
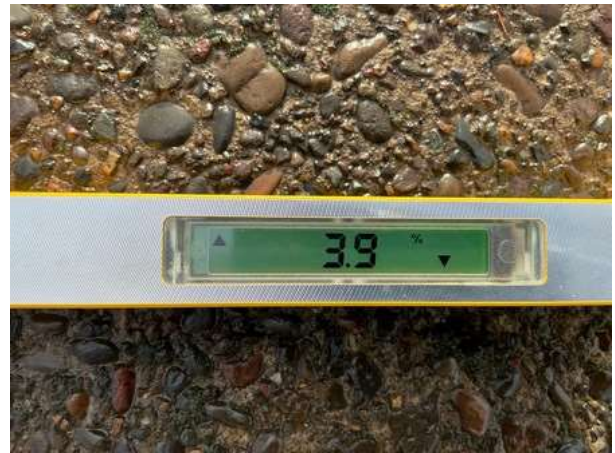
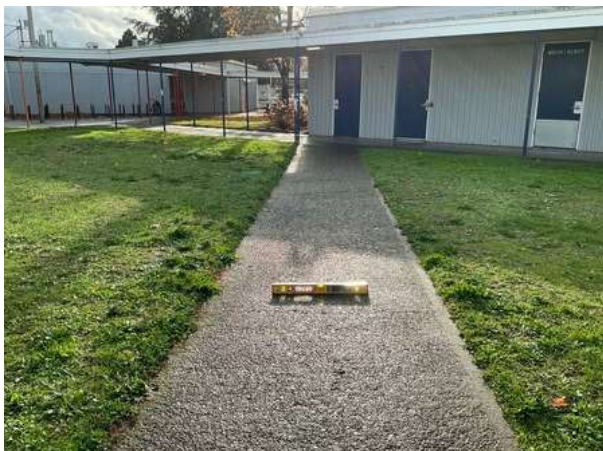
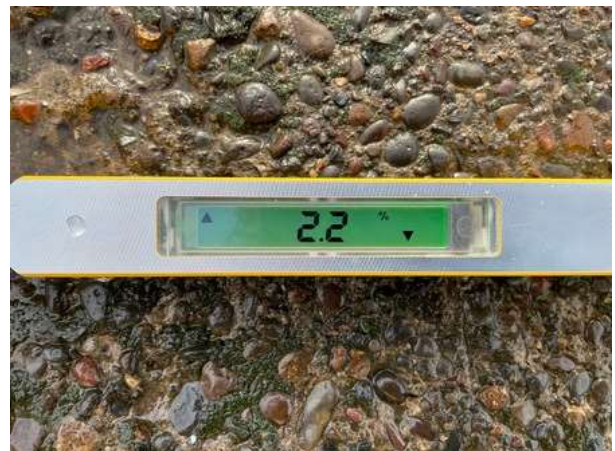
Photos for Barrier ID: AX528471

| <b>Site Conditions</b> | The accessible route has cross slopes from 2.2% to 6.1%. |

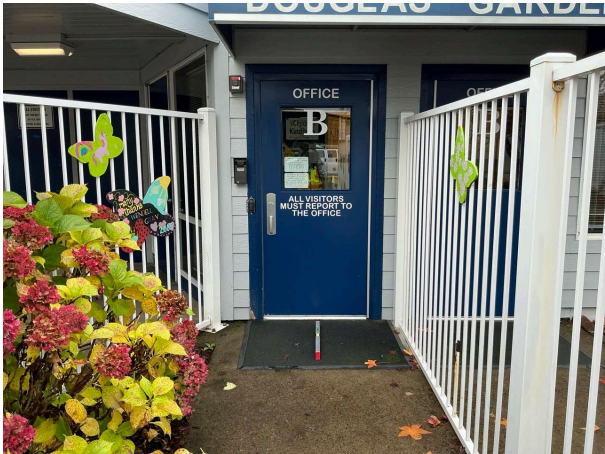
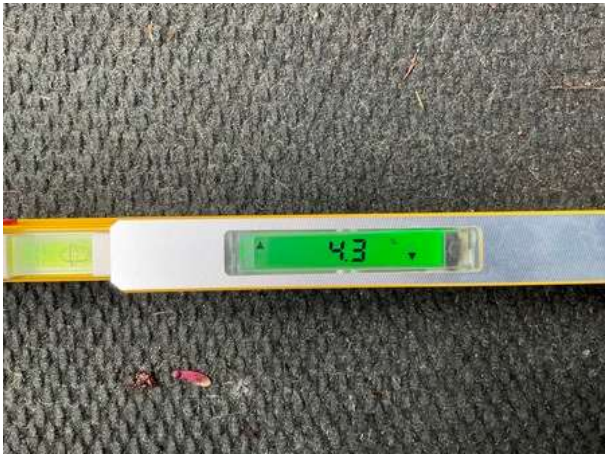
| Site Conditions | The maneuvering clearance has a slope of 4.3%. |

Remove and replace the surface within the required maneuvering clearance area so that the surface is level and clear with maximum slope 1:48 (2.08%) in any direction. The required depth of the maneuvering clearance is 60" minimum. The required side clearance is 18" minimum on the latch side of the door. Maneuvering clearance shall extend the full width of the doorway and the required latch side clearance. Floor or ground space within the required maneuvering clearance shall be maximum 1:48 (2.08%) slope. Changes in level are not permitted.

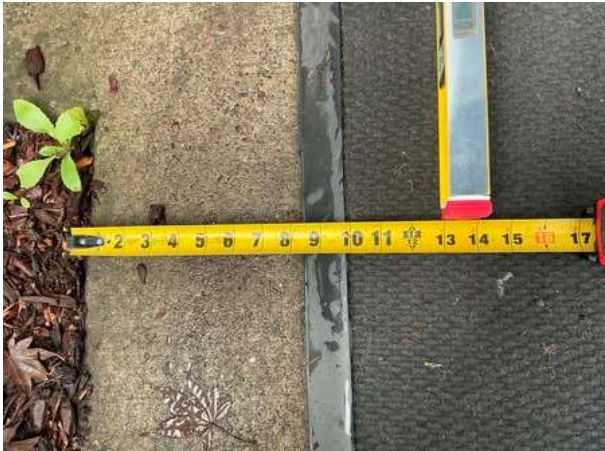
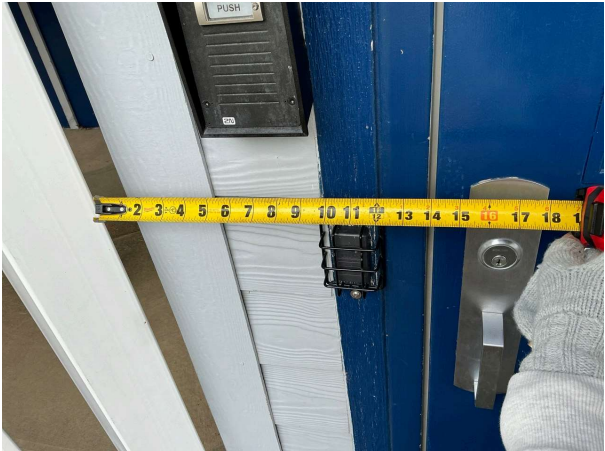
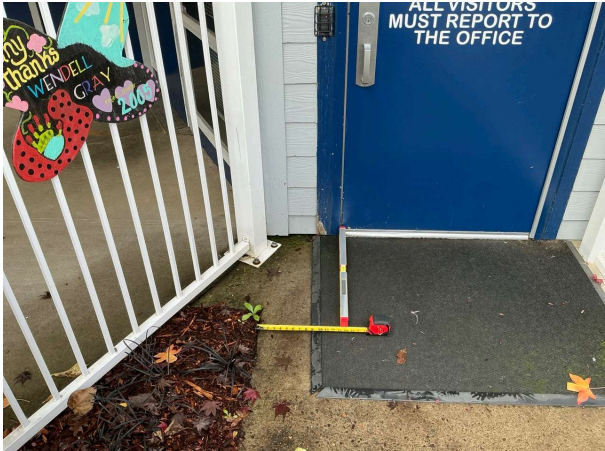
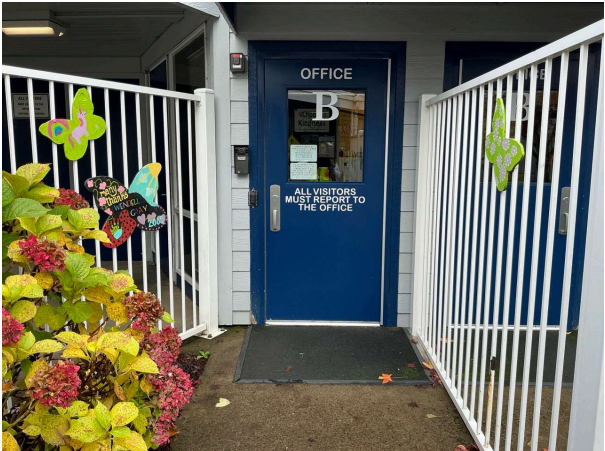
Photos for Barrier ID: AX528419

| Site Conditions | For a front approach on the pull side, the side clearance is 13 inches. | |

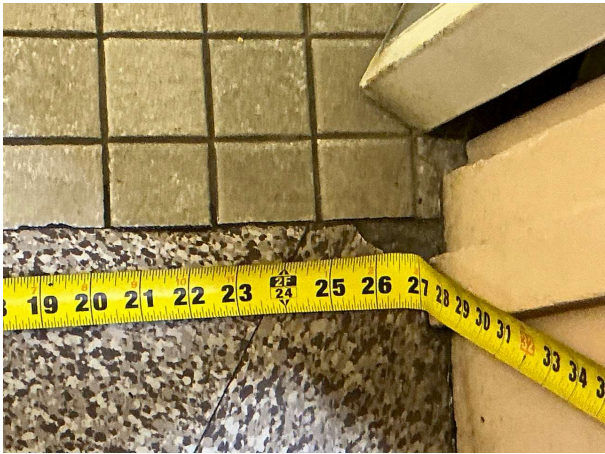
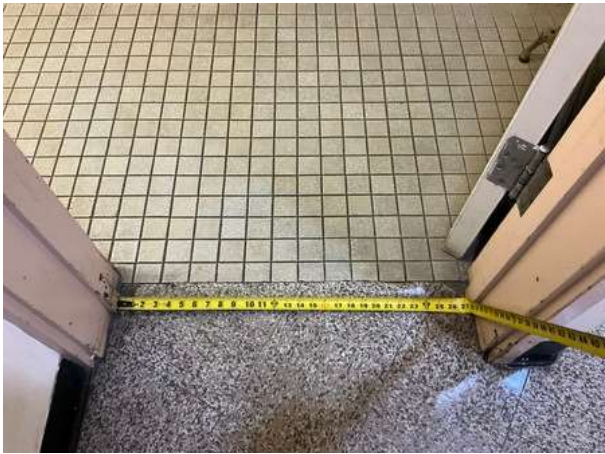
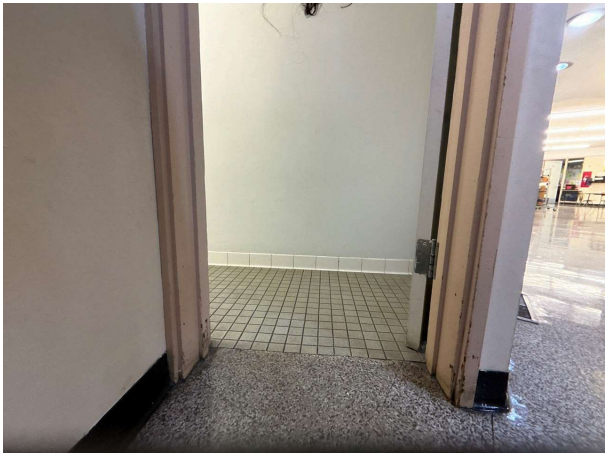
| <b>Site Conditions</b> | The door clear width is 25-1/2 inches. |

Remove and replace with a door that has a minimum clear opening of 32". Door openings shall provide a clear width of 32" minimum. Clear openings of doorways with swinging doors shall be measured between the face of the door and the stop, with the door open 90 degrees. Openings more than 24" deep shall provide a clear opening of 36" minimum. There shall be no projections into the required clear opening width lower than 34" above the finish floor or ground. Projections into the clear opening width between 34" and 80" above the finish floor or ground shall not exceed 4". [EXCEPTIONS: 1. In alterations, a projection of 5/8" maximum into the required clear width shall be permitted for the latch side stop. 2. Door closers and door stops shall be permitted to be 78" minimum above the finish floor or ground.]

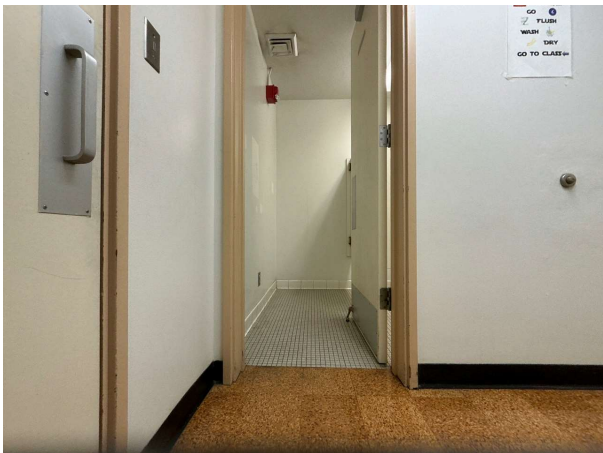
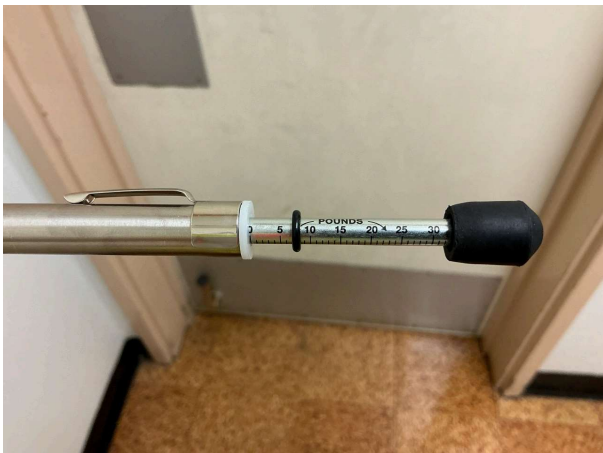
Photos for Barrier ID: AX528479

| Site Conditions | The opening force is greater than 5 pounds. |

Adjust the closer or replace with a door that requires no more than 5 pounds of force for pushing or pulling the door open. The force at the latch, the force to set the door in motion, and the force to fully open the door shall be maximum 5 pounds. These forces do not apply to the force required to retract latch bolts or disengage other devices that hold the door or gate in a closed position.

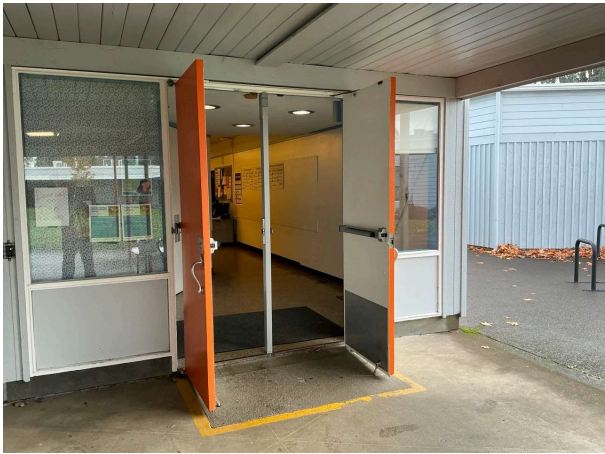
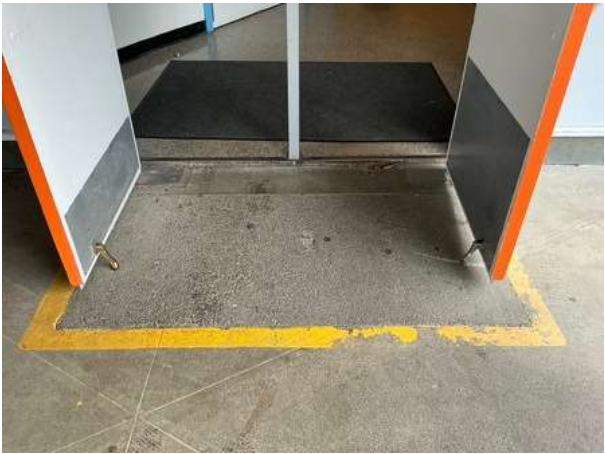
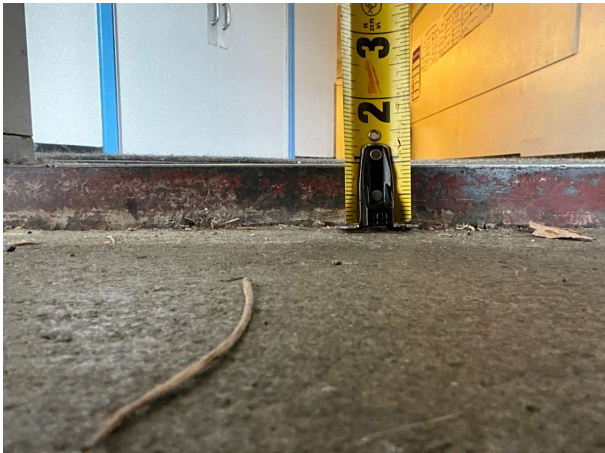
| Site Conditions | The opening force is greater than 8.5 pounds. | |

| Adjust the closer or replace with an exterior door that requires no more 8.5 pounds of force for pushing or pulling the door open. The opening force of doors along an accessible route shall be as follows: 1. Exterior doors: 8.5 pounds maximum (lbf) (37.8 N). 2. Interior doors: 5 pounds maximum (lbf) (22.2 N). 3. Stairway doors at pressurized stair enclosures: 15 pounds maximum (6.8 kg) at exterior doors. 4. Where environmental conditions require greater closing pressure, power-operated doors shall be used within the accessible route. [Exception: The force required to retract latch bolts or disengage other devices that hold the door or gate in a closed position shall not apply to panic hardware, delayed egress devices or fire-rated hardware.] | | |

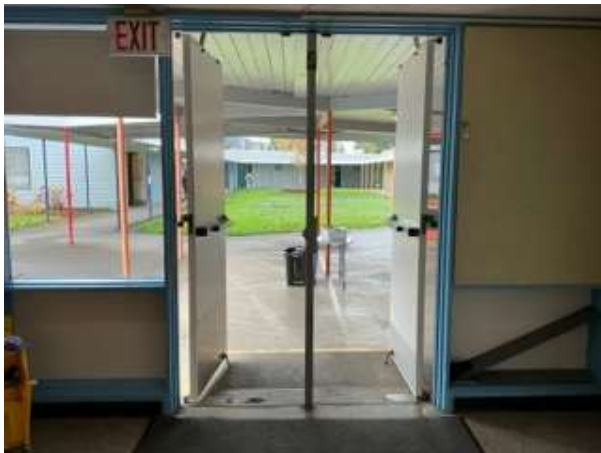
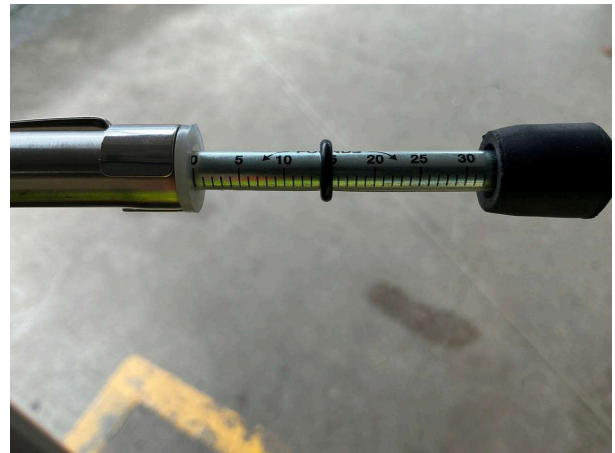
Photos for Barrier ID: AX528425

Site Conditions The opening force is greater than 5 pounds.

Adjust the closer or replace with a door that requires no more than 5 pounds of force for pushing or pulling the door open. The force at the latch, the force to set the door in motion, and the force to fully open the door shall be maximum 5 pounds. These forces do not apply to the force required to retract latch bolts or disengage other devices that hold the door or gate in a closed position.

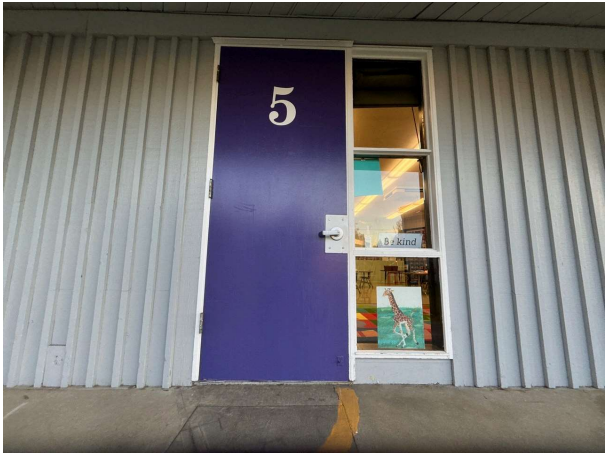
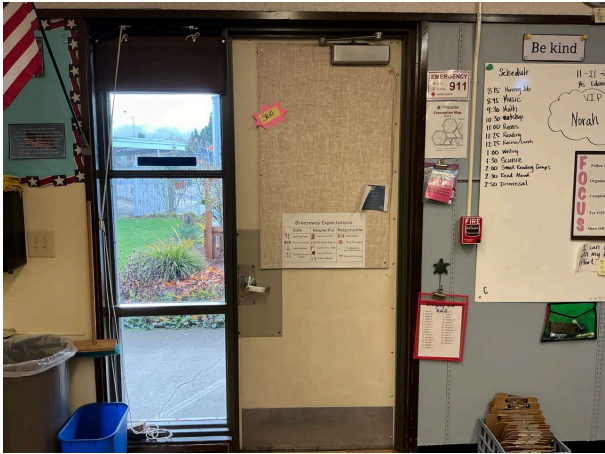
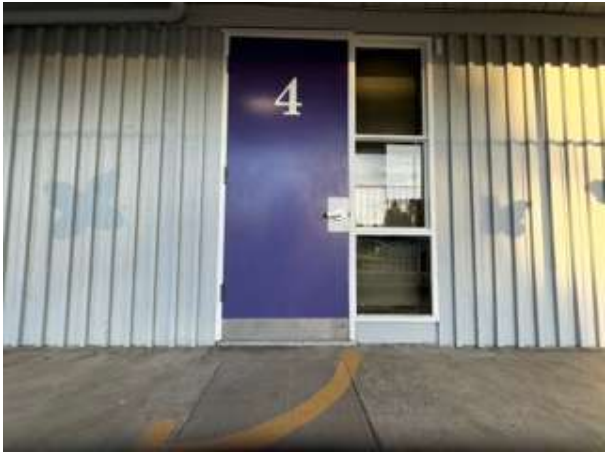
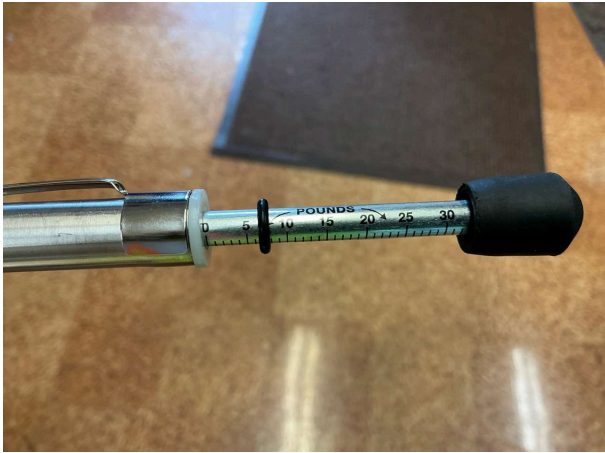
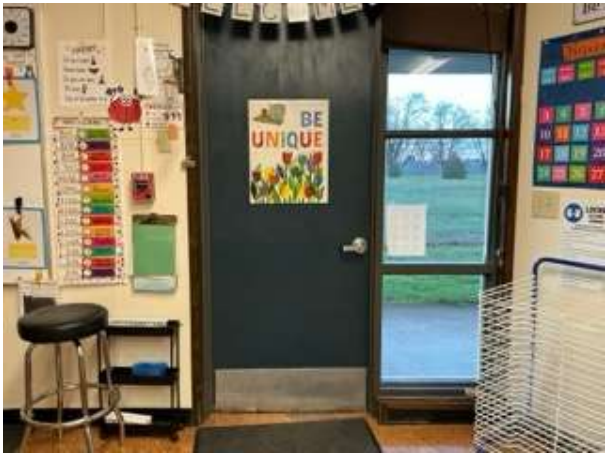
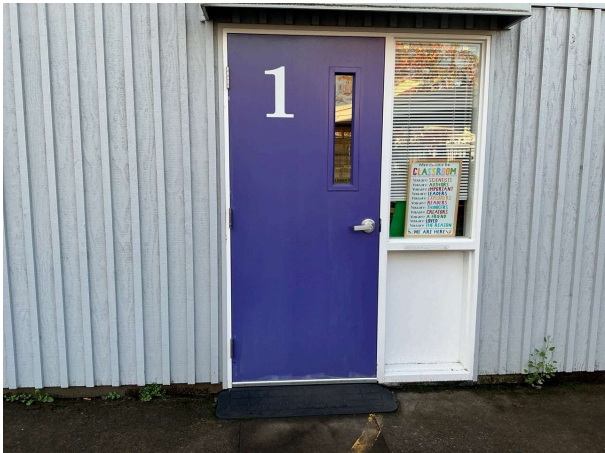
| Site Conditions | The threshold at the accessible door is greater than 1/2 inch. |

Remove and replace with a threshold that is ½" or less in height (including carpet pile allowed to be 1/2" max high). Thresholds, if provided at doorways, shall be 1/2" high maximum. Raised thresholds and changes in level at doorways shall be compliant. [EXCEPTION: Existing or altered thresholds 3/4" high maximum that have a beveled edge on each side with a slope not steeper than 1:2 shall not be required to comply.]

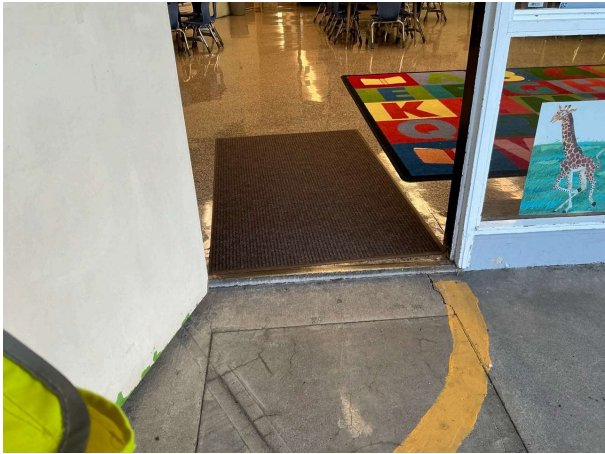
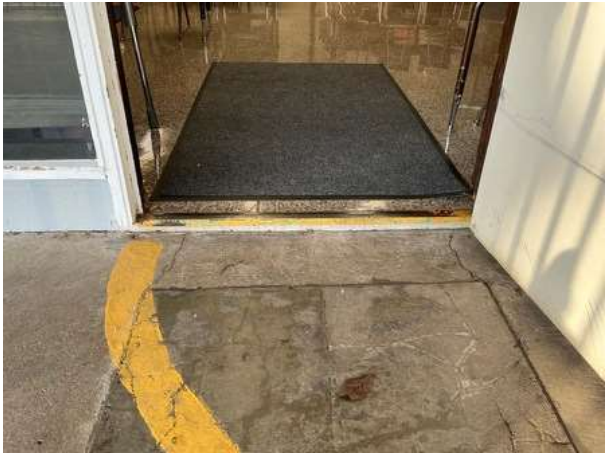
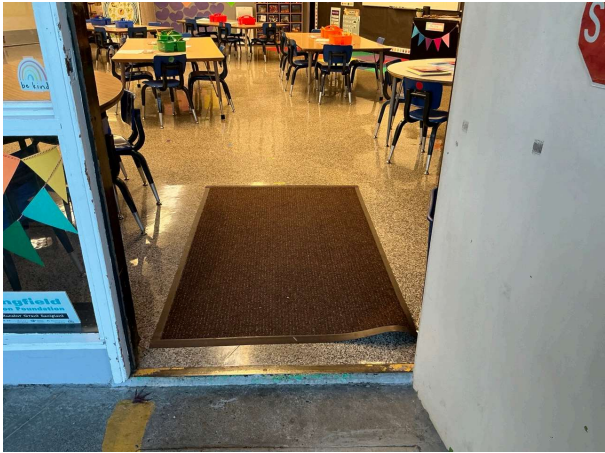
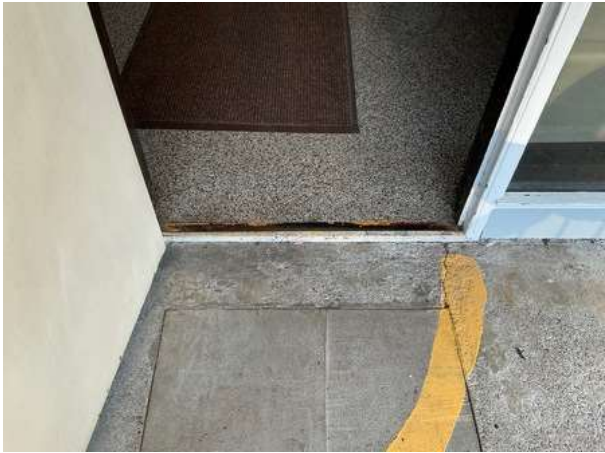
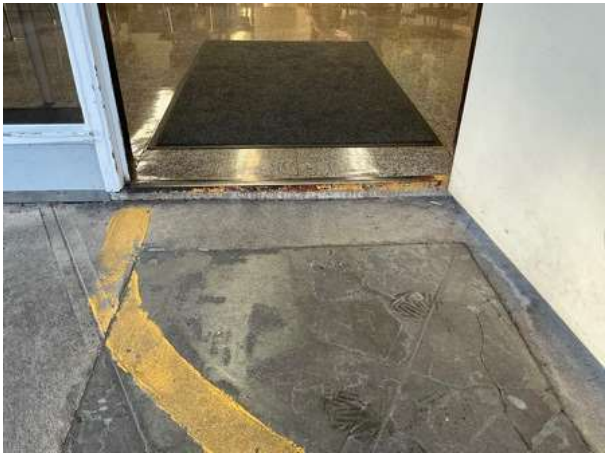
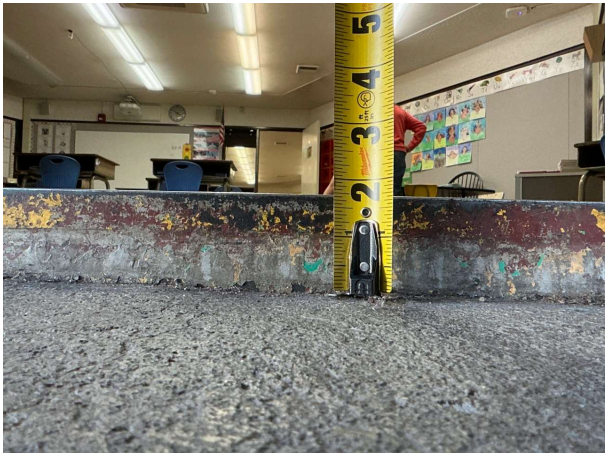
| Site Conditions | The door maneuvering clearance has a slope greater than 2.08%. |

Remove and replace the surface within the required maneuvering clearance area so that the surface is level and clear with maximum slope 1:48 (2.08%) in any direction. The required depth of the maneuvering clearance is 60" minimum. The required side clearance is 18" minimum on the latch side of the door. Maneuvering clearance shall extend the full width of the doorway and the required latch side clearance. Floor or ground space within the required maneuvering clearance shall be maximum 1:48 (2.08%) slope. Changes in level are not permitted.

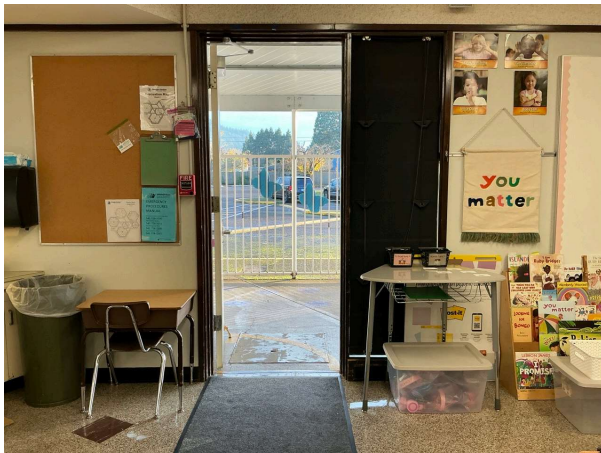
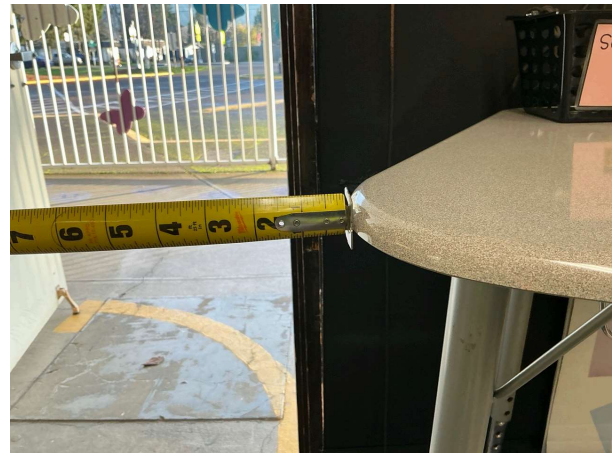
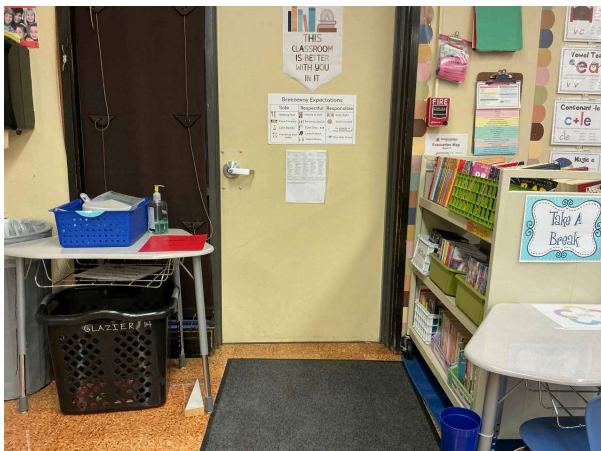
Photos for Barrier ID: AX528446

Site Conditions The closing speed is less than 5 seconds.

Adjust closer or remove and replace closer to ensure that the door has a closure time of at least 5 seconds within 12 degrees of the latch. Door closers and gate closers shall be adjusted so that from an open position of 90 degrees, the time required to move the door to a position of 12 degrees from the latch is 5 seconds minimum.

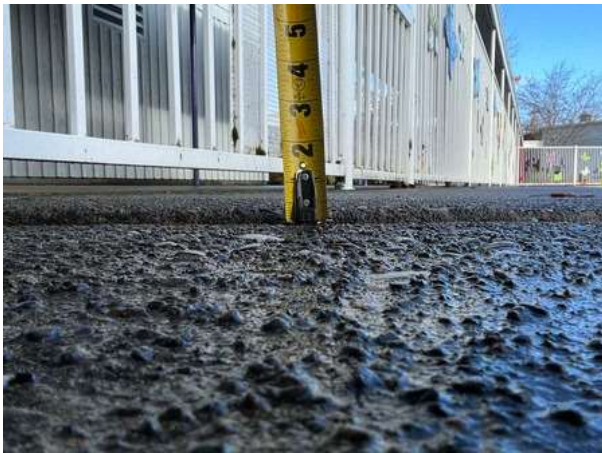
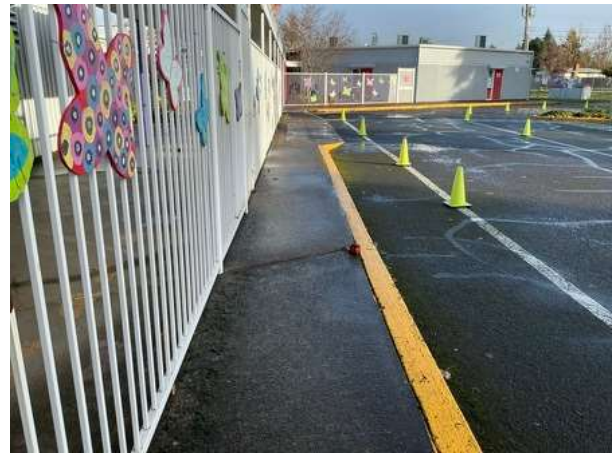
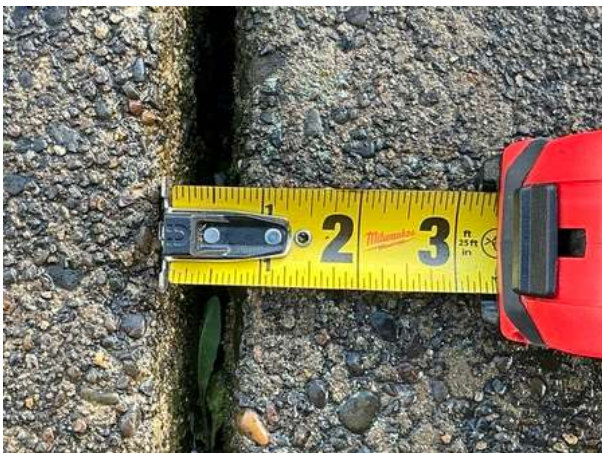
Photos for Barrier ID: AX528409

| Site Conditions | The accessible route has a 3/4-inch gap for a length of 46 inches. |

Repair the accessible route to eliminate openings in the surface greater than 1/2" wide. Openings in the ground surface of the accessible route shall not allow passage of a sphere more than 1/2" diameter. Elongated openings shall be placed so that the long dimension is perpendicular to the dominant direction of travel.

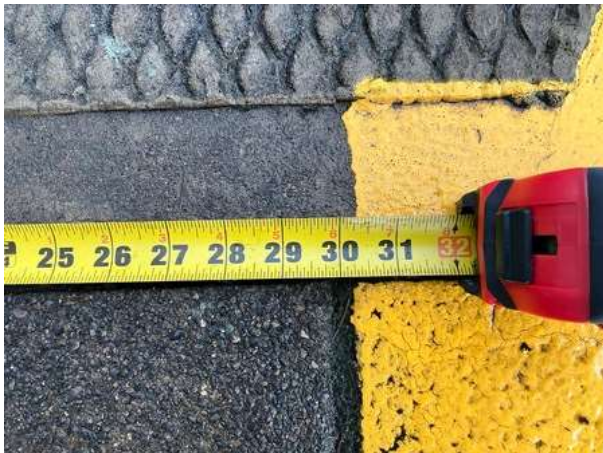
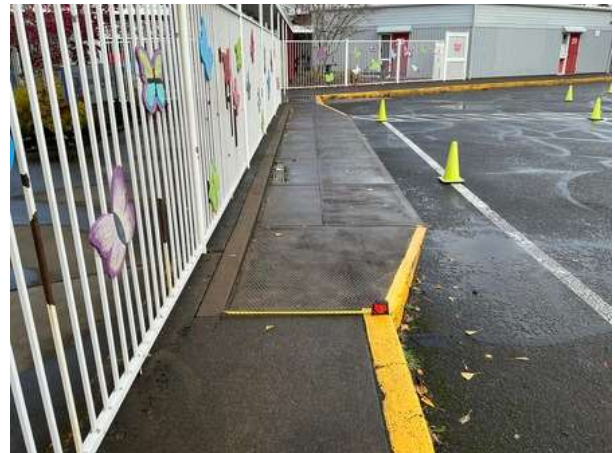
Photos for Barrier ID: AX528410

| Site Conditions | The parallel curb ramp has a 30-inch clear width. |

The curb ramp should be removed and replaced with a compliant ramp that has a minimum clear width of 36".  
[EXCEPTION: Within employee work areas, the required clear width of ramps that are a part of common use circulation paths shall be permitted to be decreased by work area equipment provided that the decrease is essential to the function of the work being performed.] Where flares are provided, flare slopes shall be no greater than 1:10 (10%).

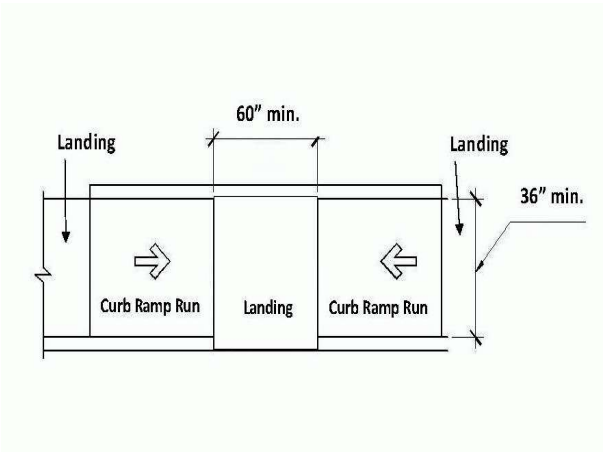
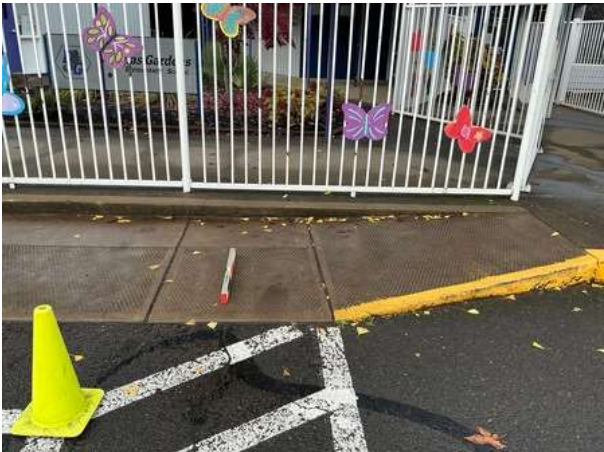
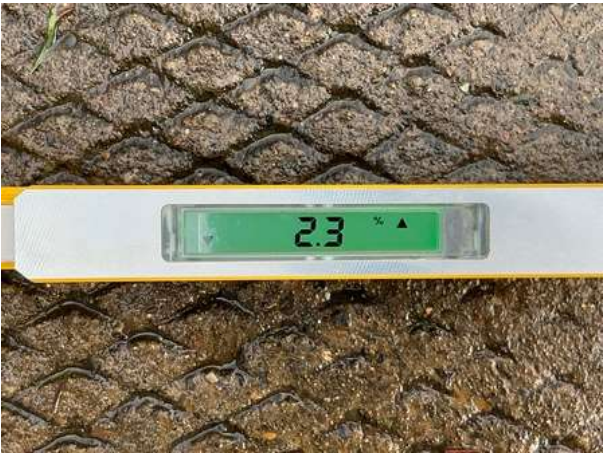
| Site Conditions | The bottom landing has a slope of 2.3%. |

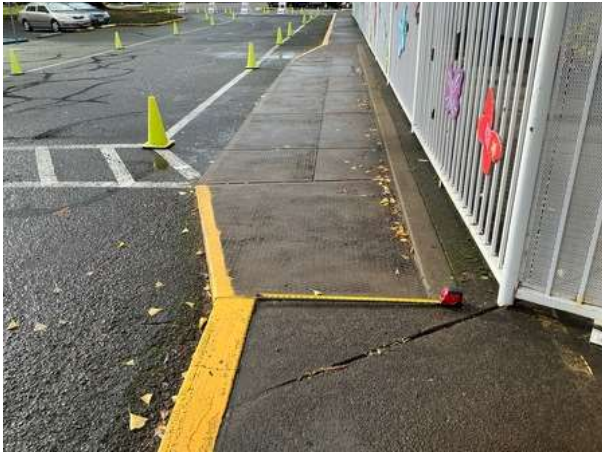
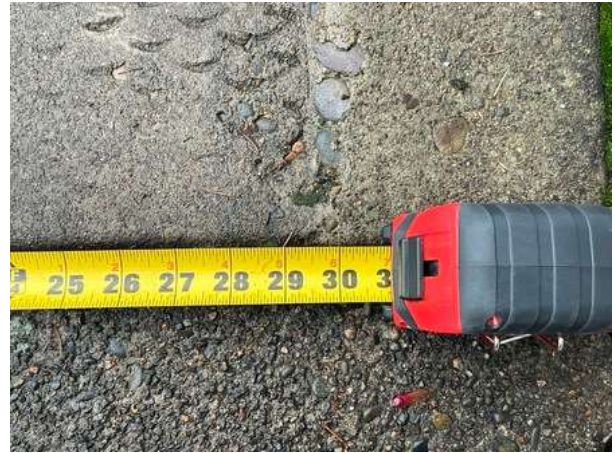
Photos for Barrier ID: AX528412

| Site Conditions | The parallel curb ramp has a 29-1/2 inch clear width. |

The curb ramp should be removed and replaced with a compliant ramp that has a minimum clear width of 36".  
[EXCEPTION: Within employee work areas, the required clear width of ramps that are a part of common use circulation paths shall be permitted to be decreased by work area equipment provided that the decrease is essential to the function of the work being performed.] Where flares are provided, flare slopes shall be no greater than 1:10 (10%).

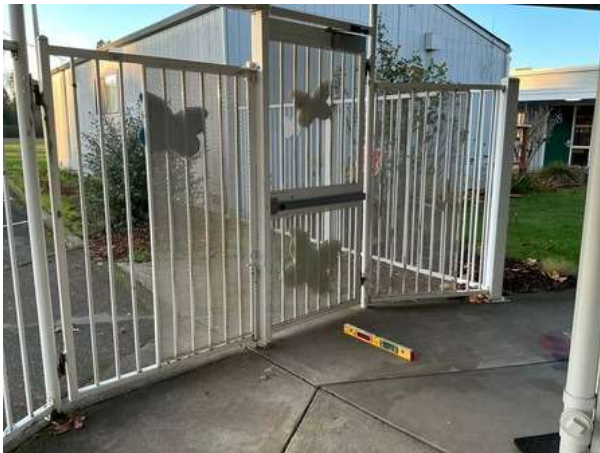
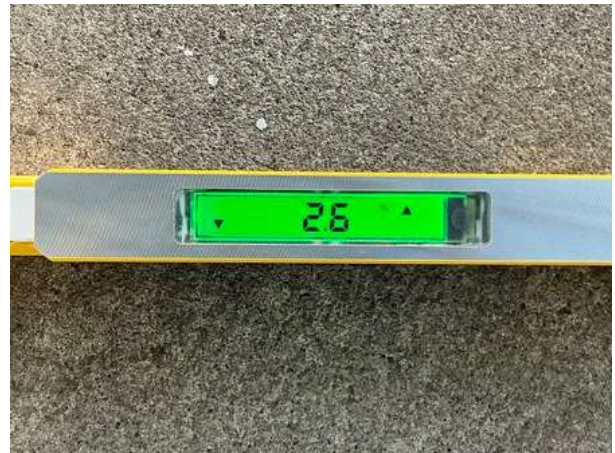
Photos for Barrier ID: AX528448

| Site Conditions | The maneuvering clearance has a slope of 2.6%. | |

| Resolution | Remove and replace the surface within the required maneuvering clearance area so that the surface is level and clear with maximum slope 1:48 (2.08%) in any direction. The required depth of the maneuvering clearance is 48" minimum. The required side clearance is 0" minimum on the latch side of the door. Maneuvering clearance shall extend the full width of the doorway and the required latch side clearance. Floor or ground space within the required maneuvering clearance shall be maximum 1:48 (2.08%) slope. Changes in level are not permitted. | |

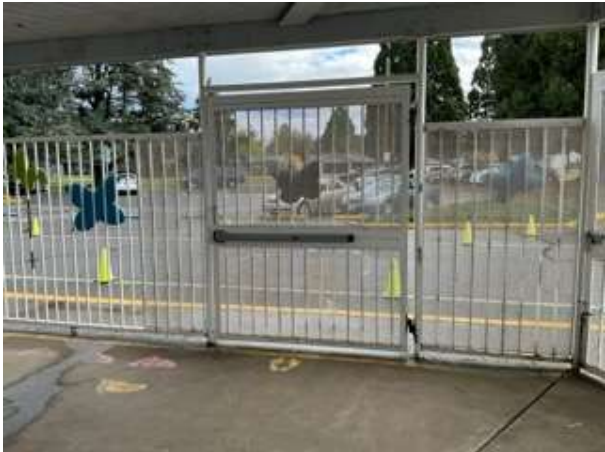
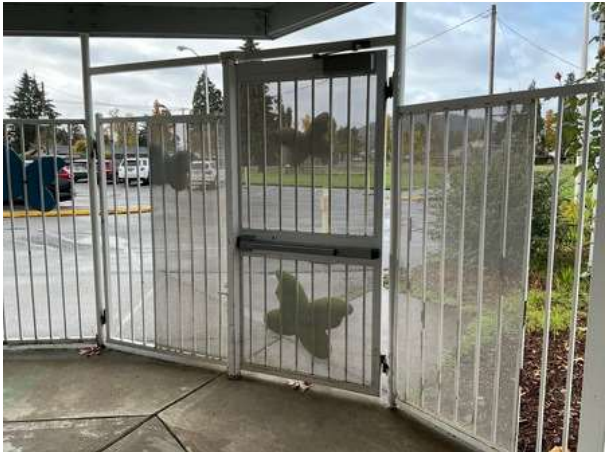
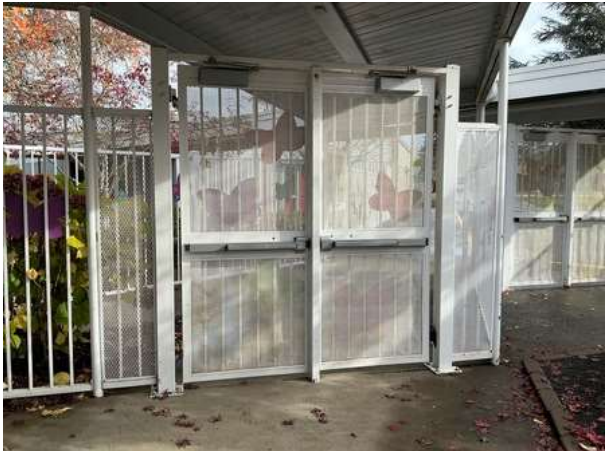
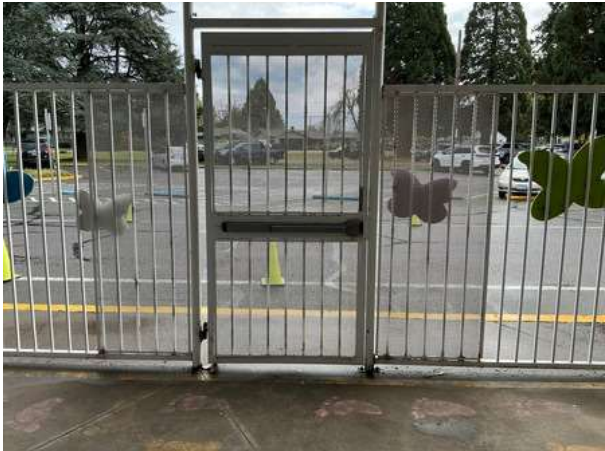
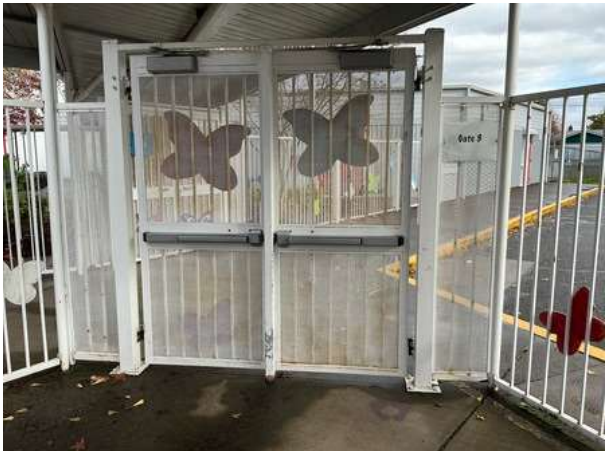
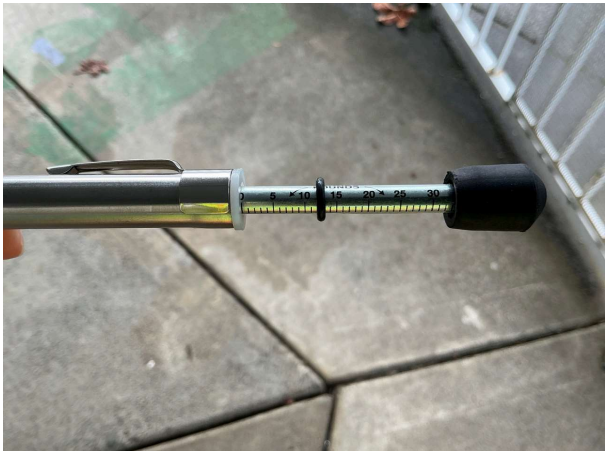
| Site Conditions | The opening force is greater than 8.5 pounds. | |

| Adjust the closer or replace with an exterior door that requires no more 8.5 pounds of force for pushing or pulling the door open. The opening force of doors along an accessible route shall be as follows: 1. Exterior doors: 8.5 pounds maximum (lbf) (37.8 N). 2. Interior doors: 5 pounds maximum (lbf) (22.2 N). 3. Stairway doors at pressurized stair enclosures: 15 pounds maximum (6.8 kg) at exterior doors. 4. Where environmental conditions require greater closing pressure, power-operated doors shall be used within the accessible route. [Exception: The force required to retract latch bolts or disengage other devices that hold the door or gate in a closed position shall not apply to panic hardware, delayed egress devices or fire-rated hardware.] | | |

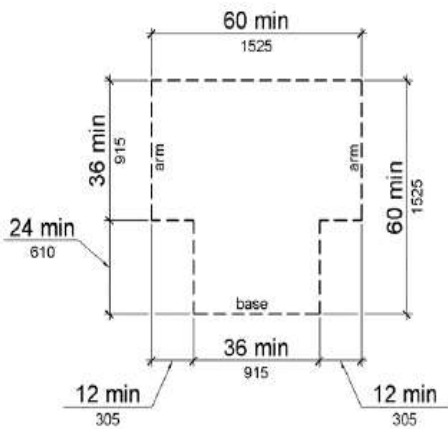
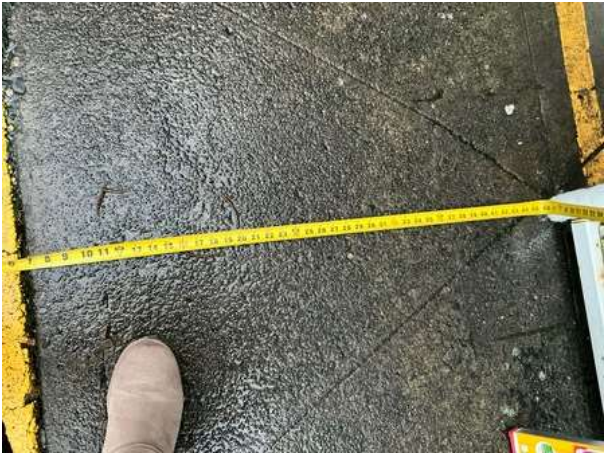
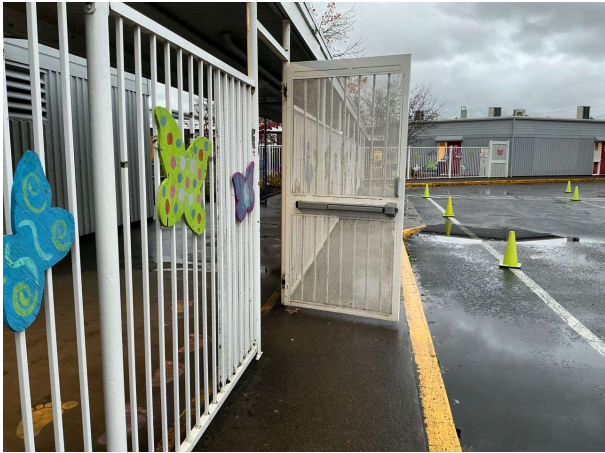
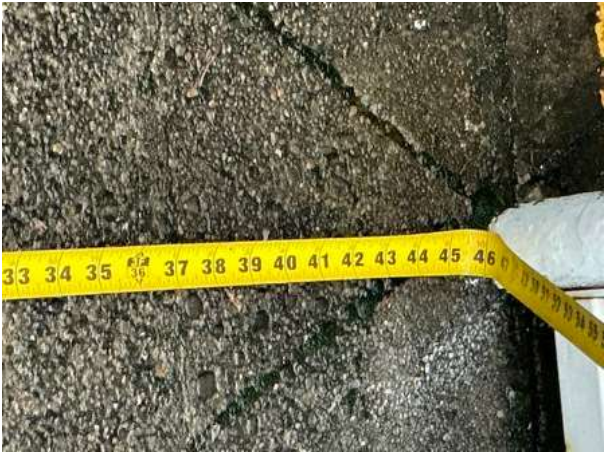
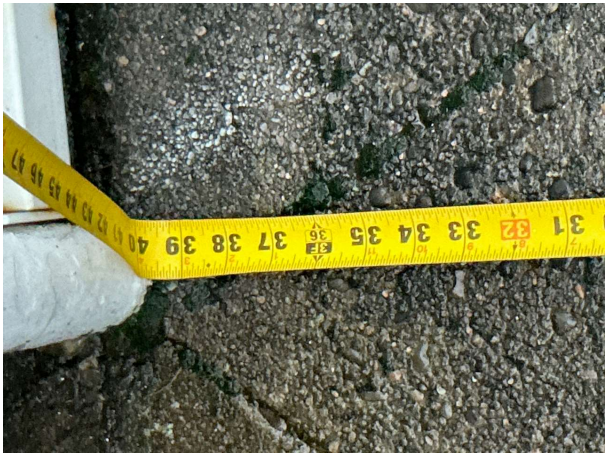
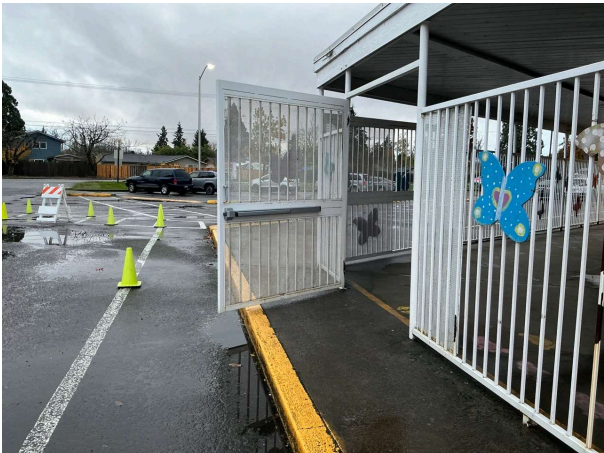
| <b>Site Conditions</b> | The walkway has a turning space of 40 inches at the exterior gates. |

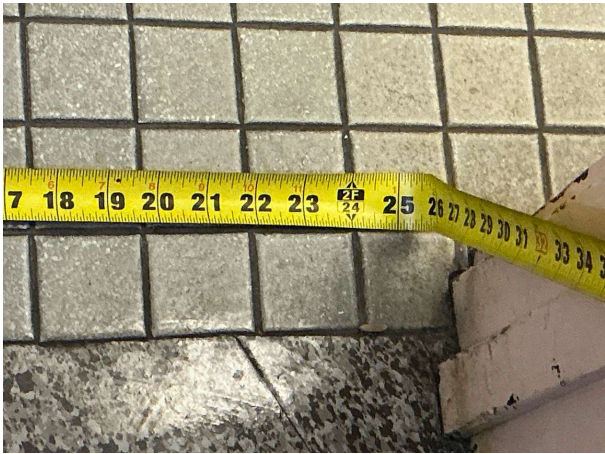
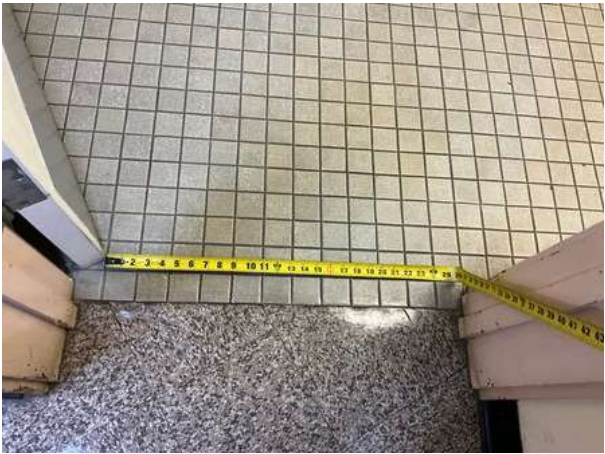
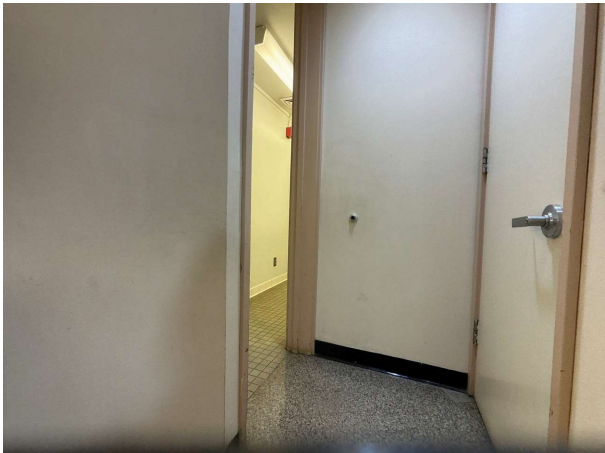
| <b>Site Conditions</b> | The door clear width is 25-1/2 inches. |

Remove and replace with a door that has a minimum clear opening of 32". Door openings shall provide a clear width of 32" minimum. Clear openings of doorways with swinging doors shall be measured between the face of the door and the stop, with the door open 90 degrees. Openings more than 24" deep shall provide a clear opening of 36" minimum. There shall be no projections into the required clear opening width lower than 34" above the finish floor or ground. Projections into the clear opening width between 34" and 80" above the finish floor or ground shall not exceed 4". [EXCEPTIONS: 1. In alterations, a projection of 5/8" maximum into the required clear width shall be permitted for the latch side stop. 2. Door closers and door stops shall be permitted to be 78" minimum above the finish floor or ground.]

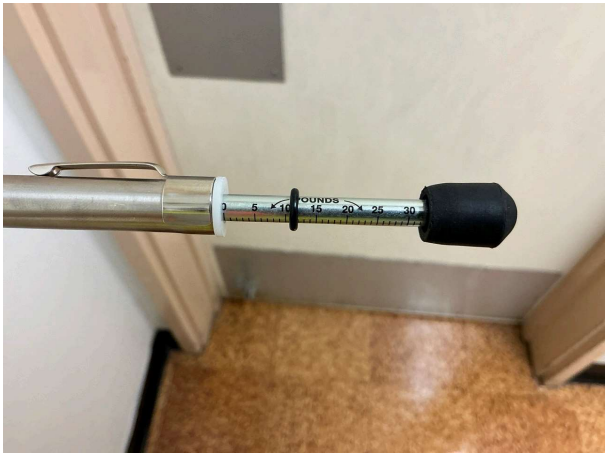
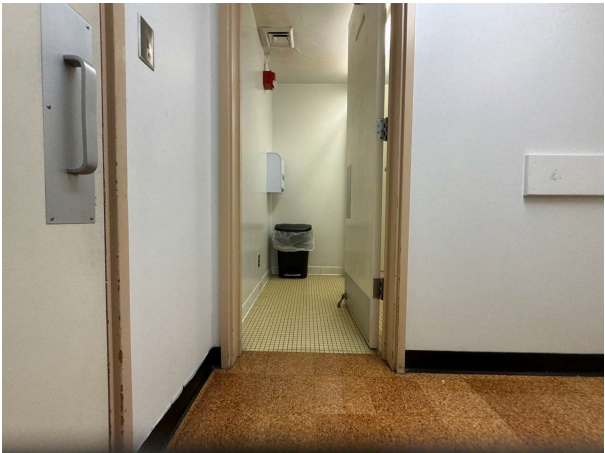
Photos for Barrier ID: AX528480

| Site Conditions | The opening force is greater than 5 pounds. |

Adjust the closer or replace with a door that requires no more than 5 pounds of force for pushing or pulling the door open. The force at the latch, the force to set the door in motion, and the force to fully open the door shall be maximum 5 pounds. These forces do not apply to the force required to retract latch bolts or disengage other devices that hold the door or gate in a closed position.
