# ACCESSIBILITY ASSESSMENT

January 8, 2025

## **ADA TITLE II ASSESSMENT**

Douglas Gardens Elementary School  
3680 Jasper Road  
Springfield, OR 97478

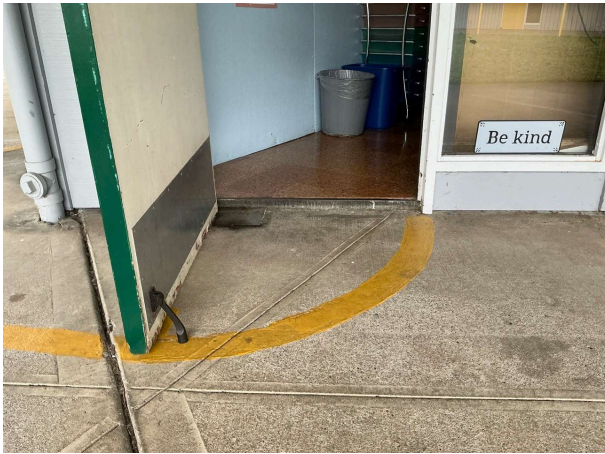
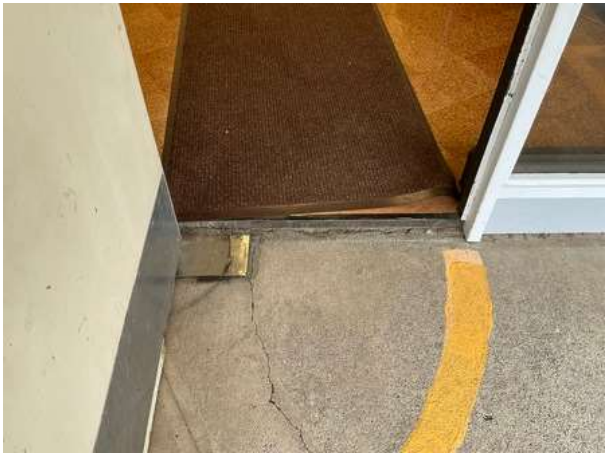
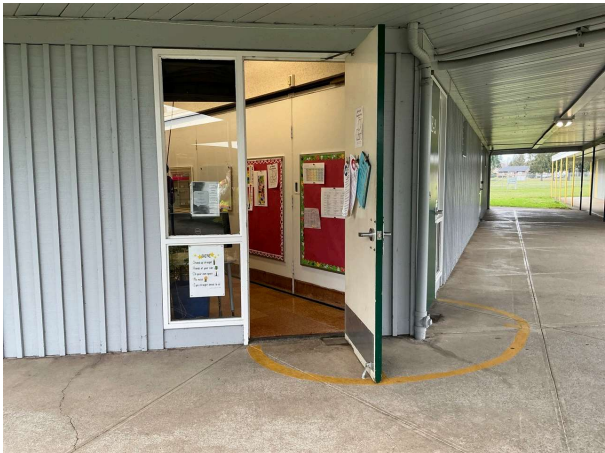
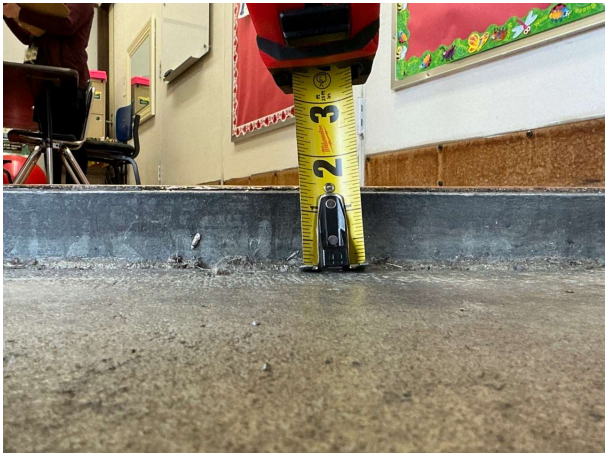
| Site Conditions | The threshold at the accessible door is greater than 1/2 inch. | |

| Resolution | <p>Remove and replace with a threshold that is ½" or less in height (including carpet pile allowed to be 1/2" max high). Thresholds, if provided at doorways, shall be 1/2" high maximum. Raised thresholds and changes in level at doorways shall be compliant. [EXCEPTION: Existing or altered thresholds 3/4" high maximum that have a beveled edge on each side with a slope not steeper than 1:2 shall not be required to comply.]</p> | |

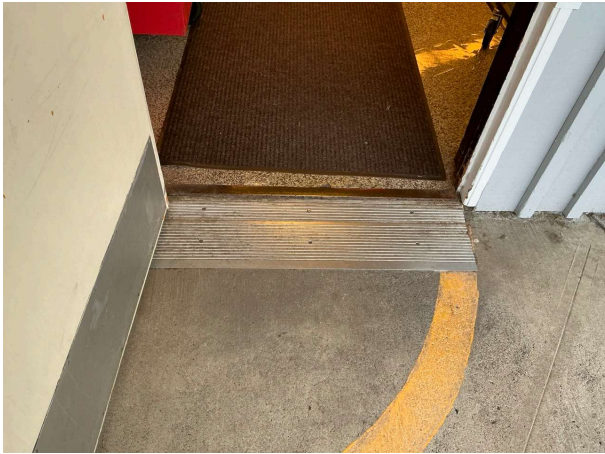
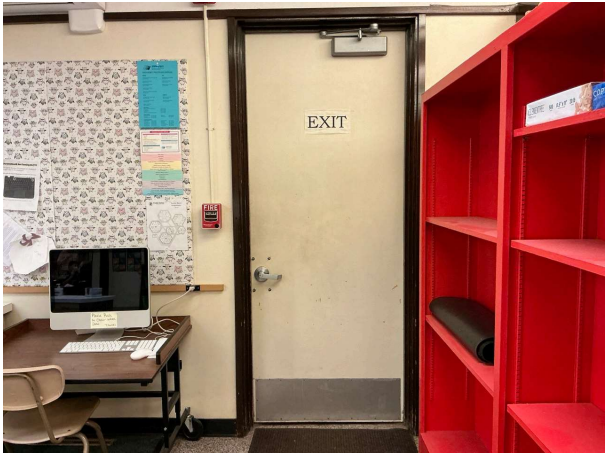
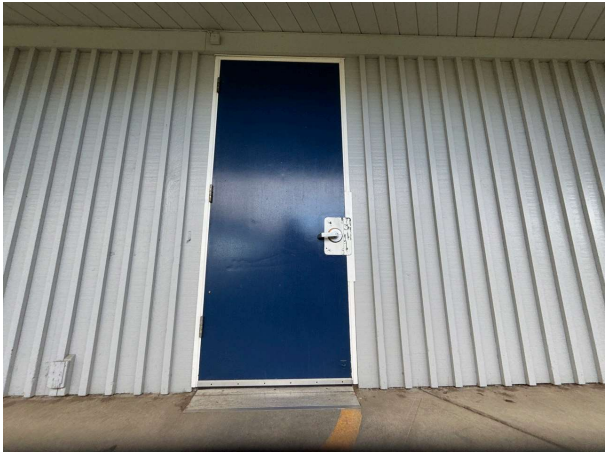
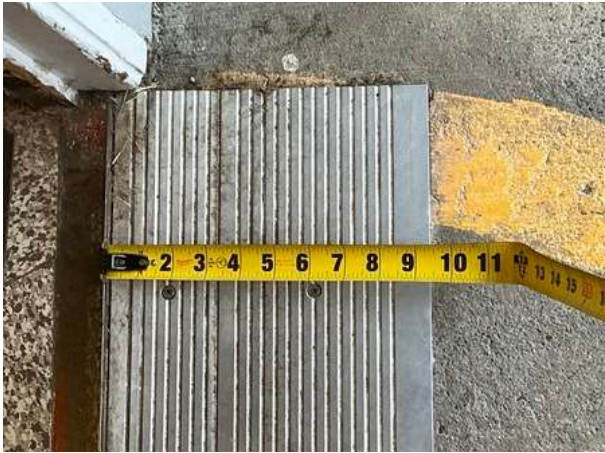
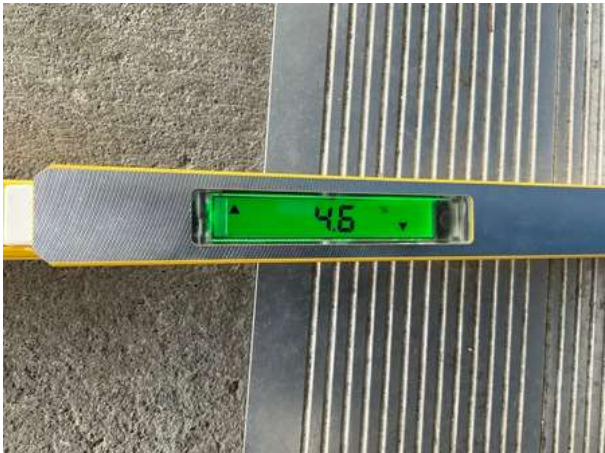
| Site Conditions | The maneuvering clearance has a slope of 4.6%. | |

| Resolution | <p>Remove and replace the surface within the required maneuvering clearance area so that the surface is level and clear with maximum slope 1:48 (2.08%) in any direction. The required depth of the maneuvering clearance is X" minimum. The required side clearance is Y" minimum on the latch/hinge side of the door. Maneuvering clearance shall extend the full width of the doorway and the required latch side or hinge side clearance. Floor or ground space within the required maneuvering clearance shall be maximum 1:48 (2.08%) slope. Changes in level are not permitted.</p> | |

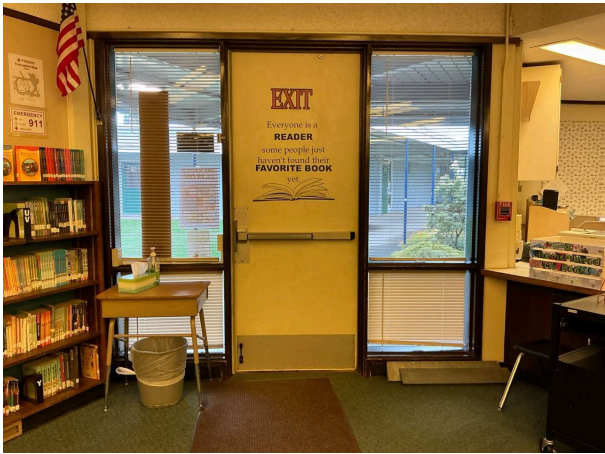
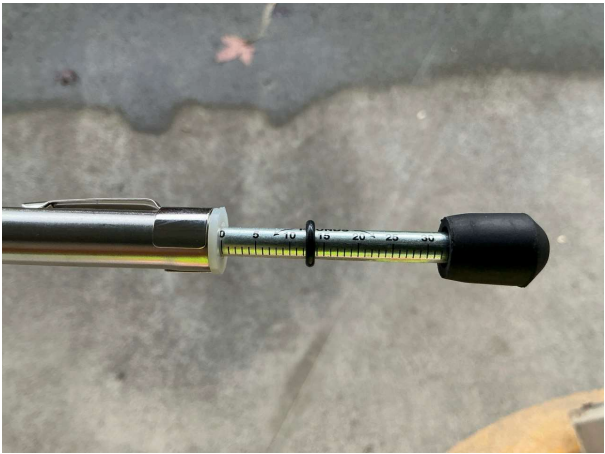
| Site Conditions | The opening force is 13 pounds. | |

| Adjust the closer or replace with an exterior door that requires no more 8.5 pounds of force for pushing or pulling the door open. The opening force of doors along an accessible route shall be as follows: 1. Exterior doors: 8.5 pounds maximum (lbf) (37.8 N). 2. Interior doors: 5 pounds maximum (lbf) (22.2 N). 3. Stairway doors at pressurized stair enclosures: 15 pounds maximum (6.8 kg) at exterior doors. 4. Where environmental conditions require greater closing pressure, power-operated doors shall be used within the accessible route. [Exception: The force required to retract latch bolts or disengage other devices that hold the door or gate in a closed position shall not apply to panic hardware, delayed egress devices or fire-rated hardware.] | | |

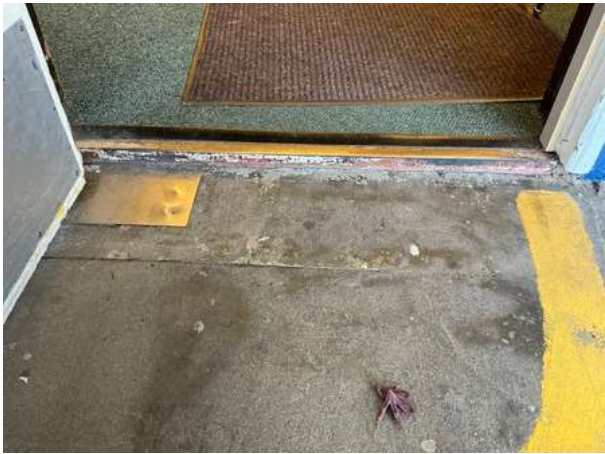
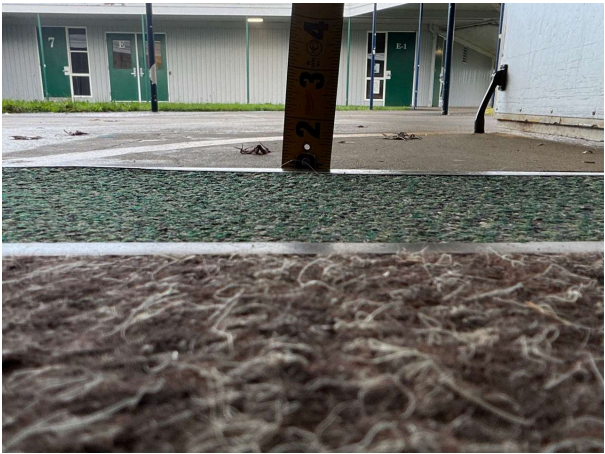
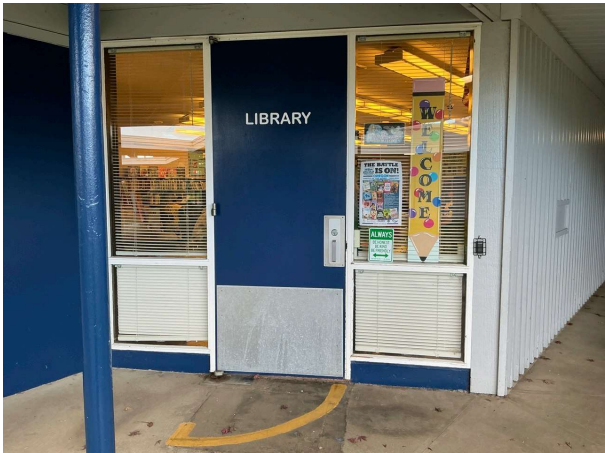
| Site Conditions | The threshold at the accessible door is greater than 1/2 inch. | |

| Resolution | Remove and replace with a threshold that is ½" or less in height (including carpet pile allowed to be 1/2" max high). Thresholds, if provided at doorways, shall be 1/2" high maximum. Raised thresholds and changes in level at doorways shall be compliant. [EXCEPTION: Existing or altered thresholds 3/4" high maximum that have a beveled edge on each side with a slope not steeper than 1:2 shall not be required to comply.] | |

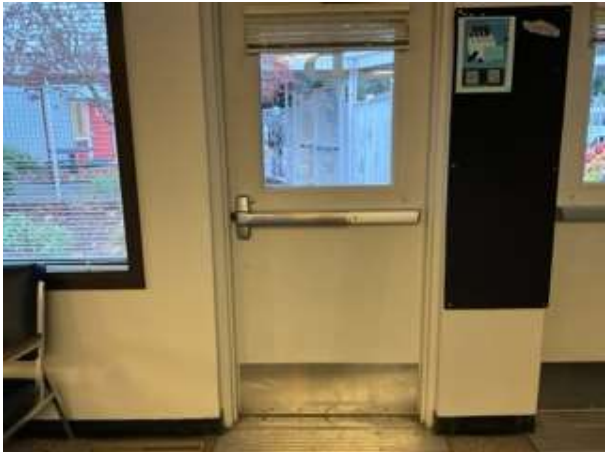
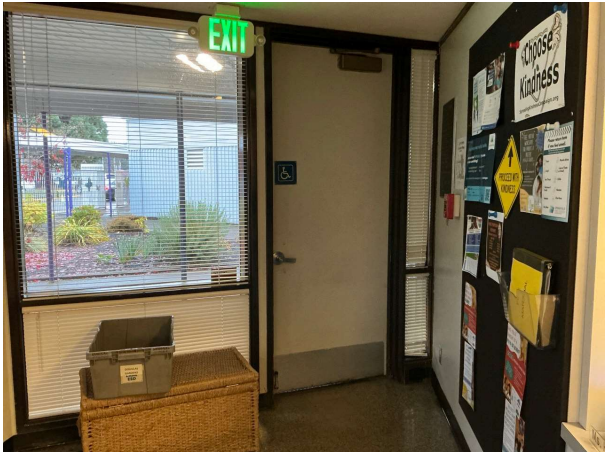
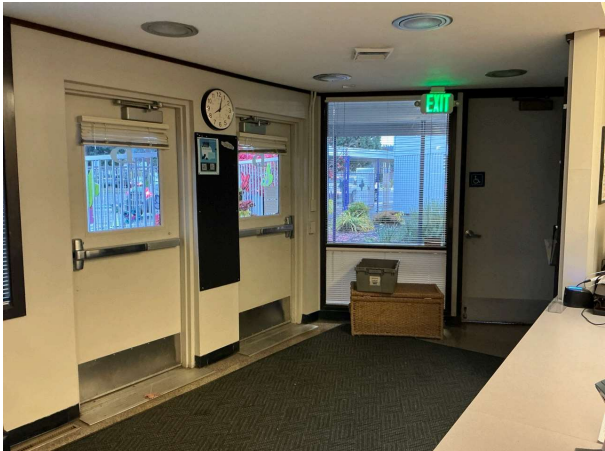
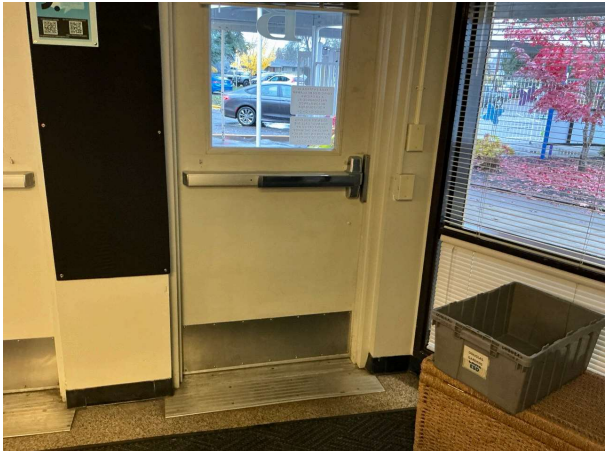
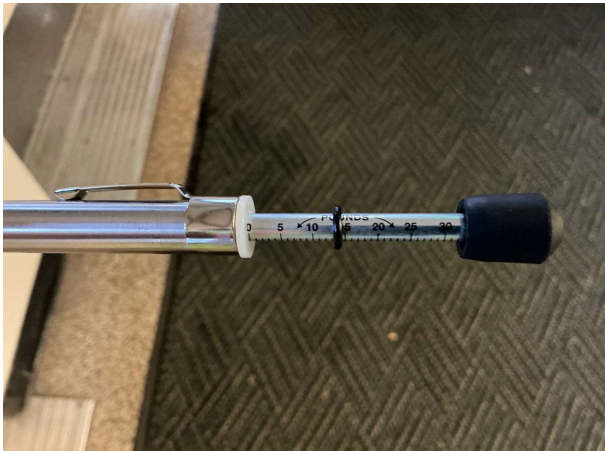
| <b>Site Conditions</b> | The accessible route has a clear width of 29 inches. |

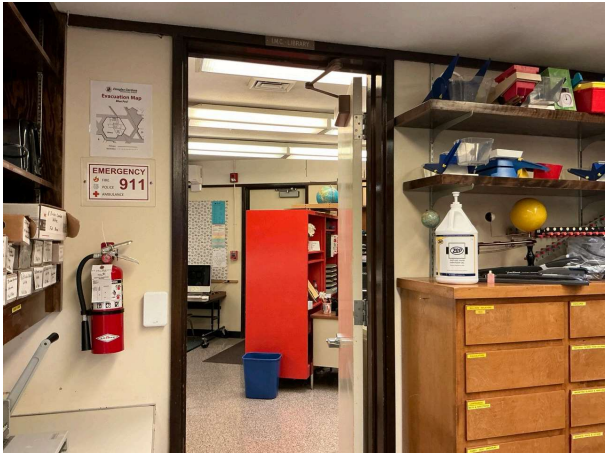
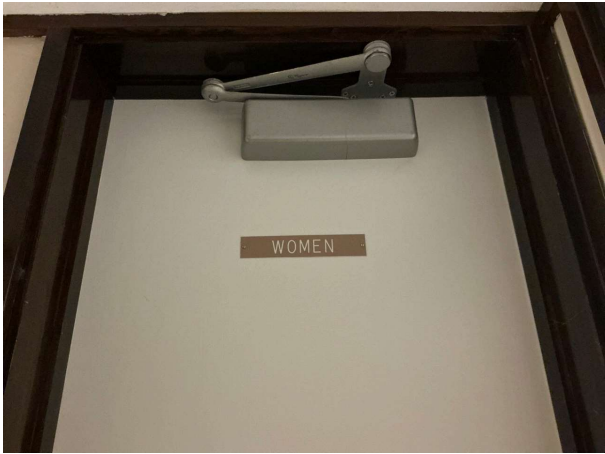
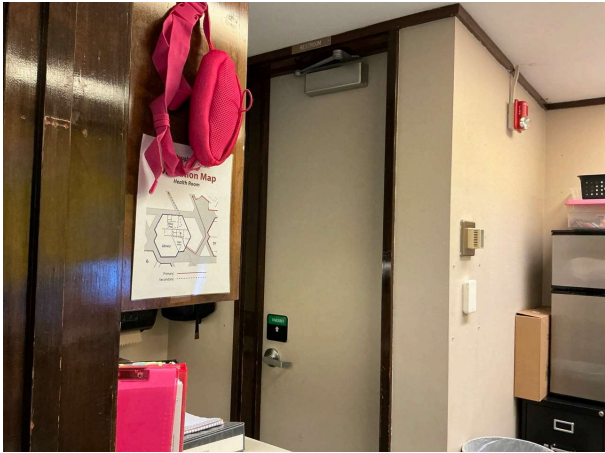
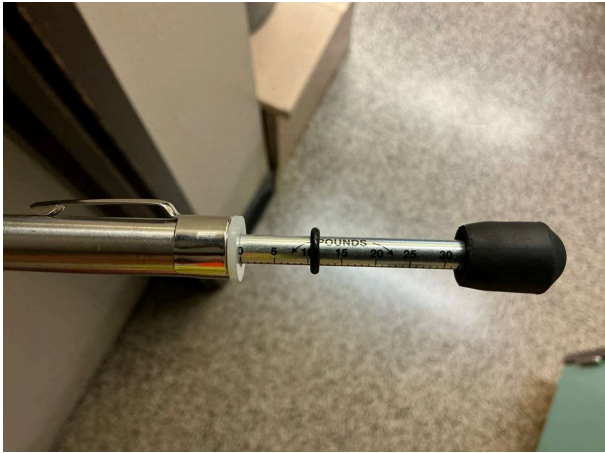
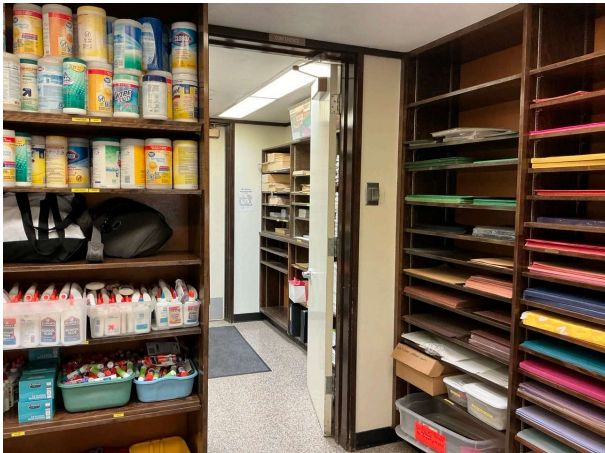
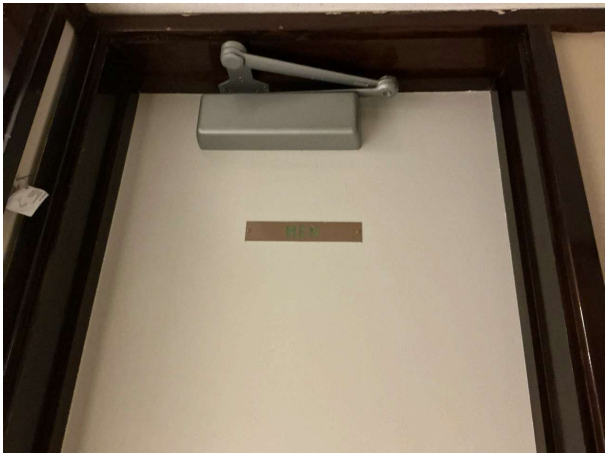
| Site Conditions | The door clear width is 31 inches. |

Remove and replace with a door that has a minimum clear opening of 32"; measured with the door open at 90°, measured from the face of the door to the stop. Door openings shall provide a clear width of 32" minimum. Clear openings of doorways with swinging doors shall be measured between the face of the door and the stop, with the door open 90 degrees. Openings more than 24" deep shall provide a clear opening of 36" minimum. There shall be no projections into the required clear opening width lower than 34" above the finish floor or ground. Projections into the clear opening width between 34" and 80" above the finish floor or ground shall not exceed 4". [EXCEPTIONS: 1. In alterations, a projection of 5/8" maximum into the required clear width shall be permitted for the latch side stop. 2. Door closers and door stops shall be permitted to be 78" minimum above the finish floor or ground.]

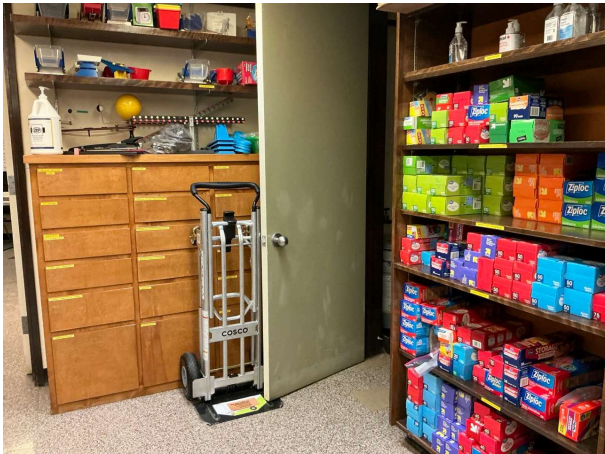
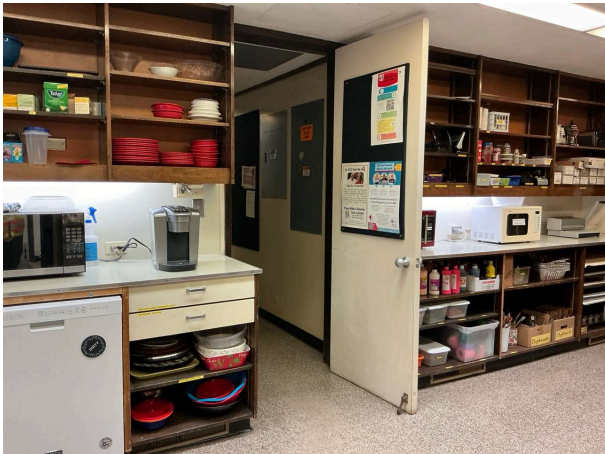
| Site Conditions | The maneuvering clearances have slopes from 2.6% to 7.7%. | |

| Resolution | <p>Remove and replace the surface within the required maneuvering clearance area so that the surface is level and clear with maximum slope 1:48 (2.08%) in any direction. The required depth of the maneuvering clearance is X" minimum. The required side clearance is Y" minimum on the latch/hinge side of the door. Maneuvering clearance shall extend the full width of the doorway and the required latch side or hinge side clearance. Floor or ground space within the required maneuvering clearance shall be maximum 1:48 (2.08%) slope. Changes in level are not permitted.</p> | |

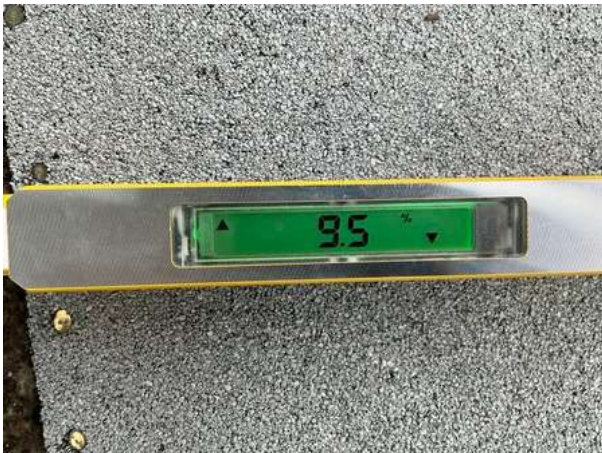
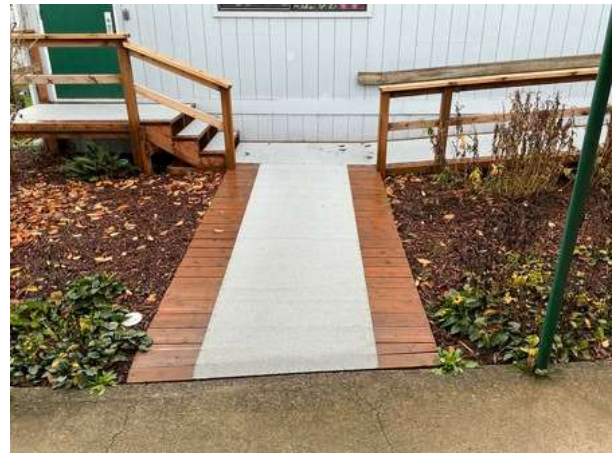
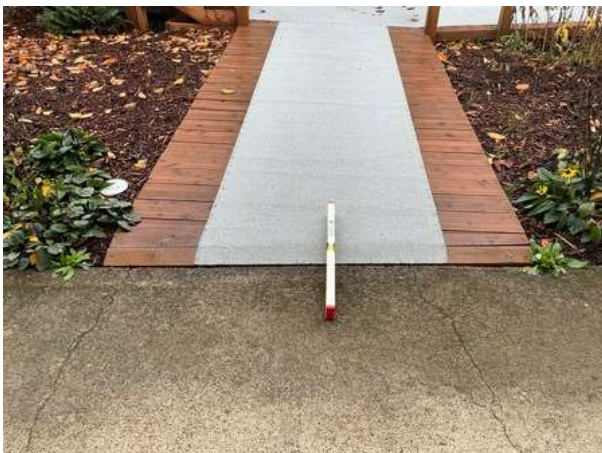
Photos for Barrier ID: AX528422

| Site Conditions | The start of the ramp has a running slope of 9.5%. |

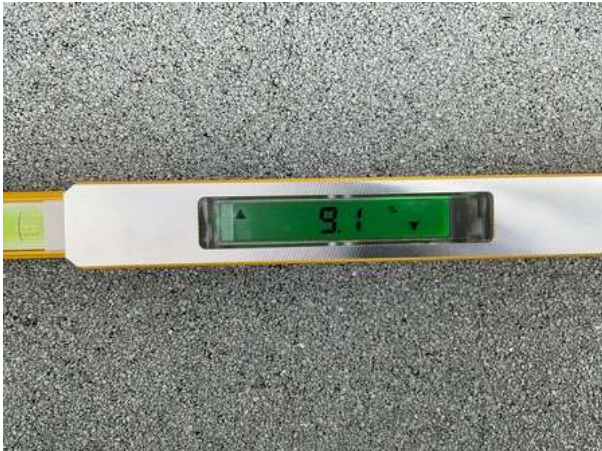
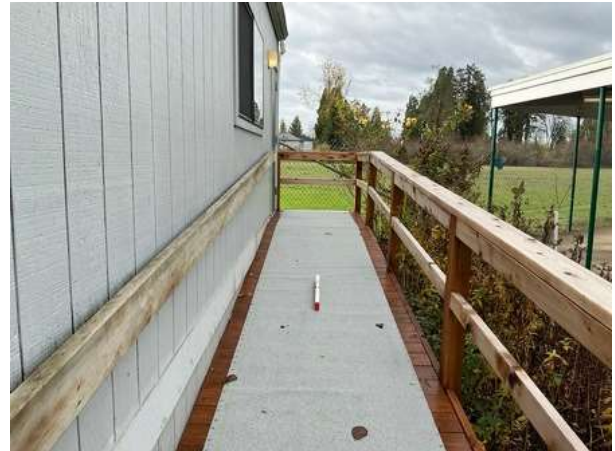
Photos for Barrier ID: AX528429

| Site Conditions | The ramp has a running slope of 9.1%. |

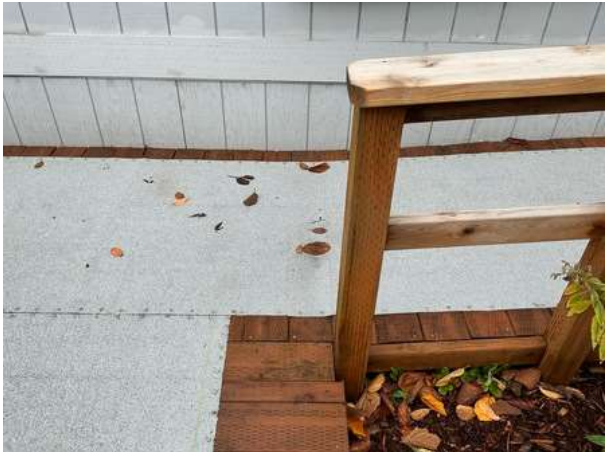
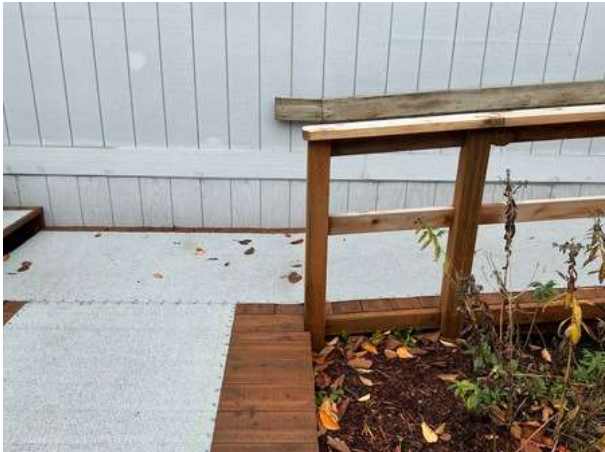
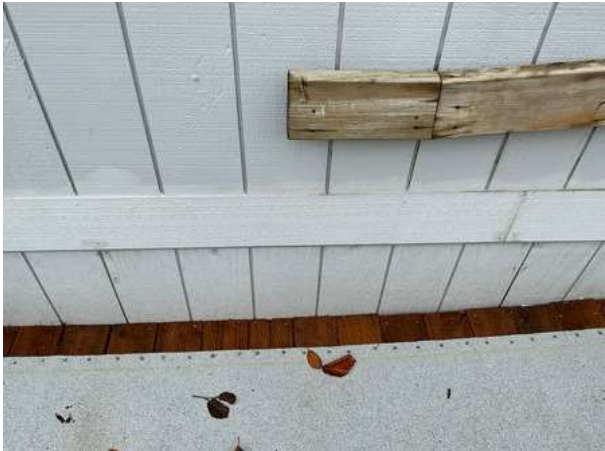
| Site Conditions | Handrail extensions are not provided. |

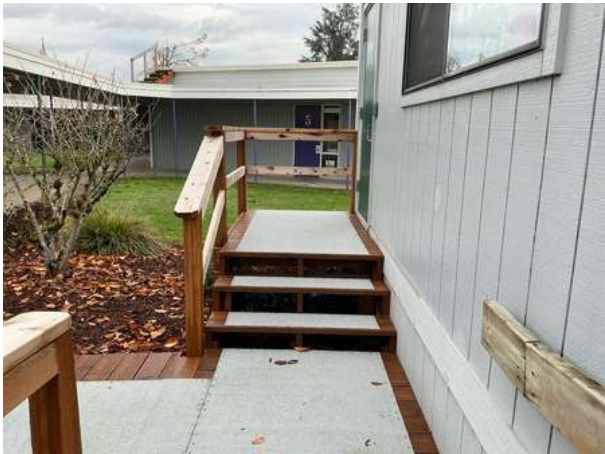
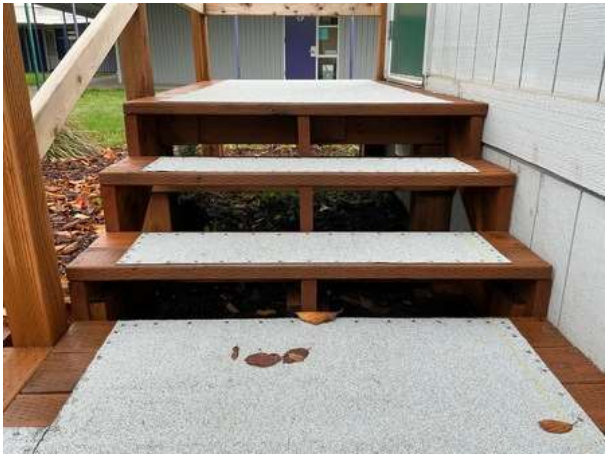
| Site Conditions | The stairs have open risers. | |

| Resolution | Replace with compliant stairs that have closed risers. Open risers are not permitted. | |

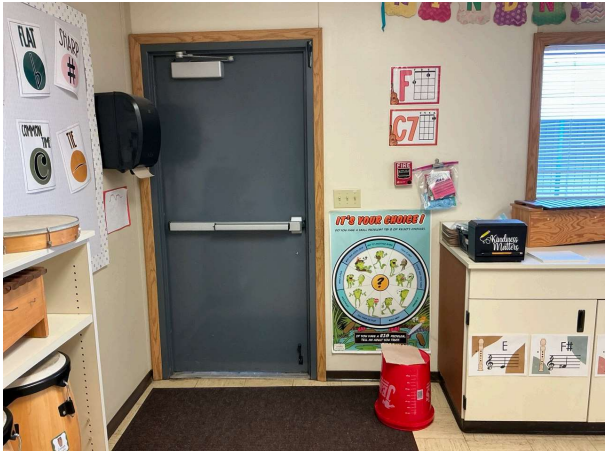
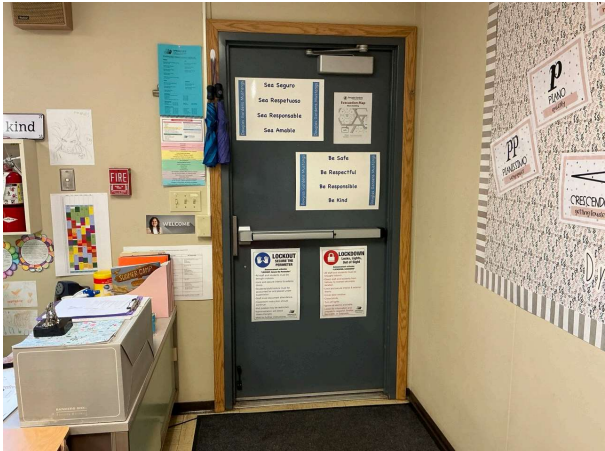
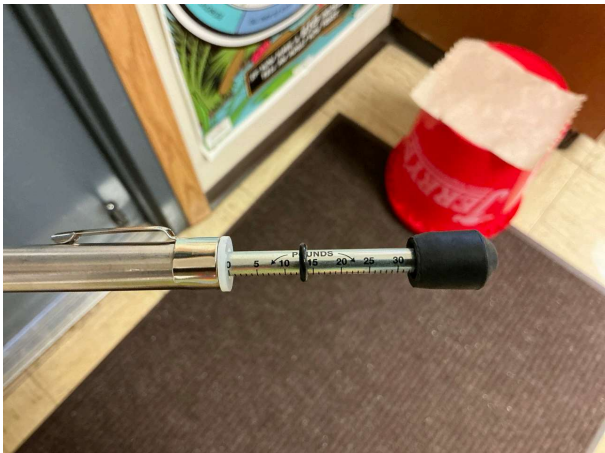
Photos for Barrier ID: AX528434

| Site Conditions | The opening force is greater than 8.5 pounds. | |

| Adjust the closer or replace with an exterior door that requires no more 8.5 pounds of force for pushing or pulling the door open. The opening force of doors along an accessible route shall be as follows: 1. Exterior doors: 8.5 pounds maximum (lbf) (37.8 N). 2. Interior doors: 5 pounds maximum (lbf) (22.2 N). 3. Stairway doors at pressurized stair enclosures: 15 pounds maximum (6.8 kg) at exterior doors. 4. Where environmental conditions require greater closing pressure, power-operated doors shall be used within the accessible route. [Exception: The force required to retract latch bolts or disengage other devices that hold the door or gate in a closed position shall not apply to panic hardware, delayed egress devices or fire-rated hardware.] | | |

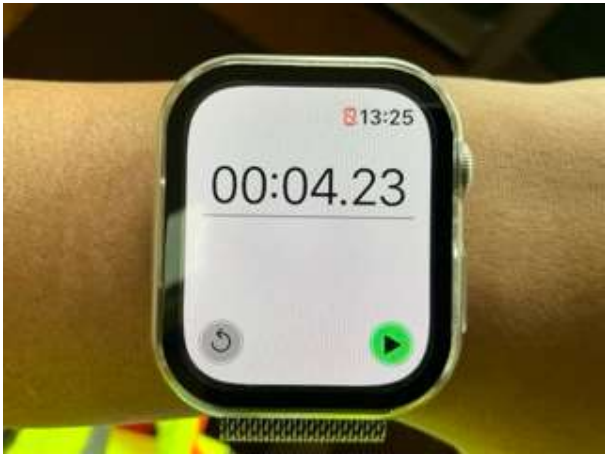
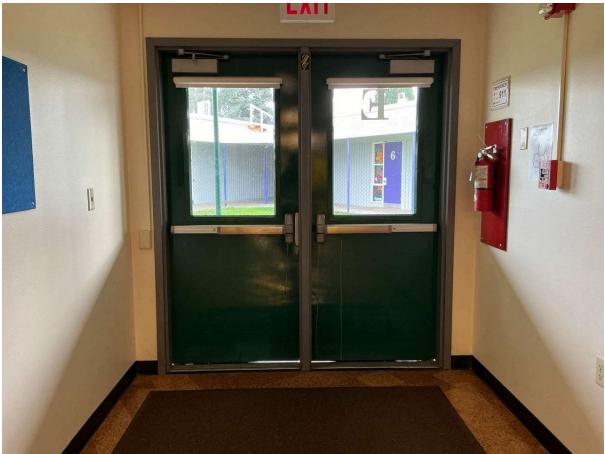
Site Conditions The closing speed is less than 5 seconds.

Adjust closer or remove and replace closer to ensure that the door has a closure time of at least 5 seconds within 12 degrees of the latch. Door closers and gate closers shall be adjusted so that from an open position of 90 degrees, the time required to move the door to a position of 12 degrees from the latch is 5 seconds minimum.

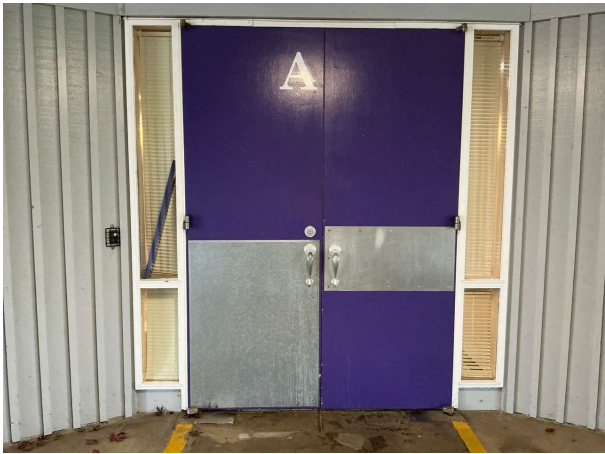
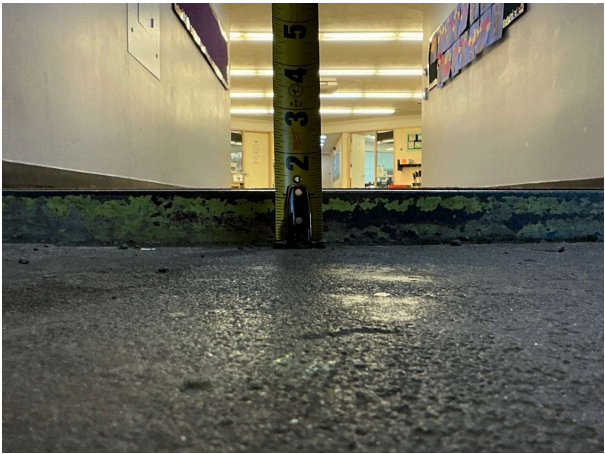
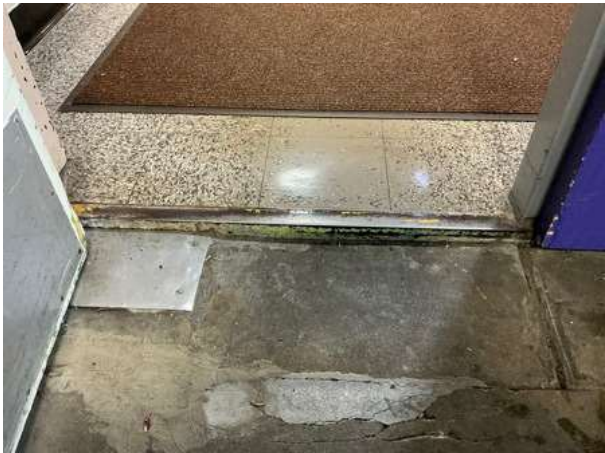
| Site Conditions | The threshold at the accessible door is greater than 1/2 inch. |

Remove and replace with a threshold that is ½" or less in height (including carpet pile allowed to be 1/2" max high). Thresholds, if provided at doorways, shall be 1/2" high maximum. Raised thresholds and changes in level at doorways shall be compliant. [EXCEPTION: Existing or altered thresholds 3/4" high maximum that have a beveled edge on each side with a slope not steeper than 1:2 shall not be required to comply.]

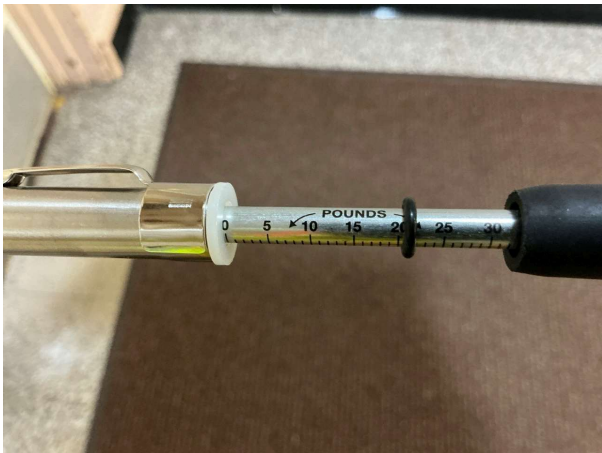
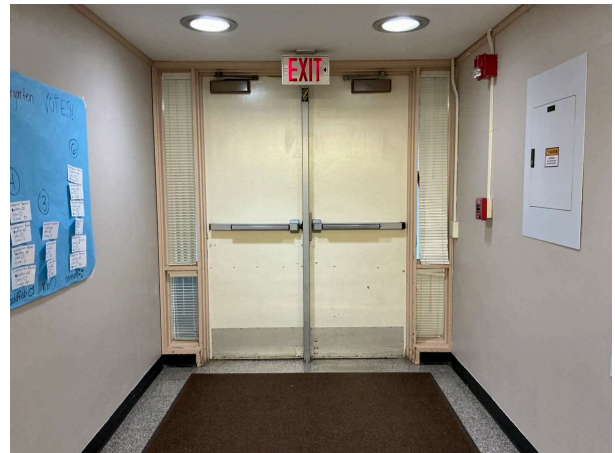
Photos for Barrier ID: AX528443

| Site Conditions | The opening force is greater than 8.5 lbs. | |

| Adjust the closer or replace with an exterior door that requires no more 8.5 pounds of force for pushing or pulling the door open. The opening force of doors along an accessible route shall be as follows: 1. Exterior doors: 8.5 pounds maximum (lbf) (37.8 N). 2. Interior doors: 5 pounds maximum (lbf) (22.2 N). 3. Stairway doors at pressurized stair enclosures: 15 pounds maximum (6.8 kg) at exterior doors. 4. Where environmental conditions require greater closing pressure, power-operated doors shall be used within the accessible route. [Exception: The force required to retract latch bolts or disengage other devices that hold the door or gate in a closed position shall not apply to panic hardware, delayed egress devices or fire-rated hardware.] | | |

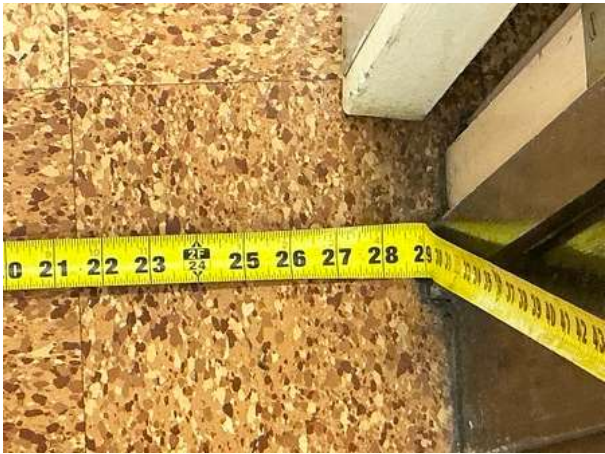
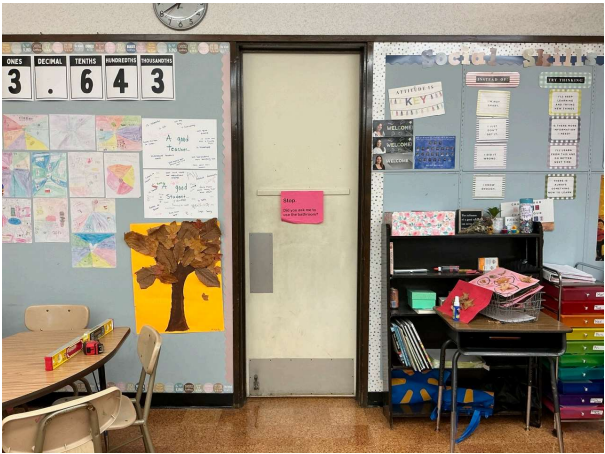
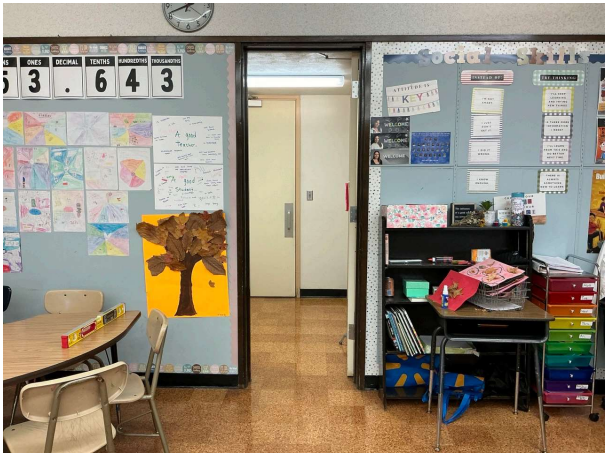
| Site Conditions | The door clear width is 27 inches. |

Remove and replace with a door that has a minimum clear opening of 32". Door openings shall provide a clear width of 32" minimum. Clear openings of doorways with swinging doors shall be measured between the face of the door and the stop, with the door open 90 degrees. Openings more than 24" deep shall provide a clear opening of 36" minimum. There shall be no projections into the required clear opening width lower than 34" above the finish floor or ground. Projections into the clear opening width between 34" and 80" above the finish floor or ground shall not exceed 4". [EXCEPTIONS: 1. In alterations, a projection of 5/8" maximum into the required clear width shall be permitted for the latch side stop. 2. Door closers and door stops shall be permitted to be 78" minimum above the finish floor or ground.]

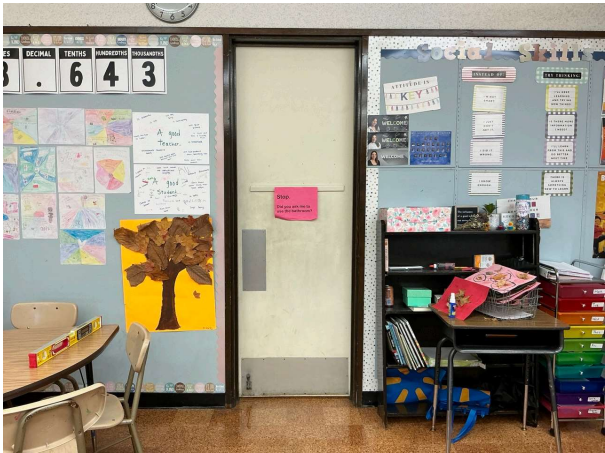
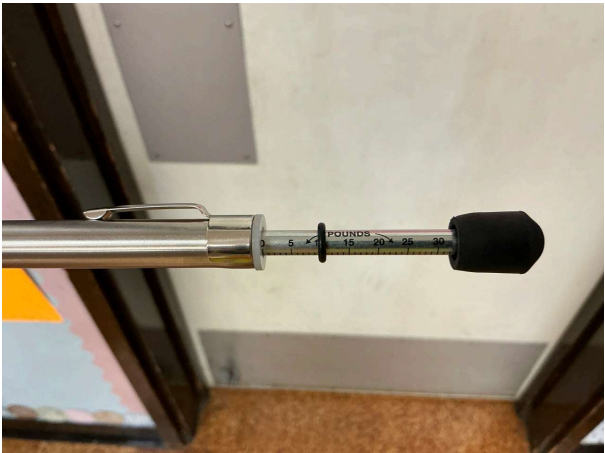
Photos for Barrier ID: AX528475

| Site Conditions | The opening force is 10 pounds. |

Adjust the closer or replace with a door that requires no more than 5 pounds of force for pushing or pulling the door open. The force at the latch, the force to set the door in motion, and the force to fully open the door shall be maximum 5 pounds. These forces do not apply to the force required to retract latch bolts or disengage other devices that hold the door or gate in a closed position.

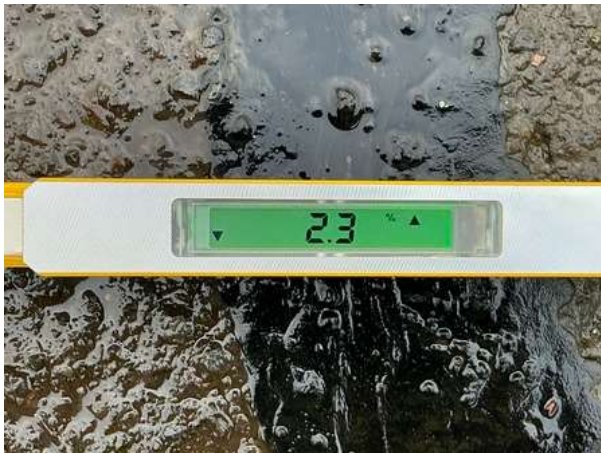
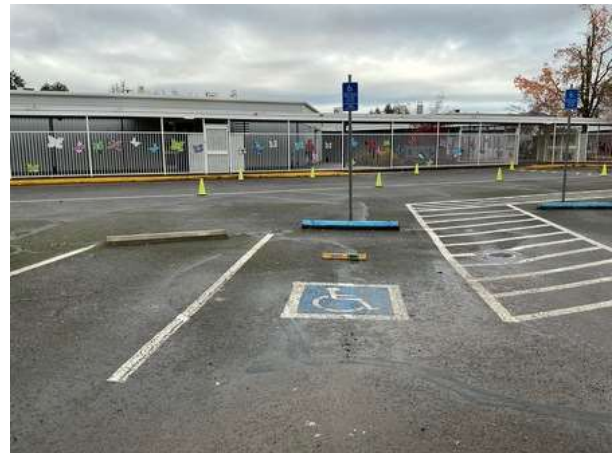
Photos for Barrier ID: AX528413

| Site Conditions | The van accessible stall has a cross slope of 2.3%. |

Remove and replace with a van space which has a slope of maximum 1:50 (2%) in all directions. [EXCEPTION: Slopes not steeper than 1:48 (2.08%) shall be permitted.] Changes in level are not permitted. Parking spaces and access aisles serving them shall be compliant. Width measurements shall be made from the centerline of the markings. [EXCEPTION: Where parking spaces or access aisles are not adjacent to another parking space or access aisle, measurements shall be permitted to include the full width of the line defining the parking space or access aisle.] The quantity and order of magnitude cost estimate provided for this barrier are limited to the extent of the area identified as non-compliant. Additional costs that may be associated with removal of the barrier are not included.

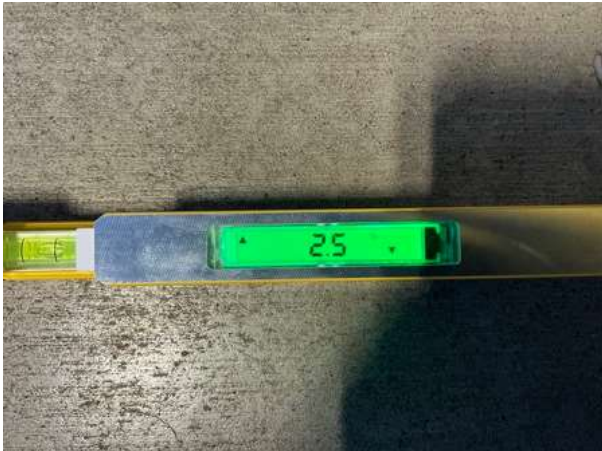
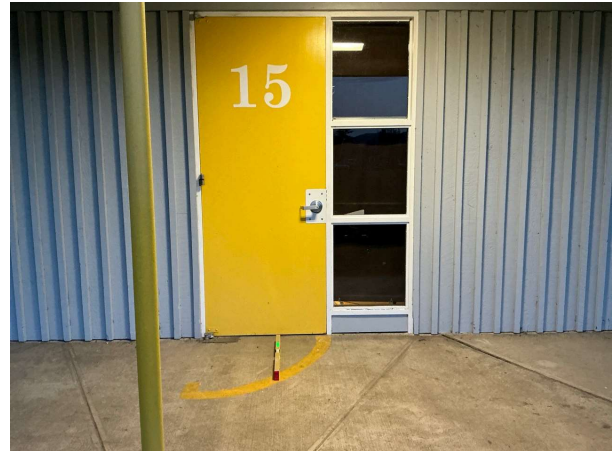
Photos for Barrier ID: AX528451

| Site Conditions | The maneuvering clearance has a slope of 2.5%. | |

| Resolution | Remove and replace the surface within the required maneuvering clearance area so that the surface is level and clear with maximum slope 1:48 (2.08%) in any direction. The required depth of the maneuvering clearance is 60" minimum. The required side clearance is 18" minimum on the latch side of the door. Maneuvering clearance shall extend the full width of the doorway and the required latch side clearance. Floor or ground space within the required maneuvering clearance shall be maximum 1:48 (2.08%) slope. Changes in level are not permitted. | |

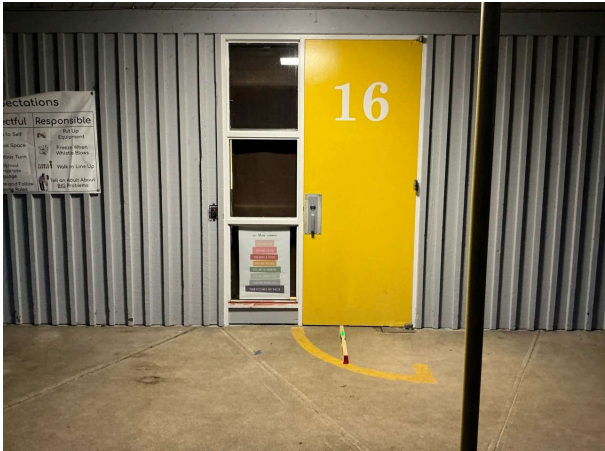
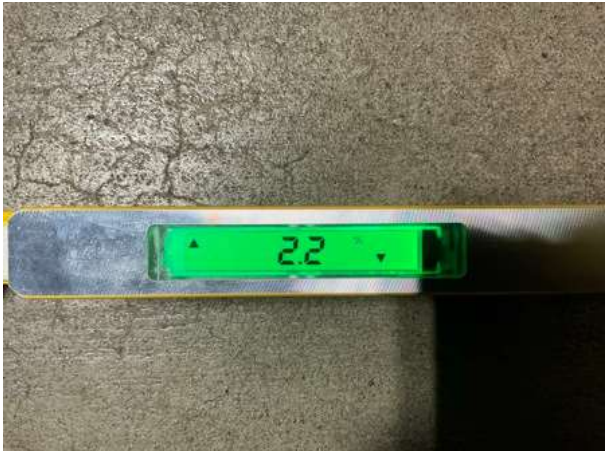
Photos for Barrier ID: AX528454

| Site Conditions | The maneuvering clearance has a slope of 2.2%. | |

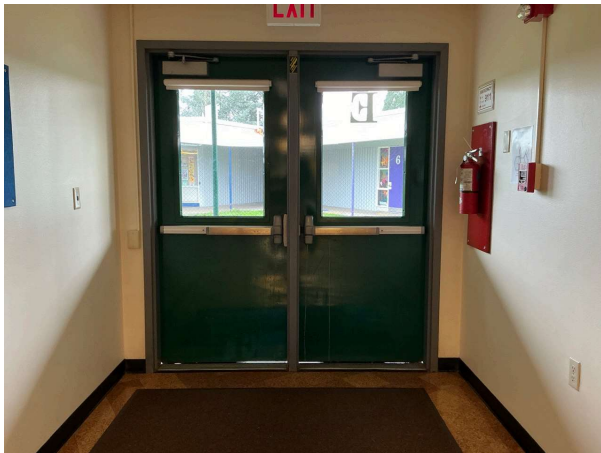
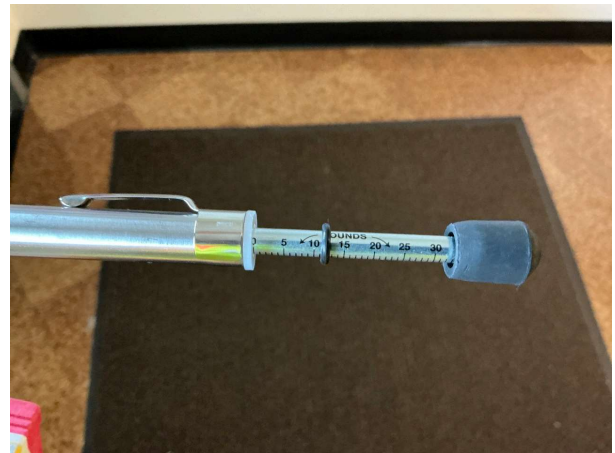
Photos for Barrier ID: AX528427

| Site Conditions | The opening force is greater than 8.5 pounds. | |

| Adjust the closer or replace with an exterior door that requires no more 8.5 pounds of force for pushing or pulling the door open. The opening force of doors along an accessible route shall be as follows: 1. Exterior doors: 8.5 pounds maximum (lbf) (37.8 N). 2. Interior doors: 5 pounds maximum (lbf) (22.2 N). 3. Stairway doors at pressurized stair enclosures: 15 pounds maximum (6.8 kg) at exterior doors. 4. Where environmental conditions require greater closing pressure, power-operated doors shall be used within the accessible route. [Exception: The force required to retract latch bolts or disengage other devices that hold the door or gate in a closed position shall not apply to panic hardware, delayed egress devices or fire-rated hardware.] | | |

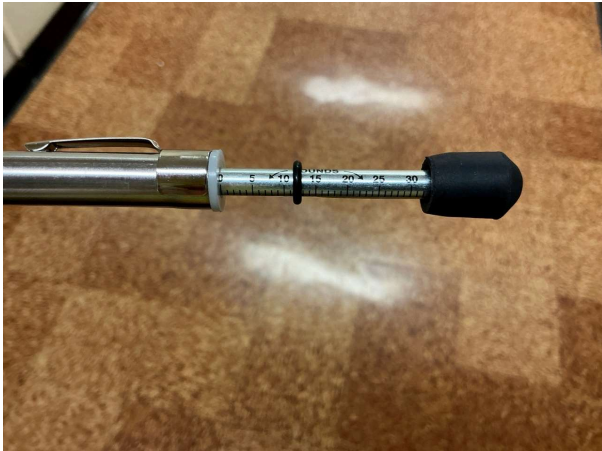
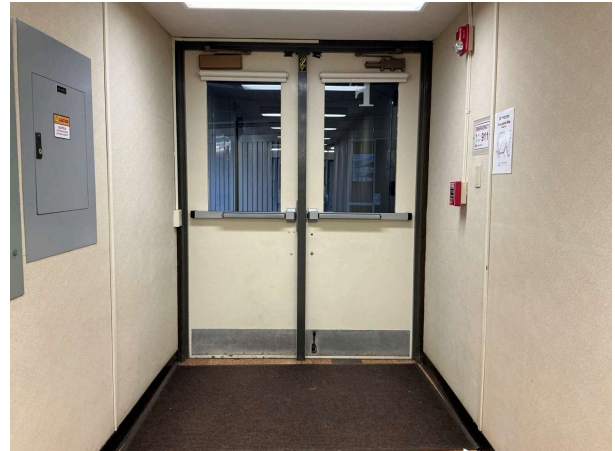
Photos for Barrier ID: AX528450

| Site Conditions | The opening force is greater than 8.5 pounds. | |

| Adjust the closer or replace with an exterior door that requires no more 8.5 pounds of force for pushing or pulling the door open. The opening force of doors along an accessible route shall be as follows: 1. Exterior doors: 8.5 pounds maximum (lbf) (37.8 N). 2. Interior doors: 5 pounds maximum (lbf) (22.2 N). 3. Stairway doors at pressurized stair enclosures: 15 pounds maximum (6.8 kg) at exterior doors. 4. Where environmental conditions require greater closing pressure, power-operated doors shall be used within the accessible route. [Exception: The force required to retract latch bolts or disengage other devices that hold the door or gate in a closed position shall not apply to panic hardware, delayed egress devices or fire-rated hardware.] | | |

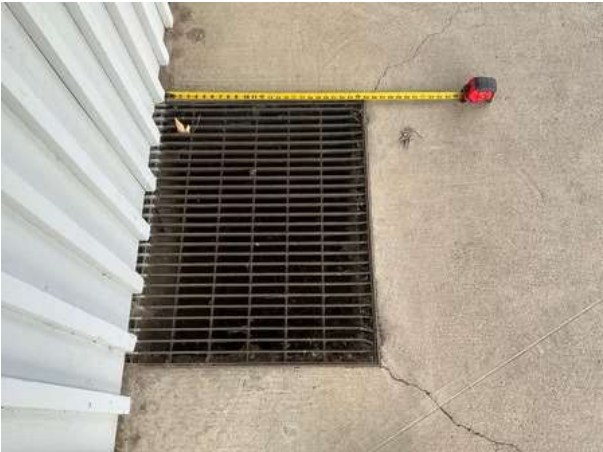
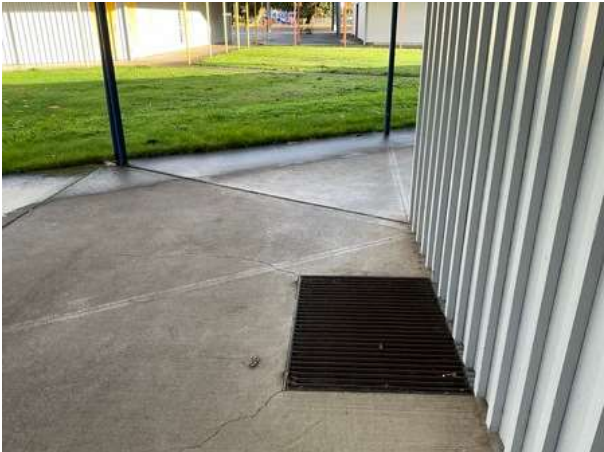
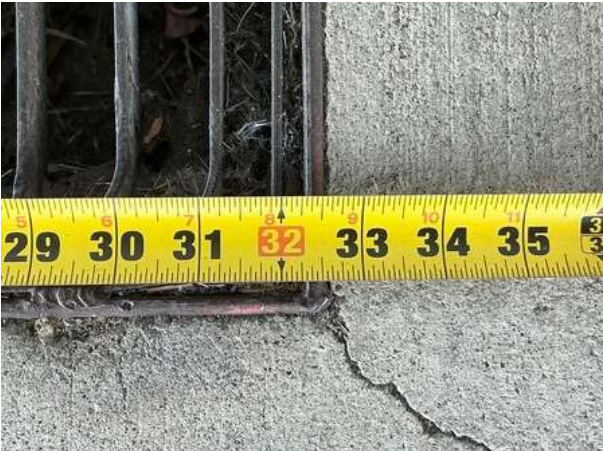
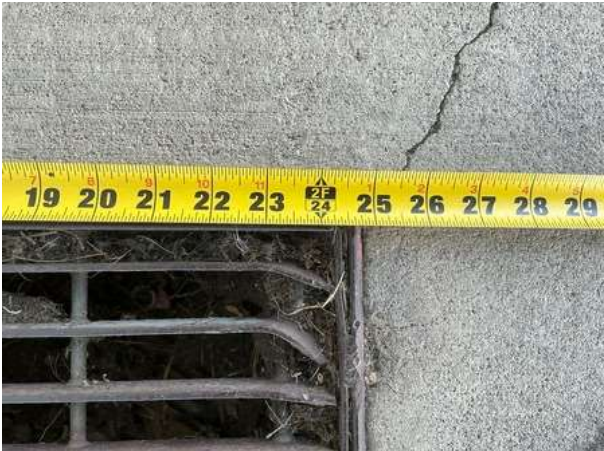
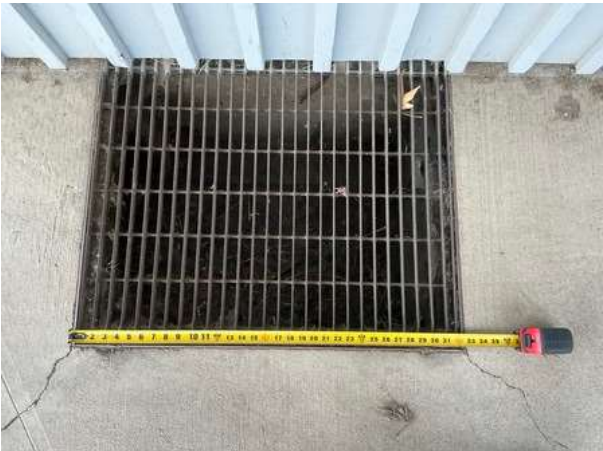
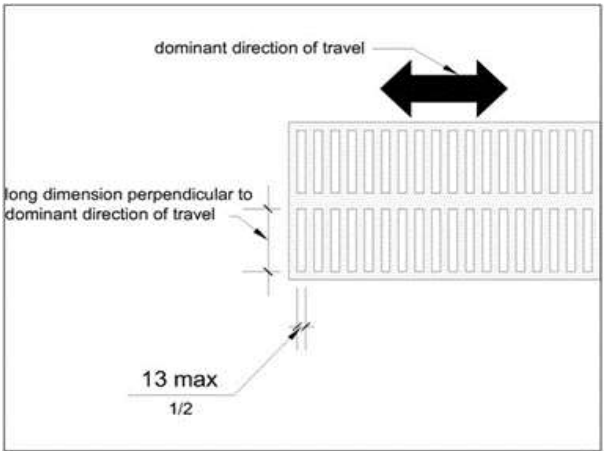
| Site Conditions | The accessible route has openings greater than 1/2 inch wide. |

Remove and replace with an ADA compliant grate that has openings no greater than 1/2" wide in one direction, and elongated openings shall be placed so that the long dimension is perpendicular to the dominant direction of travel. Openings in floor or ground surfaces shall not allow passage of a sphere more than 1/2" (13 mm) diameter'. Elongated openings shall be placed so that the long dimension is perpendicular to the dominant direction of travel.
