# ACCESSIBILITY ASSESSMENT

January 8, 2025

## **ADA TITLE II ASSESSMENT**

Douglas Gardens Elementary School  
3680 Jasper Road  
Springfield, OR 97478

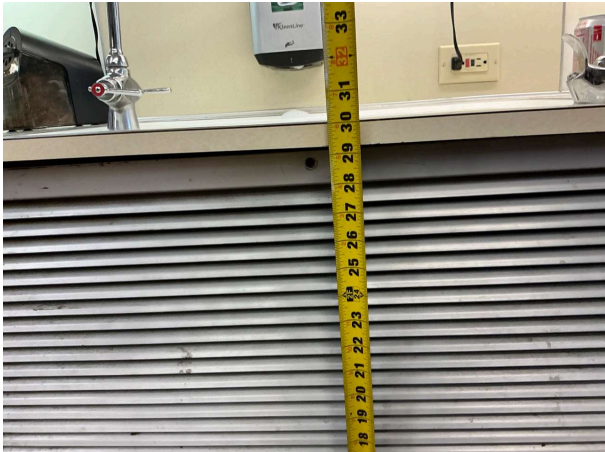
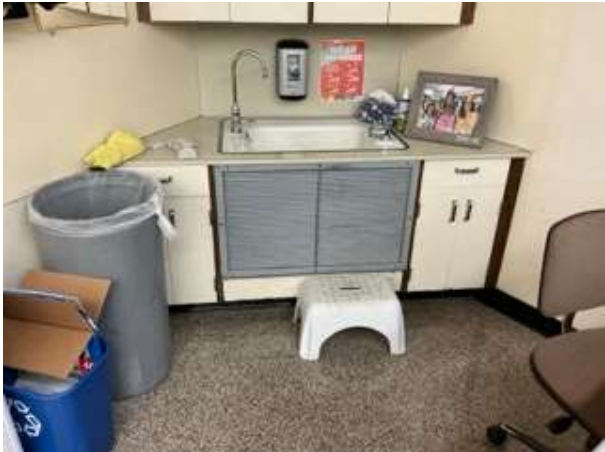
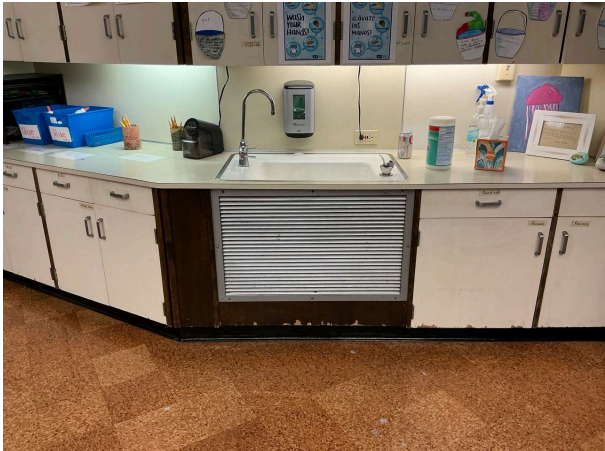
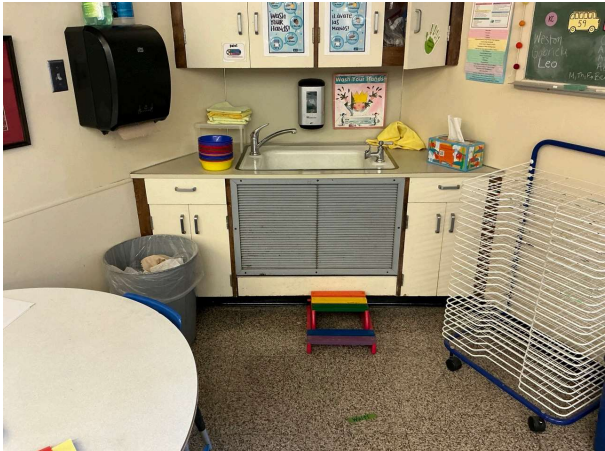
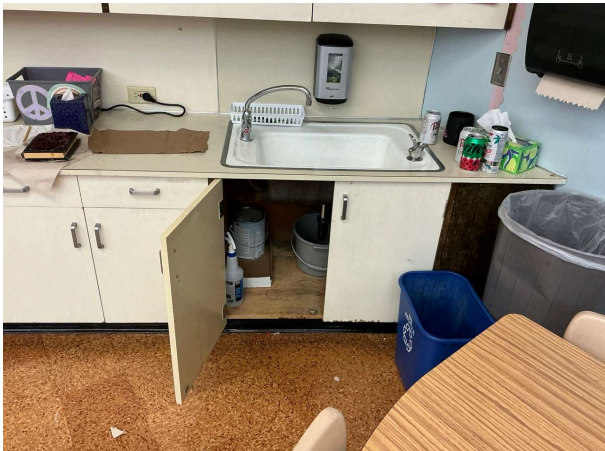
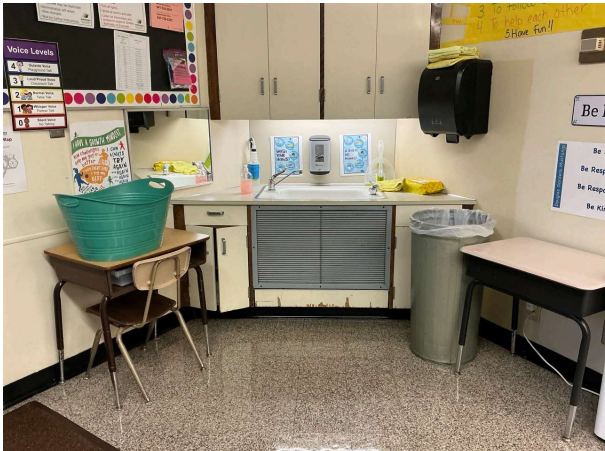
| <b>Site Conditions</b> | The sink does not have knee and toe clearance due to cabinet style. |

Relocate children's use sink to compliant height with knee and toe clearances. It is recommended that the sink which is used by children ages 6 to 9 be installed at 31" maximum height with knee clearance to 24" height provided (see exception 4 below). Sinks shall be installed with the front of the higher of the rim or counter surface 34" maximum above the finish floor or ground. [EXCEPTIONS: 1. A lavatory in a toilet or bathing facility for a single occupant accessed only through a private office and not for common use or public use shall not be required to comply. 2. In residential dwelling unit kitchens, sinks that are adjustable to variable heights, 29" minimum and 36" maximum, shall be permitted where rough-in plumbing permits connections of supply and drain pipes for sinks mounted at the height of 29".] Compliant knee and toe clearance shall be provided. [EXCEPTIONS: 2. A lavatory in a toilet room or bathing facility for a single occupant accessed only through a private office and not for common use or public use shall not be required to provide knee and toe clearance. 3. In residential dwelling units, cabinetry shall be permitted under lavatories and kitchen sinks provided that all of the following conditions are met: (a) the cabinetry can be removed without removal or replacement of the fixture; (b) the finish floor extends under the cabinetry; and (c) the walls behind and surrounding the cabinetry are finished. 4. A knee clearance of 24" minimum above the finish floor or ground shall be permitted at lavatories and sinks used primarily by children 6 through 12 years where the rim or counter surface is 31" maximum above the finish floor or ground. 5. A parallel approach complying with 305 shall be permitted to lavatories and sinks used primarily by children 5 years and younger. 6. The dip of the overflow shall not be considered in determining knee and toe clearances. 7. No more than one bowl of a multi-bowl sink shall be required to provide knee and toe clearance.] Space under an element between 9" and 27" above the finish floor or ground shall be considered knee clearance and shall comply. Knee clearance shall extend 25" maximum under an element at 9" above the finish floor or ground. Floor or ground surfaces of a clear floor or ground space shall comply. Changes in level are not permitted. [EXCEPTION: Slopes not steeper than 1:48 shall be permitted.] The clear floor or ground space shall be 30" minimum by 48" minimum. Unless otherwise specified, clear floor or ground space shall be permitted to include compliant clear space. Unless otherwise specified, clear floor or ground space shall be positioned for either forward or parallel approach to an element. One full unobstructed side of the clear floor or ground space shall adjoin an accessible route or adjoin another clear floor or ground space. Where a clear floor or ground space is located in an alcove or otherwise confined on all or part of three sides, additional maneuvering clearance shall be provided. Alcoves shall be 36" wide minimum where the depth exceeds 24". Alcoves shall be 60" wide minimum where the depth exceeds 15".

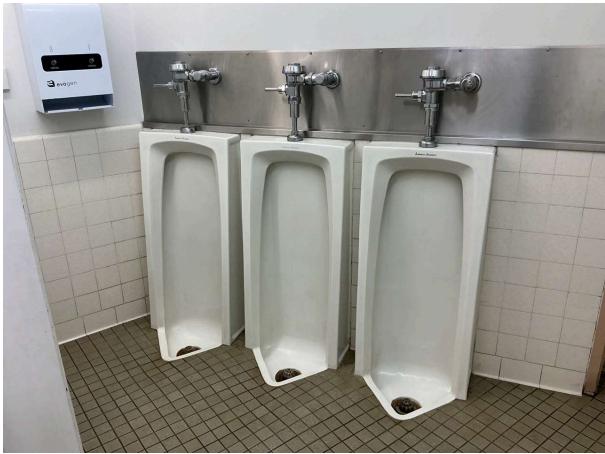
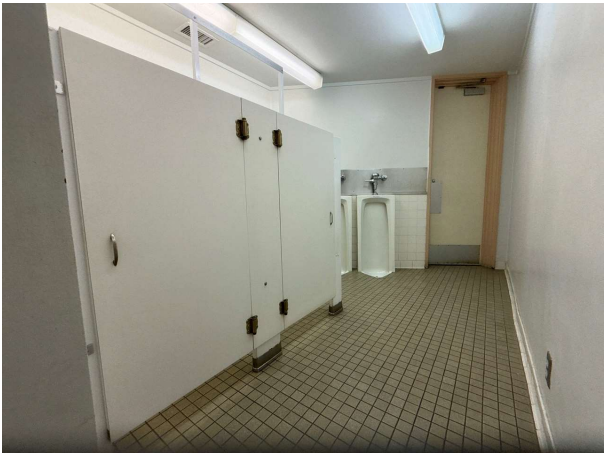
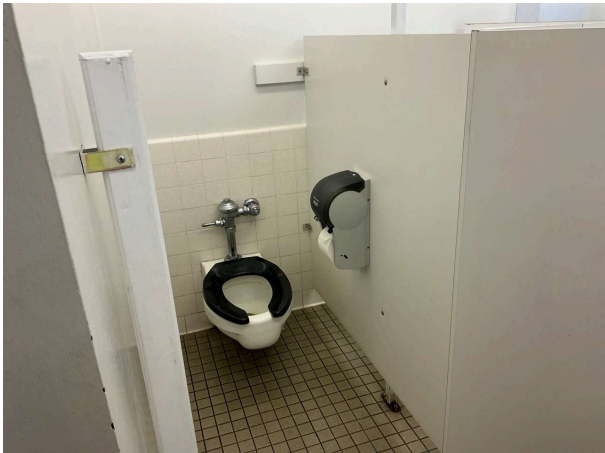
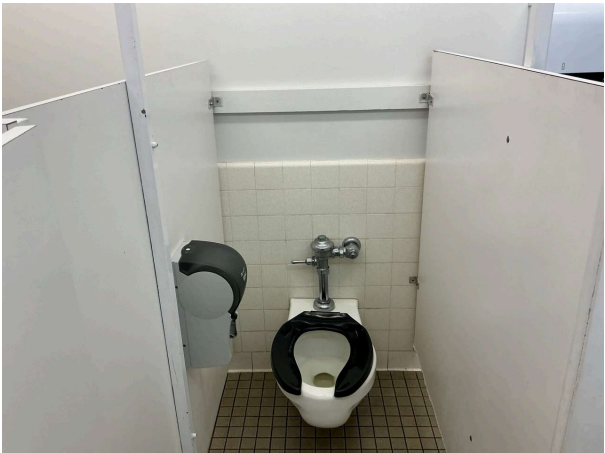
| Site Conditions | A wheelchair accessible stall is not provided. There are 3 urinals and 2 toilets. |

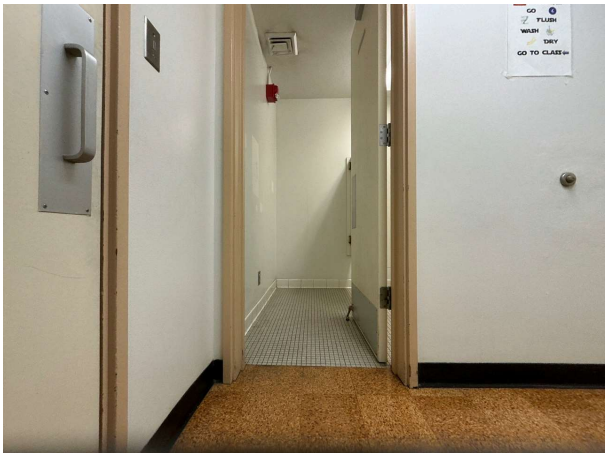
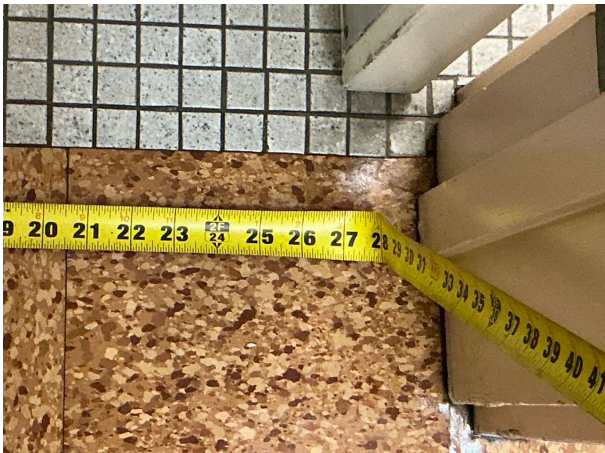
Photos for Barrier ID: AX528478

| Site Conditions | The door clear width is 27 inches. |

Remove and replace with a door that has a minimum clear opening of 32"; measured with the door open at 90°, measured from the face of the door to the stop. Door openings shall provide a clear width of 32" minimum. Clear openings of doorways with swinging doors shall be measured between the face of the door and the stop, with the door open 90°. Openings more than 24" deep shall provide a clear opening of 36" minimum. There shall be no projections into the required clear opening width lower than 34" above the finish floor or ground. Projections into the clear opening width between 34" and 80" above the finish floor or ground shall not exceed 4".  
[EXCEPTIONS: 1. In alterations, a projection of 5/8" maximum into the required clear width shall be permitted for the latch side stop. 2. Door closers and door stops shall be permitted to be 78" minimum above the finish floor or ground.]

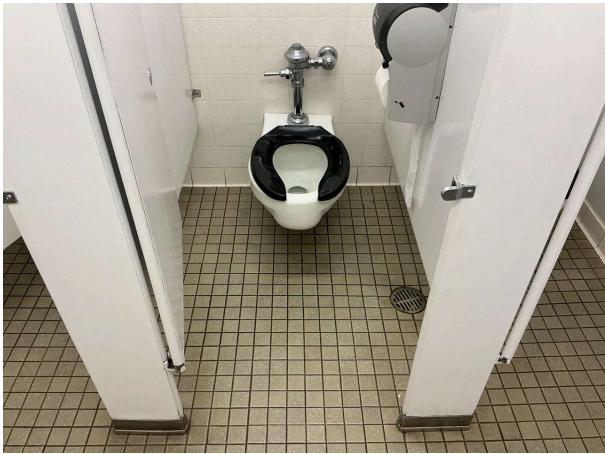
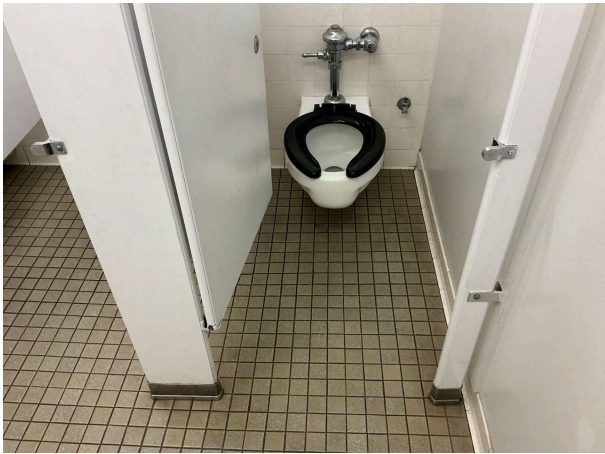
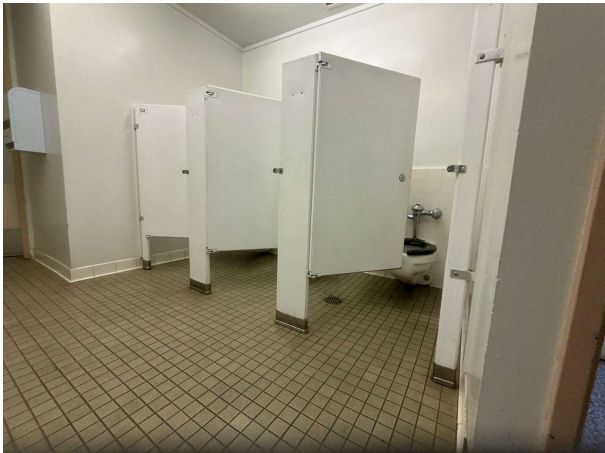
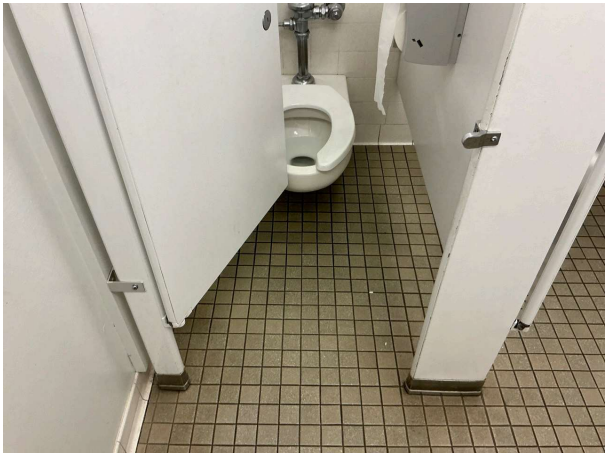
| Site Conditions | A wheelchair accessible stall is not provided. There are 3 toilets. |

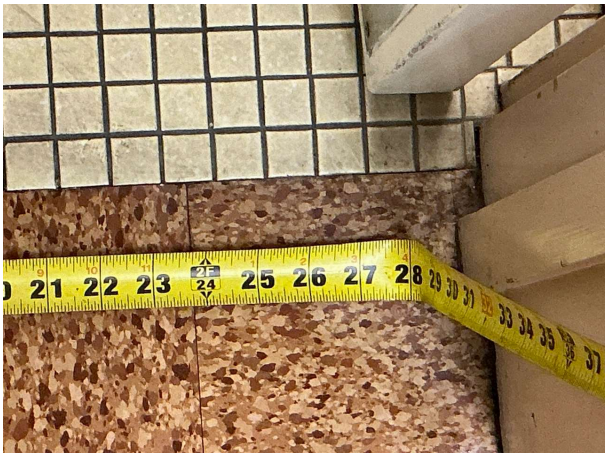
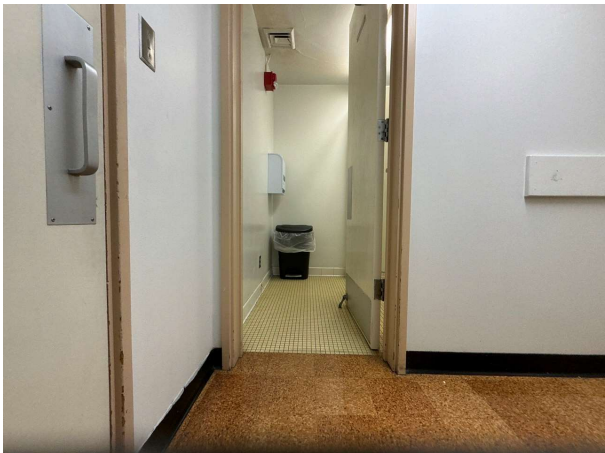
Photos for Barrier ID: AX528477

| Site Conditions | The door clear width is 27 inches. |

Remove and replace with a door that has a minimum clear opening of 32"; measured with the door open at 90°, measured from the face of the door to the stop. Door openings shall provide a clear width of 32" minimum. Clear openings of doorways with swinging doors shall be measured between the face of the door and the stop, with the door open 90°. Openings more than 24" deep shall provide a clear opening of 36" minimum. There shall be no projections into the required clear opening width lower than 34" above the finish floor or ground. Projections into the clear opening width between 34" and 80" above the finish floor or ground shall not exceed 4".  
[EXCEPTIONS: 1. In alterations, a projection of 5/8" maximum into the required clear width shall be permitted for the latch side stop. 2. Door closers and door stops shall be permitted to be 78" minimum above the finish floor or ground.]

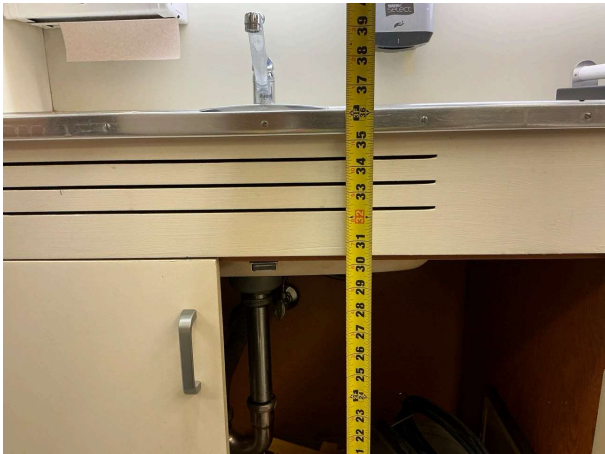
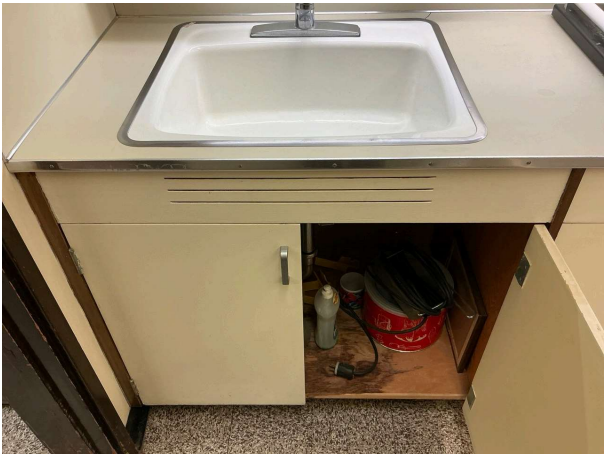
## Site Conditions

Relocate the lavatory to provide minimum 30" by minimum 48" clear floor space positioned for a forward approach to the lavatory. Compliant knee and toe clearance shall be provided. [EXCEPTIONS: 2. A lavatory in a toilet room or bathing facility for a single occupant accessed only through a private office and not for common use or public use shall not be required to provide knee and toe clearance. 3. In residential dwelling units, cabinetry shall be permitted under lavatories and kitchen sinks provided that all of the following conditions are met: (a) the cabinetry can be removed without removal or replacement of the fixture; (b) the finish floor extends under the cabinetry; and (c) the walls behind and surrounding the cabinetry are finished. 4. A knee clearance of 24" minimum above the finish floor or ground shall be permitted at lavatories and sinks used primarily by children 6 through 12 years where the rim or counter surface is 31" maximum above the finish floor or ground. 5. A parallel approach complying with 305 shall be permitted to lavatories and sinks used primarily by children 5 years and younger. 6. The dip of the overflow shall not be considered in determining knee and toe clearances. 7. No more than one bowl of a multi-bowl sink shall be required to provide knee and toe clearance.] Space under an element between 9" and 27" above the finish floor or ground shall be considered knee clearance and shall comply. Knee clearance shall extend 25" maximum under an element at 9" above the finish floor or ground. Floor or ground surfaces of a clear floor or ground space shall comply. Changes in level are not permitted. [EXCEPTION: Slopes not steeper than 1:48 shall be permitted.] The clear floor or ground space shall be 30" minimum by 48" minimum. One full unobstructed side of the clear floor or ground space shall adjoin an accessible route or adjoin another clear floor or ground space. Where a clear floor or ground space is located in an alcove or otherwise confined on all or part of three sides, additional maneuvering clearance shall be provided. Alcoves shall be 36" wide minimum where the depth exceeds 24". Alcoves shall be 60" wide minimum where the depth exceeds 15".

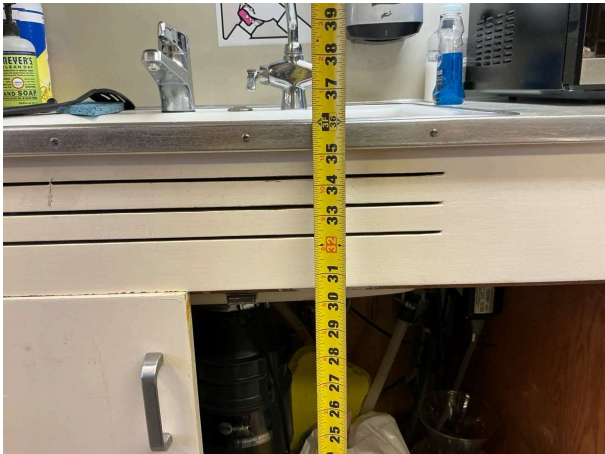
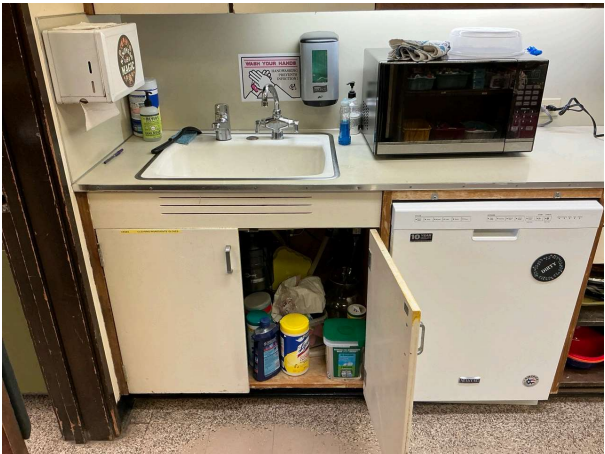
## Site Conditions

Relocate the lavatory to provide minimum 30" by minimum 48" clear floor space positioned for a forward approach to the lavatory. Compliant knee and toe clearance shall be provided. [EXCEPTIONS: 2. A lavatory in a toilet room or bathing facility for a single occupant accessed only through a private office and not for common use or public use shall not be required to provide knee and toe clearance. 3. In residential dwelling units, cabinetry shall be permitted under lavatories and kitchen sinks provided that all of the following conditions are met: (a) the cabinetry can be removed without removal or replacement of the fixture; (b) the finish floor extends under the cabinetry; and (c) the walls behind and surrounding the cabinetry are finished. 4. A knee clearance of 24" minimum above the finish floor or ground shall be permitted at lavatories and sinks used primarily by children 6 through 12 years where the rim or counter surface is 31" maximum above the finish floor or ground. 5. A parallel approach complying with 305 shall be permitted to lavatories and sinks used primarily by children 5 years and younger. 6. The dip of the overflow shall not be considered in determining knee and toe clearances. 7. No more than one bowl of a multi-bowl sink shall be required to provide knee and toe clearance.] Space under an element between 9" and 27" above the finish floor or ground shall be considered knee clearance and shall comply. Knee clearance shall extend 25" maximum under an element at 9" above the finish floor or ground. Floor or ground surfaces of a clear floor or ground space shall comply. Changes in level are not permitted. [EXCEPTION: Slopes not steeper than 1:48 shall be permitted.] The clear floor or ground space shall be 30" minimum by 48" minimum. One full unobstructed side of the clear floor or ground space shall adjoin an accessible route or adjoin another clear floor or ground space. Where a clear floor or ground space is located in an alcove or otherwise confined on all or part of three sides, additional maneuvering clearance shall be provided. Alcoves shall be 36" wide minimum where the depth exceeds 24". Alcoves shall be 60" wide minimum where the depth exceeds 15".

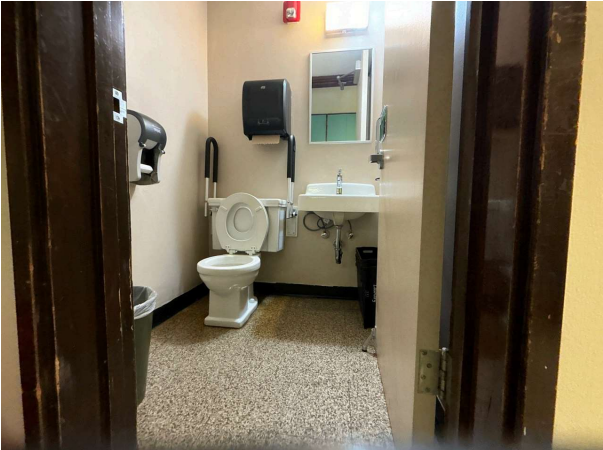
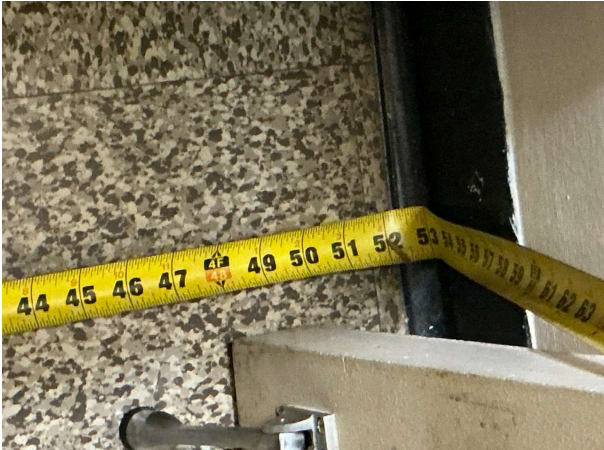
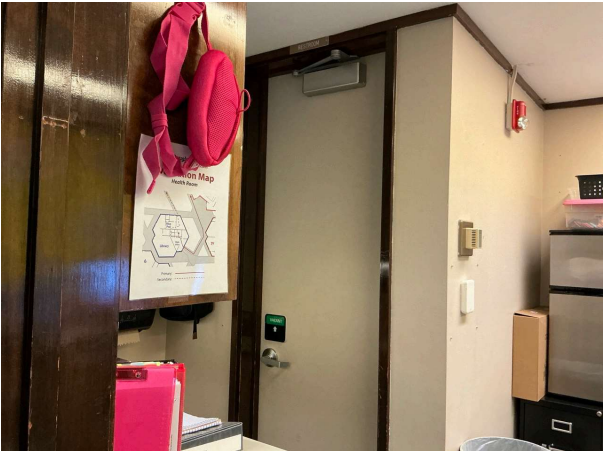
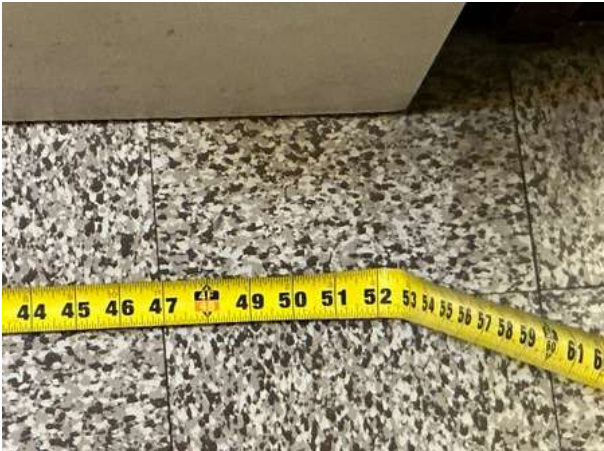
Photos for Barrier ID: AX528506

| Site Conditions | The restroom is not accessible due to limited room dimensions. The restroom is 52" by 52 1/2". |

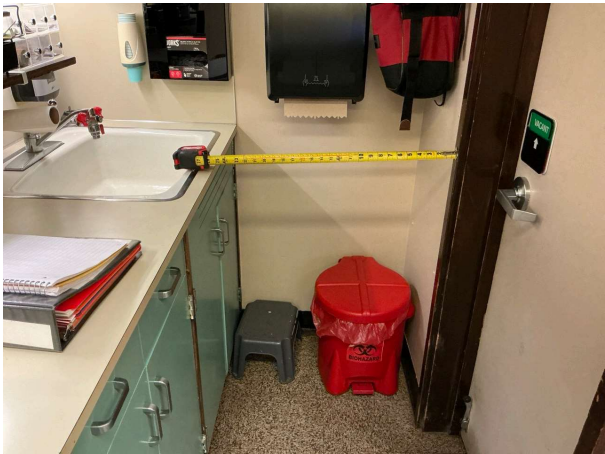
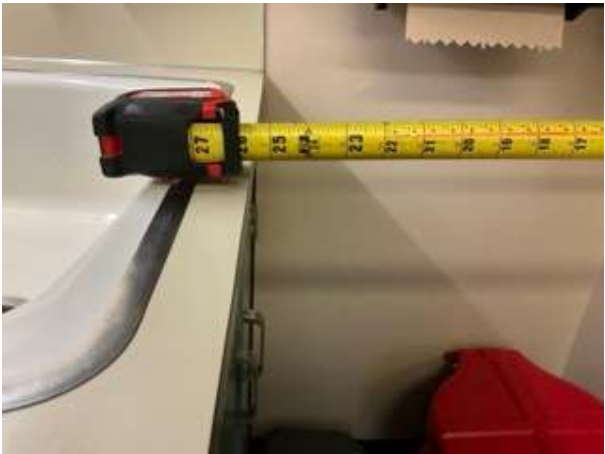
| <b>Site Conditions</b> | The sink has a 25-1/2-inch clear floor width positioned for a parallel approach. |

Relocate the lavatory to provide minimum 30" by minimum 48" clear floor space positioned for a forward approach to the lavatory. Compliant knee and toe clearance shall be provided. [EXCEPTIONS: 2. A lavatory in a toilet room or bathing facility for a single occupant accessed only through a private office and not for common use or public use shall not be required to provide knee and toe clearance. 3. In residential dwelling units, cabinetry shall be permitted under lavatories and kitchen sinks provided that all of the following conditions are met: (a) the cabinetry can be removed without removal or replacement of the fixture; (b) the finish floor extends under the cabinetry; and (c) the walls behind and surrounding the cabinetry are finished. 4. A knee clearance of 24" minimum above the finish floor or ground shall be permitted at lavatories and sinks used primarily by children 6 through 12 years where the rim or counter surface is 31" maximum above the finish floor or ground. 5. A parallel approach complying with 305 shall be permitted to lavatories and sinks used primarily by children 5 years and younger. 6. The dip of the overflow shall not be considered in determining knee and toe clearances. 7. No more than one bowl of a multi-bowl sink shall be required to provide knee and toe clearance.] Space under an element between 9" and 27" above the finish floor or ground shall be considered knee clearance and shall comply. Knee clearance shall extend 25" maximum under an element at 9" above the finish floor or ground. Floor or ground surfaces of a clear floor or ground space shall comply. Changes in level are not permitted. [EXCEPTION: Slopes not steeper than 1:48 shall be permitted.] The clear floor or ground space shall be 30" minimum by 48" minimum. One full unobstructed side of the clear floor or ground space shall adjoin an accessible route or adjoin another clear floor or ground space. Where a clear floor or ground space is located in an alcove or otherwise confined on all or part of three sides, additional maneuvering clearance shall be provided. Alcoves shall be 36" wide minimum where the depth exceeds 24". Alcoves shall be 60" wide minimum where the depth exceeds 15".

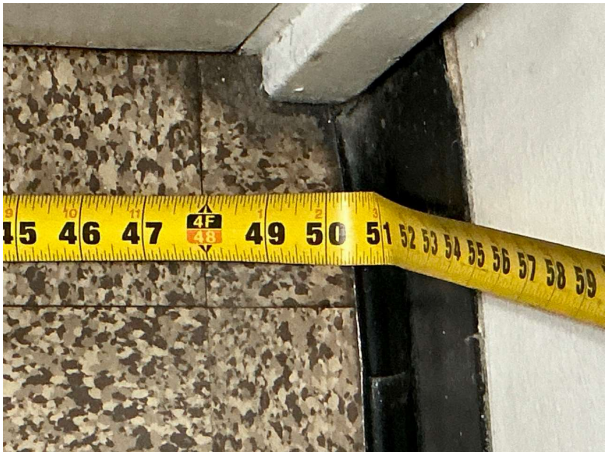
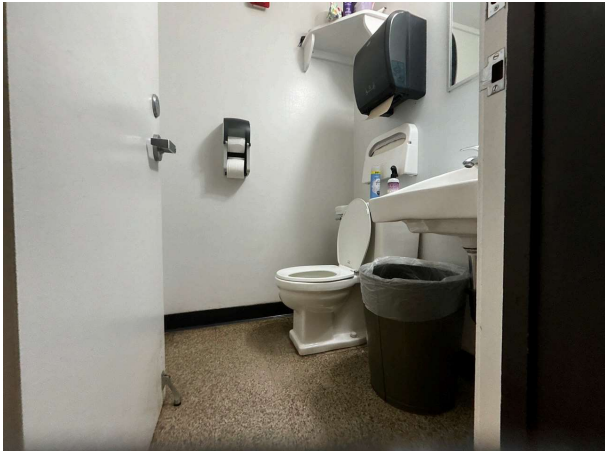
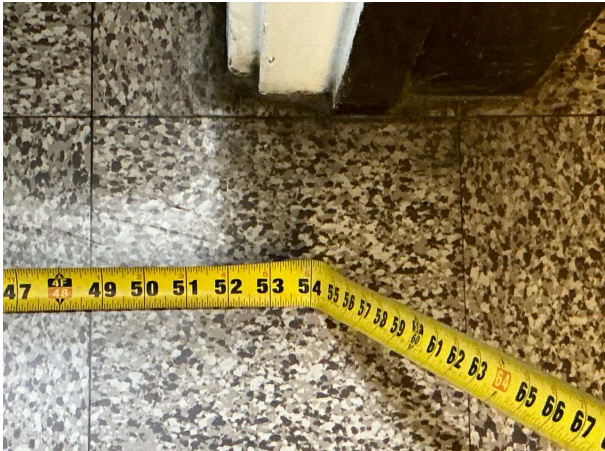
Photos for Barrier ID: AX528510

| Site Conditions | The restroom is not accessible due to limited room dimensions. The restroom is 52" by 50 1/2". |

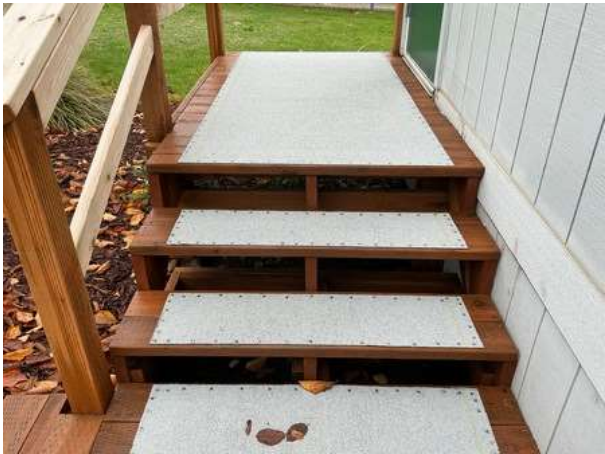
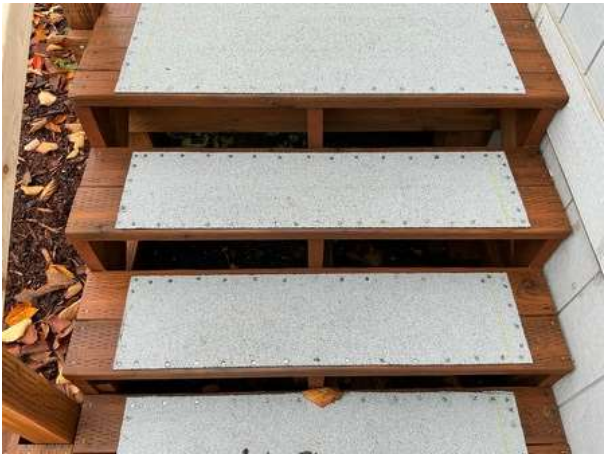
Site Conditions The leading edge of the landing and treads does not have visual contrast.

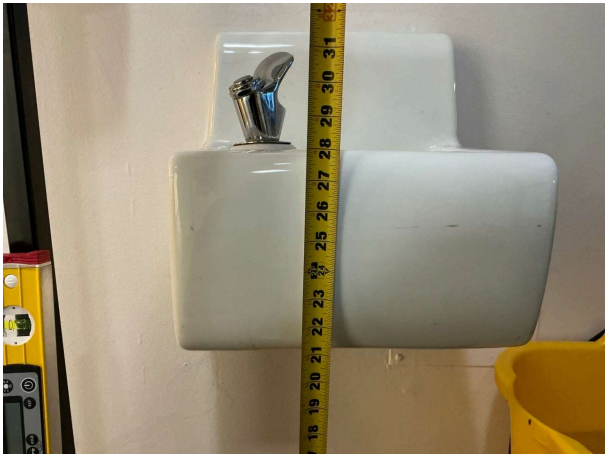
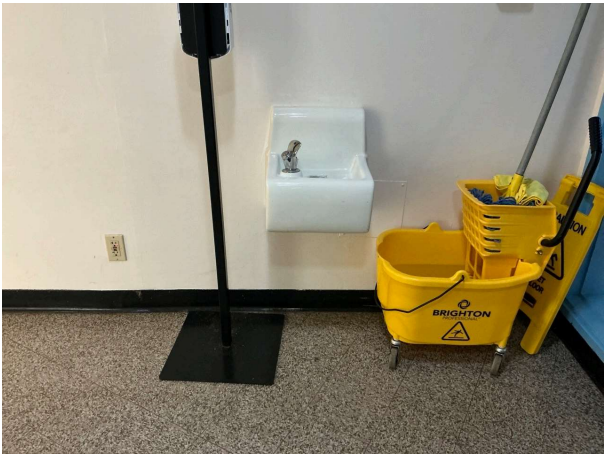
| <b>Site Conditions</b> | The minimum number of hi-lo drinking fountains is not provided. |

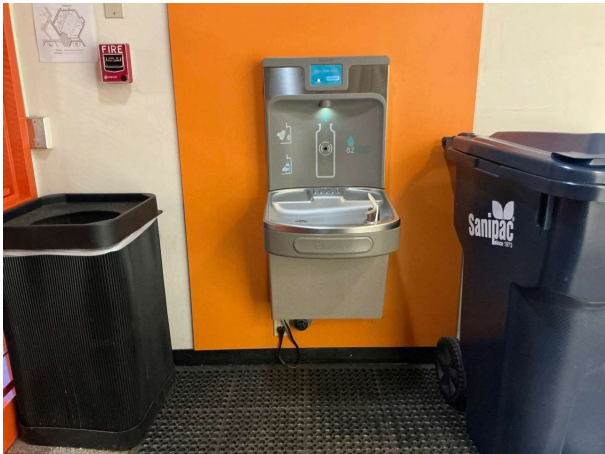
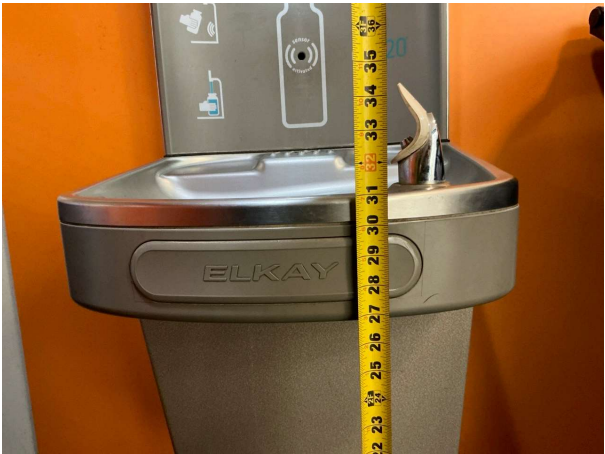
| <b>Site Conditions</b> | The minimum number of hi-low drinking fountains is not provided. |
