# ACCESSIBILITY ASSESSMENT

**DATE OF REPORT:**  
March 4, 2025

## **ADA TITLE II ASSESSMENT**

Guy Lee Elementary School  
755 W Harlow Road  
Springfield, Oregon 97477

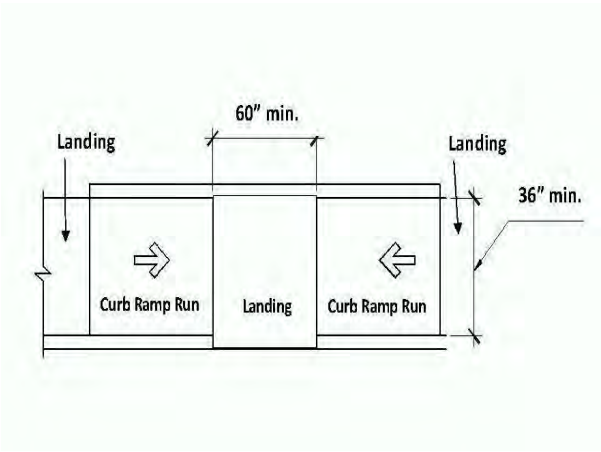
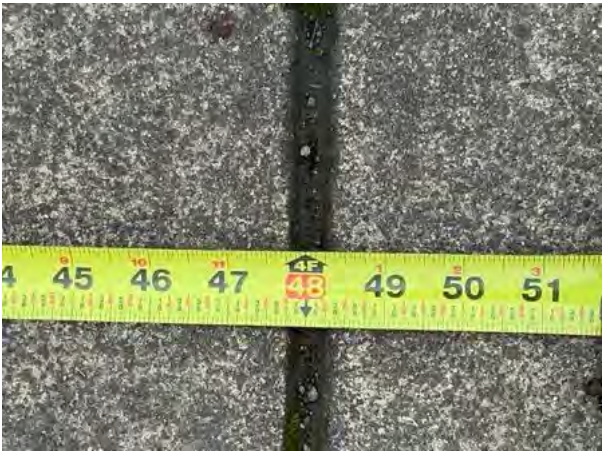
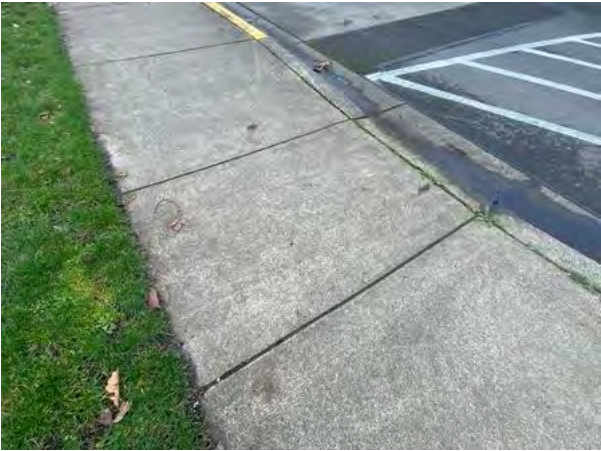
| Site Conditions | The parallel curb ramp bottom landing is 48" width. |

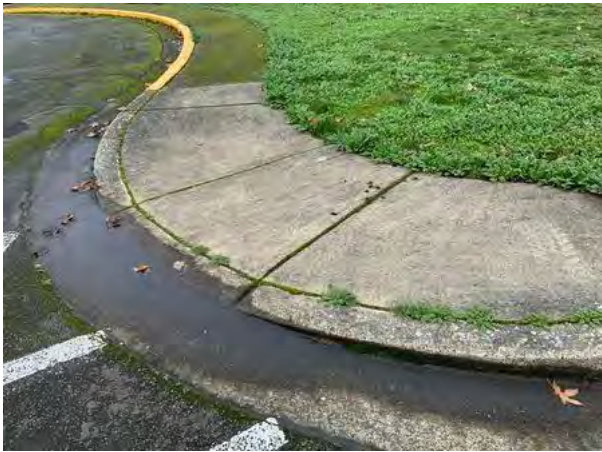
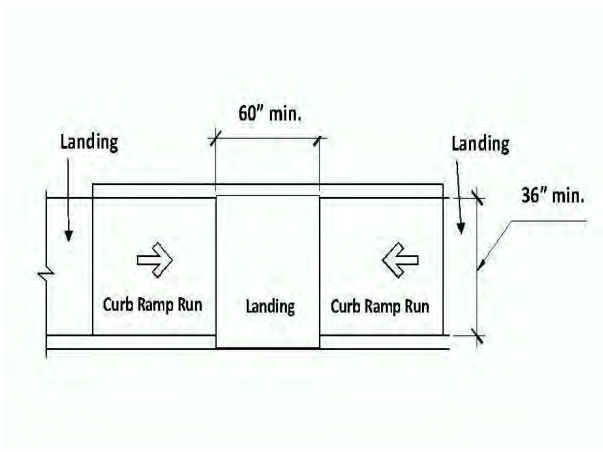
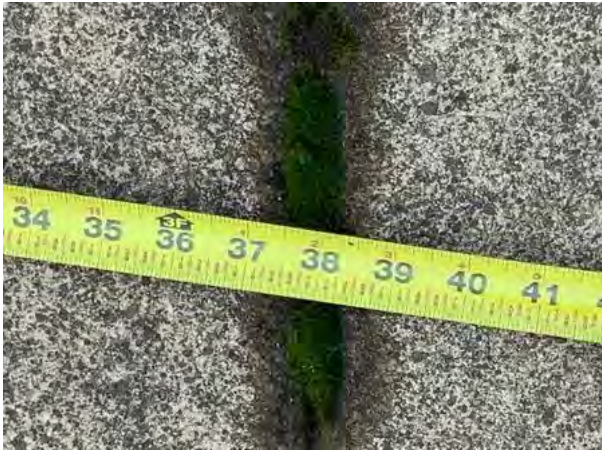
Map for Barrier ID: AX545119

| Site Conditions | The parallel curb ramp bottom landing is 38" width. |

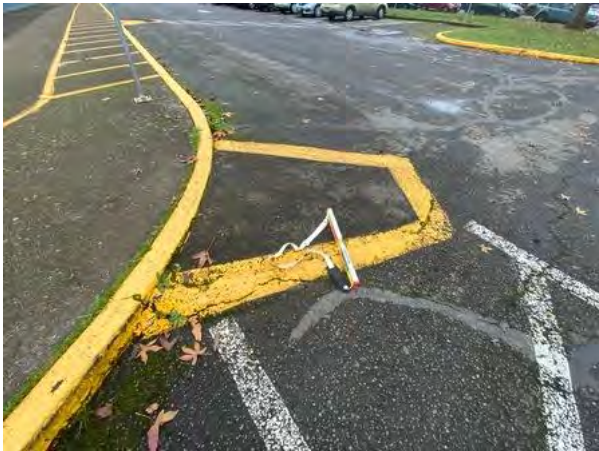
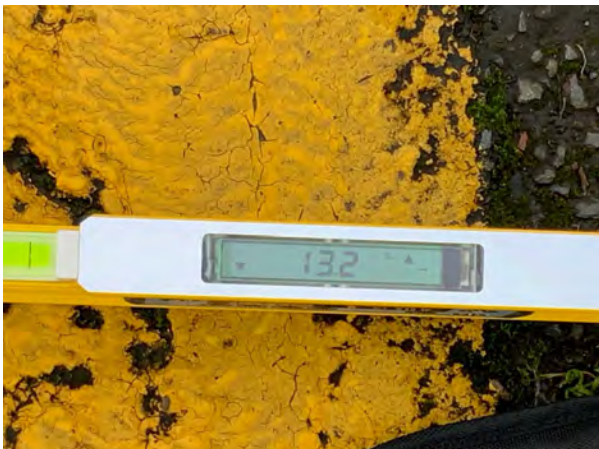
Photos for Barrier ID: AX545121

| Site Conditions | The curb ramp projects into the street. | |

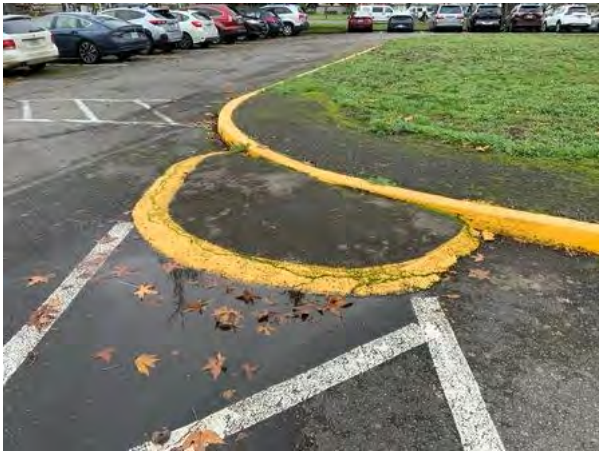
Photos for Barrier ID: AX545122

| Site Conditions | The curb ramp contains a running slope of 11.7% and projects into the street. | |

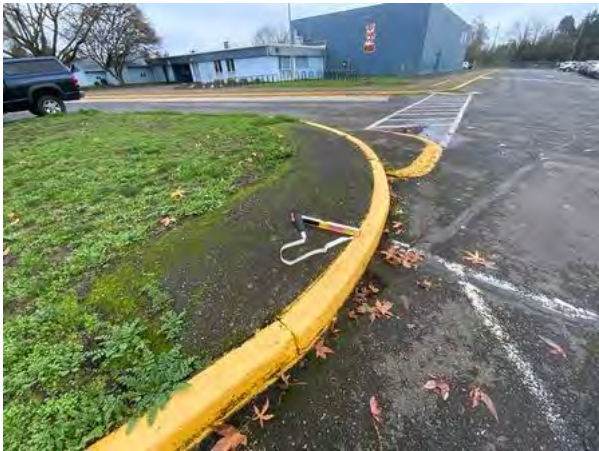
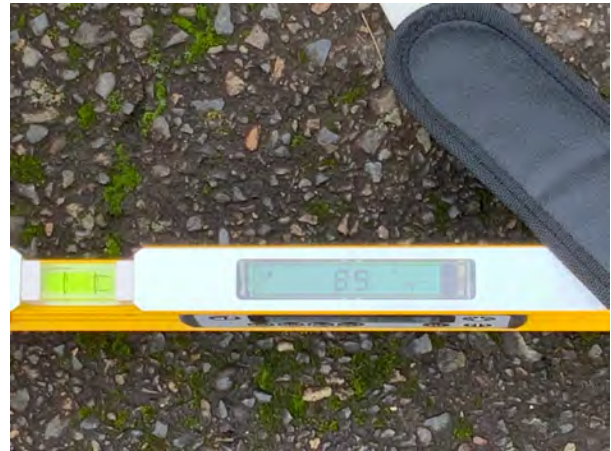
Photos for Barrier ID: AX545126

| Site Conditions | The accessible route has a cross slope of 8.9% for a length of 11' by 5' wide. | |

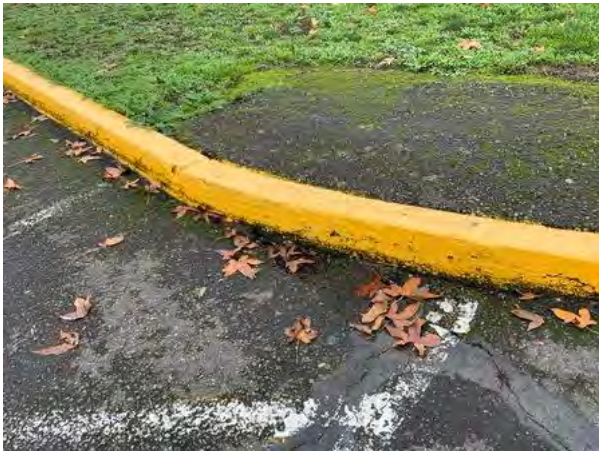
Photos for Barrier ID: AX545123

| <b>Site Conditions</b> | A curb ramp is not provided where the accessible route crosses a curb. |

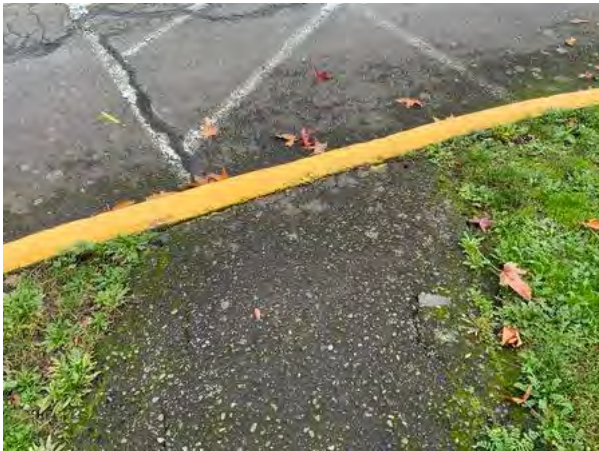
Photos for Barrier ID: AX545124

| <b>Site Conditions</b> | A curb ramp is not provided where the accessible route crosses a curb. |

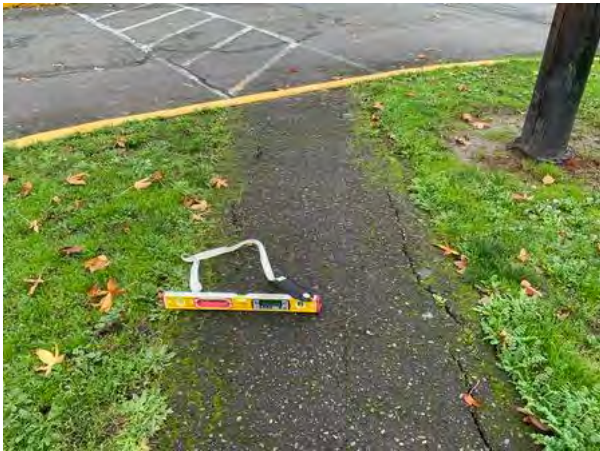
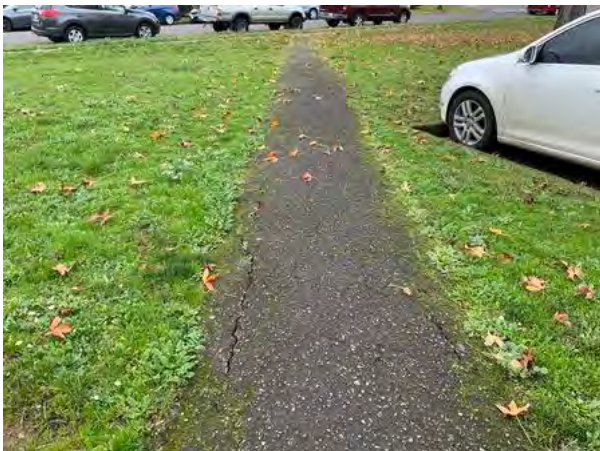
Photos for Barrier ID: AX545125

| <b>Site Conditions</b> | The accessible route has a cross slope of 5.3% for a length of 45' by 5' wide. |

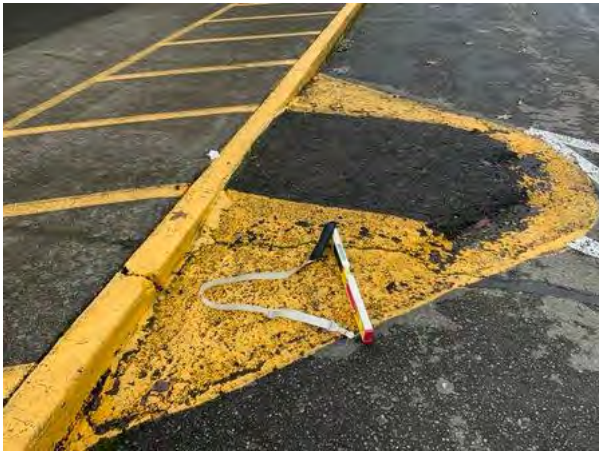
Photos for Barrier ID: AX545127

| Site Conditions | The curb ramp projects into the street. | |

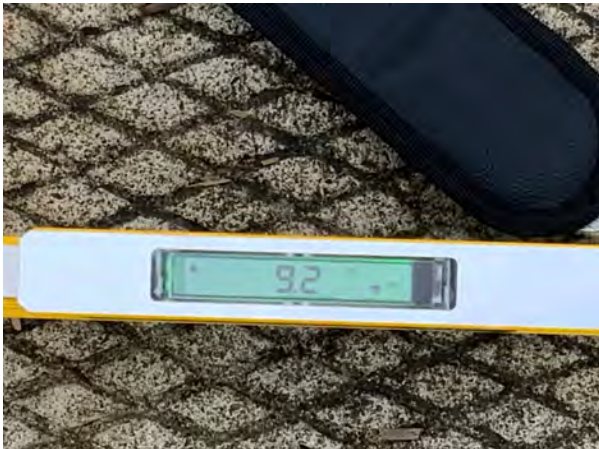
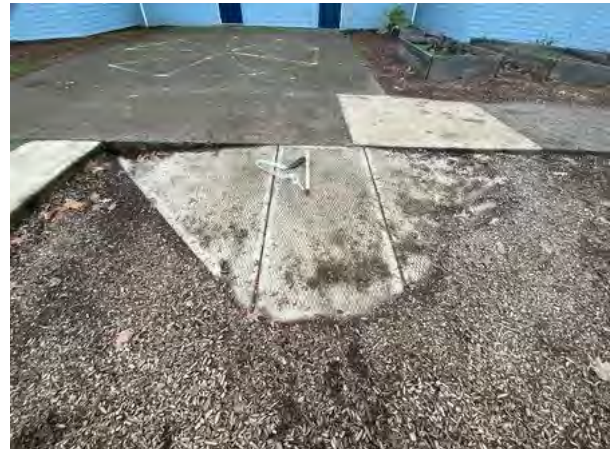
Photos for Barrier ID: AX545147

| <b>Site Conditions</b> | The curb ramp has a running slope of 9.2%. |

The curb ramp should be removed and replaced with a compliant curb ramp with no greater than the maximum allowable slopes of a ramp. Curb ramp runs shall have a running slope not steeper than 1:12 (8.33%). Cross slope of curb ramp runs shall not be steeper than 1:48. The running slope in new construction shall be 1:12 (8.33%) maximum. [EXCEPTION: In existing sites, buildings, and facilities built before 1/26/92, ramps and curb ramps shall be permitted to have running slopes steeper than 1:12 where such slopes are necessary due to space limitations. In facilities built before 1/26/92, the running slope can be 1:10 to 1:8 (10% to 12.5%) for a maximum rise of 3" OR 1:10 to 1:12 (8.3% to 10%) for a maximum rise of 6".] Where flares are provided, flare slopes shall not be greater than 1:10 (10%). [EXCEPTION: In alterations, where there is no landing at the top of curb ramps, curb ramp flares shall be provided and shall not be steeper than 1:12.]

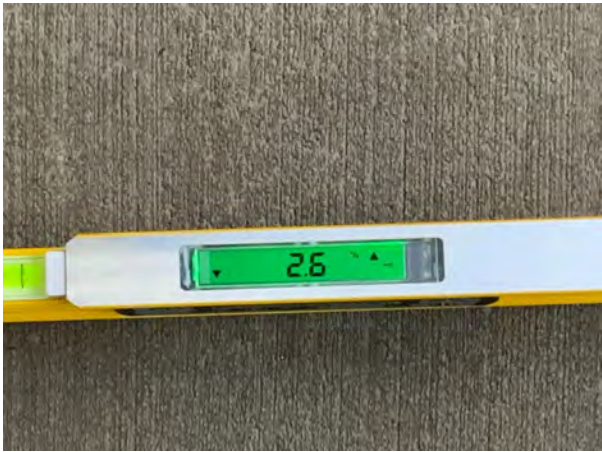
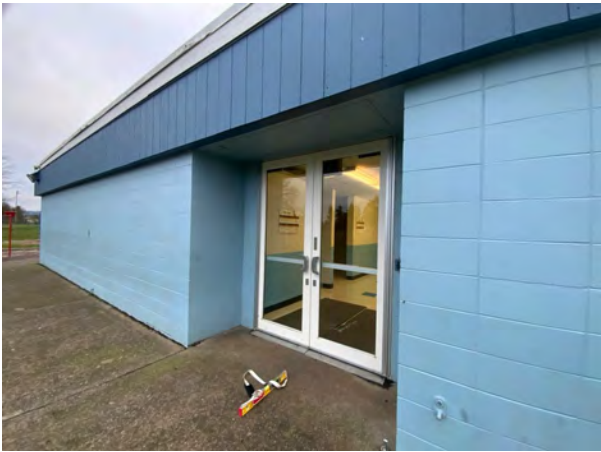
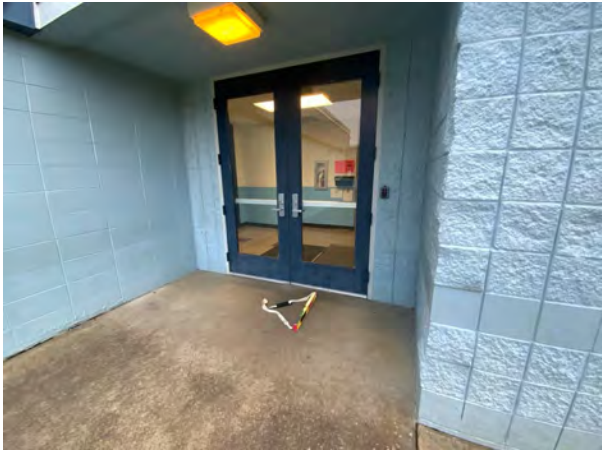
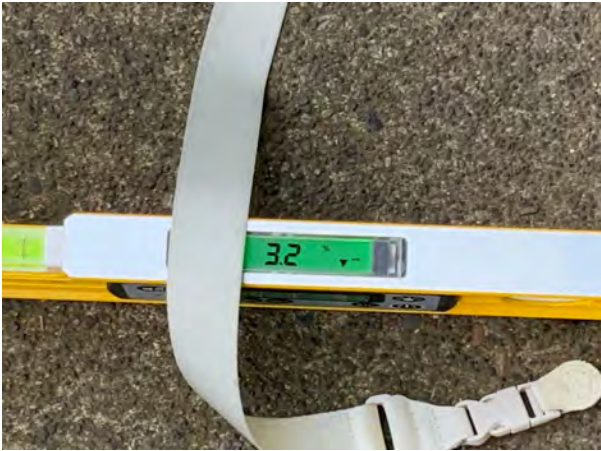
| Site Conditions | The maneuvering clearance at the door has a slope of 2.6% - 3.2%. |

Remove and replace the surface within the required maneuvering clearance area so that the surface is level and clear with maximum slope 1:48 (2.08%) in any direction. The required depth of the maneuvering clearance is X" minimum. The required side clearance is Y" minimum on the latch/hinge side of the door. Maneuvering clearance shall extend the full width of the doorway and the required latch side or hinge side clearance. Floor or ground space within the required maneuvering clearance shall be maximum 1:48 (2.08%) slope. Changes in level are not permitted.

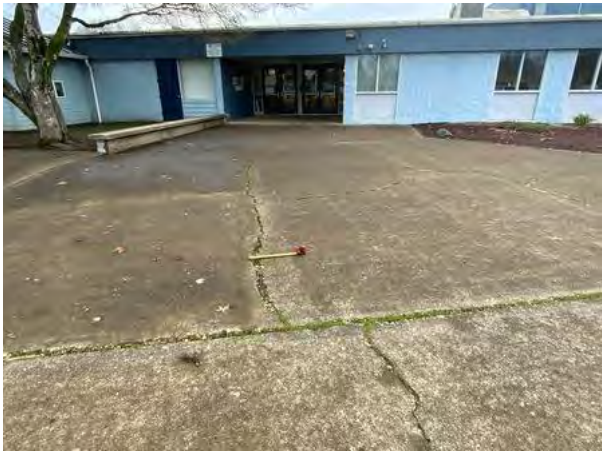
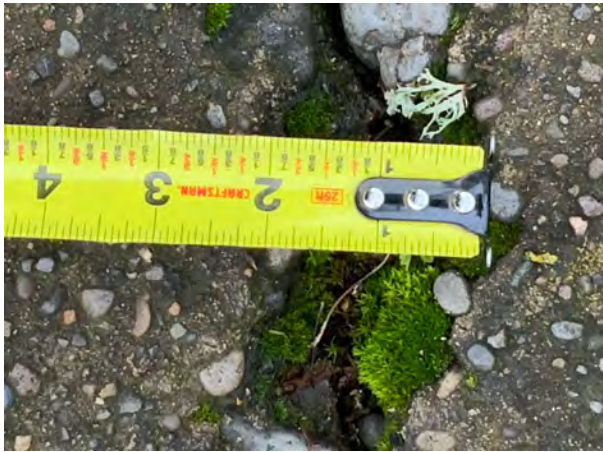
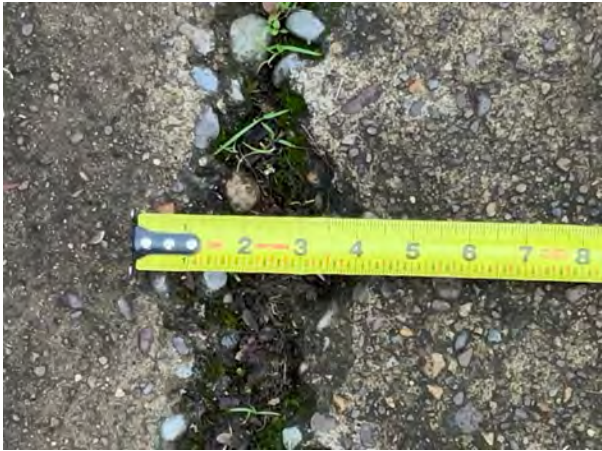
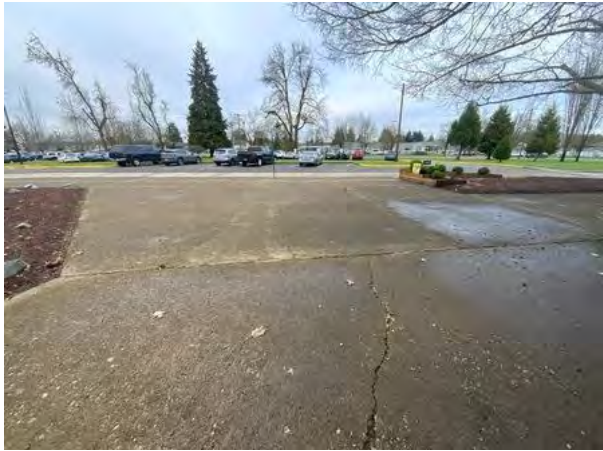
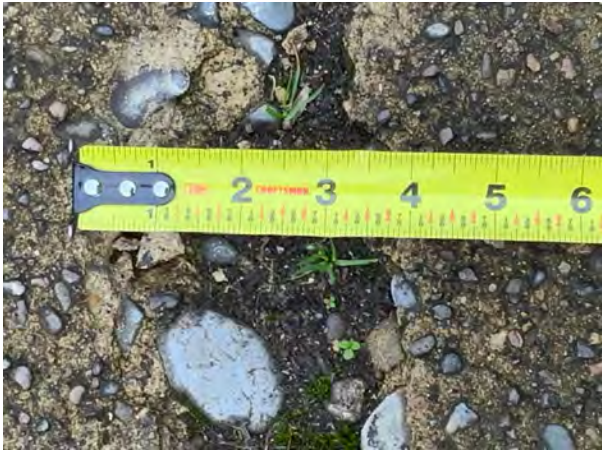
| Site Conditions | The maneuvering clearance at the door has a slope of 4.1% - 4.3%. |

Remove and replace the surface within the required maneuvering clearance area so that the surface is level and clear with maximum slope 1:48 (2.08%) in any direction. The required depth of the maneuvering clearance is X" minimum. The required side clearance is Y" minimum on the latch/hinge side of the door. Maneuvering clearance shall extend the full width of the doorway and the required latch side or hinge side clearance. Floor or ground space within the required maneuvering clearance shall be maximum 1:48 (2.08%) slope. Changes in level are not permitted.

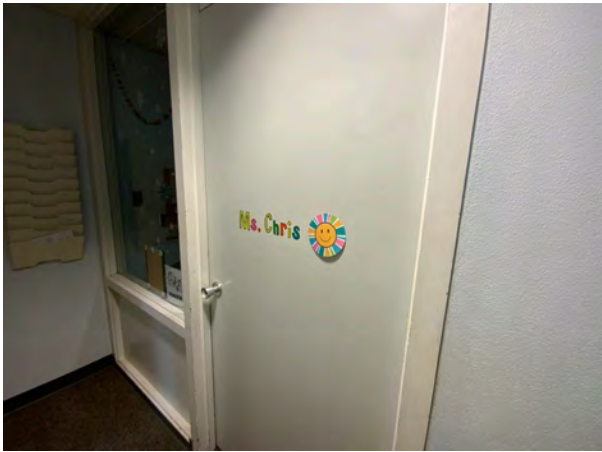
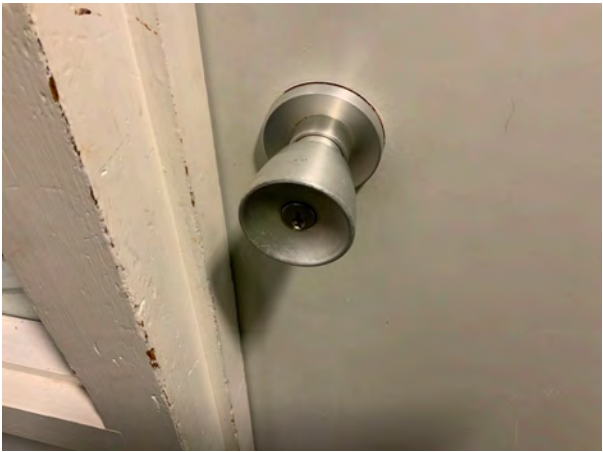
| Site Conditions | For a hinge approach on the push side, the maneuvering clearance is 40 1/2" |

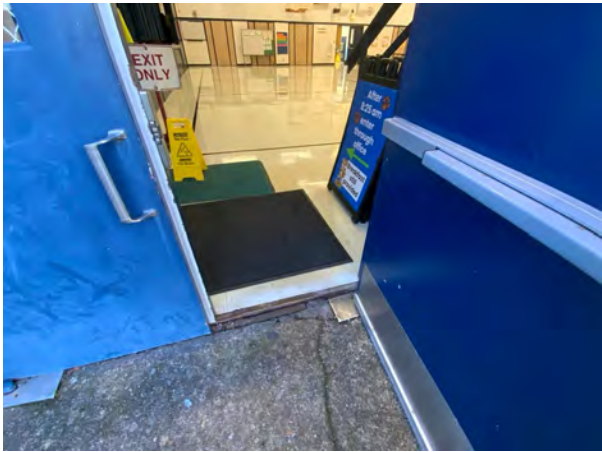
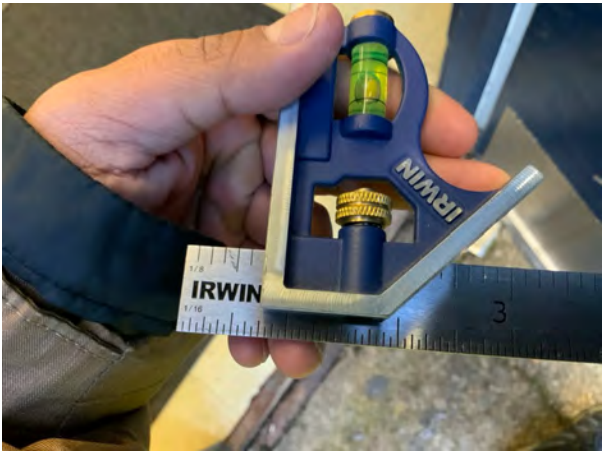
| Site Conditions | The door has a threshold of 3/4" in height. |

Remove and replace with a threshold that is ½" or less in height (including carpet pile allowed to be 1/2" max high). Thresholds, if provided at doorways, shall be 1/2" high maximum. Raised thresholds and changes in level at doorways shall be compliant. [EXCEPTION: Existing or altered thresholds 3/4" high maximum that have a beveled edge on each side with a slope not steeper than 1:2 shall not be required to comply.]

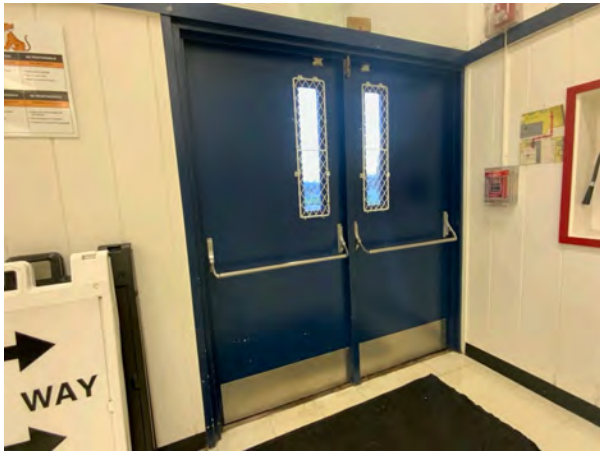
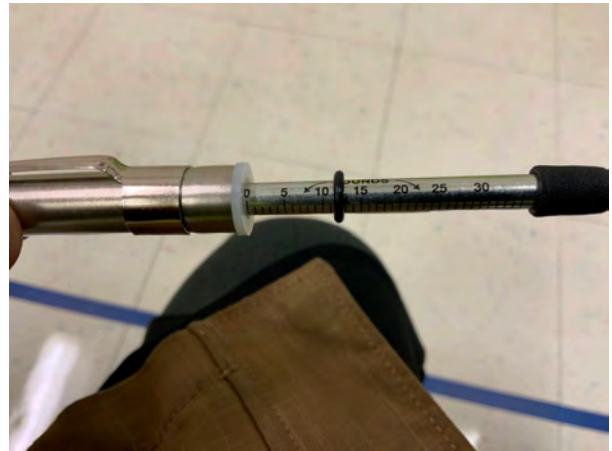
Photos for Barrier ID: AX545177

| Site Conditions | The opening force is 12 pounds. | |

| Adjust the closer or replace with an exterior door that requires no more 8.5 pounds of force for pushing or pulling the door open. The opening force of doors along an accessible route shall be as follows: 1. Exterior doors: 8.5 pounds maximum (lbf) (37.8 N). 2. Interior doors: 5 pounds maximum (lbf) (22.2 N). 3. Stairway doors at pressurized stair enclosures: 15 pounds maximum (6.8 kg) at exterior doors. 4. Where environmental conditions require greater closing pressure, power-operated doors shall be used within the accessible route. [Exception: The force required to retract latch bolts or disengage other devices that hold the door or gate in a closed position shall not apply to panic hardware, delayed egress devices or fire-rated hardware.] | | |

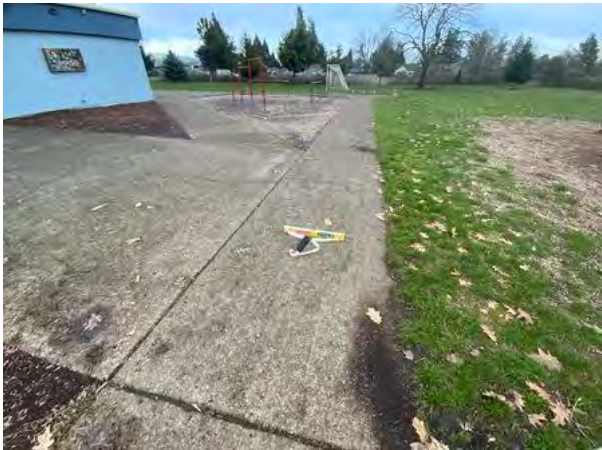
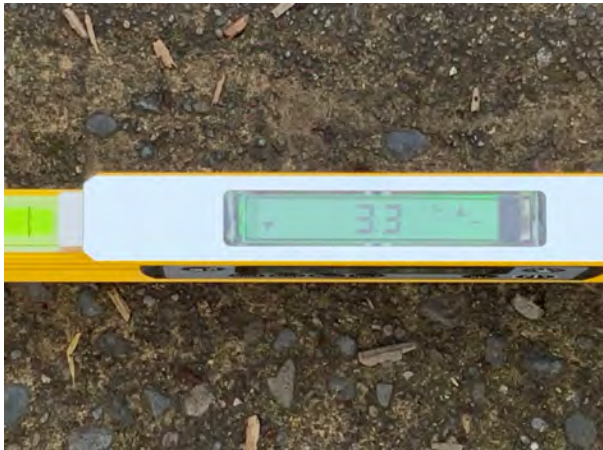
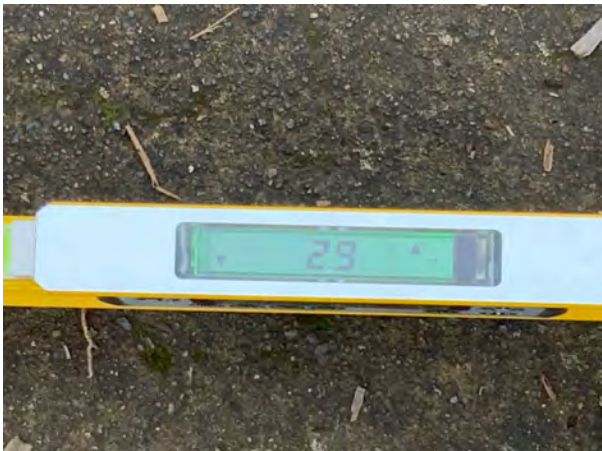
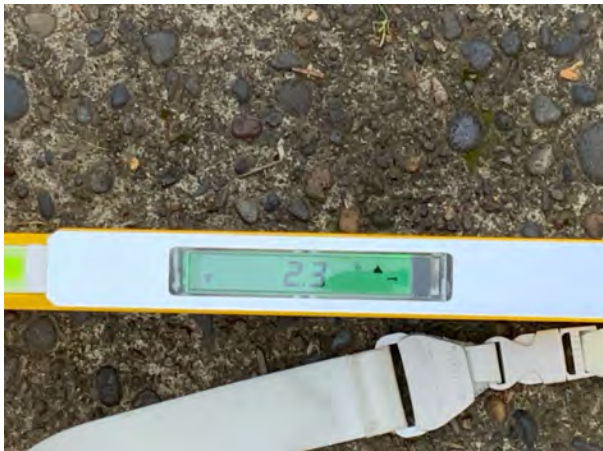
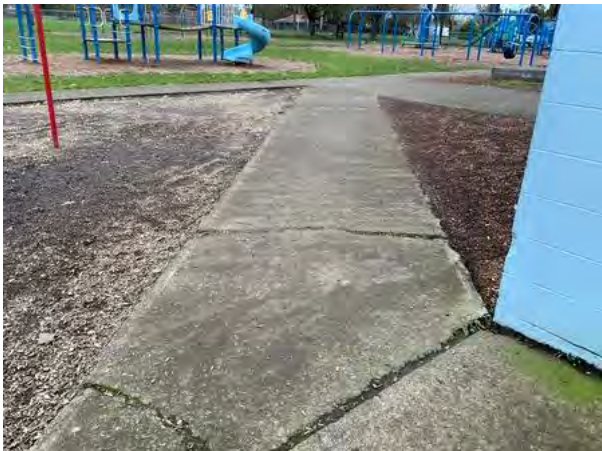
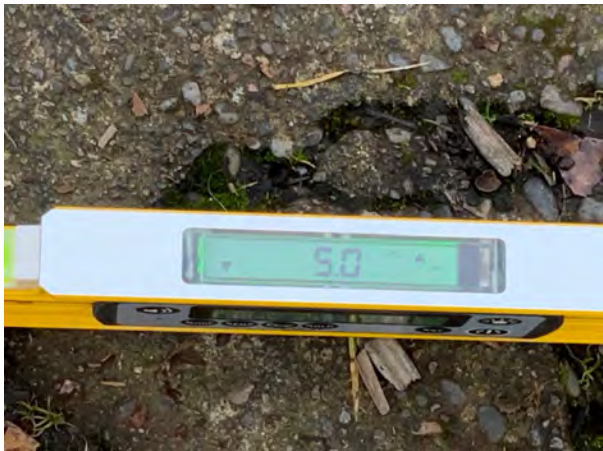
| <b>Site Conditions</b> | The accessible route has a cross slope of 5% for a length of 25' by 5' wide. |

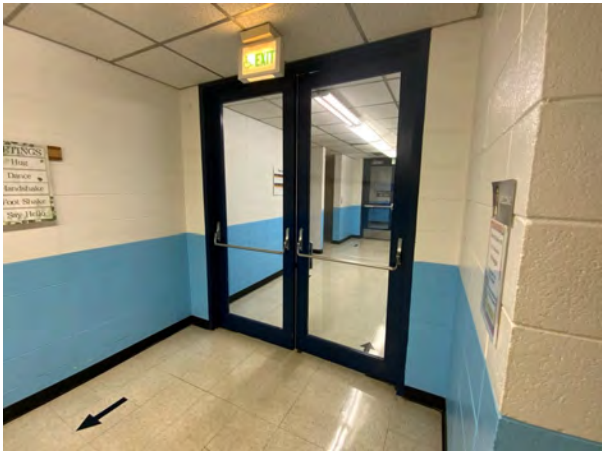
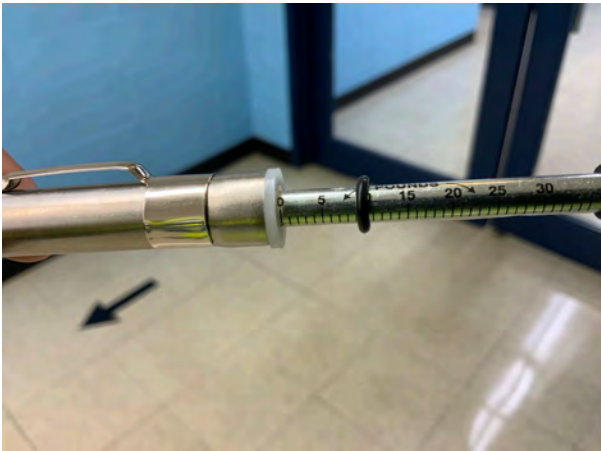
Photos for Barrier ID: AX545216

| Site Conditions | The opening force is 10 pounds. |

Adjust the closer or replace with a door that requires no more than 5 pounds of force for pushing or pulling the door open. The force at the latch, the force to set the door in motion, and the force to fully open the door shall be maximum 5 pounds. These forces do not apply to the force required to retract latch bolts or disengage other devices that hold the door or gate in a closed position.

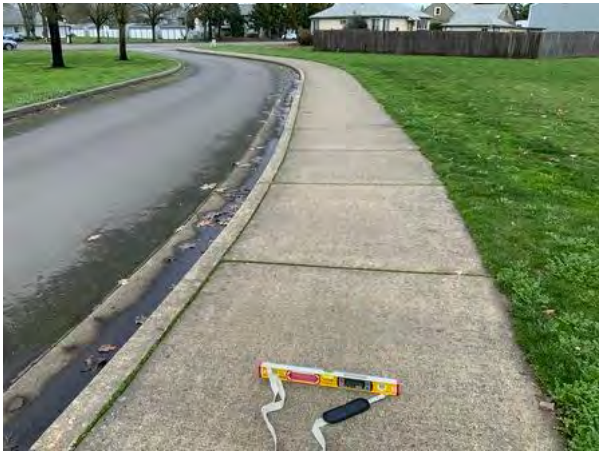
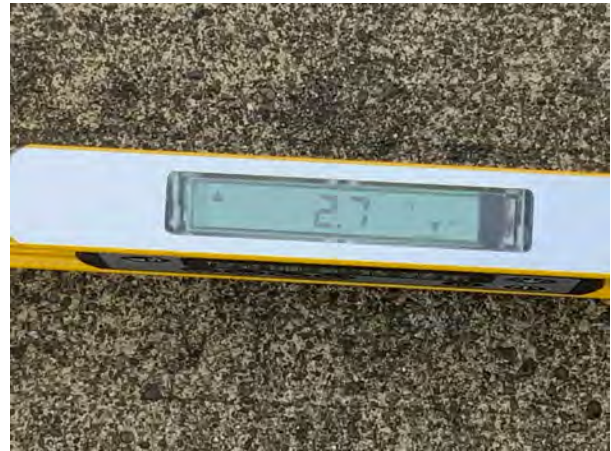
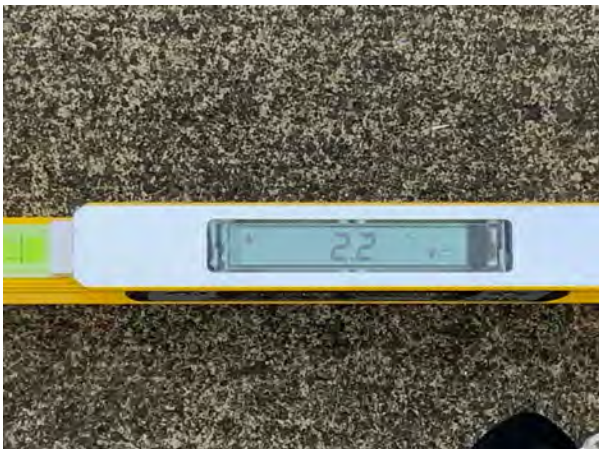
Photos for Barrier ID: AX545116

| <b>Site Conditions</b> | The accessible route has a cross slope of 2.7% for a length of 210' by 6 1/2' wide. | |

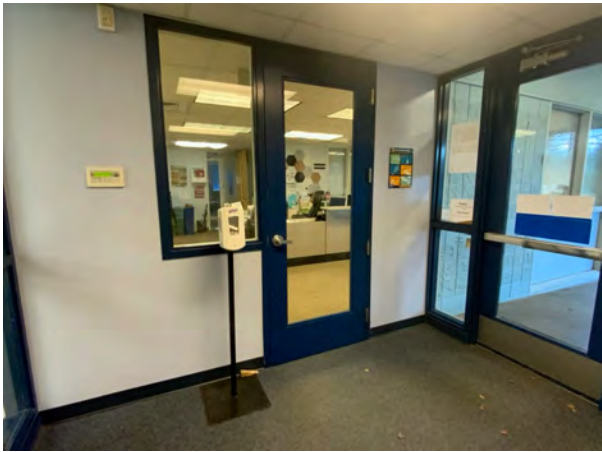
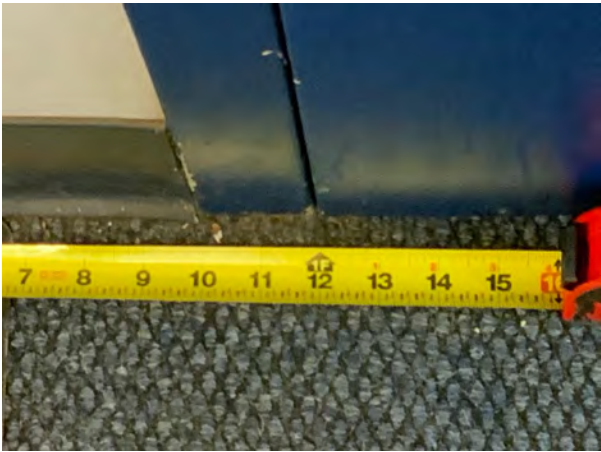
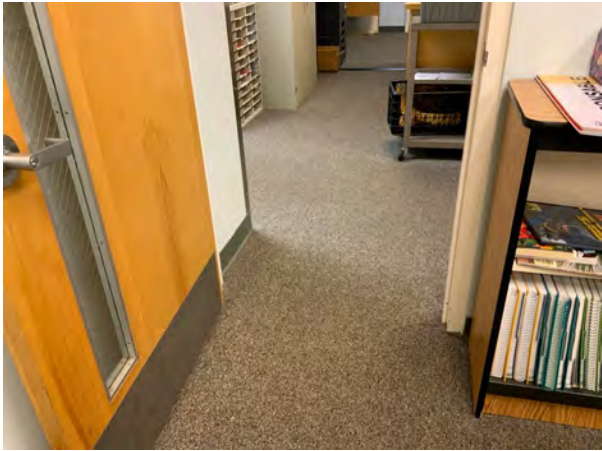
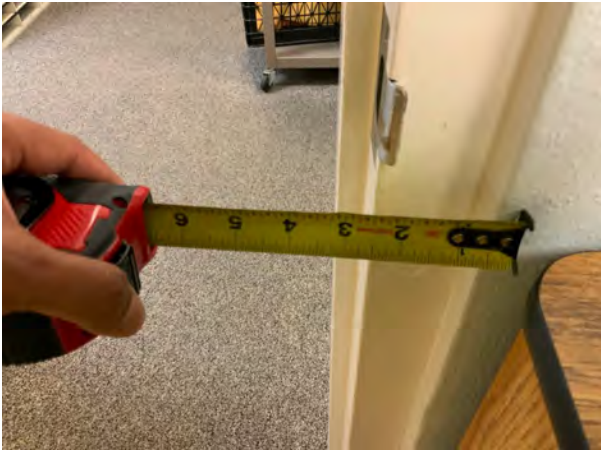
| Site Conditions | For a front approach on the pull side, the side clearance is 2 1/2" - 12". | |

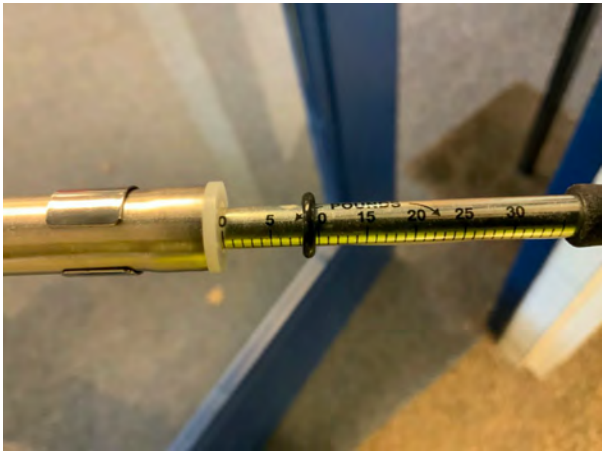
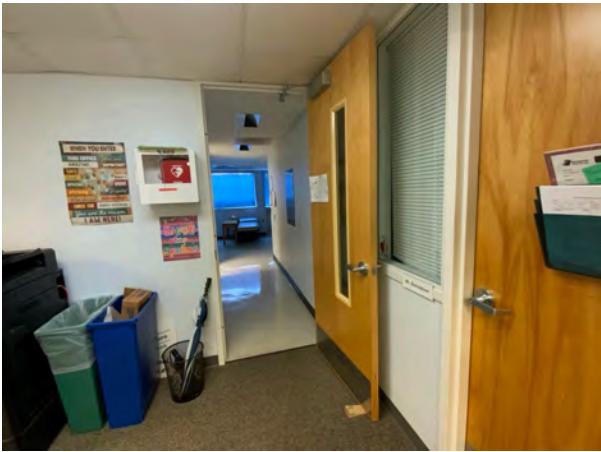
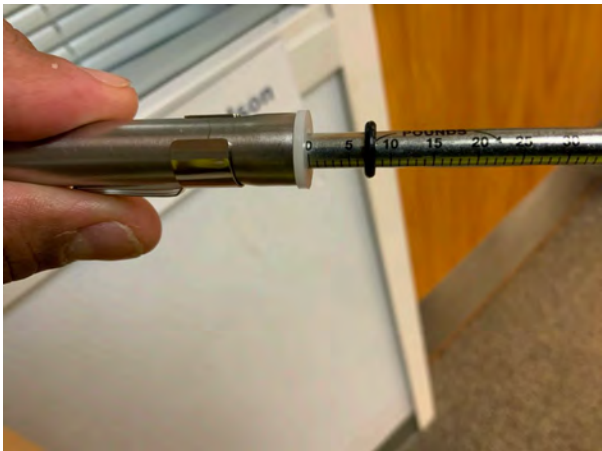
| Site Conditions | The opening force is 7 - 10 pounds. | |

| Adjust the closer or replace with a door that requires no more than 5 pounds of force for pushing or pulling the door open. The force at the latch, the force to set the door in motion, and the force to fully open the door shall be maximum 5 pounds. These forces do not apply to the force required to retract latch bolts or disengage other devices that hold the door or gate in a closed position. | | |

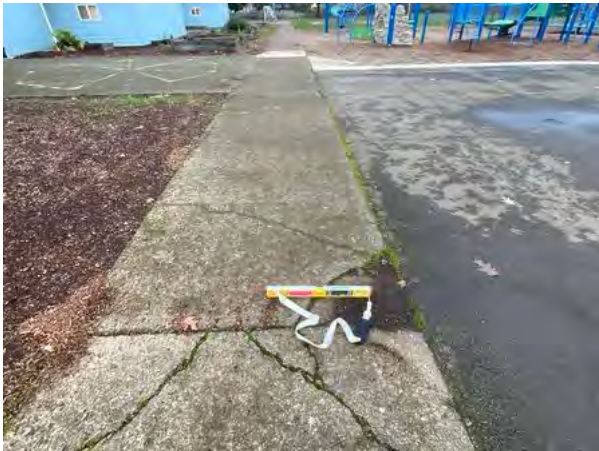
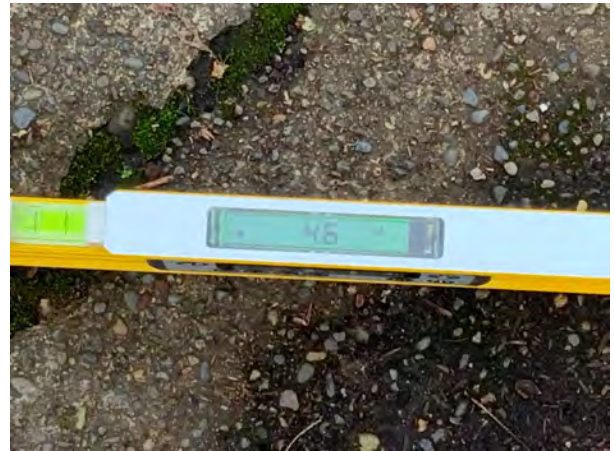
Photos for Barrier ID: AX545137

| <b>Site Conditions</b> | The accessible route has a cross slope of 4.6% for a length of 10' by 5' wide. |

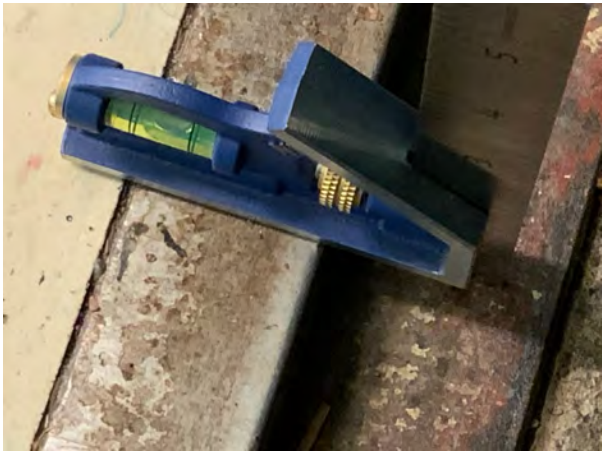
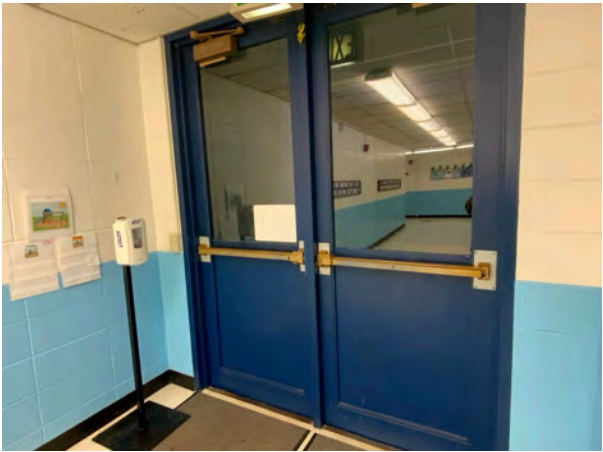
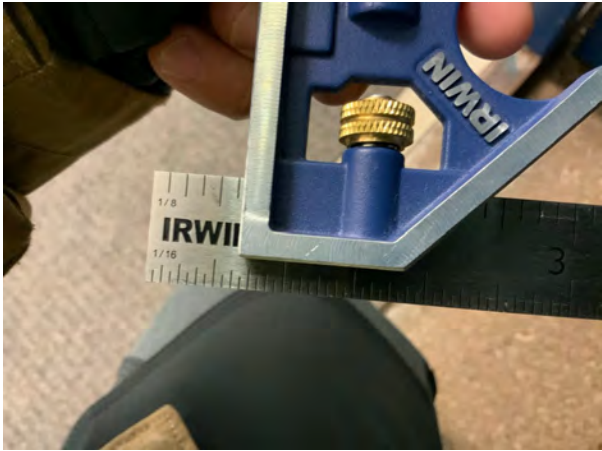
| Site Conditions | The door has a threshold of 5/8" in height. |

Remove and replace with a threshold that is ½" or less in height (including carpet pile allowed to be 1/2" max high). Thresholds, if provided at doorways, shall be 1/2" high maximum. Raised thresholds and changes in level at doorways shall be compliant. [EXCEPTION: Existing or altered thresholds 3/4" high maximum that have a beveled edge on each side with a slope not steeper than 1:2 shall not be required to comply.]

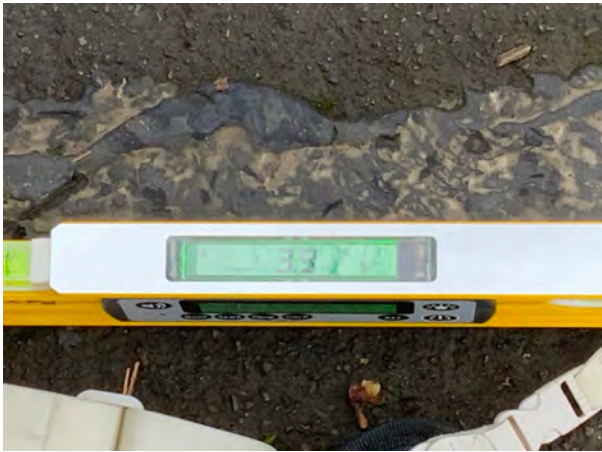
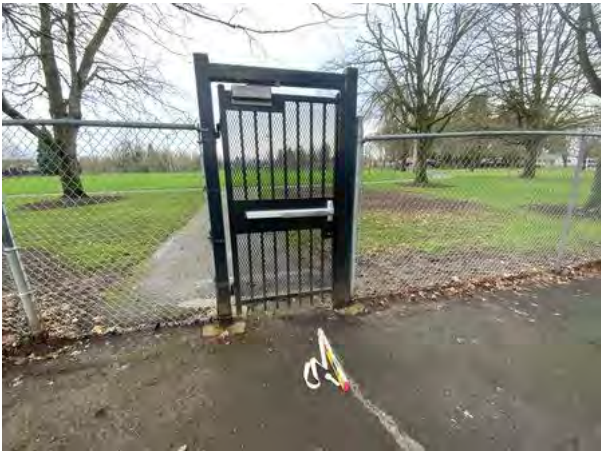
| Site Conditions | The maneuvering clearance at the door has a slope of 3.9%. |

Remove and replace the surface within the required maneuvering clearance area so that the surface is level and clear with maximum slope 1:48 (2.08%) in any direction. The required depth of the maneuvering clearance is X" minimum. The required side clearance is Y" minimum on the latch/hinge side of the door. Maneuvering clearance shall extend the full width of the doorway and the required latch side or hinge side clearance. Floor or ground space within the required maneuvering clearance shall be maximum 1:48 (2.08%) slope. Changes in level are not permitted.

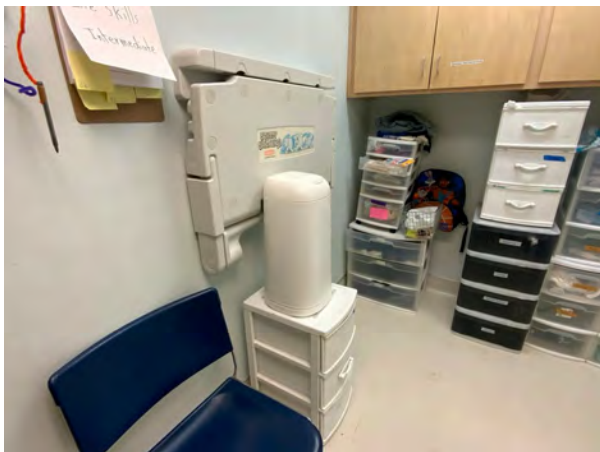
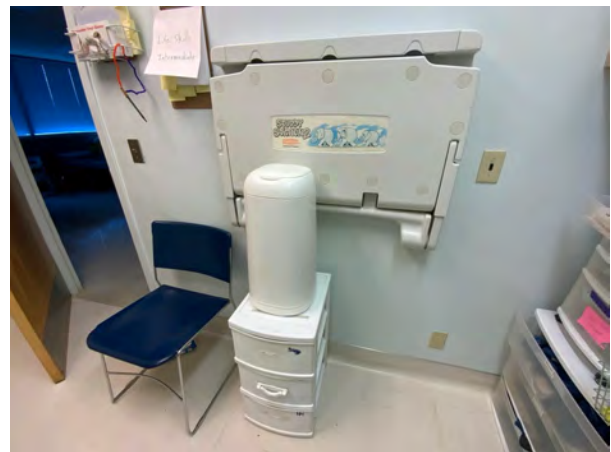
## Photos for Barrier ID: AX545156

| Site Conditions | The baby changing table clear space in front is obstructed by the equipment |

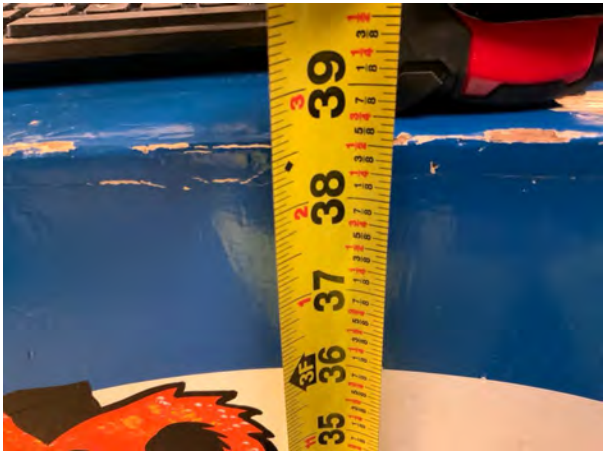
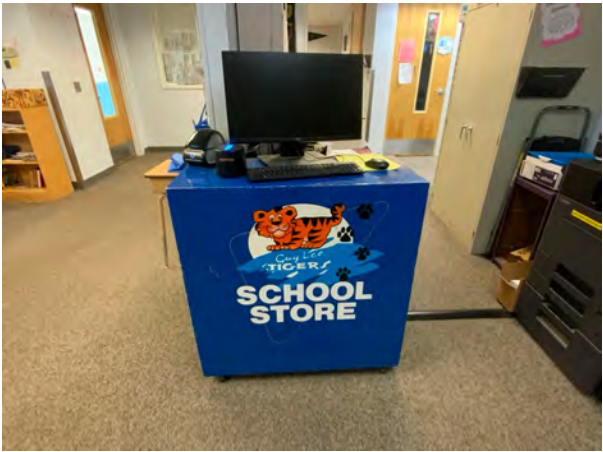
| Site Conditions | The service counter height is at 38 1/2" above the finished floor. | |

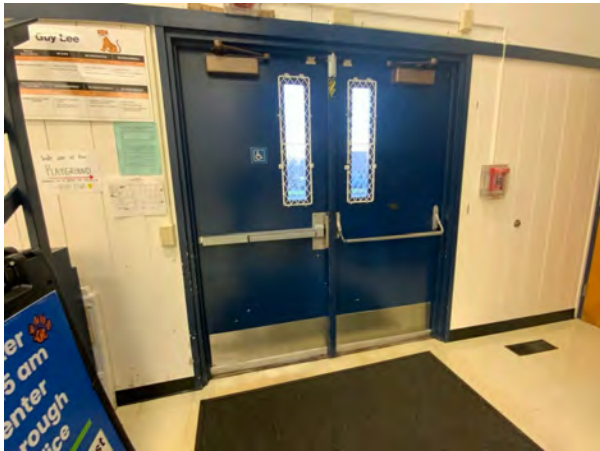
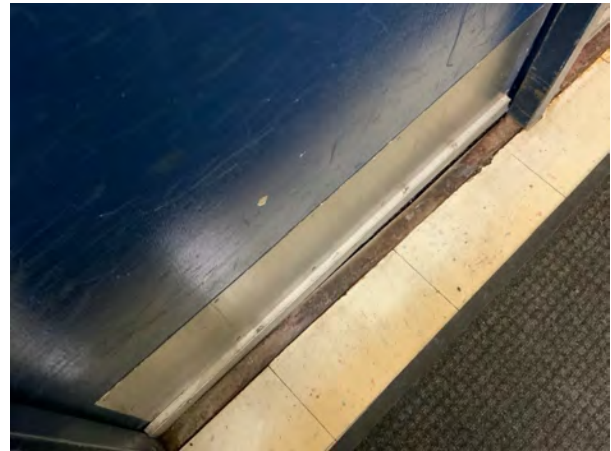
Photos for Barrier ID: AX545176

| Modify or replace the door to provide a surface of the door within 10 inches of the finish floor or ground for the full width of the door on the push side that is smooth. Swinging door and gate surfaces within 10 inches of the finish floor or ground measured vertically shall have a smooth surface on the push side extending the full width of the door or gate. Parts creating horizontal or vertical joints in these surfaces shall be within 1/16 inch of the same plane as the other. Cavities created by added kick plates shall be capped. [EXCEPTIONS: 1. Sliding doors shall not be required to comply. 2. Tempered glass doors without stiles and having a bottom rail or shoe with the top leading edge tapered at 60 degrees minimum from the horizontal shall not be required to meet the 10 inch bottom smooth surface height requirement. 3. Doors and gates that do not extend to within 10 inches of the finish floor or ground shall not be required to comply. 4. Existing doors and gates without smooth surfaces within 10 inches of the finish floor or ground shall not be required to provide smooth surfaces provided that if added kick plates are installed, cavities created by such kick plates are capped,] | | |

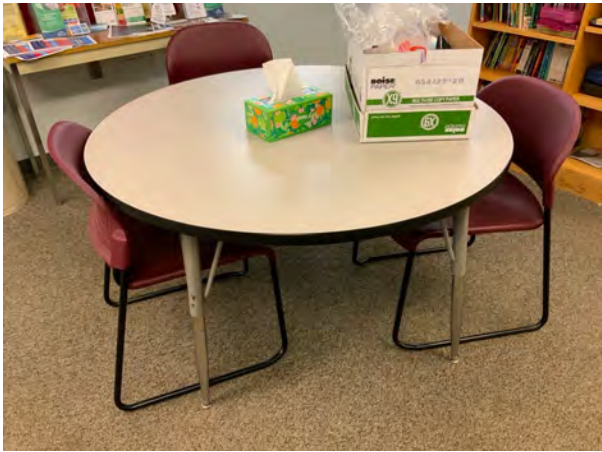
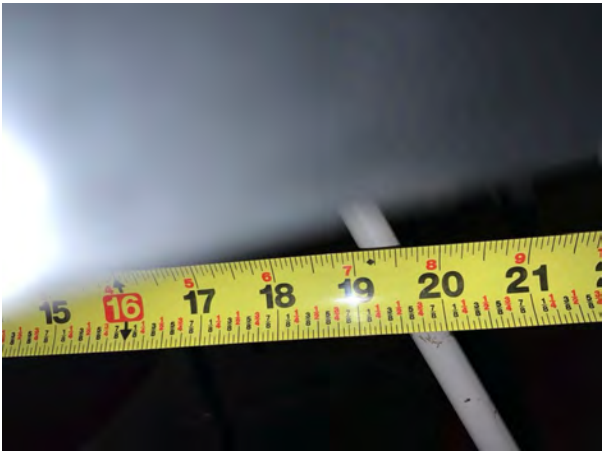
| Site Conditions | The table has clear width of 19". |

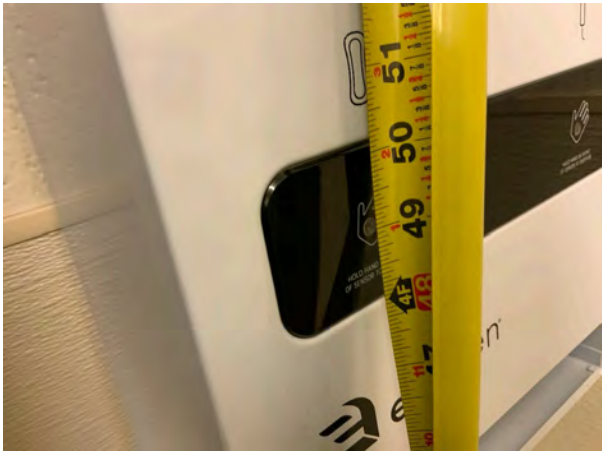
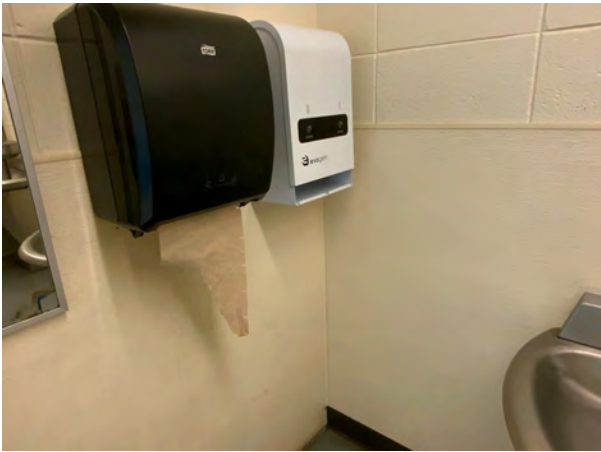
| <b>Site Conditions</b> | The feminine product dispenser controls is 49" above the floor. |

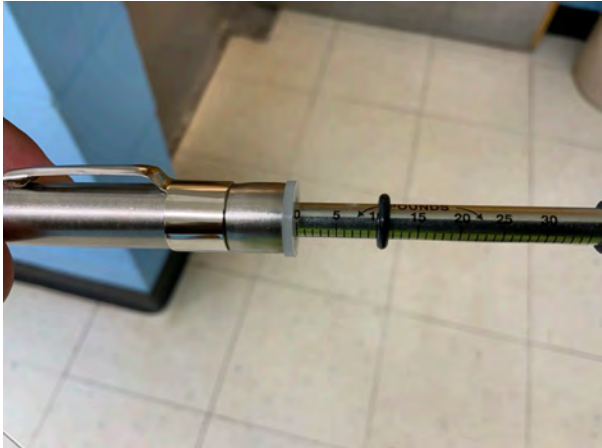
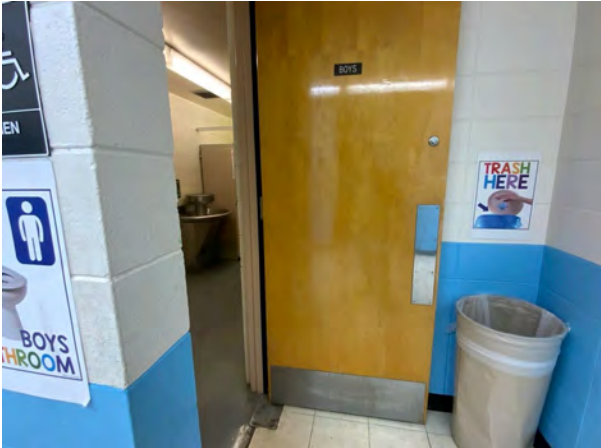
Photos for Barrier ID: AX545196

| Site Conditions | The opening force is 10 pounds. |

Adjust closer or replace with an closer that requires no more 5 pounds of force to stop the door motion. The maximum force for pushing or pulling open a door shall be for interior hinged doors: 5 lbs (22.2N). The force for pushing or pulling open a door or gate other than fire doors shall be as follows: 1. Interior hinged doors and gates: 5 pounds (22.2 N) maximum. 2. Sliding or folding doors: 5 pounds (22.2 N) maximum. These forces do not apply to the force required to retract latch bolts or disengage other devices that hold the door or gate in a closed position. Note: Fire doors shall have a minimum opening force allowable by the appropriate administrative authority.

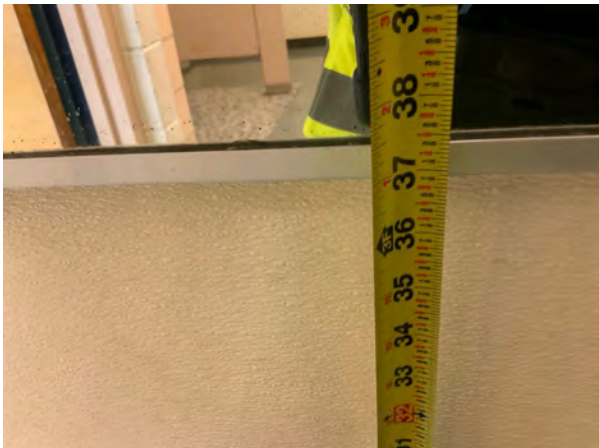
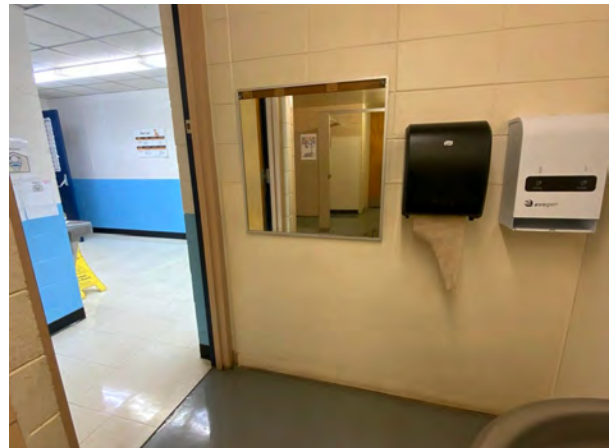
## Photos for Barrier ID: AX545195

| <b>Site Conditions</b> | The mirror is mounted 37 1/2" above the floor. |

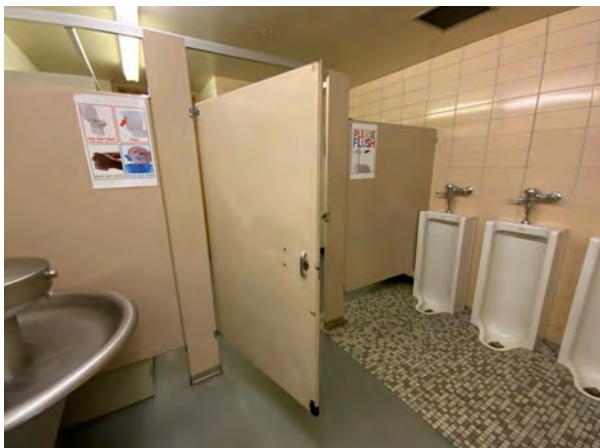
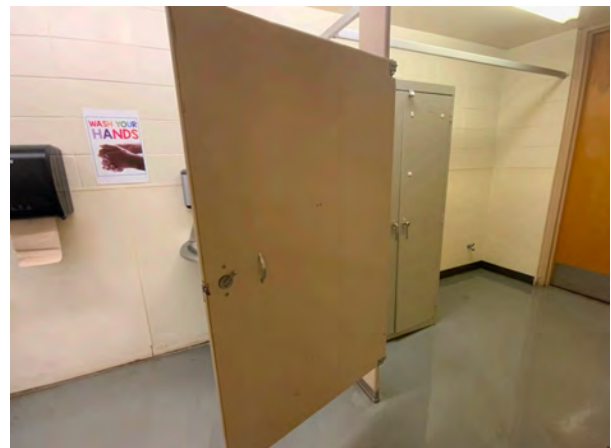
## Photos for Barrier ID: AX545199

| <b>Site Conditions</b> | The wheelchair stall door is not self-closing. |
