# ACCESSIBILITY ASSESSMENT

**DATE OF REPORT:**  
March 4, 2025

## **ADA TITLE II ASSESSMENT**

Guy Lee Elementary School  
755 W Harlow Road  
Springfield, Oregon 97477

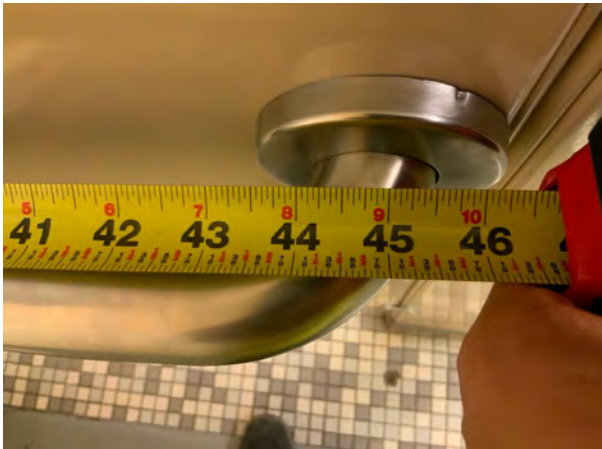
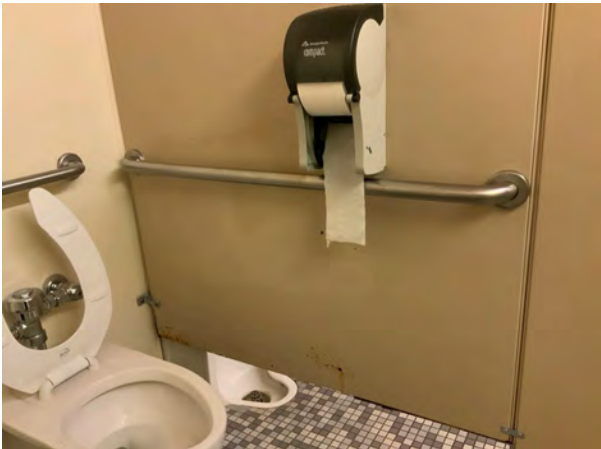
Photos for Barrier ID: AX545202

| Site Conditions | The side grab bar extends 45 1/2" measured perpendicular to the rear wall. |

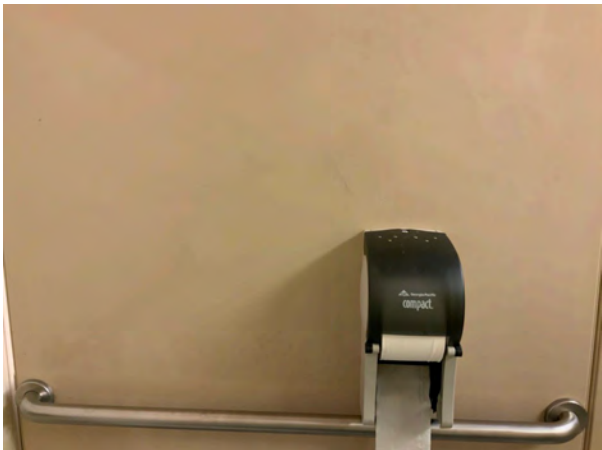
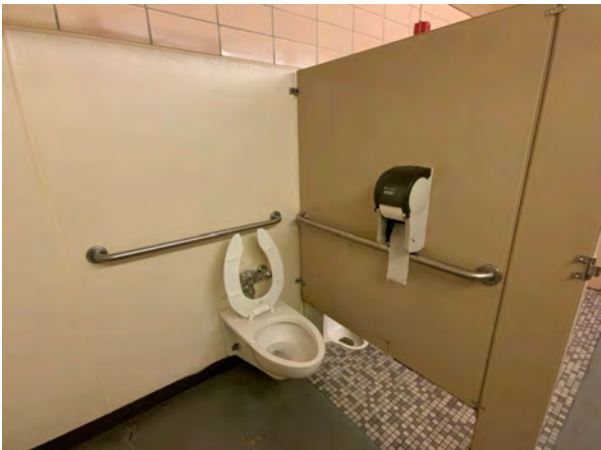
Photos for Barrier ID: AX545200

| Site Conditions | The vertical side grab bar is missing. |

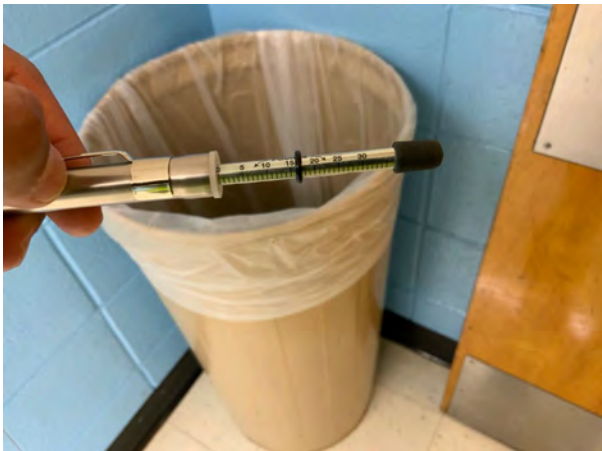
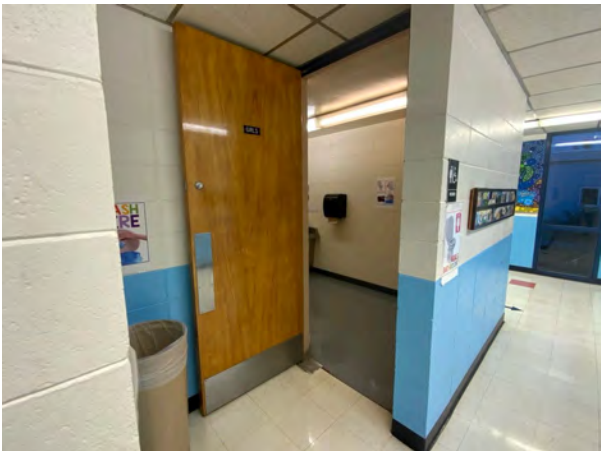
Photos for Barrier ID: AX545182

| Site Conditions | The opening force is 16 pounds. |

Adjust closer or replace with an closer that requires no more 5 pounds of force to stop the door motion. The maximum force for pushing or pulling open a door shall be for interior hinged doors: 5 lbs (22.2N). The force for pushing or pulling open a door or gate other than fire doors shall be as follows: 1. Interior hinged doors and gates: 5 pounds (22.2 N) maximum. 2. Sliding or folding doors: 5 pounds (22.2 N) maximum. These forces do not apply to the force required to retract latch bolts or disengage other devices that hold the door or gate in a closed position. Note: Fire doors shall have a minimum opening force allowable by the appropriate administrative authority.

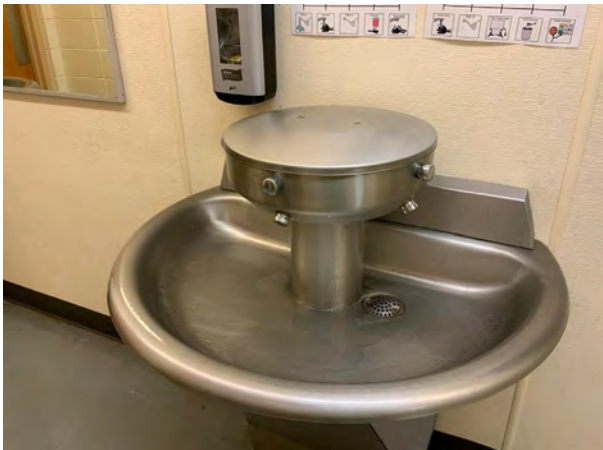
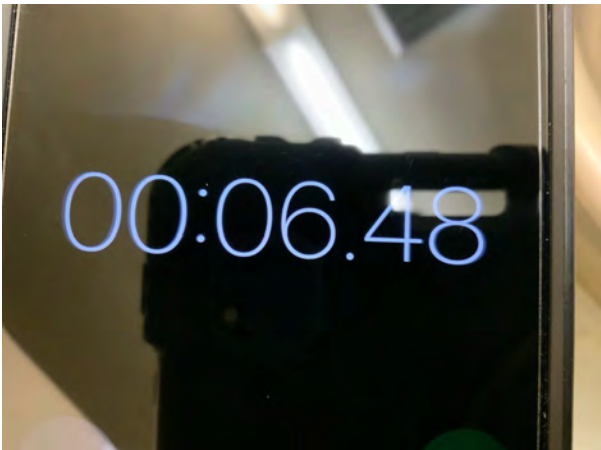
Photos for Barrier ID: AX545191

| Site Conditions | The automatic faucet turns on for 6.48 seconds. |

Replace faucets with compliant handles. Hand-operated metering faucets shall remain open for 10 seconds minimum. Operable parts shall be operable with one hand and shall not require tight grasping, pinching, or twisting of the wrist. The force required to activate operable parts shall be 5 pounds (22.2 N) maximum.

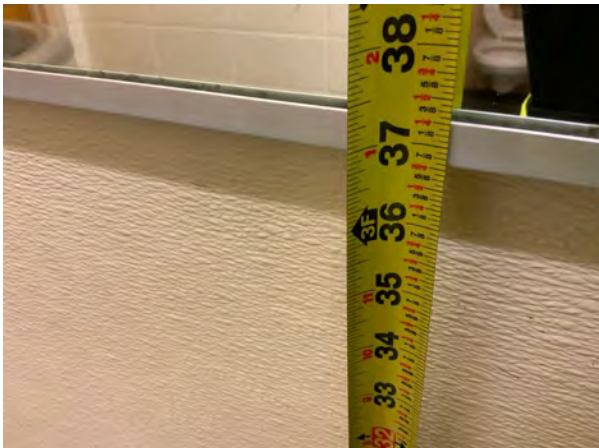
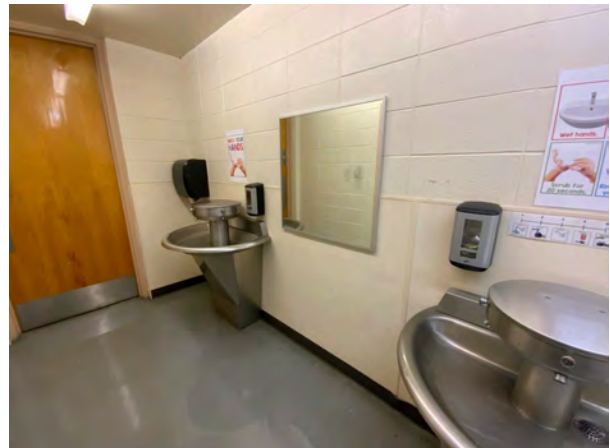
## Photos for Barrier ID: AX545194

| Site Conditions | The mirror is mounted 37 1/2" above the floor. |

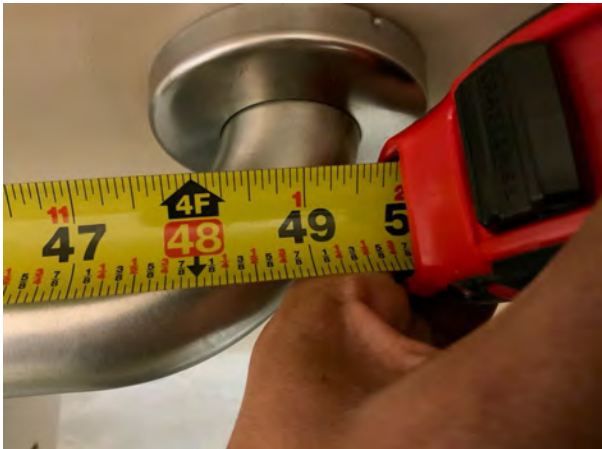
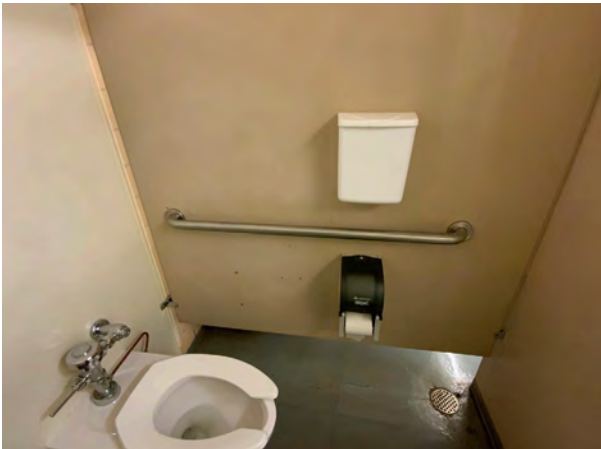
Photos for Barrier ID: AX545188

| Site Conditions | The side grab bar extends 49 1/2" measured perpendicular to the rear wall. |

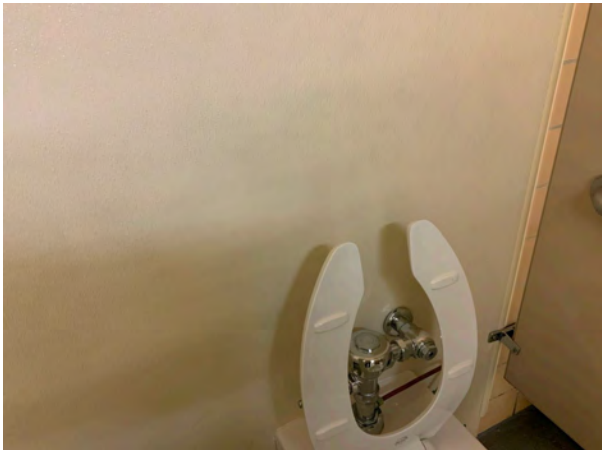
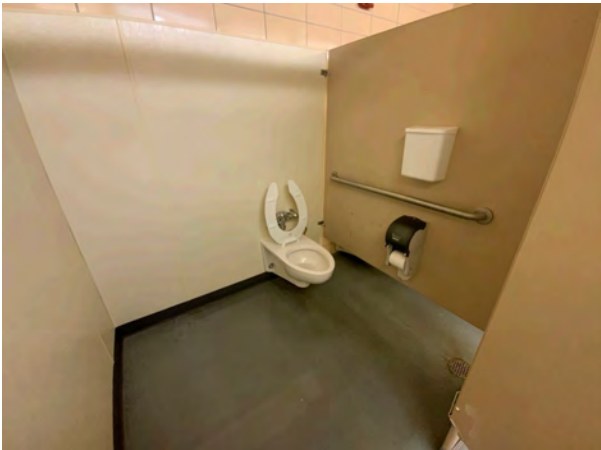
| <b>Site Conditions</b> | The rear grab bar is missing. |

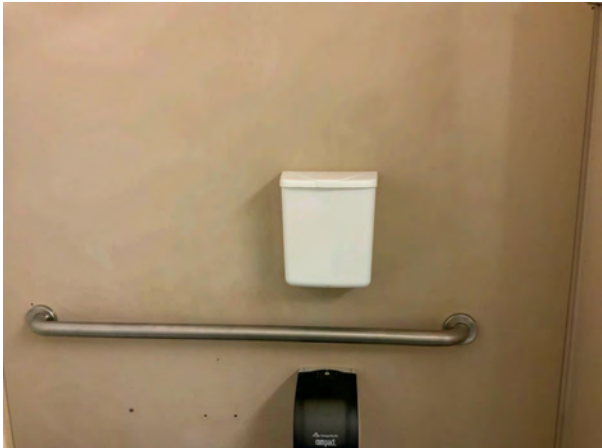
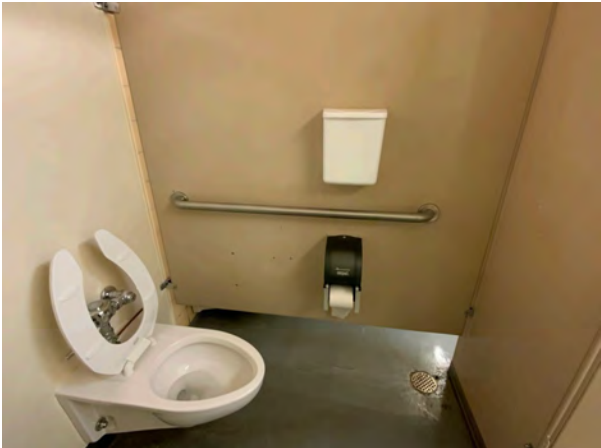
Photos for Barrier ID: AX545187

| Site Conditions | The vertical side grab bar is missing. |

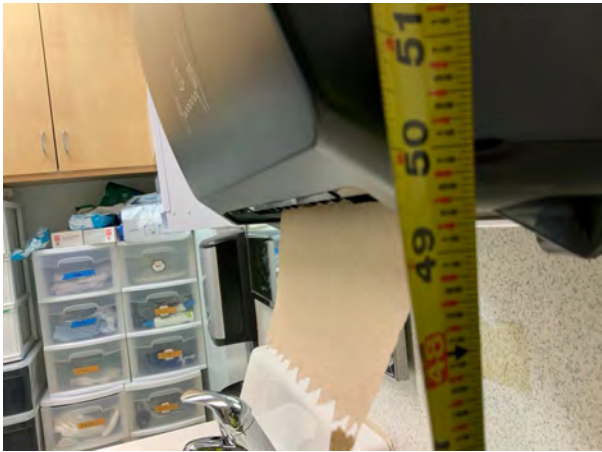
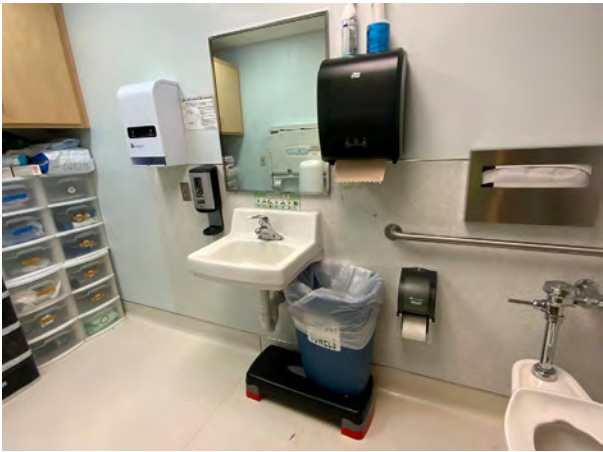
| <b>Site Conditions</b> | The paper towel dispenser is 50" above the floor. |

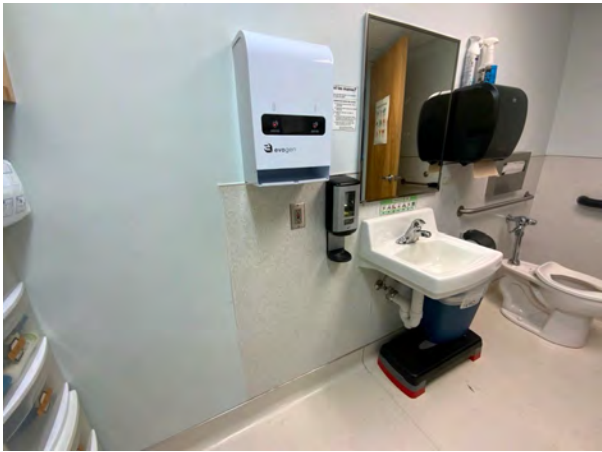
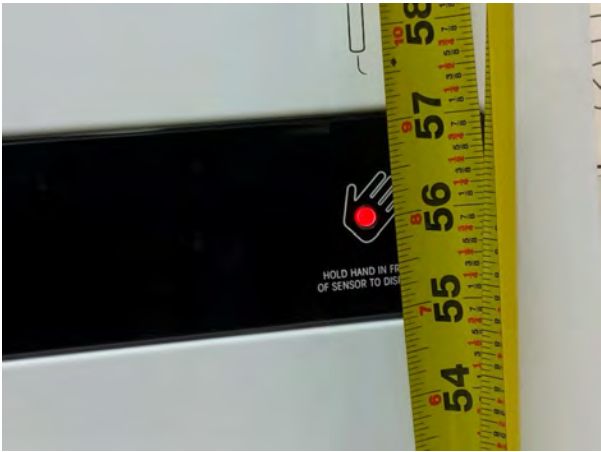
| <b>Site Conditions</b> | The feminine product dispenser is 56" above the finished floor. |

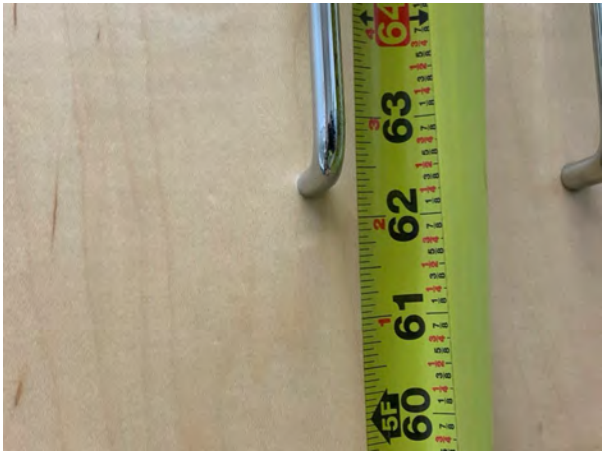
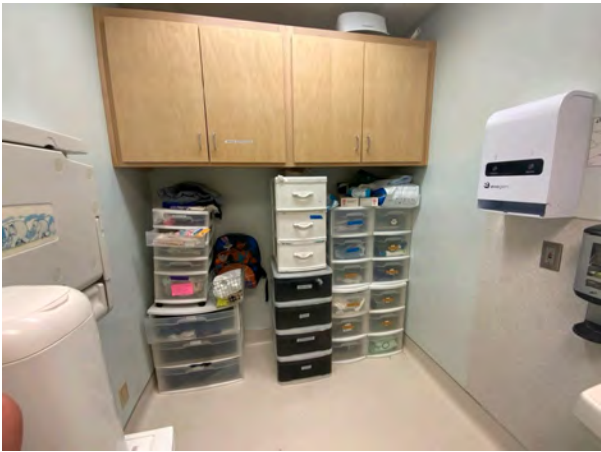
| <b>Site Conditions</b> | The cabinet handle is 62" above the finished floor. |

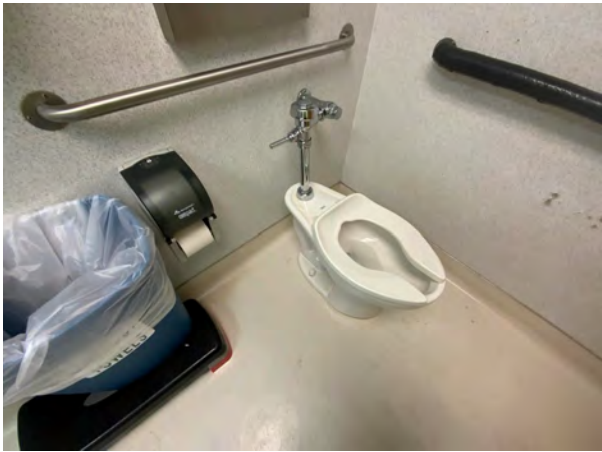
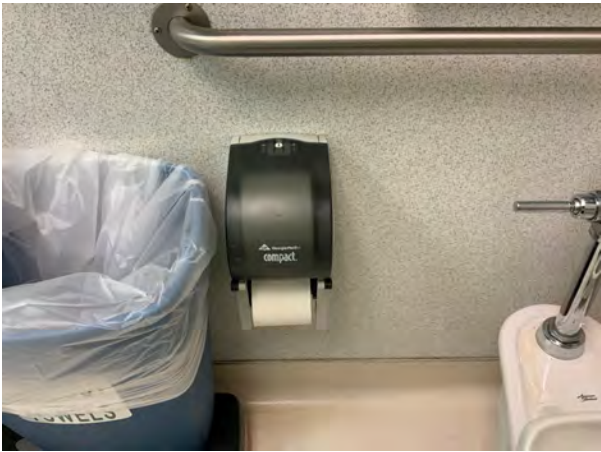
| <b>Site Conditions</b> | Toilet paper dispenser is on the side behind the water closet. |

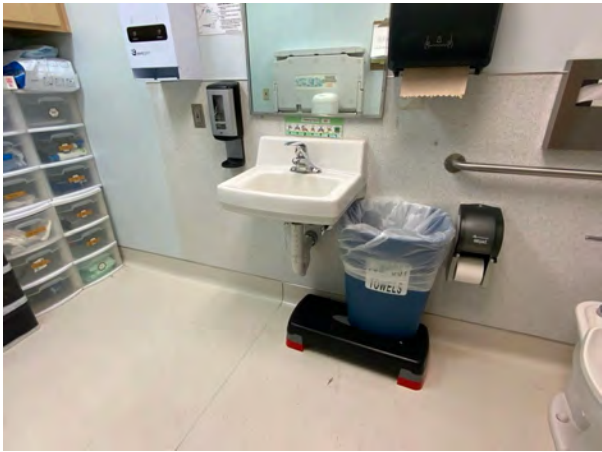
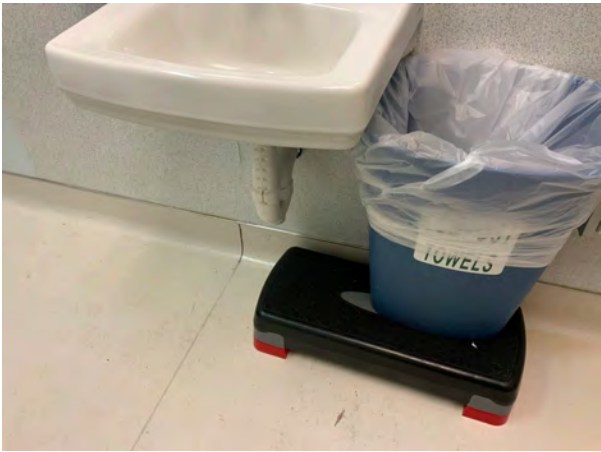
| Site Conditions | The clear floor space under the lavatory is obstructed by stored items. |

Relocate the stored items under the lavatory to provide minimum 30" by minimum 48" clear floor space positioned for a forward approach to the lavatory. Compliant knee and toe clearance shall be provided. [EXCEPTIONS: 2. A lavatory in a toilet room or bathing facility for a single occupant accessed only through a private office and not for common use or public use shall not be required to provide knee and toe clearance. 3. In residential dwelling units, cabinetry shall be permitted under lavatories and kitchen sinks provided that all of the following conditions are met: (a) the cabinetry can be removed without removal or replacement of the fixture; (b) the finish floor extends under the cabinetry; and (c) the walls behind and surrounding the cabinetry are finished. 4. A knee clearance of 24" minimum above the finish floor or ground shall be permitted at lavatories and sinks used primarily by children 6 through 12 years where the rim or counter surface is 31" maximum above the finish floor or ground. 5. A parallel approach complying with 305 shall be permitted to lavatories and sinks used primarily by children 5 years and younger. 6. The dip of the overflow shall not be considered in determining knee and toe clearances. 7. No more than one bowl of a multi-bowl sink shall be required to provide knee and toe clearance.] Space under an element between 9" and 27" above the finish floor or ground shall be considered knee clearance and shall comply. Knee clearance shall extend 25" maximum under an element at 9" above the finish floor or ground. Floor or ground surfaces of a clear floor or ground space shall comply. Changes in level are not permitted. [EXCEPTION: Slopes not steeper than 1:48 shall be permitted.] The clear floor or ground space shall be 30" minimum by 48" minimum. One full unobstructed side of the clear floor or ground space shall adjoin an accessible route or adjoin another clear floor or ground space. Where a clear floor or ground space is located in an alcove or otherwise confined on all or part of three sides, additional maneuvering clearance shall be provided. Alcoves shall be 36" wide minimum where the depth exceeds 24". Alcoves shall be 60" wide minimum where the depth exceeds 15".

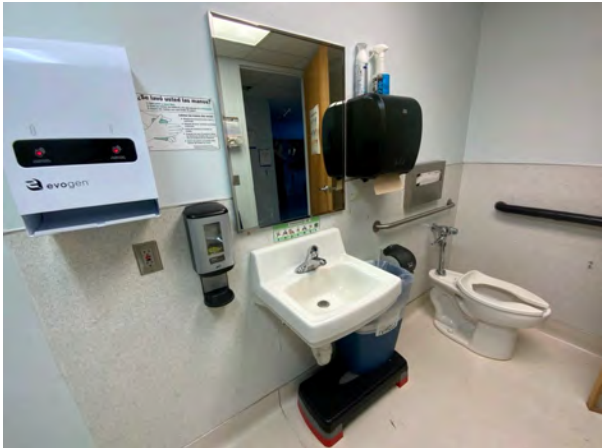
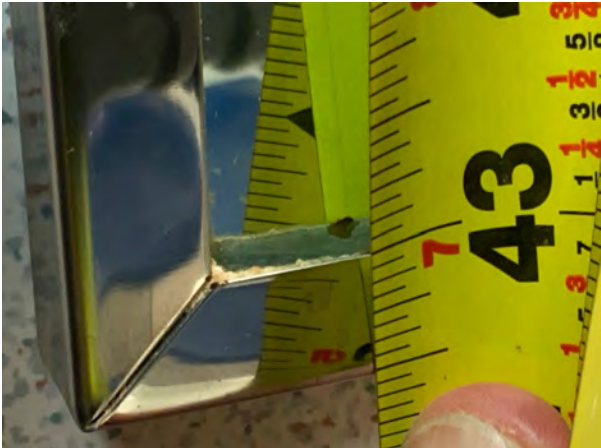
Photos for Barrier ID: AX545167

| Site Conditions | The mirror is mounted 43" above the floor. |

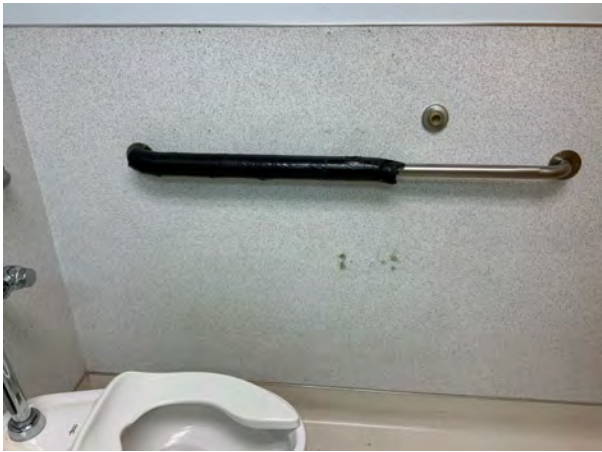
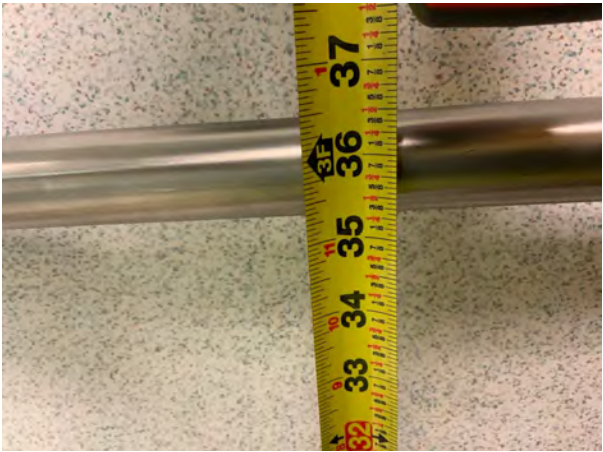
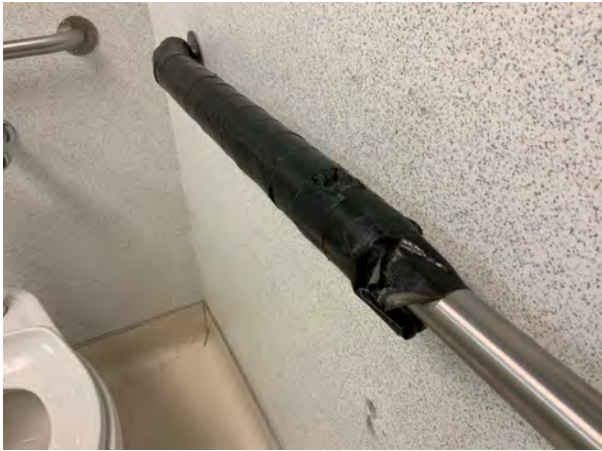
| Site Conditions | The top of the gripping surface is 36 1/2" above the floor. |

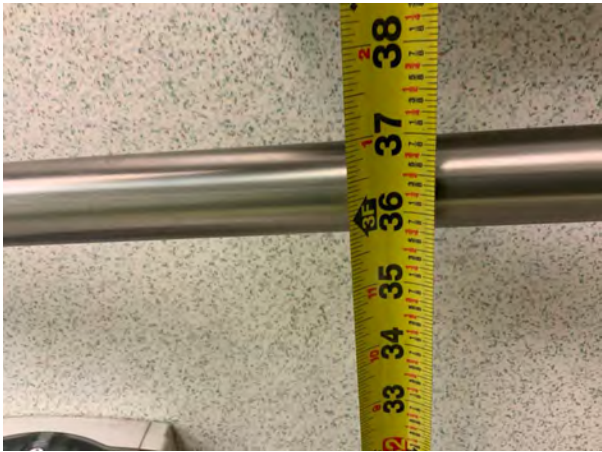
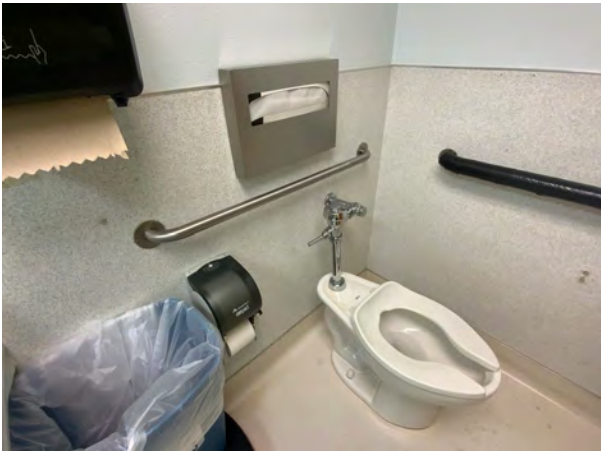
| <b>Site Conditions</b> | The top gripping surface of the rear grab bar is 37" above the floor. |

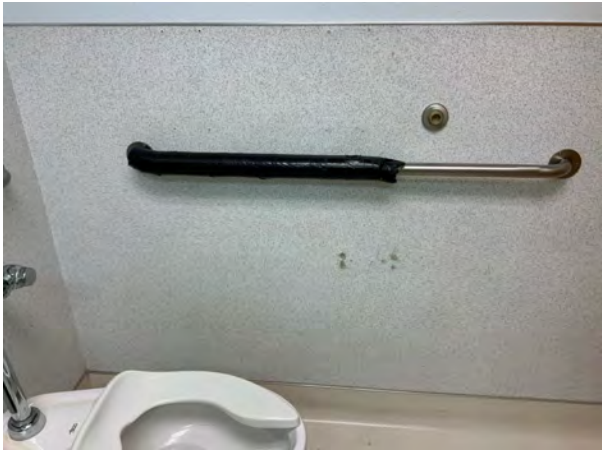
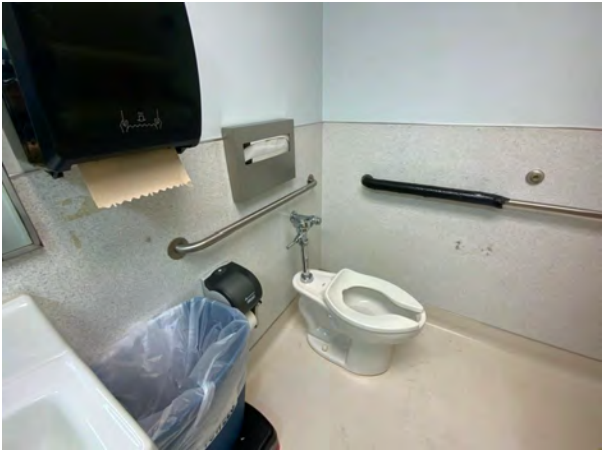
Photos for Barrier ID: AX545214

| Site Conditions | The vertical side grab bar is missing. |

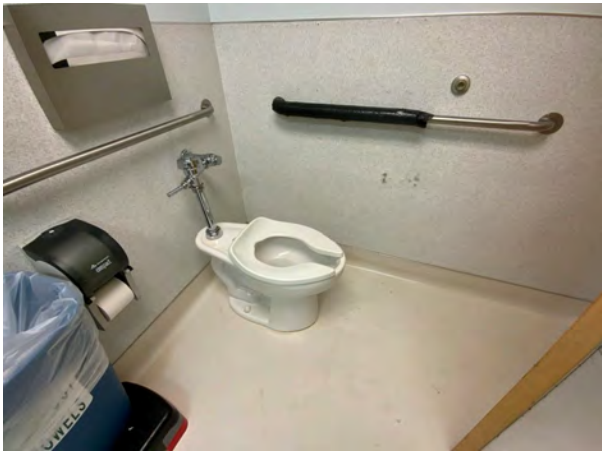
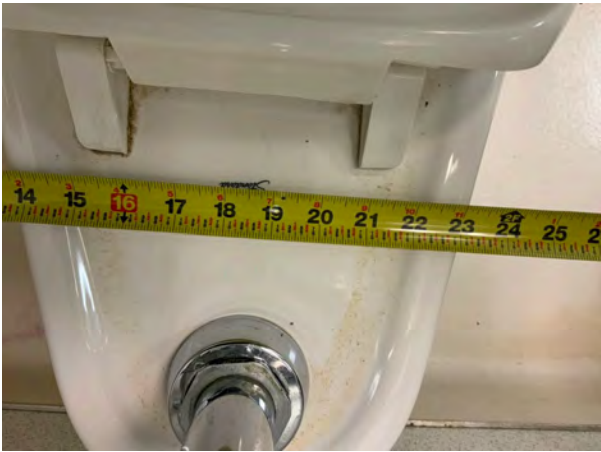
| Site Conditions | The centerline of the toilet is 18 1/2" measure perpendicular from the sidewall. | |

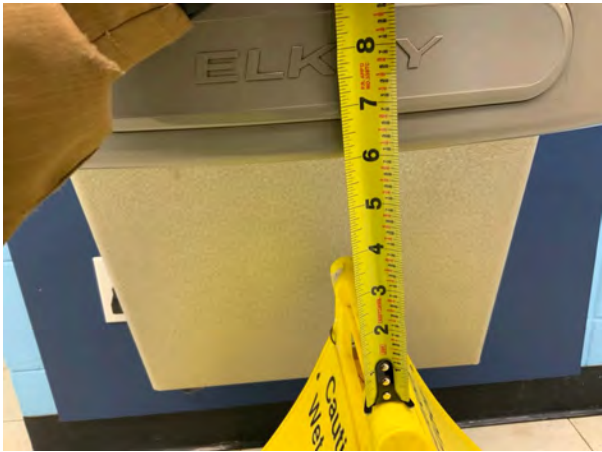
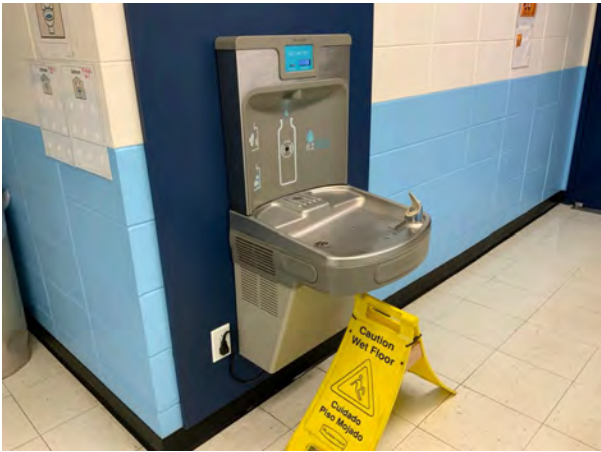
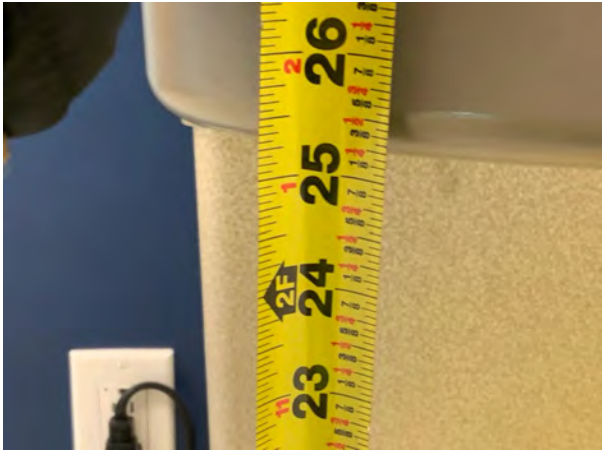
| Site Conditions | Knee clearance is 25 1/2" above the finish floor. | |

| <p>Relocate or replace the lower level unit to provide knee and toe clearance. Lower level units shall have a clear floor or ground space minimum 30" by minimum 48" positioned for a forward approach, with the 30" dimension centered on the unit. Knee and toe clearance shall be provided. [EXCEPTION: A parallel approach shall be permitted at units for children's use where the spout is 30" maximum above the finish floor or ground and is 3-1/2" maximum from the front edge of the unit, including bumpers.] For a parallel approach, the 48" dimension shall be centered on the unit. Knee Clearance: Space under an element between 9" and 27" above the finish floor or ground shall be considered knee clearance. Knee clearance shall extend 25" maximum under an element at 9" above the finish floor or ground. Where knee clearance is required under an element as part of a clear floor space, the knee clearance shall be 11" deep minimum at 9" above the finish floor or ground, and 8" deep minimum at 27" above the finish floor or ground. Between 9" and 27" above the finish floor or ground, the knee clearance shall be permitted to reduce at a rate of 1" in depth for each 6" in height. Knee clearance shall be 30" wide minimum. Toe Clearance: Space under an element between the finish floor or ground and 9" above the finish floor or ground shall be considered toe clearance. Toe clearance shall extend 25" maximum under an element. Where toe clearance is required at an element as part of a clear floor space, the toe clearance shall extend 17" minimum under the element. Space extending greater than 6" beyond the available knee clearance at 9" above the finish floor or ground shall not be considered toe clearance. Toe clearance shall be 30" wide minimum.</p> | | |

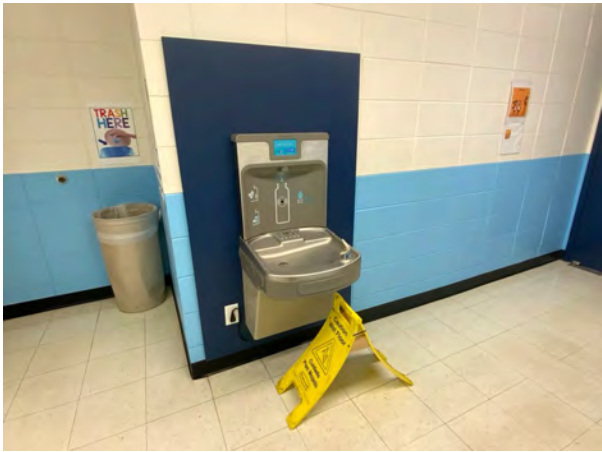
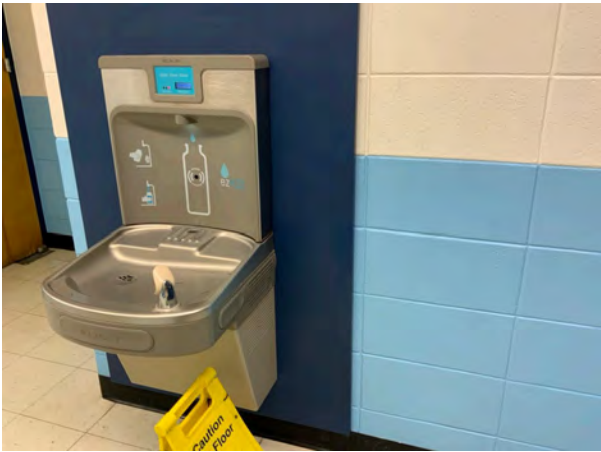
| Site Conditions | The minimum number of drinking fountain is not provided. |
