# ACCESSIBILITY ASSESSMENT

February 14, 2025

## **ADA TITLE II ASSESSMENT**

Mount Vernon Elementary School  
935 Filbert Lane  
Springfield, Oregon 97478

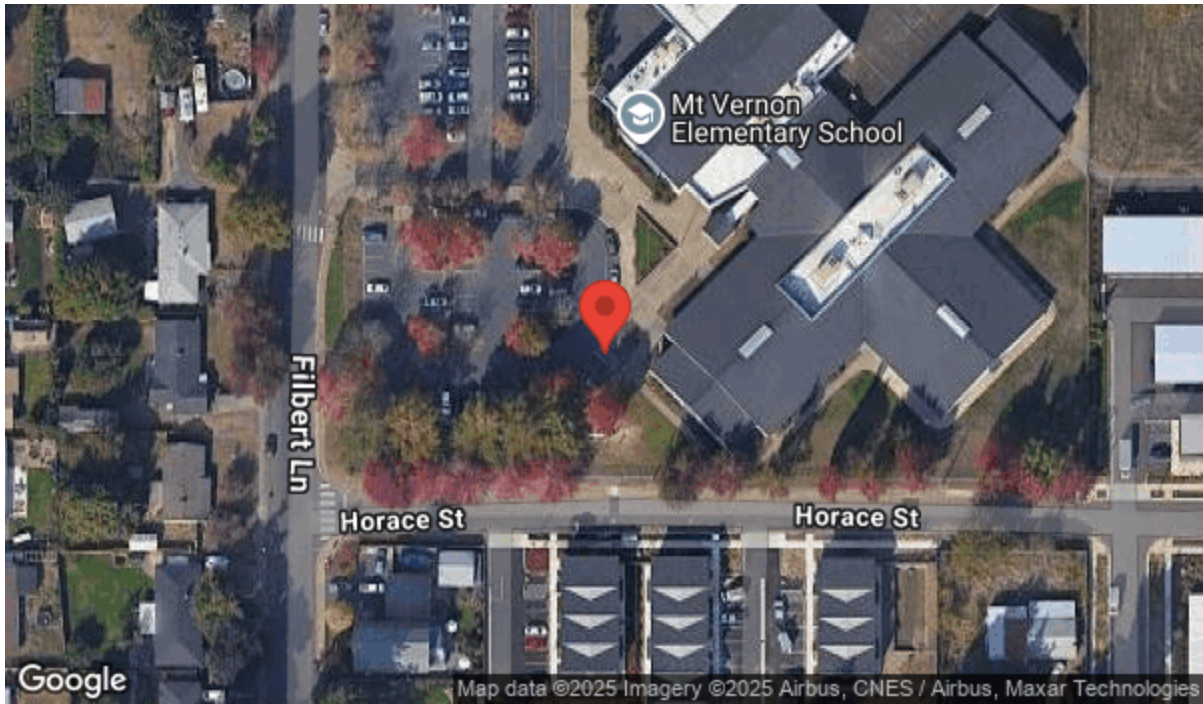
Map for Barrier ID: AX553710

| Site Conditions | The van access aisle has a running slope of 2.4%. |

Remove and replace with an adjacent access aisle that has a slope of maximum 1:50 (2%) in all directions. [EXCEPTION: Slopes not steeper than 1:48 (2.08%) shall be permitted.] Changes in level are not permitted. Parking spaces and access aisles serving them shall be compliant. Access aisles shall be at the same level as the parking spaces they serve. Measurements shall be made to the centerline of the stripe. Where accessible stalls and aisles are not adjacent to another stall or aisle, measurements shall be permitted to include the full width of the line defining the accessible parking space or aisle. The quantity and order of magnitude cost estimate provided for this barrier are limited to the extent of the area identified as non-compliant. Additional costs that may be associated with removal of the barrier are not included.

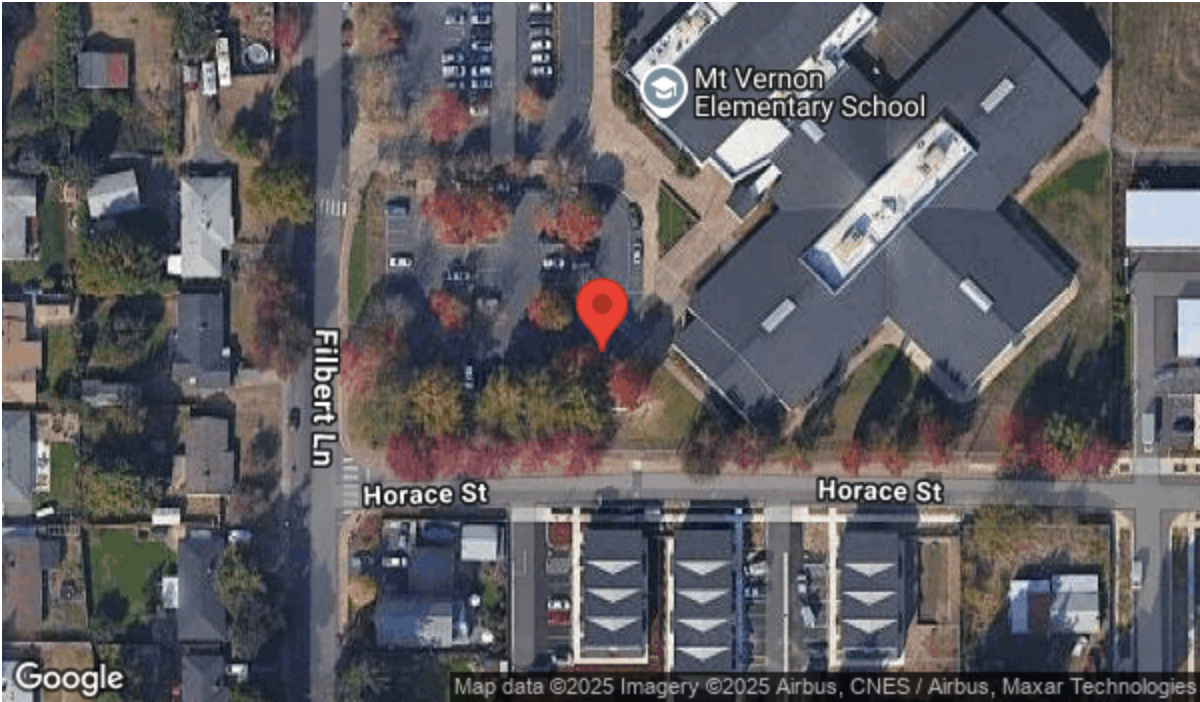
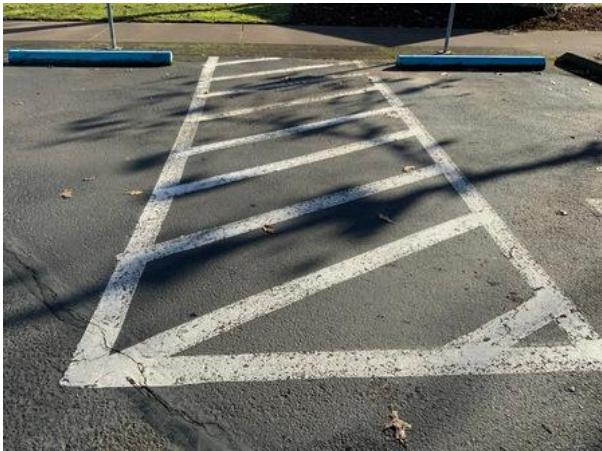
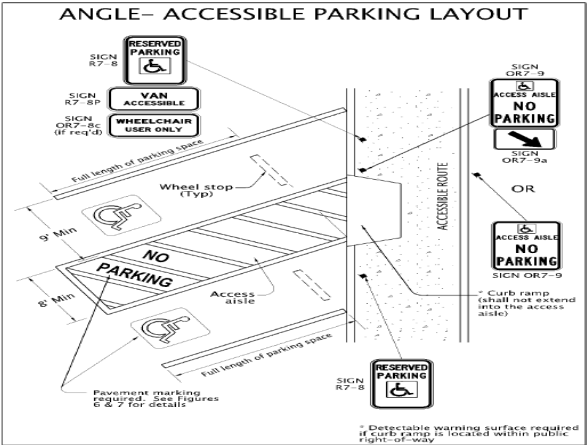
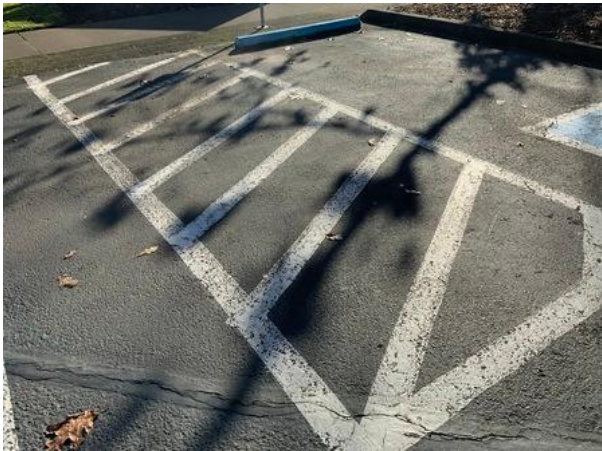
Photos for Barrier ID: AX553717

| <b>Site Conditions</b> | "No Parking" is missing from the access aisle. |

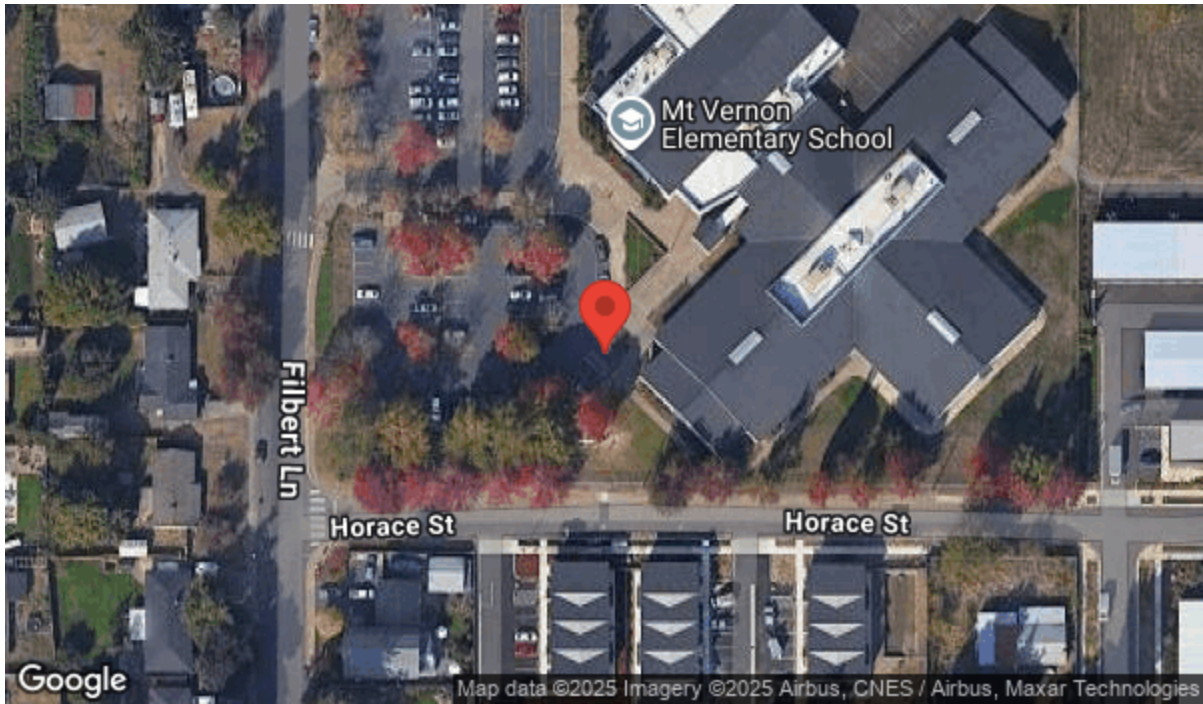
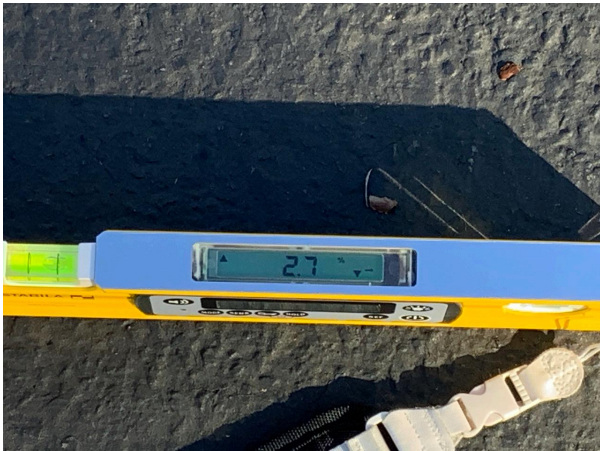
Map for Barrier ID: AX553706

| <b>Site Conditions</b> | The van accessible parking space has a running slope of 2.7%. |

Remove and replace with a van space which has a slope of maximum 1:50 (2%) in all directions. [EXCEPTION: Slopes not steeper than 1:48 (2.08%) shall be permitted.] Changes in level are not permitted. Parking spaces and access aisles serving them shall be compliant. Width measurements shall be made from the centerline of the markings. [EXCEPTION: Where parking spaces or access aisles are not adjacent to another parking space or access aisle, measurements shall be permitted to include the full width of the line defining the parking space or access aisle.] The quantity and order of magnitude cost estimate provided for this barrier are limited to the extent of the area identified as non-compliant. Additional costs that may be associated with removal of the barrier are not included.

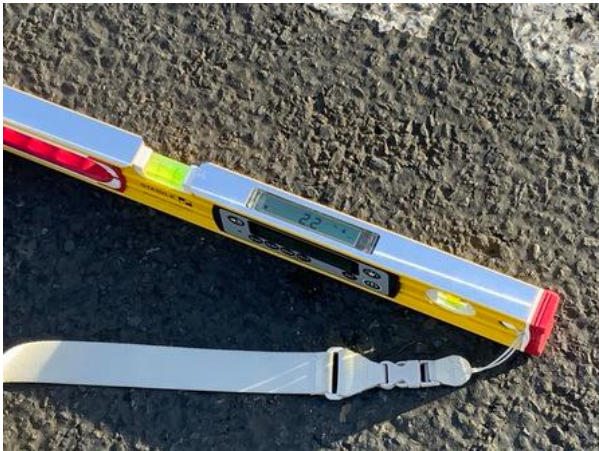
Photos for Barrier ID: AX553770

| <b>Site Conditions</b> | The access aisle has a slope of 2.2%. |

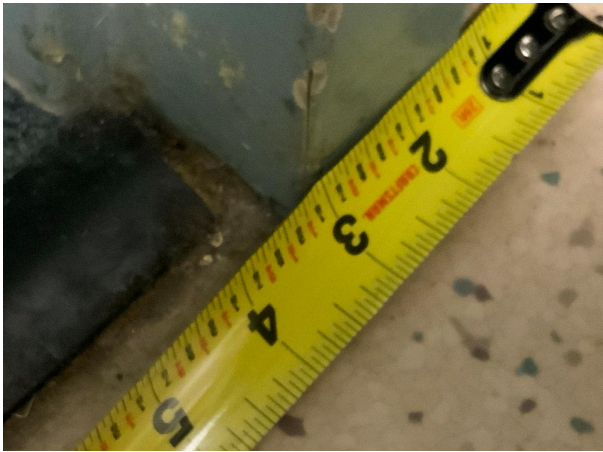
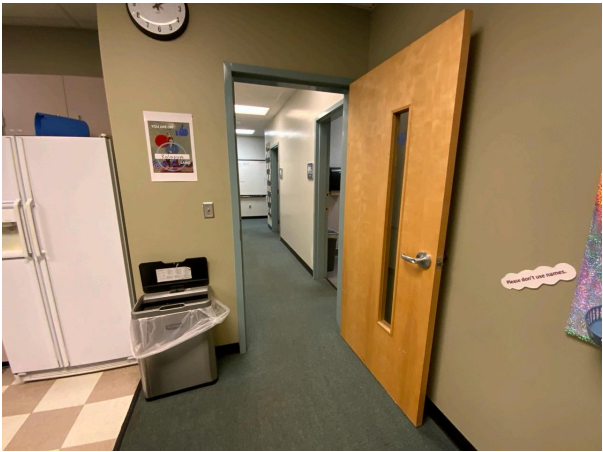
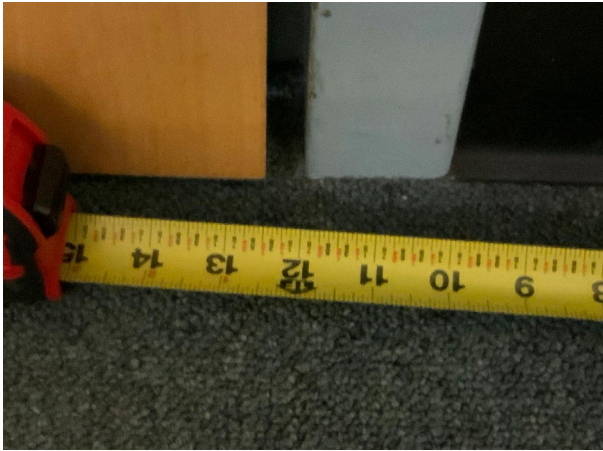
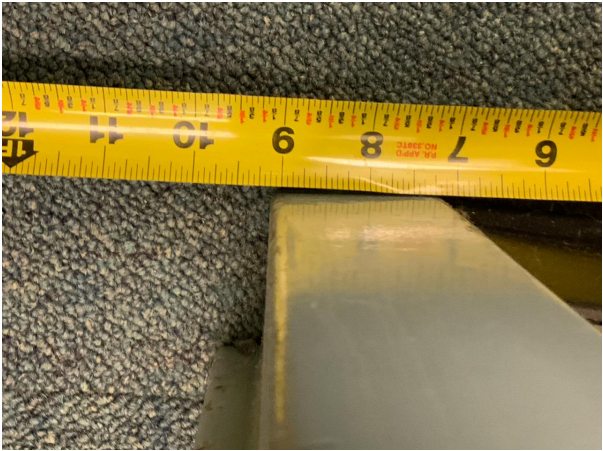
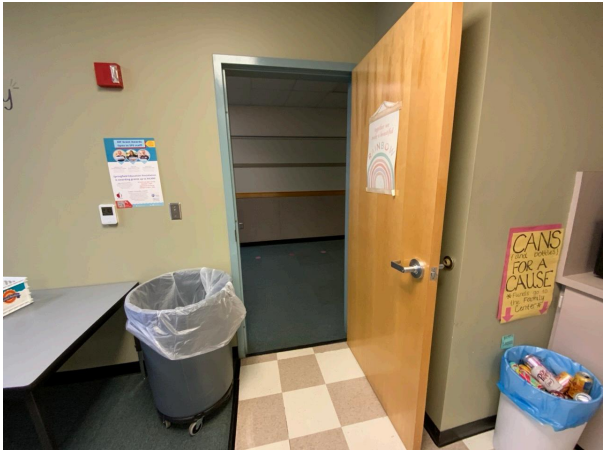
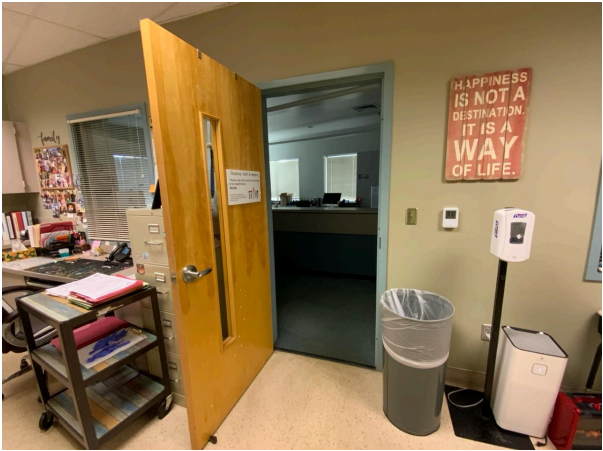
| Site Conditions | Items are in the required maneuvering clearance at the doors. | |

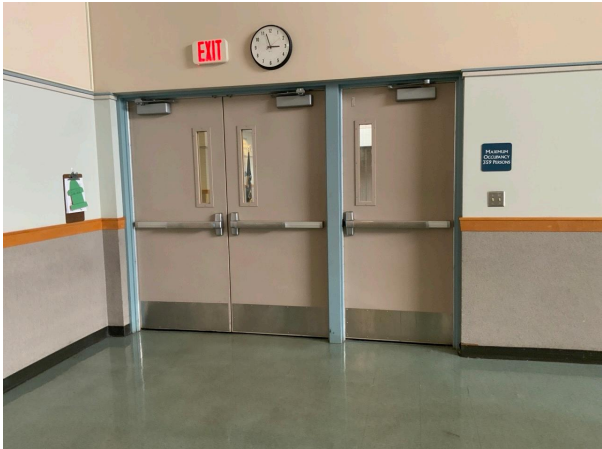
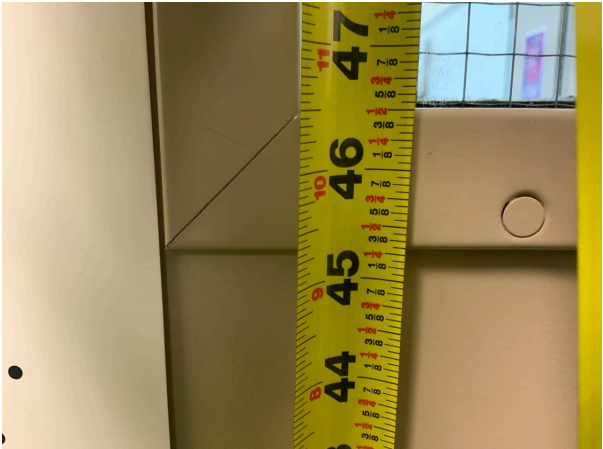
Photos for Barrier ID: AX553767

| Site Conditions | The bottom of the door vision light is 46 1/2" above the finished floor. | |

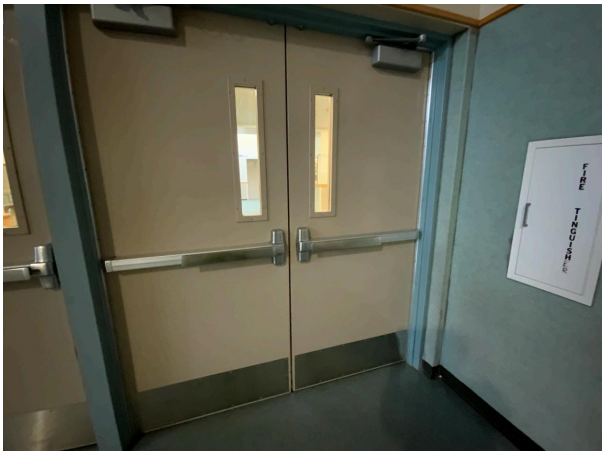
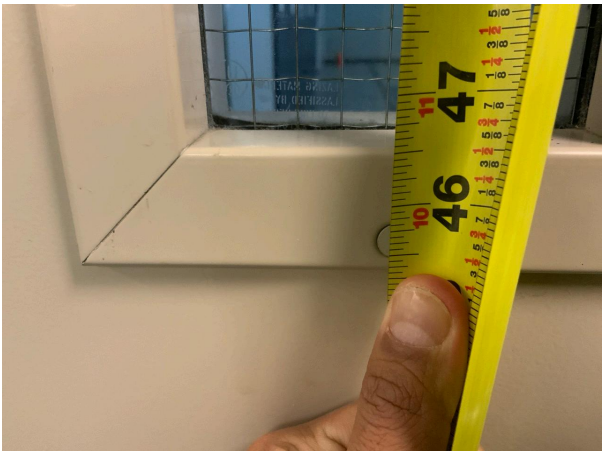
Photos for Barrier ID: AX553766

| Site Conditions | The bottom of the door vision light is 46 1/2" above the finished floor. | |

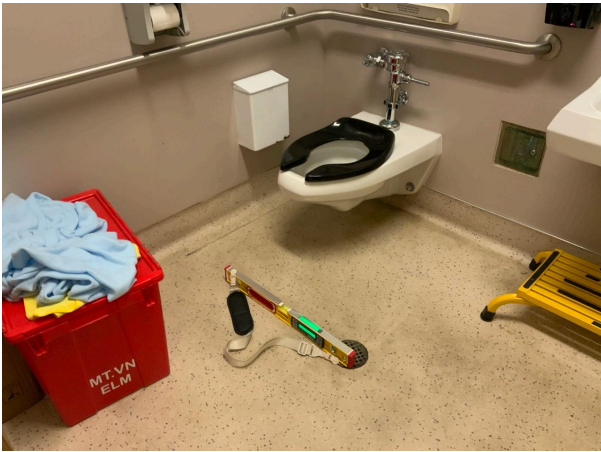
Photos for Barrier ID: AX553734

| Site Conditions | The clear space for the water closet has a slope of 5%. | |

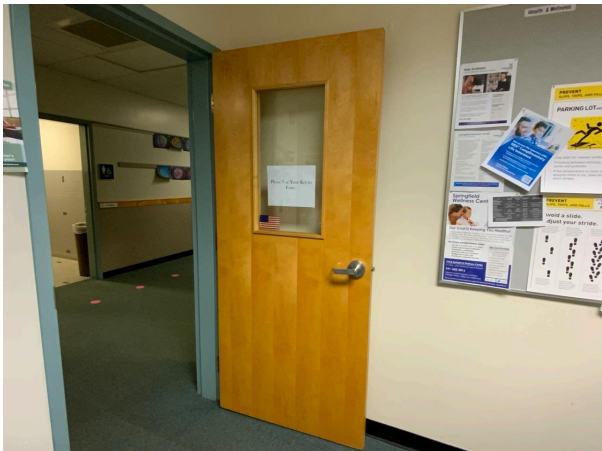
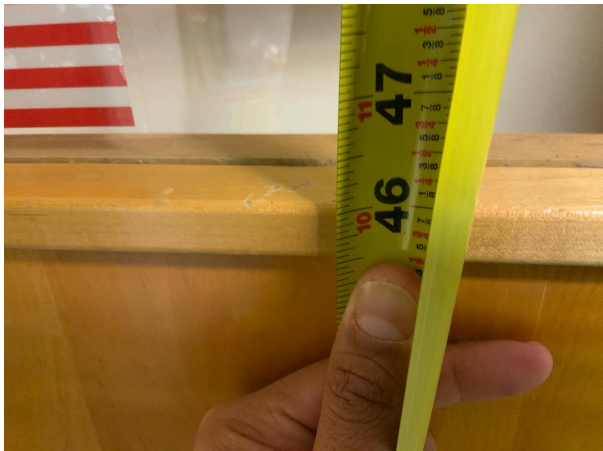
Photos for Barrier ID: AX553744

| Site Conditions | The bottom of the door vision light is 46" above the finished floor. |

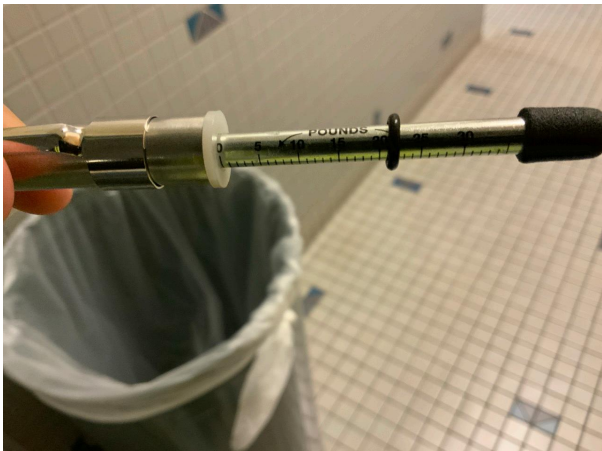
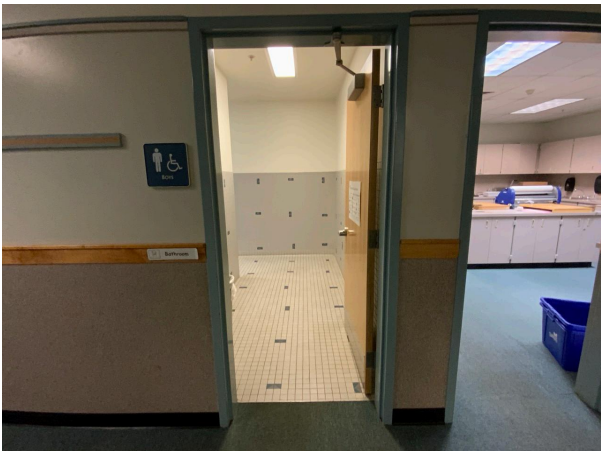
Photos for Barrier ID: AX553749

| Site Conditions | The force required to open the interior, hinged, non-fire door is 21 pounds. |

Adjust closer or replace with an closer that requires no more 5 pounds of force to stop the door motion. The maximum force for pushing or pulling open a door shall be for interior hinged doors: 5 lbs (22.2N). The force for pushing or pulling open a door or gate other than fire doors shall be as follows: 1. Interior hinged doors and gates: 5 pounds (22.2 N) maximum. 2. Sliding or folding doors: 5 pounds (22.2 N) maximum. These forces do not apply to the force required to retract latch bolts or disengage other devices that hold the door or gate in a closed position. Note: Fire doors shall have a minimum opening force allowable by the appropriate administrative authority.

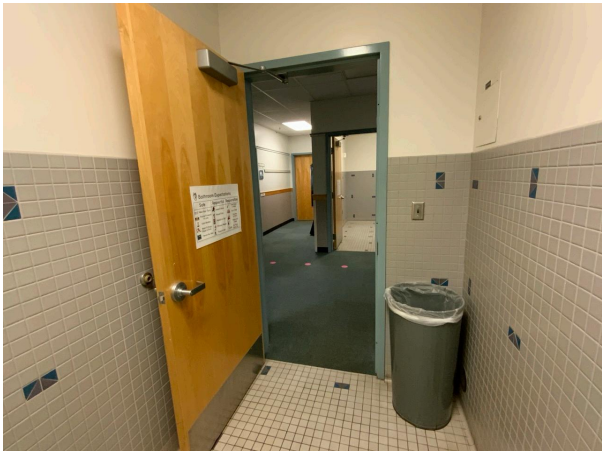
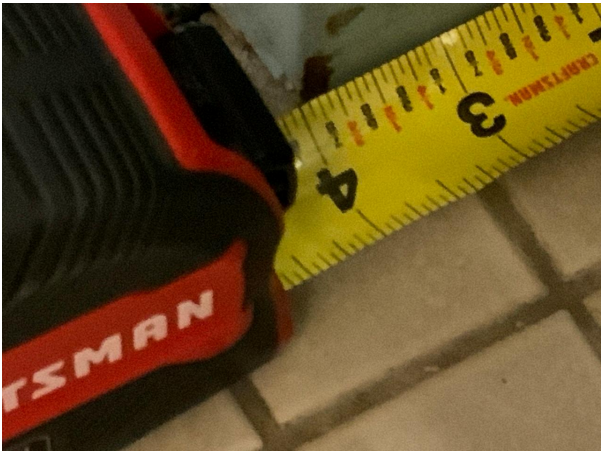
Photos for Barrier ID: AX553750

| Site Conditions | The trash can is in the required maneuvering clearance at the door. |

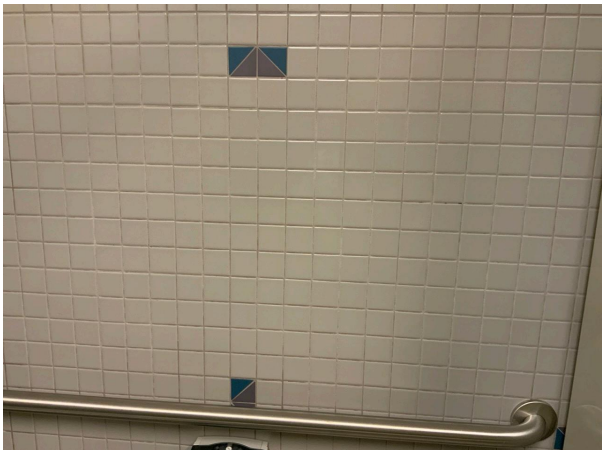
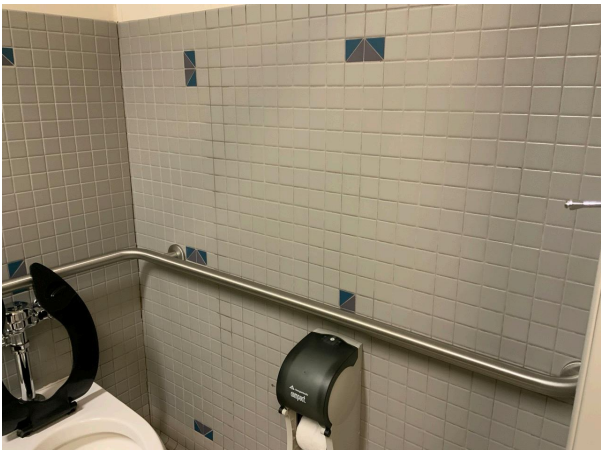
Photos for Barrier ID: AX553753

| Site Conditions | A vertical side grab bar is not present in the wheelchair stall. |

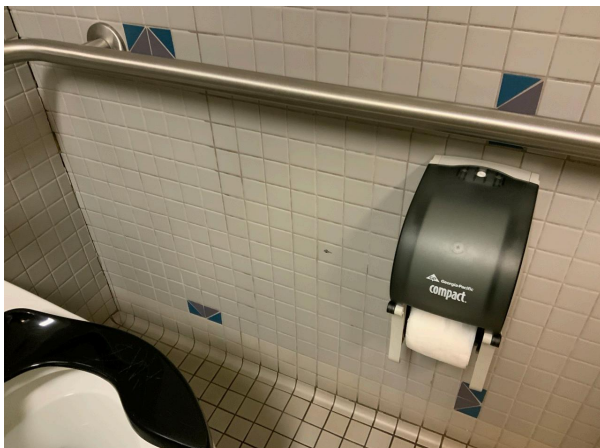
## Photos for Barrier ID: AX553755

| Site Conditions | The centerline of the toilet paper dispenser is 10" in front of the water closet. |

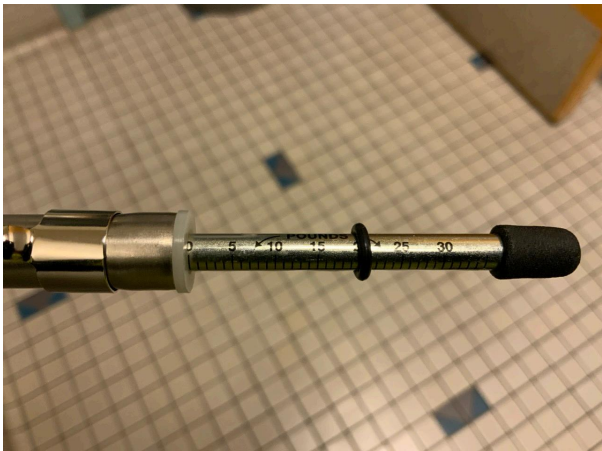
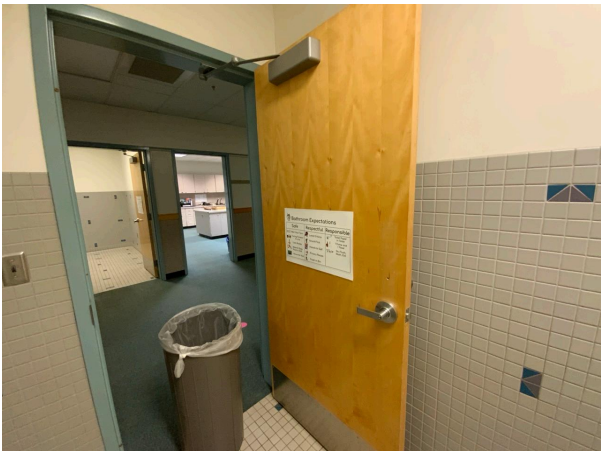
Photos for Barrier ID: AX553756

| Site Conditions | The force required to open the interior, hinged, non-fire door is 20 pounds. |

Adjust closer or replace with an closer that requires no more 5 pounds of force to stop the door motion. The maximum force for pushing or pulling open a door shall be for interior hinged doors: 5 lbs (22.2N). The force for pushing or pulling open a door or gate other than fire doors shall be as follows: 1. Interior hinged doors and gates: 5 pounds (22.2 N) maximum. 2. Sliding or folding doors: 5 pounds (22.2 N) maximum. These forces do not apply to the force required to retract latch bolts or disengage other devices that hold the door or gate in a closed position. Note: Fire doors shall have a minimum opening force allowable by the appropriate administrative authority.

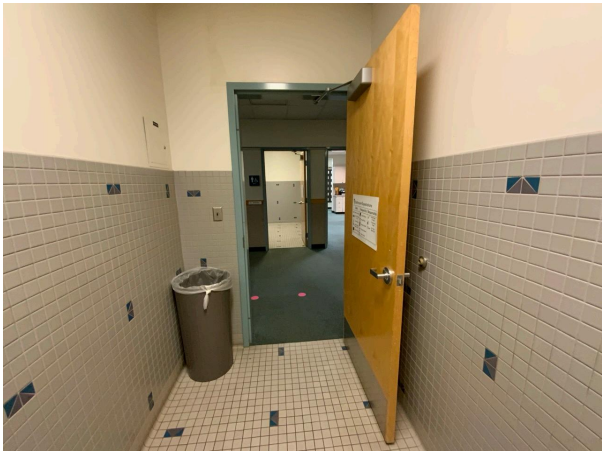
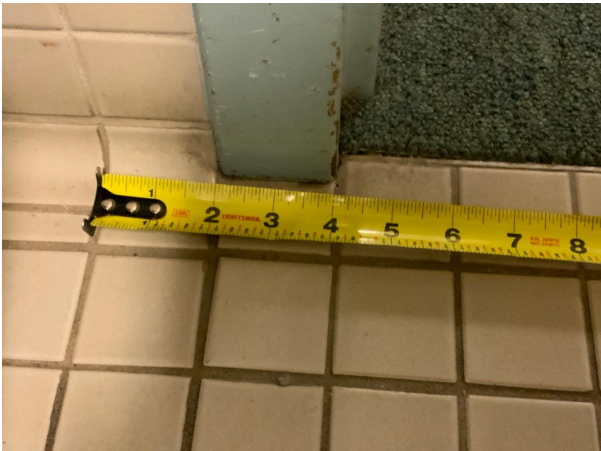
Photos for Barrier ID: AX553757

| Site Conditions | The trash can is in the required maneuvering clearance at the door. |

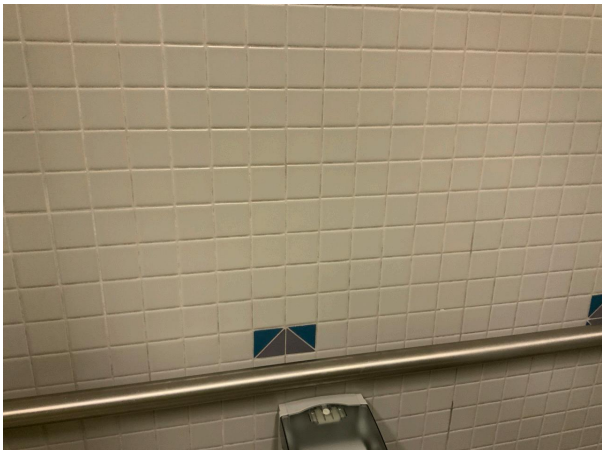
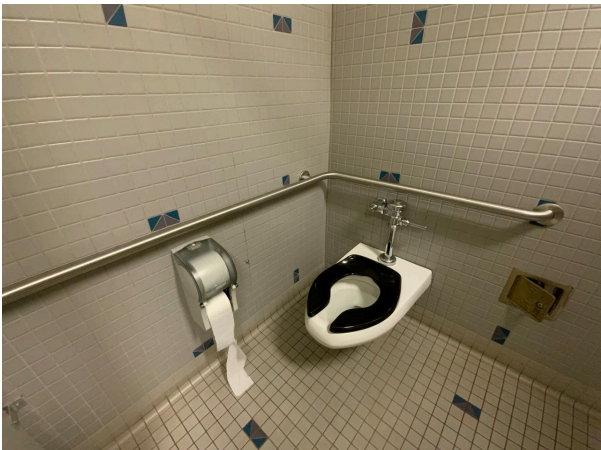
Photos for Barrier ID: AX553760

| Site Conditions | A vertical side grab bar is not present in the wheelchair stall. | |

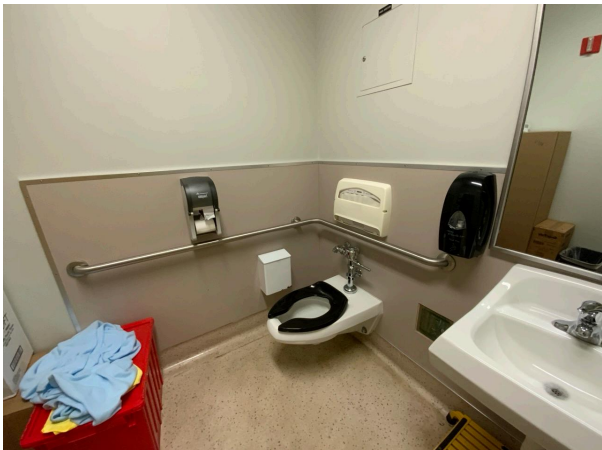
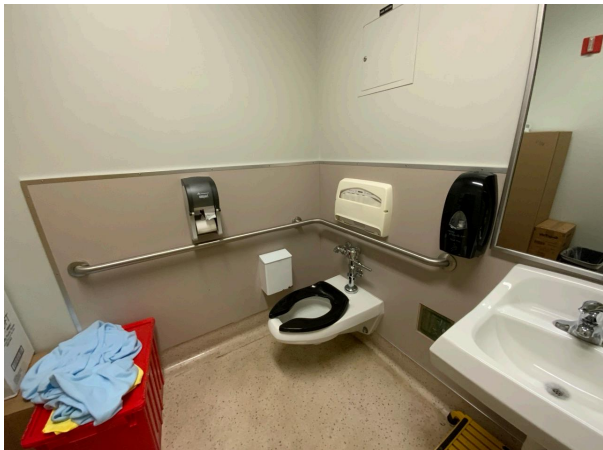
Photos for Barrier ID: AX553727

| Site Conditions | A vertical side grab bar is not present in the wheelchair stall. |

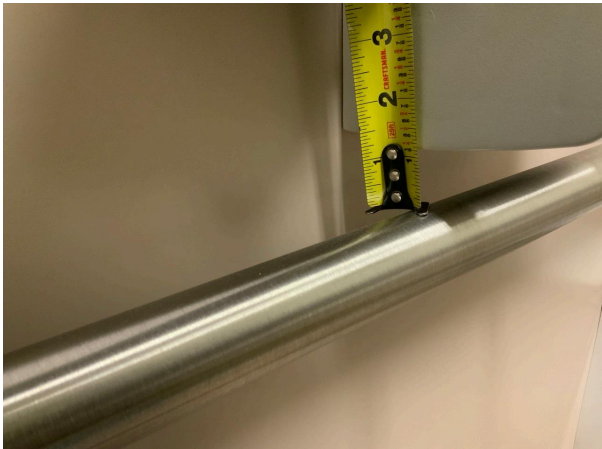
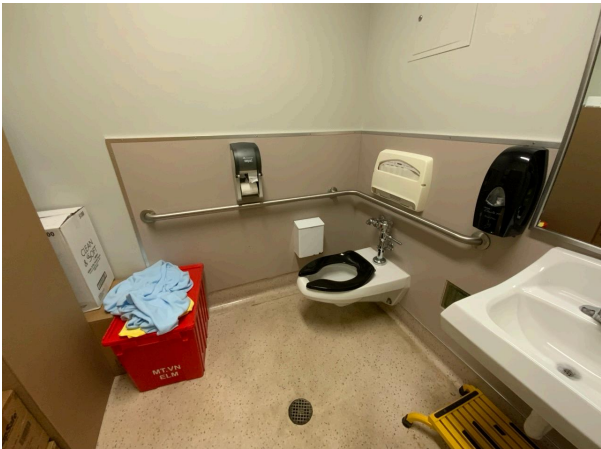
Photos for Barrier ID: AX553728

Site Conditions The space between the side grab bar and the toilet paper dispenser is 1".

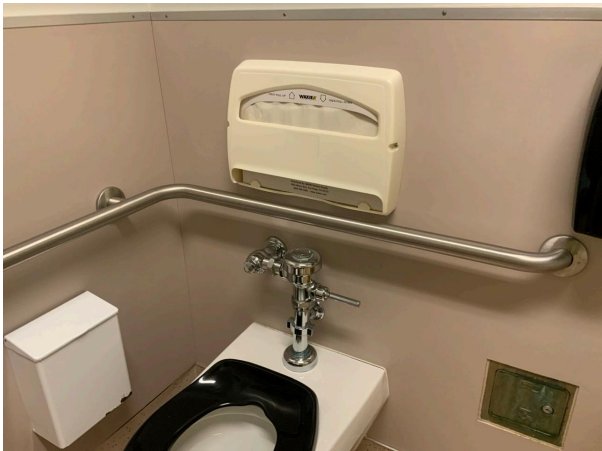
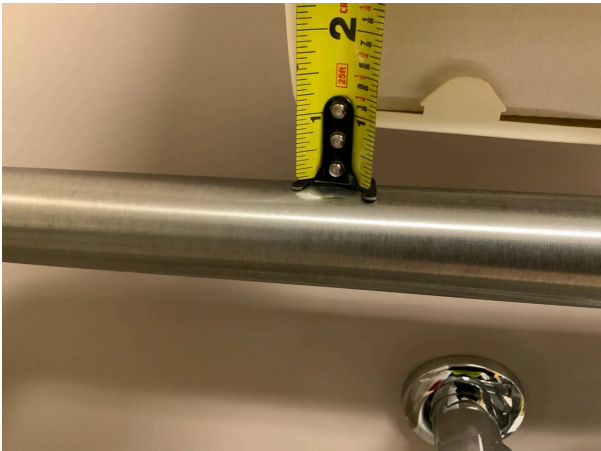
Photos for Barrier ID: AX553729

| Site Conditions | The space between the rear grab bar and the toilet paper dispenser is 1". |

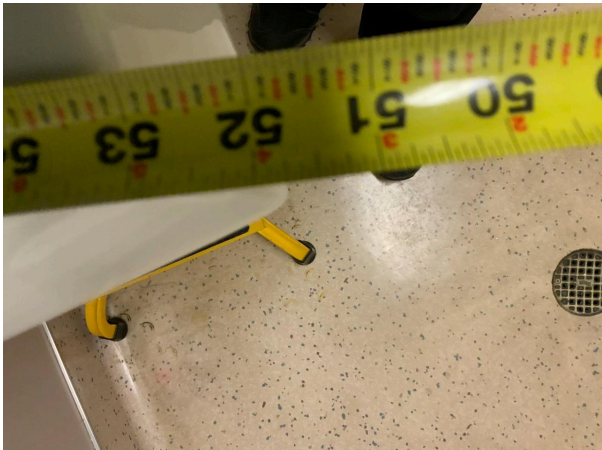
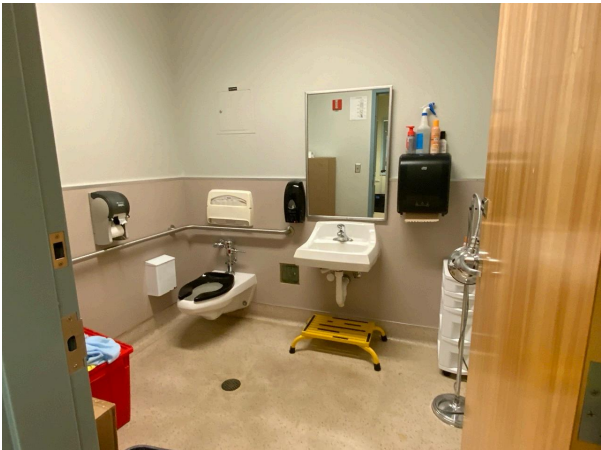
| <b>Site Conditions</b> | The turning space in the restroom is 52" wide due to stored items. |

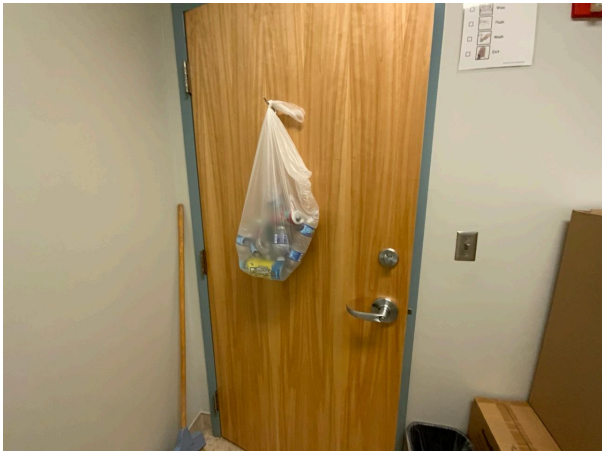
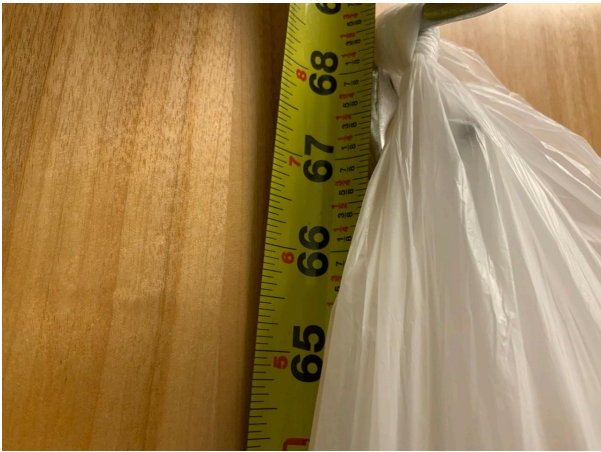
| <b>Site Conditions</b> | The coat hook is 67" above the floor. |

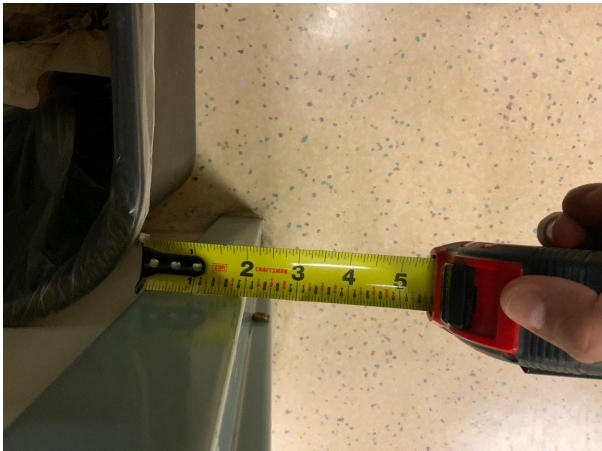
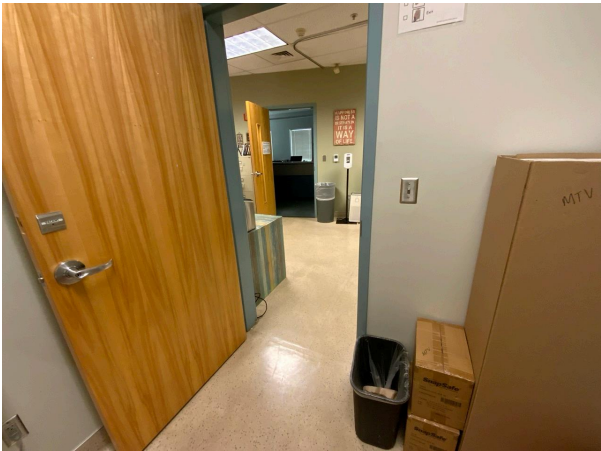
Photos for Barrier ID: AX553735

| Site Conditions | Items are in the required maneuvering clearance at the door. |

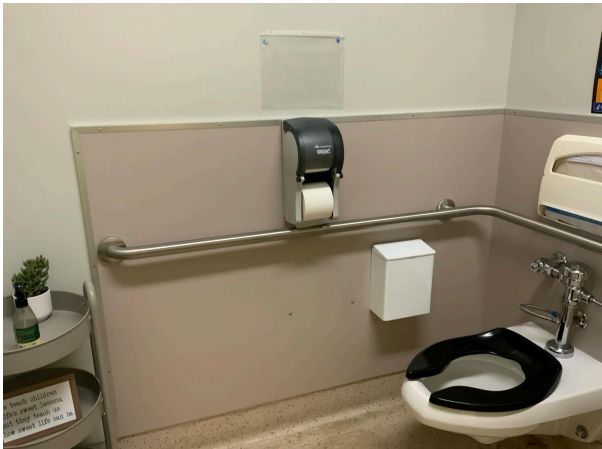
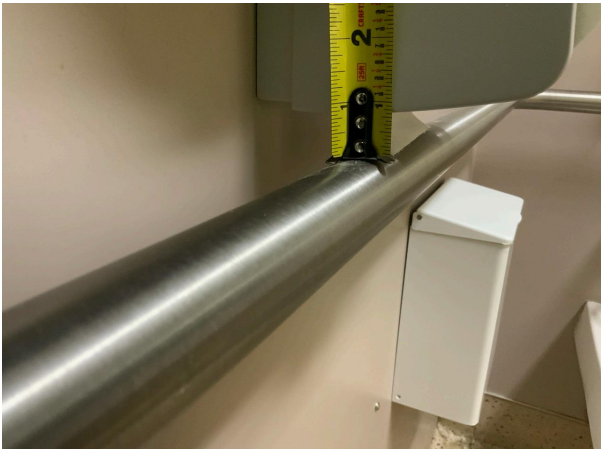
Photos for Barrier ID: AX553738

| Site Conditions | The space between the side grab bar and the toilet paper dispenser is 1". |

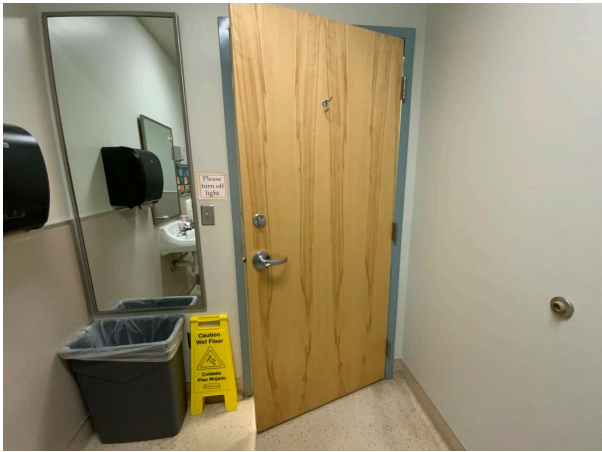
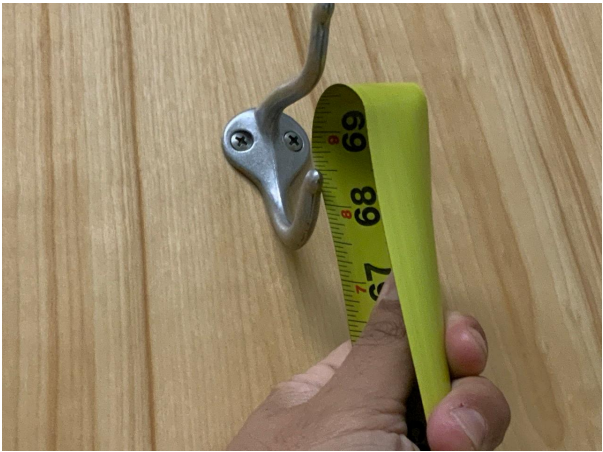
| <b>Site Conditions</b> | The coat hook is 68" above the floor. |

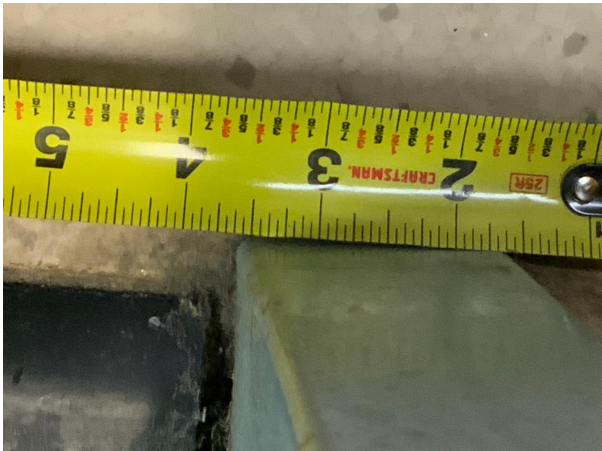
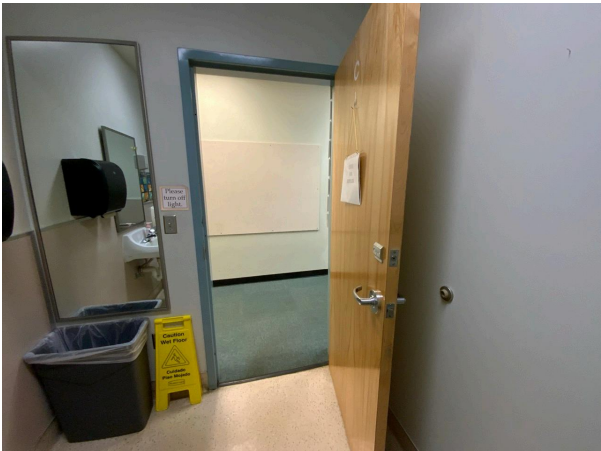
Photos for Barrier ID: AX553743

| Site Conditions | Items are in the required maneuvering clearance at the door. |

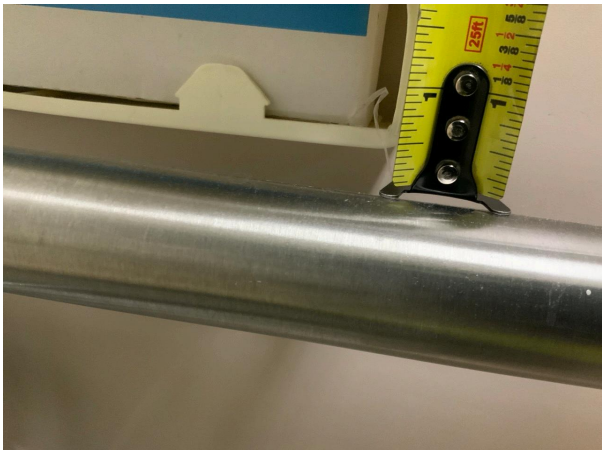
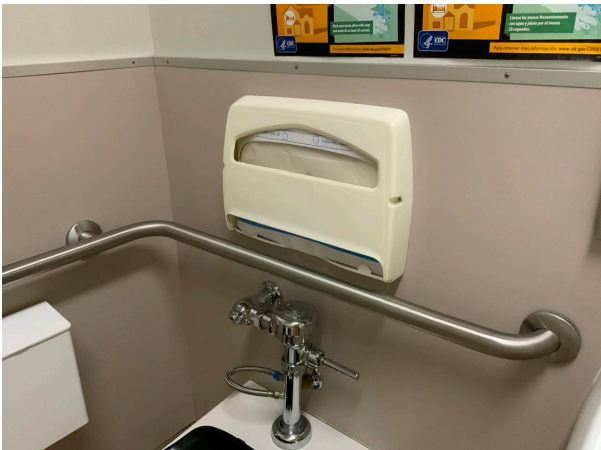
Photos for Barrier ID: AX553740

| Site Conditions | The space between the rear grab bar and the seat cover dispenser is 1/2". |

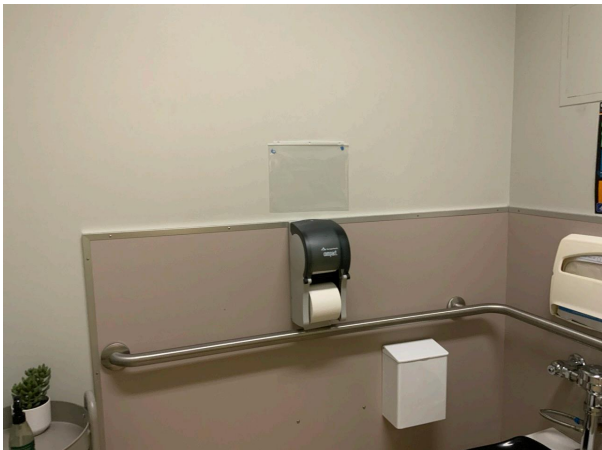
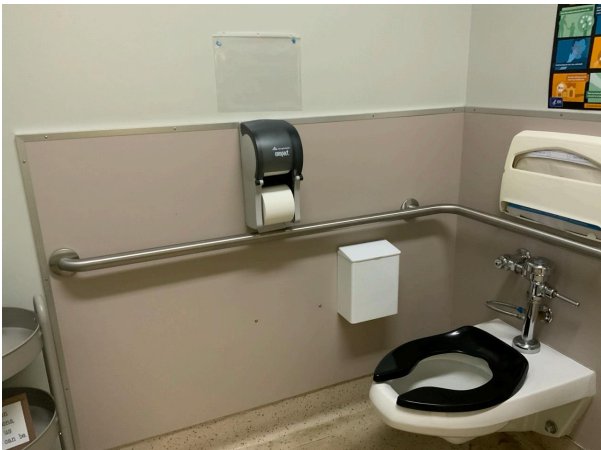
Photos for Barrier ID: AX553737

| Site Conditions | A vertical side grab bar is not present in the wheelchair stall. |
